## GHQ/SCAP Records(RG 331)
## Description of contents

(2) Folder title/number: (11)
Reports on Personal Inspection of Allied Property

The following corrections are to be made to the "Report on the Properties Owned By Nationals of the United Nations".

REPORT NO. 28

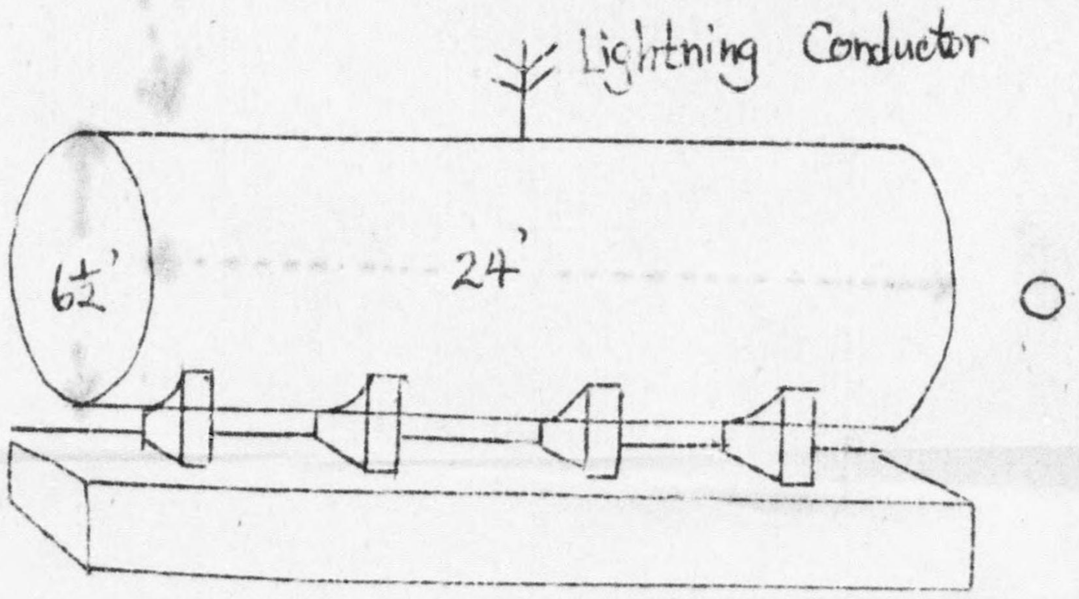
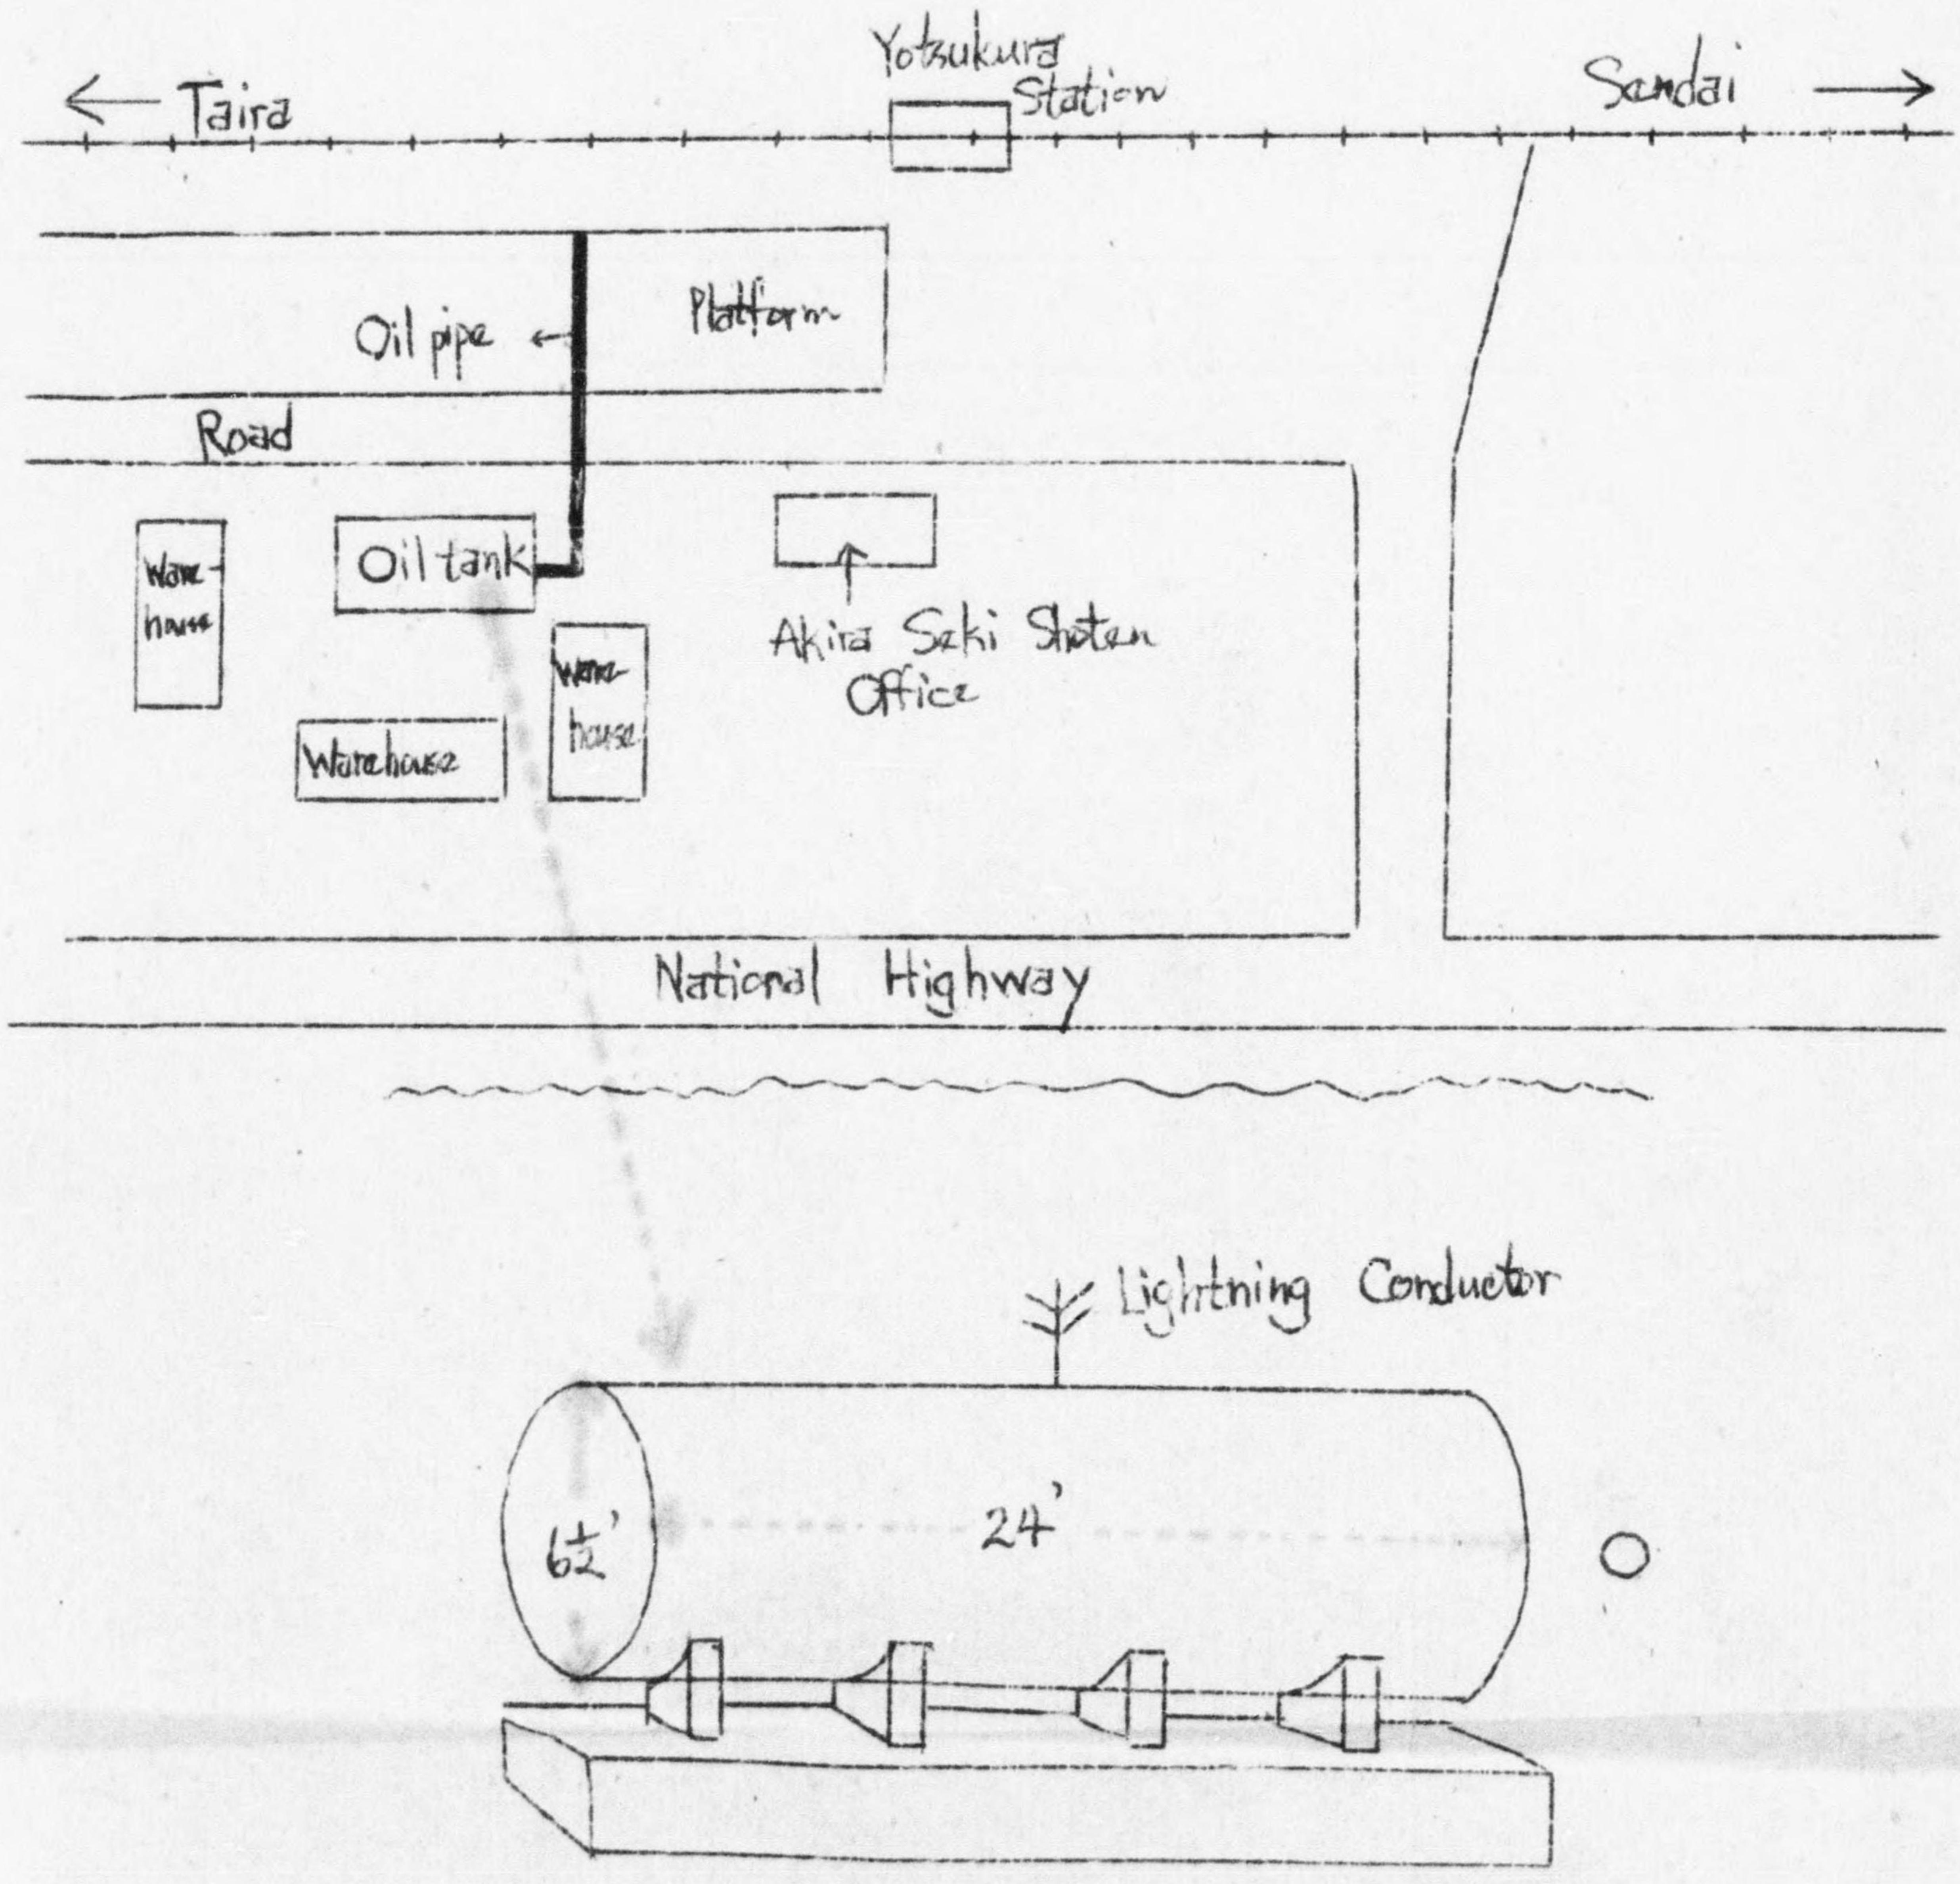
E. Sketch :

Oil Tank
(Capacity: Heavy oil 30 ton)

Oil Tank
( Capacity : Heavy oil 30 ton )

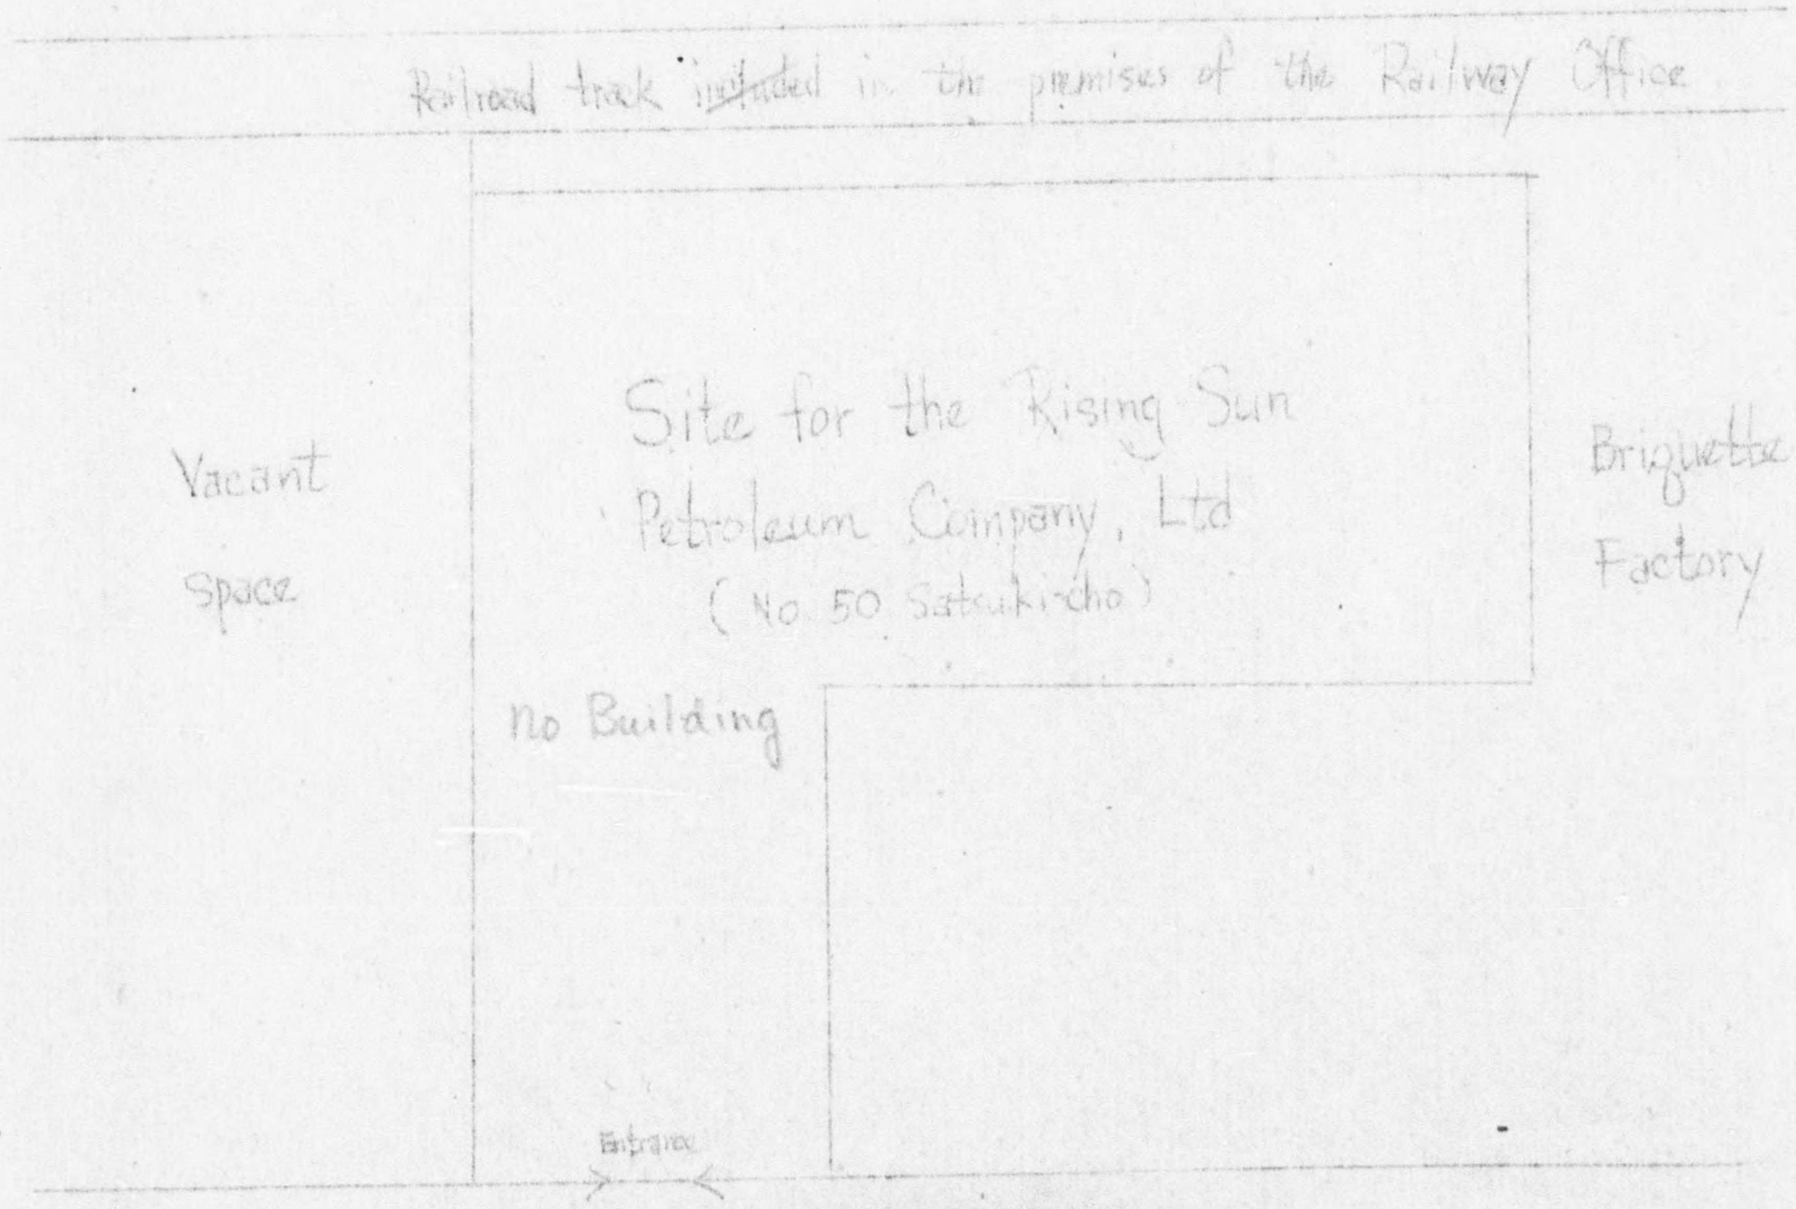
# Sketch

There is no damage to the lot & building, but the shutter, 'tatami', paper sliding-door and kitchen etc are badly damaged.
