STRIKE ATTACK REPORT NO. 103

Target No.: 90.20-198
Aichi A/C, Atsuta Plant
90.20-2010
Aichi A/C Engine Works
Nagoya Plant

U.S. STRATEGIC BOMBING SURVEY
AICHI-ATSUTA ENGINE PLANT
NAGOYA, JAPAN

BUILDING # 17
AICHI AIRCRAFT PLANT
ATSUTA BRANCH
TARGET NO.
SCALE AS NOTED
C. QUALLER

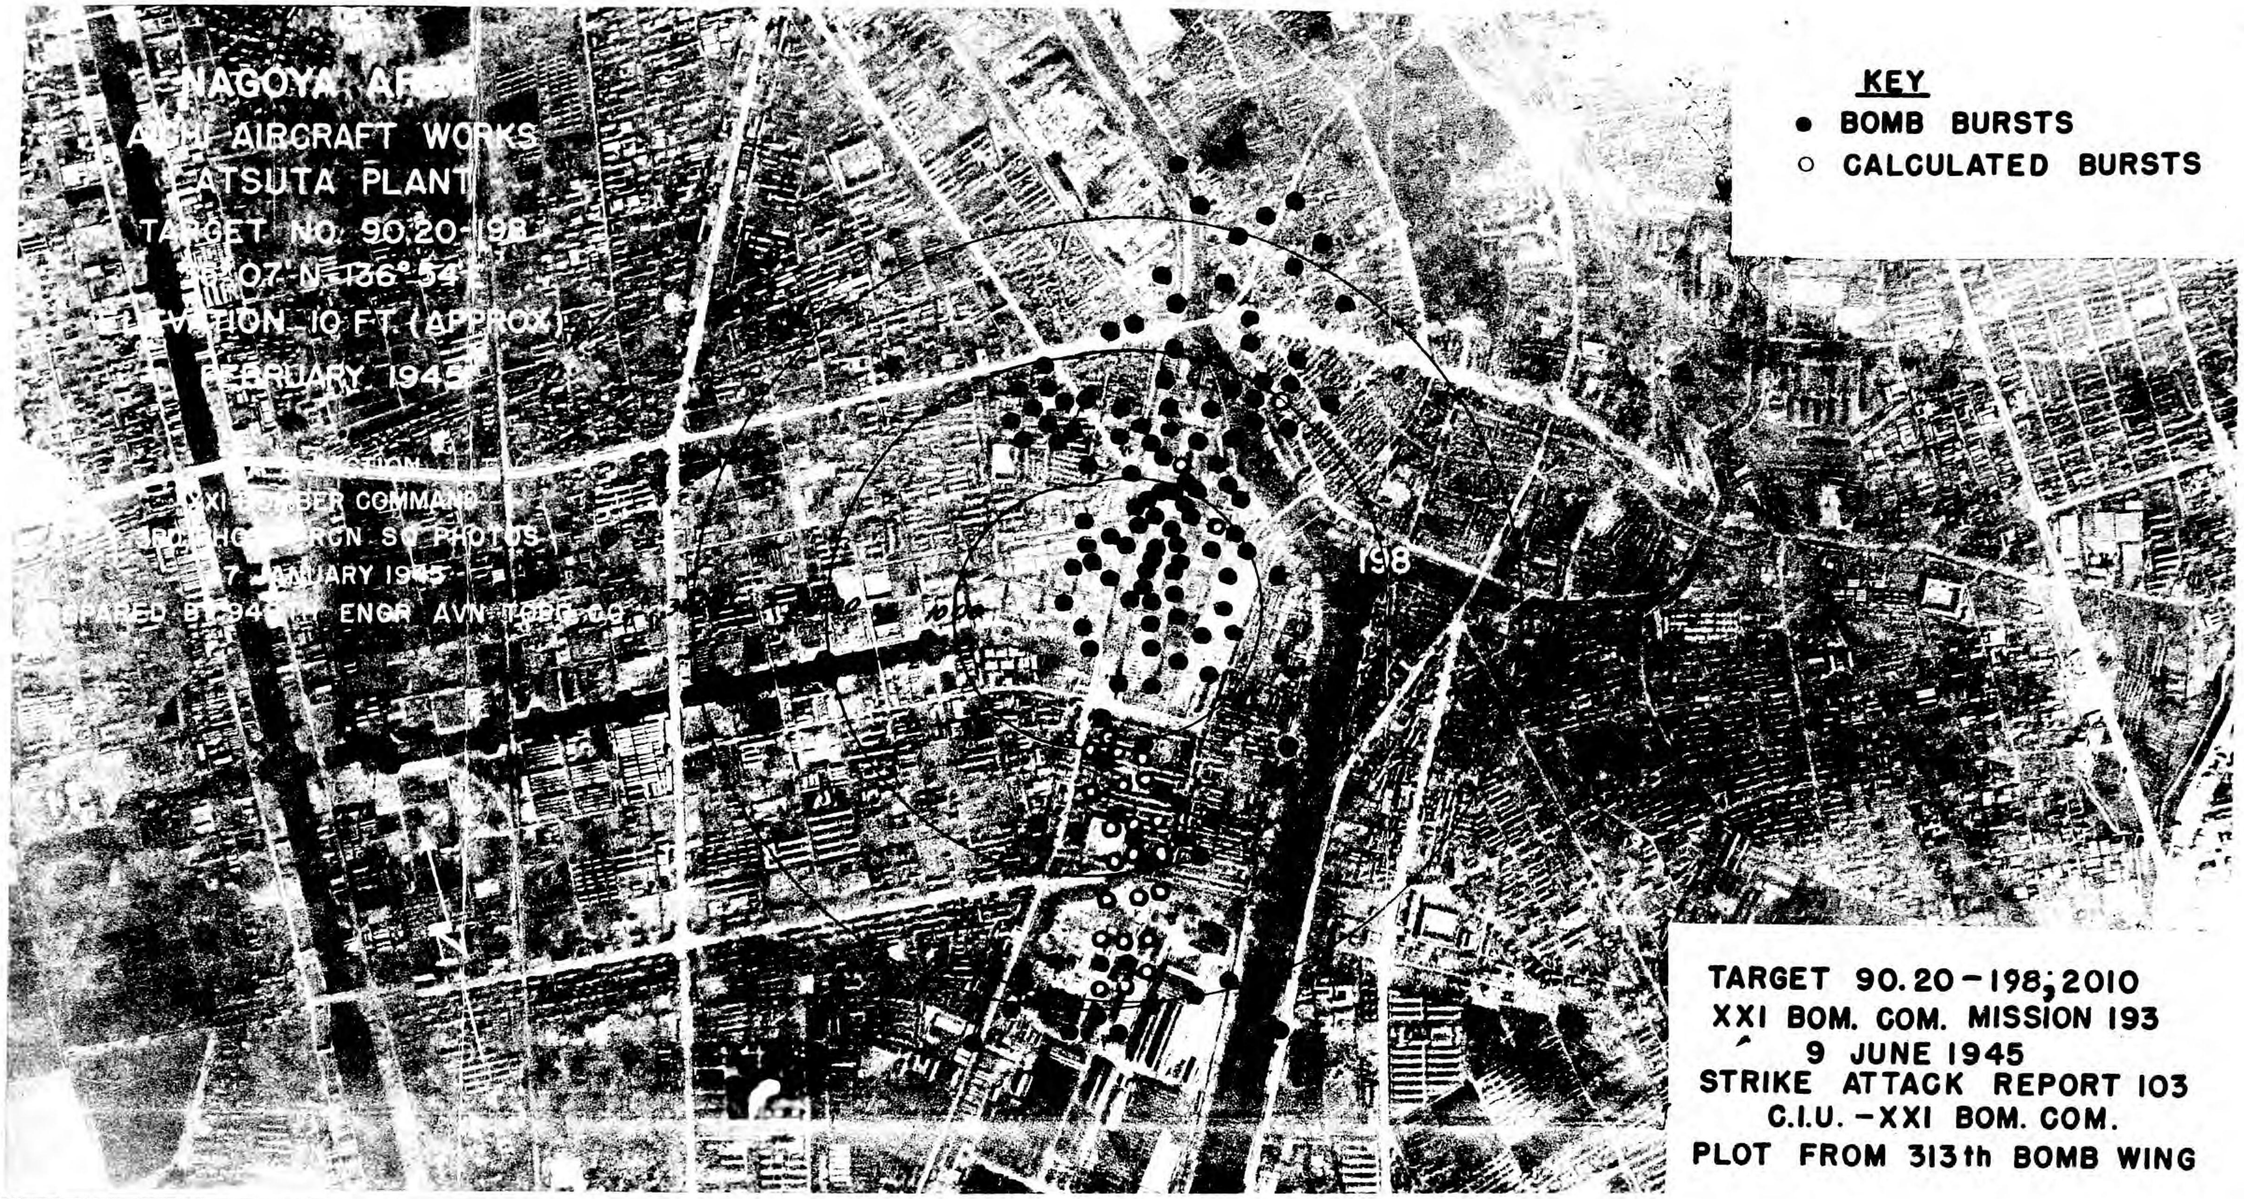
9th GP.: Of the 3 air squadrons attacking the target, 2 obtained excellent results; the third obtained good results. Bomb hits were concentrated in Target 198, the N half being very heavily hit. Target 2010 was not as heavily hit, but several direct hits are believed to have been scored on buildings in that area. Both manufacturing and assembly buildings appear to have sustained damage. Numerous smaller buildings were damaged.

NAGOYA, AR
AICHI AIRCRAFT WORKS
ATSUTA PLANT
TARGET NO. 90.20-198
07 N 136° 54
ELEVATION 10 FT. (APPROX)
FEBRUARY 1945
XXI BOMBER COMMAND
RCN SQ PHOTOS
7 JANUARY 1945
ENGR AVN
198
KEY
● BOMB BURSTS
○ CALCULATED BURSTS
TARGET 90.20-198; 2010
XXI BOM. COM. MISSION 193
9 JUNE 1945
STRIKE ATTACK REPORT 103
C.I.U. -XXI BOM. COM.
PLOT FROM 313th BOMB WING

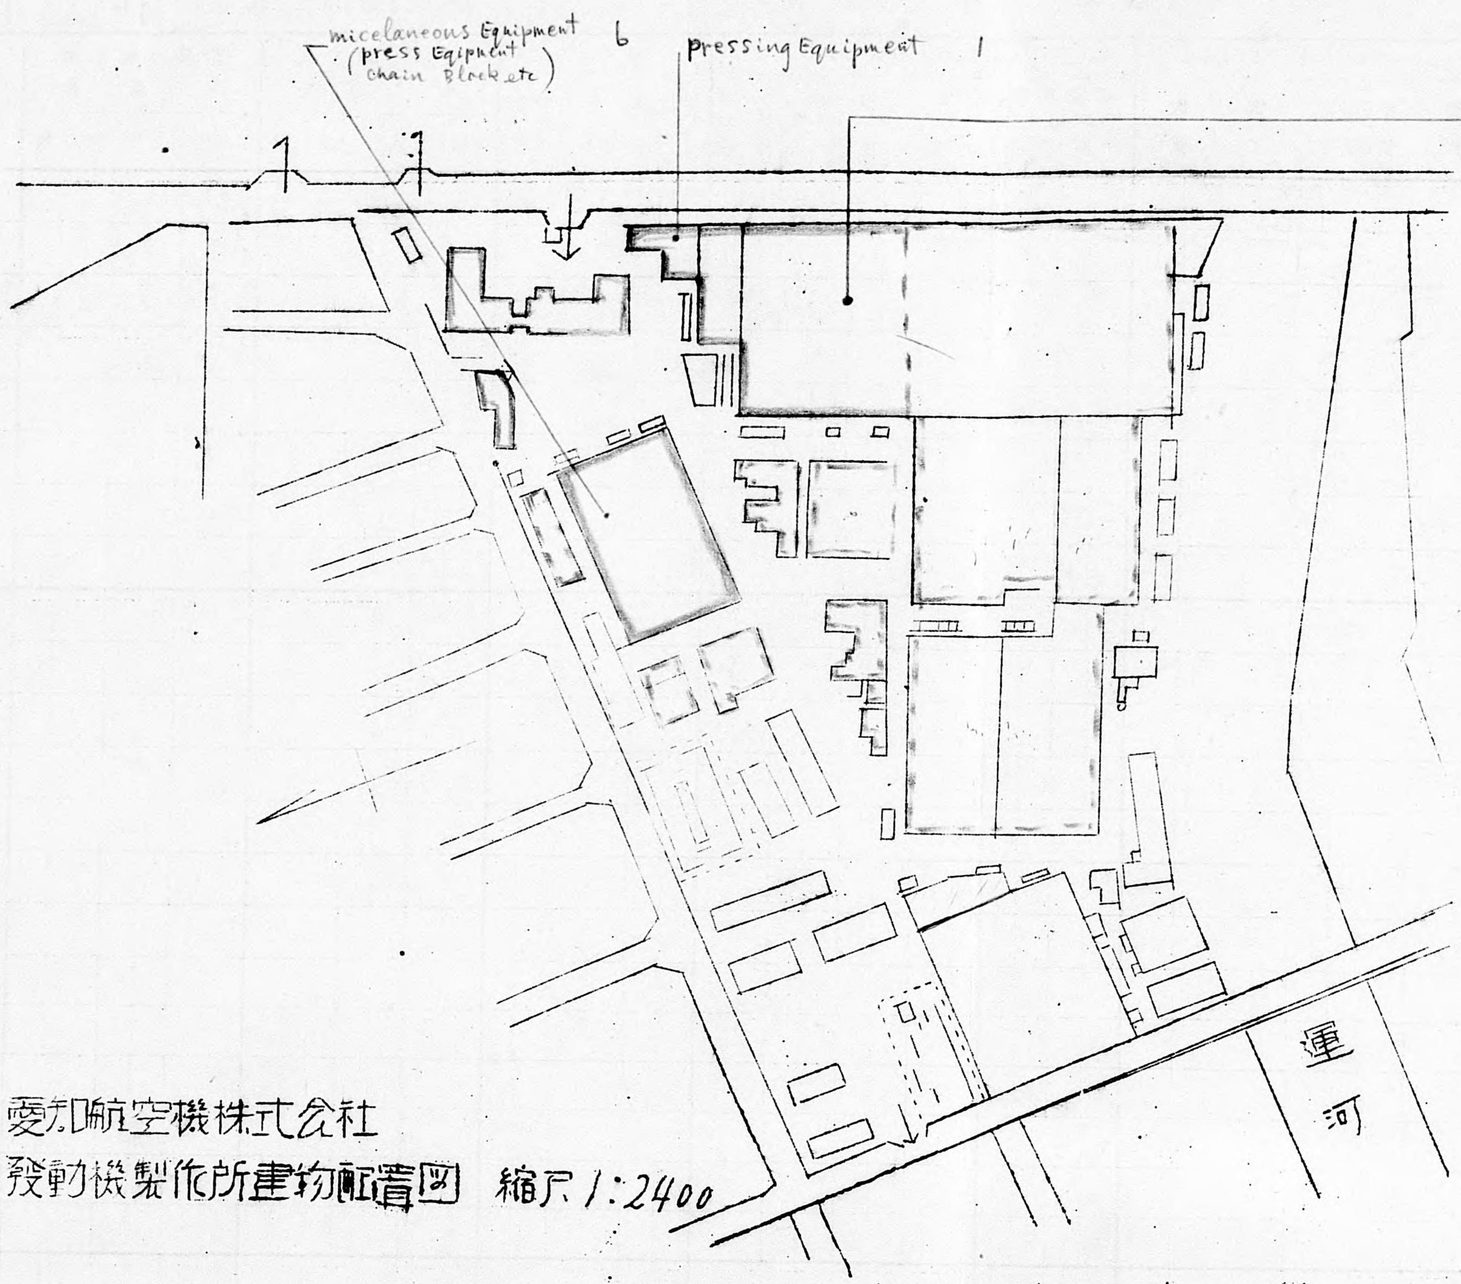
Physical Damage Sustained to Machinery by the Air attach at the Atsuta Plant on June 9th. 1954

Lathe	8	(1)
Drilling Machine	10	(1)
Boring Machine	2	
Milling Machine	4	
Shaper	1	
Grinder	1	(1)
Planer	1	
Horning Machine	2	
Hacksow	0	
The others	3	
Total	32	(3)
	[35]	
motor	71	
measuring Machine	42	(Damaged by the air attack on March 19th. 1941)

( ) shows repairable machines.

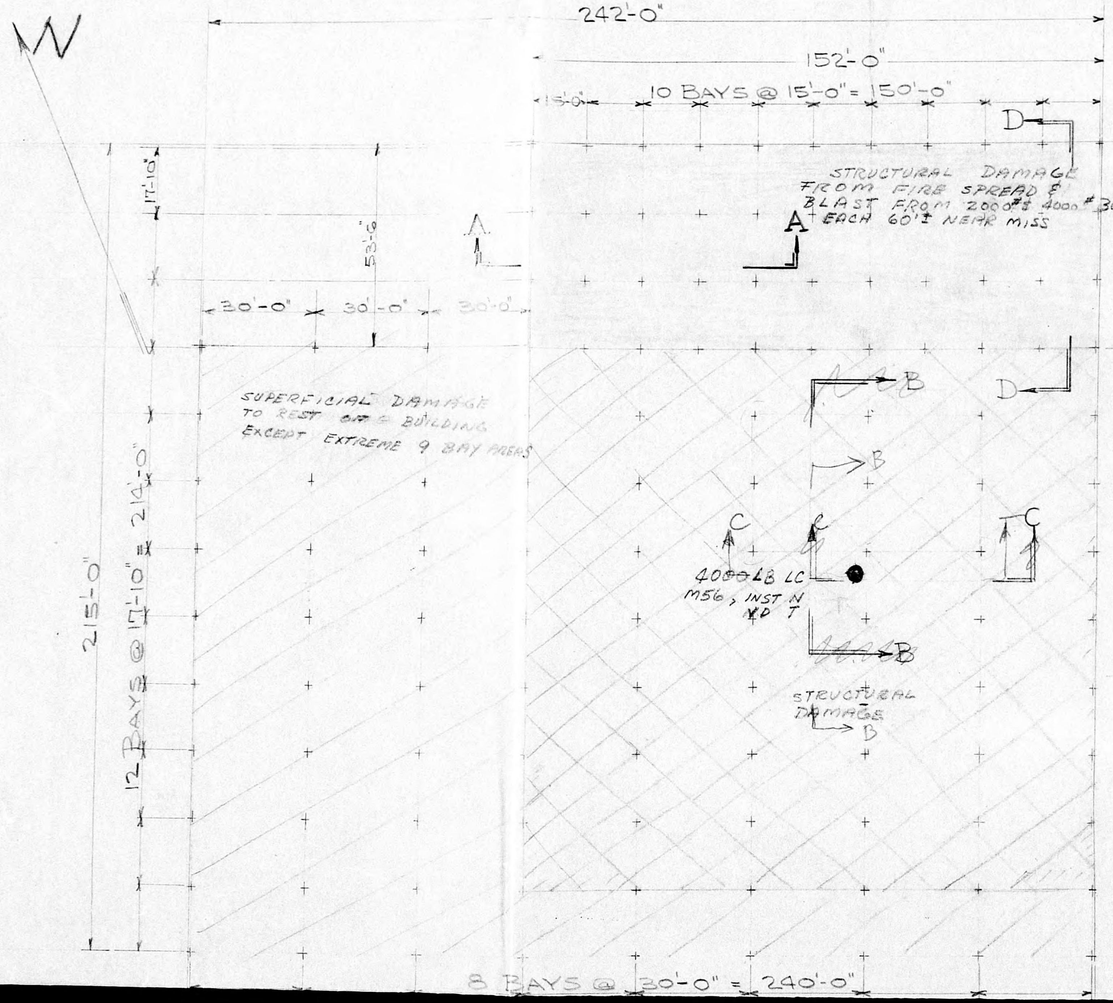
W
242'-0"
152'-0"
10 BAYS @ 15'-0" = 150'-0"
15'-0"
D
STRUCTURAL DAMAGE FROM FIRE SPREAD & BLAST FROM 2000# & 4000# BOMBS, EACH 60'± NEAR MISS
A
A
17'-10"
53'-10"
30'-0"
30'-0"
30'-0"
SUPERFICIAL DAMAGE TO REST OF BUILDING EXCEPT EXTREME 9 BAY PANELS
B
D
B
C
C
C
4000 LB LC
M56, INST N XD T
B
STRUCTURAL DAMAGE
D
215'-0"
12 BAYS @ 17'-10" = 214'-0"
8 BAYS @ 30'-0" = 240'-0"
