SHOWA FERTILIZER CO., LTD.

KAWASAKI

U. S. S. B. S.
DAMAGE ASSESMENT WORK SHEET

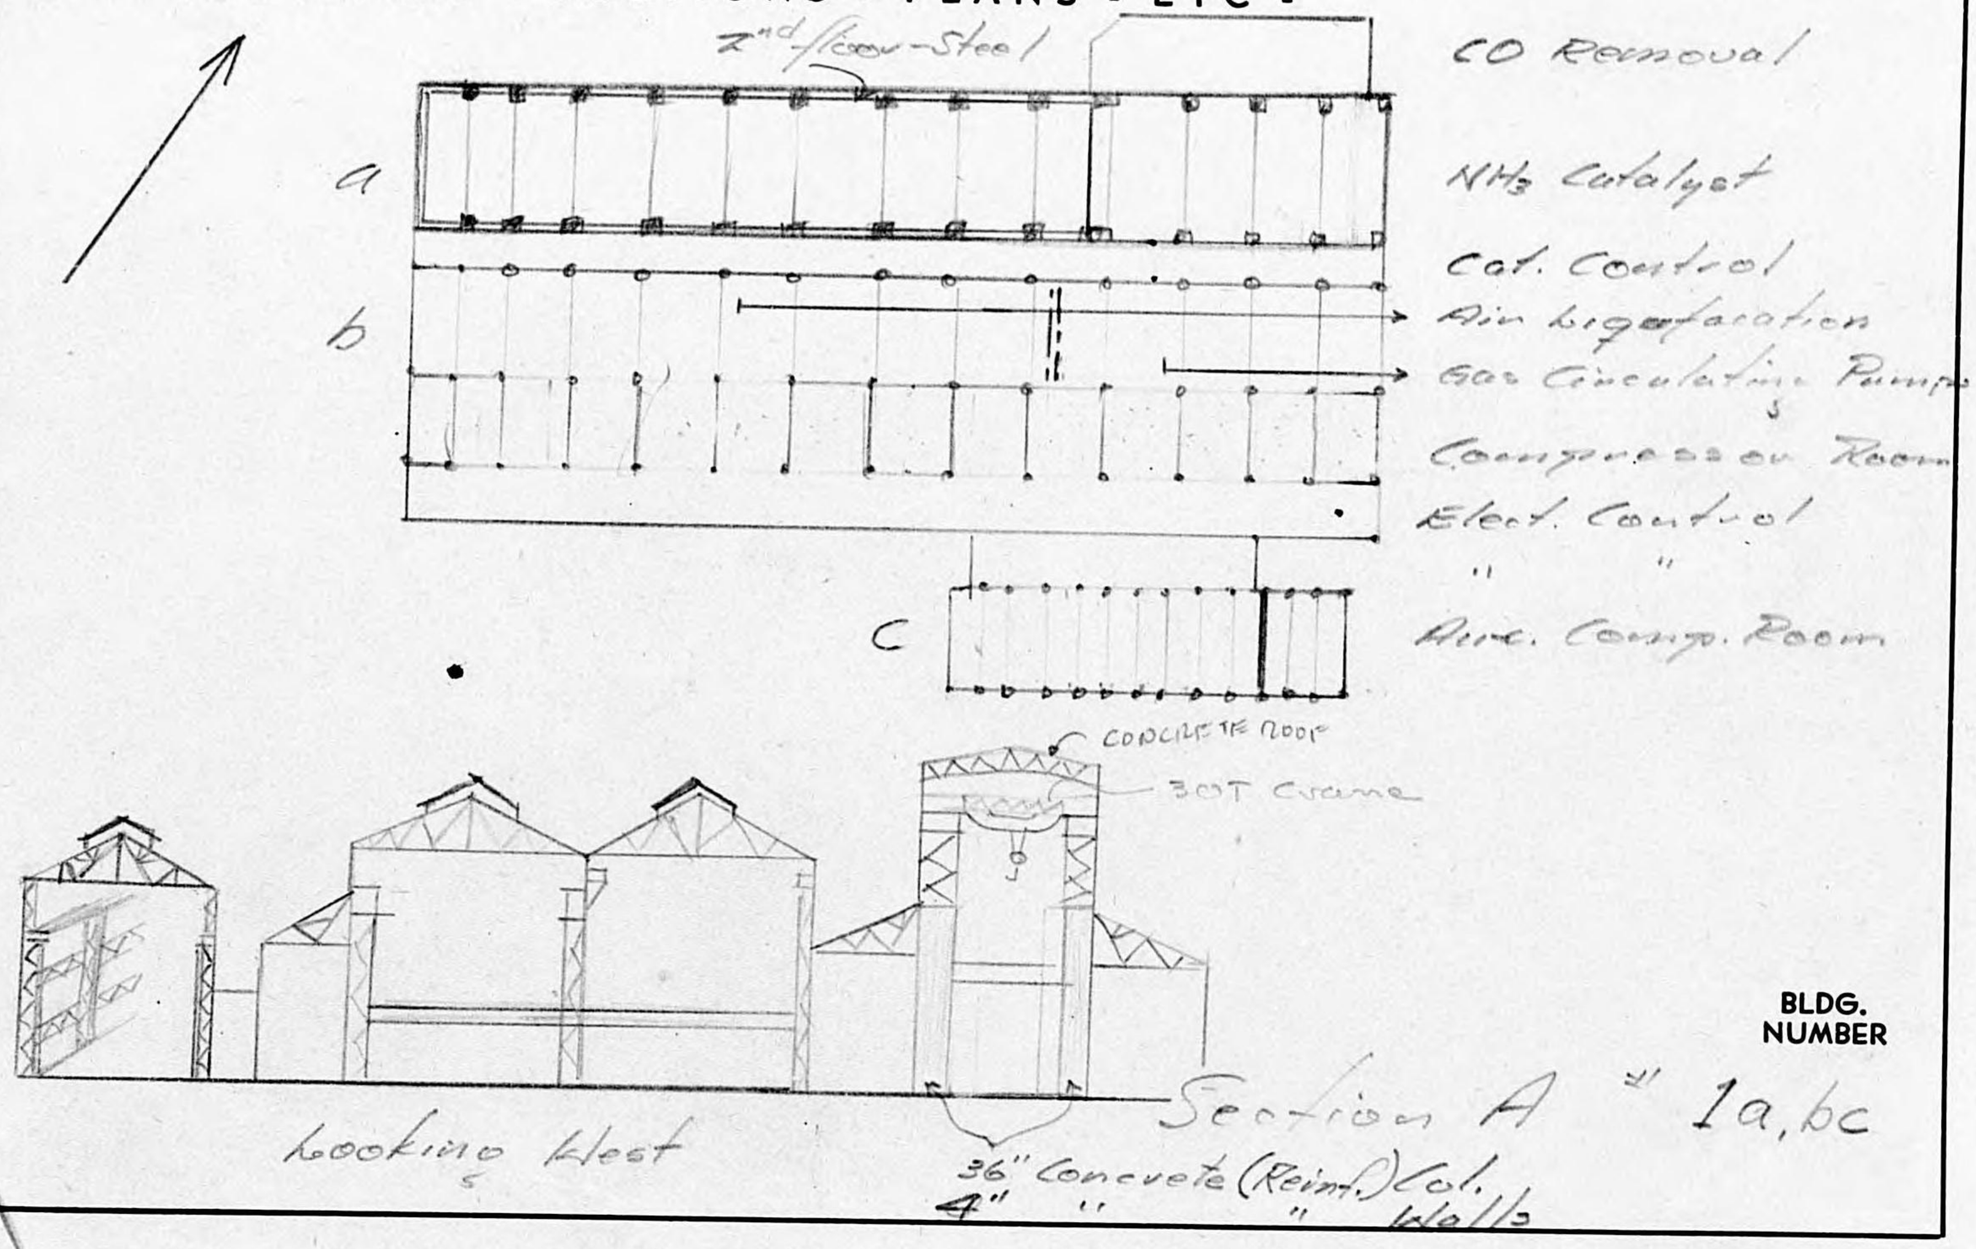
BLDG. NUMBER 1a, bc

YEAR BUILT	ORIGINAL USE		REMARKS: STEEL FRAME
FLOOR	TYPE	THICKNESS	
1) CONCRETE (COOLARS.			
FLOOR	TYPE	THICKNESS	
CONCRETE & STEEL.			
WALLS	TYPE	THICKNESS	CONCRETE PANELS.
SHEET METAL - AF 30' HIGH			
ROOF MATERIAL	TYPE	THICKNESS	
TRUSS	TYPE	SPAN	
CRANES NO.	TYPE	LOAD CAPACITY	6 - 2 7.5 T.
MACHINERY REMOVED TO		REASON	
REPAIRS AND CLEARANCES			
NEW CONSTRUCTION

GENERAL NOTES - SECTIONS - PLANS - ETC - CU. LIQ CIRCULATING PLANS FOR CO REMOVAL PLANS

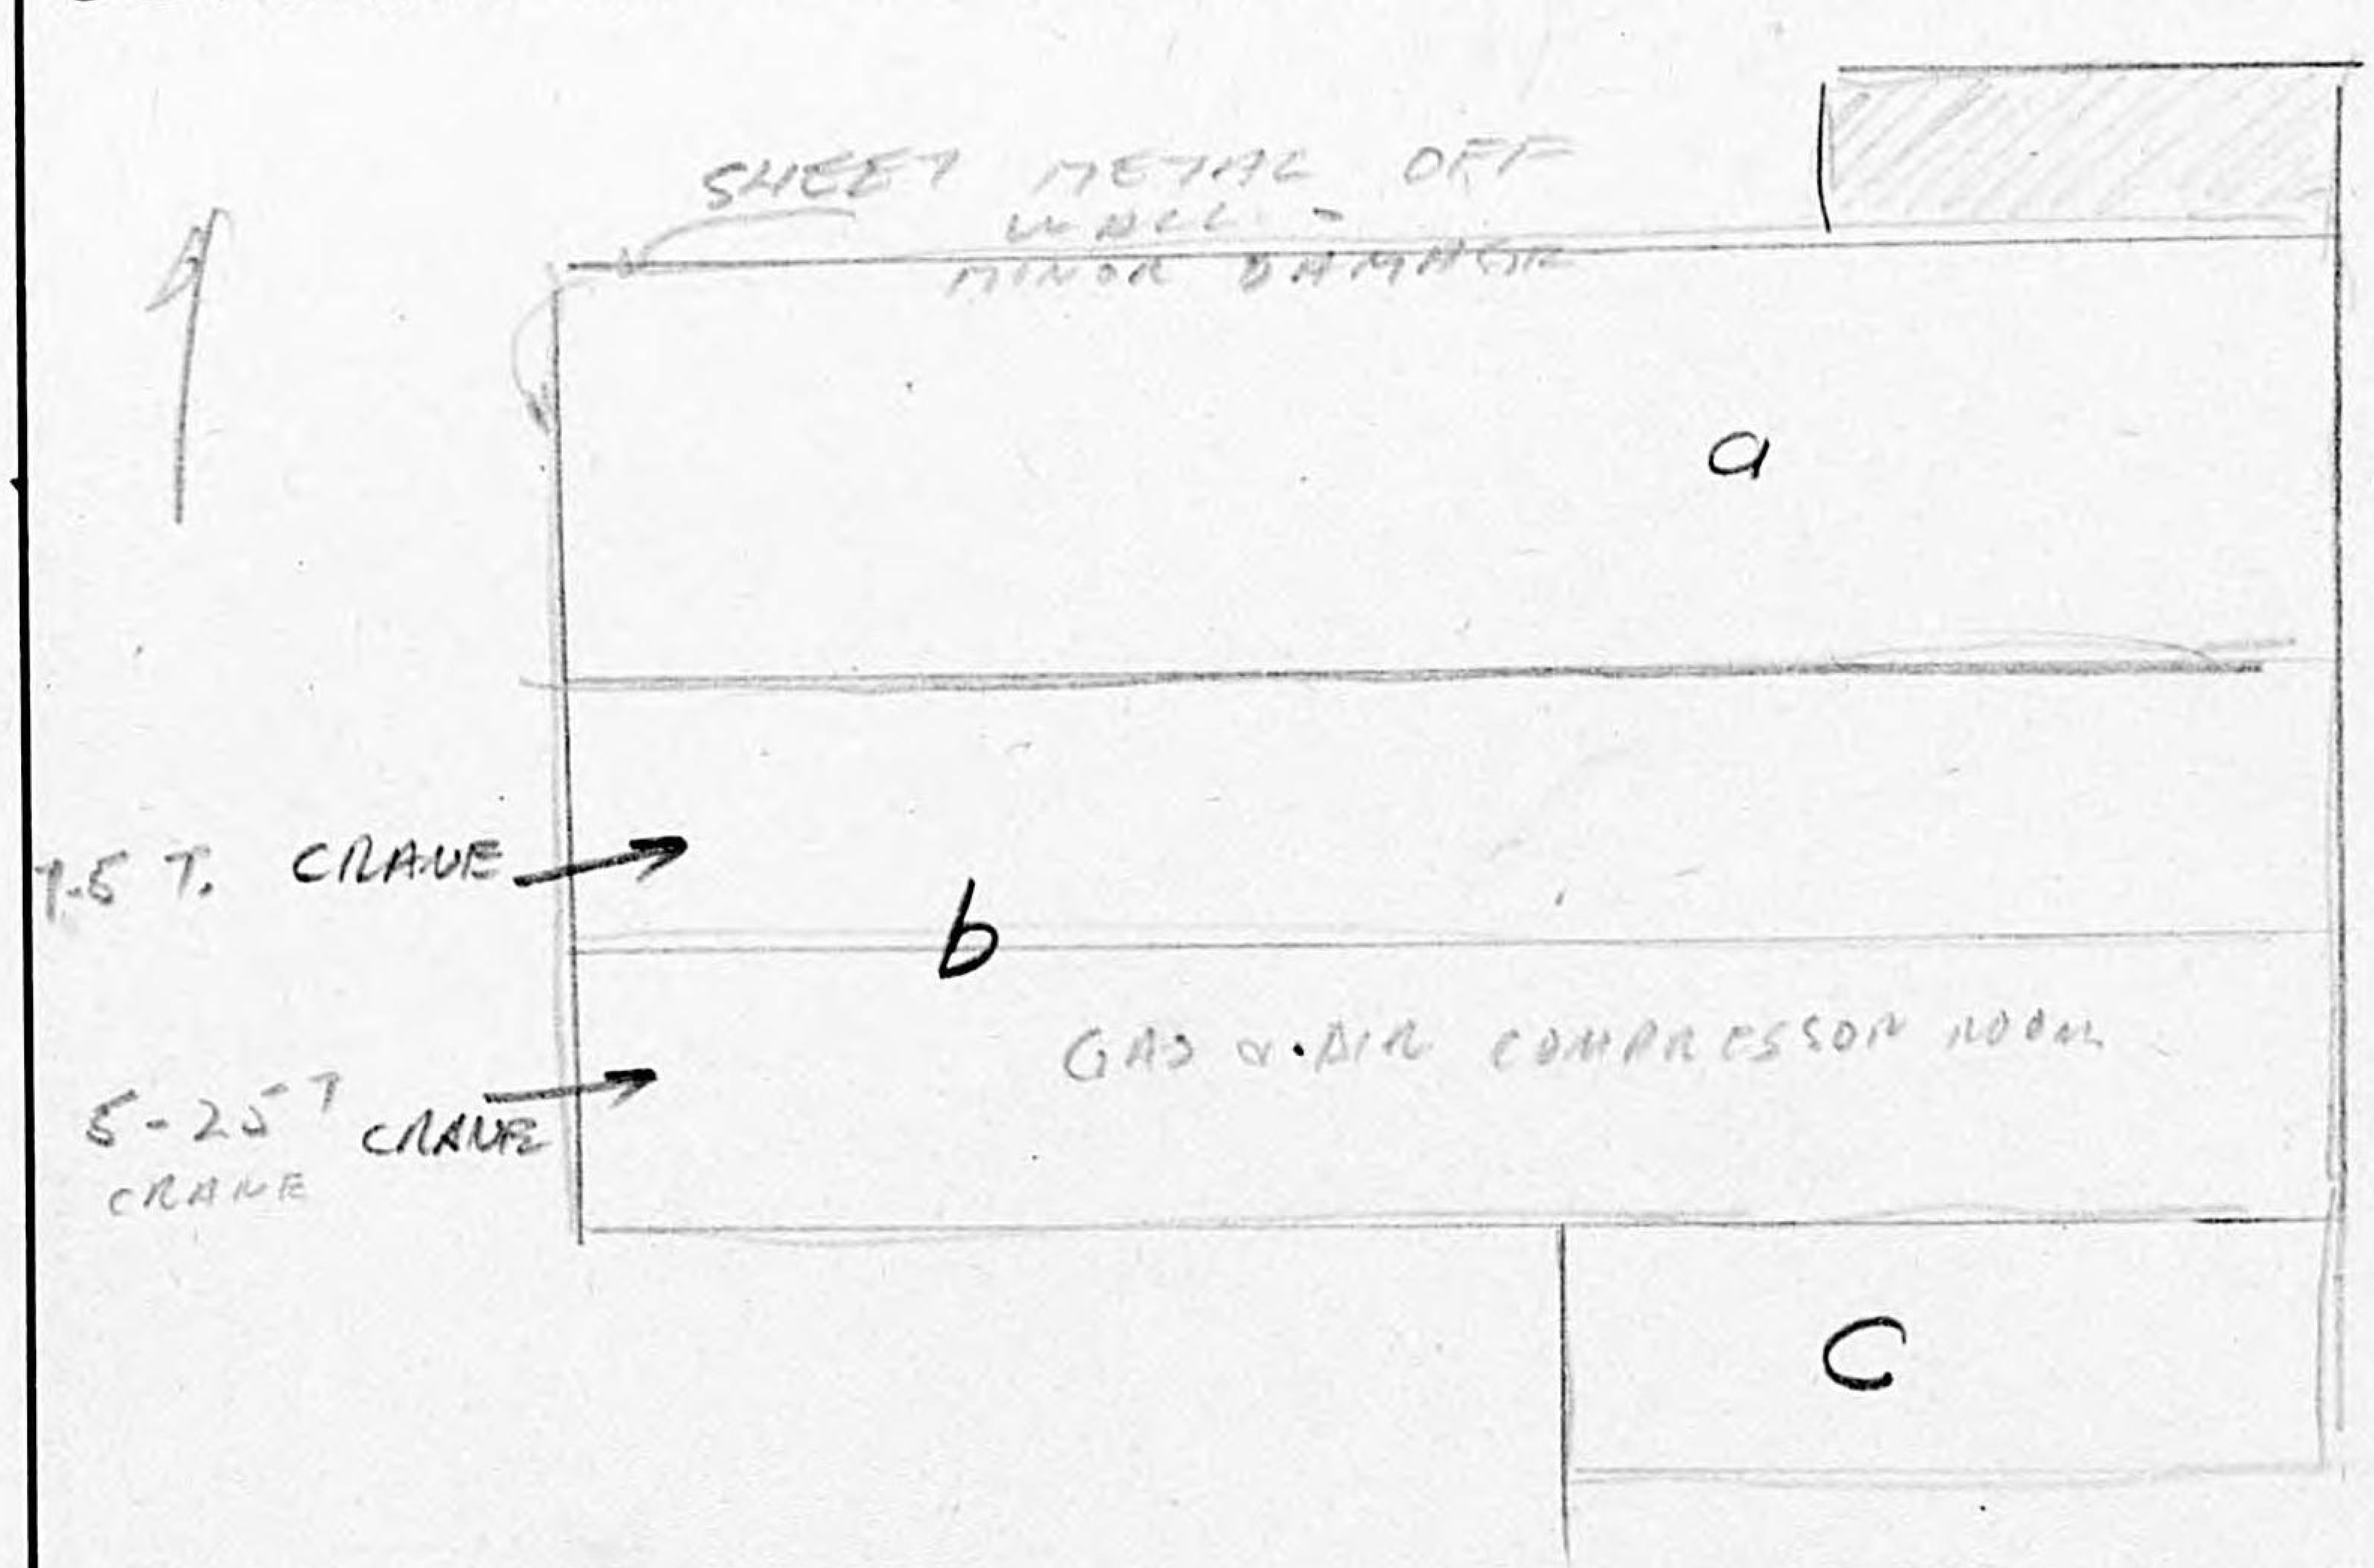
BLDG. NUMBER 1

ABOUT 30% OF ROOF REMOVED. OTHERWISE NO DAMAGE
SINCE REPLACED

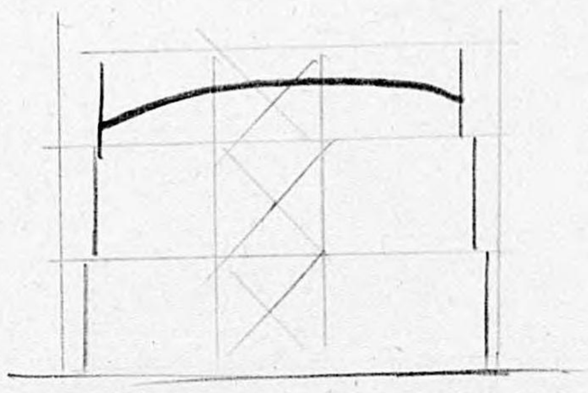
SHELL SEVERELY DAMAGED BY FRAGMENTS OF BOMBS.

STILL NOT OPERATIVE.

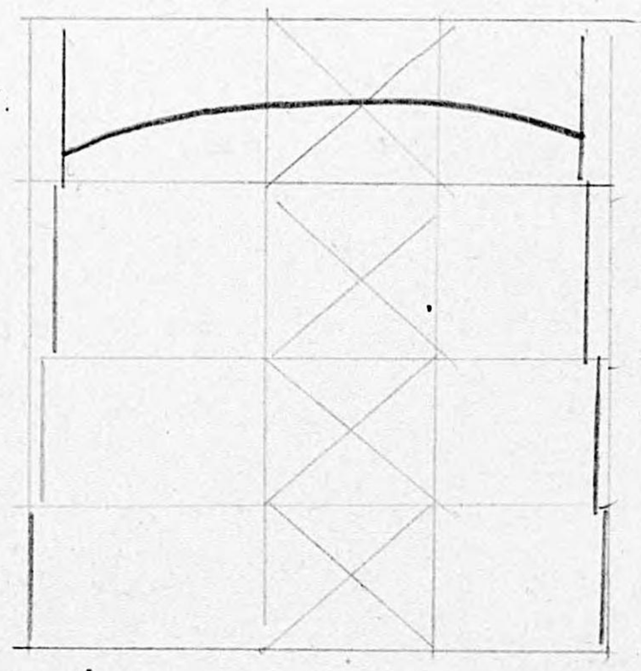
BLDG. NUMBER
3

SHELL WAS PUNCTURED BY BOMB FRAGMENTS.
NO FIRE.
IS NOW BEING REPAIRED.

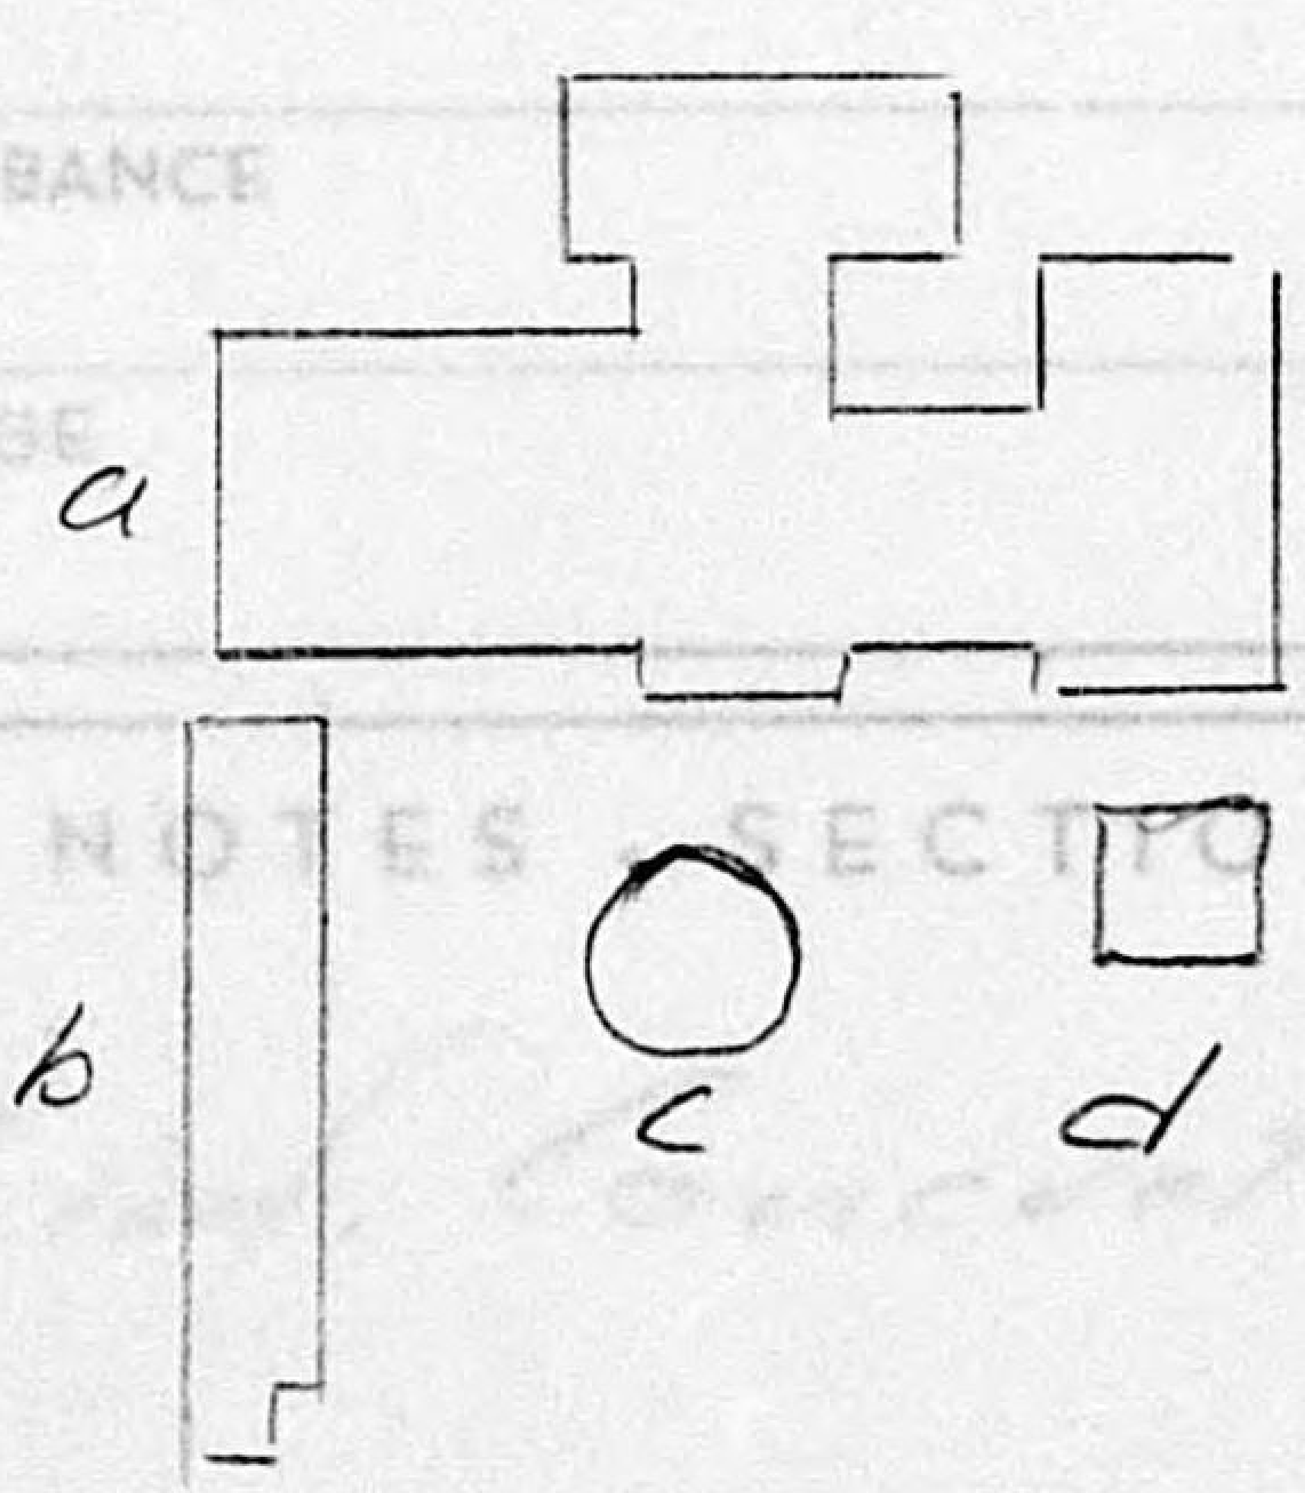
Reinf. Concrete Bldg. – 8°

b, c, & d – Destroyed

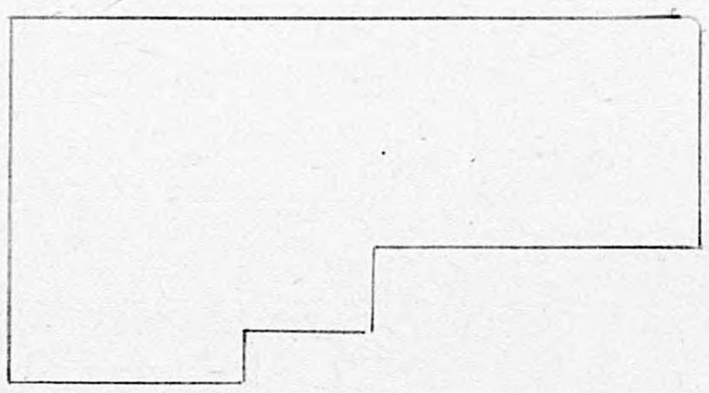
BLDG. NUMBER 7

Destroyed

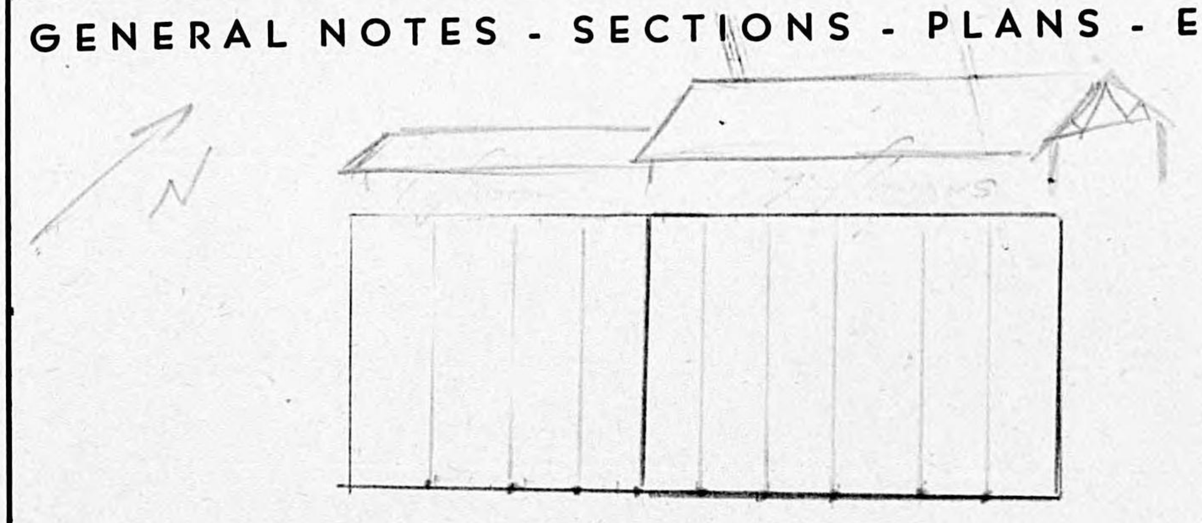
BLDG. NUMBER
8

ALL ROOF REMOVED BY BLAST.
ASPHALT OVER WOOD.

DIRECT HIT ON BLDG.

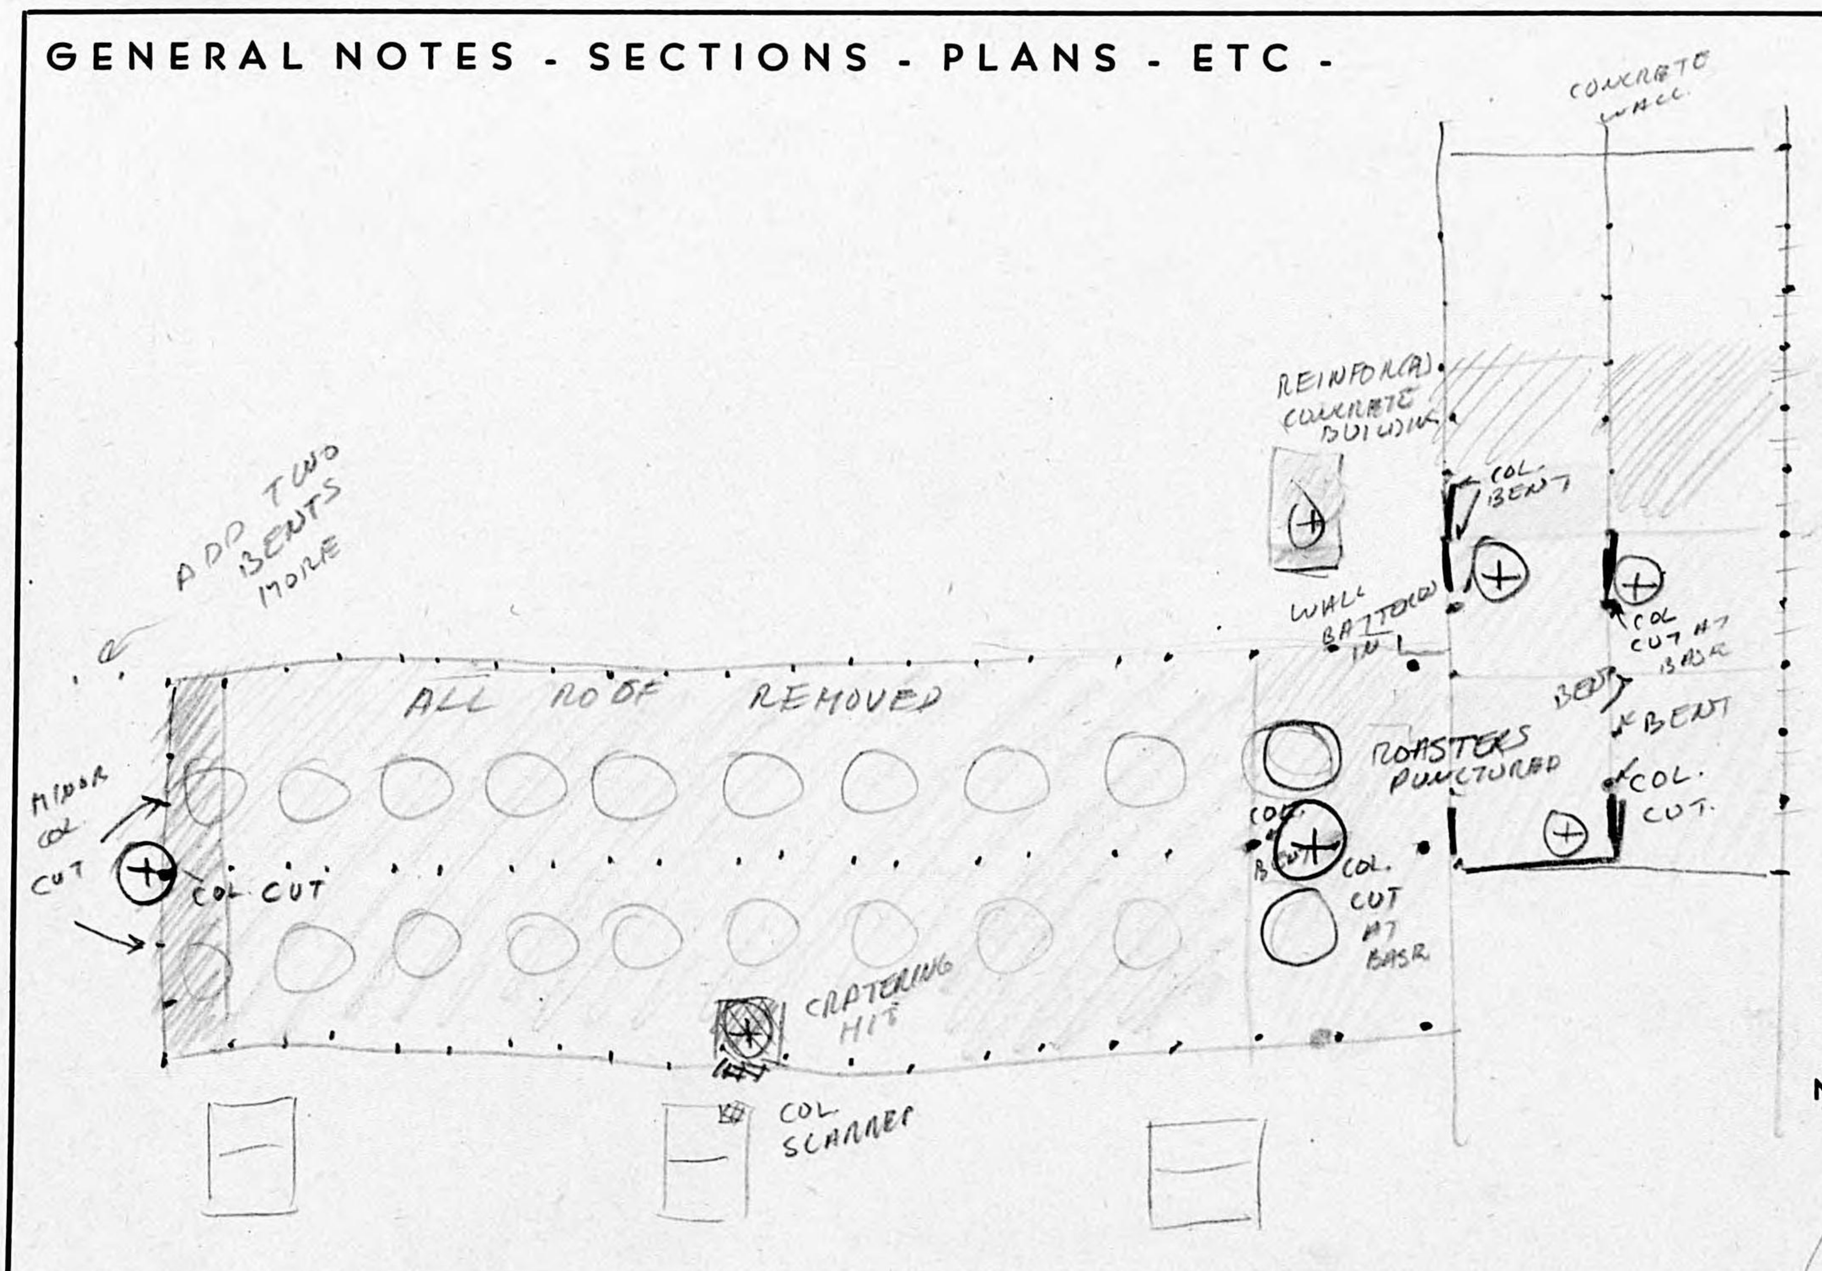
10

ROOF OFF

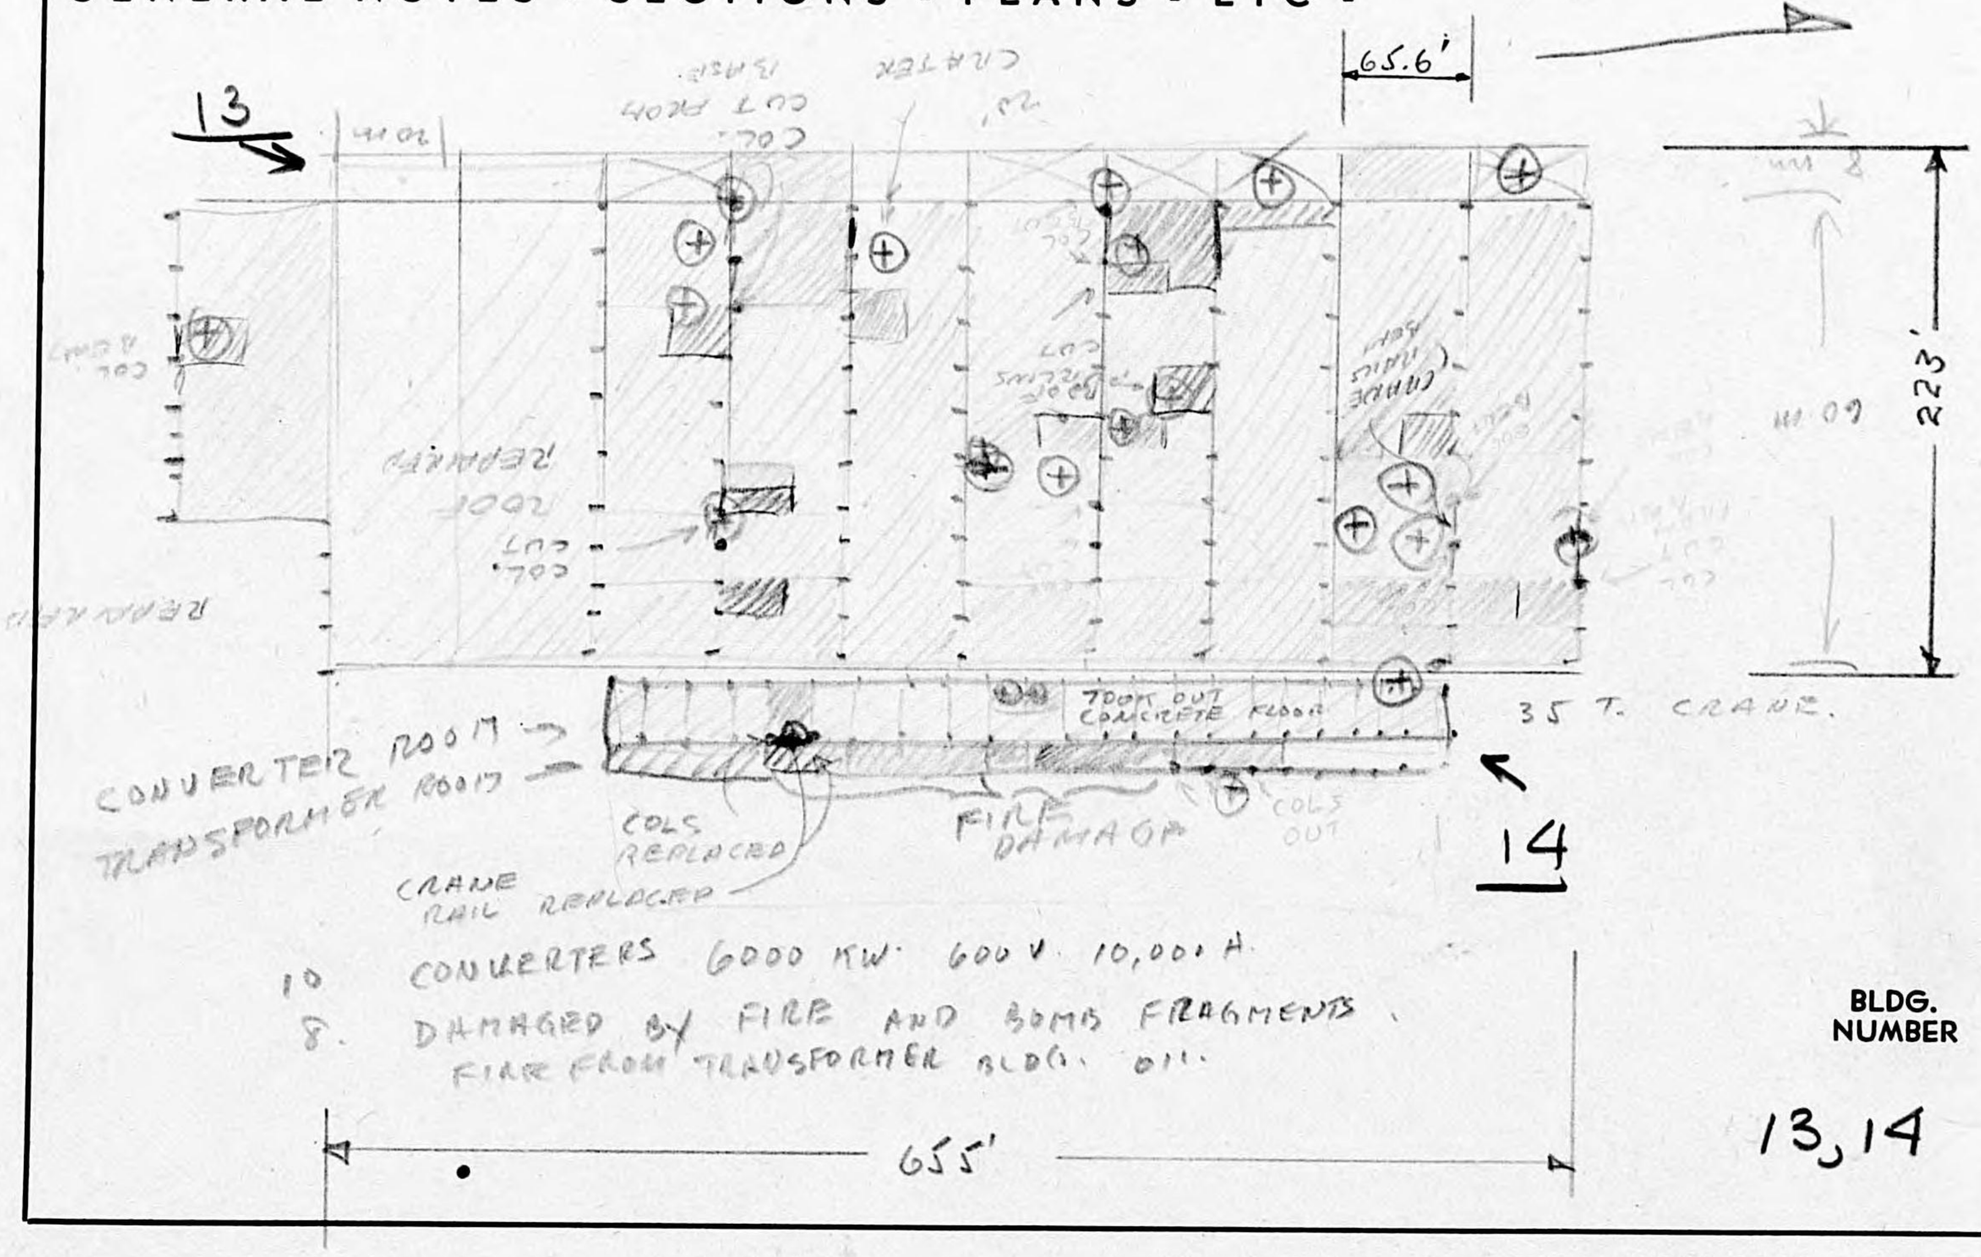
BLDG. NUMBER
13,14

DESTROYED	☒
STRUCTURAL DAMAGE	▨
SUPERFICIAL DAMAGE	▨
ROOF DISTURBANCE	
~~MINOR~~ DAMAGE	▨ (ROOF + WALLS REMOVED.

10 CONVERTERS 6000 KW. 600 V. 10,000 A.
8. DAMAGED BY FIRE AND BOMB FRAGMENTS.
FIRE FROM TRANSFORMER BLDG. OIL.

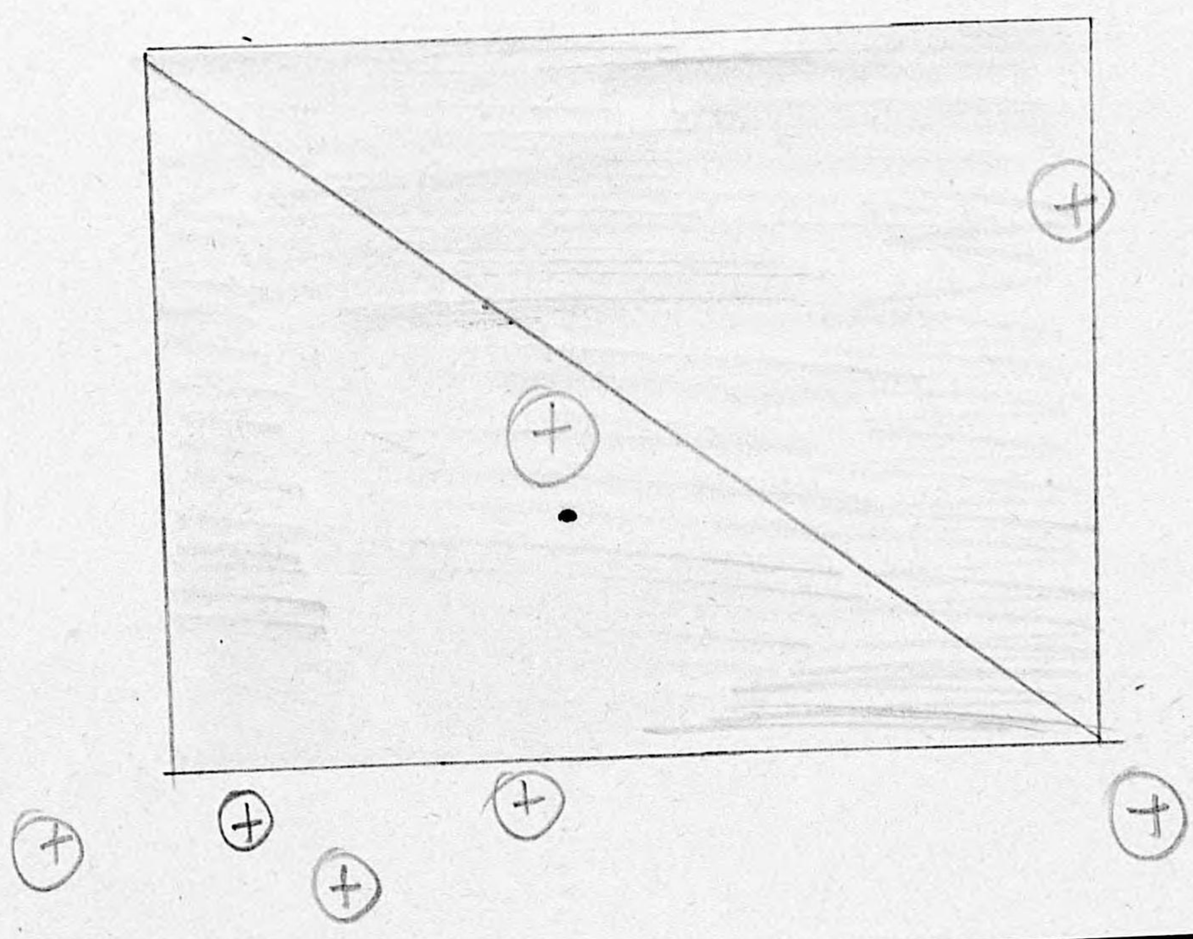
BLDG. NUMBER 24

BUILDING SUFFERED 100% STRUCTURAL DAMAGE.

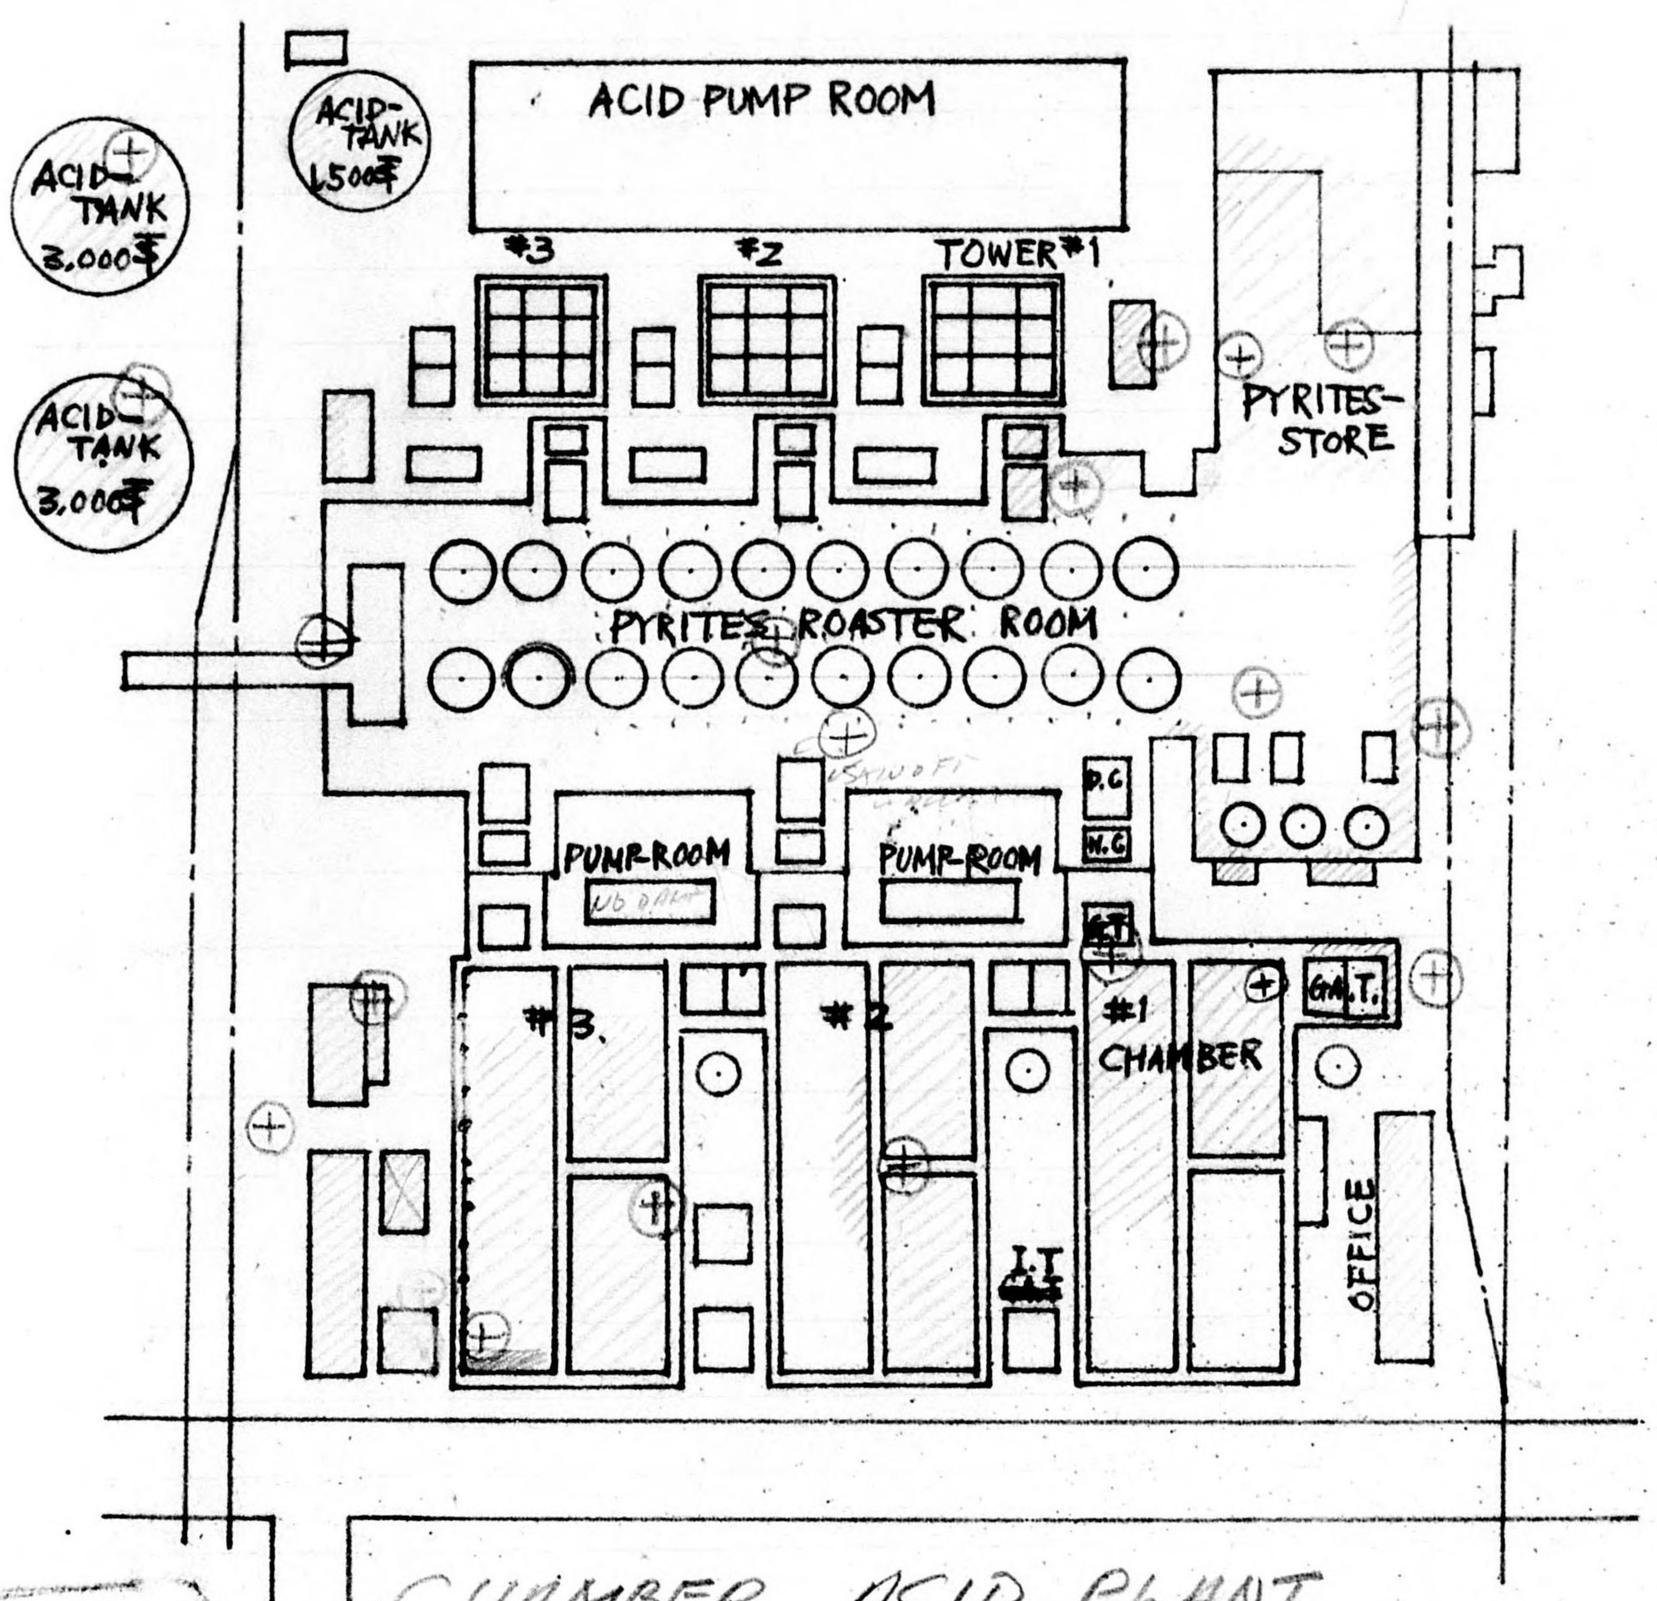
CHAMBER ACID PLANT
BUILDING #10

DESTROYED	
STRUCTURAL DAMAGE	
SUPERFICIAL DAMAGE	
ROOF DISTURBANCE	
MINOR DAMAGE	(ROOF OFF)

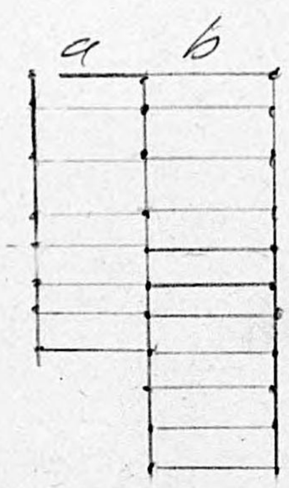
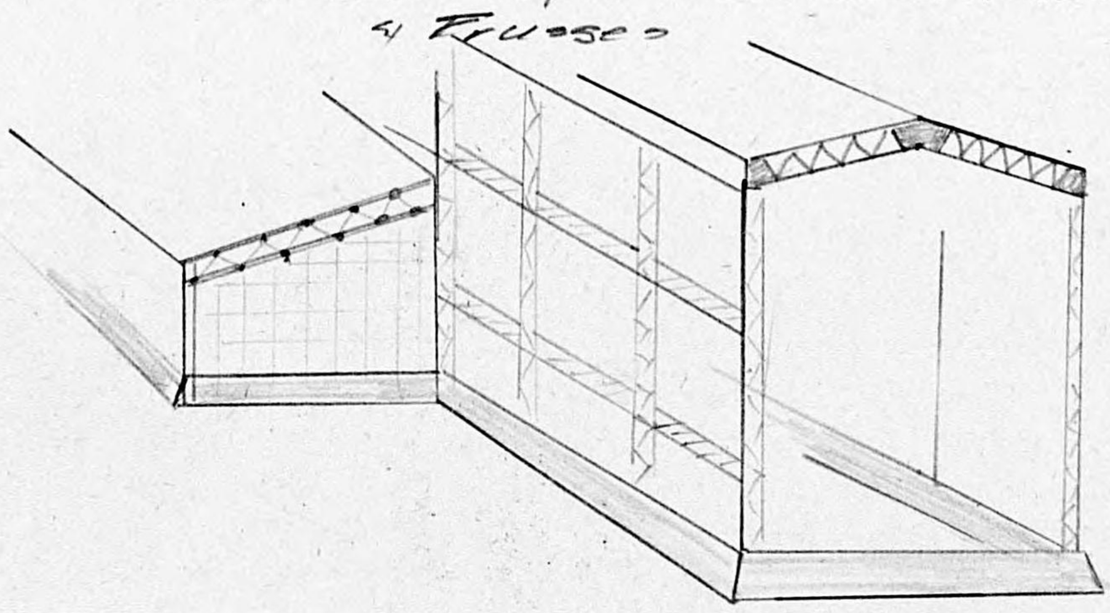
31, 32

#31 — Small, Wood Truss & frame bldg. - Asbestos Walls & Roof

#32 a - Shed of wood construction & Frames

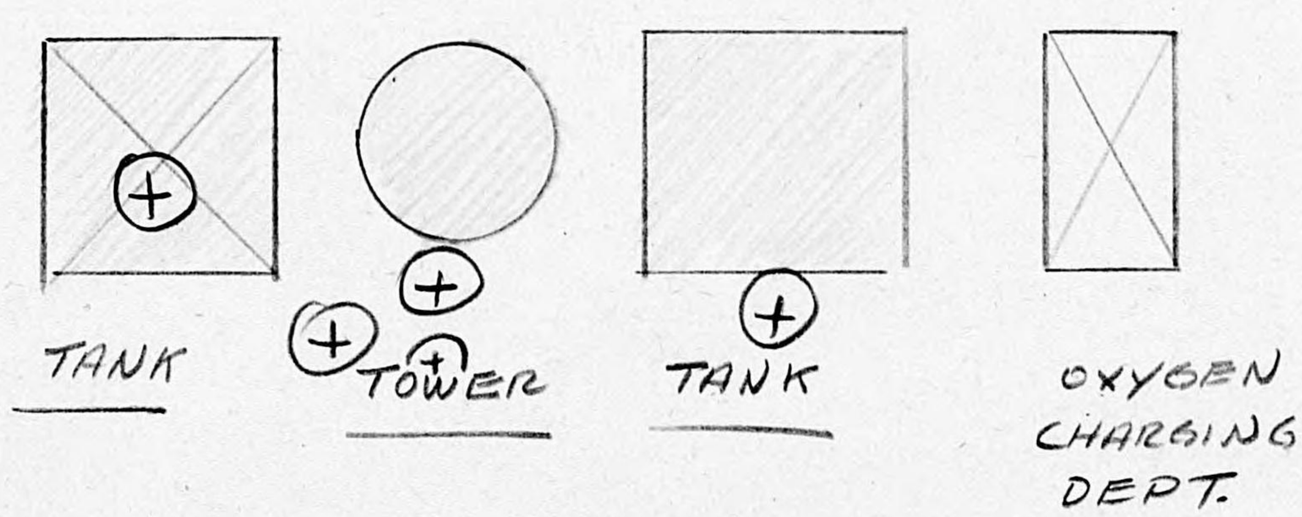
BLDG. NUMBER
33

DESTROYED	☒
STRUCTURAL DAMAGE	☐
SUPERFICIAL DAMAGE	
ROOF DISTURBANCE	
MINOR DAMAGE

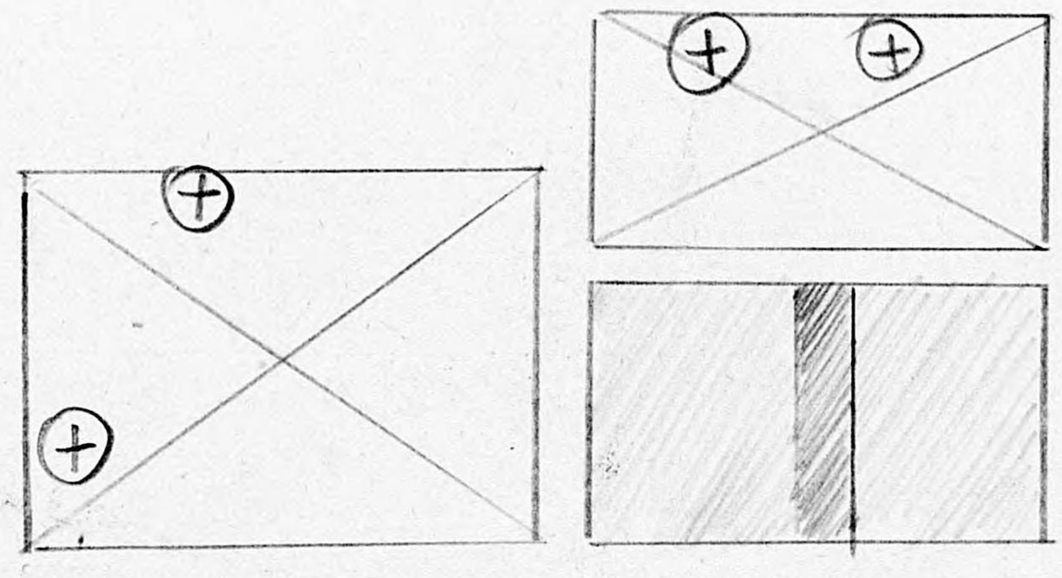
BLDG. NUMBER 35

DESTROYED	☒
STRUCTURAL DAMAGE	▨
SUPERFICIAL DAMAGE	▨
ROOF DISTURBANCE	
MINOR DAMAGE	▨

WOODEN BUILDINGS.

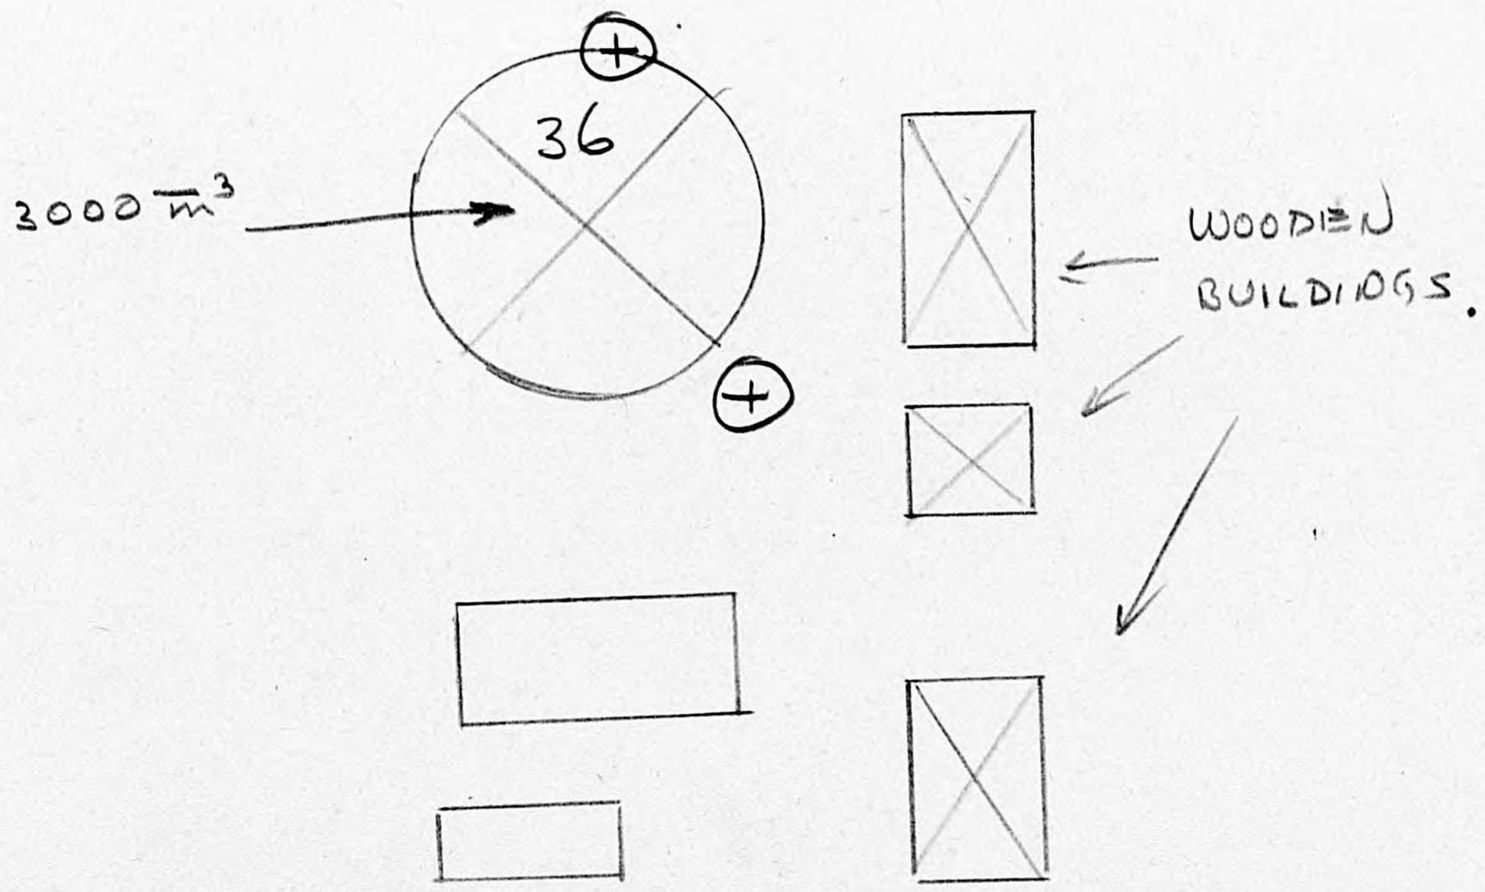
BLDG. NUMBER
36

DESTROYED ☒
STRUCTURAL DAMAGE
SUPERFICIAL DAMAGE
ROOF DISTURBANCE
MINOR DAMAGE

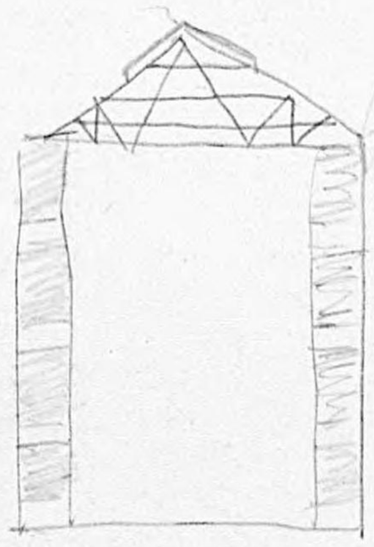
BLDG. NUMBER 37

ROOF & WALLS REMOVED

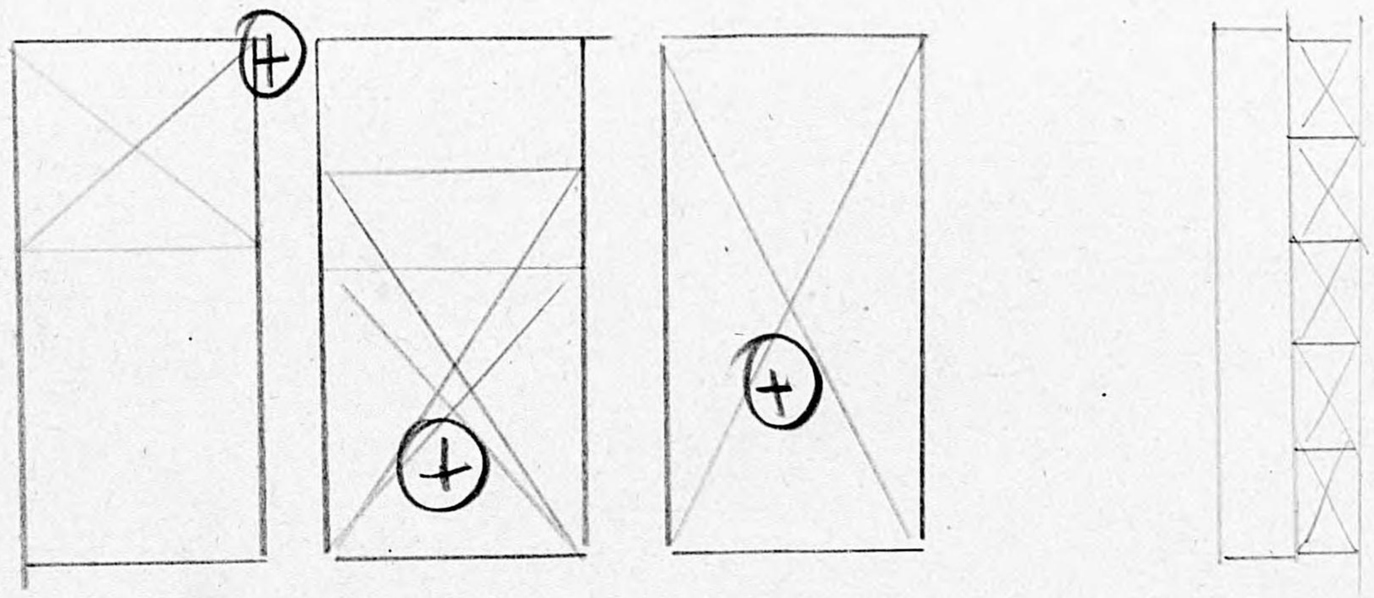
BLDG. NUMBER
38

STEEL TANKS
