SHOWA FERTILIZER CO., LTD.

KAWASAKI

U. S. S. B. S.
DAMAGE ASSESMENT WORK SHEET

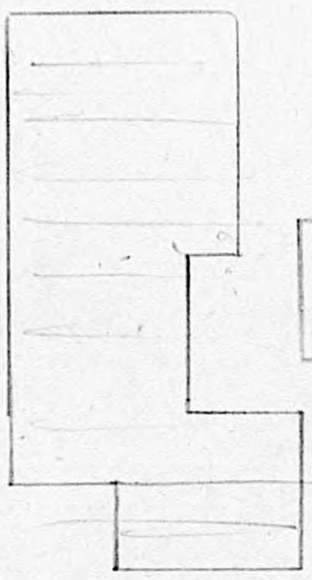
Wood Structure - Destroyed

Mill Type Constr.

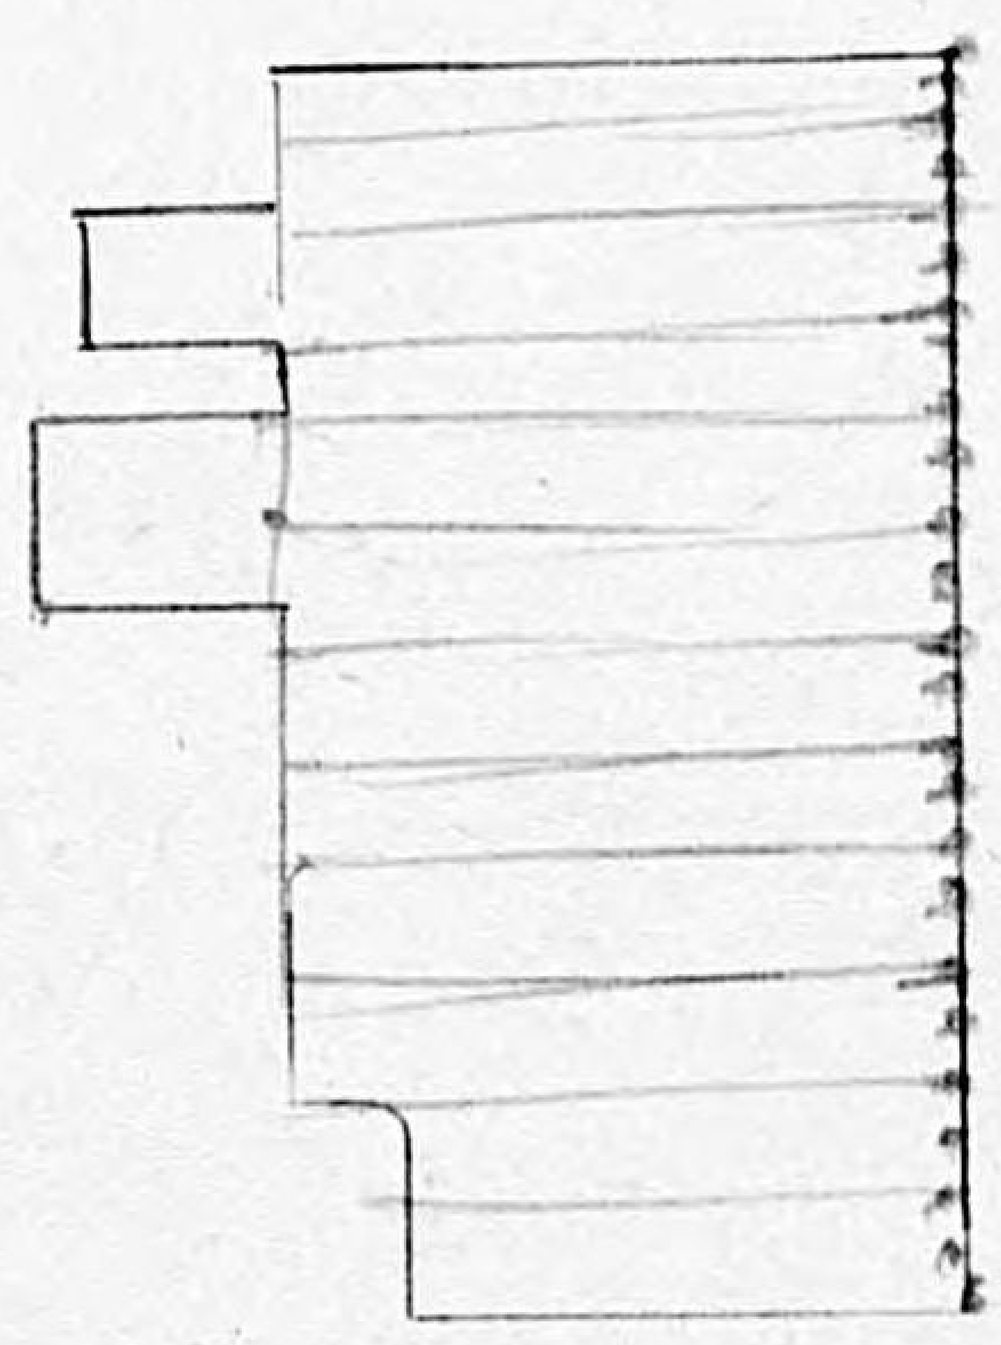
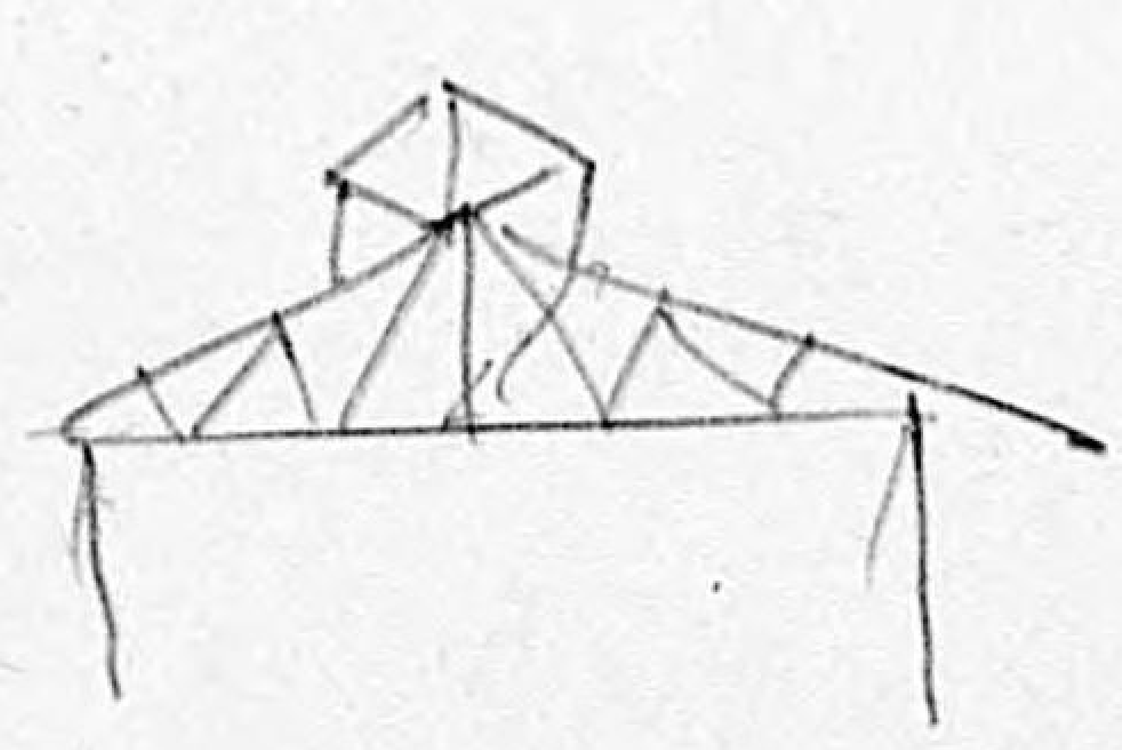
BLDG. NUMBER 40

Light Steel frame Bldg.
