(2) Folder title/number: (3)
Coal Mine Damage in Kyushu

(3) Date: Dec. 1949

FUKUOKA MITI

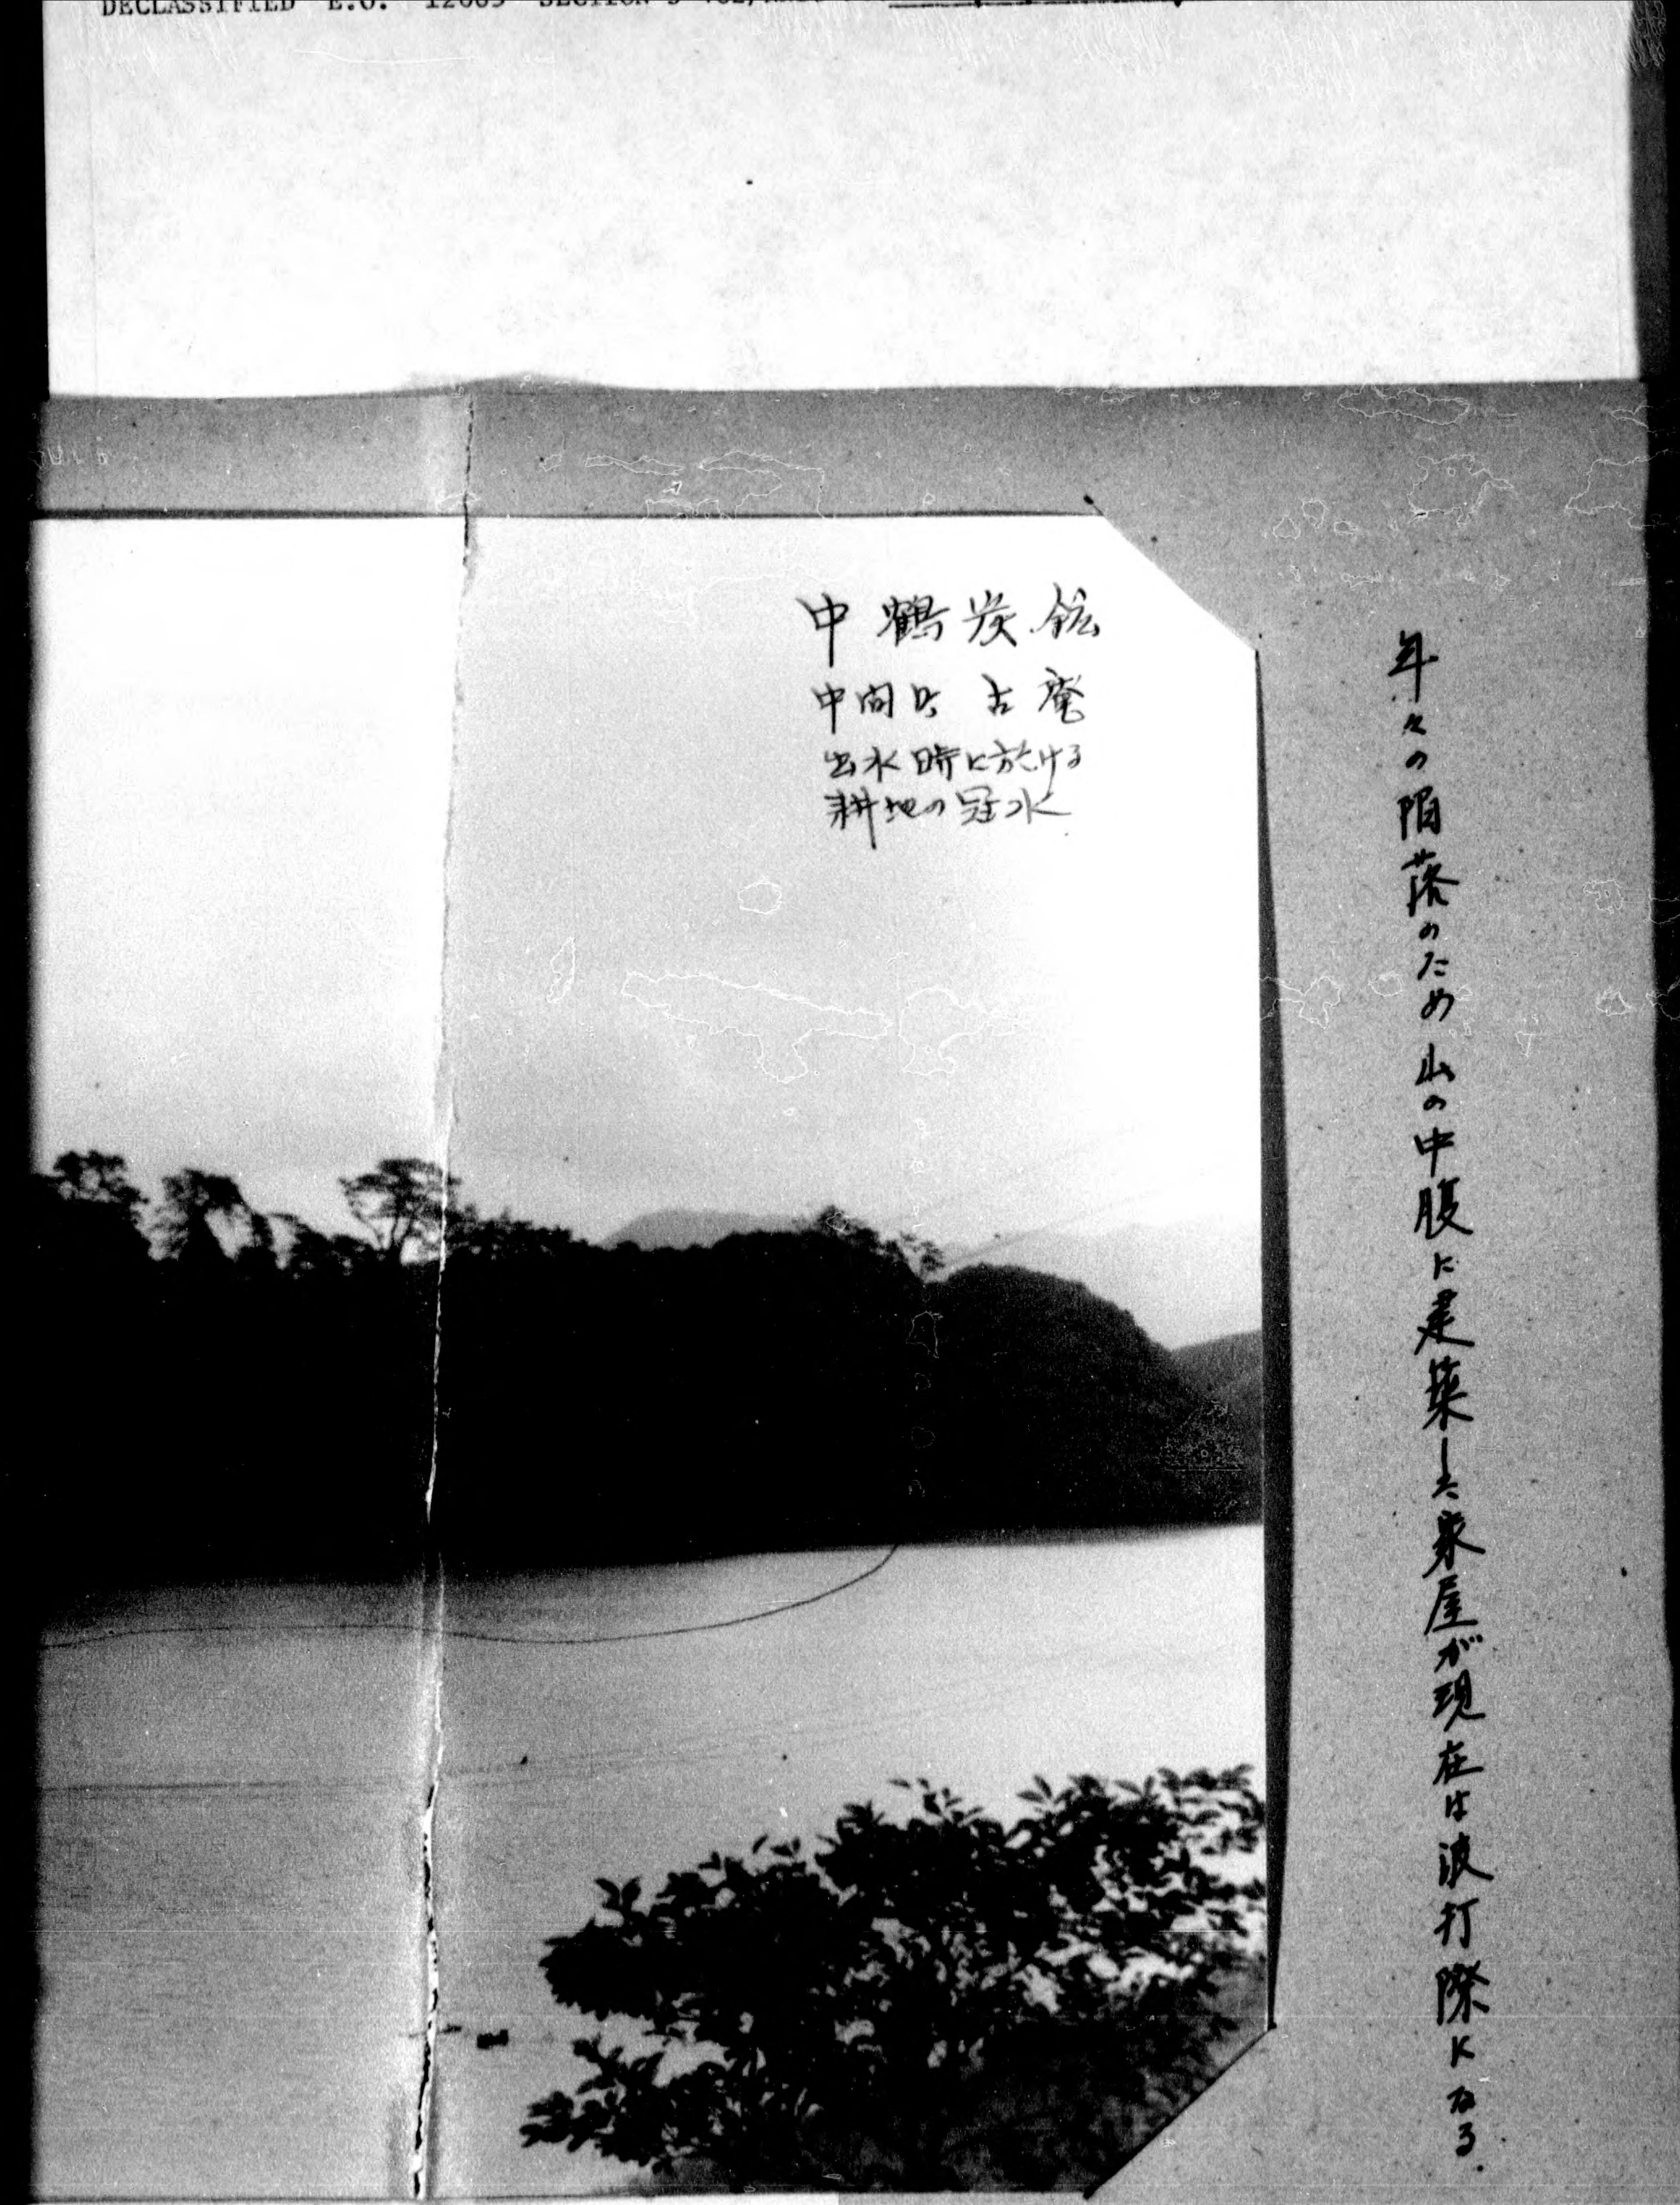
NAKAZURU COAL MINE
Taisho Mining Co.,

Houses which were built on the middle of hillsides, houses are bank of the pond. Due to subsidence.

年々の陷落のため山の中腹に建築した家屋が現在は波打際にある。

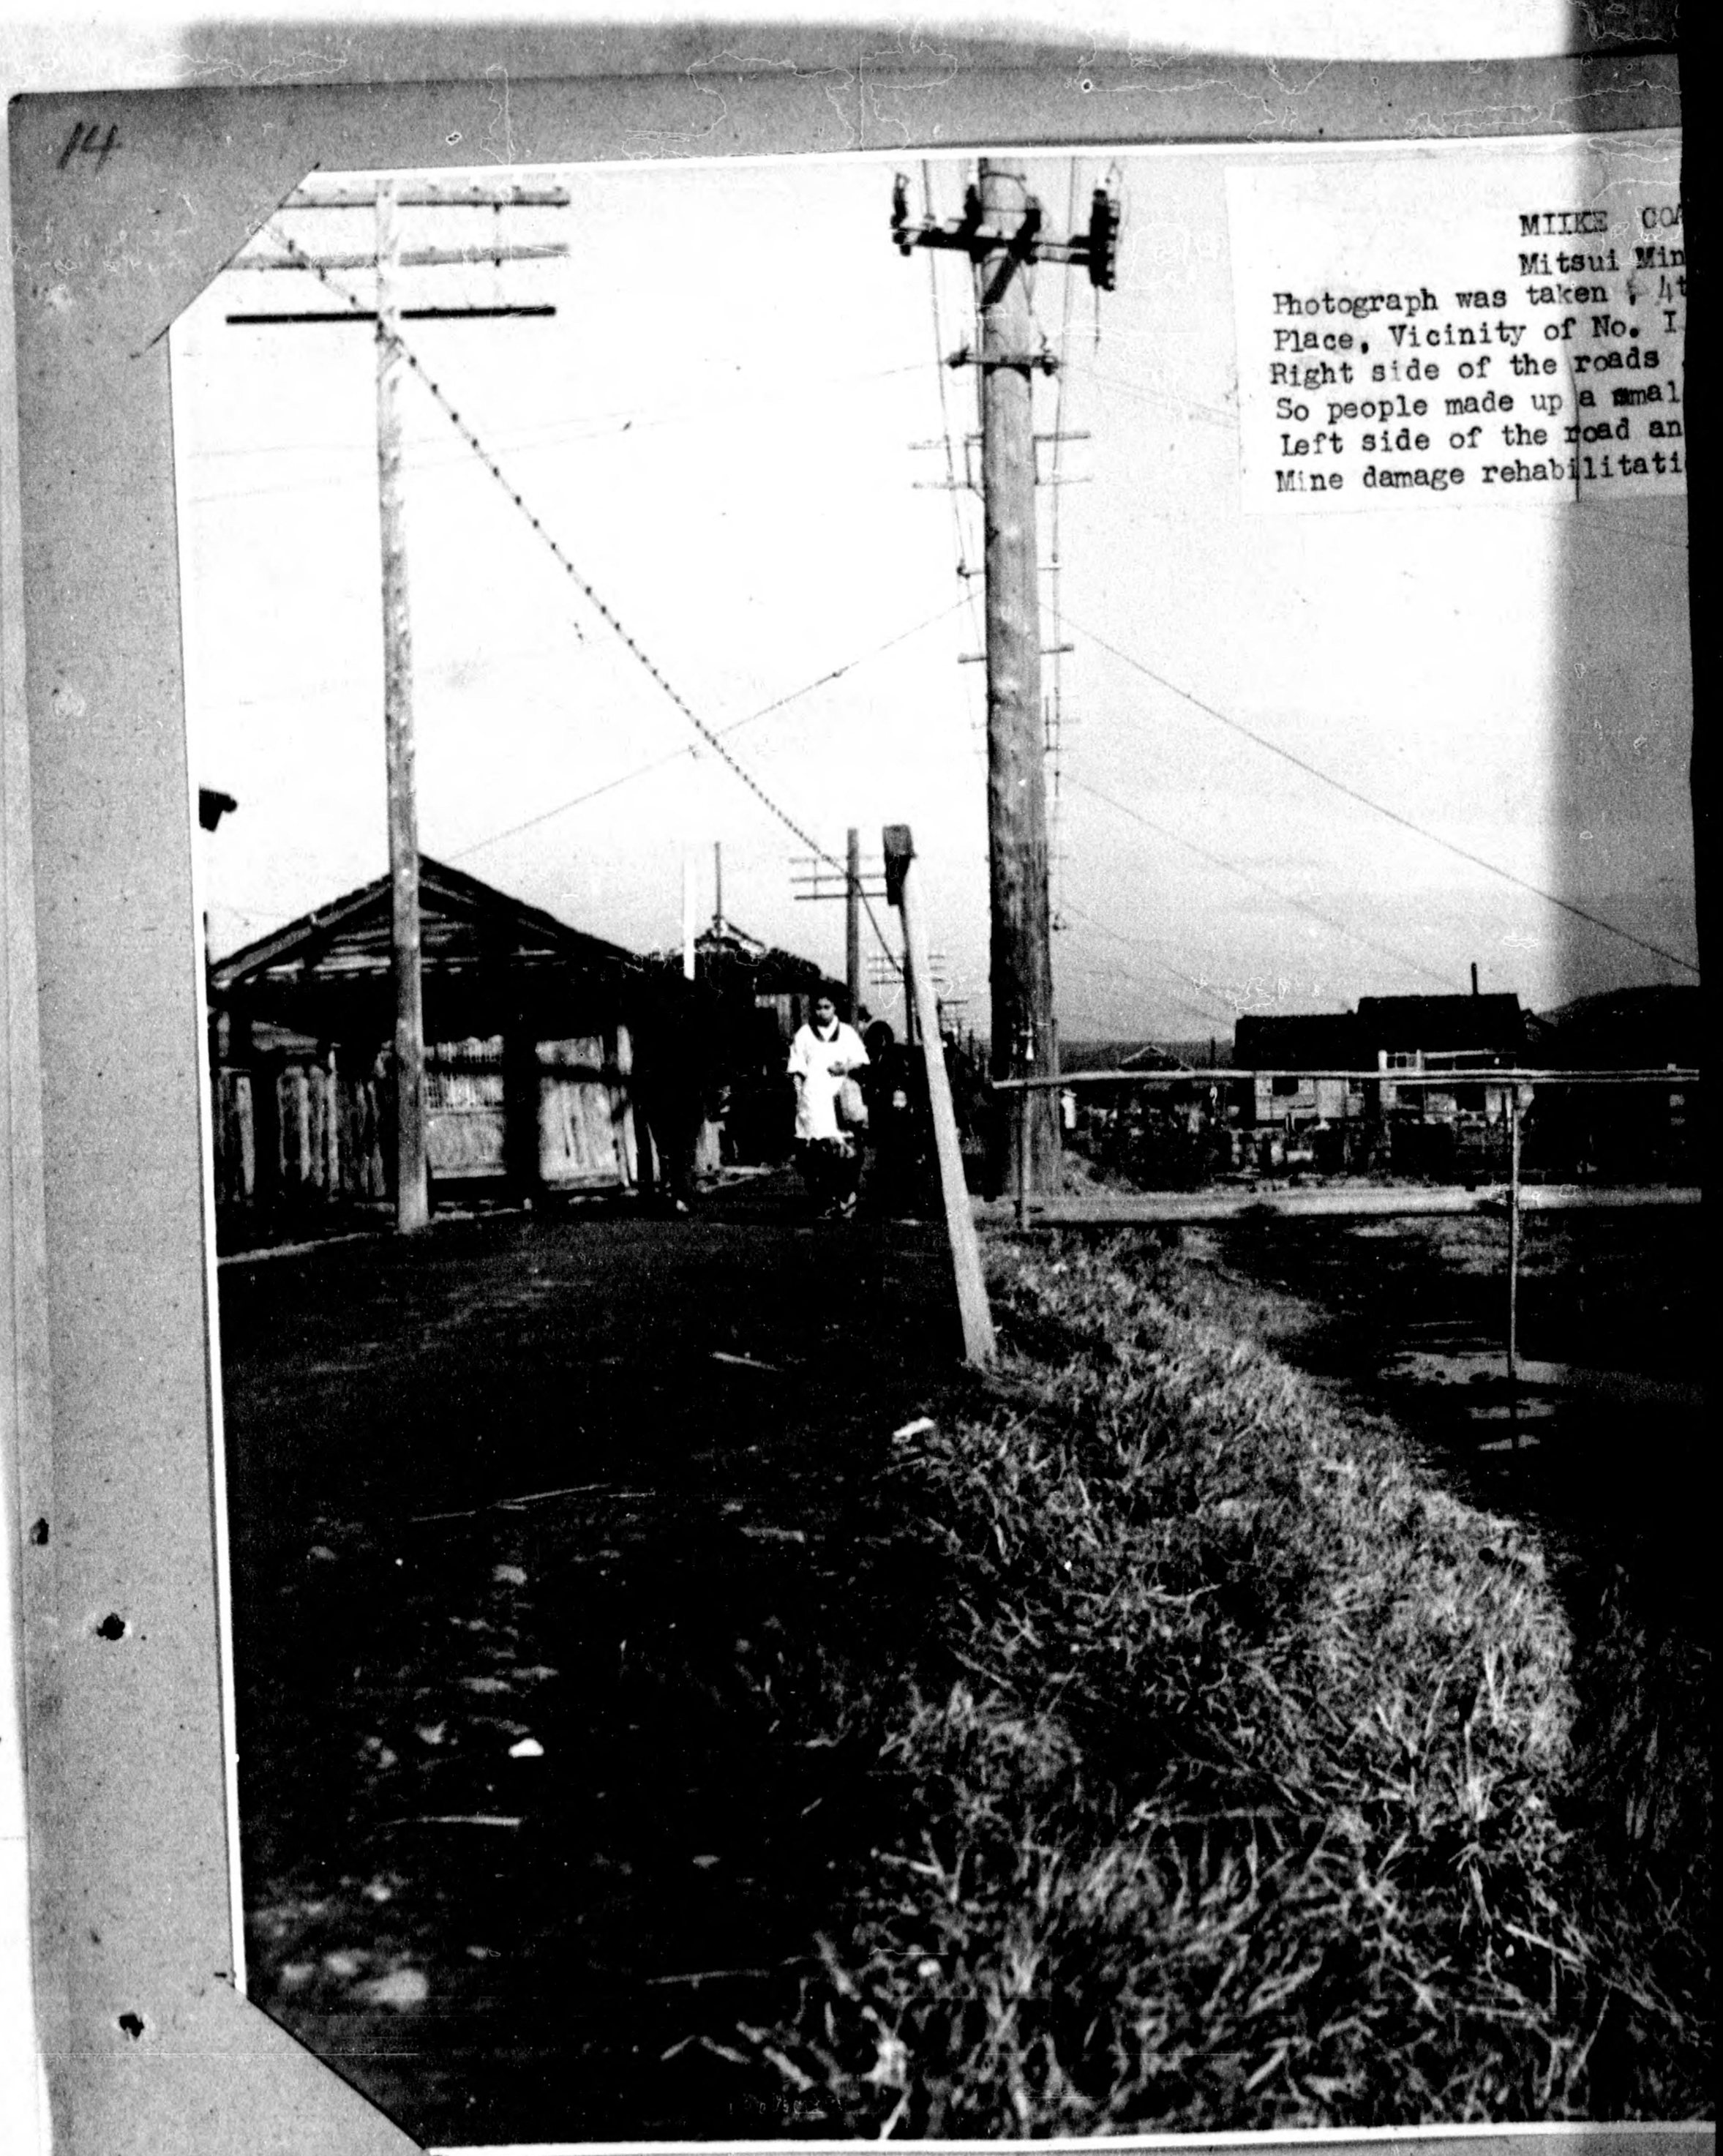
FUTASE COAL MINE

Nittetsu Mining Co.,

Place, Honami-mura, Kaho-gun, (ken highway from Iizuka to Umi)
This highway is very important truckroad to Iizuka City,
The surface of this highway sank about one meter, Due to mining.

本線は嘉穂郡穂波村大字安恒一太春を経て飯塚市に通ずる重要なる幹線道路であるが日鉄二瀬鉱業所潤野坑の石炭採掘に依り地表は平均約10米沈下してゐる.

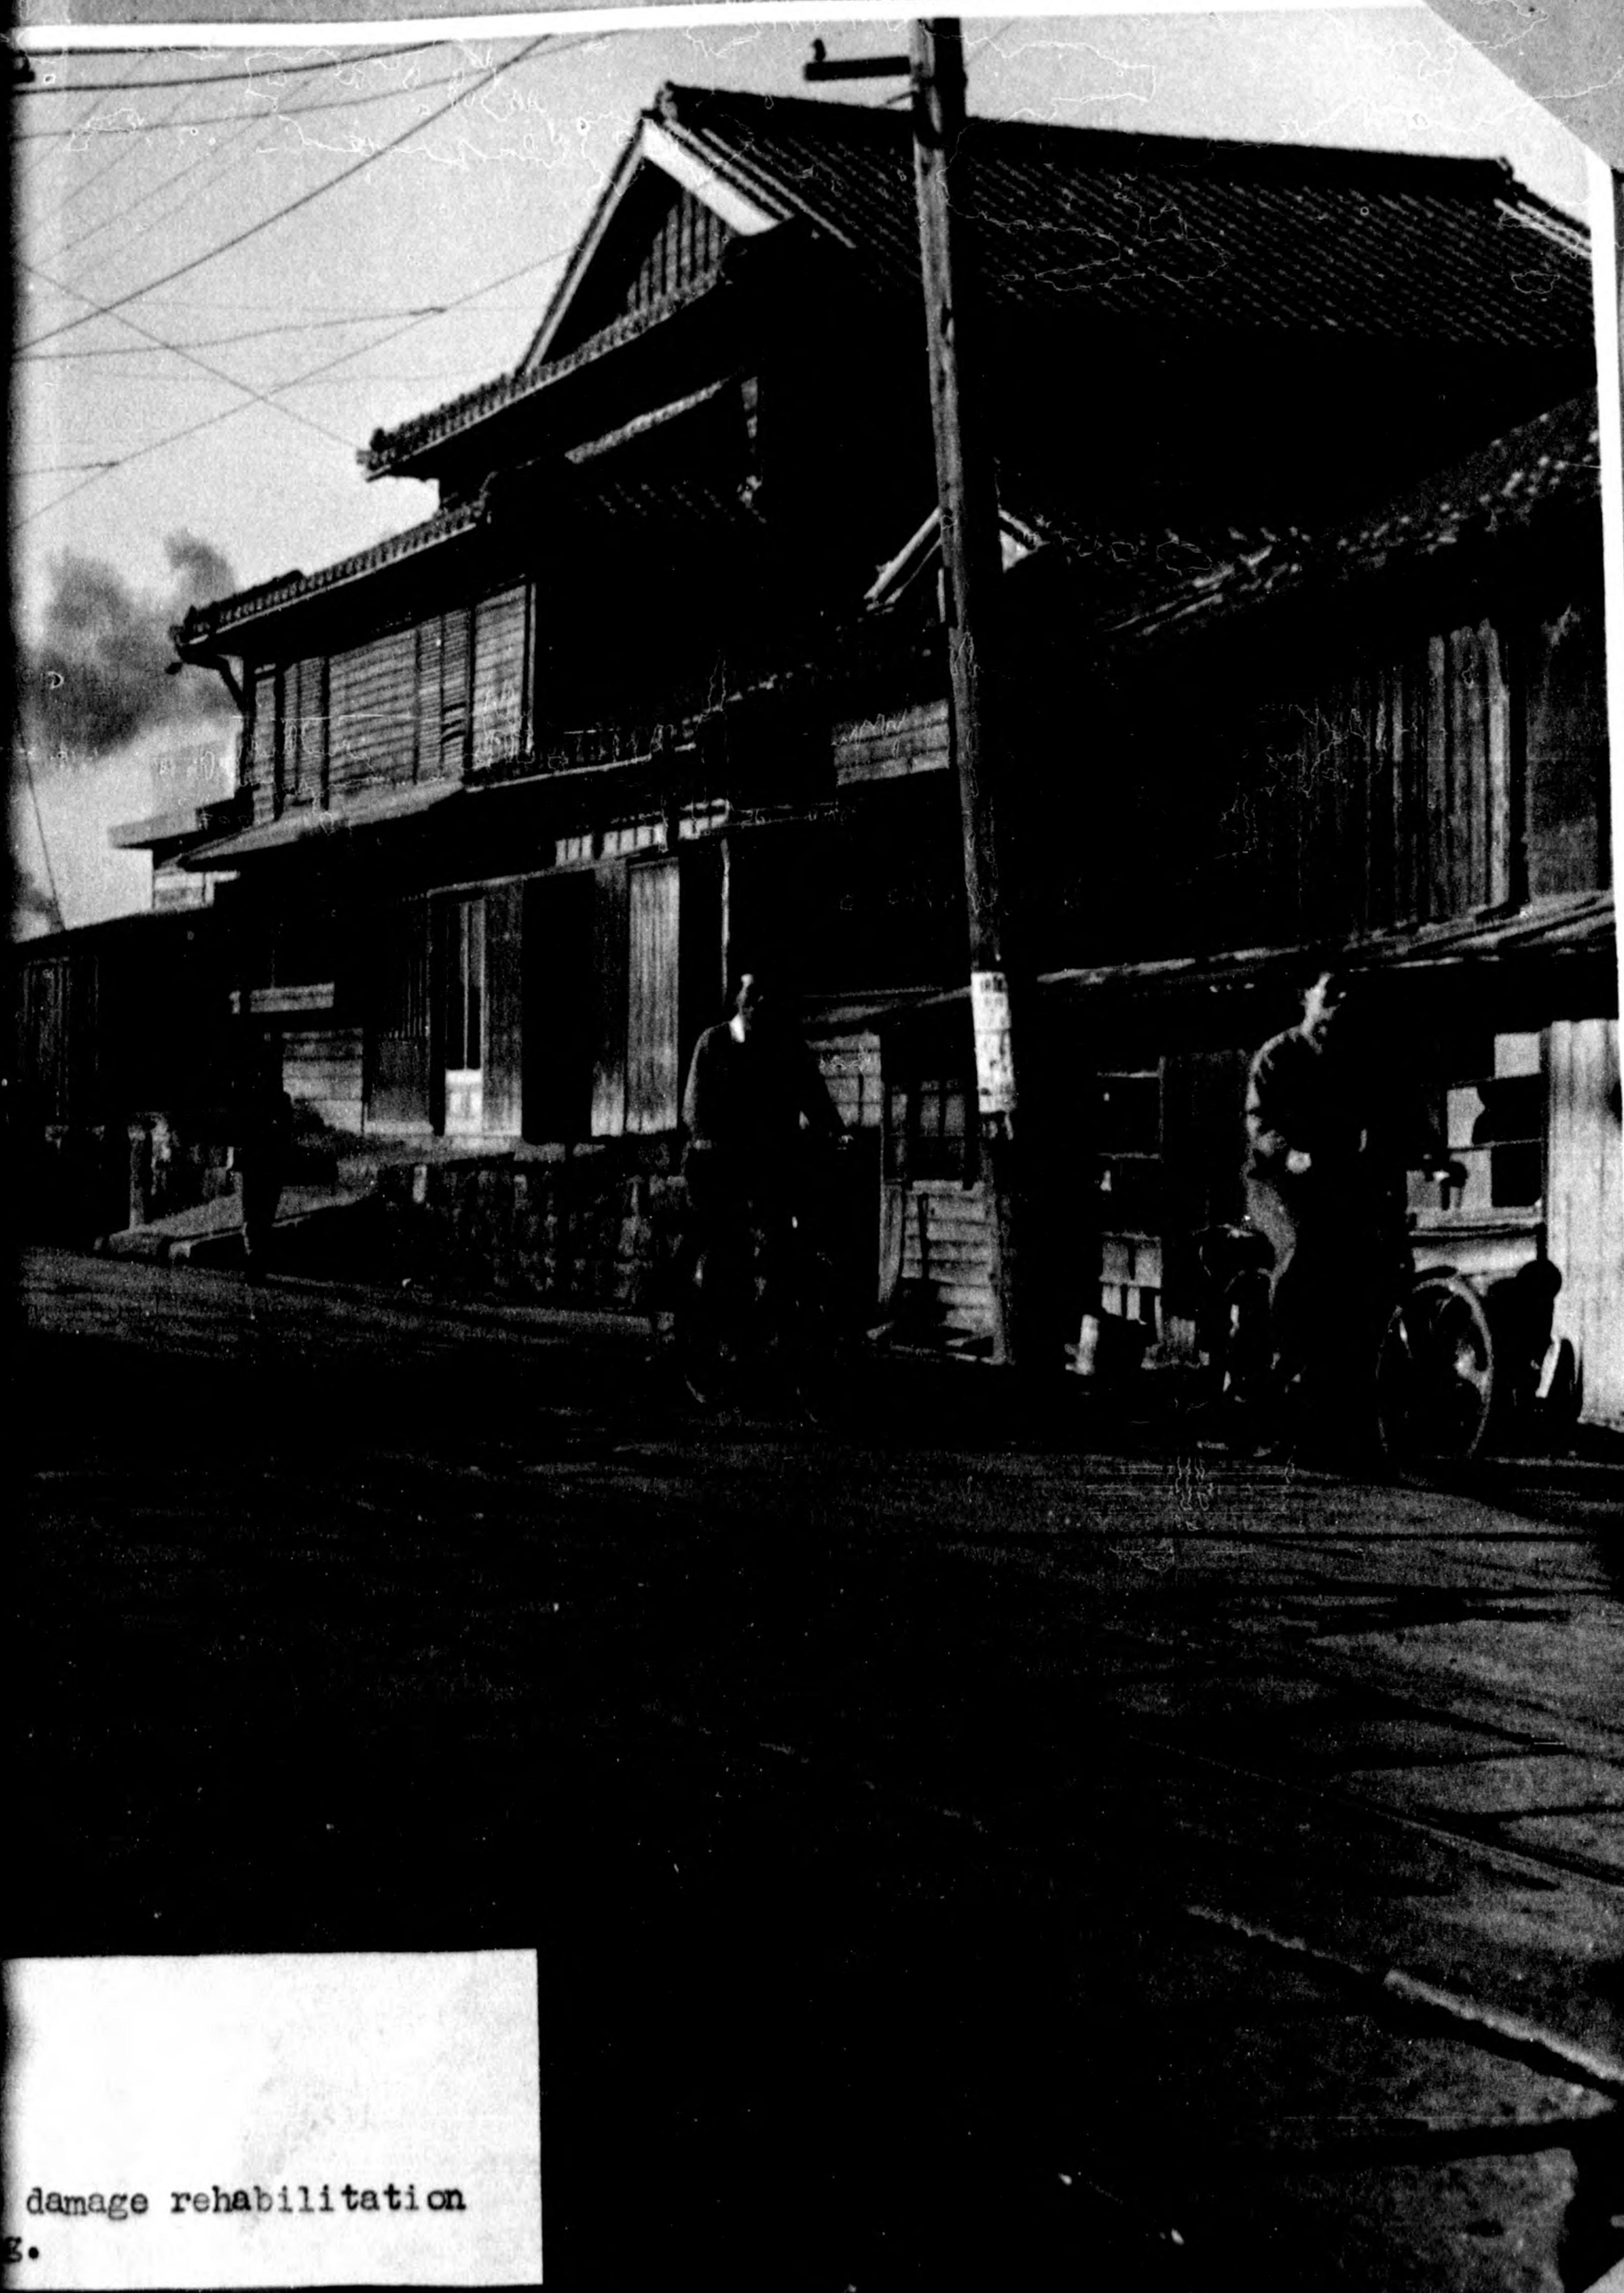
016

MIIKE COAL MINE

Mitsui Coal mining Co.,

Photogragh was takeh 5th. Dec. 1949

Place, Suha-Bridge and its vicinity, Omuta city

House on the right side,was restored by special coal mine damage rehabilitation expences, Bridge, highway, and other houses need repairing.

三池炭礦（八）（昭和廿四年十月五日撮影）

場所　大牟田市諏訪橋附近

◎右側家屋は、特別鑛害復旧費にて工學濟み

橋、道路及家屋の大部分は未濟

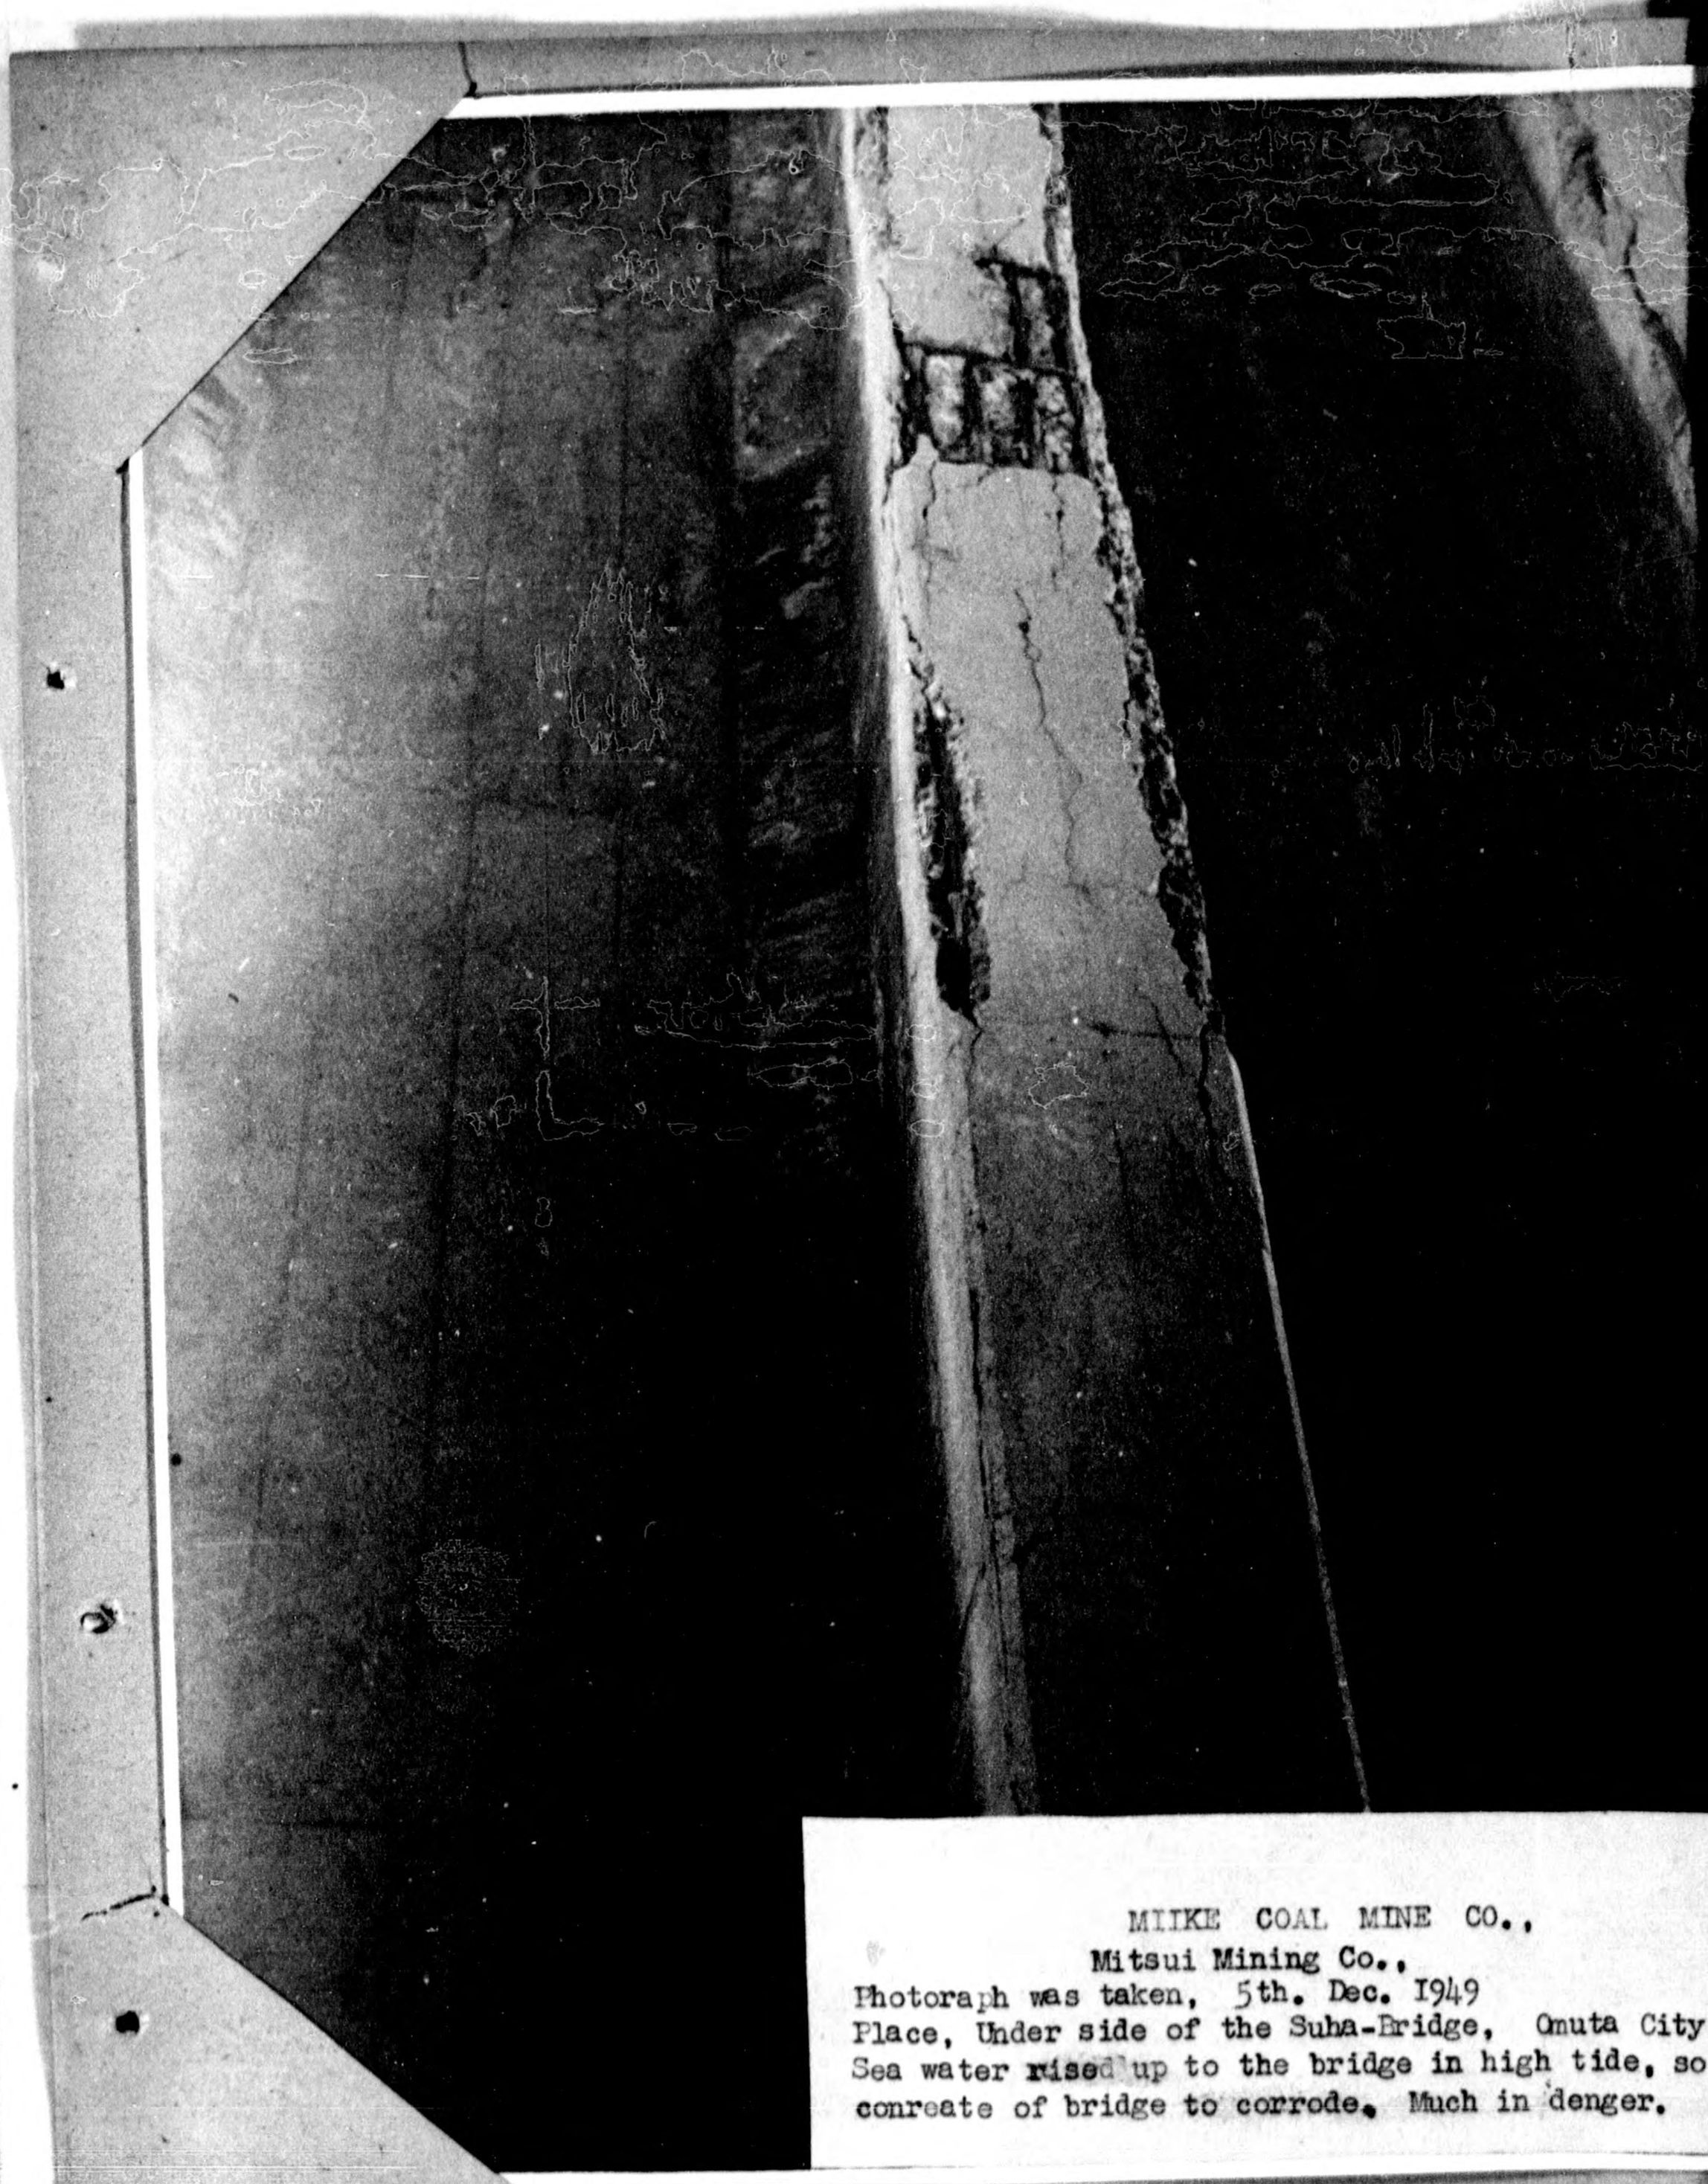
017

MIIKE COAL MINE CO.,
Mitsui Mining Co.,
Photoraph was taken, 5th. Dec. 1949
Place, Under side of the Suha-Bridge, Omuta City
Sea water rised up to the bridge in high tide, so t
conreate of bridge to corrode. Much in denger.

三池炭礦 (九) 昭和廿四年十二月五日撮影

場所 大牟田市諏訪橋裏面

◎満潮時には海水が橋迄上り橋の裏面は

洗い流され鉄筋腐朽し危険に瀕す

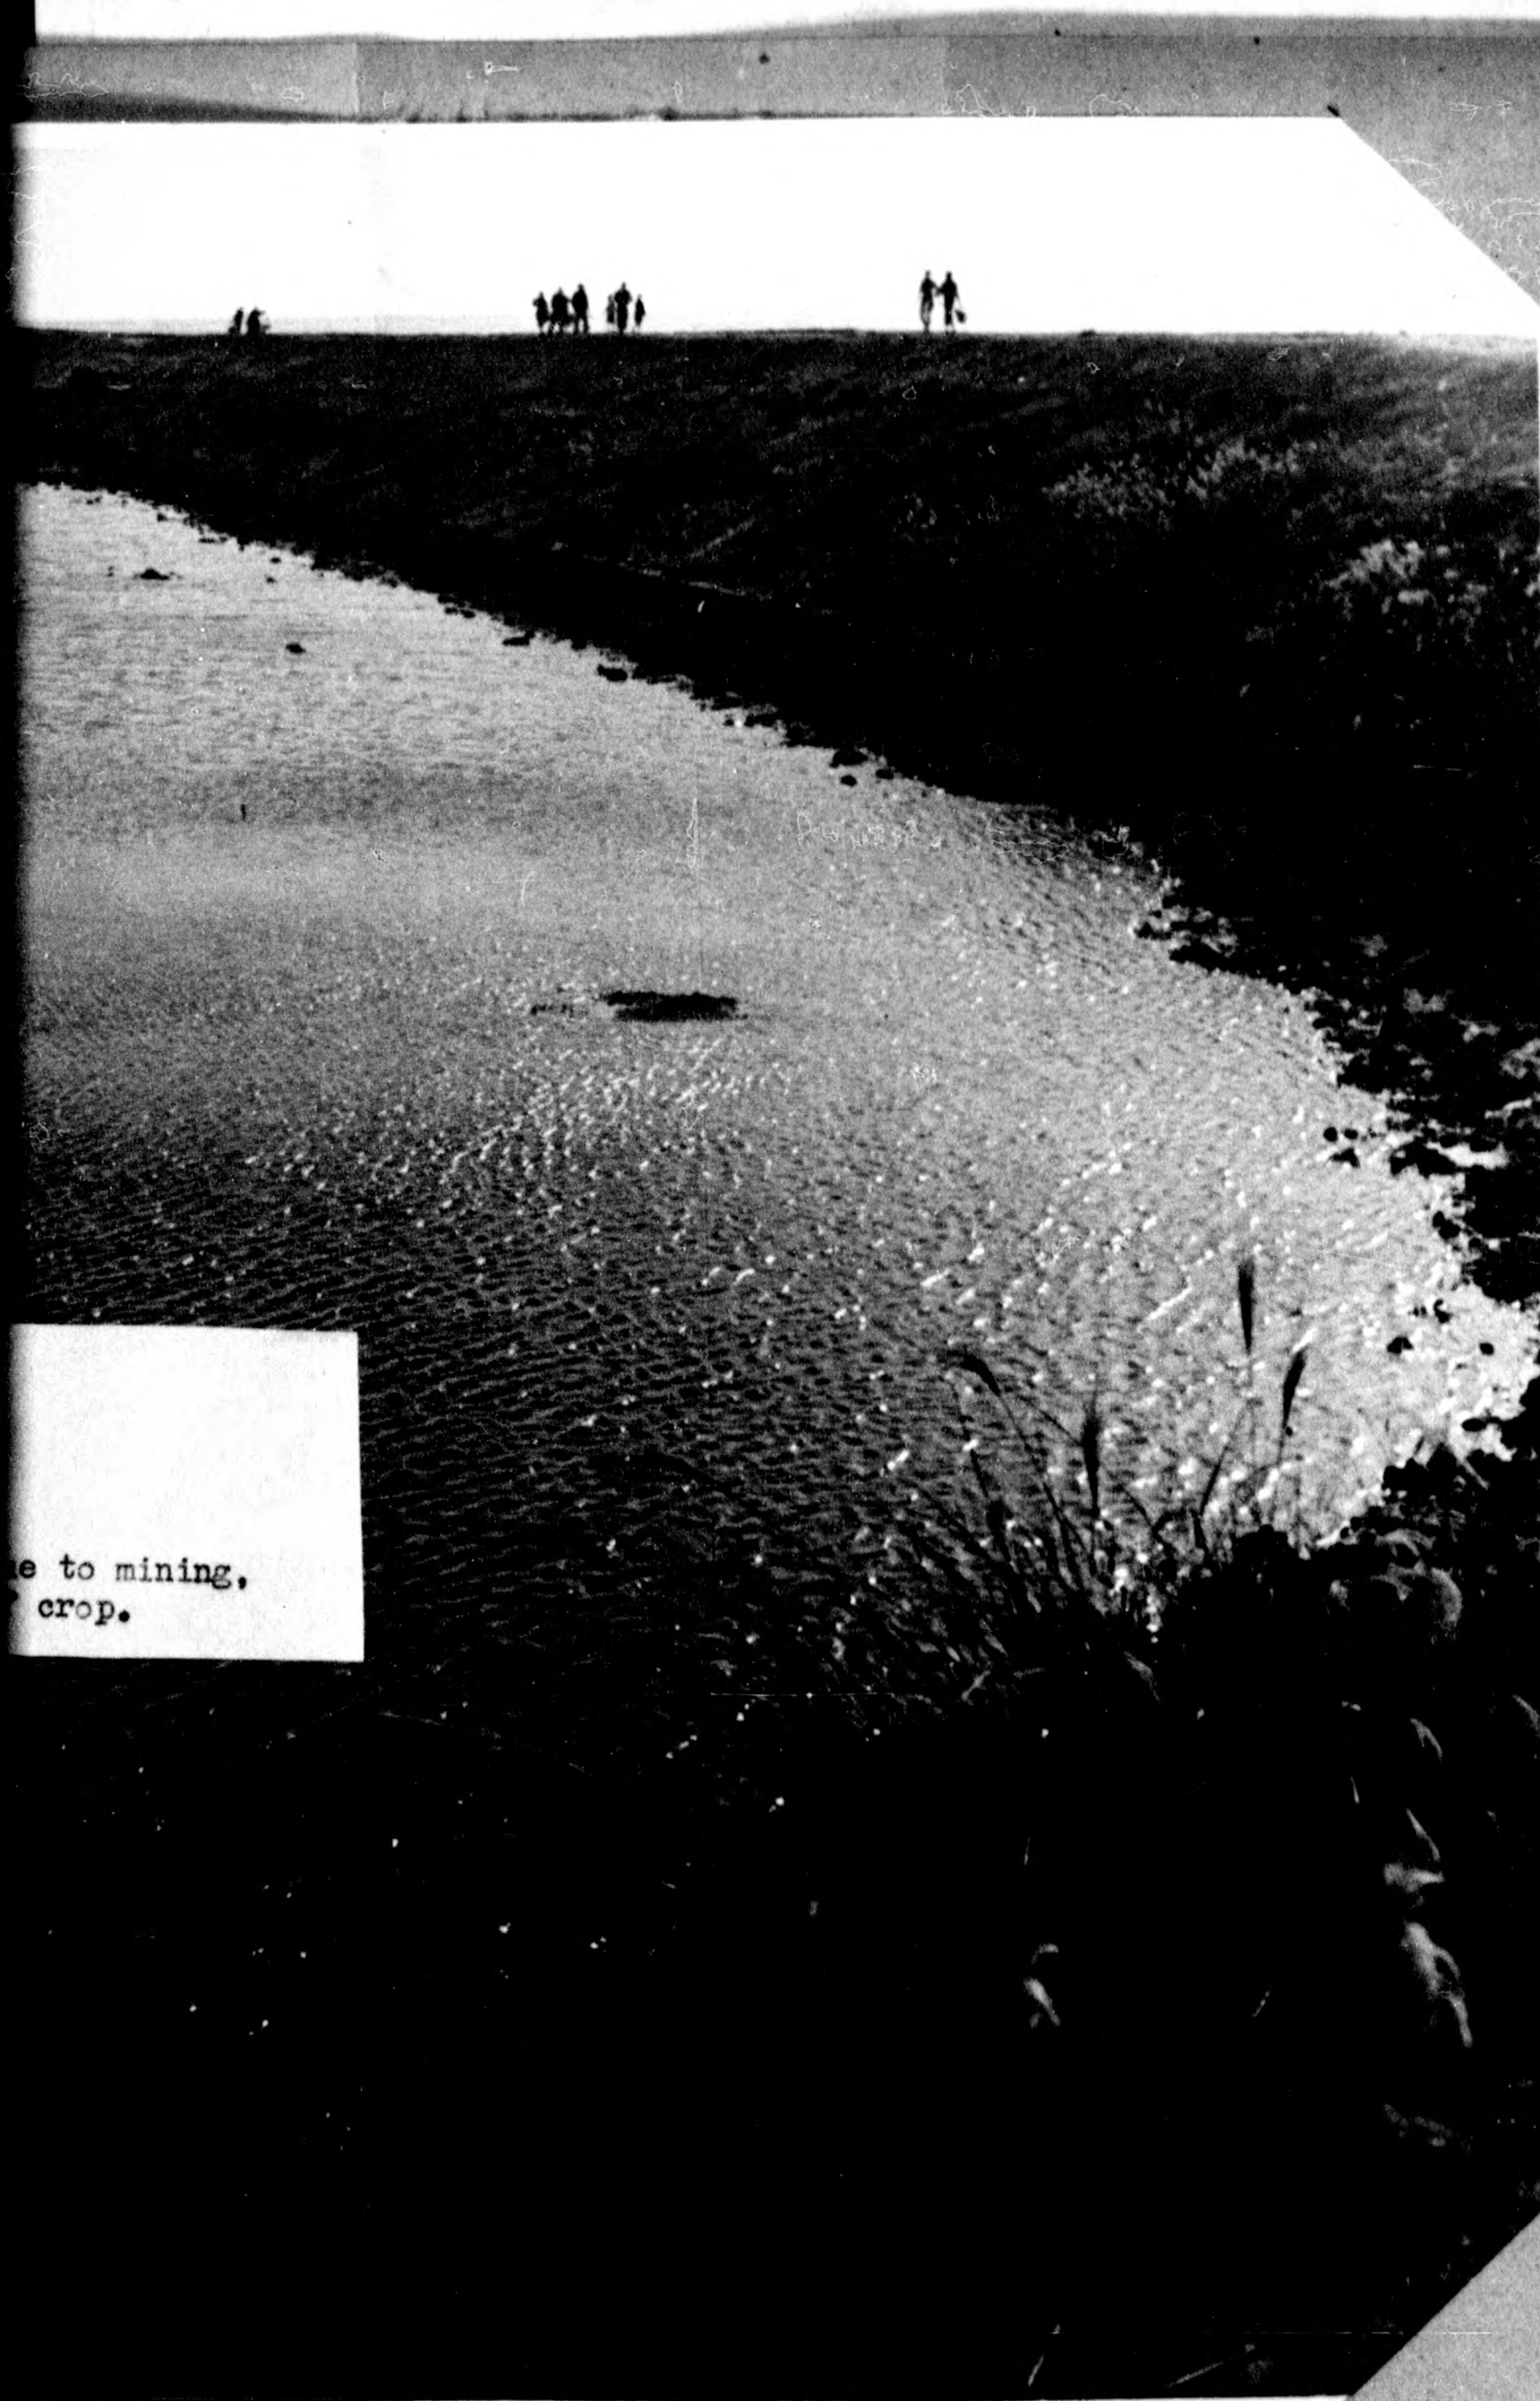
018

MIIKE COAL MINE

Place, Minami-shinmachi, Arao city

Weakened coast bank by subsidence of land, which were due to mining, cultivating land is always flooded, It is incompetent of crop.

三池炭礦(十) 昭和廿四年十二月四日撮影

場所 荒尾市南新地

◎海岸堤防弱化し、耕地には常時滯水して、

耕作不能となる。

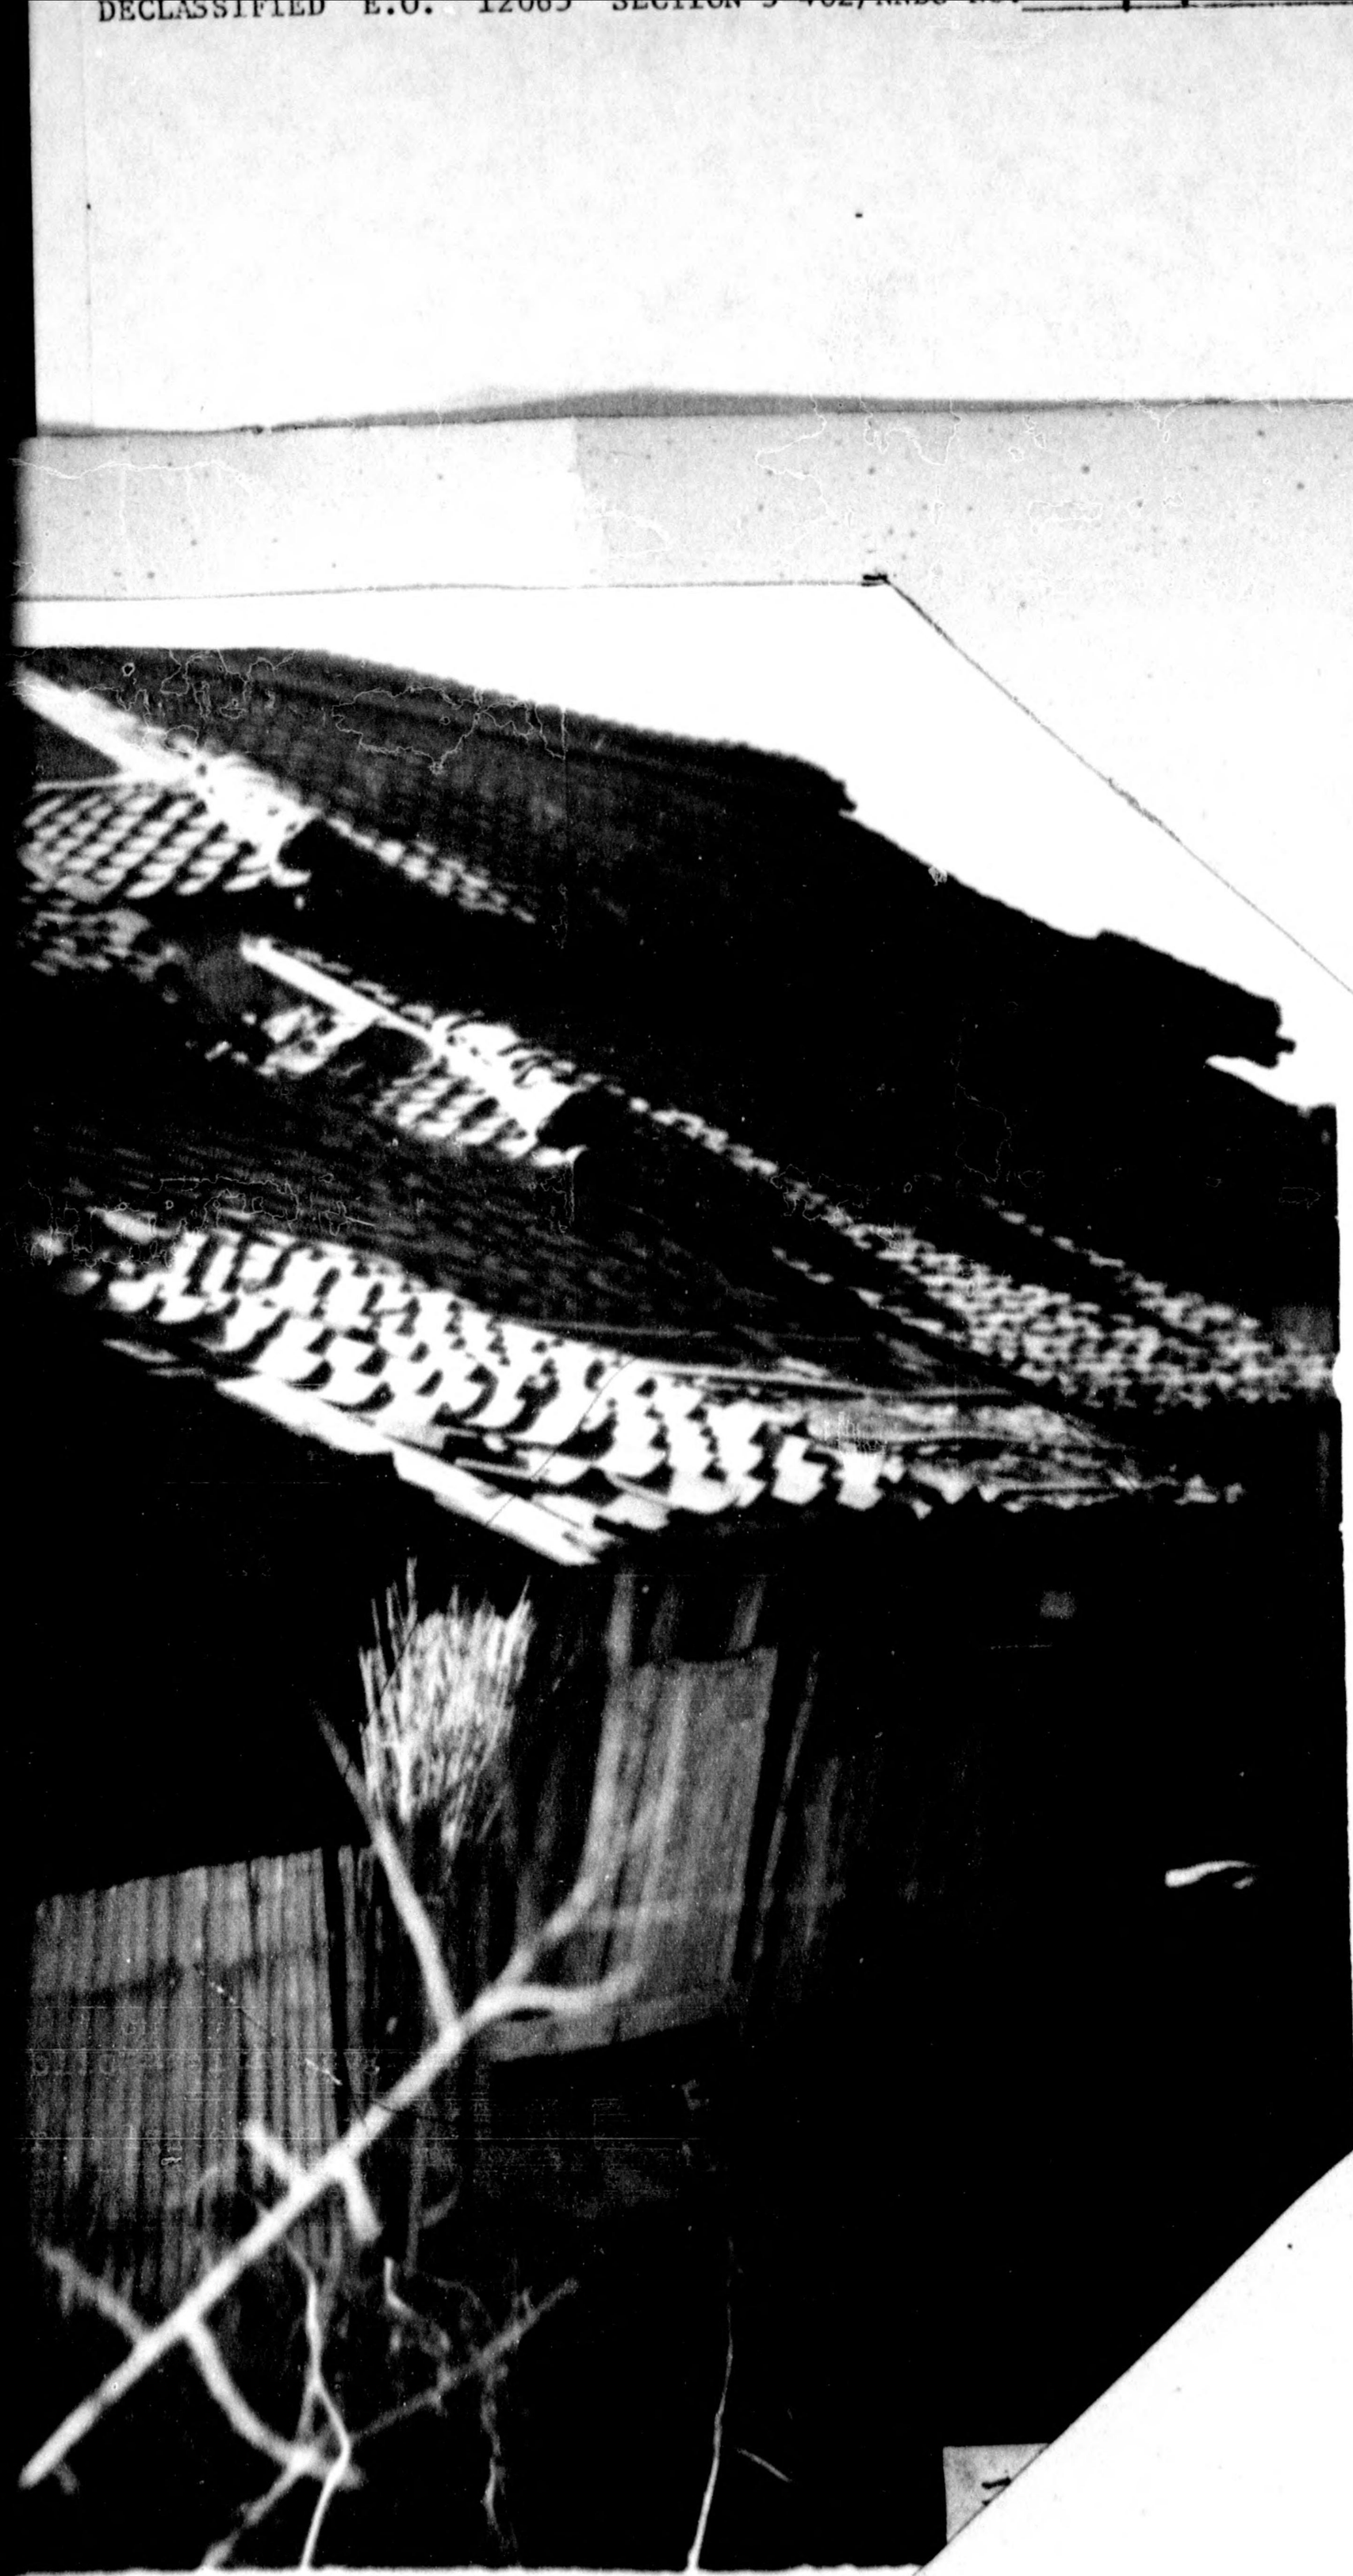
NAMAZUTA COAL MINE
Mitsubishi mining
This house may fall down, due to decline

傾斜のため倒壊のさまかり
