(2) Folder title/number: (3)
Coal Mine Damage in Kyushu

(3) Date: Dec. 1949

FUKUOKA MITI

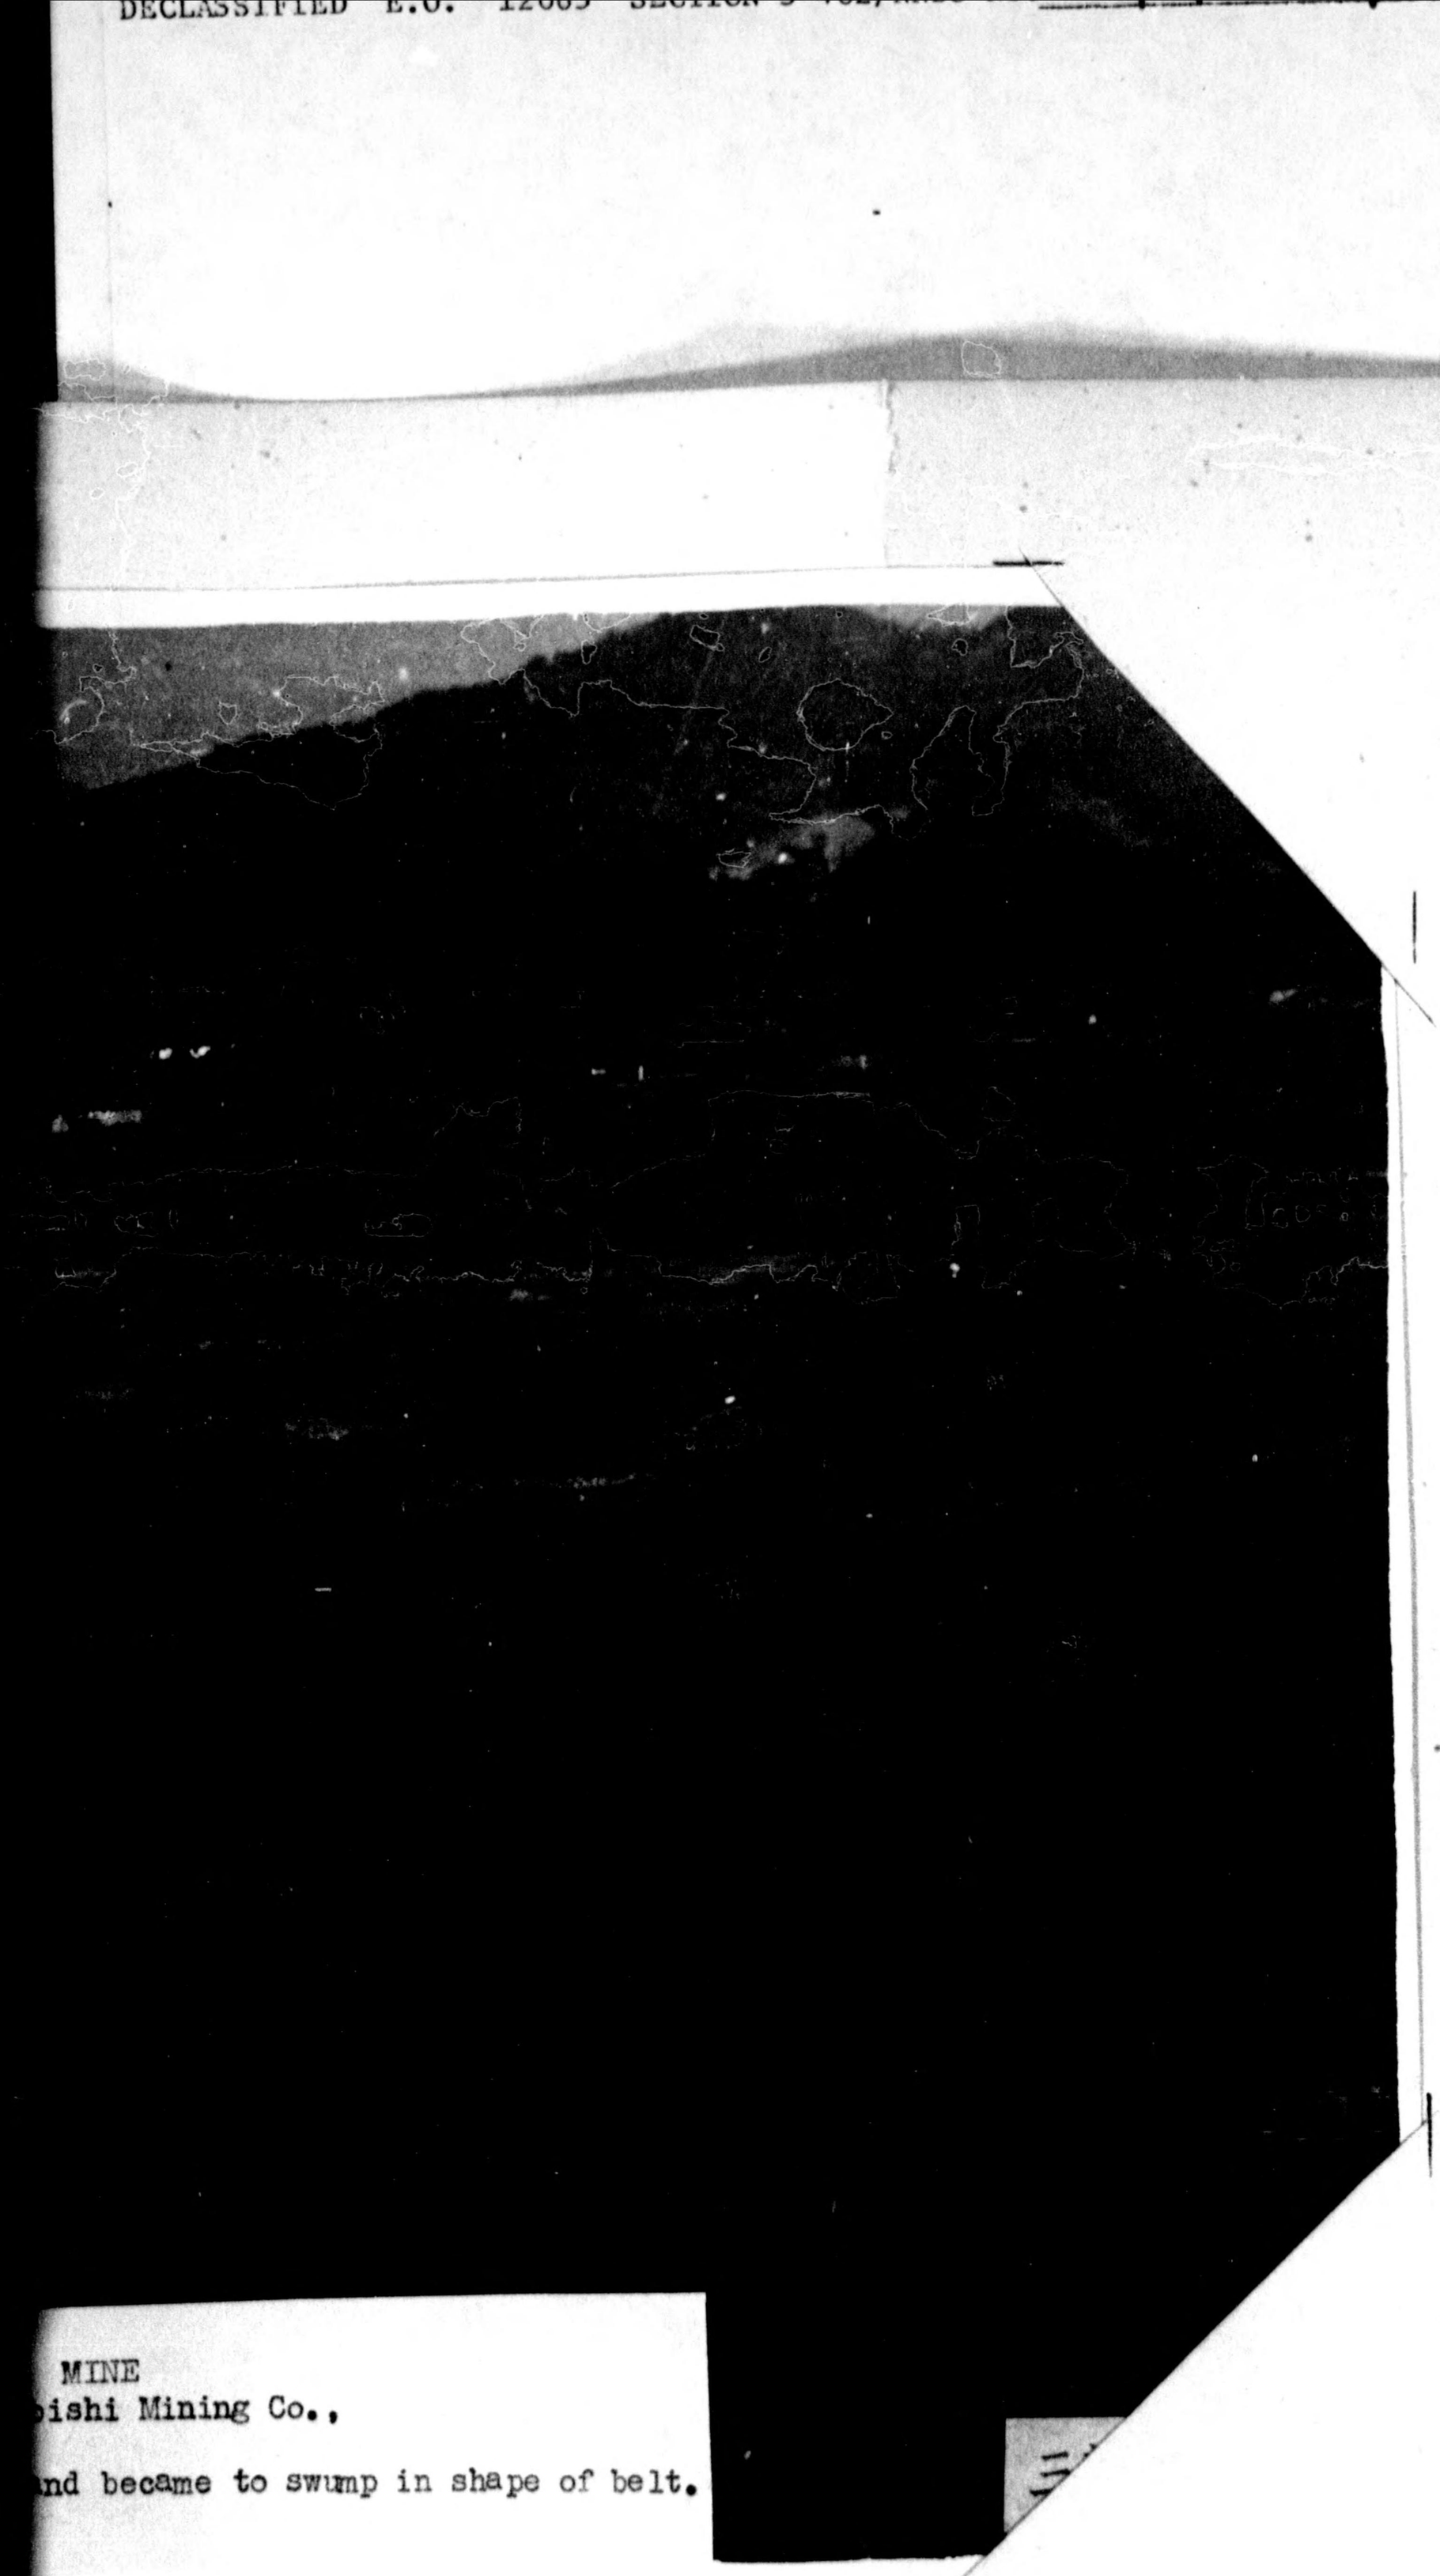
NAMAZUTA COAL MINE
Mitsubishi Mining Co..

The middle parts of curtivation land became to swamp
Due to subsidence.

耕地中央部に帶狀の陷落を起し沼となる

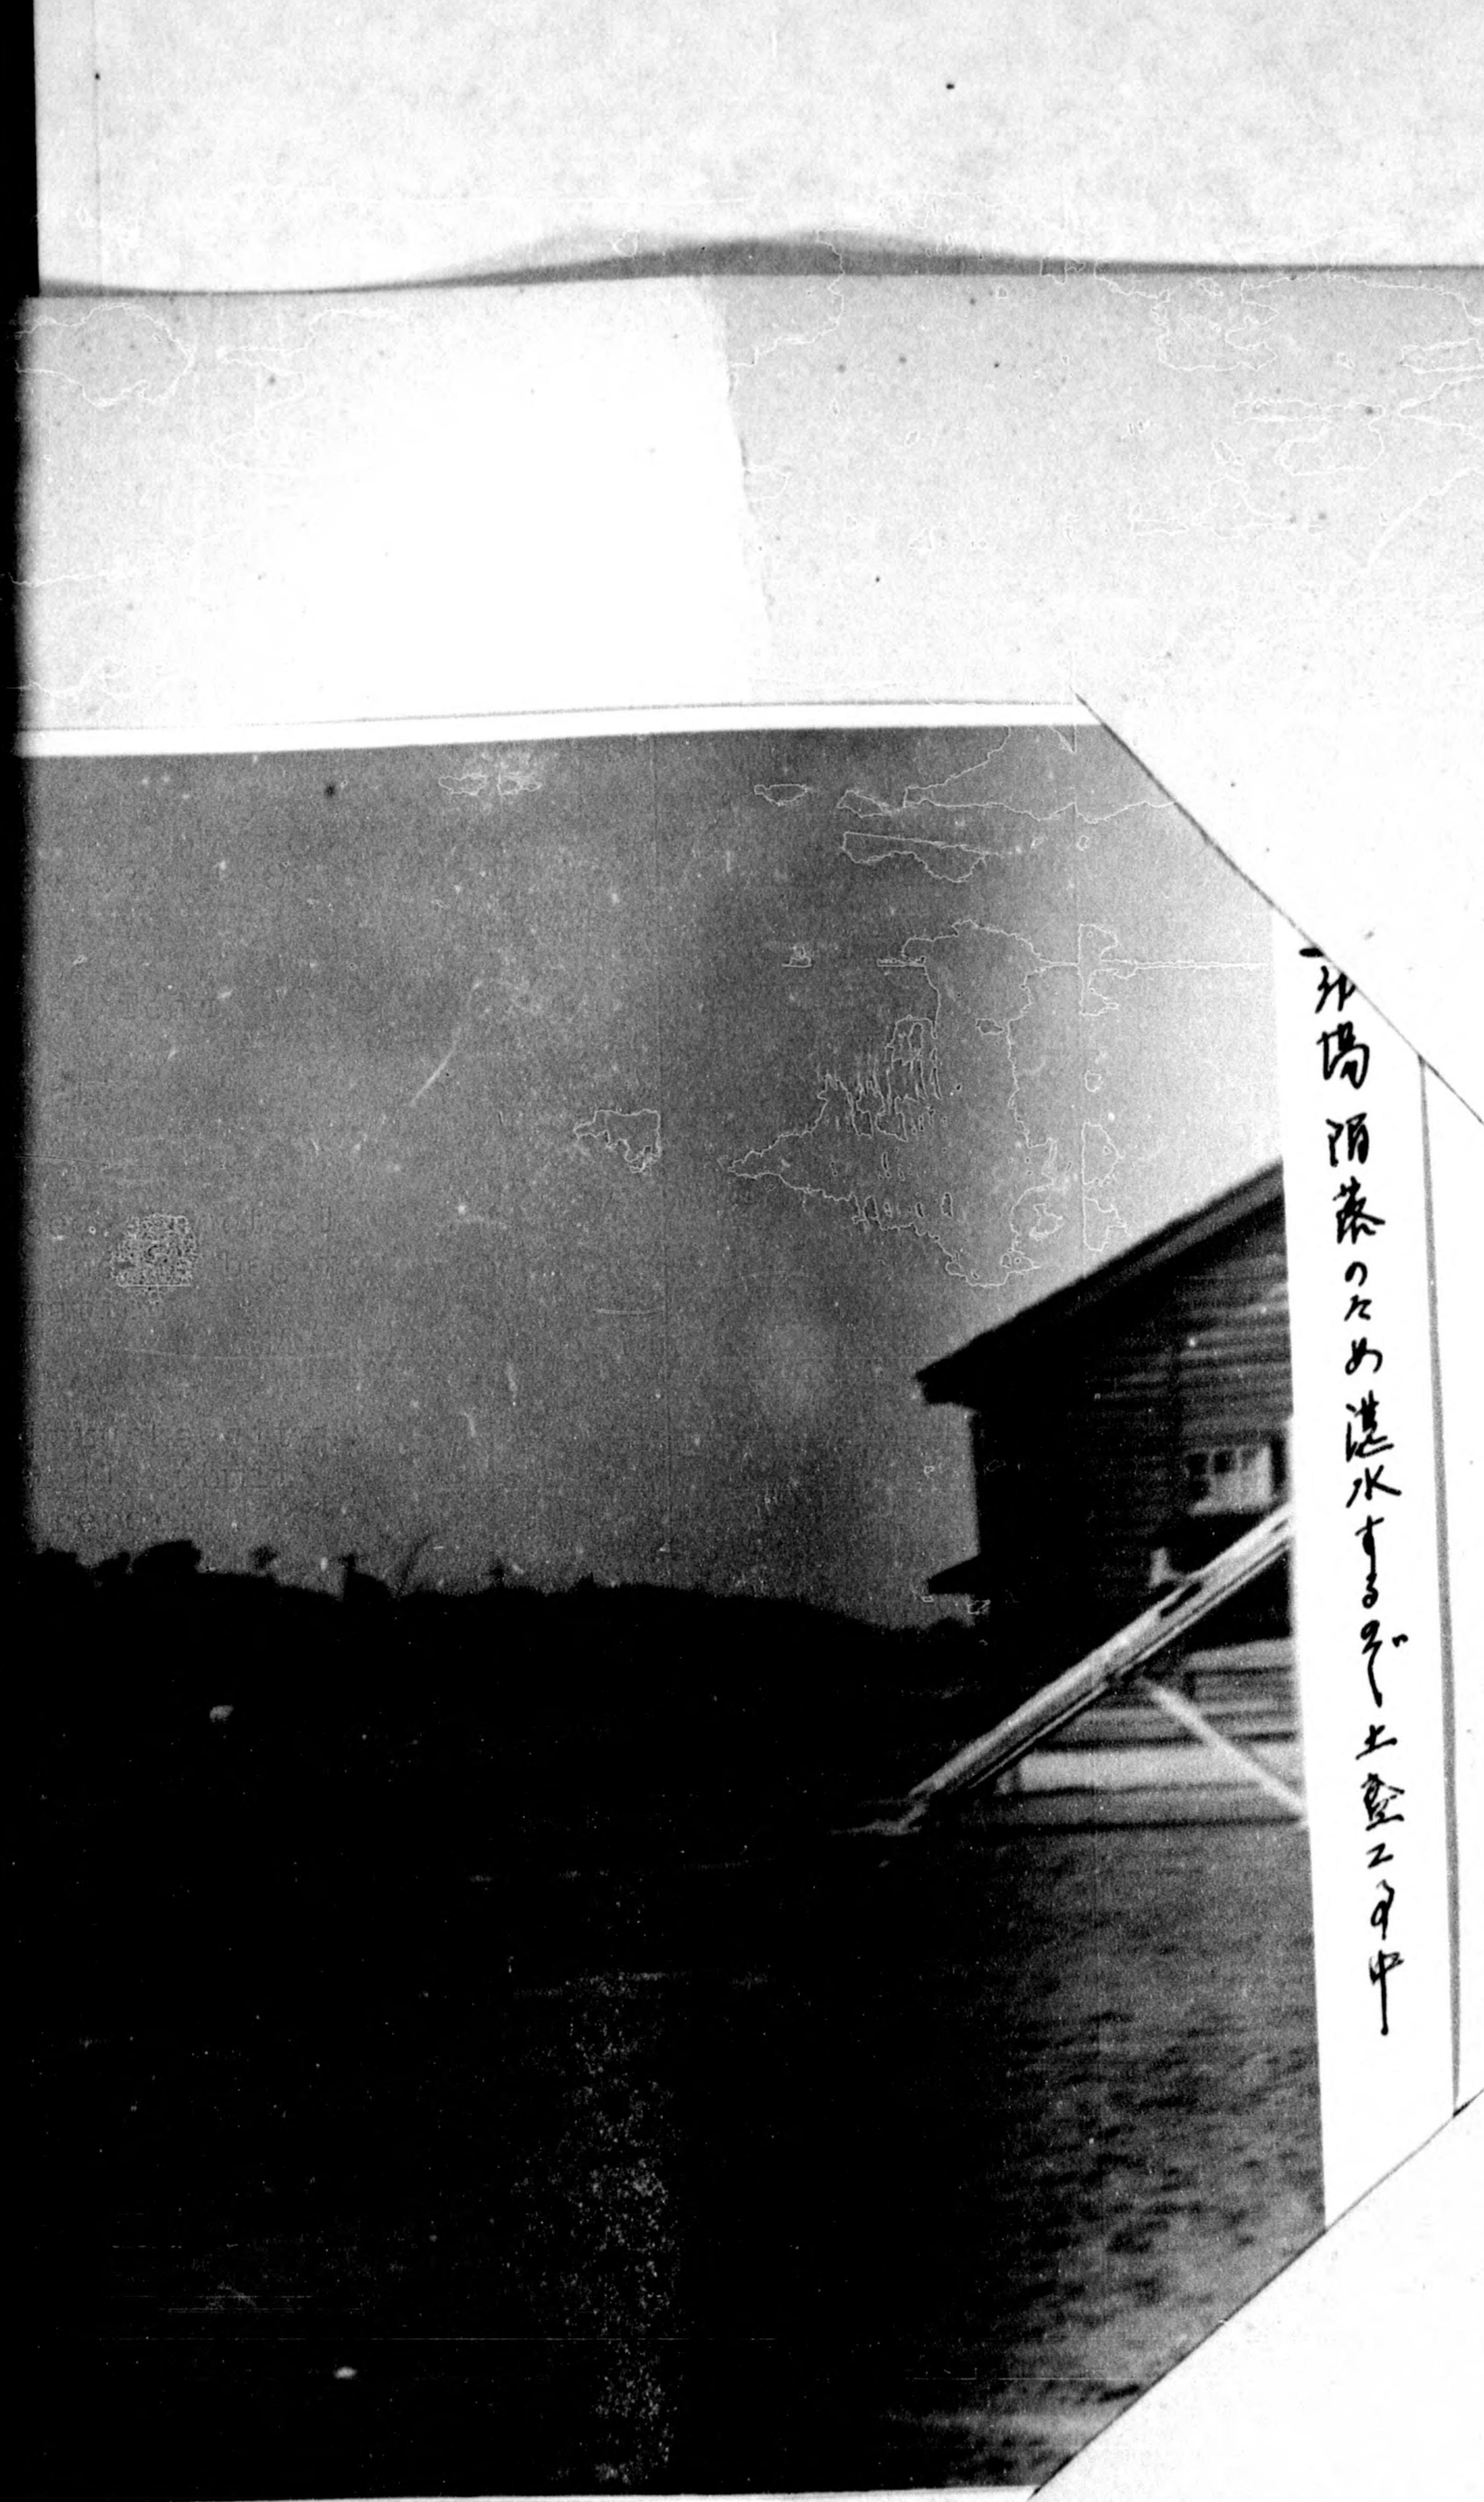
SHIMOYAMADA COAL MINE
Furukawa Mining Co.,
Reconstruction work of playground is being done in dr

工場消毒のため湛水する迄土盛工事中

ADA COAL MINE
Furukawa Mining Co.,
yground is being done in order to prevent the flooding.

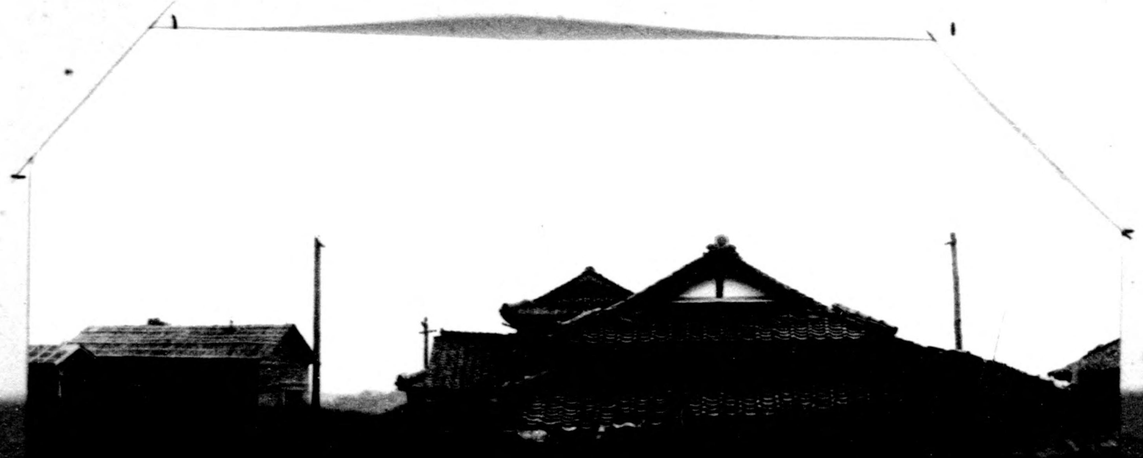
陥落のため家屋は傾斜し
県道より二米低くなっている

SHAKANOO COAL MINE

As ken-highway were made several repairing, the position of house is 2 meters lower than highway, house is decline, due to mining ,subsidence.
