SUBJECT: Expenditure of Funds for Building Repairs, Boki Seizo K.K., Haruki Plant, 32-28

SUBJECT: Application for Approval of Repair Work of Reparations Plant: Boki Seizo Kabushiki Kaisha Haruki plant

SUBJECT: Expenditure of Funds for Building Repairs, Showa Seiki Seizosho K.K., 32-92

SUBJECT: Expenditure of Funds for Building Repairs and Maintenance of Equipment, Futaba Kikai, K.K., 32-101

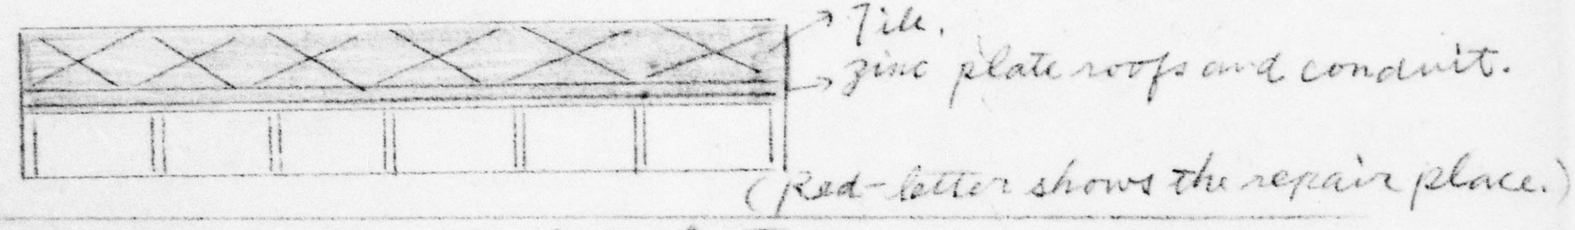
Sketch of the building in which reparation machine custodied.

(Red-letter shows the repair place.)

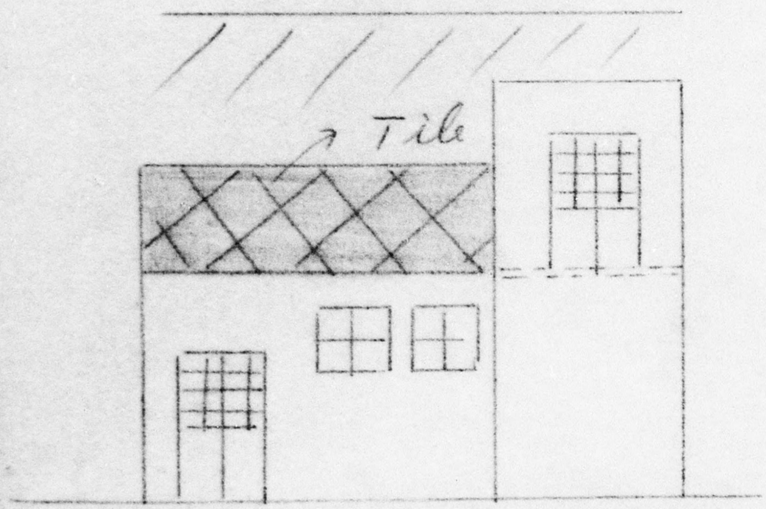
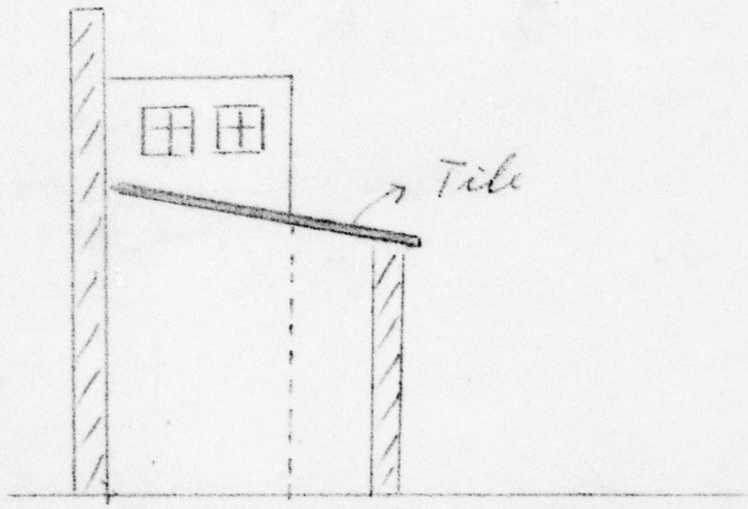
Transformer sub-station.

(Red-letter shows the repair place.)

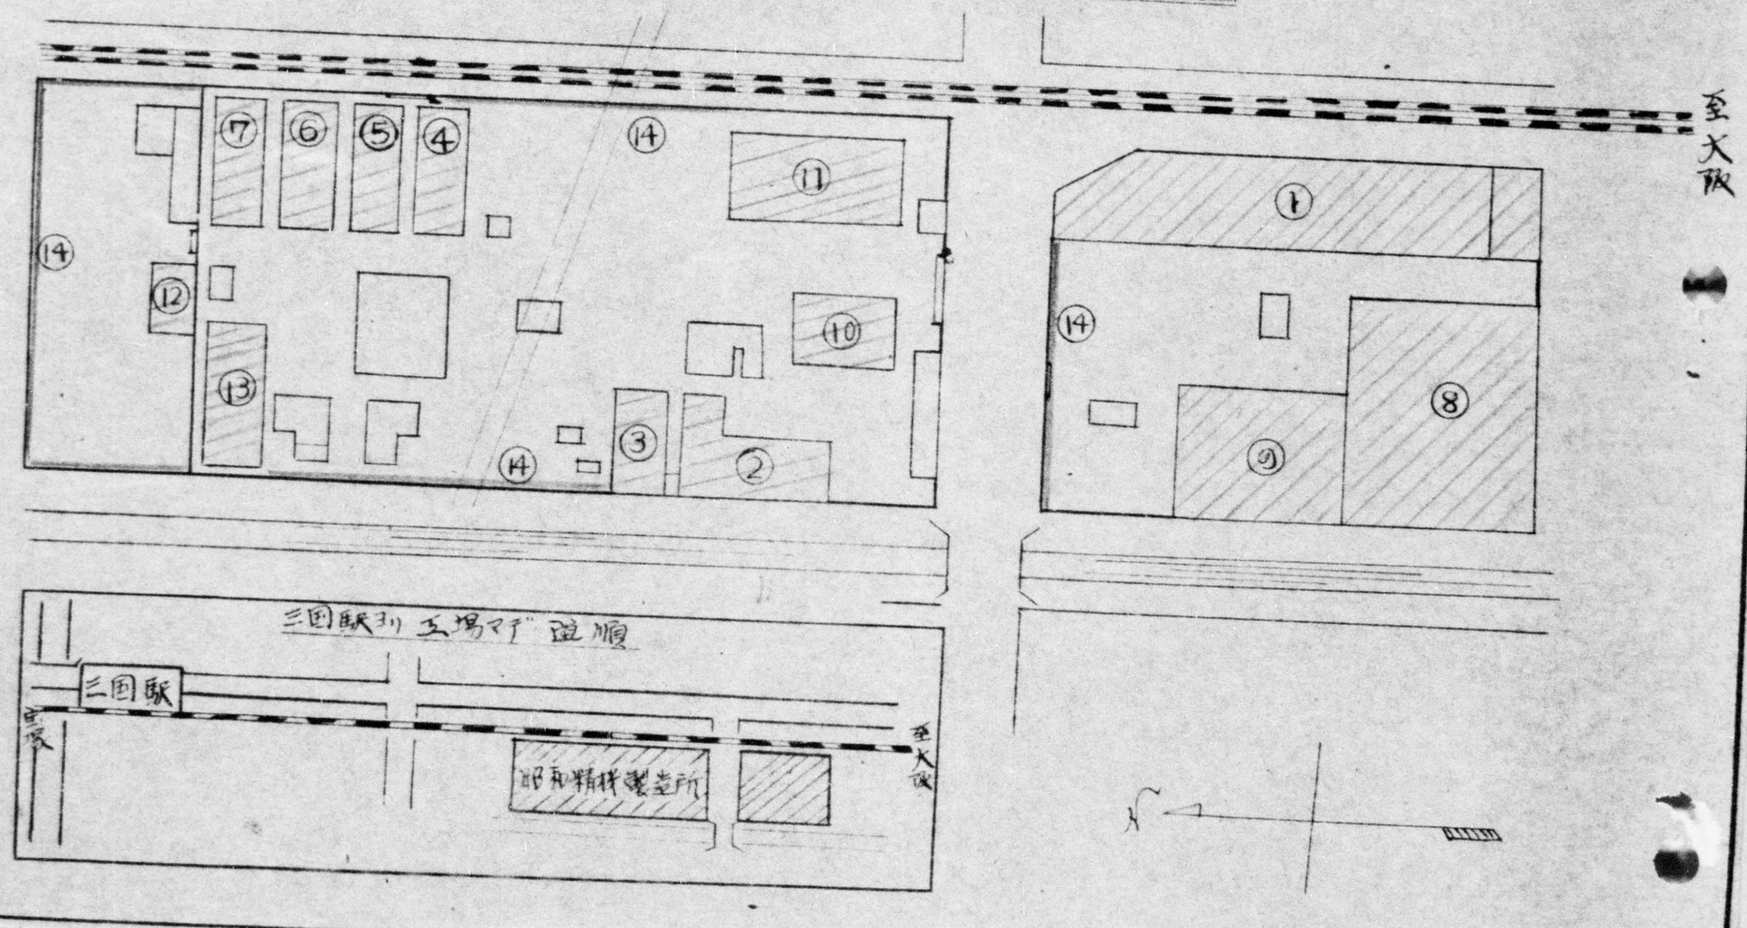
株式会社昭和精機製造所 工場配置図

(a) Recommend repair of Bldgs 3 thru 7 and ~~Bldg 9.~~

(b) Number of machines stored, as compared to the number in operation, and the extent of damages to Bldgs 1, 2, 8, 10, 11 and 13 do not warrant allocation of funds.

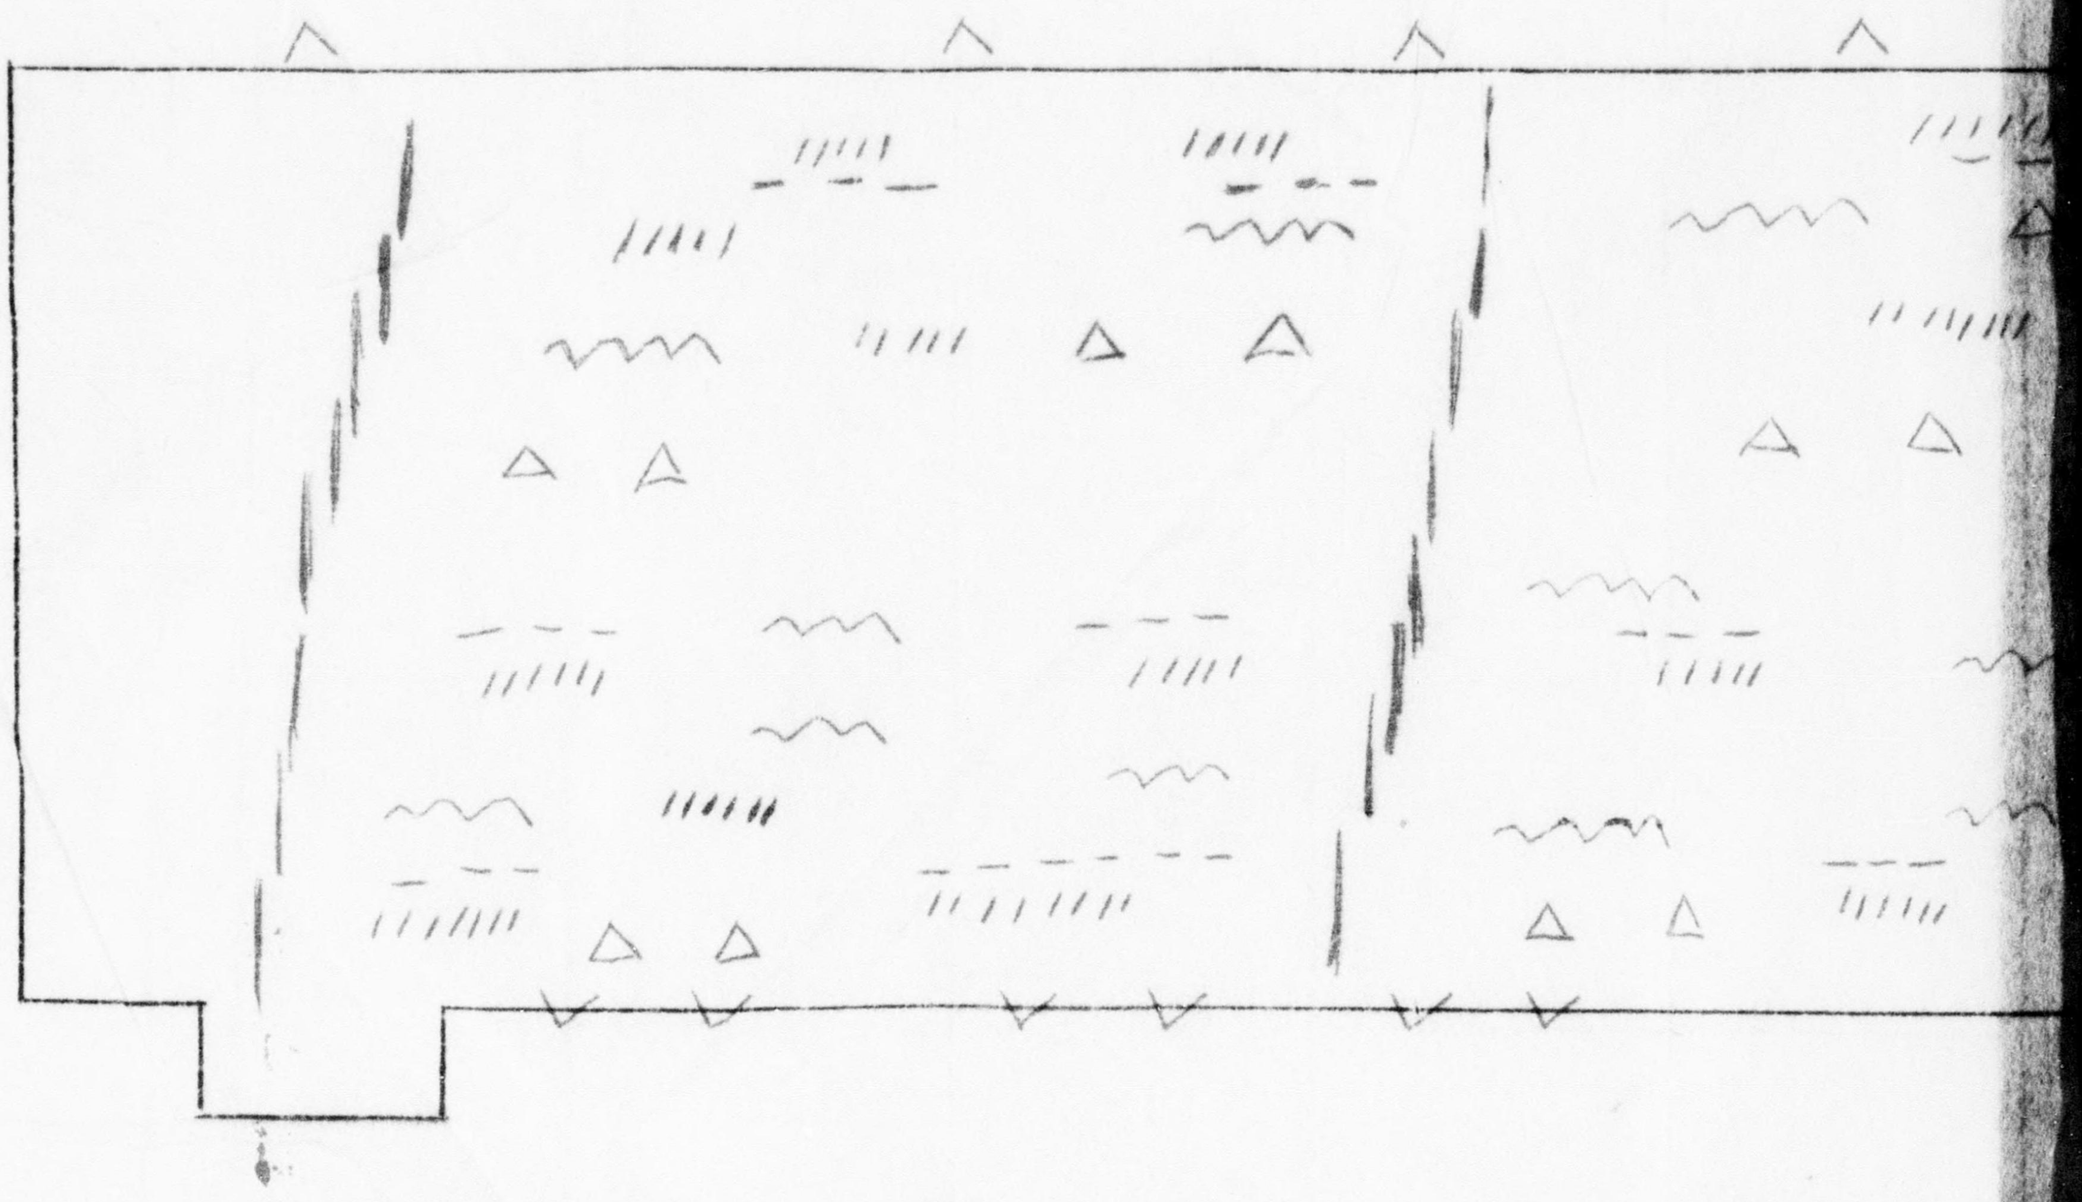
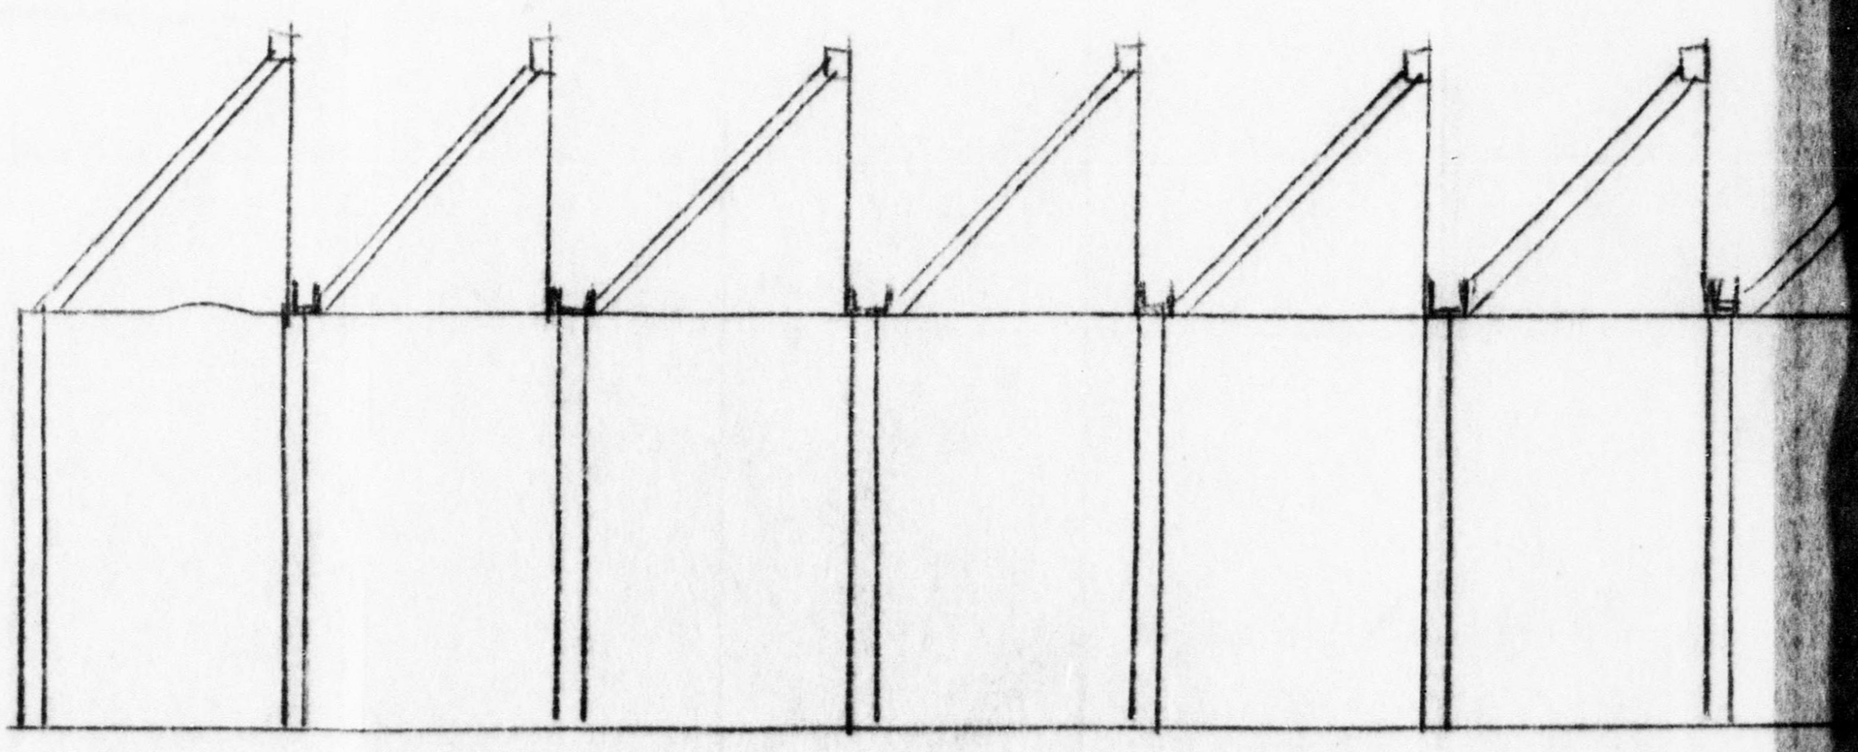
rain leak from roof tile breakage

rain leak, from ridge tile breakage

roof-board damage

Repair of the roofs, the rain-pipes, the windows and the electric wires.

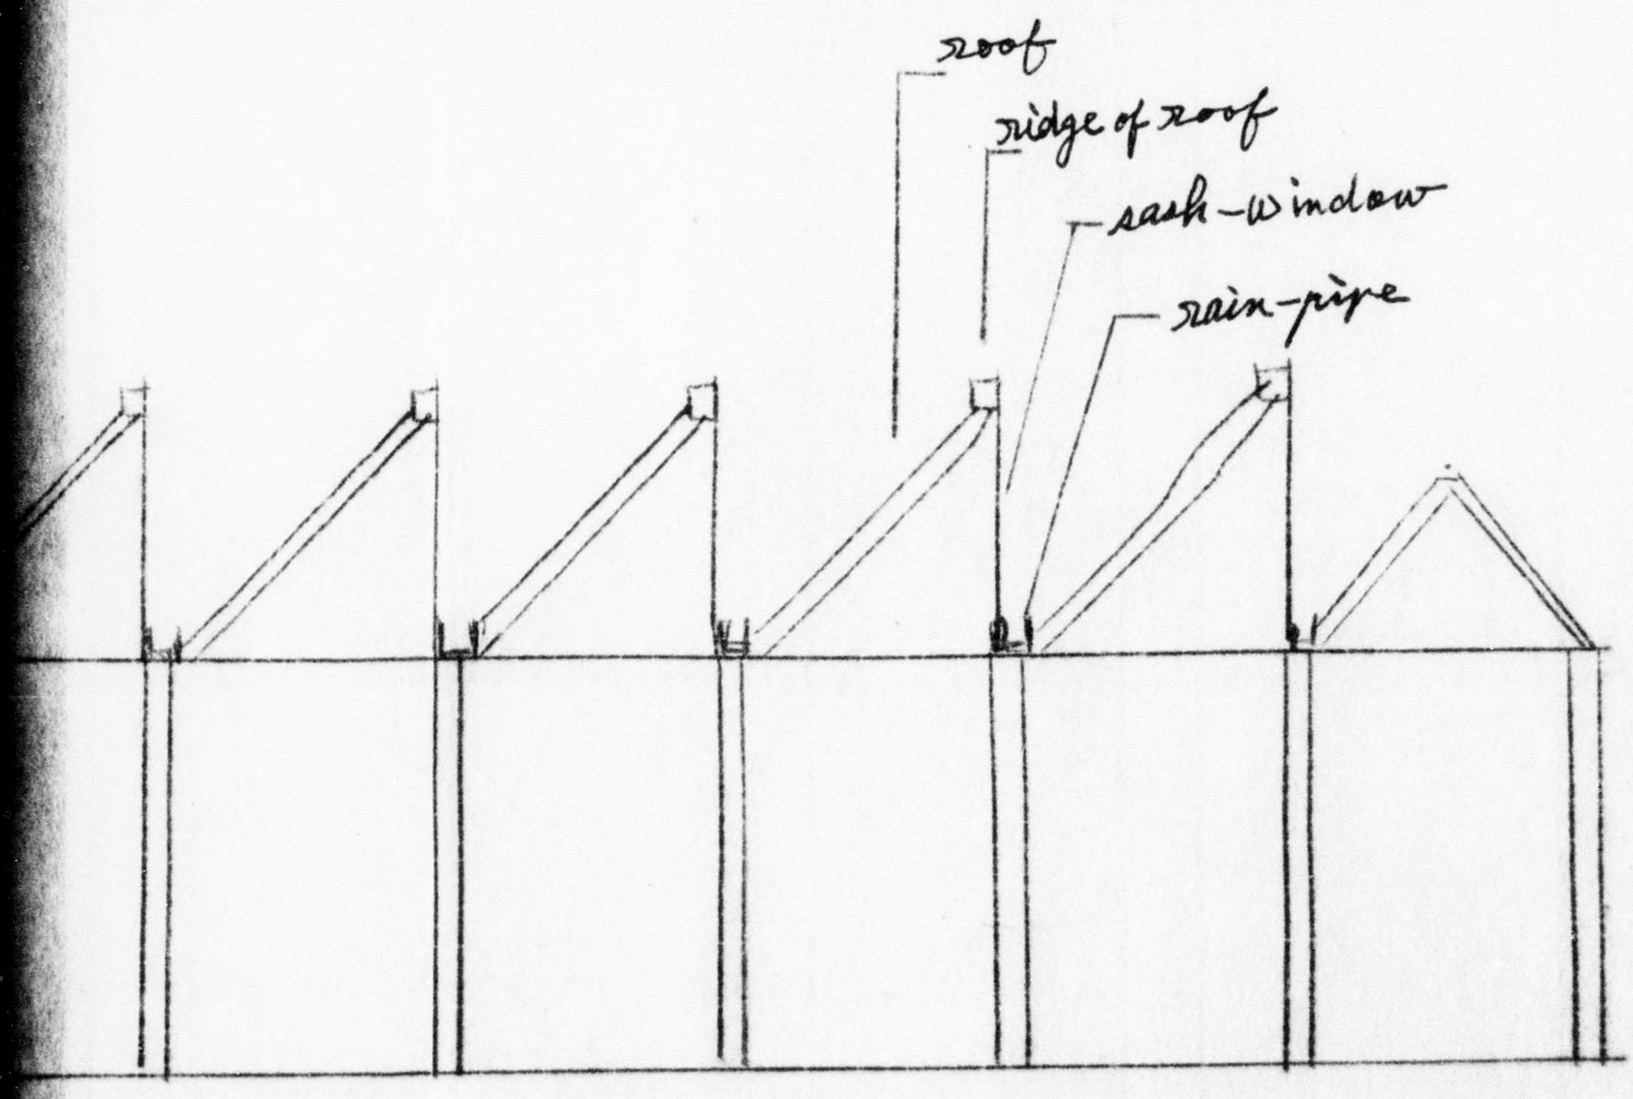
Cross section drawing

rain leak, from ridge tile breakage
