*NIST Special Publication 862*

# 1994 Northridge Earthquake Performance of Structures, Lifelines, and Fire Protection Systems

*Diana Todd, Nicholas Carino, Riley M. Chung, H. S. Lew, Andrew W. Taylor,  
William D. Walton, James D. Cooper, and Roland Nimis*

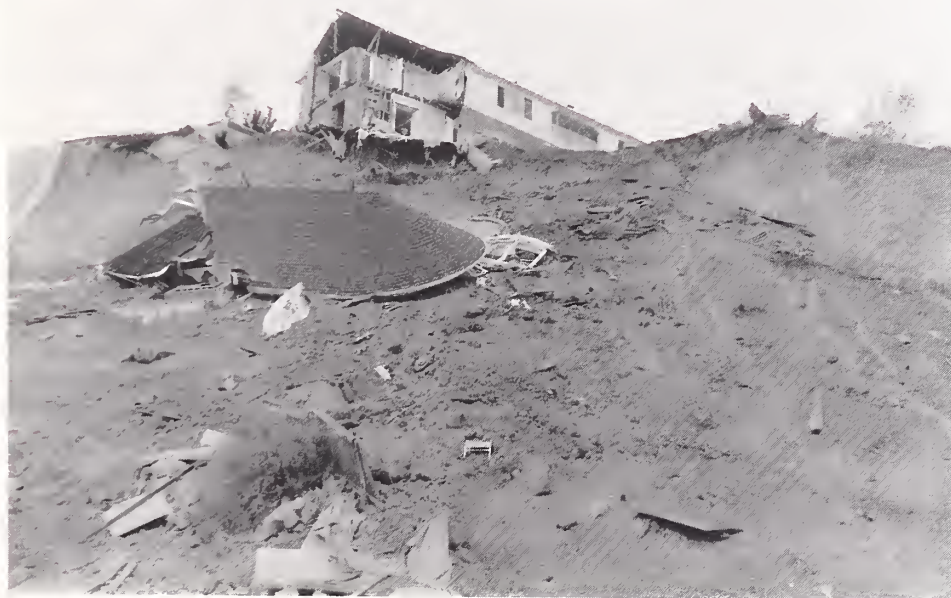
Landslides, rock slides and slope failures were the most visible geotechnical effect caused by the earthquake. Landslides along the Pacific coast in Santa Monica and Malibu damaged several buildings (fig. 2.8). Rockfalls in the Santa Monica, Santa Susana, and San Gabriel Mountains closed roads. Mulholland Drive in Sherman Oaks was temporarily closed because of the threat of slope failure.

Figure 2.8. A landslide along the Pacific Coast Highway north of Santa Monica undermined the foundation of a house at the crest of the slope, bringing a portion of the house down.

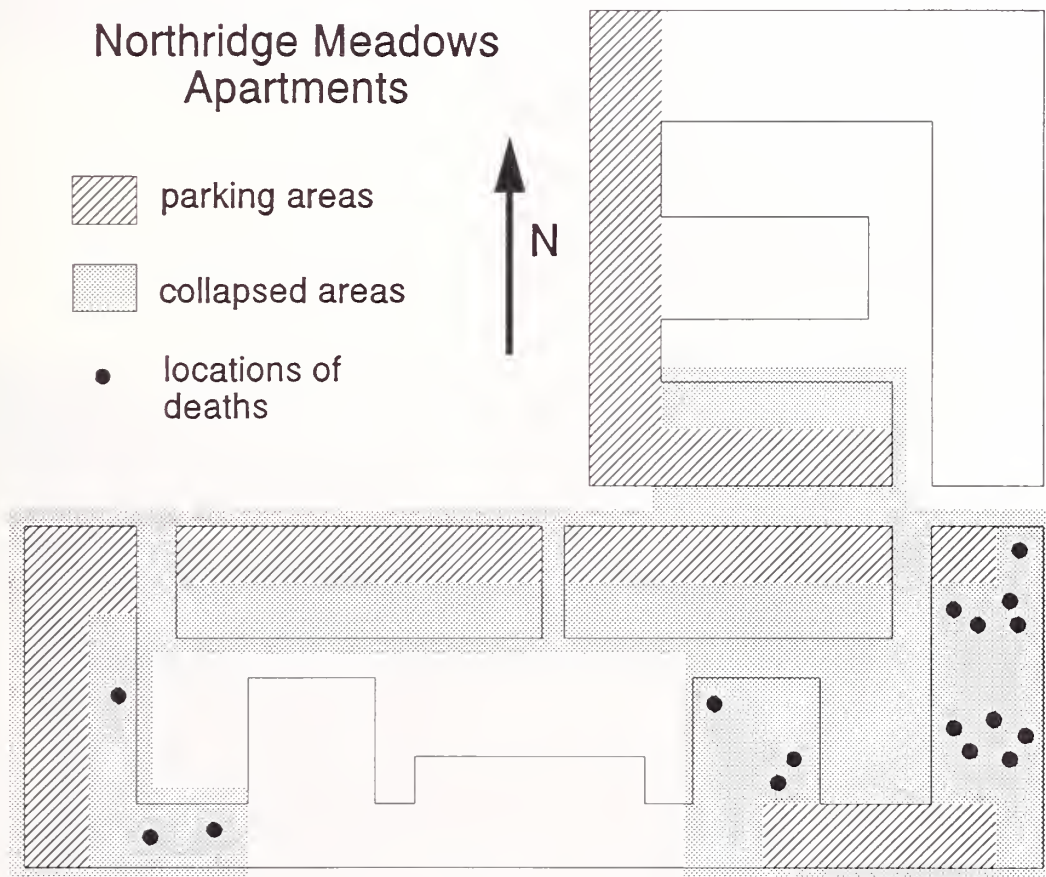
Figure 3.3. This plan of the Northridge Meadows apartment complex shows the distribution of parking and living spaces at the first level, and locations of deaths (source: Los Angeles Times, January 24, 1994). The shaded areas indicate the portions of the complex which collapsed.

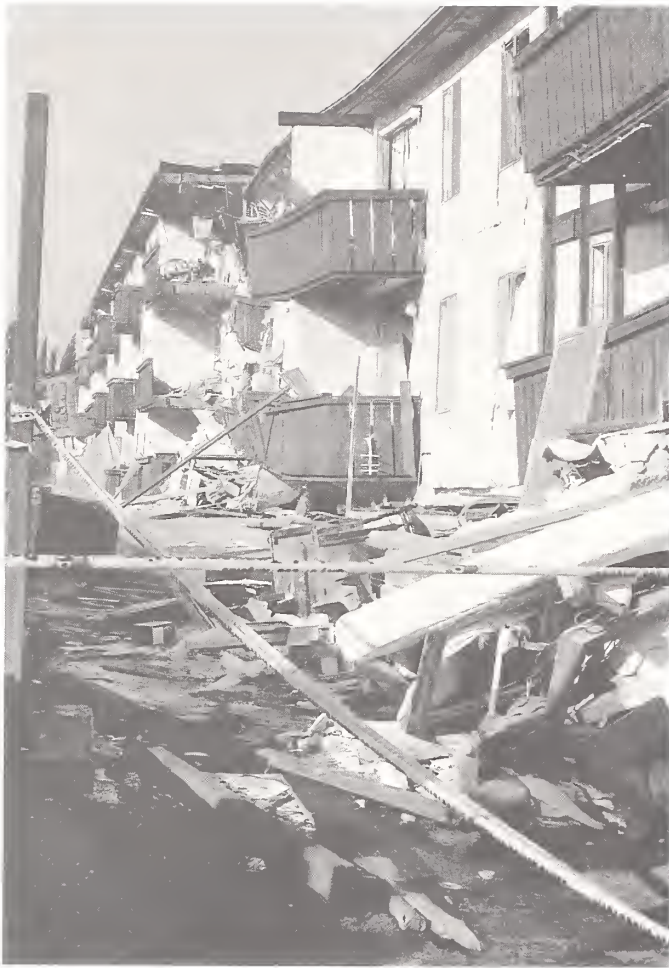
Collapses in a single apartment complex caused sixteen of the twenty-two deaths related to building failures [12]. The Northridge Meadows complex, constructed in 1972 (Los Angeles Times, January 19, 1994), consisted of several three-story wood-frame buildings, arrayed around courtyards on two sides of a mid-block alley. About half of the units had open spaces for parking on the street level. Typically these were around the perimeter of the complex. Most of the interior courtyard-facing units had living space at the ground level rather than parking. About half of the buildings in the complex collapsed. In all of the collapses, the first story gave way while the second and third stories remained largely intact. The 16 people killed were in first story apartments. All the buildings in the complex suffered some damage (figs. 3.3 and 3.4).

Figure 3.4. At the Northridge Meadows apartment complex near the epicenter the first story in several of the buildings collapsed, killing sixteen people. The second and third stories remained essentially intact. Large portions of the first story in these buildings were open space for parking. This type of collapse occurred in a significant number of similar apartment buildings throughout the affected area.

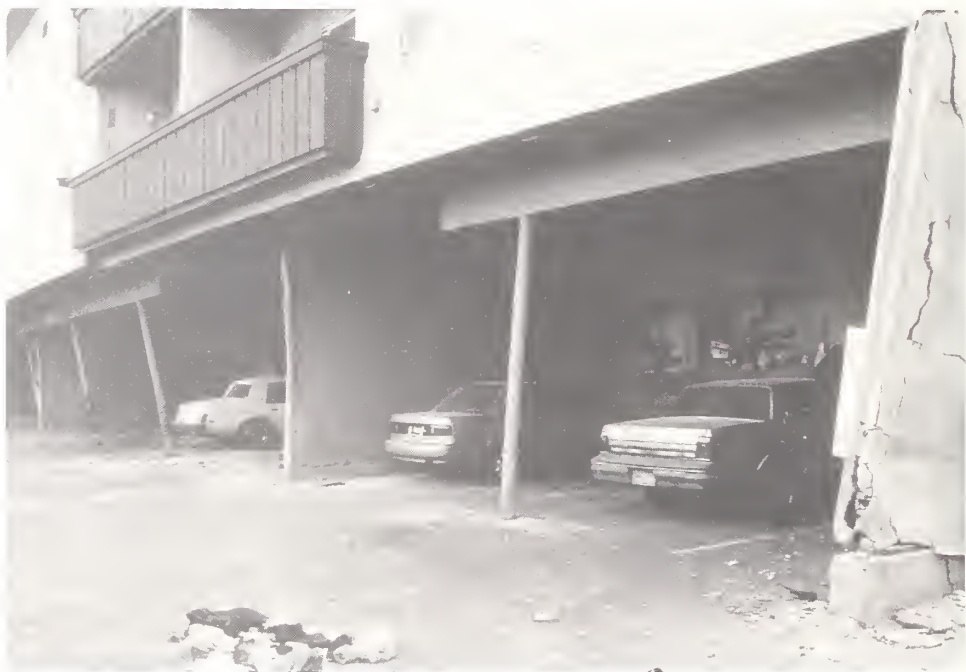
The buildings were predominantly wood-frame, with wire mesh and stucco walls. Rows of steel pipe columns supported the upper stories along the building perimeter between parking bays (fig. 3.5). Transverse walls were typically spaced about every three parking bays. Longitudinal walls separated the parking areas from first story living spaces. The wire mesh and stucco coating on these walls provided insufficient resistance to the lateral earthquake forces generated by this earthquake.

Figure 3.5. Steel pipe columns between parking bays supported the upper stories of the Northridge Meadows apartment buildings. Few of the buildings in the north half of the complex collapsed, but all were damaged.

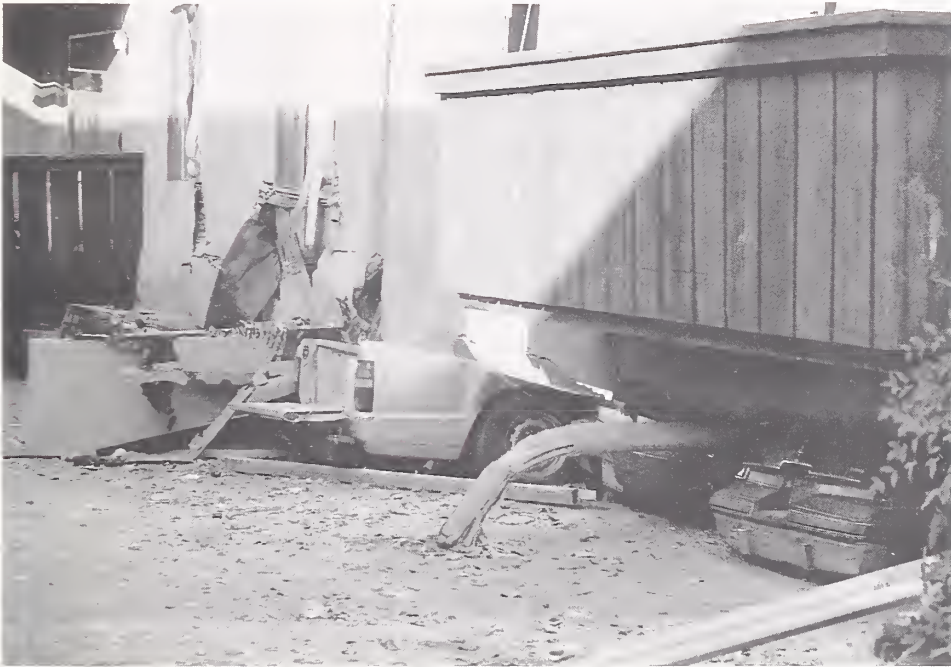
Figure 3.6. At Northridge Meadows, the first story steel pipe columns generally hinged near their bases but retained their length, controlling the displacement of the upper stories.

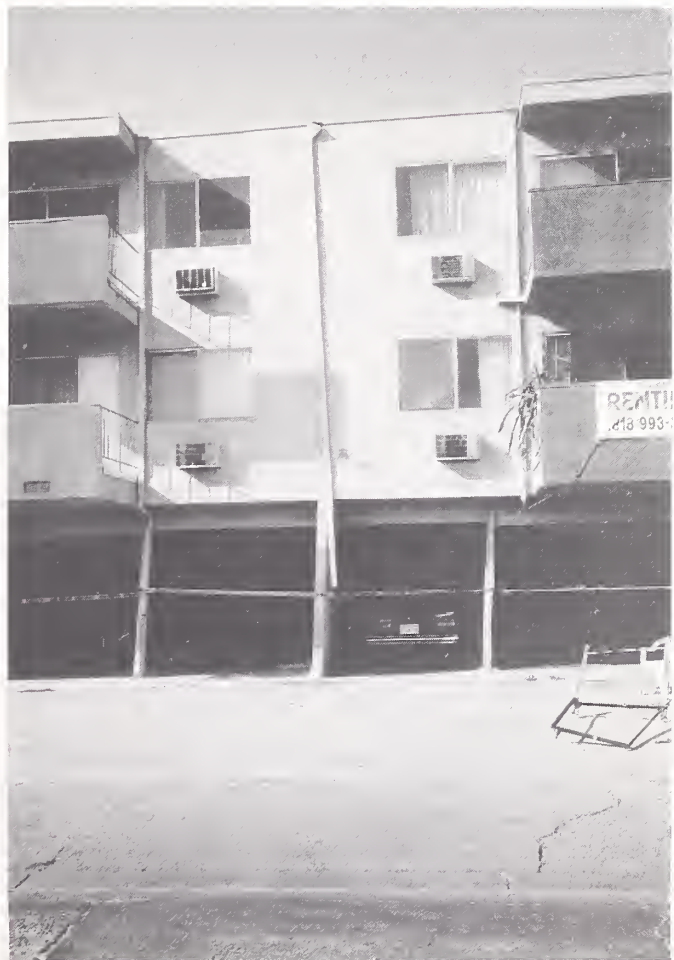
Figure 3.7. Racking, or leaning, of open first story parking areas was a common feature of damaged two and three-story apartment buildings.

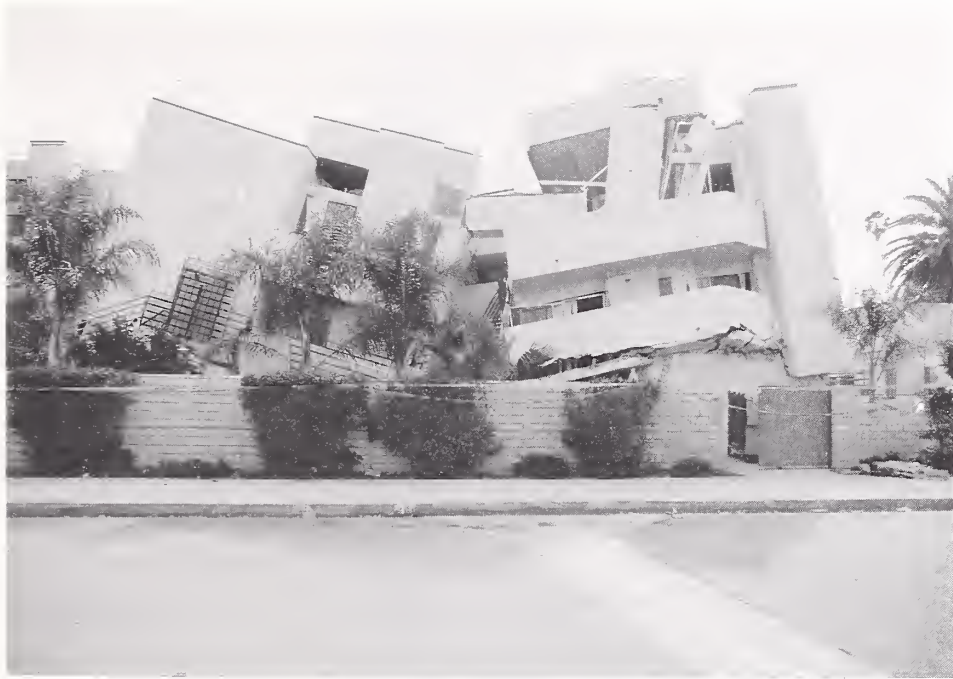
entire first story used for parking, located on Sherman Way in Sepulveda. In this building, the first story parking area was open only on the transverse ends. Concrete block walls formed the longitudinal walls at the first story and a row of concrete columns supported the mid-span of the flat plate concrete floor slab above. The two stories of living space over the parking level were wood-framed with a stucco facade. The entire line of mid-span concrete columns failed. The two halves of the upper stories settled in towards the middle (figs. 3.10 and 3.11), essentially destroying the structure.

Figure 3.10. The central row of concrete first-story columns in a three story apartment building on Sherman Way in Van Nuys collapsed, causing the wood-framed upper stories to settle inward.

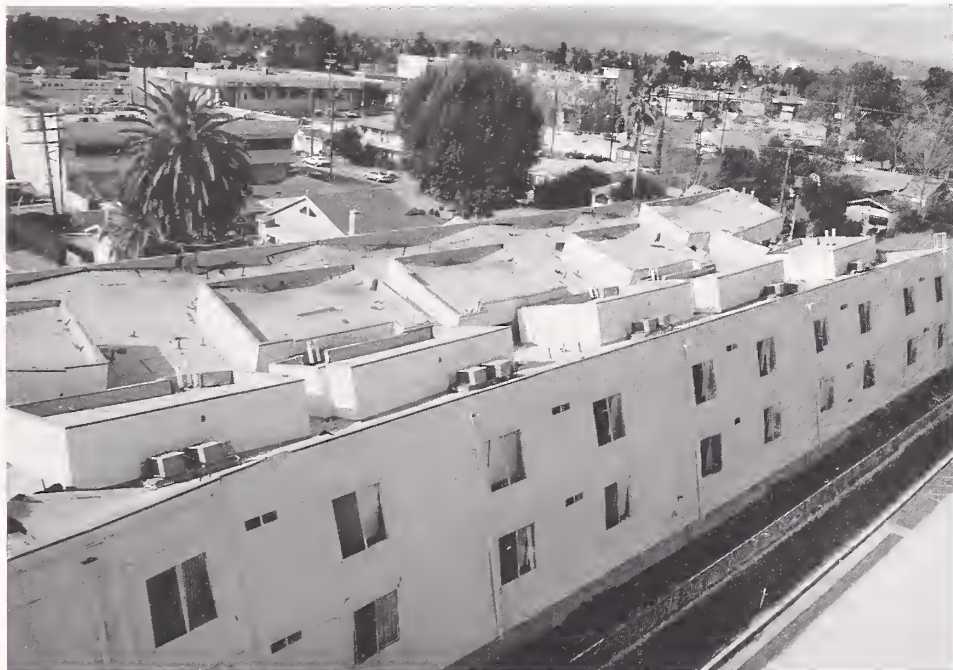
Figure 3.11. This overhead view of the partially-collapsed apartment building on Sherman Way shows the solid concrete masonry block perimeter walls along the longitudinal axis of the building. Access to the first story parking was limited to the transverse ends of the building. When the row of interior columns failed, both sides of the building settled in towards the middle.

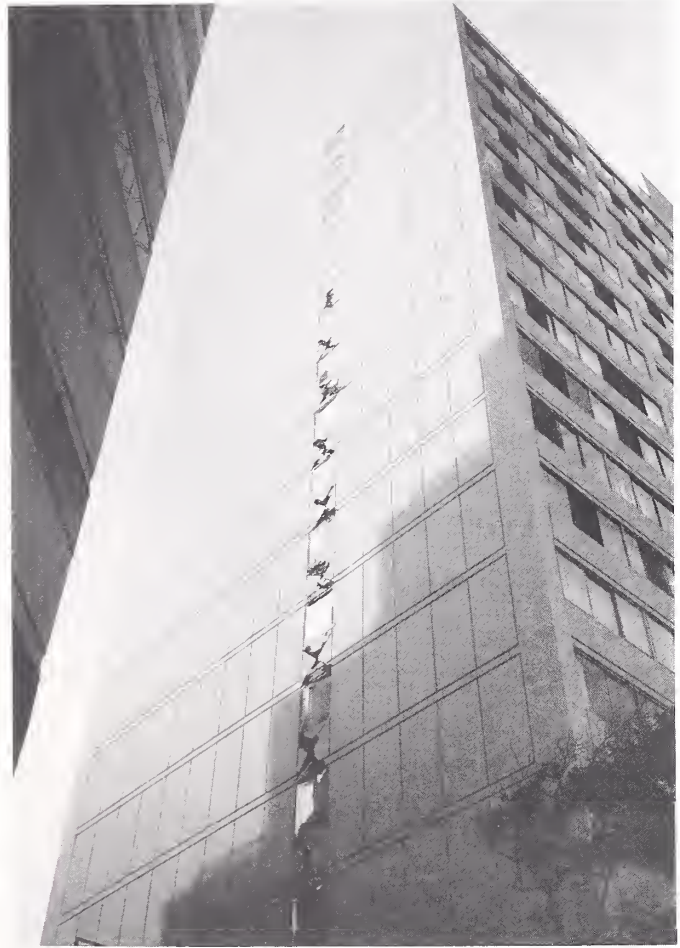
Figure 3.12. Champagne Towers apartment building in Santa Monica suffered a classic form of earthquake damage: shear failure of the coupling beams between linked shear walls at the transverse end of the building.

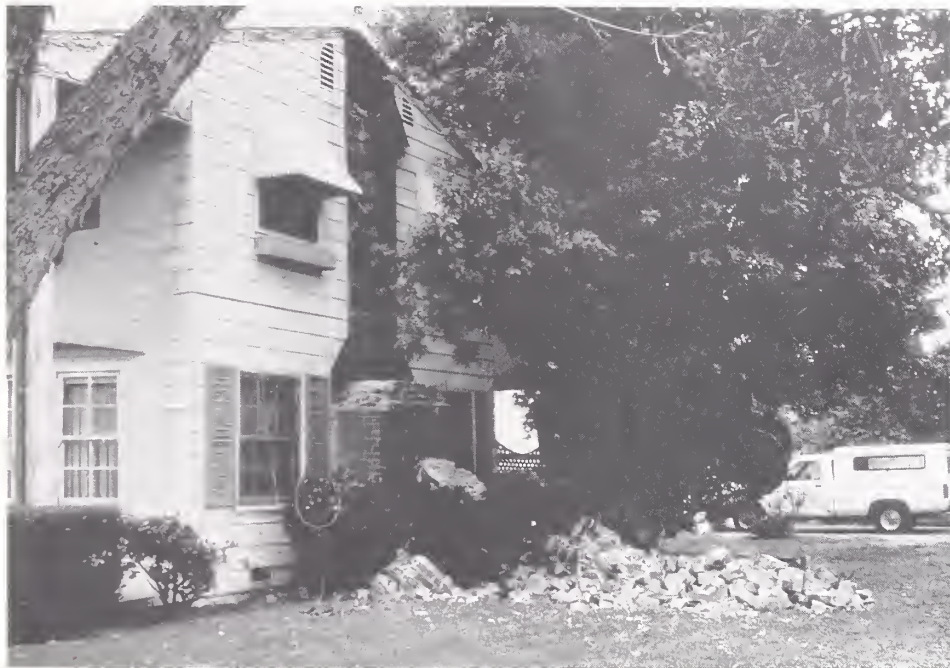
Figure 3.17. Failure of masonry chimneys was common.

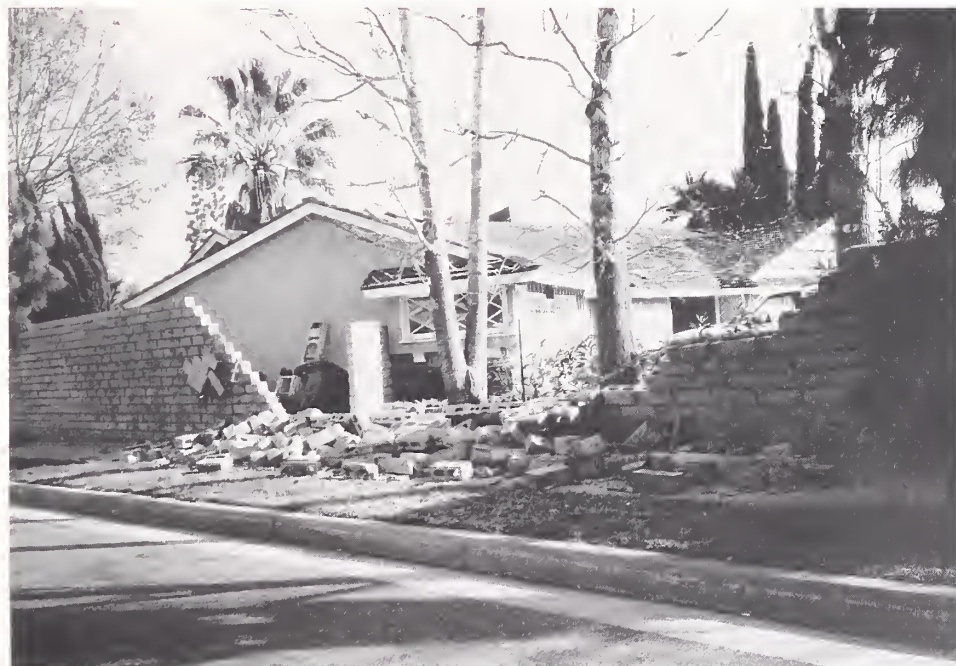
Figure 3.18. Damage to masonry privacy fences was ubiquitous. Many of these fences were tall enough to have been a serious threat to passersby when they failed. Luckily, due to the early morning hour of the quake, yards and sidewalks were essentially deserted.

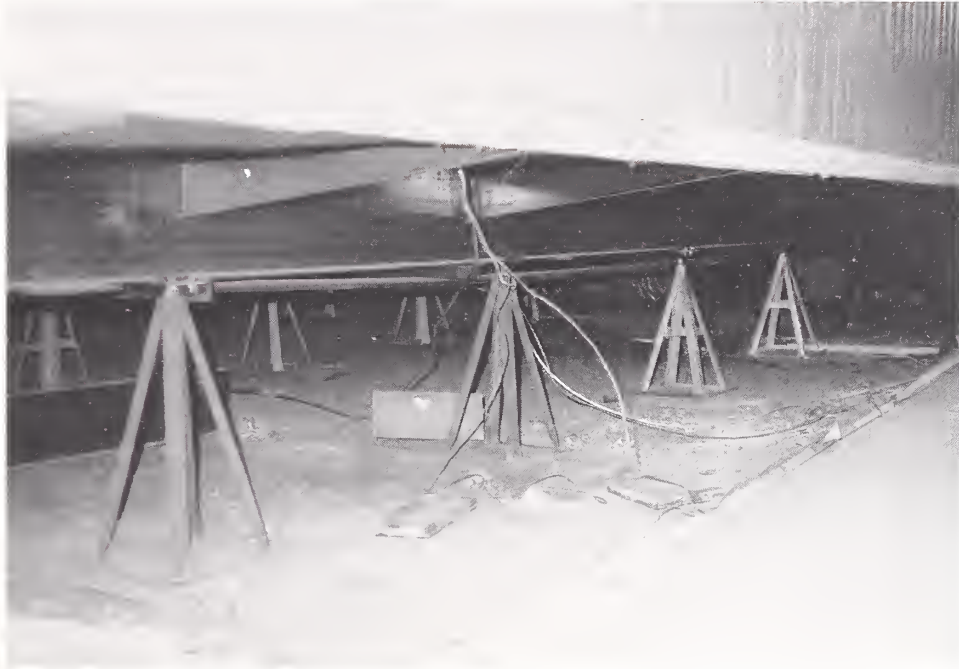
Figure 3.21. Another foundation system used for manufactured housing consists of supports constructed of small metal angles.

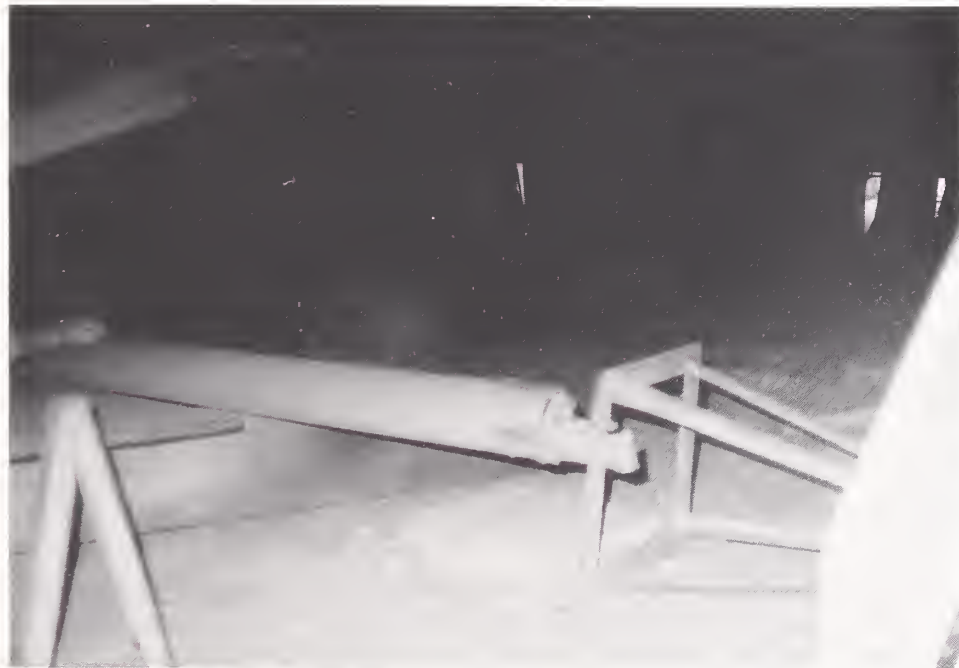
In some cases, the metal base supports were braced with small steel angle members. However, they were not adequately fastened to the supports and did not prevent the supports from rocking.

Figure 3.22. The metal supports under many homes tipped over, bringing down the houses above.

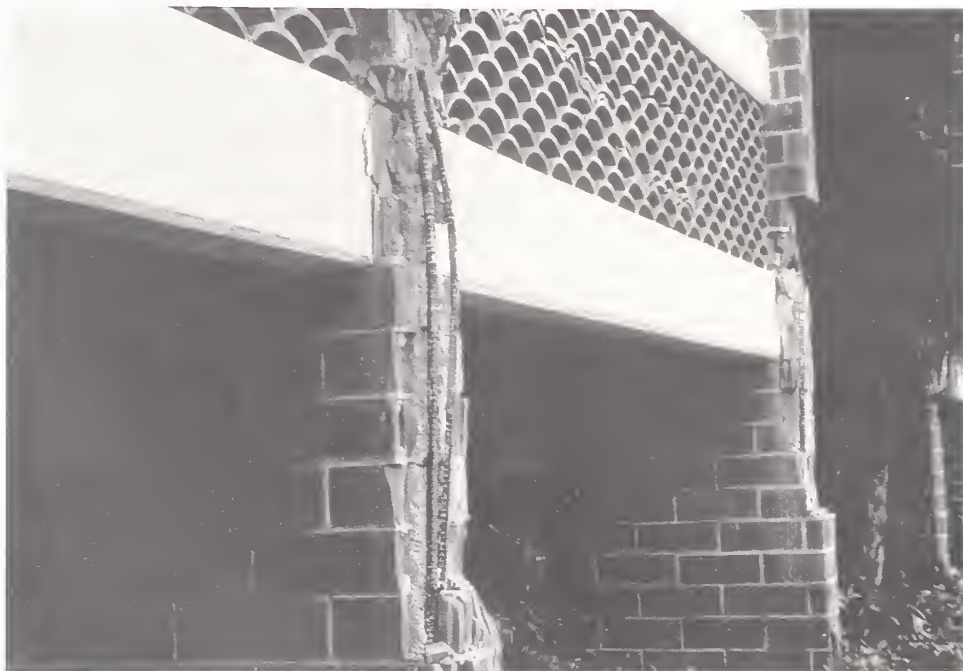
Figure 3.28. Two faces of the Berkley Convalescent Hospital had wing walls separating balconies. The ends of these wing walls spalled at the lower stories.

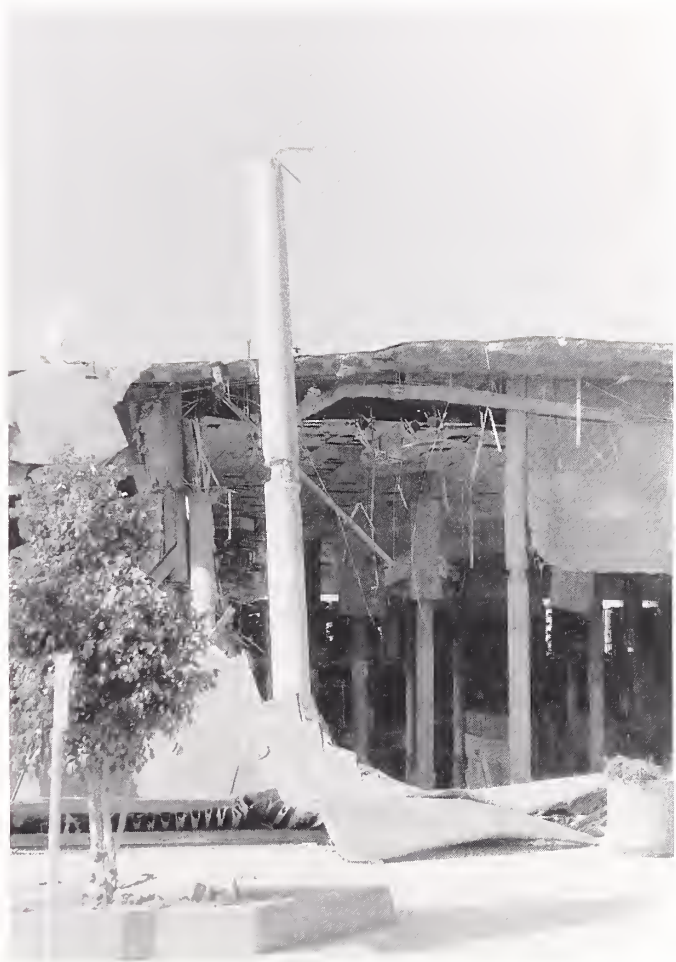
The collapse of large portions of the roof and floors of the three-story concrete Bullock's department store at the Northridge Fashion Center mall could have caused more deaths than any other single building failure in this earthquake. Many multi-story columns were left intact as the concrete slab floors and roof fell on top of each other to the basement, presumably due to punching shear failure of the slabs. The still-standing columns showed no evidence that slab reinforcement had been continuous through the columns (fig. 3.29). At the roof level, about a half meter of the column bar ends were bent over into the slab. The original building was extremely irregular, with a non-rectilinear vertical profile (fig. 3.30). Even in extremely regular buildings, this type of construction, which depends on the slab-column connection for moment-frame action, is vulnerable to damage from earthquake forces.

Figure 3.30. The Bullock's department store had an extremely irregular vertical geometry. At the northeast end it was shaped like a truncated pyramid.

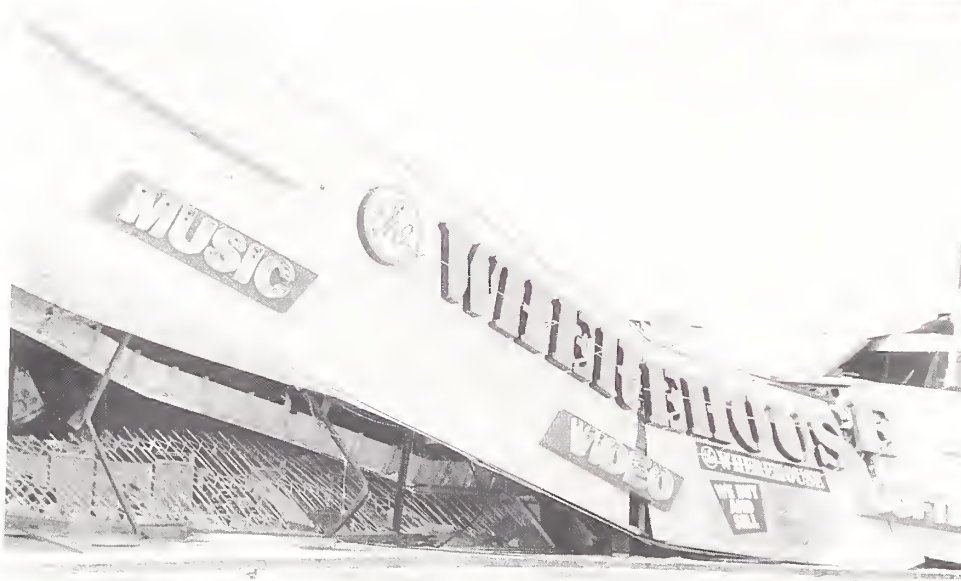
Figure 3.32. Many commercial buildings were damaged in the blocks south of the Northridge Fashion Center. The single-story Warehouse collapsed completely.

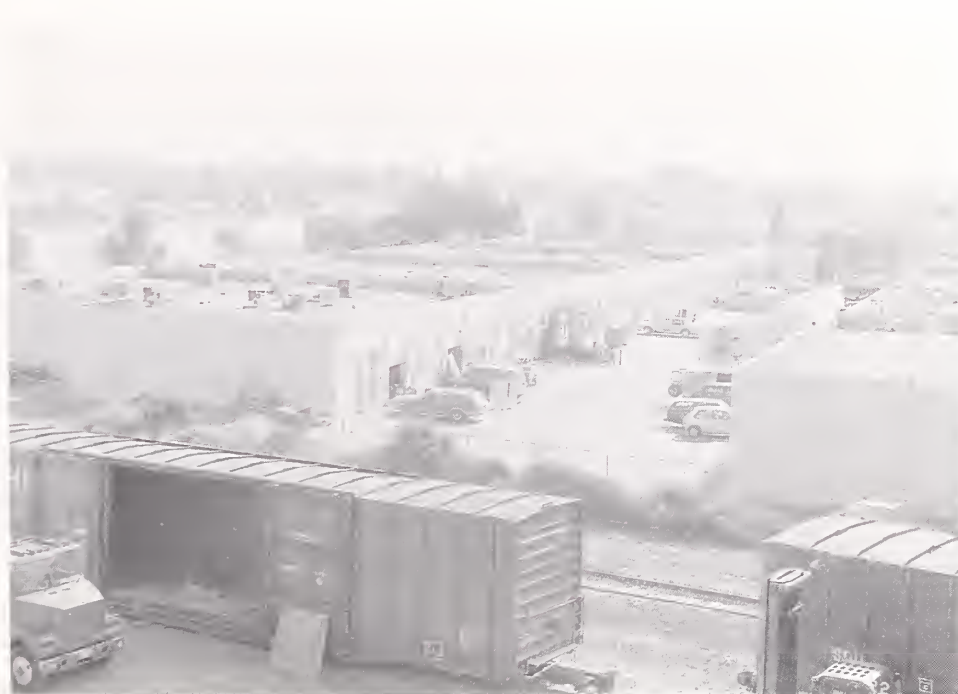
Figure 3.34. The single-story modern masonry commercial buildings directly south of the damaged Levitz furniture store and train derailment were apparently undamaged. All parapets and piers between garage openings appeared intact.

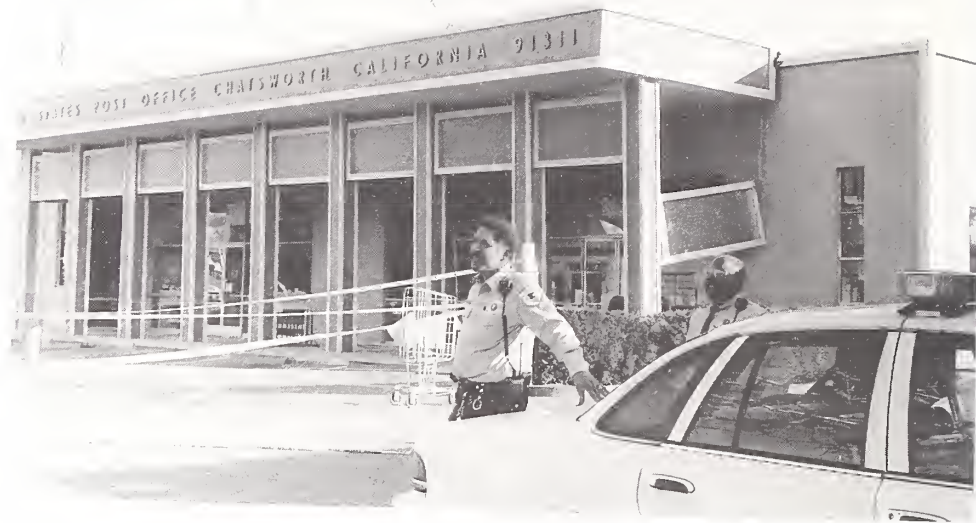
facade panel had become detached and interior ceiling panels had fallen (fig. 3.35). Mail was being collected in the parking lot.

Figure 3.35. The Chatsworth Post Office was closed due to damage. Mail was being collected in the parking lot.

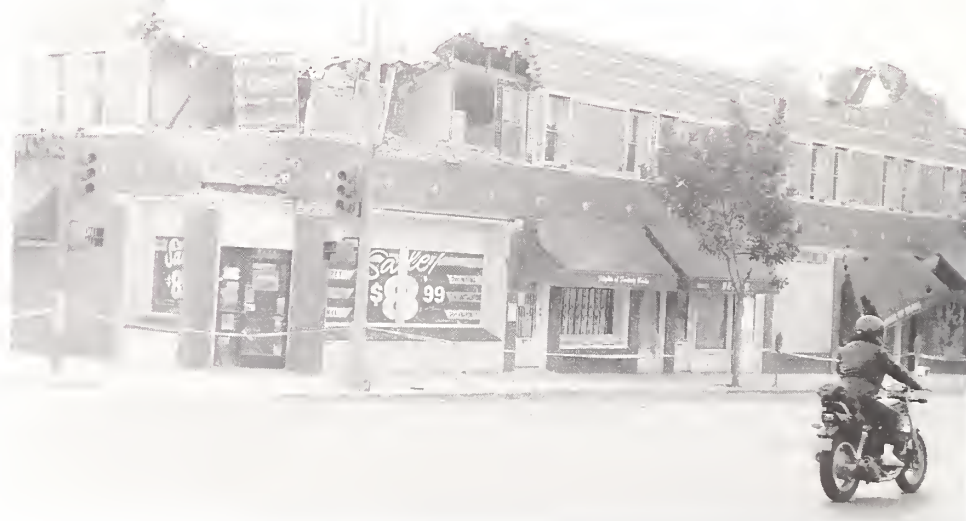
Figure 3.36. Damage to unreinforced masonry buildings, even those that had been rehabilitated, was common. Upper stories and corners were particularly vulnerable to damage. The rows of light-colored diamonds on the face of this building are the end plates of through-bolts used to connect the wall to the floor joists, a typical rehabilitation technique. The remains of parapet braces can be seen on the roof.

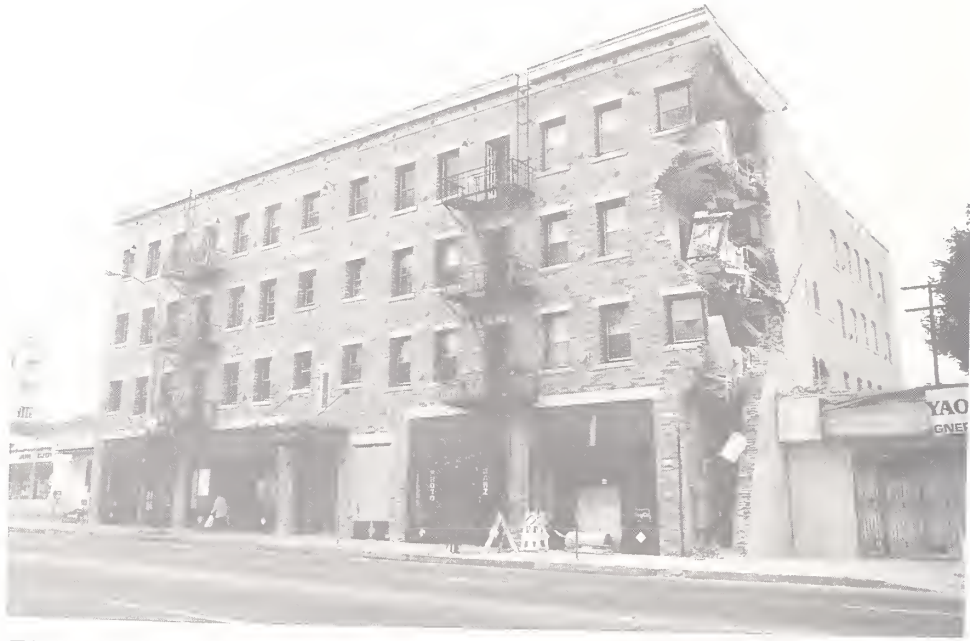
Figure 3.37. The corner of this rehabilitated unreinforced masonry apartment building in East Hollywood crumbled on all four stories.

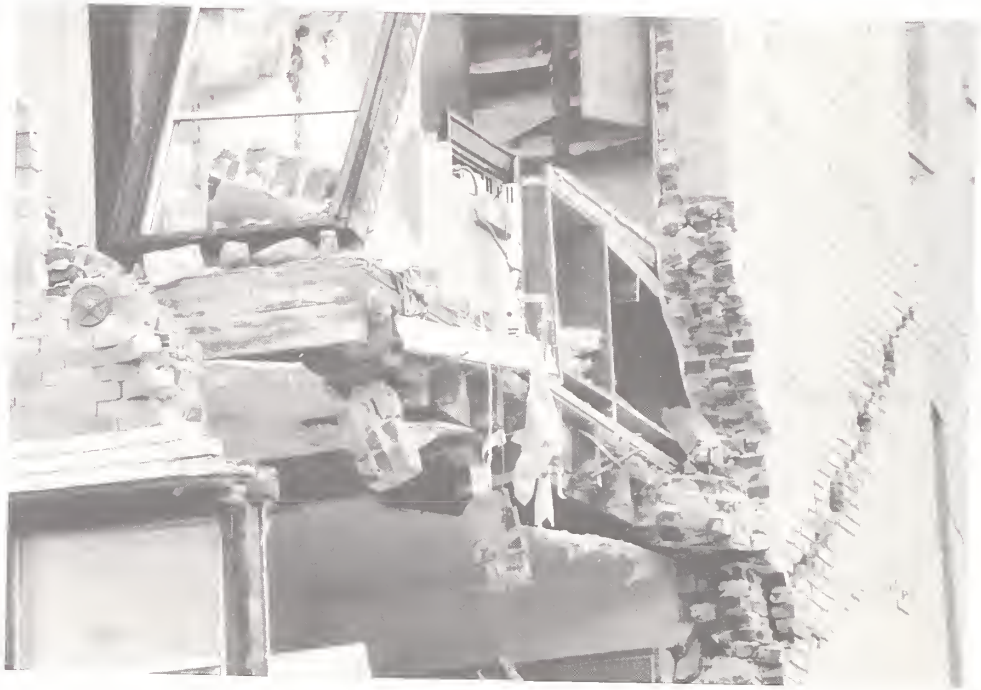
Figure 3.38. A close-up view of the third-story floor diaphragm of the building picture above shows (lower right) a rehabilitation bolt still holding a few bricks to the floor joists, after all the walls on three out of four sides of the bolts had disintegrated.

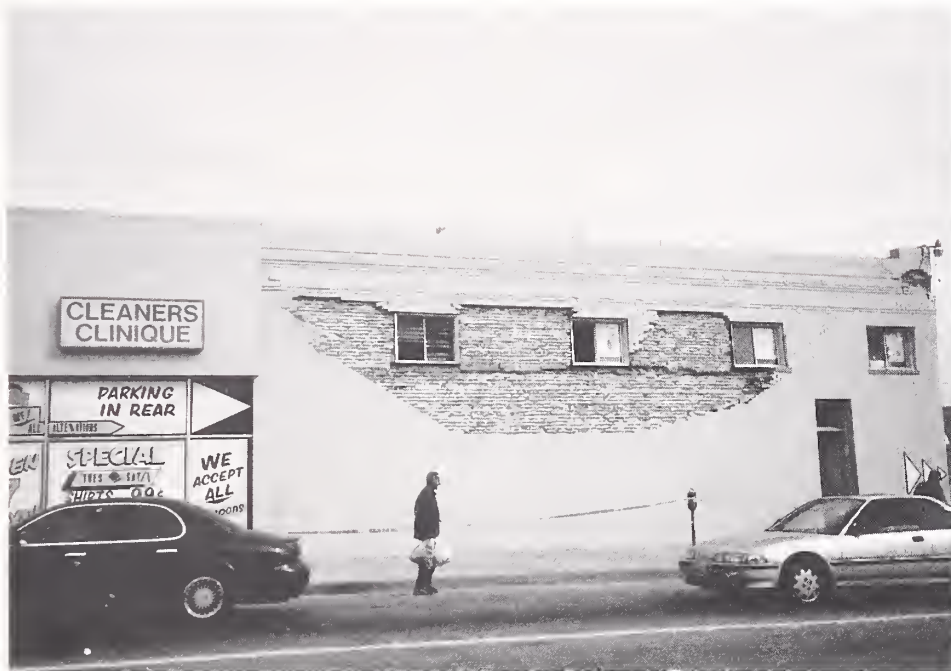
Figure 3.39. Only the exterior wythe of brick peeled off of this rehabilitated unreinforced masonry building in Santa Monica.

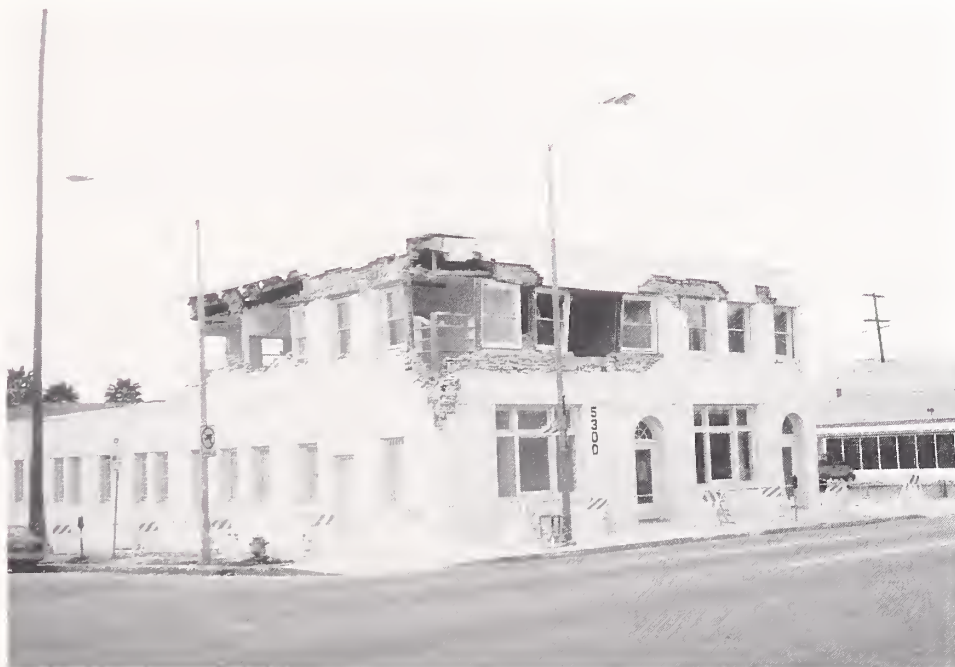
Figure 3.40. In other rehabilitated unreinforced masonry buildings, such as this two story structure in Hollywood, entire wall thicknesses were lost between rows of through-bolts.

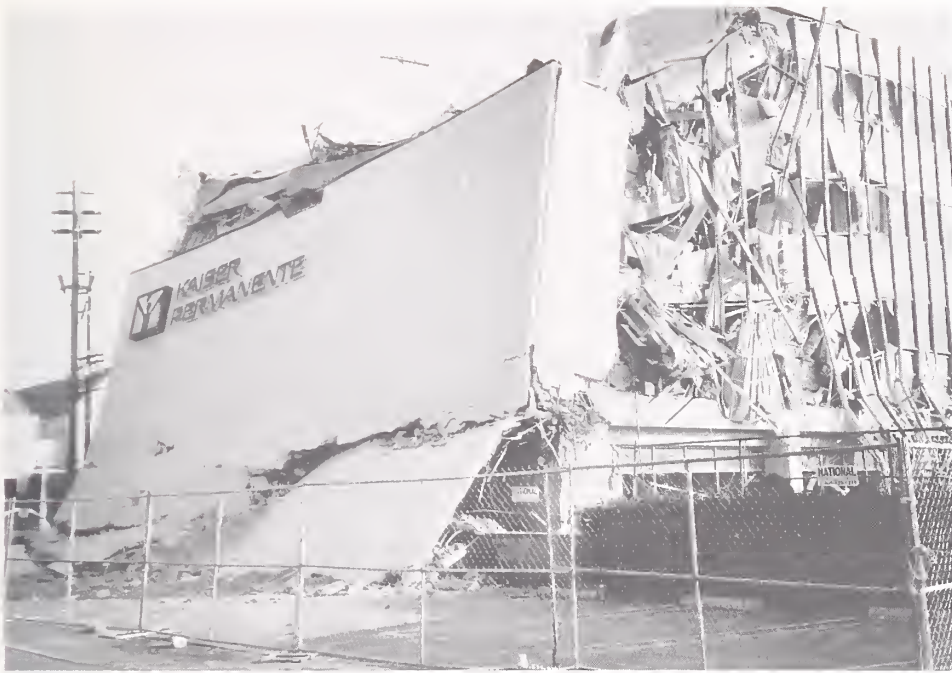
Figure 3.43. Damage at the north end of the building was similar to damage at the south.

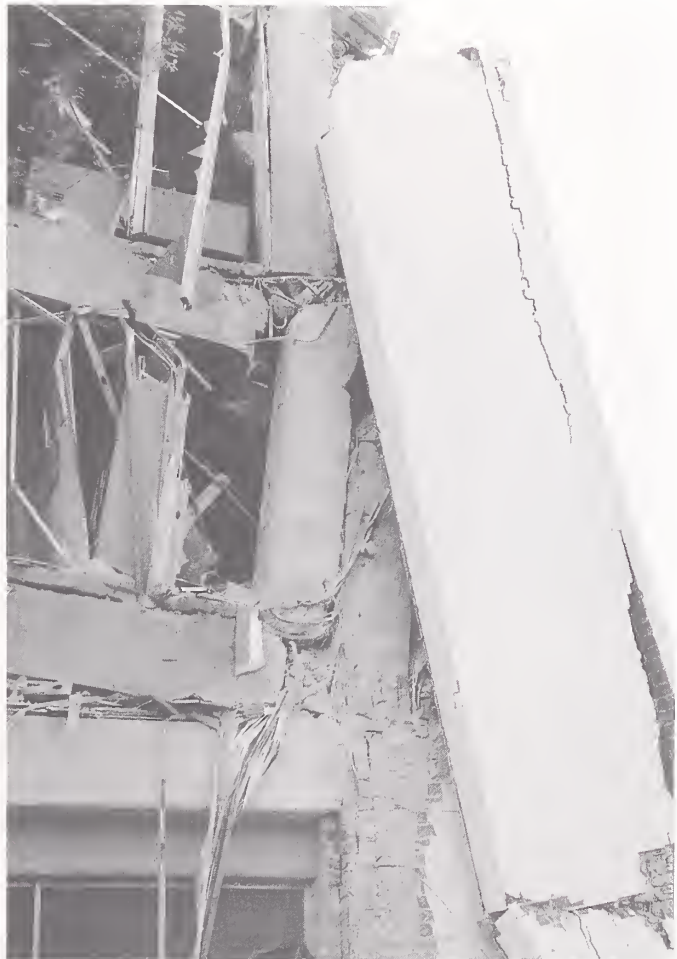
The bare frame exposed by the damage suggests that the buildings had a strong-beam/weak-column configuration (fig. 3.44). The damage appears to have initiated at the joints. At the damaged ends, the beams and columns remained essentially intact, but the joints disintegrated.

Figure 3.44. The exposed concrete frame of the Kaiser Permanente building, revealing deep beams, suggests that the building had a strong-beam, weak-column configuration. Except for the second story columns, the columns and beams remained intact while the joints disintegrated.

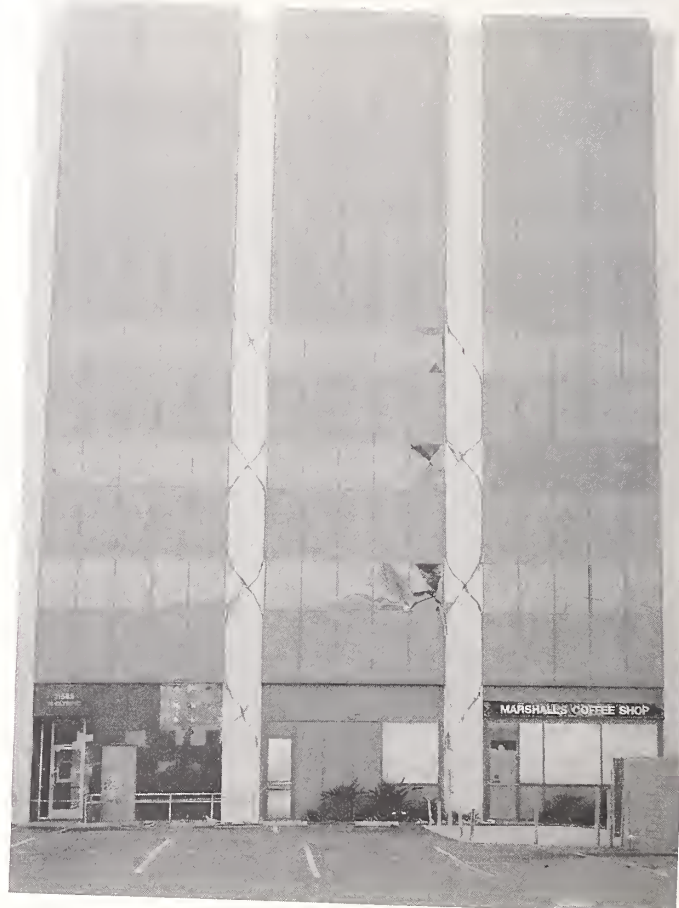
The L-shaped concrete frame Barrington Building in West Los Angeles also had damage concentrated in the second story columns (fig. 3.45). In this building, the horizontal architectural panels stiffened the lower half of the columns at each story, creating a short-column effect. The effectively shortened columns failed in shear between the windows, creating a pattern of X-cracking in the columns that diminished in severity towards the top (fig. 3.46). At the second story, the cracking was severe enough to cause a loss of vertical-load-carrying capacity; the bulging window frames indicate about a 50 to 100 mm reduction in height (fig. 3.47). The building was demolished within a few days of the quake.

Figure 3.46. The stiff infill panels of the Barrington Building effectively shortened the concrete columns, forcing all the displacement into the column sections bounded by windows. Diagonal X-cracking decreased in severity towards the top of the building.

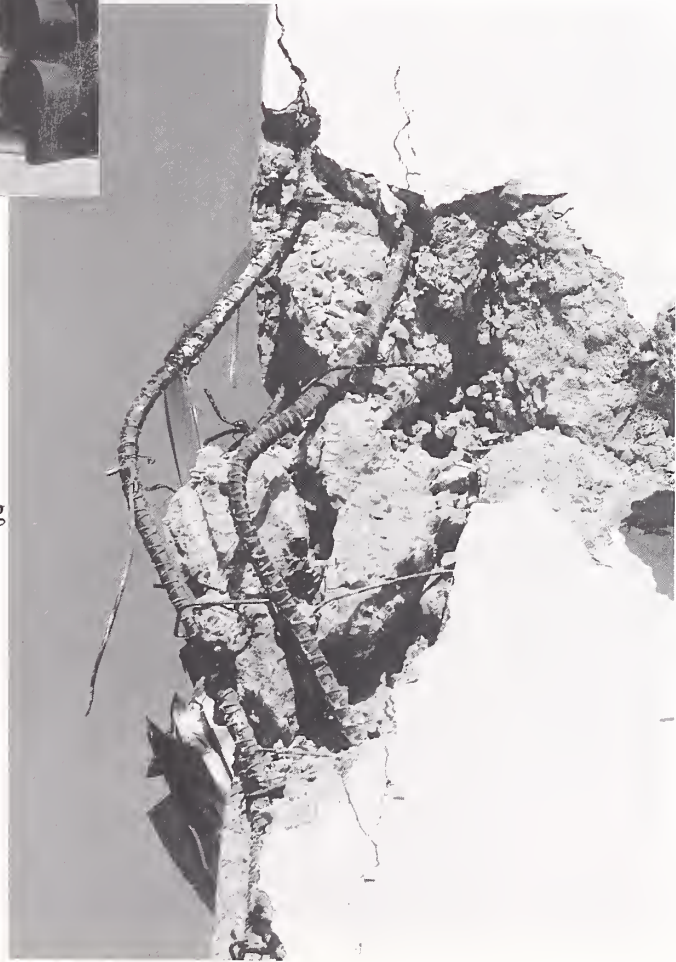
The column-shortening effect of the infill panels was apparently not considered in the design. Where column reinforcing was exposed, transverse bars of undeformed steel spaced at about 300 mm on center could be seen (fig. 3.48), not sufficient to provide confinement of the concrete in a region of high shear.

Figure 3.48. A close up of the damaged southeast corner of the Barrington Building shows the widely spaced, undeformed bars used for transverse reinforcement.

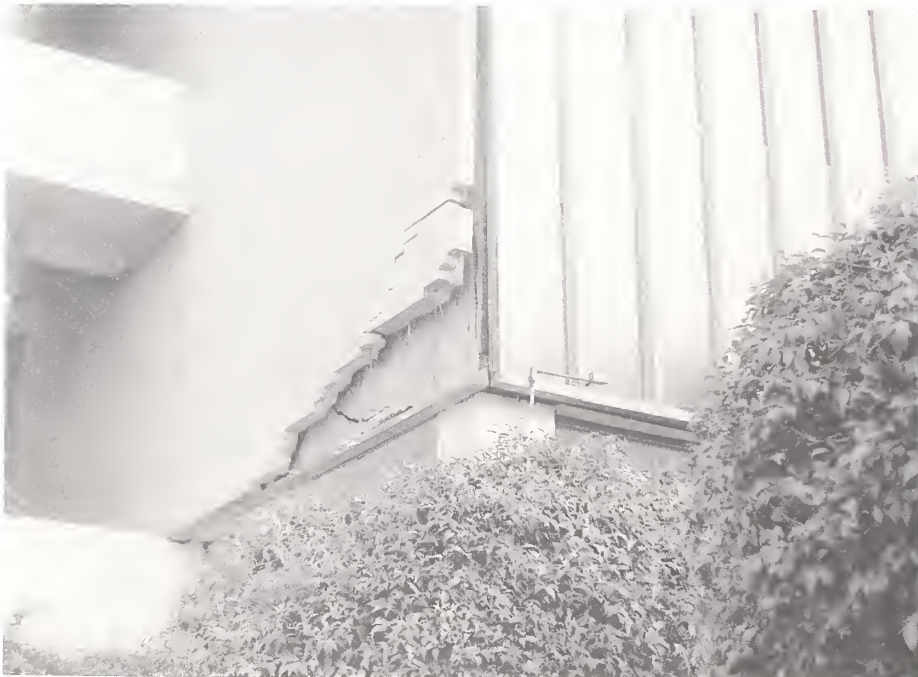
Figure 3.50. The similar west wall of was damaged, but did not peel away from the structure. This close up of the interface between the first and second stories shows that the masonry facade is supported on a steel angle. At the west end of the building, the facade was crushed at the toe where it is supported by the angle.

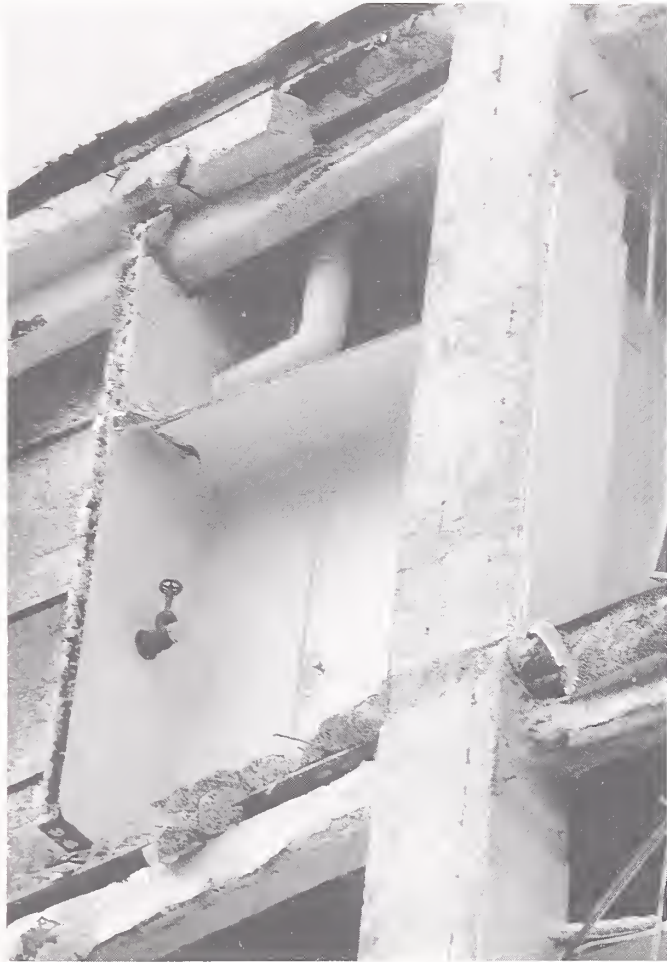
Figure 3.51. The exposed structure of the Sherman Way office building shows remains (at the floor level and the column) of the minimal ties that anchored the masonry facade.

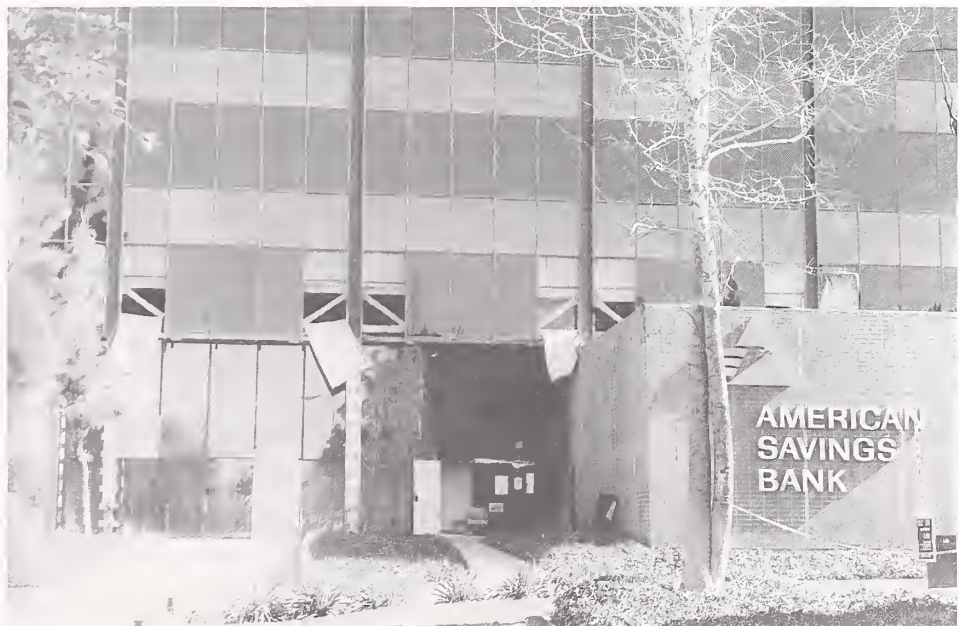
A steel-frame office building on the west side of Topanga Canyon Boulevard in Canoga Park, housing the American Savings Bank, experienced significant movement in its first story columns, apparently swaying in a north-south direction during the quake. It did not return to its original position, but suffered a permanent offset to the north (fig. 3.52). A nearly identical building on the same site, oriented at right angles to the first, had only minor damage to glass at the first

Figure 3.52. The first-story columns of the steel-framed building housing the American Savings Bank on Topanga Canyon Road in Canoga Park flexed during the quake and ended up slightly displaced from their original positions.
