*NIST Special Publication 862*

# 1994 Northridge Earthquake Performance of Structures, Lifelines, and Fire Protection Systems

*Diana Todd, Nicholas Carino, Riley M. Chung, H. S. Lew, Andrew W. Taylor,  
William D. Walton, James D. Cooper, and Roland Nimis*

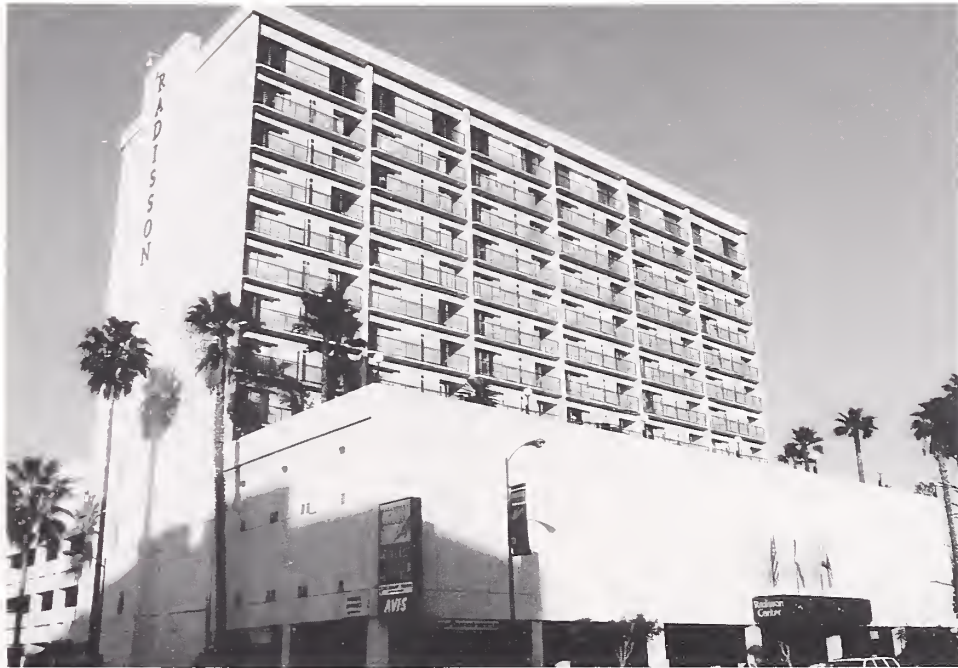
The Radisson Valley Center Hotel is located at 15433 Ventura Boulevard in Sherman Oaks (fig. 3.55). This 13-story concrete structure sustained serious damage to columns located at the first and fifth stories. Exterior columns which support the three-story appendage at the front of the hotel were also damaged (fig. 3.56).

Figure 3.55. The concrete Radisson Valley Center Hotel in Sherman Oaks had serious damage to the columns at the first and fifth stories.

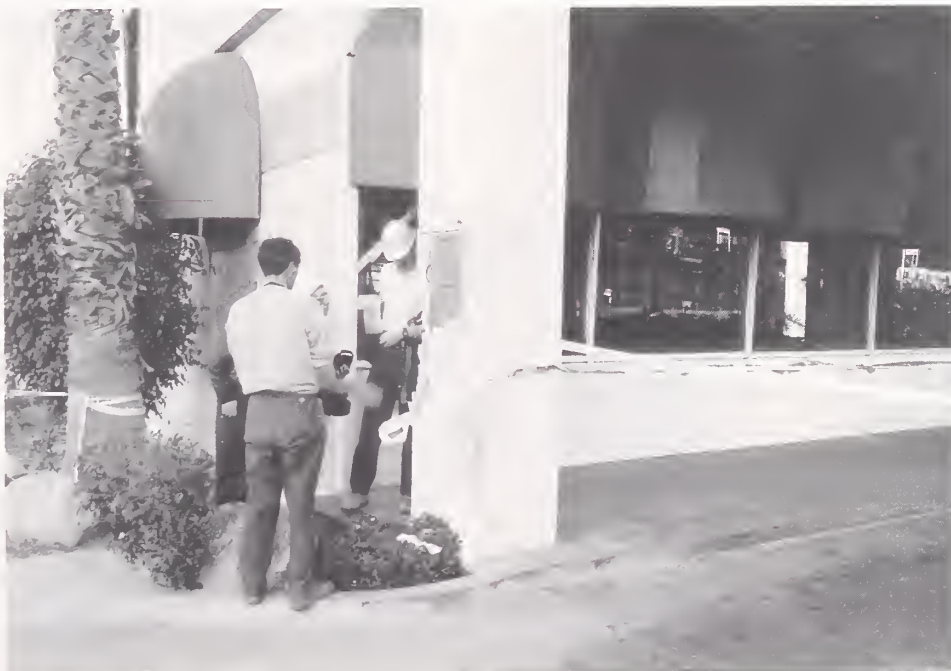
Figure 3.56. The columns supporting the three-story appendage at the front of the Radisson Hotel had serious shear cracks and related spalling.

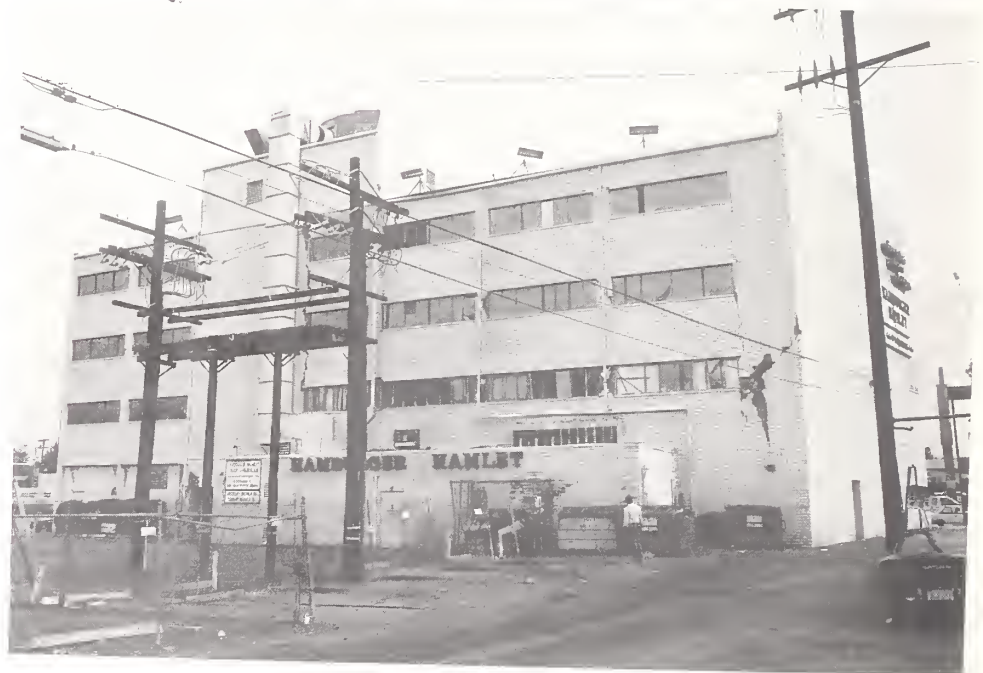
A four-story steel frame structure located at the intersection of Moorpark Street and Cedros Avenue in Sherman Oaks was shaken seriously during the earthquake (fig. 3.58). The exterior reinforced masonry wall was cracked in many places, particularly at the second floor level (fig. 3.59). The evidence of large ground shaking in the Sherman Oaks area was also seen by serious lateral displacements of single family houses and three-story apartment buildings from their foundation. In fact, a strong-motion instrument station in Tarzana located only a few kilometers away from this general area recorded the largest acceleration in this earthquake (1.82g horizontal, 1.18g vertical).

Figure 3.59. A close-up view of the damage shows the pattern of reinforcing used in the masonry facade.

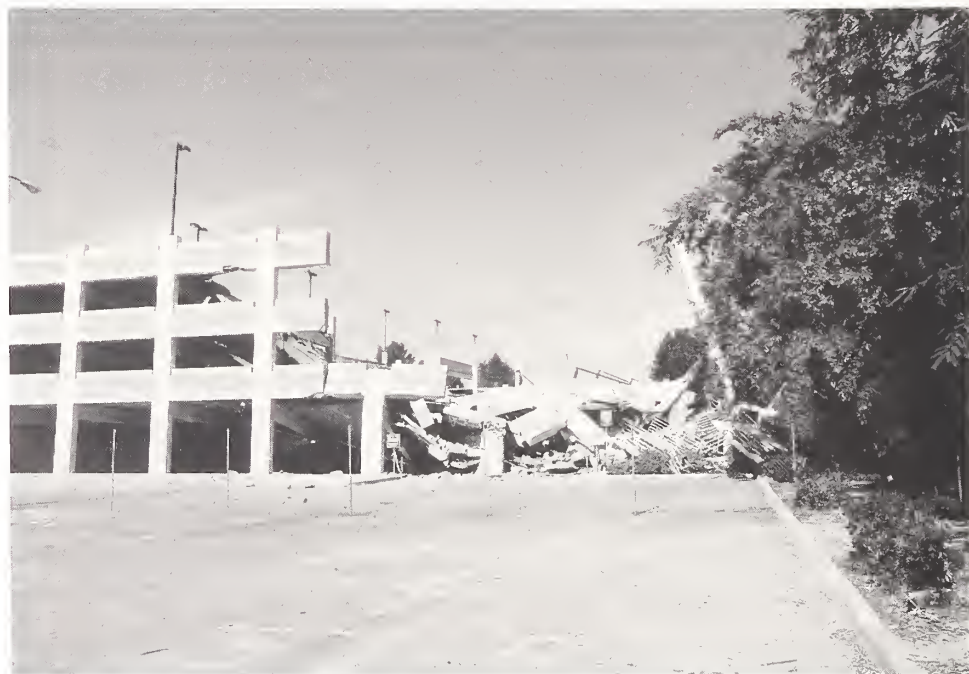
Figure 3.61. Some interior columns of the Northridge campus parking garage remained standing.

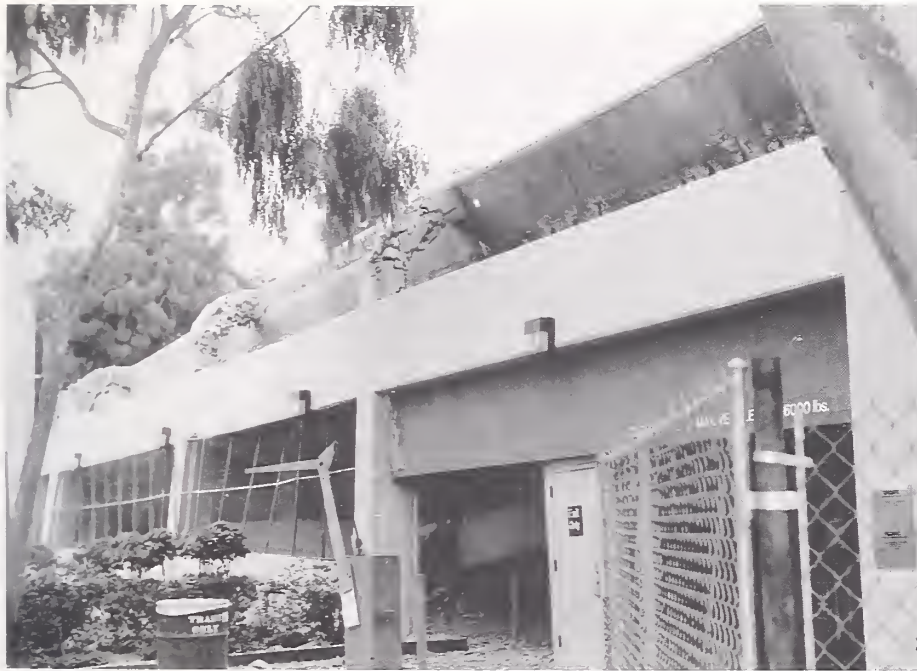
The five-level parking garage at the Kaiser Permanente medical complex on Cadillac Avenue in West Los Angeles experienced a similar collapse. All four facades were pulled inward, suggesting that an interior failure precipitated the damage (fig. 3.62). This garage was a post-tensioned cast-in-place concrete structure with shear walls providing the lateral-force resisting system at the east and west ends, and moment frames at the north and south perimeter. The shear walls were cracked horizontally throughout their height due to the out-of-plane bending (fig. 3.63). There was minor diagonal cracking, suggesting that the lateral load was not fully transmitted to the shear walls. The stair towers remained standing. Typically, these towers are structurally isolated from the post-tensioned slab to minimize potential deformations in the towers due to creep and shrinkage in the post-tensioned slabs.

Figure 3.62. The cast-in-place concrete parking garage at the Kaiser Permanente Hospital complex in West Los Angeles collapsed in on itself. The moment frame that provided lateral resistance on the south face of the structure could not resist the out-of-plane forces apparently caused by the collapse of interior elements.

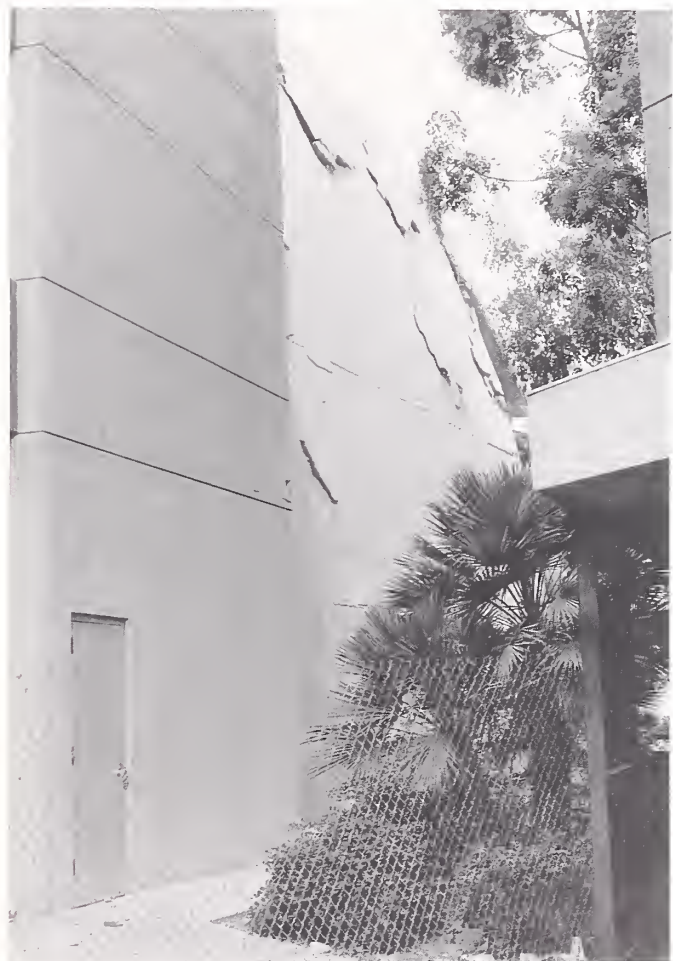
Figure 3.63. At the east and west faces of the Kaiser Permanente Hospital parking garage, shear walls made up the lateral force resisting system. Both walls had horizontal cracks caused by the out-of-plane bending when the walls were pulled inward. Neither wall had major diagonal cracking, suggesting that the lateral load was never fully delivered to the walls. The stair towers remained erect. The east wall and stair tower are shown here.

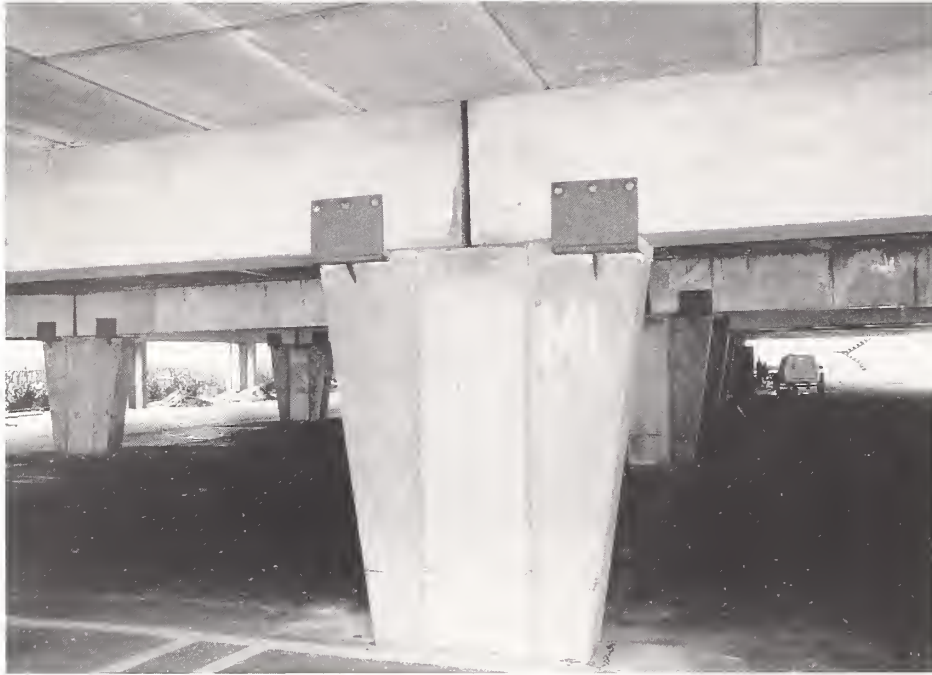
The two-level concrete parking structure adjacent to the Trans World Bank in Sherman Oaks had been seismically strengthened after suffering serious damage in the 1971 San Fernando quake. Flared extensions were cast next to the interior columns along their north-south axes (fig. 3.64), creating short wing walls supporting the precast beams. During the 1994 quake, the unrehabilitated exterior columns were badly cracked (fig. 3.65). The ramp was also heavily damaged. The interior columns were relatively undamaged.

Figure 3.64. The interior columns of the two-level parking garage at the Trans World Bank in Sherman Oaks had been seismically strengthened after it suffered damage in the 1971 San Fernando quake. The interior columns fared well in the 1994 Northridge quake.

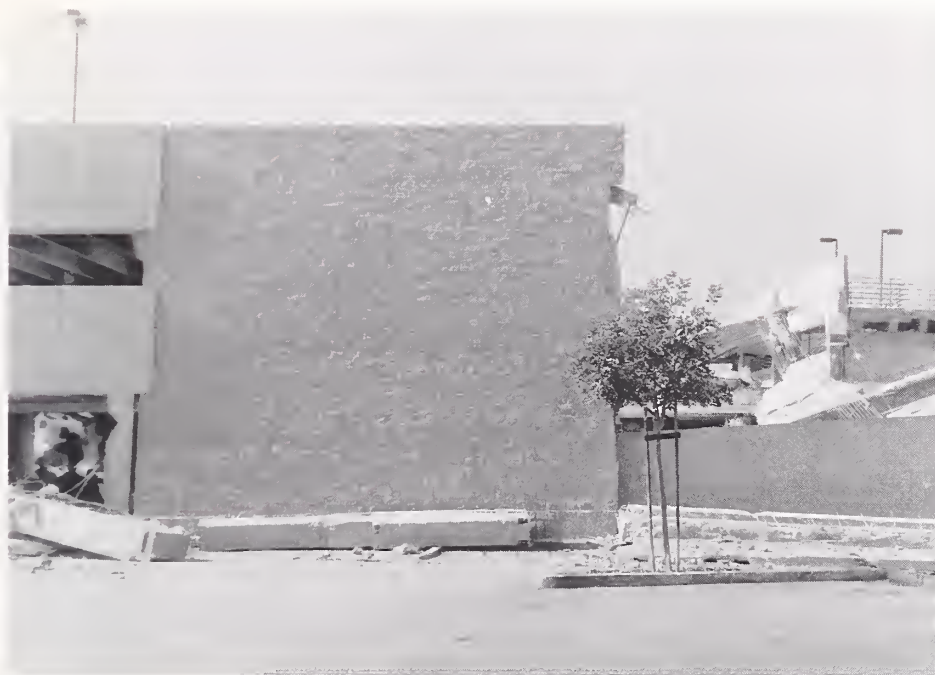
At the Northridge Fashion Center, three parking structures suffered damage. A large three-level concrete garage at the south end of the site, approximately 10 years old, suffered an almost complete collapse. The largely pre-cast concrete structure had intermittent shear walls which remained standing (fig. 3.66). The lack of diagonal cracks in these walls suggests that, like the walls at the Kaiser Permanente garage, they were never fully loaded. A similar, but smaller, precast garage at the north end of the Northridge Fashion Center also partially collapsed (fig. 3.68). At the east end of the site, an older two-level cast-in-place concrete garage showed

Figure 3.66. At the Northridge Fashion Center, major portions of the three-level south parking garage collapsed. The garage was precast concrete with intermittent shear walls. Most of the shear walls remained standing, largely undamaged, indicating that the lateral load was not adequately transmitted to these walls.

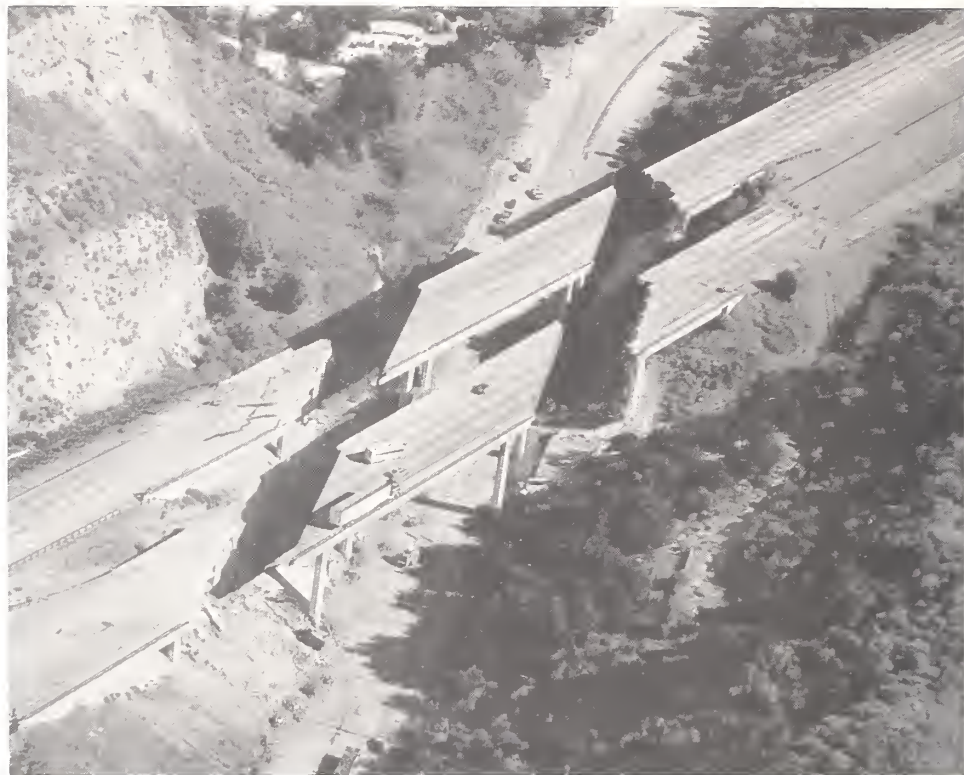
This bridge was designed in 1964 and constructed in 1967. It carries Interstate 5 over Gavin Canyon, about 3 km (2 mi) north of the intersection of Interstate 5 and State Route 14. An aerial photograph of the damaged bridge, after demolition had begun, is shown in figure 4.2, and a ground level view is shown in figure 4.3. Schematic structural drawings are shown in figures 4.4 and 4.5. The structure consists of two parallel bridges, with about a 66 degree skew alignment. Each bridge is composed of five spans. Each bridge has four two-pier bents, and there is a structural hinge near each of the two center bents (figs. 4.3 and 4.4). The superstructure consists of reinforced concrete box girders, and the central portion (between hinges) is post-tensioned. The bridge survived the 1971 San Fernando earthquake with virtually no damage. In 1974, the hinges were retrofitted with cable restrainers, as shown in figure 4.5. The seat length at the hinges is 200 mm (8 in), which by current design standards would be considered inadequate, especially for a structure of this size and flexibility.

Despite the presence of cable restrainers at the hinges, failure of three of the four end spans of the bridge was apparently initiated by the spans falling off the hinge seats. The fourth end span, at the far western corner of the bridge, partially came off its hinge seat but did not collapse, as indicated in figure 4.4. After support was lost at the hinges, a triangular portion of three of the end spans collapsed, as shown in figure 4.4. Demolition of the remaining portions of the end spans was carried out very soon after the earthquake, as shown in figure 4.2. It is likely that the skewed alignment of the bridge was an important contributing factor in this failure. The skewed alignment permitted rotation of the superstructure in a counter-clockwise direction, when viewed from above. The tall, flexible piers of the two center bents would have offered relatively little resistance to rotation in a horizontal plane. (EERC reconnaissance team members noted cracking patterns at the bases of the piers, which may have been evidence of such rotation [5]). Rotation of the superstructure would have resulted in differential displacements at the hinges, and eventually unseating of the end spans at the hinges. Demolition of the bridge was completed a few days after the earthquake.

Figure 4.2. Aerial view of the bridges at Gavin Canyon, looking to the east, showing appearance of the four end spans shortly after demolition had begun.

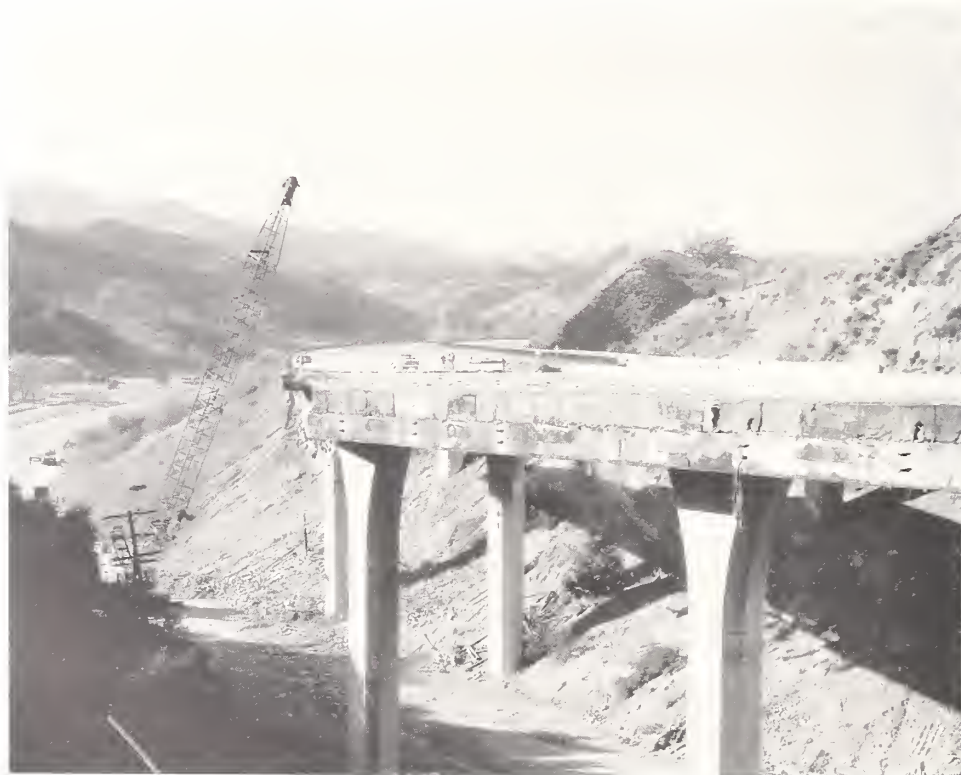
Figure 4.3. Ground level view of the southbound bridge at Gavin Canyon, looking to the northwest, showing the hinge bearing seat near Bent 3.

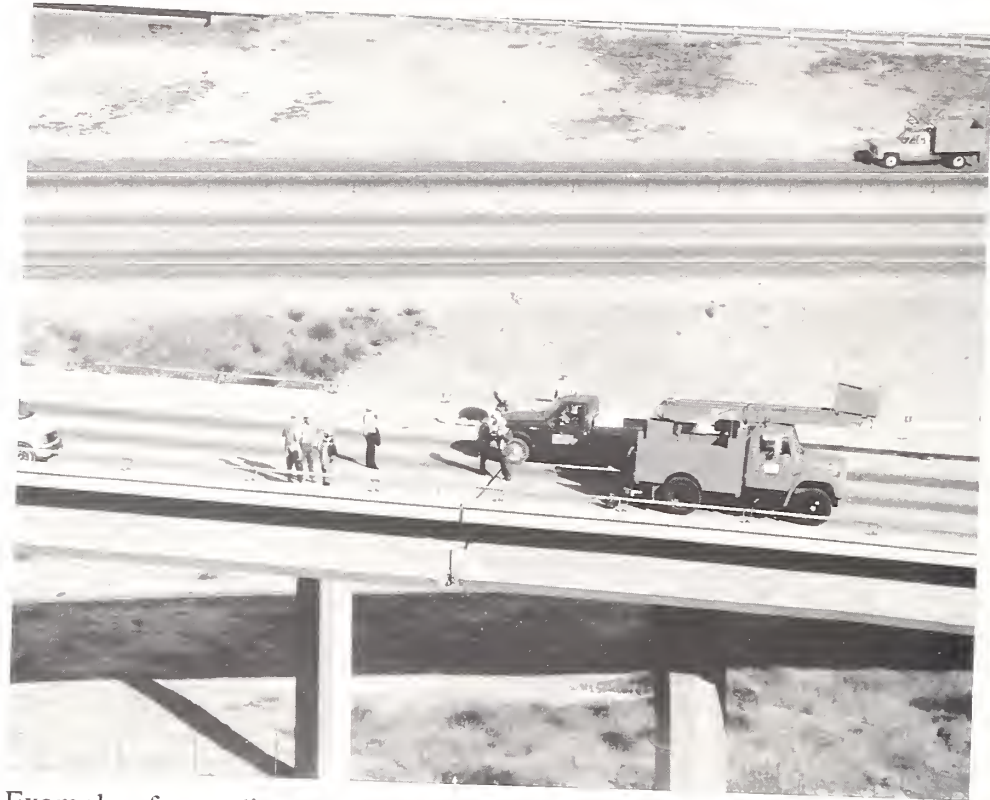
Figure 4.7. Example of pounding and offset at a hinge in the SR14/I5 interchange.

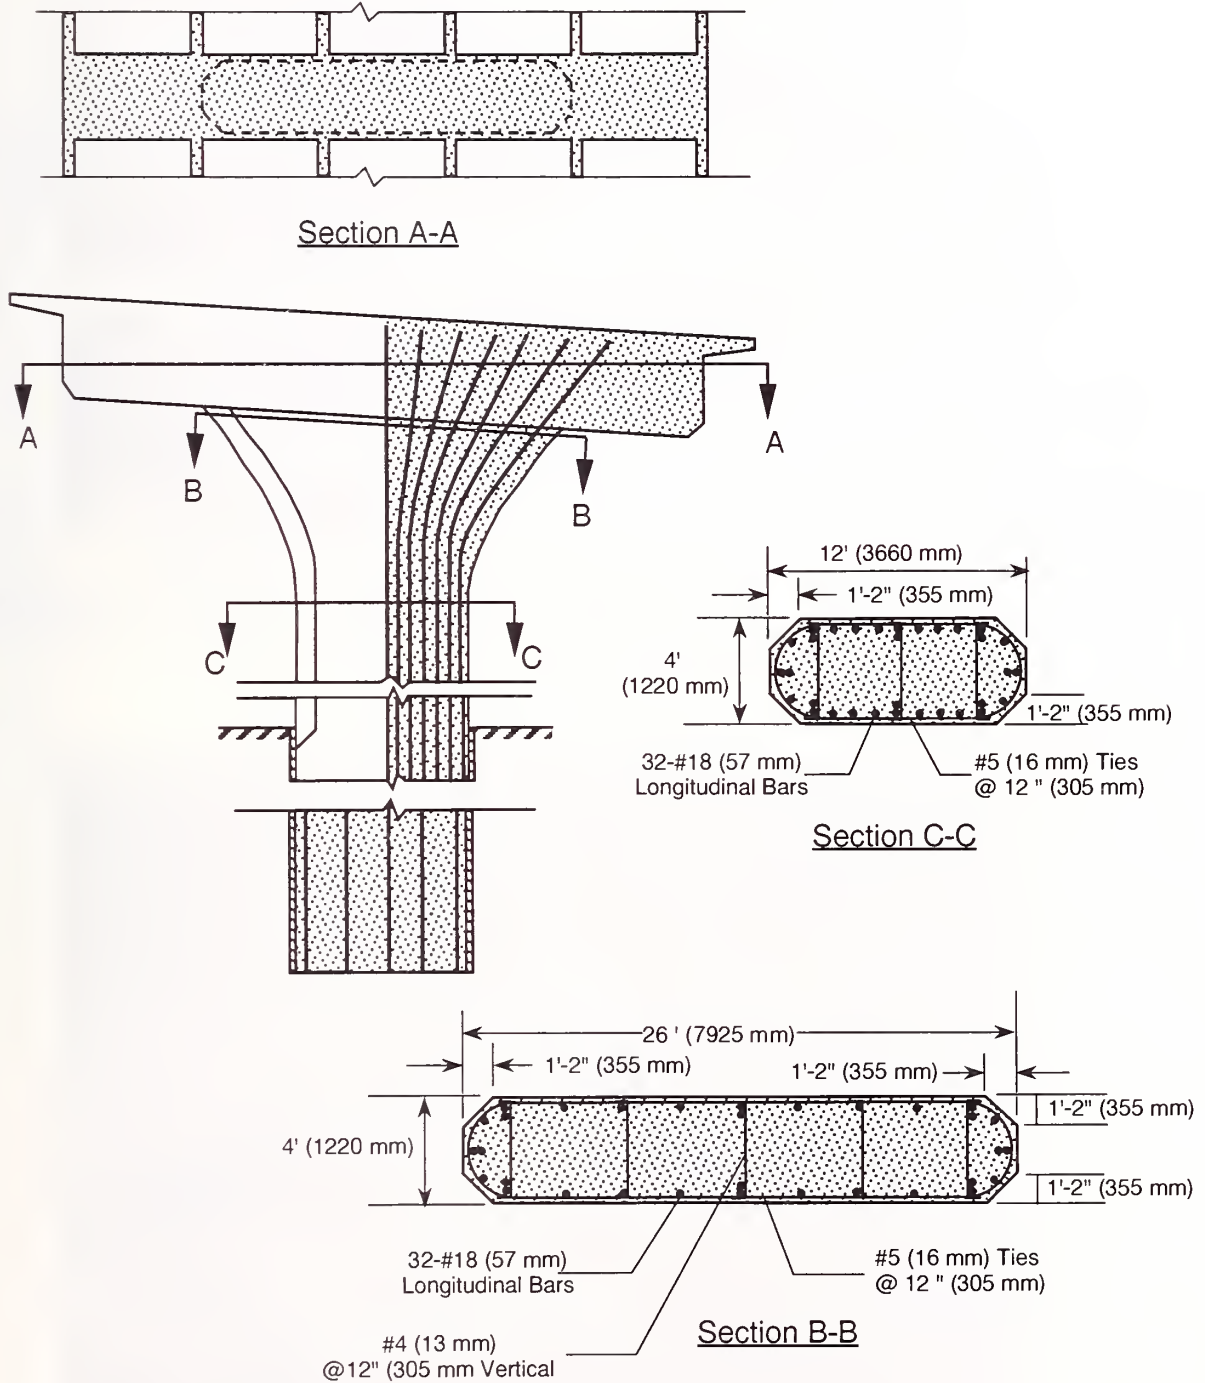
SR14/I5 Separation and Overhead Ramp C - Piers 2 and 3

Figure 4.10. Details for Piers 2 and 3 of the SR14/I5 Separation and Overhead, Ramp C.

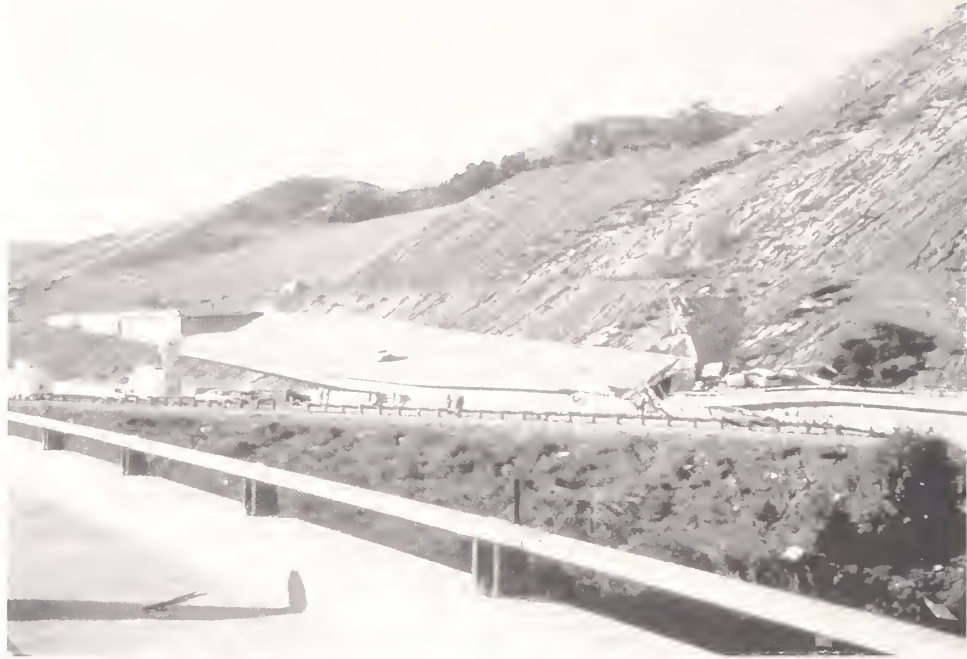
<sup>2</sup> It has been suggested that the superstructure was first pulled off the abutment seat, transferring excessive loads to Pier 2, causing it to fail. However, this appears unlikely as the bearing seat length at Abutment 1 was rather long: 24 inches (610 mm).

Figure 4.11. Overview of the collapse of the SR14/I5 Separation and Overhead, Ramp C, looking to the south at Abutment 1. Pier 3 can be seen at the right of the photograph (Photo courtesy of EERC).

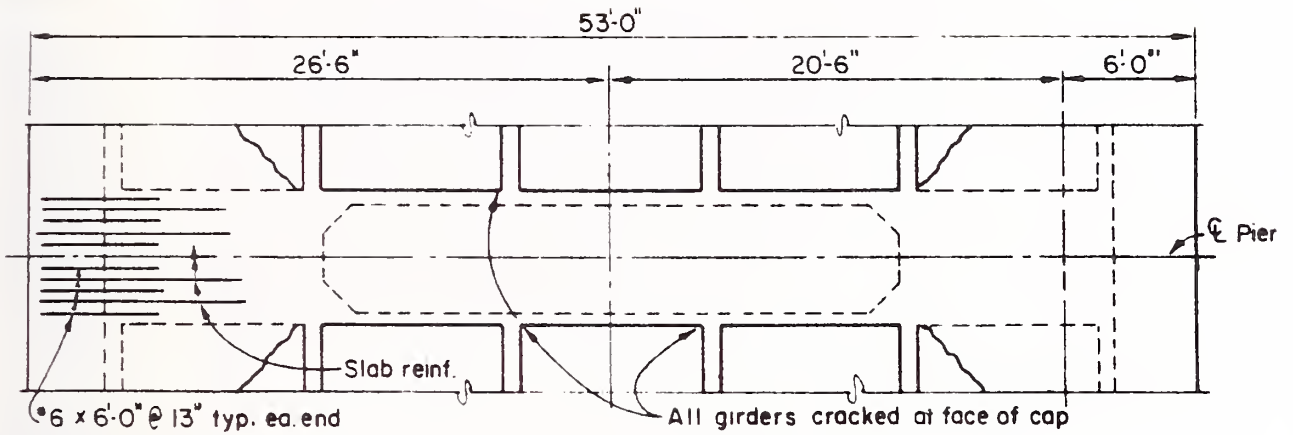
When the 1971 San Fernando earthquake occurred this ramp was under construction. Piers 2 and 3 had already been completed, and the bottom soffit and webs of the box girder between Abutment 1 and the hinge near Pier 4 had been cast and were resting on falsework. Settlement and shifting of the falsework resulted in damage to the parts of the ramp already constructed. After the San Fernando earthquake investigators noted cracking in the caps of Piers 2 and 3, consisting of cracks in the soffit slabs radiating 45 degrees from the pier corners, and vertical cracks in the box girder webs at the face of the pier cap, as shown in figure 4.13 [23]. It is not known how these cracks were treated in the repair work following the 1971 earthquake, or whether they were a contributing factor in the Northridge earthquake failure.

Figure 4.13. Cracking reported at Piers 2 and 3 following the 1971 San Fernando earthquake (reproduced from "The San Fernando Earthquake: Field Investigation of Bridge Damage," State of California, 1971).

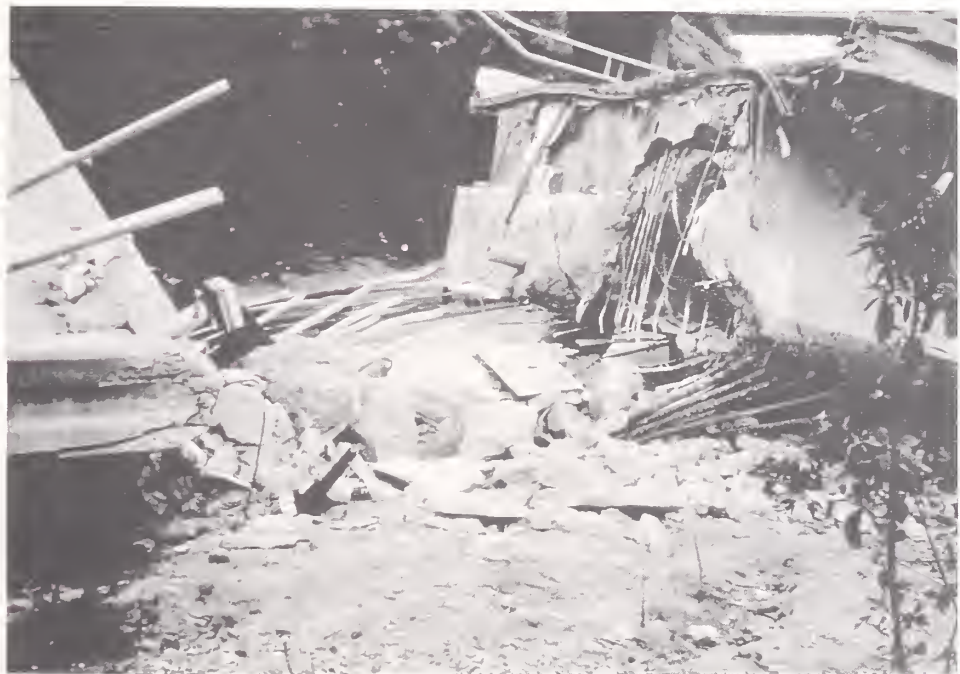
The collapse in the Northridge earthquake appears to have been initiated by the failure of Pier 2. After Pier 2 failed, the simply supported span between Abutment 1 and the hinge near Pier 2 collapsed, and, as shown in figure 4.15, the superstructure failed near Pier 3 due to a large negative moment. Pier 2 completely disintegrated, as shown in figure 4.16. This is the shortest pier in the structure, so it is likely that it attracted a high level of lateral force, was damaged in shear, and finally collapsed in compression. Pier 10 is similar in height to Pier 1, but the quantities of lateral reinforcement in Pier 10 are greater than those in Pier 1, as shown in figure 4.18. This is because Pier 2 had already been completed, but Pier 10 had not yet been constructed, when the 1971 earthquake occurred. Following the 1971 earthquake the plans for Pier 10 were revised to provide increased lateral reinforcement, as shown in figure 4.18.

Figure 4.16. View of crushed Pier 2 and the hinge near Pier 2 (Photo courtesy EERC).

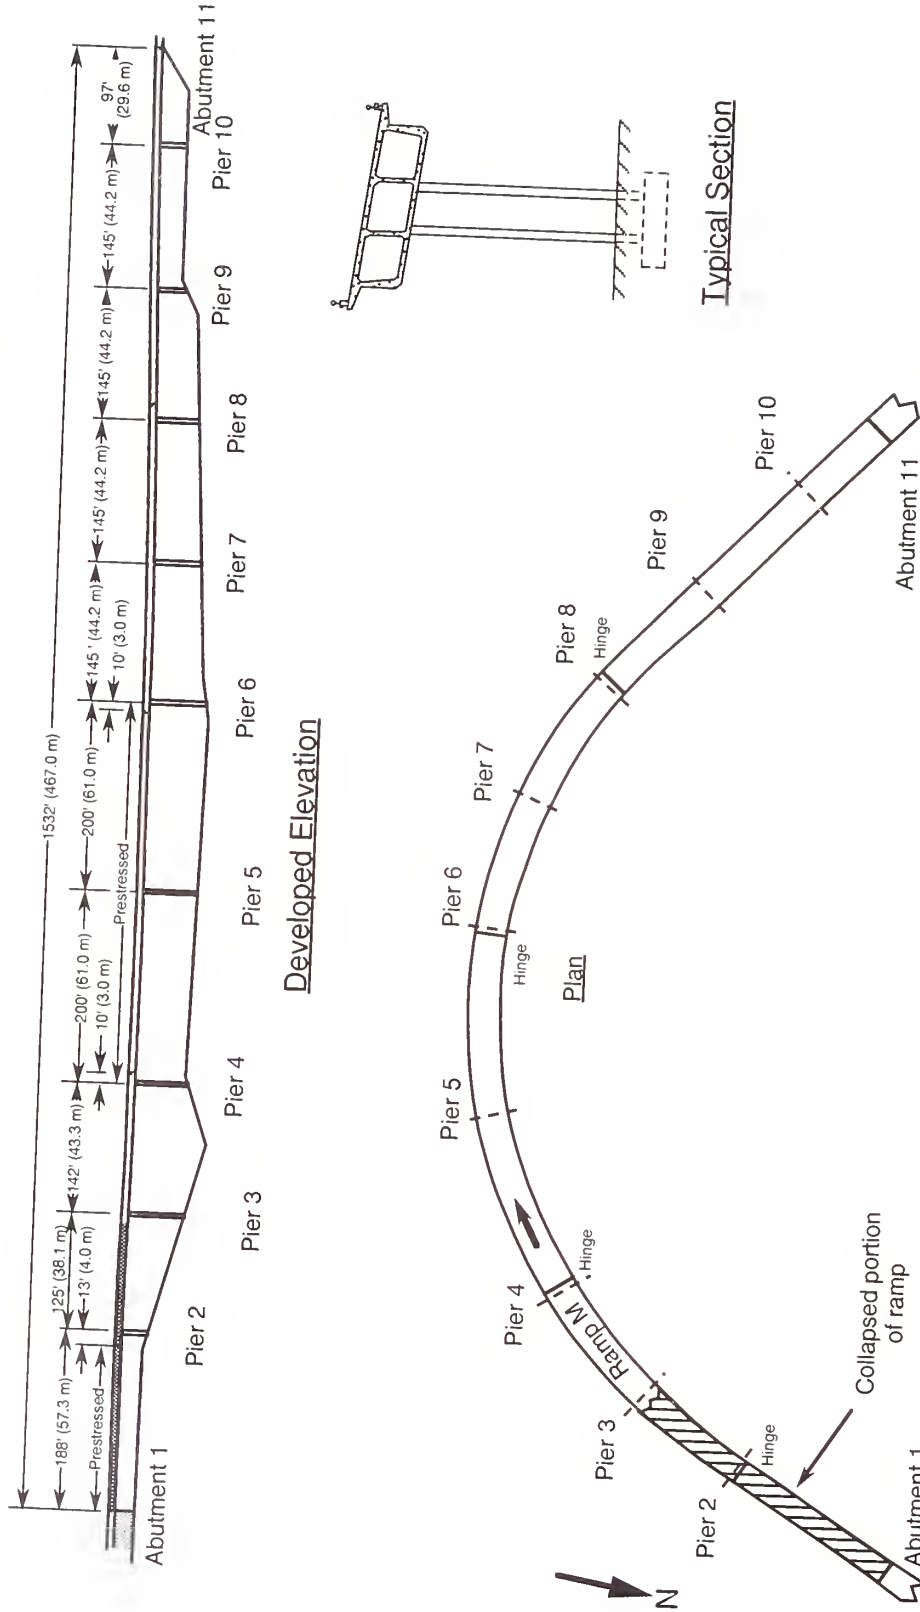
North Connector Overcrossing, Ramp M - SR14/15 Interchange

Figure 4.17. Plan and elevation view of the SR14/15 North Connector Overcrossing.

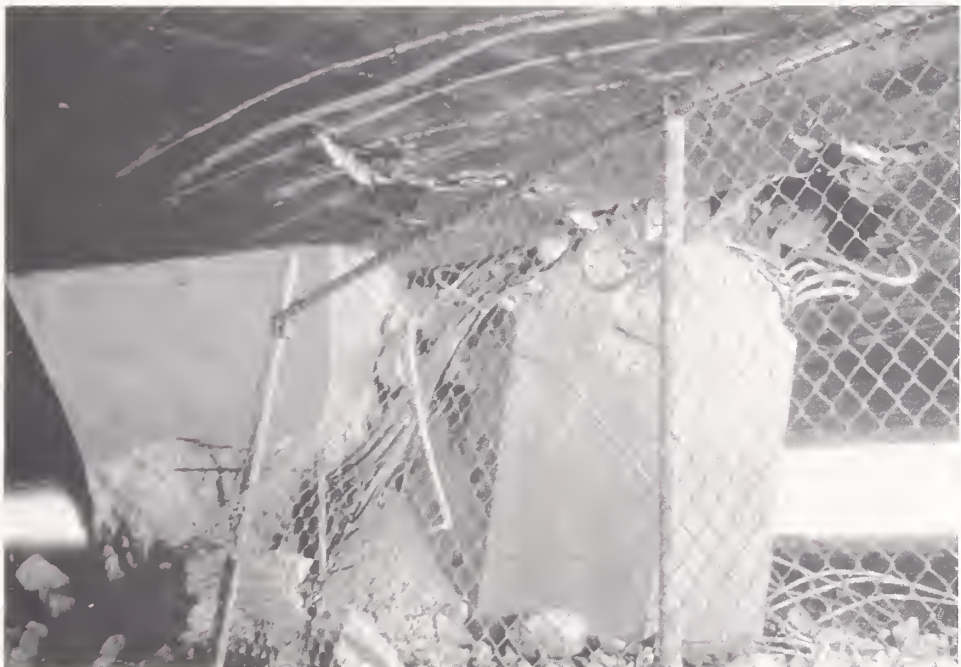
The likely failure mode of the bridge was that the piers initially suffered severe shear damage, followed by crushing of a number of piers in compression. The structure may also have shifted to the southwest, as constrained by the geometry of the abutments. Although unseating at Abutment 5 did occur, this was probably a secondary effect, as the seat lengths were generous by current standards. Rather, failure was probably initiated by damage to the piers. In this case the failure of piers has important theoretical implications, as the piers of this bridge contained quantities of lateral reinforcement similar to those required by current seismic design standards. Therefore, further research will be required to determine why the pier reinforcement was inadequate in this case.

Figure 4.22. Damage to a pier of the SR118 Mission-gothic Undercrossing, looking to the west at Bent 4 of the eastbound bridge, which collapsed (Photo courtesy of EERC).

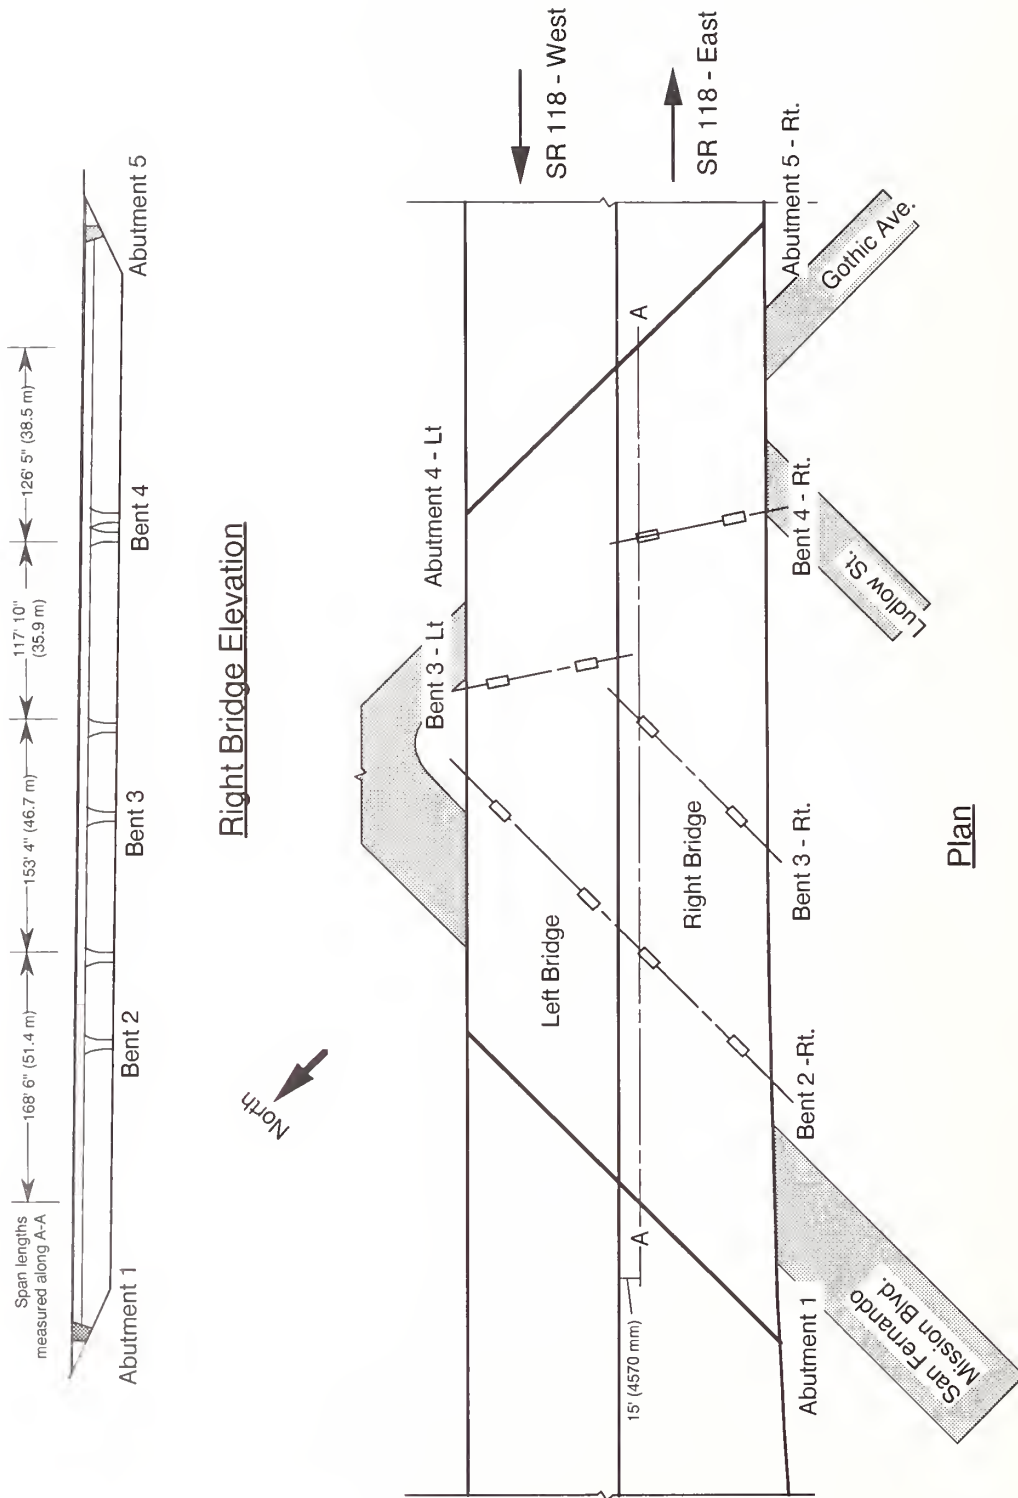
# SR 118 - Mission-Gothic Undercrossing

The first important feature of the bridge is its irregular geometry. Figure 4.23 shows that the plan shape of the bridge is a trapezoid. Thus, because of the orientations of the abutments, the structure was constrained to move in only one lateral direction during the earthquake, roughly to the southwest. Indeed, figures 4.21 and 4.22 show that the superstructure moved in this direction, creating a diagonal shear failures in many of the piers. There is also a highly irregular placement of piers, dictated in part by the trapezoidal plan shape of the bridge, and in part by right-of-way restrictions. The irregular plan shape and placement of piers created asymmetric stiffness and mass distributions, which undoubtedly lead to some piers being more heavily loaded than others during the earthquake. Detailed analyses will be required to determine how lateral earthquake loads were distributed among the piers.

Figure 4.23. Plan and elevation views of the SR118 Mission-Gothic Undercrossing.

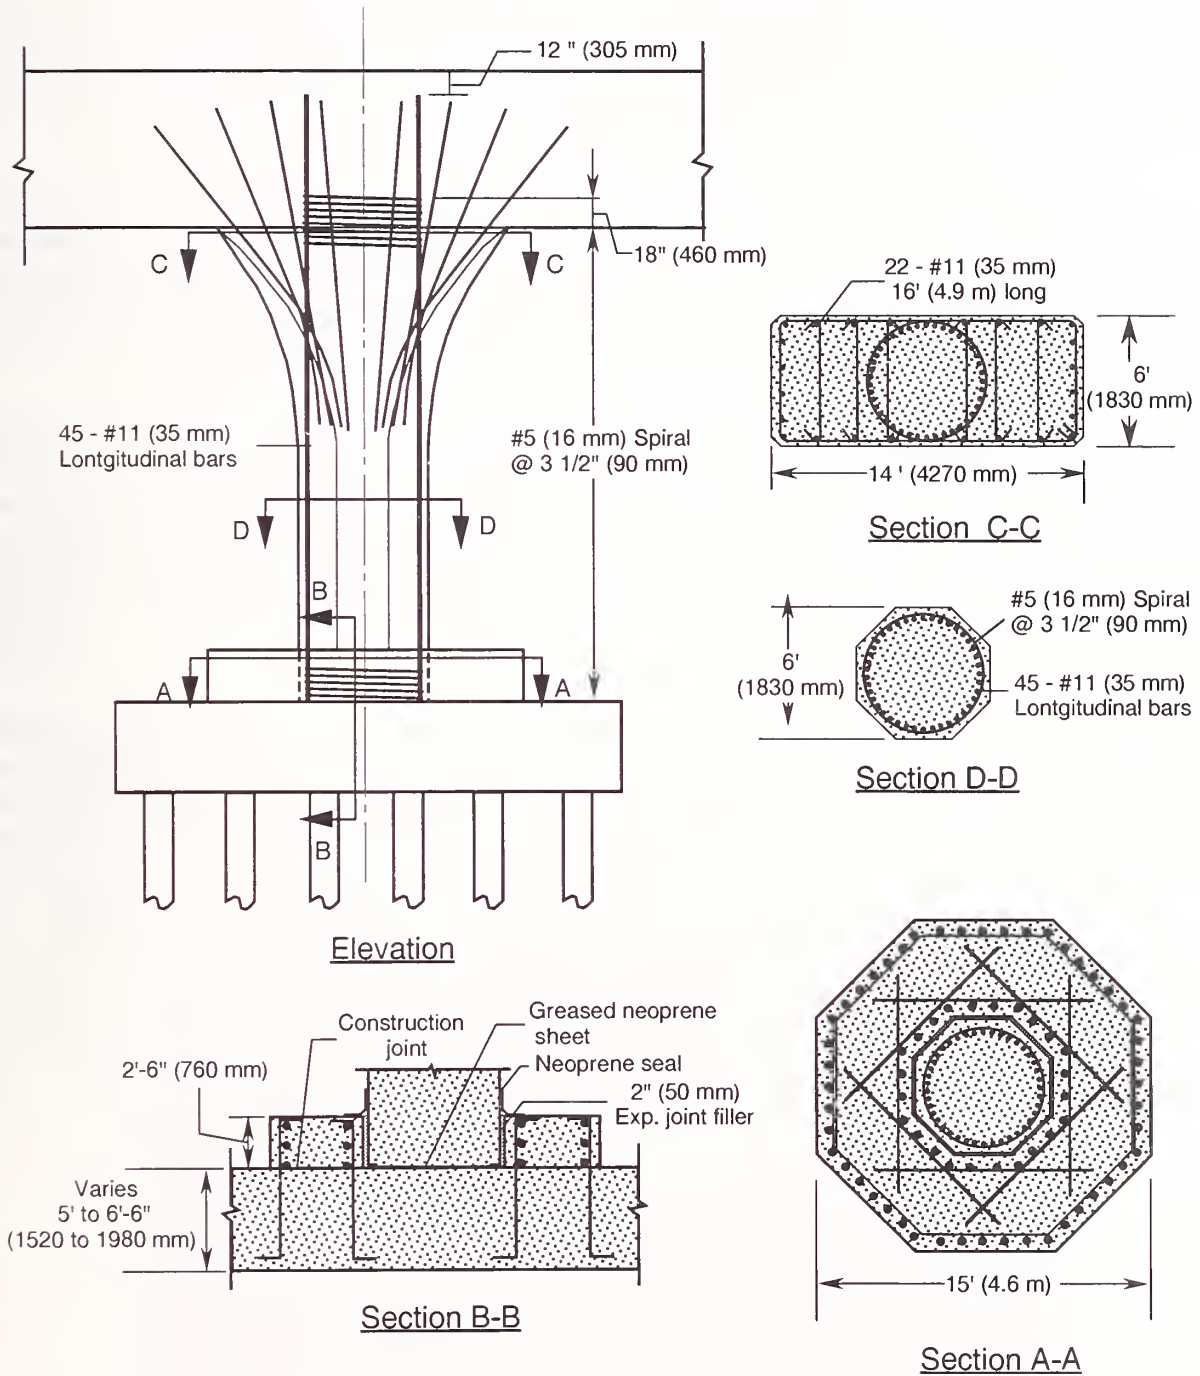
SR 118 - Mission-Gothic Undercrossing Pier Details

The second, and perhaps more important, feature of this bridge is the geometry of the bridge piers. Pier details are shown in figure 4.24. The piers were all relatively short, roughly 7200 mm (24 ft) tall by 1800 mm (6 ft) across, making an aspect ratio of only 4:1. However the piers also featured architectural flares at the tops, roughly 3600 mm (12 ft) tall. These flares were intended to be non-structural features of the piers. It was believed that the flares would spall or otherwise deteriorate during earthquake loading so that they would not contribute to the bending stiffness of the piers. However, it is clear that in actual performance the flares created a zone of added stiffness, reducing the aspect ratio of the piers to approximately 3:1. Thus the piers were very stiff laterally, and were dominated by shear rather than bending. The detail at the footing/ pier interface was also somewhat unusual for this bridge. Figure 4.24, section B-B, shows that the base of the pier rested inside a collar at the top of the pier footing. This detail was intended to permit free translation of the pier base during post-tensioning operations of the superstructure, before the collar was cast. The detail also had the effect of creating a hinge at the pier base. It is not immediately apparent whether this hinge improved or worsened the seismic performance of the bridge, although for a given lateral force the bending moments at the tops of the piers were greater than if the hinges at the bases of the piers had not been present.

Figure 4.24. Pier details for the SR118 Mission-Gothic Undercrossing.

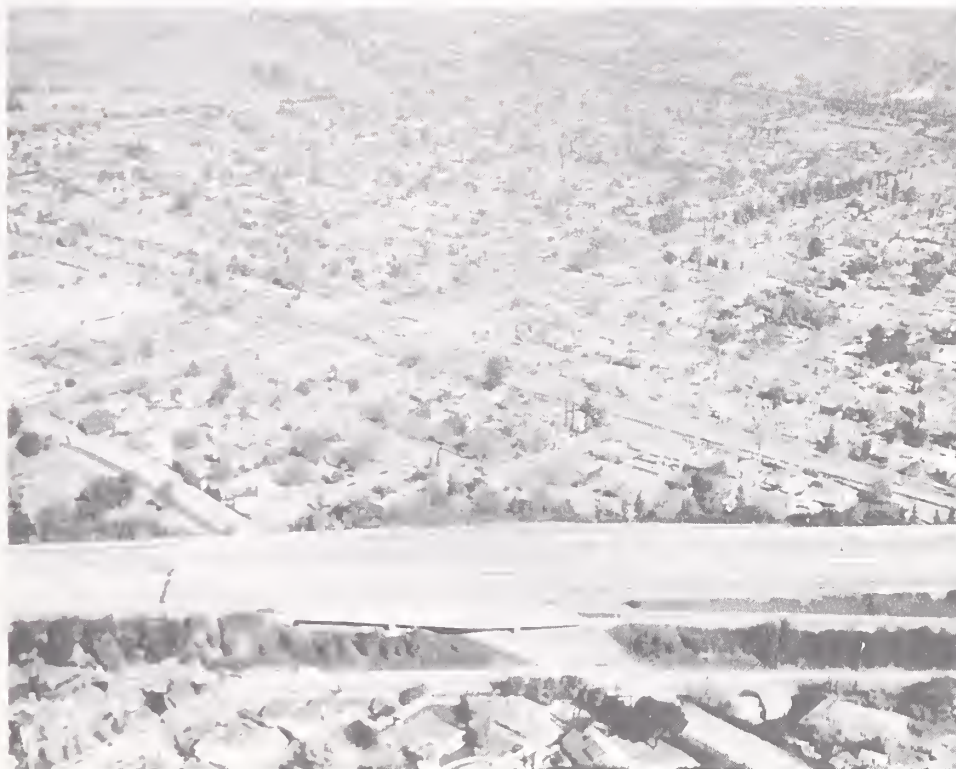
Figure 4.25 shows an aerial view, and 4.26 a ground-level view, of the SR118 bridge at Bull Creek Canyon Channel. The bridge did not collapse completely, but many of the piers were severely damaged, as shown in figures 4.27 and 4.28. In addition to pier damage, there was significant damage to the abutments, including cracked wing walls, settlement of soil behind the abutments, and possible shifting of the abutments. Plan and elevation views of the bridge are shown in figure 4.29, and pier details in figure 4.30.

Figure 4.25. Aerial view of State Route 118 at Bull Creek Canyon Channel, looking to the north (Photo courtesy of FHWA).

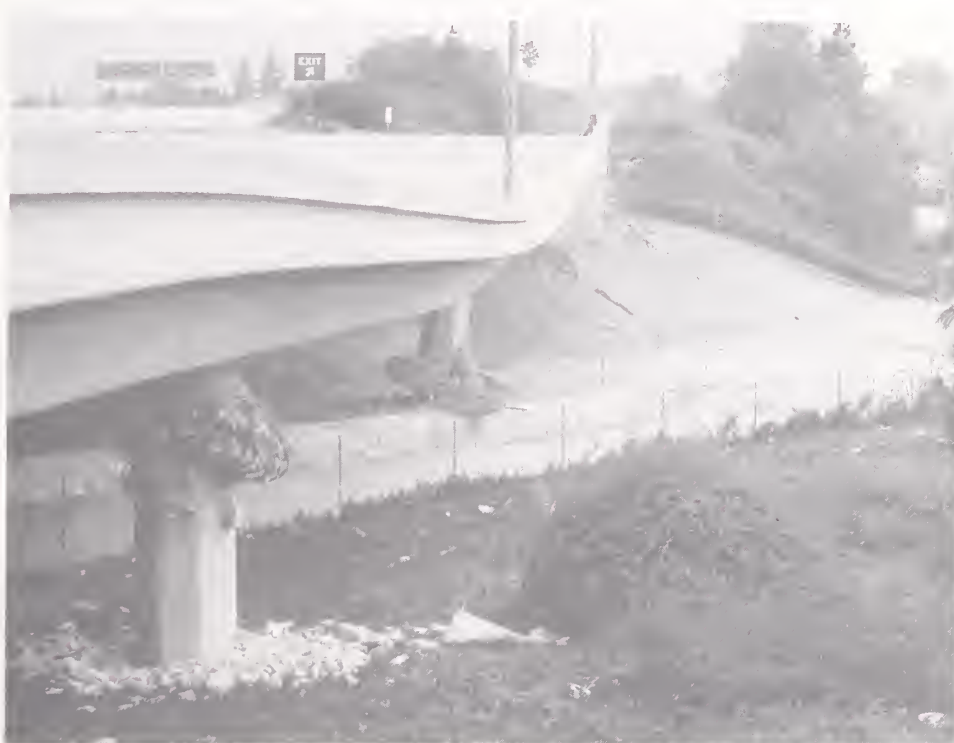
All ten of the piers in Bent 3 failed in combined shear and compression near their bases, as shown by figures 4.27 and 4.28. In Bent 2, Piers on the south side of the span failed near their top end, as shown in the left foreground of figure 4.26, and the damage became progressively less for piers to the north in Bent 2. The farthest north piers in Bent 2 showed relatively little damage - only diagonal shear cracks near the base, with no spalled concrete. This uneven distribution of damage to piers was probably caused by the asymmetric plan geometry of the bridge, as shown in figure 4.29.

Figure 4.26. Ground-level view of State Route 118 at Bull Creek Canyon Channel, looking along the south edge, towards the east.
