*NIST Special Publication 862*

# 1994 Northridge Earthquake Performance of Structures, Lifelines, and Fire Protection Systems

*Diana Todd, Nicholas Carino, Riley M. Chung, H. S. Lew, Andrew W. Taylor,  
William D. Walton, James D. Cooper, and Roland Nimis*

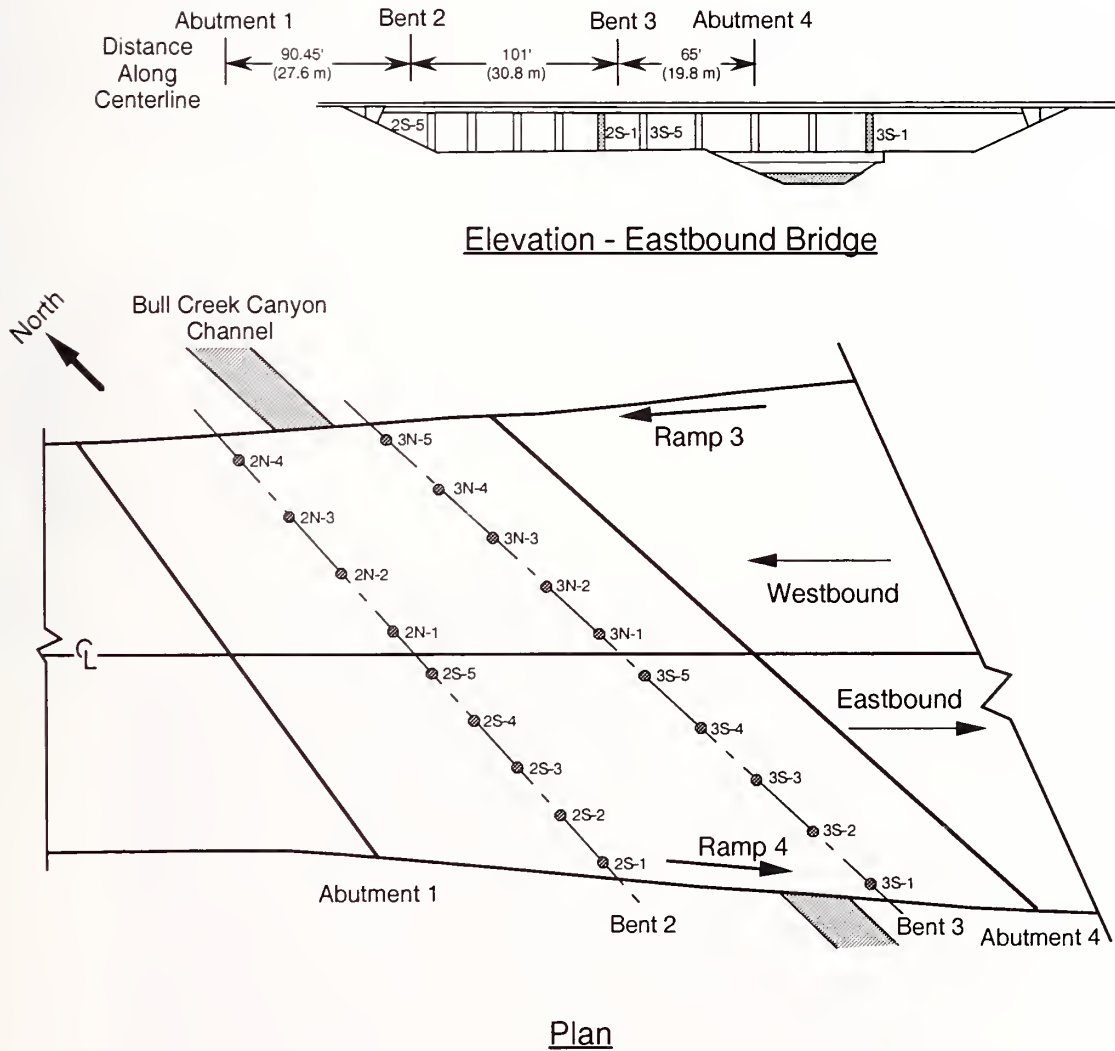
## SR 118 Bull Creek Canyon Channel Bridge

All ten of the piers in Bent 3 failed in combined shear and compression near their bases, as shown by figures 4.27 and 4.28. In Bent 2, Piers on the south side of the span failed near their top end, as shown in the left foreground of figure 4.26, and the damage became progressively less for piers to the north in Bent 2. The farthest north piers in Bent 2 showed relatively little damage - only diagonal shear cracks near the base, with no spalled concrete. This uneven distribution of damage to piers was probably caused by the asymmetric plan geometry of the bridge, as shown in figure 4.29.

Figure 4.29. Plan and elevation views of State Route 118 at Bull Creek Canyon Channel.

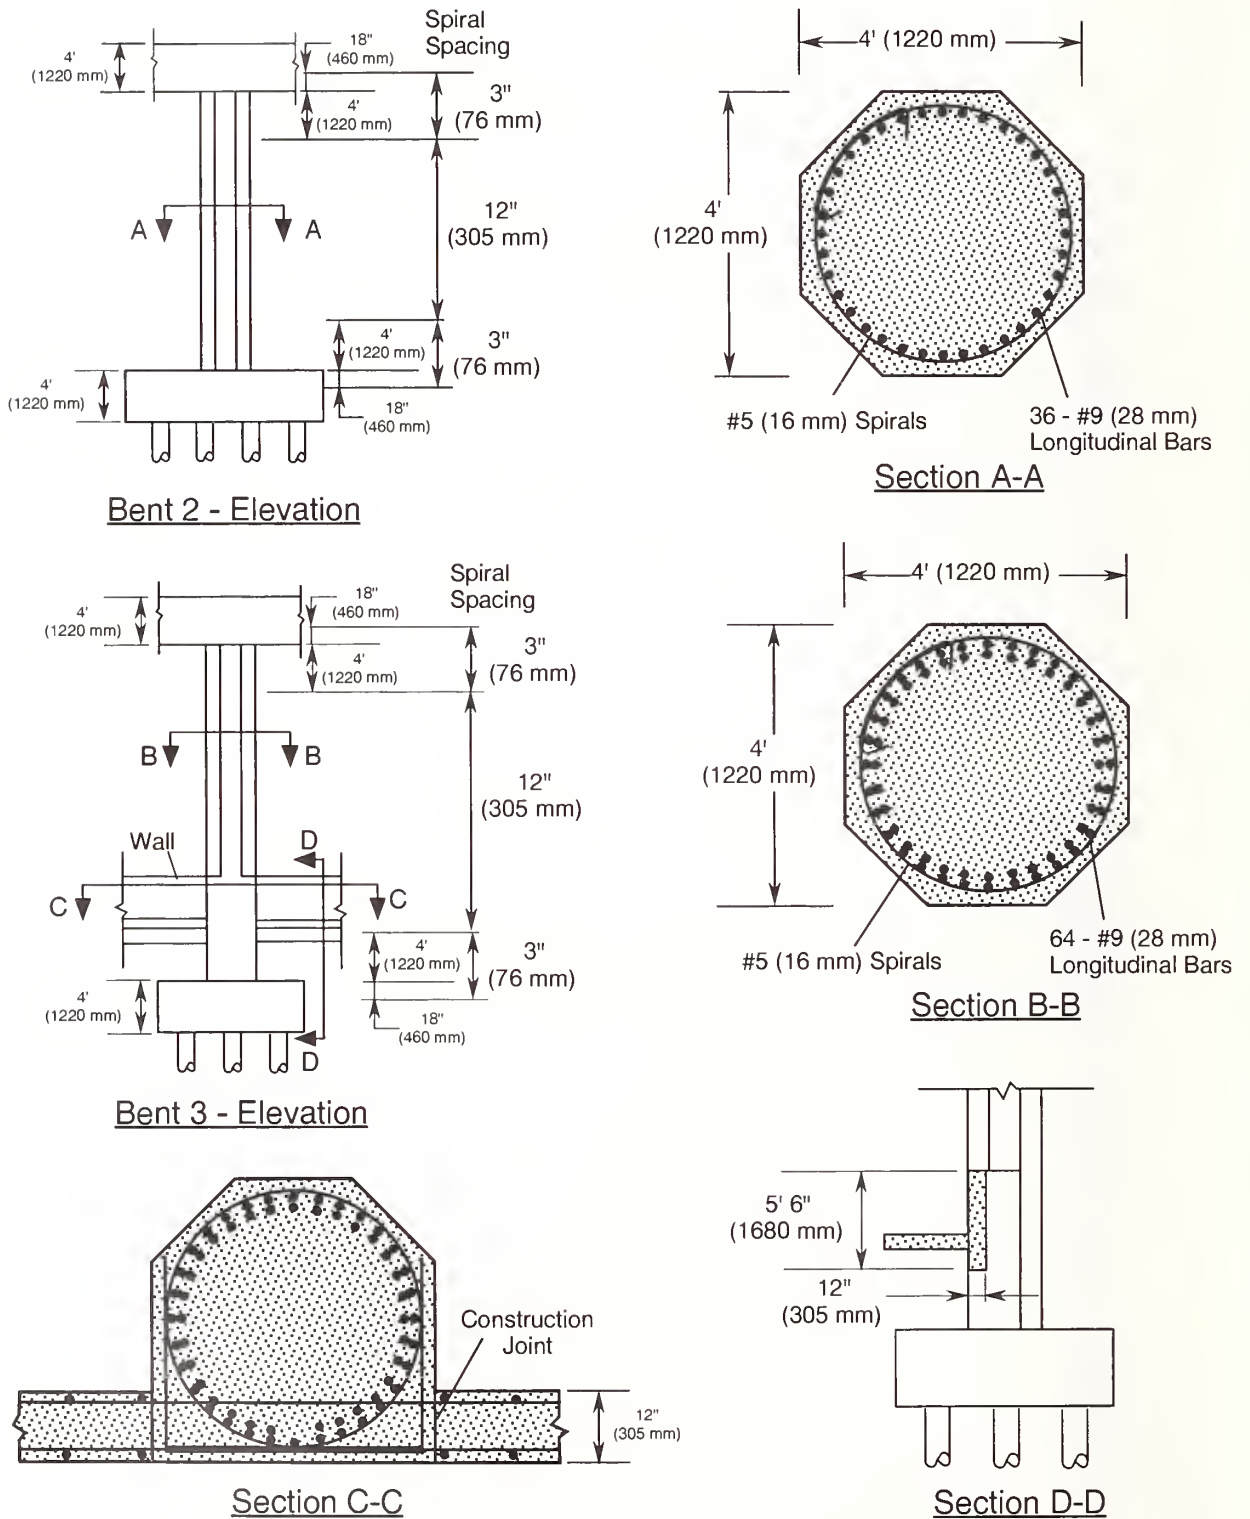
## SR 118 Bull Creek Canyon Channel Bridge Piers

The confining reinforcement in the piers, shown in figure 4.30, is inadequate by current standards. Spiral confining hoops were spaced at 76 mm (3 in) near the top and bottom of each pier (presumably to provide confinement in potential plastic hinge regions), but the spacing was 305 mm (12 in) over most of the pier height. All pier failures occurred in the zone of wide spiral spacing. Another factor contributing to pier failure was that the effective lengths of the piers were much shorter than the distance between the footings and the girder soffit. The lengths of piers varied between roughly 6000 and 9100 mm (20 and 30 ft). In Bent 2, the effective pier lengths were decreased roughly one-third by compacted backfill soil above the pier footings. In Bent 3, the pier lengths were also decreased roughly one-third, but by a reinforced concrete channel liner wall, which was cast abutting the piers (fig. 4.30, section C-C). The shortened effective pier length resulted in stiffer piers, which were more susceptible to shear-dominated failure than bending-dominated failure.

Figure 4.30. Pier details for State Route 118 at Bull Creek Canyon Channel.

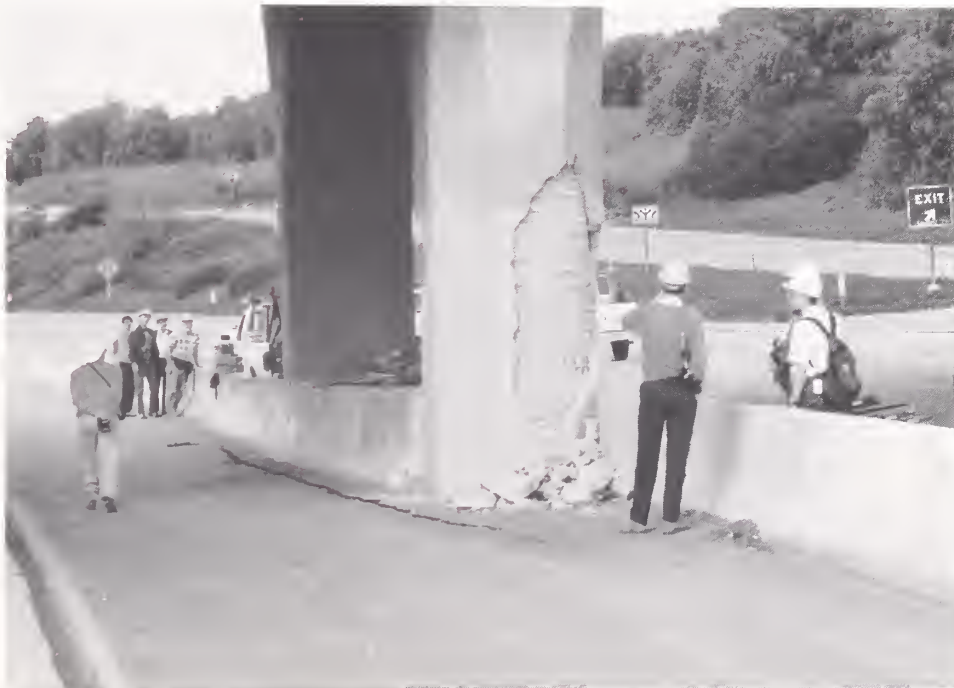
The good seismic performance of this bridge can probably be attributed to two factors. First, the central piers performed well because they contained adequate confining reinforcement and they were slender enough that they were not prone to a shear-dominated failure mode. Second, the overall geometry of the bridge is fairly compact, so that much of the lateral forces were carried by the abutments rather than the central piers. It is not common to see extensive seismic damage to short-span overpasses of this type.

Figure 4.31. SR118 Ruffner Ave. Overcrossing, easternmost central pier, looking to the west.

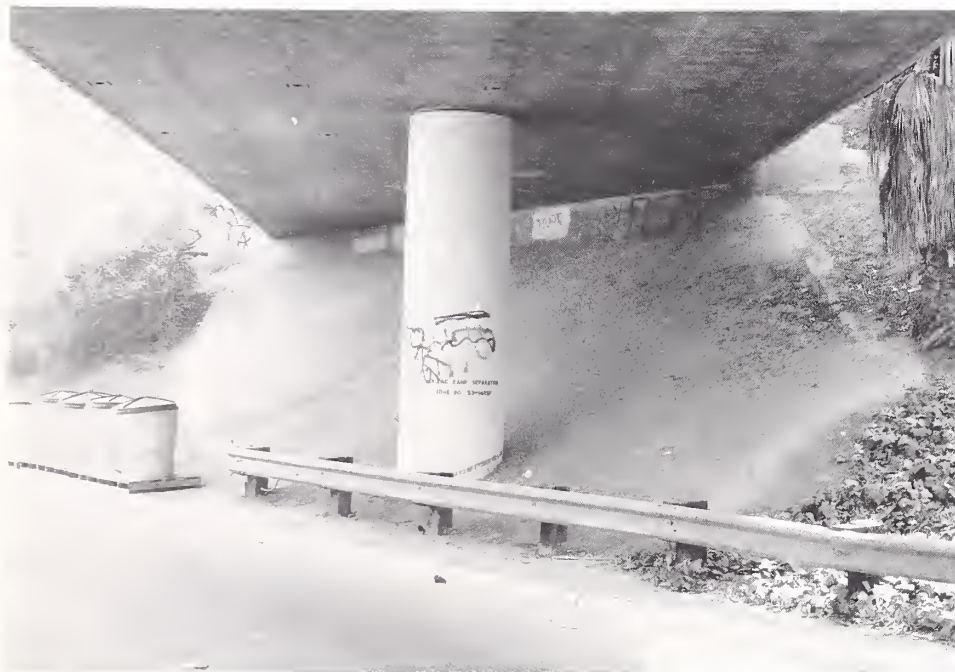
Figure 4.34. Cadillac Ave. ramp; view to east showing jacketed pier.

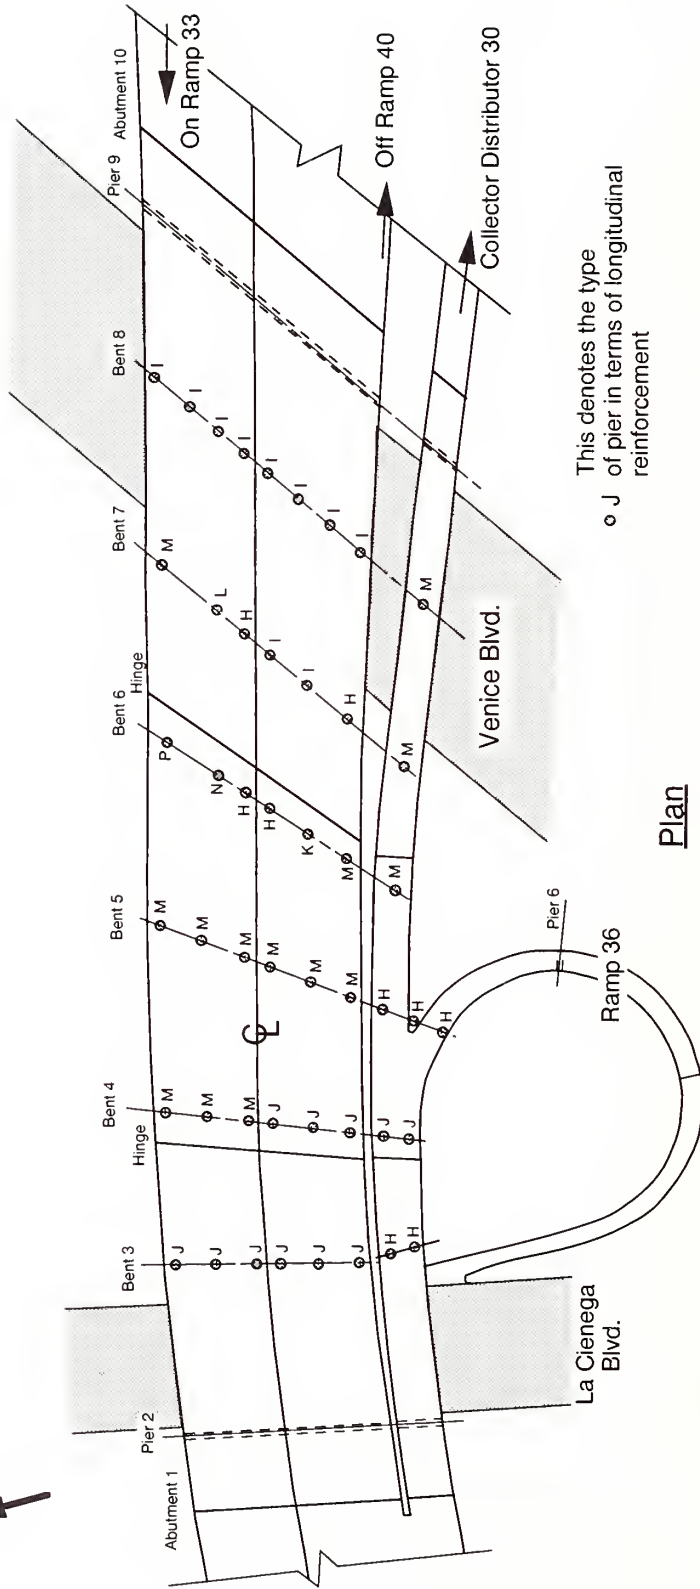
# I-10 La Cienega-Venice Separation

Figure 4.36 shows elevation and plan views of the nine-span bridge structure. Solid wall piers provided support adjacent to the abutments, and the remainder of the supports were multiple-pier bents. Two expansion joints (hinges) were provided as shown. Bents 3 to 7 included three supporting piers for each lane, while Bent 8 had four piers per lane. The exit ramp to La Cienega Blvd. and the eastbound collector-distributor did not collapse. Figure 4.37 shows the pier details. The piers had circular cross sections with a diameter of 1220 mm (4 ft), and the longitudinal reinforcement consisted of #11 (35 mm) or #18 (57 mm) deformed bars. The different pier reinforcement configurations were identified by pier "types" as shown in figure 4.37. These pier types are indicated in the plan shown in figure 4.36. The lateral reinforcement consisted of #4 bars (13 mm) at 305 mm (12 in) vertical spacing.

Figure 4.36. Elevation and plan of I10 Separation at La Cienega Blvd. and Venice Blvd.

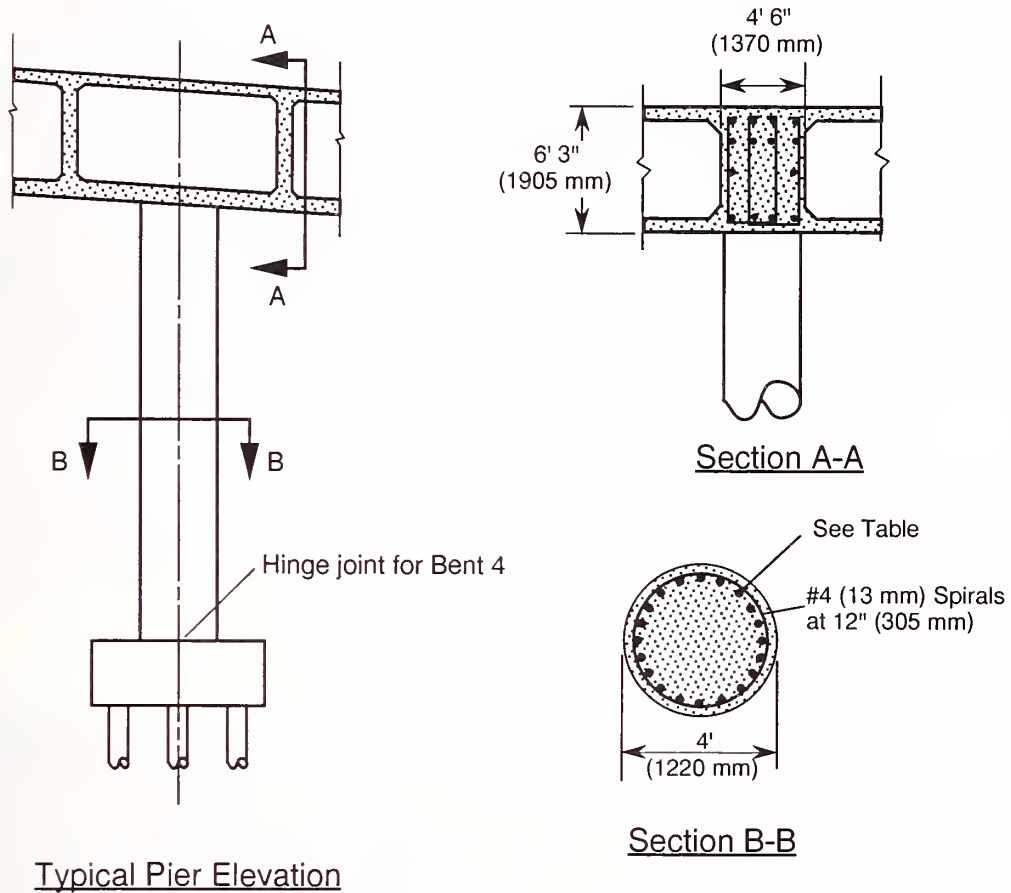
### I-10 La Cienega-Venice Separation Pier Details

Figure 4.37. Pier details for I10 Separation at La Cienega Blvd. and Venice Blvd.

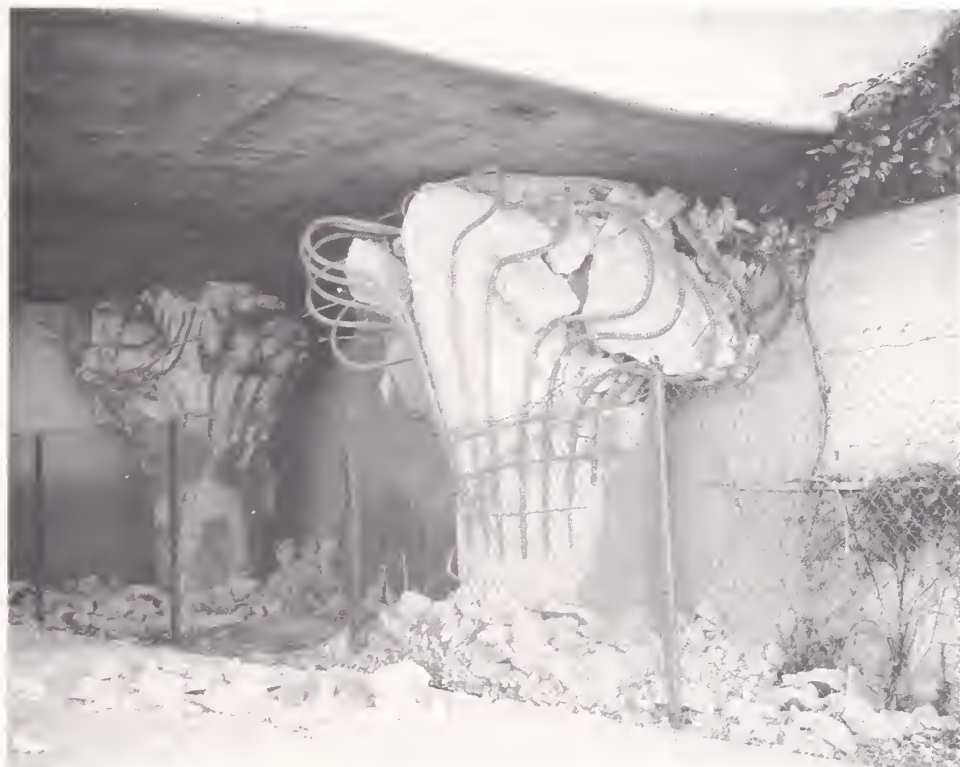
Figure 4.40 shows the northernmost pier of Bent 6, located just to the west of the hinge. This pier totally disintegrated, but the storage building prevented the roadway from collapsing to the ground. Figure 4.41 shows the southernmost pier supporting the eastbound lane at Bent 3. The top of the pier is severely damaged and it is likely that the storage building prevented the total collapse of the roadway.

Figure 4.41. Piers of Bent 3 supporting eastbound lane of I10 at La Cienega Blvd.

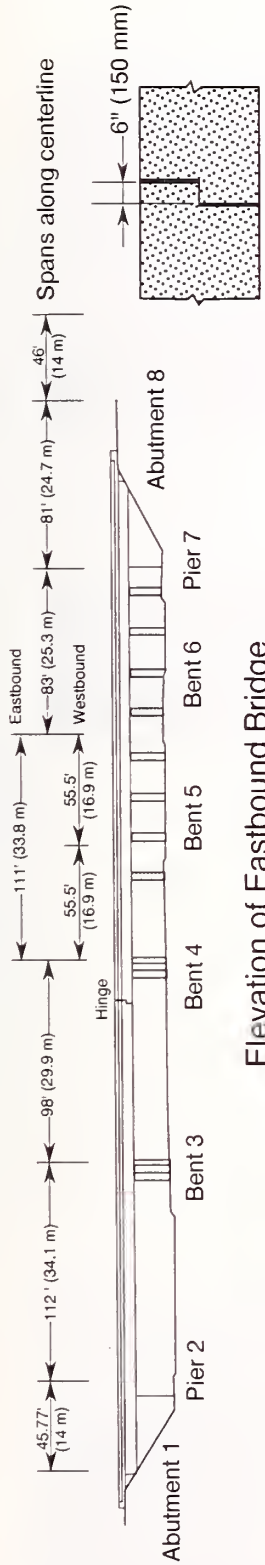
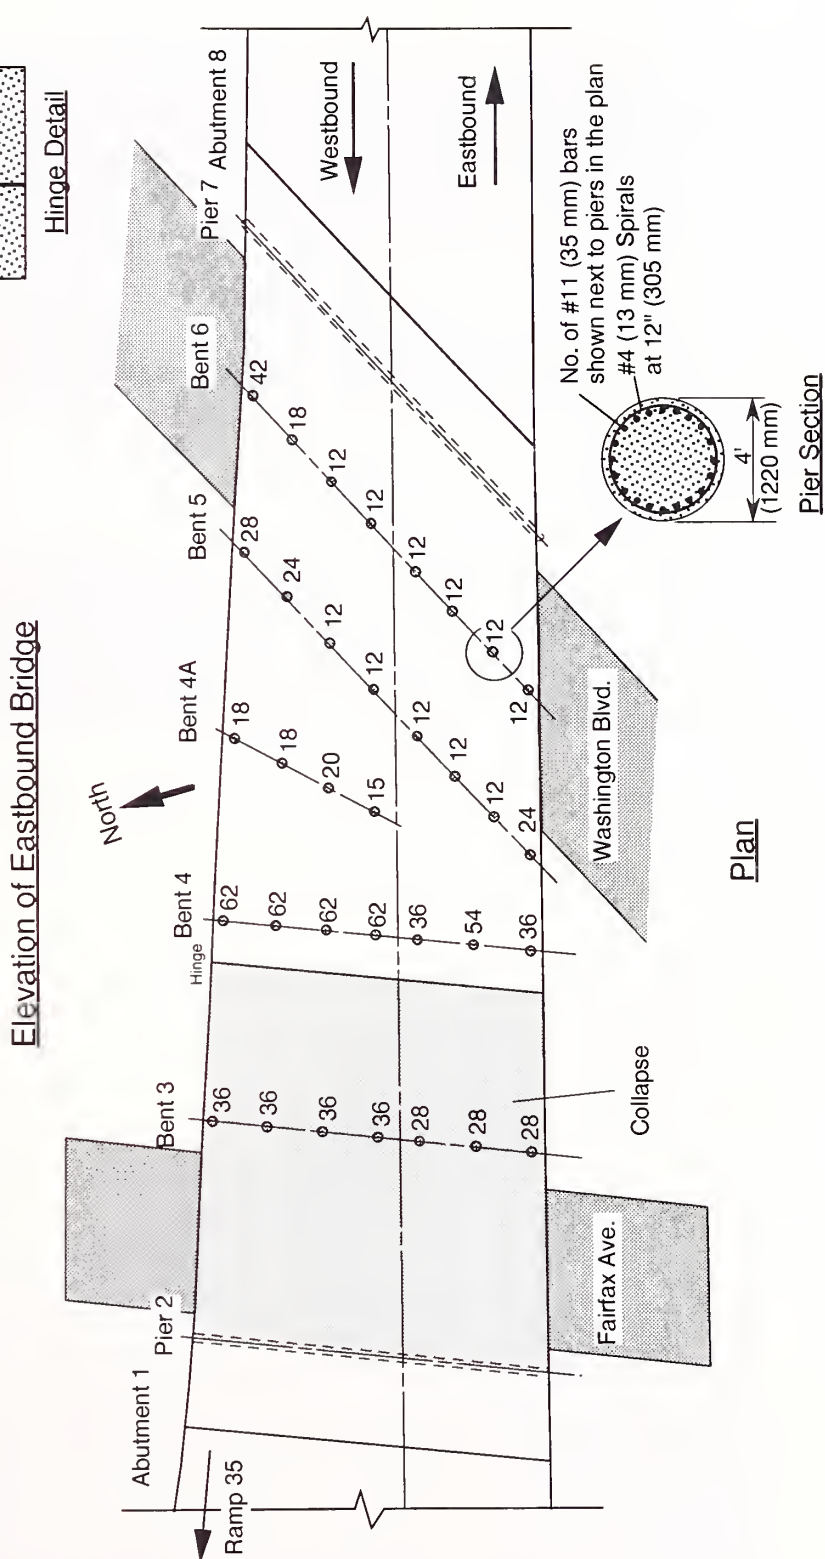
# I-10 Fairfax-Washington Undercrossing

Figure 4.42 shows the elevation and plan of the Fairfax Ave.-Washington Blvd. Undercrossing. The eastbound and westbound lanes of I10 were supported by solid wall piers adjacent to the abutments and by multiple-pier bents at the remaining locations. A construction joint (hinge) was located to the west of Bent 4. Because of the skewed alignment of I10 relative to Washington Blvd., the westbound lane of I10 was designed with an additional bent (Bent 4A) compared with the eastbound lane. The piers were of circular cross section with a diameter of 1220 mm (4 ft). The longitudinal reinforcement consisted of #11 (35 mm) deformed bars. The number of longitudinal bars in each pier is shown adjacent to the pier locations in figure 4.42. It can be seen that the piers in Bent 4 had significantly more longitudinal bars compared with the other piers. The lateral reinforcement was #4 (13 mm) bars at a vertical spacing of 305 mm (12 in).

The earthquake caused partial collapse of two spans of the eastbound and westbound lanes on either side of Bent 3 (fig. 4.42). When the reconnaissance team arrived at the site, the collapsed spans had been completely removed and workmen were preparing to open up traffic on Fairfax Ave. Hence it was not possible to examine the collapsed structure. Conversations with Caltrans engineers at the site revealed that the piers in Bent 3 had failed and caused the girders to sag at this location. However, cable restrainers at the hinge west of Bent 4 prevented the girders from falling off of the hinge seats (fig. 4.43). Figure 4.44 is a photograph provided by EERC which shows the westbound lane of I10 over Fairfax Ave. It can be seen that the piers in Bent 3 shortened and caused the girder to sag. It can also be seen that the span to the west of Pier 2 lifted off of the abutment. Figure 4.45 is a close up view of one of the piers in Bent 3. The failure mode is similar to that observed at Venice Blvd. and La Cienega Blvd. When the piers were subjected to lateral ground motions, the lateral reinforcement was not able to adequately confine the core concrete. As a result of lateral load damage, there was a loss of axial load capacity and the piers shortened under the action of the vertical loads. As mentioned, the piers at Bent 4 had considerably more longitudinal reinforcement than the other piers. Examination of the piers in Bent 4 revealed varying degrees of diagonal cracking and spalling of the concrete cover. At the time of the site visit, these piers were surrounded with wooden shoring as a precautionary measure during the demolition of the collapsed spans.

Figure 4.42. Elevation and plan of I10 at the Fairfax Ave./Washington Blvd. Undercrossing.

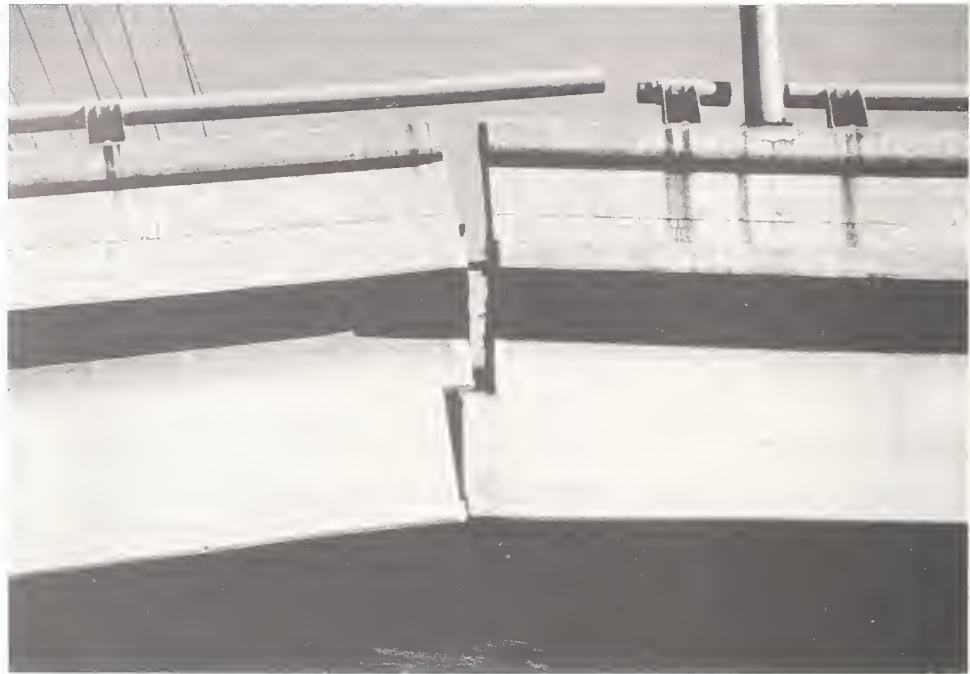
Figure 4.43. Hinge adjacent to Bent 4 of I 10 at Fairfax Ave.; cable restrainers prevented loss of support (Photo courtesy of EERC).

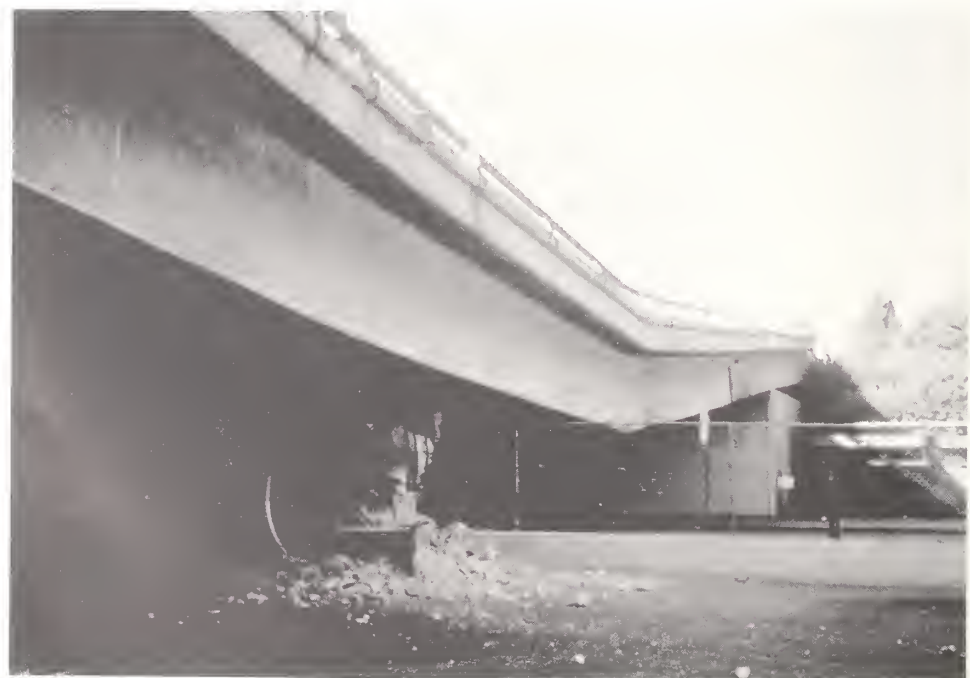
Figure 4.44. View of collapsed span of I10 over Fairfax Ave.; note rotation of girder over Pier 2 (Photo courtesy of EERC).

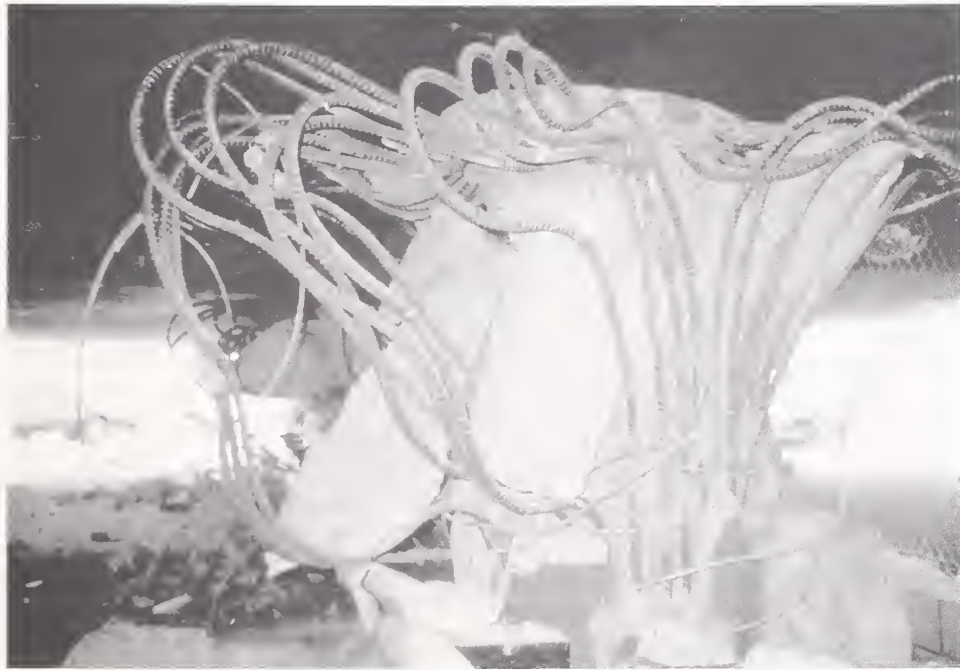
Figure 4.45. Failed column in Bent 3 of I10 at Fairfax Ave. (Photo courtesy of EERC).

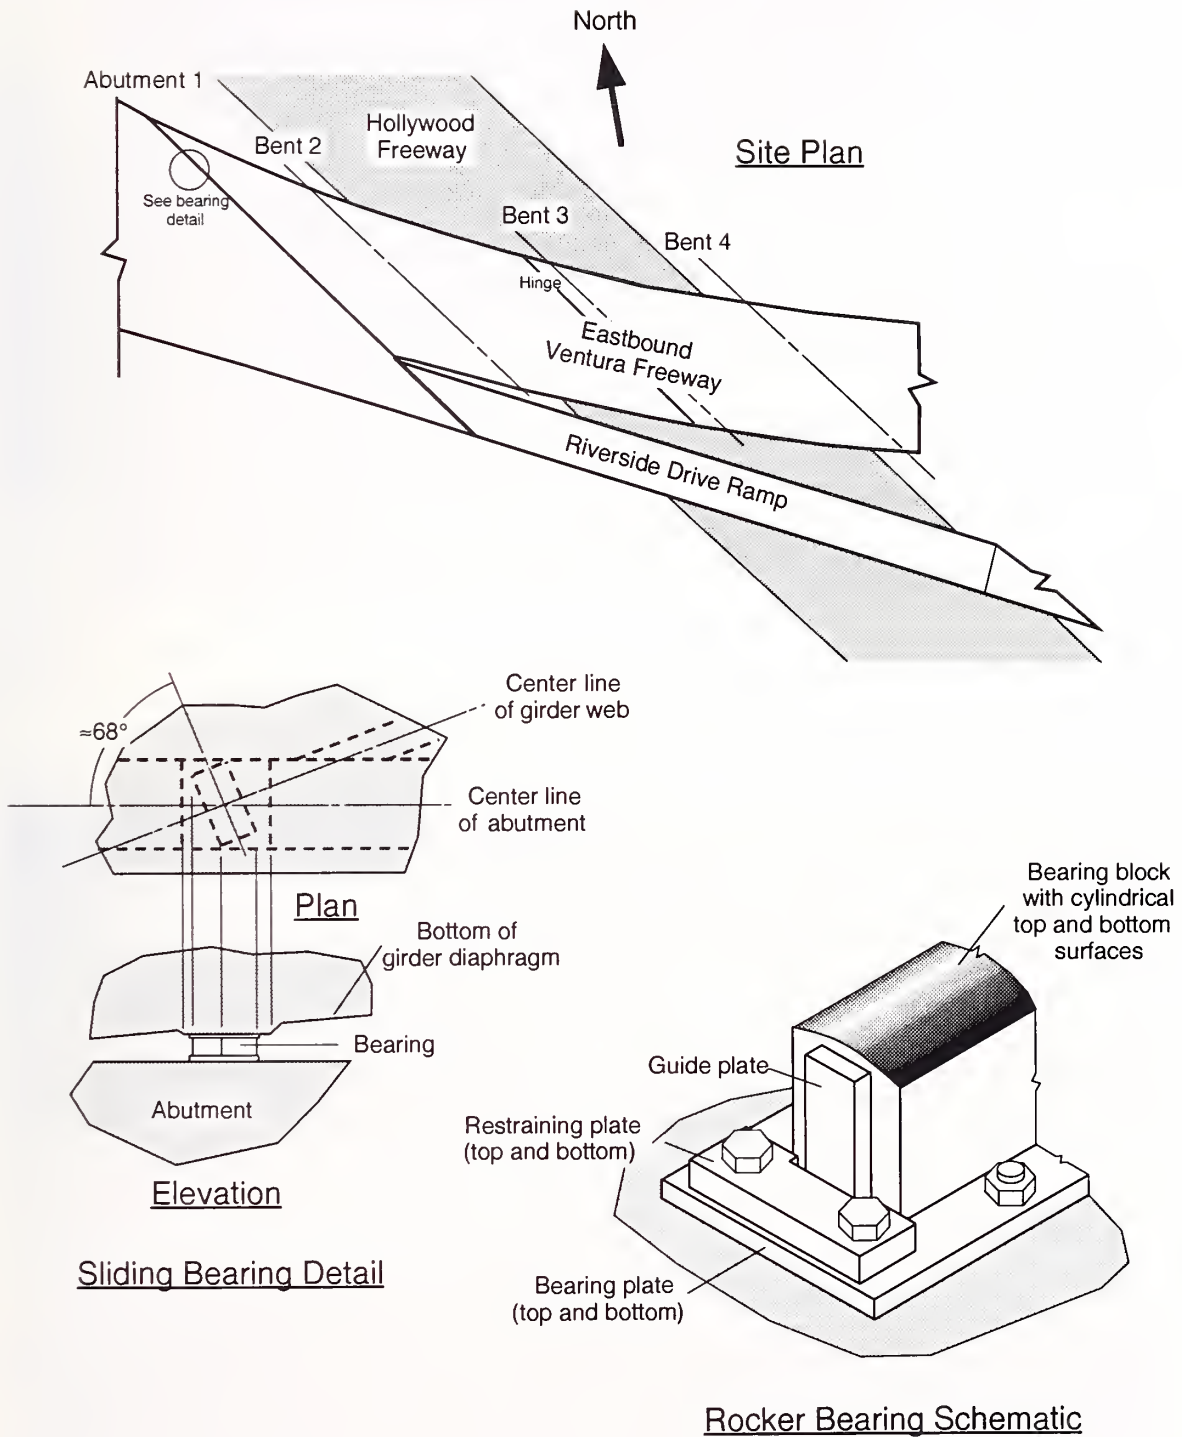
Figure 4.46 shows a simplified plan of the eastbound lane of the Ventura Freeway and the Riverside Drive ramp. Figure 4.47 is a ground level view of the eastbound lane as seen from the northbound lane of the Hollywood Freeway. At Abutment 1 (fig. 4.46), bearing supports are provided at the locations of the webs in the box girder. As shown in figure 4.46, the longitudinal axes of the bearings are aligned at right angles to the longitudinal axes of the girder webs. The four bearings on the north side of the eastbound lane of Ventura Freeway are of the sliding-type. Figure 4.48 shows the type of damage that was observed at these locations. Apparently, the dynamic frictional resistance of the bearing resulted in forces sufficient to spall off the shell of the abutment. The remainder of the bearings supporting the eastbound lane and the Riverside Drive ramp are of the rocker type. Figure 4.46 shows a schematic of this type of bearing. A steel bearing block with cylindrical surfaces is located between steel plates set into the abutment and girder end diaphragm. The blocks are kept in position with a system of guide plates and restraining plates as shown in figure 4.46. All of the rocker bearings showed some type of earthquake damage. The bolts for the restraining plates were sheared off at many locations, and the sheared bolt heads were found at distances of up to several meters from their original position. Some of the bearing blocks were skewed from their original positions (fig. 4.49). In one case, the bearing block had tipped over resulting in a complete loss of support at that location (fig. 4.50).

Figure 4.46. Eastbound lane of Ventura Freeway crossing over Hollywood Freeway; site plan and bearing details.

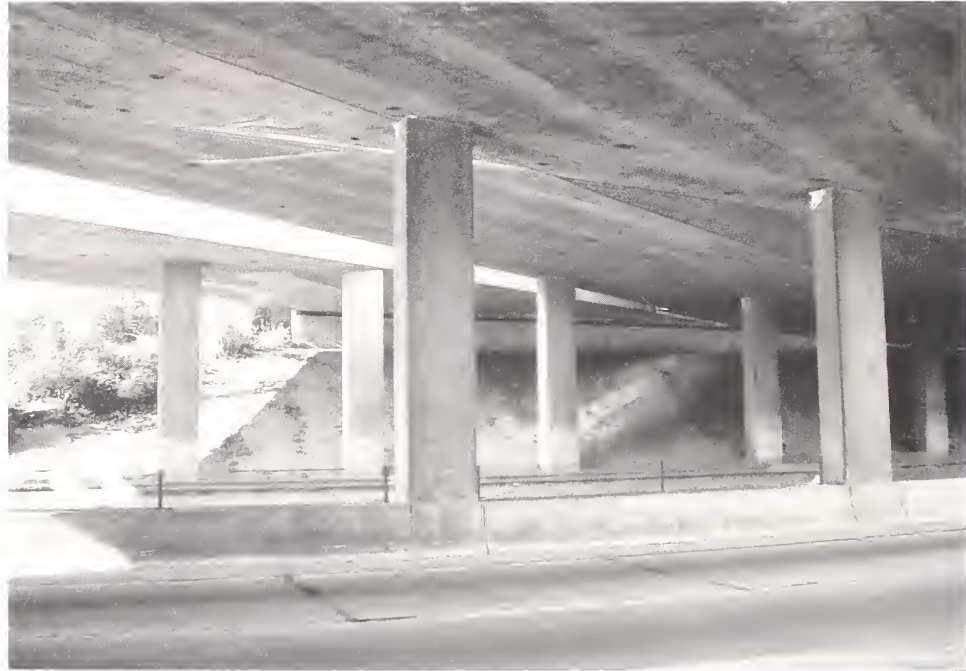
Figure 4.47. Eastbound lane of Ventura Freeway as seen from the northbound lane of Hollywood Freeway.

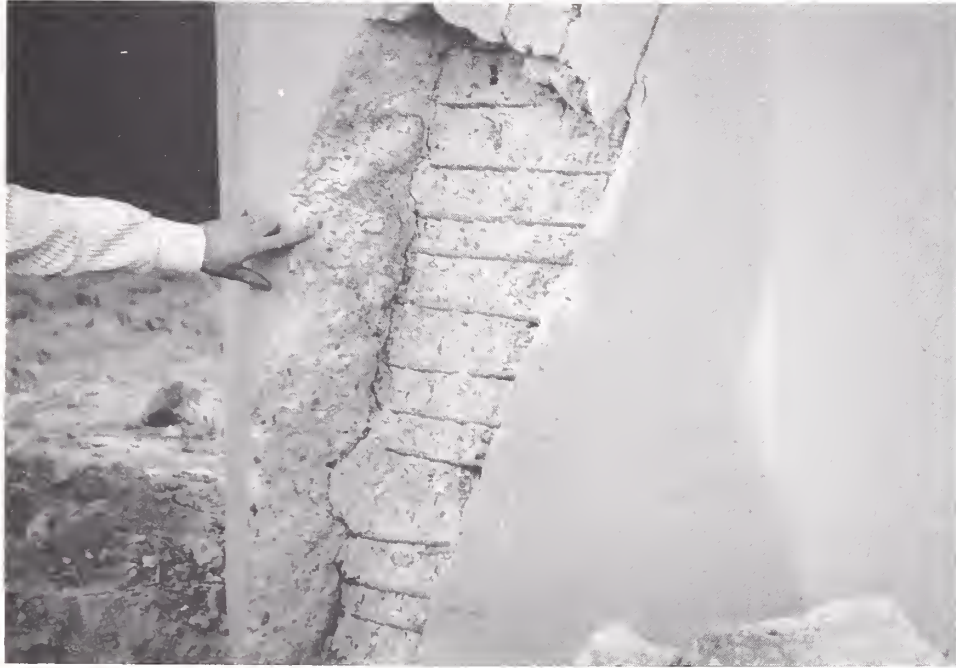
This is a long, curved ramp structure with piers of varying height. The last pier before the west abutment, adjacent to Sharp Avenue, exhibited severe shear cracking. This was one of the shortest and stiffest piers in the structure, so it probably attracted large lateral forces. Damage to the pier is shown in figures 4.51 and 4.52. Note that when the photos in figures 4.51 and 4.52 were taken the loose cover concrete had been removed by Caltrans workers to inspect damage to the core. It appeared that cracks extended into the core of the pier. The pier is octagonal in cross section, measuring 2440 mm (8 ft) across, and has a flared section at the top. Longitudinal reinforcement consists of 64 #11 (36 mm) bars (EERC 1994). This pier contains high levels of shear reinforcement: #4 (13 mm) spirals spaced at 89 mm (3.5 in). Damage to the abutment just to the west of this pier was also observed. This damage was apparently due to pounding between the superstructure and the abutment.

Figure 4.52. Close-up view of the westernmost pier at the Interstate 5, State Route 118, Southwest Connector, looking to the southeast. Loose cover concrete has been removed by Caltrans.

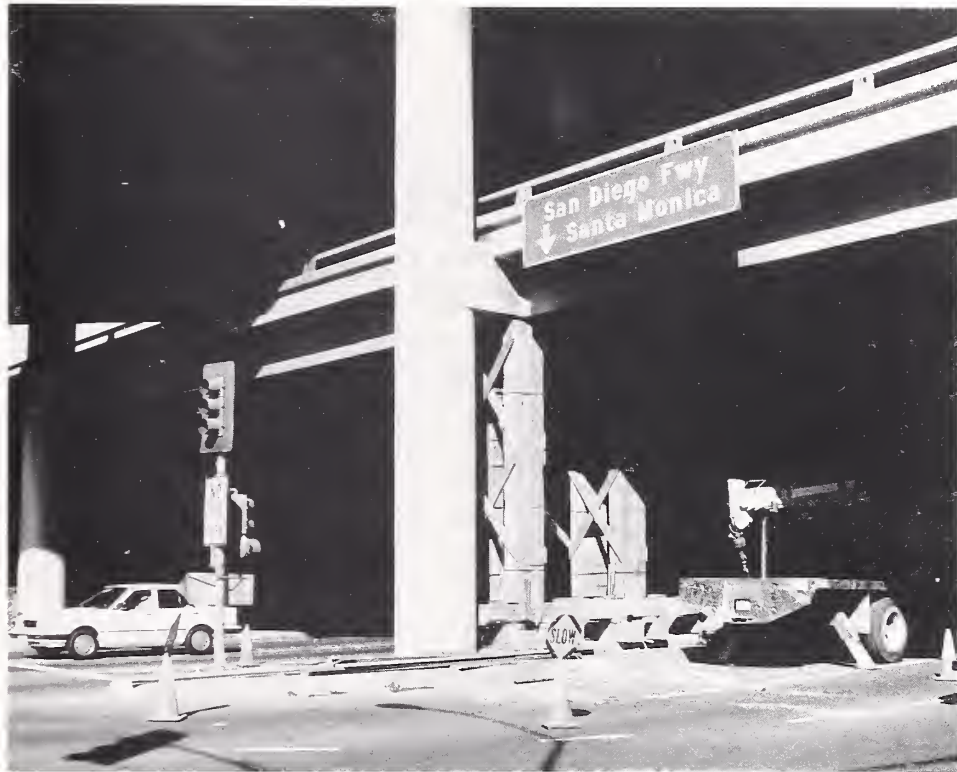
The damage observed in the Northridge earthquake possibly arose from three factors. First, the joint regions where cracking occurred are not as heavily reinforced as they would be under current design standards. Second, the structural hinges at the bases of most outrigger piers tended to increase the moments imposed on the outrigger joints. Third, the Jefferson Blvd. Undercrossing shares piers with the SR90 ramp above, as shown schematically in figure 4.55. The upper SR90 structure is more flexible than the lower Jefferson Blvd. Undercrossing, possibly resulting in further concentrations of moments at the outrigger joints.

Figure 4.53. Overview of the outrigger joint at the SR90/I405 interchange, Jefferson Boulevard Undercrossing, center bent, west side, looking to the north.

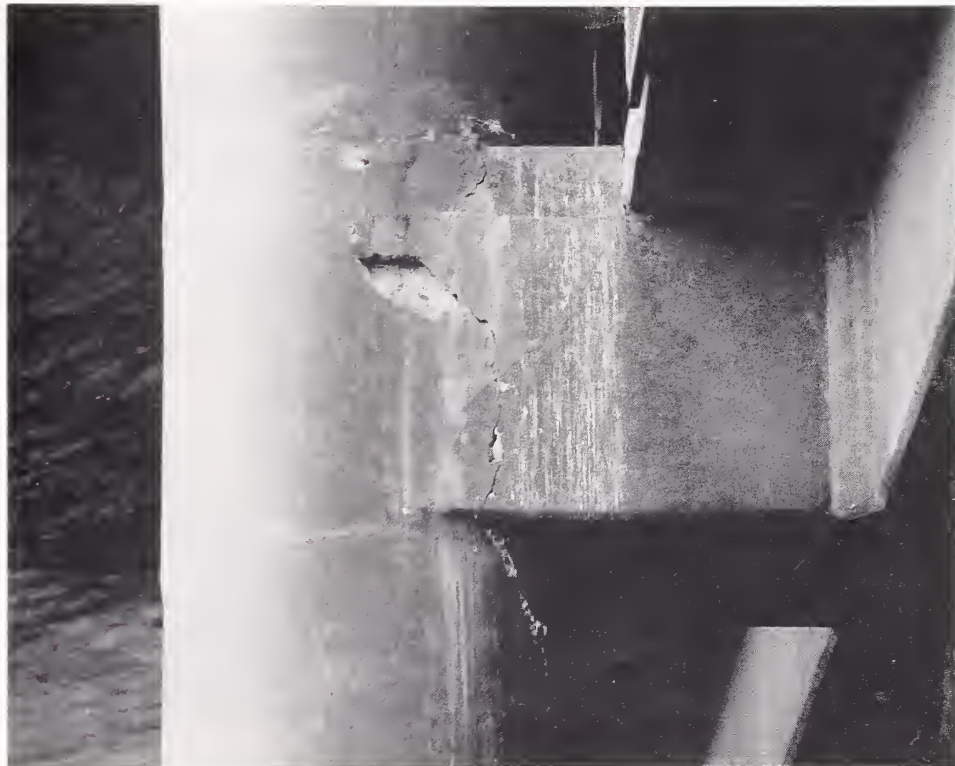
This is a cast-in-place reinforced concrete bridge which carries Interstate 405 over Jefferson Blvd. The bridge consists of four spans: two 8.5 m (28 ft) long end spans and two 16.0 m (52.5 ft) long center spans. The bridge is supported on three six-pier bents, making a total of 18 piers. The piers are circular and 1220 mm (4 ft) in diameter. All but two of the eighteen piers have structural hinges at the top of the pier footing. The outer piers of each bent are located outside the bridge girders, creating an "outrigger" configuration, as shown in figure 4.53. After the Northridge earthquake, diagonal cracks were observed in all six outrigger joints at the ends of the three bents. The cracking was most serious on the east end of the center bent. A close-up photograph at that location are shown in figure 4.54.

Figure 4.54. Close-up of the outrigger joint at the SR90/I405 interchange, Jefferson Boulevard Undercrossing, center bent, east side, looking to the south.

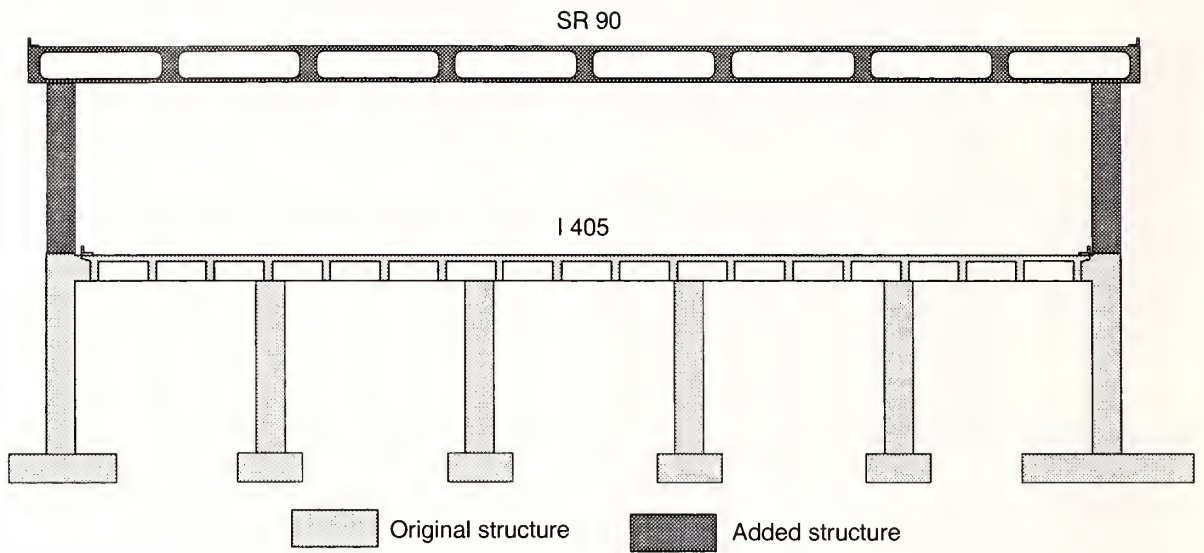
This bridge was constructed in about 1961, so generally speaking it does not meet current seismic design standards. The bridge is somewhat unusual because in the original design allowances were made for future construction of the ramps of the SR90/I405 interchange passing overhead: the outermost piers of the bridge were more heavily reinforced to allow for later extensions of the height of those piers. The reinforcement in the exterior piers consisted of 22 #18 bars (57 mm) longitudinally, and #5 bar (16 mm) spiral hoops spaced at 114 mm (4.5 in); the inner piers were reinforced with 14 #9 bars (29 mm) longitudinally, and #4 (13 mm) spirals spaced at 305 mm (12 in). The exterior piers were later extended in height, as can be seen in figure 4.53. It is not clear how structural continuity was achieved between the original exterior piers and the pier extensions, since no explicit provisions were made in the original design for extending the longitudinal reinforcement.

Figure 4.55. Schematic cross section, showing columns shared by SR90 and the Jefferson Boulevard Undercrossing.

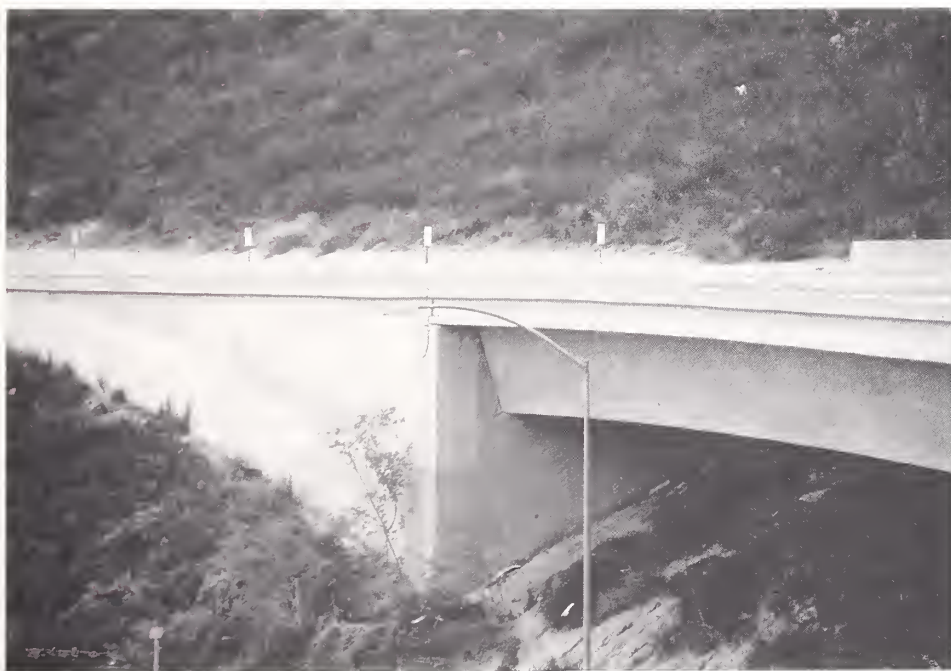
In the Northridge earthquake, bridge abutment damage ranged from minor settlement of backfill soil at the approaches, to cracking of wing walls, to permanent displacement of the entire abutment. For example, at the intersection of State Route 118 and Interstate 210, there was damage to the abutment at the east end of the long elevated structure connecting eastbound SR118 with northbound I210. An overview of the abutment is shown in figure 4.56, and a close-up of some of the abutment sidewall cracking is shown in figure 4.57. At the interchange of US101, SR134 and SR170, at the Riverside Drive Offramp Overcrossing (Caltrans bridge No. 53-1493S, described above) the abutments at both ends of the offramp exhibited severe cracking in the wing walls. Damage to concrete abutment piles was reported [5] at the Las Virgenes Overcrossing on US101 (Caltrans bridge No. 53-1442). There were many other cases of bridge abutment damage observed by the reconnaissance team, and reported by other investigators, which are too numerous to list here.

Figure 4.56. Overview of abutment at the east end of the ramp connecting eastbound SR118 with northbound I210.

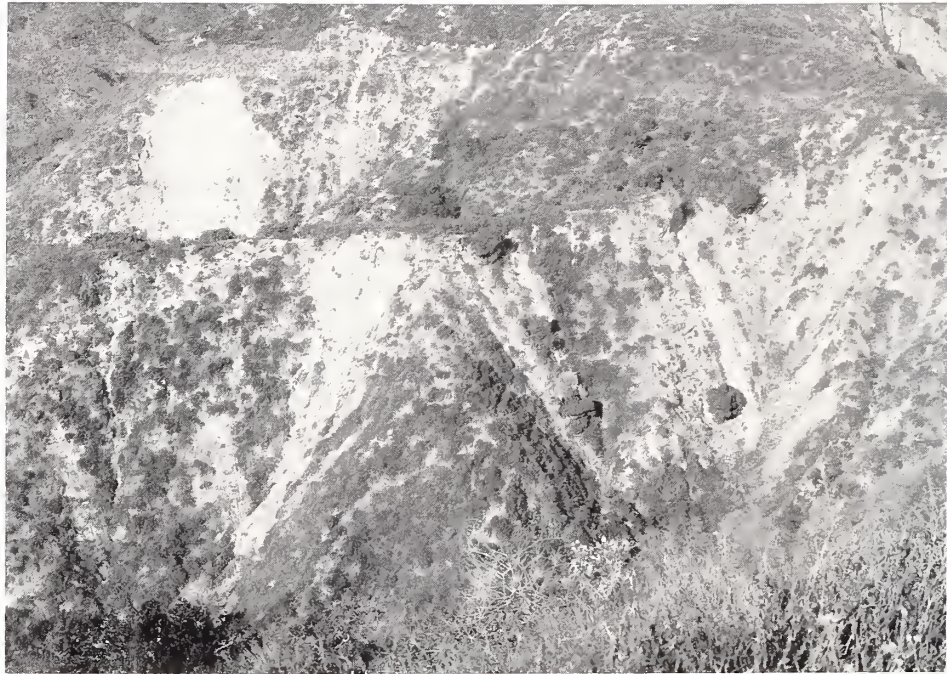
Among the numerous situations that contributed to the disruption of the water supply system was damage to Los Angeles Aqueduct No. 2 at Terminal Hill. Aqueduct No. 2 is made of 2.1-m (77 in) diameter steel pipes. Terminal Hill is located about 20 km (12.5 mi) north-northeast of the epicenter, southeast of the intersection of I5 and SR14. There is no strong motion record available for the site. However, two stations maintained by the California Division of Mines and Geology (CDMG) and the U.S. Geological Survey (USGS) about 5 km (3 mi) south of the site showed peak ground accelerations over 0.9g, indicating that the site probably was strongly shaken by the earthquake. Other indications of strong shaking can be seen from the numerous landslides along the mountainside to the north of the site (fig. 5.1), and the bridge failures at the intersection of I5 and SR14.

Figure 5.1. Strong shaking at Aqueduct No. 2 at Terminal Hill can be inferred from the numerous landslides along the mountain slopes to the north of the site.

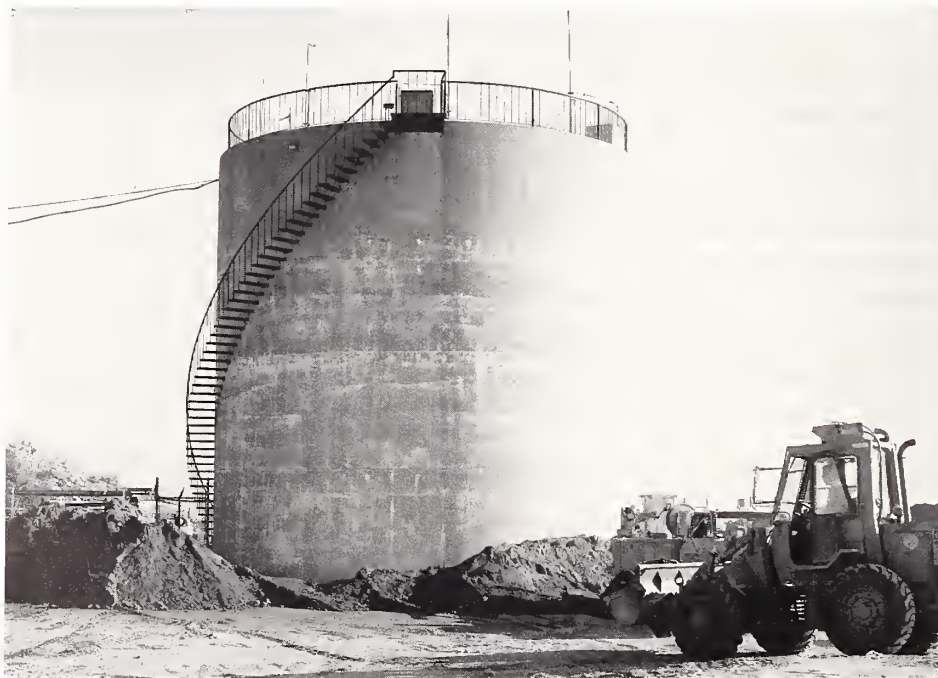
The reinforced concrete relief tank (surge chamber) on top of the hill appeared to perform well through the earthquake--no damage was observed (fig. 5.2). A steel pipe brings water up from the canyon below (fig. 5.3). The pipe is supported on concrete saddles built along the mountain slope. At a few places, the pipe separated from the saddles creating 50 to 80 mm (2 to 3 in) gaps. In at least one location, the pipe crashed vertically into the saddle. At two other locations, the pipe sections bulged 80 mm and 150 mm (3 and 6 in), however, no rupture or leakage was noticed. The ruptured section of the 2.1-m pipe is located near the hilltop. The two sections where the rupture occurred were connected using a mechanical coupling system (fig. 5.4). The pipe sections were connected by eight pairs of restrainer rods 35 mm (1-3/8 in) in diameter and 2.2 m (7 ft) long. The rods were attached to brackets, which were welded to the pipes. These welds broke during the earthquake (fig. 5.5) and resulted in the separation of the two pipe sections.

Figure 5.2. The reinforced concrete surge tank at Terminal Hill performed well during the earthquake--no damage was observed.
