*NIST Special Publication 862*

# 1994 Northridge Earthquake Performance of Structures, Lifelines, and Fire Protection Systems

*Diana Todd, Nicholas Carino, Riley M. Chung, H. S. Lew, Andrew W. Taylor,  
William D. Walton, James D. Cooper, and Roland Nimis*

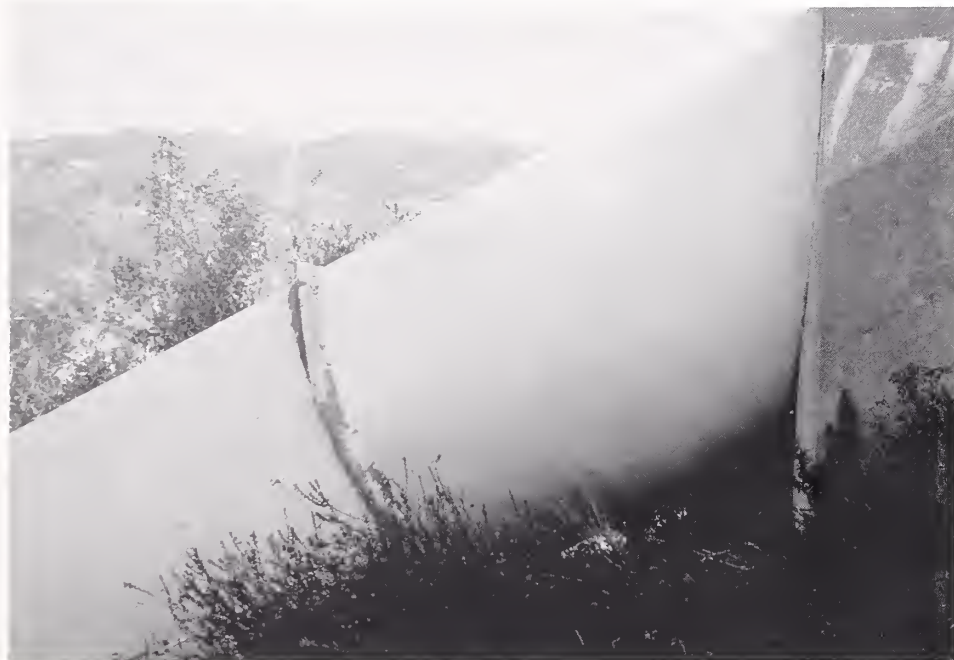
The reinforced concrete relief tank (surge chamber) on top of the hill appeared to perform well through the earthquake--no damage was observed (fig. 5.2). A steel pipe brings water up from the canyon below (fig. 5.3). The pipe is supported on concrete saddles built along the mountain slope. At a few places, the pipe separated from the saddles creating 50 to 80 mm (2 to 3 in) gaps. In at least one location, the pipe crashed vertically into the saddle. At two other locations, the pipe sections bulged 80 mm and 150 mm (3 and 6 in), however, no rupture or leakage was noticed. The ruptured section of the 2.1-m pipe is located near the hilltop. The two sections where the rupture occurred were connected using a mechanical coupling system (fig. 5.4). The pipe sections were connected by eight pairs of restrainer rods 35 mm (1-3/8 in) in diameter and 2.2 m (7 ft) long. The rods were attached to brackets, which were welded to the pipes. These welds broke during the earthquake (fig. 5.5) and resulted in the separation of the two pipe sections.

Figure 5.3. The steel pipeline at Terminal Hill separated from its supporting saddle at several places and pipe sections bulged at other locations along the alignment.

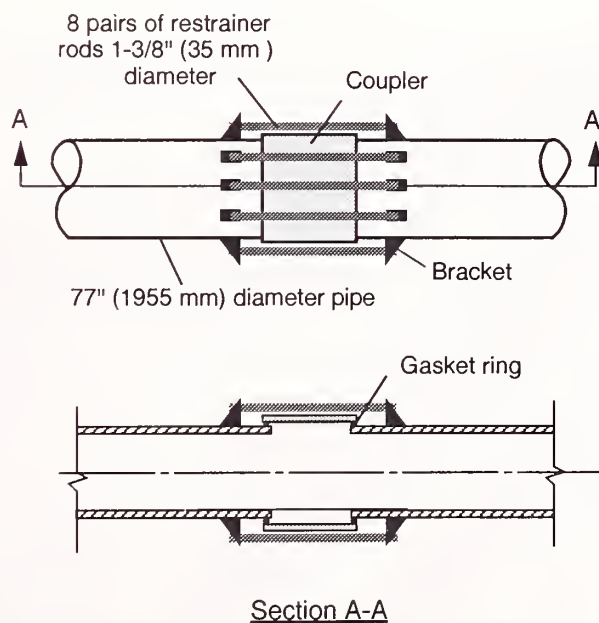
Figure 5.4. Schematic drawing of connection of the two steel pipe sections which were pulled apart during the earthquake.

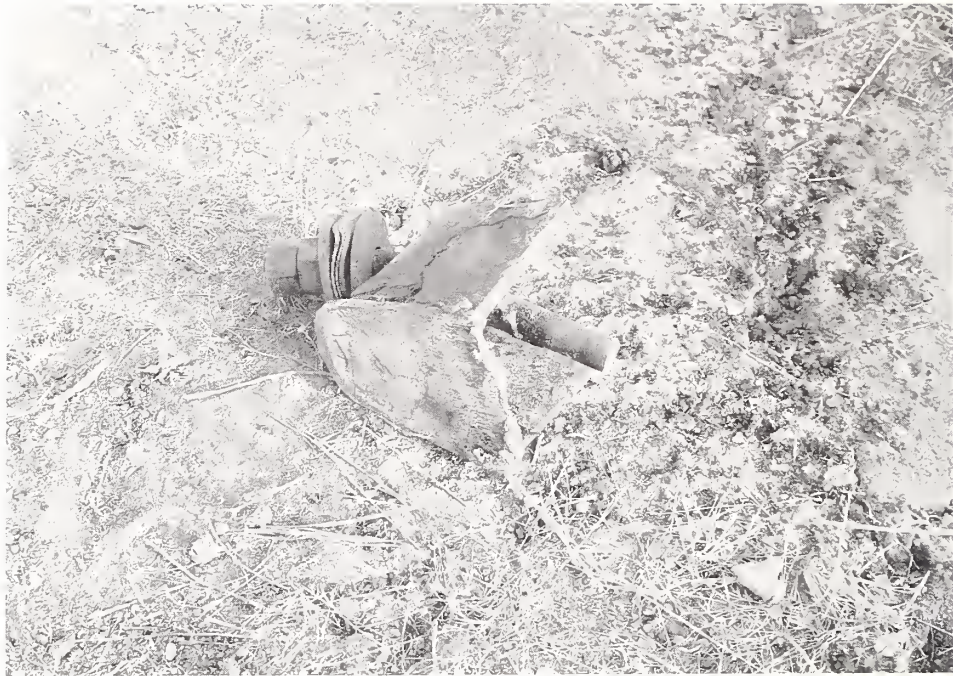
Figure 5.5. Welds of the restrainer brackets broke as the result of strong shaking.

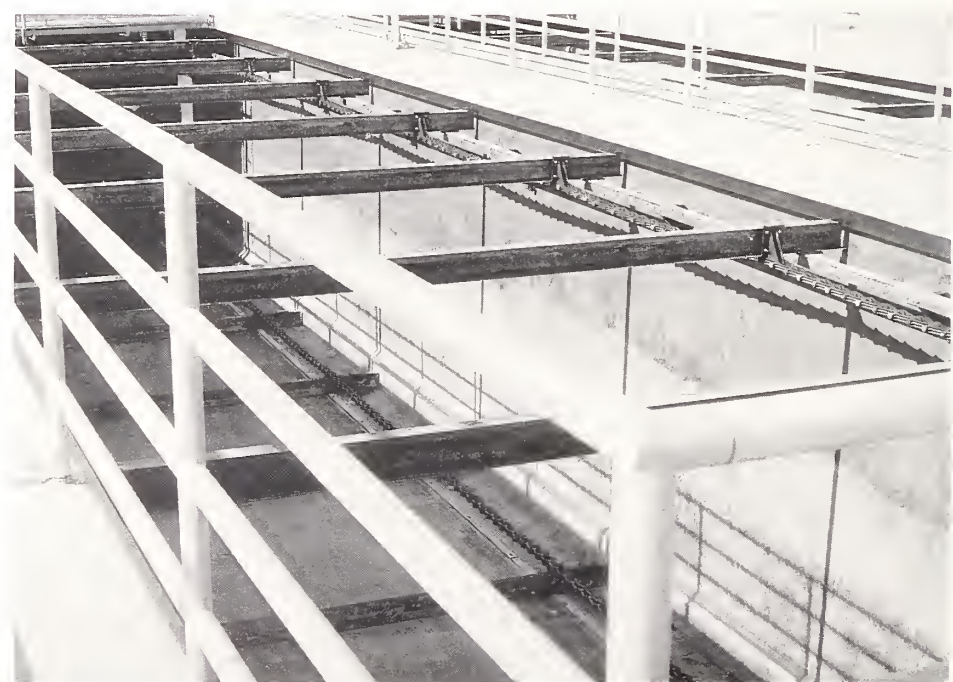
Figure 5.6. Undamaged clarifier tank at the Tillman Water Reclamation Plant.

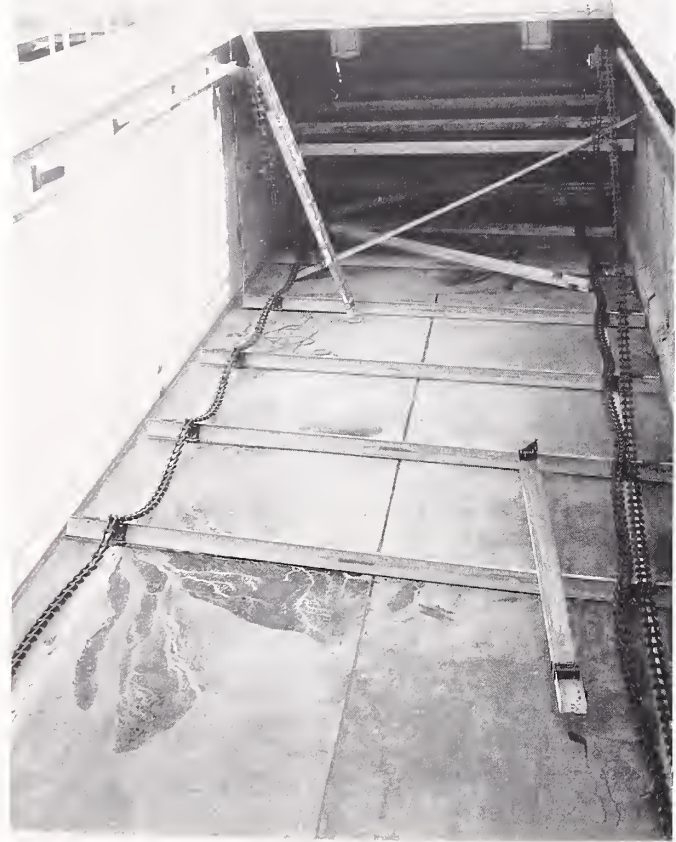
The earthquake resulted in damage to five out of twenty-two final clarifier tanks built in 1991 as part of the Phase II expansion. Twenty-two Phase I tanks built in 1983 were not damaged. Figure 5.6 shows a typical undamaged final clarifier tank. The scrapers are supported by railings attached to the walls with brackets. Chains are used to move the scrapers. All these components were made of plastic in the Phase II construction, whereas the brackets were made of metal and railings and sludge scrapers were made of redwood in the Phase I construction. Pins about 10 mm (3/8 in) in diameter and 19 mm (3/4 in) long connected the brackets to the railings. In the tanks where there was damage, it is suspected that the pins dislodged due to wave action in the tank and the railing became displaced. This caused jamming of the chain movement, which disabled the system (fig. 5.7).

Figure 5.7. A damaged sludge scraper in a clarifier tank at the Tillman Water Reclamation Plant.

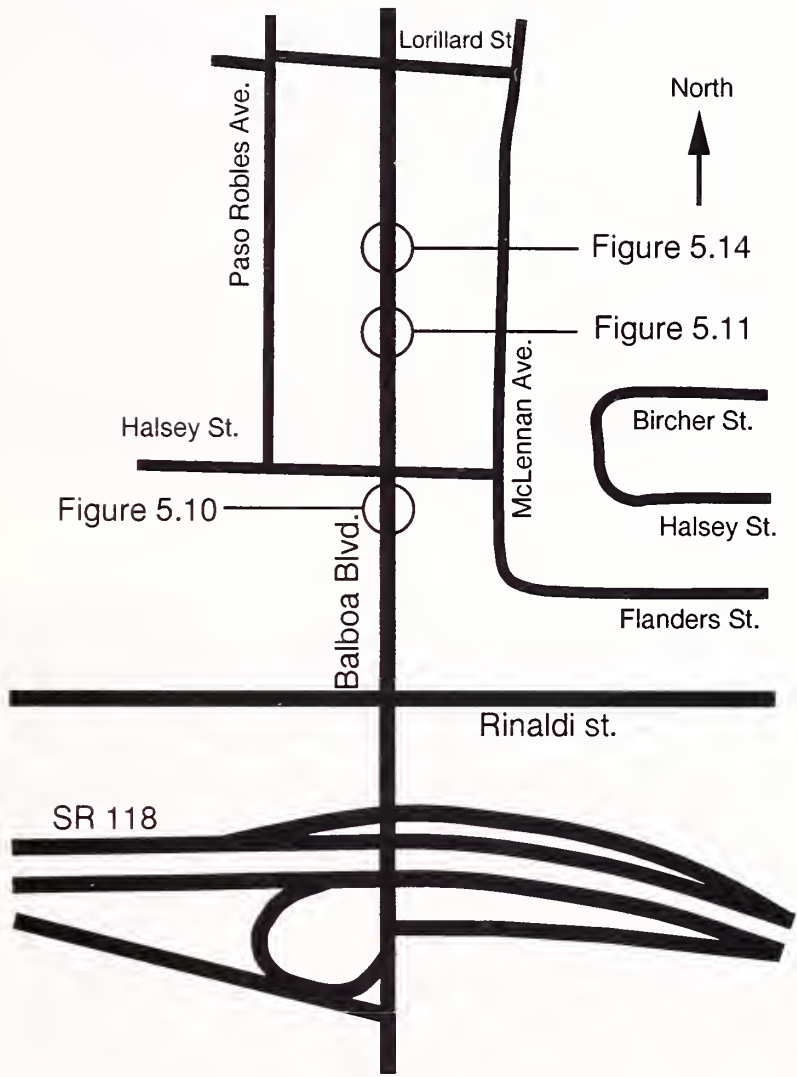
The rupture of a 0.6-m (22-in) gas main occurred along Balboa Boulevard between Rinaldi Street to the south and Lorillard Street to the north (fig. 5.8). Along this stretch, compressional ground failures occurred between Rinaldi Street and Halsey Street, and extensional ground failures occurred between Bircher Street and Halsey Street. Ground extension at this location is prominently exhibited by the transverse cracks in the pavement as shown in figure 5.9. Further, lateral spreading of 25 to 100 mm (1 to 4 in) toward the west was observed along the sidewalk on the west side of Balboa Boulevard north of Halsey Street, whereas no lateral spreading was observed on the east side of Balboa Boulevard.

Figure 5.8. Location of the 0.6-m gas main rupture on Balboa Boulevard.

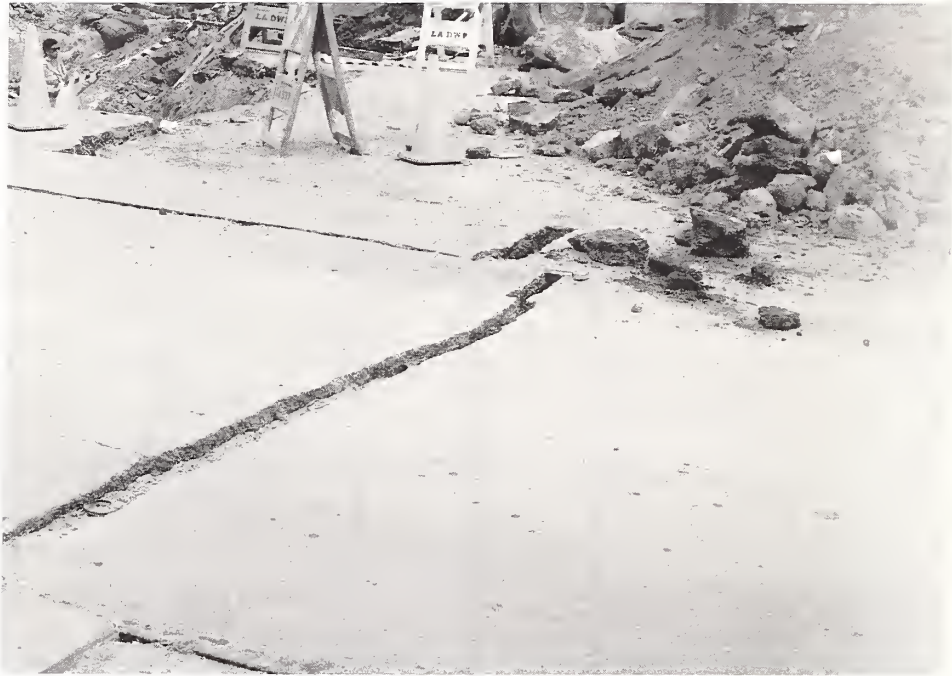
Figure 5.9. Ground extension at the gas fire site on Balboa Boulevard can be seen by the transverse cracks in the pavement.

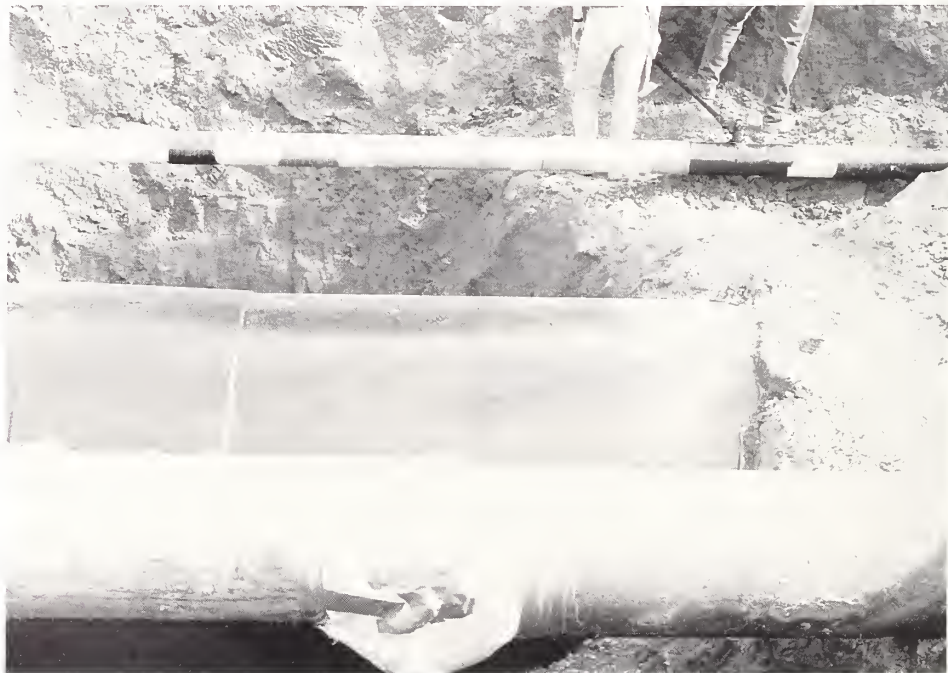
Three pipelines ruptured as the result of ground contraction; a 150-mm (6-in) gas distribution line, the 1.8-m (68-in) Rinaldi trunk water line, and a 0.6-m (22-in) gas main (fig. 5.10). The Rinaldi trunk line was of post-1971 construction, and the gas main was of 1930 vintage. These pipes showed a shortening of 125 to 150 mm (5 to 6 in).

Figure 5.10. Ground contraction along Balboa Boulevard caused the rupture of a gas distribution line (top), the Rinaldi trunk 1.8-m (68 in) water main (center), and a gas main (bottom). The pipes were being repaired at the time this photograph was taken.

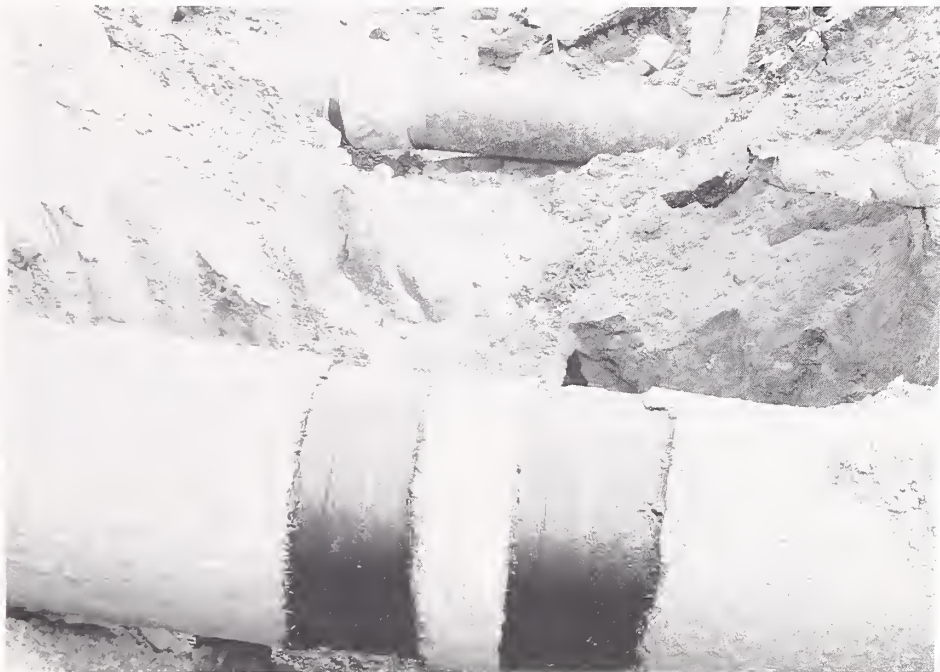
About one block north, the ground extension caused rupture of the same 0.6-m (22-in) gas main and a 1.2-m (48-in) water main (fig. 5.11). These pipes were pulled apart as the result of the ground extension. The rupture of the gas main caused a major fire at the site that destroyed five houses (figs. 5.12 and 5.13). The loss of both water mains at this location and the difficult access to the site due to the fire and street flooding made fire fighting difficult.

Figure 5.11. Ground extension along Balboa Boulevard resulted in the rupture of the same gas main shown in figure 5.10 (top) and a 1.2-m (48 in) water main (bottom). The rupture of the gas main here caused a major fire that engulfed five houses.

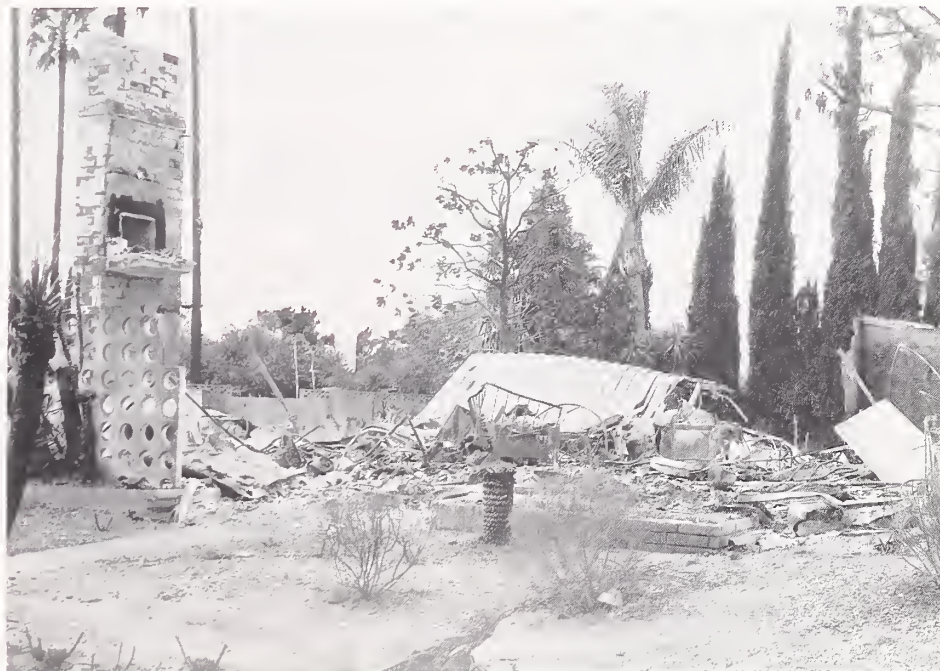
Figure 5.12. Houses destroyed by a fire resulting from the rupture of the 0.6-m gas main along Balboa Boulevard.

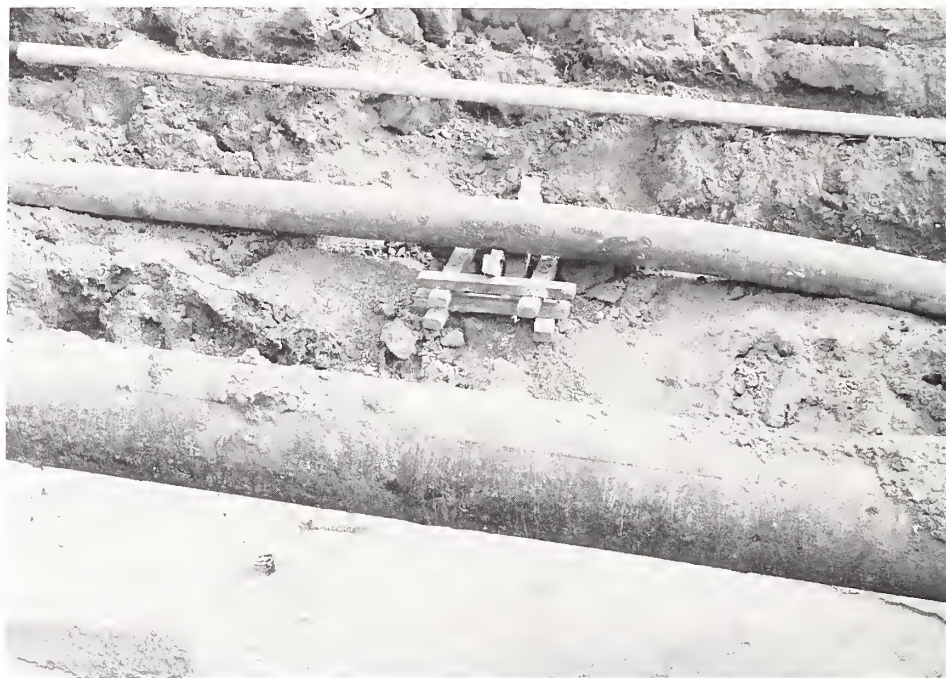
An excavated section just north of the fire site revealed some additional underground lines (fig. 5.14). The 460-mm (18-in) crude oil line in the middle of the photo performed well. The 150-mm (6-in) gas distribution line shown at the top of the photo is a replaced section.

Figure 5.14. Some of the buried pipelines located near the intersection of Balboa Boulevard and Bircher Street showing the potential hazard of co-location of lifeline systems. At this site are three water lines (two of them main lines); three gas lines; two sewers; one crude oil line; overhead power, telephone, and cable TV lines; the street lighting system; and the street itself.

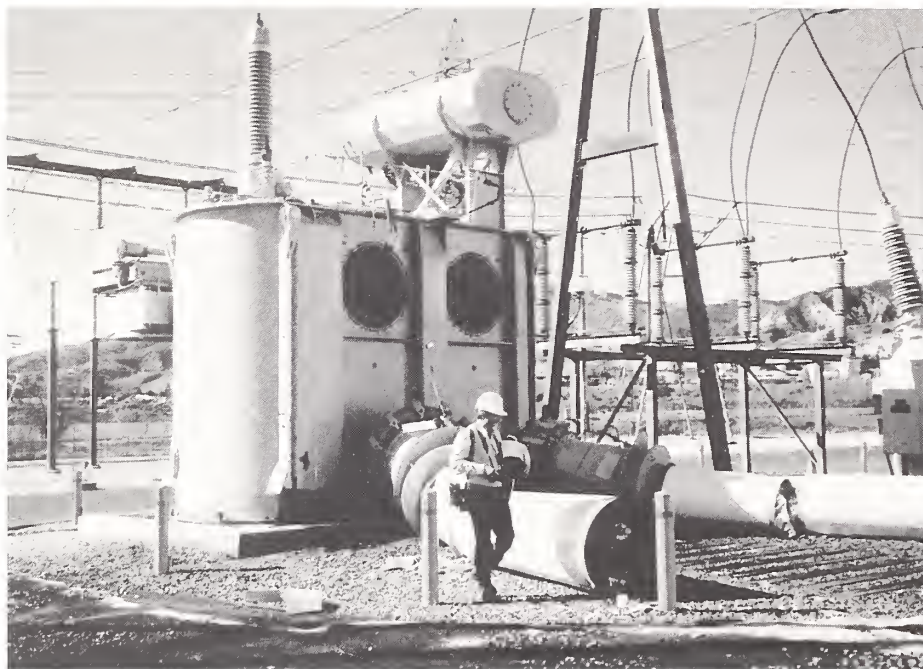
Some transmission towers suffered significant damage, many as the result of foundation failure. Damage to several high voltage substations near the epicenter, such as Sylmar, Pardee, and Rinaldi, led to the widespread power outage in the Los Angeles basin, as well as isolated outages throughout seven western states (fig. 5.15). As happened during the 1971 San Fernando earthquake, porcelain elements of 230-kV and 500-kV equipment suffered the most damage (fig. 5.16). This highlights the urgent need for developing new earthquake-resistant materials to replace porcelain, which is very brittle. Furthermore, most of the 230-kV circuit switchers, similar to those at the Sylmar substation shown in figure 5.17, were damaged. However, none were damaged during the 1971 earthquake, a possible indication of much stronger ground shaking by the Northridge earthquake. Most of the capacitor banks, similar to those in the background in figure 5.17, performed well in this earthquake, whereas most collapsed during the 1971 quake. Better performance of the capacitor banks is the result of stricter seismic requirements in equipment qualification and in installation practices.

Figure 5.15. Damage to DC equipment at several high voltage substations, such as this one at Sylmar, led to widespread power outages in the Los Angeles area as well as isolated outages throughout seven western states. (Photo courtesy of Edward Matsuda, Pacific Gas and Electric Company.)

- Improved methods for avoiding damage to high voltage substations should be developed. New materials are needed to replace the brittle porcelain insulators. Better switch systems should be developed and installed to prevent blackouts. Failures of foundations for transmission towers should be thoroughly investigated.

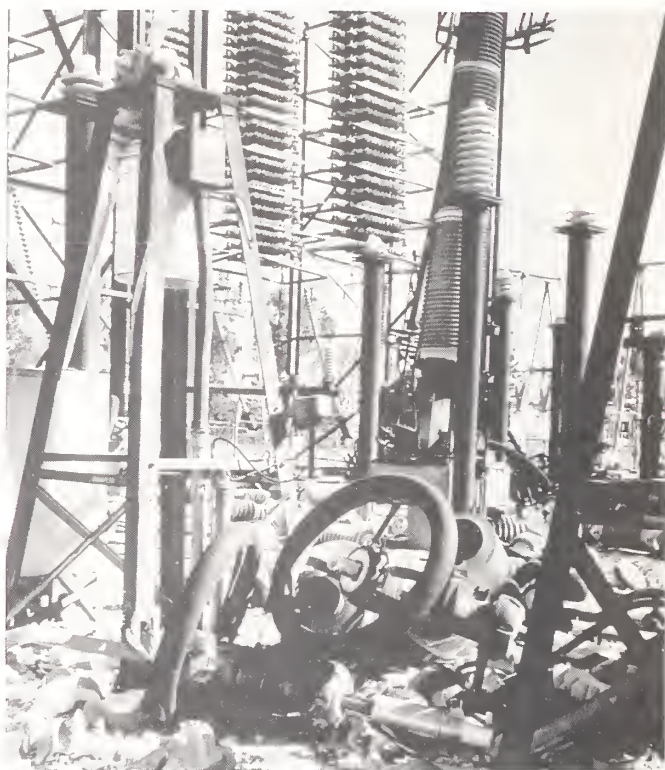
Figure 5.16. Porcelain is an integral part of high voltage electrical equipment due to insulation requirements and is also the most vulnerable to damage during strong earthquake shaking. (Photo courtesy of Edward Matsuda, Pacific Gas and Electric Company.)

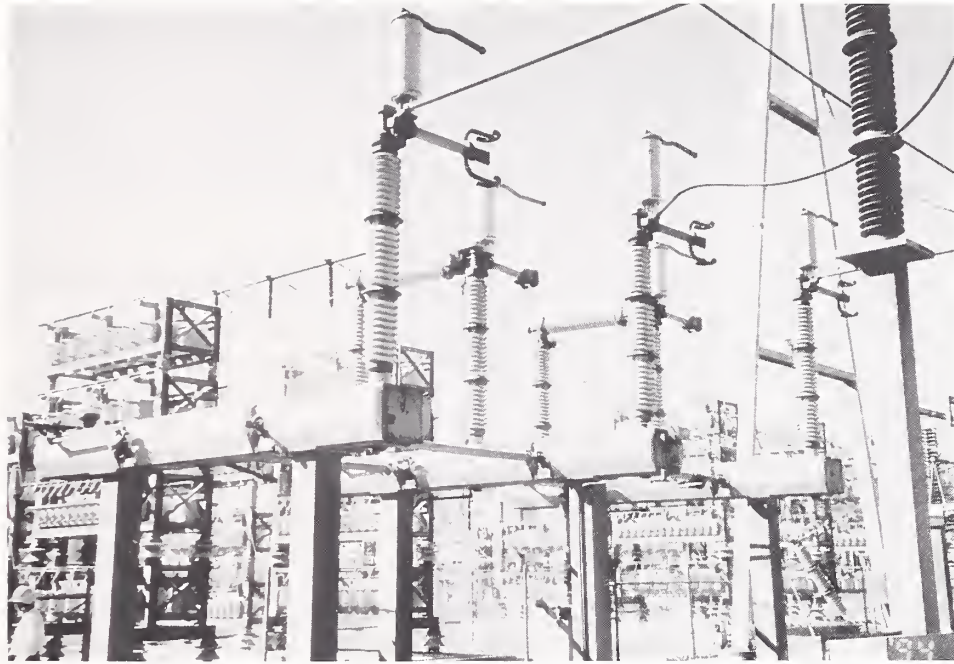
Figure 5.17. Most of the 230-kV circuit switchers (in the forefront) at the Sylmar substation were damaged. Most of the capacitor banks (in the background) performed well in this earthquake, whereas most collapsed during the 1971 quake. (Photo courtesy of Edward Matsuda of Pacific Gas and Electric Company.)

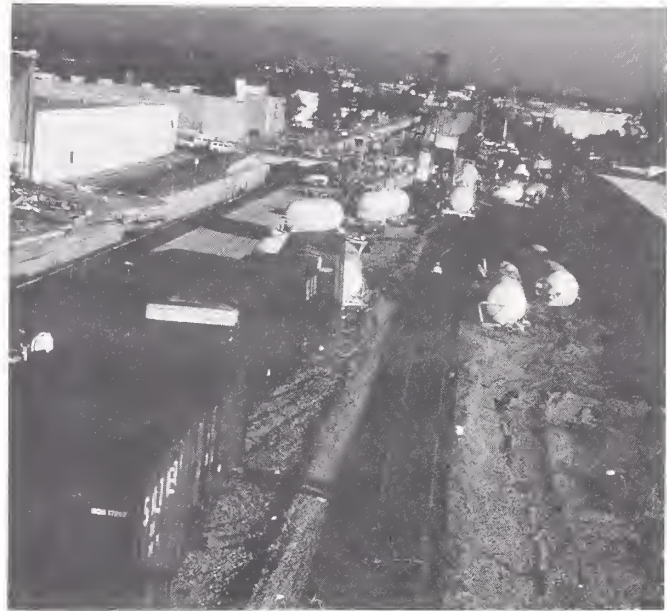
The earthquake caused a freight train derailment in Northridge (fig. 5.18). The 64-car freight train belonged to the Southern Pacific Railroad and was on its way from Houston to Sacramento. Twenty-five cars derailed, sixteen of which carried sulfuric acid or diesel fuel. The derailment resulted in the spill of 30 000 L (8000 gal) of sulfuric acid and 7500 L (2000 gal) of diesel fuel. There were no casualties in this incident. About 200 m (650 ft) of railroad tracks were replaced immediately following the earthquake and rail service was restored at 2:00 a.m., January 19. Removal of damaged cars and cleanup of debris were completed on January 21.

Figure 5.18. Derailment of a 64-car freight train in Northridge. The incident resulted in the spill of 30 000 L of sulfuric acid and 7500 L of diesel fuel. (Photo courtesy of LeVal Lund.)

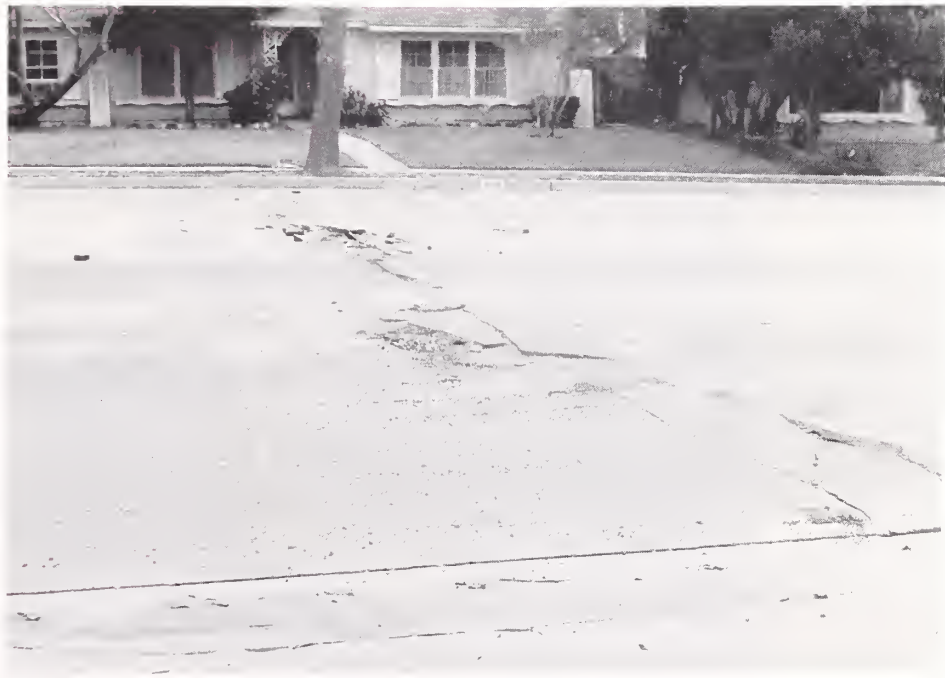
Strong ground shaking and lateral movement of subgrade materials resulted in numerous ruptures of asphalt pavement and concrete sidewalks in the epicentral area (figs. 5.19 and 5.20). In some instances, local traffic was interrupted temporarily until these cracks were repaired. In most cases, damage was minor and local traffic was not interrupted. The south approach of Balboa Boulevard at SR118 caved in because of loss of abutment fill due to a water main break (fig. 5.21). This bridge was closed for traffic due to some structural damage to the piers and the loss of the south abutment fill, as described in chapter 4.

Figure 5.19. Transverse cracks in pavement along Balboa Boulevard in Northridge area.

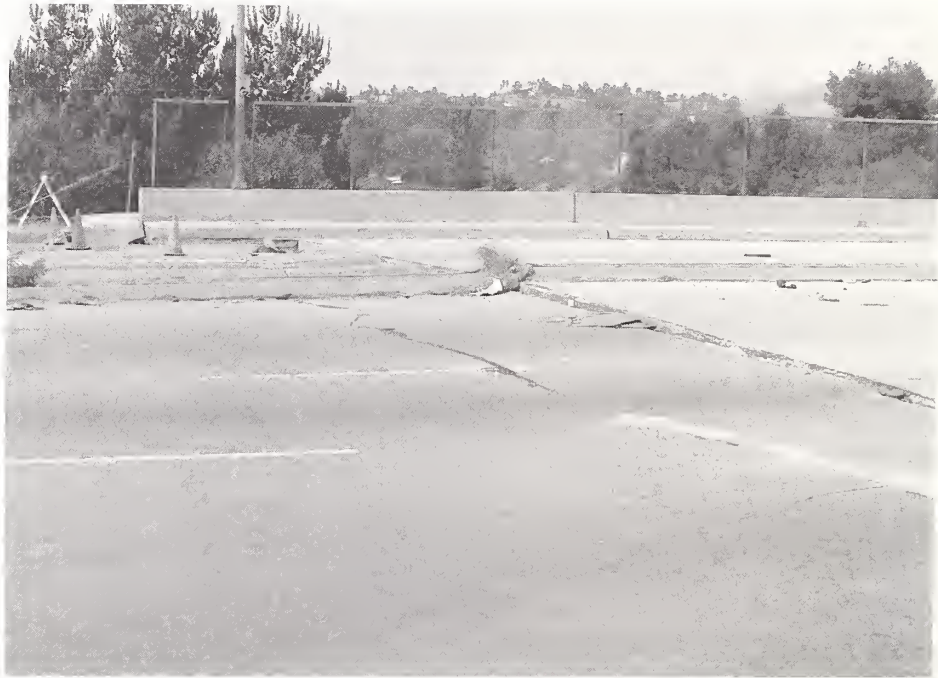
Figure 5.20. Transverse cracks in pavement near the intersection of Balboa Boulevard and SR118.

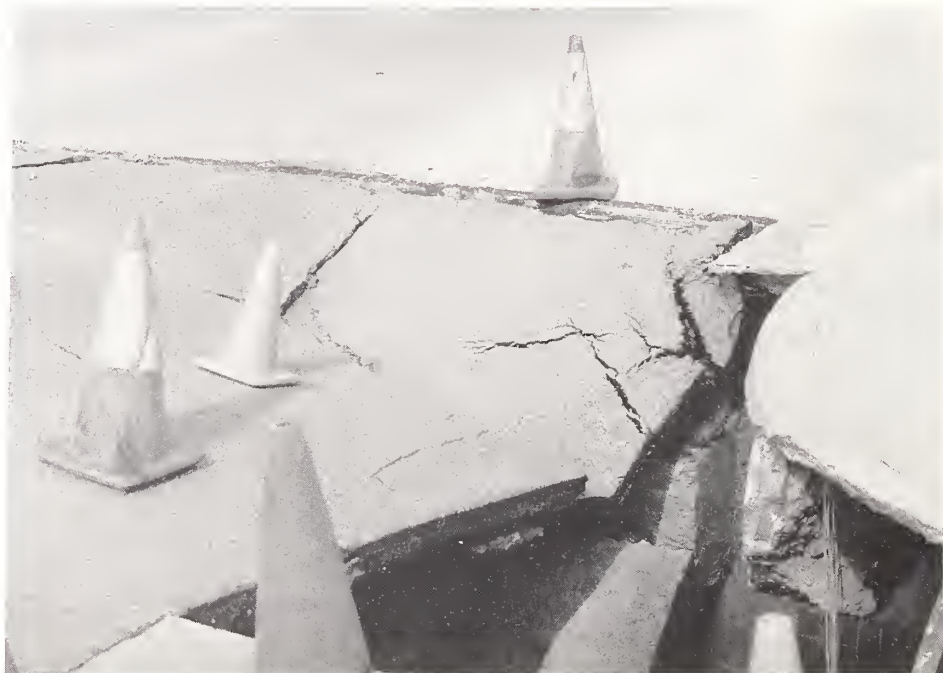
Figure 5.21. The approach of Balboa Boulevard at SR118 caved in due to the loss of the abutment fill because of a water main break.

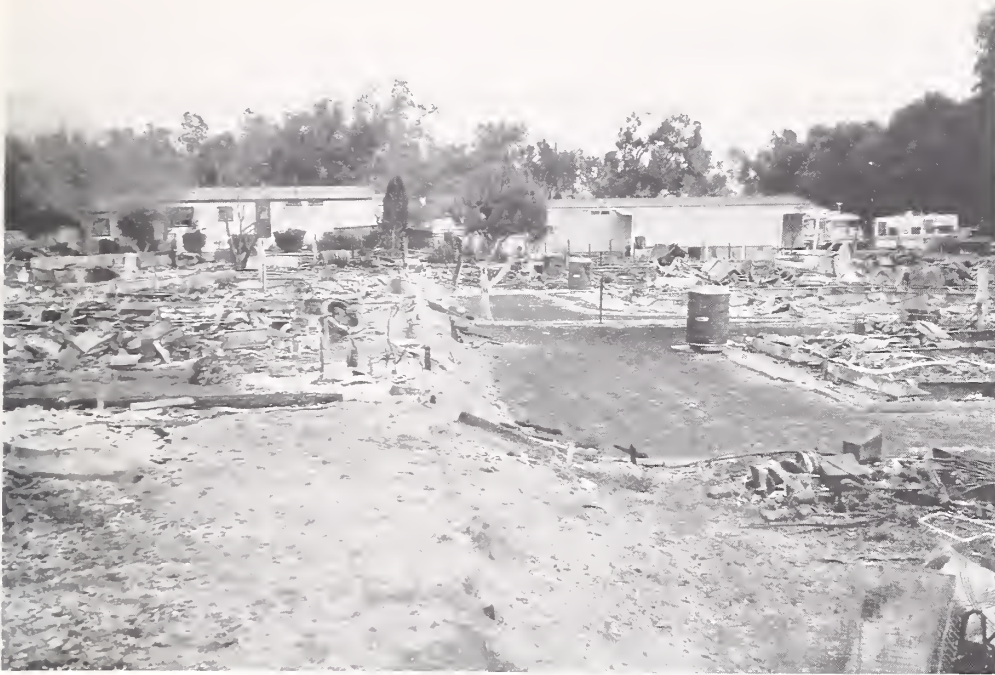
Building-to-building fire spread was limited to three manufactured housing developments (mobile home parks). Figure 6.8 shows the typical spacing between units in one of these developments. Figure 6.9 shows an area of the development destroyed by fire. Observations made at this development indicate that the method of unit-to-unit fire spread was primarily through windows. Once a unit became completely involved in fire, the thermal radiation was sufficient to cause the breakage of windows in an adjacent unit or to ignite combustibles within the unit directly through the windows. The fire department reported low water pressure in the area which combined with multiple independent fires and limited resources hindered fire fighting operations. The fire spread was stopped either by separation such as roads and open areas or by fire fighting operations.

Figure 6.9. Impact of a multiple unit fire in a manufactured housing development.

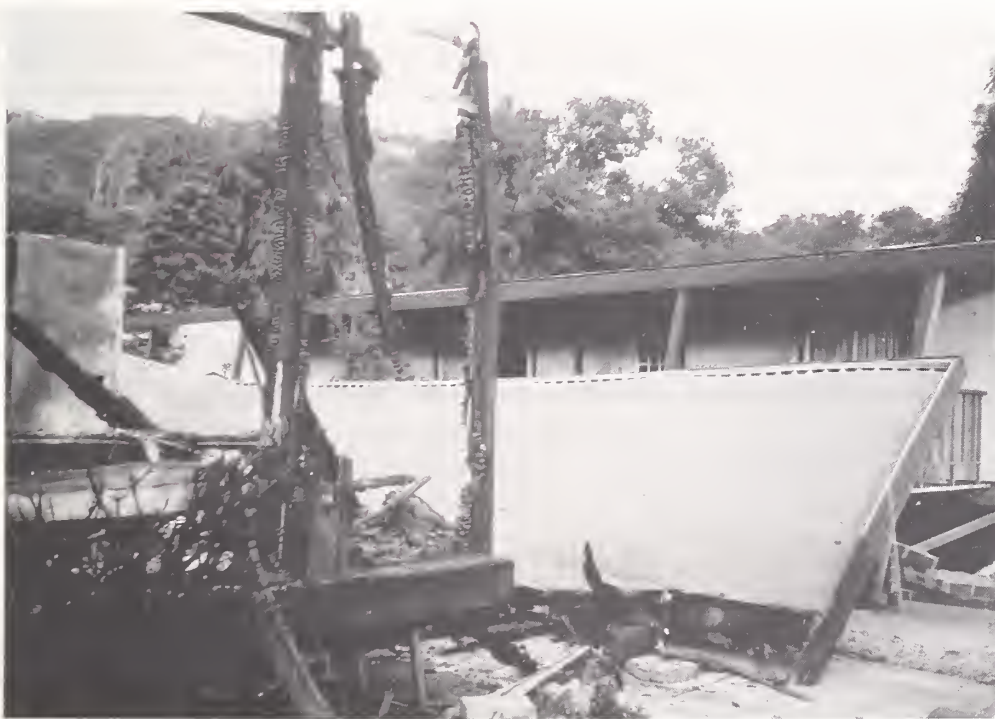
A unique aspect of the construction of these manufactured units played a role in limiting fire spread and assisting fire department actions. As the units burned from the inside, the carport roofs collapsed from the building side, coming to rest on the outside supporting columns. In this way the carport roofs formed fire breaks as shown in figure 6.10. Although these roofs would not necessarily have survived the fire by themselves, they reduced the fire exposure on adjacent units and thus enhanced fire fighting operations.

Figure 6.10. Collapsed roof which acted as a fire break in a manufactured housing development.
