The Locomotive

THE HARTFORD STEAM BOILER
INSPECTION AND INSURANCE CO.

VOL. XL

1934-1935

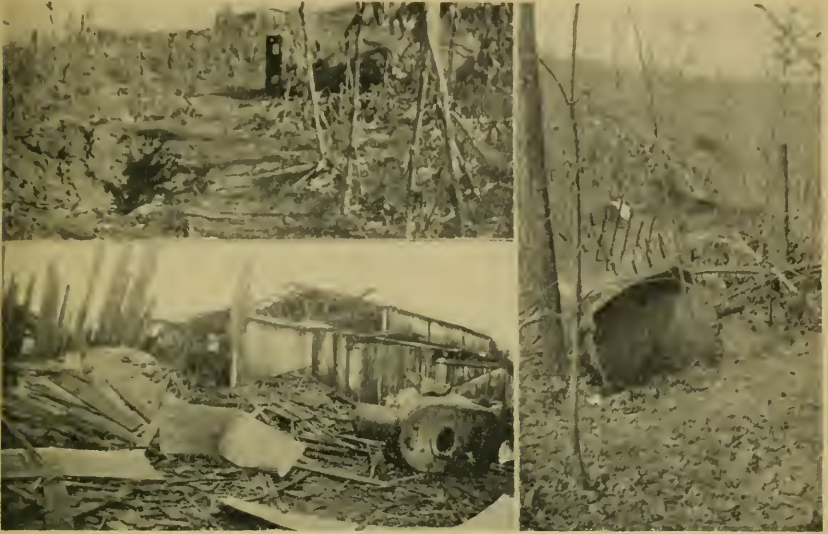
Upper left—Camden, Tennessee, boiler in a cornfield 300 ft from its setting; the hole at the left shows where the shell first landed. Lower left—results of an explosion in a Hohenwald, Tennessee, sawmill. Right—found two days after its explosion in a Powellsville, Ohio, sawmill. This part of the boiler traveled over a hill near the plant.

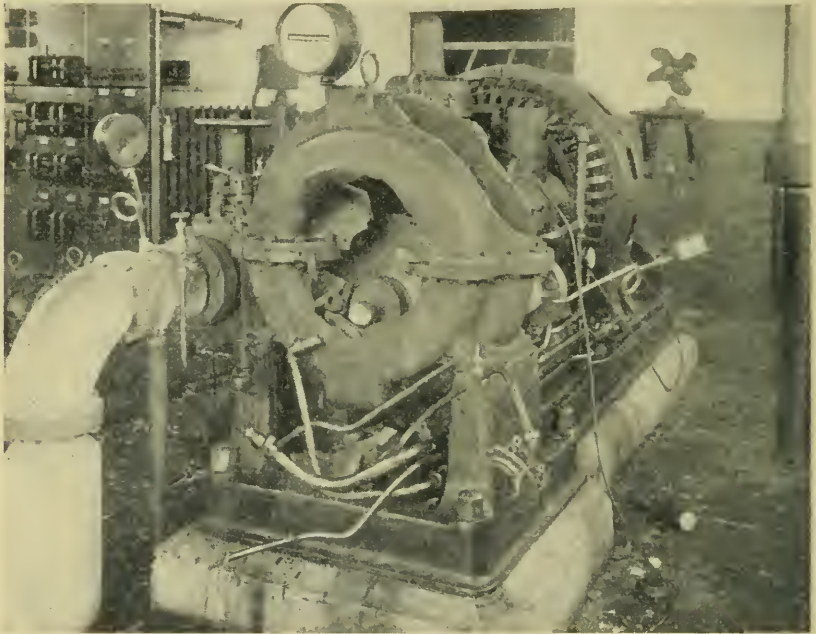
Two men were peppered with flying cast iron when the buckets came through the casing of this turbine. The shaft broke in three pieces during the accident, which was attributed to overspeed.

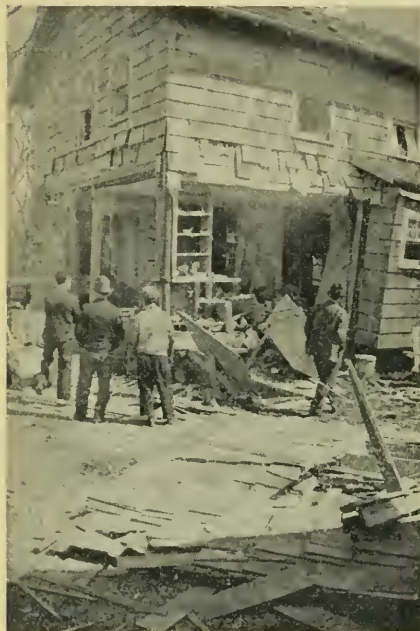
After a hot water tank exploded.

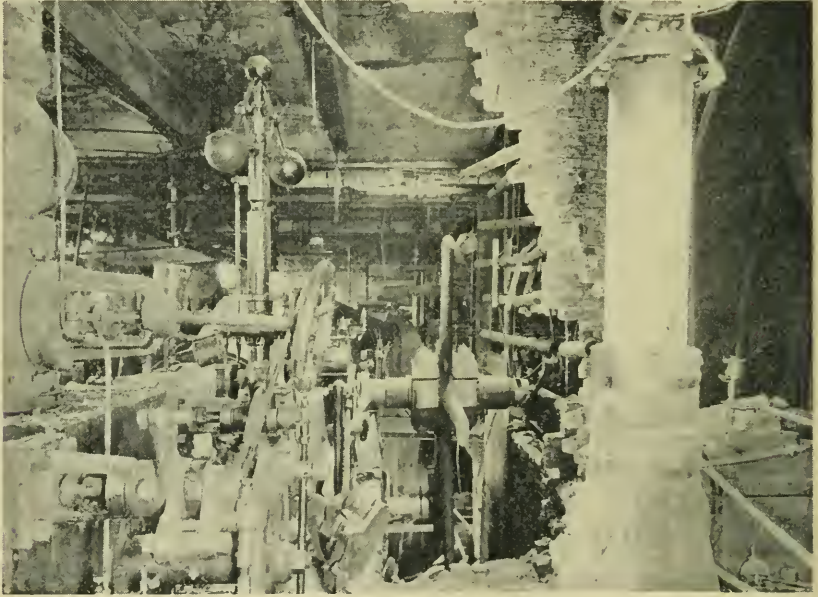
machine), then the screen box in front of a paper machine and finally an 8" x 8" steel column. It came to rest 115 ft from where it started. Another piece of the wheel weighing approximately 1900 lb tore a hole 4' wide and 11' long in the 6" reinforced concrete slab forming the floor of the second story. Still another piece of metal followed the second and went through the roof and finally came down again through the roof at another point. In all the damage to property amounted to more than \$7,000.

*"That whirled the wheel
That burst its rim"*

The wheel which exploded was 14' in diameter, of the belt type, and had a 31" rim.

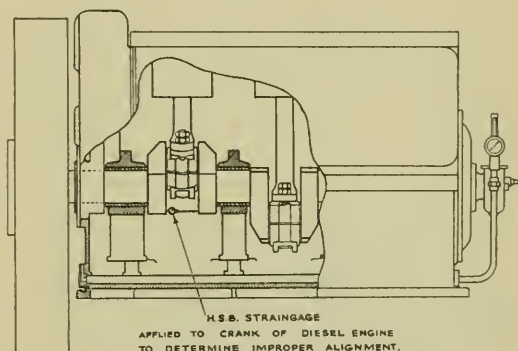
FIGURE 4.

H.S.B. STRAINGAGE
APPLIED TO CRANK OF DIESEL ENGINE
TO DETERMINE IMPROPER ALIGNMENT.

considerably. Figure 4 shows how the gage is used between the webs of a Diesel crankshaft. The broken shaft shown in Figure 5 shows the baneful result of serious crank distortion caused by worn bearings.

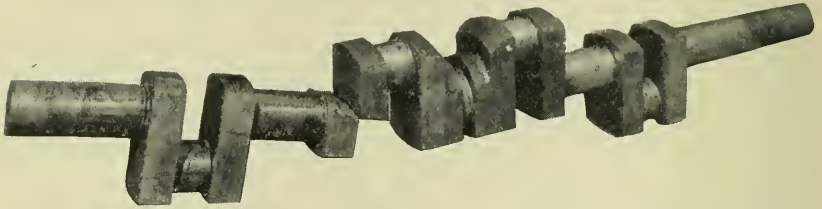
When the apparent fibre stress in the crank webs exceeds 20,000 lb per sq in. by this method of investigation, the shaft should be taken out of service immediately, for it is reasonable to expect that dangerous progressive cracks will have already developed in the crank webs or in the fillets of the crank pin, or in the fillets of the journals.

FIGURE 5—*The result of serious over-stresses in a crankshaft caused by bearing wear.*

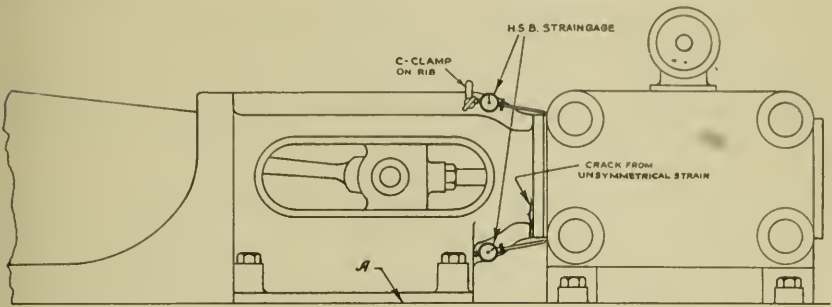
FIGURE 6.

APPLIED TO ENGINE FRAME (WHILE OPERATING)
DIFFERENCE BETWEEN TOP AND BOTTOM READINGS OF
THE STRAINGAGE INDICATES IMPROPER ALIGNMENT, CAUSING CRACKS.

The misalignment that causes the overstress which results in cracking the frame neck, is generally due to softening of the grouting by lubricating oil at "A", Figure 6. In any installation where lubricating oil is allowed to run down the sides of the engine frame and to soak into the foundation, it is certain that serious misalignment will eventually result because concrete and brick become quite soft and compressible when saturated with oil. After some years of operation under these conditions it becomes noticeable that oil is pressed out from under the frame at point "A" when the crosshead moves over that end of the

guide barrel, and the oil is drawn in again as the crosshead moves to the crank end. When this occurs it is clear that the engine frame is not being properly supported at point "A" because the grouting has become soft and compressed.

The consequence is that the downward force of the crosshead, acting on the guide barrel, is transferred through the frame neck to the nearest support under the cylinder which produces a bending action in the frame neck that is almost certain to result in a cracked casting. An example of the results of unsymmetrical strain in the frame neck is shown in Figure 7.

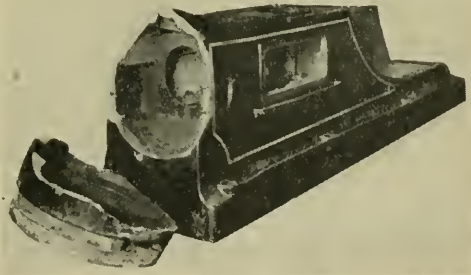
FIGURE 7—Result of crack in engine frame neck caused by unsymmetrical strain.

The vertical movement of the frame at the point where the grouting has become compressed has given some operators the erroneous impression that the nut of the nearest foundation bolt had worked loose. Tightening of the foundation bolt nut under such circumstances, while the engine was running, put such a severe bending stress in the frame neck in a few cases that it was only a matter of minutes before a long crack had formed. The tightening of foundation bolts of engines should never be undertaken without first carefully analyzing the real cause of the looseness of the bolts. The looseness as pointed out in the foregoing, may be the result of the softening of the grouting. If so, a re-aligning of the castings on the foundation and regrouting is necessary before the foundation bolts can be properly tightened.

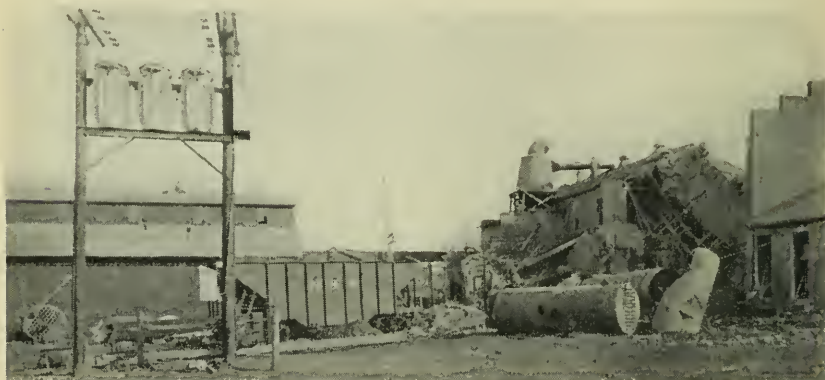
Another view of the mill at Hertford. In the foreground is No. 3 boiler and part of the stack. The front course of No. 2 boiler is shown at the extreme left where it fell after the explosion.

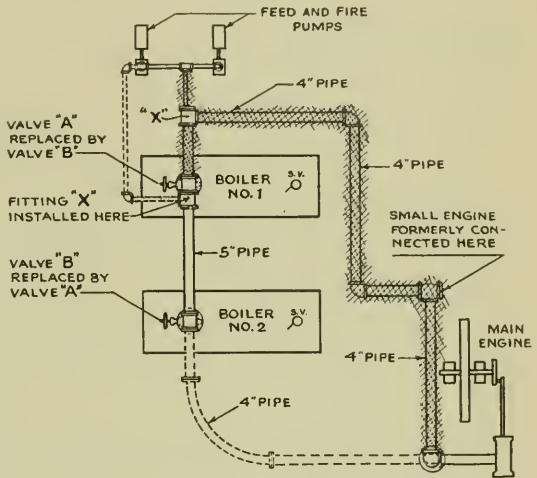
With the exception of a 4" long-turn bend and the insulating material, the piping and fittings in position at the time of the investigation were utilized in a changed position. The indicator had brought to light evidence of a slight leakage of the engine admission valves, so

the assured was advised to have the cylinder ports rebored and new valves installed. This advice was followed and resulted in an appreciable saving of fuel.

Five years from the date when the pressure was reduced to 78 lb a further reduction in pressure will be necessary. At that time the pressure will be limited to 72 lb. We have reason to believe that even at that reduced pressure the boilers will be able satisfactorily to operate the plant for a further limited period of time.

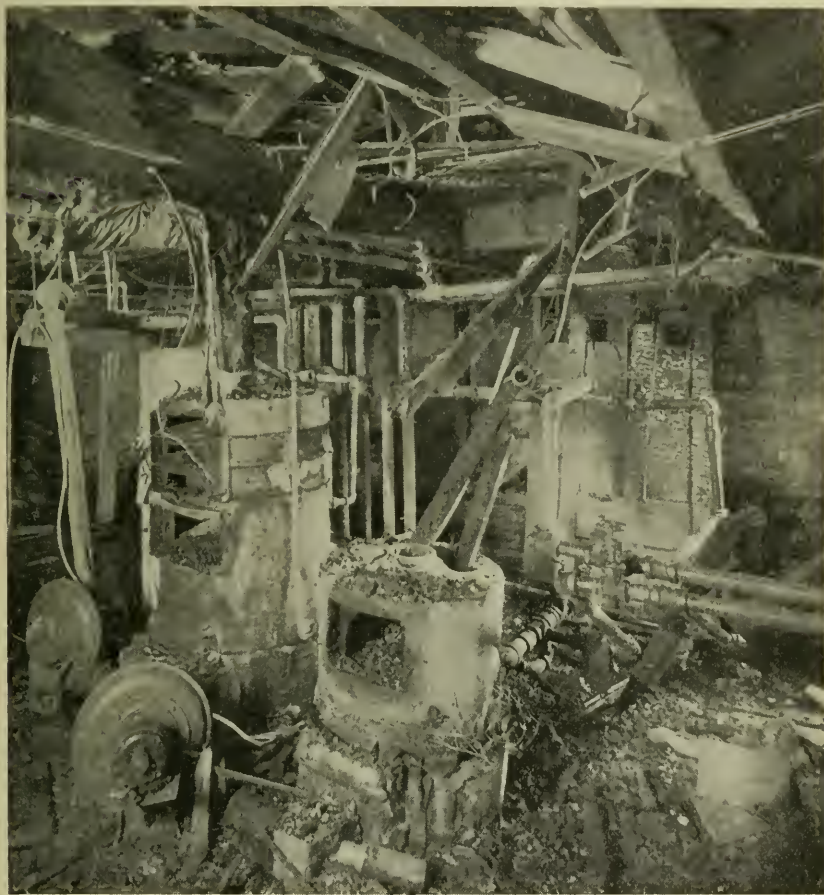
RESULT OF HEATING PLANT VIOLENCE

WHILE all available evidence indicated that an accident to cast iron sectional boilers used in an Ontario residence was due to the explosion of furnace gases, the investigators found it difficult to understand why the top section of the right-hand boiler was so badly shattered. The boilers were used in connection with a hot water heating system. The top section of the

smaller boiler went through two floors, hit the ceiling in the upper room and came to rest across the foot of the bed in which the housekeeper was sleeping. The opinion was expressed that internal steam pressure must have developed to some extent at least in a manner which available evidence did not make clear. No boiler insurance was carried.

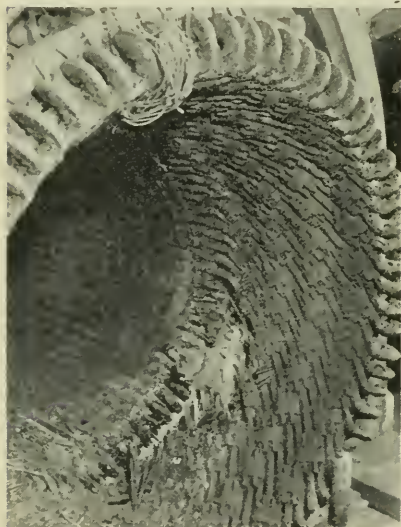
THE generator end of a 5,000 kw turbine, operating at 3600 rpm, broke down on June 2, 1933, in the municipal power plant of Austin, Texas, and caused damage in excess of \$6,500. The burn-out was attributed either to a phase-to-phase short circuiting with subsequent damage caused by a balancing plug in the field becoming loose and protruding far enough to gouge out the coils of the armature, or else to the entrance of some foreign metal into the generator winding.

A small steel object resembling a part of a $\frac{1}{2}$ " bolt was found close to the radial end ring.

After Generator Burnout.

After the fire had been extinguished it was found that the coils in 44 of the 72 slots were entirely or partly melted, as shown in the accompanying photograph, and the field was grounded. The cause of the ground was attributed to molten copper finding its way inside the radial end ring and burning the insulation. Repairs included rewinding of both rotor and stator and the replacement of some of the iron.

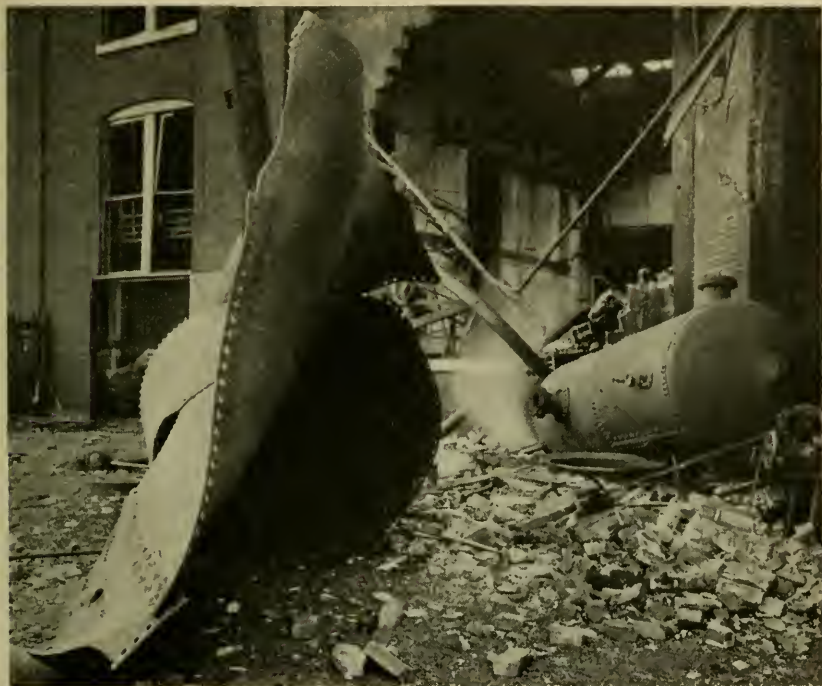
There seems to be no doubt whatsoever that the oil used for lubrication must form the basis for an explosive gas or vapor. However,

Following the ignition of lubricating oil vapor.

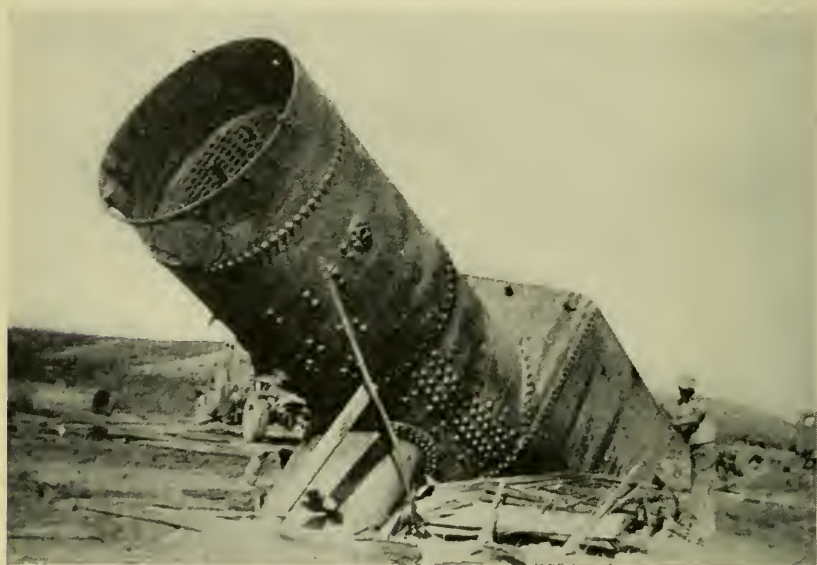
THE collapse of the crown sheet of a comparatively new 60" locomotive firebox boiler used at a Texas oil property hurled the boiler from its setting, caused property damage in excess of \$3,000 and burned a fireman about the face and arms. The boiler was the center one of a battery of three and in its flight it broke the steam connections to the other boilers and smashed the structure which held

After the crown sheet pulled off its stays.

them. It came to rest upside down, its dome embedded in soft earth.

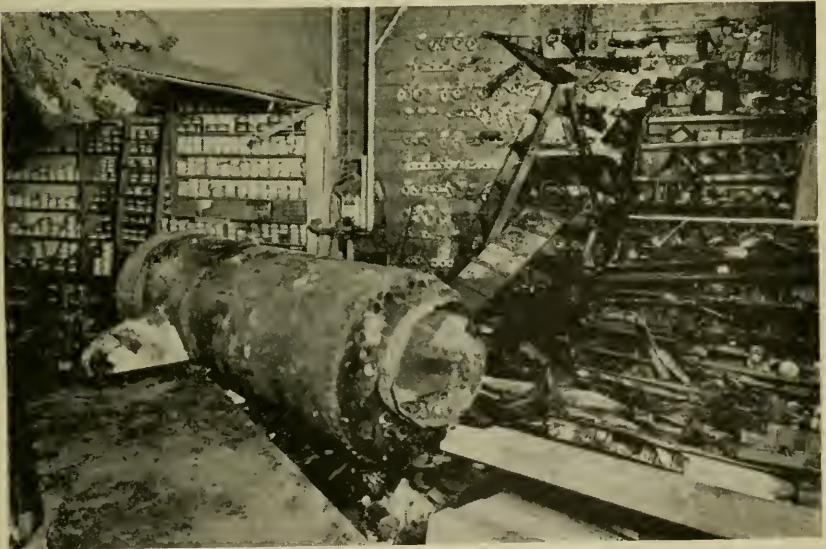
The 38" diameter boiler, where it landed in a neighboring store.

the sprinkler system, so that stock was damaged by fire and water.

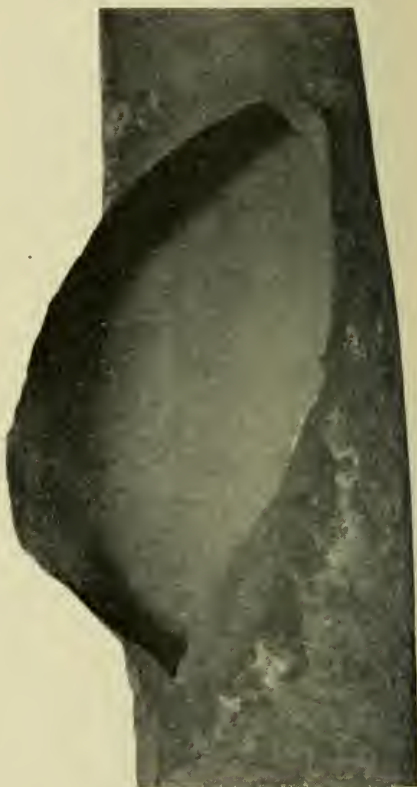
One man was scalded and more than 2,000 shoes workers in five plants were inconvenienced on February 9, 1934, when a 4" tube in a 500 hp boiler burst, putting out the fire and filling the boiler room with steam. Some power and heating needs were supplied by two 300 hp boilers which were brought up to pressure following the accident. However, other power needs were not filled until some three and a half hours later when an electrical connection was made with a local utility line.

Tube failure which had serious consequences.

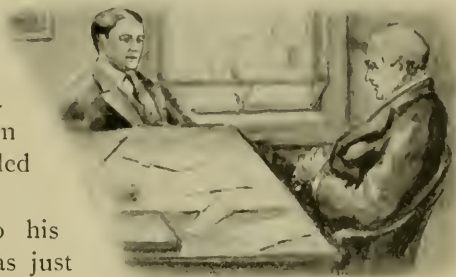
"When they took things apart they found that the bull ring was badly worn, a keeper spring had come loose and jammed and a piston ring had broken. The bull ring had been in operation only about 10 days, and had so worn down in that time from a thickness of

14/16" that the top sections of the ring were not over 5/16" thick, and steam was getting by pretty badly.

"Inspector Johnson reached the plant Sunday morning. He blamed the accident to lubrication difficulties, aggravated by highly superheated steam. They were using steam at from 457° to 500° F. He figured that no ordinary ring would stand up in this rebored engine and recommended the installation of a bronze ring which would have to be made by the manufacturers who were 1,000 miles away. The manufacturers were called by 'phone and their chief engineer readily agreed to Inspector Johnson's recommendation and promised continuous work until the ring was ready.

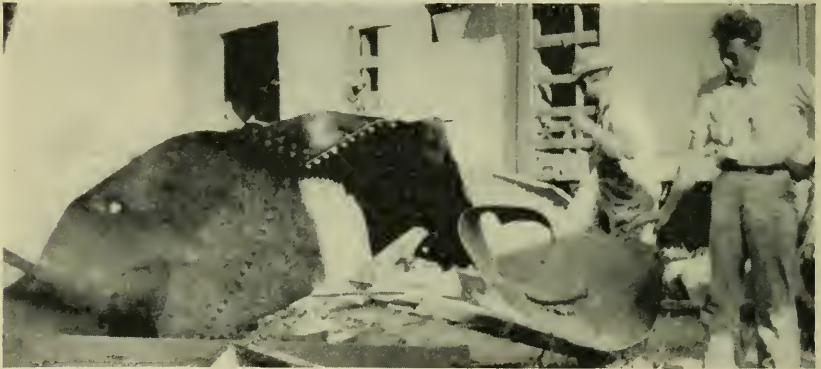
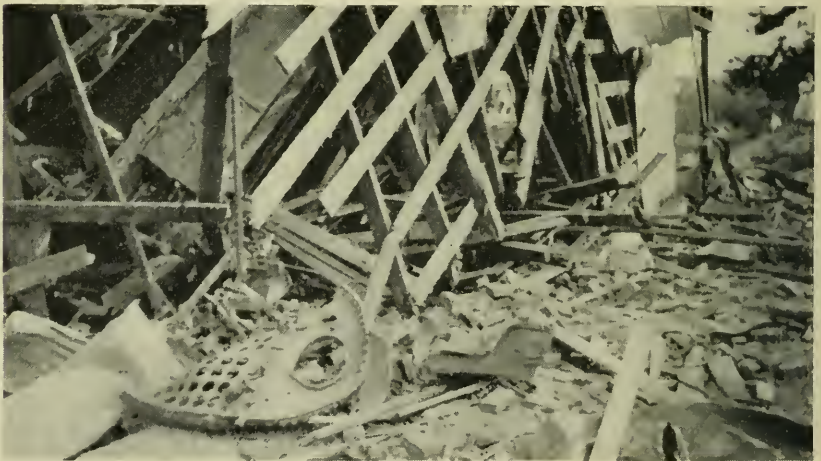
*Above—Middle and rear courses of Neal, Georgia, boiler.
Below—Where eight were killed in cotton gin boiler explosion.*

working around a cotton gin, or were watching the start of work on the 1934 crop. The gin structure was destroyed, and the bodies of two of the victims were hurled several hundred feet. The front tube sheet of

the 54" horizontal tubular boiler landed 600 feet from its former location and other parts were widely scattered. It was not determined what caused the accident although it was evident that there was considerable pressure in the boiler when the failure occurred.

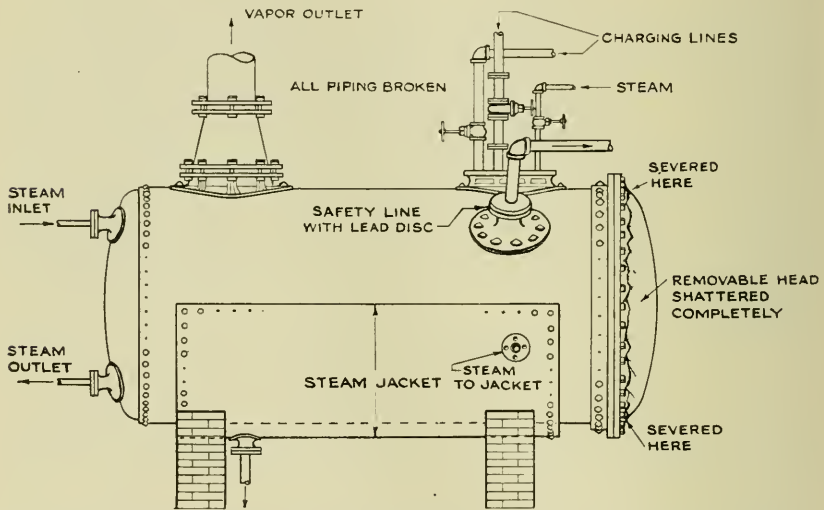
ture, it was customary, when starting, to admit steam to the shell as well as to the coils and the jacket in order to liquefy all of the still's contents. It was thought by investigators that the safety relief pipe was stopped up by the congealed material in the still at the time of the accident. In any event the safety relief failed to work and pressure built up within the vessel until the head gave way.

Figure 1—Diagram of still showing steam lines and head which failed.

of 150 lb was used in the jacket and coils; and as the supplementary line leading to the shell contained no reducing valve, it was possible, with the relief valve inoperative, to subject the shell of the still to boiler pressure.

The force of the explosion shattered a removable cast iron cover at one end of the still and caused the rest of the vessel to leave its foundation and go hurtling across the plant. The connecting piping, which included a 10" diameter vapor pipe, was completely severed and the vessel itself passed through a brick wall where its progress finally was checked by a large storage tank. The parts of the cover were blown through the building, causing considerable damage.

that the chemical mixture had congealed in this pipe as well as elsewhere in the still and had prevented the functioning of the emergency pressure-relieving disc. To minimize the risk of a similar accident in the future, it was deemed advisable that the safety relief pipe be installed near the steam inlet to the shell itself in order that steam would enter the still above the contents in such a way that the space under the lead disc would be kept clear. In addition, a safety valve and also a reducing valve set at about 30 lb were recommended to be installed on the steam line to the still. This would make it less likely that boiler pressure would build up within the shell.

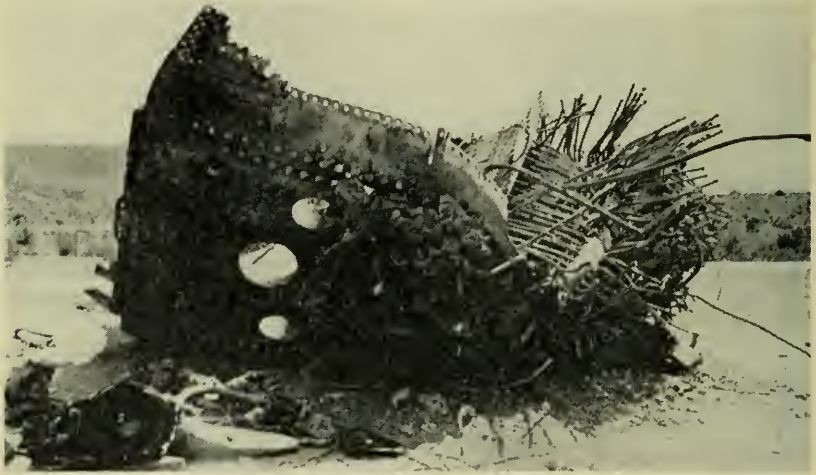
Part of locomotive's crown sheet and left wrapper sheet.

18, 1934, caused the death of three trainmen, and resulted in the derailment of eight cars and damage to freight and livestock.

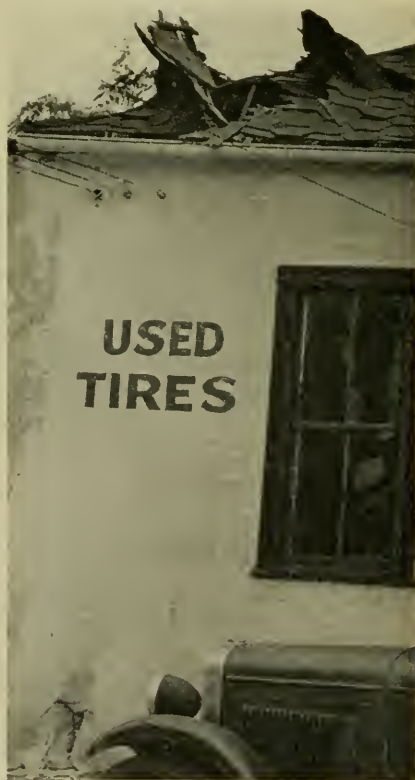
Buildings in the vicinity of the county fair grounds at Valparaiso, Indiana, were shaken when an air tank on the second floor work shop of a highway department garage exploded. The tank was 3' long and 1' in diameter, and according to witnesses was blown 100 feet into the air, scattering shingles in all directions. This explosion was attributed to the fact that the automatic cut-off failed to shut down the compressor at the proper time.

The air tank happened to go upward.

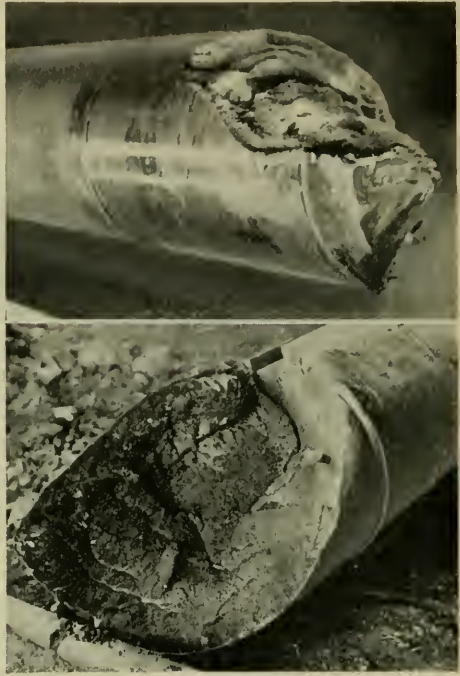
A progressive crack with stresses localized at the keyways was blamed for the fracture of a large shaft 15" in diameter and 17' long, used in connection with a mill roll train in an Ohio steel mill. The accident occurred on May 4, 1934, and consisted of a break in the connecting or extension shaft from the low speed gear coupling to the mill roll train. The part of the shaft which broke was enclosed in a bearing and the accident shattered the pedestal bearing cap, the shell and the pedestal itself.

The two pictures indicate the presence of an old crack at the keyway extending circumferentially about 9" and about 7" toward the center of the shaft. At the opposite keyway there was likewise an old crack which opened up about 1/16" and extended toward the center of the shaft several inches and circumferentially about 5".

Result of progressive crack in 15" shaft.

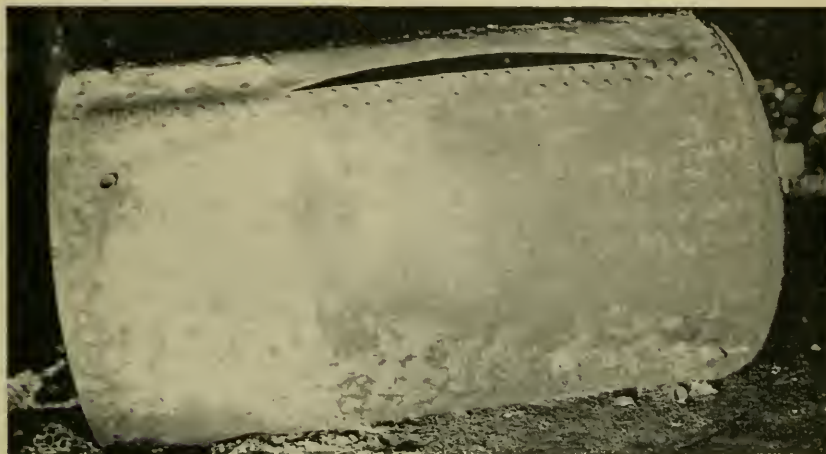
Lap seam crack inconveniences utility.

from its setting and projecting it across the boiler room. The accident caused little damage except to the boiler itself. The nature of the failure may be seen in the accompanying photograph. Following along the edge of the inside lap a distance of 41", the rupture extends from about 7½ inches below the top head seam and to within about 3 inches of the top staybolt. The boiler was under pressure of about 40 lb of steam at the time of the accident.

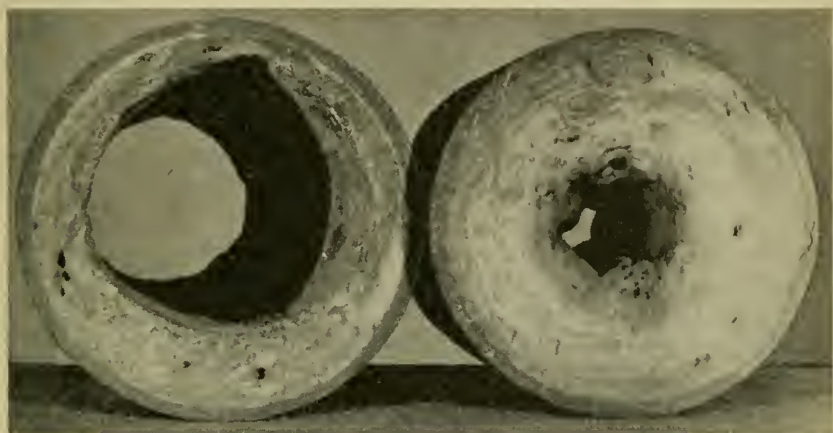
An extreme example of scale in boiler tubes.

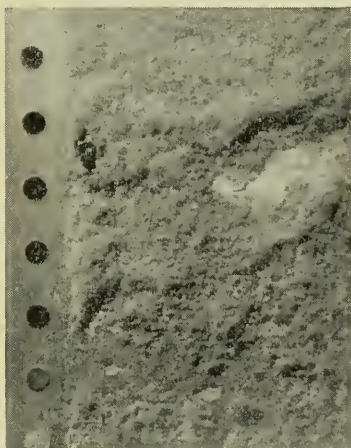
The result of corrosion.

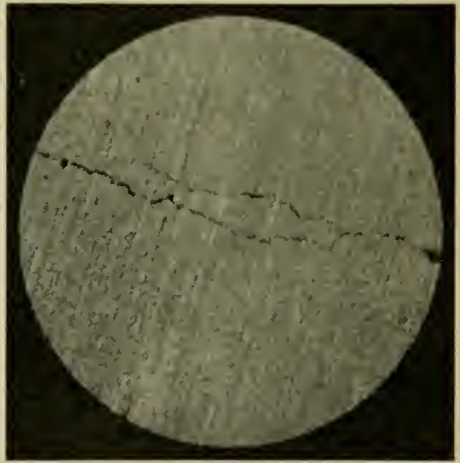
There are still some differences of opinion concerning the fundamental cause, or causes, responsible for the form of failure of boiler steel which is now commonly known as “embrittlement”, or more frequently as “caustic embrittlement”. However, the condition is invariably accompanied by the presence, in the boiler water, of sodium carbonate, which, in the absence of neutralizing sulphates or certain other substances, and in the presence of heat and pressure, leads to the formation of sodium hydroxide. It is quite generally agreed that two conditions must be present simultaneously to produce “embrittlement”: First, the high concentration of sodium hydroxide in the seams or

“Caustic embrittlement” under the Magniscope.

under the rivet heads; and second, stressing of the metal to about the yield point. It is an established fact that the zone of greatest stress in fabricated boiler seams is in the riveted area, and it is there that deterioration of the boiler steel, resulting from “embrittlement”, occurs.

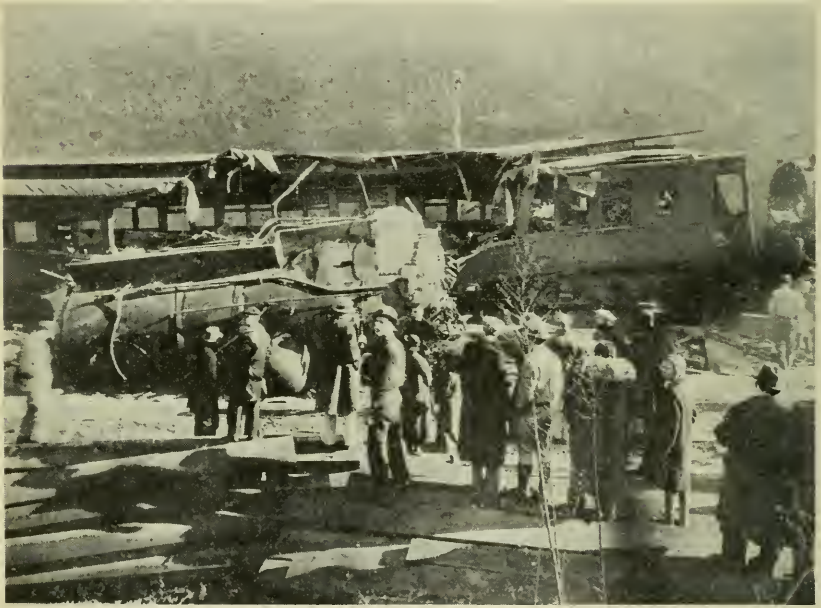
SIXTEEN men lost their lives and forty-two were injured, some of them seriously in the early morning of December 27, 1934, when a railroad locomotive boiler exploded, hurtling in the air and crashing down on a wooden passenger coach.

Where 16 miners lost their lives in locomotive boiler tragedy.

Failure, which was attributed to low water and overheating, evidently occurred in the crown sheet, the released steam tearing off the engine's smoke box cover and hurling it into the first car, which was coupled to the front end of the locomotive. Simultaneously the boiler was blown up into the air, and came down in the center of the leading coach, tearing away the top and one side. The cab was hurtled through the roof of a nearby house.

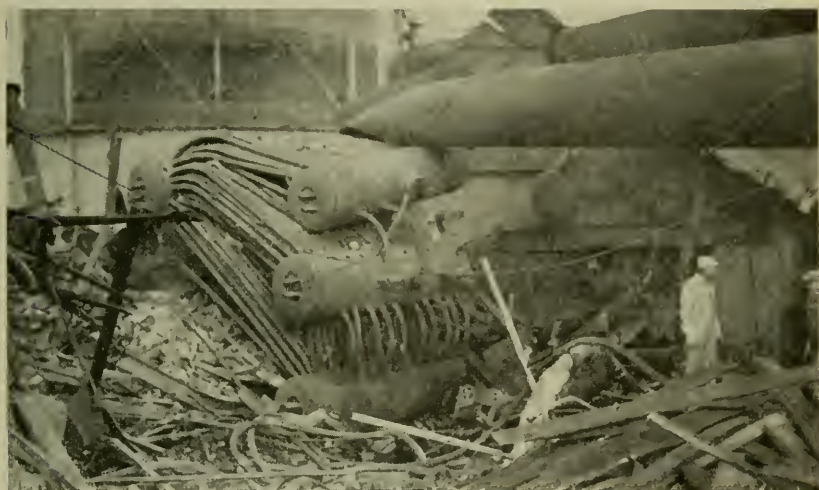
The explosion was attributed to the failure of the concealed head

Wreckage after failure of concealed mud drum head.

of the lower drum in a 250 hp bent tube type boiler. The blank head is reported to have plowed through the setting of a second boiler, bending the shell, smashing through the tube banks and passing out through the setting on the other side.

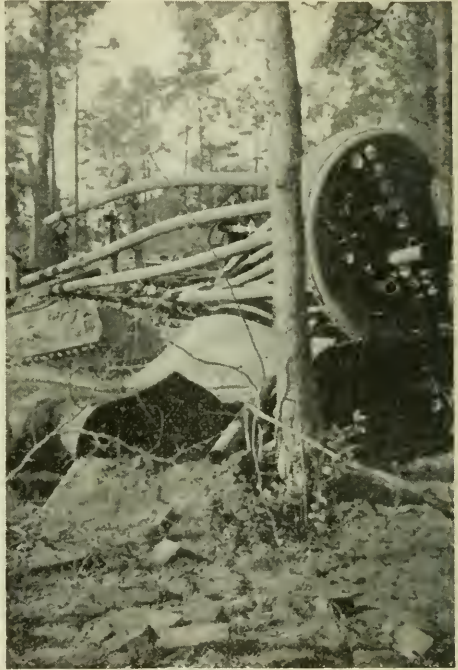
SIX men lost their lives when a second-hand horizontal tubular boiler exploded at the scene of hard-wood lumber cutting operations near Baggs Bay, 15 miles south of Claxton, Georgia, on December 12, 1934. The photograph shows a section of one of the heads and some of the tubes. An investigation revealed that the initial rupture probably occurred in the rear tube sheet around the manhole opening. The sheet had become thin at that spot as the result of corrosion from a leaking manhole gasket. The boiler was of the horizontal tubular type, 48" diameter and 12' long. Its two courses had double lap riveted longitudinal seams.

*Part of exploded sawmill boiler
in Georgia forest.*

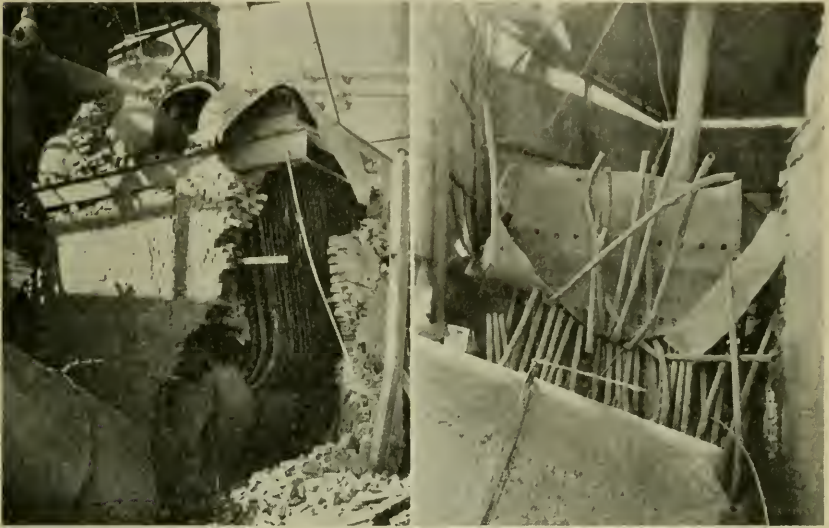
THE top rear drum of a bent tube type boiler operating at 89 lb exploded on October 22, 1934, at a southern cooperage works, causing property damage and minor injuries to three men. Failure started in the double-riveted lap-joint of the longitudinal seam. The tear ran through the row of rivets next to the caulking edge for about 6 feet, then through the solid plate to the heads at each end

and finally into the heads themselves. So severe was the blast that it demolished the setting of an adjacent boiler, blew down the sheet-iron boiler shed, and brought the steel smokestack crashing down on the ruins.

Damage from explosion of water tube boiler after seam failed.

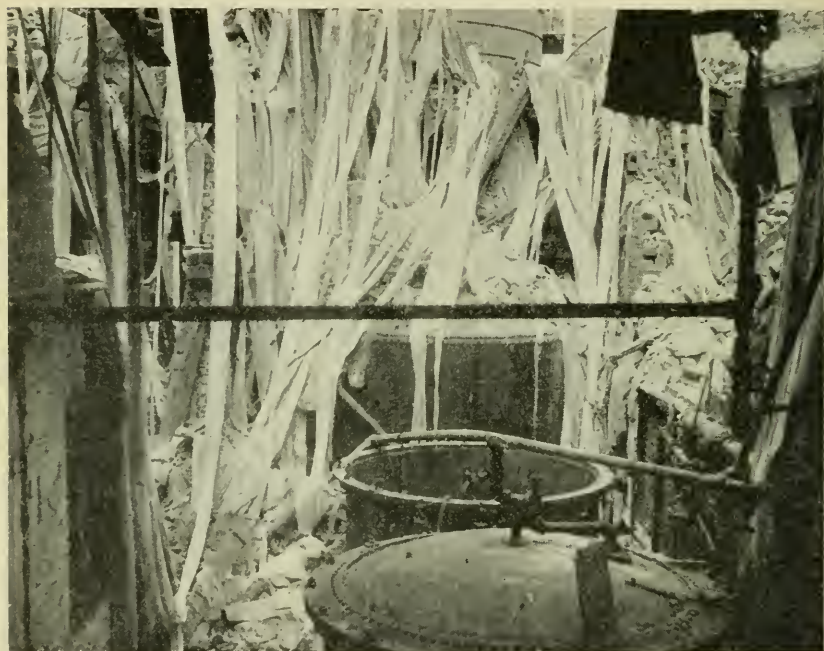
Empty kier and contents. The head landed in a nearby street.

The accident blew the 1000 lb cover over an adjacent one story building, the heavy metal disc coming to rest in a street about 80 ft away. The contents, which happened to be 30,000 yards of cheesecloth, were hurled in the opposite direction and strewn over nearby buildings, draping them in fantastic fashion much to the interest of the residents of the thickly settled neighborhood. The brick walls and roof of the building housing the kiers were wrecked, and bricks and large stones, which were hurled onto the roofs of four adjacent houses, resulted in some damage to them and in minor injuries to their occupants.

The train of events which led to the explosion probably never will be accurately known, but probably the circulating pipe became clogged, thereby permitting pressure to accumulate in the lower part of the vessel to such an extent that the entire contents were moved upward toward the top of the kier, eventually closing the relief valve outlet and the outlet to the steam regulator. This would have caused the regulating device to remain in full open position and admit boiler pressure to the vessel, which was more than the head of the kier could stand.

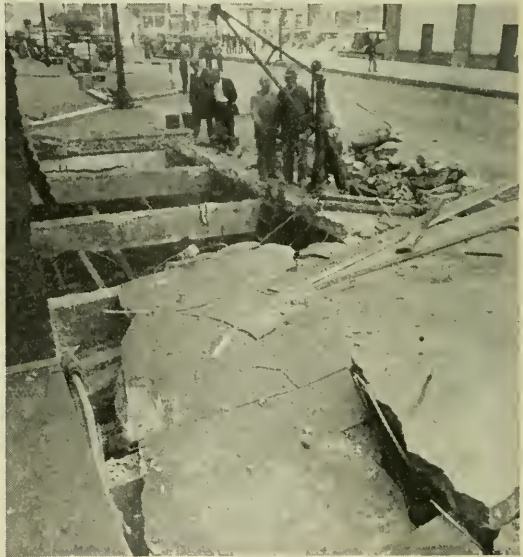
ONE of the most disastrous accidents of its kind occurred on October 12, 1934, at the plant of an Illinois cold storage company, when a bursting steam engine flywheel ruptured an ammonia condenser, releasing liquid ammonia which vaporized, mixed with air, and exploded with great violence. Two men were killed, seventeen were injured, and property was damaged to an extent estimated at \$80,000. The steam engine, direct connected to a generator, had been brought up to speed and the generator had just taken over the load when there was a flash in the generator and it started to burn. The engineer immediately closed the throttle, but at that instant the 5'2" engine flywheel burst.

the oil was ignited and caused an explosion of minor violence. A little while later, ammonia gas having been released from an ammonia condenser and from a high pressure ammonia pipe, both damaged by the flywheel, there was another explosion of extreme violence which shook the surrounding neighborhood and greatly damaged the buildings of the cold storage company. Girders were blown from their moorings and tossed against a building across the street, a part of the lower floor wall was hurled down, and a stretch of concrete sidewalk was torn up for almost the full length of a city block. A part of the damage outside the building is shown in the accompanying photograph.

Result of ammonia explosion in cold storage warehouse.

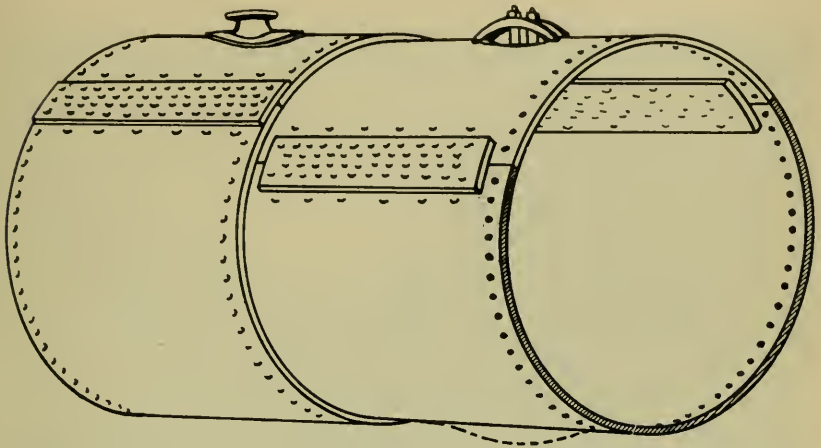
A bulge in the fire sheet of a horizontal tubular boiler, if caused by overheating because of oil, is frequently of considerable area but may be more or less shallow. The distorted area may extend longitudinally from girth seam to head seam and girthwise through an arc of 90° or more. If the depth of the bulge does not exceed the thickness of the plate and the oil can be entirely eliminated, no repairs, save perhaps the caulking of the seams, are necessary since the reduction in the thickness of the plate has been negligible. Any effort to "set

Figure 1—Repair of a bulge caused by overheating because of an oil deposit on the plate.

When a new fire sheet is installed, the longitudinal seams must be located well above the fire line. It is good practice to attach the new

sheet on one side at the original longitudinal seam of the course. On the other side the new seam should be located so that it will "break joint" with the longitudinal seam of the adjoining course, that is, the two seams should not be at the same point on the circumference of the boiler. (Figure 1). The cost of a repair of this kind, when made with the boiler in place, may exceed the cost of putting on a complete new course at a well equipped boiler shop. The expense of removing the boiler from its setting, shipping it to and from the boiler shop, the repair work (which is likely to include a number of new tubes), and the reinstallation of the boiler will probably equal, if not exceed, the cost of a new bare boiler. All of these factors, in addition to the question of safety, must be taken into consideration when deciding upon what repairs to make and how to make them.

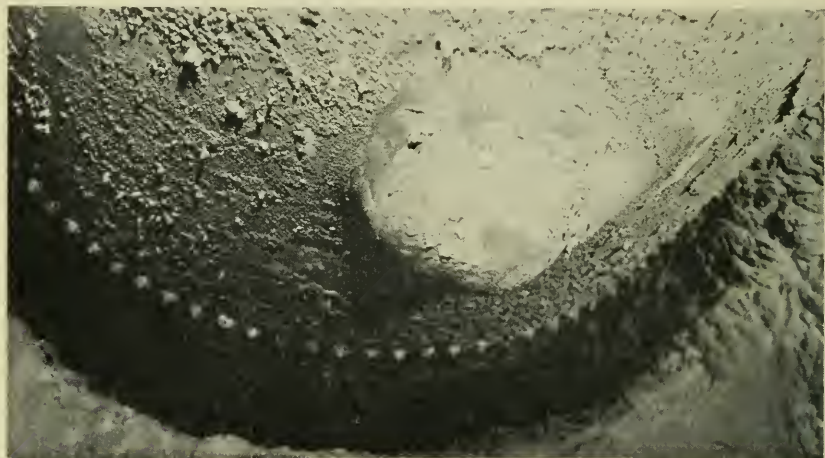
Figure 2—An example of an extreme bulge because of scale.

If the accumulation of scale is not dislodged when the shell plate bulges slightly, the overheating and bulging may continue until the plate ruptures and leakage develops at the apex of the bulge. Bags or bulges resembling the crown of a derby hat are not uncommon where poor feedwater is used and where the boilers are not cleaned as thoroughly or as frequently as they should be. A bulge, because of overheating due to scale, is shown in Figure 2.

If the depth of such a bulge is not more than 25% of its diameter, it may be possible to restore the plate to practically its original shape by proper heating and hammering. Even if there is no rupture at the apex of the bulge it is well to drill a hole of about 1" diameter at that point in order to determine the thickness of the plate and to facilitate the upsetting of the bulged metal. A welding torch, secured to a long

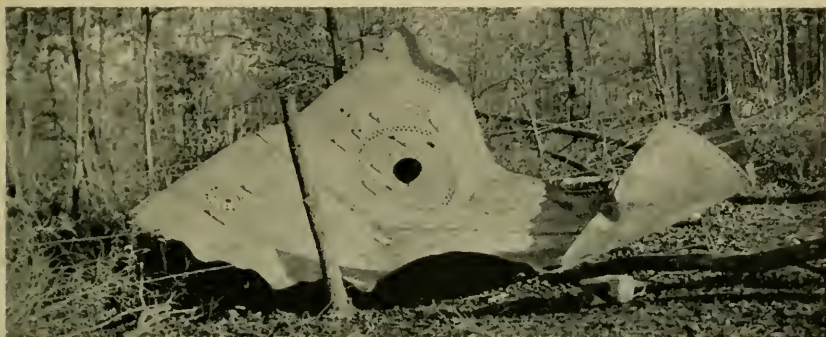
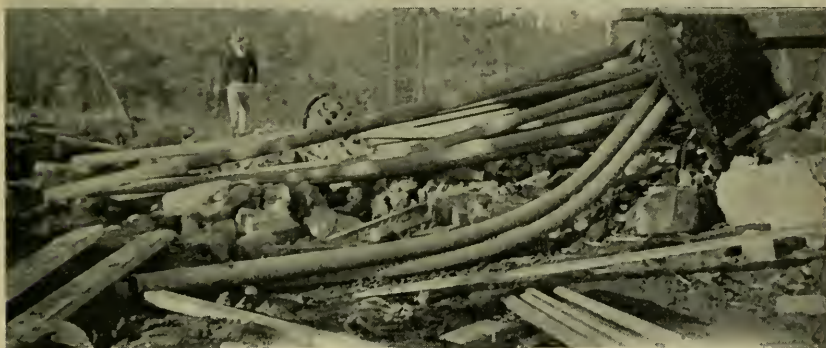
FOUR men lost their lives as the result of a sawmill boiler explosion at Woodman, Kentucky, on January 2, 1935. A crack in a lap seam of a locomotive firebox type boiler opened up with force sufficient to blow the boiler over a slab pile 20 feet high. A steam engine nearby was demolished. The men, who were eating their lunch

Parts of mine boiler following its explosion.

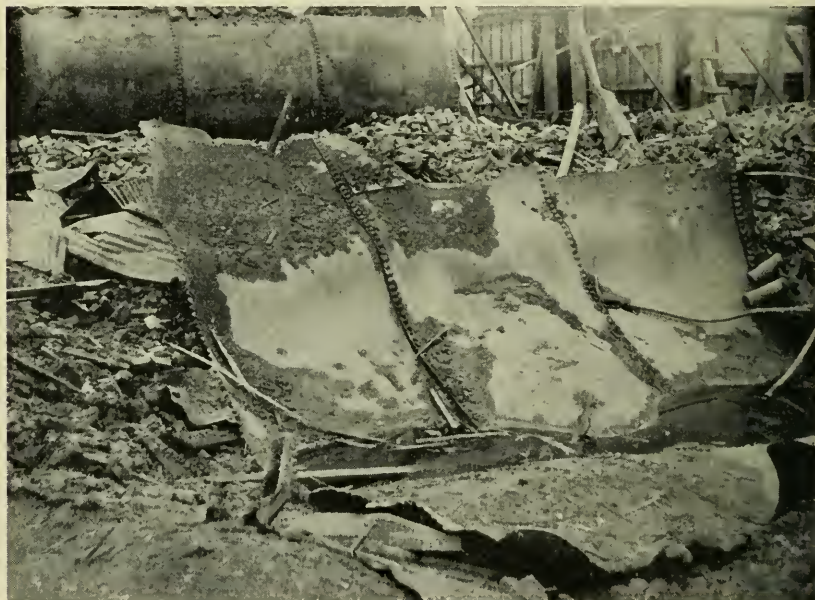
THREE men were killed and three were injured by the explosion on February 11, 1935, of a horizontal tubular boiler operated by a Georgia cooperage company. The exploding boiler was demolished, as were the setting of an adjacent boiler, the boiler shed and fuel house. Two smokestacks were blown down and several adjacent buildings damaged to some extent.

Just prior to the explosion, according to employes, the steam gage showed a pressure close to 200 lb, which was nearly twice the approved

Partial view of wreckage from Georgia boiler blast.

pressure. The boiler tore itself to pieces, parts of it traveling 700 feet. The shock and noise were reported as having been noticed several miles distant.

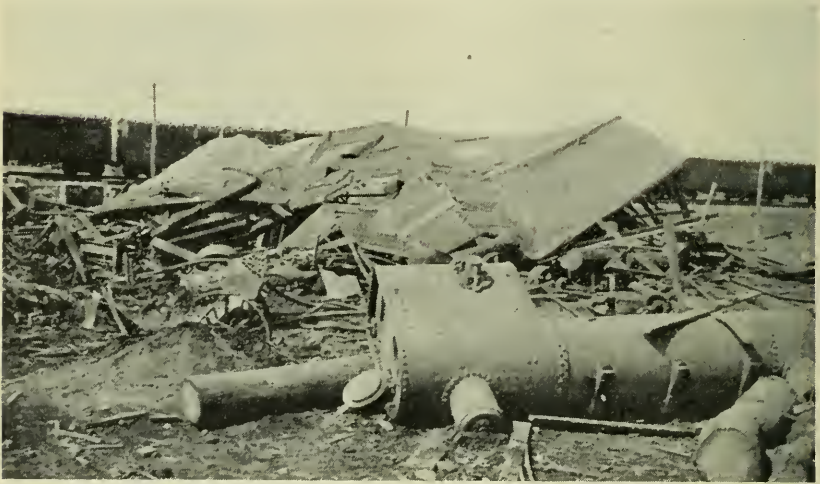
A Mississippi hardwood mill was completely destroyed, as is shown in the accompanying photograph, when its boiler blew up some weeks

Complete destruction of a southern mill by a boiler explosion.

ago. Attention was called to the boiler by its safety valve blowing. As the negro fireman went to attend to the boiler, it exploded, killing him instantly. Overheating and rupturing of the fire sheet because of low water was given as the cause of the accident.

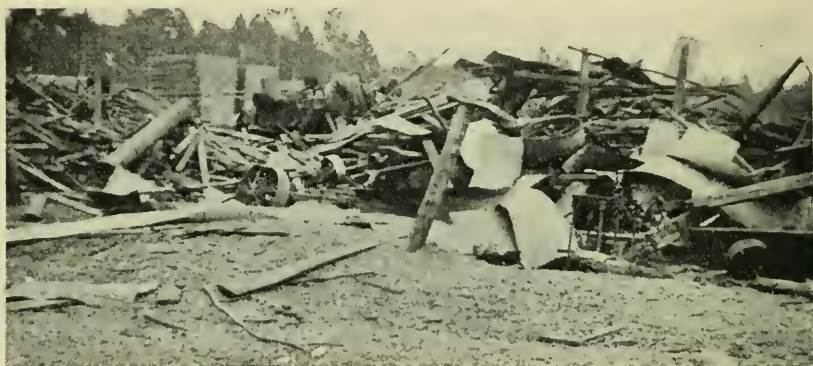
The above photograph shows wreckage after a boiler explosion at a Southern lumber mill in June. Two persons were killed instantly and four seriously injured. Property loss was estimated at \$5,000.

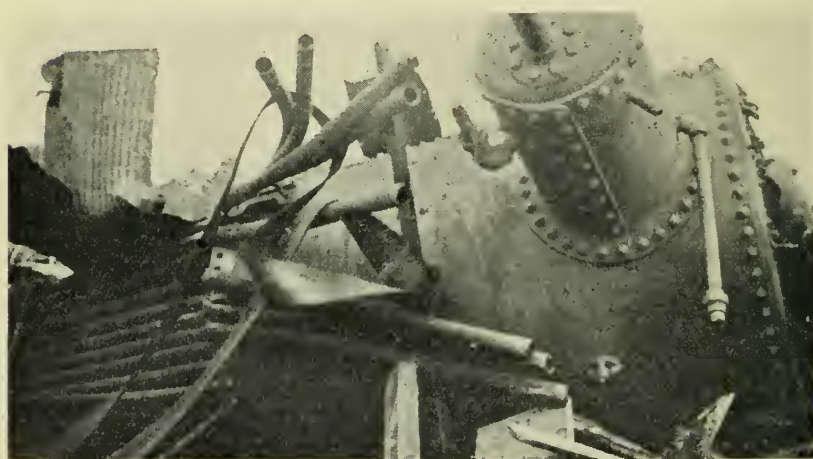
This boiler caused the wreckage in the picture at the top of the page. It is a dry back marine type and was mounted on wheels. An investigation revealed that the accident was caused by the cracking of the shell plate along the edge of the inside butt strap. The plate gave evidence that there was an old interior crack which had spread through the plate as the result of flexing action. The force of the explosion hurled the boiler about 25 feet.

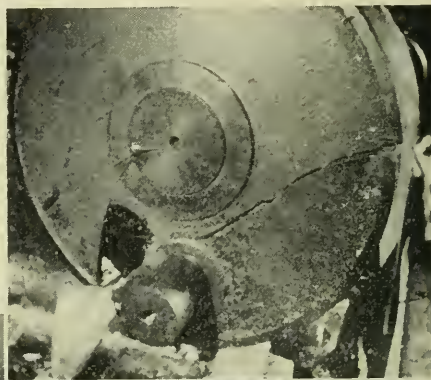
WHEN a crank disc of a paper mill engine broke on May 22, 1935, the engine and its 6' belt wheel stopped suddenly, the wheel flew to pieces and the 200 hp variable speed twin engine was wrecked beyond repair. Large paper machines rolled to a stop and a New Jersey mill faced costly delays because it could not fill its orders. Insurance took care of the direct damage loss to the machine and of the use and occupancy losses, but the mill wanted to make paper. Its customers wanted delivery.

Spoke stumps and a tangle of belts and machinery after the engine stopped suddenly. Above—The cracked crank disc.

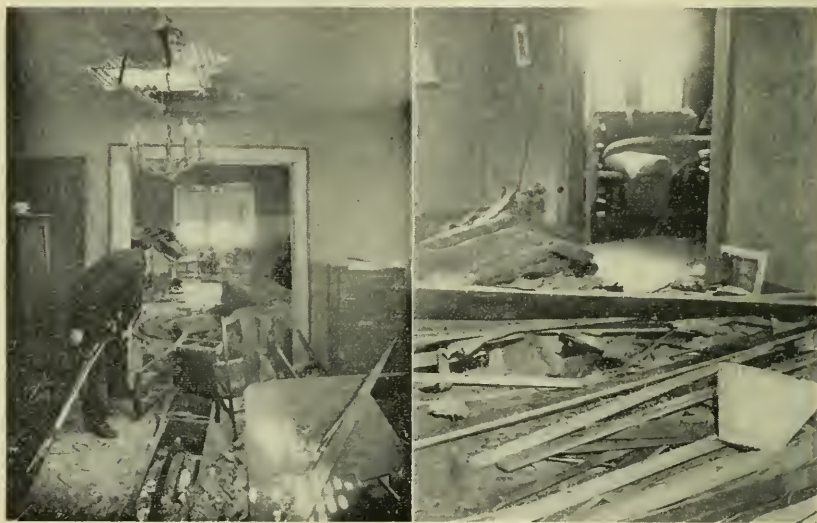
Forgetfulness in leaving non-automatic burners in service was blamed for the two accidents to small hot water tanks in residences pictured on this page. That at the left occurred in a Middle Western residence which was lifted from its foundations. The hot air furnace

After hot water tanks hurtled upward.

was demolished and several rooms damaged as the tank forced its way through floors and the roof. The photograph at the right shows the living room of a New York residence, after a hot water tank had exploded. Passing through two floors and the roof, the tank landed 70 feet from the house. The force of the explosion and actual physical damage by the tank itself virtually wrecked the dwelling. Both accidents were attributed to a combination of over-heating and over-pressure. On automatically controlled installations and on an increasing number of manually operated burners, pressure and temperature relief valves are being used to reduce the likelihood of accidents of this sort.
