The Locomotive

THE HARTFORD STEAM BOILER
INSPECTION AND INSURANCE CO.

VOL. XL

1934-1935

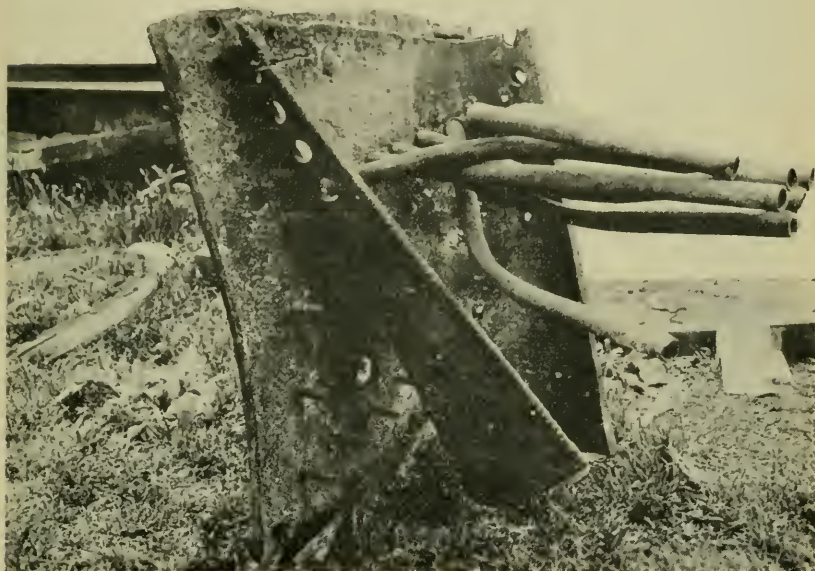
The operation of a Texas hotel was seriously disturbed when the explosion of a hot water supply boiler of the garbage burner type caused the breaking of gas and water lines, damage to switchboards and the flooding of the elevator pit. In addition to destroying the burner, the accident resulted in approximately \$5,000 damage to walls, doors, decorations, elevators and cables, heating boilers, and other equipment.

The hotel garbage burner was auxiliary to the regular hot water heating equipment and was fired up each morning. This oil-fired boiler

Once part of a hot water supply system.

was of fusion welded construction and was operated without automatic control, although there was a relief valve set at 105 lb. The normal service water pressure was 90 lb.

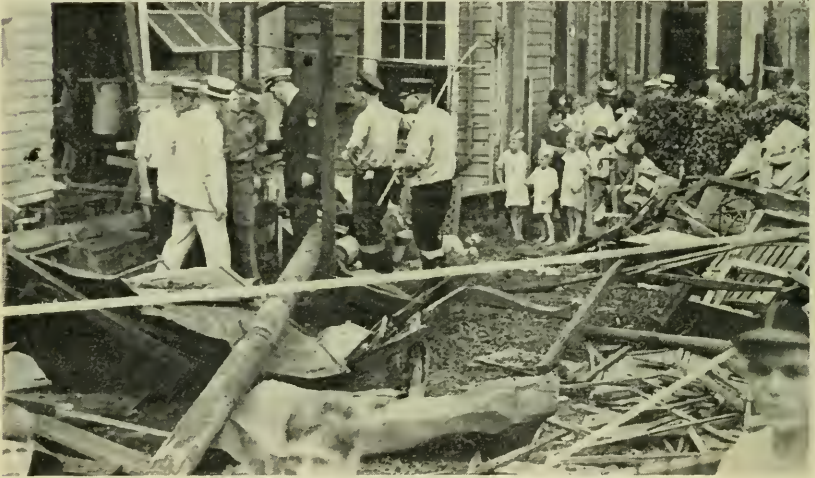
At 7:01 A. M. on June 2, 1935, the boiler operator of a Southern cleaning and dyeing company was attending his boiler. At 7:02 A. M. he was 30 feet in the air looking over buildings at traffic in a street some distance away. Then he plunged back to a friendly plot of soggy earth. His injuries proved slight. The 42" dry back marine boiler, which had caused the trouble, went 200 feet, demolishing part of the building housing it, carrying off a porch, and damaging a store and an apartment kitchen in its flight. The injured operator said the explosion occurred just as he was about to "turn some steam into the plant pipes." Apparently the furnace of the boiler collapsed as pressure rose. Part of the damage is depicted in the photograph.

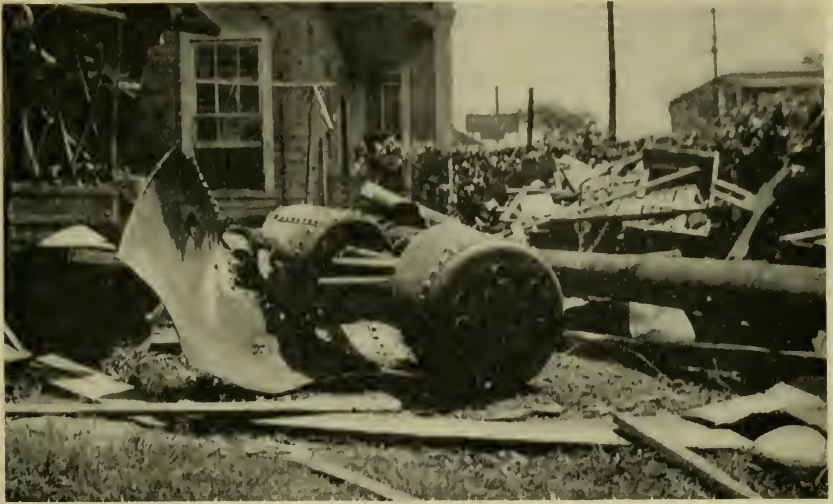
The woman proprietor of another Southern cleaning establishment sustained serious injuries when the small vertical boiler, 20" in diameter and 4' high (shown above), exploded on June 4, 1935. Corrosion just above the base ring, a common cause of failure in this type of boiler, was blamed for the accident. The woman's shop was wrecked.

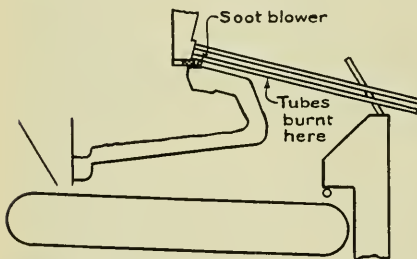
Repeated burning out of the bottom-row tubes in a battery of water tube boilers caused much speculation at a Springfield, Illinois, plant. Failures always occurred at some distance from the front header, and looked as if a blow-torch had been directed on the tubes. The trouble, according to Julius Brodsky in *Power*, was traced to the soot-blower. The arrangement of the soot-blower steam jets was such that it was impossible to keep an air seal

between the bottom of the header and the ignition arch. With air flowing through this opening and contacting unburned gases from the furnace above the back end of the ignition arch, combustion occurred with blow-torch intensity and damaged the tubes. The soot-blower arc of travel was changed so that steam would not impinge on the header, and an air seal was provided under the front header by laying a row of brick, caulking with asbestos rope and finishing with asbestos fire-clay plaster. Provisions were also made for admission of additional air over the fire, so as to complete combustion of gases before they struck the tubes. After correcting the conditions, no further tube failures occurred.

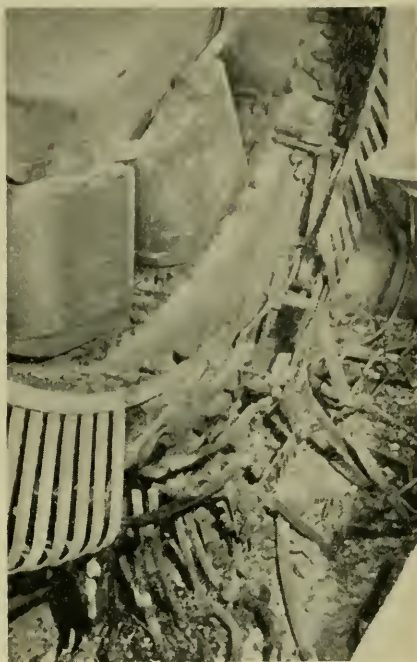
SHORT circuiting and fire in a water-turbine generator at a New England power plant some months ago, resulted in a loss of more than \$8,000 to the unit and smudge and fire damage in the room housing it. The 3-phase, 2,300 volt machine had been re-wound only a few months before the accident. This fact, coupled with an excellent system of maintenance, made the possibility of gradual breakdown of the insulation remote. The immediate cause of the accident, however, was a short circuiting which originated in the leads between the winding and the machine terminals. Investigators blamed the trouble on an electrical disturbance outside the plant, which produced a line surge that broke down the lead insulation. Repairs involved the reinsulating of 12 field coils and 202 bar conductors, and replacement of damaged wires, cables, conduits, and lightning arrestors. The loss was covered by insurance.

Windings and leads damaged by short-circuiting and fire

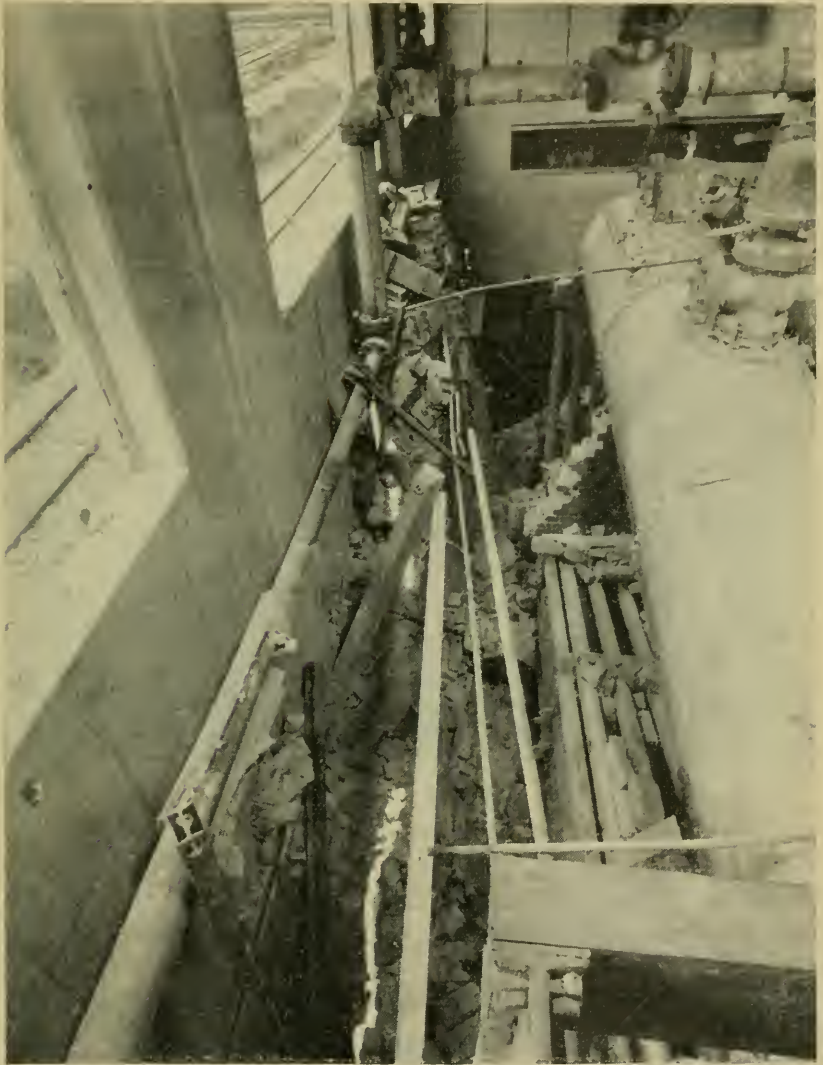
The installation was in a large canning plant, and the boilers were scheduled to go on the line eight days after the accident to care for the apricot crop. Since furnace explosion and use and occupancy insurance were carried, the repair was expedited by The Hartford Steam Boiler Inspection & Insurance Company, which authorized the employment of three shifts of workmen and suggested other emergency measures to hasten the work. As a result, the boiler went on the line as scheduled and none of the crop was lost.

Brick masons worked night and day to rebuild this setting.

had not presented itself. In any gas-fired installation the pipe to each burner should be provided with a straight-way plug cock marked in line with the passage, and there should be a rising spindle gate valve or some equivalent device which indicates positively whether the valve is open or closed, and which can be seen from a distance.

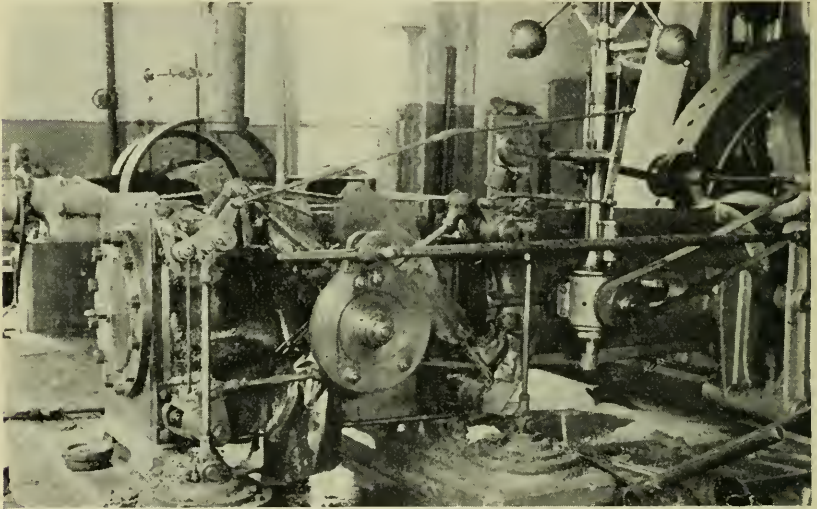
Steam end of compressor after the blowing out of the exhaust-steam cylinder-jacket.

could finish the operation, the exhaust steam chest blew off the cylinder, bending various reciprocating parts and breaking the throttle valve and piping.

In seeking the cause of the accident, investigators considered several contributing factors. Although the steam pipe was well drained by traps, they felt that water may have gotten into the cylinder at some prior time and the "bump" then sustained may have started cracks in the cast iron. The face of the break showed two old defects, each about 2" long, but otherwise the metal was clean. A new 18" steam cylinder, a new throttle valve and the repair of the valve gear and other parts were necessary to restore the compressor to service.

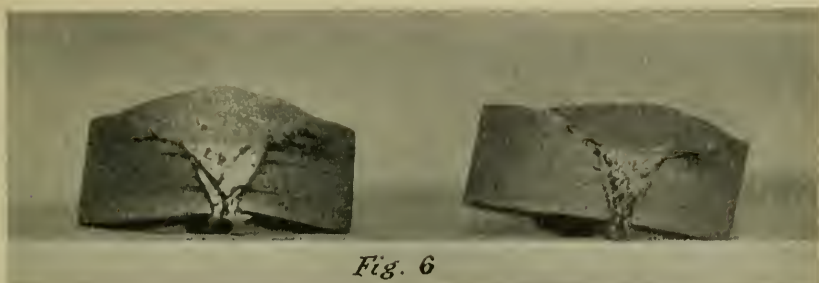
*Fig. 6*

Figure 6—Specimens from a fusion welded ammonia brine cooler.

Some examples of plugs that have been cut from questionable vessels will be of interest. Figure 6 shows specimens removed from a fusion welded ammonia brine cooler which had been in service for several years. It is interesting to compare these plugs with the etched cross section of the weld shown in Figure 3. What might have happened if the vessel, from which the plugs were cut, had remained in service may readily be conjectured.

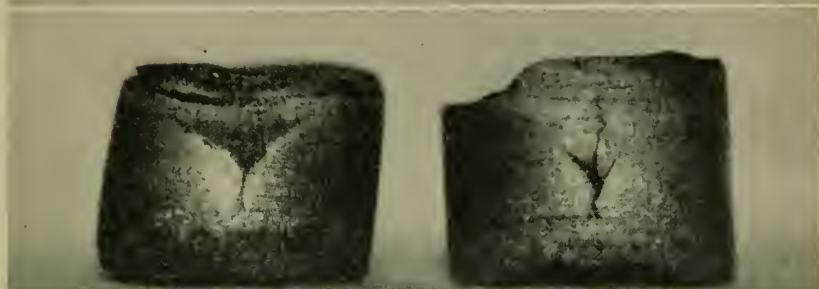
*Fig. 7*

Figure 7—Plugs cut from a fusion welded ammonia generator.

Figure 7 shows plugs cut from a fusion welded ammonia generator in an absorption system. After seeing these plugs, the owner decided to replace the vessel.

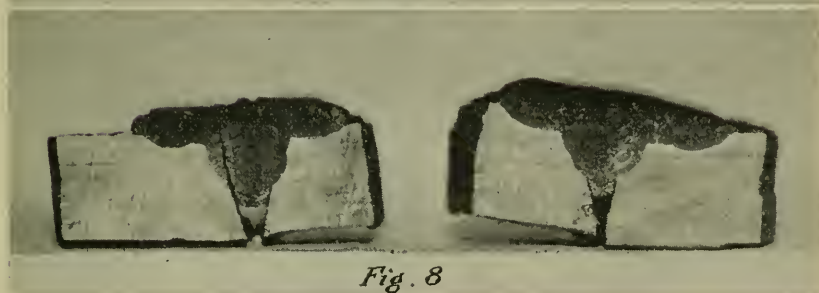
*Fig. 8*

Figure 8—Plugs from a fusion welded soap kettle.

Figure 8 shows specimens cut from a fusion welded soap kettle. The defective seam of this vessel was rewelded by a competent operator.

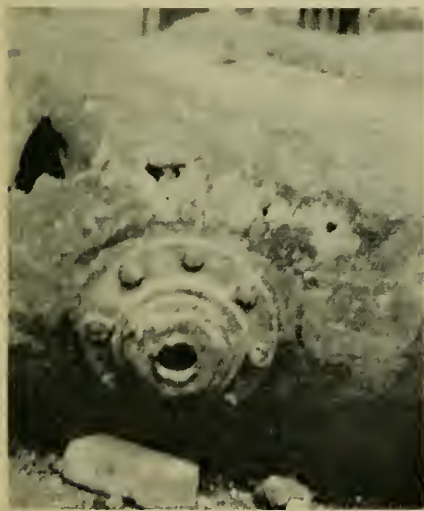
What will eventually happen to any tank buried in the earth is illustrated here. This is a blow-off tank recently dug up at the suggestion of a Hartford Steam Boiler inspector. It is absolutely impossible to tell what the external condition of a buried tank may be, even though it is known that, when buried, it was covered with some sort of a protective coating. These coatings do not last indefinitely and it is only a question of time before some vulnerable point will be attacked by corrosion. Failure of a buried tank may cause serious inconvenience, particularly if the tank is expected to carry pressure.

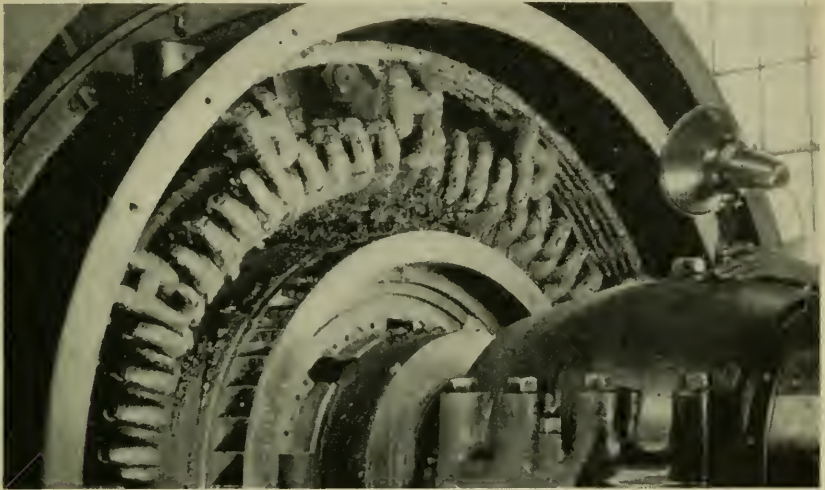
Collector ring end of the idle alternator after its electrical burnout.

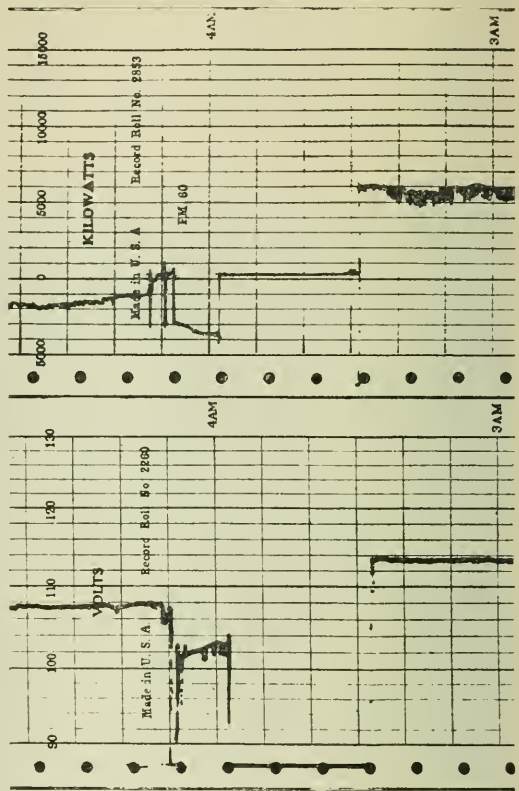
An accident in graph form. Above—Wattmeter chart showing power conditions on No. 1 Edison feeder. The generator stopped supplying power at about 3:28 A. M. The plant was dark until 3:58 A. M., when utility power was admitted for ten minutes, burning out the idle alternator. Below—Bus voltage chart for the same period revealing why the plant's direct current motor-generator sets would not start during the 10-minute interval mentioned above.

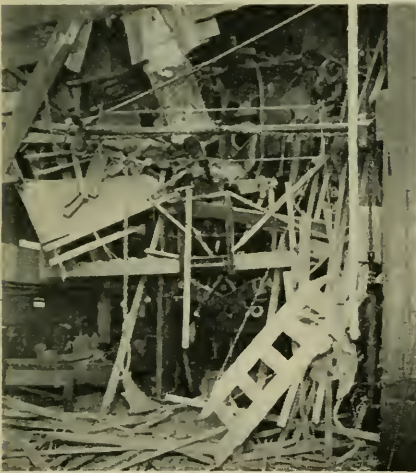
*Cotton compress after explosion
of its steam cylinder.*

The cause of this accident was undetermined, but it is probable that a crack had weakened the cylinder, which is open at the top and is of massive construction with girthwise reinforcing ribs and a heavy flange at the top. The cylinder broke into four pieces, each of them weighing many hundred pounds.

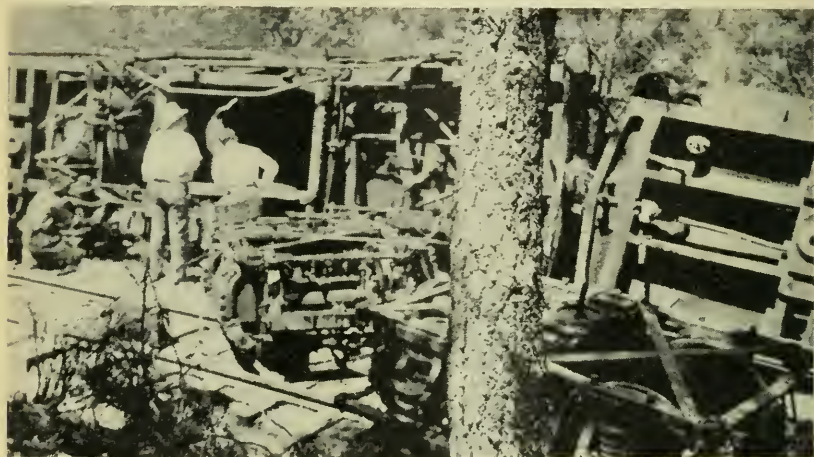
FIVE men were injured on July 29, 1935, when a locomotive fire box type boiler at an Illinois saw mill exploded, supposedly because the safety valve was corroded in its seat. When the rising pressure could not be relieved by normal means, it blew out the lower sheet of the barrel. The force thus released virtually demolished the mill. One man was thrown against a shed, the blast tearing off his overalls

Scene of logging locomotive explosion.

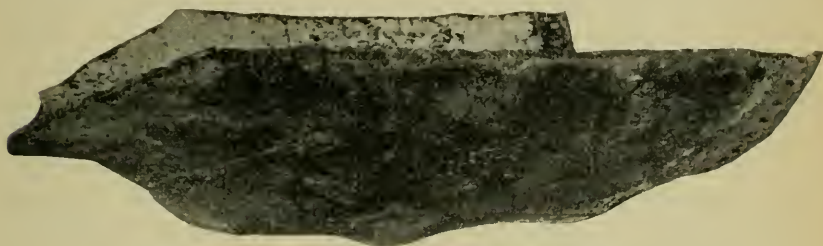
Bagged plate showing bulges and scale accumulation.

Southern lumber mill on October 5, 1935. The bagged area was on the rear course near the blow-off flange and extended approximately 50" girthwise of the boiler and 40" lengthwise. The most serious bulge was 8" in depth and there were two ruptures, one 3" long and another 3½" long, at the bottom of the bag. The bulging had caused the rear tube sheet to pull forward about 2" and the lower rows of tubes to distort. According to the plant manager, the first warning of the trouble was the fireman's report that he could not keep water in the boiler. It is evident from the photograph that the inside of the plate carried a heavy coating of adhering scale. In addition to this, however, there undoubtedly was a large accumulation of loose scale which fell off when the section was removed.

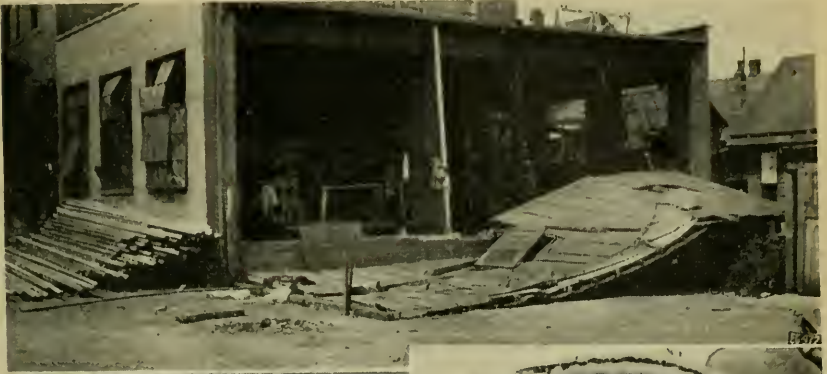
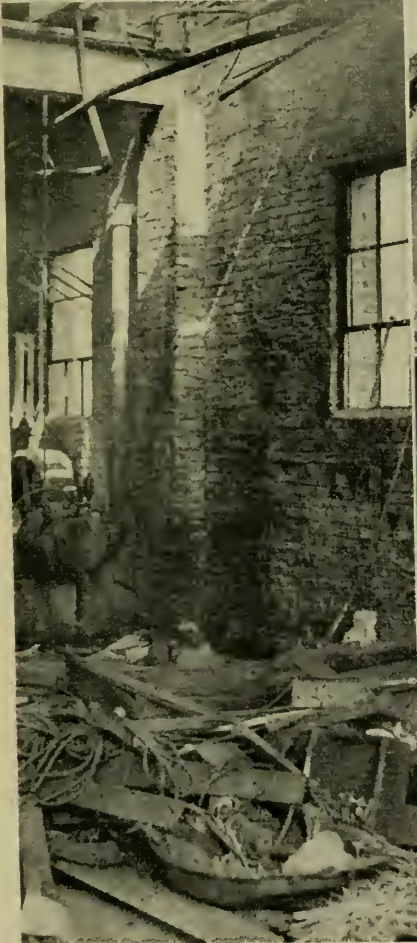
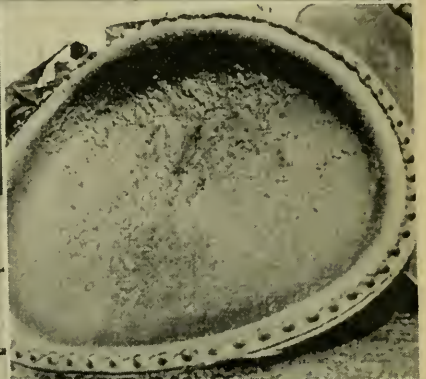
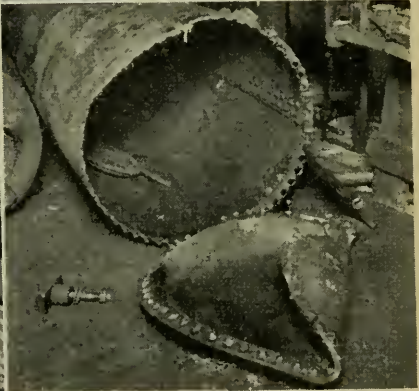
Top—Side of building blown out by the explosion of the tank shown at the lower right. Upper right—Minus head reversed by oil vapor explosion. Center right—Failure caused by corrosion of rivets. Lower left—One man died and two were hurt when an air tank exploded and soared through the roof.

An Ohio scrap-iron baling plant was wrecked by the explosion of an air receiver 3' 6" by 7' with a minus head $\frac{3}{8}$ " thick. Again it was the reversal of the minus head because of an oil vapor explosion which tore open the tank. In this case, just prior to the blast, flame was noted issuing from the safety valve. Employees also reported that the safety valve had been operating intermittently and that the discharge pipe from the compressor was red hot. The air compressor was definitely in need of extensive repairs, and as its large oil feeders were filled at least twice a day, it may be assumed that an abnormally large amount of lubricant was used. The head of the tank is shown in the accompanying illustration.

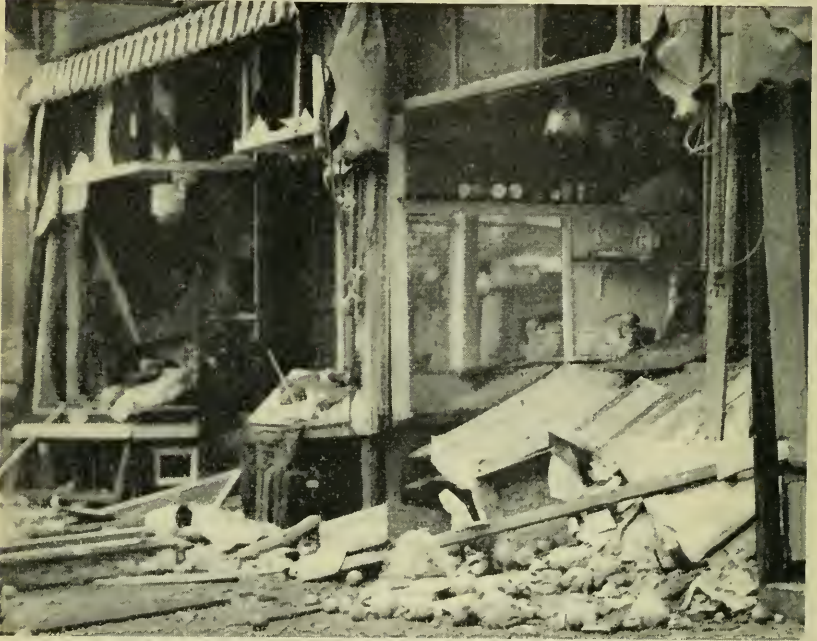
A cast iron boiler explosion on November 18, 1935, injured four persons and wrought damage estimated at \$10,000 to these stores.

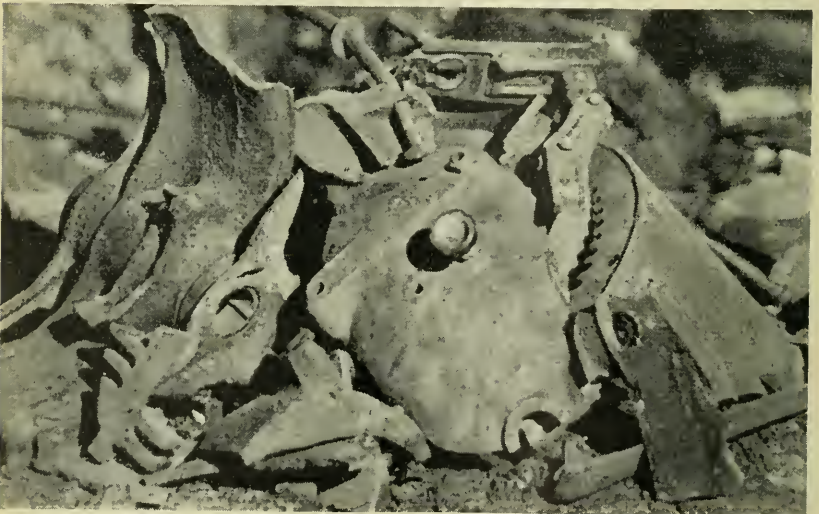
Parts of the boilers which were picked up after the accident. The boiler, which was one year old, was not insured.

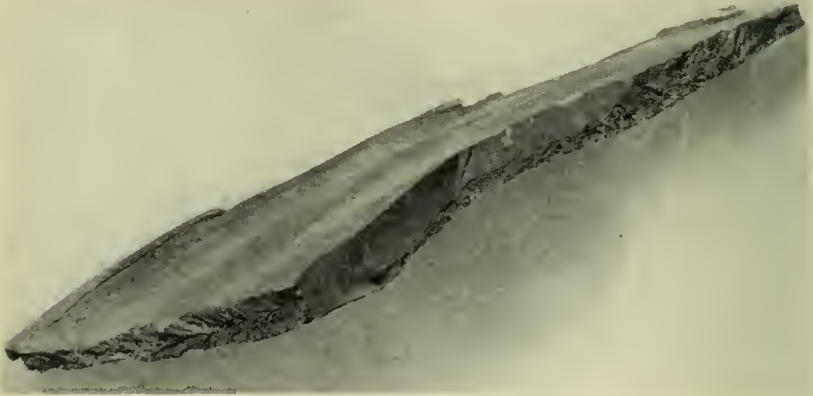
A 3,500 kw impulse turbine driving a generator at a Southern cotton mill was destroyed when the 3rd stage disc exploded because of

Section of turbine disc which exploded because of a fatigue crack.

a progressive crack. Replacement of the machine, which was about 12 years old, involved an estimated cost of more than \$100,000. The explosion took place while the emergency governor was being tested. When the machine reached 8 per cent above its operating speed, vibration suddenly increased and the accident occurred. The steam end was wrecked, there was serious damage to the generator because of the distortion of its shaft and the rubbing of the field against the stator, the foundation was cracked in several places, and extensive damage was suffered in the condenser room. As the severed section of the wheel did not go through the steel turbine casing, there was no loss of life or serious injury to the operators, although the jolt knocked a helper off his feet. It was felt that, although the testing of the emergency governor may have hastened the time of the ultimate failure, the accident would have occurred at some later date under ordinary

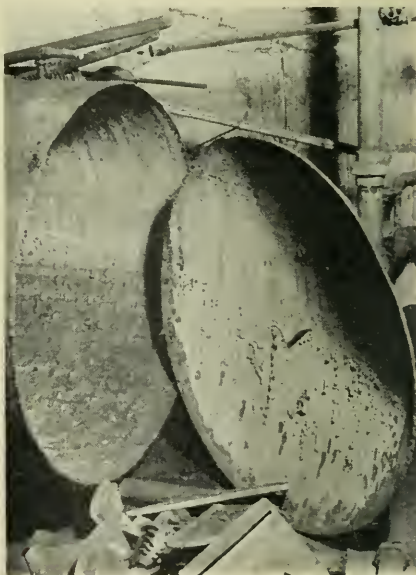
Hydro-Pneumatic Tank Fails Due to Poor Weld

This hydro - pneumatic tank with its saucer-shaped head failed because of a poor weld. The pressure at the time of failure was 35 pounds. The dimensions of the vessel were 14' by 42", and both the shell and the heads were of $\frac{1}{4}$ " thickness.

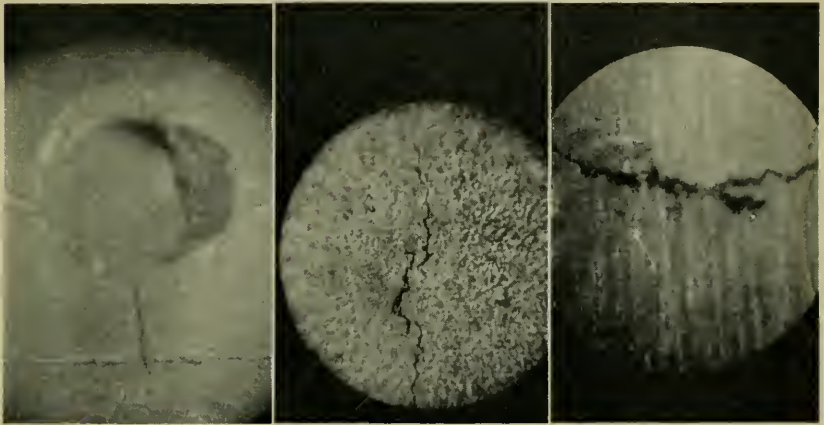
Left—crack which caused the leakage. Center—the crack at the left as it appeared in the rivet hole. Right—characteristic embrittlement cracks with which the plate was affected.

from time to time. As these symptoms pointed to the probable existence of serious distress, the inspector took steps to verify his suspicion. His investigation led to the discovery of a case of plate embrittlement which had progressed to a dangerous degree.

The boiler was of the bent tube type, and of medium size. Its seams were of double-riveted lap construction. The leakage came from a crack in the plate under the lap of the longitudinal seam and since it did not extend beyond the caulking edge of the seam, its presence would not have been suspected by one not conversant with this type of failure. Each time the seam had been recaulked the defect had progressed and further leakage had been increasingly difficult to stop. When the drum was examined in detail, the seam was found to be seriously weakened

for most of its length by a multitude of embrittlement cracks. A test of both the raw and the treated feedwater showed that either could have led to the development of the condition.

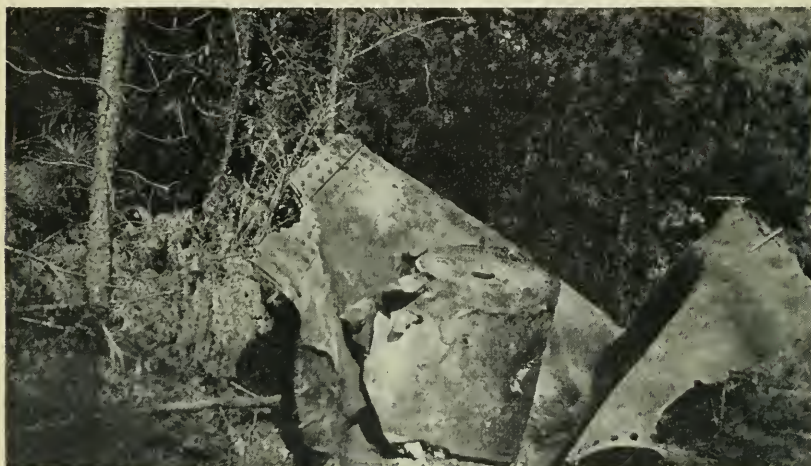
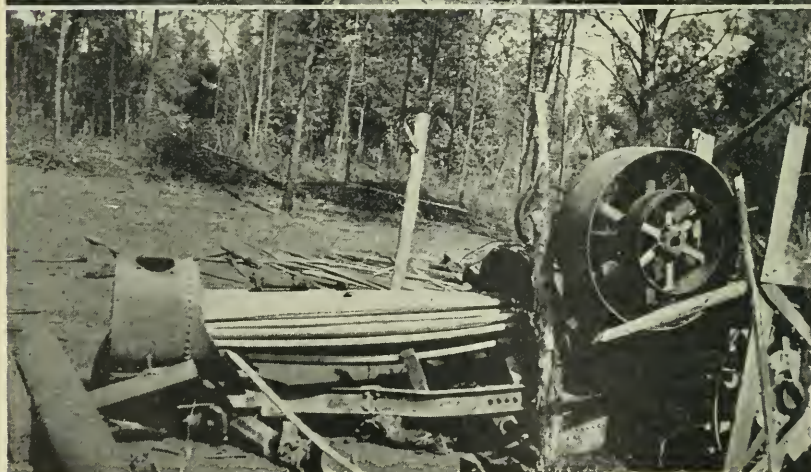
One man was killed and another injured at a portable sawmill in Virginia, when a welded repair broke loose on a locomotive type boiler, causing a rupture the entire length of the longitudinal seam. The barrel of the boiler tore away at the front head and at the throat sheet, demol-

Above—The barrel of the boiler where it came to rest 400 feet from the sawmill. Below—The remainder of the boiler, showing the torn plate.

ished the engine, and came to rest in the forest more than 400 feet away. The internal surface of the shell plate along the longitudinal seam was pitted and grooved throughout most of its length. In the middle of the joint was a $\frac{1}{2}$ " wide weld that had been applied externally parallel to the seam for about 2 feet, obviously to stop leakage, because the pitting and grooving had extended through the plate. The man who was killed was thrown more than 30 feet and the other workman sustained a broken leg and a scalded thigh. The boiler was uninsured.

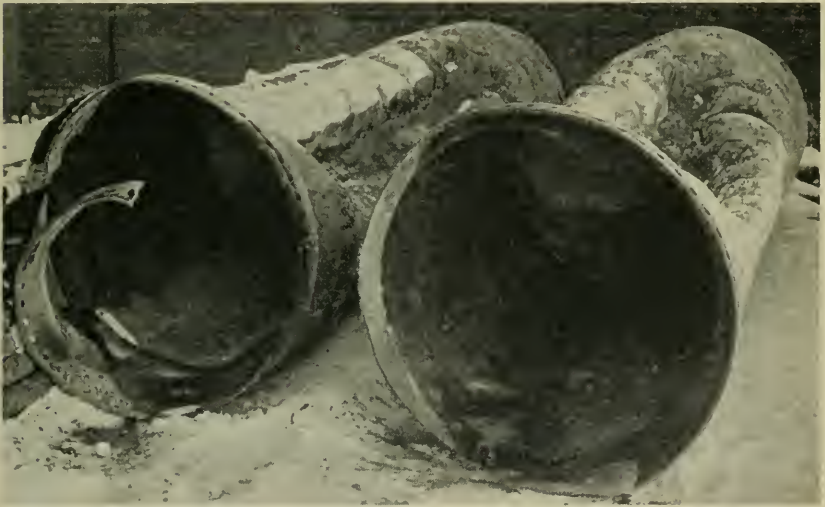
Collapsed Scotch-Marine boiler furnaces, the result of overheating.

was full of water, he had opened the blow-off valve, letting the water down to about half a gage, but had not disturbed the banked fire. About a half hour later he observed smoke issuing from the front of the boiler and on opening the fire doors saw that the furnaces had collapsed and were pressing against the grates. Whatever the train of events, it was evident that the furnaces, each 36" in diameter and 13'3" in

length, had collapsed because of a condition of low water and over-heating, brought about, probably, because of failure to close the blow-off valve tightly. The replacement of both furnaces was necessary.

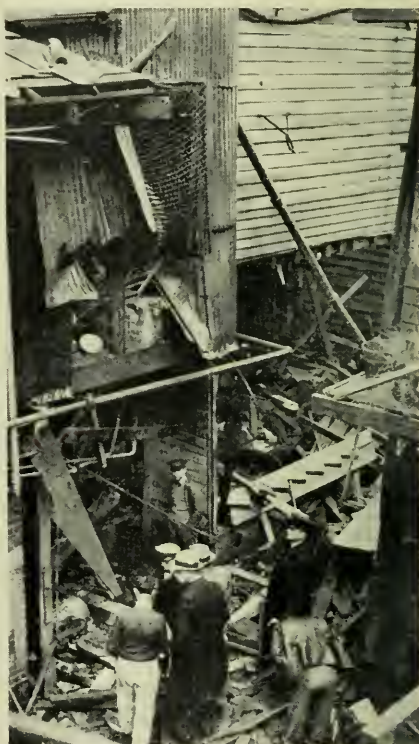
The explosion of a vertical tubular boiler 30" x 7' at a Southern ice cream plant damaged three buildings, one of which is shown in the accompanying photograph. There was no evidence of over-heating, and the accident was attributed to operation of the boiler at a pressure in excess of that for which it was built. The boiler traveled about 10 feet after the furnace sheet failed.

Damage following explosion of vertical tubular boiler.

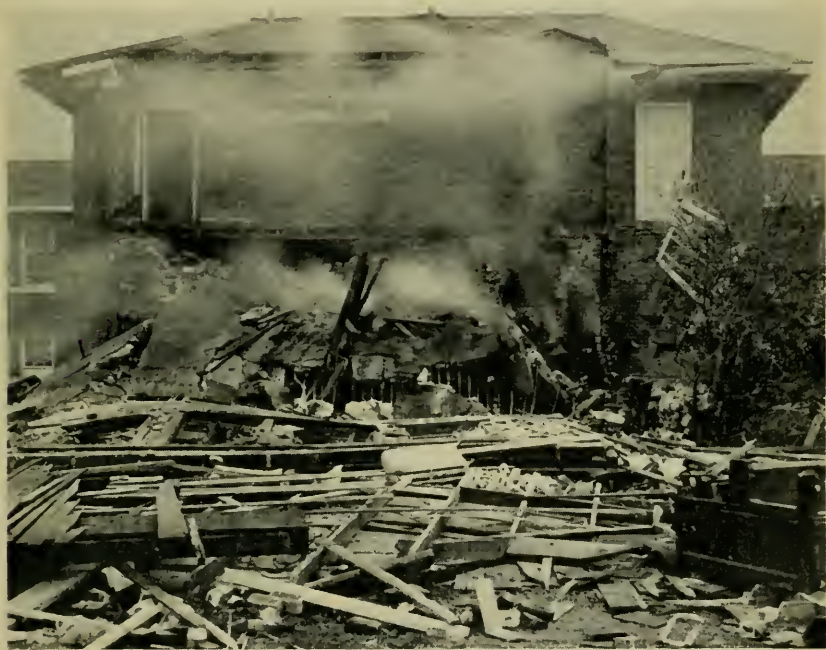
A YOUNG music teacher was killed when a hot water supply tank exploded in the boiler room of the consolidated school at Horn Lake, Mississippi, on the morning of February 17. Fortunately a recess saved the children. The sixth grade had left the music room, situated over the boiler room, barely five minutes before the explosion, and the school quartet was due there for rehearsal in another

Wreckage of music room and boiler room after explosion.

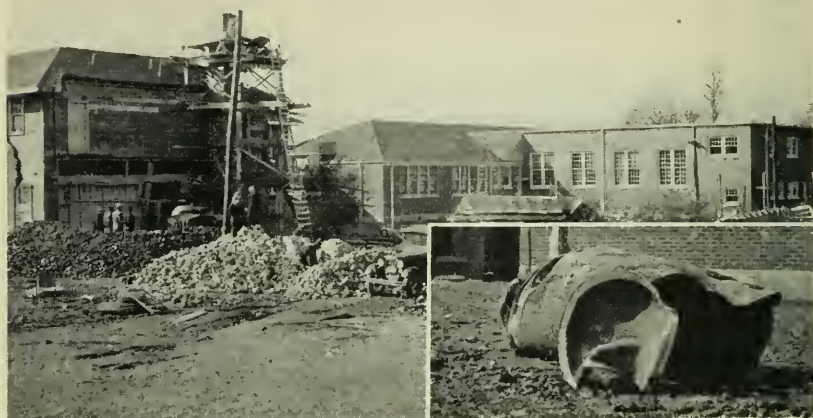
Water for it was heated in pipe coils in the fire box of one of two cast iron sectional steam heating boilers. Inquiry subsequent to the accident revealed that there had been a check valve in the cold water supply to the tank and that there had been no relief valve on the sys-

Repairing damage after explosion. Observe the 3' hole (boarded up) in brick wall of gymnasium, extreme right of picture by small double windows. Inset—Remains of tank showing reversed minus head.

tem. As it was a cold day, both boilers were in operation, but due to stoppage of drains in the shower room, no hot water was being used. Pressure built up in the tank until the minus head reversed and tore away, striking one of the boilers. The rest of the tank broke its way through the six-inch reinforced concrete floor of the music room, ripped down one of the brick side walls and hurtled across 150 feet of lawn to the gymnasium where it knocked a large hole in the wall, showering bricks and debris on boys who were playing basketball there.

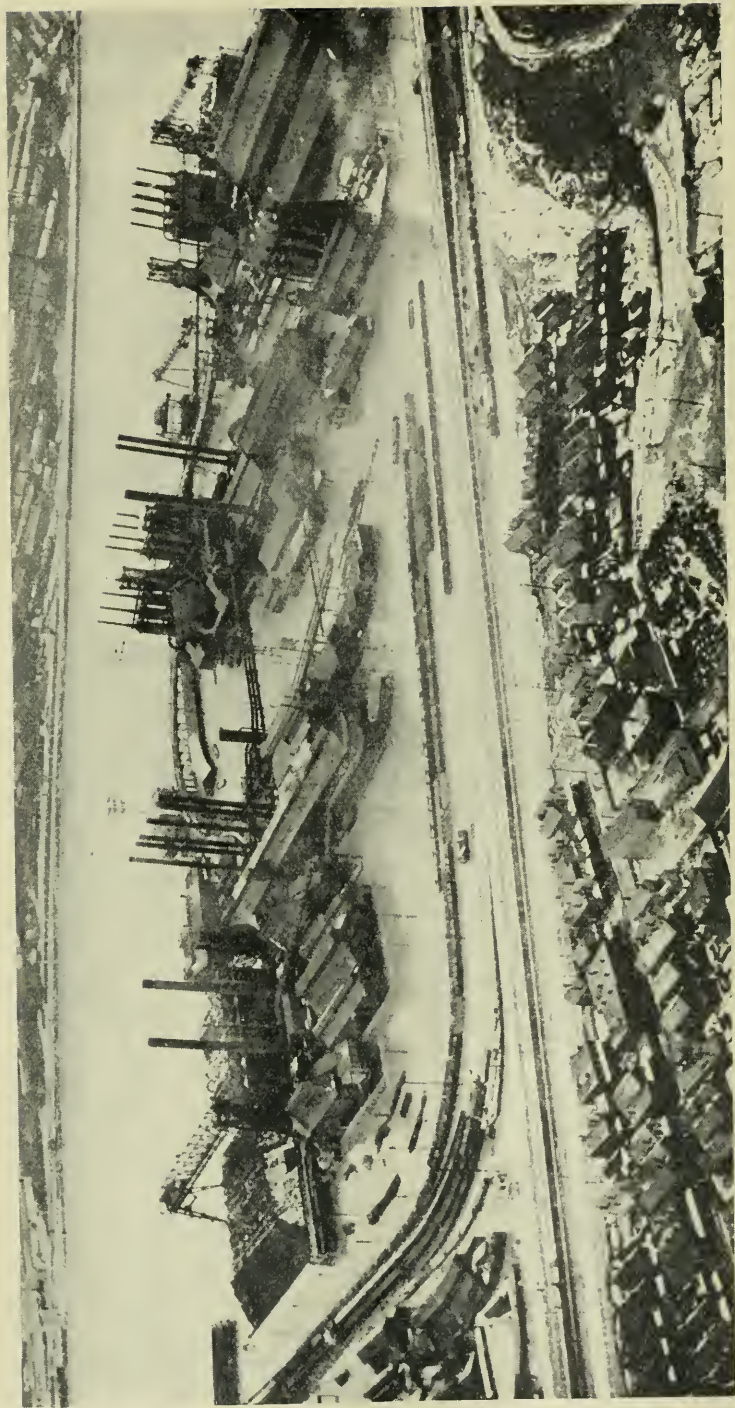
Part of the flooded area in the Pittsburgh section. Hundreds of electrical machines were inundated in these steel mills and in many other industrial plants both in this and in other areas.

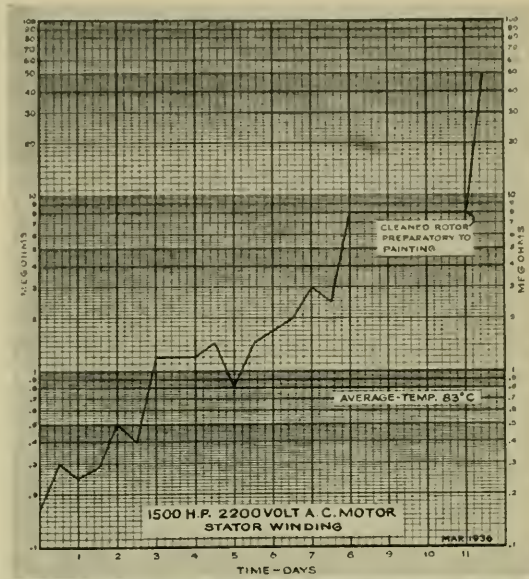
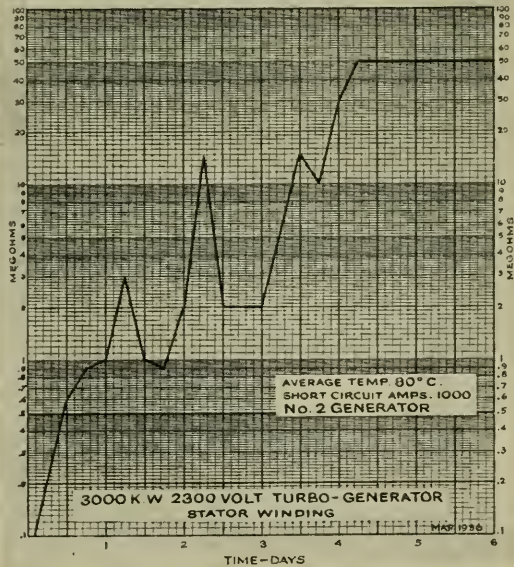
Representative graphs from log readings taken while drying out rotating electrical machines.

A separate log was kept for each machine. Operators recorded the temperature, insulation resistance and other information of value hourly in judging the progress of the drying out and the machine's fitness for actual service. Graphs illustrating drying out routine are shown on page 71. Where the machine was equipped with Class "A" insulation (cotton, silk, paper, and similar organic materials that have been impregnated), a temperature of from 80° to 85° C. maximum was maintained. Class "B" insulation (mica, asbestos and similar inorganic materials in built-up form combined with binding cement) permitted the use of maximum temperatures as high as 90° to 95° C. It was found that the older type windings in many instances dried out quickly, while considerable difficulty was experienced in getting moisture out of comparatively new windings. Where the insulation consisted of mica and asbestos tape well impregnated, the higher maximum temperatures could be maintained but the drying out time was longer.

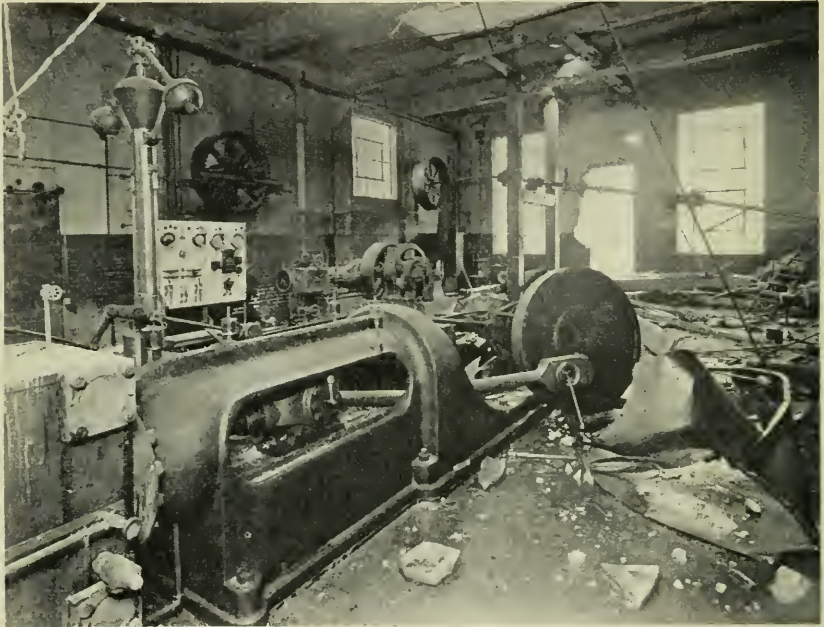
PROCESSING machines in a Southern textile mill in February began to speed up to such an extent that the operators shut them down. The reason for the trouble was made manifest a few seconds later when the 14' flywheel on a Corliss type steam engine exploded because of over-speed, the accident wrecking the engine,

Engine room after the flywheel exploded and wrecked the engine.

and damaging other machines, shafting, belting, sprinkler pipes, walls and roofs. The damage exceeded \$12,000. Parts of the wheel cut great gaps in the engine room roof, and metal and other debris was scattered over the property adjacent to the plant. A piece of the wheel about 70 lb in weight was found 1600 ft from the engine room. While several theories were advanced as to the cause of the accident, the facts obtainable with respect to it did not lead to a conclusive explanation. The most likely cause was the failure of the governor belt.

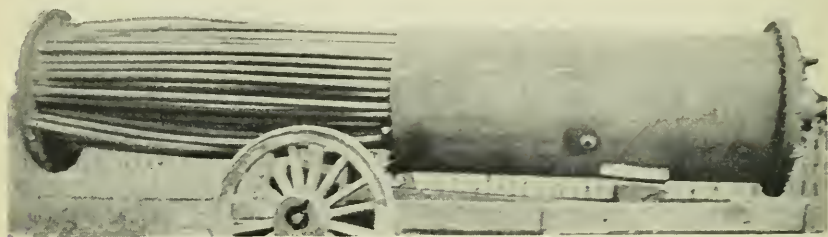
Fusion welded ammonia condenser which failed; welding procedure and testing have advanced greatly since this vessel was built.

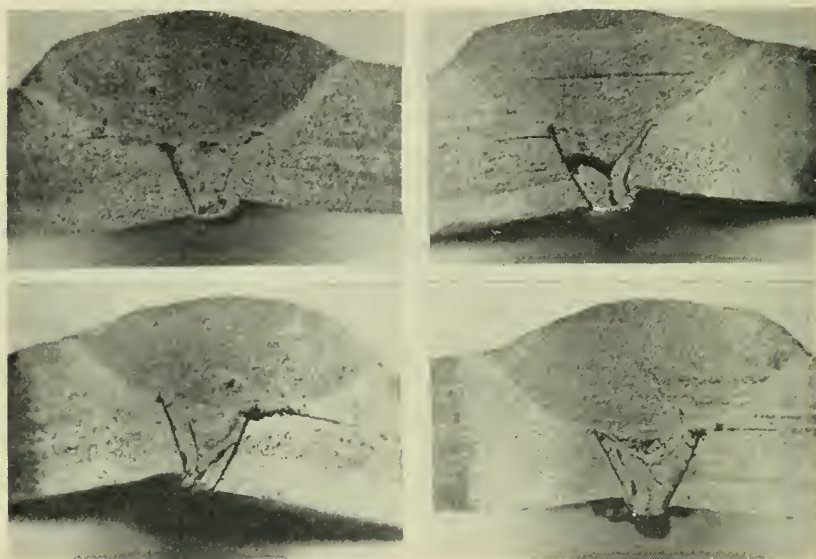
Samples of characteristic defects in welded seams.

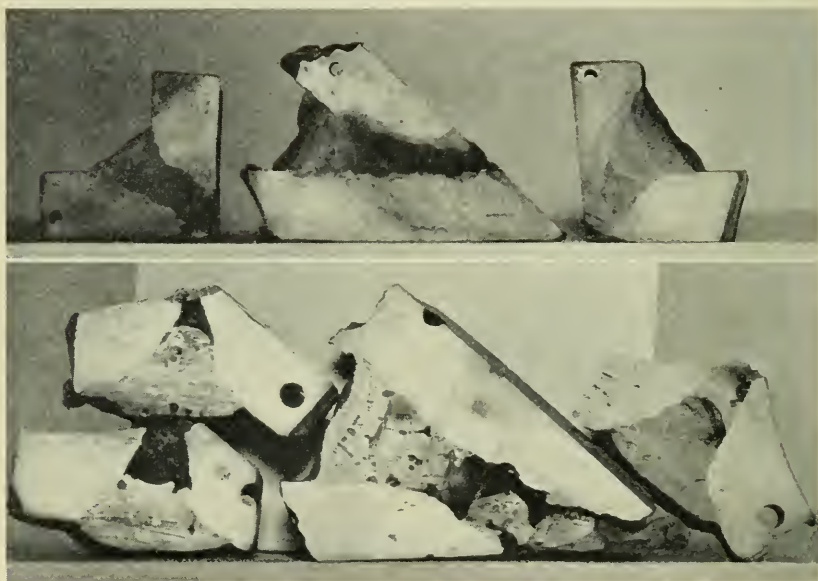
Good and bad fusion in pipe joints.

special ability on the part of the welding operators to do work in all positions. Furthermore, although welding can be done only from the outside of the pipe, it is important that full penetration be obtained throughout the thickness of the pipe wall and without the formation of "icicles" inside the pipe.

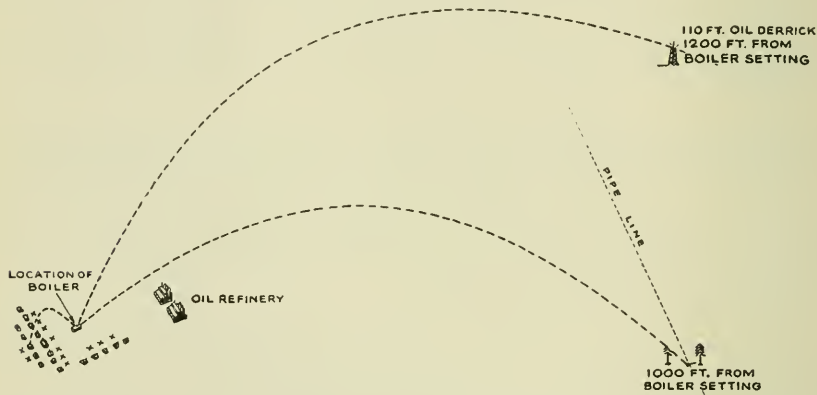
EIGHT persons were injured and property over a wide area (as shown in the sketch) was damaged when a locomotive type boiler exploded at a Texas oil well location in April. The accident, clearly a case of over-pressure, tore the boiler into several pieces and resulted in damage to property as far distant as 1200 feet from the boiler setting.

Path taken by parts of boiler which exploded at a Texas oil well location. The boiler was used to furnish power for pumping oil through various pipe lines.

aged. One piece of metal passed over a two-story hotel and crashed into a hut behind it, the metal falling in such a way that a negro woman was pinned in bed, but was not seriously injured. Other pieces hurtled over the refinery building, one whole course passing through the top of a large pine tree 1000 feet distant, cutting a 6" oil pipe buried about 2 feet underground, and making a deep gash in a second tree. Another piece of the boiler broke off the top of a 110' oil derrick which was 1200 feet from the boiler.

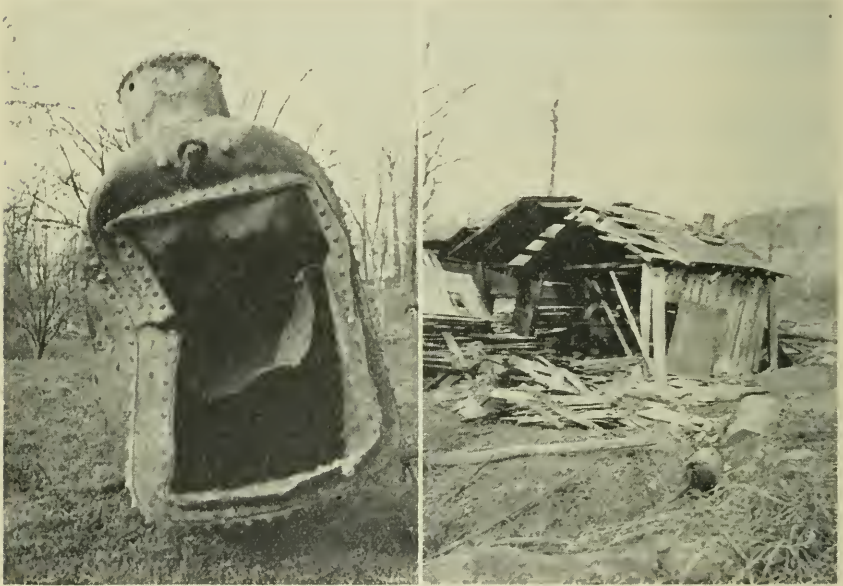
8-year-old son and three boys about 16 years of age. Another man and two youths were burned. Parts of the boiler were scattered over the mountain side. Of the wet bottom horizontal firebox type, the boiler was 32" in diameter and was built with a large firebox door for wood burning. The explosion was caused by the failure of the firebox crown sheet, which stripped off the staybolts due to serious corrosion. When the firebox door and door frame blew off, the fireman and two of the

Left:—Boiler after 300 ft. journey. Right:—The shattered engine house where the eight persons who were killed or injured had gathered.

boys were killed. The other two fatalities were caused by burns. Rocketing through the board wall of the boiler room, the boiler demolished a board fence, uprooted one apple tree and broke down another, and came to rest 300 feet from its starting point.

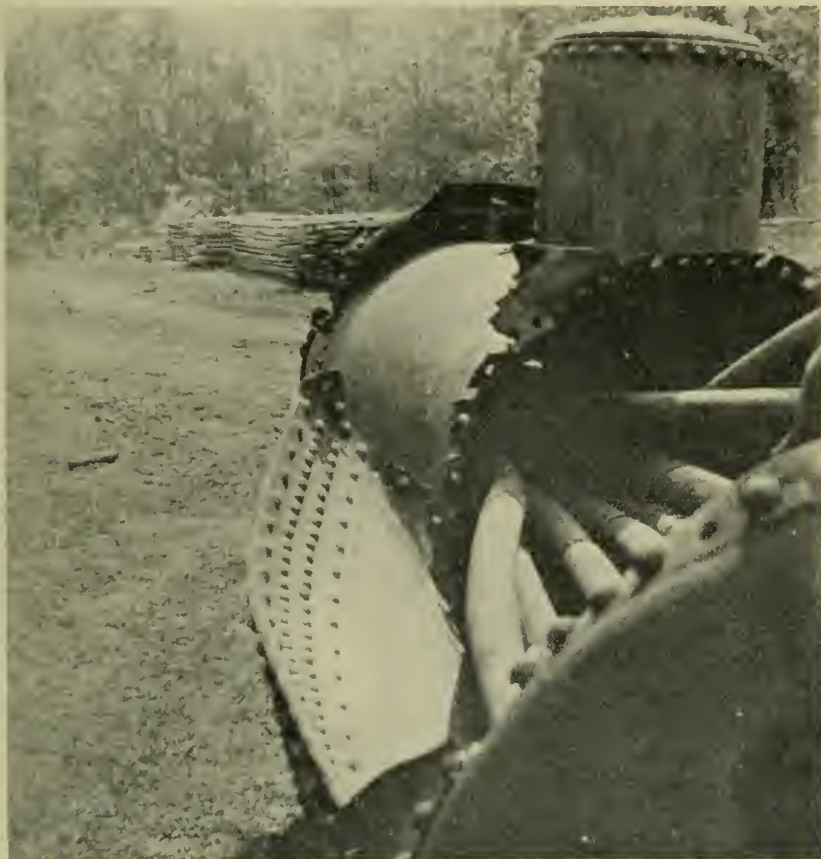
An old crack in the rear course of a 36" diameter horizontal tubular boiler, used at a Southern sawmill, in April brought about the result shown in the accompanying photograph. The vessel was projected 60

After the boiler had traveled 60 ft.

feet from its setting. Although the setting was made of mud and stones and was scattered over a wide area, only one of the nine men about the mill at the time was injured. A pair of mules escaped injury when the shell landed immediately in front of them. The 20-year-old boiler had been idle for two years. It had been fired up only a few hours when the shell tore along the crack which extended for almost

the full length of the 6' course and nearly through the plate. The photograph shows the inside of the butt strap and the line of failure adjacent to the top edge of the strap. The crack bore evidence of having existed for a long time and the metal adjacent to it was reported to be nearly as brittle as cast iron. The accident was attributed to inferior metal and excess pressure over a prolonged period.

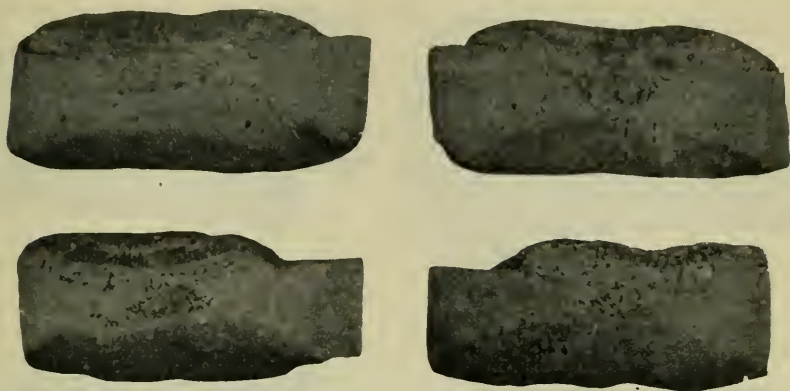
*Figure 1*

Figure 1. Although the weld is well fused the metal contains con-

siderable impurities. The four sections are from two plugs removed from the same seam.

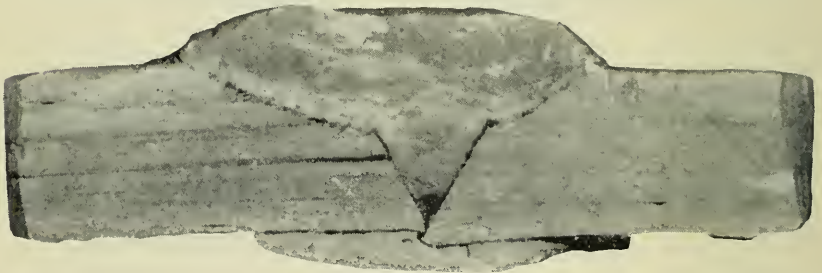
Figure 5

Figure 5. Illustration of an extreme case of lack of fusion in the lower half of the welding groove, slag on the fusion line and almost entire lack of fusion of reinforcement on the underside.
