The Locomotive

THE HARTFORD STEAM BOILER
INSPECTION AND INSURANCE CO.

VOL. XL

1934-1935

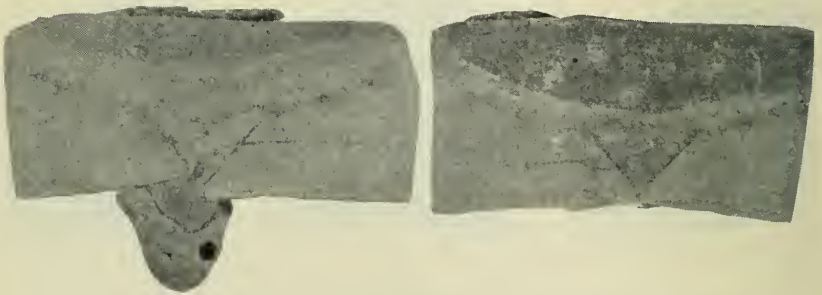
Figure 6

Figure 6. An example similar to that shown in Fig. 4. The two plugs are from the same seam.

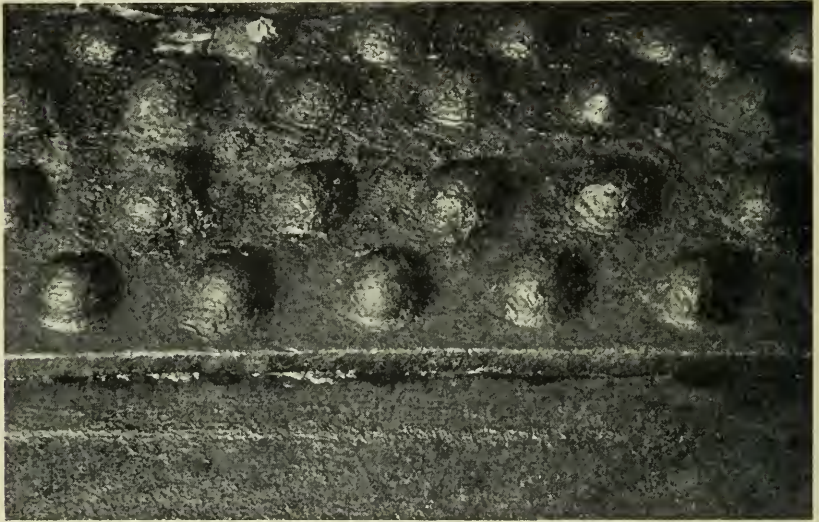
Figure 1—Seam which pulled apart for 6 feet after embrittlement had developed to a serious extent.

In the case under consideration the plant had 8 bent tube type boilers operating at about 150 lb pressure. Some of them were rated at 823 hp and the others at 324 hp, the boiler which failed being of the larger size. The first indication of trouble was a noise such as

would be made by the rupturing of a small tube, but the accident obviously was more serious than a tube failure since a sufficient volume of water escaped to put out the fire. An examination of the boiler after the accident brought to light the condition shown in Fig. 1. The metal of the shell plate had separated as much as $1\text{-}5/16''$ in places until the rivet holes were actually visible where they had pulled out from beneath the butt strap of the lower or mud drum. This drum was $48'' \times 16' 9''$, and seams were double riveted with $1\text{-}1/32''$ diameter rivet holes and $3''$ pitch. The plate had cracked for a distance of $6'$ along the outer row of rivets and there were also cracks in the outer butt strap between

the rivet holes in the top row. These cracks were characteristic of embrittlement in its final stages.

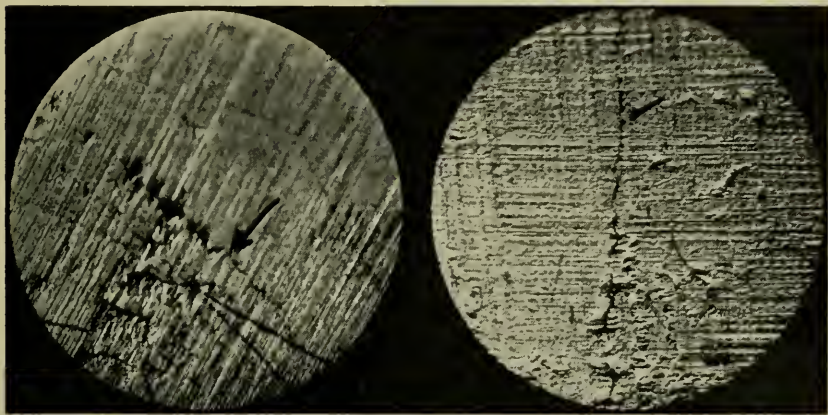
Figure 2—Characteristic embrittlement in another boiler of the same battery as the affected vessel.

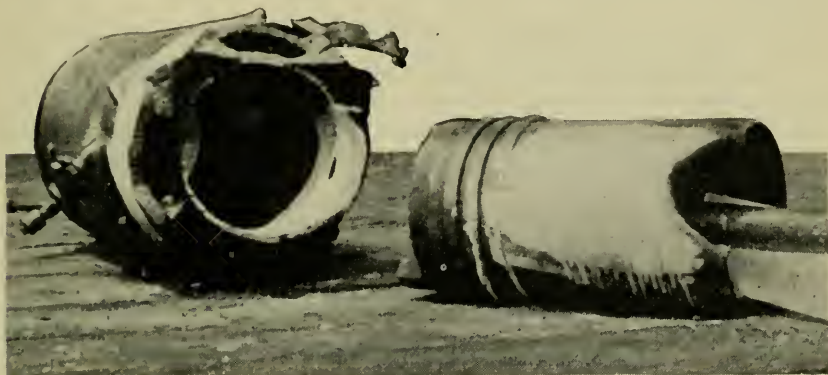
Figure 8—Piston and part of cylinder which broke off due to over-heating. The machine was a small two-cylinder engine.

effect of the silicon. It may well be asked why this action does not take place on the surface of the piston. The theoretical explanation of this is that the separated carbon is re-fused into the solid solution by the higher temperatures at the top of the cylinder and further, that the oil which comes in contact with the piston top saturates it and acts as a protective influence. At any rate the distortions because of "growth" in Diesel engines occur as is shown in Figures (1) and (2). From these it will be seen that the "growth" itself is only part of the difficulty, as its presence leads to a distortion of the entire cylinder, which distortion is contributory to the eventual seizing of the piston.

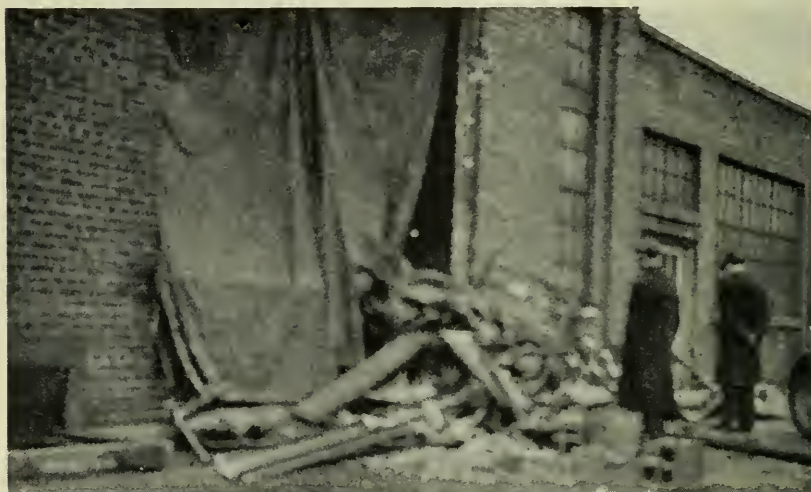
Such an accident occurred some months ago at a dairy where a feedwater heater of the open type was used with two large horizontal tubu-

Damage caused by the explosion of an open type feedwater heater.

lar boilers operated at 120 lb pressure. The heater was six years old, of fusion welded plate steel construction, and was supplied with exhaust steam when enough was available. It also was connected to the high pressure steam lines through a pressure regulating valve, so that when exhaust steam was not available the feedwater was heated by live steam.

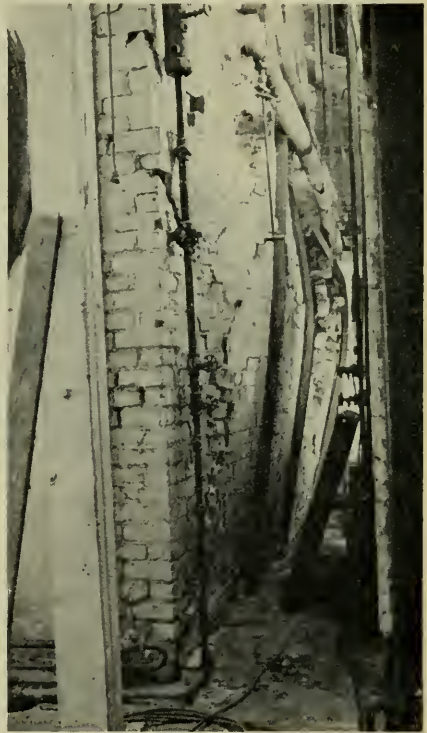
A LEAKY stop valve on the pilot light and a leaky plug cock on the main burners of a gas-fired power boiler—No. 2 of a pair in a California plant—caused a furnace explosion which did \$2,500 damage to the boiler setting. The escaping gas, which had filled the furnace and flues of the idle boiler, was ignited through cracks in the center brick wall between the two boilers five minutes after the No. 1 burner had been lit. The rear wall was budged and pushed back about nine inches. The right side wall was blown out entirely, leaving no support under that side of the boiler, as the boilers were set on brickwork instead of being supported from the beams. This caused an excessive strain on the main steam pipe which held the boiler in place. Fortunately, there was no water in the boiler at the time, for that added weight would probably have caused the piping to break and the boiler to fall.

View of right side wall of No. 2 boiler showing the damaged setting. The boiler is 72" in diameter and 16' long of the horizontal return tubular type.

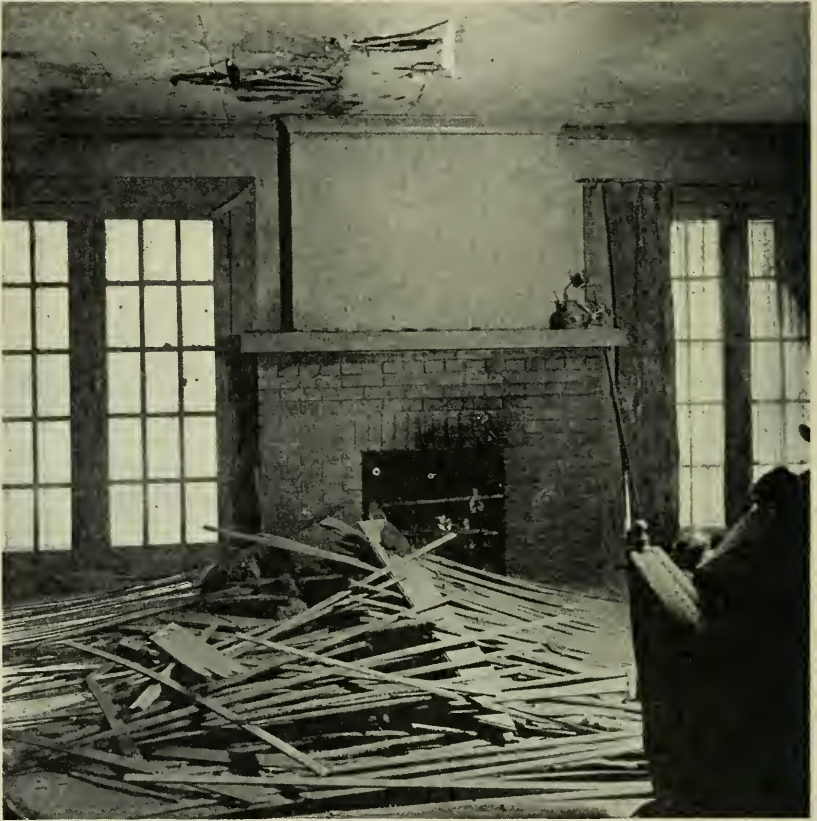
Above is pictured a wrecked living room, part of the damage caused by the explosion last spring of a small round type cast iron hot water heating boiler in a Buffalo residence. Its explosion led to the injury of three women who were knocked to the floor by the blast or were struck by flying glass or other objects. Damage to the house, which was a two-story frame dwelling, included that shown in the living room, the breaking of all the windows, and the demolition of the heating plant. The property damage was estimated at about \$2,000.

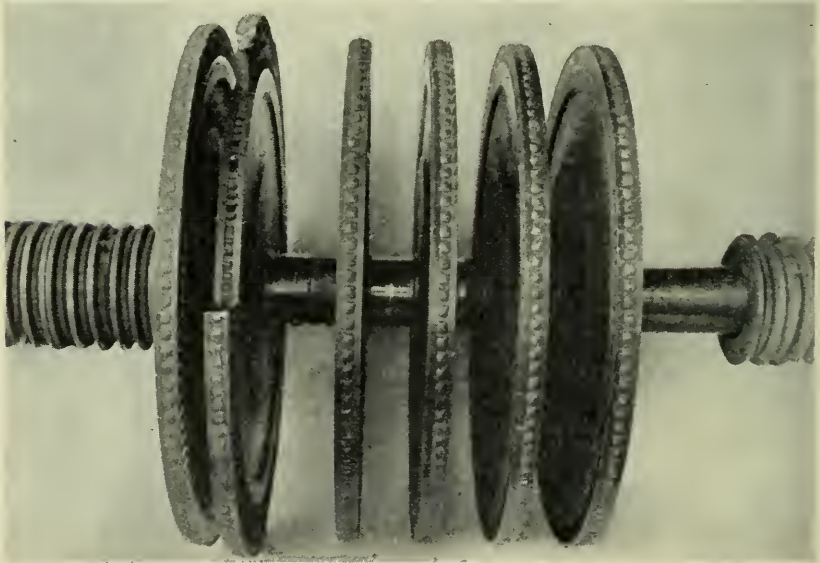
Water in an amount sufficient to move the wheels of a 600 hp steam turbine axially on the shaft caused the second row buckets to rub on the intermediate stationary buckets and 24 of the former to break at a

Wheel from which 24 blades were broken when water forced it out of line and permitted it to rub.

paper mill in May. This accident resulted in a loss of more than \$8,000 of which two-thirds was Use and Occupancy loss occasioned by reason of the stopping of the paper machine while repairs were being made. The loss was covered by insurance in Hartford Steam Boiler.

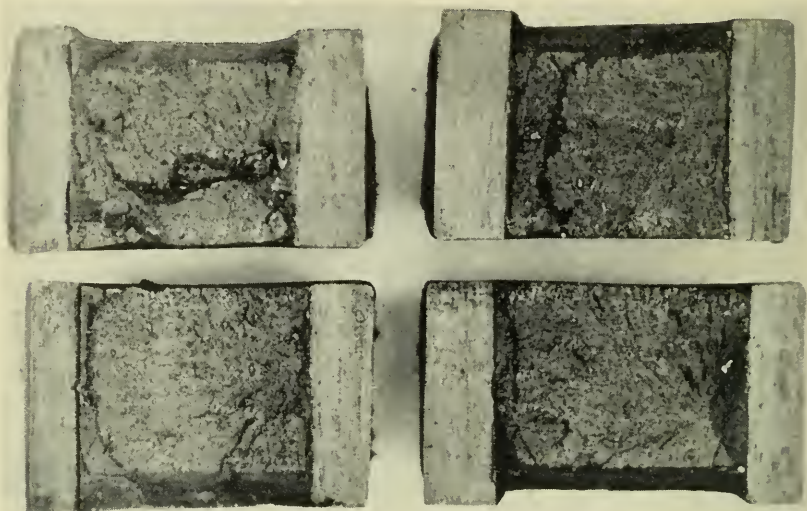
*Figure 8*

The side break test is somewhat new. It had been felt that the nick break specimen might not reveal defects that might exist on the side walls of the welding groove. To investigate this matter a defective weld was made in which there was a slag streak of somewhat minor proportions on the side wall. The weld was X-rayed and it was found that the defect continued throughout the length of the weld. Four nick break specimens and three side break specimens were removed. Two of the nick break specimens were broken in the customary manner with a quick, sharp blow, and the other two nick break specimens were broken by a slow bending. All of the nick break specimens broke directly through from notch to notch as shown in Figure 8. The side break specimens broke through the side wall defect as shown in Figure 9.

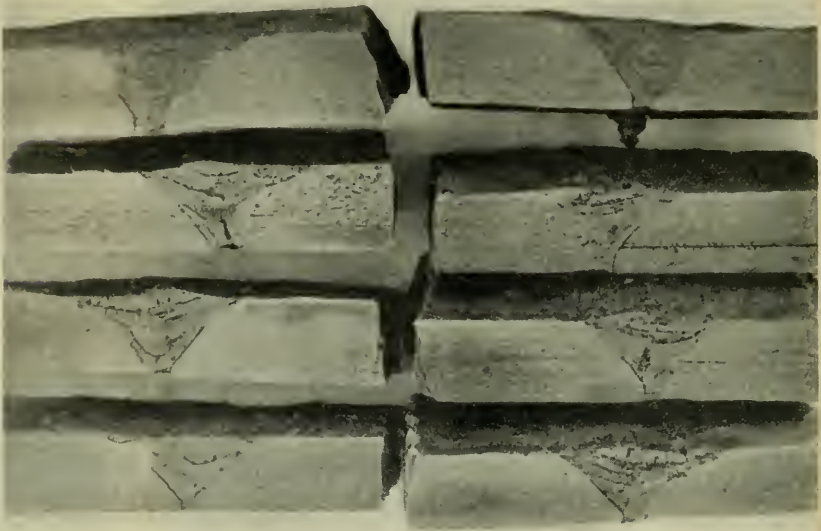
have been constructed by operators who had demonstrated their ability to make sound welds, yet joints cut from the line have revealed unsound welds. Figure 11 shows an example of this. A constant prodding thought in the mind of a welding operator, to encourage him to do his best work at all times, will have a most beneficial effect and will be the most effective instrument that can be used to secure properly welded joints

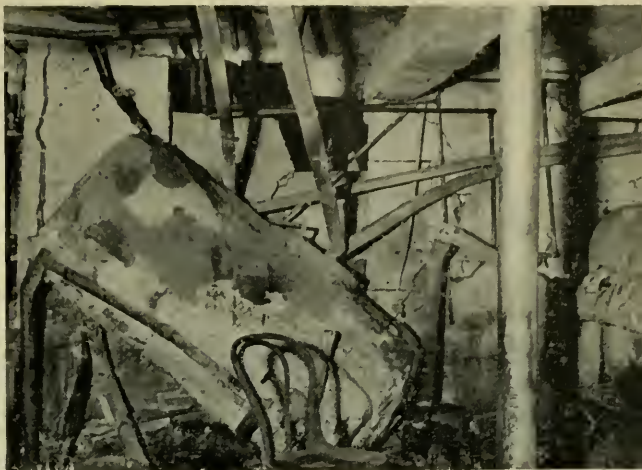
Upper Right—A hot water heater failure in a Pennsylvania business block injured a woman and resulted in property damage estimated at \$5,000. The blast tore loose the 750-gallon hot water tank shown in the photograph. **Lower Right** — A welded quill pipe steam radiator exploded, scalding an employe and damaging equipment, walls and show window of an Iowa shop. Windows were shattered in automobiles parked in the street in front of the store.

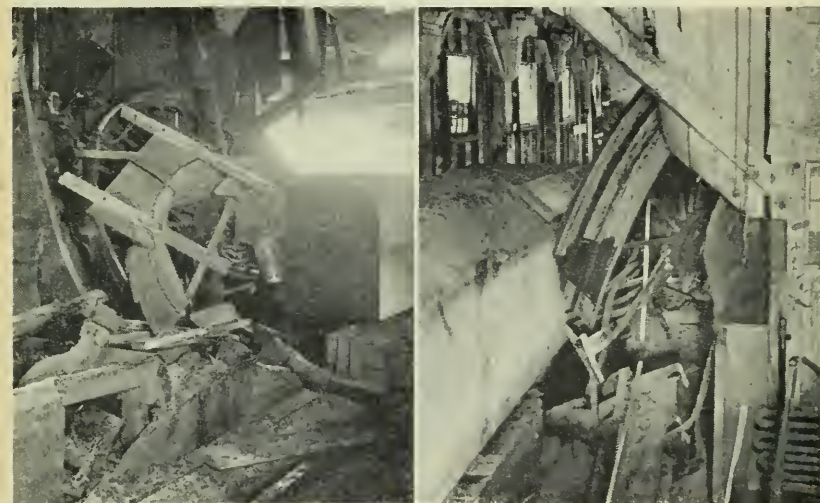
Wreckage following a band saw wheel explosion at a Western mill.

A top band saw wheel 8' in diameter exploded at a Western mill on May 18, with the result illustrated on Page 146. As all of the fractures in the wheel casting appeared to be new and as there were no old flaws discernible, the only reasonable explanation of the wheel failure was a possible jamming of the saw that may have placed an excessive stress on the wheel rim or on the main bearing support. Property replacement necessitated by the accident was estimated at \$5,000. Flywheel insurance was not carried.

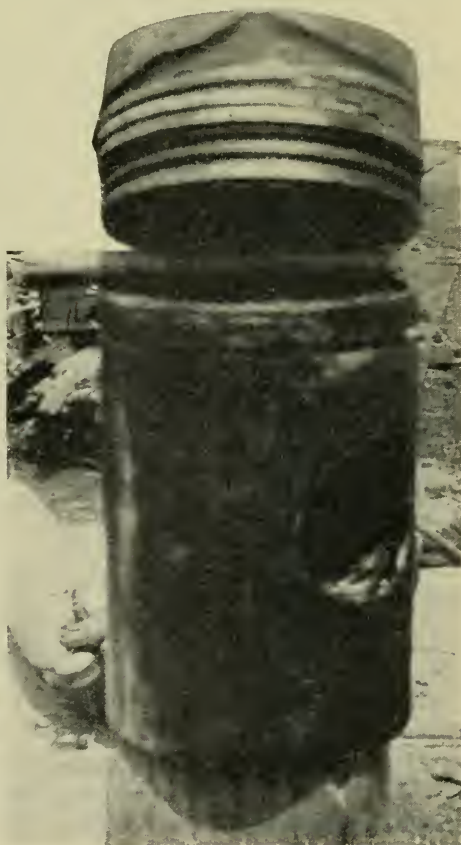
When an 8-cylinder Diesel engine on a dredge in Southern waters was operated for a considerable time under an over-load, its 11½" pistons became so over-heated and distorted that one of them broke, as shown in the photograph. Each of the other pistons was scored and at least one ring on each piston was broken. The photograph shows the piston head and skirt, separated by a bar to bring out the peculiar burning away of the top land, which permitted the top ring to break and become distributed in small fragments in the cylinder. Obviously the cylinder liners were all so badly scored that they needed replacing.

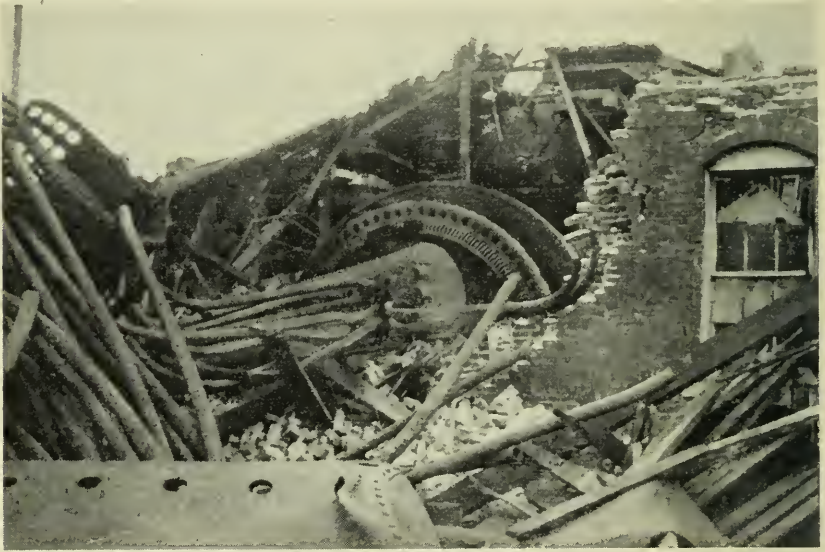
WHEN the lower drum of a bent tube type water tube boiler failed on October 30, a Middle-Western utility's power plant was demolished, five employes lost their lives, and a sixth was injured. Damage to the building, two engine-generators, electrical equipment, two other boilers, and auxiliaries involved a replacement cost estimated at \$100,000 and seriously hampered the utility's service. The

Wreckage following a lower drum failure at a Middle-Western utility.

supply of electricity for five towns was cut off and light, power, telephone and water service interrupted until supplementary hookups could be completed or emergency power plants, long out of service, could be started. The photograph illustrates the extent of the demolition.

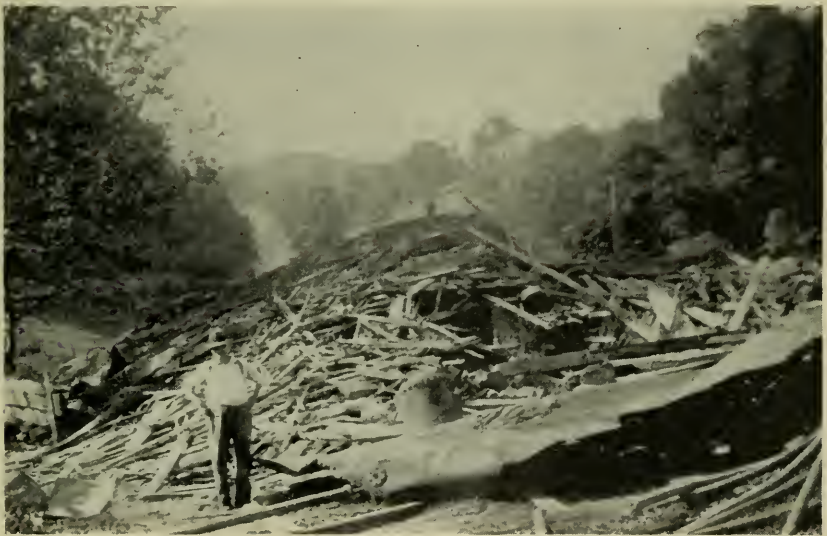
Deep grooving of the under plate of a horizontal tubular boiler and a sticking safety valve were causes contributory to an explosion at a West Virginia mill on June 4. A workman was on top of the boiler trying to fix the safety valve when the boiler exploded, tearing the shell from head to head, shearing off the front head completely and

After a sawmill boiler explosion in West Virginia. The scene is typical of wreckage following this type of accident.

ripping about nine-tenths of the way around the rear head. The illustration gives an idea of the accompanying wreckage. The man on top of the boiler and another workman were killed and a third was seriously injured. The mill was wrecked and parts of it and the boiler were strewn as far as 500 feet.

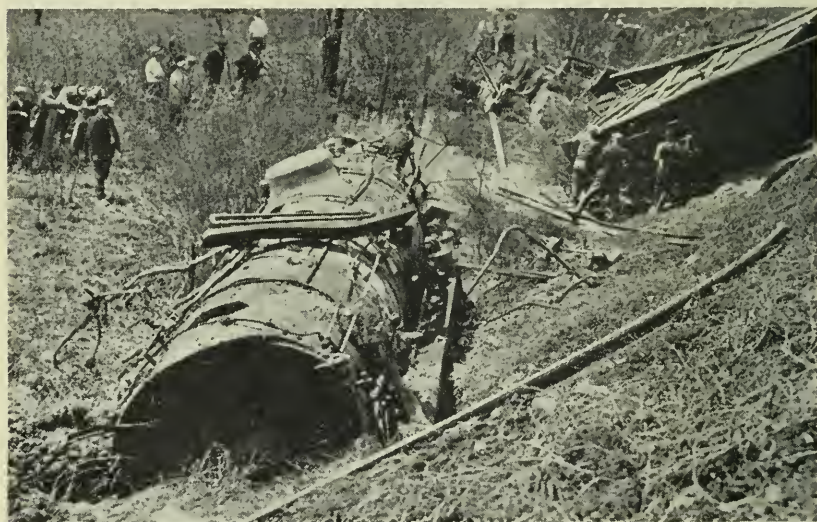
The engineer, fireman and head brakeman of a freight train traveling at about 15 miles an hour near Alexander, New York, on May 7, were killed when the crown sheet dropped, probably because of low

Main shell of locomotive after explosion which probably was caused by low water.

water. Several cars of live steers and calves piled up in a ditch or were strewn over a 25-foot embankment.

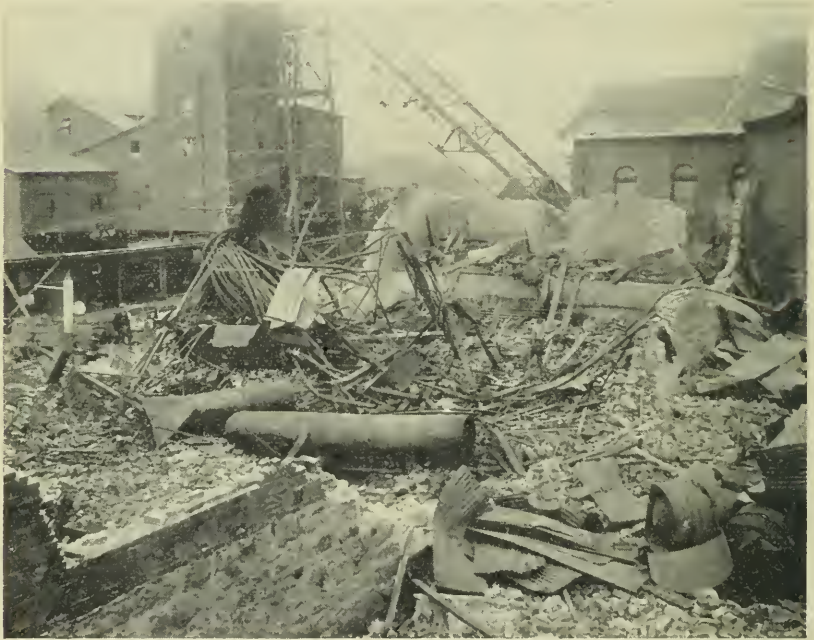
Wreckage at the mine following the boiler explosion.

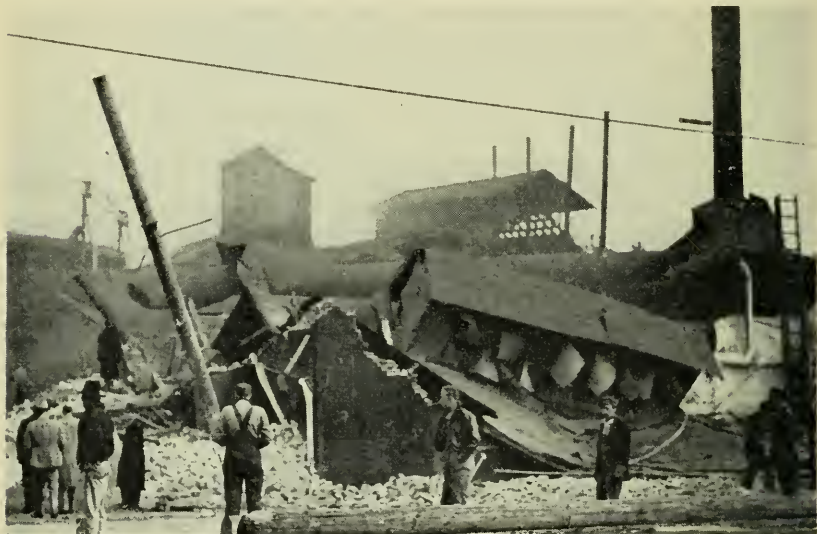
External corrosion has been responsible for so many boiler explosions, because of failure of the lower drum heads, as to make their

Result of external corrosion of a blank head in a bent tube type boiler.

examination absolutely necessary. By far the greatest hazard exists in the blank heads, which, as has been frequently pointed out, should never be embedded in the setting walls. Of approximately 6,500 drum heads once concealed in setting walls, 10 per cent were found to be corroded appreciably and about 1 per cent were in a very dangerous condition and no longer serviceable. Had any of these boilers failed in service, the property damage would have been severe and there probably would have been loss of life. There have been a number of such failures in the past.

In general, if a tube which has corroded until its wall thickness, over a section having any dimension equivalent to the tube diameter, is not greater than 75 per cent of the original wall thickness, it is too thin to be depended upon, and should be replaced with a new tube.

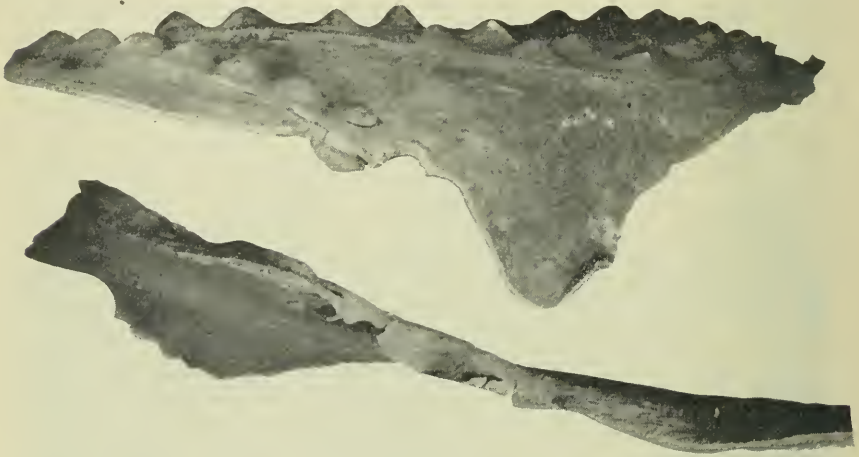
Typical thinning because of external corrosion in boiler plate originally $7/16''$ in thickness. In places this plate had thinned to less than $1/8''$.

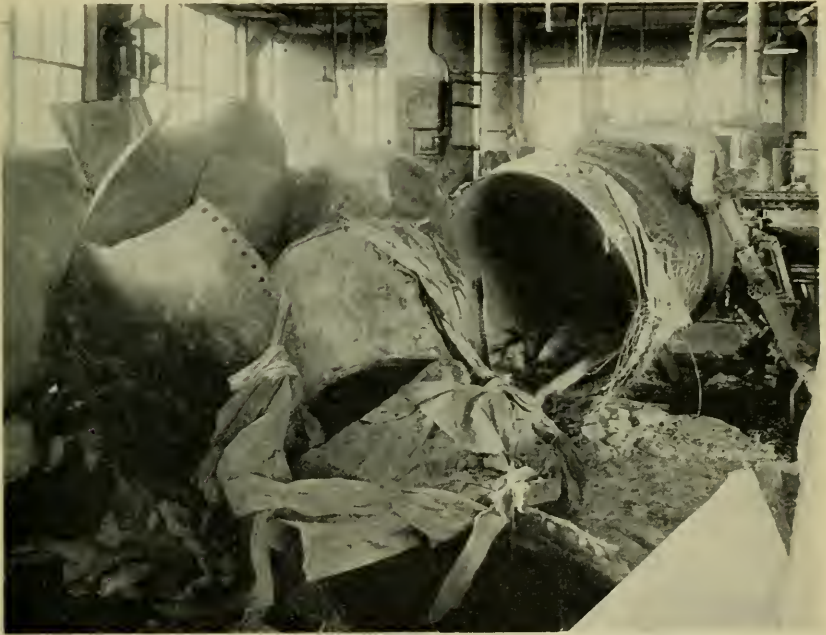
Figure 1. Remains of the vulcanizer after its explosion.

exploded at its normal operating pressure of about 100 lb, the outer lap of the rear course tore along a line about $\frac{3}{4}$ " from the edge of the inner lap and parallel with the girth seam. The fracture extended through the girth seam and then tore almost all the way around the other course.

Although the vessel had been in use for only two years, the plate had been reduced on the average to about half of its original thickness and the wasting was quite general.

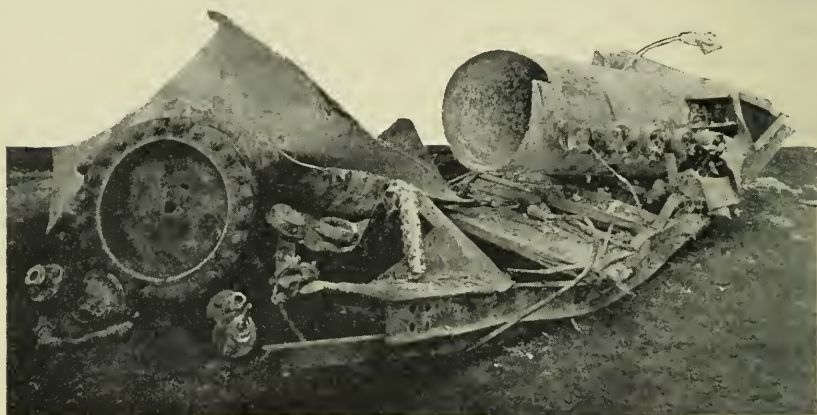
Figure 1. Parts of the destroyed vessel gathered together after the accident.

Except for necessitating the special materials, the process itself had nothing to do with the explosion, nor was the vessel more complicated than numerous other specialized autoclaves and digesters used in the chemical industries. It was 1' 10" by 14' mounted vertically with a removable top head of alloy-lined steel, bolted to a steel flange. The sides of the vessel, as is shown in Figure 1, contained a number of connections for the introduction of steam during the process. Seams, including the bottom head seam, were welded. The seam which failed was the vertical seam of the upper of two courses, and it was a double "V" butt weld.

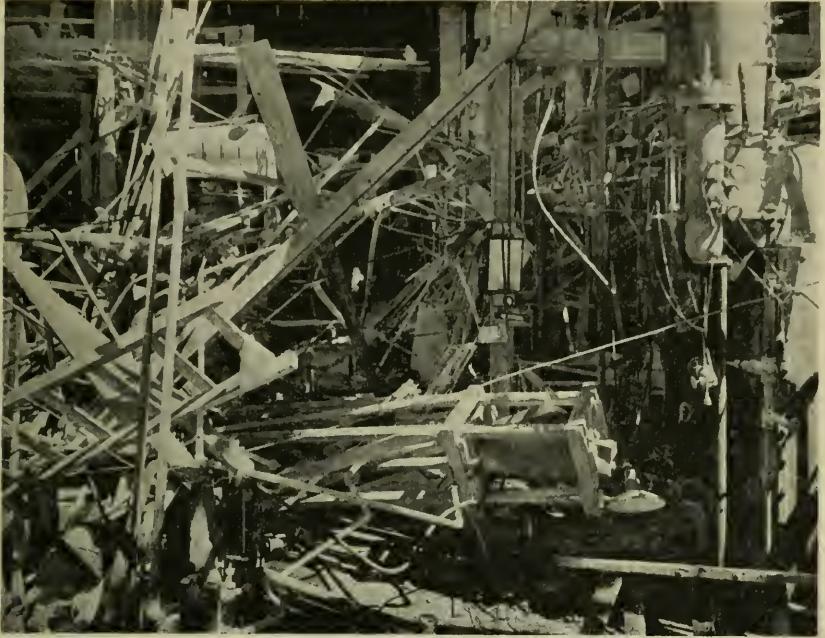
Figure 2. Wreckage caused by the explosion and the subsequent collapse of the building.

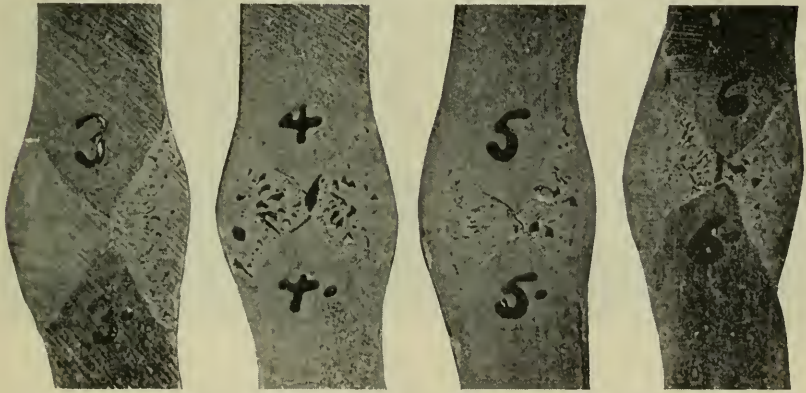
Examination of the weld metal, as illustrated in Figures 3-6, revealed a definitely defective weld, which, coupled with the fact that the vessel was subject to periodic fluctuations of pressure and temperature, may have combined to bring about the failure which occurred during its normal operation.

Figures 3-6. Etched specimens of welds from the vessel which failed, showing lack of fusion and general porosity in specimens 4, 5 and 6.

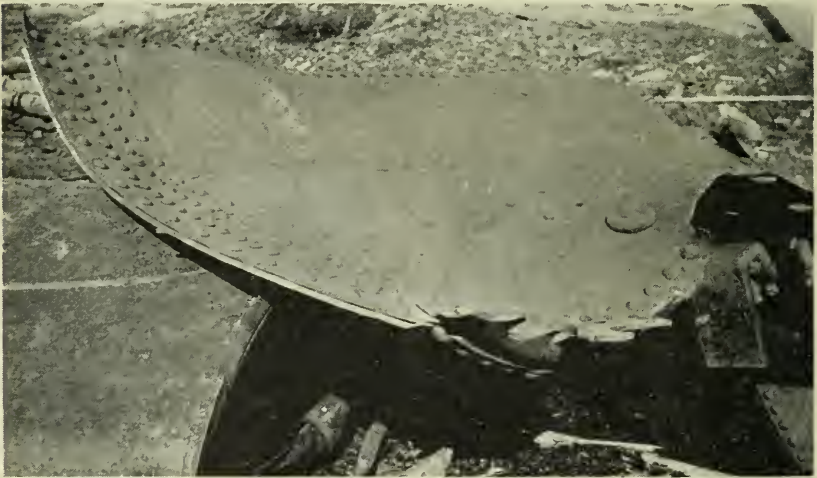
In an investigation of the accident, it was learned that the failure started at a crack in the plate near the butt seam, as revealed by the

Part of the boiler plate after an explosion which killed three.

accompanying photograph. The white line along the edge of the plate indicates the thickness of the metal, which measured from $1/16''$ to $1/8''$ instead of the normal $11/32''$. It was said that the boiler had leaked at the crack for some time prior to the accident.

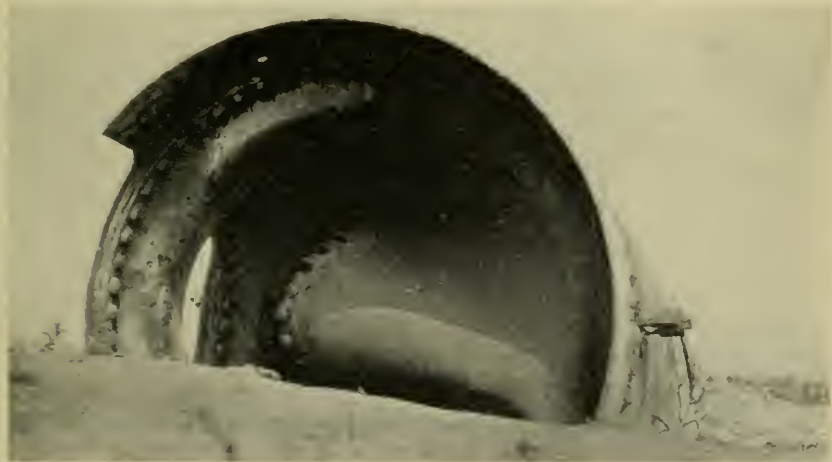
Vertical tubular boilers, when they fail, are apt to take the path of a skyrocket. Such was the case of the boiler shown in the photograph. It formerly was the steam source for a small Wisconsin cheese factory, but at the time the picture was taken it had demolished the boiler shed, had traveled over a house and had come to rest 340 feet away in a plowed field.

This 39" diameter boiler buried itself 14 inches in a field after traveling 340 feet.

An examination of the boiler revealed a rupture near the girth seam where the vertical section of the furnace sheet joined the cone section.

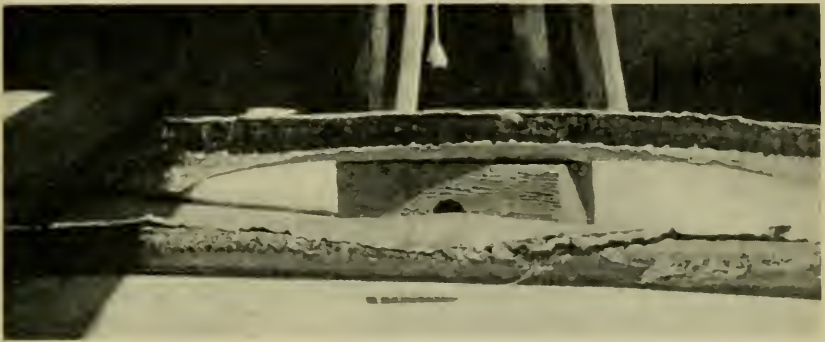
When the defective cable had been pulled and laid out on the floor, it was found that the lead was corroded through for about two-thirds of the length of the cable and could be stripped off without cutting. This condition is shown in Figure 1. There was no point on the cable

Figure 1—Cable attacked by corrosive caustics in seepage water.

indicating that injury had taken place during installation or afterward, except possibly at the lower end, which had rested on the edge of the duct. Apparently that was the point where current leakage had taken place and resulted in local heating.

Chemical analysis of the seepage water showed total alkalinity of 1264 parts per million consisting mainly of sodium hydroxide and some calcium hydroxide, both of which are active in corroding lead.

The cable which was selected to replace the damaged lead-covered cable was one with the copper strands properly tinned, these strands, of course, being spirally wound. Over the stranded copper was placed a 12/64" layer of rubber composition. This rubber composition was then wrapped with a layer of cambric tape over which was wound a copper shielding tape which could be grounded. A 7/64" outside jacket of 60 per cent tellurium non-hygroscopic compounded rubber furnished protection against moisture, mechanical injury and practically all chemicals.

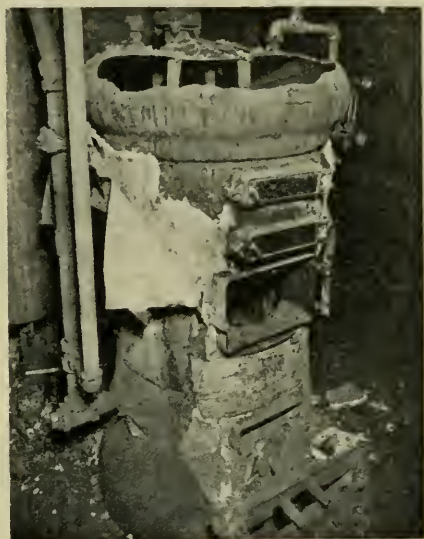
Explosions of cast iron steam heating boilers occurred principally in uninsured installations. A typical case is illustrated in Figure. 2. The residence, in which this boiler was located, suffered extensive damage and a woman occupant narrowly escaped injury. . . . In a church in a Mid-West town such an explosion severely injured the custodian and caused damage estimated at \$8,000 to the edifice, stained glass windows, organ and furnishings.

Figure 2. Partial damage following a cast iron boiler explosion.

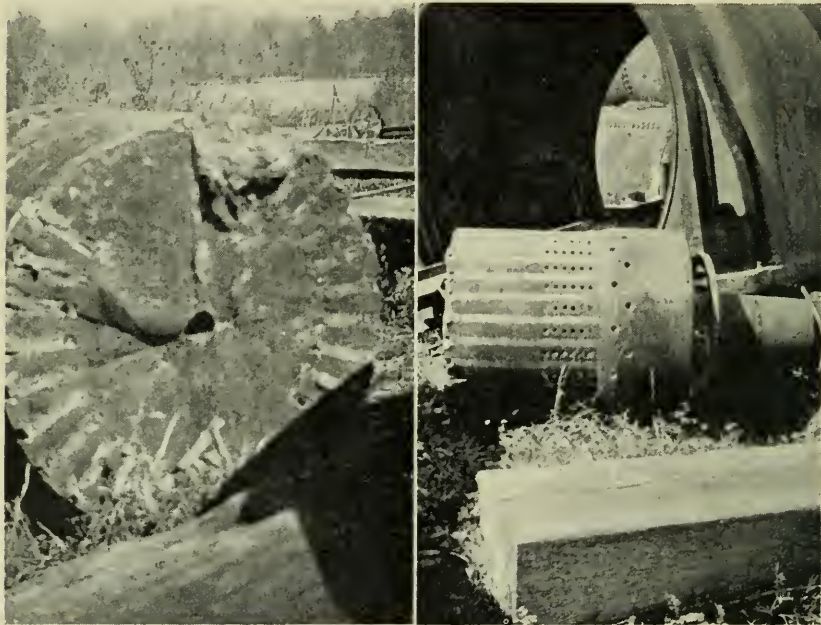
THE breaking in half of the rotor of a 3600 rpm, 1500 kva generator driven by a reaction type turbine at a Southern plant gives evidence that the generator end of turbines is not exempt from "explosions." When this accident occurred, one man, in attempting to

Generator rotor which exploded.

avoid injury, jumped from a window and broke his ankle, and another received minor injuries because of flying metal. A turbine erector, who tried to knock out the emergency trip by hand, reported that he found it was already out. Damage was estimated at \$20,000.

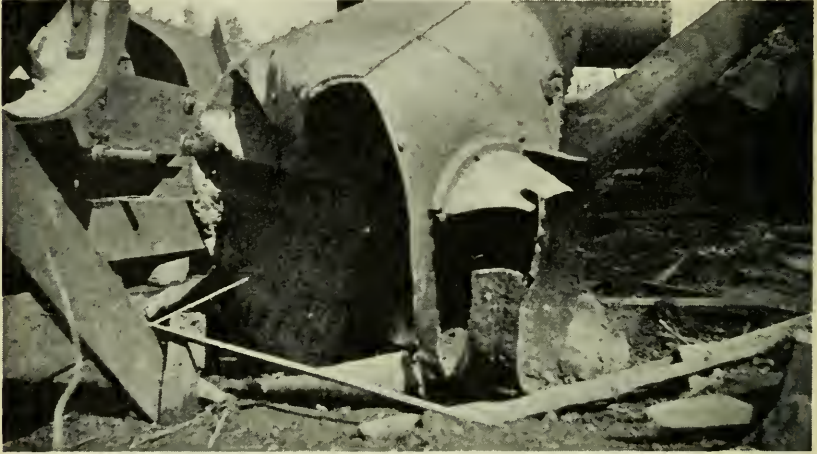
Figure 2. Aftermath of corrosion around the crown bolts of a locomotive type boiler.

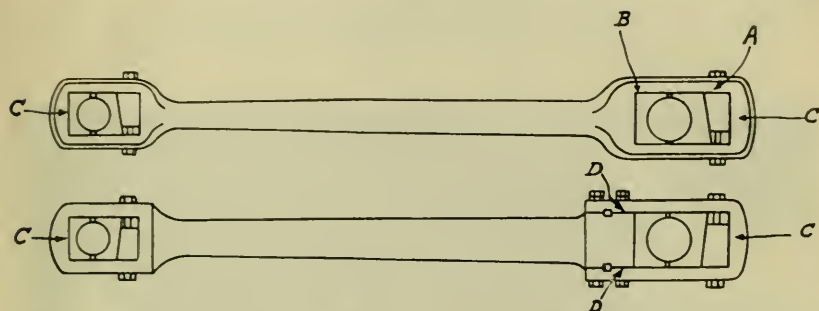
Cracks in the end members "C" are, as a rule, caused by sudden obstructions such as water in the cylinder. Weakness in these members usually occurs because the designer apparently assumed that the load was uniformly distributed over the entire length of the "beam." Actually, in view of the fact that the wedge may be considerably shorter than member "C," it is safer to regard the "beam" as having fixed ends and its load applied in the middle. In rods which are properly designed, "C" is made very heavy.

Figure 2 (above)—Solid-end type of connecting rod. Figure 3 (below)—Open-end type of connecting rod for center crank engines.
