CHART SHOWING AIR-RAID DAMAGES
ON THE RY. BRIDGE OVER THE RIVER KOMARU

Report of the investigation of the damage
to KOMARU BRIDGE

Report of the Investigation of Damage to KōMARU
River BRIDGE

Komarugawa Bomb Damage Conditions

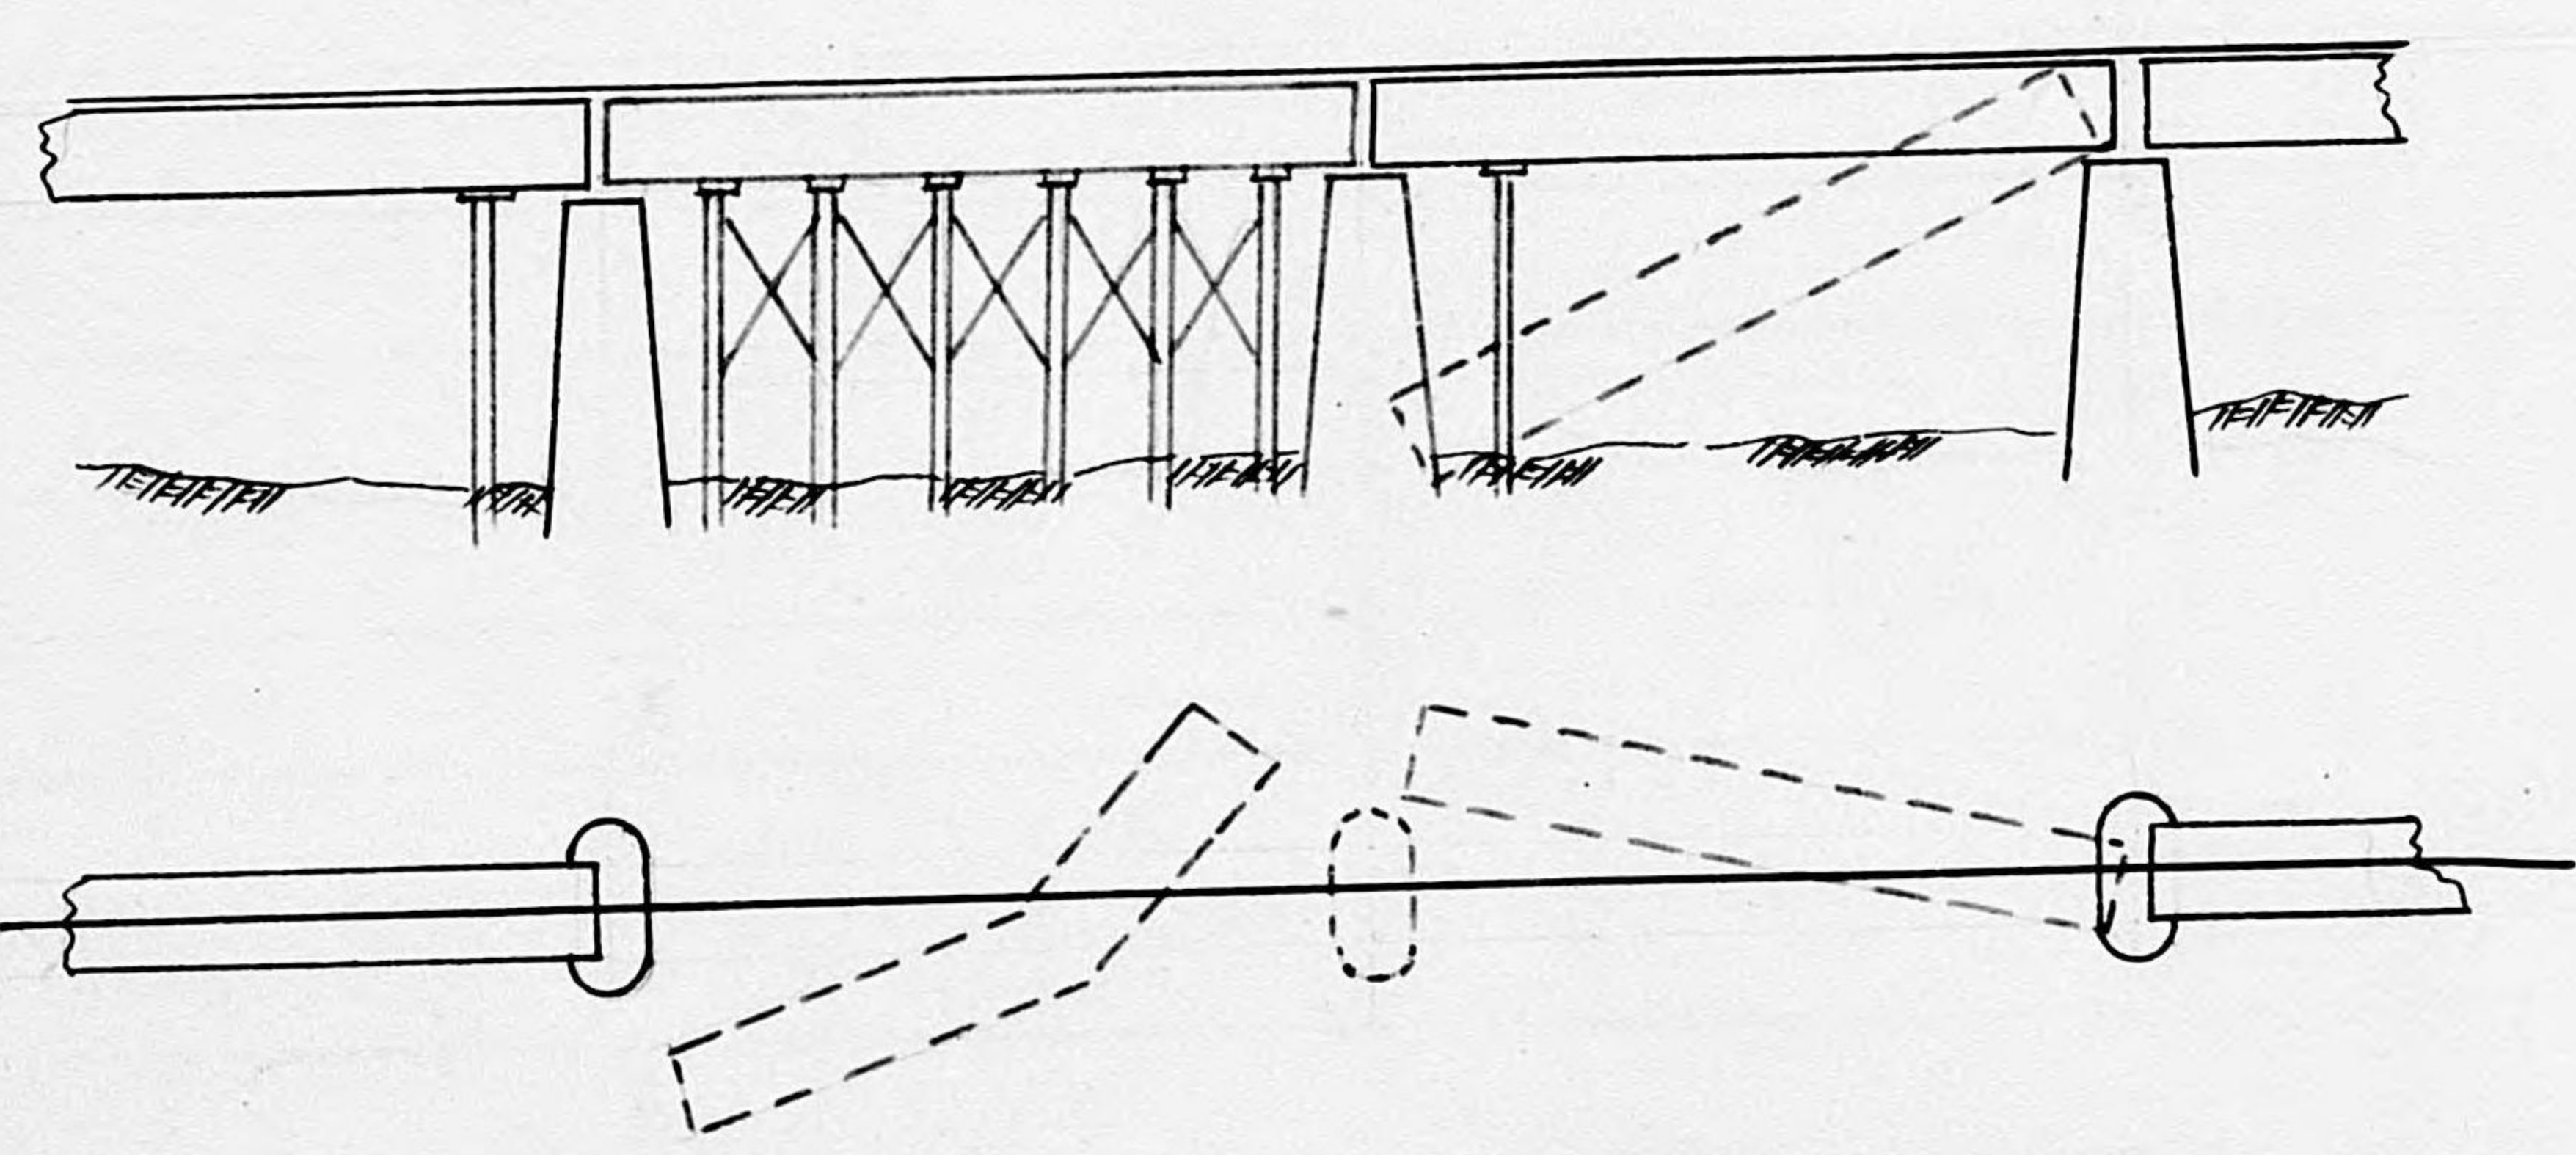
- (1) NOs. 7. 12. 17 and 18 were damaged by air-raid of July 16. 1945
- (2) NOs. 3. 6. 9. 15. 17. 30. 31. and 32 were damaged by air-raids of August 7. and 8. 1945

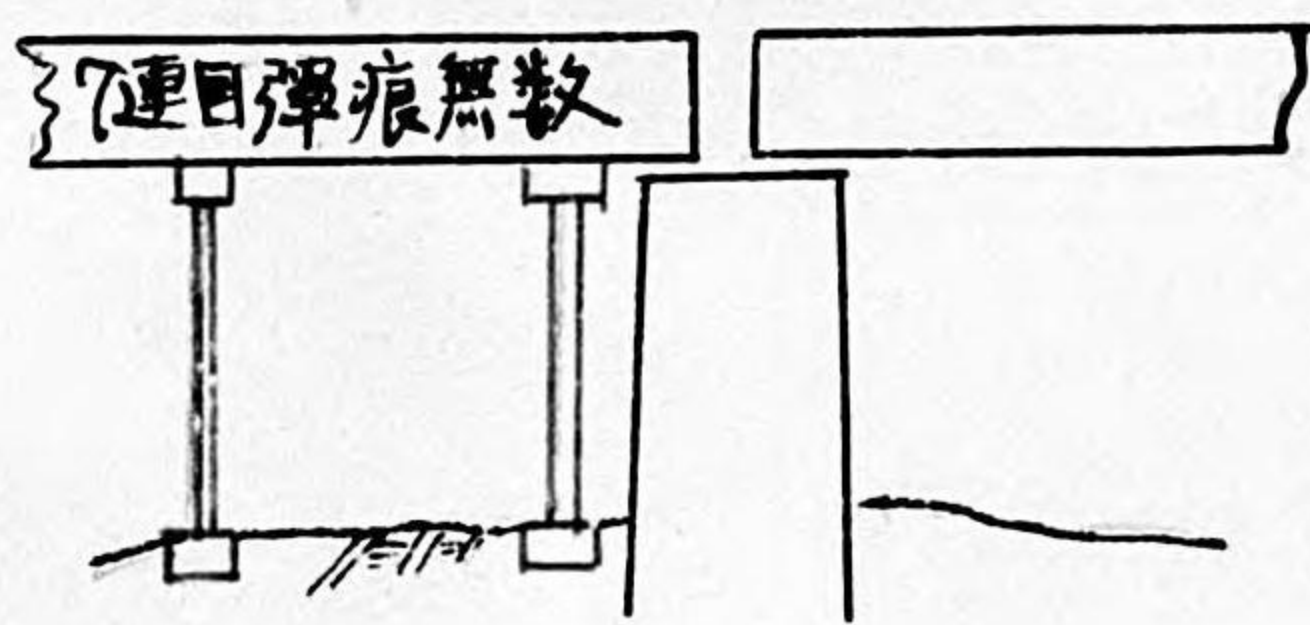
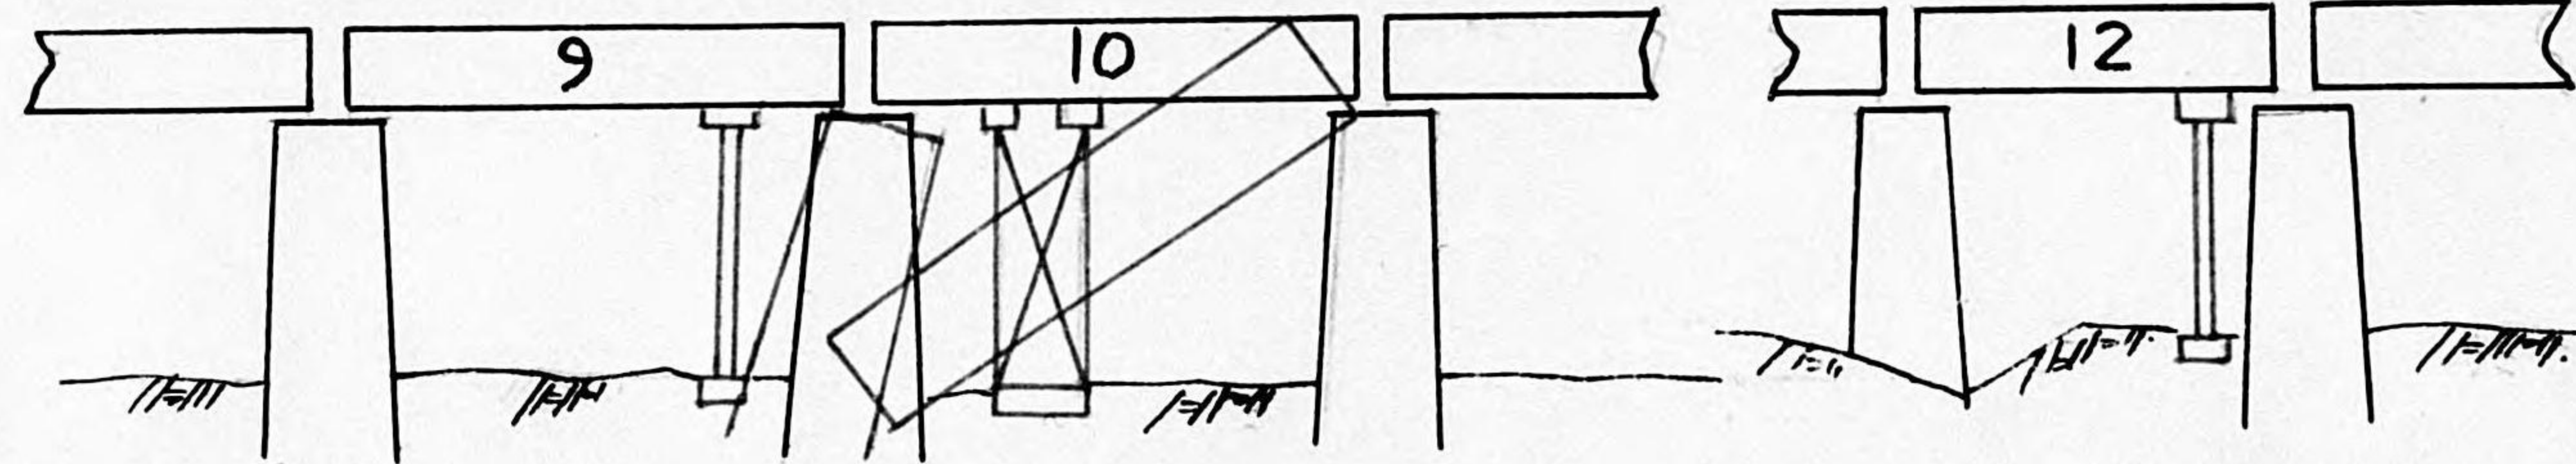
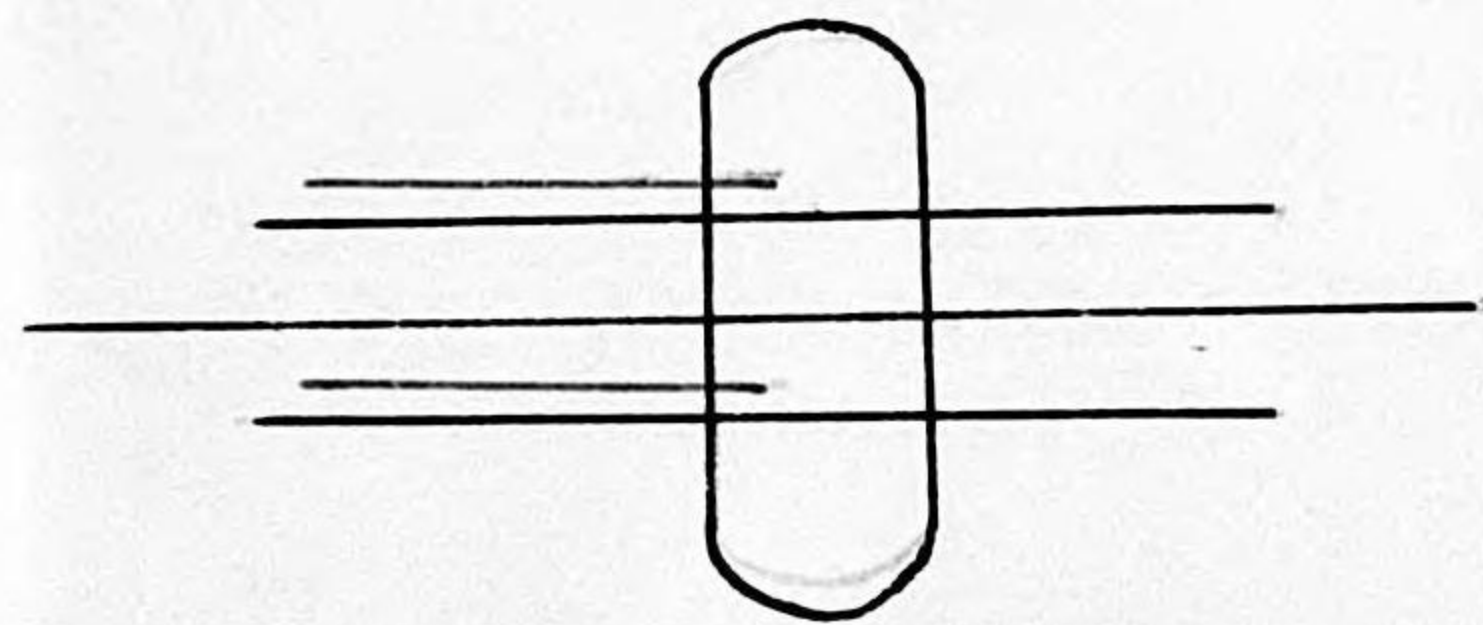
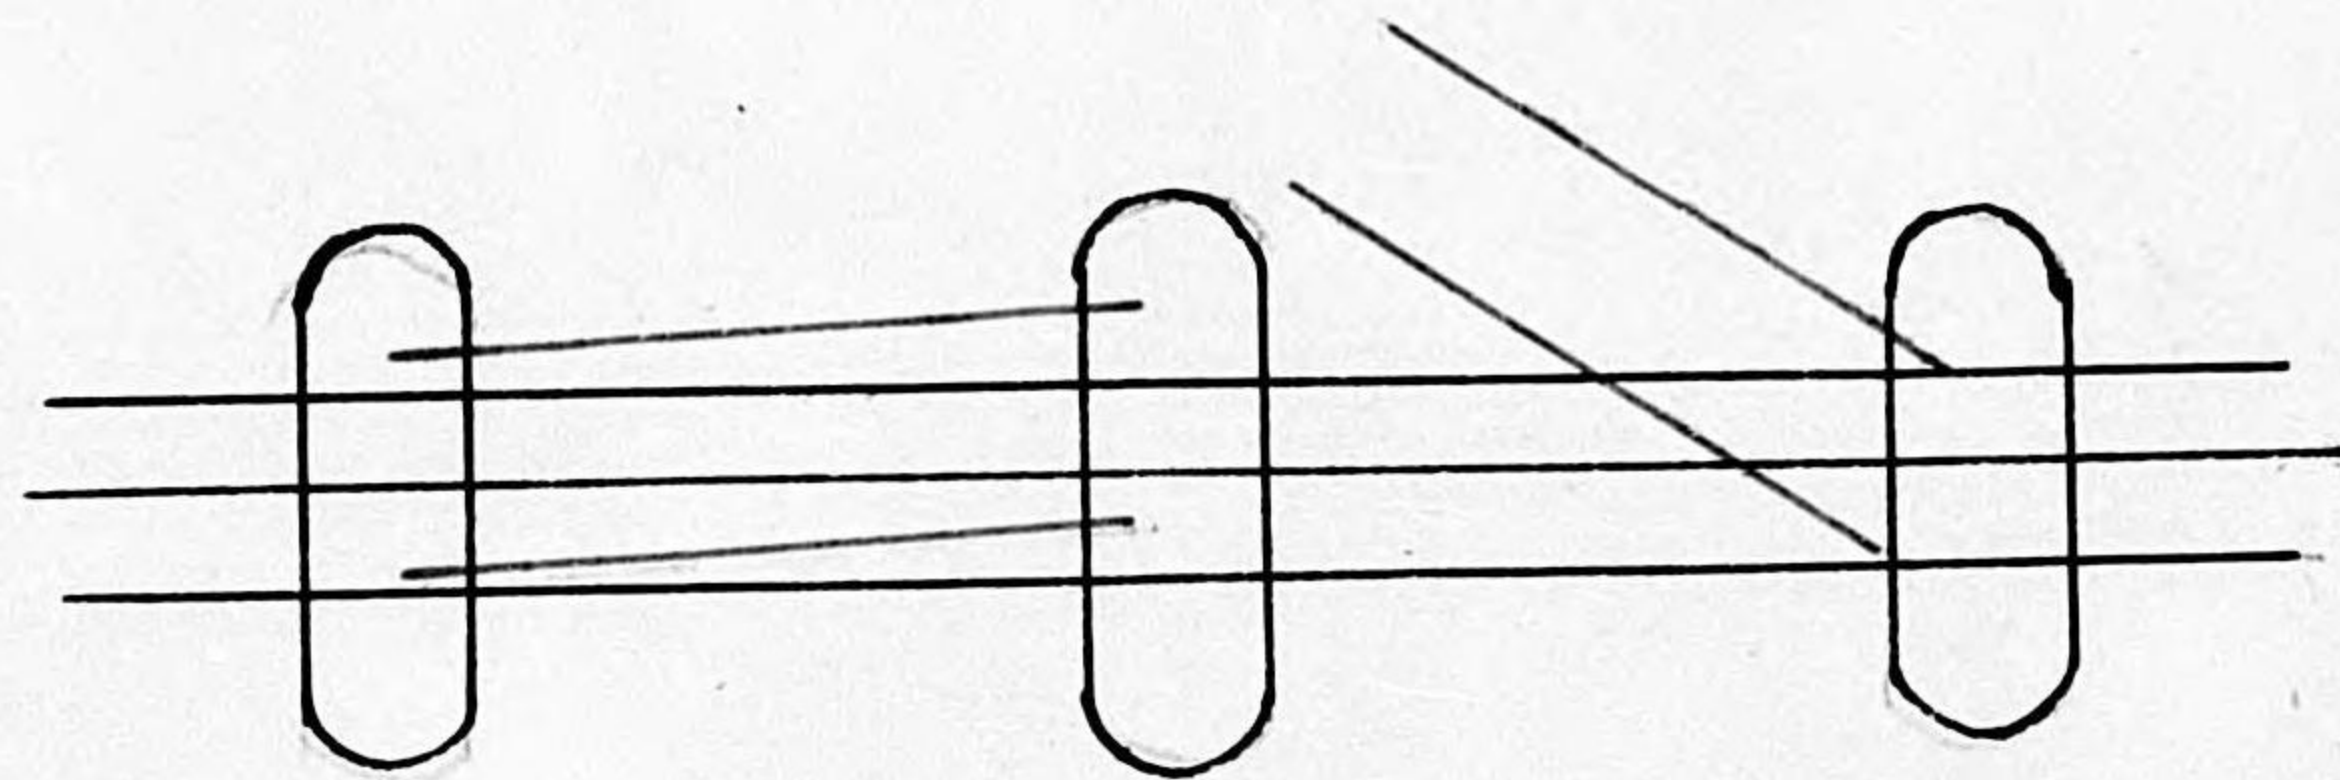
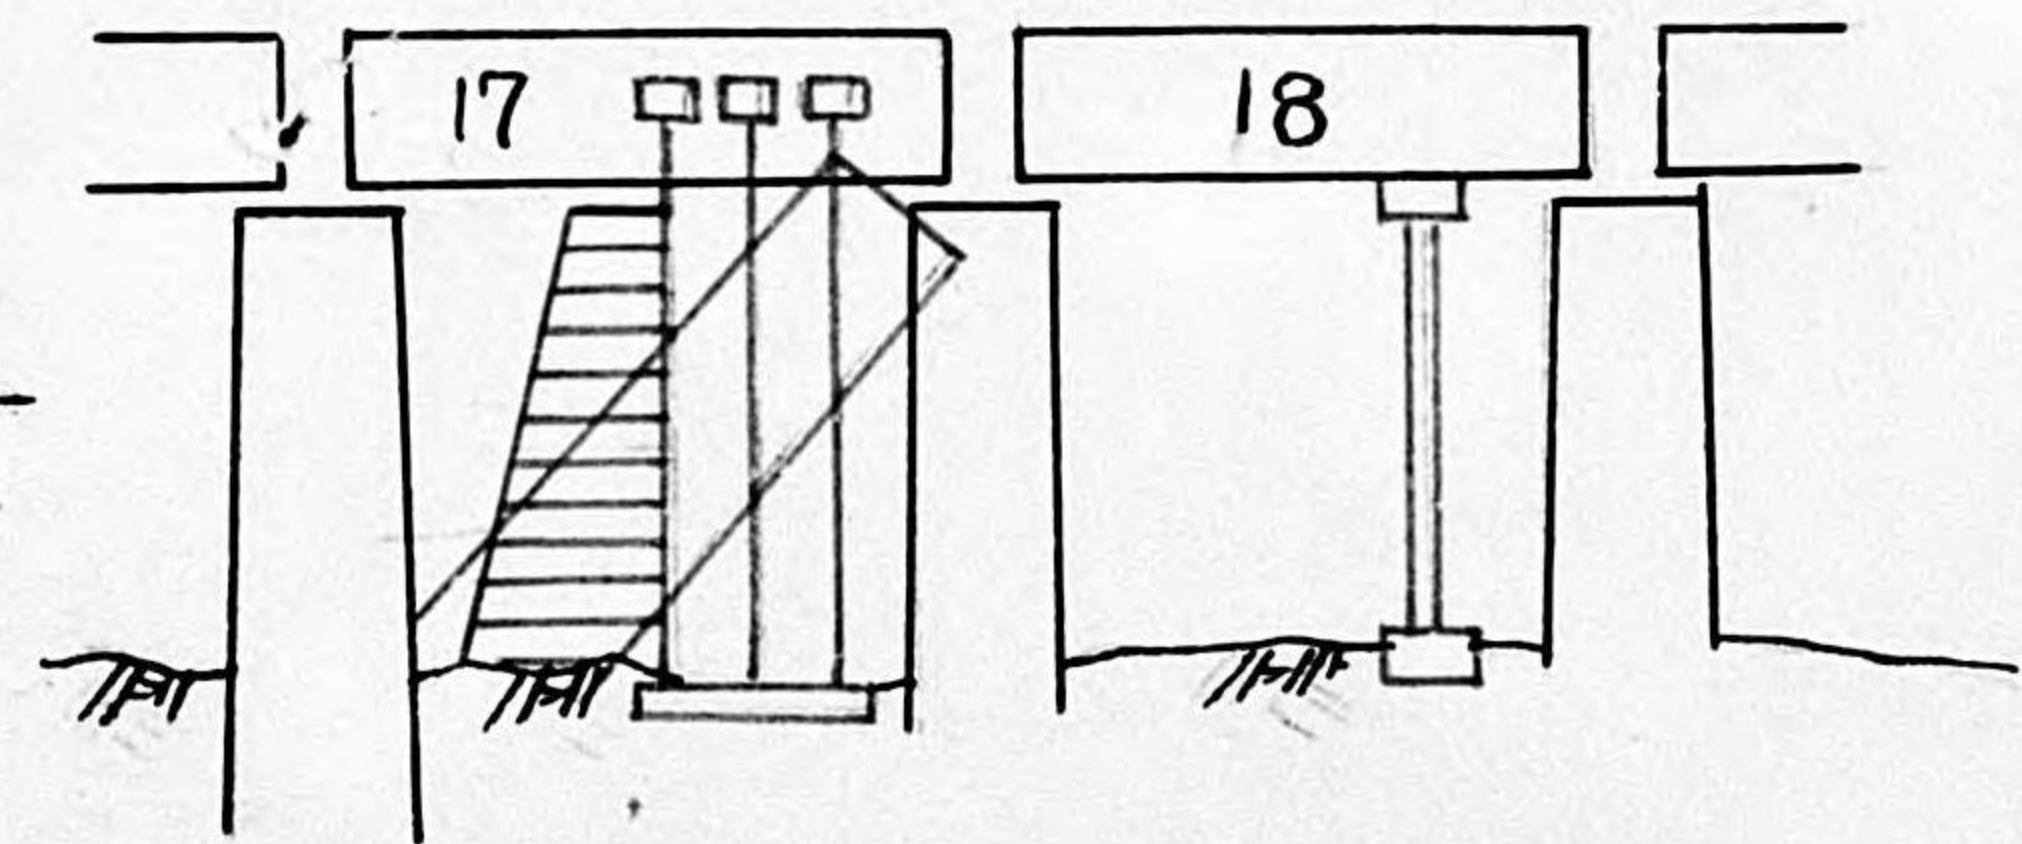
NO3
 NO3 桁起点側ハ橋脚上ニ僅カカリ轉落寸前、形ニ歪曲シアルモ正位置ニ復歸セバ現状ニ復ス

The starting point of No3 beam fell down temporarily a little on top of the bridge leg and appeared to be a little in front of it. Although it is bent, if restored to its proper position, it will probably return to its present condition.

THE BENT PARTS of the beam WERE RE-ENFORCED WITH wooden materials and raised to proper POSITION. Three BEAM foundations STAND IN A ROW.
