HISTORIC STRUCTURE REPORT

THE SHERIFF'S HOUSE  
FIRST STATE NATIONAL HISTORIC SITE  
NEW CASTLE, DE

FINAL

*Submitted by:*  
JOHN MILNER ARCHITECTS, INC.  
SEPTEMBER 16, 2016

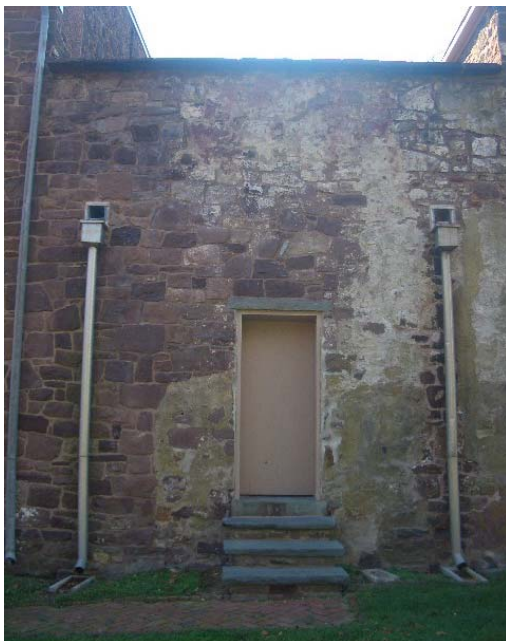
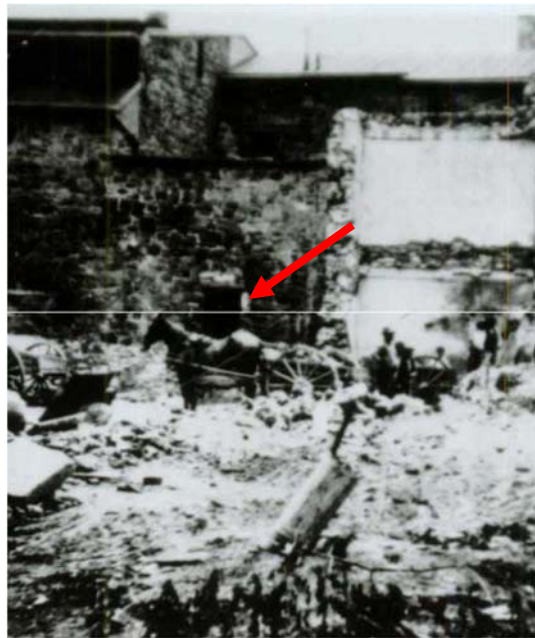
Figure 1.2-15: (Left) The wall at the center of the north elevation formed an original open courtyard. The scuppers mark the level of the roof that was later constructed to cover the courtyard. The existing door opening appears in the 1911 photograph of the prison demolition (Right).

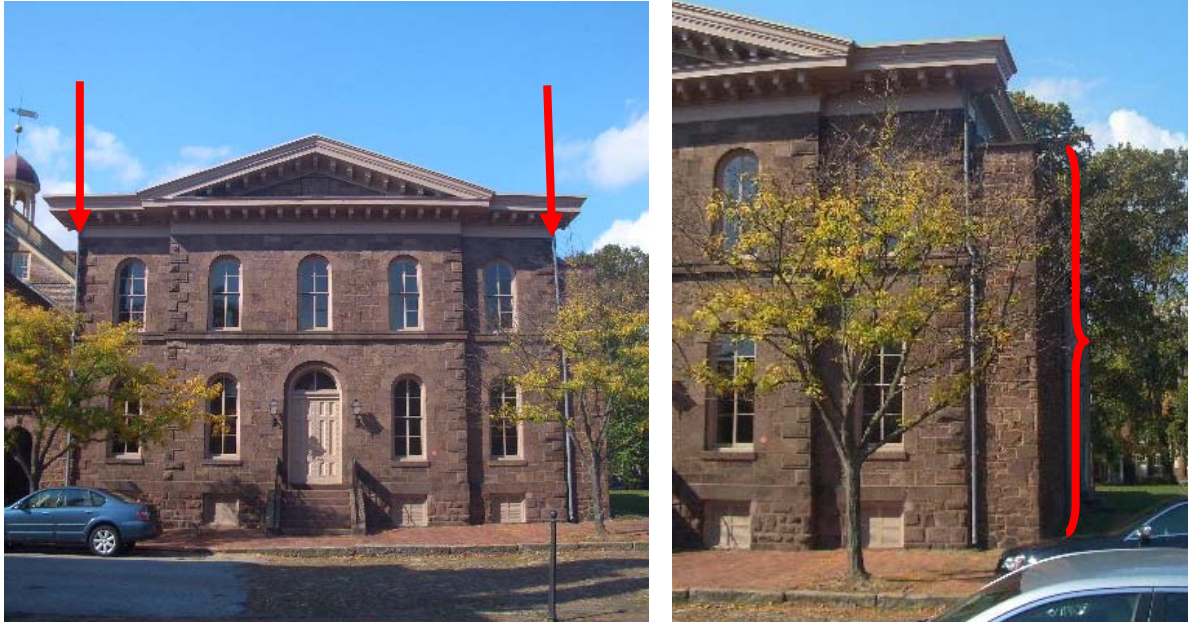
*Figure 1.2.18: (Left) The street facade of the Sheriff's House is intended to appear symmetrical with the northeast and southeast corner quoins placed equidistant from the center entrance. (Right) The north end of the building from basement through second floor extends approximately 24 inches farther north in plan.*

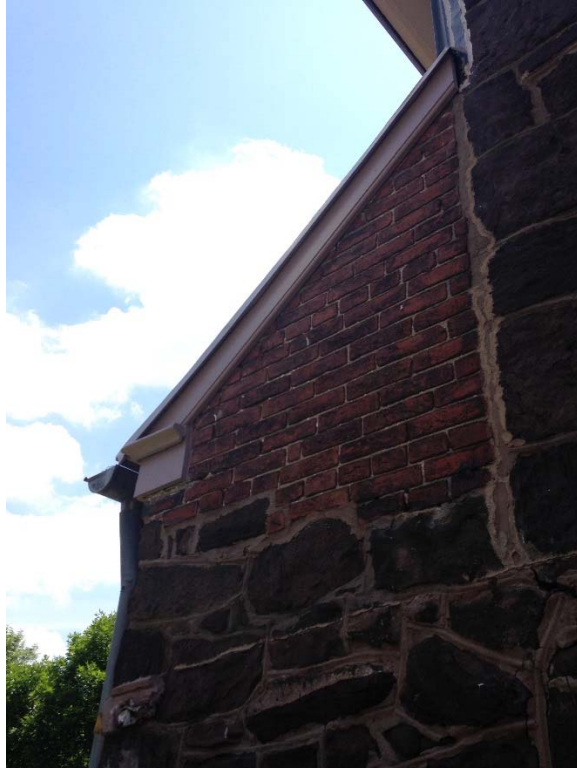
*Figure 1.2.19: To accommodate existing walls, the symmetrical main mass of the Sheriff's House appears to have been set just south of center on the foundation of the previous structure, leaving a 24-inch extension at the north end which is truncated to fit behind the adjoining prison yard wall (now removed). Above the height of the prison yard wall, the north wall of the building steps back in line with the main block and is of wood-framed construction rather than masonry.*

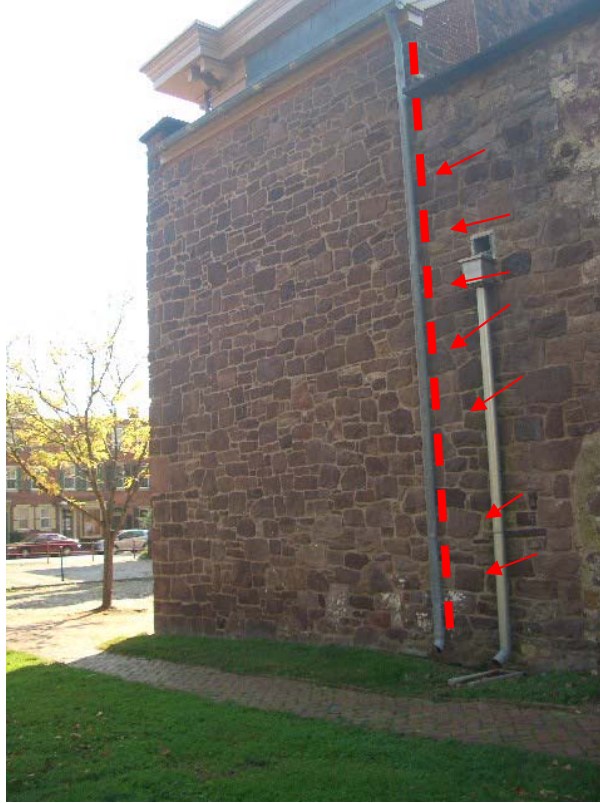
The fourth clue that an existing structure was reused lies in the brownstone masonry itself. The character of the stonework changes subtly where the west wall of the Sheriff's House abuts the one-story jail area. Though there is no distinct seam, the wall of the Sheriff's House is constructed of smaller, flatter masonry units laid in rough courses. The masonry to the west includes more large stones, including what appear to be rough quoins located at the intersection of the two wall segments. The stones of the wall enclosing the jail also appear to be of a generally different color.

*Figure 1.2.20: The character of the brownstone masonry changes slightly where the north wall of the Sheriff's House abuts the wall of the jail area. The masonry seen to the left of the line consists of stones that are generally smaller and flatter than those seen to the right of the line. Also visible to the right of the line is a vertical line of larger stones which may indicate an earlier outside corner.*

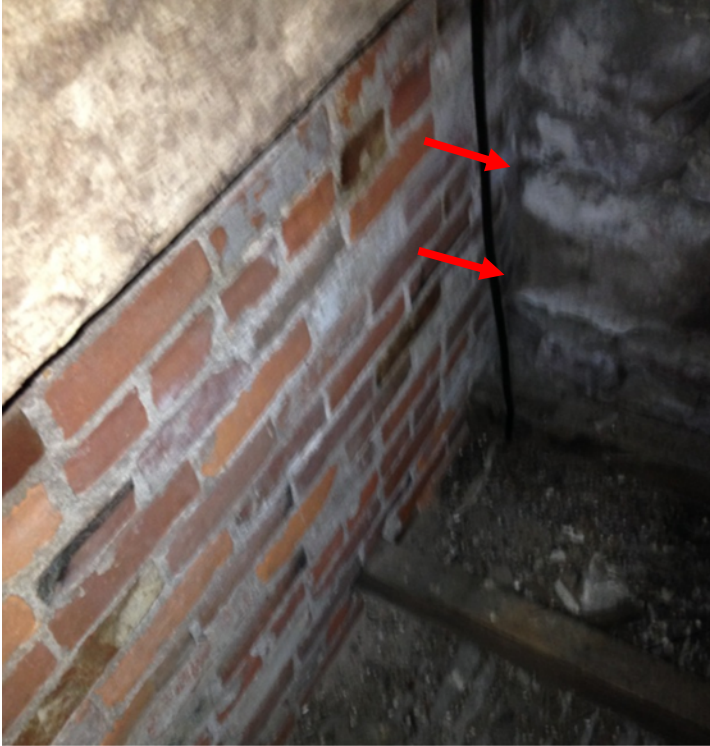
The top portions of the brick walls enclosing the stair are visible from the attic due to the dropped ceiling in the closet. An examination of the joints between these brick walls and the brownstone masonry of the south wall suggests that the brick walls pre-dated at least the upper part of the south wall of the Sheriff's House as the brownstone is filled in around the south end of the brick wall with little attempt to bond the two together.

*Figure 1.2-22: The brownstone masonry of the south wall appears to have been filled in around the south end of the brick masonry walls enclosing the stair with little attempt to bond the two together.*

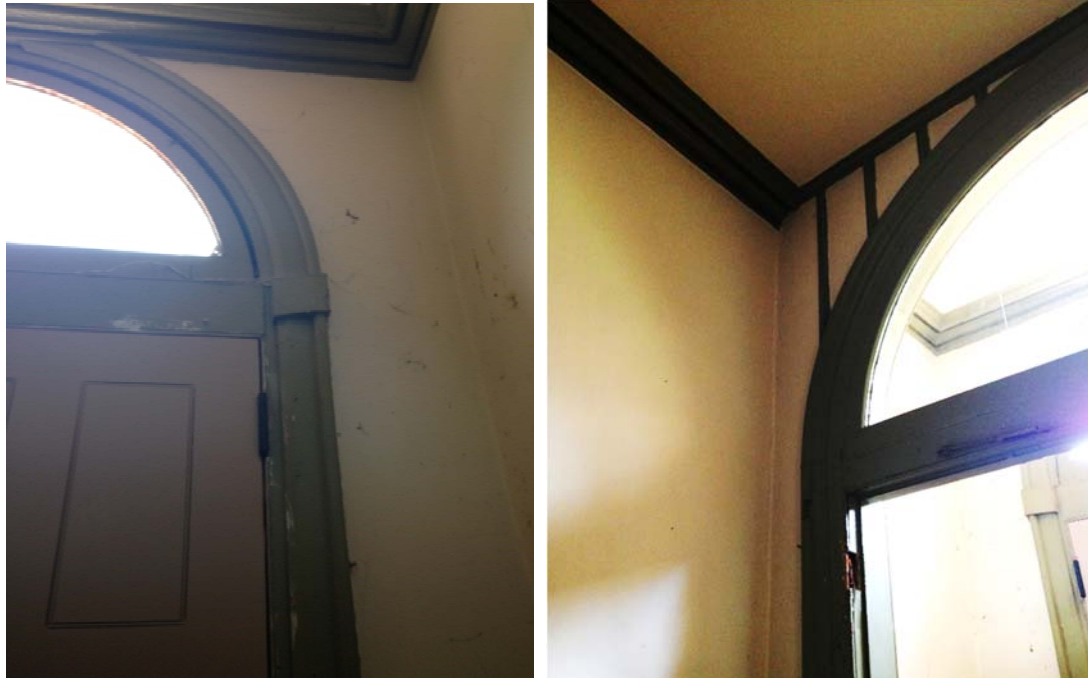
*Figure 1.2.24 (Left) The trim on the arched transom collides with the run plaster cornice at the east end of the center hall. The awkward transition suggests that Sloan was trying to enlarge the door opening within the confines of existing second-floor framing. The trim on this door is a simple profile with a narrow backband; (Right) The partition forming the vestibule is a later addition and the complex trim profile with beaded edge, ogee molding and backband is consistent with a late 19<sup>th</sup>-century date.*

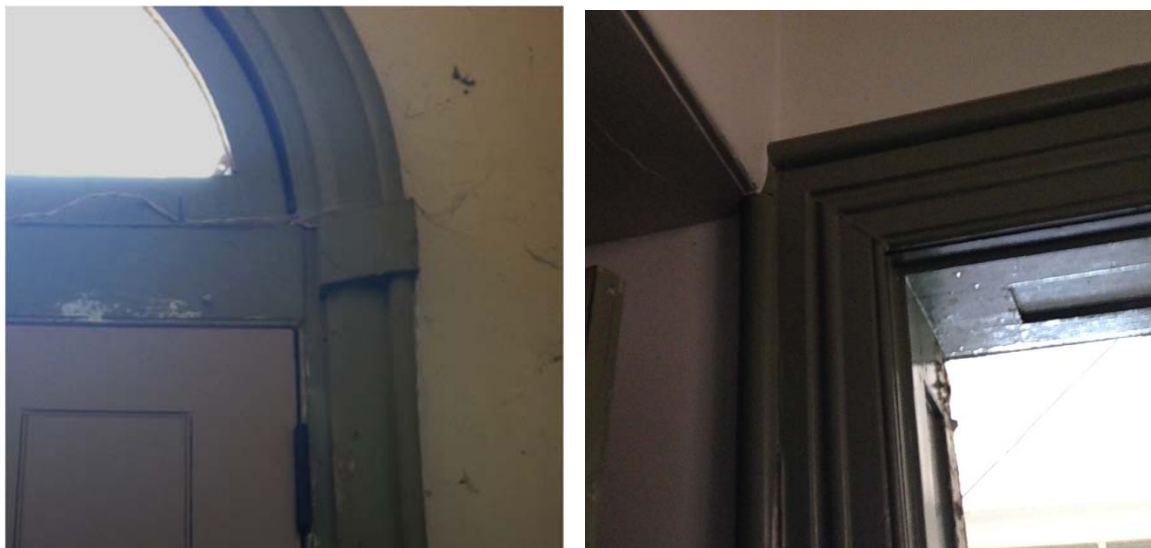
*Figure 1.2.25: (Left) The door trim molding at the front entrance doors is simpler in profile than that seen at other openings (Right) which suggests an earlier date in keeping with the late Greek Revival of the mid-19<sup>th</sup> century rather than the late 19<sup>th</sup>-century Victorian period. The paneled jamb seen at right is simpler and consistent with the front door trim and is likely original to 1857.*

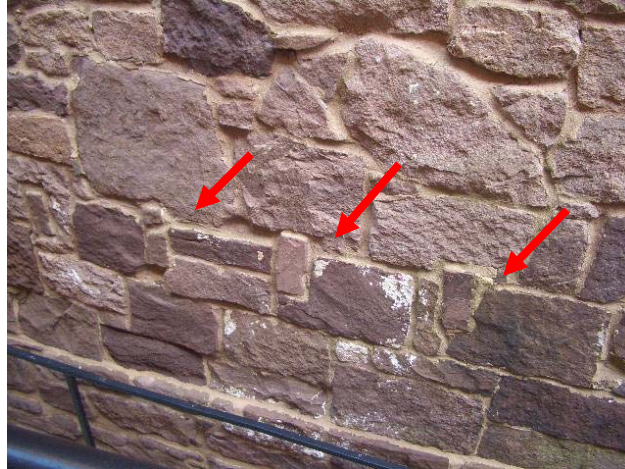
*Figure 1.2-28: A series of joist pockets in the south wall appear to mark the location of an exterior platform or stair to access the south door except for the fact that the joists are located above the level of the door sill. The presence of fragments of baseboard nailers indicates this was once an interior surface, probably associated with the courthouse addition. Note also the change in the character of the masonry below the joist level, suggesting this wall was substantially altered.*

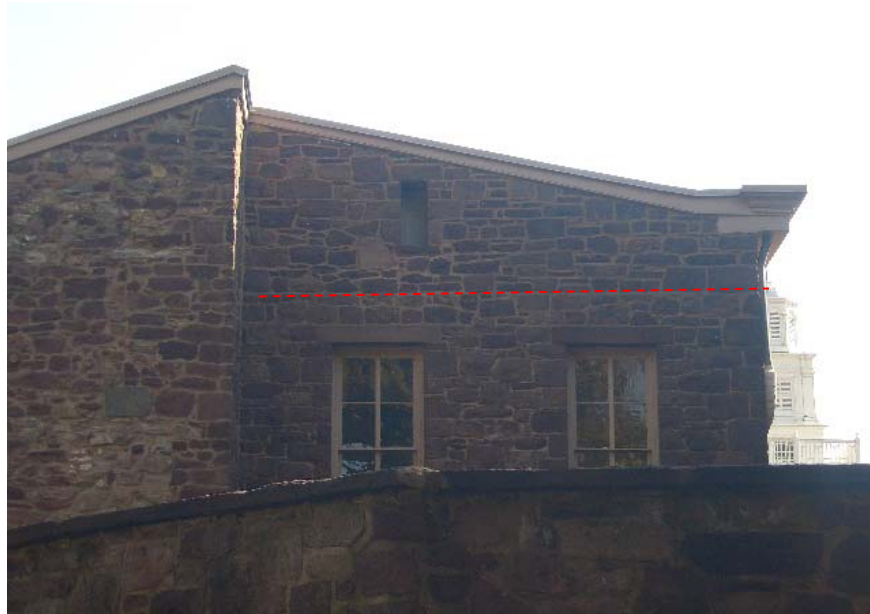
Figure 1.2-30: A masonry seam above second-story windows suggests that the west wall preceded the 1857 construction and was raised as the north end became part of the prison tower.

as part of Sloan's project. Additional probing of the second-floor framing in this location is recommended to confirm whether or not the roof level was raised in this area.

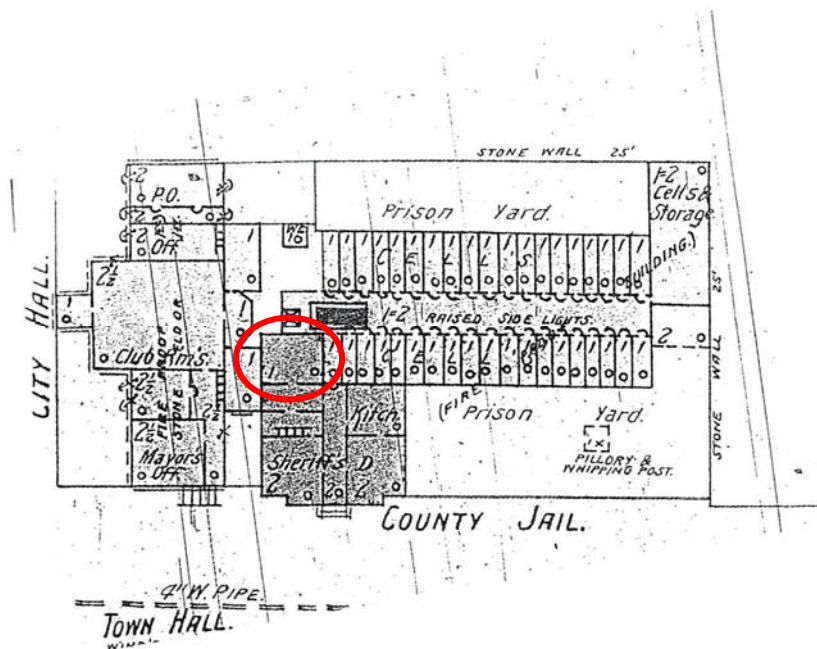
Figure 1.2-31: The 1901 Sanborn insurance map shows the southwest room to the west of the stair as divided in two with the western section noted as a single story. No evidence was found to indicate that this space was ever one story high. Additional probing of the second-floor framing is recommended to confirm or refute the configuration shown on this map.

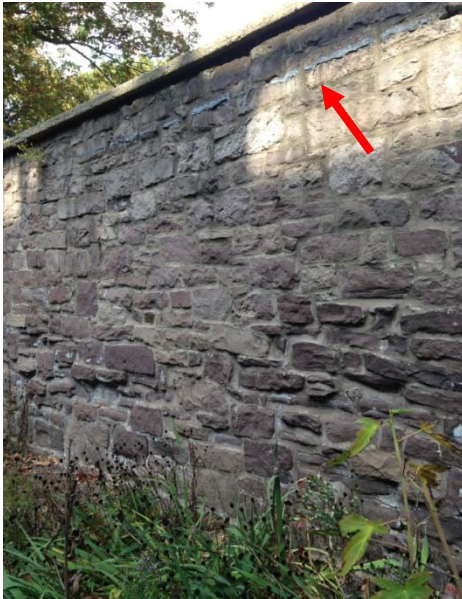
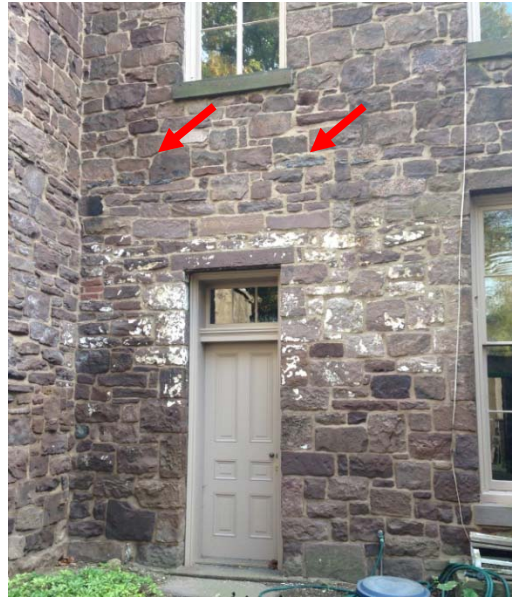
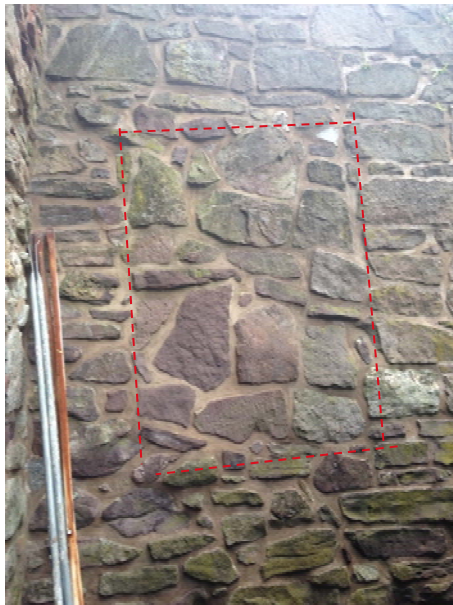
Examination of the masonry walls in the courtyard revealed evidence of a single-story structure in the form of a mastic line and a closed window opening on the north courtyard wall and traces of whitewash on the west wall of the Sheriff's House. This one-story structure would have been located on the approximate site of the former prison tower and would therefore have post-dated the demolition of the tower in 1911. The west door 1/110 is surrounded by traces of white wash on the exterior, suggesting that it once opened into this one-story structure. It seems unlikely that this would have been a porch as there would have been no need for the now-closed window opening. No documentary evidence regarding this structure was identified.

*Figure 1.2-32: (Upper Right) A line of mastic above the west door and traces of whitewash around the door opening define the dimensions of a former structure. Whether this was a connector to the prison as shown on the 1885 plan or simply a later porch has not been determined. (Upper Left) The mastic line continues around onto the courtyard wall. (Lower Left) A closed window opening is visible in the north side of the courtyard wall.*

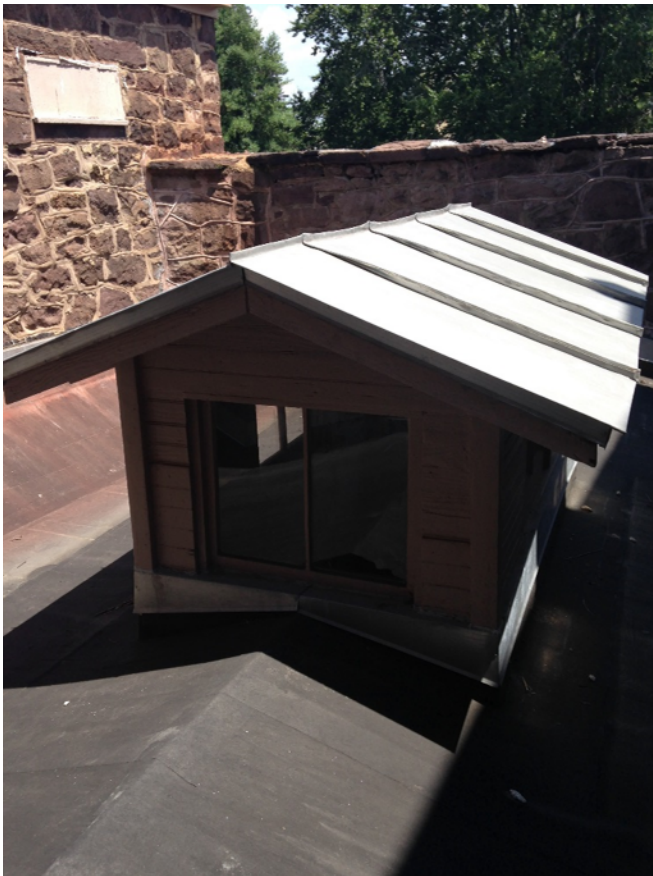
*Figure 1.3-7: The asphalt-covered roof over the interior courtyard, most recently the lock-up area, includes a roof monitor to provide light and air.*

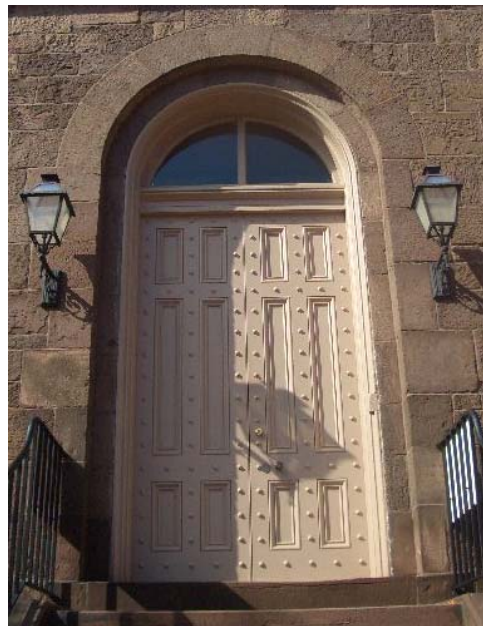
*Figure 1.3-8: The main entrance doors are reproductions based on the design of the original doors. The existing transom is likely a replacement. It seems unlikely that a prison would not have had a more secure transom opening.*

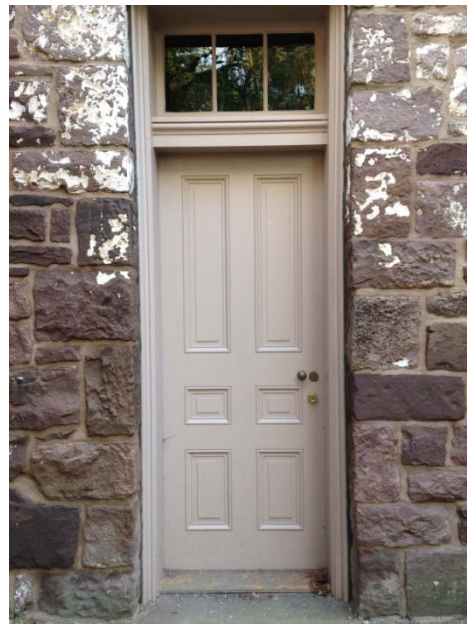
*Figure 1.3-9: The west and south doorways are extremely similar. However, it seems unlikely that the west doorway shown above is original.*

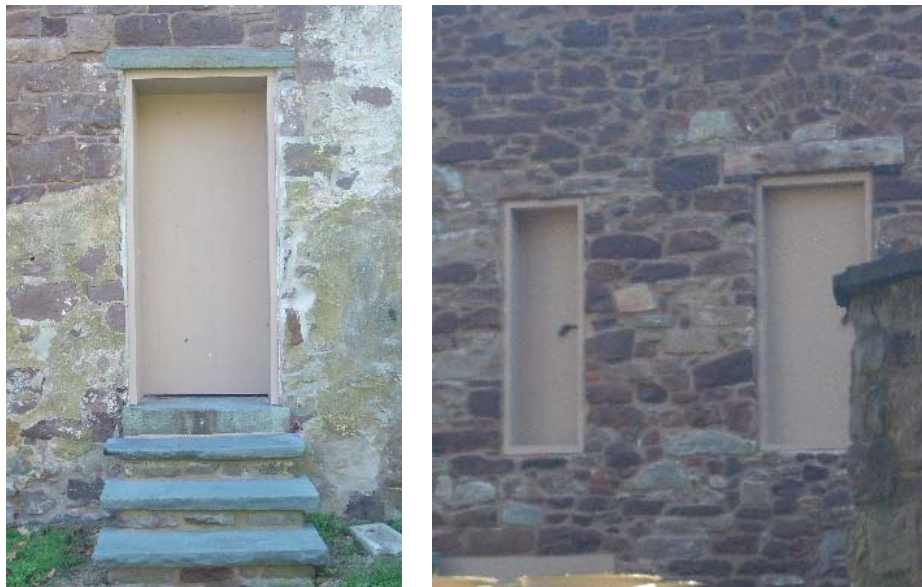
*Figure 1.3-10: (Left) The north door opening into the former lock-up area is a later addition. (Right) The two doors on the west elevation access the surviving second-tier jail cells.*

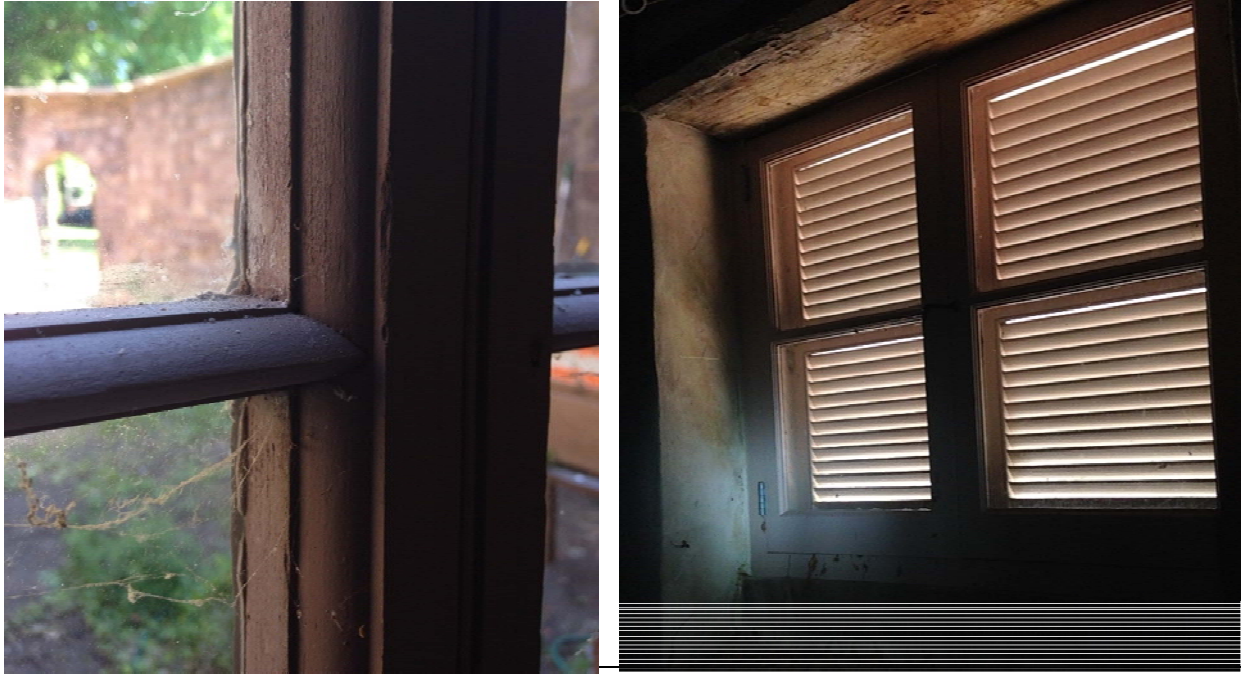
*Figure 1.3-11: (Left) The crisp profiles and lack of paint accumulation on the window sashes suggest strongly that they are replacements, likely dating to 1969; (Right) The paired two-light basement casements and the exterior louvered shutters date to 2011.*

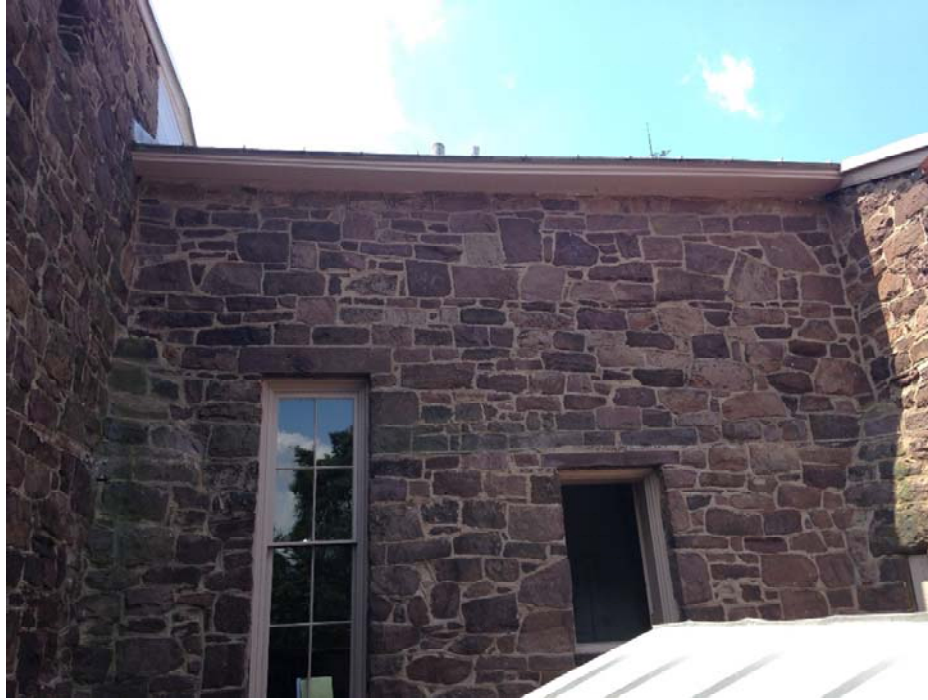
*Figure 1.3-14: The second-story windows on the north elevation were installed at different times. The trim at the double-hung window at left does not match the simple trim on the casement window at right. The casement is a later addition.*

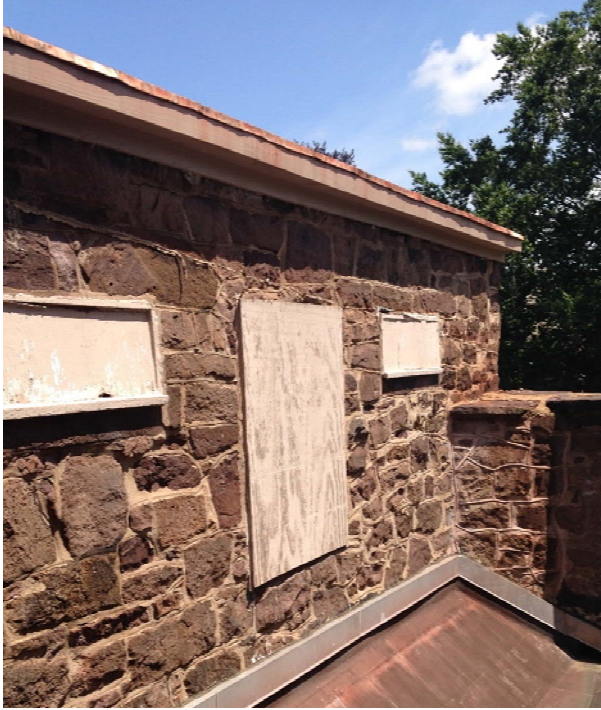
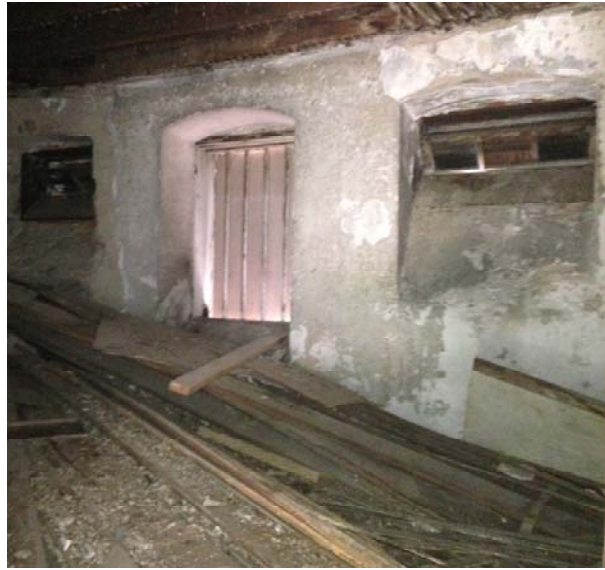
*Figure 1.3-15: (Left) Original window openings survive in the north wall of the prison; (Right) Seen from the interior, these openings contain metal grilles. The smaller openings are also equipped with sashes.*

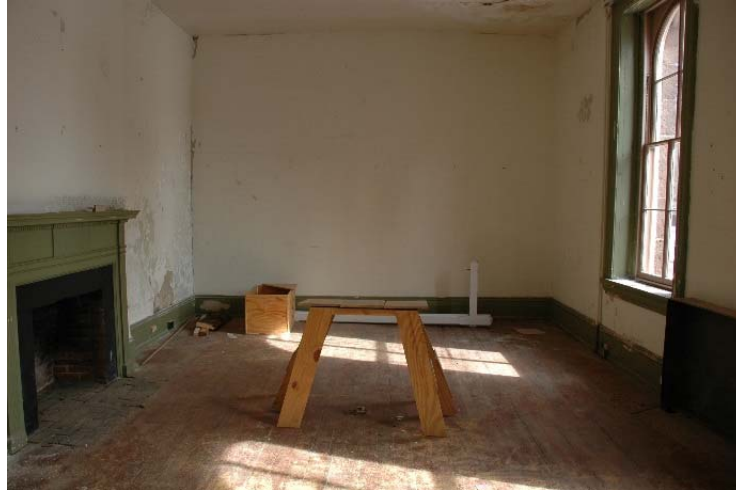
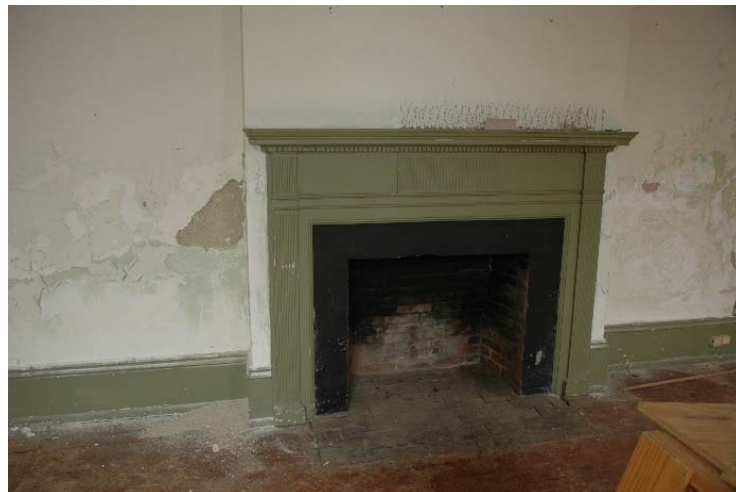
Other: While the firebox is original, the Colonial-style mantel does not appear to be original and was likely added at the beginning of the 20<sup>th</sup> century. The brick hearth also dates to the early 20<sup>th</sup> century and is dry-laid in a running bond pattern.

*Figure 1.3-22: View of Room 101 looking north (top) and detail view of fireplace at west wall of Room 101 (bottom).*

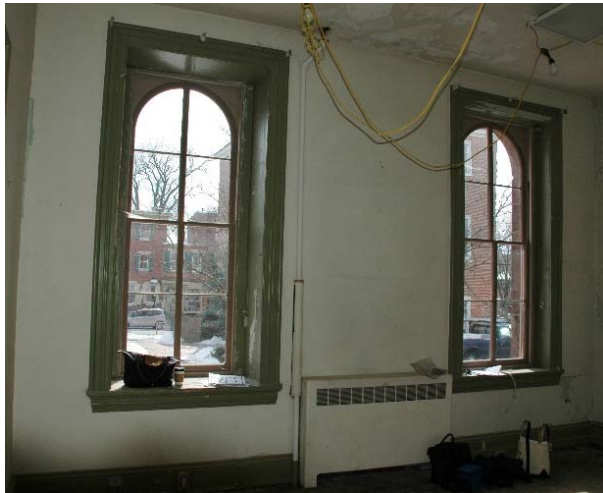
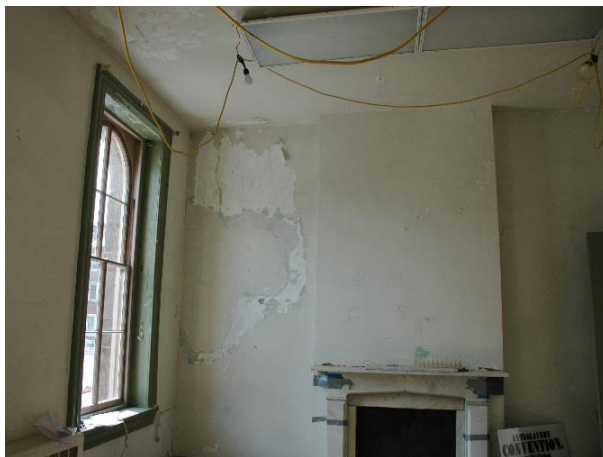
Walls: Original plaster (1857) on masonry (early 19<sup>th</sup> century) with a painted finish and original 8 ½ -inch wood baseboards (1857). There are patches and modern skim coat throughout.

*Figure 1.3-24: Views of Room 103 looking east (top) and a detail view of plaster damage at the southeast corner (bottom).*

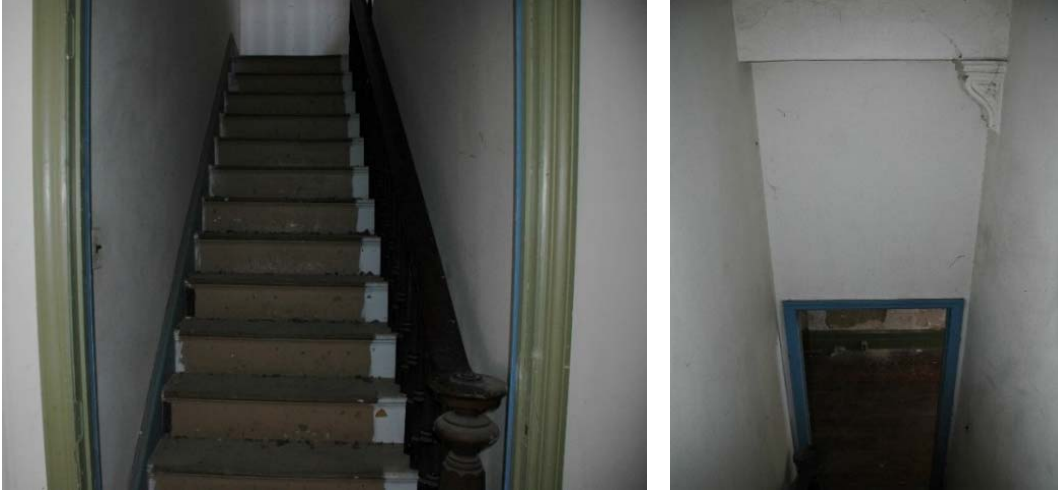
*Figure 1.3-25: Views of Room 104 looking south up the main stair to the second floor (left) and looking north with an original plaster bracket visible (right).*

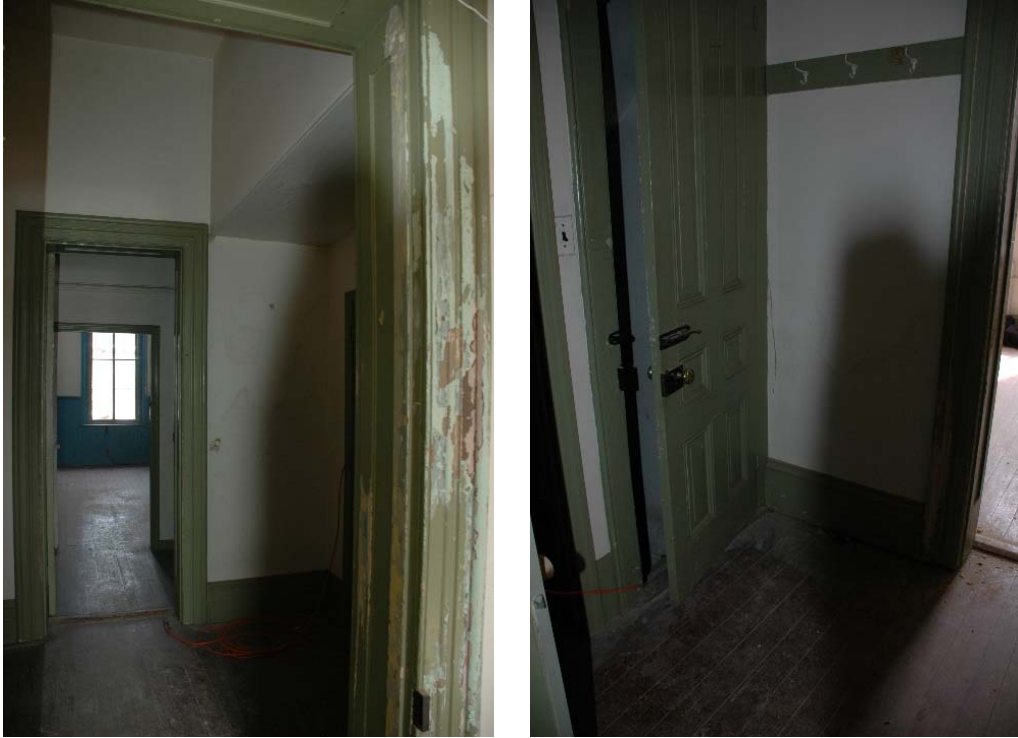
*Figure 1.3-26: View of Room 105 looking west with Rooms 107 and 108 beyond (left) and looking northeast to door to basement stair (right).*

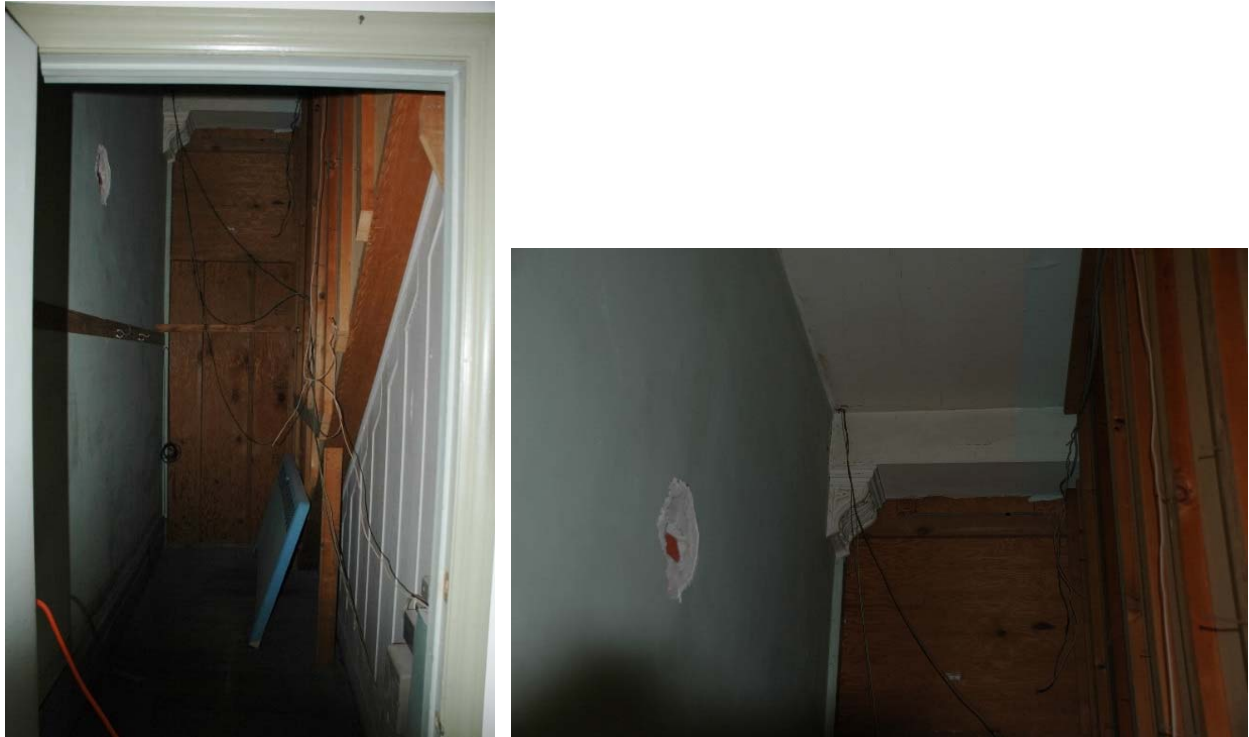
*Figure 1.3-27 View of Room 106 looking north (left) and detail view of northwest corner where plaster bracket is visible (right).*

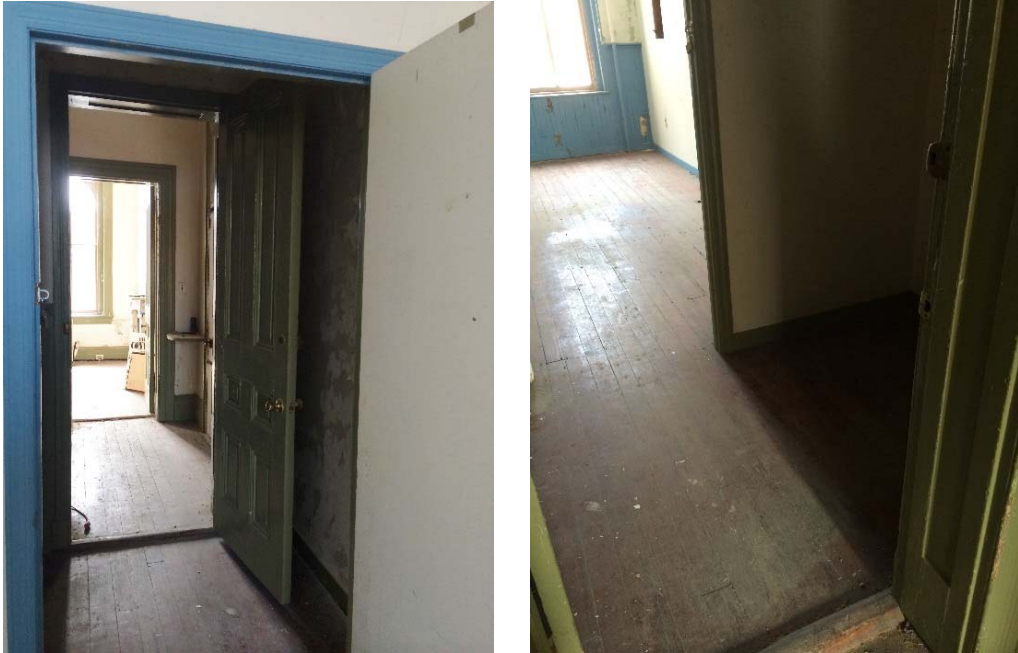
*Figure 1.3-28: Views of Room 107 looking east from Room 108 with Room 105 beyond (left) and looking northwest from Room 105 (right).*

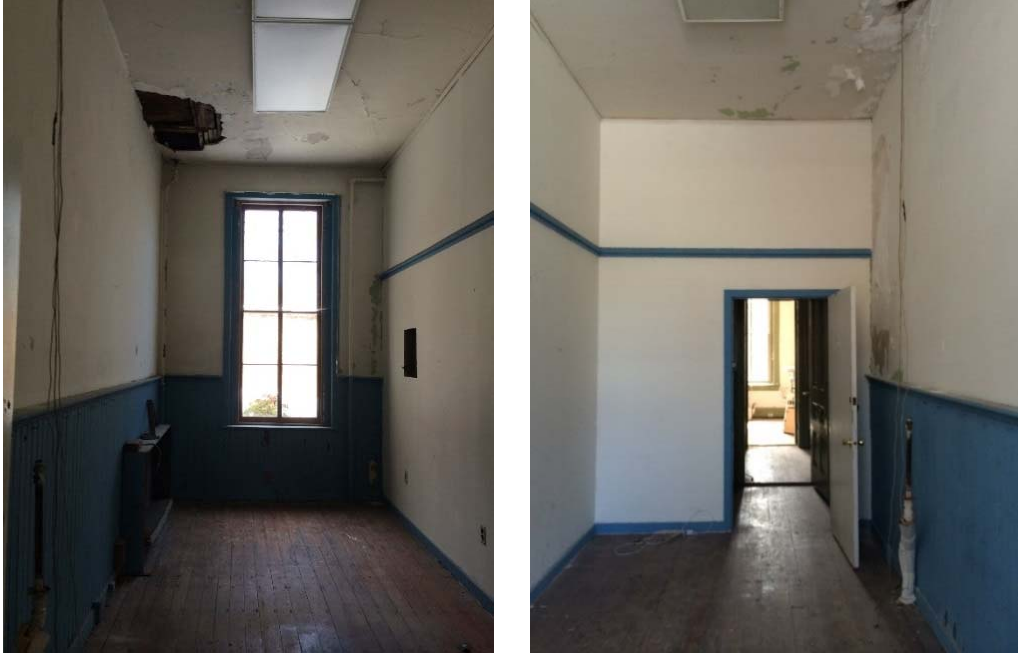
*Figure 1.3-29: Views of Room 108 looking west (left) and looking east (right).*

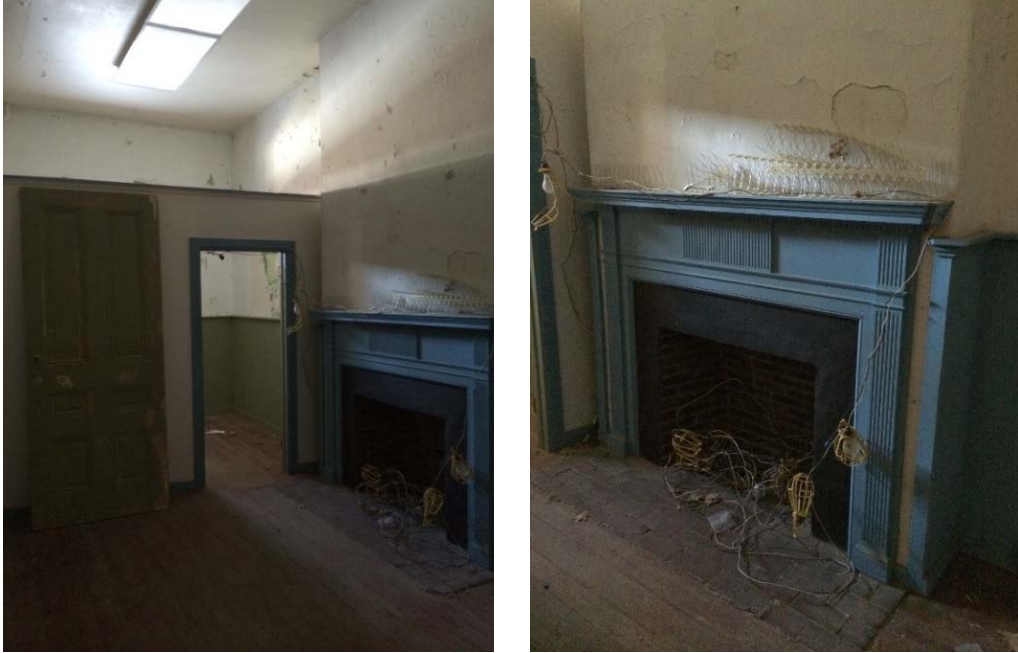
*Figure 1.3-30: Views of Room 109 looking northwest (left) and detail view of fireplace at north wall (right).*

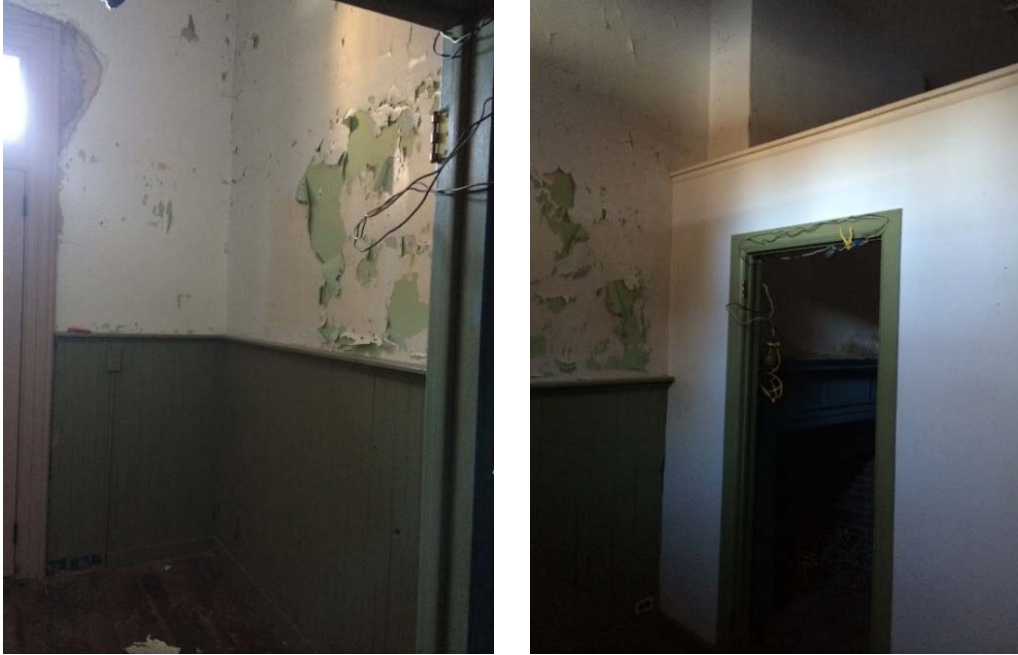
*Figure 1.3-31: Views of Room 110 looking northwest from Room 109 (left) and looking northeast (right).*

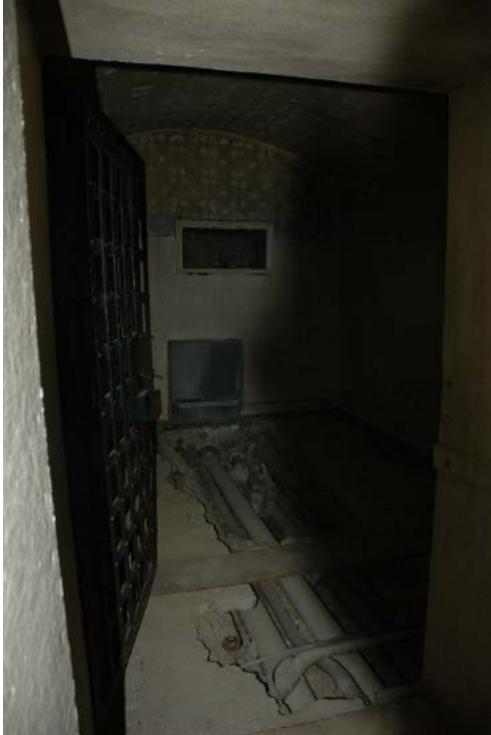
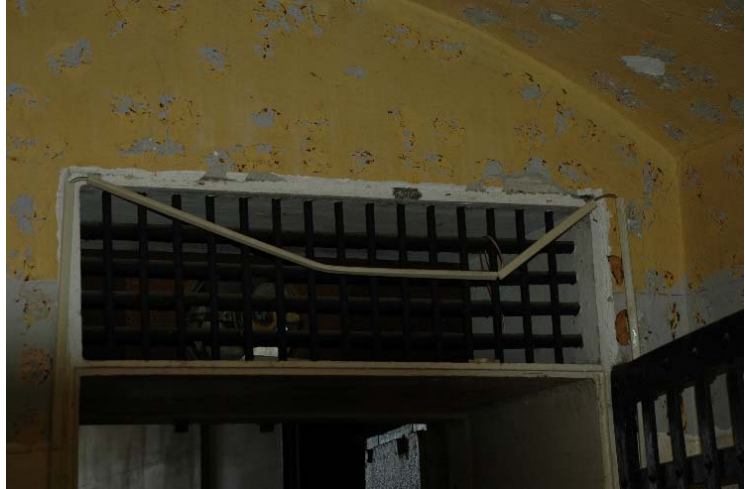
**Floor:** Concrete, not original to the building, as well as remnants of wood flooring. The concrete has largely been removed in the center, exposing pipes running east-west that date from the installation of a mechanical system that joins with the Court House system.

*Figure 1.3-32: View of Room 111 looking west from Room 102 (left) and detail view looking east at security lattice at transom over Door 1/111 (right).*

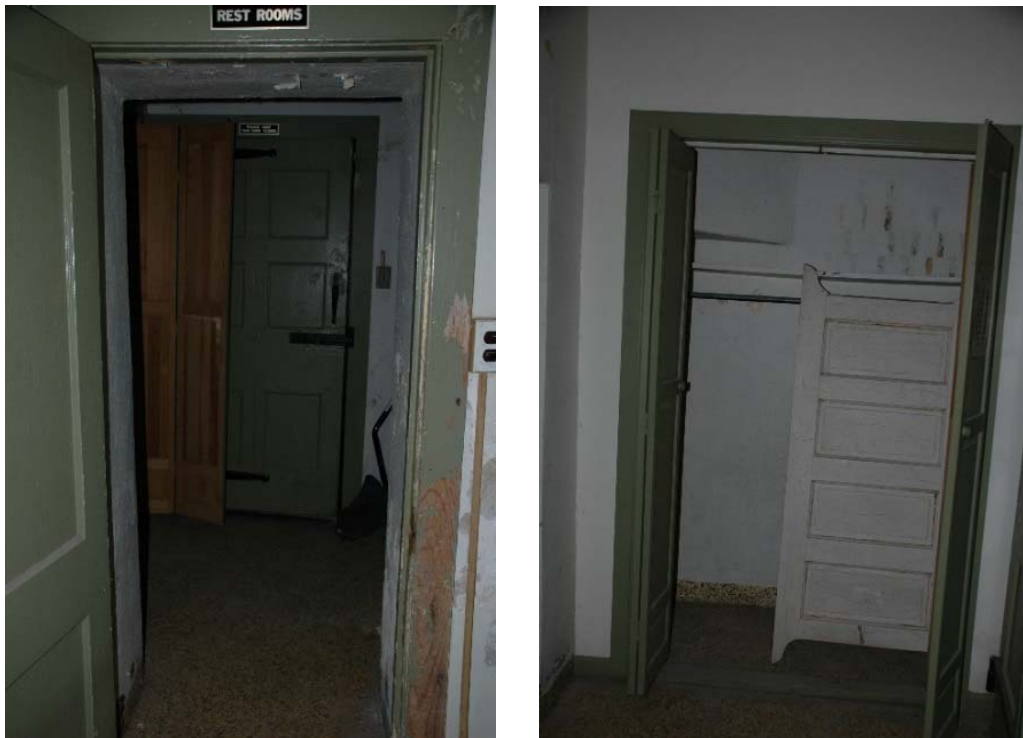
*Figure 1.3-33: Views of Room 112 looking south from Room 114 (left) and looking west at closet (right).*

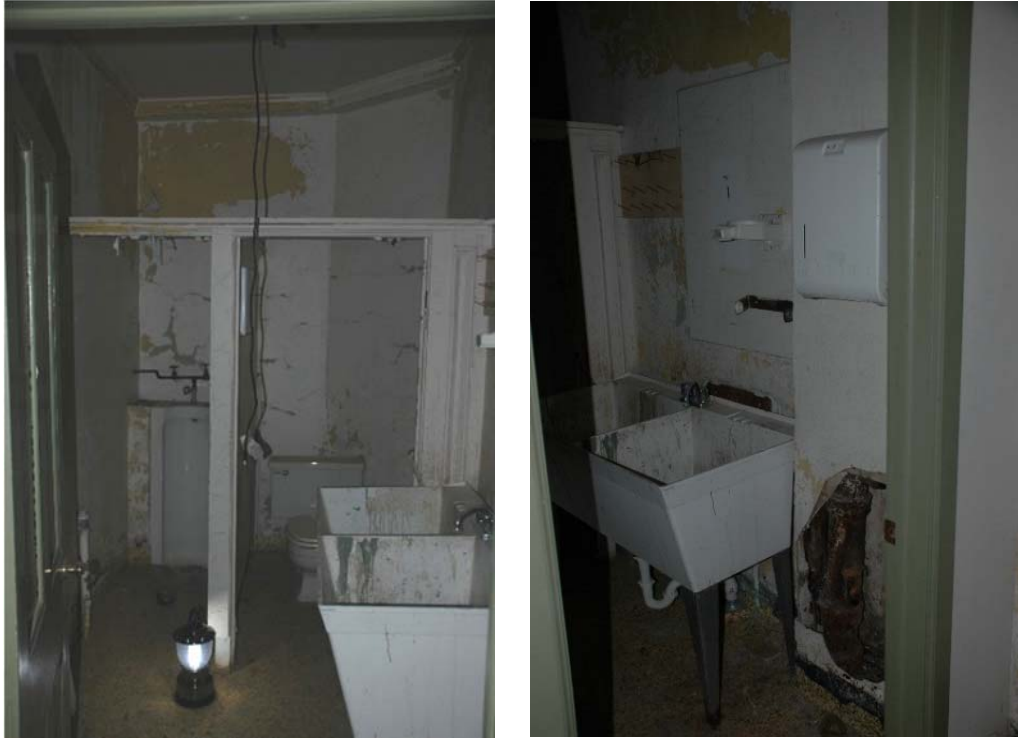
*Figure 1.3-34: Views of Room 113 looking east (left) and looking southeast (right).*

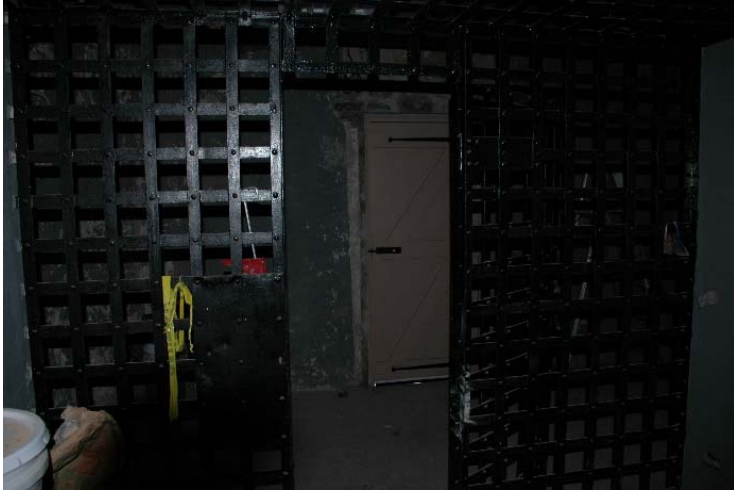
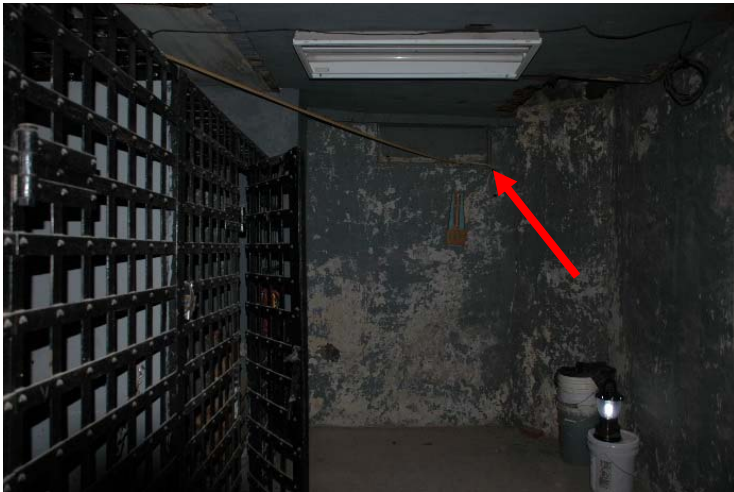
*Figure 1.3-35: View of Room 114 looking south at steel jail cells (top) and looking east with former window visible near ceiling (bottom).*
