HISTORIC STRUCTURE REPORT

THE SHERIFF'S HOUSE  
FIRST STATE NATIONAL HISTORIC SITE  
NEW CASTLE, DE

FINAL

*Submitted by:*  
JOHN MILNER ARCHITECTS, INC.  
SEPTEMBER 16, 2016

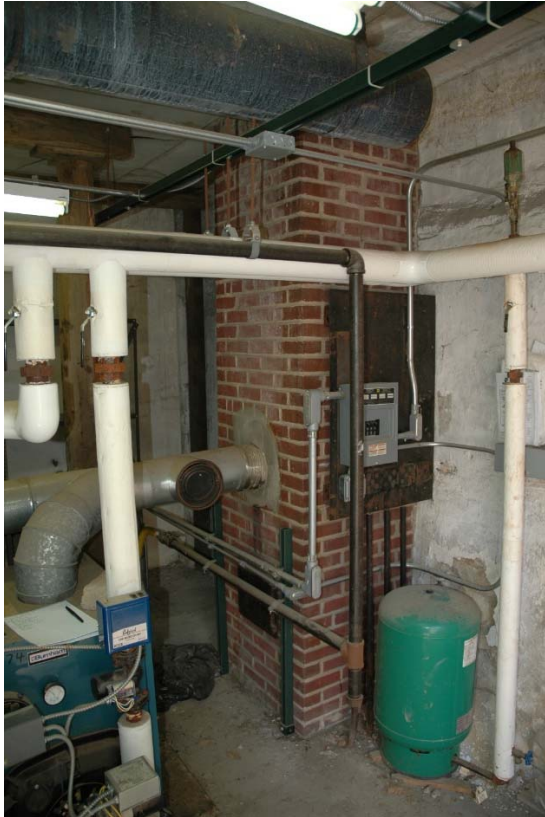
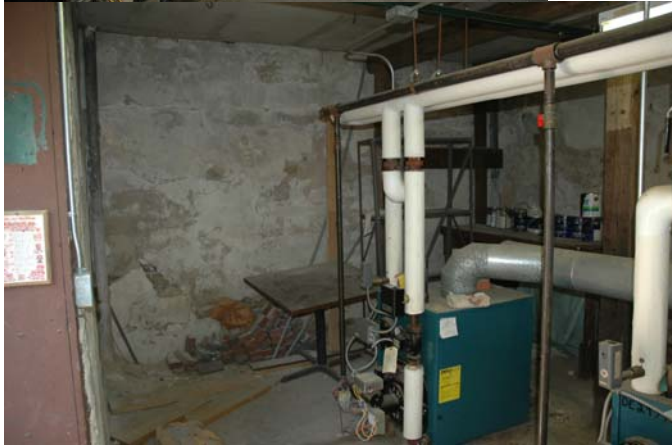
Other: Timber framing including posts and beams have been installed to support the ceiling and floor above. The framing appears to have been constructed with salvaged historic timber. The original (1857) vaulted masonry ceiling has been removed and a modern brick chimney has been installed at the south wall to evacuate the mechanical equipment exhaust.

Figure 1.3-36: Views of Room 115 looking southeast at modern brick flue (left) and looking northeast at north wall and mechanical equipment (bottom).

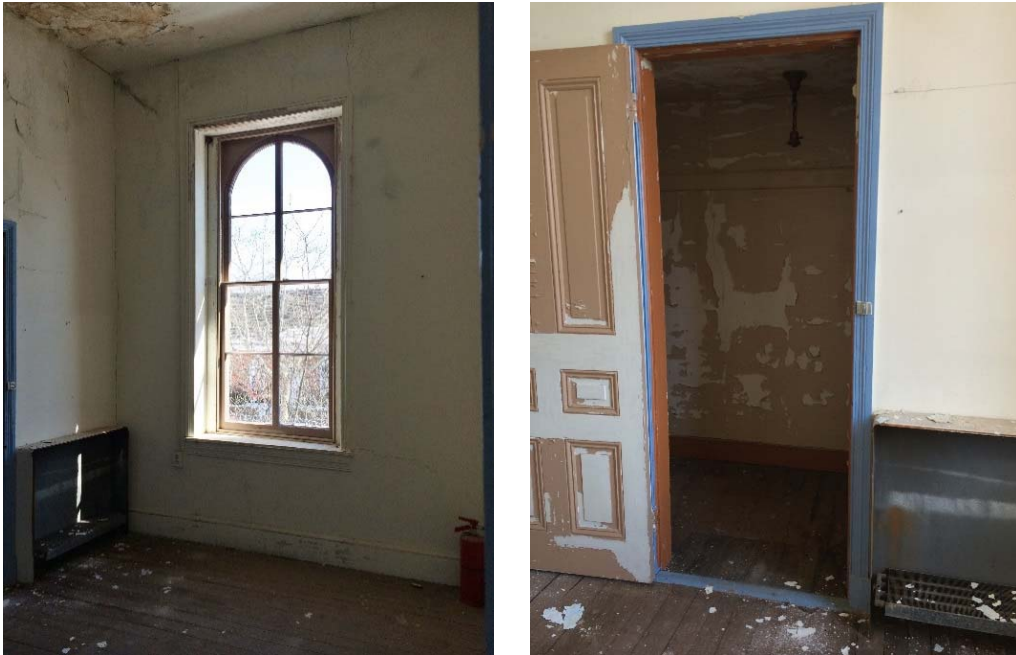
*Figure 1.3-37: Views of Room 201 looking northeast (left) and looking east at original closet (right).*

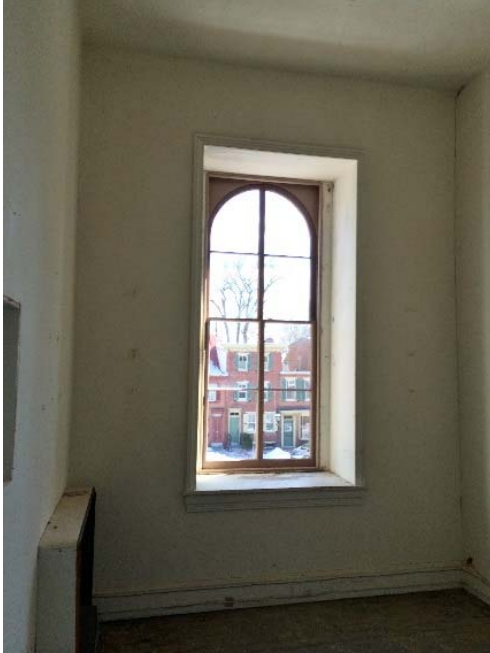
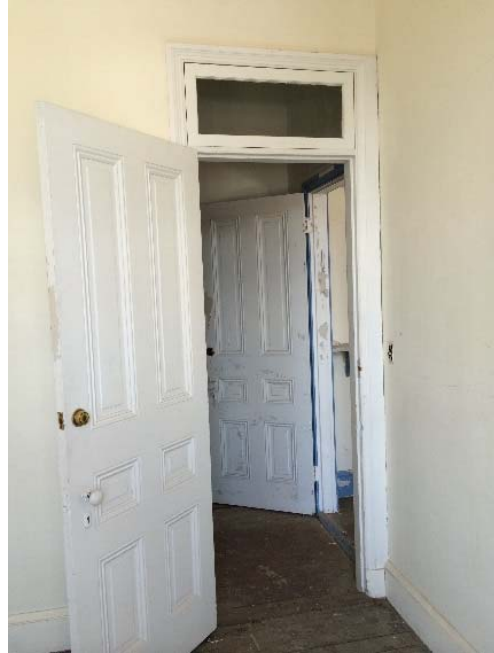
Floor: Original random-width (5"-8") pine floor boards, face-nailed with machine cut nails (1857), are extant but show staining from a later modern flooring that was installed over the boards and later removed.

*Figure 1.3-38: Views of Room 202 looking east (left) and looking west with Room 203 beyond (right).*

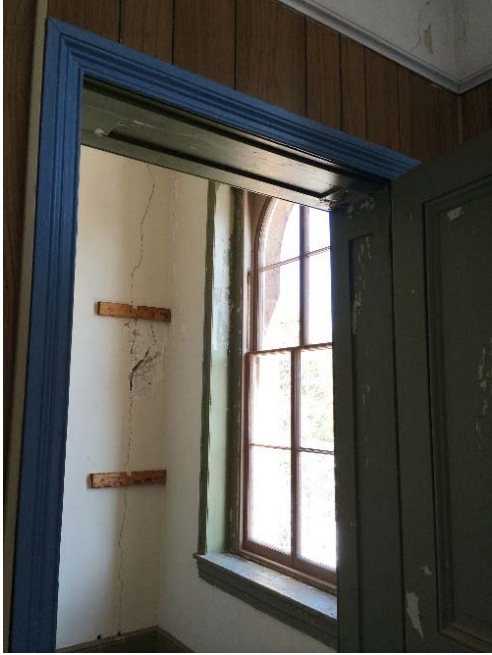
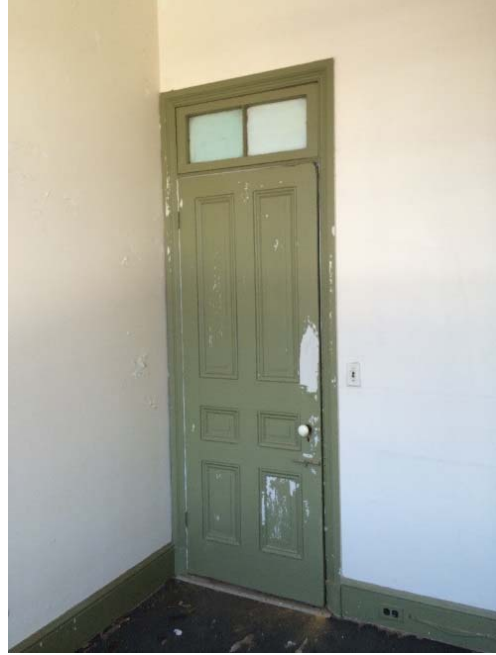
Floor: Original random-width (5"-8") pine boards, laid east-west and face-nailed with machine cut nails (1857), is exposed under a deteriorating modern floor.

*Figure 1.3-40: View of Room 204 from Room 206 (left) and looking southwest (right).*

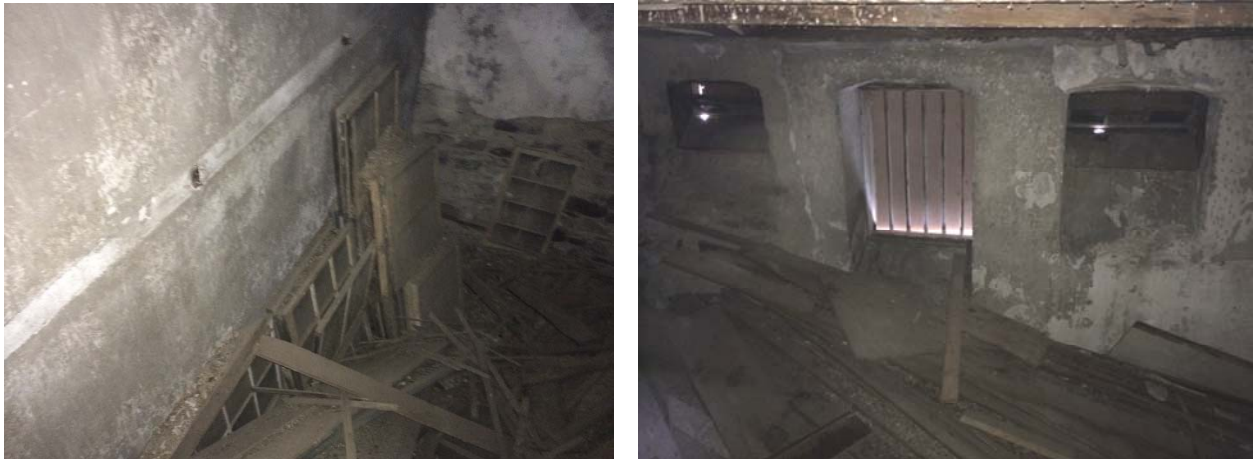
Walls: Areas of the walls were not visible due to the large piles of debris. Where visible, the original plaster (1857) on masonry (1857) is in fair to poor condition. Large areas of plaster are missing completely, especially at the north wall. At the east wall large areas of plaster, concentrated

in the area between the east door and the windows, have lost their finish layer exposing scratch coat beneath. At the west wall, a “ghost” on the wall and remnant metal fasteners suggest that some horizontal element had been attached directly to the plaster. The remainder of the visible plaster is in fair condition with significant soiling present throughout.

**Ceiling:** Original plaster on wood lath ceiling (1857) is missing. The exposed ceiling framing and roof structure appears to be in good condition with moderate water staining and animal soiling visible throughout.

*Figure 1.3-46: View of Room 211 looking northwest (left), view of Room 211 looking east at wall, door and windows (right).*

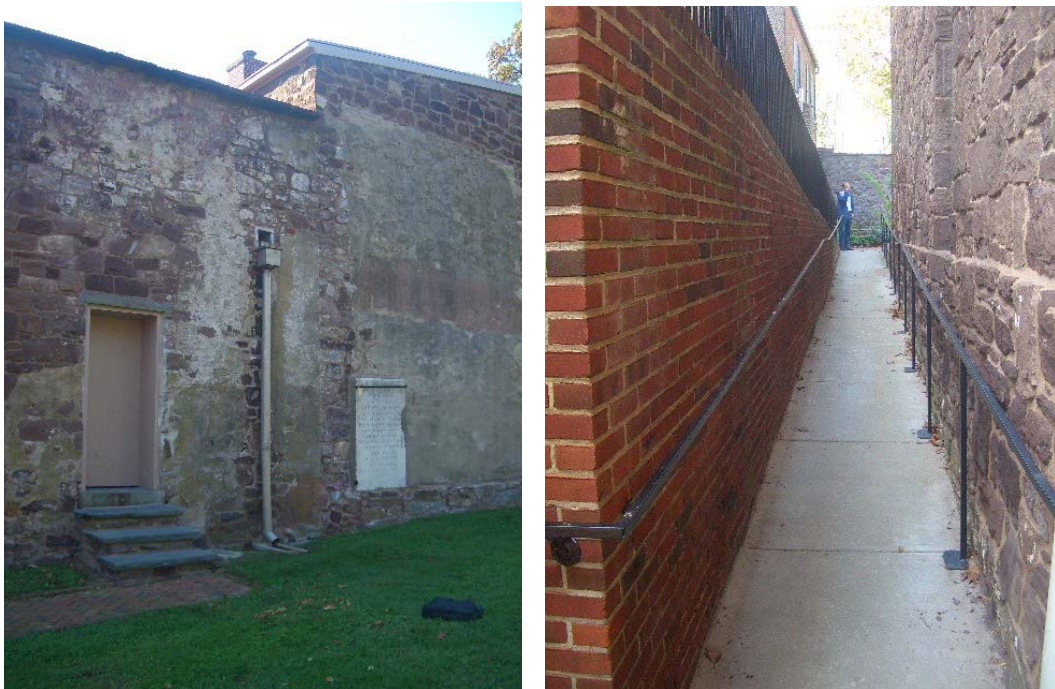
- Site
  - With the exception of the handicapped access ramp located on the south side of the building, the grade around the perimeter of the Sheriff's House is relatively flat. Several shallow depressions in the vicinity of the downspouts are negatively sloped toward the building walls.

*Figure 1.5-1: (Left) Except for the minor depressions located at the downspout discharge points, the grade is relatively flat. (Right) By necessity, the concrete surface of the access ramp located to the south of the building has a neutral slope except at the landing area.*

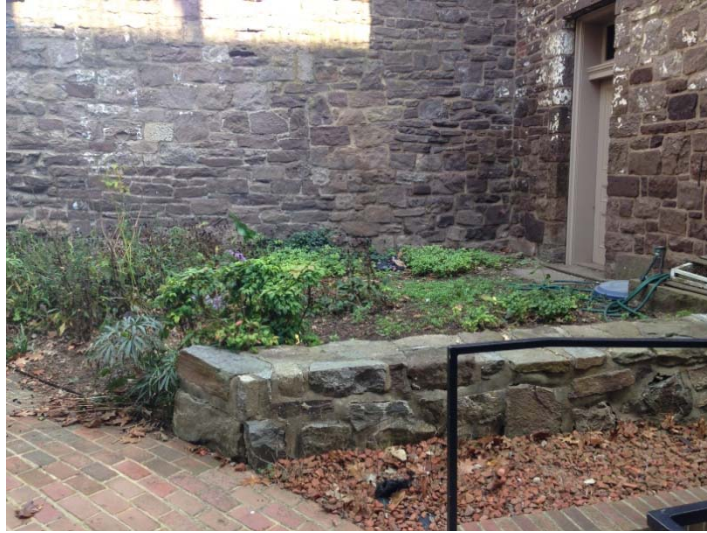
- Due to the presence of potential archaeological resources in the courtyard between the Sheriff's House and the Courthouse, landscaping is limited to mulch and shallow-rooted planting beds. Significant 19<sup>th</sup> and early 20<sup>th</sup>-century resources are believed to remain in this area.<sup>1</sup>

*Figure 1.5-2: Significant archaeological remains survive in the Sheriff's yard. The stone wall at the foreground is part of those remains which was chosen for interpretation.*

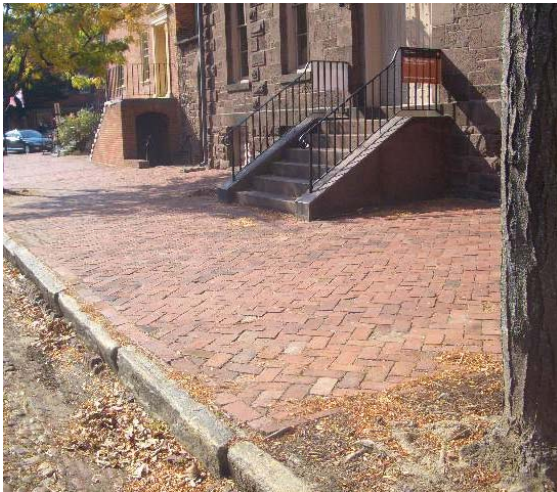
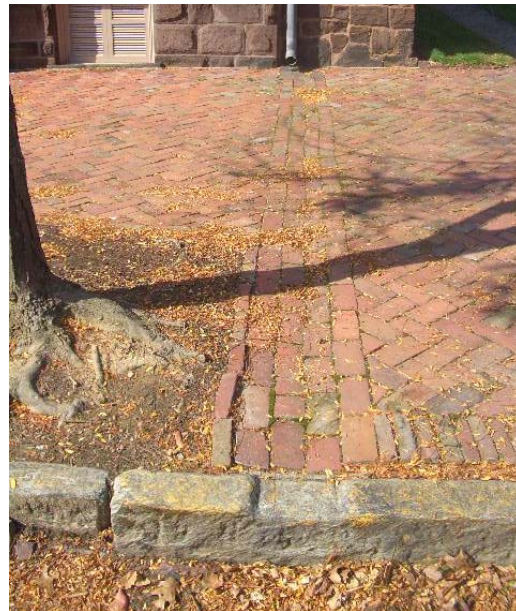
- The herringbone brick paving that adjoins the east side of the building dates to the mid-20<sup>th</sup> century and is in good condition. Minor disruption of the stone curbs and the bricks surrounding the trees has occurred due to freeze-thaw action and penetration by tree roots.

*Figure 1.5-3: (Left) The brick-paved walking surface in front of the Sheriff's House is in good condition despite settlement of individual bricks. The surface is generally level with minor lipping. (Right) Tree roots have dislodged bricks in their immediate vicinity as well as some curb stones.*

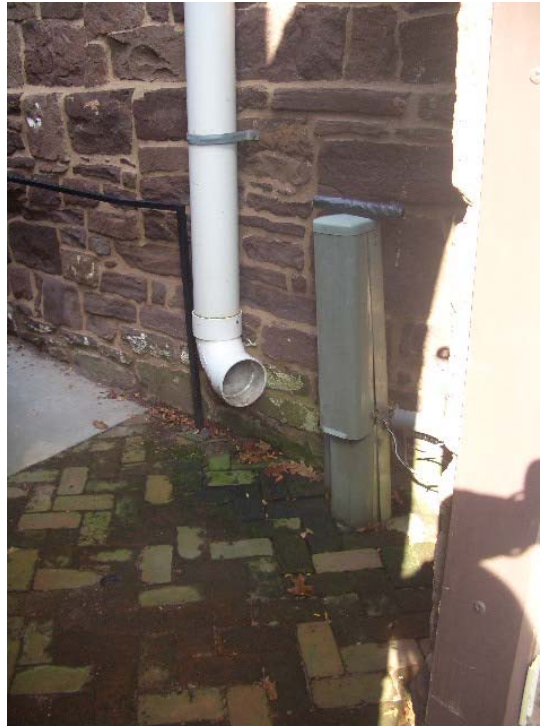
- The brick paving at the base of the handicapped access ramp is heavily coated with algae due to the high moisture level caused by the downspout discharge. This area is extremely slippery when wet and should be considered a safety hazard.

*Figure 1.5-4: The brick paving under the downspout is extremely slippery due to a heavy build-up of algae and constitutes a safety hazard.*

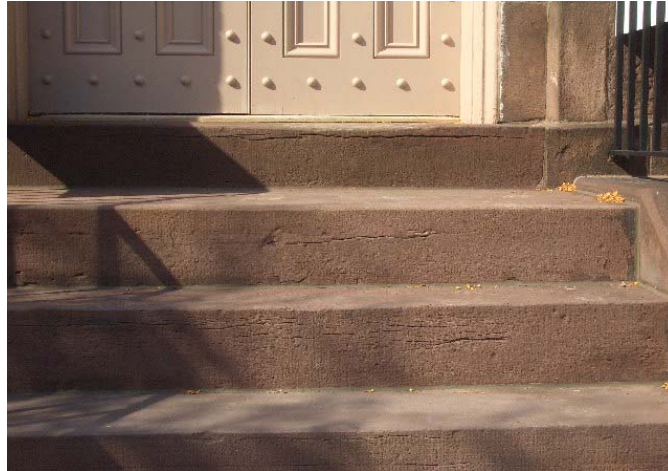
- The brownstone stair treads located at the east entrance to the Sheriff's House display minor erosion and separation at bedding planes. The top surface of the top tread will eventually delaminate completely. Though all treads remain sound at this point, it is critical to avoid the use of de-icing salt on these stairs to minimize further damage.

*Figure 1.5-7: The front steps of the Sheriff's House consist of large slabs of brownstone. Though the bedding planes are properly oriented, minor delamination is occurring in scattered locations.*

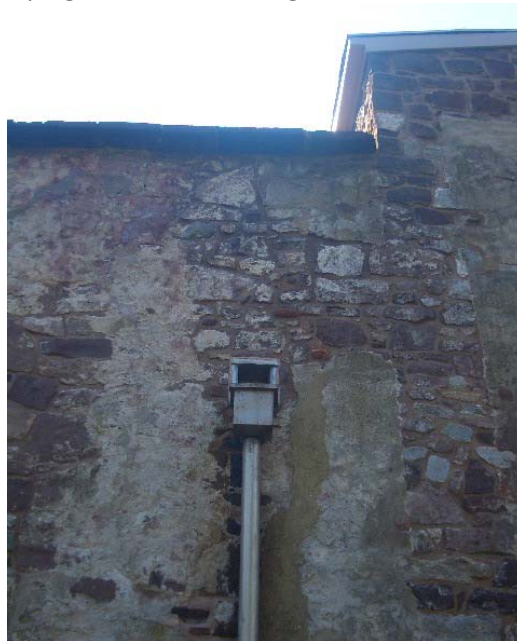
- Water penetration through the coping joints in the north wall has caused deterioration in the rubble stone masonry. The wall has been spot pointed in scattered locations. This stonework contains significant evidence regarding the evolution of the building and care should be taken in future repointing campaigns to avoid erasing architectural evidence.

*Figure 1.5-8: Rubble stone masonry on the north wall contains significant architectural evidence. Future maintenance repointing should be kept to a minimum to avoid loss of features.*

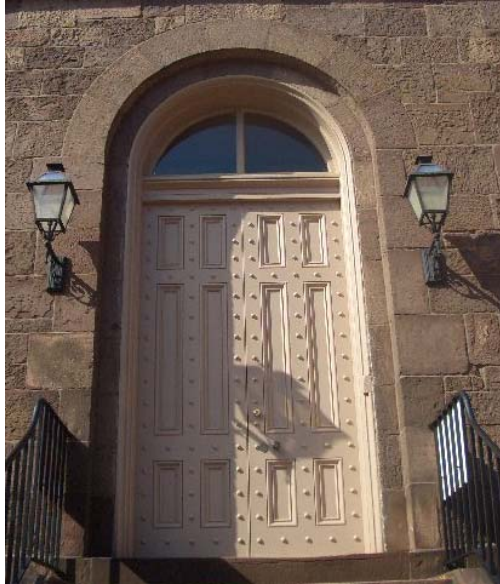
- Doorways
  - There are three exterior doors in the main Sheriff's House, located in the east, west and south facades. The door at the main entrance on the east elevation consists of a pair of six-panel doors hung in an arched frame with a two-light transom. The original doors were irreparably damaged by chemical paint stripping and were replaced c. 1995. These doors were reproduced from the original pair and are in good condition. The remaining doors in the south

*Figure 1.5-10: The existing doors were reproduced from the originals and are in good condition. The glass transom is almost certainly a replacement.*

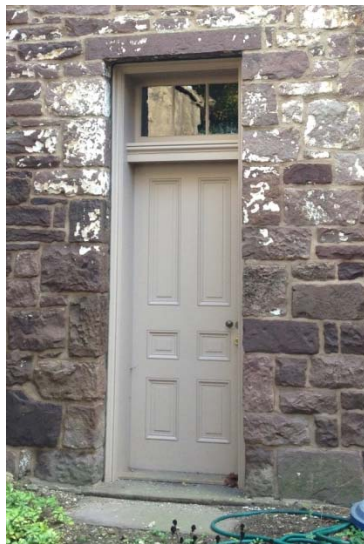
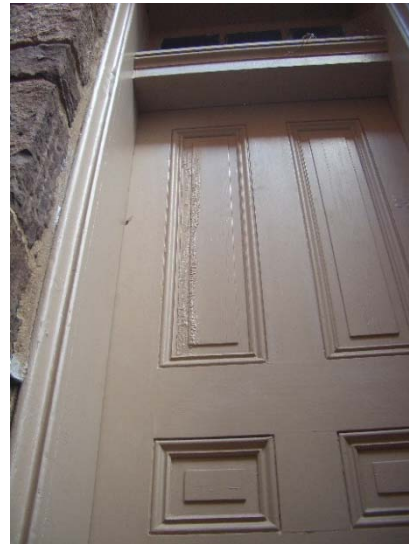
and west facades are six-panel doors with three-light transoms that are virtually identical to one another. Both doors and frames are in good condition despite some scattered paint failure on the south door. The west door opening originally led into the prison complex and would certainly have had a more substantial door and frame.

*Figure 1.5-11: (Left) The door in the west elevation opening to the courtyard is in good condition. Its age is yet to be determined. (Right) The door in the south elevation exhibits minor to moderate paint failure in scattered locations but otherwise appears to be in good condition.*

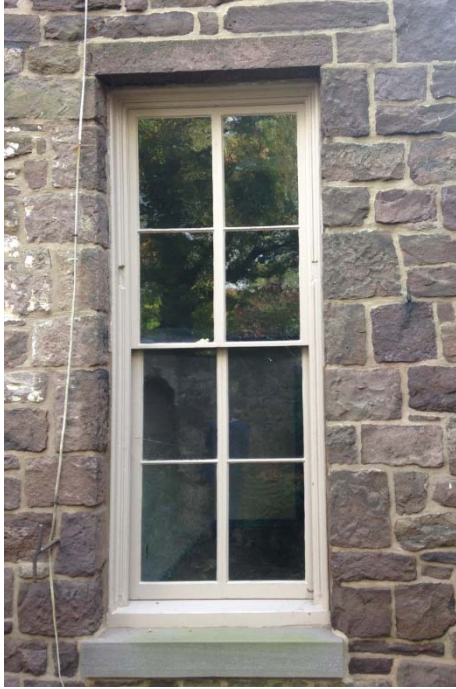
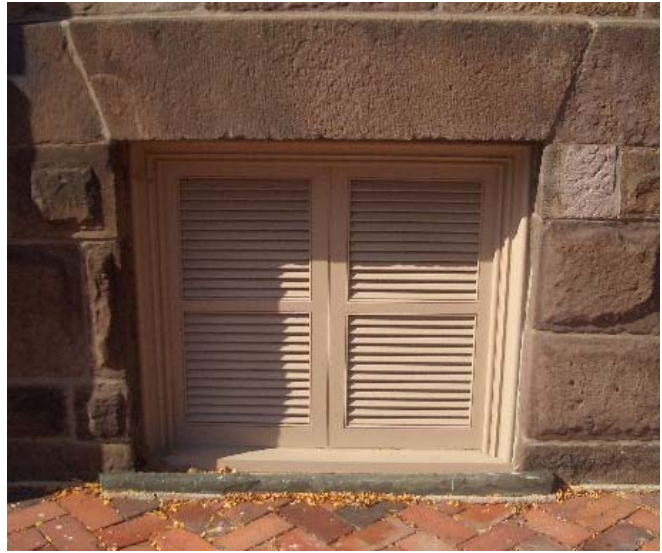
- The windows on the less-public facades of the Sheriff's House are less elaborate than those on the street façade, consisting of rectangular, double-hung, four-over-four sashes installed in rectangular wood frames. These windows, too, display suspiciously little paint build-up and little to no rot or UV damage. They are also likely replacements. All appear to be in good condition. The basement windows are certainly recent replacements and all are in good condition, if slightly soiled.

*Figure 1.5-15: (Left) The windows on the south and west facades are of similar muntin configuration as those on the front of the building. The sills and sashes also appear to be replacements. (Right) The basement windows and their louvered shutters are in very good condition aside from minor to moderate soiling.*

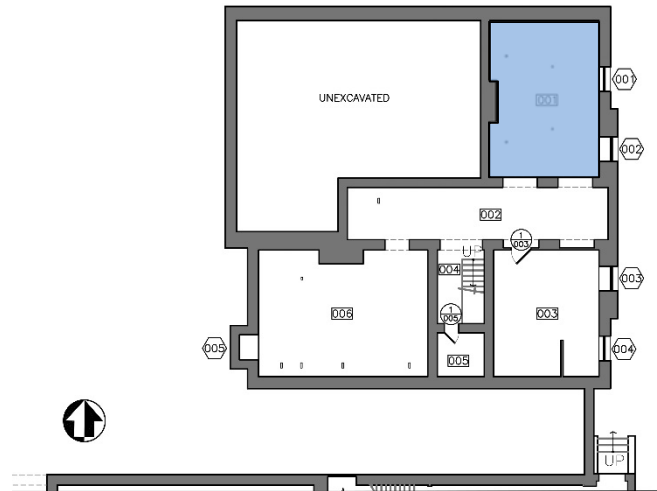
#### Room 001

Walls: The walls are in fair condition. There is plaster damage from water penetration at the chimney support on the west wall.

Ceiling: The ceiling is in fair condition, including wood beams and posts that have been installed to stabilize the joists. The steel beam and two steel posts are in good condition.

Other: Arched support on the west wall for fireplace in Room 101 above is in good condition.

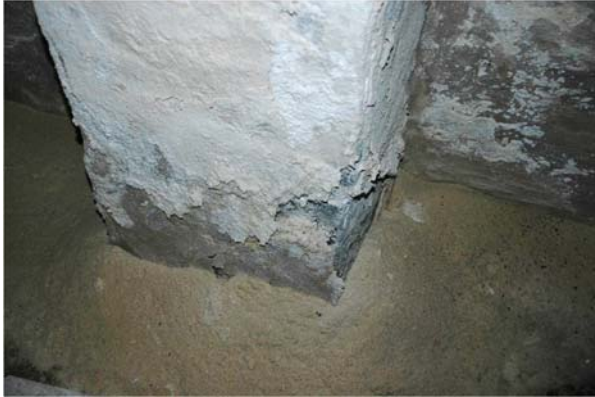
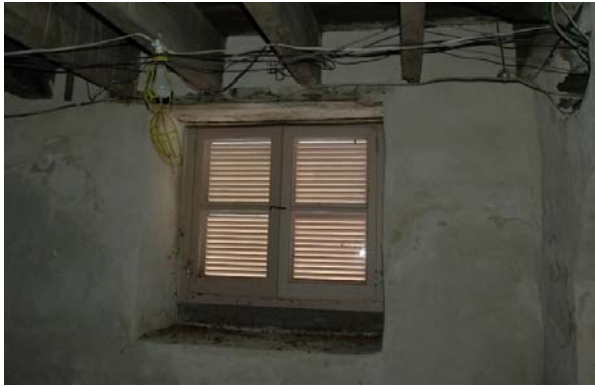
*Figure 1.5-16: Detail views of plaster deterioration at west chimney support in Room 001 (top) and detail view of Window 001 in Room 001 (bottom).*

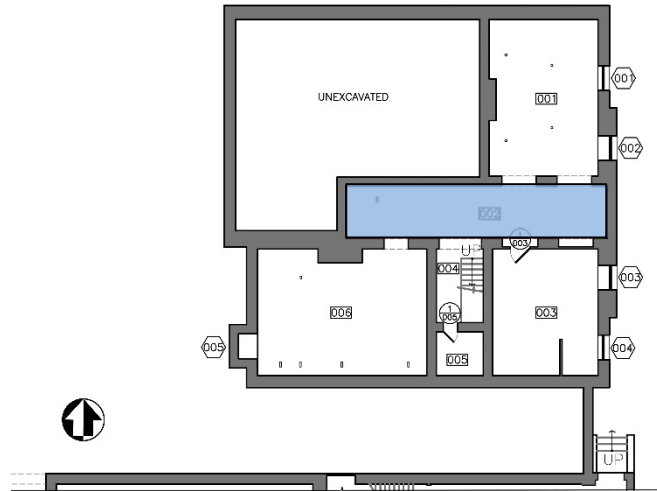
## Room 002

Walls: The walls are in fair condition with some damage from water penetration on the lower portion of the parged walls.

Electrical: Loose hanging wires in the ceiling and an electrical panel that appears to be in good condition.

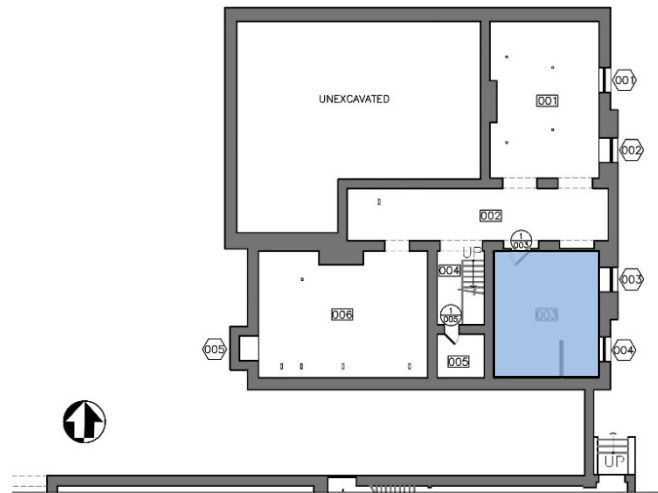
## Room 003

Walls: The walls are in fair condition with damage from water penetration on the east wall.

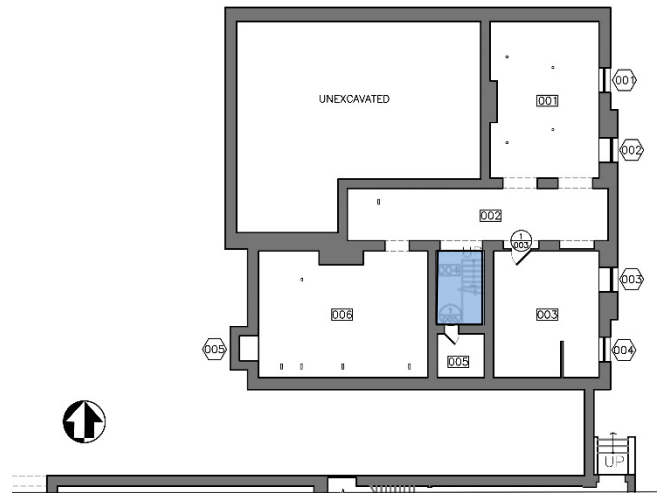
## Room 004

Walls: The walls are in fair condition; the parging is peeling and delaminating.

Other: The original wood basement stairs are intact and are in fair condition with worn and split treads.

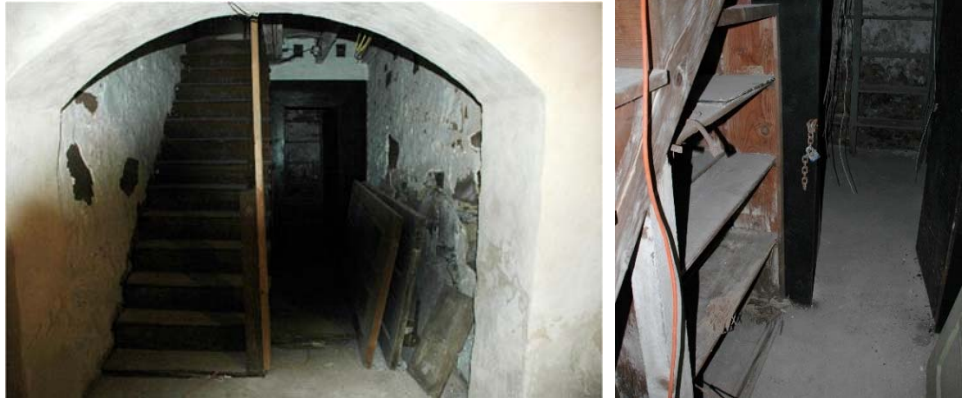
*Figure 1.5-19: View of missing plaster (left) and under-stair shelving (right) in Room 004.*

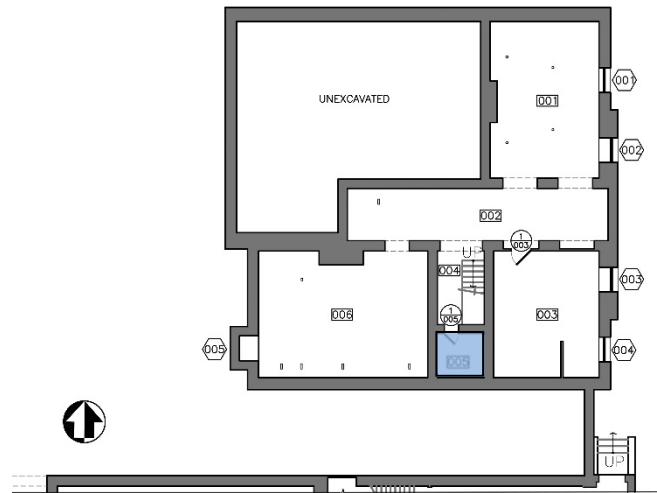
## Room 005

Walls: The brick walls are in good condition. The parged walls are in fair condition; the parging is spalling or missing and there are penetrations throughout.

Doors: Door 1/005: The steel door is in poor condition, exhibiting rust on both sides. The west hinge jamb is more severely rusted and is beginning to buckle. There are open joints in the door trim.

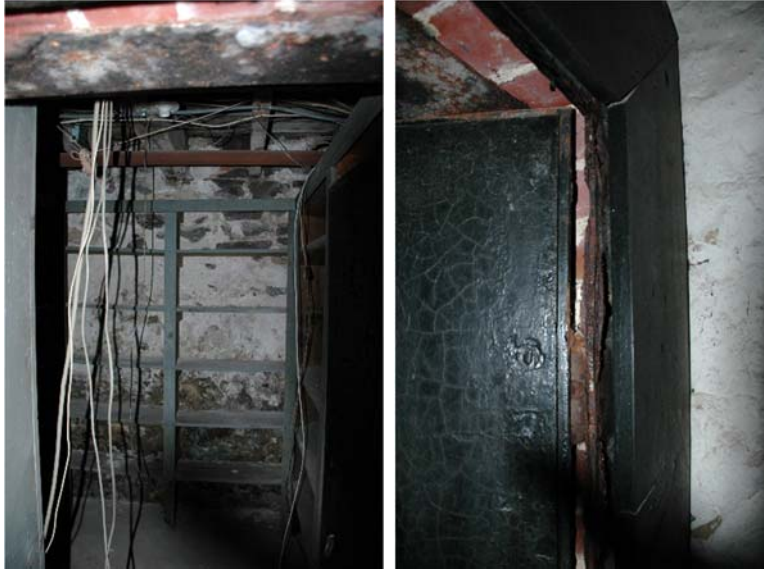
*Figure 1.5-20: View of missing plaster and wood shelving at south wall (left) and of rust damage to metal door in the north wall (right) of Room 005.*

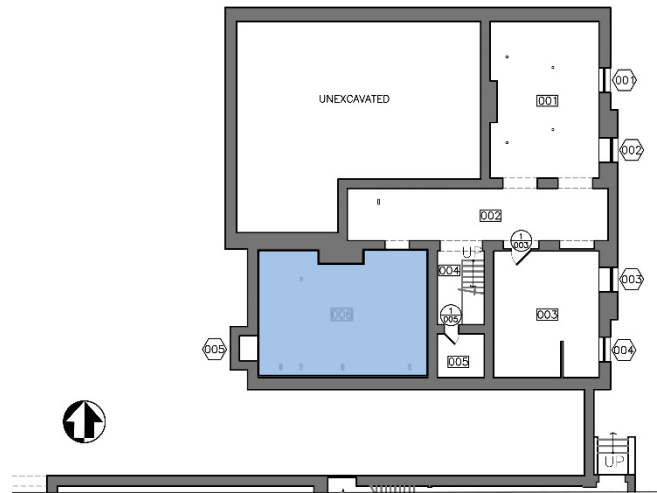
## Room 006

**Walls:** The walls are in fair condition with damage from water penetration on the south wall and southwest corner.

**Ceiling:** The ceiling is in fair condition; rotting joists and headers have been stabilized with blocking and wood posts on concrete bases.

**Windows:** Window 005 is in poor condition. The lintel over the opening is deteriorating and the room is exposed to the elements.

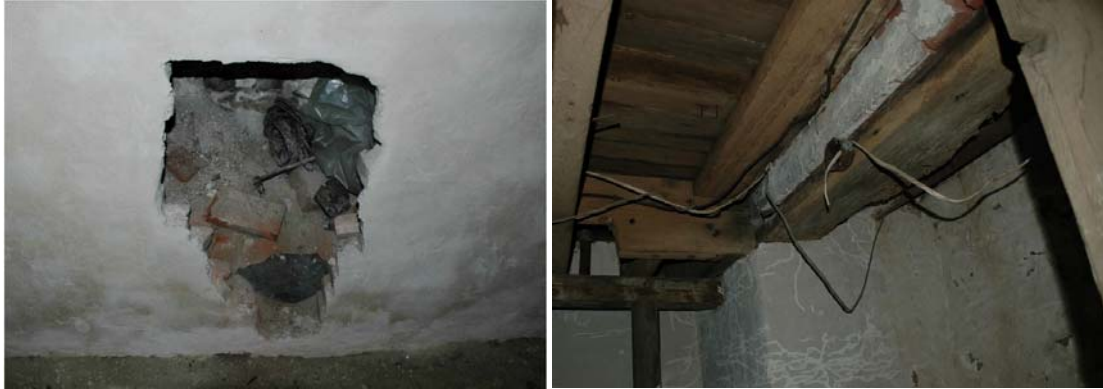
*Figure 1.5-21: Area of parging damage/removal at north chimney support in Room 006 (left). Damage/removal appears to have occurred at location of chimney's ash dump. Detail view of deteriorating lintel over exterior wall opening in west wall of Room 006 (right).*

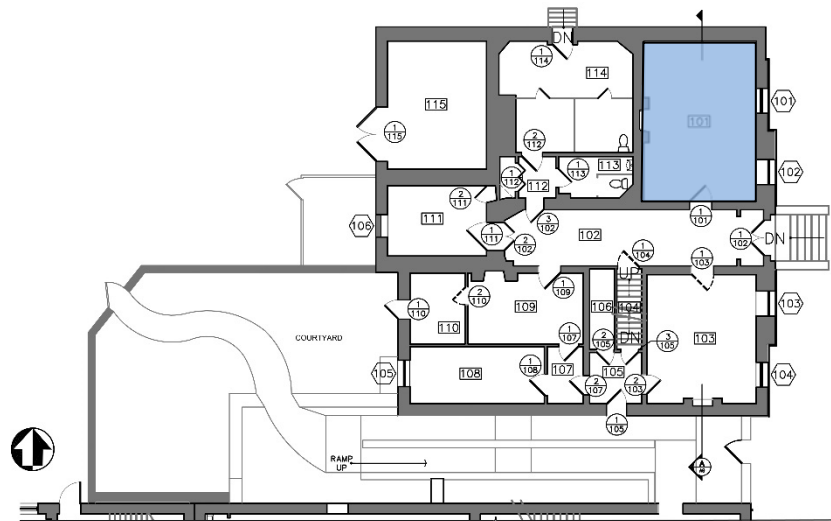
### Room 101

**Floor:** The floor is in good condition. Most of the original boards are intact, however there is patching in the southwest corner, sagging in the southeast and southwest corners and several penetrations for systems. There is evidence of water infiltration and damage at the flooring near the windows.

**Walls:** The walls are in fair condition. There are small penetrations, plaster cracks, particularly in the southeast corner and on the south and west walls. There are areas of plaster deterioration and failing paint, as well as holes from anchors and fasteners, spalling plaster at the south wall and full height cracks. The wood baseboards are damaged on the east wall and the northeast and northwest corners. The baseboards are pulling away on the east and west walls.

**Ceiling:** The ceiling is in poor condition; there are large areas of missing plaster and wood lath, due to water damage, exposing the second story framing. The ceiling is also exhibit cracking at the perimeter and near the windows, some cracks more widespread than others. There are penetrations from systems throughout.

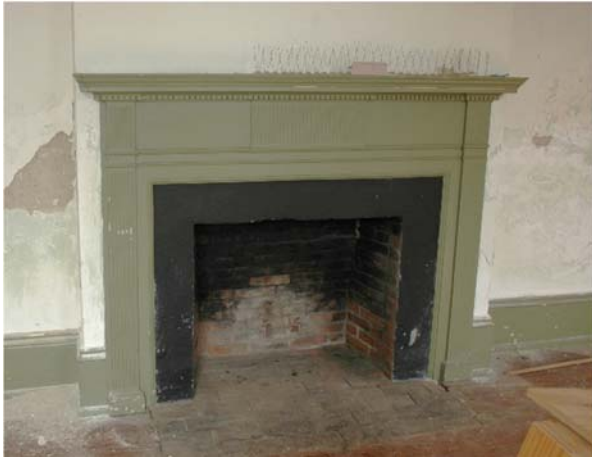
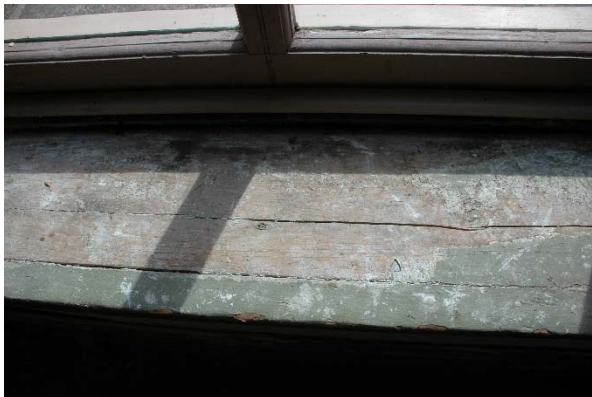
**Windows:** Windows 101 and 102 are in fair condition. It appears as though the sashes have been replaced in kind, reusing the salvaged mid-19<sup>th</sup> century glass. The trim is a combination of original and modern, generally in good condition. The window sills show evidence of deteriorating wood, checking, splitting and paint failure. The trim on Window 101 shows minor UV and water damage, as well as splitting. Although the trim is pulling away from the jamb on Window 103, the window is generally in good condition. There is evidence of water and fastener damage, as well as open joints along the trim, sills and frames.

Other: The fireplace in Room 101 is in fair condition; the fasteners and brick fire box are damaged, the paint is peeling and the hearth is exhibiting signs heaving and settling. The mantel was likely replaced at the beginning of the twentieth century as it is in the colonial revival style.

*Figure 1.5-22: Detail view of fireplace in Room 101. Note damage at firebox and hearth (top). Detail view of window sill damage in Room 101 (bottom).*

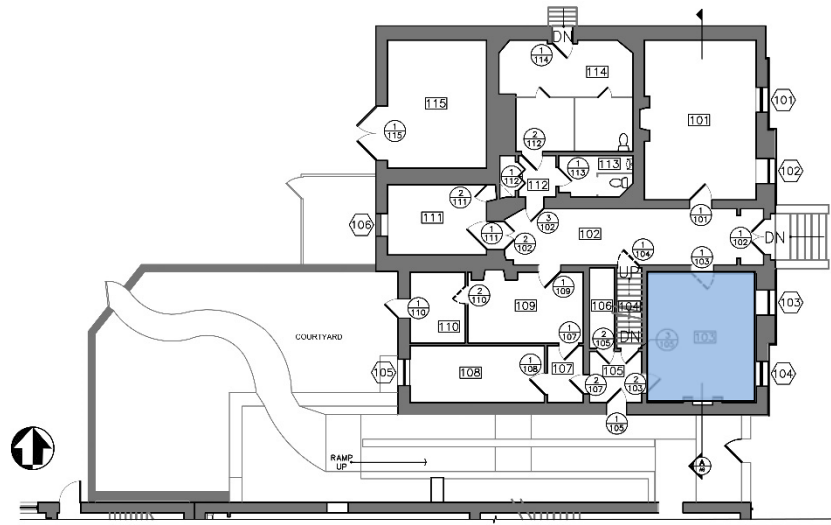
## Room 103

**Floor:** The floor is in fair condition in Room 103. The original wood boards are extant with some evidence of fading, scratching and discoloration. They are partially scored and sagging in the northeast and southeast corners. There is evidence of water infiltration and damage at the flooring near the windows.

**Walls:** The walls are in fair condition with small penetrations, plaster cracks, areas of plaster deterioration and failing paint. There are perimeter cracks, large settlement cracks, deteriorated plaster, particularly around the mantel, and spalled skim coat (due to water damage). The wood baseboards are pulling away from the walls and there is water and systems damage along the baseboards.

**Ceiling:** The ceiling is in poor condition with large areas of missing plaster and wood lath, as well as exposed second-story framing. The ceiling is also exhibiting cracking at the perimeter and near the windows, some cracks more widespread than others. Other penetrations in the ceiling were created for systems that are no longer in use.

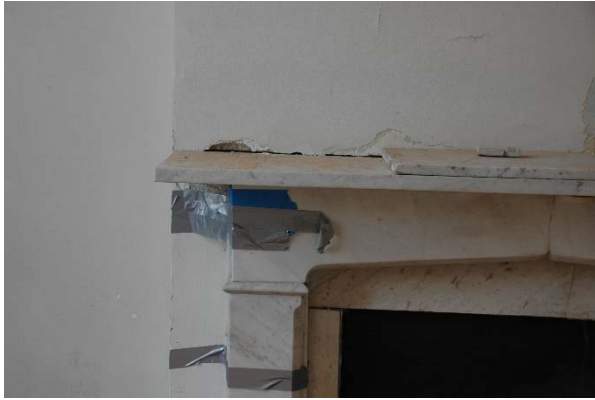
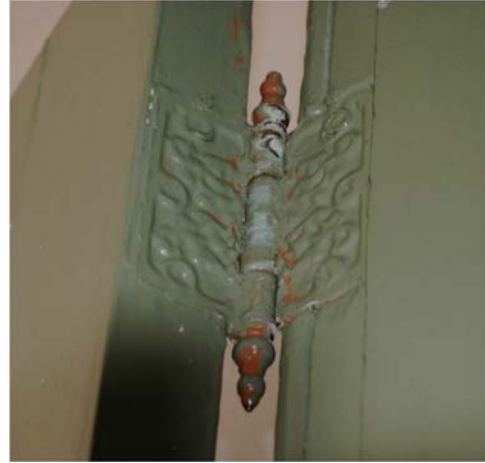
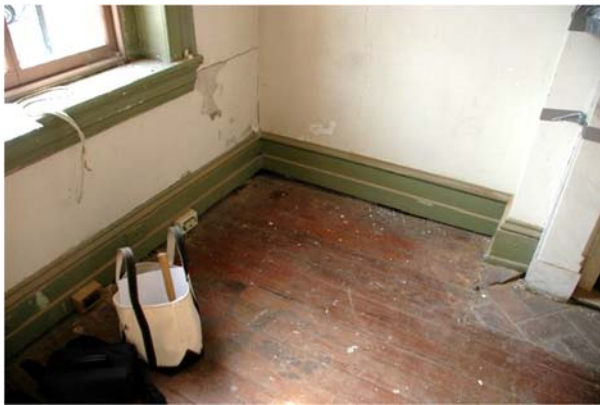
**Other:** The original marble mantel is in poor condition; the individual pieces are in good condition, however it is being held together with duct tape. The brick hearth and marble hearth are both cracked.

*Figure 1.5-26: Detail view of original marble mantel damage in Room 103. Note plaster damage where it abuts mantel (top left). Detail view of hinge at Door 2/103 (top right). Detail view of flooring deterioration at southeast corner of Room 103. Gap between floor and wood base indicates floor sagging. Sagging has resulted in cracking at the fireplace hearth.*

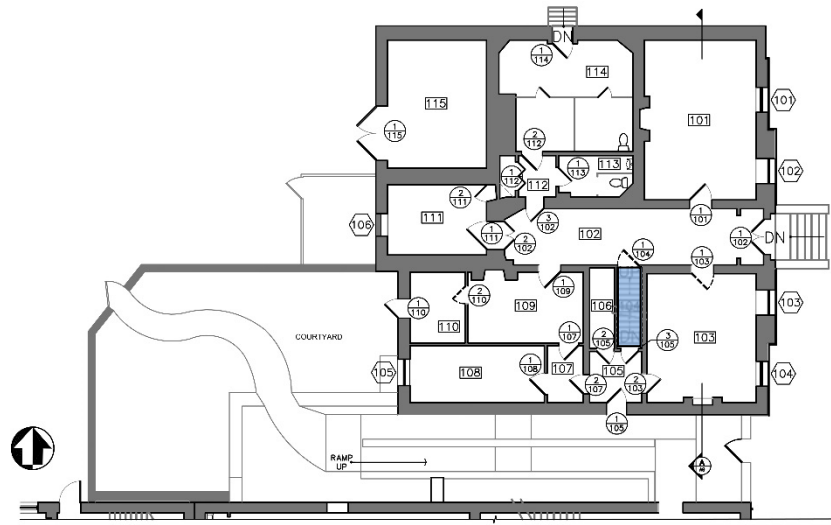
## Room 104

**Floor:** The stair treads are in fair condition. Several of the treads are cracked or badly worn and the fasteners for the old floor covering are still in place.

**Other:** The original wood banister for the staircase is intact and in fair condition; there is a crack in the newel and a loose rail. The original decorative plaster bracket in the northeast corner is intact and in good condition.

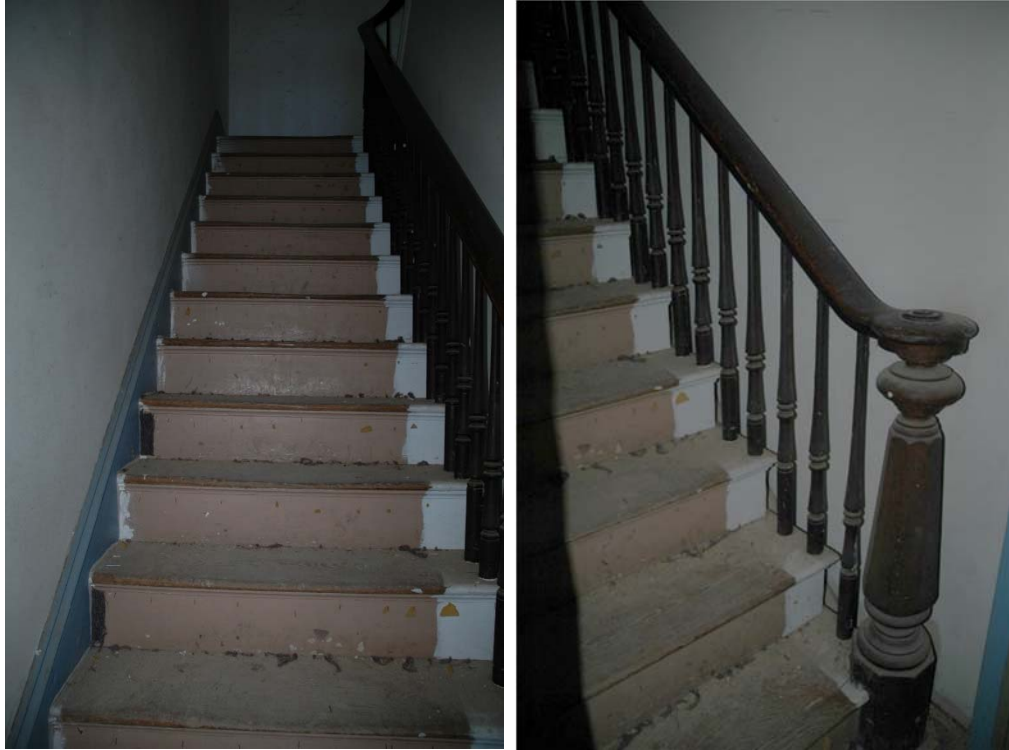
*Figure 1.5-27: Views of the wood stair in Room 104.*

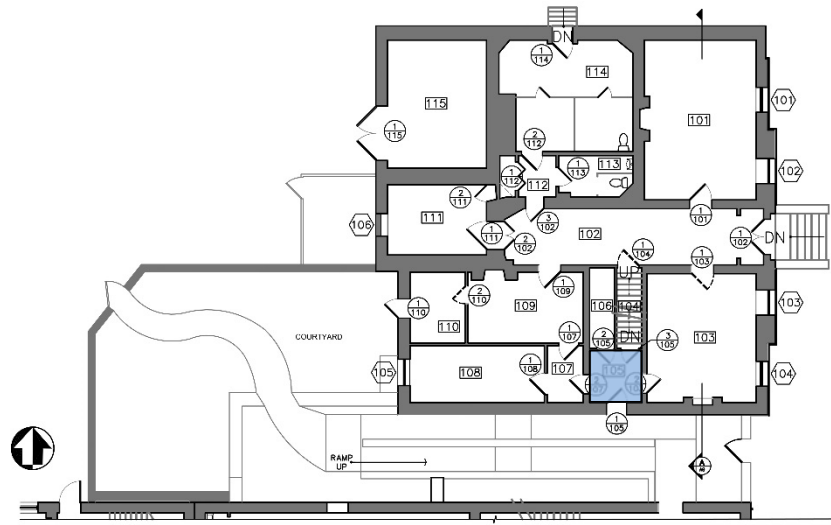
## Room 105

**Floor:** The floor is in fair condition with most boards intact and some evidence of fading, scratching, sagging and discoloration. The floor is damaged at the east and south doors.

**Walls:** The walls are in fair condition with small penetrations, plaster cracks, areas of plaster deterioration and failing paint. There is evidence of water damage at the lower portions of the walls and perimeter cracking near the landing at the south wall. The plywood is also in good condition. The wood trim is in good condition with some paint failure.

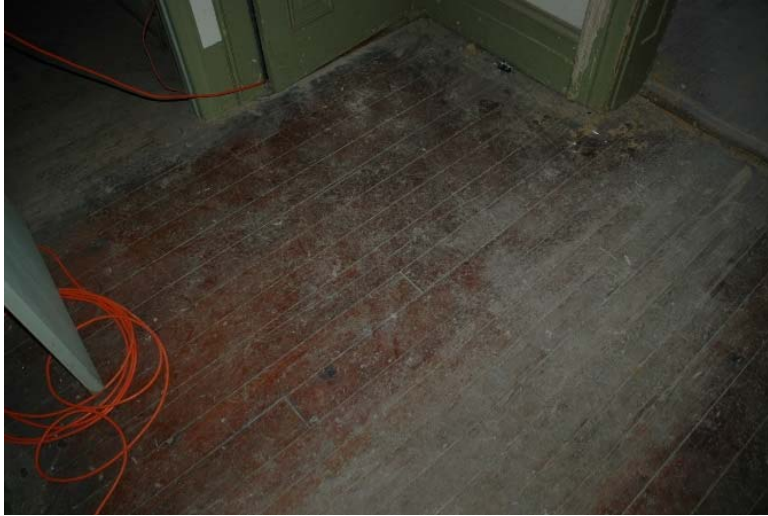
*Figure 1.5-28: View of floor wear in Room 105. Note more serious wear at flooring near the east door in the upper right corner.*

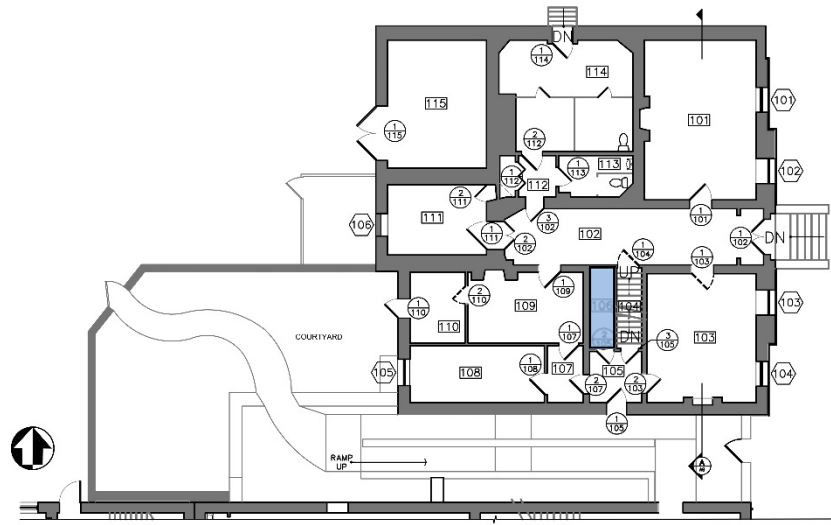
## Room 106

Walls: The plaster walls are in fair condition with a large area of spalling on the west wall and evidence of water damage at the lower portions of the walls. The plywood walls are in good condition with some fastener damage. The wood baseboards are in fair condition and starting to pull away from walls.

Ceiling: The ceiling is in fair condition with widespread cracking and penetrations throughout.

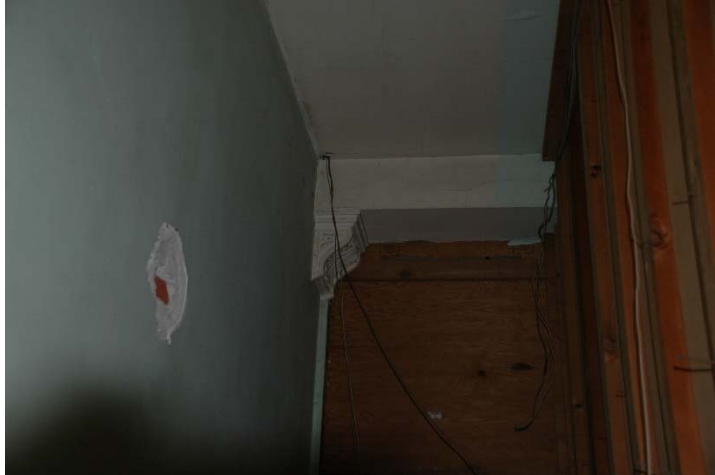
*Figure 1.5-29: View of plaster bracket and plaster damage at west wall in Room 106.*

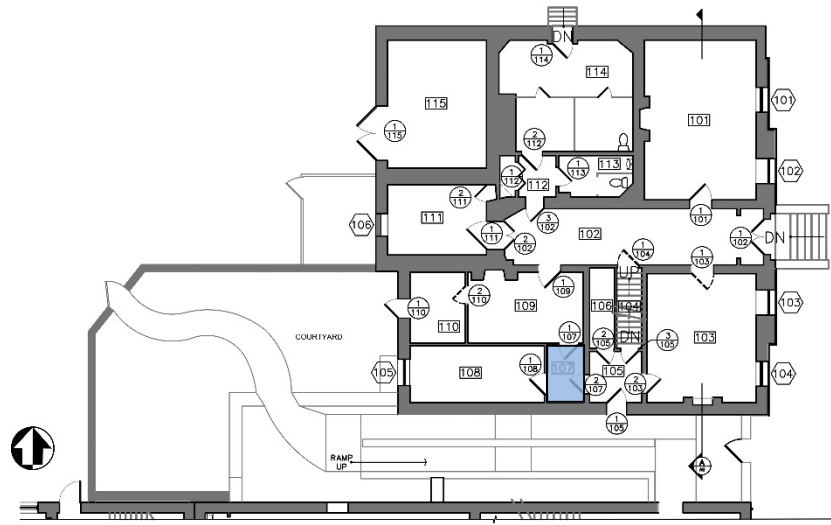
## Room 107

Walls: The walls are in poor condition with small penetrations, plaster cracks, areas of plaster deterioration and failing paint. There is severe water damage on the southwest corner of the drywall partition, exposing the studs and insulation. The wood baseboards are not original but are in good condition. The wainscot on the east wall is in good condition.

*Figure 1.5-30: View of plaster damage in southwest corner (left) and south wall (right) of Room 107.*

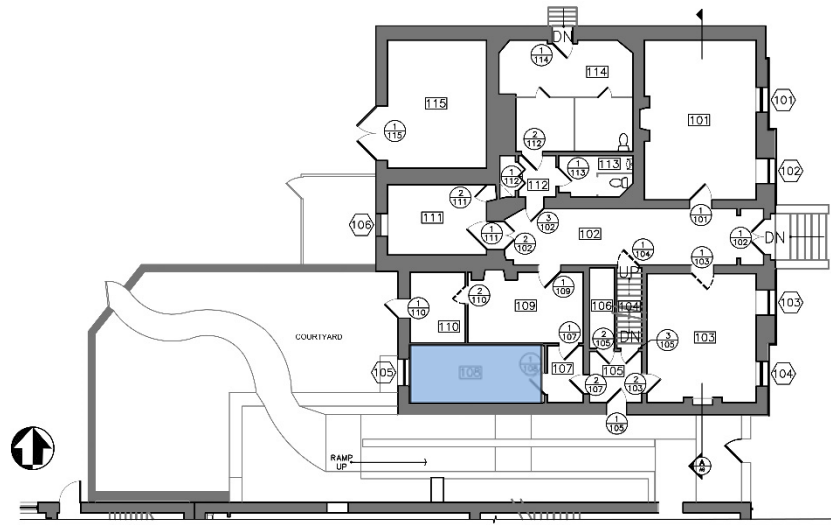
## Room 108

**Walls:** The plaster walls are in fair condition with small penetrations, plaster cracks, areas of plaster deterioration and failing paint. The north drywall partition is in good condition with a hole cut on the west side. The wood baseboards are in good condition. The beadboard wainscot is in fair condition on the south wall and poor condition on the west wall.

**Ceiling:** The ceiling is in poor condition with cracking near the perimeter, large areas of missing plaster and wood lath, and exposed second-story framing.

*Figure 1.5-31: Detail view of wood wainscot damage in Room 108. Note plaster wall damage behind the wainscot and mechanical system penetration at wood floor (right). Detail view of plaster ceiling damage in Room 108 (left).*

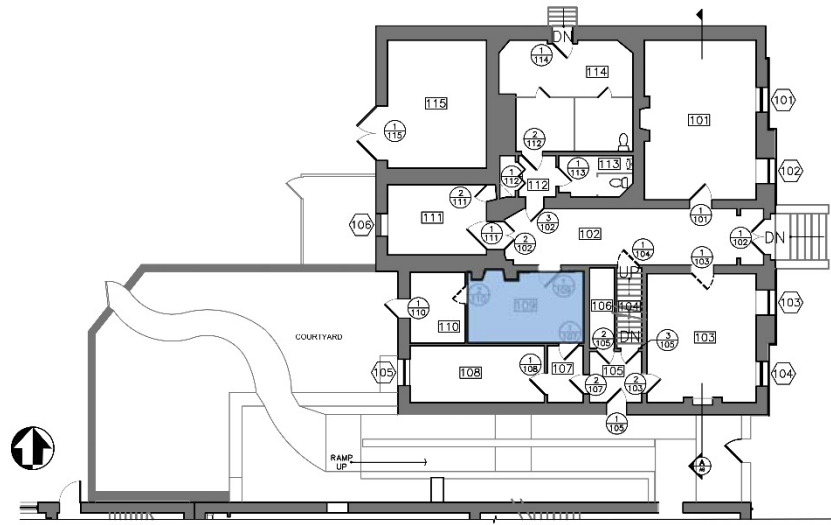
## Room 109

**Walls:** The plaster walls are in fair condition with small penetrations, plaster cracks, areas of plaster deterioration and failing paint. The drywall partitions are in good condition. The wood baseboards are in good condition and the beadboard wainscot is in fair condition.

*Figure 1.5-32: View of fastener damage at east wall (left) and flooring wear (right) in Room 109.*

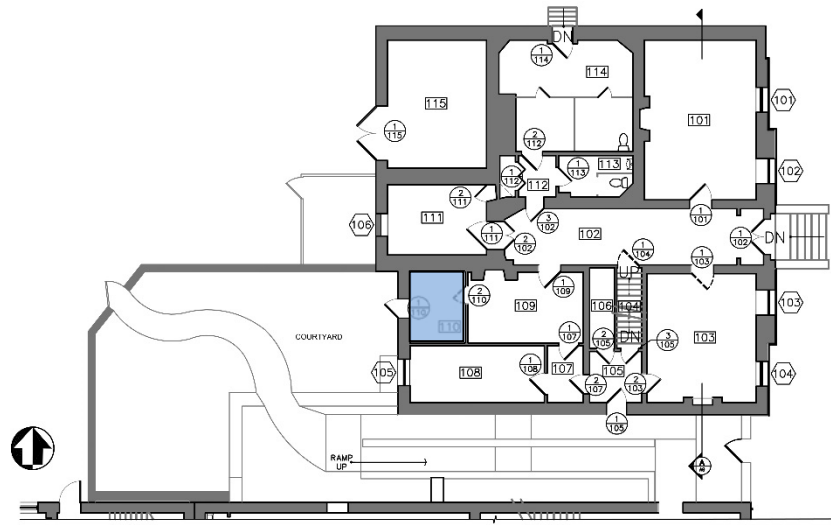
## Room 110

Walls: The plaster walls are in poor condition; there are penetrations, plaster cracks, areas of plaster deterioration and paint failure, especially around the exterior door. The drywall partitions are in good condition. The baseboards are in fair condition and the wainscot is in poor condition; the boards are splitting and warping, missing in areas and the paint is failing.

*Figure 1.5-33: View of plaster damage at west door (top left) and north wall (bottom) in Room 110. View of penetration in the south drywall partition.*
