HISTORIC STRUCTURE REPORT

THE SHERIFF'S HOUSE  
FIRST STATE NATIONAL HISTORIC SITE  
NEW CASTLE, DE

FINAL

*Submitted by:*  
JOHN MILNER ARCHITECTS, INC.  
SEPTEMBER 16, 2016

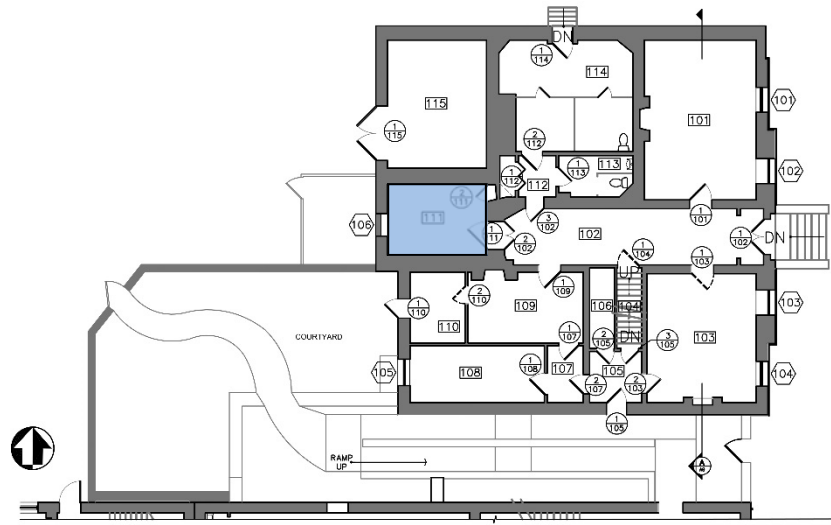
## Room 111

**Floor:** The floor is not original and is in poor condition. More than fifty percent of the concrete and stone floor has been removed, exposing pipes that are running east-west for the entire length of the room. Impressions for wood sleepers are visible. Remnants of the original narrow strip flooring are intact near the closet.

**Walls:** The walls are in fair condition overall with minor water damage at lower portions, spalling plaster and adhesive staining. The wood baseboards are exhibiting splitting and bowing due to water damage.

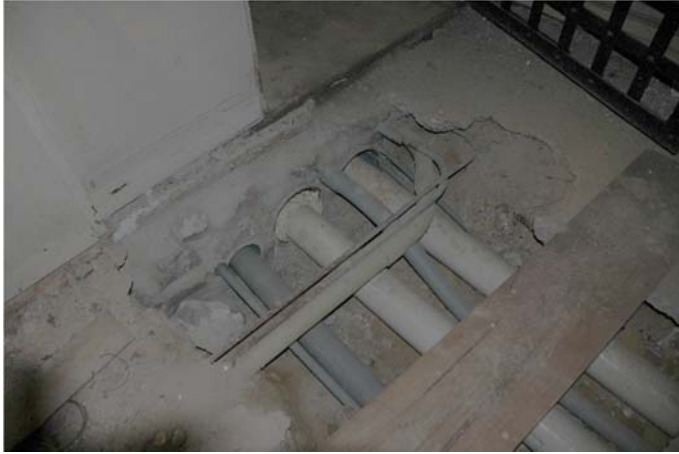
*Figure 1.5-34: Detail view of badly damaged floor in Room 111.*

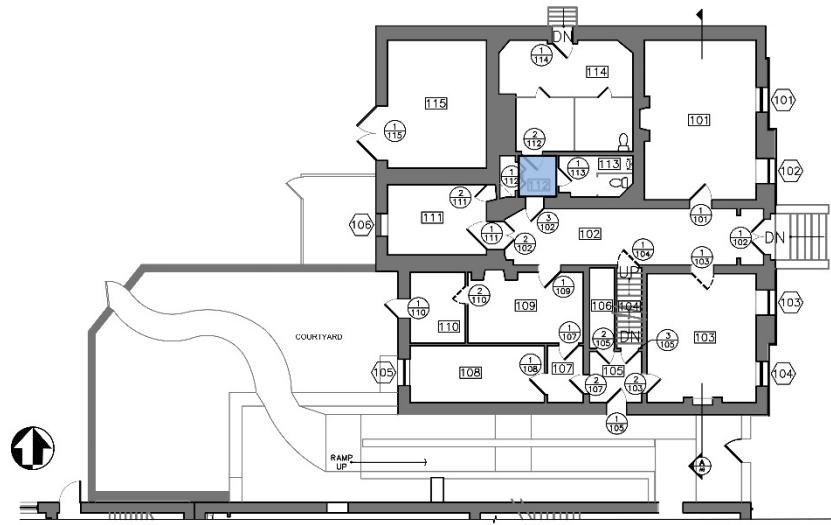
## Room 112

Floor: The epoxy floor in Room 112 is in fair condition, exhibiting minor spalling and damage.

Walls: The plaster walls are in poor condition with widespread cracking, spalling, large and small penetrations and areas where the plaster is missing entirely. The drywall partitions are in good condition overall. The baseboards are a combination of wood and epoxy and are in good condition.

Figure 1.5-35: View of cracking at ceiling (left) and 20<sup>th</sup> century epoxy flooring (right) in Room 112.

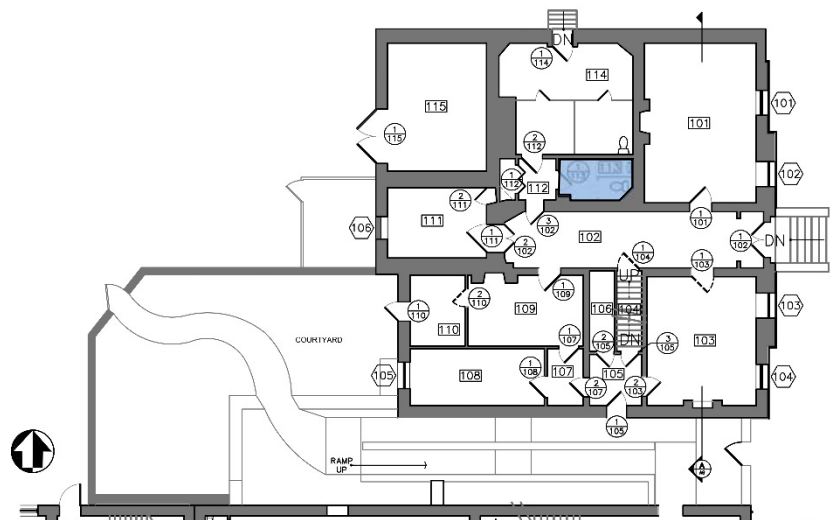
### Room 113

Floor: The epoxy floor is in fair condition with some areas that are damaged and spalling.

Walls: The plaster walls are in poor condition with widespread cracking, particularly on the north wall. There are areas of spalling, penetrations including a large hole at the plumbing chase, and areas where the plaster is missing entirely. Overall, the drywall partitions are in good condition. The epoxy “baseboards” are in poor condition and deteriorating.

Plumbing: All elements of the previous plumbing system are in poor condition; the systems have been drained of water and look to have been non-functioning for an extended period of time.

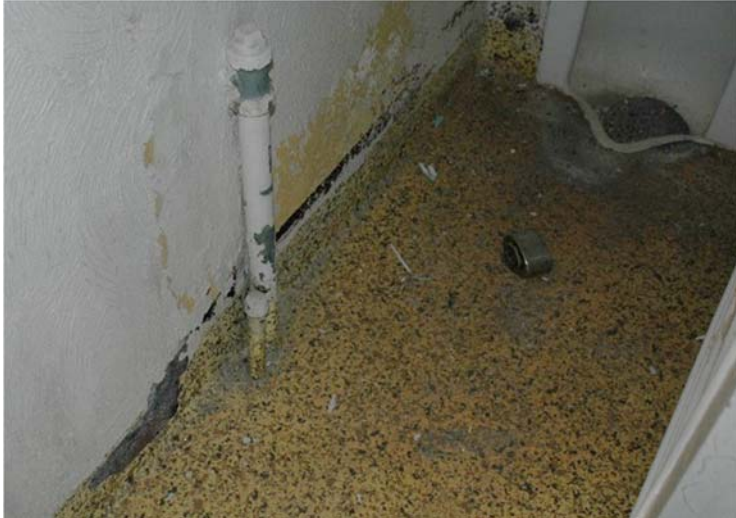
*Figure 1.5-36: Detail view of epoxy floor and damaged integral base in Room 113.*

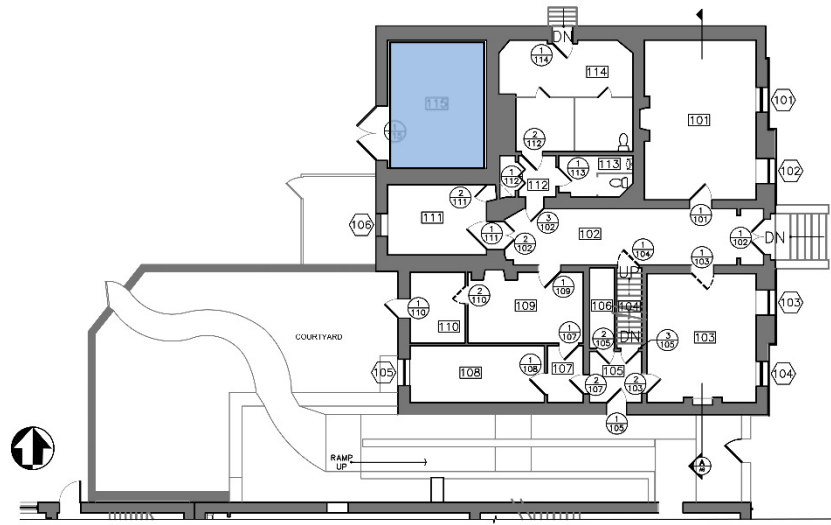
Room 115:

Floor: The concrete floor is in good condition with only minor chipping and wear at the edges of the concrete equipment pad.

Walls: The plaster throughout the room has been patched in multiple locations and in several different campaigns. None of the patches are well-matched or blended with the remaining portions of original plaster, but they are sound. Portions of the original plaster at the north wall near the floor have detached and fallen away from the rubble stone masonry.

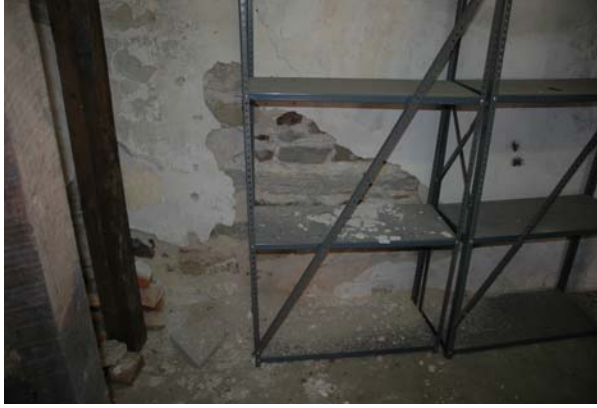
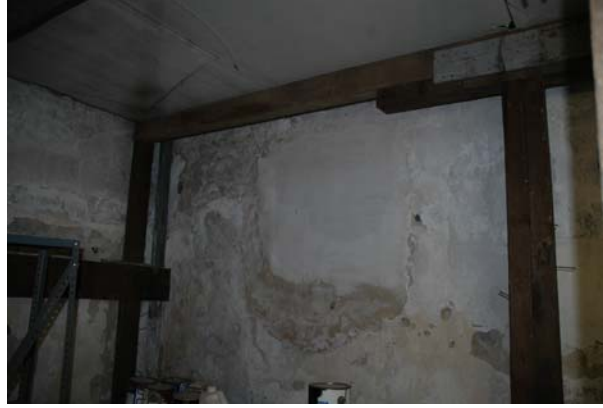
*Figure 1.5-39: Detail view of plaster damage (left) and plaster patches (right) in Room 115.*

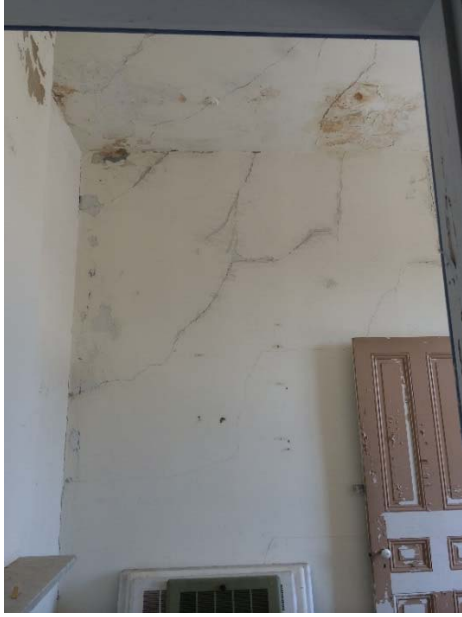
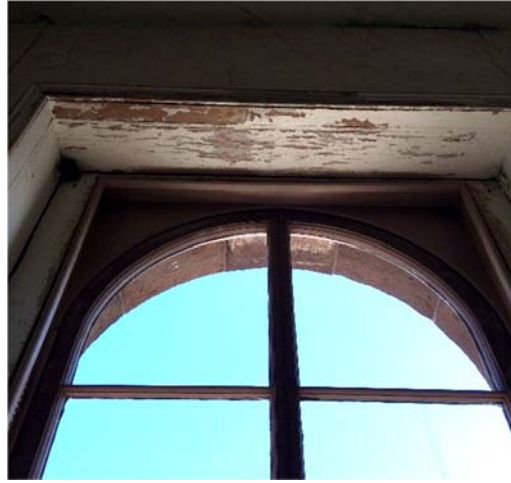
**Walls:** The walls are in poor condition; there are large plaster cracks, deteriorating plaster and chipping and peeling paint. There are large plaster cracks and exposed lath on the closet walls. There is a square opening cut into the south drywall partition. The wood baseboards are original and in good condition with minor paint failure.

**Ceiling:** The ceiling is in poor condition: severe plaster cracks and paint failure throughout. There is a large hole in the closet ceiling, exposing wood lath and the attic framing above.

**Windows:** Window 201 is generally in good condition, however water damage is evident. The sashes were replaced in kind; it is possible that the original glass was salvaged and reused. The window sill is in fair condition with some checking, ultraviolet deterioration, minor splitting and paint failure throughout.

*Figure 1.5-40: South view of wall and ceiling plaster cracking and water damage in Room 201 (left) Detail view of water damage at window head in Room 201 (right).*

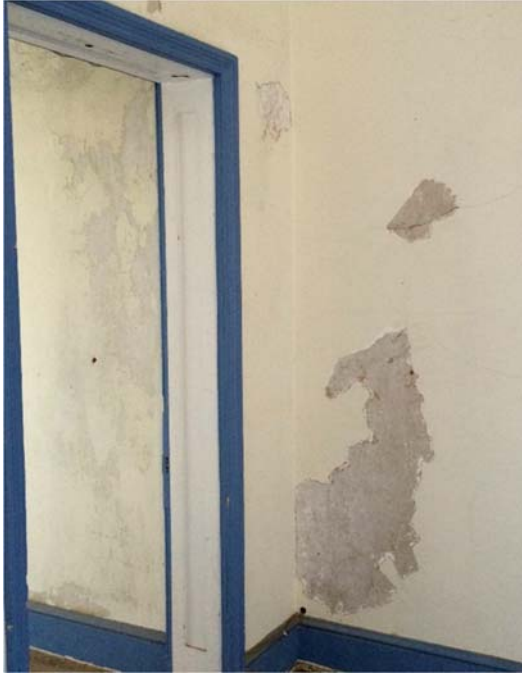
**Walls:** The walls are in poor condition; there are large plaster cracks, chipping and peeling paint, and severely deteriorating plaster, particularly on the west wall. There is a hole in the south wall for modern wires.

*Figure 1.5-42: Detail view of paneled jamb at door to Room 203 from Room 205. Note plaster damage at wall (right).*

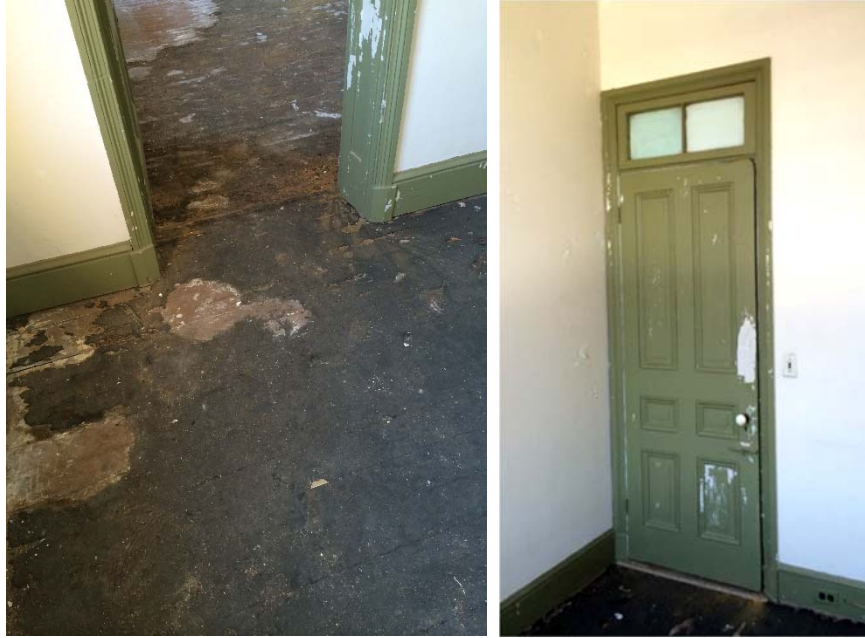
Floor: Modern flooring has been installed over the original wood floor, making assessment of the original wood flooring difficult. The modern flooring system is deteriorated and in poor condition.

*Figure 1.5-43: Detail view of modern flooring remnant over original floor in Room 204 (left). Detail view of west door and transom in Room 204 (right).*

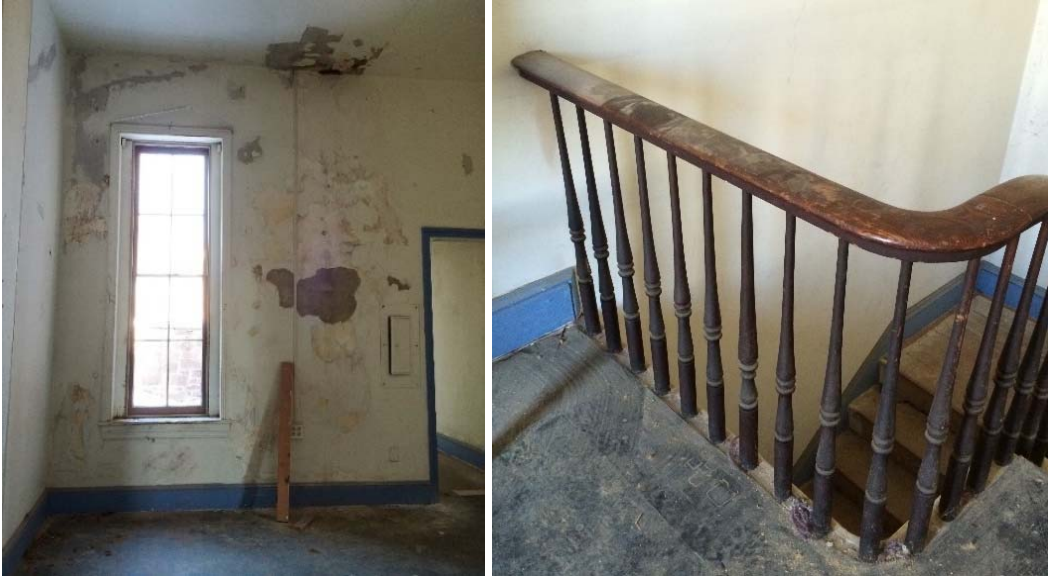
Ceiling: The ceiling is in poor condition with a large areas of missing plaster, exposing the wood lath. There are also plaster cracks and deteriorating paint.

*Figure 1.5-44: North view of plaster damage in Room 205 (left).  
Detail view of second floor stair balustrade in Room 205 (right).*

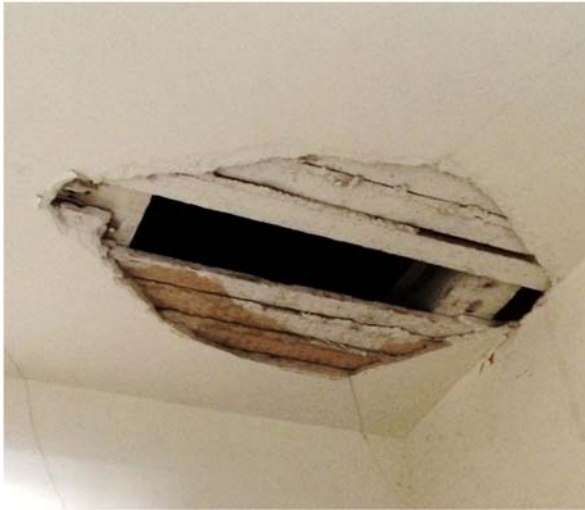
**Ceiling:** The ceiling is in poor condition. There are severe plaster cracks throughout, accompanied by paint failure. There is a large hole in the ceiling, exposing wood lath and the attic framing above. The lath is missing in the center of the hole in the ceiling.

*Figure 1.5-45: Detail views of damaged and missing plaster in Room 206 (left).*

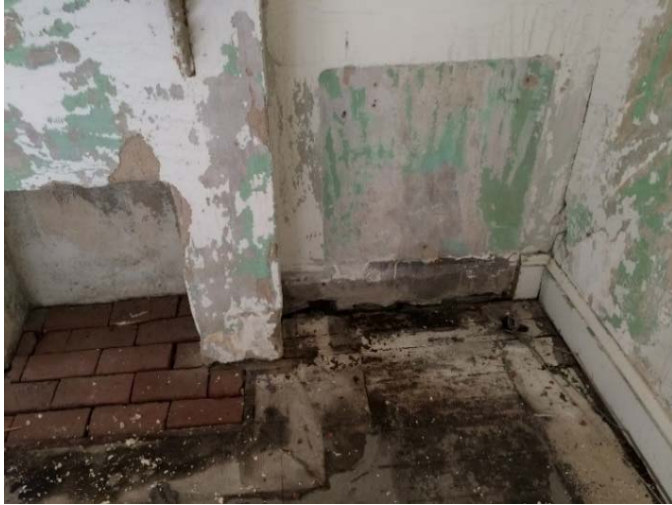
**Walls:** The walls are in poor condition, exhibiting plaster cracks, areas of deteriorating plaster and failing paint. There is a large plaster crack in the southeast corner of the closet. There are several penetrations, mostly for electrical wiring, which is no longer in use. The original baseboards are in poor condition and missing in some sections.

*Figure 1.5-46: Detail view of plaster and wood base damage at Room 207 (left).*

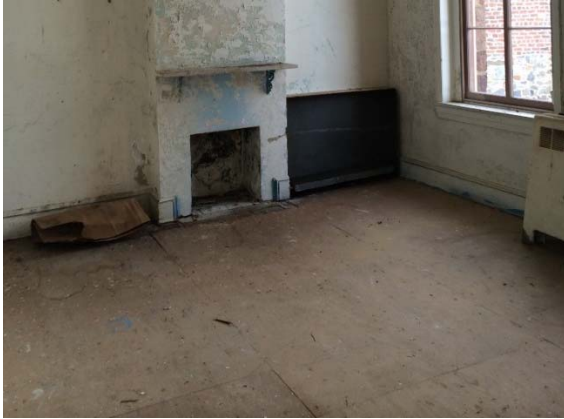
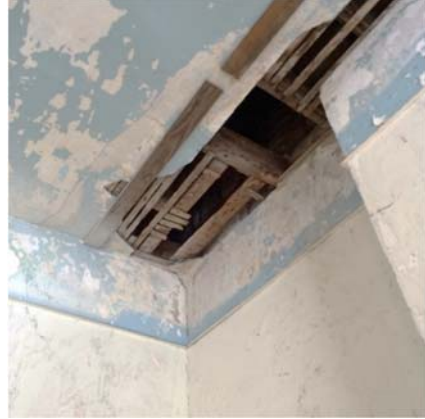
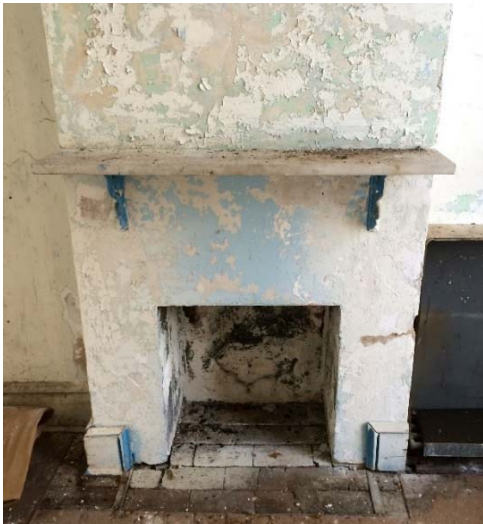
**Floor:** Large sheets of plywood have been installed on top of the original floors, making assessment of the original wood flooring difficult. The original wood floor, however, appears to be rotting in several areas. The original brick hearth is extant and in fair condition with some cracking.

**Ceiling:** The ceiling is in poor condition, exhibiting severe plaster damage. There is a large hole in the south end with exposed lath and floor joists.

*Figure 1.5-47: Detail view of plywood covering in Room 208 (top left). Detail view of damaged and missing plaster in Room 208 (top right). Detail view of fireplace in Room 208 (left).*

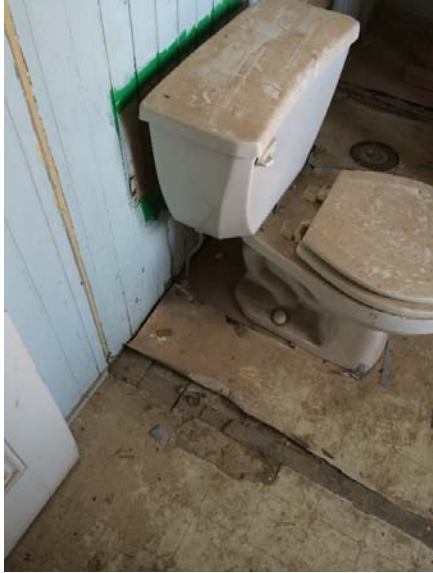
Floor: The linoleum floor is warping, exposing the original wood floors underneath. The wood floors appear to be in fair condition.

Figure 1.5-48: Detail view of modern sheet flooring over wood flooring in Room 209 (left).

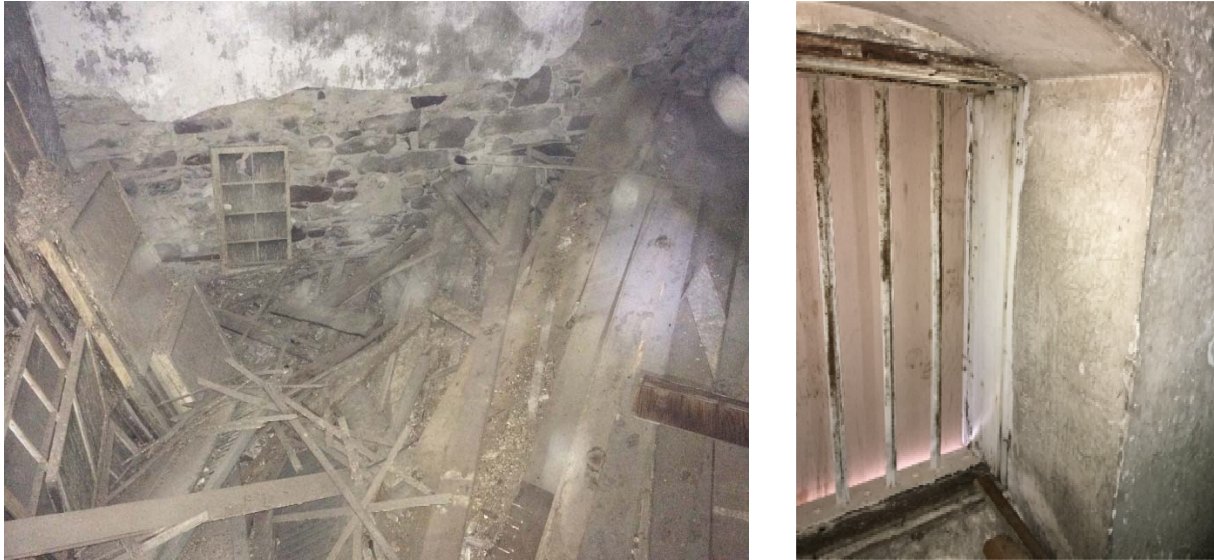
**Walls:** The north, west and south walls are original plaster on masonry though large areas are missing exposing the original rubble stone masonry. Plaster had a painted or whitewash finish.

Door 2/211: The plaster head and jambs at the arched masonry opening are in good condition. The sill has a large crack near the door frame and all of the plaster at the opening exhibits general soiling. The round metal vertical bars in a metal frame are in good condition overall with areas of minor surface rust and significant overall paint loss. The jambs of the wood door frame are in good condition with only minor soiling. The head and sill of the wood frame appear to have been exposed to significant moisture and are beginning to show evidence of rot.

Figure 1.5-49: View of debris on the floor and plaster deterioration at the north wall in Room 211 (left). View of iron bars and deteriorating wood sill and head at Door 2/211 (right).
