UNITED STATES STRATEGIC BOMBING SURVEY

REPORT 72

EFFECTS OF THE FOUR THOUSAND-POUND BOMB

A Report on Five Incidents

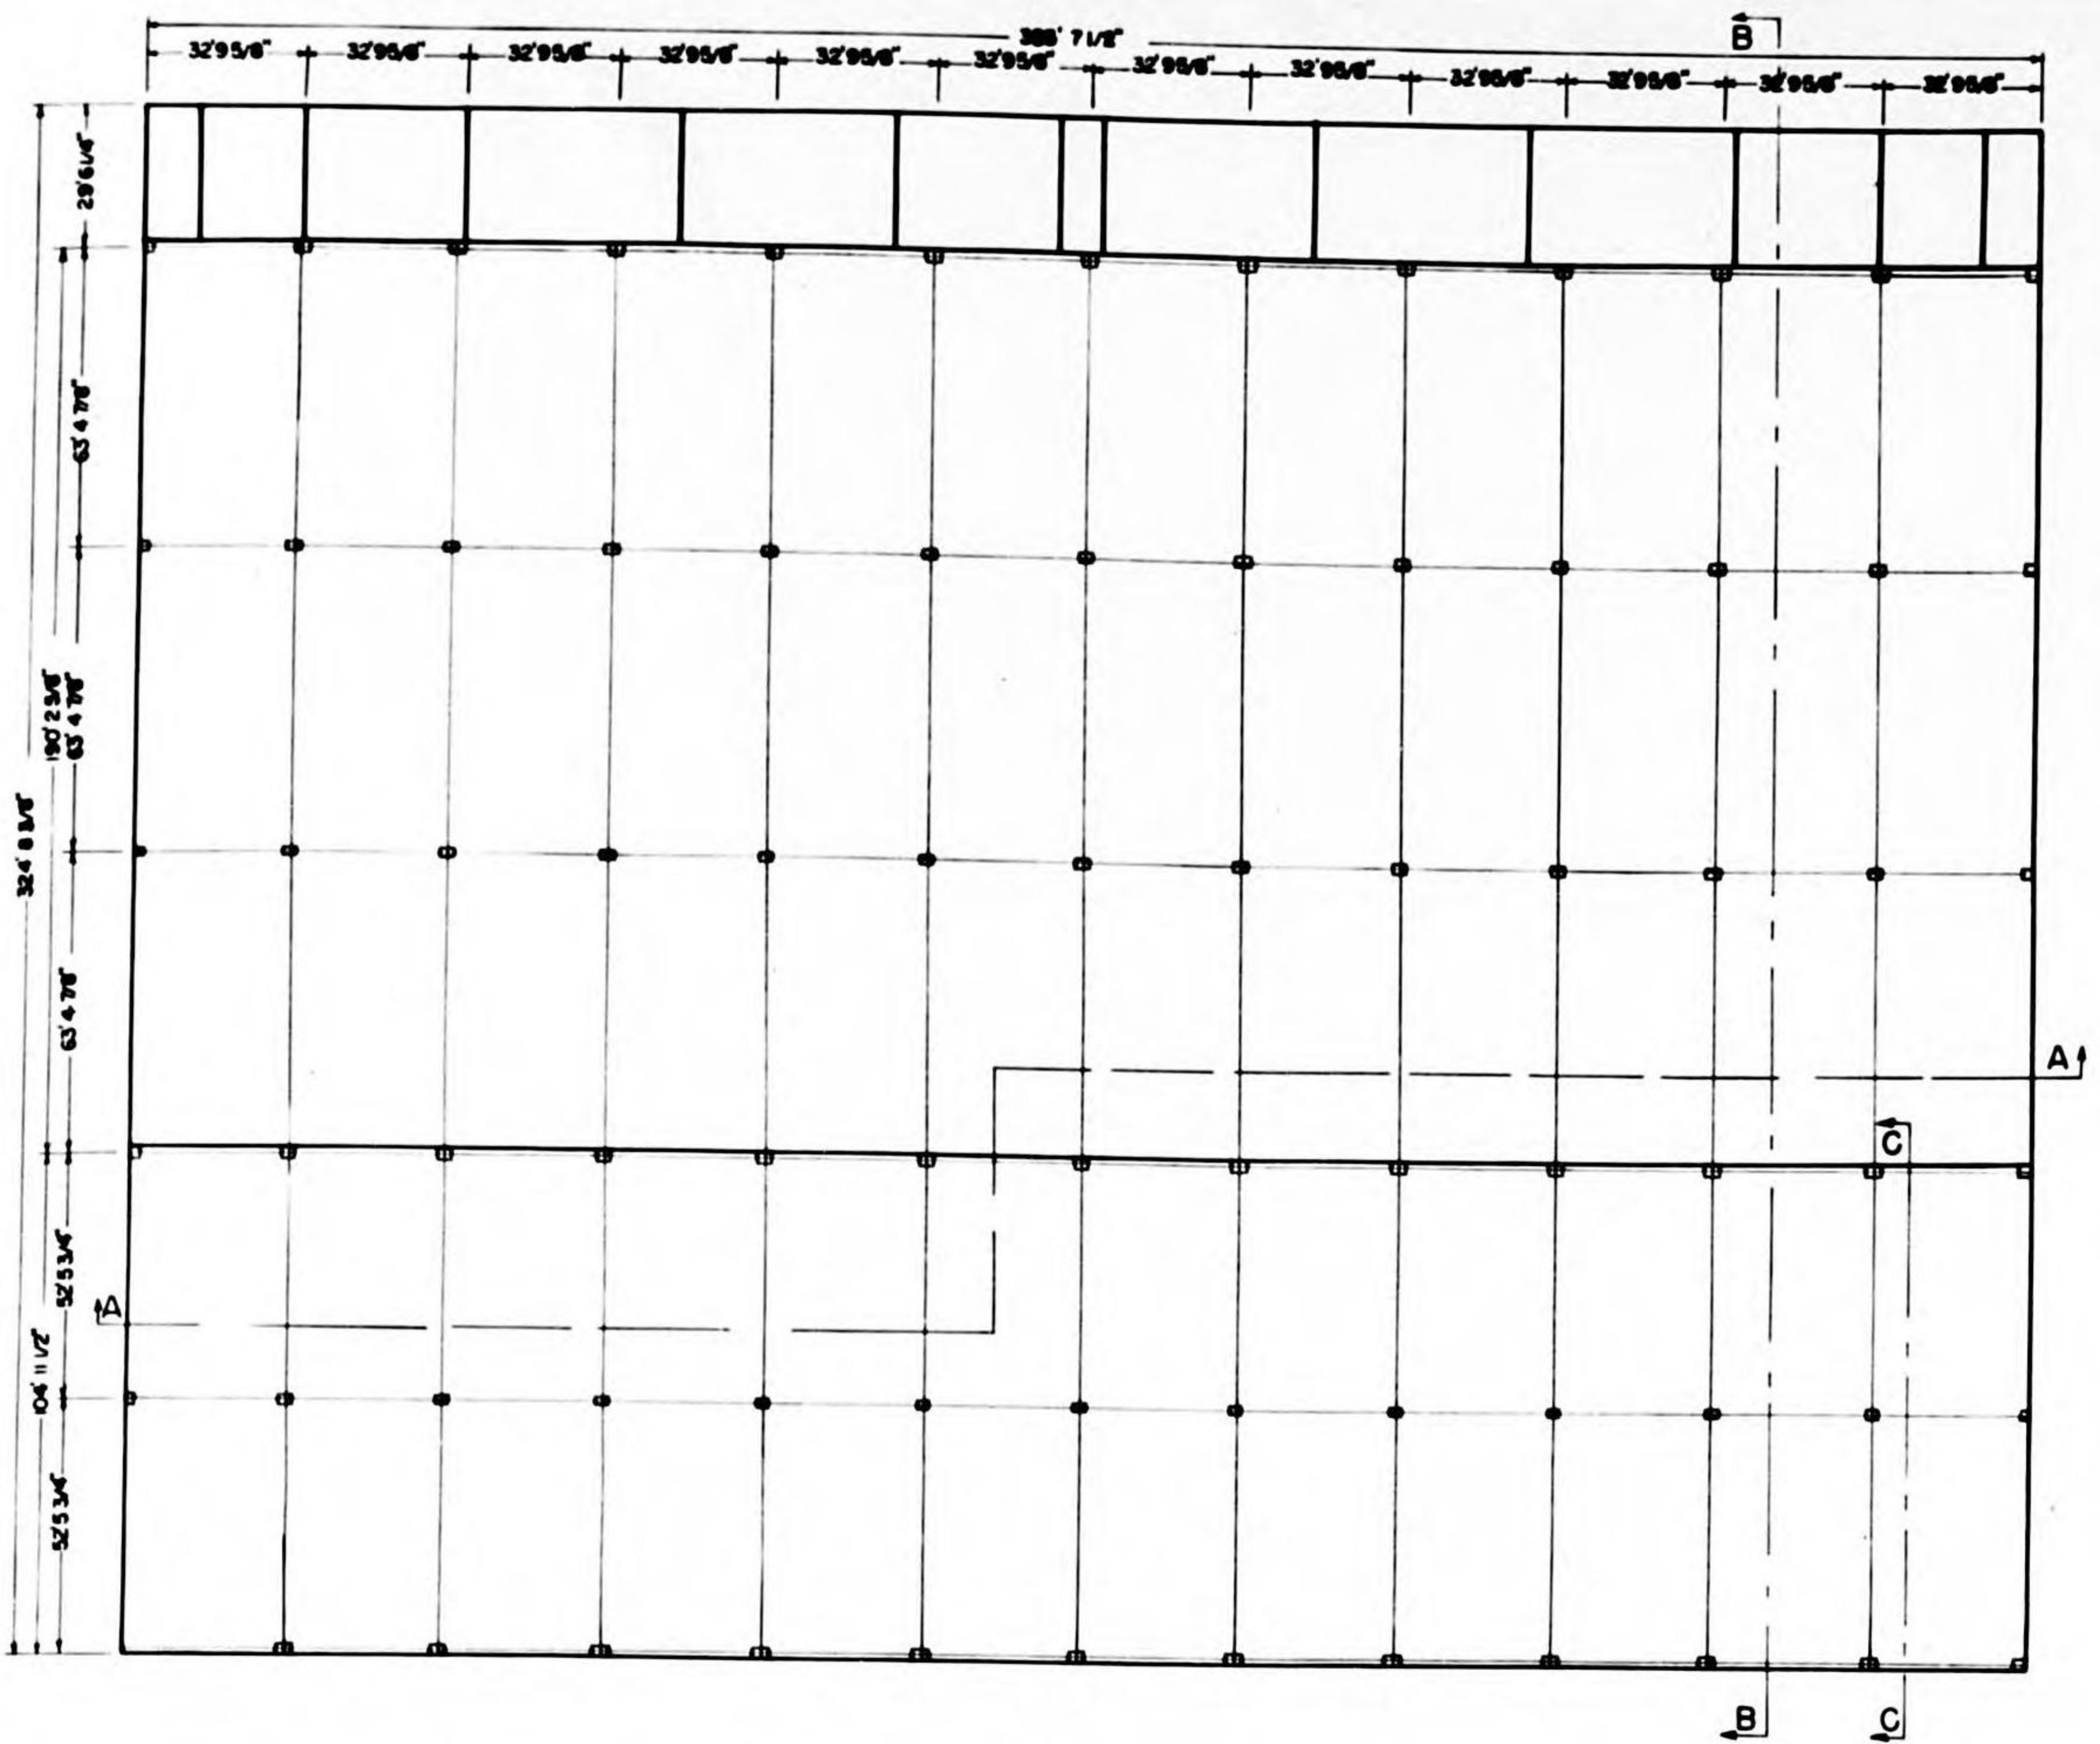
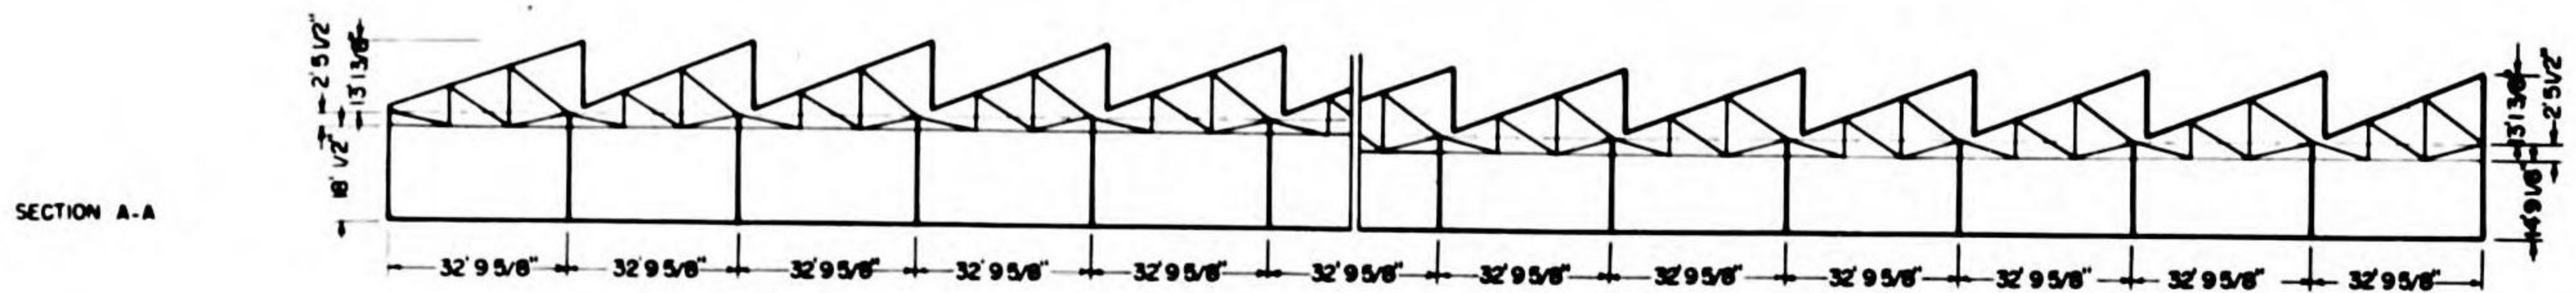
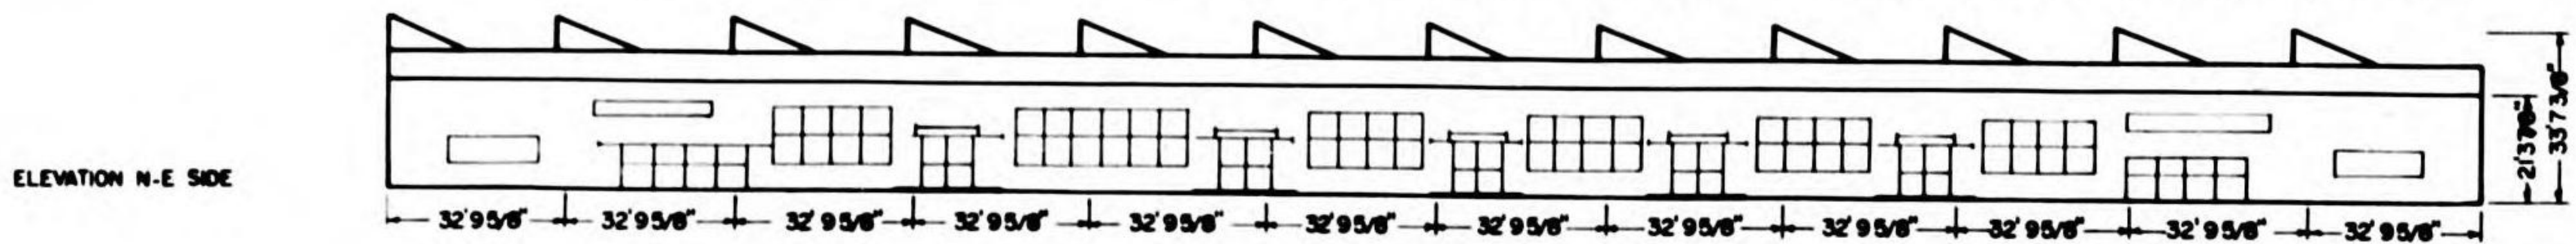
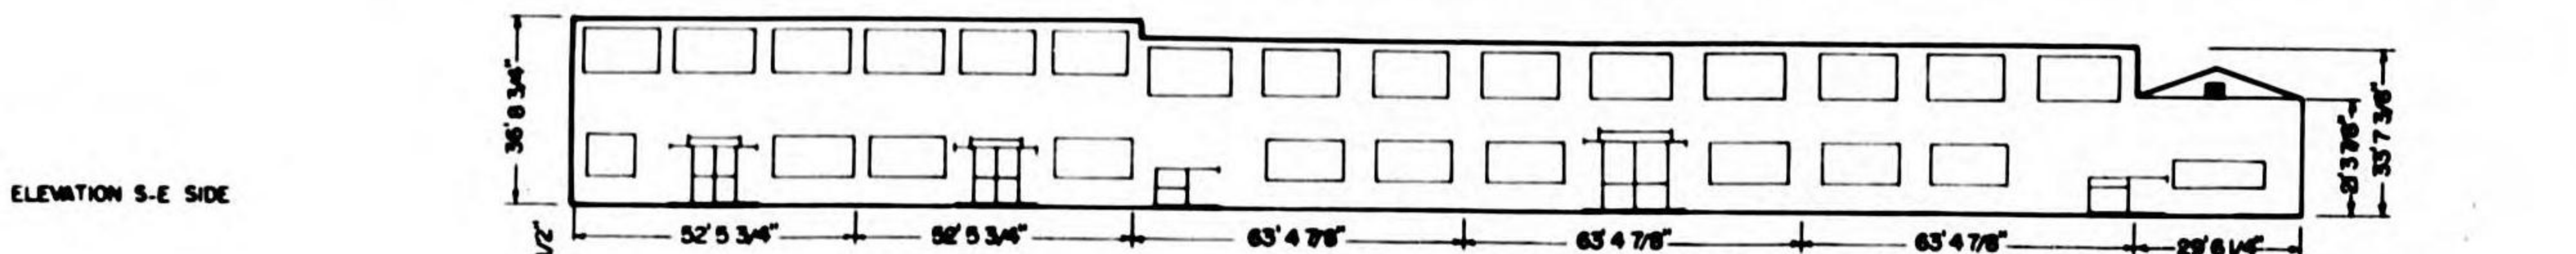
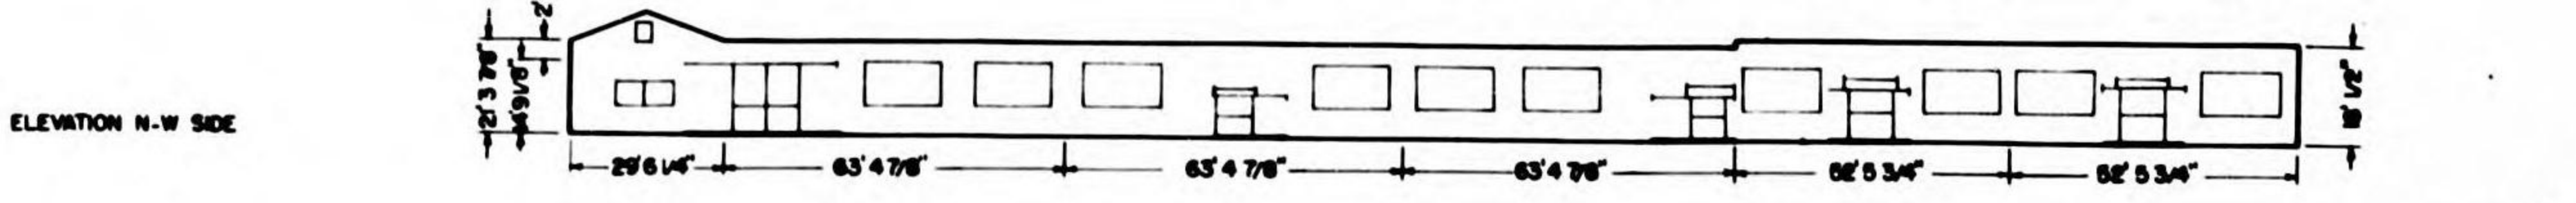
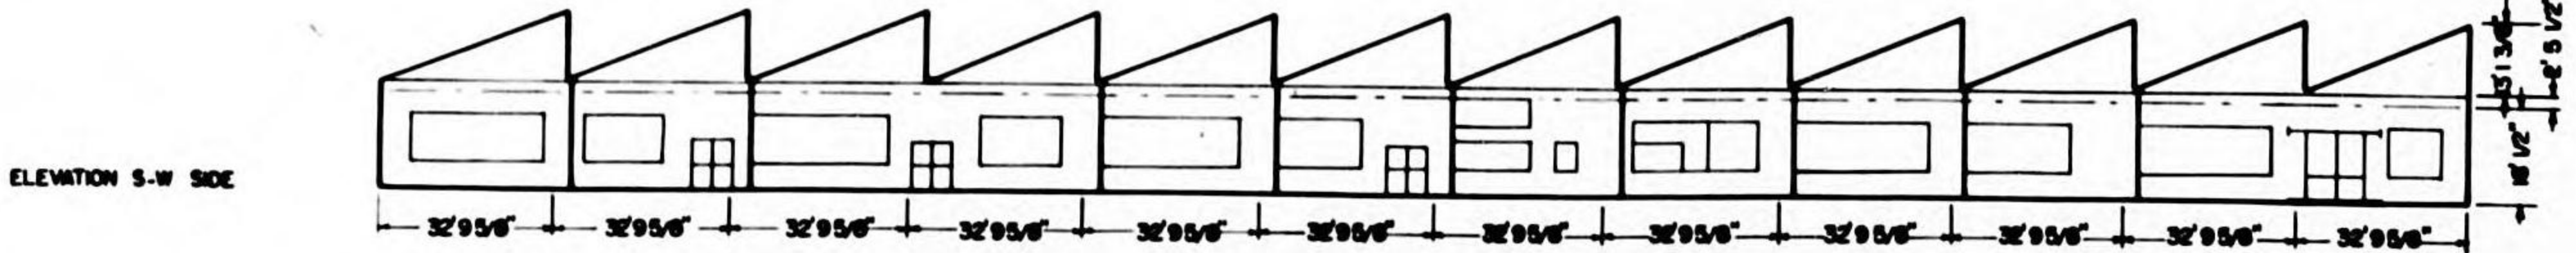
U.S. STRATEGIC BOMBING SURVEY	
KAWASAKI AIRCRAFT INDUSTRIES	
AKASHI PLANT	
BLDG. NO. 182	FIG. 3.

PLAN, ELEVATIONS, & SECTIONS,
OF BLDG. NO. 182
