ACCIDENTS IN MINES,

NORTH STAFFORDSHIRE COALFIELD,

FALLS OF ROOF AND SIDES;

THEIR CAUSES, AND THE MEANS OF DIMINISHING
THEIR FREQUENCY.

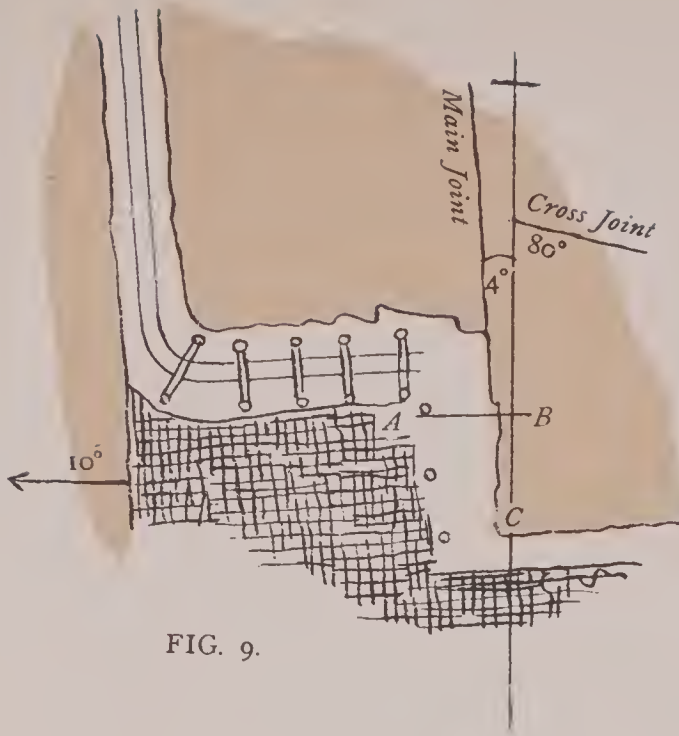
FIG. 9.

Figs. 9 and 10. Plan and Section N. of last Figs. Board and pillar. The latter are about 25 × 30 yds, and are worked off in slices. A small coal pillar 18" square (spurn) is always left at the loose end (C) whilst holing. It is afterwards broken up from a distance by means of a pointed iron rod 9ft. long. These spurns are said to be 5—6 times more efficient than a sprag at a loose end. Main joints run 2'—4' apart, and cross joints 18" to 2'; they often set off or ride over when passing from one band to another. Where the pillars have stood a long while and been subjected to weight by proximity to the gob, the joints open greatly and secondary planes of division of very small extent appear between the joints and branching from them. They are called pincracks, and occur specially in the top stone. Old pillars are consequently easier to work off than new ones, but this method entails more timber and is more dangerous than the other methods. The grits are taken down and leave a clod roof which is full of slips and very treacherous.

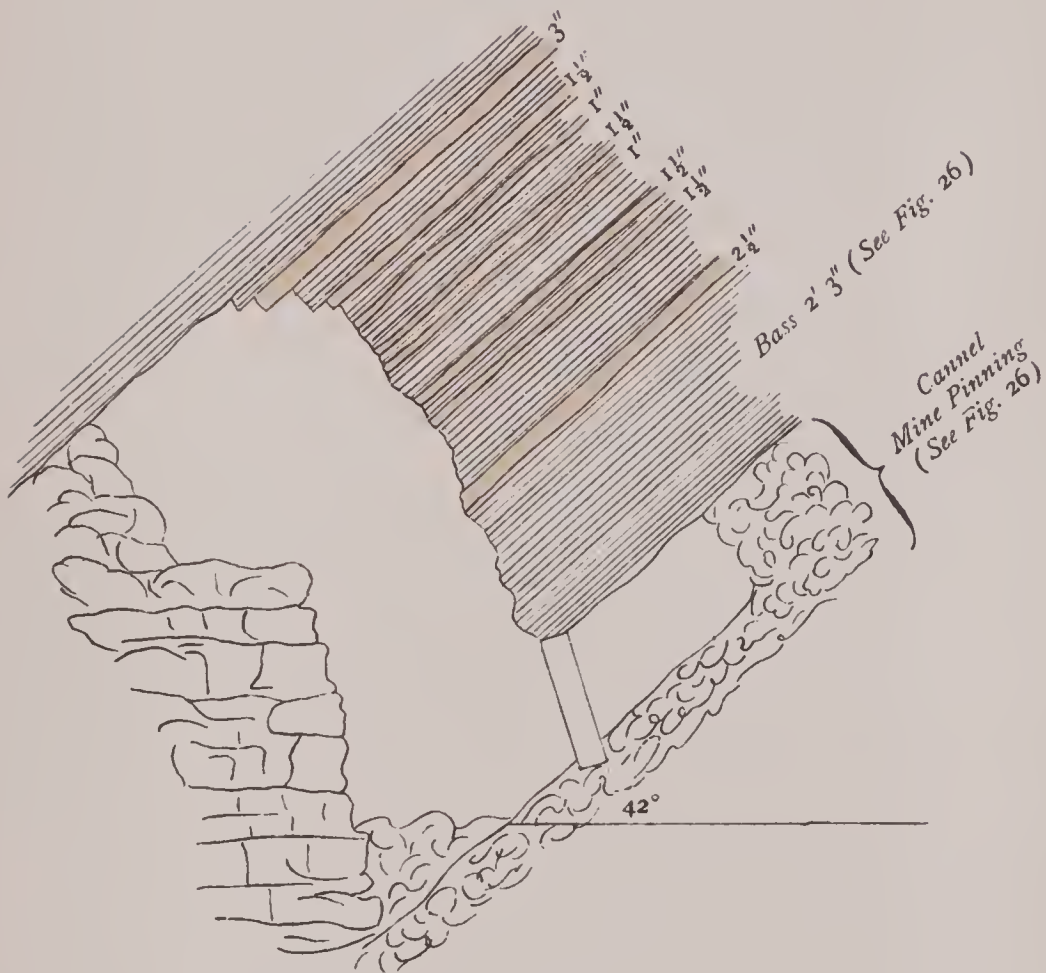
FIG. 21.

Fig. 21. Section C. Worked a considerable time after the Cannel Mine Ironstone which underlies it. (Fig. 26). Longwall, drifts 7 yds. on each side of sladder. Gob entirely packed, some bass being sent out. The roof is broken where the Cannel Mine gob has not been well packed. Little timber is otherwise set. A footlid is placed under sprags where the Cannel mine pinning is not solid.

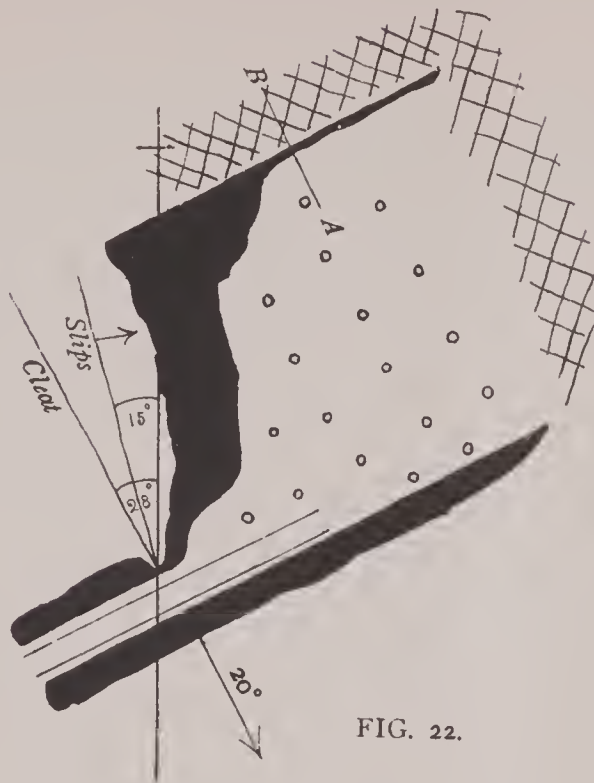
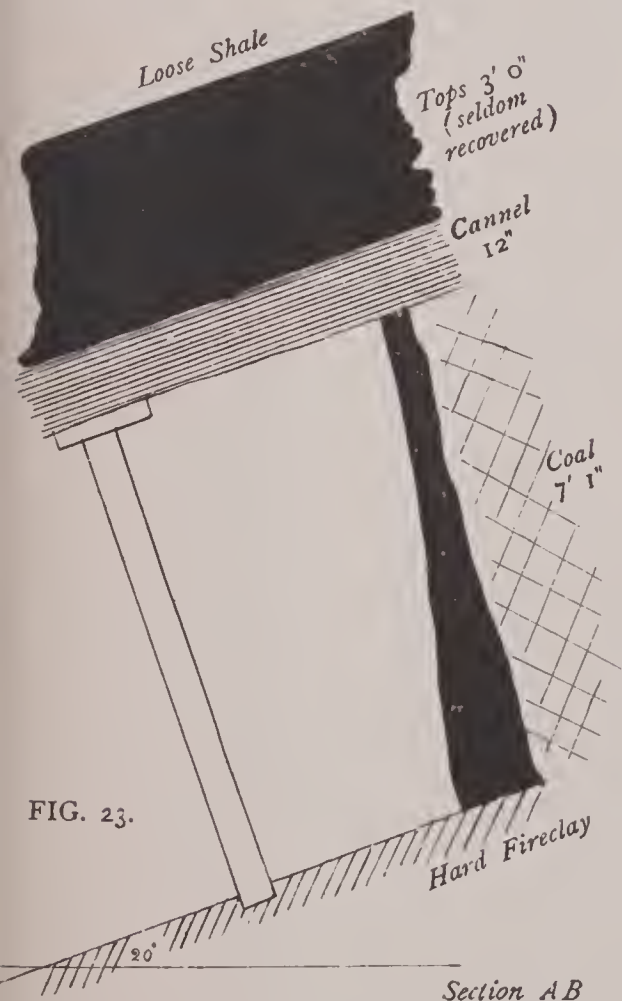
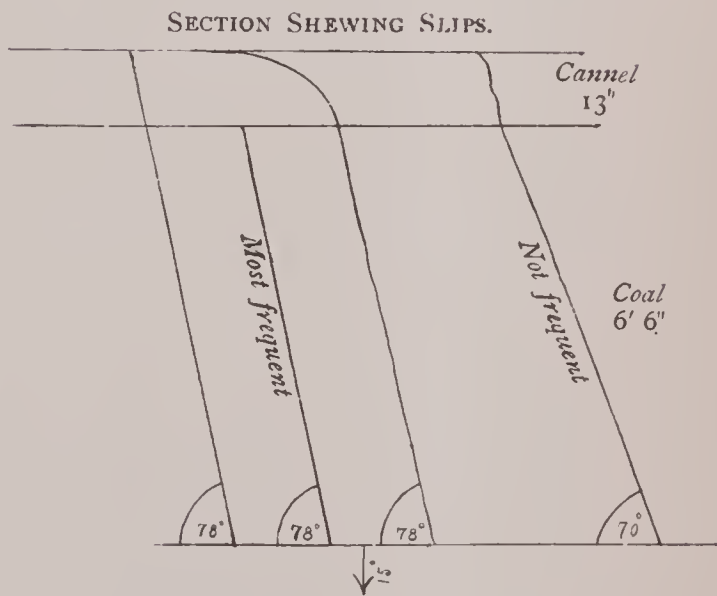
Figs. 22, 23 and 24. Plan and Sections S. Lancashire method. A small rib of coal is left against the gob above; it is tightened by the lifting action of the floor; the inclination of the seam being small the gob d bris has no tendency to push it in. Cleat distinct. Slips from 3'—6', but further in places; from 13°—20° NW. Only a few run through into the Cannel, and some bend over on entering it, but not for any distance. (Fig. 24). A collier was killed whilst pulling down

the Cannel in a dip 8 ft. in width. The Cannel had begun to work and was unsafe. It came off a slip on either side of the dip. The slips were known to be in the coal, but not supposed to run into the Cannel. The Cannel Mine Stone Bands lie 18' above the top coal. They are worked a long time after the coal has been got. Though the intervening strata contain numerous small bands, those lying between the Grits and the Blue Band, which are about 7' apart, are alone worked. Further South the Cannel dwindles down to 2" and the bottom coal thickens. Southwestwards the top coal is 18" thick and very hard and tough, and the bottom coal 5' thick, and they are separated by a bed of Cannel coal 6" thick.

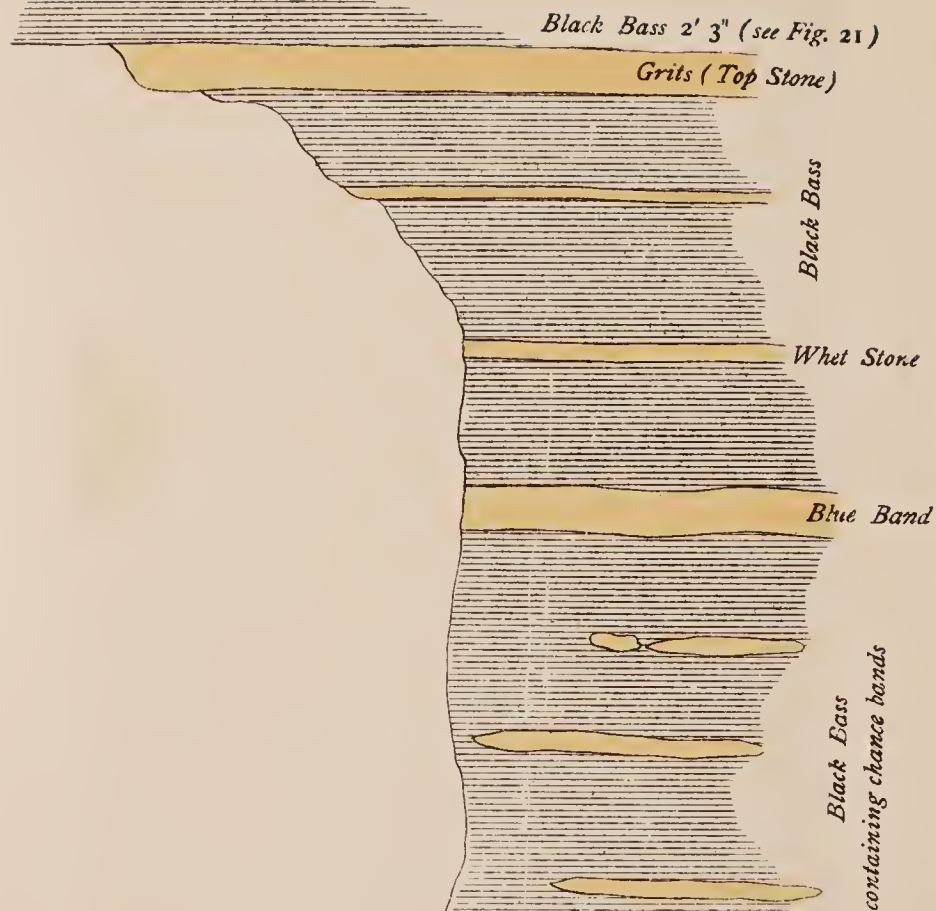
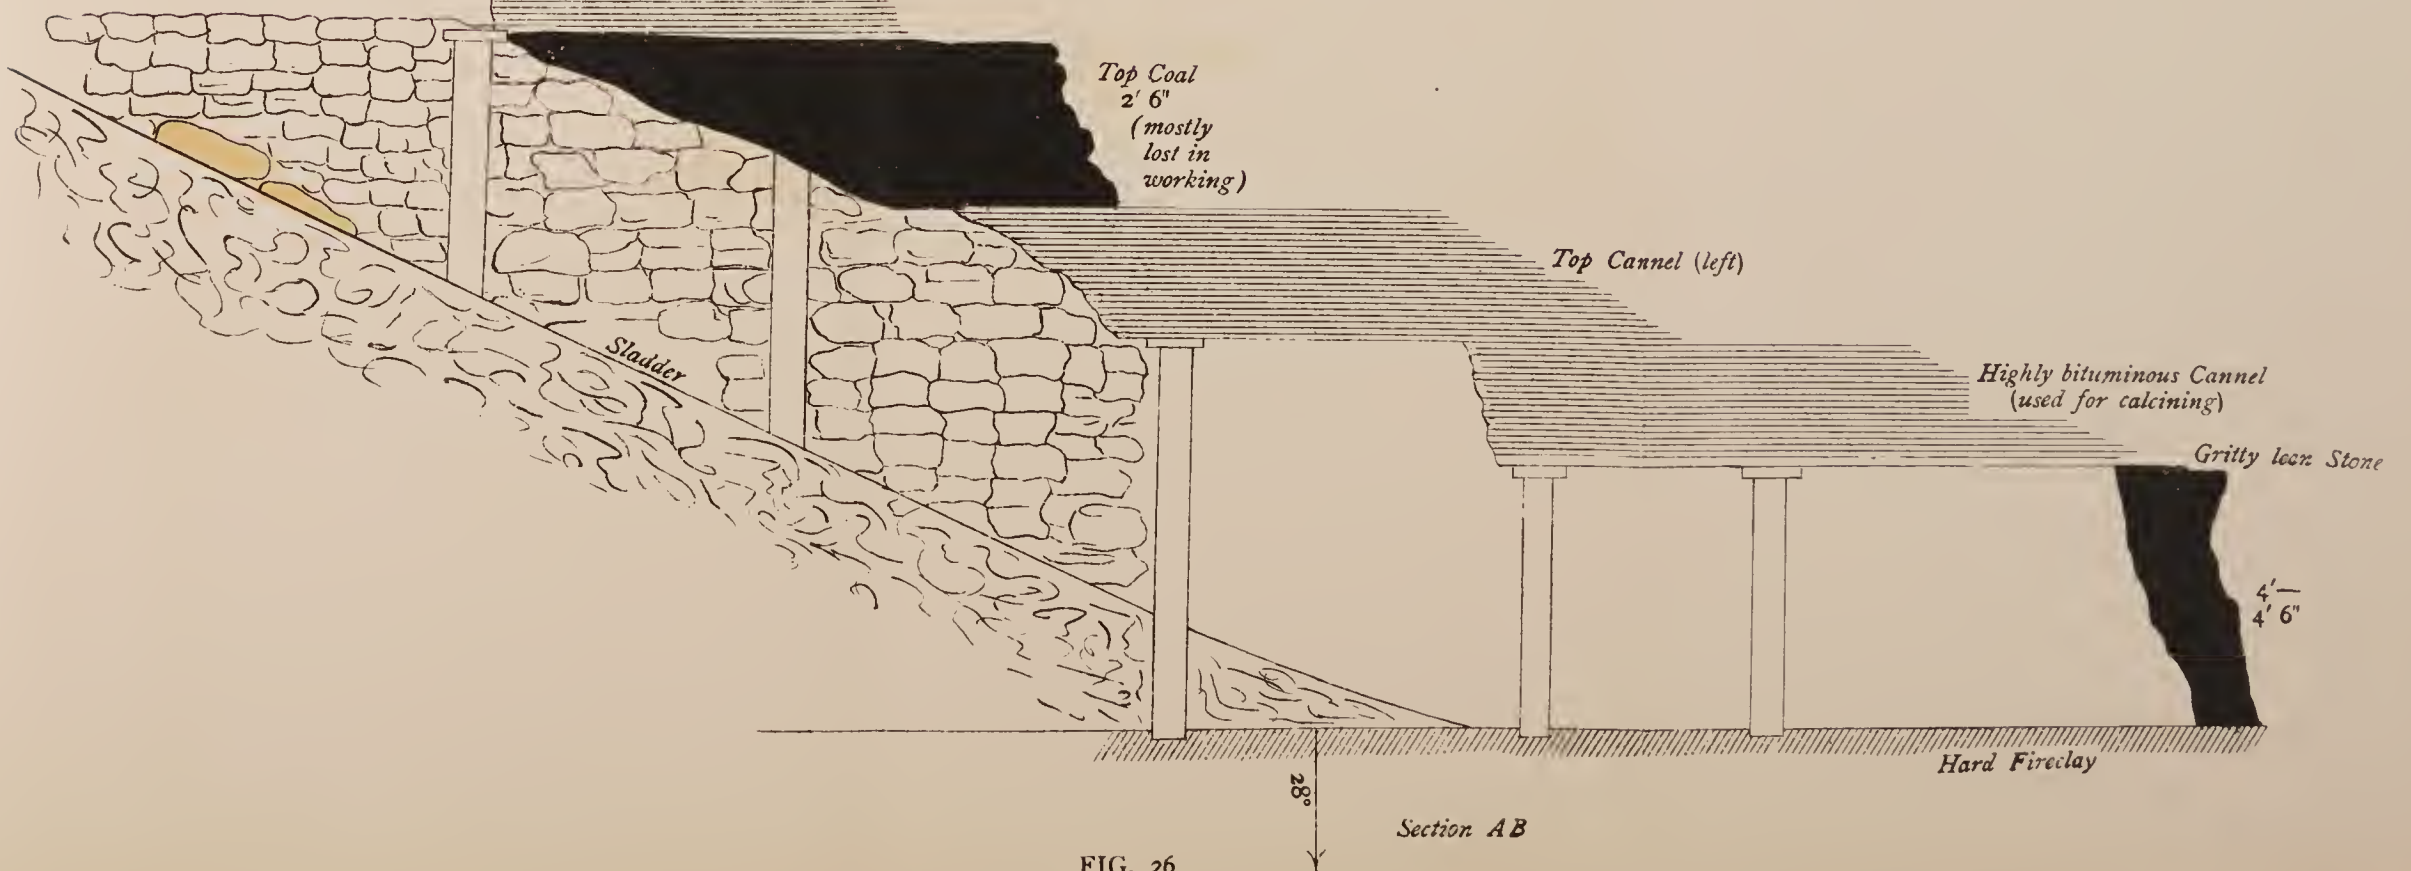
FIG. 26.

Figs. 25 and 26. Plan and Section N. of last Figs. Coal worked by Lancashire method. It is drifted back 18—20 yds. according to the fall of the measures. The old gob above is then slipped and packed under the top coal (unless a fall has taken place preventing it). The stone measures are then turned over; the bottom half in going in and the top half in coming back. A sladder is formed with iron plates, down which the stone is thrown. Hardly any timber is used in the stone work. Cleat distinct. Slips 2—4 yds. apart. Runners not frequent. Joints: in Cannel very distinct, in stone bands irregular, but in the same direction. The bands of stone are very regular.

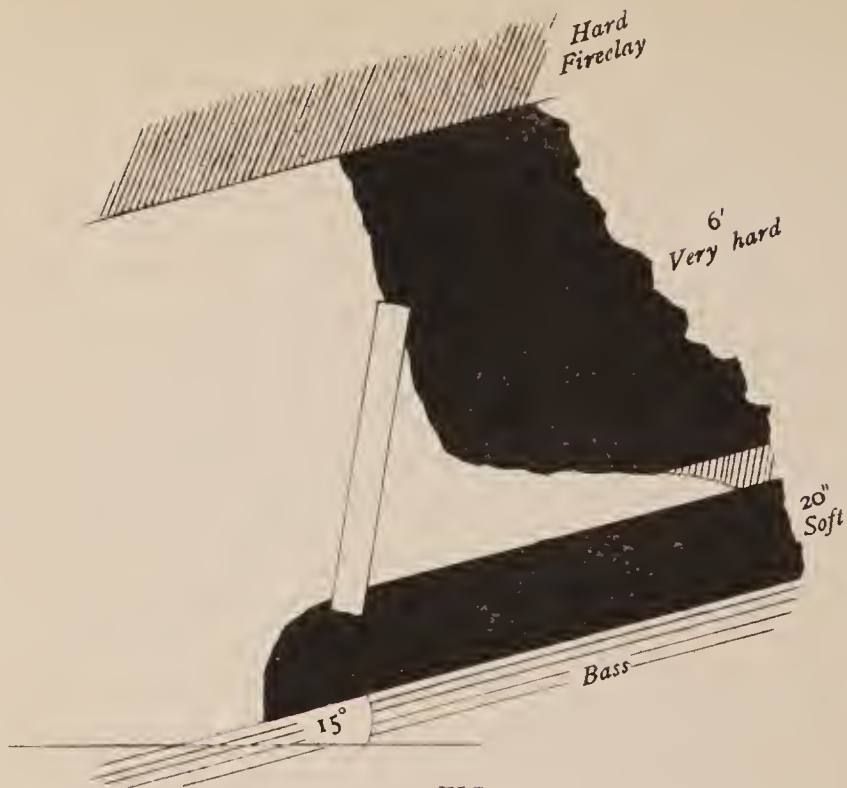
FIG. 34.

Fig. 34. Section SW. Ten tons of roof fell over an area of 20 square yards in an open place intended for a horse gin, near a dip. Seven posts, with stretchers and bars which were supporting it were knocked down; four men were injured, but none fatally.

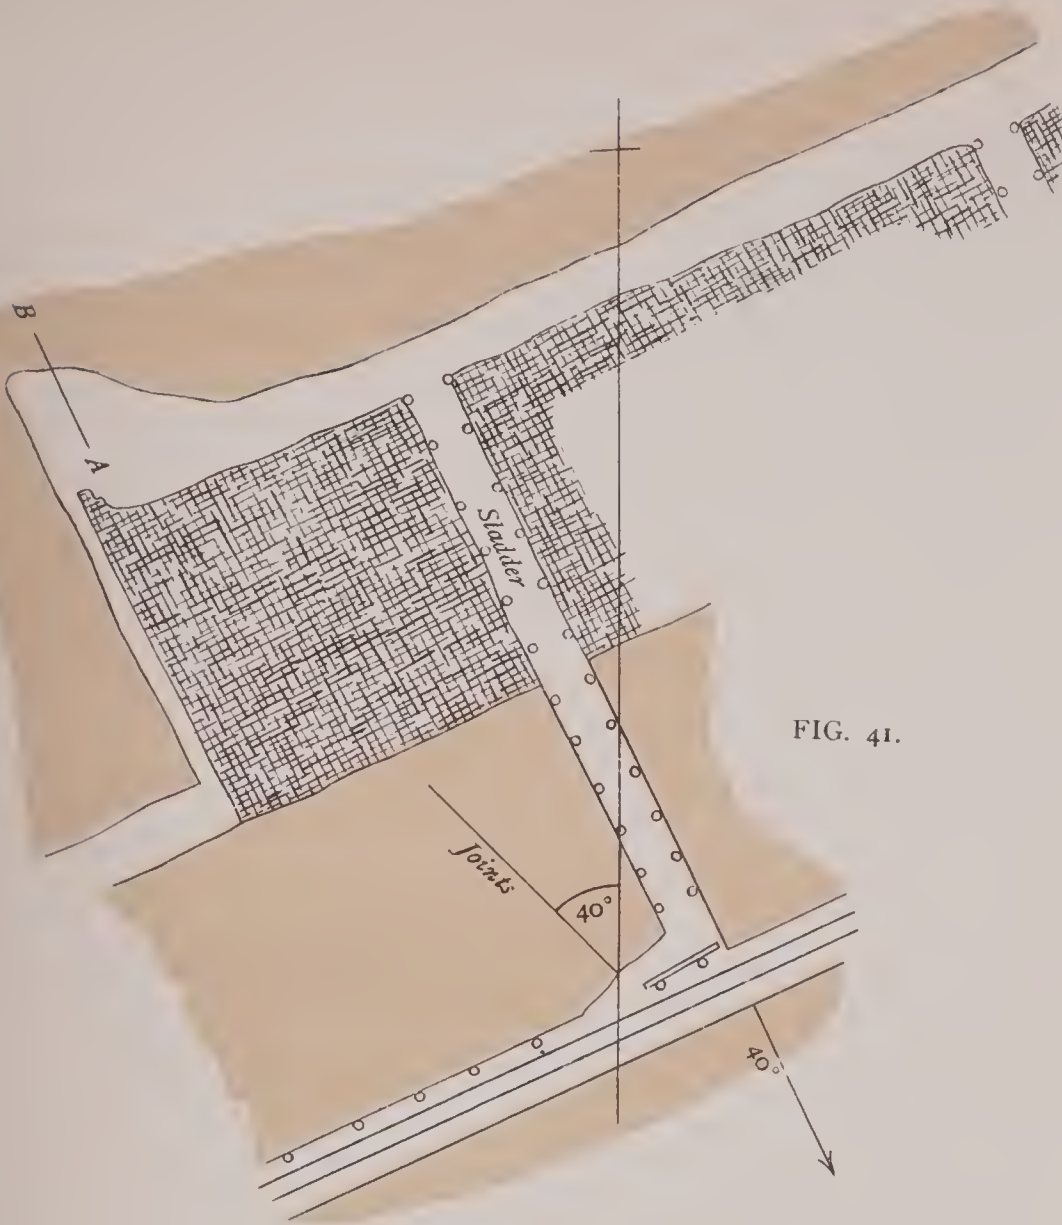
FIG. 41.

Figs. 41 and 42. Plan and Section C. No posts are set. Joints do not run very parallel. They run in the bass bands in the same direction as in the stones.

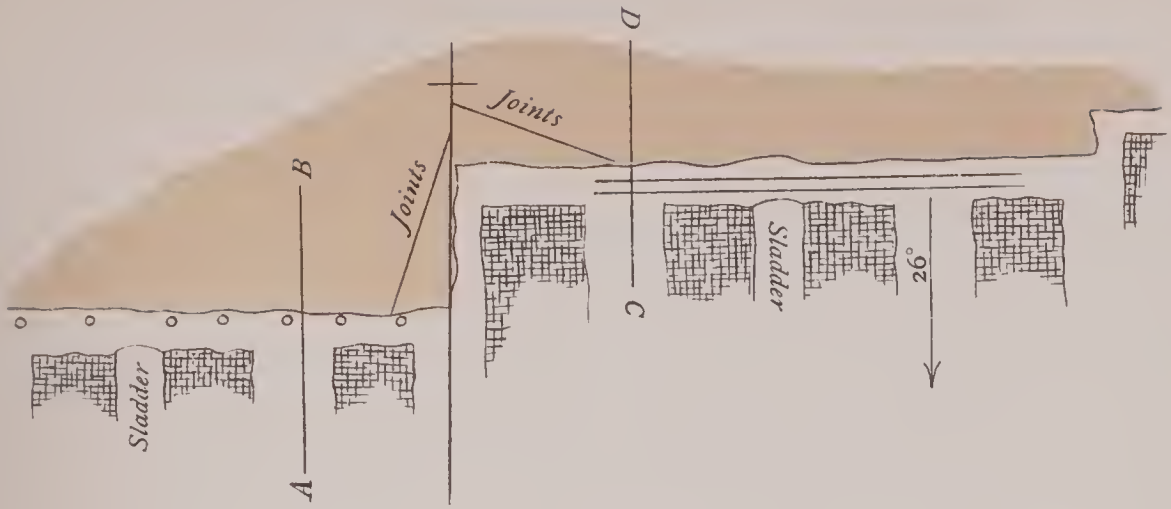
FIG. 43.

Figs. 43, 44 and 45. Plan and Sections C. The joints pass through all the stone and bass bands.

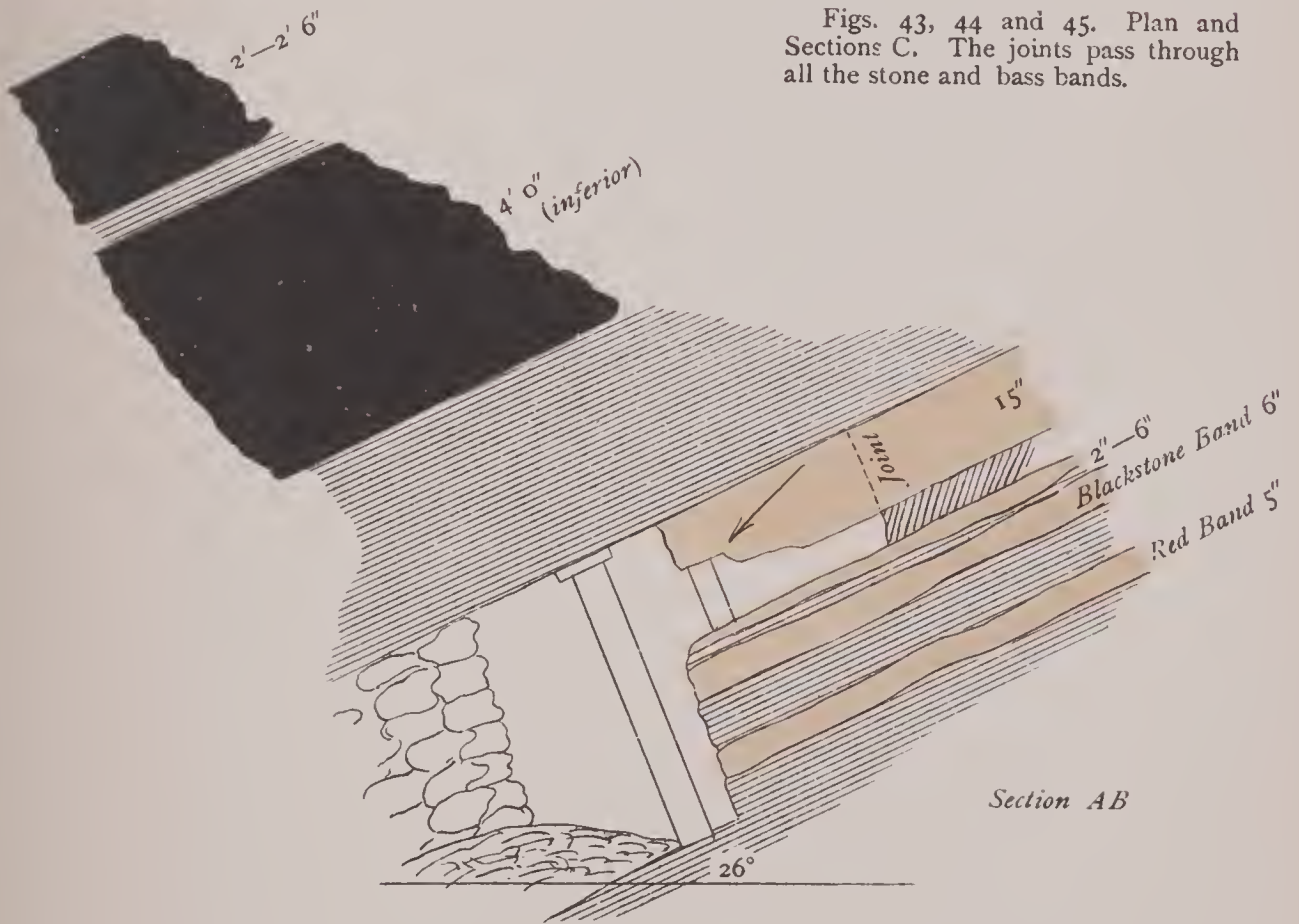
FIG. 44.

Fig. 44 represents the place in which a fatal accident occurred. (See page 45).

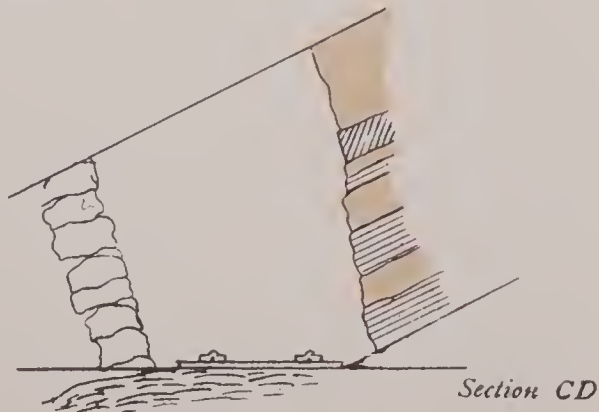
FIG. 45.

By insecure spragging, under peculiar conditions	Fig. 45
By insufficient stamping of sprags ...	„ 94
By improper setting of sprags in steep mines	„ 237
By breaking of overhanging coal over sprags	„ 130
By passing in front of the coal after having drawn the sprags	„ 268
By dislocation of adjoining piece of coal through concussion produced by a shot	
Whilst resetting a sprag	
By a fall of bottom stone whilst preparing to hole, and neglecting to sound the face	„ 10

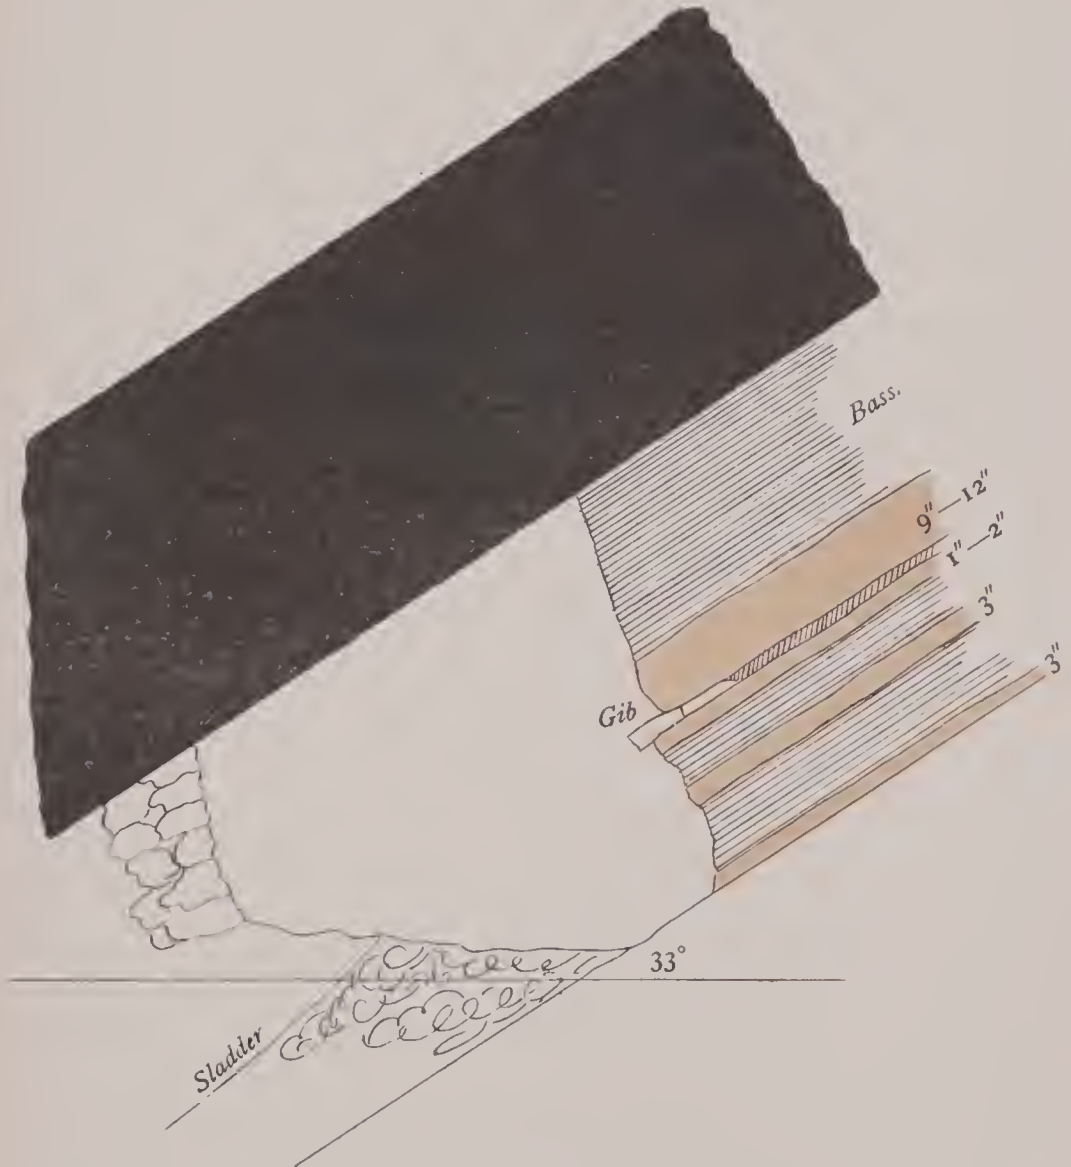
FIG. 46.

Fig. 46. Section SW. Tapering wooden wedges (gibs or block sprags), well hammered in, are used instead of sprags. The gib is entirely packed, so that the coal above is not injured. It forms a very good roof, and requires no timber. The stone is brought to the sladders in wheelbarrows.

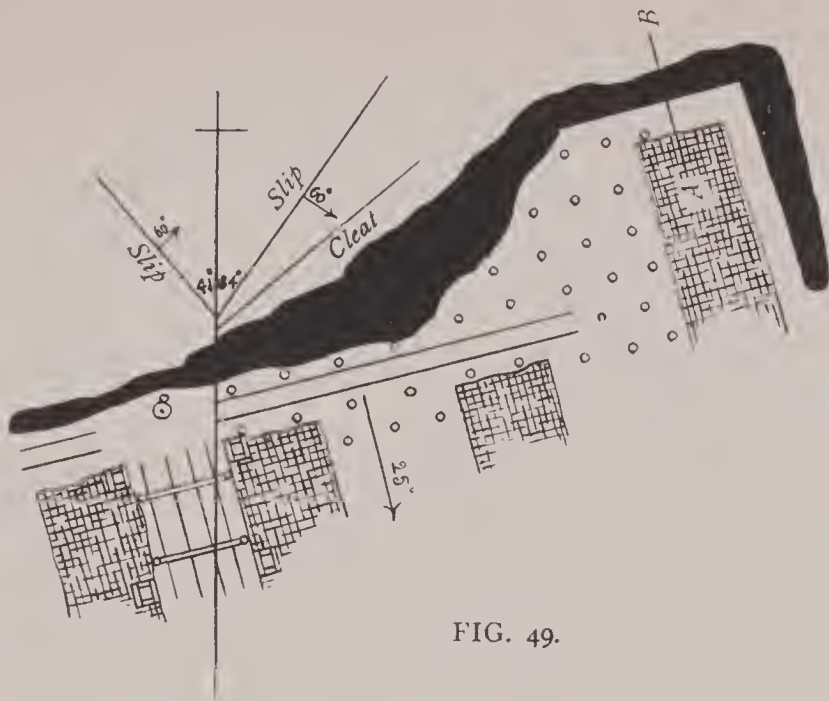
FIG. 49.

Figs. 49 and 50. Plan and Section E. The roof is so bad that as little of it is laid bare at a time as is possible, and the packs are kept close to the face, and built as soon as there is room for them. The drifts are 20 yards on each side the jig, and the face is advanced towards it from either side. It is sometimes worked as in Fig. 60. Cleat distinct. Slips: NE- 34° , very frequent; from 6"—3' apart; do not run into roof. NW- 41° , occasional and run into roof.

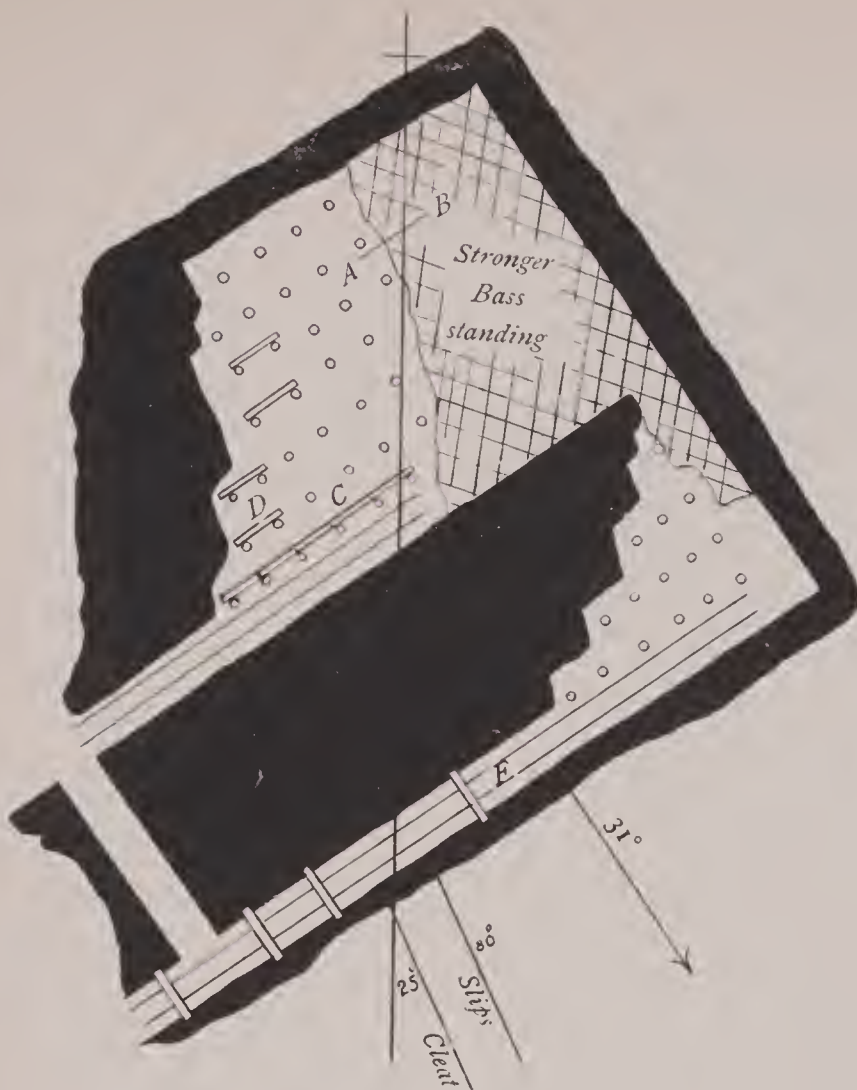
FIG. 51.

Figs. 51 and 52 Plan and Section C. The roof necessitates close timbering. C represents posts laid across to form a jetty, and D posts to stand on whilst working. Cleat very distinct; cleat planes from $\frac{1}{2}$ to 1 inch apart in the Cannel coal, and much oftener in the coal. There are numerous floors in the coal.

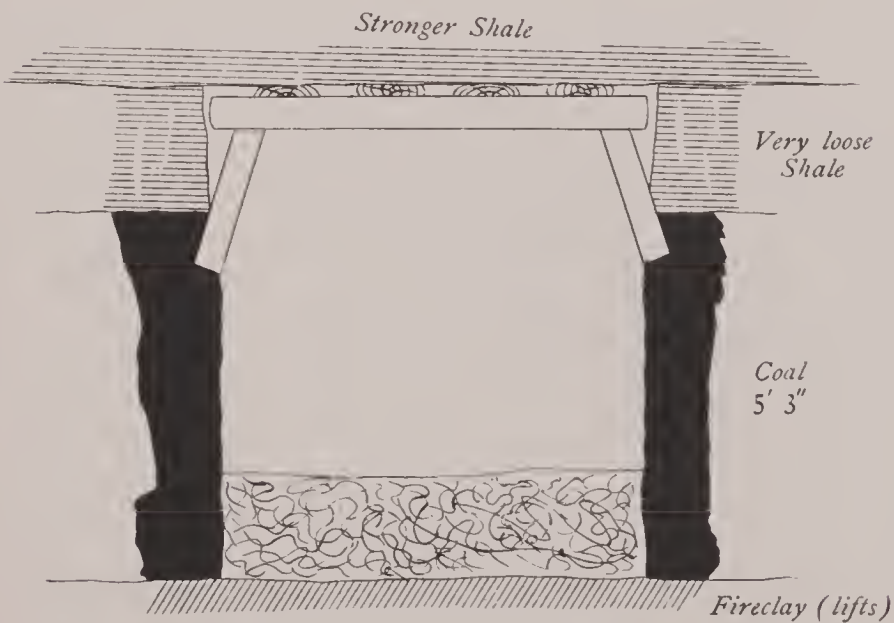
FIG. 54.

Fig. 54. Section of a main road SW. The inclination is slight. The seam is worked by longwall with regularly formed packs; but the wastes are mostly filled. The holing is done in the loose shale lying above the coal.

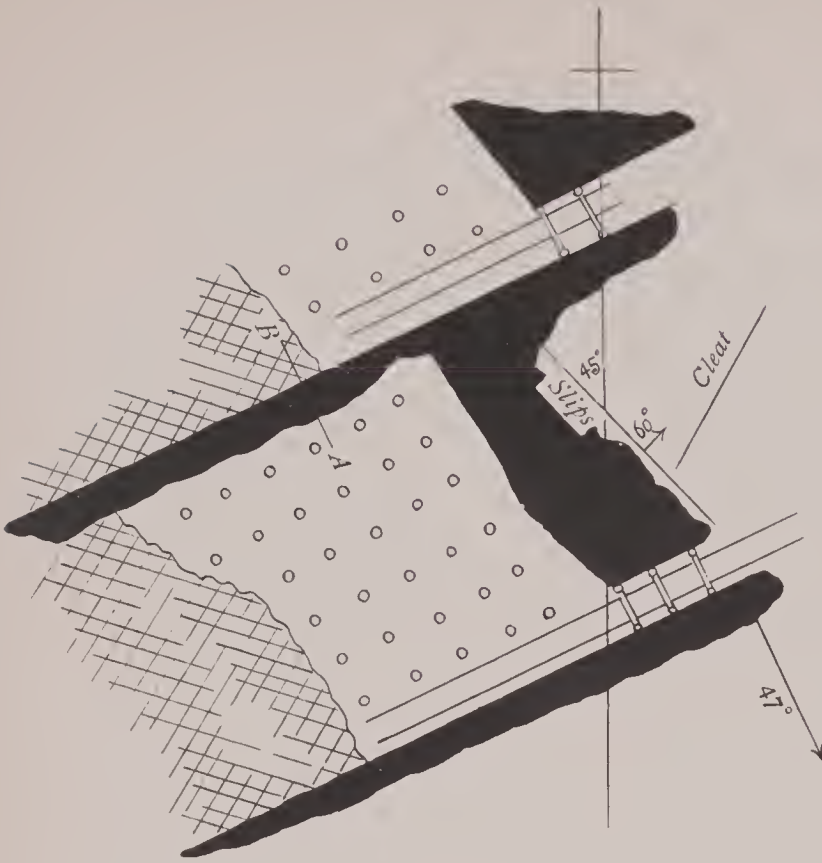
FIG. 55.

Figs. 55 and 56. Plan and Section S. The roof is good and smooth when first exposed, but soon peels off irregularly. Cleat distinct. Slips frequent, almost every yard; they invariably run into the roof.

Fig. 55 represents a back way drift, worked face-way, owing to the pillars being rather crushed, and so easier to work.

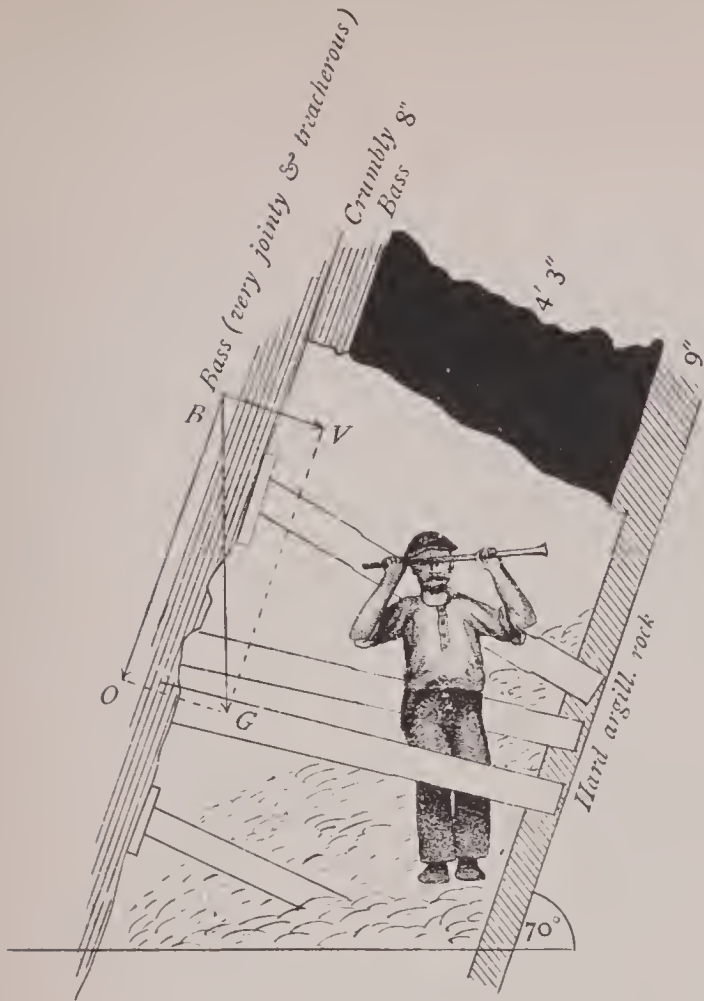
FIG. 61.

Fig. 61. Section W. Lancashire method as "Rearer." Roof very bad, necessitates timbering.

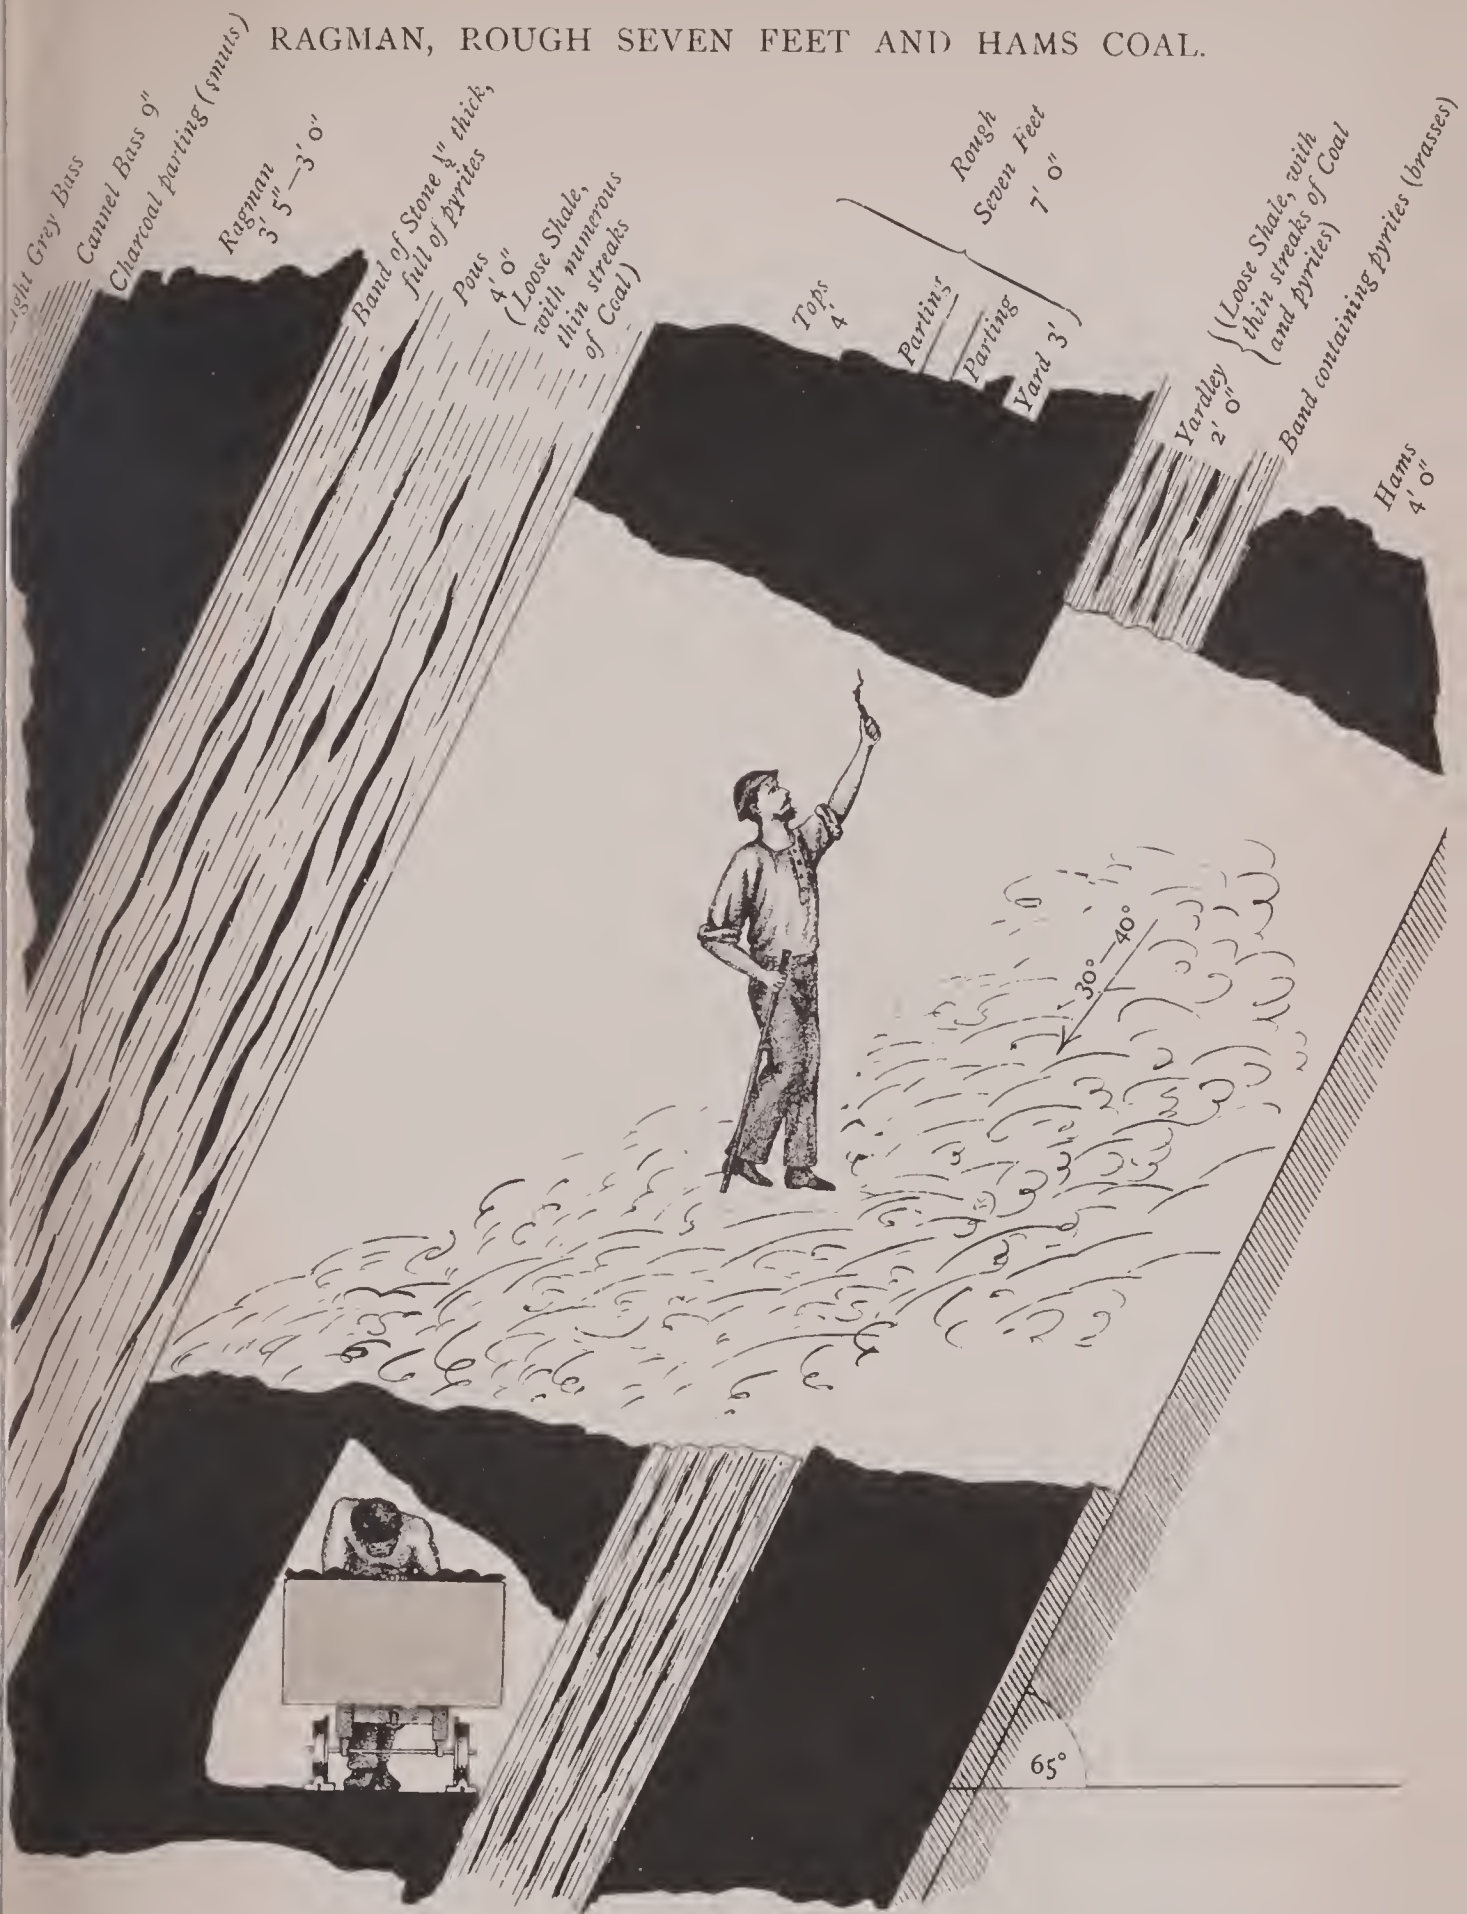
FIG. 63.

Fig. 63. Section W. The three seams are worked together. Heads are driven in the Seven Feet and in the Ragman coal, with occasional small holes through the Pous for ventilation. They are driven to the boundary (300 yds.) at different levels, leaving pillars 10 yds. thick. A 2 yds. rib is left; the rest of the pillars are drifted back, beginning at the higher levels. As many as four levels are drifted back together; but generally two. The Hams and Seven Feet are drifted back together; no timber whatever is set; the gob occasionally shoots down, after which a new breadth is started. The Ragman is got down partly from its own level, and partly, when the Pous falls, before the gob shoots down, from the Seven Feet level. About one-third of the Ragman is left behind; very little of the other seams, except the ribs which give way when the gob shoots down.

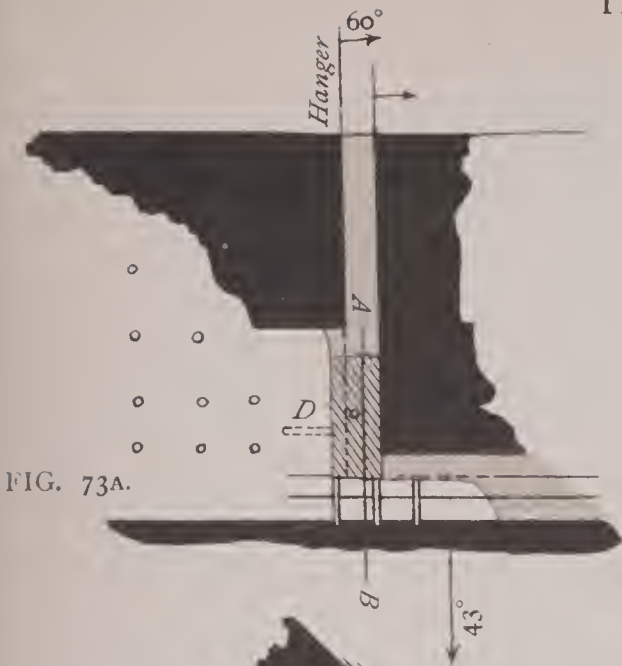
Figs. 73A and 73B. Plan and Section of a drift near Fig. 73, illustrating a fatal accident which occurred to the fireman during his examination, after he had fired a shot higher up the drift. The drift had reached an old thurling, in which the Top Coal was supported by a post *P*, and two stretchers or sprags, such as *S*. The fireman was standing near the tub, and the collier was stamping a hole, preparatory to drilling it, for the purpose of blowing the Top Coal down, when five tons of it fell off a slip towards the drift, reeling out the post and the two stretchers. Had another post been set under the Top Coal in the thurling, or a sprag *D* set against the Top Coal the accident would have been prevented.

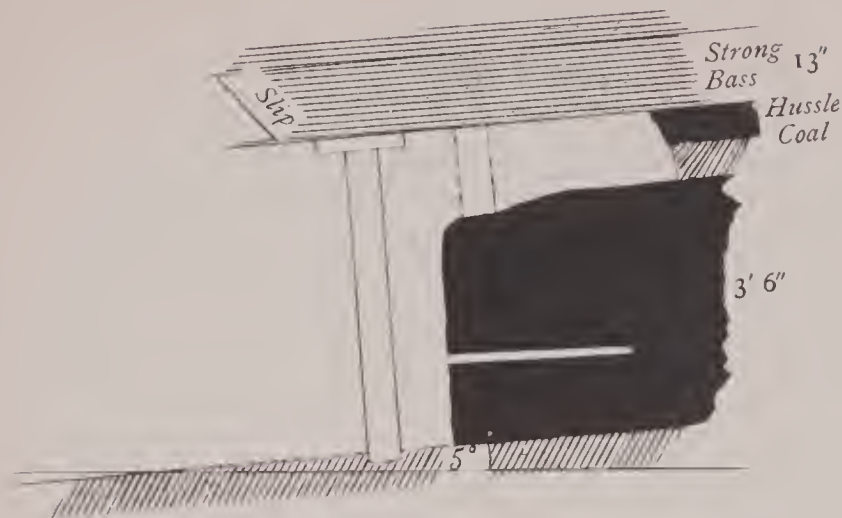
FIG. 77.

Fig. 77. Section N. Cleat irregular. The roof is strong, but contains slips, through disregard of one of which an accident occurred to a collier.

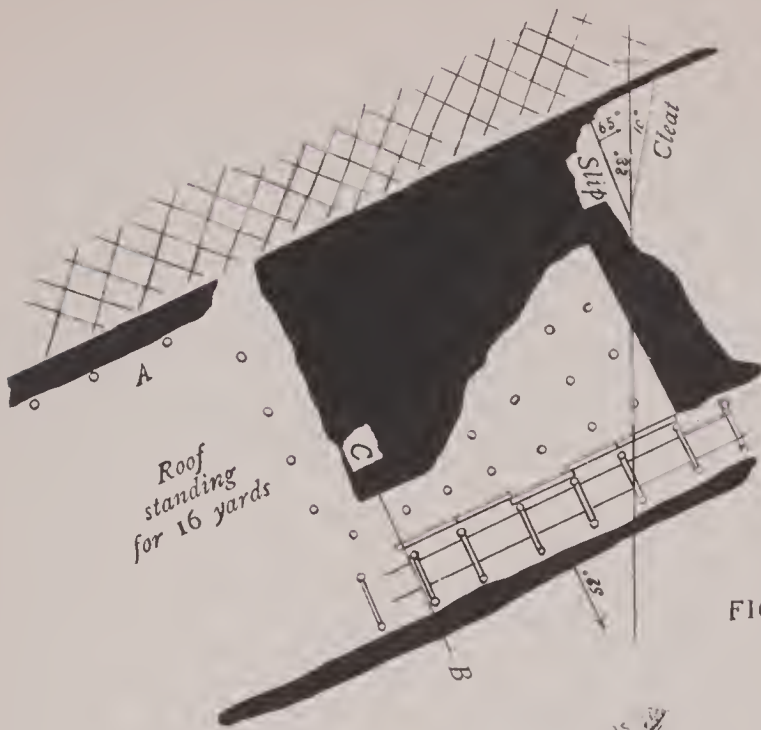
FIG. 79.

Figs. 79 and 80. Plan and Section S. Cleat distinct. Slips very frequent in places; they pass through the black bass, and occasionally through the 18" bass. The last row of posts in the preceding drift is left to protect the men when finishing the drift; also the gob posts *A*.

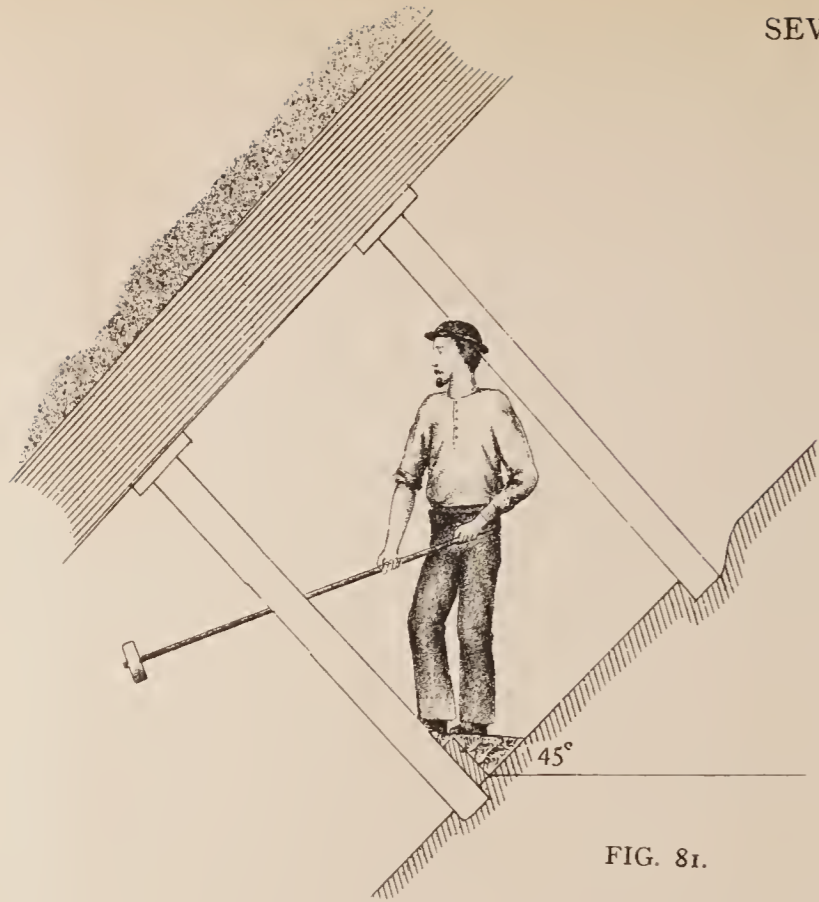
FIG. 81.

Fig. 81. Section S. Shewing how the timber is drawn.

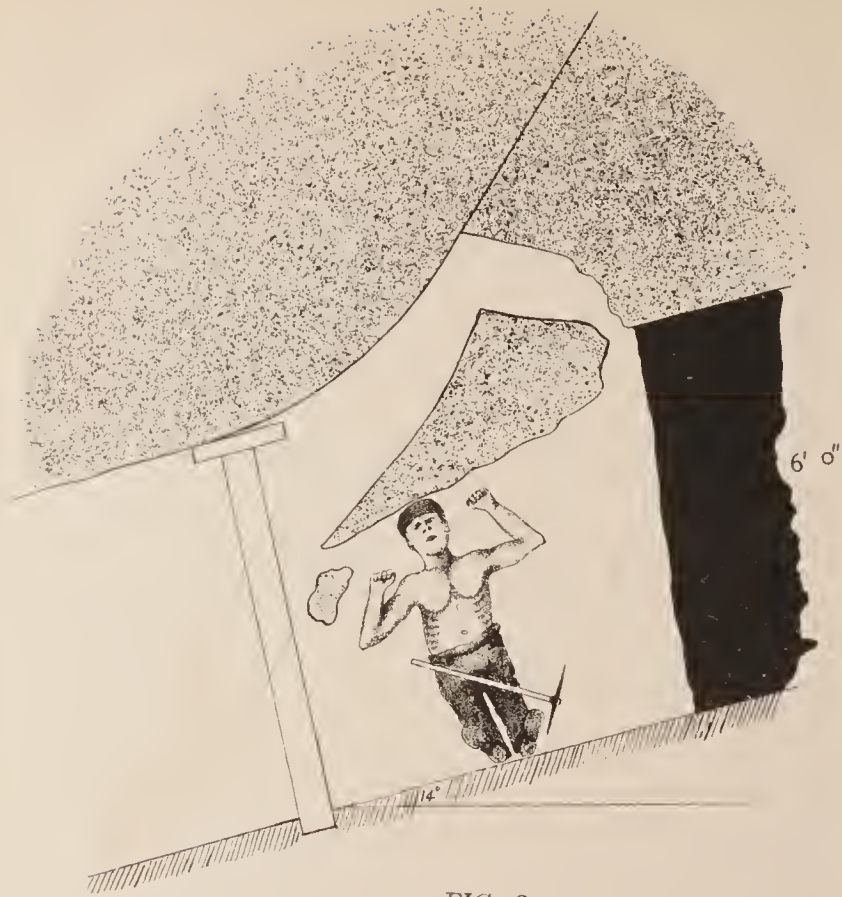
FIG. 84.

them. Fig. 84 shews such an arrangement. In this case the post is so long that, unless supported in the centre by a stretcher stamped in the rock roof, it would bulge out in the middle. Fig. 53 also shews how part of the side has to be slabbed. It was from a want of this precaution that the accident illustrated in Fig. 101 occurred.

Fig. 84. Section of horse road, shewing mode of timbering after the bass has fallen.
