ACCIDENTS IN MINES,

NORTH STAFFORDSHIRE COALFIELD,

FALLS OF ROOF AND SIDES;

THEIR CAUSES, AND THE MEANS OF DIMINISHING
THEIR FREQUENCY.

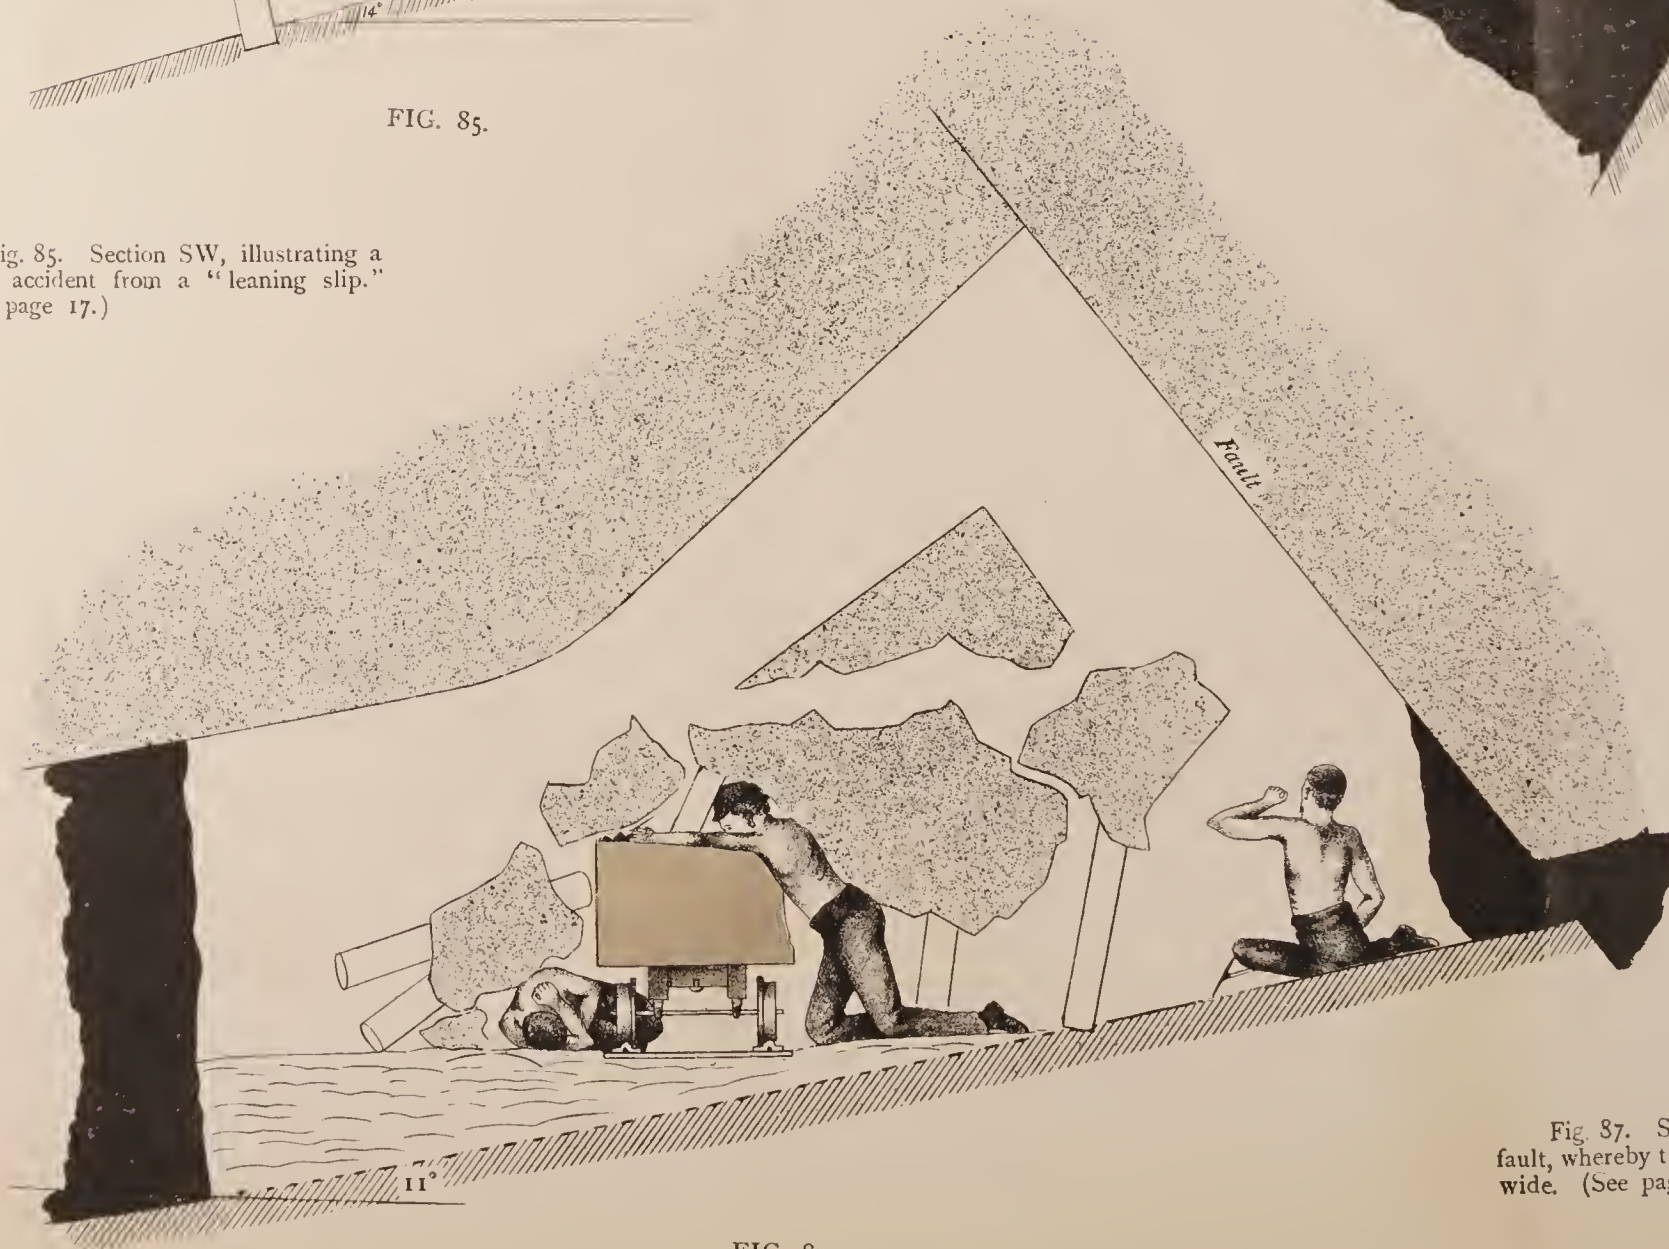
FIG. 86.

Fig. 86. Section also SW, shewing an overlap fault, throwing the sandstone roof, which lies immediately above the coal, into the heading. It was whilst attempting to blow down this projecting piece of rock that an explosion occurred, whereby 62 lives were lost. The coal is close-grained, curly and hard. Cleat just visible in places. Slips frequent. The floor lifts, and in most cases closes the gob up to the roof. (See pages 18 and 27.)

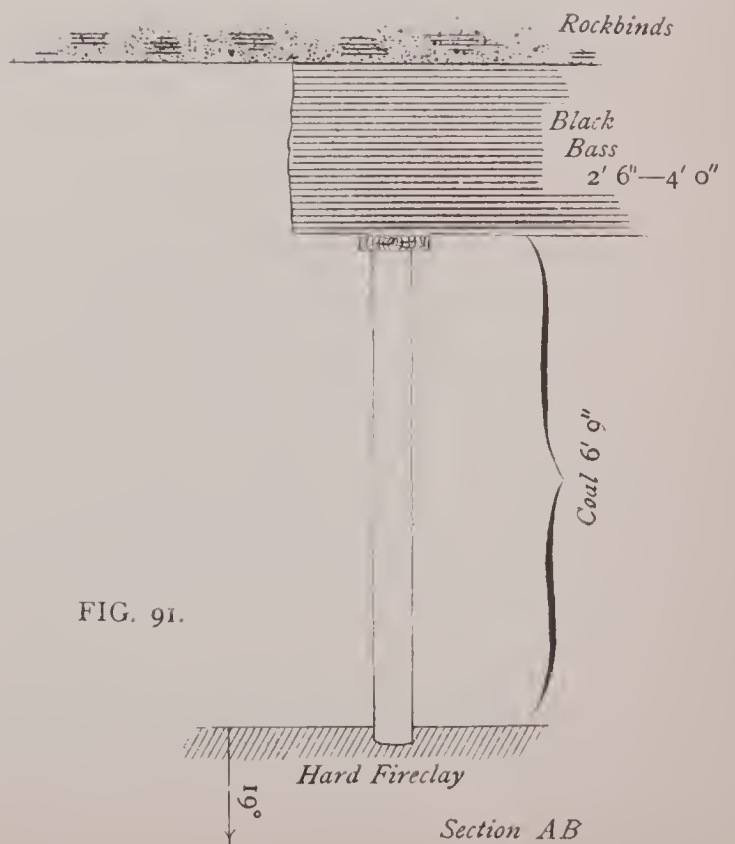
FIG. 90.

Figs. 90 and 91. Plan and Section further North. Slips: 3° NE, are very frequent, and pass through the black bass; 16° NW, called "straight things," are less frequent.

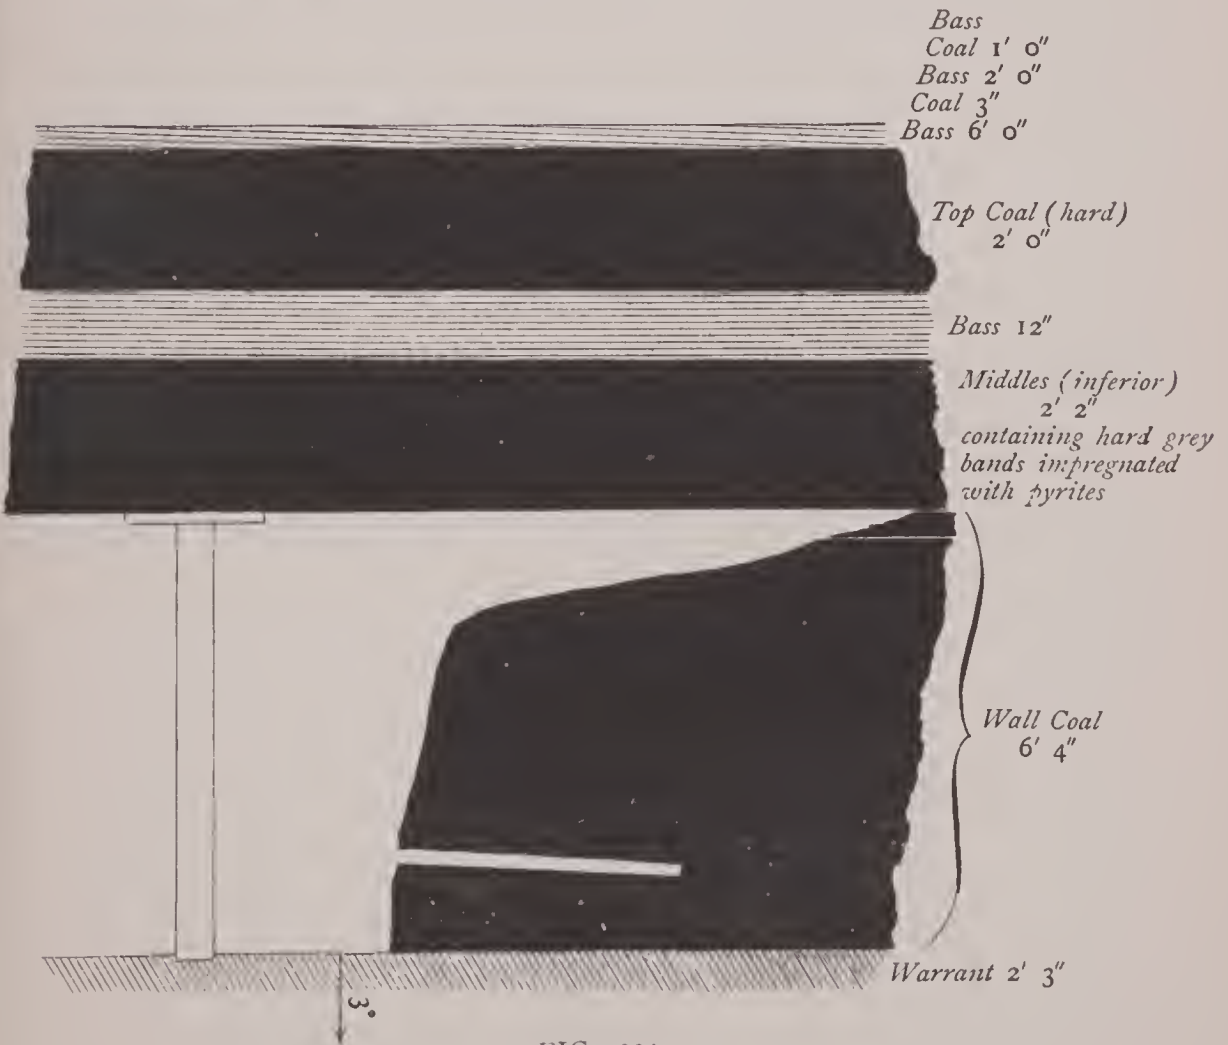
FIG. 92A.

Fig. 92A. Section of heading, extreme West. The headings are 12' wide. The Middle Coal is taken down as soon as it shews signs of giving. The Top Coal forms a very good roof.

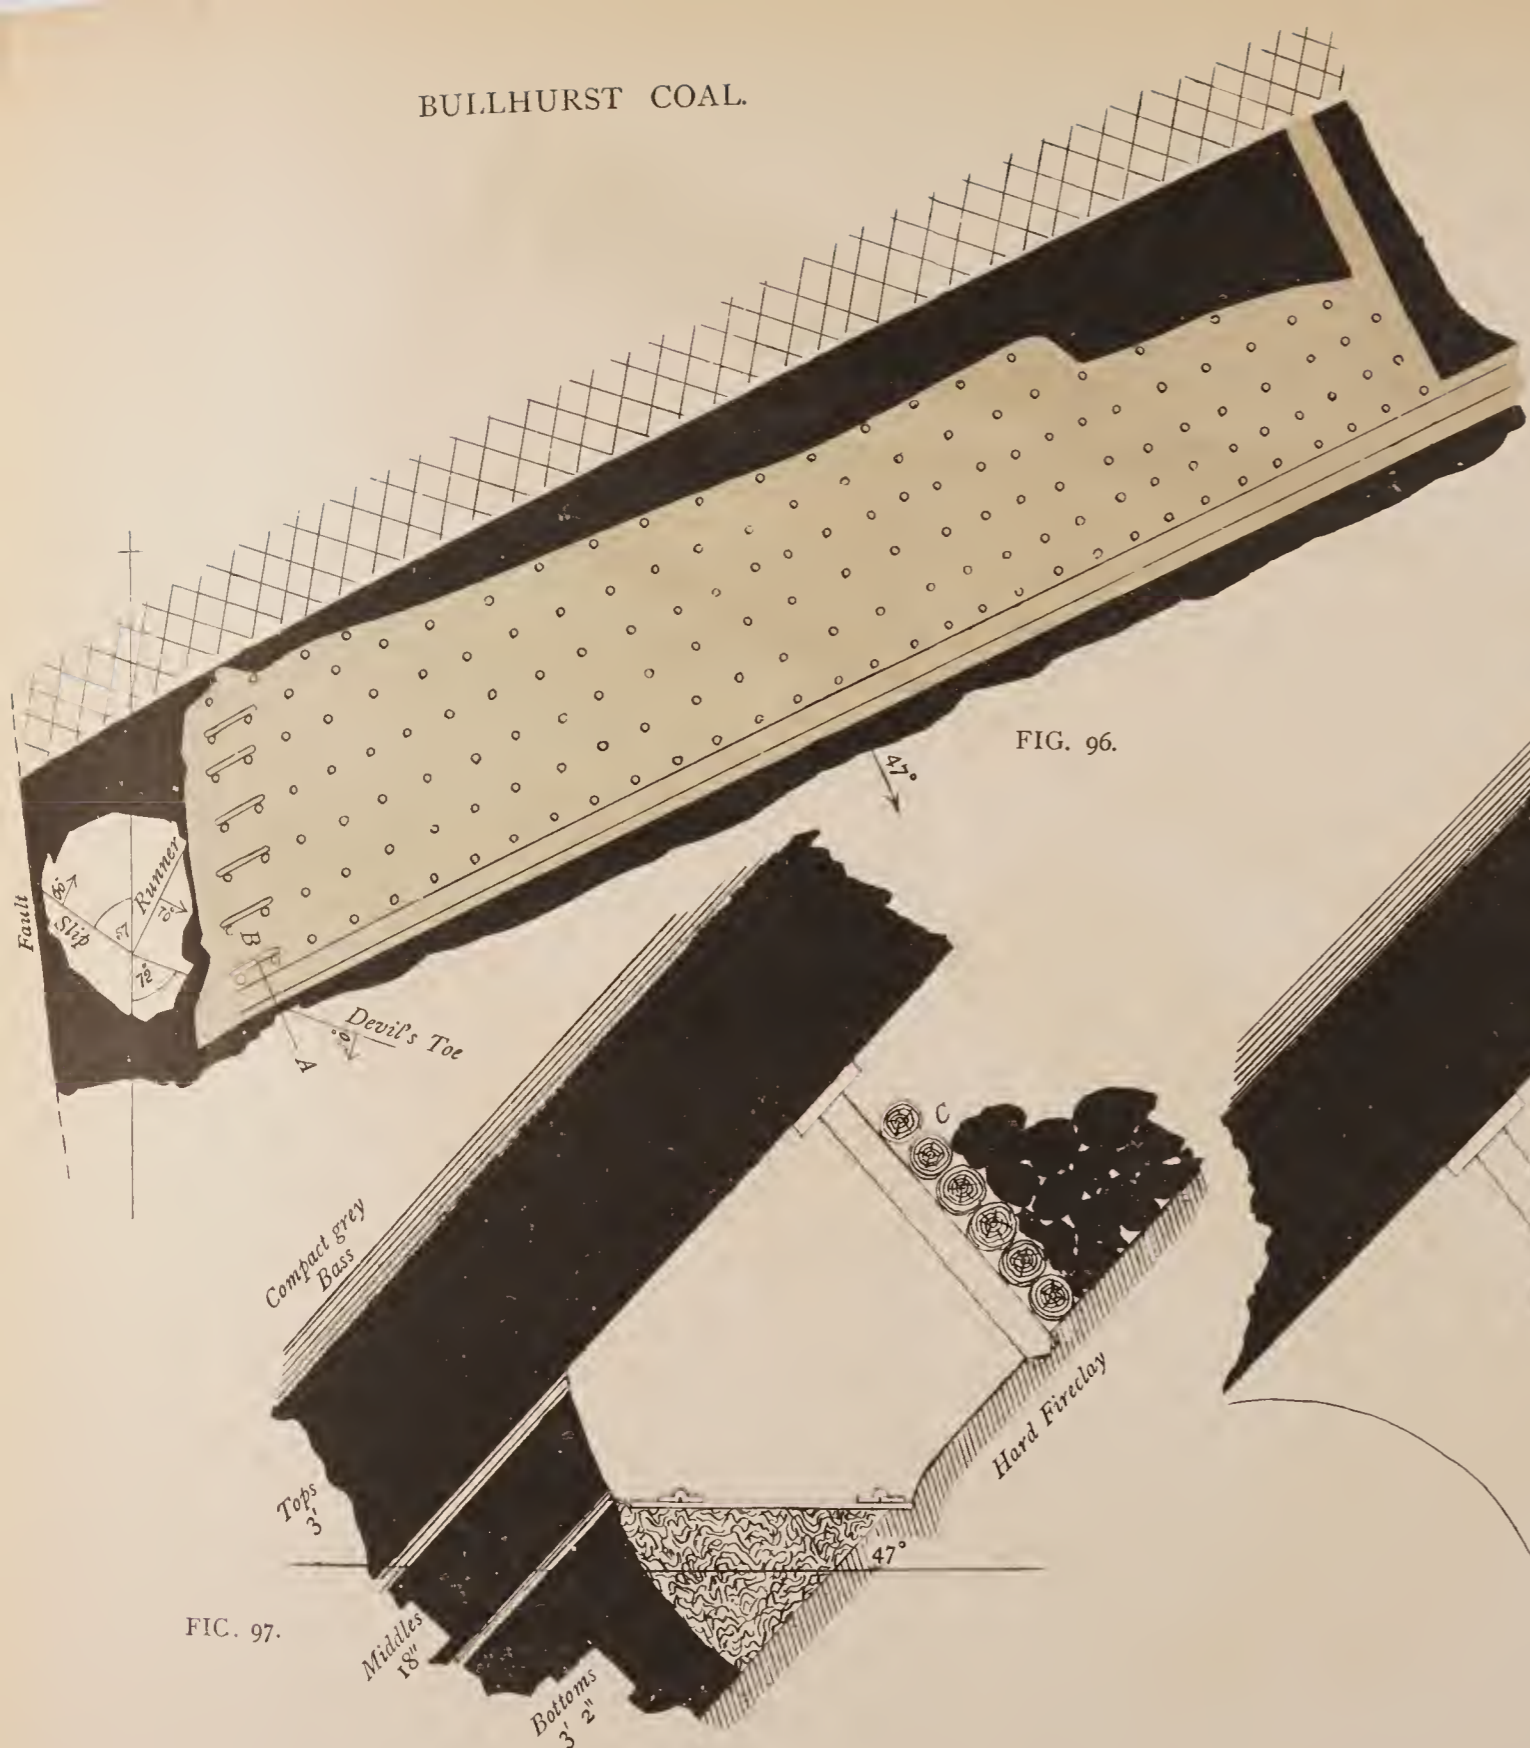
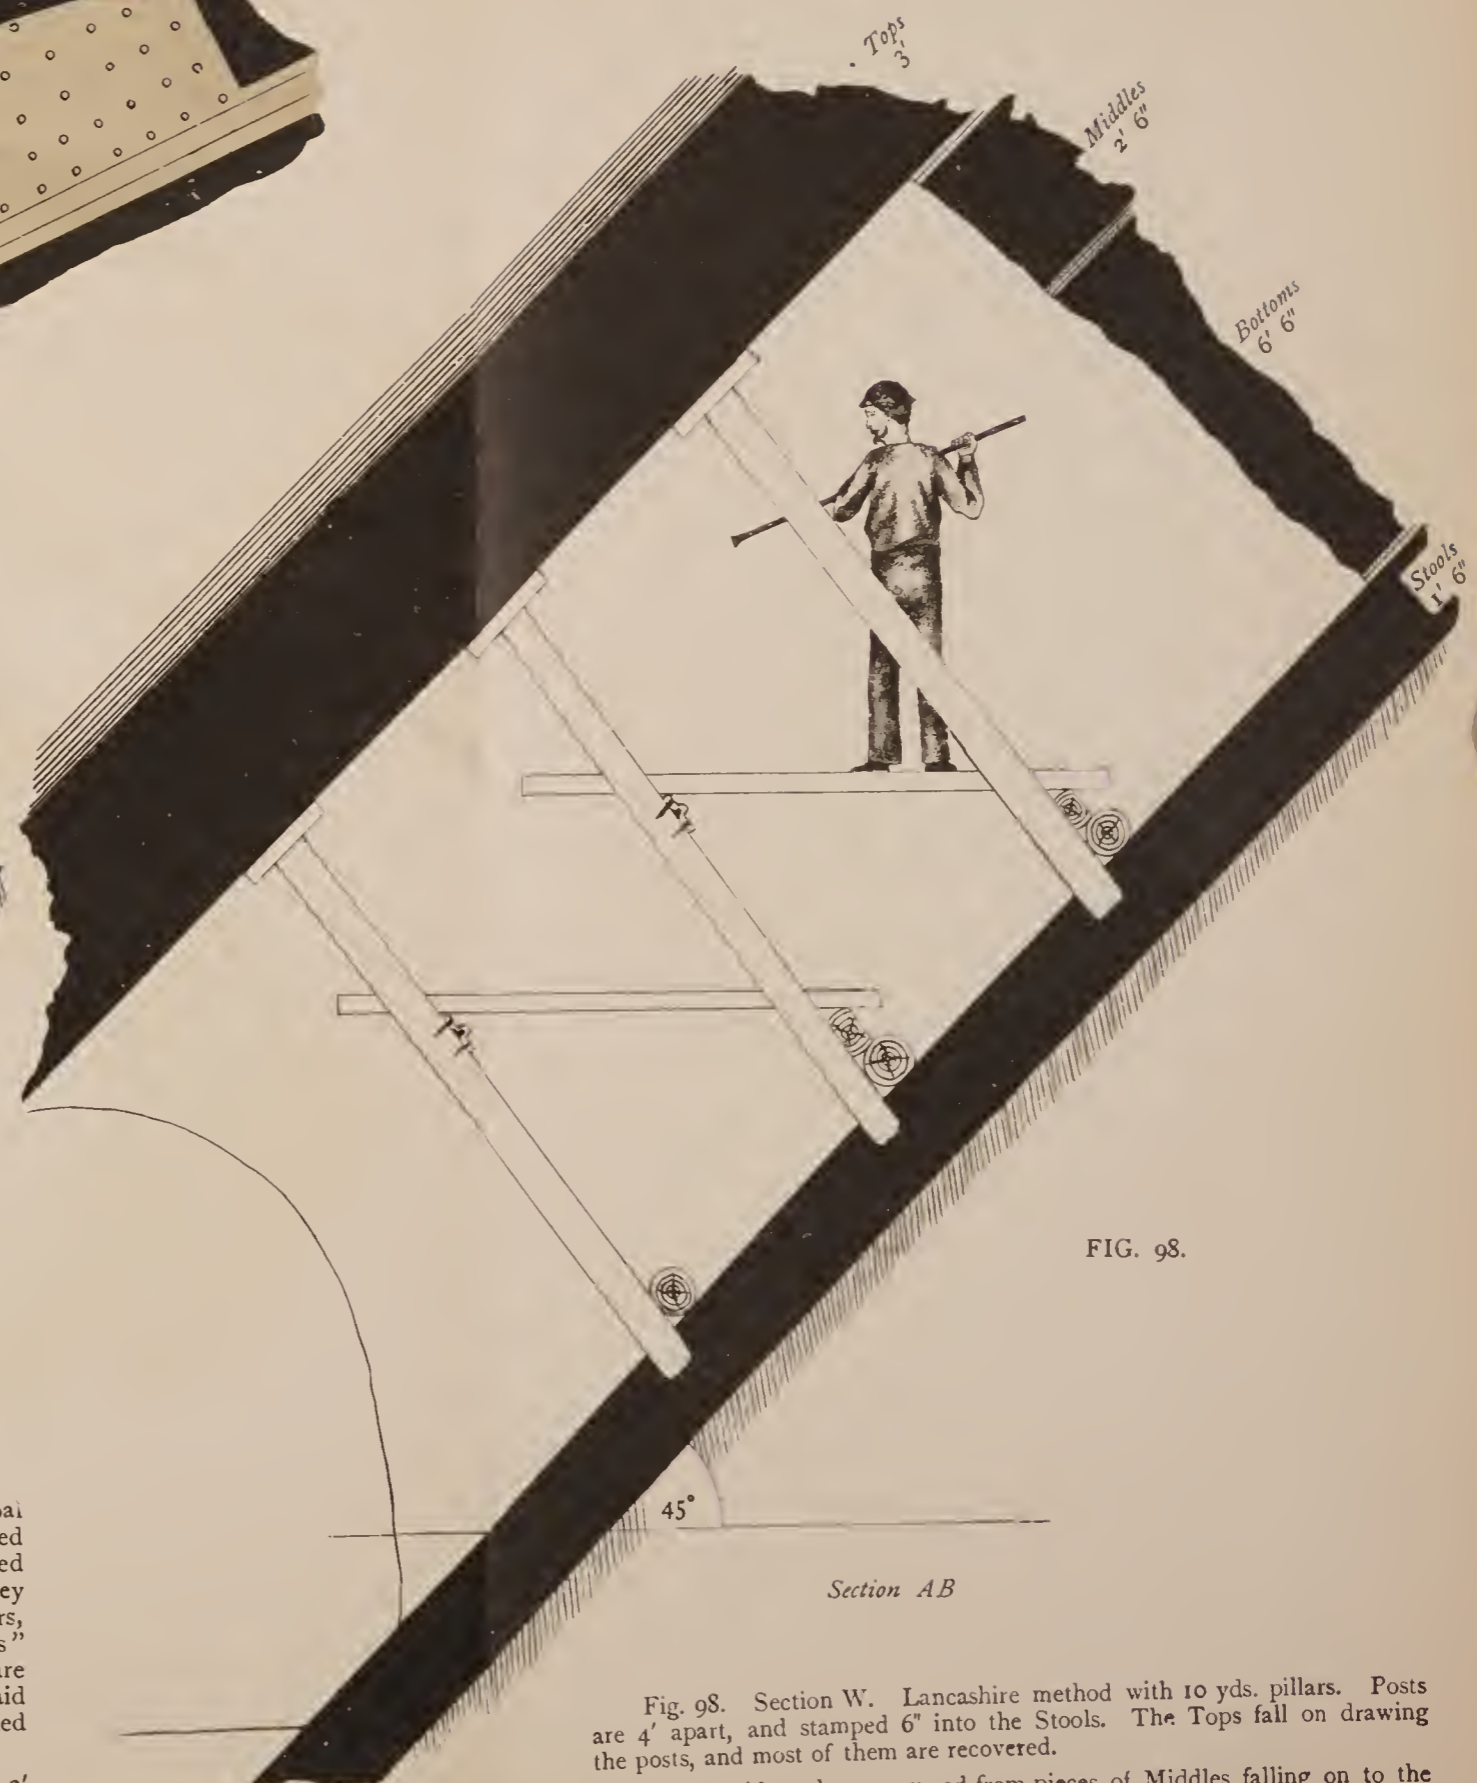
In the Bullhurst Seam in the Silverdale district (Figs. 96 and 97), the tops are cut up to the roof on the high side next the small rib which is usually left, and on the lower side for a distance of a few yards, generally to a slip. The lids are loosened by picking the coal around and above them, and the posts are then sometimes battered out from a distance, by throwing a post against them. If the removal of the posts does not bring down the tops a wedge is applied in the roof at a slip, and hammered in until they drop. In some cases a plug and feathers are used for this purpose. Volumes of dust are produced by even a small fall of tops. The tops are not dropped at a greater rate than about one yard a day.

Figs. 96 and 97. Plan and Section (S.) of an exceptionally long drift, possible only from the top coal being very strong. (See page 59.) The Middles are first holed about 3' and the Bottoms are then wedged up. On reaching the fault the Tops are cut and wedged down, and the high side of the pillar partly flitched back. The coal has no cleat; it breaks up easiest in the plane of stratification. Slips are frequent; they ride over in the different beds, and sometimes run out, but often run along the whole drift. Runners, which seldom extend further than 5', and which are frequent, cut the slips out. Slips called "Devil's toes" occur occasionally. The floor is very hard, and the posts are pointed and let in slightly. Slabposts C are put up to collect the coal and protect the loader. When placed at the lower side of thurlings they are said to form a "battery." The headings stand well for some time without timber, but have eventually to be lined at the high side.

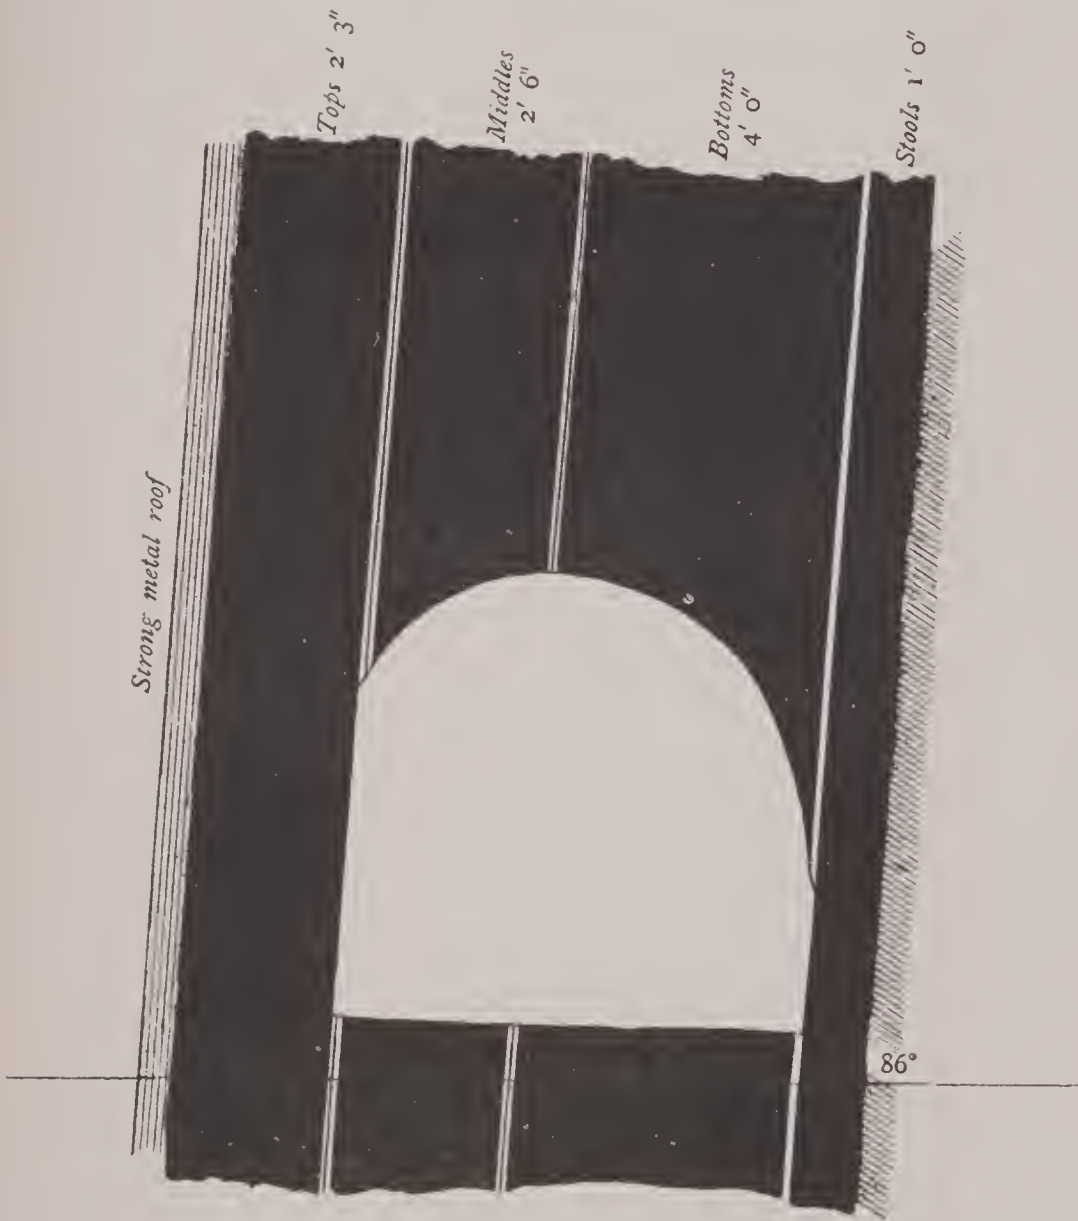
FIG. 99.

Fig. 99. Section W. N. of Fig. 98. The headings stand well without timber, except in the neighbourhood of faults.

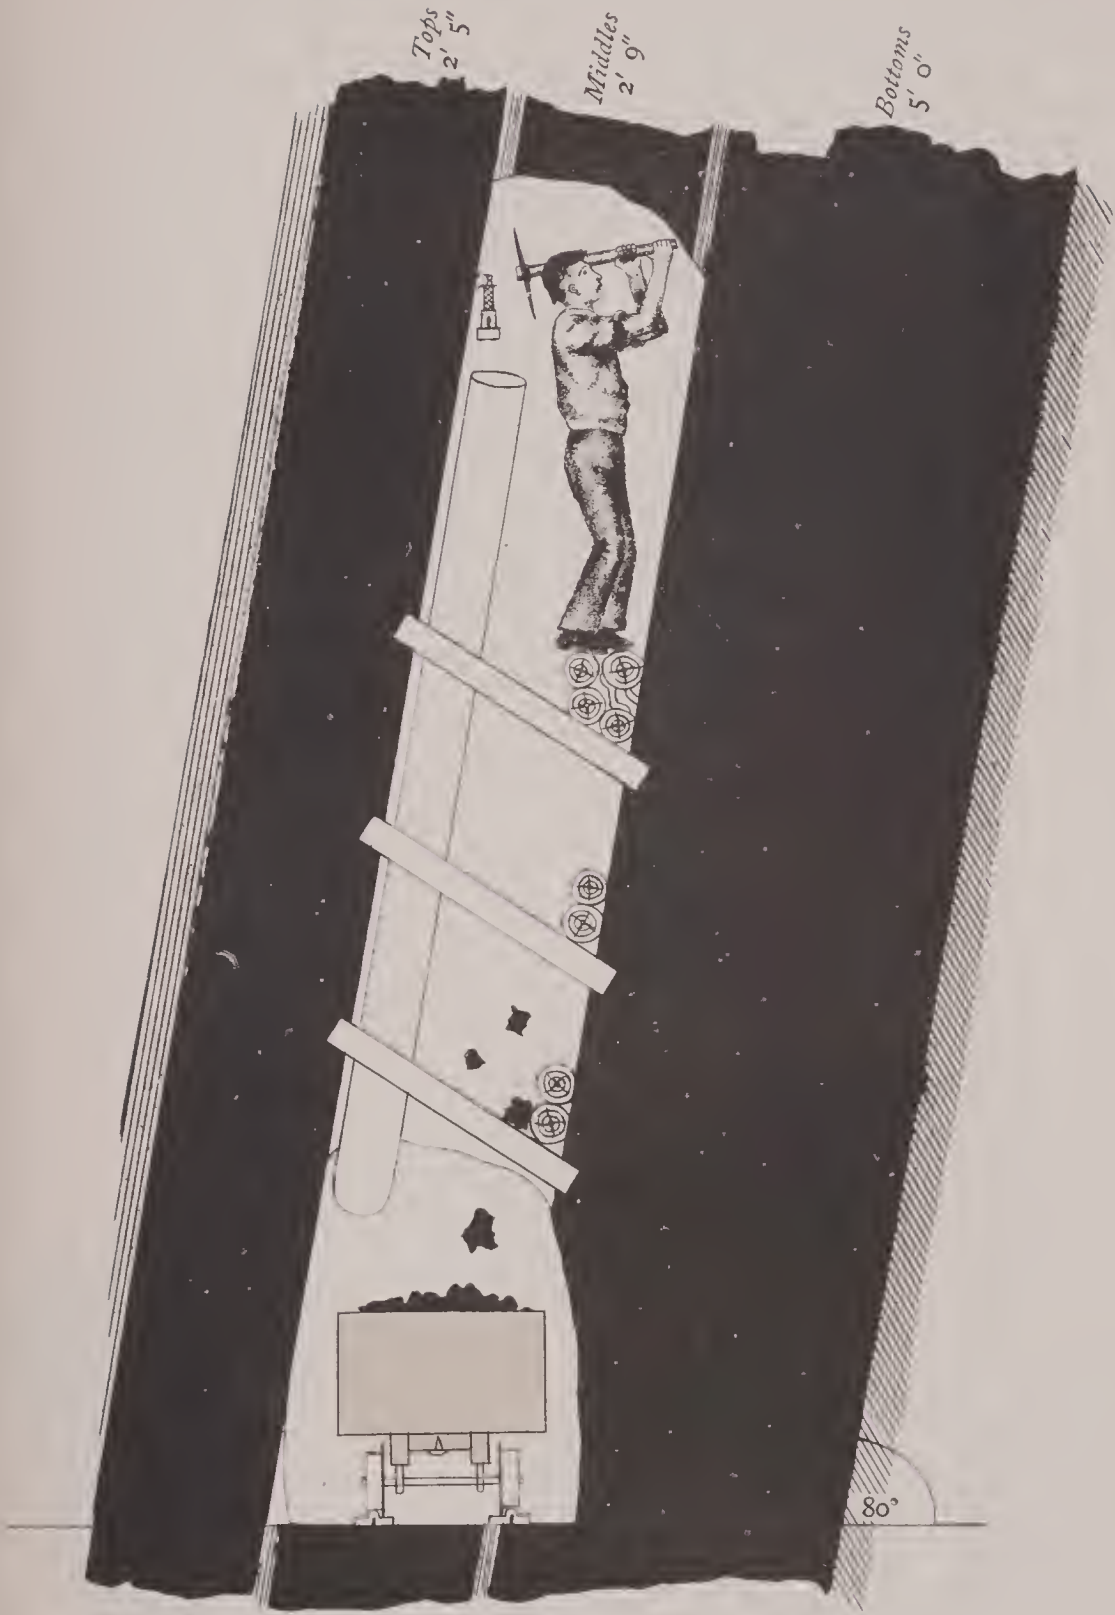
FIG. 100.

Fig. 100. Section W. N. of Fig. 99. Shewing a collier driving a thurling. The Stools have run out.

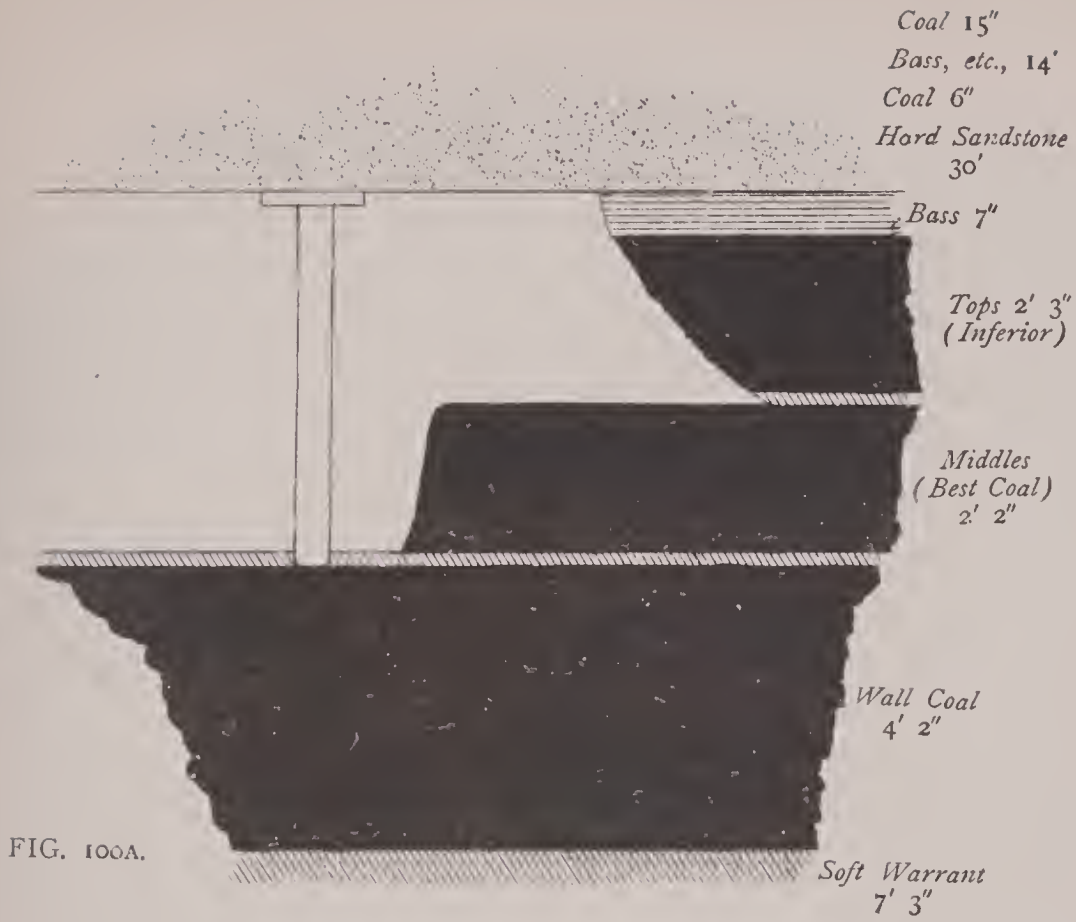
FIG. 100A.

Fig. 100A. Section of heading, extreme West. "Strait" places driven as shewn from 2 to 4 yds. wide. The wall coal is taken up 60 yds. behind.

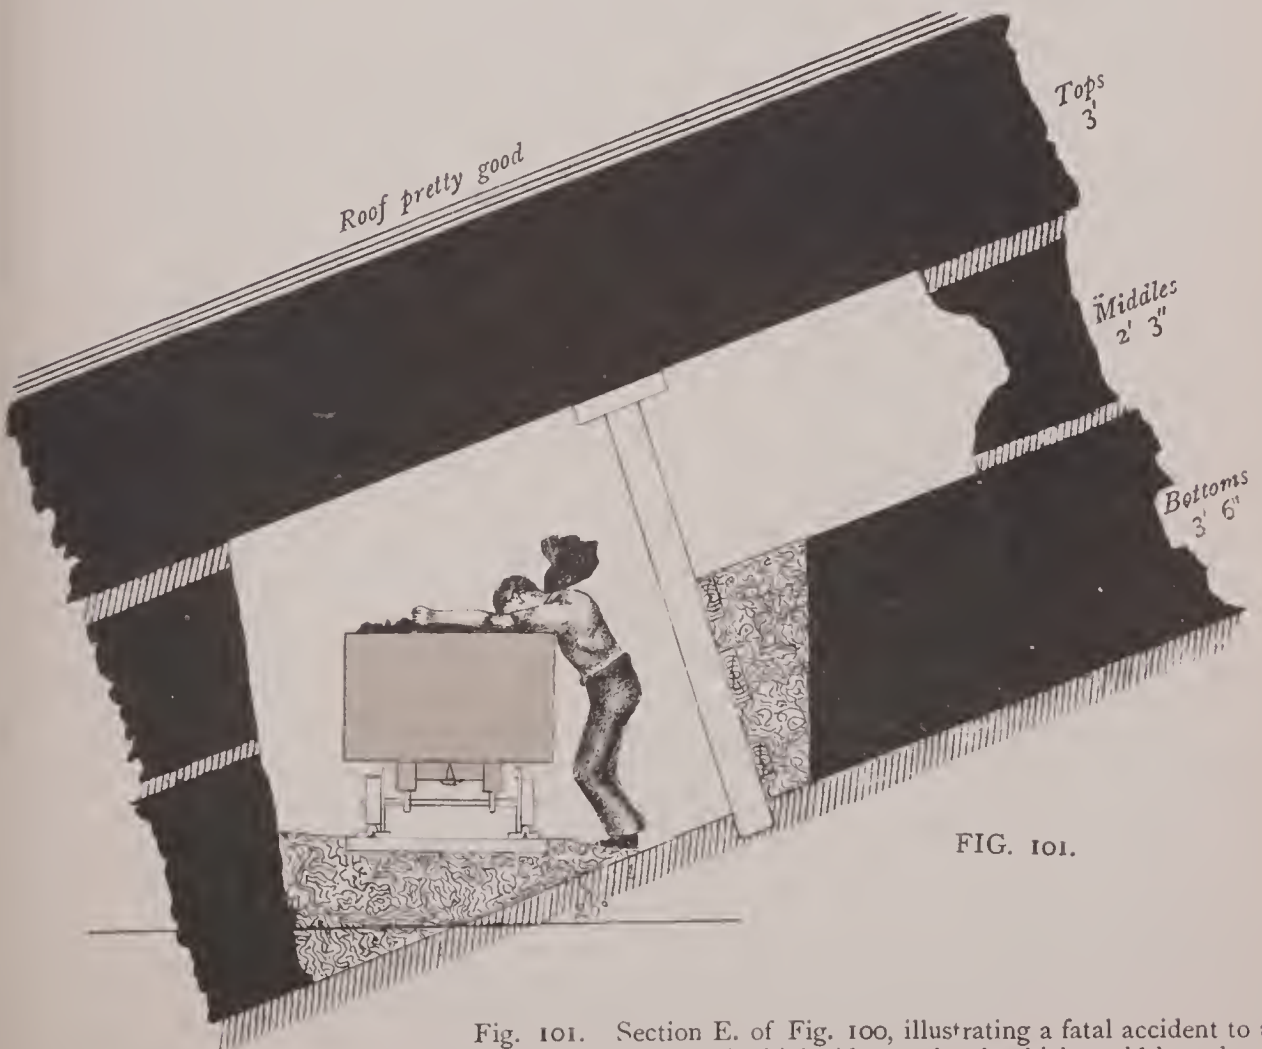
FIG. 101.

From not protecting high side of level or dips in steep mines	Fig. 101
---	----------

Fig. 101. Section E. of Fig. 100, illustrating a fatal accident to a boy, from not protecting the high side in a level, which could have been done with short posts and slabs.

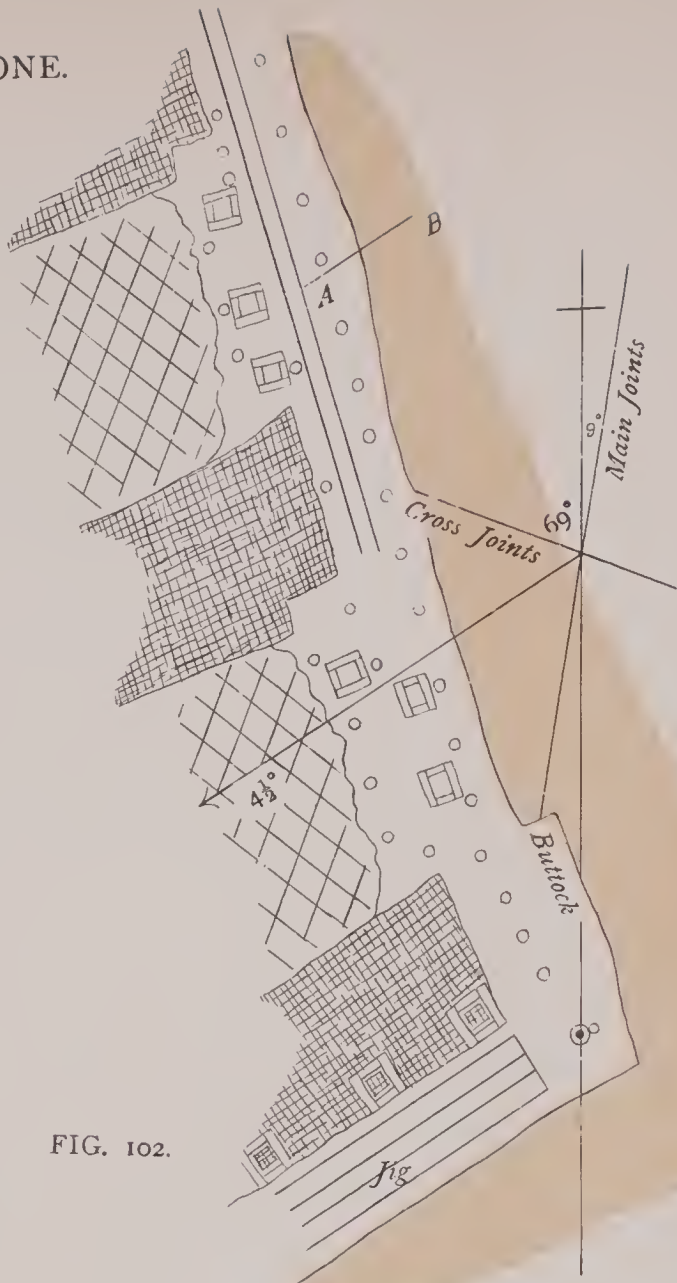
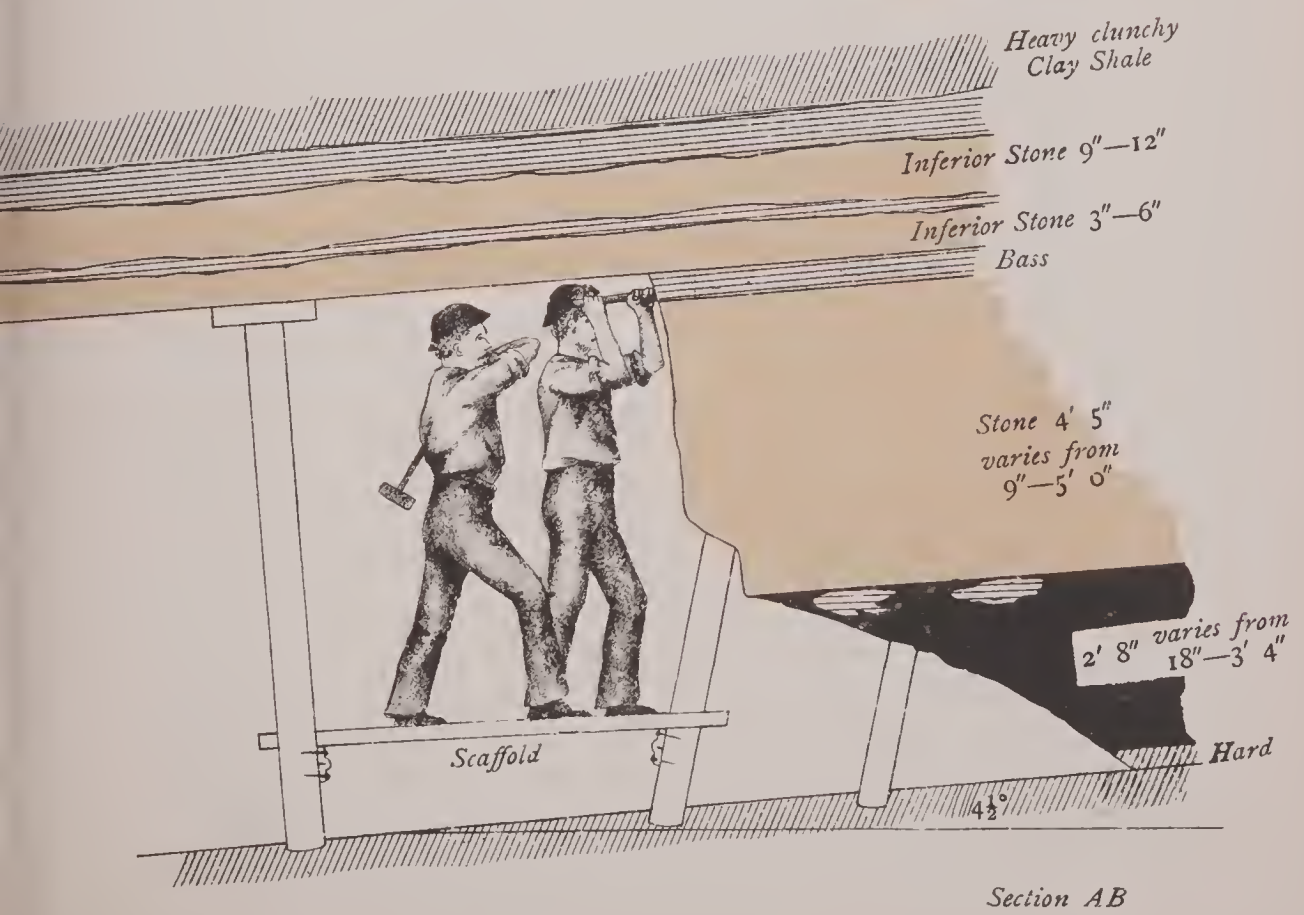
Figs. 102 and 103. Plan and Section W, shewing the rails being taken up and a new buttock started near the jig. The chocks are taken out of the waste and moved forward. The roof breaks behind them.

Dips and levels are driven 4 yds. wide. Though the roof is extremely hard a row of posts is usually set on either side of the rails in the levels, one of which carries the brattice. The stone varies considerably in thickness, and when thin is sometimes of inferior quality.

Joints very distinct and regular; main joints from 4'—6' apart, but closer in places; they are best defined in the bottom and middle bands; they do not run through into the roof, stones and bass, though the latter are jointy.

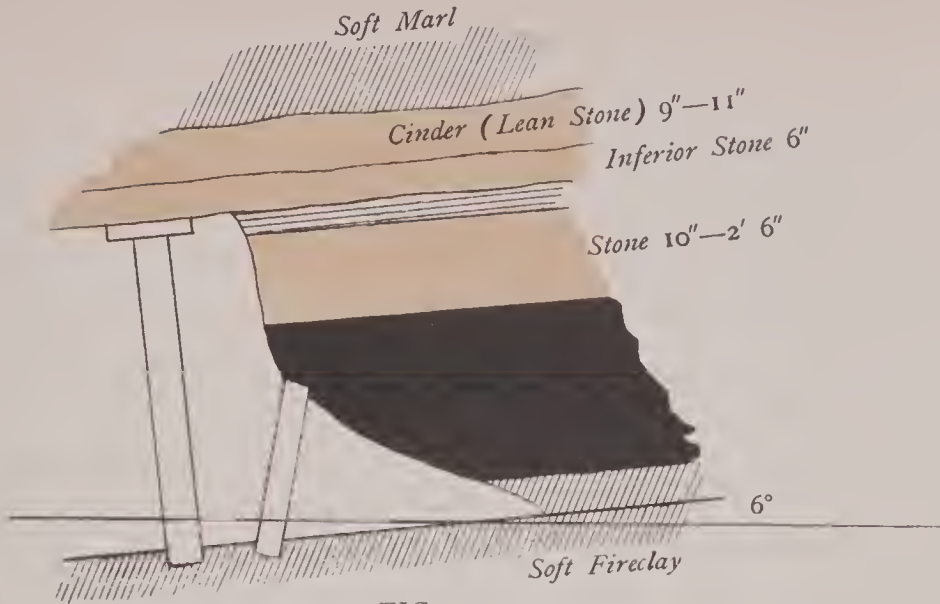
FIG. 104.

Fig. 104. Section about one mile Eastwards. The joints in the stone, which run 10° NE, are from 6"–18" apart. The cleat of the coal is distinct, and is 22° NW.

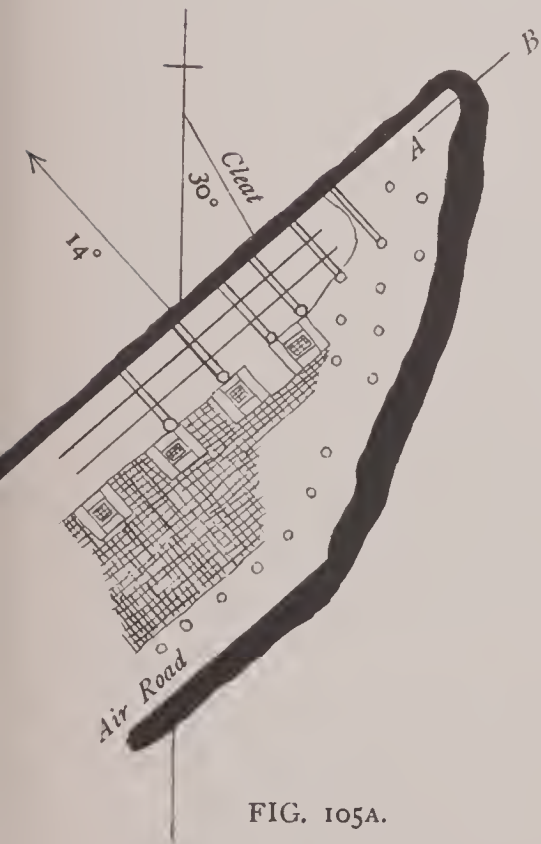
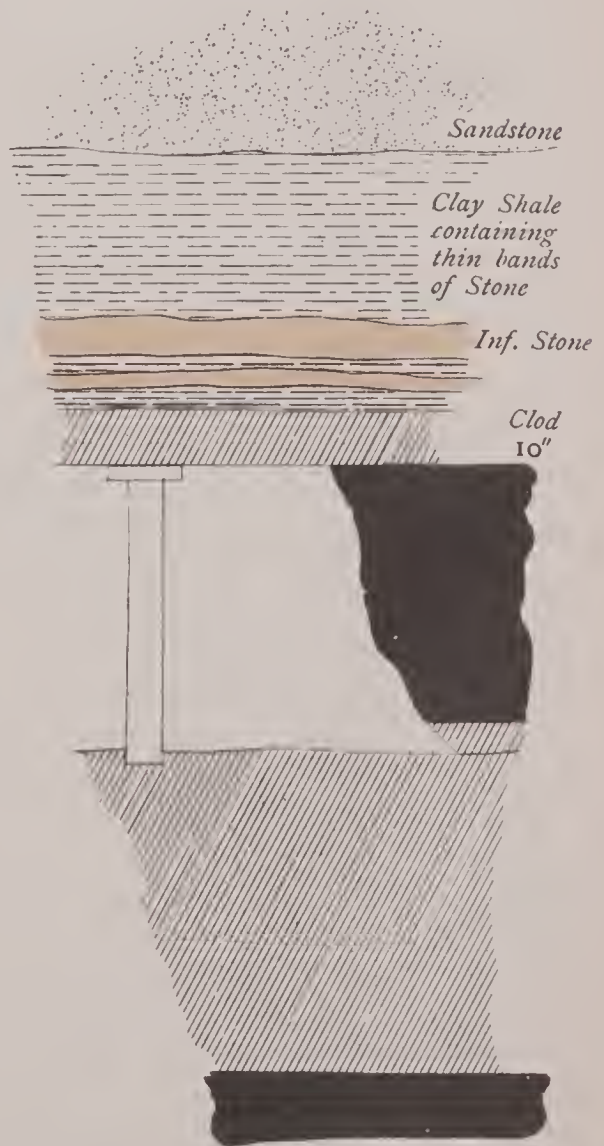
Fig. 105 A & B. Plan and Section N. Opened out by "breasting." The roof, and especially the clod, is bad, and contains numerous slips. The clod is taken down in the main levels. The levels are usually barred; the lower end of the bars is sometimes placed on short 12" posts (truncheons), which are set on the coal when it is hard and not likely to rate off. Cleat pretty distinct.

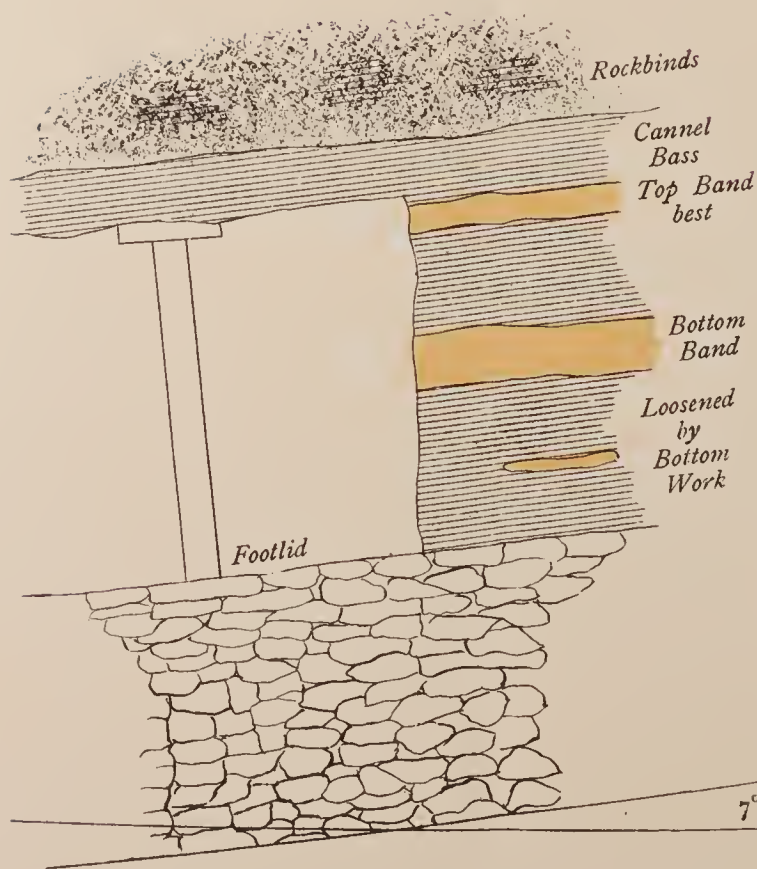
FIG. 114.

Footlids are sometimes placed under posts where the floor is soft or broken. (Fig. 114).

Figs. 113—117. Plans and Sections W. in Top and Bottom works. The Bottom bands are worked in advance of the Top bands, the gob of the former, which is tightly packed, forming the floor of the latter. The posts in the Top works are occasionally placed on footlids. The Top bands have distinct joints; but those in the bottom bands are indistinct.

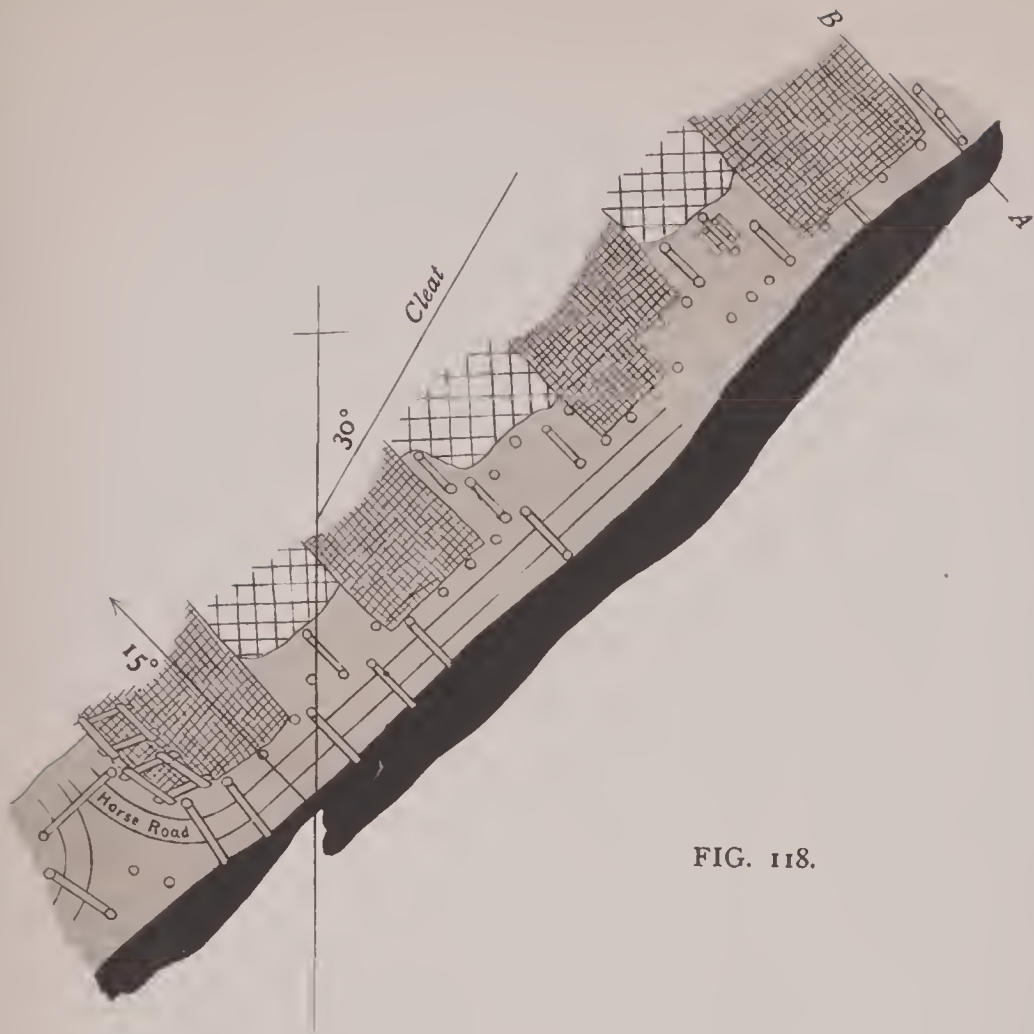
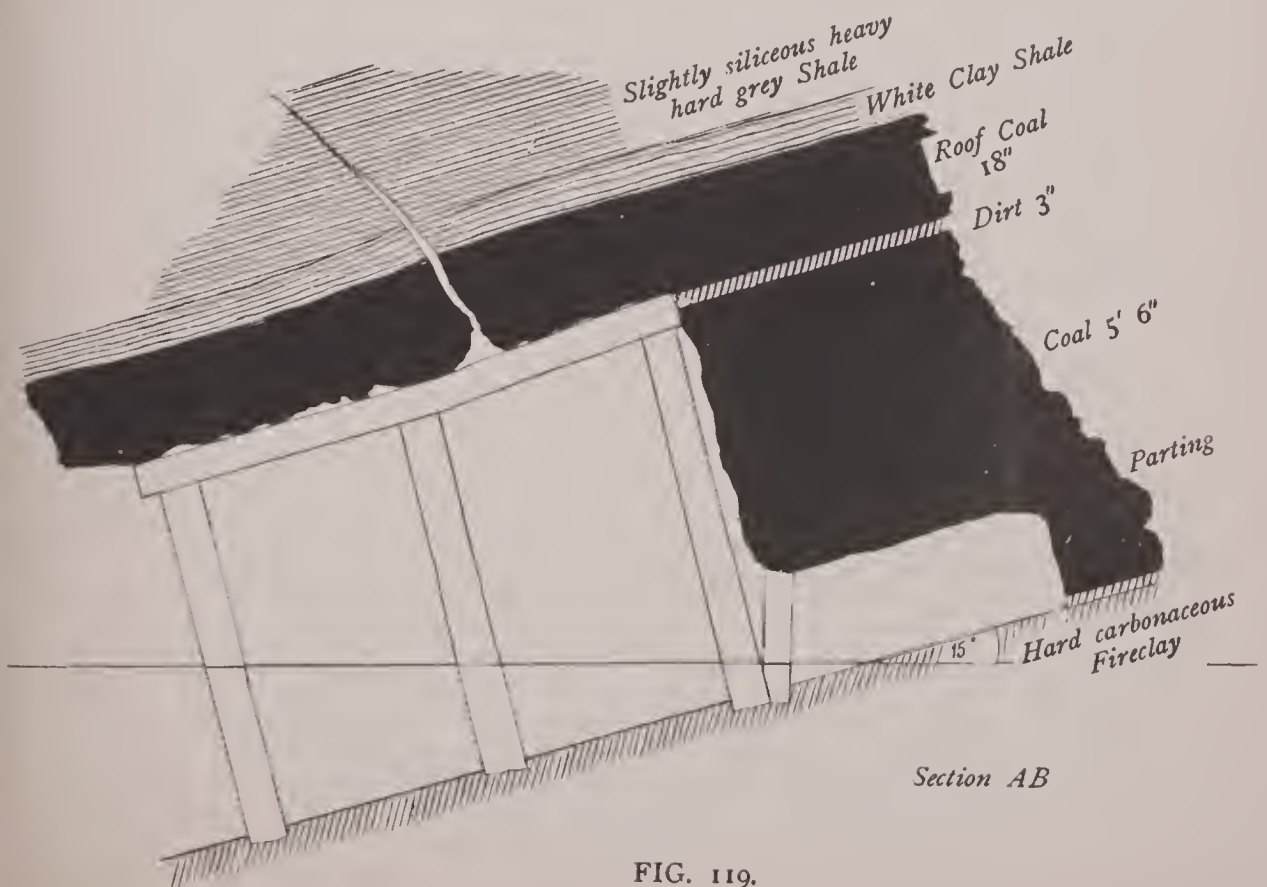
Figs. 118 and 119. Plan and Section N. The Top Coal is got in the wastes. It forms a pretty good roof in the drift, though bars are necessary in places. Cleat very distinct. Large tubs are used, and the gauge of the rails is 2' 6½", which necessitates wider roads than is advisable.
