ACCIDENTS IN MINES,

NORTH STAFFORDSHIRE COALFIELD,

FALLS OF ROOF AND SIDES;

THEIR CAUSES, AND THE MEANS OF DIMINISHING
THEIR FREQUENCY.

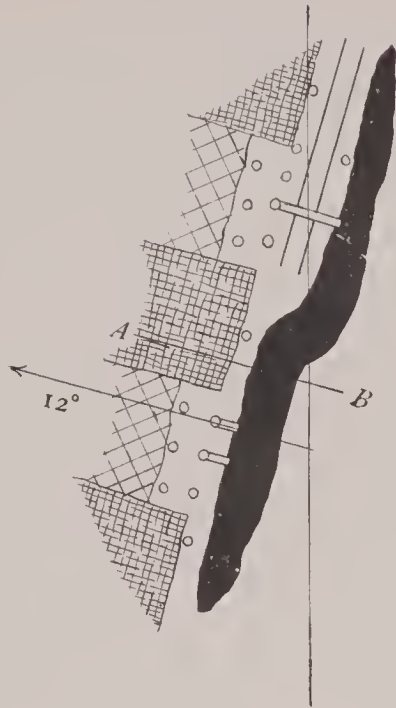
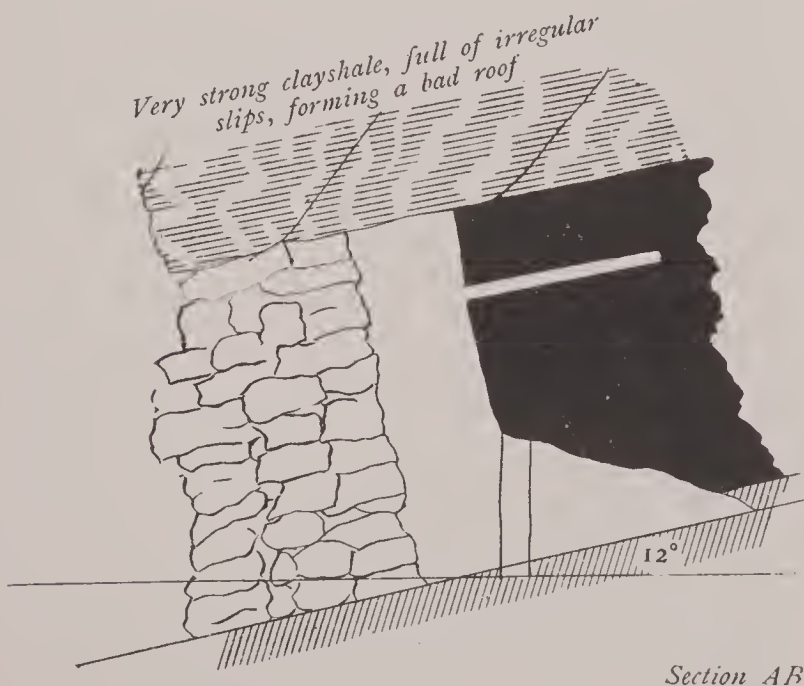
Figs. 120 and 121. Plan and Section N. over a small area. The Top Coal is about three yards above the working coal, and the intervening clay shale forms an exceedingly bad roof. The packs are built very close, and the coal holed only so far as it is required. Cleat not very regular; NS in the harder and 9° NW in the softer coal bands.

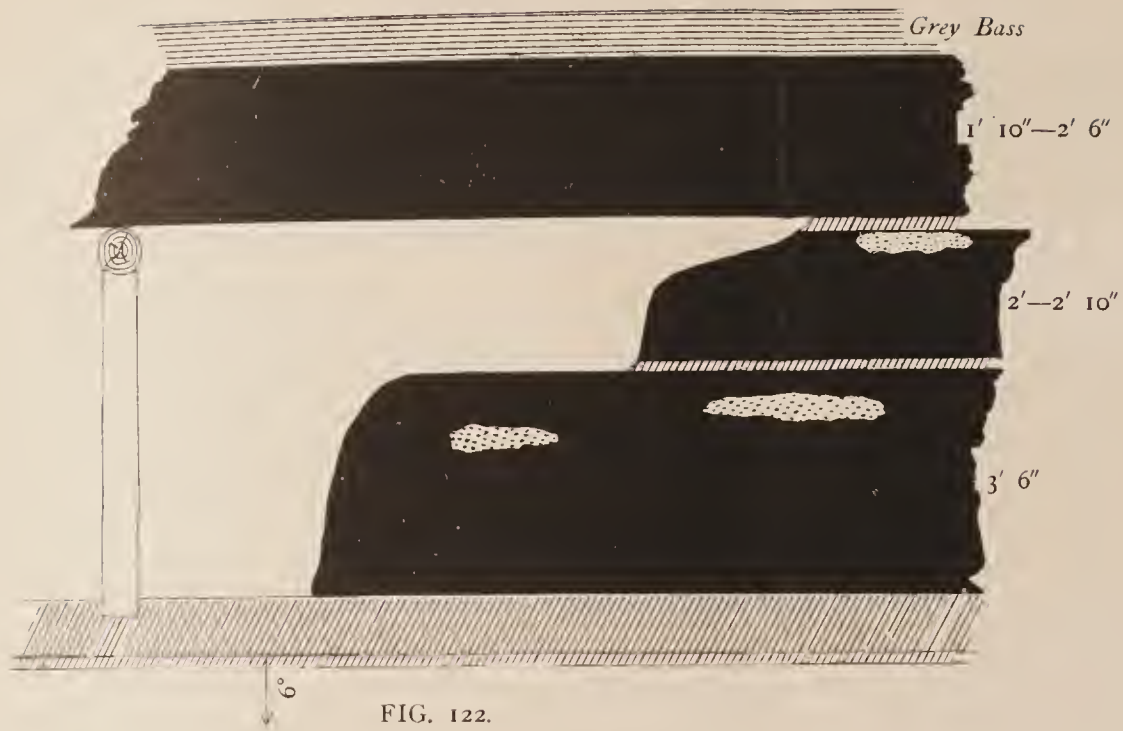
FIG. 122.

Fig. 122. Section W. The coal is dull and inferior. The cleat is distinct; 10° NW.

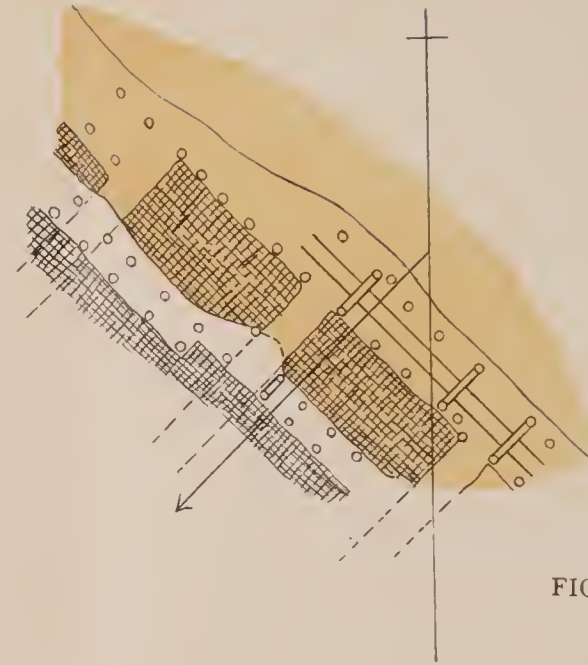
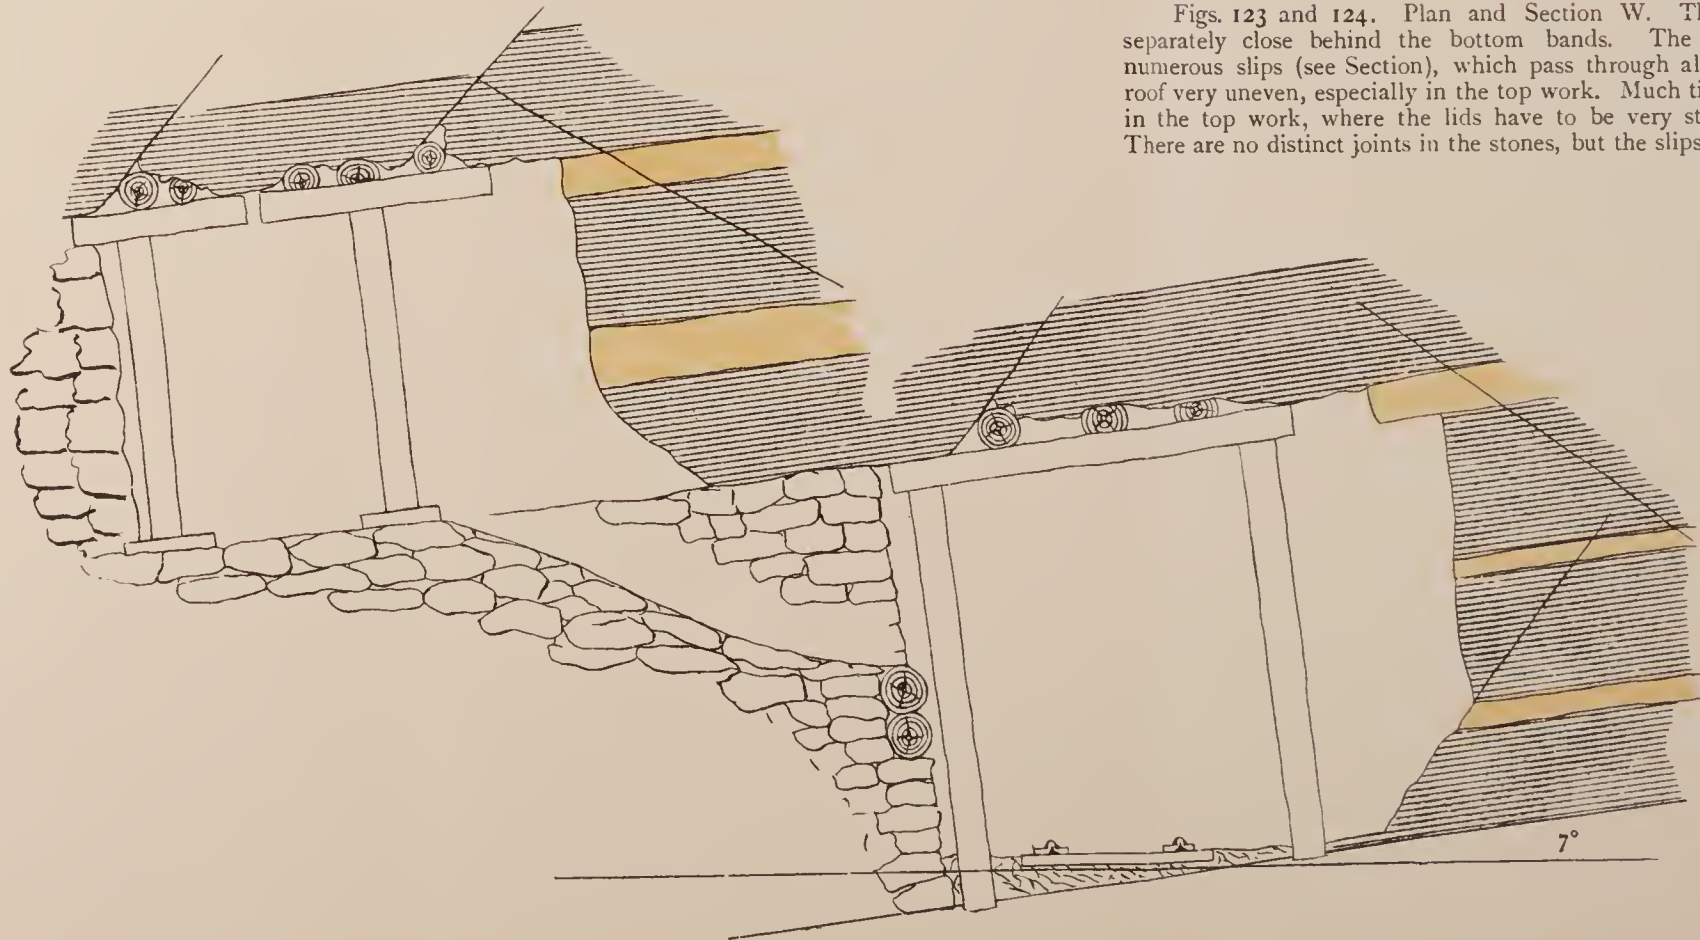
Figs. 123 and 124. Plan and Section W. The top bands are worked separately close behind the bottom bands. The stones and bass contain numerous slips (see Section), which pass through all the strata and make the roof very uneven, especially in the top work. Much timber is required, especially in the top work, where the lids have to be very strong, and footlids are used. There are no distinct joints in the stones, but the slips pass through them.

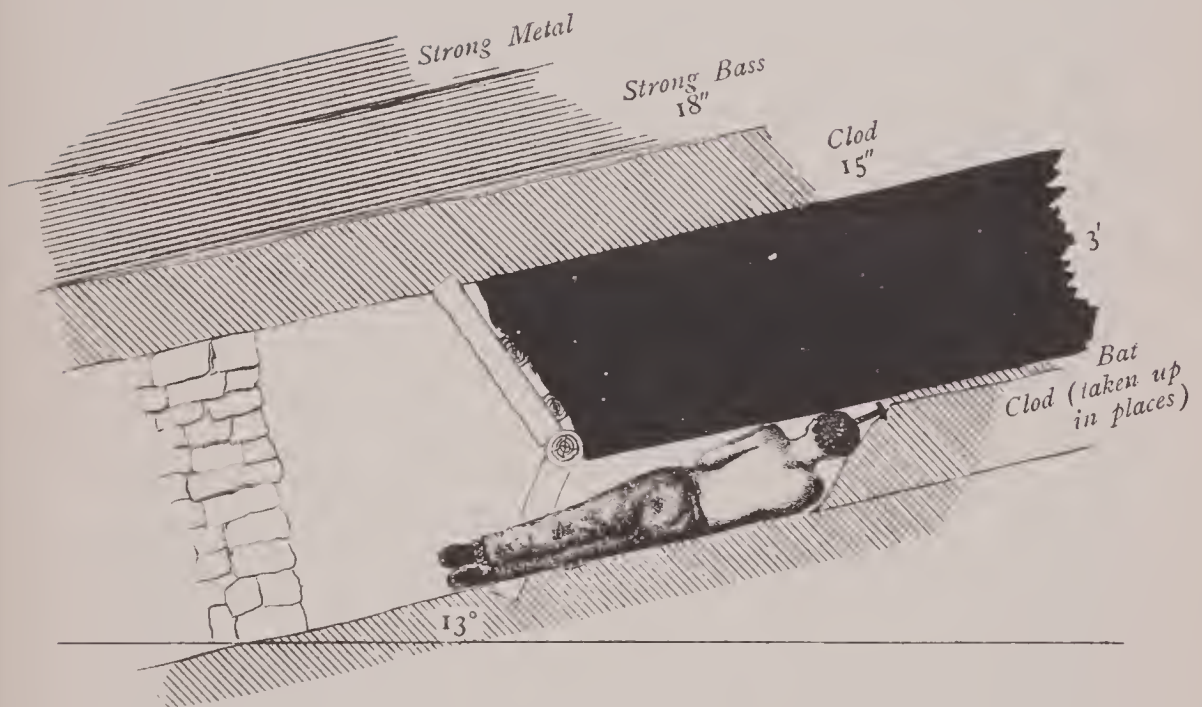
FIG. 135.

Fig. 135. Section S. Longwall, with 70 yds. faces. The clod is treacherous, containing smooth surfaces, and requires to be carefully supported. It is taken down in the jigs. On one occasion it had been taken down to about 4' from the jig post, the jig being 9' wide. A piece of the projecting clod, 7' 6" \times 3' 6" and 18" thick, broke off and killed the jigger. A bar should be placed under such projecting pieces of roof, or the latter should be taken down to nearer the jig post.

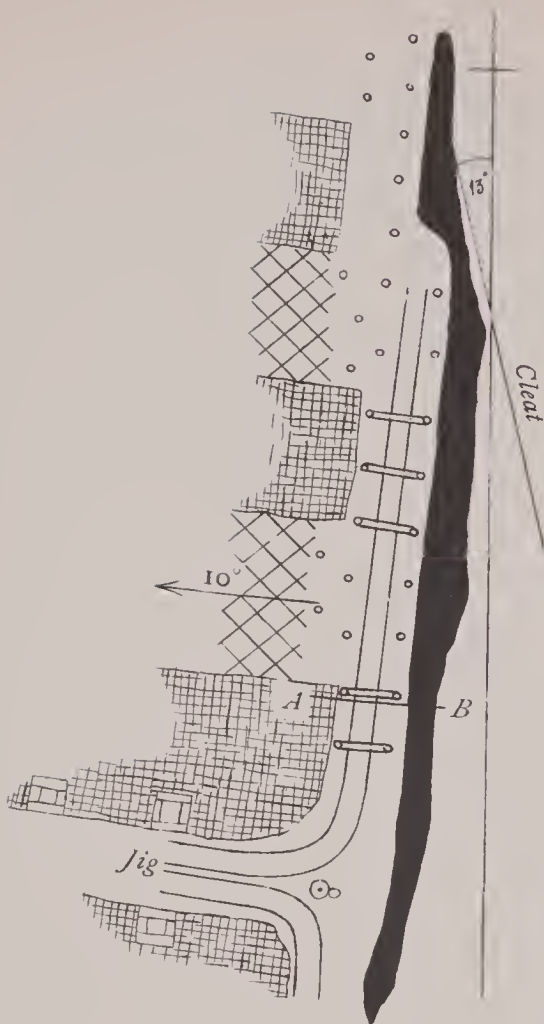
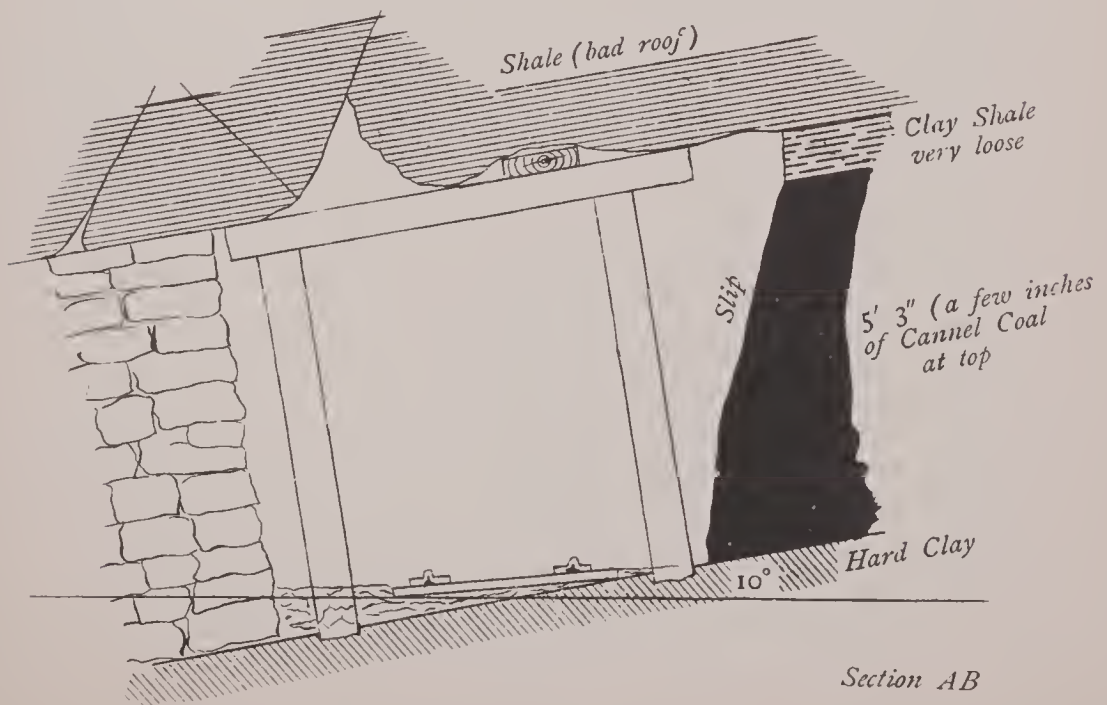
Figs. 136 and 137. Plan and Section S. Cleat very distinct; cleat planes being as near as $\frac{1}{8}$ " apart in places. Slips like the one shown in Section run in the coal at intervals. The shale roof breaks up small easiest in the direction of the coal cleat; it forms a very bad roof, and necessitates much timber. Lids are formed of broken posts and bars are frequently put up. The jig post is shifted after two falls, so that the rails are bent as in plan for the second fall. The roof is too bad to allow of a back fall.

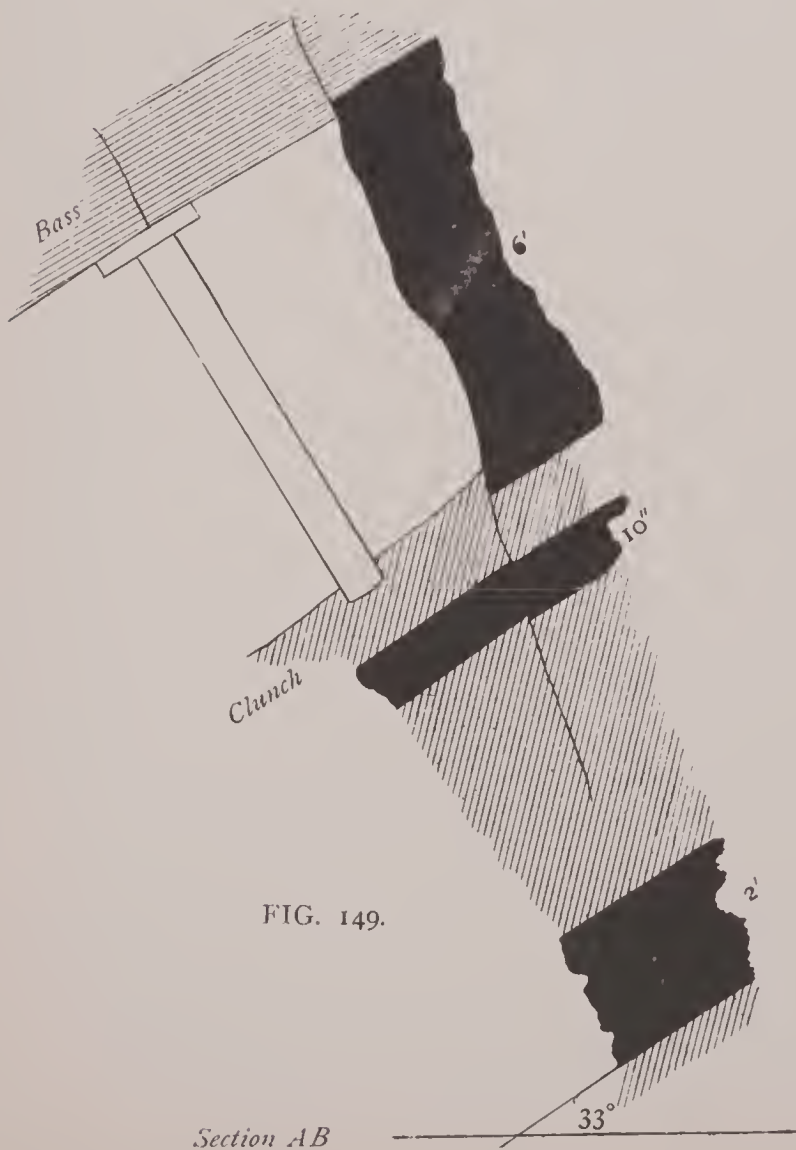
FIG. 149.

Figs. 148 and 149. Plan and Section NE. The roof is very short and jointy, and occasionally falls in at the face, in which case pillars are left to recover a new roof, as in Plan. It very soon cuts at the face, and the floor lifts, as in Section. Where the bass is exceptionally loose 15" of Top Coal are left over the packs. Where the roof is stronger a back fall of 1½ yards is got in going back. Cleat very distinct. The coal is rated off, very little holing being done.

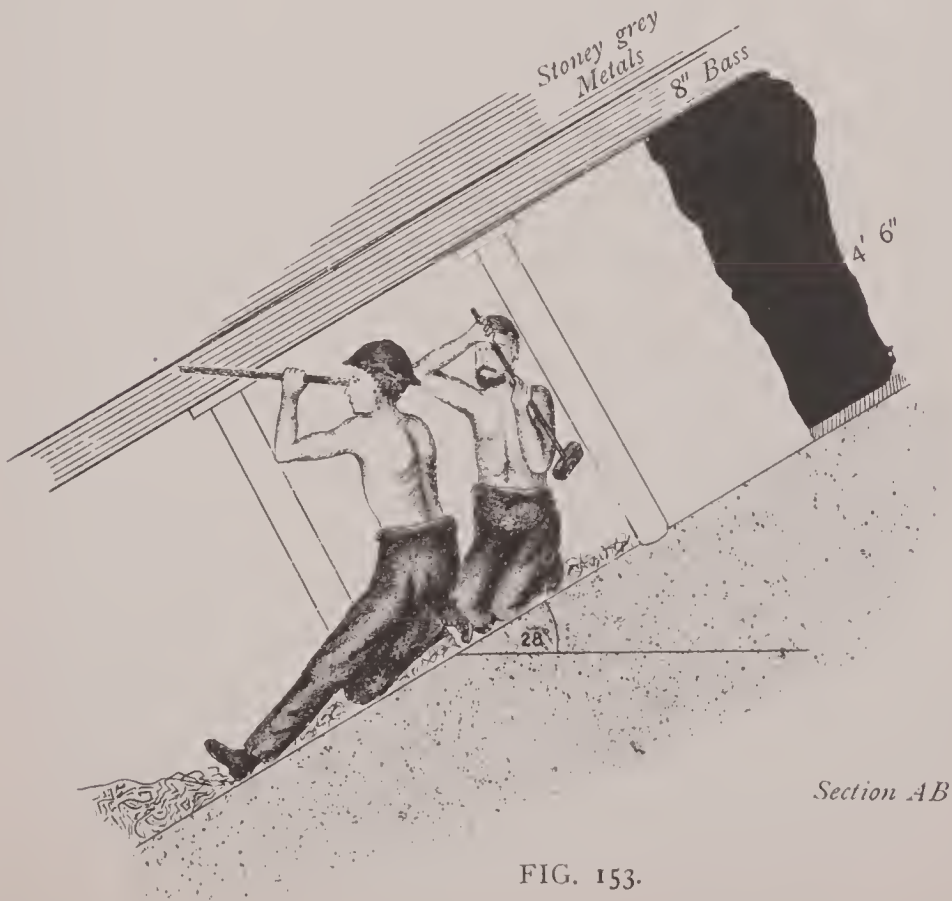
FIG. 153.

In flatter mines the first builders are sometimes brought from adjoining levels or other places in which suitable material is produced. At other times the roof is partly blown down to obtain the first builders, as shewn in Fig. 153.

Figs. 152 and 153. Plan and Section NE. The roof is strong, and contains a fossil band. Section shows a shot hole being bored to blow down the bass, to form builders for the packs. The bass is down over spaces S, S. The coal is soft, and requires little holing. Cleat very distinct, but varies from 8°—18° NW. The clay underneath it varies much in thickness. The bass contains two very distinct series of joints, from 6" and more apart.

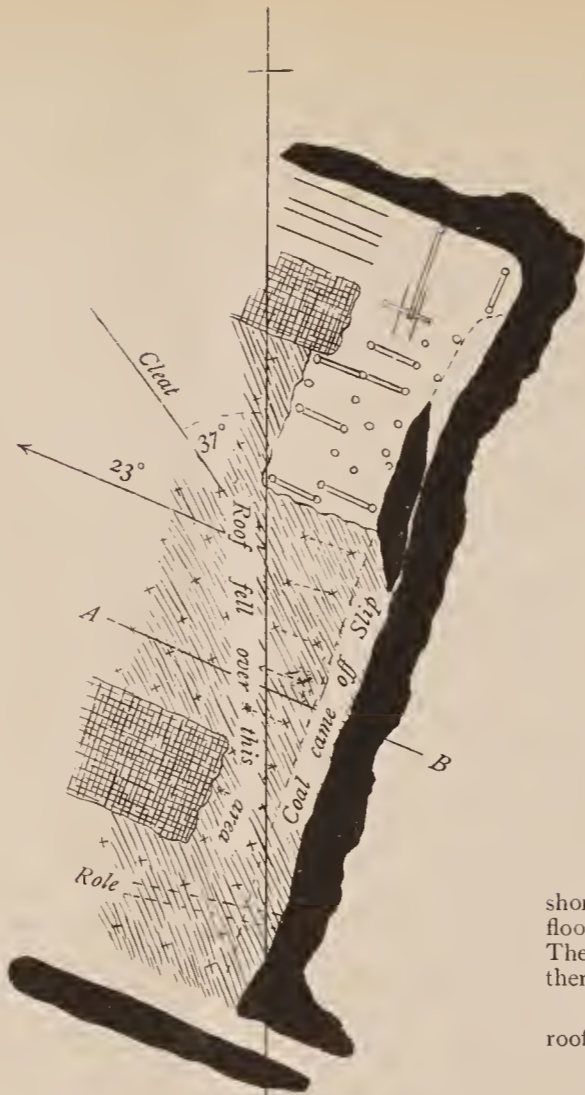
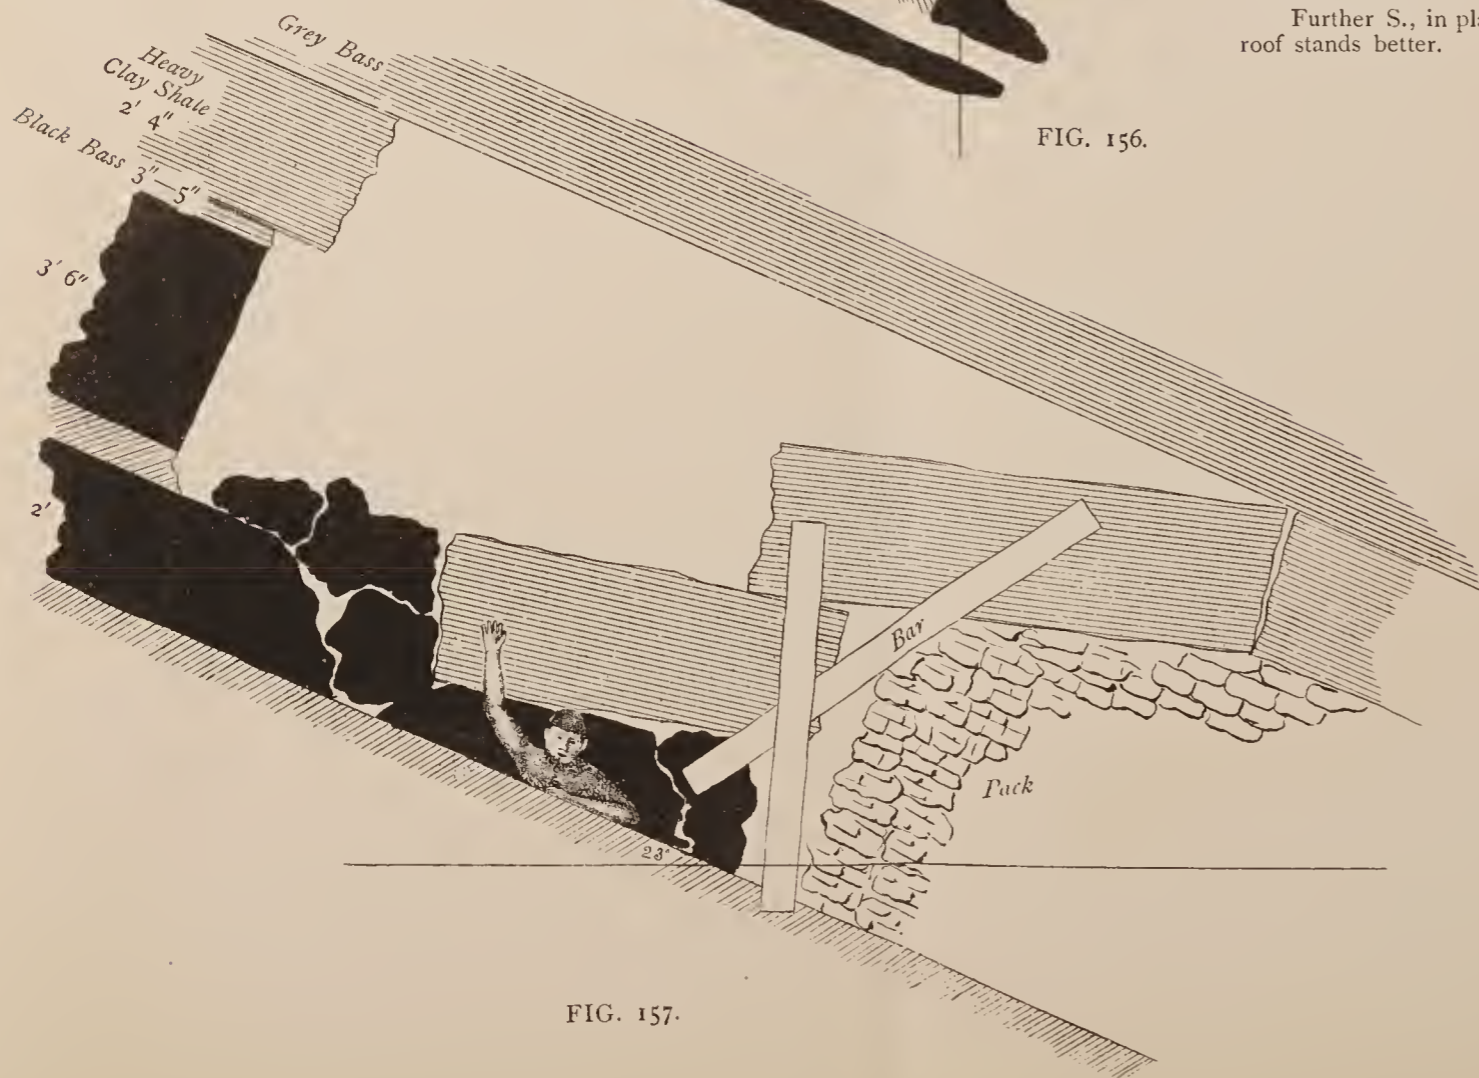
Where builders are plentiful the packs should not be built too far apart. The accident illustrated in Fig. 157 occurred partly in consequence of the waste being so wide. Packs should be regularly formed and kept up to the face systematically.

Accidents have occurred from the back timber having been left in too long (Figs. 156 and 157), and though timber drawing is dangerous, if the timber were left the danger would increase considerably, quite irrespective of the waste of timber which this would entail.

Figs. 156 and 157. Plan and Section E, illustrating the falling in of the roof in a drift over an area of about 150 sq. yds., by which a collier was killed.

There is a layer of clay shale, 2' 4" thick, which forms the roof. It is usually strong, but owing to the presence of slips and to the drift having stood for some weeks it was tender, and was loosened from the roof above along a smooth parting. There was an ample supply of timber; × × represent the posts, and × --- × the posts and bars which were knocked out by the fall, about 50 in number.

This large fall of roof occurred owing to the packs being so far apart, and the back timber not having been drawn in consequence. The pack had also not been built close up to the face. The two back rows of posts, by supporting the roof, threw additional weight on to the coal and the timber at the face. The posts were easily knocked out, from being set too square with the dip, which, with a loose roof, was wrong. The other five men who were in the drift at the time escaped almost miraculously.

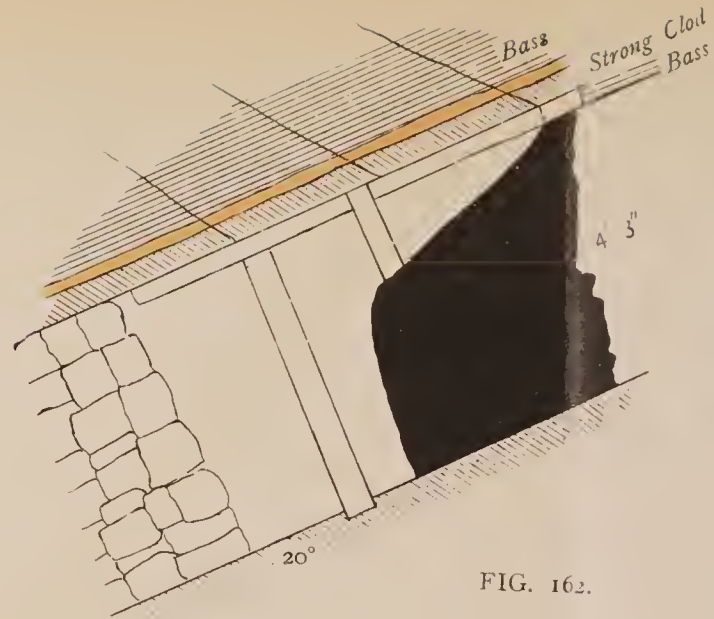
FIG. 162.

Fig. 162. Section of a drift N. of last Figs., which is only occasionally worked, and in which the roof consequently breaks so badly that bars have to be placed up to the end of the holing, to support the roof before the sprags are taken out. Both the coal and the 3" bass are intersected at intervals of from about 6" to 18", by two sets of parallel planes, 22° NW and 45° NE. They break in blocks from between these planes, and shew no sign of cleavage, and are very hard.

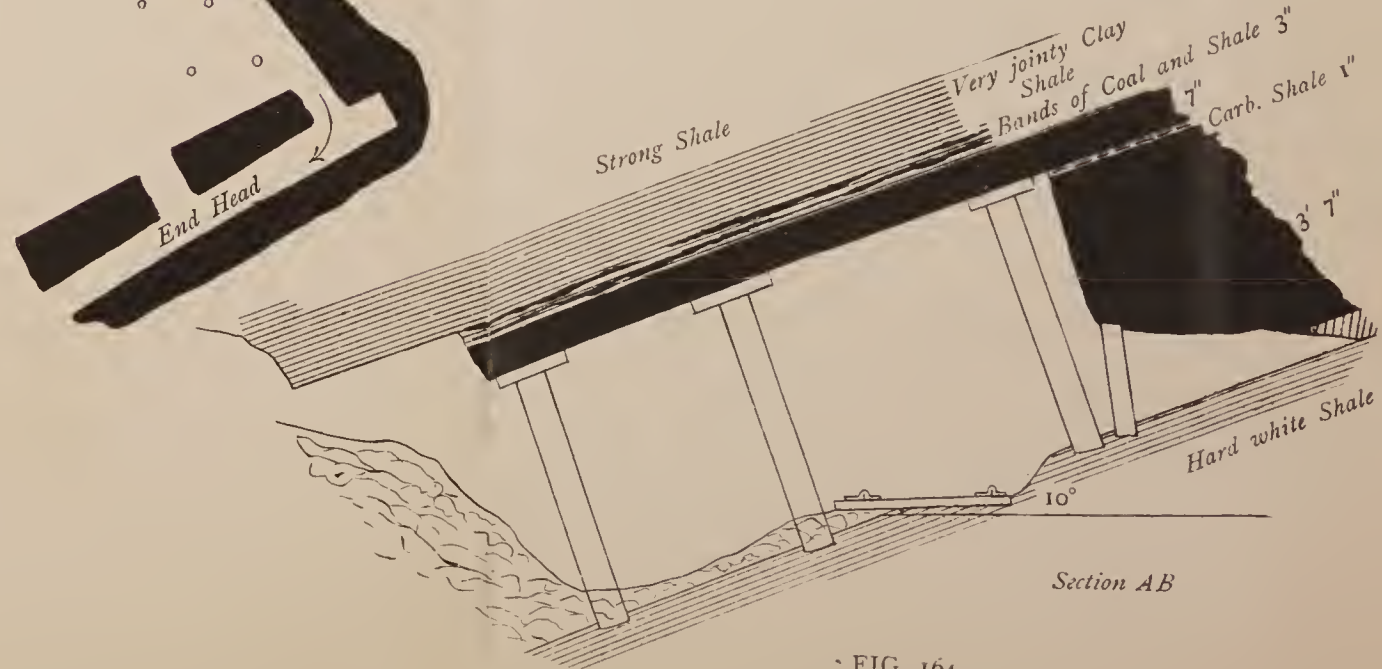
FIG. 164.

Figs. 163 and 164. Plan and Section SE. Drifts are kept 50 yards on each side the jig. The Top Coal is cut down in the wastes. Usually two falls are got before moving the jig post, and occasionally also a backfall, as shewn in plan. There is a parting in the roof, 4' 6" above the coal, above which it stands well, and forms the roof in jigs and other roads.

Cleat planes, presenting reddish-brown surfaces, run 42° NW, 3"—12" apart; cross cleat, 45° NE, pretty distinct. The coal breaks in little blocks; it yields gas, which smells of SH₂ pretty freely.

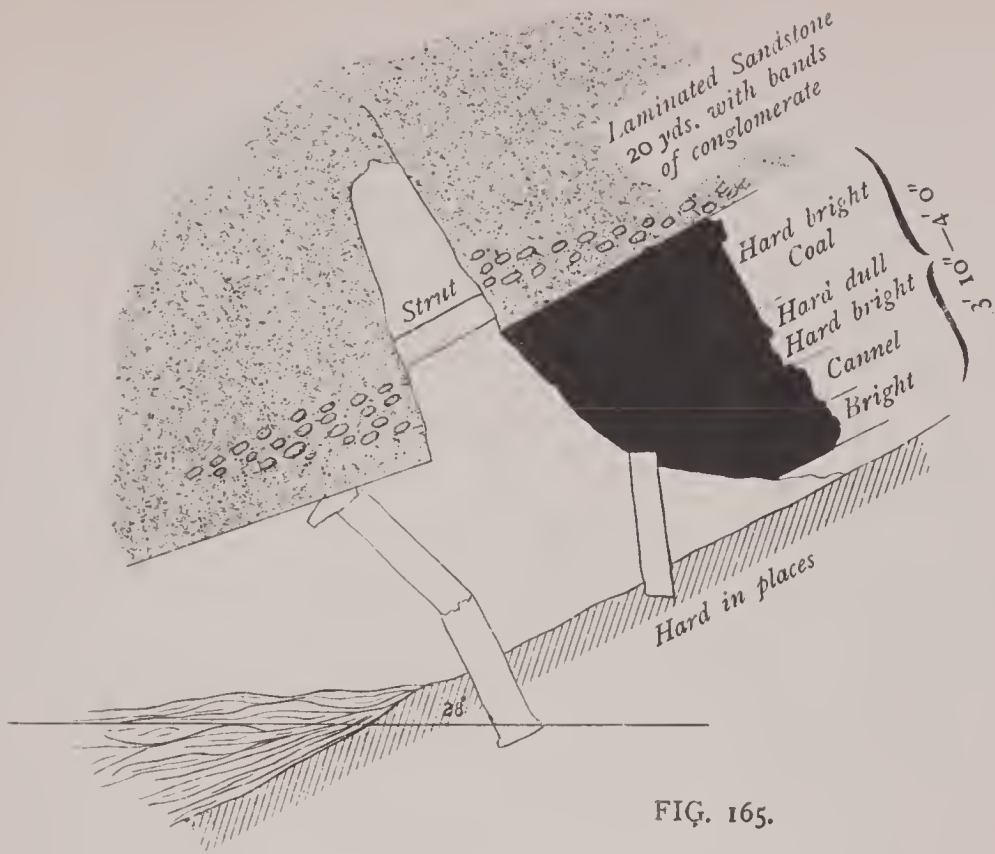
FIG. 165.

Fig. 165. Section N. Worked by 30–40 yds. drifts on each side the jig. Jig packs, 4 yds.; others 2 yds. Wastes, 6–8 yds. A large weight comes on about every 12 yds. It gives from one to six days warning. The roof sinks gradually about one foot, and breaks off at the face (see Fig.), presses the posts into the floor, or breaks them and flattens the packs. On the roof beginning to weight in a drift, the rails are at once pulled up and the men with drawn until the weight has had its fling. To get under new roof the jig is first moved up, and the coal “breasted” from 6’–12’ on each side, the new roof being timbered and supported by struts placed against the old roof, which are of great assistance. A back fall of coal is brought back and the new packs are begun. The old timber is all lost.

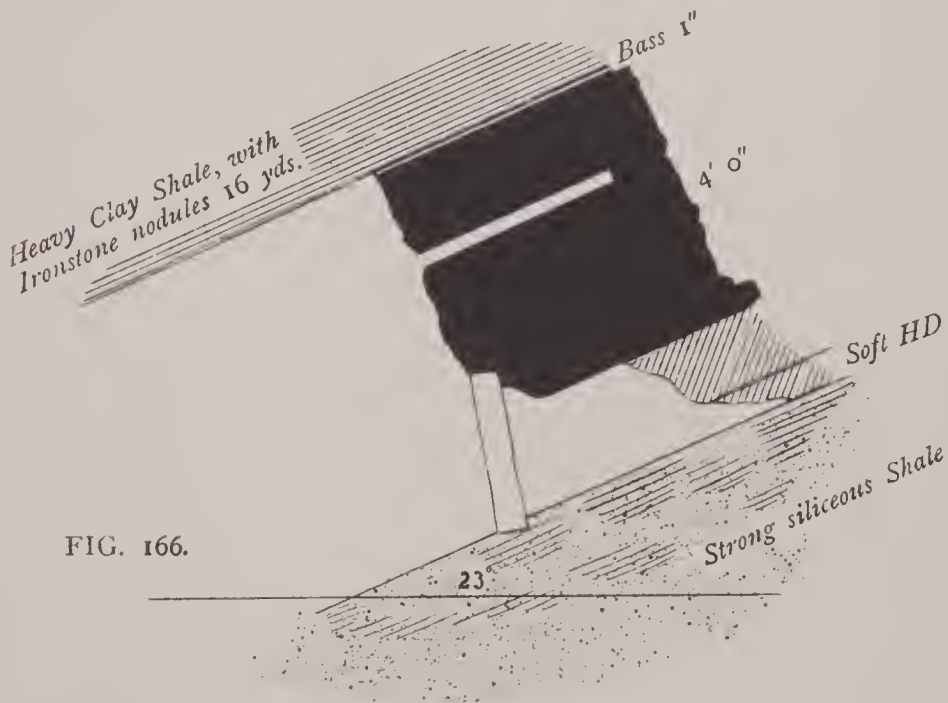
FIG. 166.

Fig. 166. Section E. The roof is very good; it contains no slips. The first peel which falls in the wastes is 4’ thick. 1” bass sticks to the coal and comes down with it; a very smooth parting separates it from the roof above. The gob is nearly filled. Cleat, which runs 30° NW, is not very distinct. The coal breaks readily in plane of stratification.

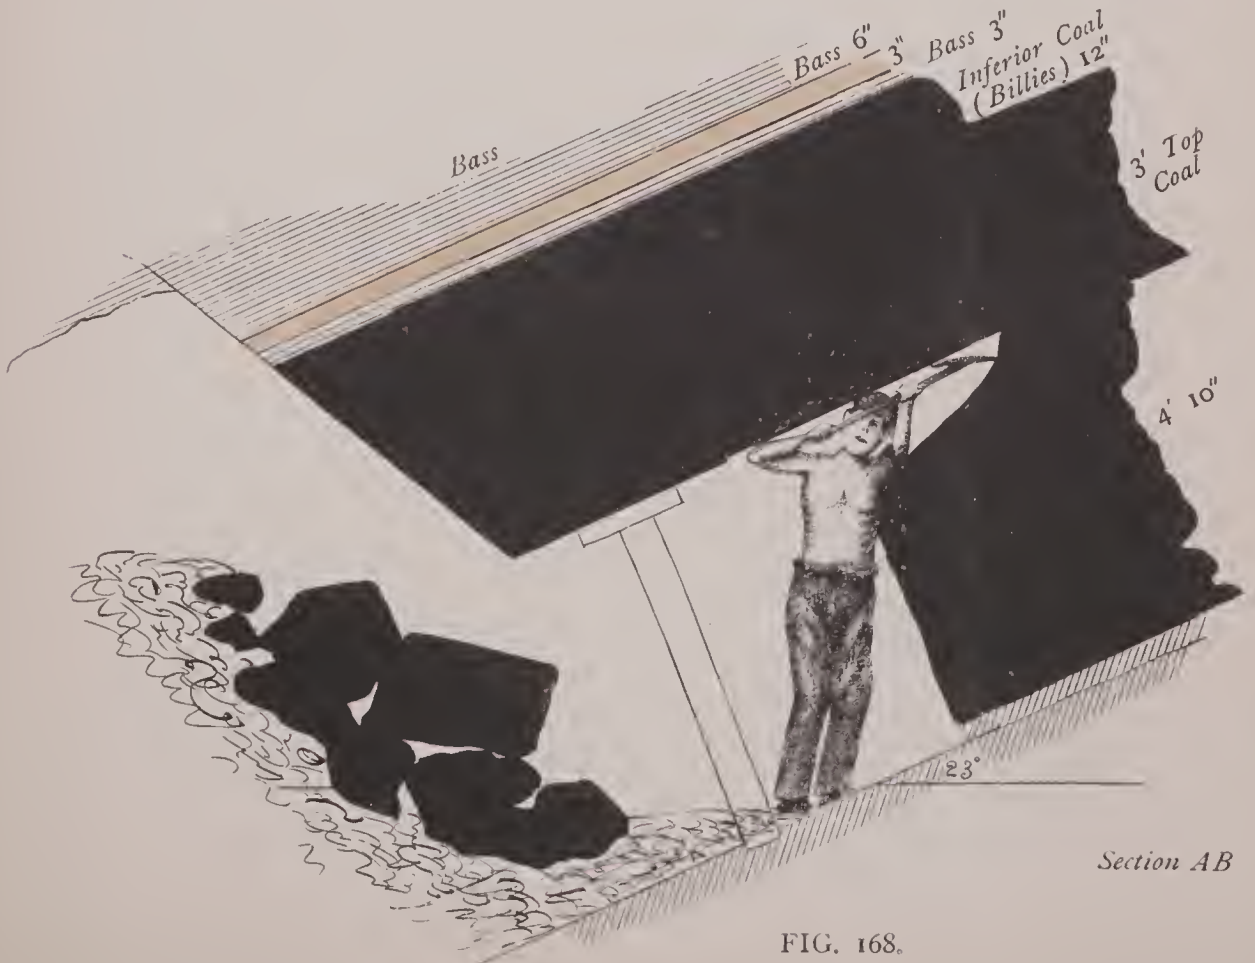
FIG. 168.

Northwards: A fatal accident occurred from the Top Coals falling on to the buttocker, who was pulling the Bottom Coals off. There was a post and bar 6' from the end of the buttock, and the pack was 4' from it. The coals came off a large slip, the presence of which was known. A post, or a post and bar, should be set not further than 4' from the buttock end under tender coals.

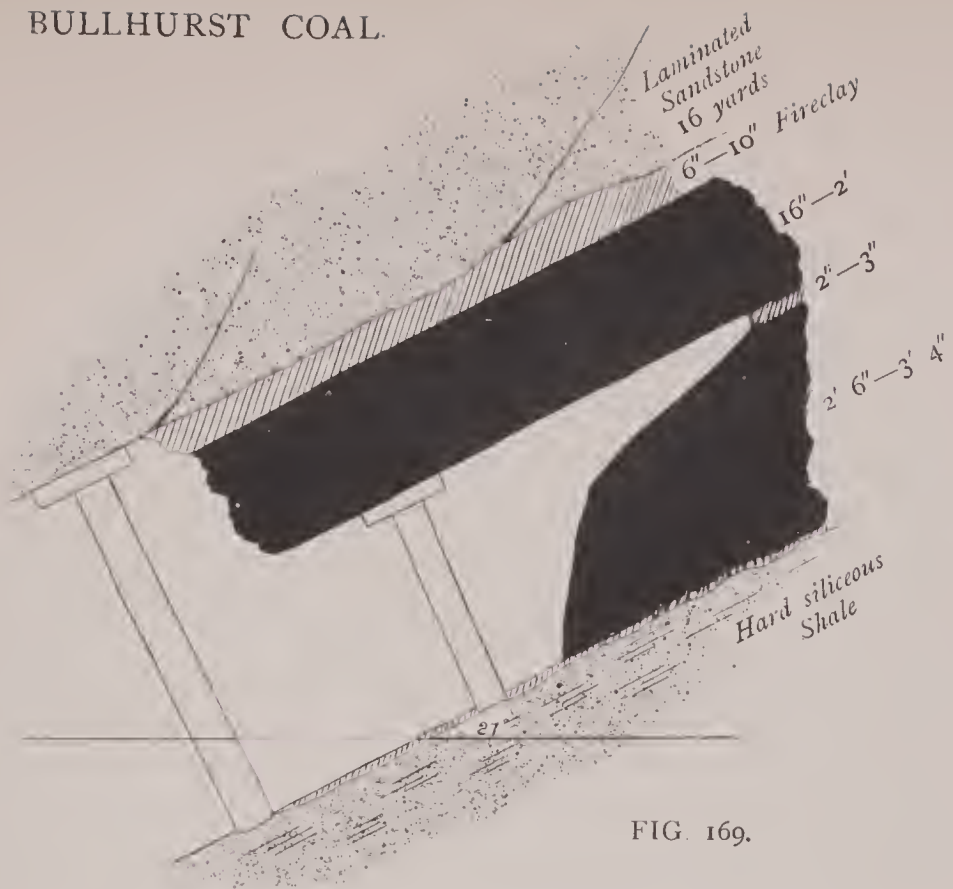
FIG. 169.

Fig. 169. Section NE. Cleat not very regular, except in places where it runs 43° — 50° NW. Usually worked by post and thurl, walls from 6—10 yds. wide; the coal posts being quite lost. The Tops are cut down behind, usually when the wall is completed. The roof does not fall, so that there are no builders, and if coal posts were not left the roof would take the face on the occurrence of a weight. The sandstone contains numerous slips, from which large pieces fall. The coal is much ground between the hard roof and floor, and much slack is made. Fatal accidents have occurred whilst cutting the Tops down incautiously.

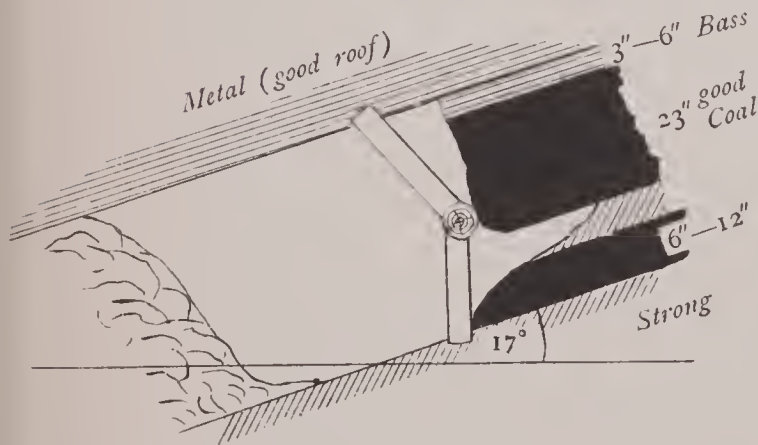
FIG. 170.

Fig. 170. Section E. Longwall to the rise. The coal is soft and cleat distinct. Gob almost entirely packed with dirt and slack.

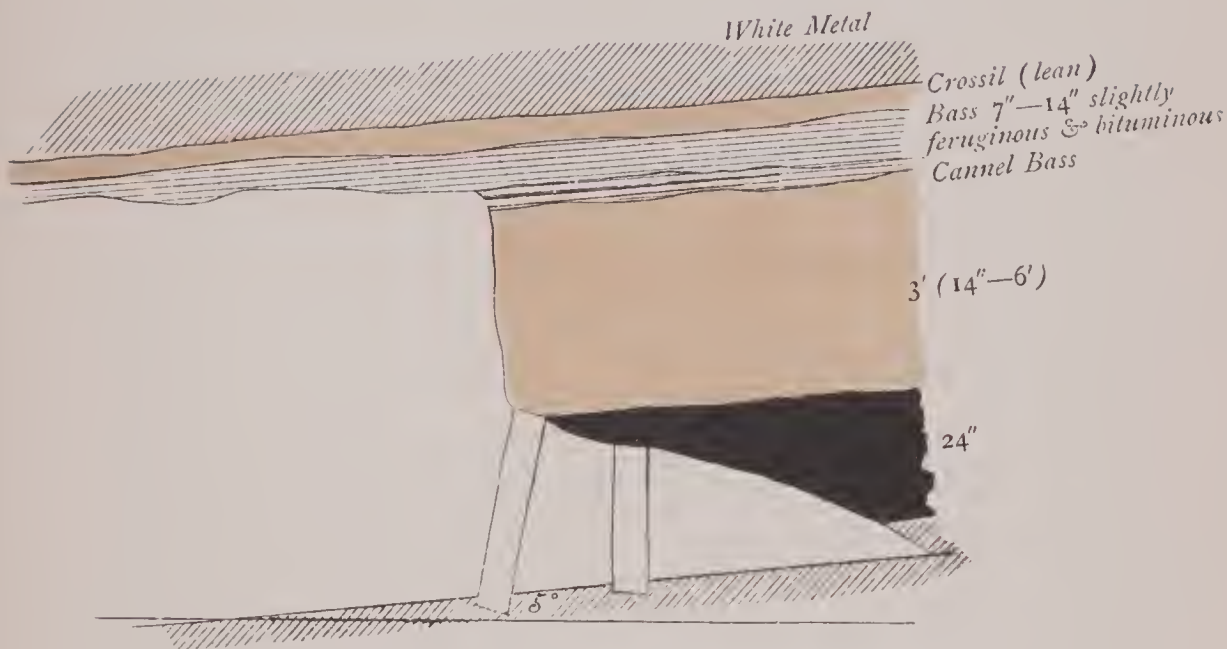
FIG. 174.

Fig. 174. Section W. The stone varies much in thickness. It is worked by longwall outwards, with as long faces as possible; 6 yds. packs and 8 yds. wastes. The roof breaks in the wastes and affords packing material. The turn of the dip destroys the parallelism of the joints, which run through bass and crosssil. It used to be worked by headings and 20 yds. pillars, but this necessitated more timbering. A small coal seam (12") lies 8 yds. above the stone.

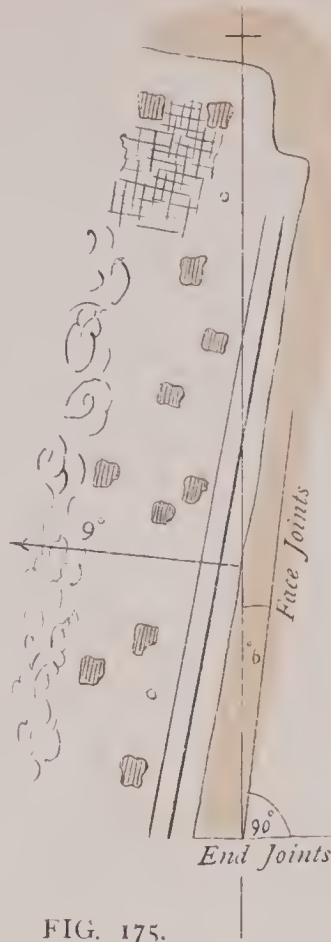
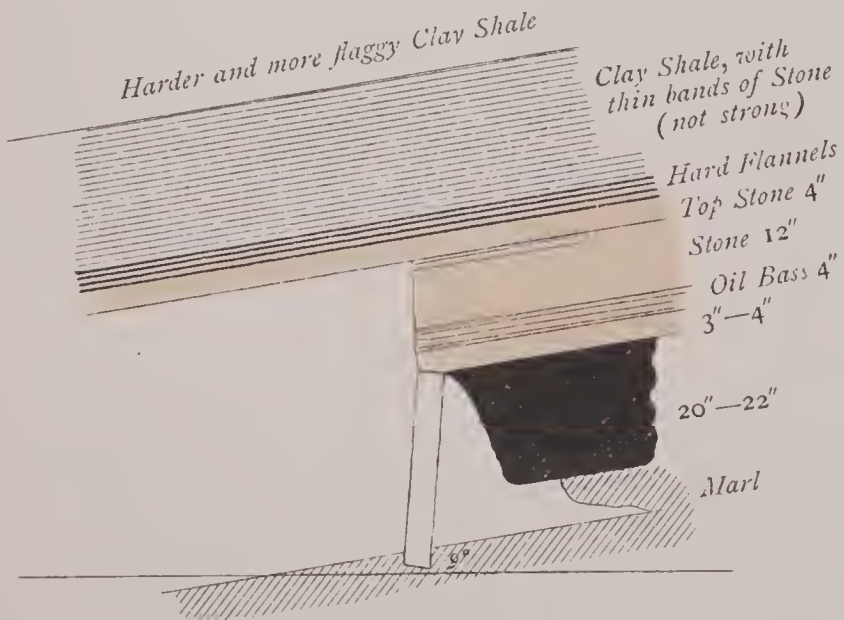
FIG. 175.

Figs. 175 and 176. Plan and Section SW. The grey clay shale roof being bad, both flannels and top band are left, and form a strong roof. It is supported by cogs made of pieces of oil bass (which here is too thin to send out) 2' 9" square, and at intervals of 6'—9'. The remainder of the gob is filled with holing dirt and slack. The face or main joints run very regularly, from 2'—4' apart ; the end joints are not so regular.

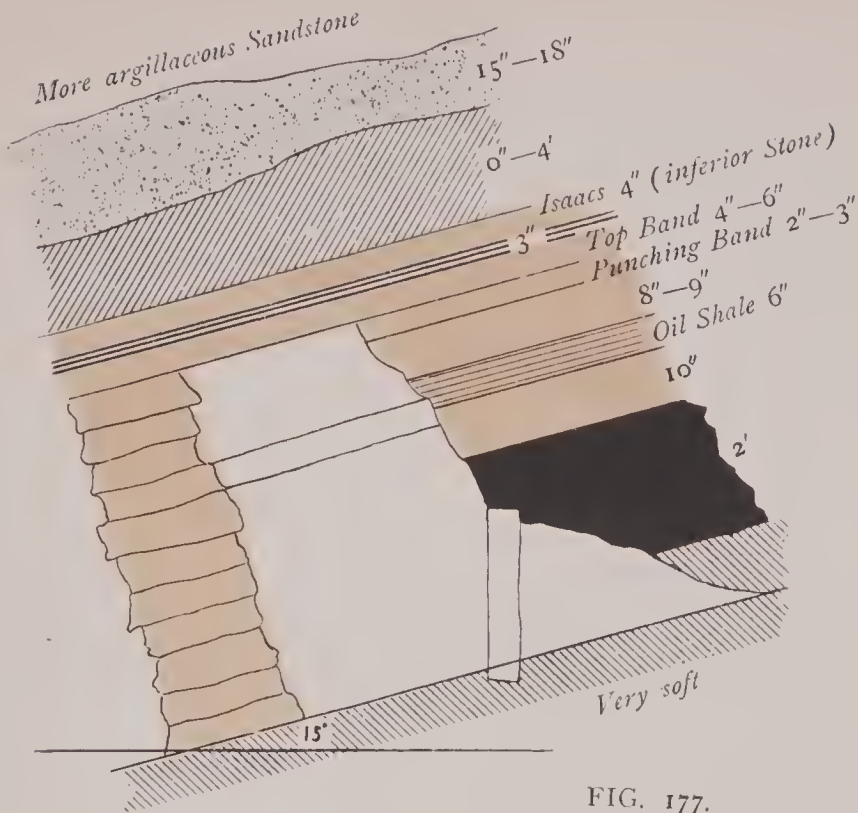
FIG. 177.

Fig. 177. Section further North. Joints as last Fig. Worked as last Fig., but Riflemen placed in a line with each other, so as to get the top band down between them, as it is of good quality. The floor is very soft, and a piece of oil bass is often placed under the posts.

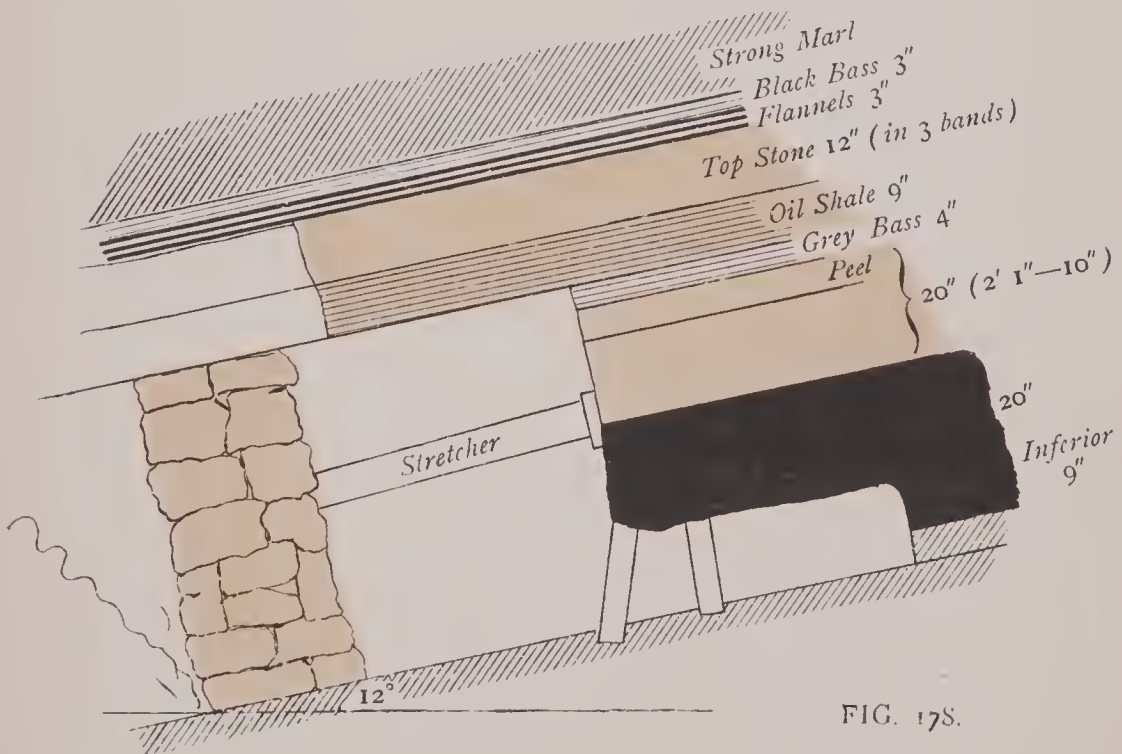
FIG. 178.

Fig. 178. Section further North and Centre. The oil shale and top stone are got down in the spaces between the stone cogs, which are from 3—4 yds. apart. The top stone and oil shale form a strong roof, but where they are removed the roof is bad. The oil shale is sent out.

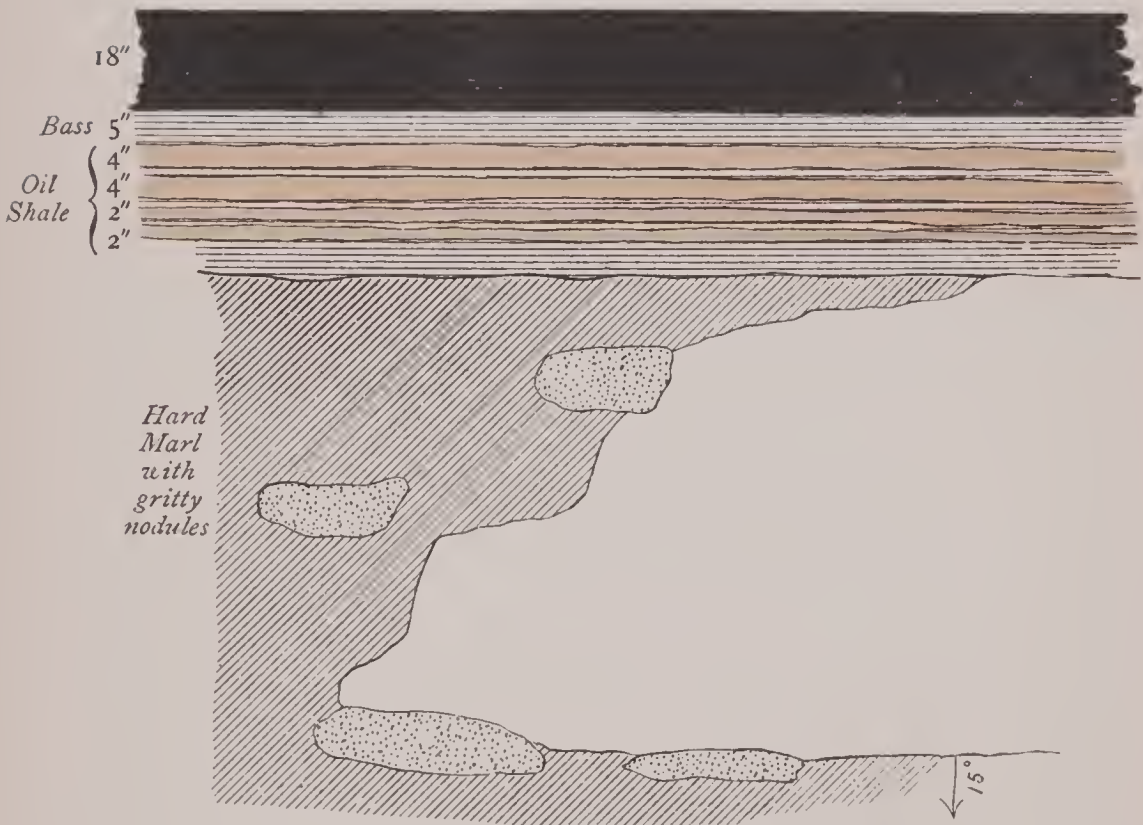
FIG. 179.

Fig. 179. Section of heading C. The stone and coal which are not worked at present form a good but jointy roof. The headings are from 6'—7' wide. Little timber is required. The marl is very strong, and has to be blown down. About 4' of it is sometimes left as a roof. It is used for making "saggars" and Queenware.

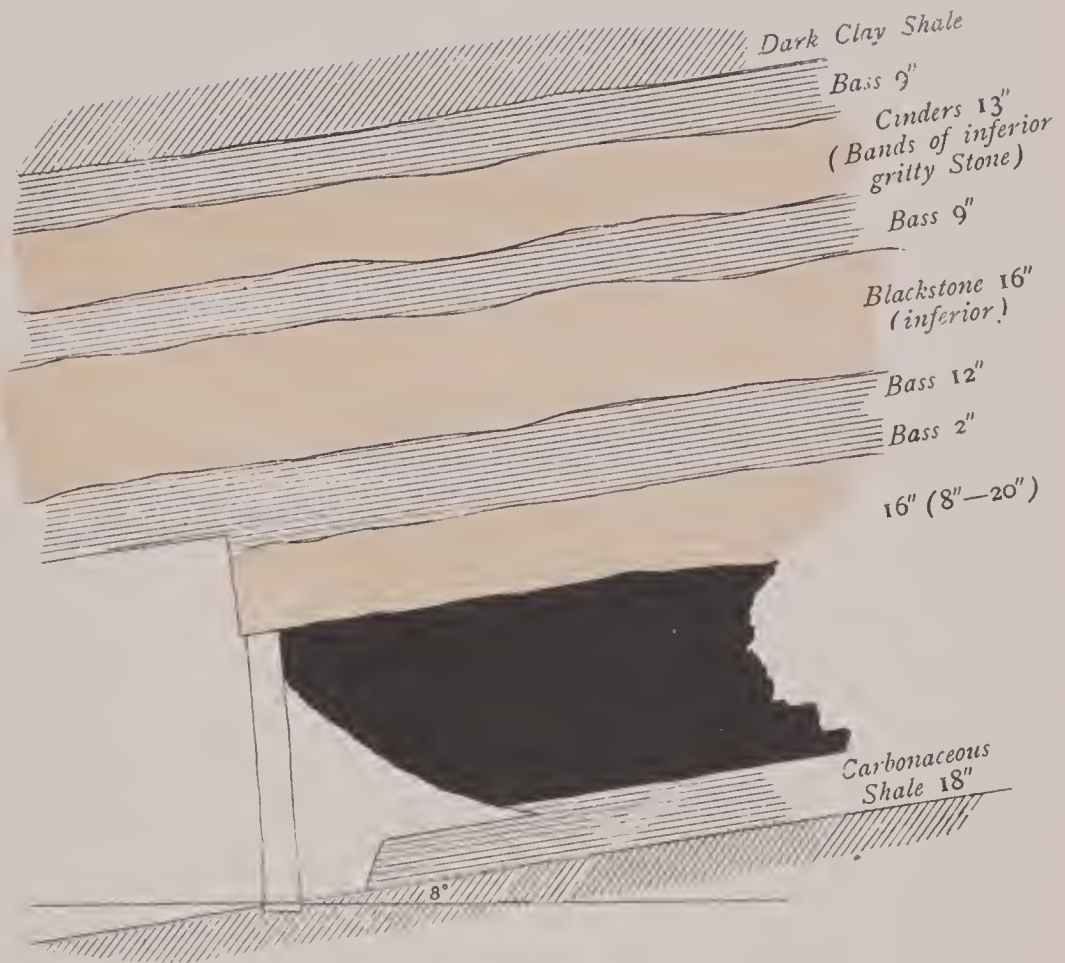
FIG. 180.

Fig. 180. Section S. The stone and coal vary much in thickness at short intervals. In some places the stone is 3' 7" thick. Where it is thin the coal thickens, and is of good quality, but where the stone is thick the coal thins and contains coalstones. Longwall, the gob being entirely packed, except where the stone is thick, when packs are formed. The roof is excellent, and requires little timber.
