ACCIDENTS IN MINES,

NORTH STAFFORDSHIRE COALFIELD,

FALLS OF ROOF AND SIDES;

THEIR CAUSES, AND THE MEANS OF DIMINISHING
THEIR FREQUENCY.

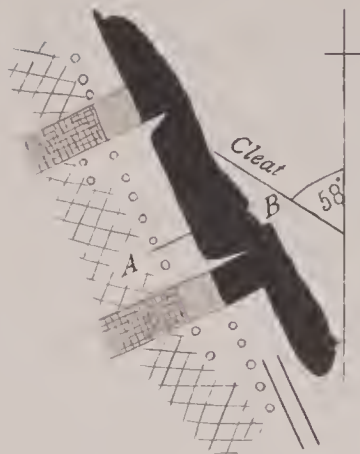
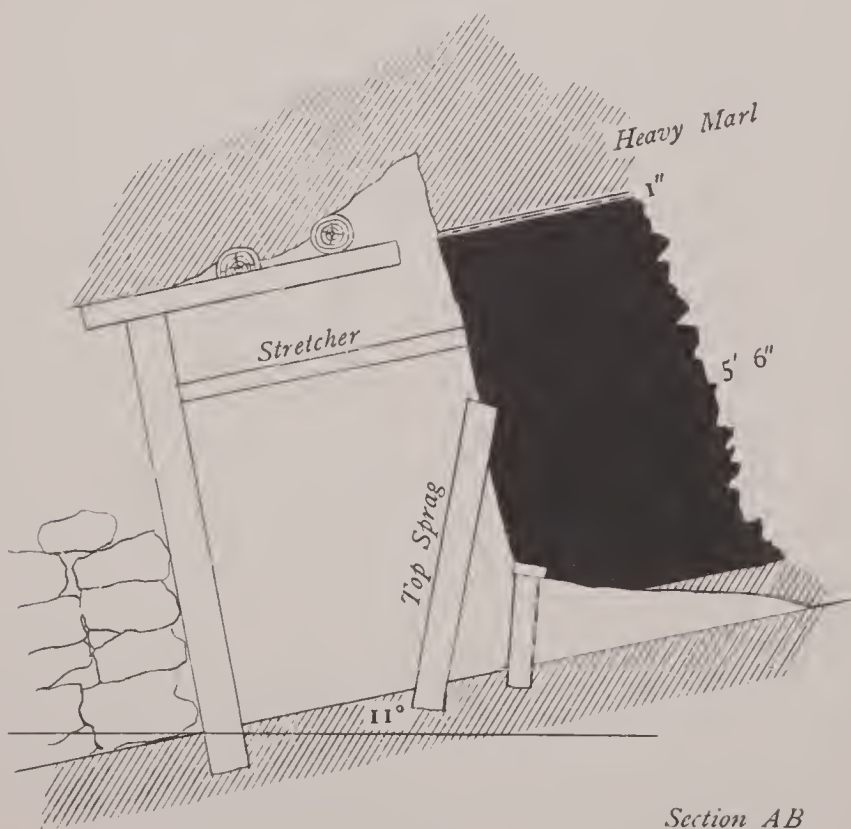
FIG. 181.

Figs. 181 and 182. Plan and Section NW. The roof is very heavy and breaks at the face at each dressing. 18" of Top Coal is left over the packs to divide the walls, and to make the roof break separately in each. The roof is supported in the wastes by one row of posts closely set, and well stamped, generally nine in a 5 yds. wall. They are supplied with long lids, to catch loose pieces. The coal is soft, and the bottom sprags all require lids. There are also stretchers from every post. Cleft distinct, but very short. The corner stretchers in each wall have to be removed to cut the corners; before this is done top sprags are set. The Top Coal which is left over the packs forms a bridge at the face. Bridge posts are set to prevent the Top Coal falling before the walls are cut. Foreset posts are set whilst drawing the back timber. Corners of dips are chocked and the dips barred, levels are driven just wide enough for tubs to pass along, and even then they require stretchers.

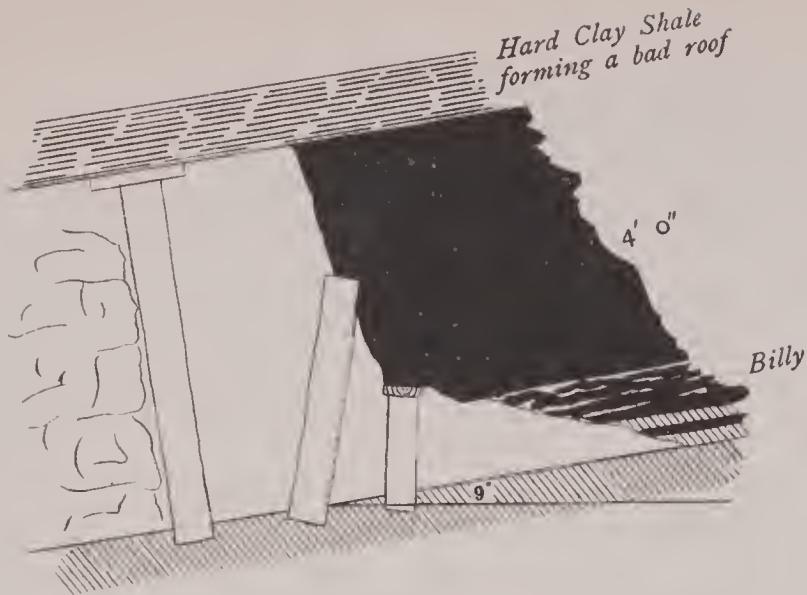
FIG. 183.

Fig. 183. Section W. Longwall, with 30—40 yds. drifts; 4 yds. packs and 4 yds. wastes. A row of posts is set on the gob side of the rails only, the posts being from 3' to less apart. Most of these posts support bars at one end, which are let in the solid at the other end. As soon as holing recommences foreset posts are set under the bars. The coal is very brittle, and has to be supported by top as well as bottom sprags. Cleat indistinct, 42° NW.

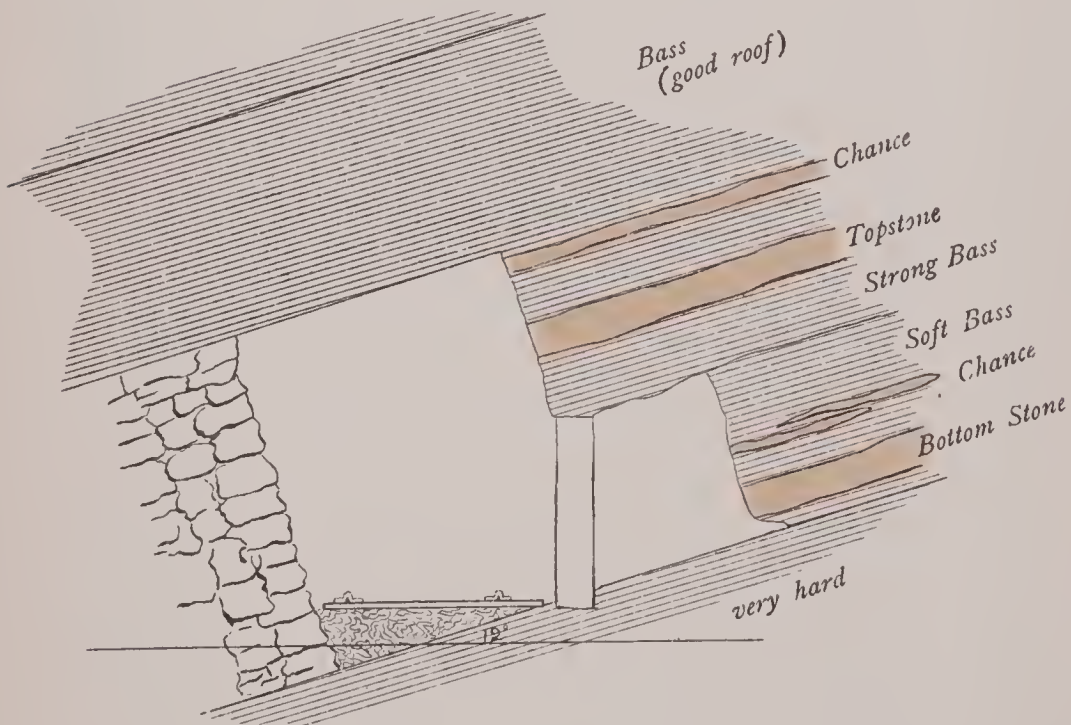
FIG. 184.

Fig. 184. Section S. The stone bands and chance bands are very irregular. Joints are very frequent and distinct in stone bands; they occur at greater intervals in the strong bass, and are absent in the soft bass below. Longwall outwards; gob entirely packed; a large amount of dirt having to be sent out for want of space. The roof stands well in drifts, in which little timber is used. The jigs and levels, however, require much timber. Holing is facilitated by water being thrown on to the soft bass. Sprags are usually 6" in diameter and are strong; they last three dressings or two months.

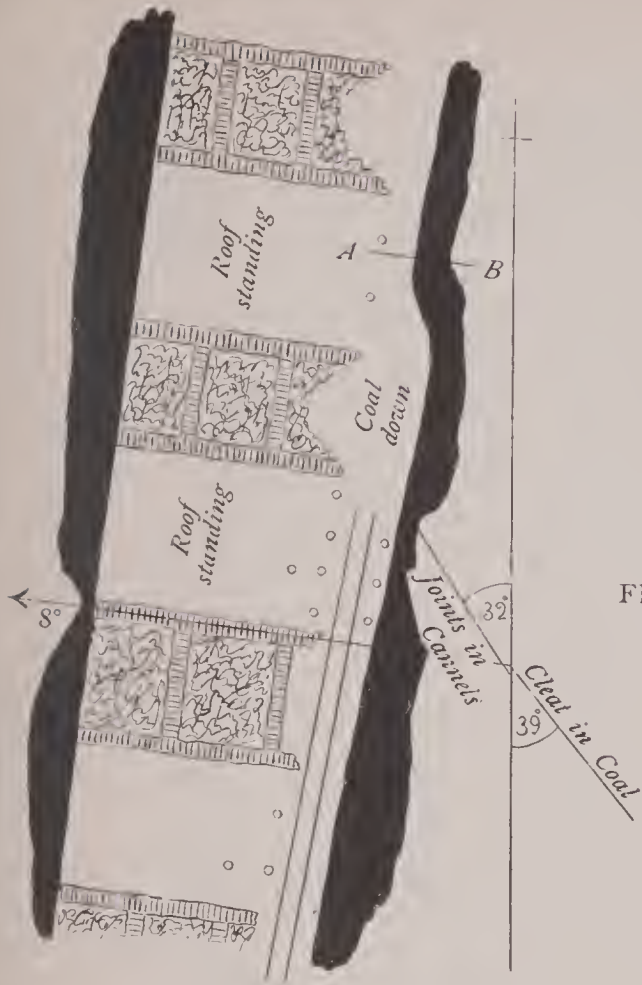
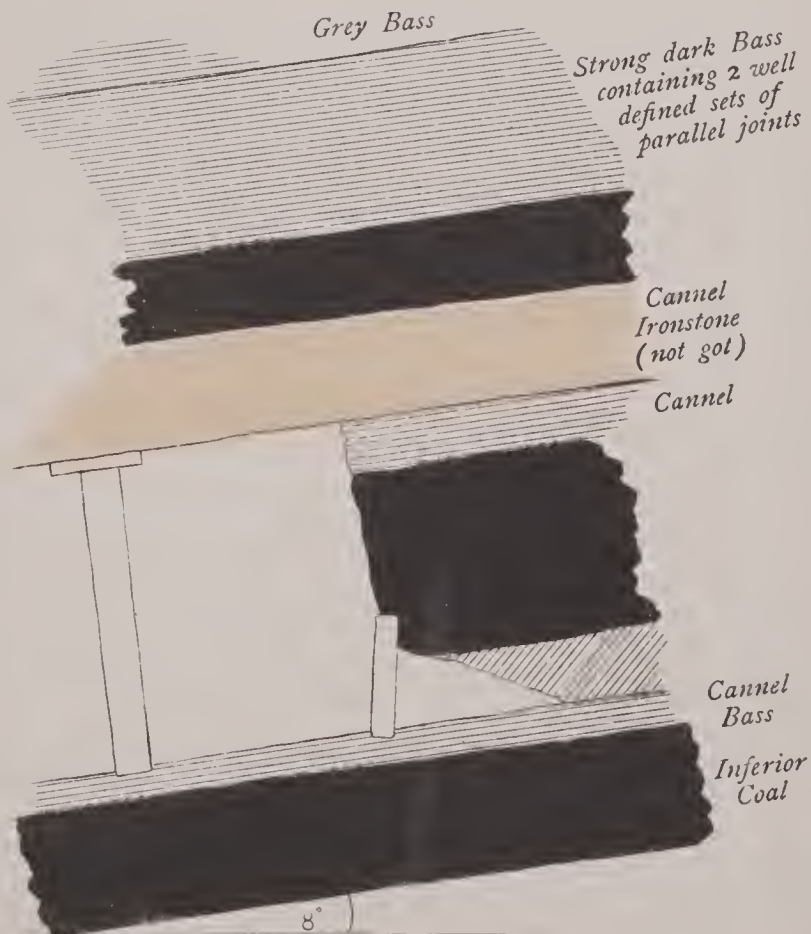
FIG. 188.

Figs. 188 and 189. Plan and Section S. Cleat irregular in places. The Cannel Ironstone forms an exceptionally good roof. The drifts are often opened 30 yds. before the roof weights sufficiently to afford builders. Until then, when starting a drift walls and cross walls are built with the Cannel, about 18'' thick, and the intervening space is filled with holing dirt and slack. 10 yds. pi lars are left on each side the jig.

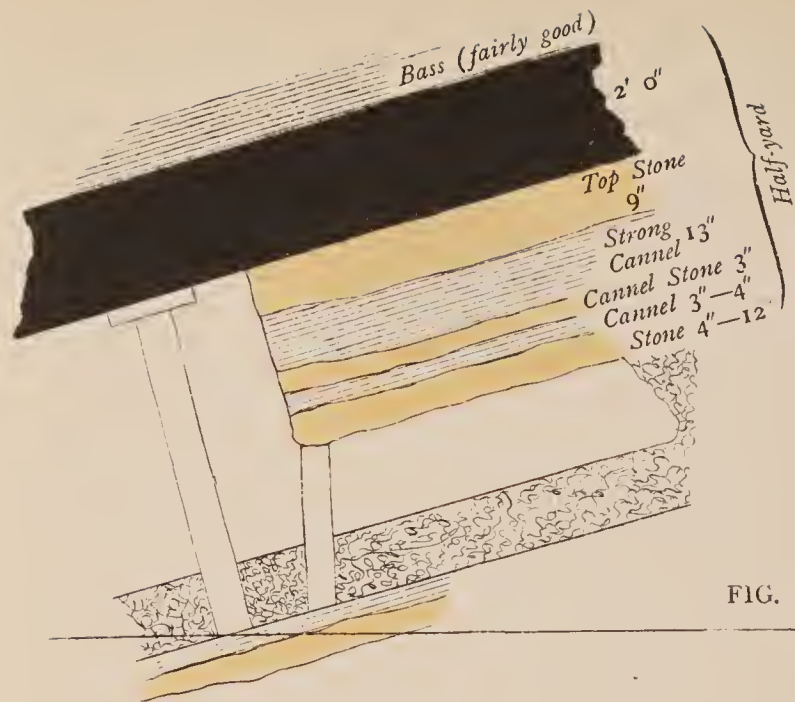
FIG. 190.

Fig. 190. Section NW. The stone called Half-yards and the Cannel Row Coal are worked separately; the former about two years after the latter. They are both worked in 40 yds. drifts. The stone forms a very good roof in the Cannel Row workings. No packs are formed, the gob being almost completely filled. The roof seldom breaks. Only one row of posts is set, and that on the gob side of the rails. If the roof begins to cut at the face posts are set on the high side. The coal is brittle, and lids are placed on the sprags.

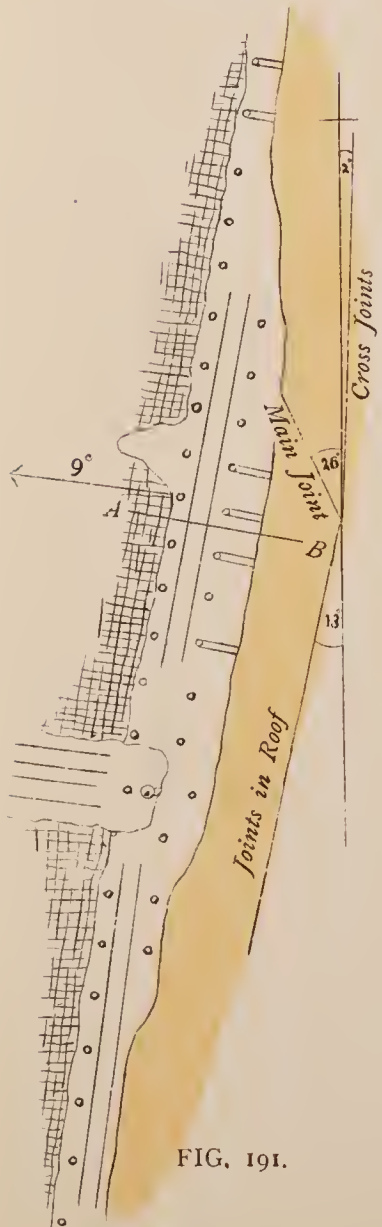
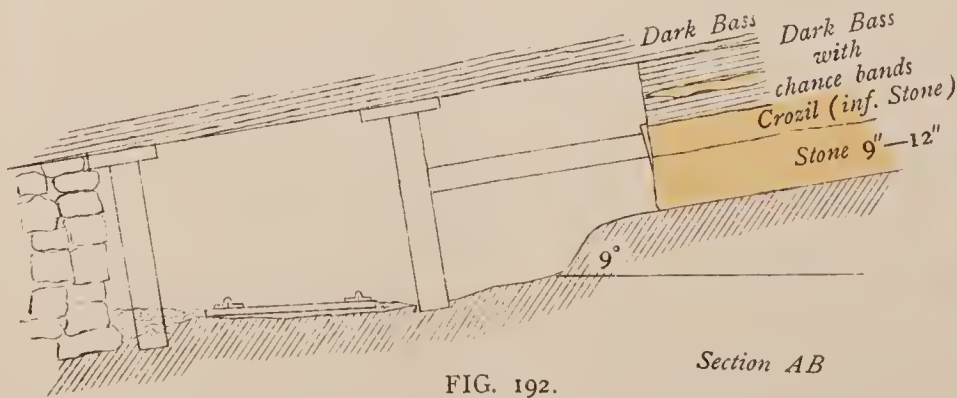
FIG. 191.

Figs. 191 and 192. Plan and Section S. The main joints run from 12"–18" apart; a few pass into the crozil, with a slight set off. Joints in bass frequent. Worked by 40 yds. longwall drifts on each side the jig. 2'–3' of floor are taken up in levels and jigs, in which larger tubs are used than at the face; the stone being tipped at the top of the jig and reloaded. The gob is entirely packed, except where the holing dirt is thin. Whilst the buttock is being pushed forward the stone is rated off the side where it works off easily. Little holing or blasting is needed.

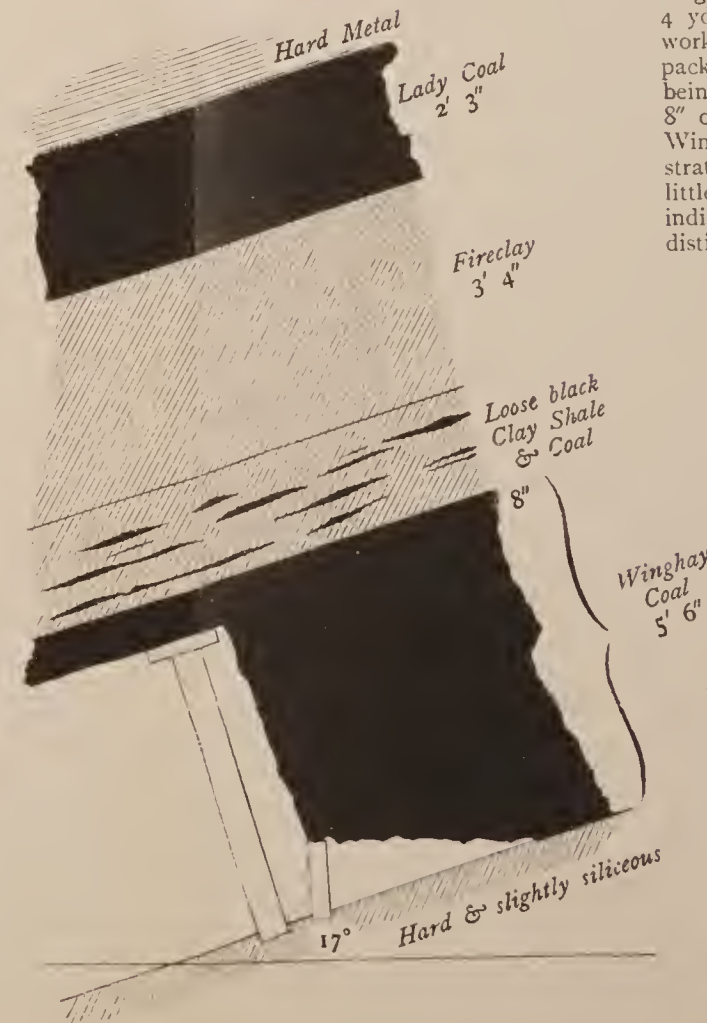
FIG. 194.

Fig. 194. Section Centre. Worked together. First the Winghay, in 80 yds. longwall faces, with 3 yds. packs and 4 yds. wastes. The Lady Coal is worked about 8 yds. behind over the packs and in the wastes, the fireclay being first dropped in the latter. About 8" of coal are left as a roof in the Winghay drifts, owing to the clay strata above forming a very bad roof; little of it is recovered. The cleat is indistinct in the Winghay, but pretty distinct 23° NW. in the Lady Coal.

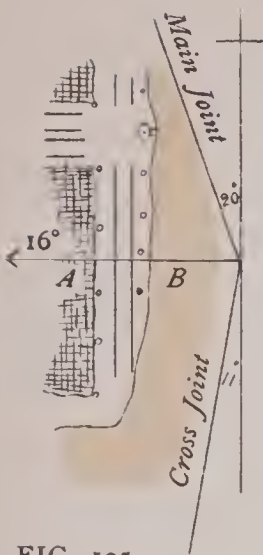
FIG. 195.

When a leg has either to be replaced or reset, from its having been moved out at the foot or broken, another post (foreset) is first set under the bar, and afterwards removed. An accident described in Fig. 195 was caused by neglecting this precaution.

Figs. 195 and 196. Plan and Section NW. Joints run very regularly from 12"—18" apart. Worked by short longwall faces.

A fatal accident occurred in a level 5' wide, with a pack on one side, owing to a deficient post (stoop) which supported a bar being loosened at the foot, without a foreset post being first set under the bar. The roof, which was considerably loosened by water, fell, though it was barred and planked.

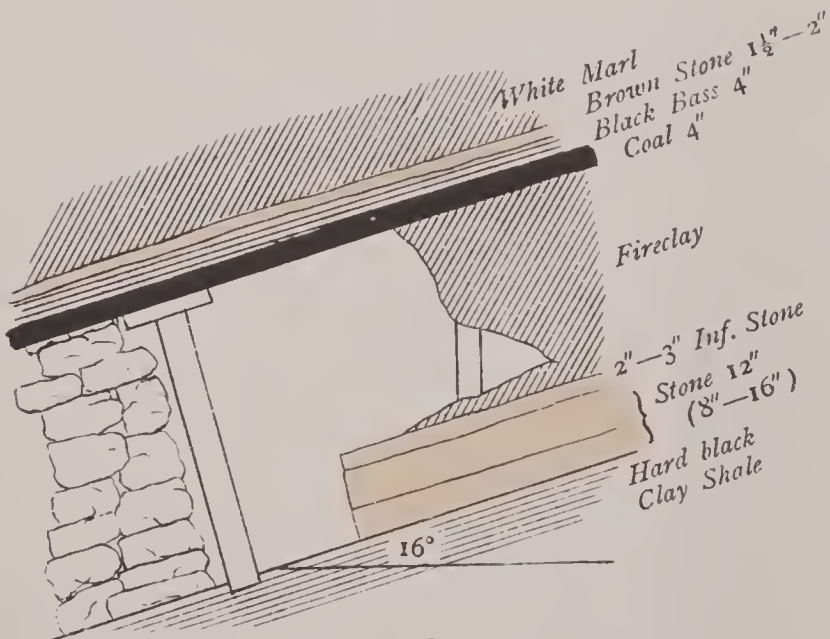
FIG. 197.

Fig. 197. Section E. of Fig. 196. The coal forms a good roof. The gob is all packed, and one tub of dirt is sent out to four of stone. Longwall drifts, with one row of posts on gob side of rails.

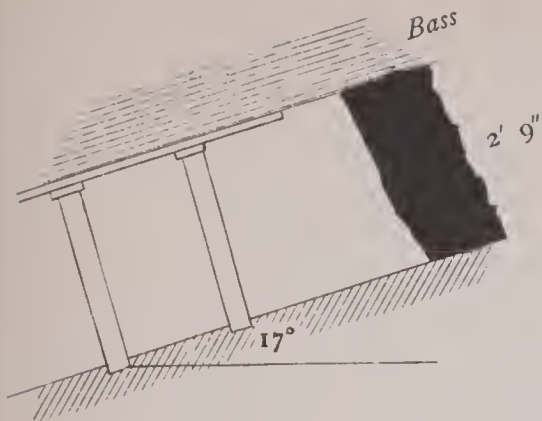
FIG. 198.

Fig. 198. Section of thurling in course of being driven. N.W. The roof, which is usually good, is extremely loose here, from the proximity of the working to the surface, and has to be slabbed, even in thurlings. Cleat 40° NW., good.

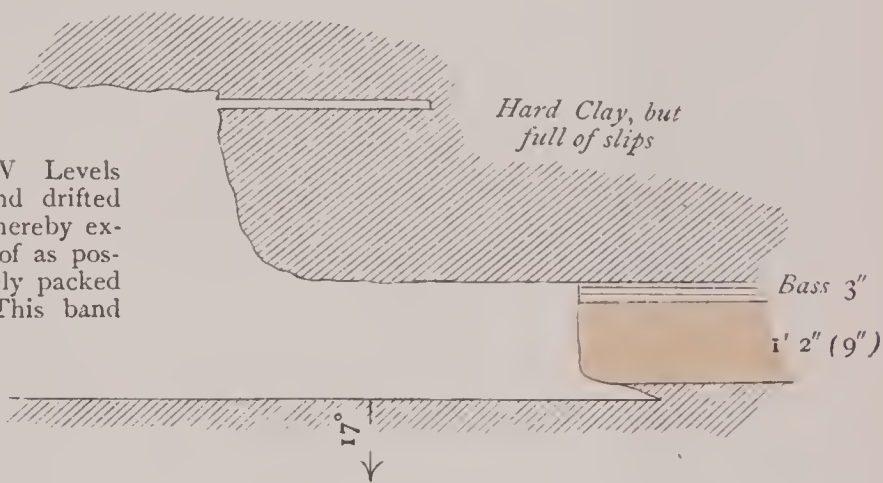
FIG. 199.

Fig. 199. Section NW Levels driven every 10 yds. and drifted back in $4\frac{1}{2}$ yd. slices, thereby exposing as little of the roof as possible. The gcb is entirely packed with bass and marl. This band thins Southwards.

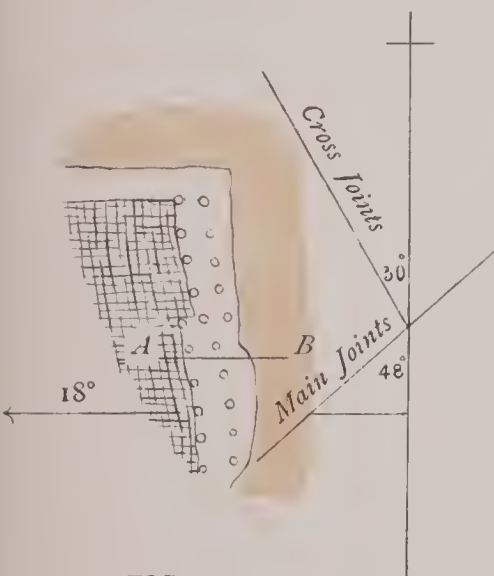
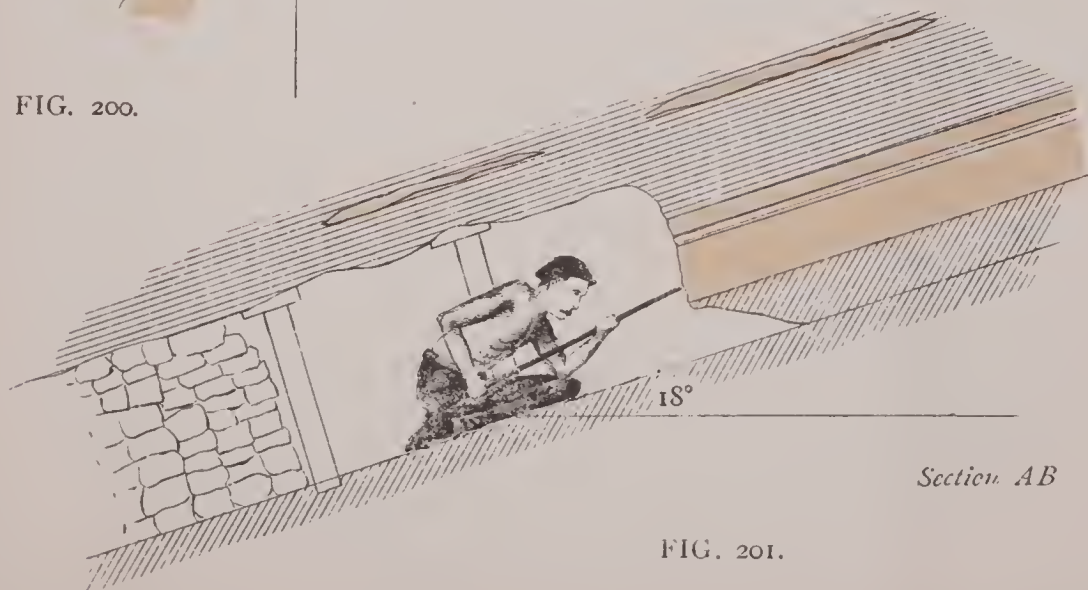
FIG. 200.

Figs. 200 and 201. Plan and Section NW. Joints very frequent and distinct. The roof is very jointy and bad. Worked in short longwall faces.

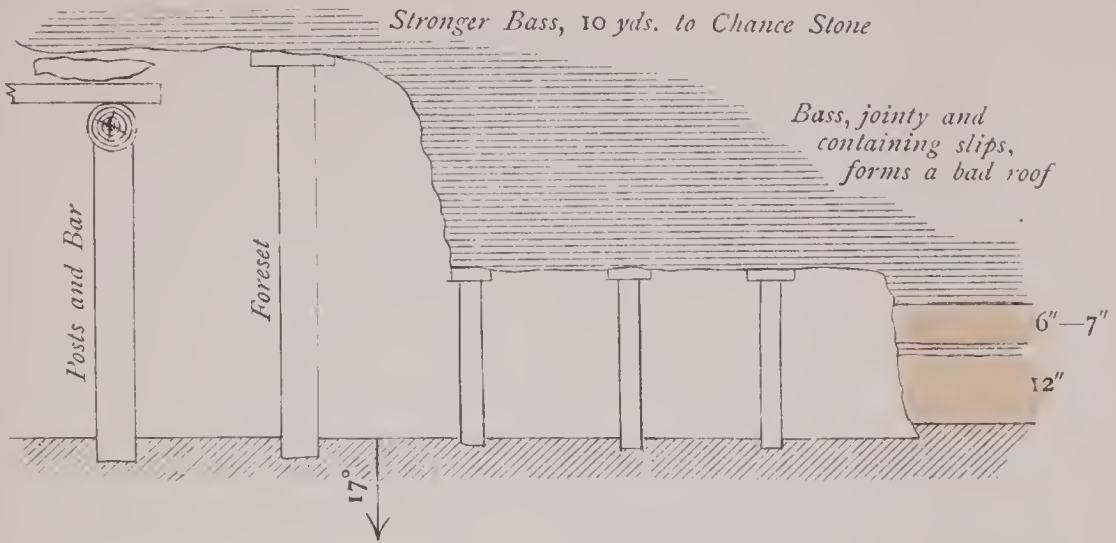
FIG. 202.

Fig. 202. Section further North. Heads are driven 10 yds. apart, and intervening pillars drifted back. Section represents a principal heading in the solid, 5' wide. The roof, which is usually good, is bad at this point, from its proximity to the surface, and has to be well timbered in strait work. Joints as above.

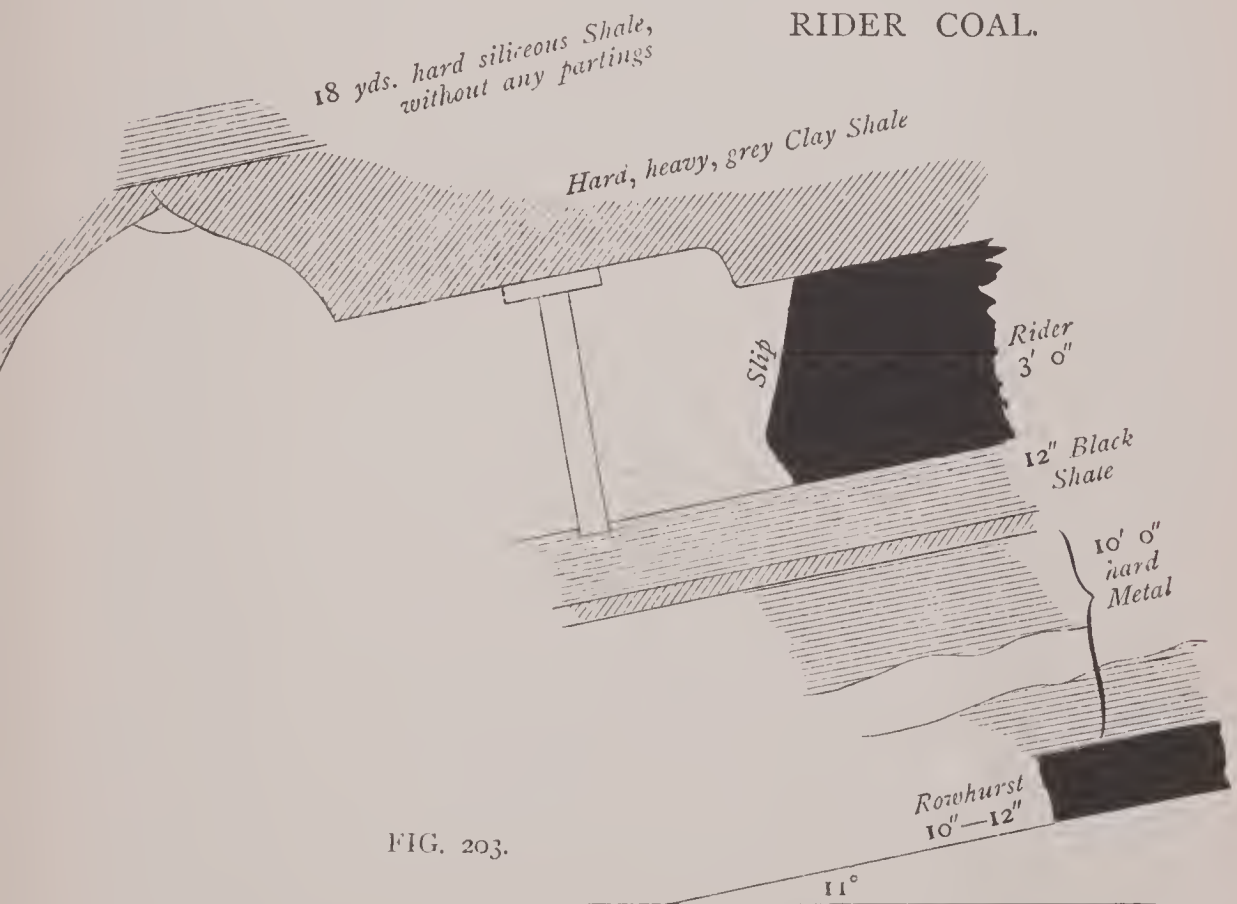
FIG. 203.

Fig. 203. Section N. Worked in 18—20 yds. longwall faces. The coal contains slips, which run 30° NW, from 2' 6"—3' 6" apart, along the whole length of the drift, which facilitate the getting, as there is no holing done. The slips do not run into the roof. The clay shale breaks in places in curved surfaces, but forms a good roof until a weight of the shale above occurs, when neither posts, chocks, or even packs are able to resist it, and the drift comes in. It gives ample warning, and rails are taken up and everything removed. It often takes a week to settle, and a new drift is then re-opened.

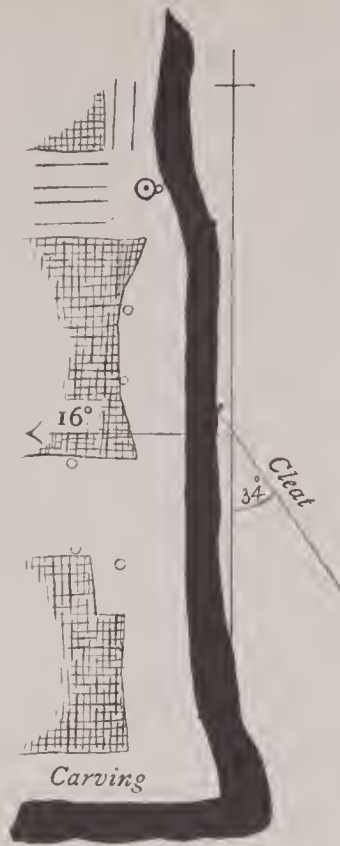
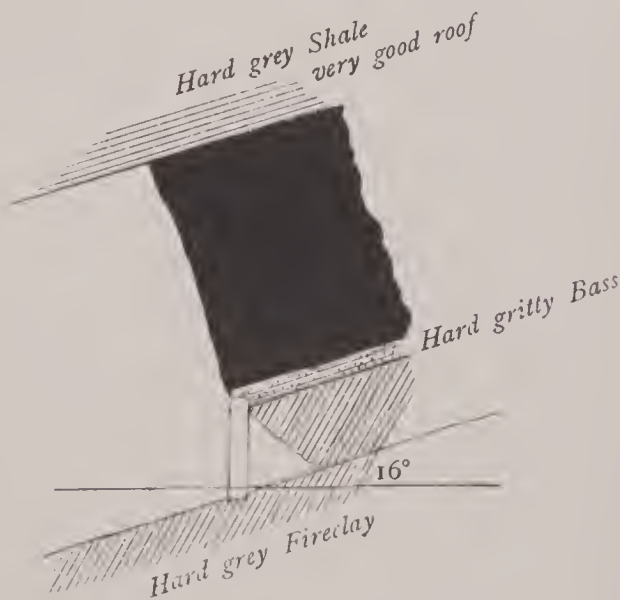
FIG. 204.

Figs. 204 and 205. Plan and Section further South. Cleat very distinct. The coal is tender and rates off and requires little holing. The roof is very good and little timber is set.

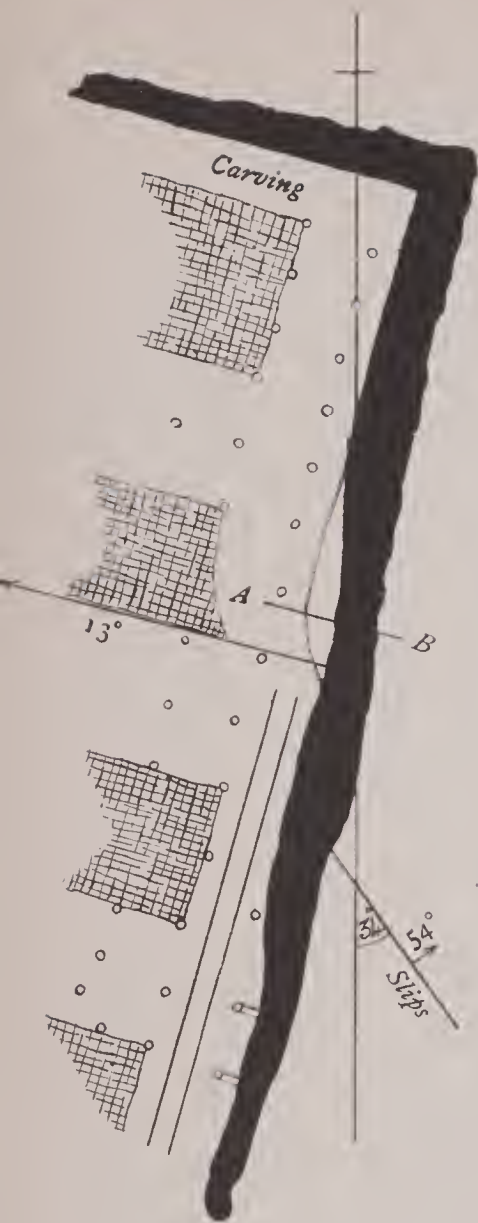
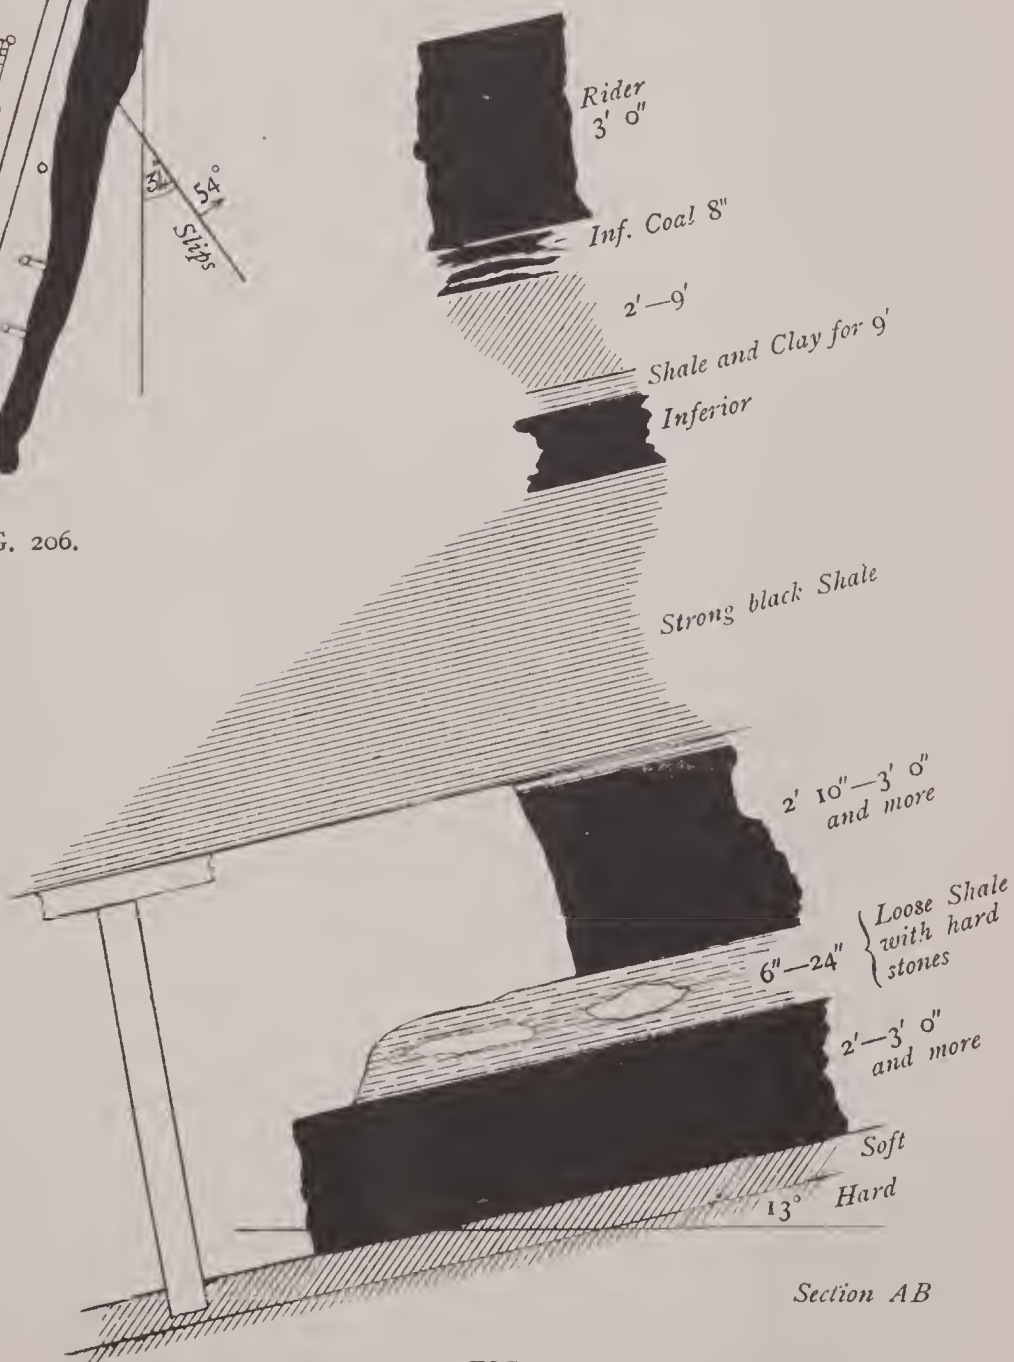
FIG. 206.

Seam. (Fig. 206). It is found that where the coal is breasted the roof does not break so readily as where the coal is opened out by ordinary "strait" work. The pressure in strait work is concentrated along one line, but in wide work it is spread over a large surface, and each individual point feels it in a reduced amount. On the other hand the quality of the roof also at times influences the mode of working.

Figs. 206 and 207. Plan and Section S. Cleat indistinct. Slips run very frequently, but independently, in top and bottom coal. Longwall drifts and breasting; as "stret work" in opening out injures the roof, necessitating much timber. The drifts extend 30—35 yds. on each side the jig. A post is sometimes left in the wastes, to prevent a pot hole being formed, as it would immediately fill with gas. The wastes are often open for a distance of 15—20 yds., the roof and floor bending towards each other, and closing the cavities.

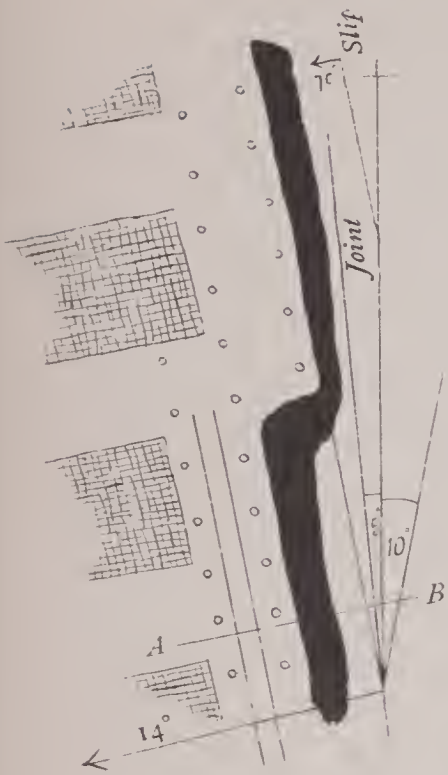
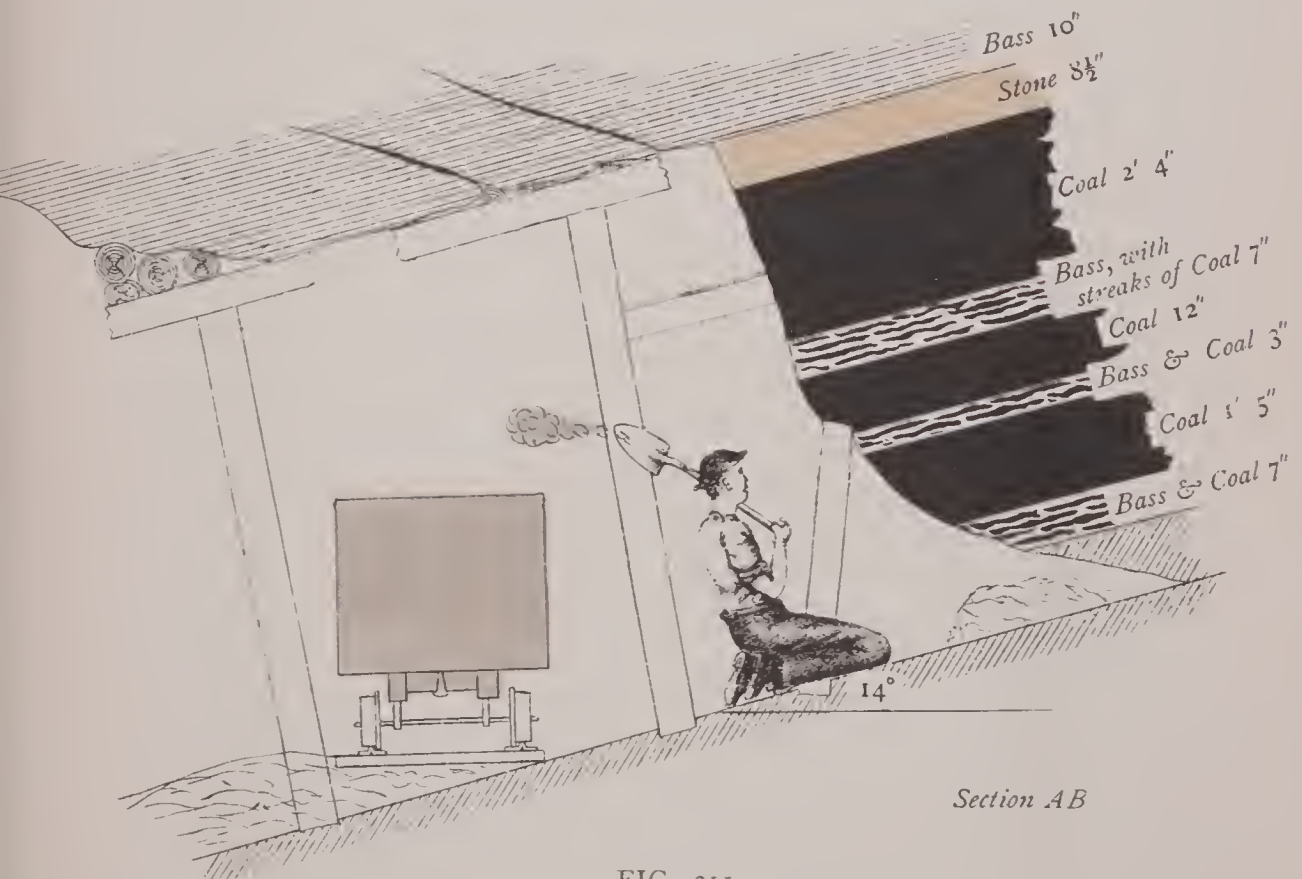
FIG. 210.

Broken bars are sometimes used as lids (Fig. 211) where the roof is full of slips and breaks readily; they are 5"—6" square, rather long, and the unevenness of the roof is filled in with small wedges (timps), or larger pieces of wood.

Figs. 210 and 211. Plan and Section C. The stone and the coal are close together. Cleat is distinct. Joints in stone and roof are not regular. Regular slips occur in the coal at intervals; they run through the stone, and sometimes into the roof. The roof is very jointy and loose, and requires specially large lids. Broken posts are used for the purpose. The drifts extend 25 yds. on each side the jig. After the coal is dressed the rails are laid to the far end, there being a row of posts on each side of them. As the coal is dropped another row of posts is set next the face, and the rails are taken up, the bottom row is then drawn and the packs are built. In this way the men are not under the fresh roof whilst breaking up the coal, and are at once protected. The coal is fallen against the posts in such a way as not to injure them.

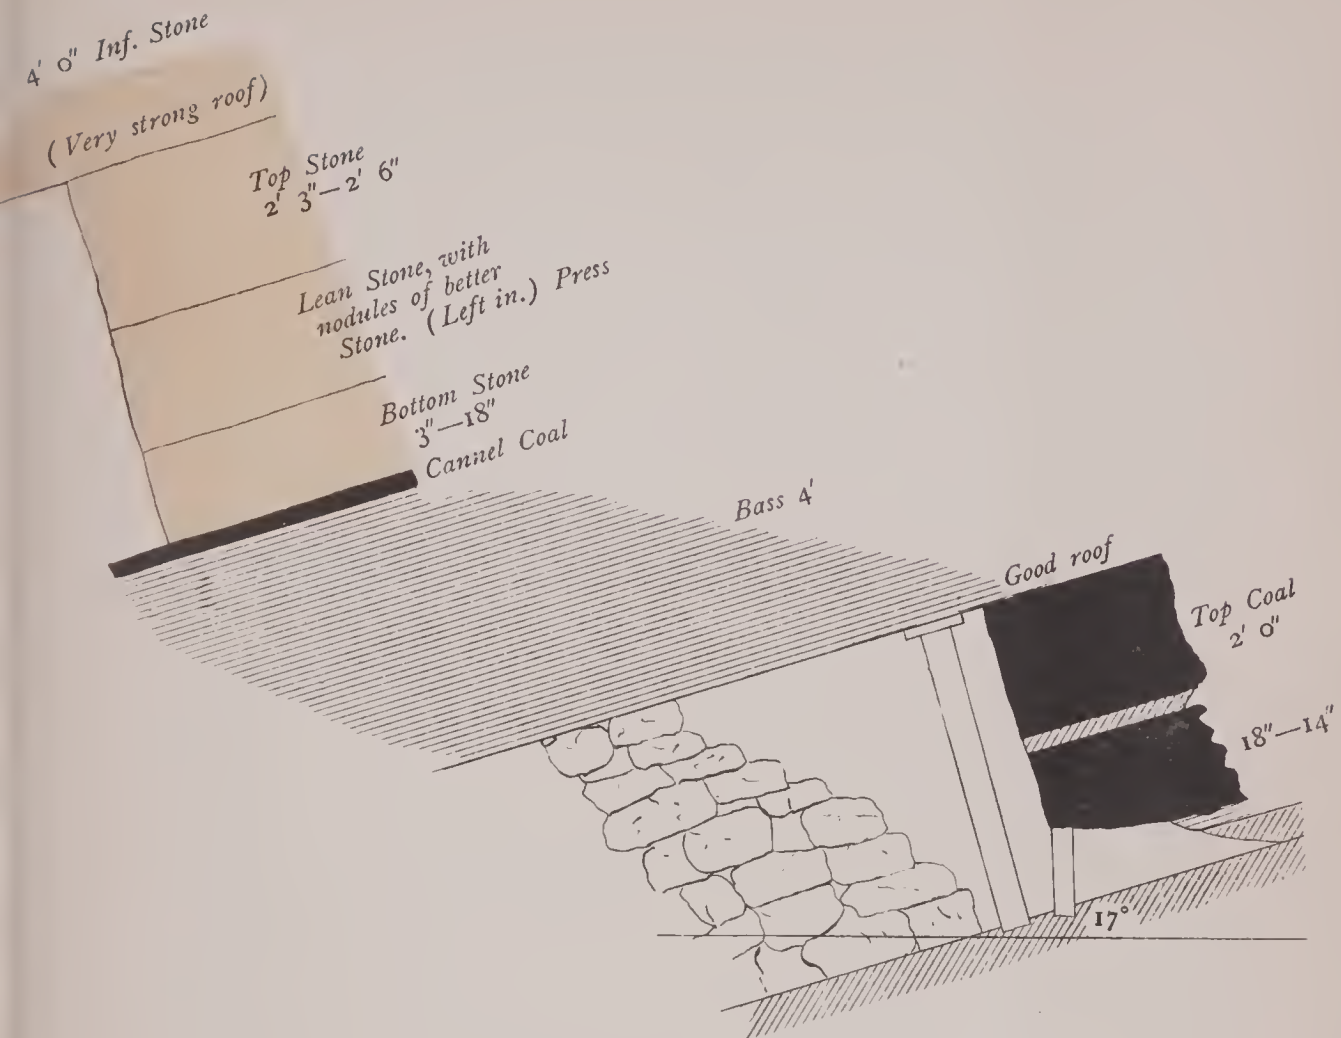
FIG. 212.

Fig. 212. Section NW. Cleat distinct 47° NW, and slips occasionally 34° NW. The joints in the Top Stone are distinct from those in the Bottom Stone; both are very irregular: Top Stone, 47° — 59° NW; Bottom Stone, 28° — 35° NW and 115° NW. The coal and stone are both worked by long-wall faces, the latter about 8 yds. behind the former. The stone work requires very little timber.

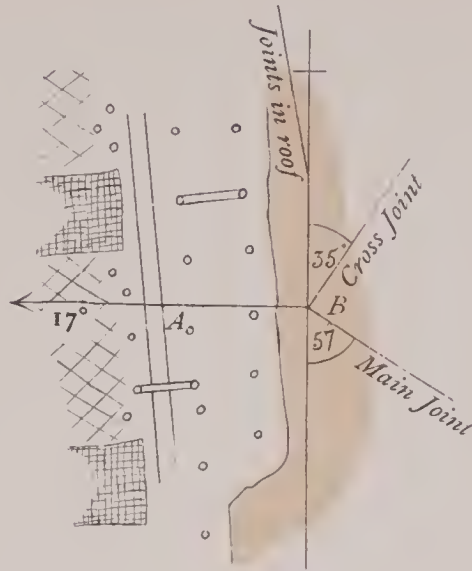
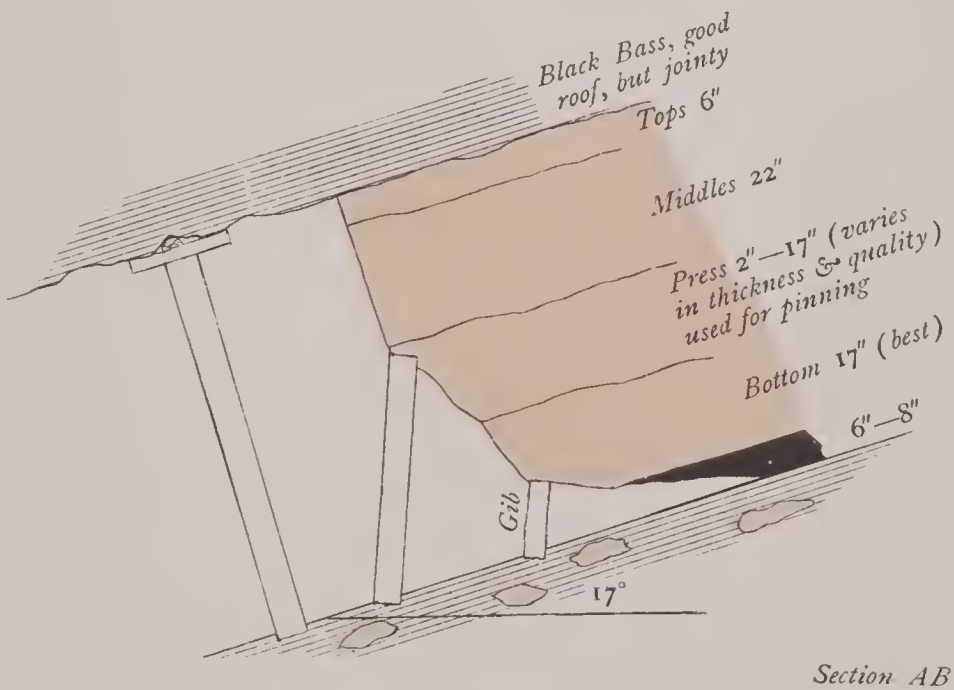
FIG 213.

Figs. 213 and 214. Plan and Section N. Worked by 30—50 yds. drifts, with the rails below the buttock which necessitates two rows of posts on the high side of the rails. Small wooden wedges (gluts) are driven into open joints in the roof. The joints in stone are regular and frequent through all the bands.

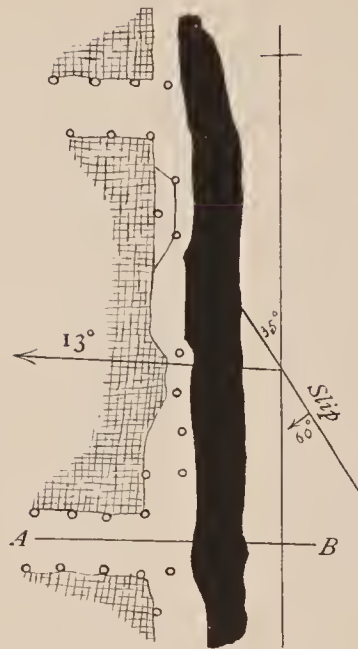
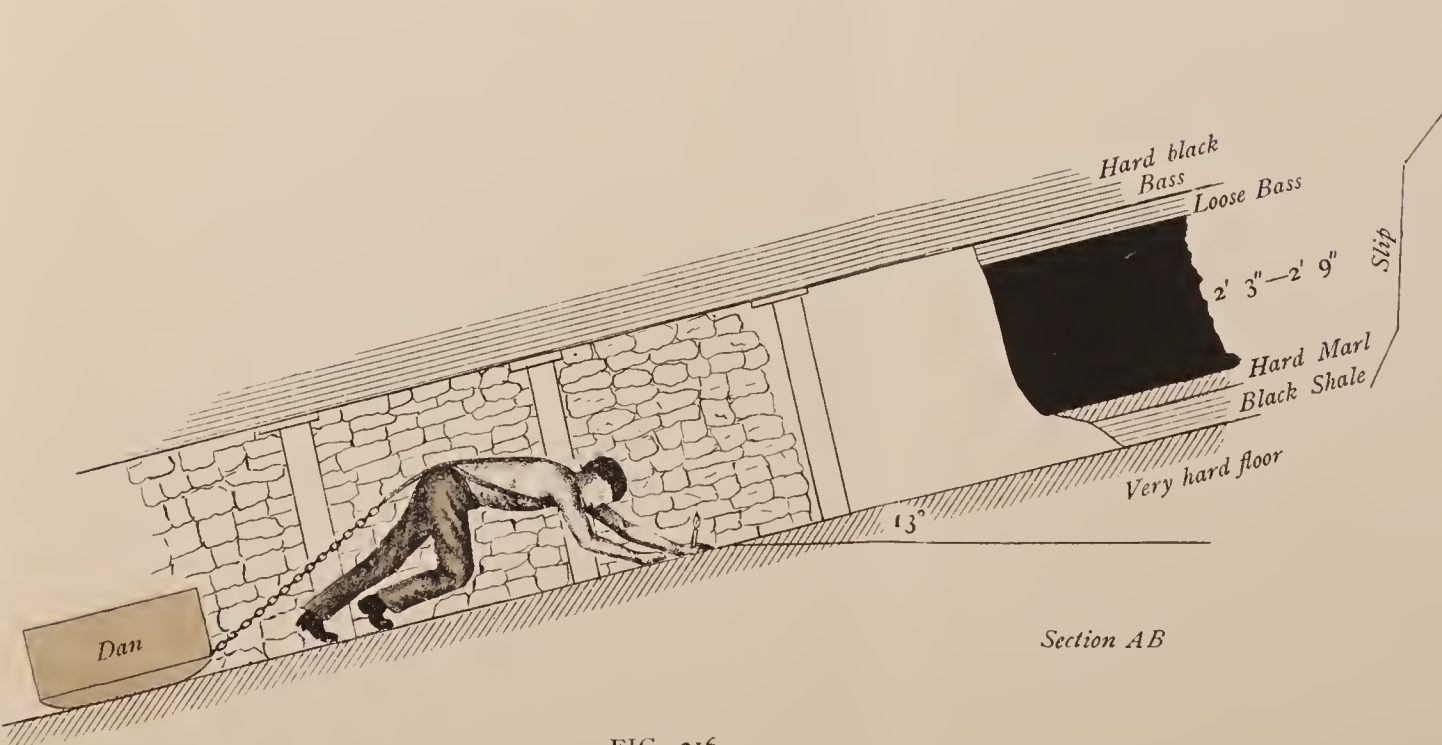
FIG. 215.

Figs. 215 and 216. Plan and Section N. Cleat indistinct. Slips every 3' or 4'. They are deflected on passing into top and bottom layers, and sometimes pass into the roof. Longwall, without much holing, except occasionally in top or bottom.

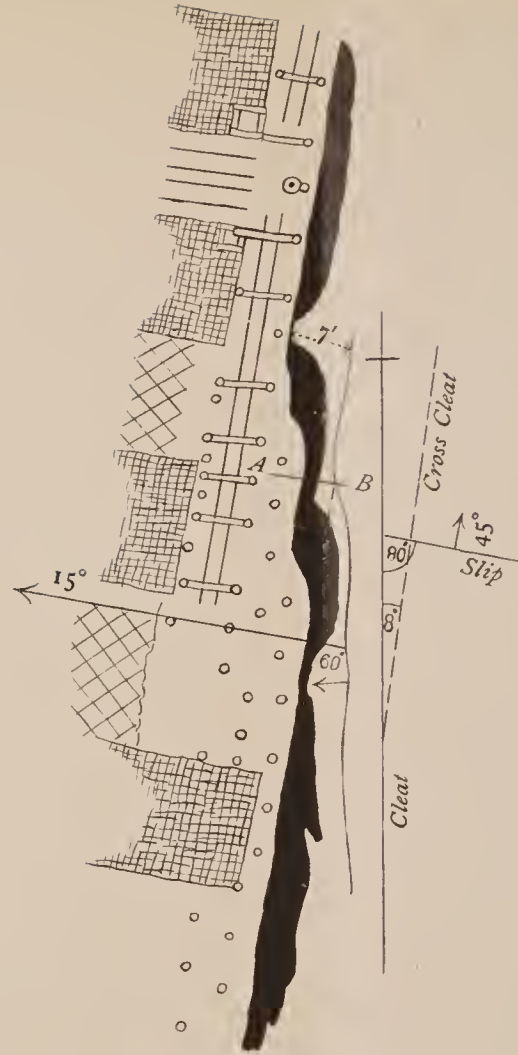
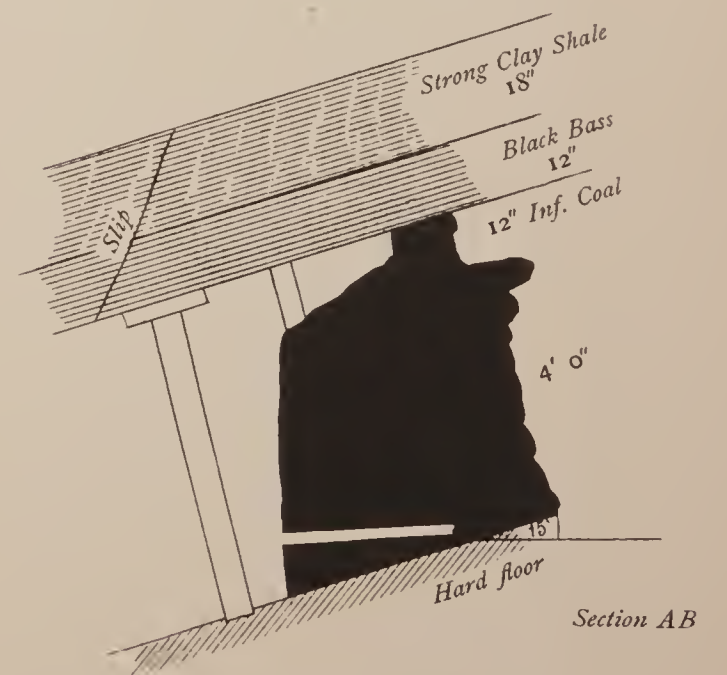
FIG. 217.

Figs. 217 and 218. Plan and Section S. Cleat due N and S, pretty distinct, and cross cleat in places. Coal short grained and hard. Pig backs, or elevations of the floor without any corresponding elevation of the roof, are frequent. They are accompanied by wavy slips in the coal. Longwall; a backfall 7' in width is taken home-wards. Slips occur in the roof.

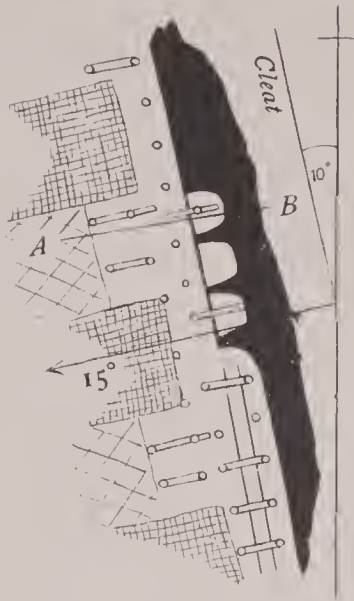
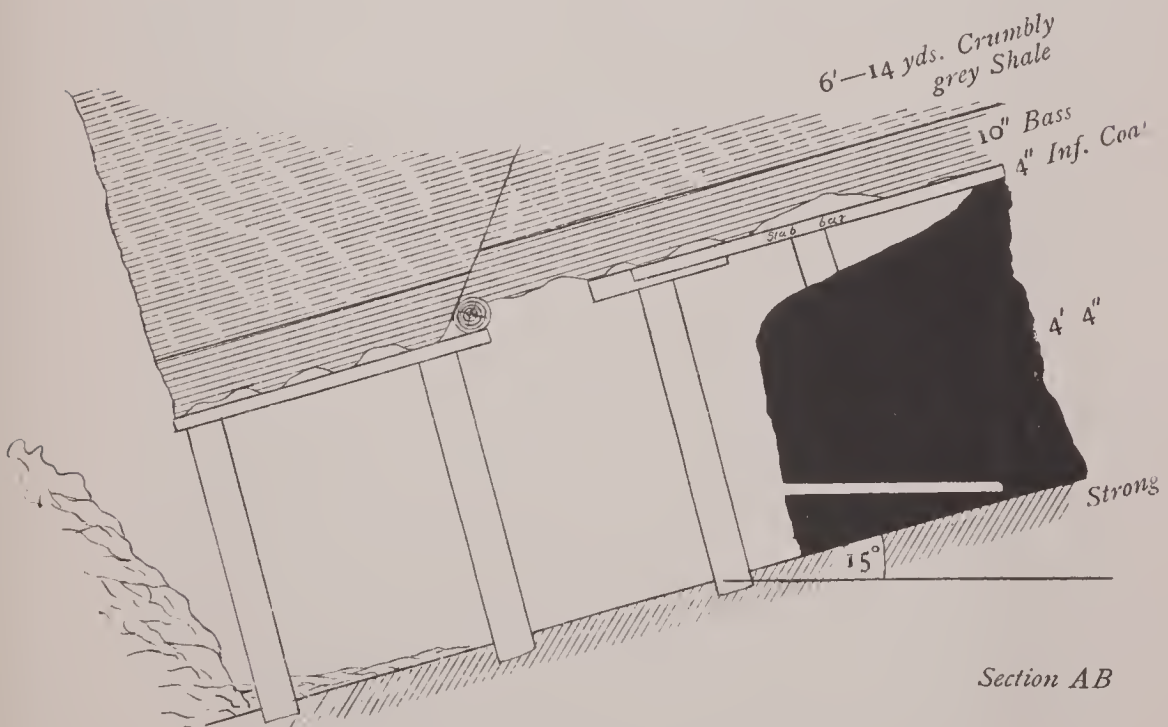
FIG. 219.

A soft or tender roof breaks as soon as the temporary supports are removed near the face, and forms wastes between the permanent supports left in the gob. (Figs. 220, 186).

Where the roof is exceedingly soft and crumbly, as in Figs. 219 and 220, the coal is holed in patches, and slabs used even whilst holing.

Figs. 219 and 220. Plan and Section further North. Cleft indistinct. Coal breaks in curly or round lumps. The holing is done at the top, owing to the coal sticking to the floor, which is very hard. The roof is so short and brittle in places that holing can only be done at intervals, separated by small unholed distances forming coal supports (bunches). These little intervals are called panes. A slab (slab-bar) has to be placed against the end of the holing after the pane is holed, and supported at first by a short post on the coal, and eventually by a long post at one end. The roof breaks abruptly behind the timber in the wastes up to a hard bass. Much timber is required, of which $75\frac{1}{2}\%$ is lost. The wastes soon fill up. Where the roof is a little stronger the bass and 7" of shale are taken down with the holing.
