ACCIDENTS IN MINES,

NORTH STAFFORDSHIRE COALFIELD,

FALLS OF ROOF AND SIDES;

THEIR CAUSES, AND THE MEANS OF DIMINISHING
THEIR FREQUENCY.

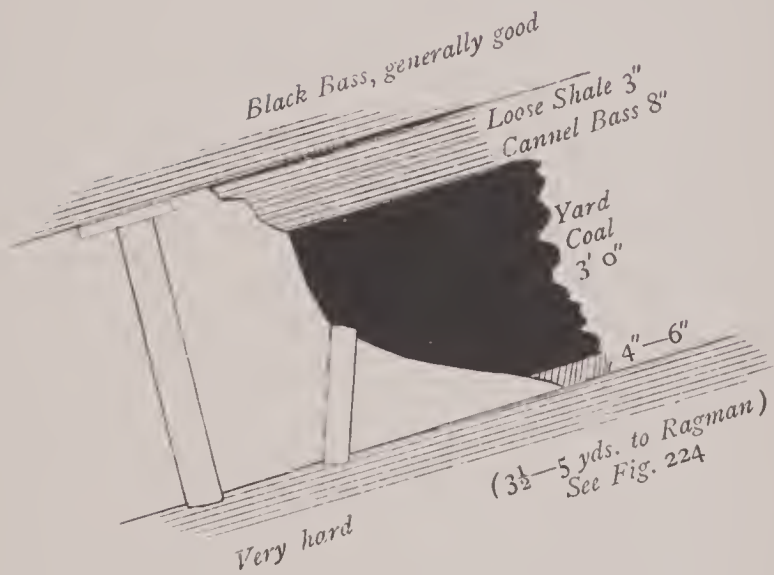
FIG. 221.

Fig. 221. Section S. Longwall; 30 yds. drifts on each side the jig; the gob is almost entirely packed. Cleat, 6° NW, distinct. Two rows of timber are set, one on the gob side of the rails and one next the face, until the rails are taken up and the holing completed, when the former is removed. A large weight occurs about every 40 yds., when the roof drops 5" at the face.

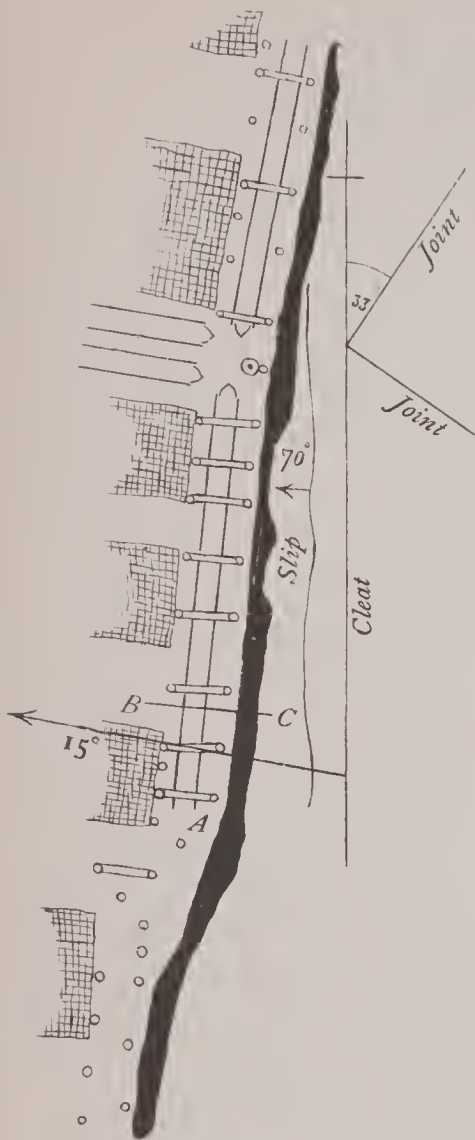
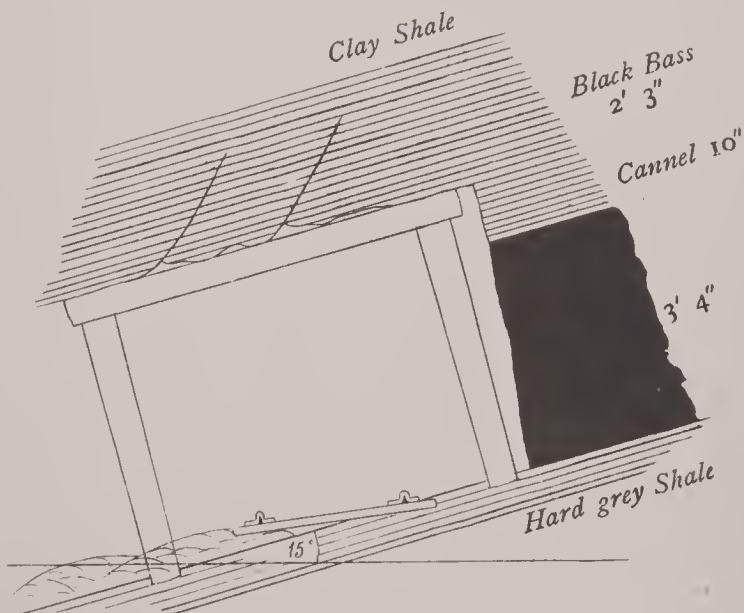
FIG. 222.

Figs. 222 and 223. Plan and Section further North. Cleat: due N and S, very distinct but short. Slips: in coal and cannel due N and S but wavy, about every 3'; in roof frequent. Joints: distinct in two directions in black bass, 3° NE, and ½" and more apart in Cannel. The coal is not holed; it is "rated" down, so that a large portion of roof is exposed before the proper timbering can be set. It is important under a roof such as this, therefore, to set a temporary post *A* (Fig. 222) whilst "rating," as the posts and bars or high side posts cannot be set until the place is "squared up." Several fatal accidents have occurred from neglecting this necessary precaution.

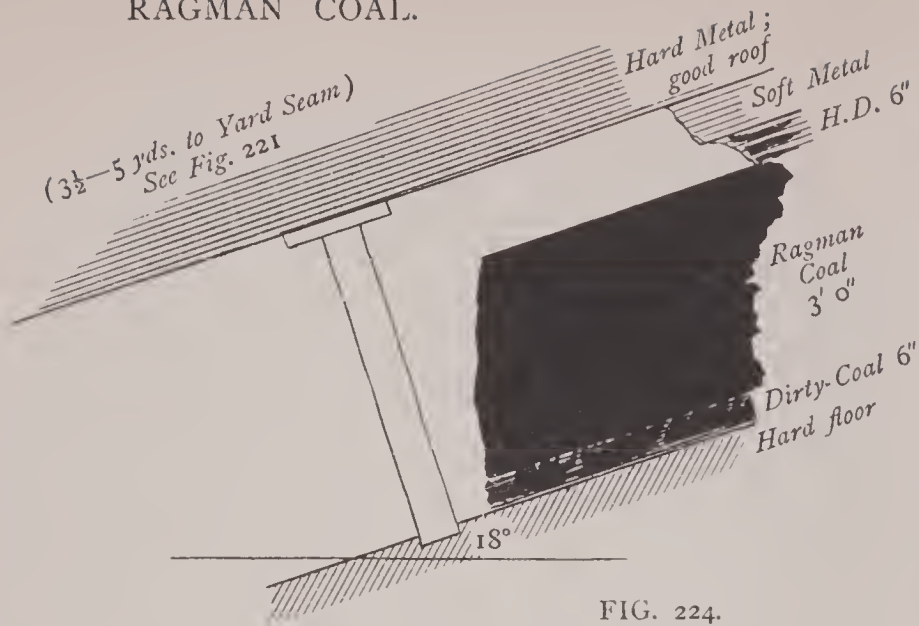
FIG. 224.

Fig. 224. Section SE. Worked the same as the Yard Coal (Fig. 221), but in 40 yds. drifts, the roof being stronger. Packs are formed 3 yds. wide and are 3 yds. apart. Weight and timbering as in Yard. Cleat indefinite, but predominating 5° NE.

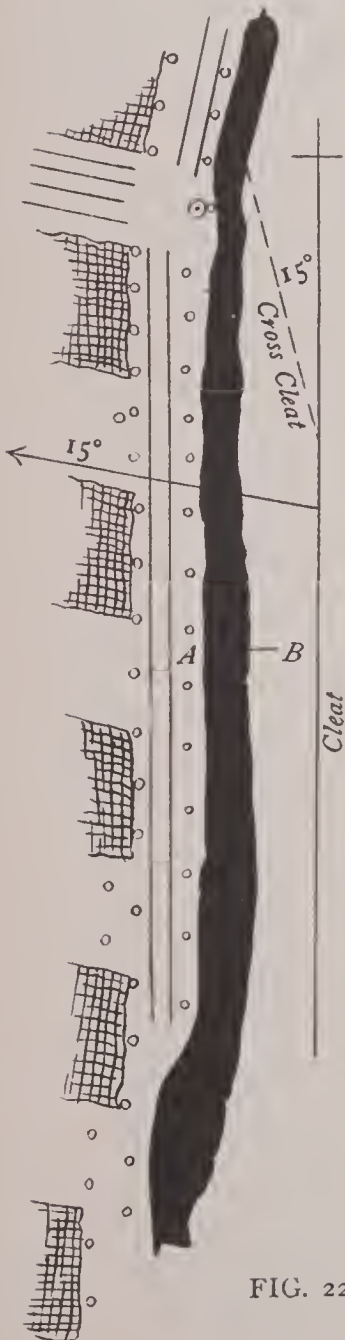
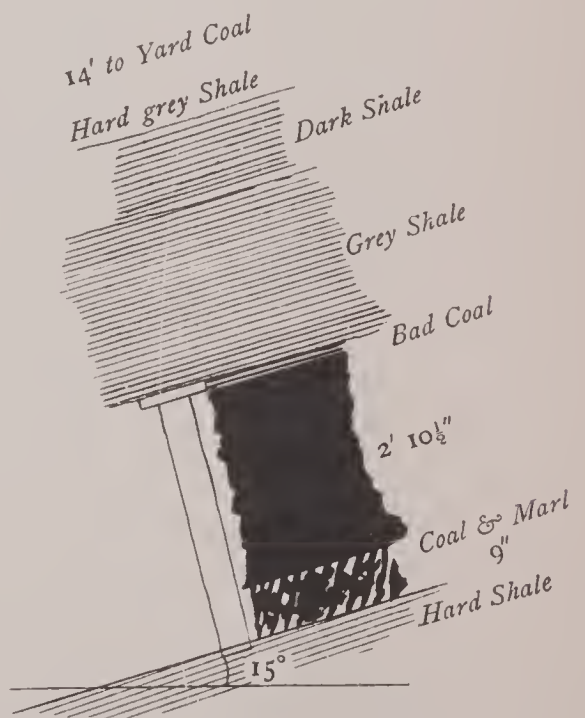
FIG. 225.

Figs. 225 and 226. Plan and Section S. Cleat: due N and S, very distinct, but short. Cross cleat: short and in patches, but frequent. Coal: soft and short-grained, but harder in this instance from Yard Coal (Fig. 223) having been worked. The roof, which is very strong, and contains no slips, is not thereby affected.

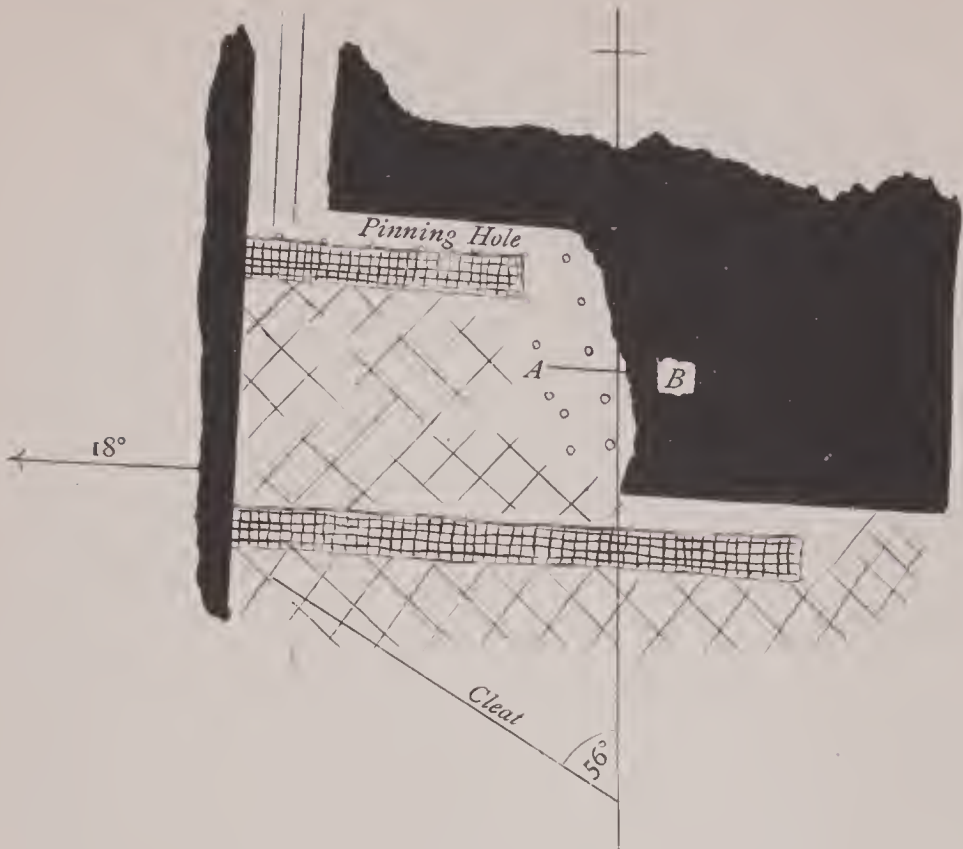
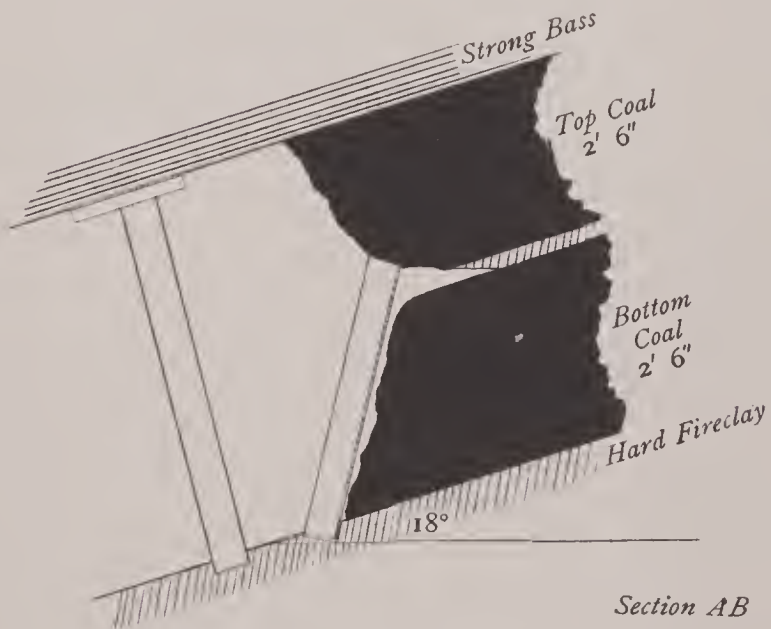
FIG. 227.

Fig. 227 and 228. Plan and Section N. The cleat is short. Lancashire method: headings 20 yds. apart; 8 yds. slices taken off. There are always two rows of posts at the face.

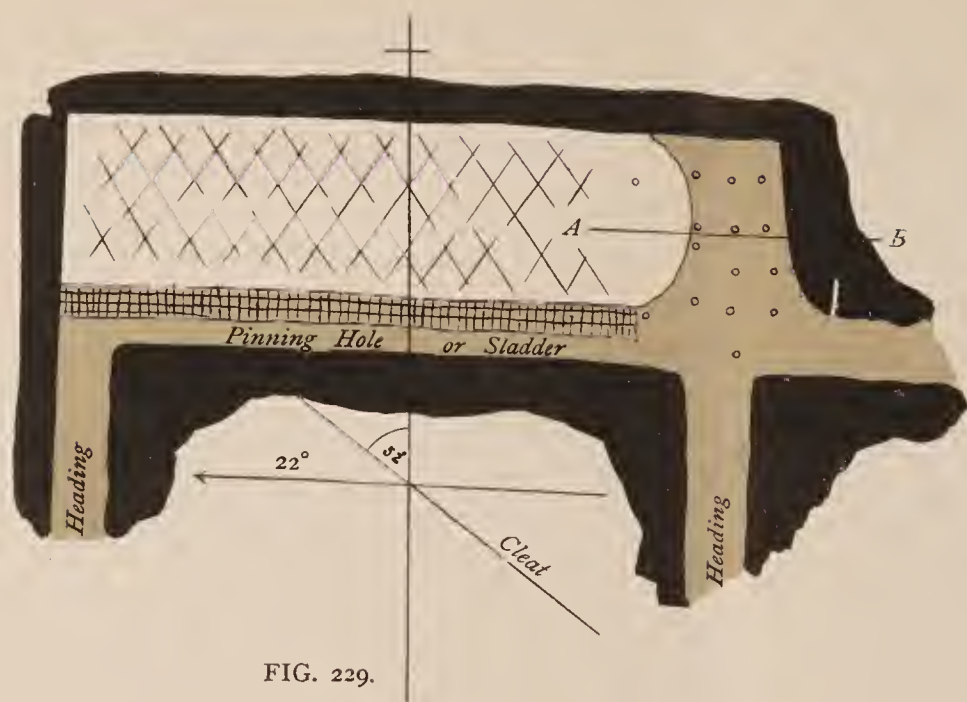
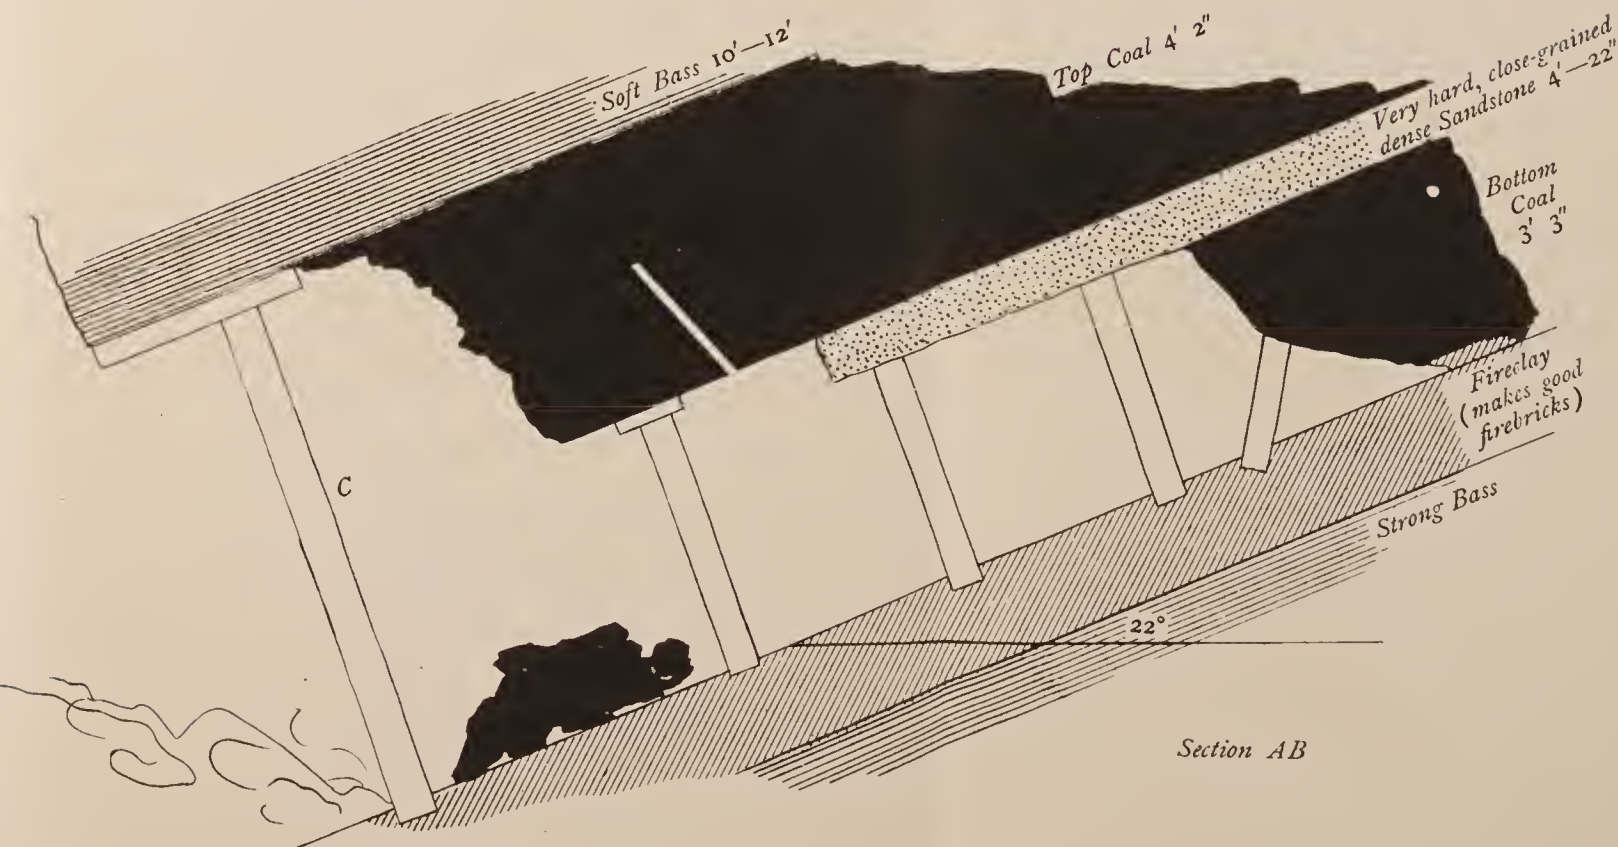
FIG. 229.

Figs. 229 and 230. Plan and Section N. Coal very hard and cleat short. Lancashire method: headings 20 yds. apart; 7-8 yds. slices taken off. Top Coal got in wastes. Post C set to prevent roof from falling with Top Coal. The pinning, which is 3' at its base and 18" at the top, is built of pieces of the sandstone band. It is built up to the Top Coal.

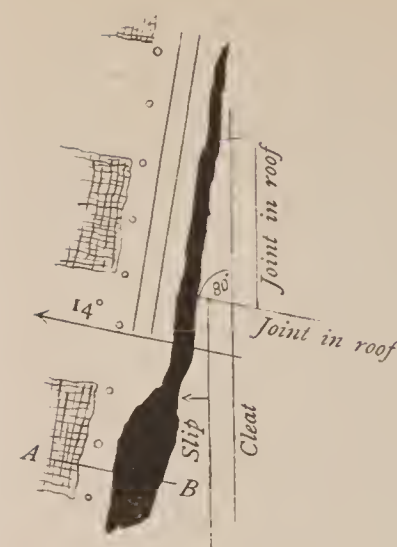
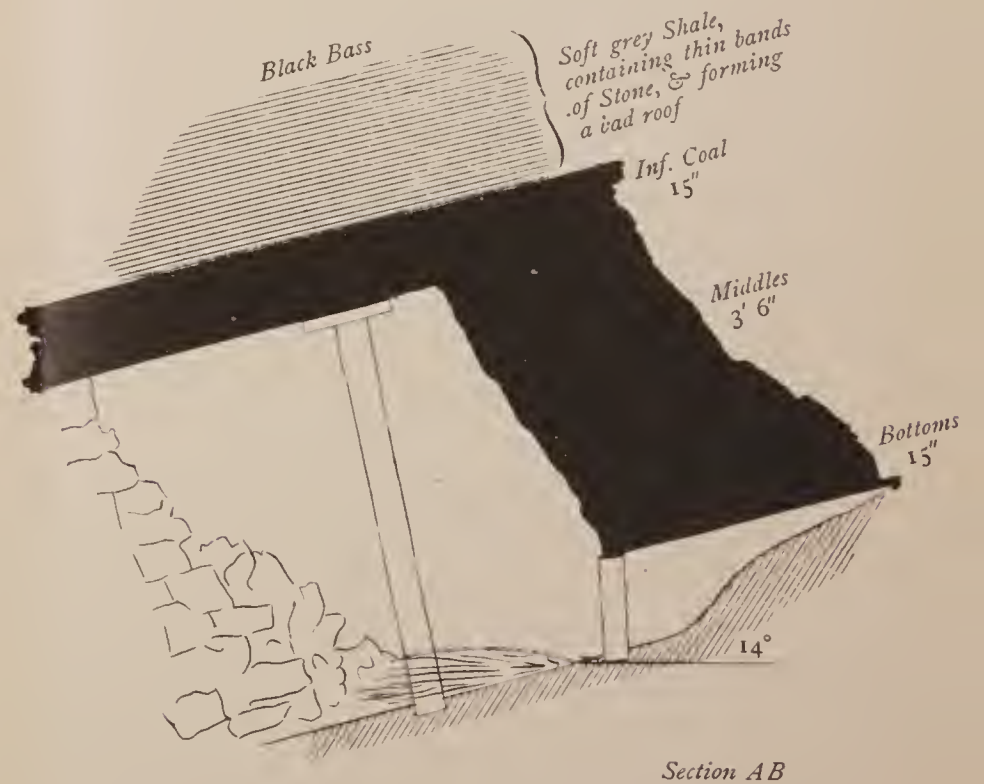
FIG. 231.

Figs. 231 and 232 S. Cleat due NS, very distinct. Cleat planes coated with carbonate of lime. Coal: long-grained.

Slips in coal N and S, from 18"-4' apart. The Top Coal is left to form a better roof; it is inferior. The Middles stick to it and project over, preventing a row of posts from being set next the face.

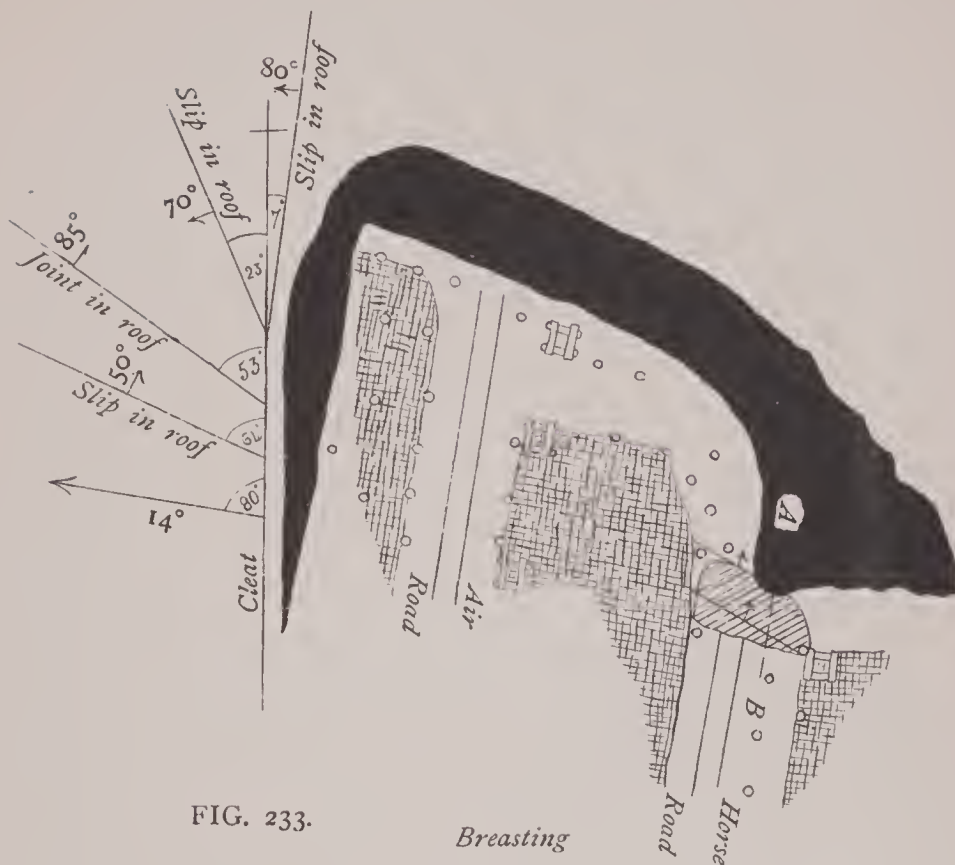
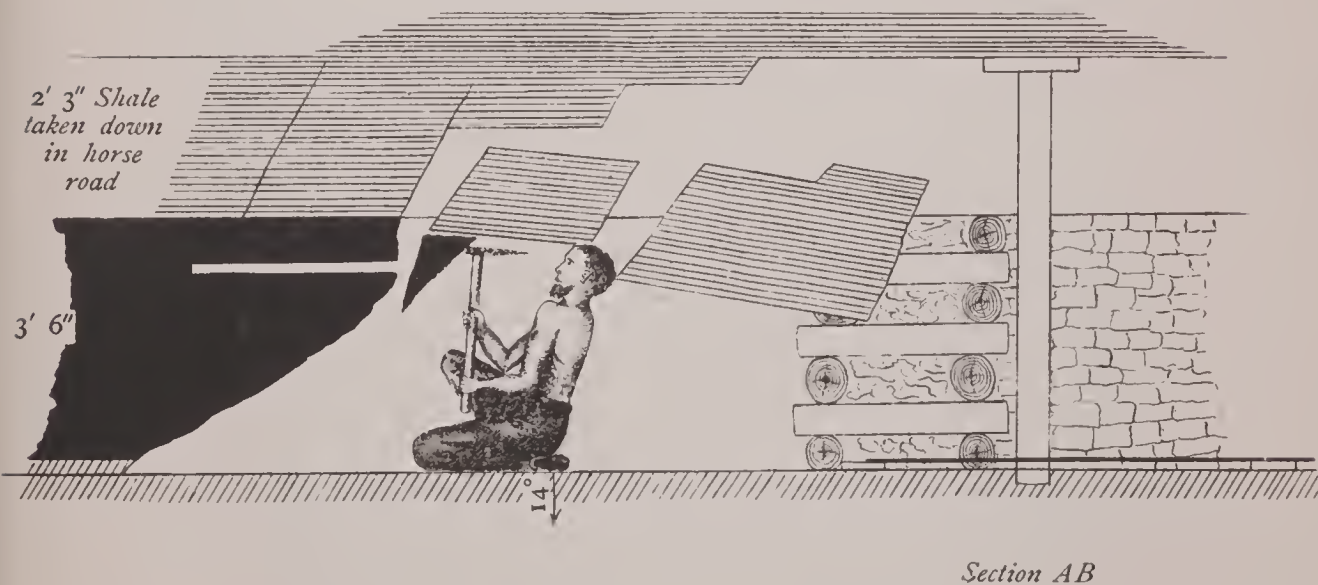
FIG. 234.

Figs. 233 and 234. Plan and Section S, illustrating a fatal accident in a breasting. The collier fired a shot, which did not take effect, and instead of first protecting himself by timbering the overhanging roof, through which it was reasonable to expect slips to run, he started to pull the coal down, when the roof, which had been shaken by the shot, broke off two slips and killed him. The levels are breasted out; the longwall drifts start immediately from them. Cleat very distinct, due N and S. Slips in roof in three well defined directions. 2' 3" of shale is taken down in horse roads behind the coal face. The roof is good, and contains two thin bands of stone. Abrupt corners, like the place of this accident, try the very best roofs.

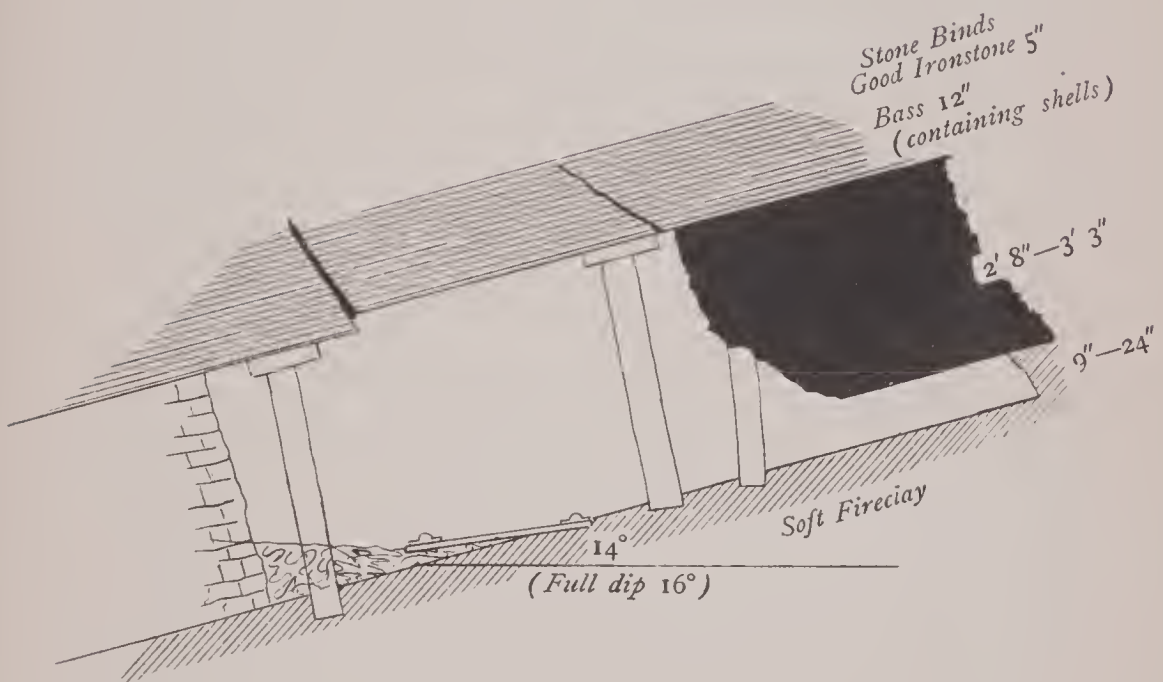
FIG. 235.

Fig. 235. Section N. Worked by pure longwall, with as long faces as possible, either straight or along the arc of a large circle. The jigs are from 80—90 yds. apart. The coal is holed 4' 6"—6' 0" under, and the men are under a fresh roof every three days. It is best worked on end, enabling it to be holed deeper and easier. Regular packs are built at intervals when the gob is not completely filled. Timbering as in Fig. 241. Cleat distinct 43° NW.

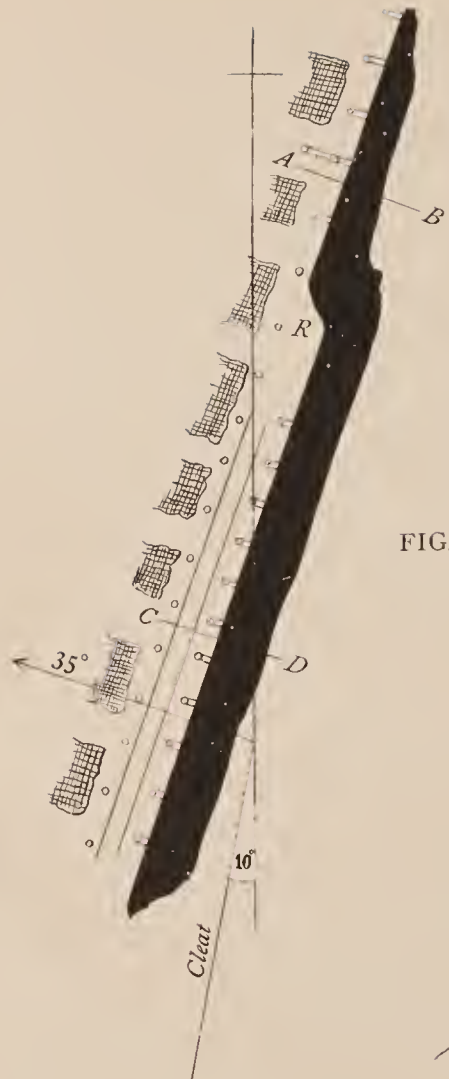
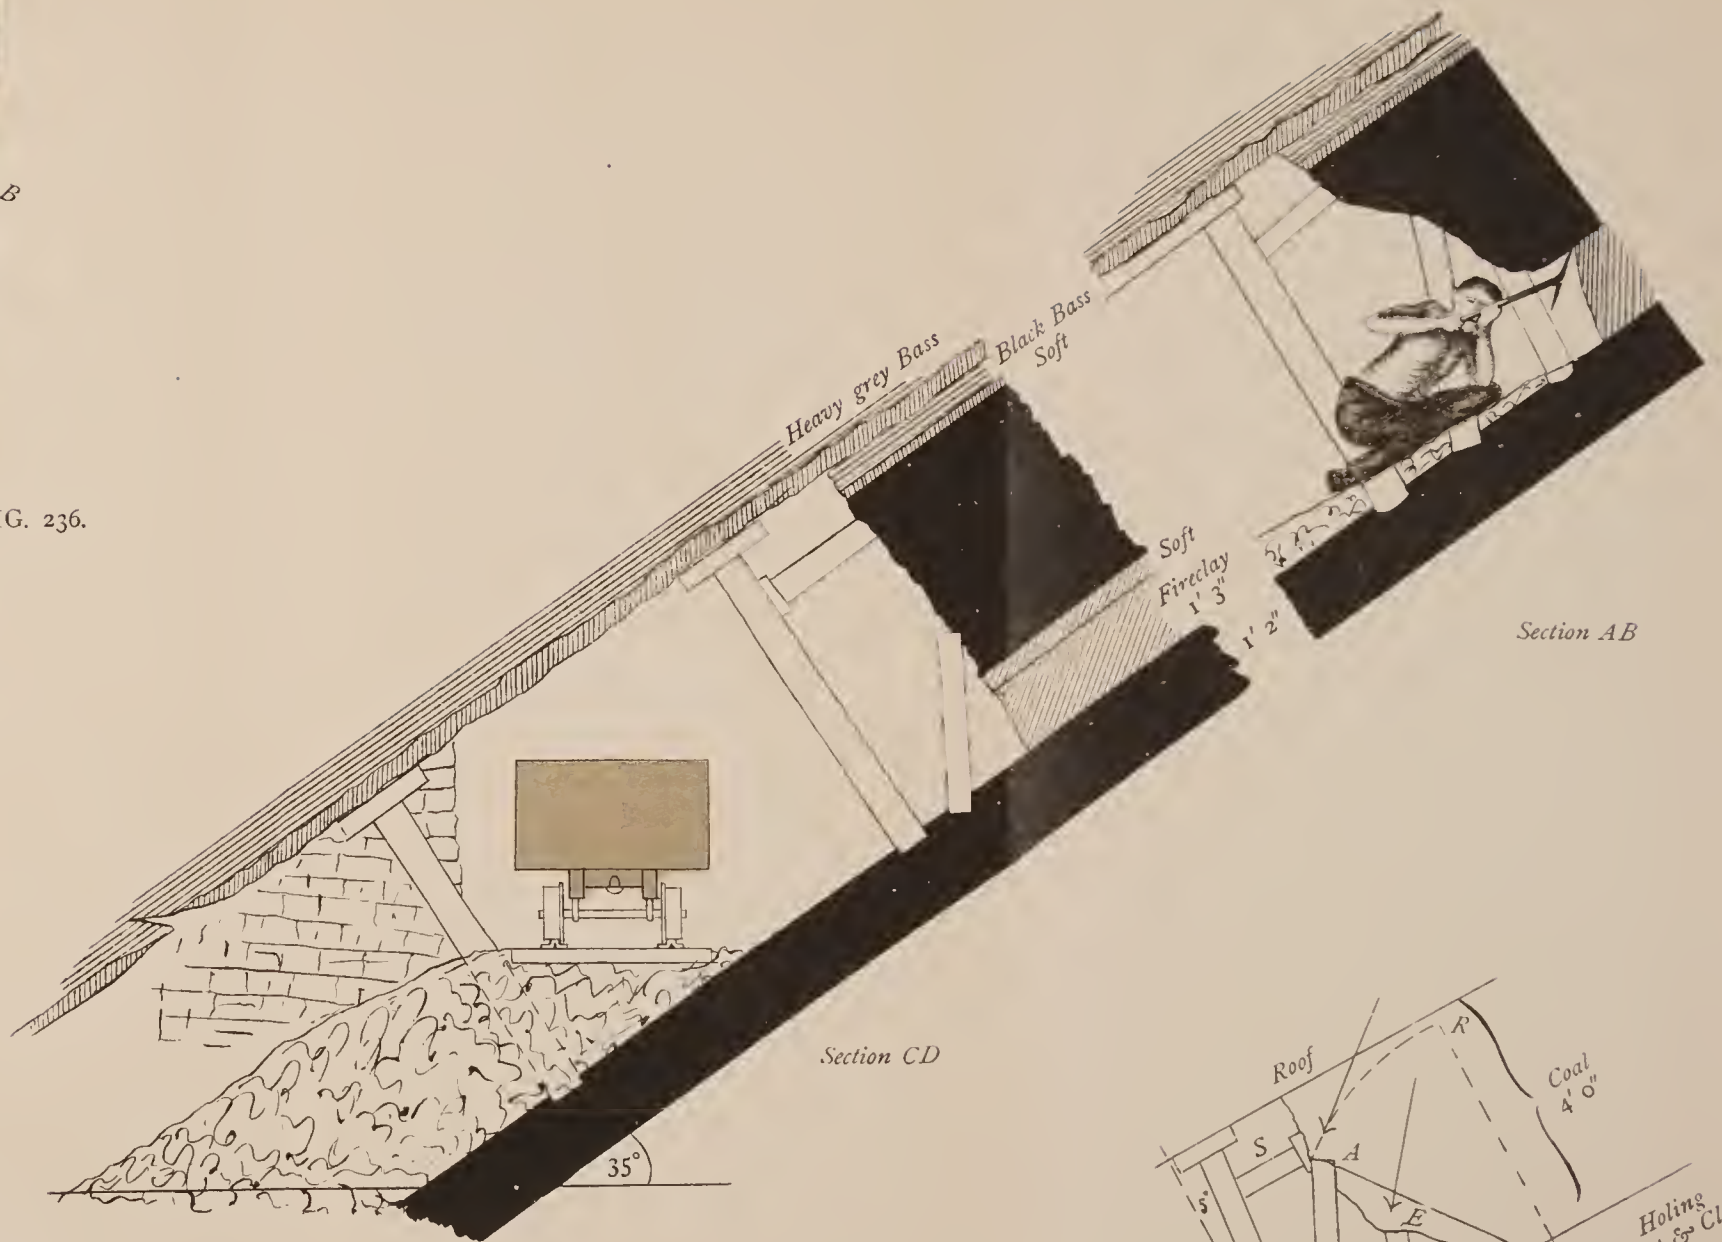
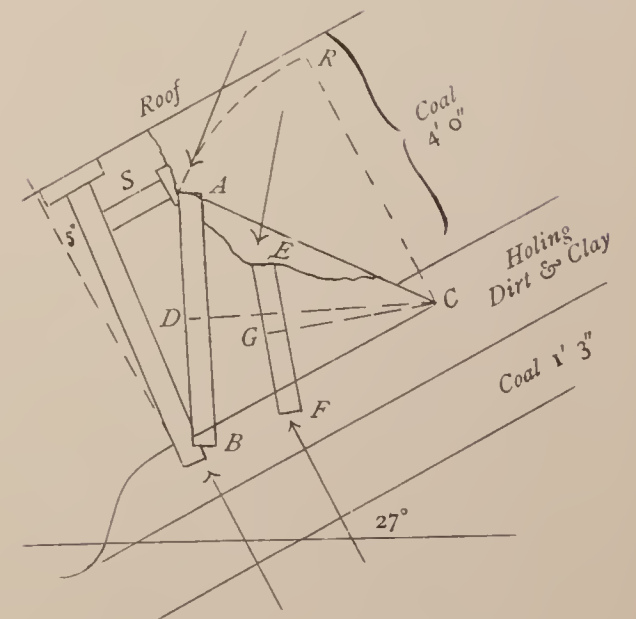
FIG. 236.

In steep mines (Figs. 237 and 238) it is preferable not to trust to sprags entirely, as there is a probability that they may not be correctly set. Several accidents have occurred from this cause. The sprag has either not been stamped sufficiently and has given way at the foot, or has not been properly notched into the coal, and has slid up along its face, or the sprag not being placed at the right inclination has been reeled over by the falling coal. In such cases stretchers set from a post to the face are indispensable. The post should be placed as near the face as possible, thereby

Figs. 236—238. Plan and Sections SE. Longwall drifts, 40 yards on each side the jig; 34 out of 40 yards are packed. The roof subsides without breaking; it peels off in long pieces parallel to the cleat. The holers are about seven yards in advance of the buttocker, who falls the coals at *R* (Fig. 232). This is done with a view of having as little roof unsupported as possible. The coal gets very easily, and the loaders are fully occupied. The cleat is very distinct. Several accidents having occurred from sprags giving way and coal falling on to the colliers, the following rule has been established: "In addition to ordinary sprags, stretchers must be set against holed or unsafe coal, at intervals of not less than 6', and oftener if necessary." No accidents have been recorded since.

RULES IN HOLLY LANE. (Fig. 236).

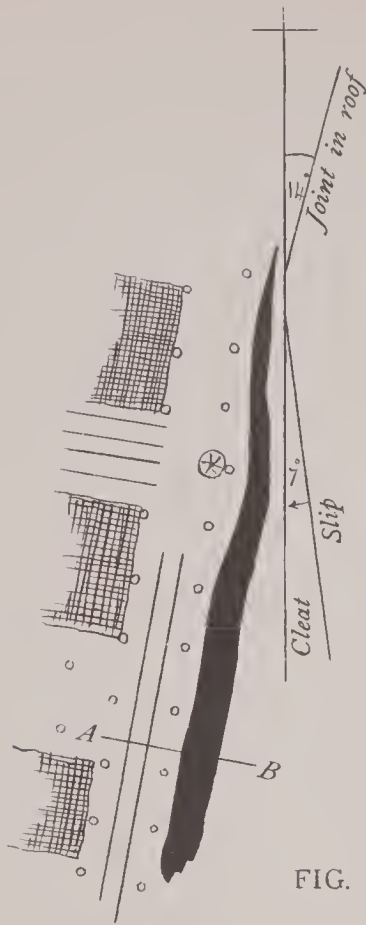
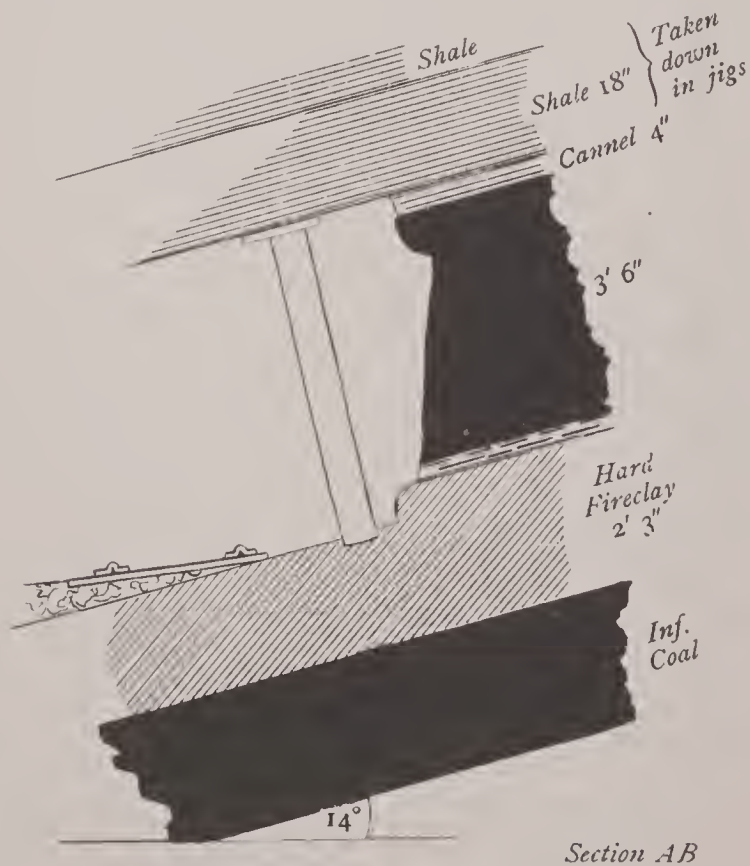
FIG. 239.

Figs. 239 and 240. Plan and Section S. Longwall. Cleat very distinct due N and S; the cleat planes contain calcic carbonate in abundance. The coal is long-grained. Slips in coal frequent. Joints in roof $\frac{1}{2}$ " and more apart. The roof is very strong; it does not break in the wastes, the floor heaves up to it. Floor is taken up to form builders. Large weights, which break off at the face, occur frequently.

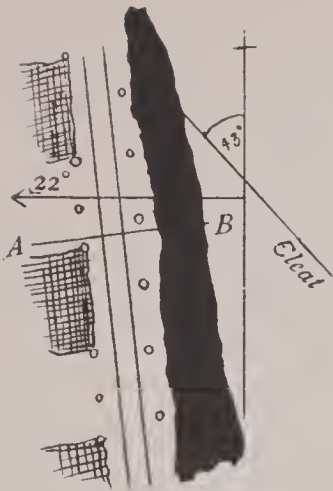
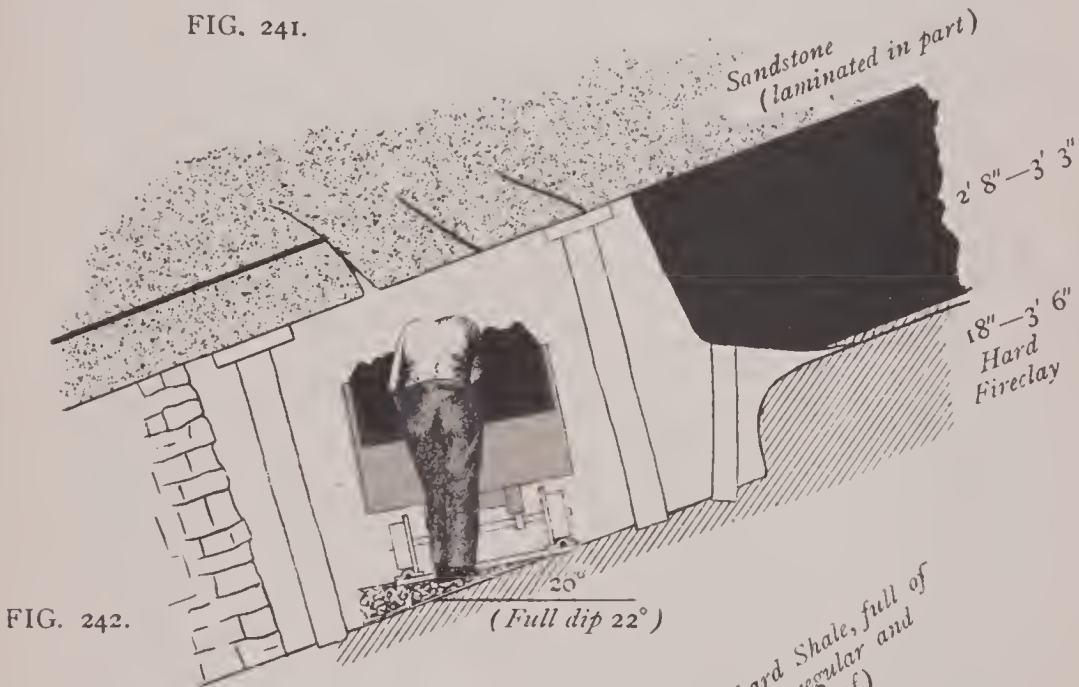
FIG. 241.

Figs. 241 and 242 Plan and Section NE. Worked as in Fig. 235. The sandstone roof breaks mostly in leaning faces, as in Section. Cleat very distinct. The coal is holed 6' under. A fatal accident occurred in a dip from the driftman getting coal off the side against orders, and without setting posts. A slip was visible, which passed from the coal to the roof, and some of the roof had previously fallen.

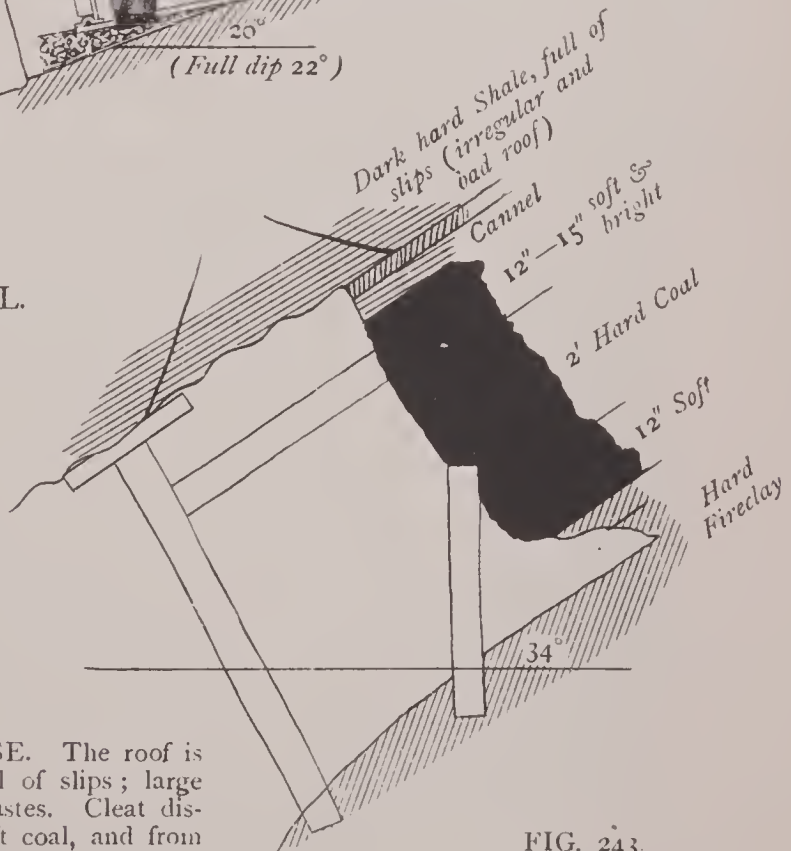
FIG. 243.

Fig. 243. Section SE. The roof is very irregular, and full of slips; large pieces fall out in the wastes. Cleat distinct 10° NW in the soft coal, and from 8° — 20° NW in the hard coal. The coal had set very hard, from the Holly Lane, which is 30 yds. above, having been worked first. It is worked like the Holly Lane (Fig. 236), and the same precautions are adopted as to timbering.

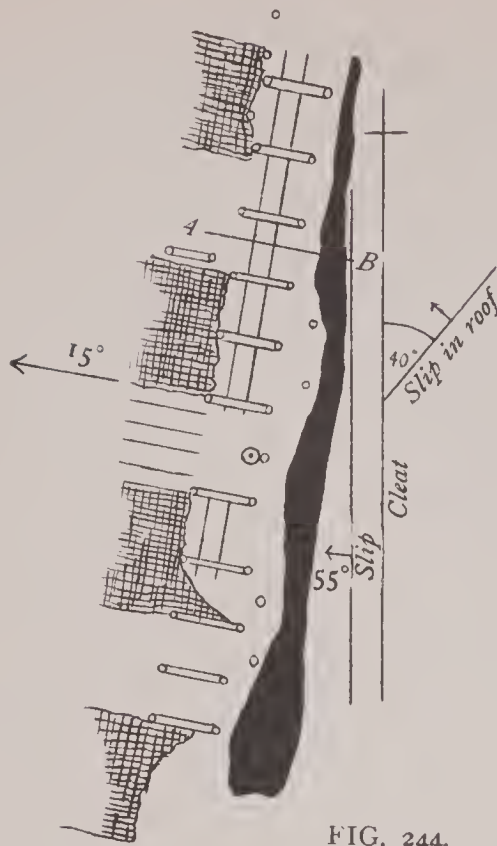
FIG. 244.

Figs. 244 and 245. Plan and Section S. Plan shows temporary posts set near jig wheel whilst making room to move it up. Cleat due N and S, very distinct. Slips, N and S, very frequent; their surfaces are coated with fine dust. Coal exceptionally long-grained. Joints in Cannel N and S, at short intervals. The roof is jointy, and contains slips with very smooth surfaces. The clayshale forms a very bad roof, and requires to be well supported; it weights after each dressing.

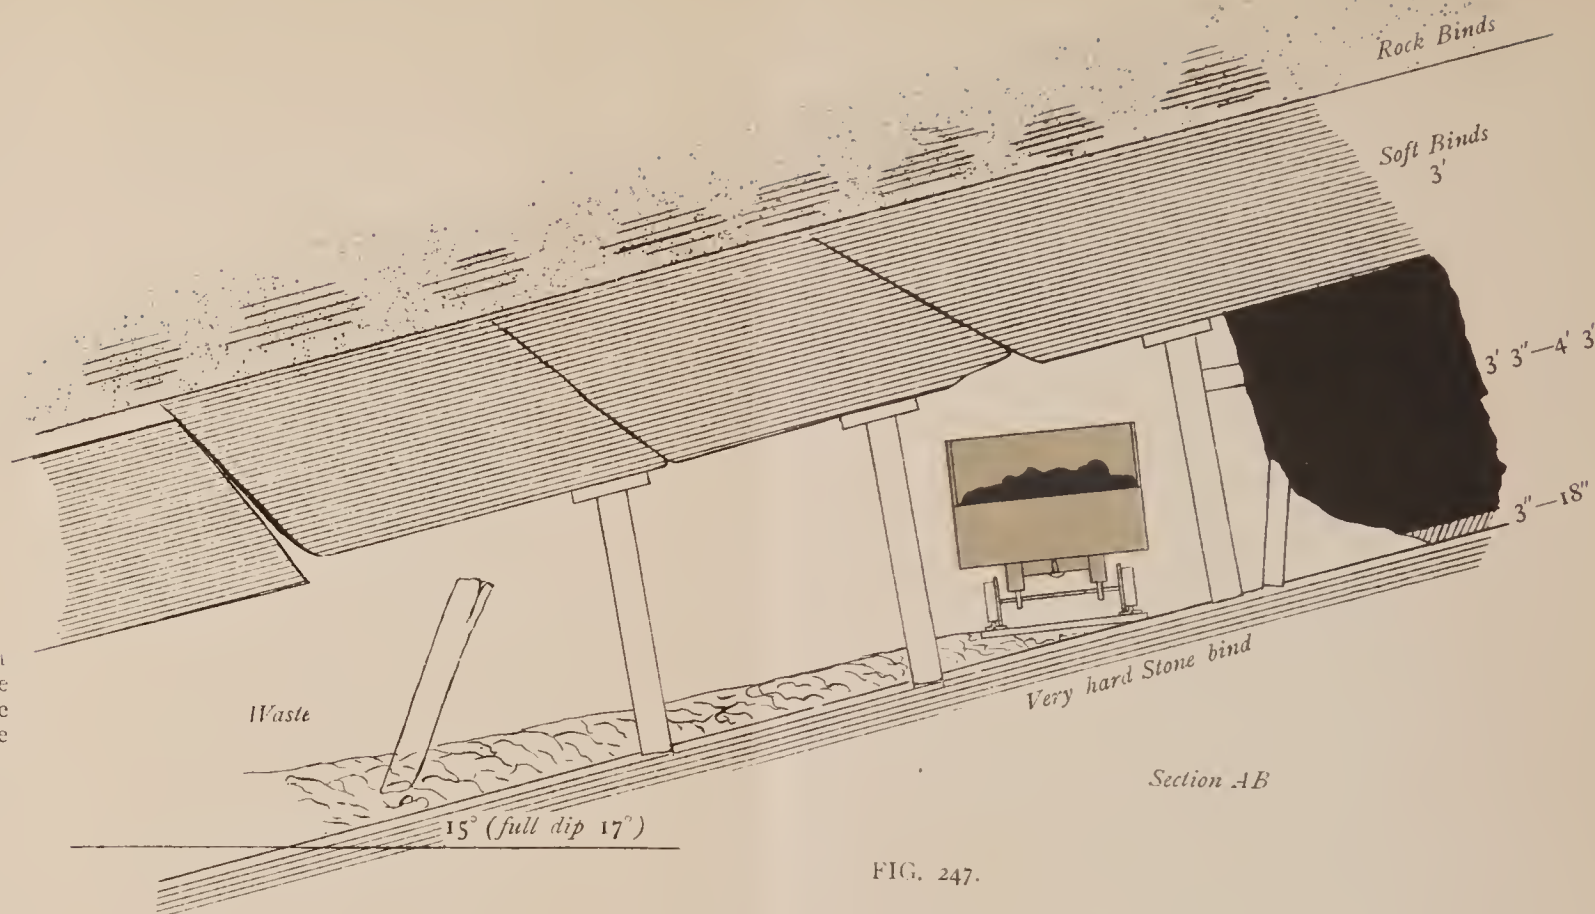
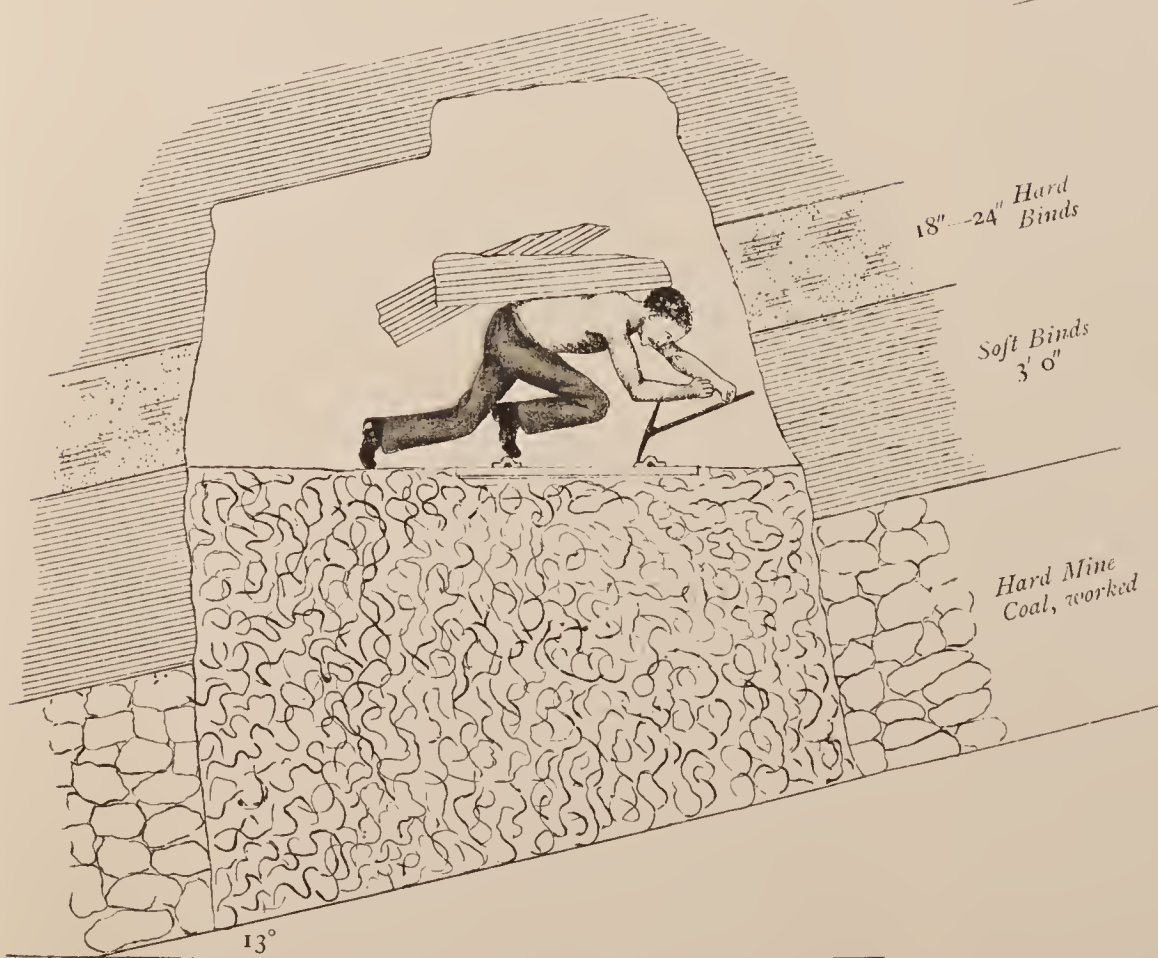
FIG. 247.

Figs. 246 and 247 Plan and Section NE. Worked as in Fig. 235. Cleat very distinct; there are one or two hard coal bands in which the cleat planes are far apart. Owing to the hardness of the floor, the posts are not stamped. The coal is holed 4' 6" under; where the holing dirt is thin the coal requires to be slotted, and a certain amount of slack is produced. Jigs are 50-60 yds. apart.

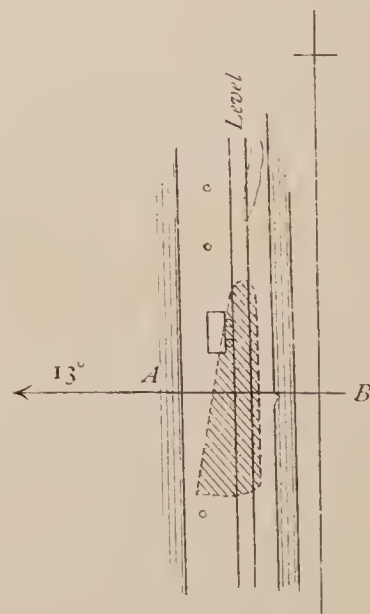
FIG. 247A.

Figs. 247A and 247B. Plan and Section NE, illustrating a fatal accident in a level. Two datallers were told off to set four bars or stretchers under a slightly defective part of the roof in a level. Whilst one of them was holing out the hole to receive the first bar, a large piece of roof, weighing about 2½ tons, fell, killing him instantly. He had knocked at the roof before starting to work, and thought it safe. Had he set a temporary post, as is usually done before beginning to disturb the roof the accident would not have occurred. Temporary posts should always be set whenever timbering is to be done in main roads; this should not be left to the discretion of the timberers. The disturbance and appearance of breaks in the roof was due to the approach of the Holly Lane workings over the Hard Mine level.
