ACCIDENTS IN MINES,

NORTH STAFFORDSHIRE COALFIELD,

FALLS OF ROOF AND SIDES;

THEIR CAUSES, AND THE MEANS OF DIMINISHING
THEIR FREQUENCY.

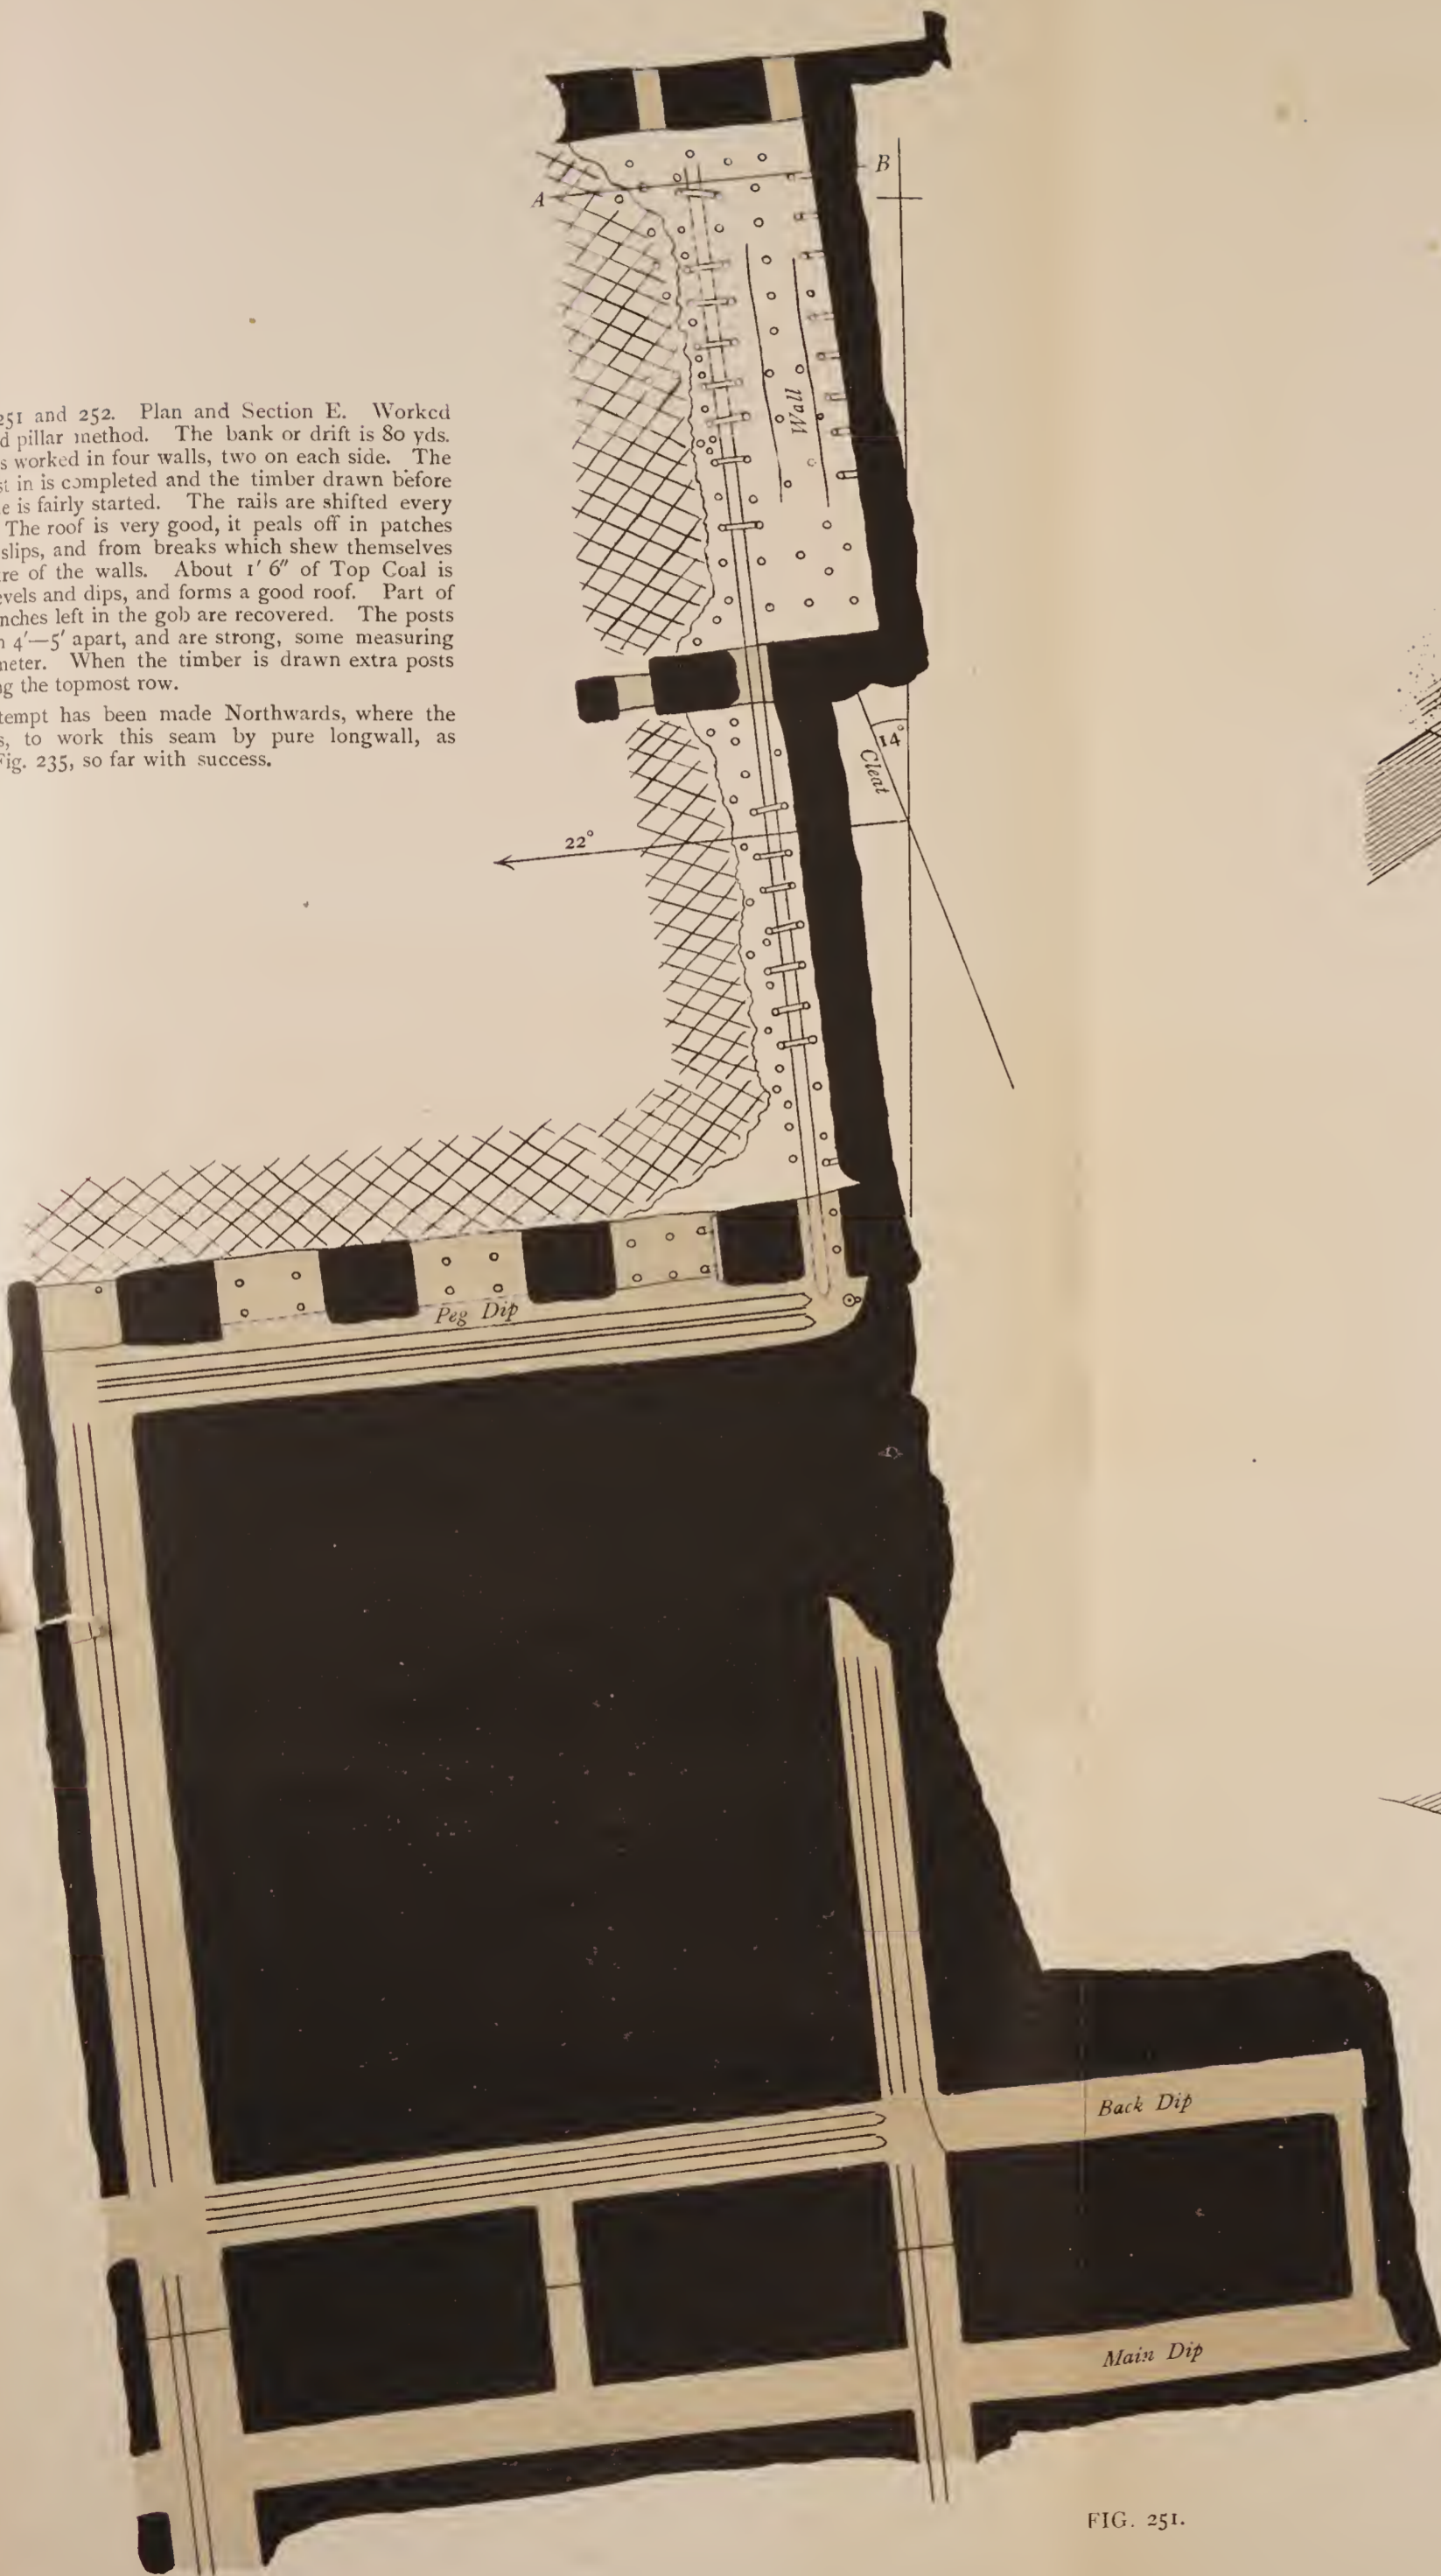
FIG. 251.

A certain percentage of timber is lost throughout, which is as high as 50% in the bank and pillar work, shewn in Fig. 251. It is lowest in pure longwall.

Figs 251 and 252. Plan and Section E. Worked by bank and pillar method. The bank or drift is 80 yds. wide, and is worked in four walls, two on each side. The wall furthest in is completed and the timber drawn before the near one is fairly started. The rails are shifted every 6 yds. The roof is very good, it peels off in patches from small slips, and from breaks which shew themselves in the centre of the walls. About 1' 6" of Top Coal is left in all levels and dips, and forms a good roof. Part of the coal punches left in the gob are recovered. The posts are set from 4'-5' apart, and are strong, some measuring 12" in diameter. When the timber is drawn extra posts are set along the topmost row.

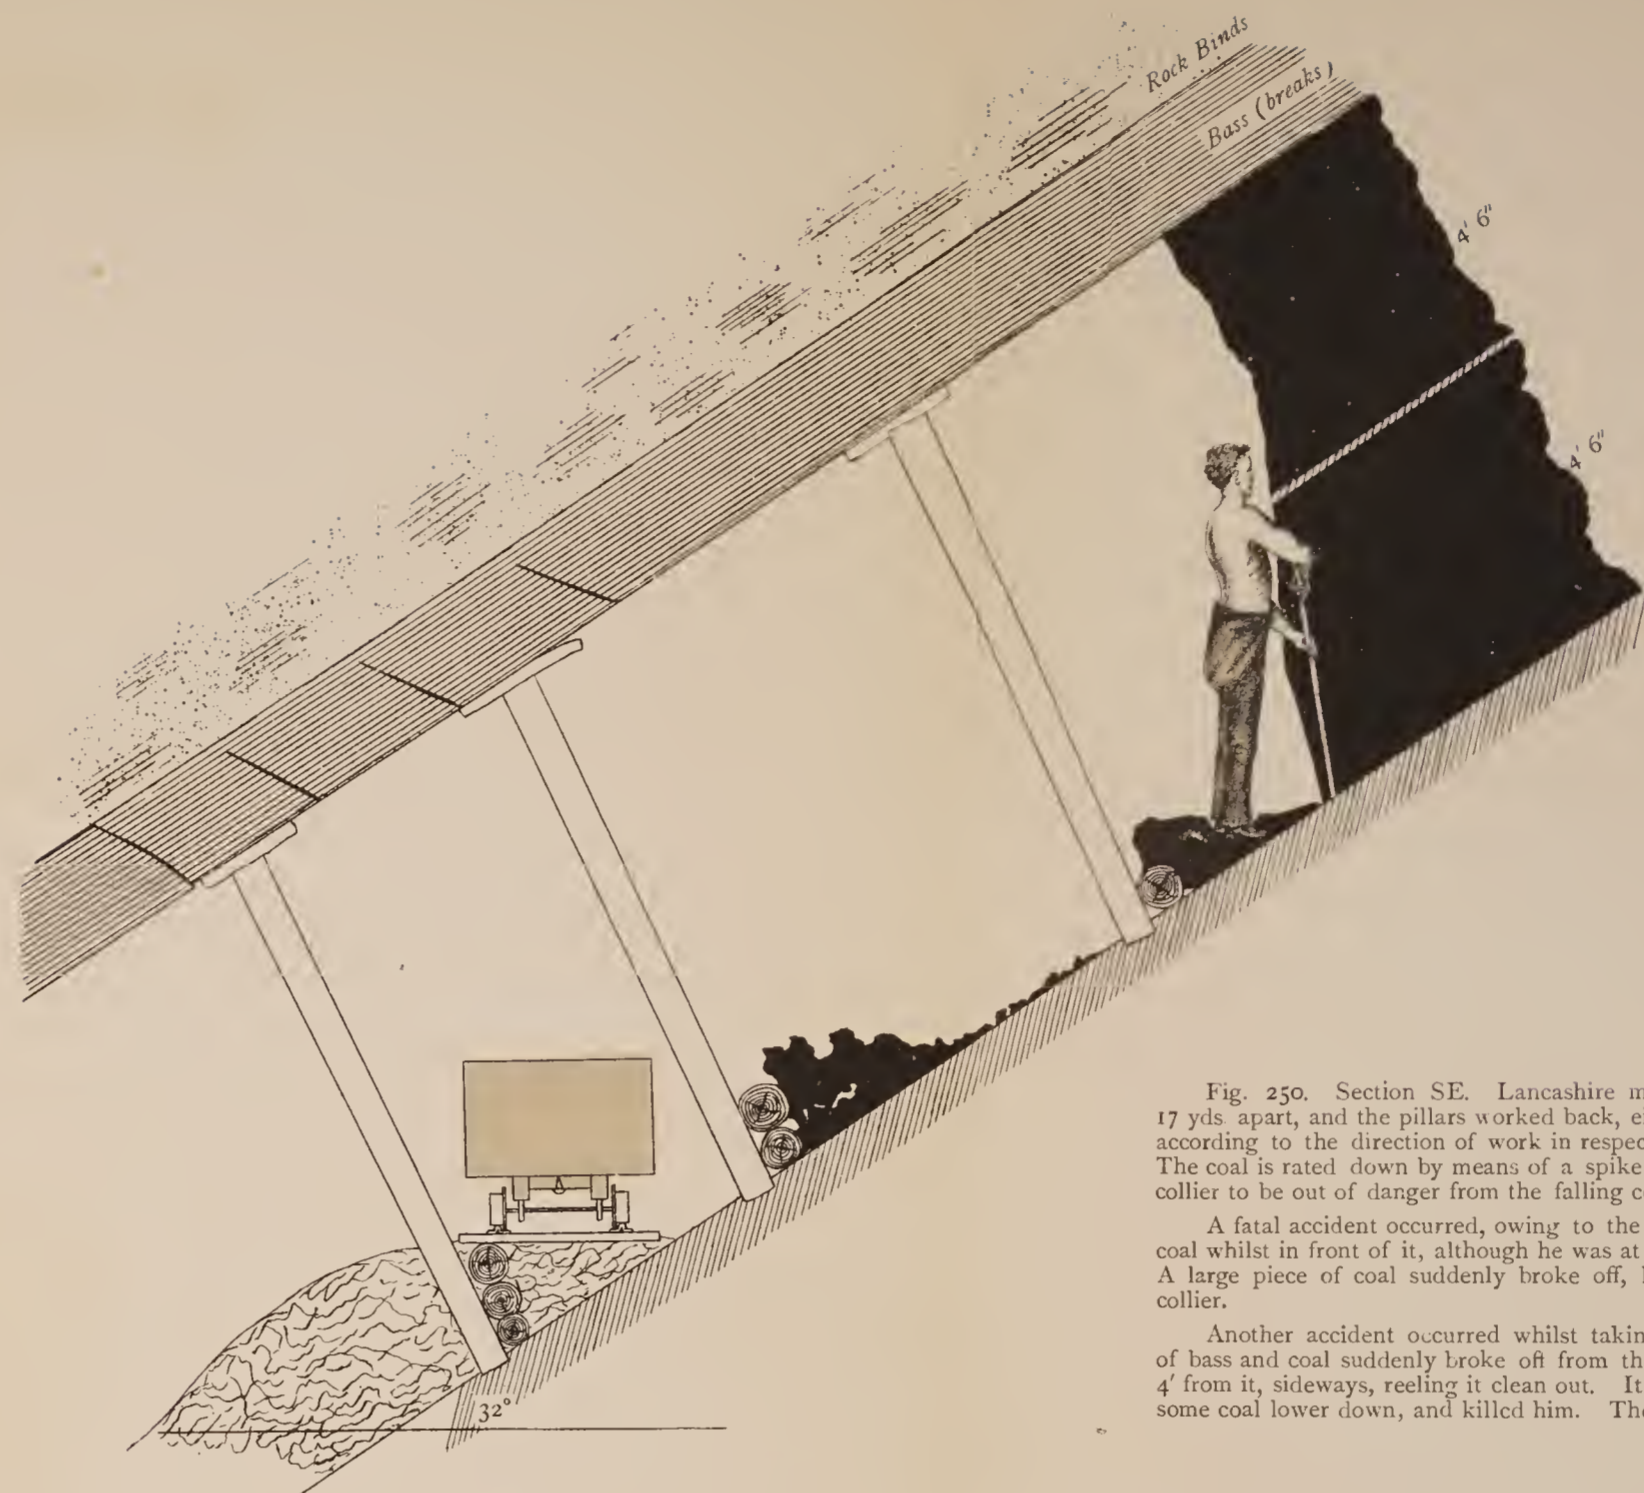
FIG. 250.

The adjoining post, which had been set longer, was broken by the fall. A similar accident occurred in the Cockshead Seam. (Fig. 250). There is at times a tendency to set posts slack, relying on the tightening action of roof, or floor to fasten them, as they are then in some cases not so soon broken. This may account for posts being frequently so easily knocked out by a blow when only recently set. In some seams the colliers set their last posts slack and find them set fast the next morning. Long posts are easily displaced by a fall in steep mines unless set very fast, and this is especially the case if the roof is slippery.

Fig. 250. Section SE. Lancashire method. Headings are driven about 17 yds. apart, and the pillars worked back, either with a fast end or continuously, according to the direction of work in respect to the cleat, which is very distinct. The coal is rated down by means of a spike (jobber) 9' long, which enables the collier to be out of danger from the falling coal.

A fatal accident occurred, owing to the collier improperly pulling at the top coal whilst in front of it, although he was at some distance from it behind a post. A large piece of coal suddenly broke off, knocked the post out and killed the collier.

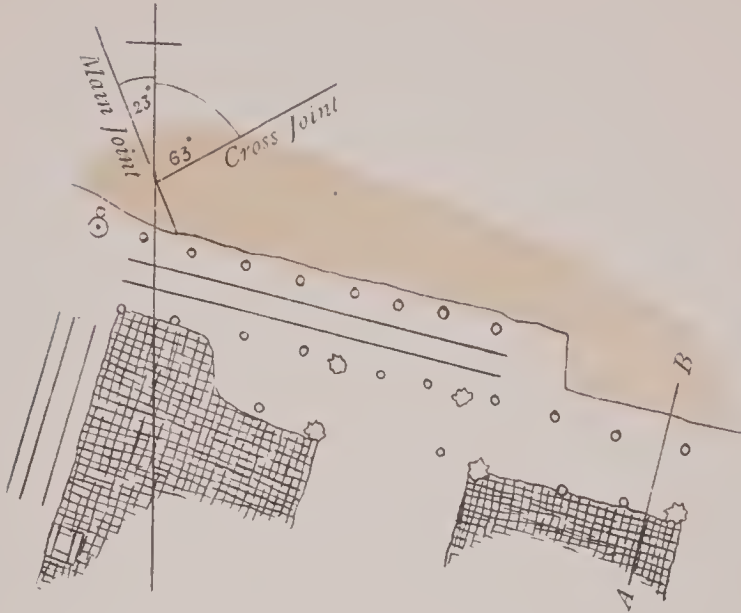
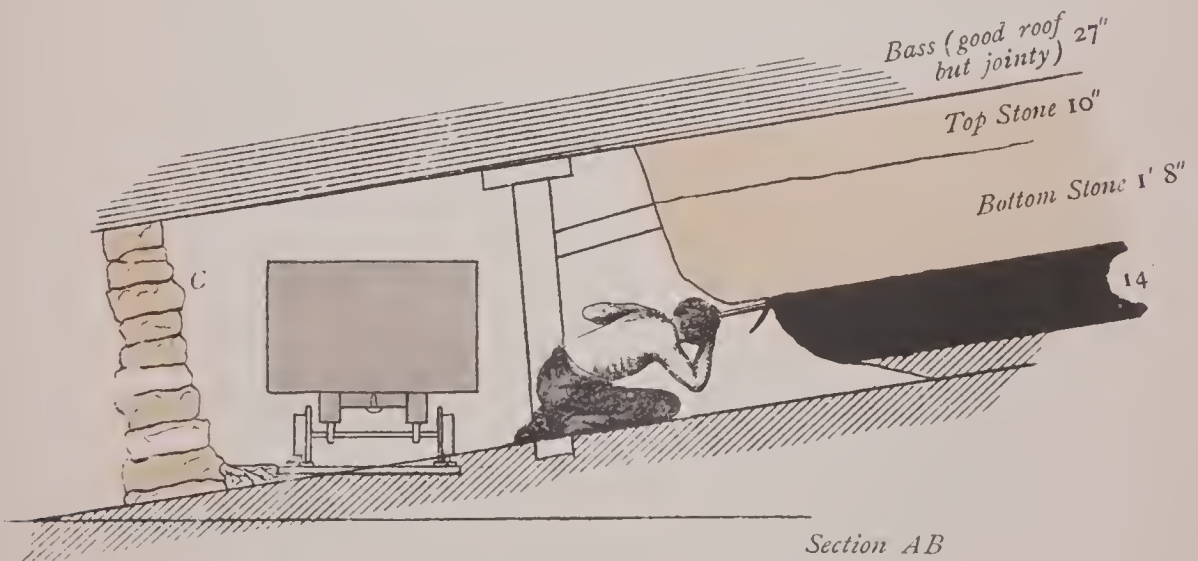
FIG. 253.

Figs. 253 and 254. Plan and Section S. The joints run irregularly, owing to proximity to faults and to change of dip. The roof is jointy, but good, and does not break down in the wastes. Riflemen, *C*, are erected in places. The stone is thicker than on the Norton side. The Bottom Stone varies greatly in thickness, reaching as much as 5' in places. The seam is worked outwards by extended longwall faces. Whilst working out an old pillar, which was surrounded by gob on three sides, two men were killed by a fall of roof at the face within 6' from posts. The men had begun to hole after completing their dressing without first setting a post. No accidents have occurred along the longwall face.

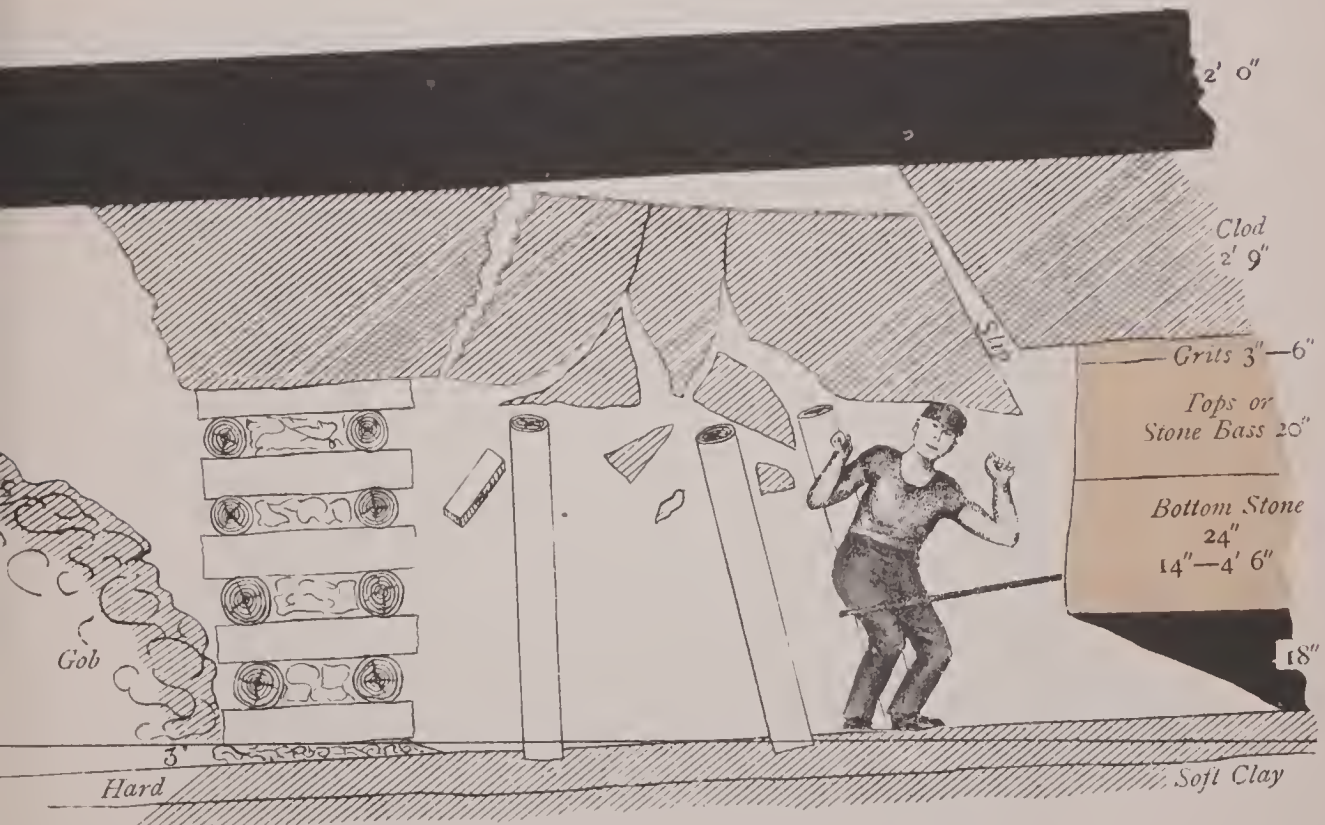
FIG. 257

Chocks are extremely efficient supports, and a freer use of them would tend to reduce a certain class of accidents, such as the one described in Fig. 92, and the fall described in Fig. 271. The one illustrated in Fig. 257 would not have occurred had the chock been nearer the face.

Figs. 256 and 257. Plan and Section S, illustrating a fatal accident. The clod which forms the roof contains many slips in irregular directions, some of which form bell mouths. The clod in this instance fell over an area of 60 square feet. It lay between two slips which were seen and another at the face, which was invisible. These slips leaned towards each other, forming a bell mouth. There was a chock 9' from the face; this effectually supported the clod roof, which was found to be detached from the coal above. The clod in the waste behind the chock had fallen easily. The mass being detached from the surrounding clod by the slips, and also from the coal above, rested almost entirely on three posts, which were not under its centre. One side must have given way first, and the lump having once started to move, the posts were immediately uncrowned and knocked out.

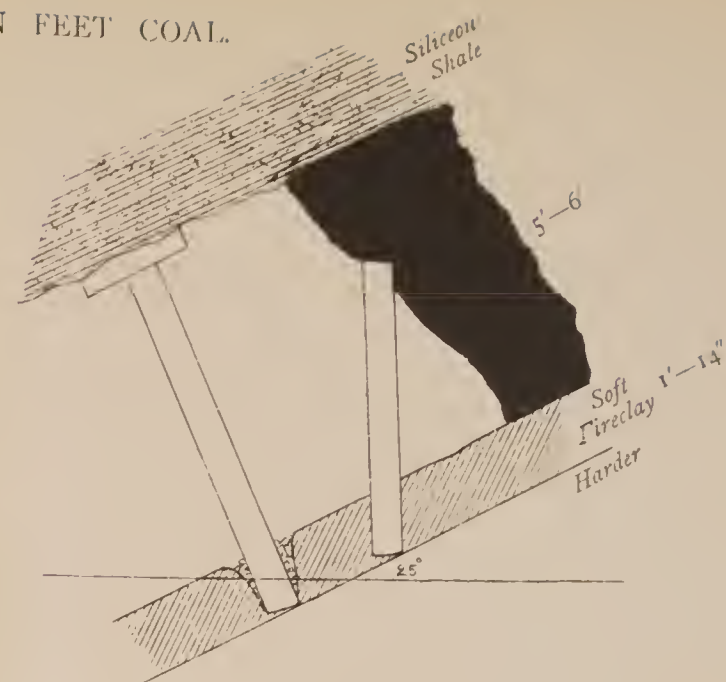
FIG. 265.

shewn in Fig. 265, where it is necessary to get to a firm bottom. Stamping is often neglected in seams of moderate inclination, and several accidents have occurred in consequence, from the posts slipping out at the foot.

Fig. 265. Section in Centre. Flakes drop off the roof, and it contains a few slips. Lancashire method, with headings 9 yds. apart. Cleat indistinct.

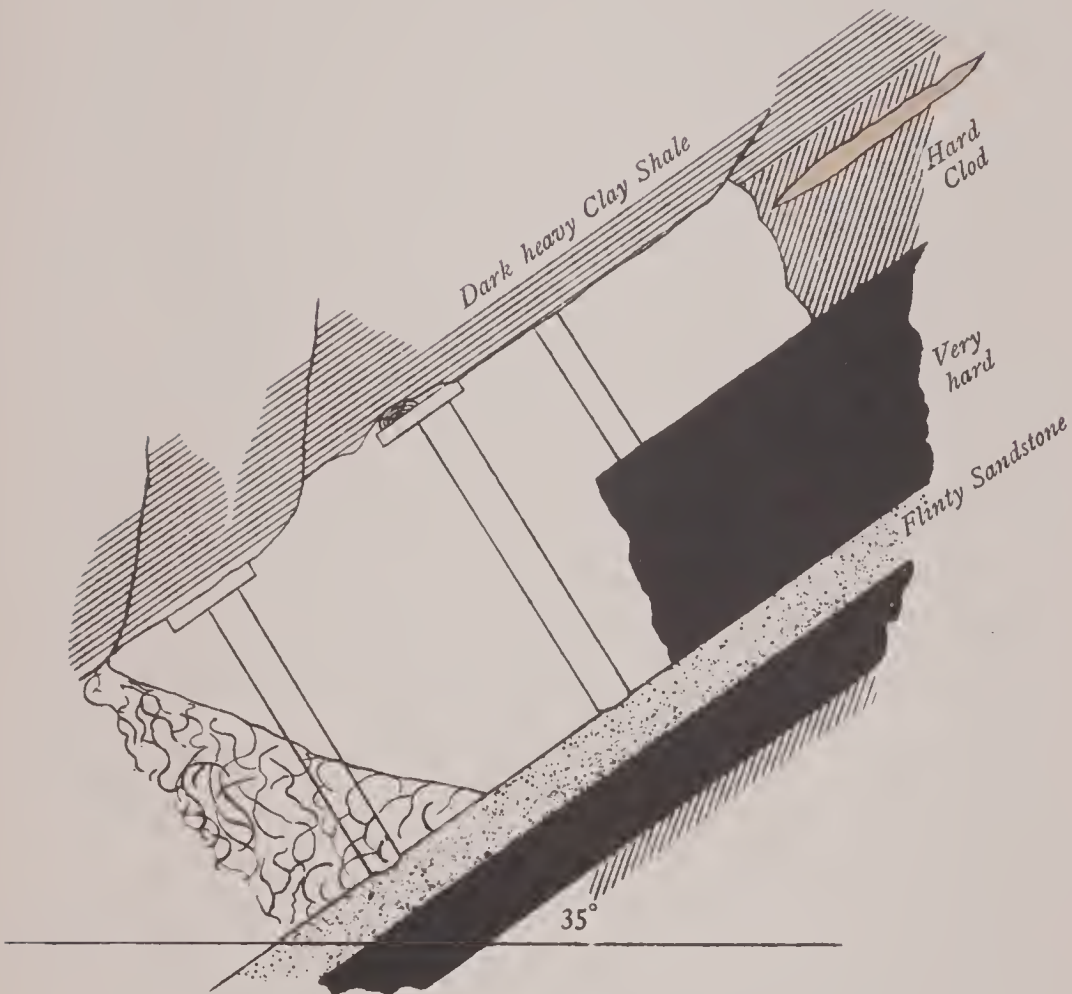
FIG. 267.

Fig. 267. Section in Centre. The Bottom Coal is left. Eastwards the Bottom Coal becomes thicker (2'), and the flinty sandstone dwindles down to 5"; the holing is then done in the Bottom Coal, or in the fireclay when soft enough. The coal is sladdered down. The longwall drifts are 15 yds. on each side the sladder, and the coal is danned to it. The posts are not stamped, owing to the hardness of the floor; they are slightly sharpened, and a small incision made with a blunt pick for their reception. The gob is nearly filled up. There are numerous slips in the roof, which run in the direction of level, about 6' apart, and tail into the plane of stratification. The coal is very hard, and the cleat indistinct. A fatal accident occurred to a collier in a drift from a piece of roof 12' long \times 2' in width \times 1' 3" thick falling off one of these slips. It was visible, but was not provided against.

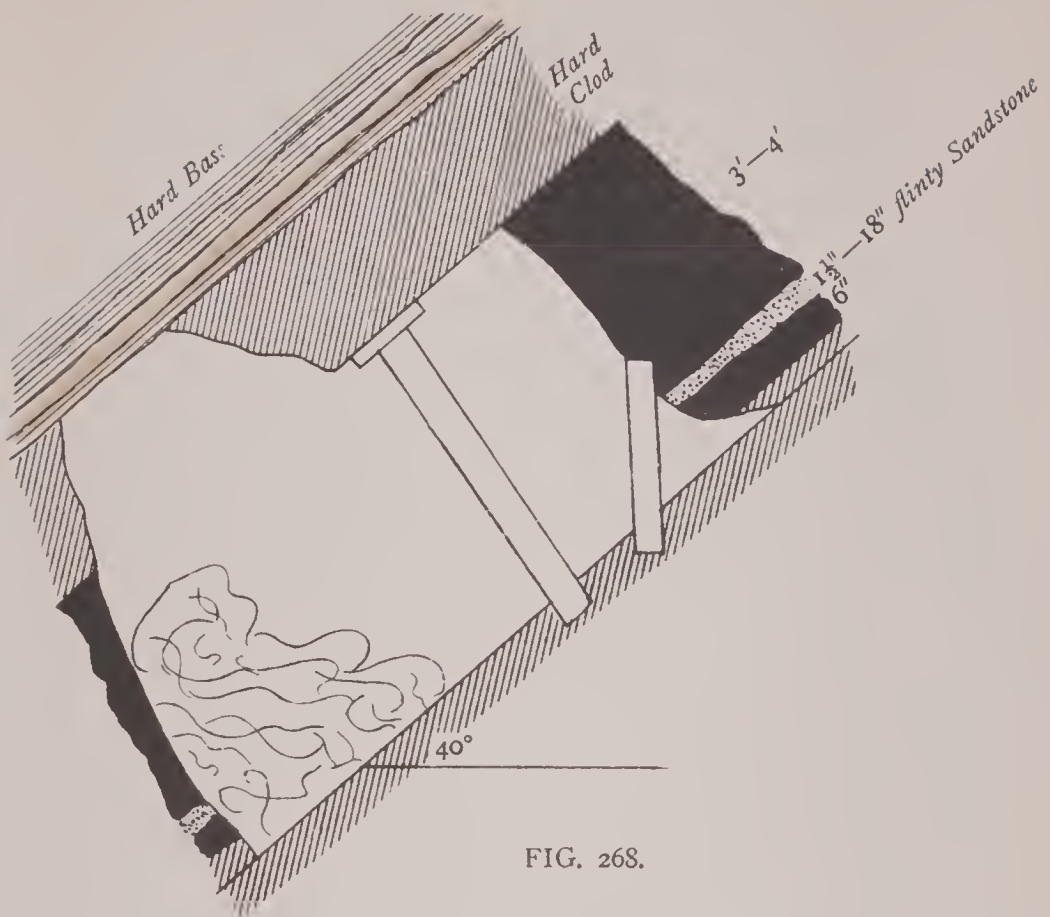
FIG. 268.

Fig. 268. Section S. Starting a shoulder. Worked by headings 7—8 yds. apart, and drifting back diagonally; shoulders 5' wide being taken off. The clod comes down in the drifts, and holing is done underneath the Bottom Coal. A fatal accident occurred from the collier passing in front of the coal face, from which he had withdrawn the sprags. A large piece of coal became detached and fell on to him. Not more than two or three posts are set in each of the drifts.

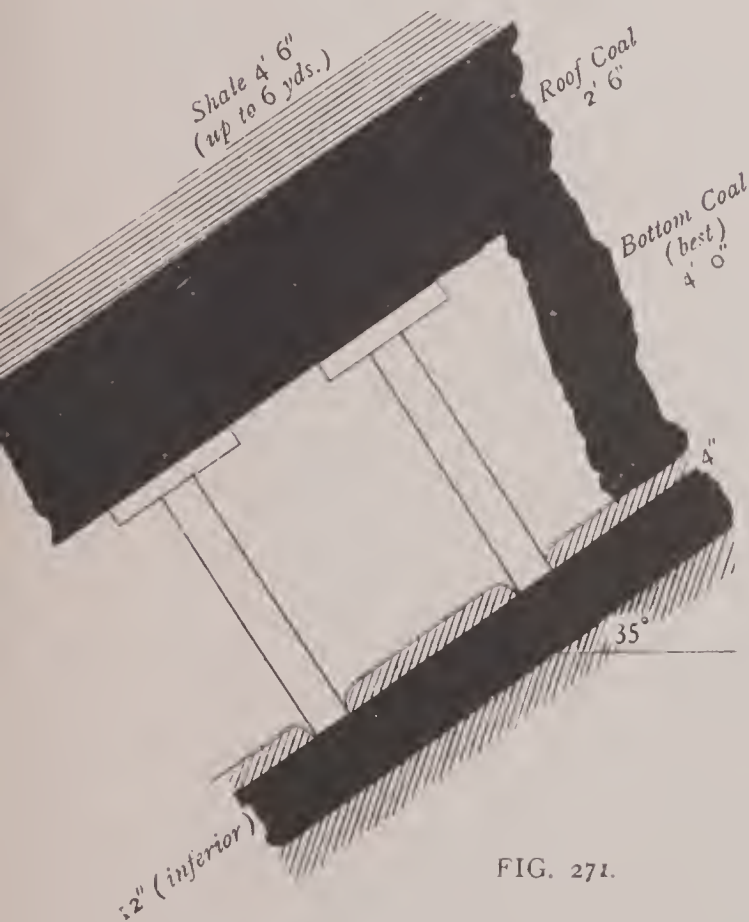
FIG. 271.

Fig. 271. Section of drift C. The shale which lies between the Banbury Rock and the coal forms a bad roof, and necessitates much timbering in the roads. Lancashire method; headings 8-9 yds. apart. 2' 6" of coal forms the roof in the drifts; there are five rows of posts, about 27" from each other; the posts in each row being 1-1 1/4 yds. apart. The roof coal drops, or is got down on drawing the back rows of posts, and little of it is lost. Long posts are sometimes set to the shale roof whilst the coal lumps are being loaded. Cleat: 10° NW, distinct.

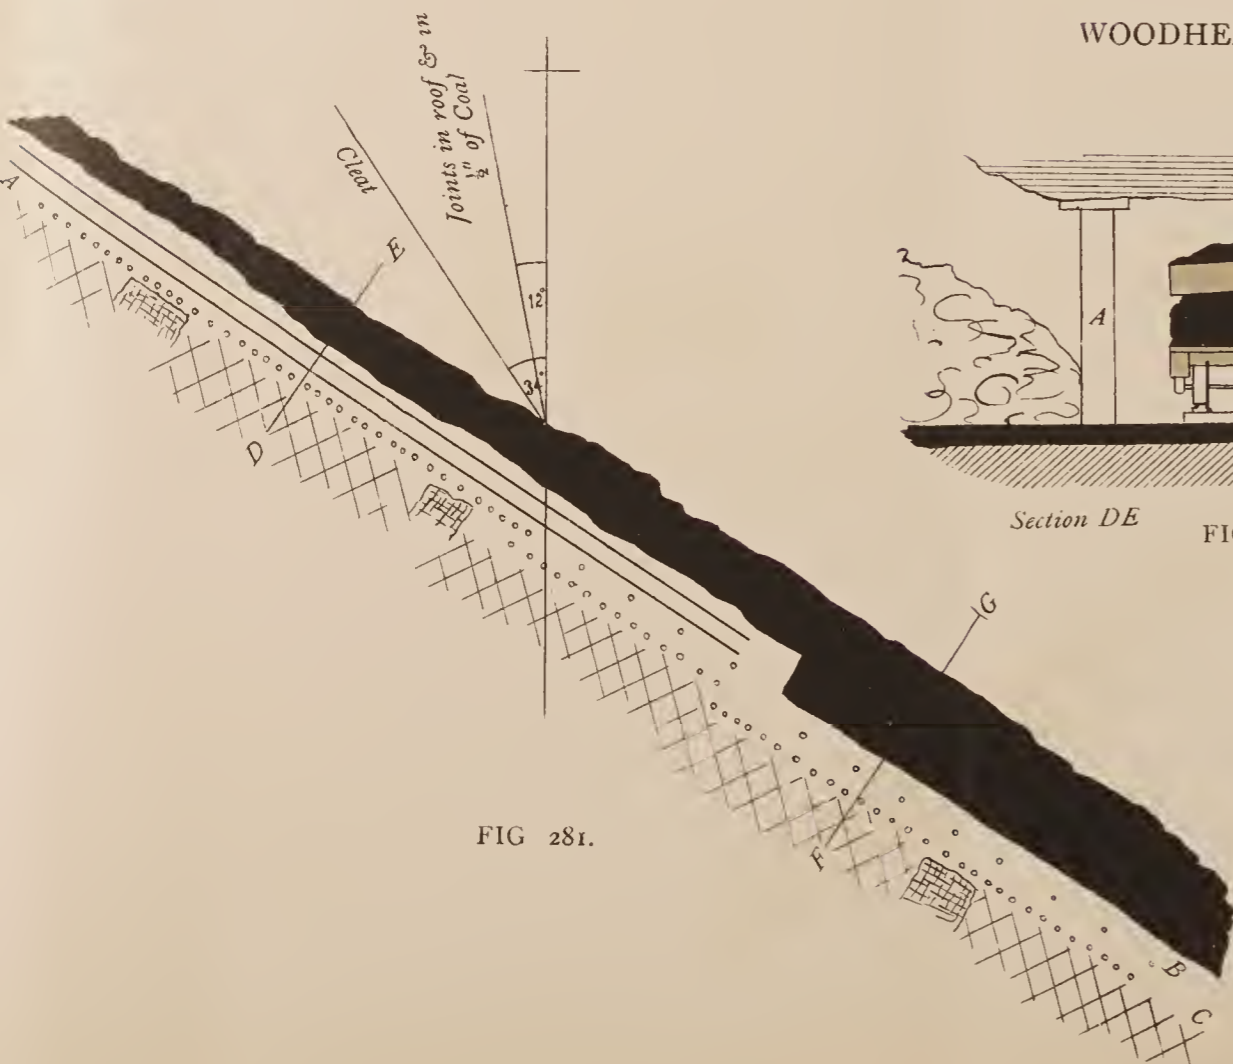
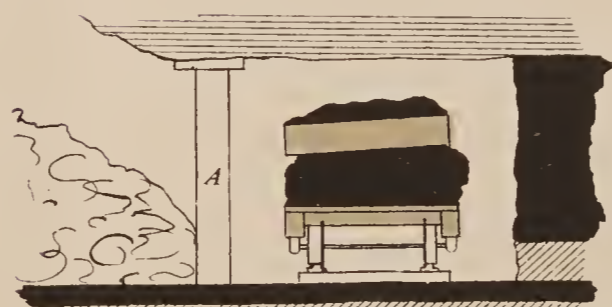
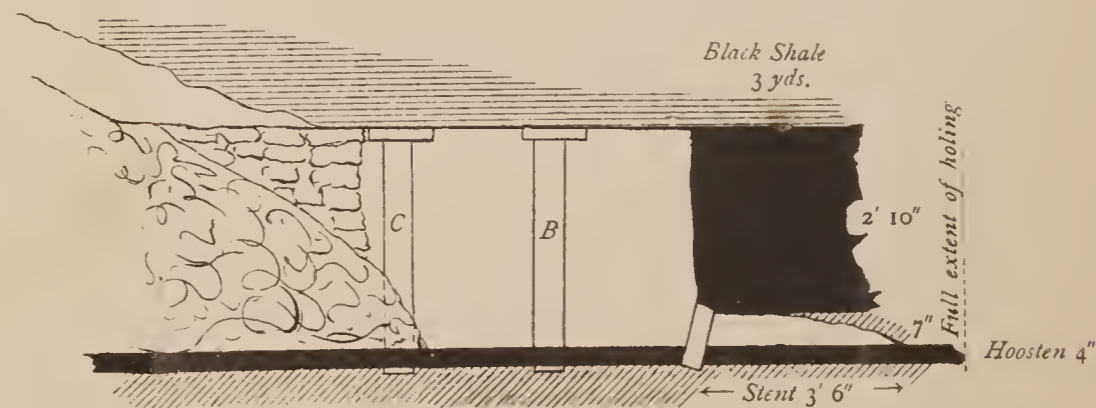
FIG. 281.

A roof containing joints, as that over the Woodhead Seam (Fig. 281), will be good or bad according as to whether the face is kept more at right angles to the joints, or parallel with them.

Figs. 281, 282, 283. Plan and Sections. Worked in 40—50 yds. longwall faces. Weights occur every 9—10 yds. Cogs are more or less frequent. The coal gets best when the face forms an angle with the cleat; if square on end the coal is "too fast." Foreset posts B are set before holing. As the "buttock" advances the backrow posts are drawn and set in between the foreset posts. Two men were killed by a fall of roof at the face. It was known that the roof "stirred" by knocking; but the coal, though holed, was expected to support it, and the men were engaged removing a post to reset it at a short distance, without previously setting a temporary one. The workings had been standing a fortnight, and the roof and coal were broken behind the holing, unknown to the men.

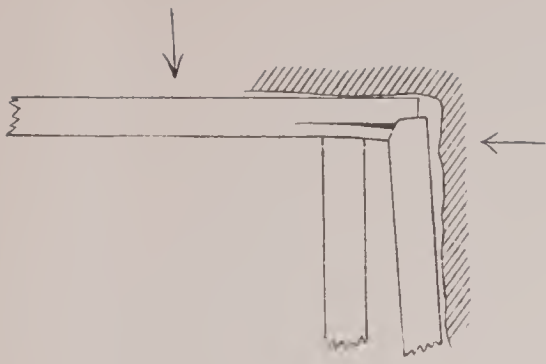
FIG. 286A.

Injured bars are often made serviceable a little longer by arrangements as shewn in Fig. 286, A, B and C.
