RAILROAD ACCIDENT REPORT
COLLISION OF
ILLINOIS CENTRAL GULF RAILROAD
COMMUTER TRAINS.
CHICAGO, ILLINOIS
OCTOBER 30, 1972

NATIONAL TRANSPORTATION SAFETY BOARD
Washington, D.C. 20591
REPORT NUMBER: NTSB-RAR-73-5

ADOPTED: JUNE 28, 1973

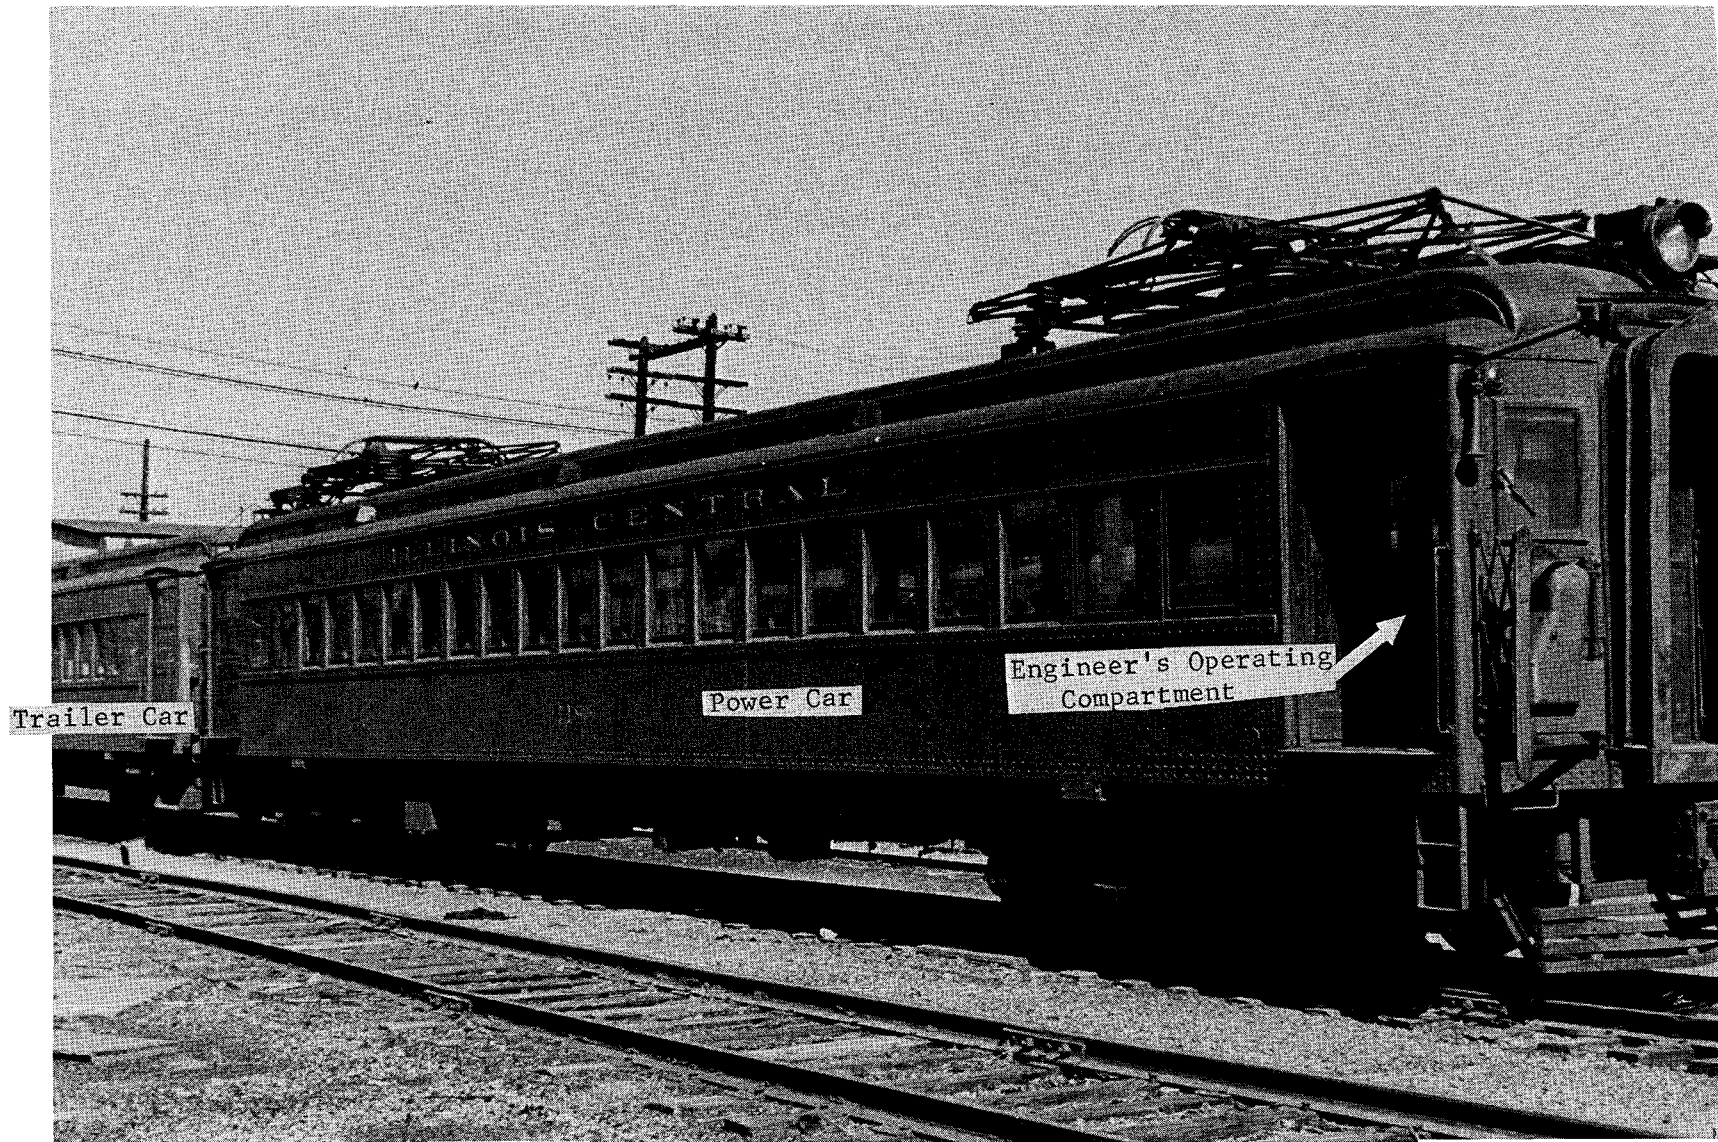
Train 720. The six multiple-unit (MU) cars of train 720 were of steel construction and had been built between 1924 and 1926. The cars operated in pairs, with a motor car and a trailer car forming a semipermanent unit. The first car of 720 was a trailer car. A vestibule with side doors was located at each end of each car. The operating controls, which did not include a speedometer, were in the end vestibules of each pair of cars. (See Figure 3.)

The cars of train 720 were constructed prior to the establishment of Federal regulations for MU equipment and the couplers, the anti-climbing arrangement, and the collision posts did not comply with the requirements in 49 CFR 230.457.

Figure 3. "Old" car, similar to those of train 720.

The first 10 feet of the lead car of train 720 was demolished. The center sills and couplers on several of the other cars of the train were broken, and these cars sustained sufficient damage to prevent prompt return to service.

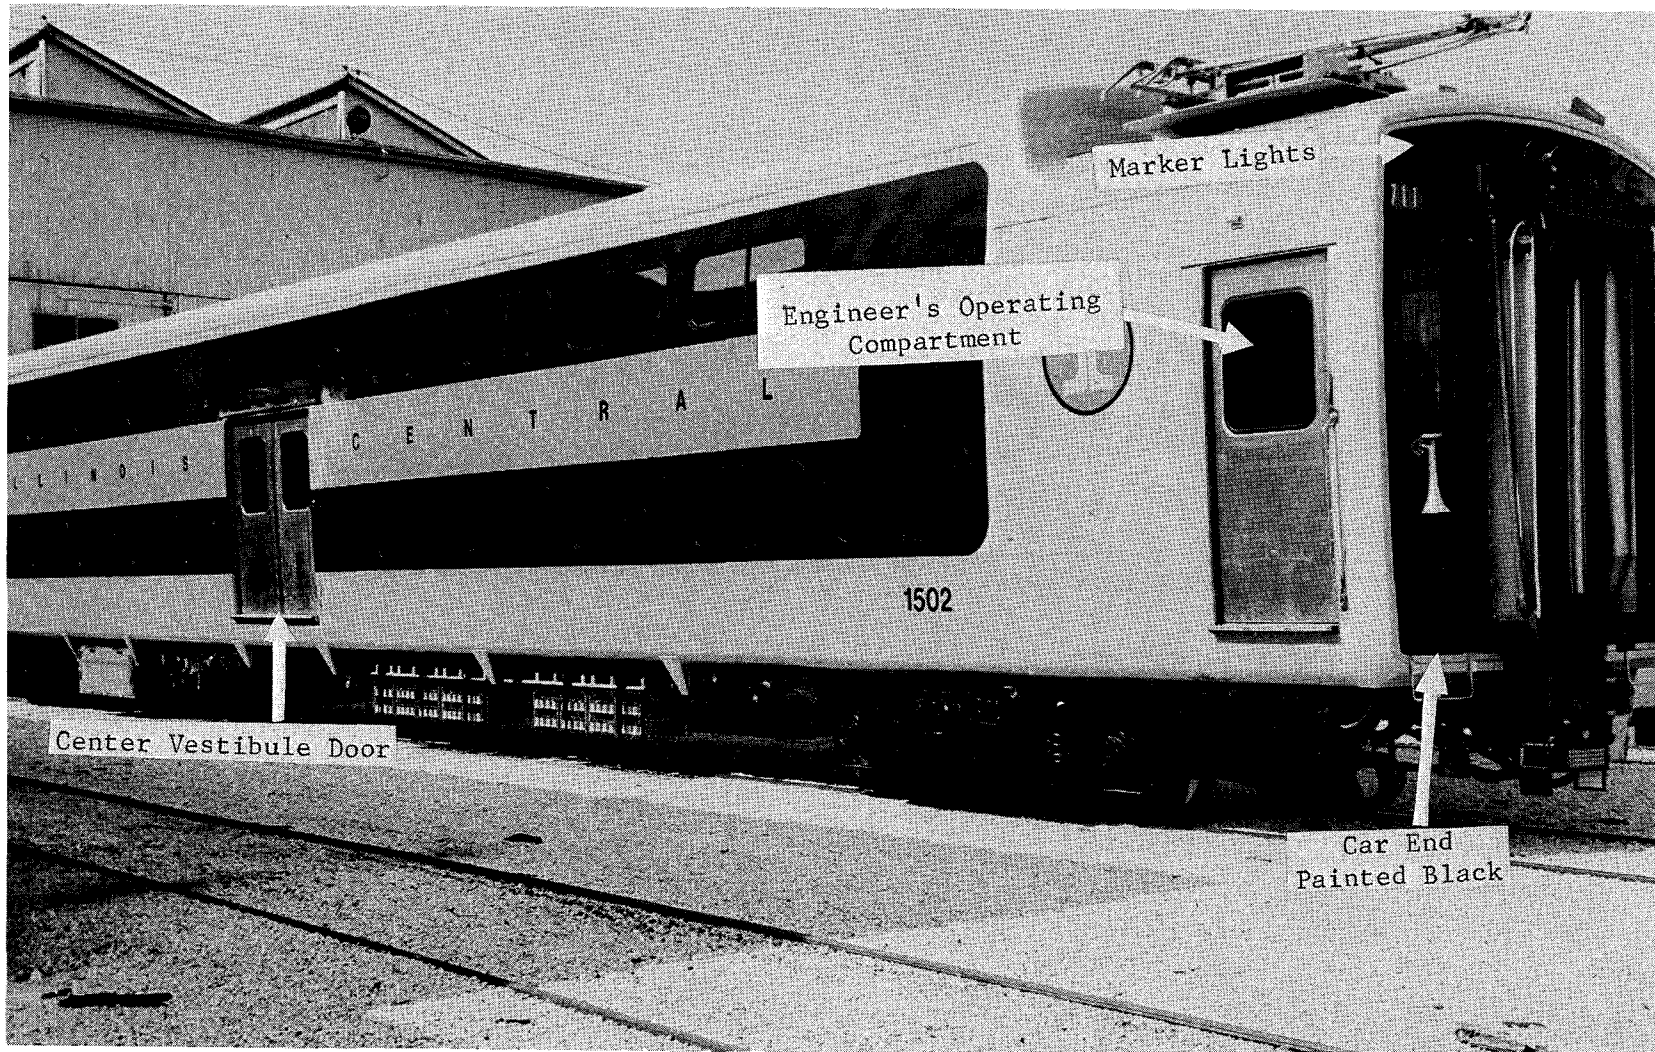
Train 416. The Highliner cars were self-propelled, electric MU cars in which passengers were seated on two levels. Each car was 85 feet long, 15 feet 10 inches high, and 10 feet 6 inches wide, and weighed about 134,000 pounds. (See Figure 4.)

Figure 4. Highliner car, similar to those of train 416.

Train damage. The rear half of the last car of train 416 was demolished. The end of the car and most of the right side were sheared off at floor level. A portion of the left side and several seats on the upper level remained intact. All lower-level seats were destroyed. The underframe of the car was not buckled, and the three other cars of 416 received only minor damage and were returned to service.
