This document is an English translation of the Preliminary Report on the fatal accident involving the Boeing 747-412F aircraft registered TC-MCL that occurred on January 16, 2017 at Manas International Airport, Bishkek, Kyrgyz Republic.

**INTERSTATE AVIATION COMMITTEE
AIR ACCIDENT INVESTIGATION COMMISSION**

PRELIMINARY REPORT

Type of occurrence	Fatal accident
Type of aircraft	Boeing 747-412F
Registration mark	TC-MCL
Owner	LCI Freighters One Limited (Ireland)
Operator	ACT Airlines
Aviation Authority	Turkish DGCA
Place of occurrence	Near Manas International Airport, Bishkek, Kyrgyz Republic, coordinates: N 43°03.248' E 074°2.271'
Date and time	16.01.2017, 07:17 local time (01:17 UTC), nighttime

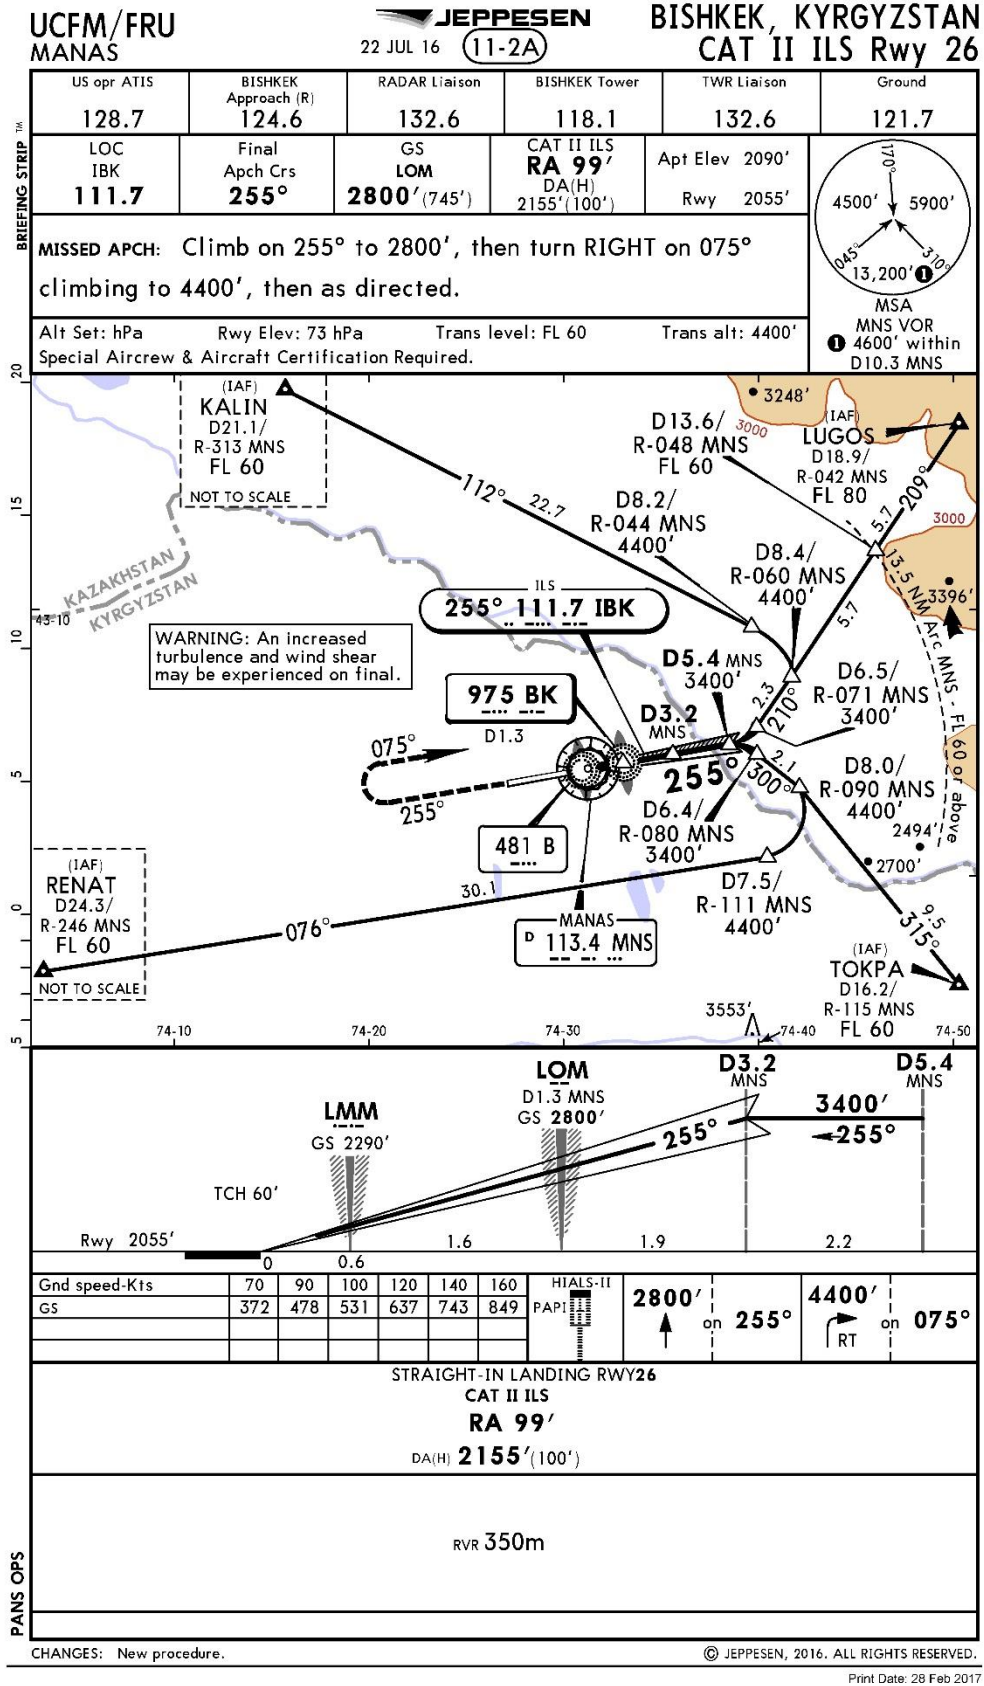
Figure 4. Approach chart for RWY 26

Since 01:14:08 the three A/Ps were engaged. Autoflight was continued, LOC MODE engaged laterally and FLIGHT LEVEL CHANGE was active vertically. 3400 ft was selected as target altitude (glideslope capture altitude). As per the approach chart (Figure 4) this altitude shall be reached at a distance of 5.4 nm and maintained until 3.2 nm (glideslope capture).

A glideslope signal was captured at 01:15:52, at that time the a/c was almost over VOR/DME MANAS at a distance of approximately 1.1 nm from RWY 26 threshold, at an angle of approximately 9° (Figure 1). However, as per the approach chart, the rated glideslope angle is 3°(Figure 4).
