90.20 - 241 - *Nippon Vehicle Mfg. Company*

AREA NO. 90:20	TARGET I. 241	LIMITED DAMAGE INTERPRETATION NO. <u>30</u>	CONFIDENTIAL	D/P
			SHEET NO.	OF

NIPPON VEHICLE COMPANY

NIPPON VEHICLE MANUFACTURING CO.
90.20-241
Lat. 35° 07' N - Long. 136° 55' E
NAGOYA, JAPAN

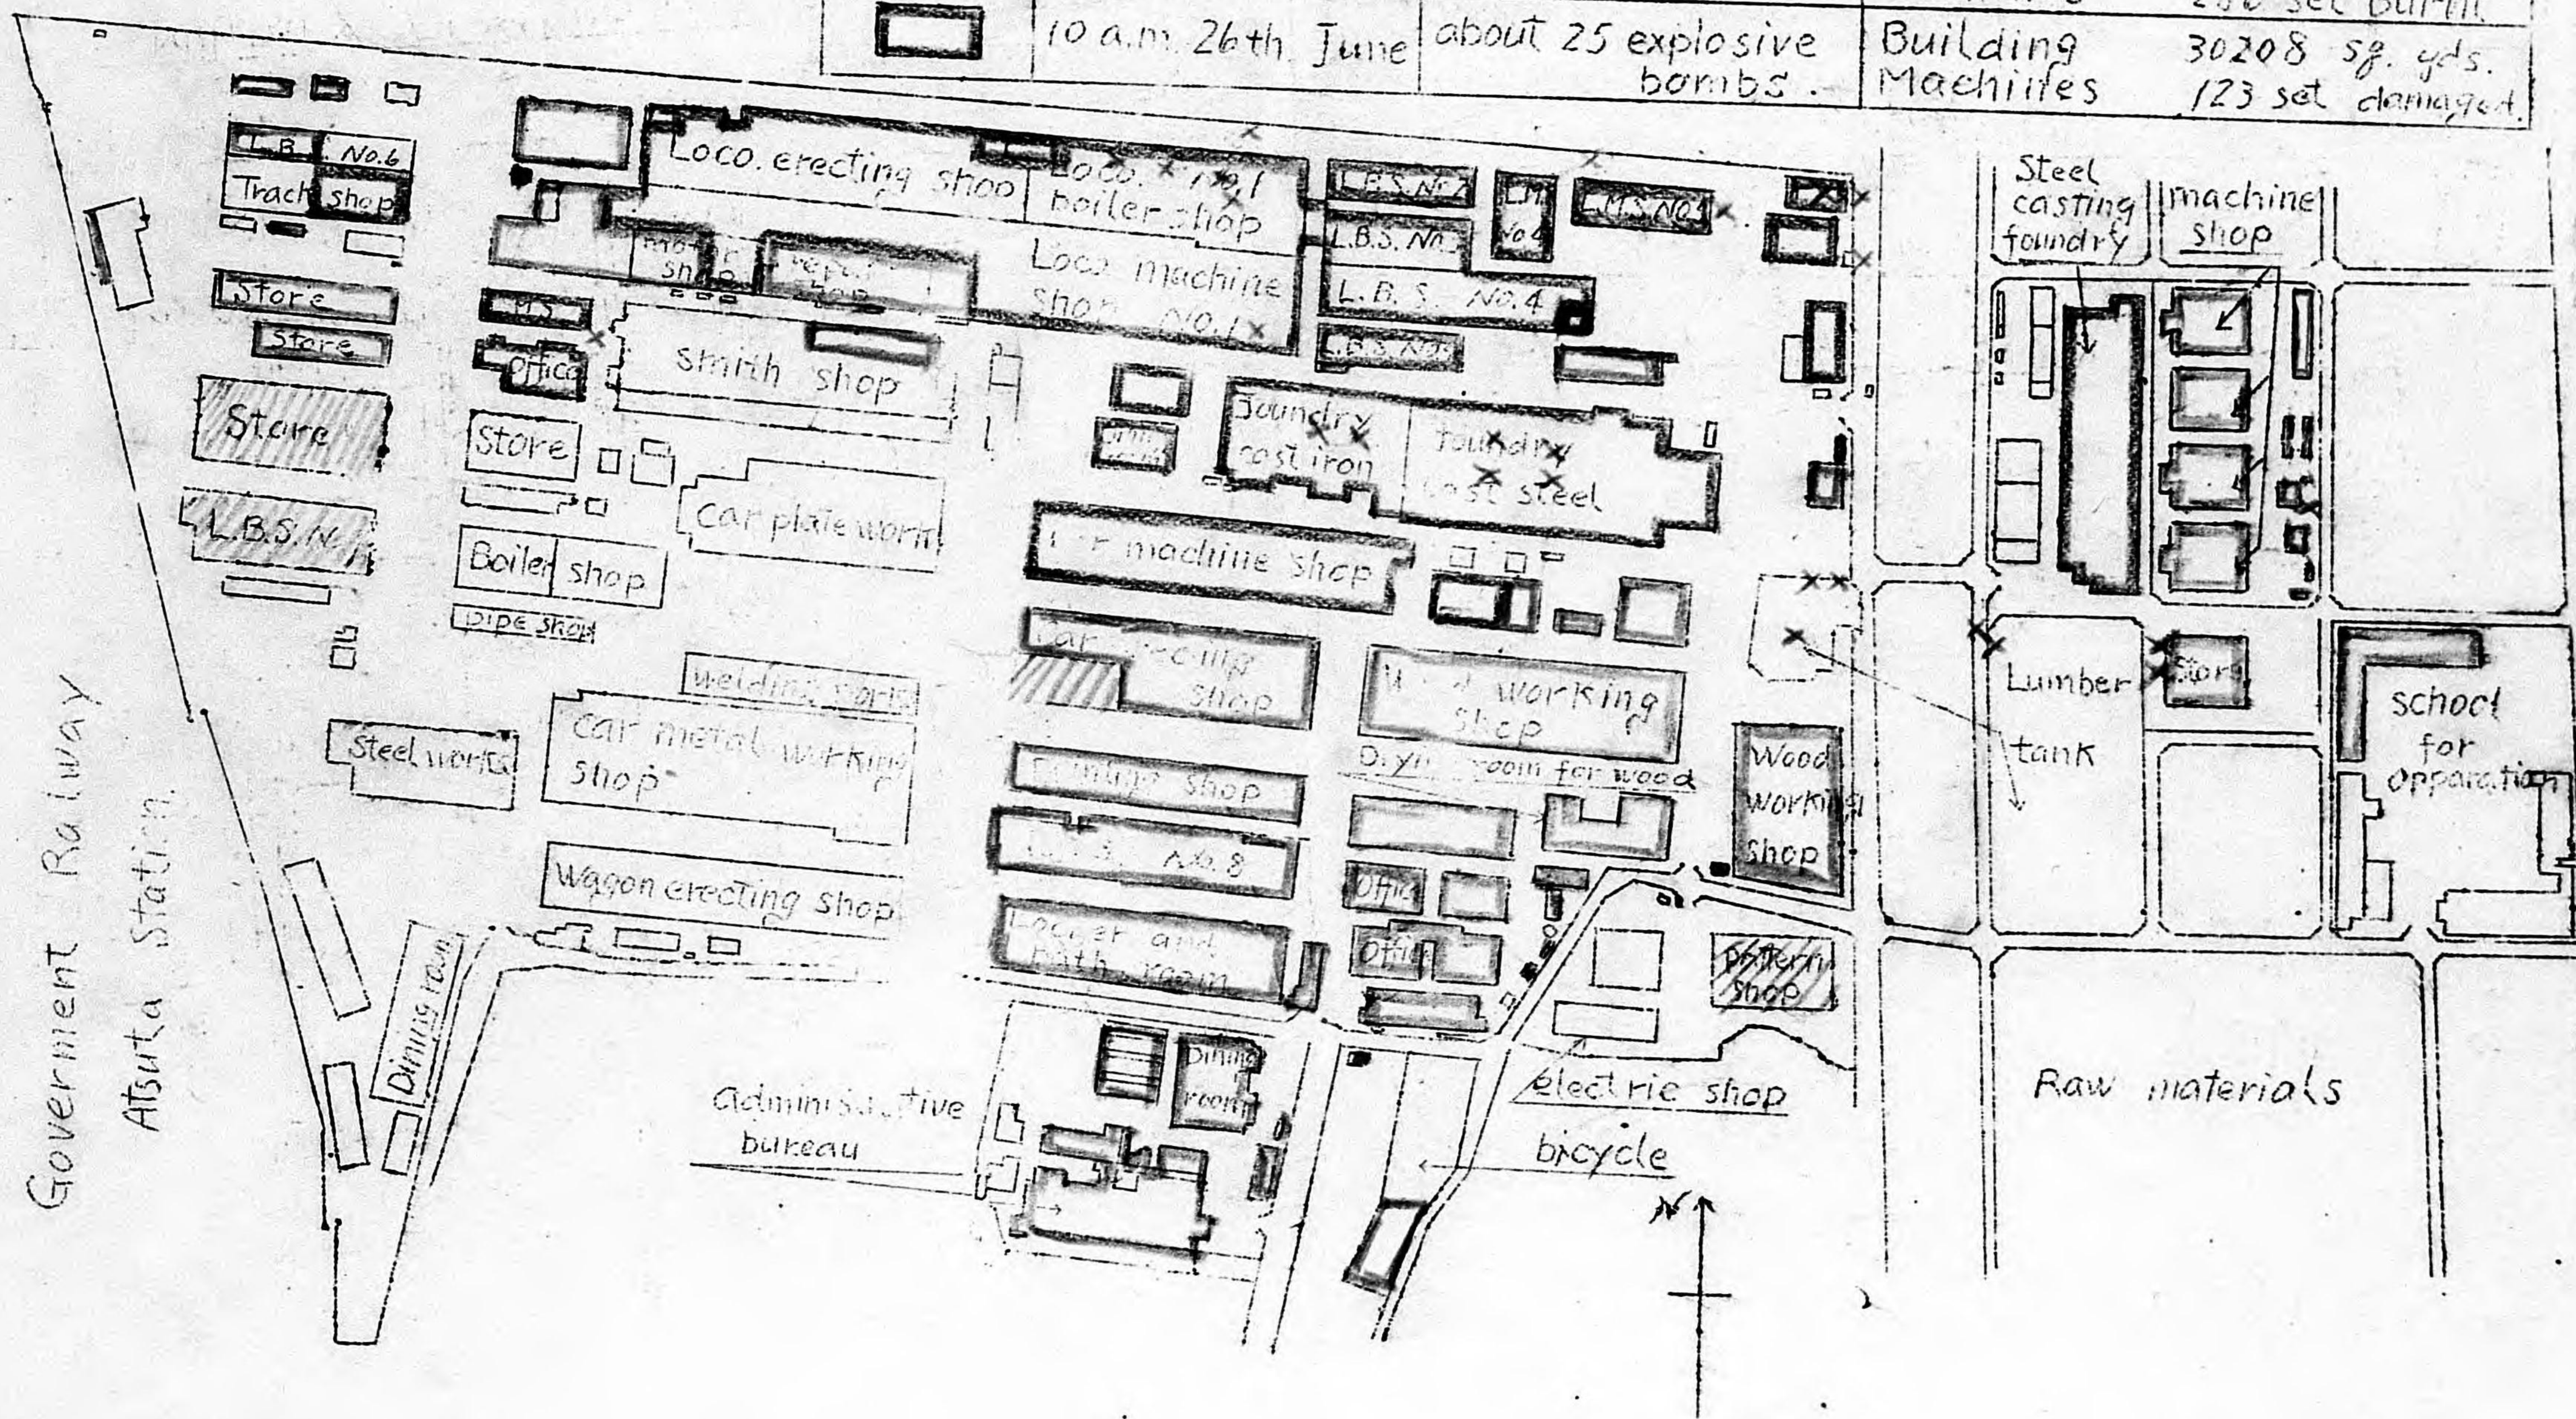
FIG-AA-X5

10 a.m. 26th June	about 25 explosive bombs	Building 30208 sq. yds. Machines 123 set damaged

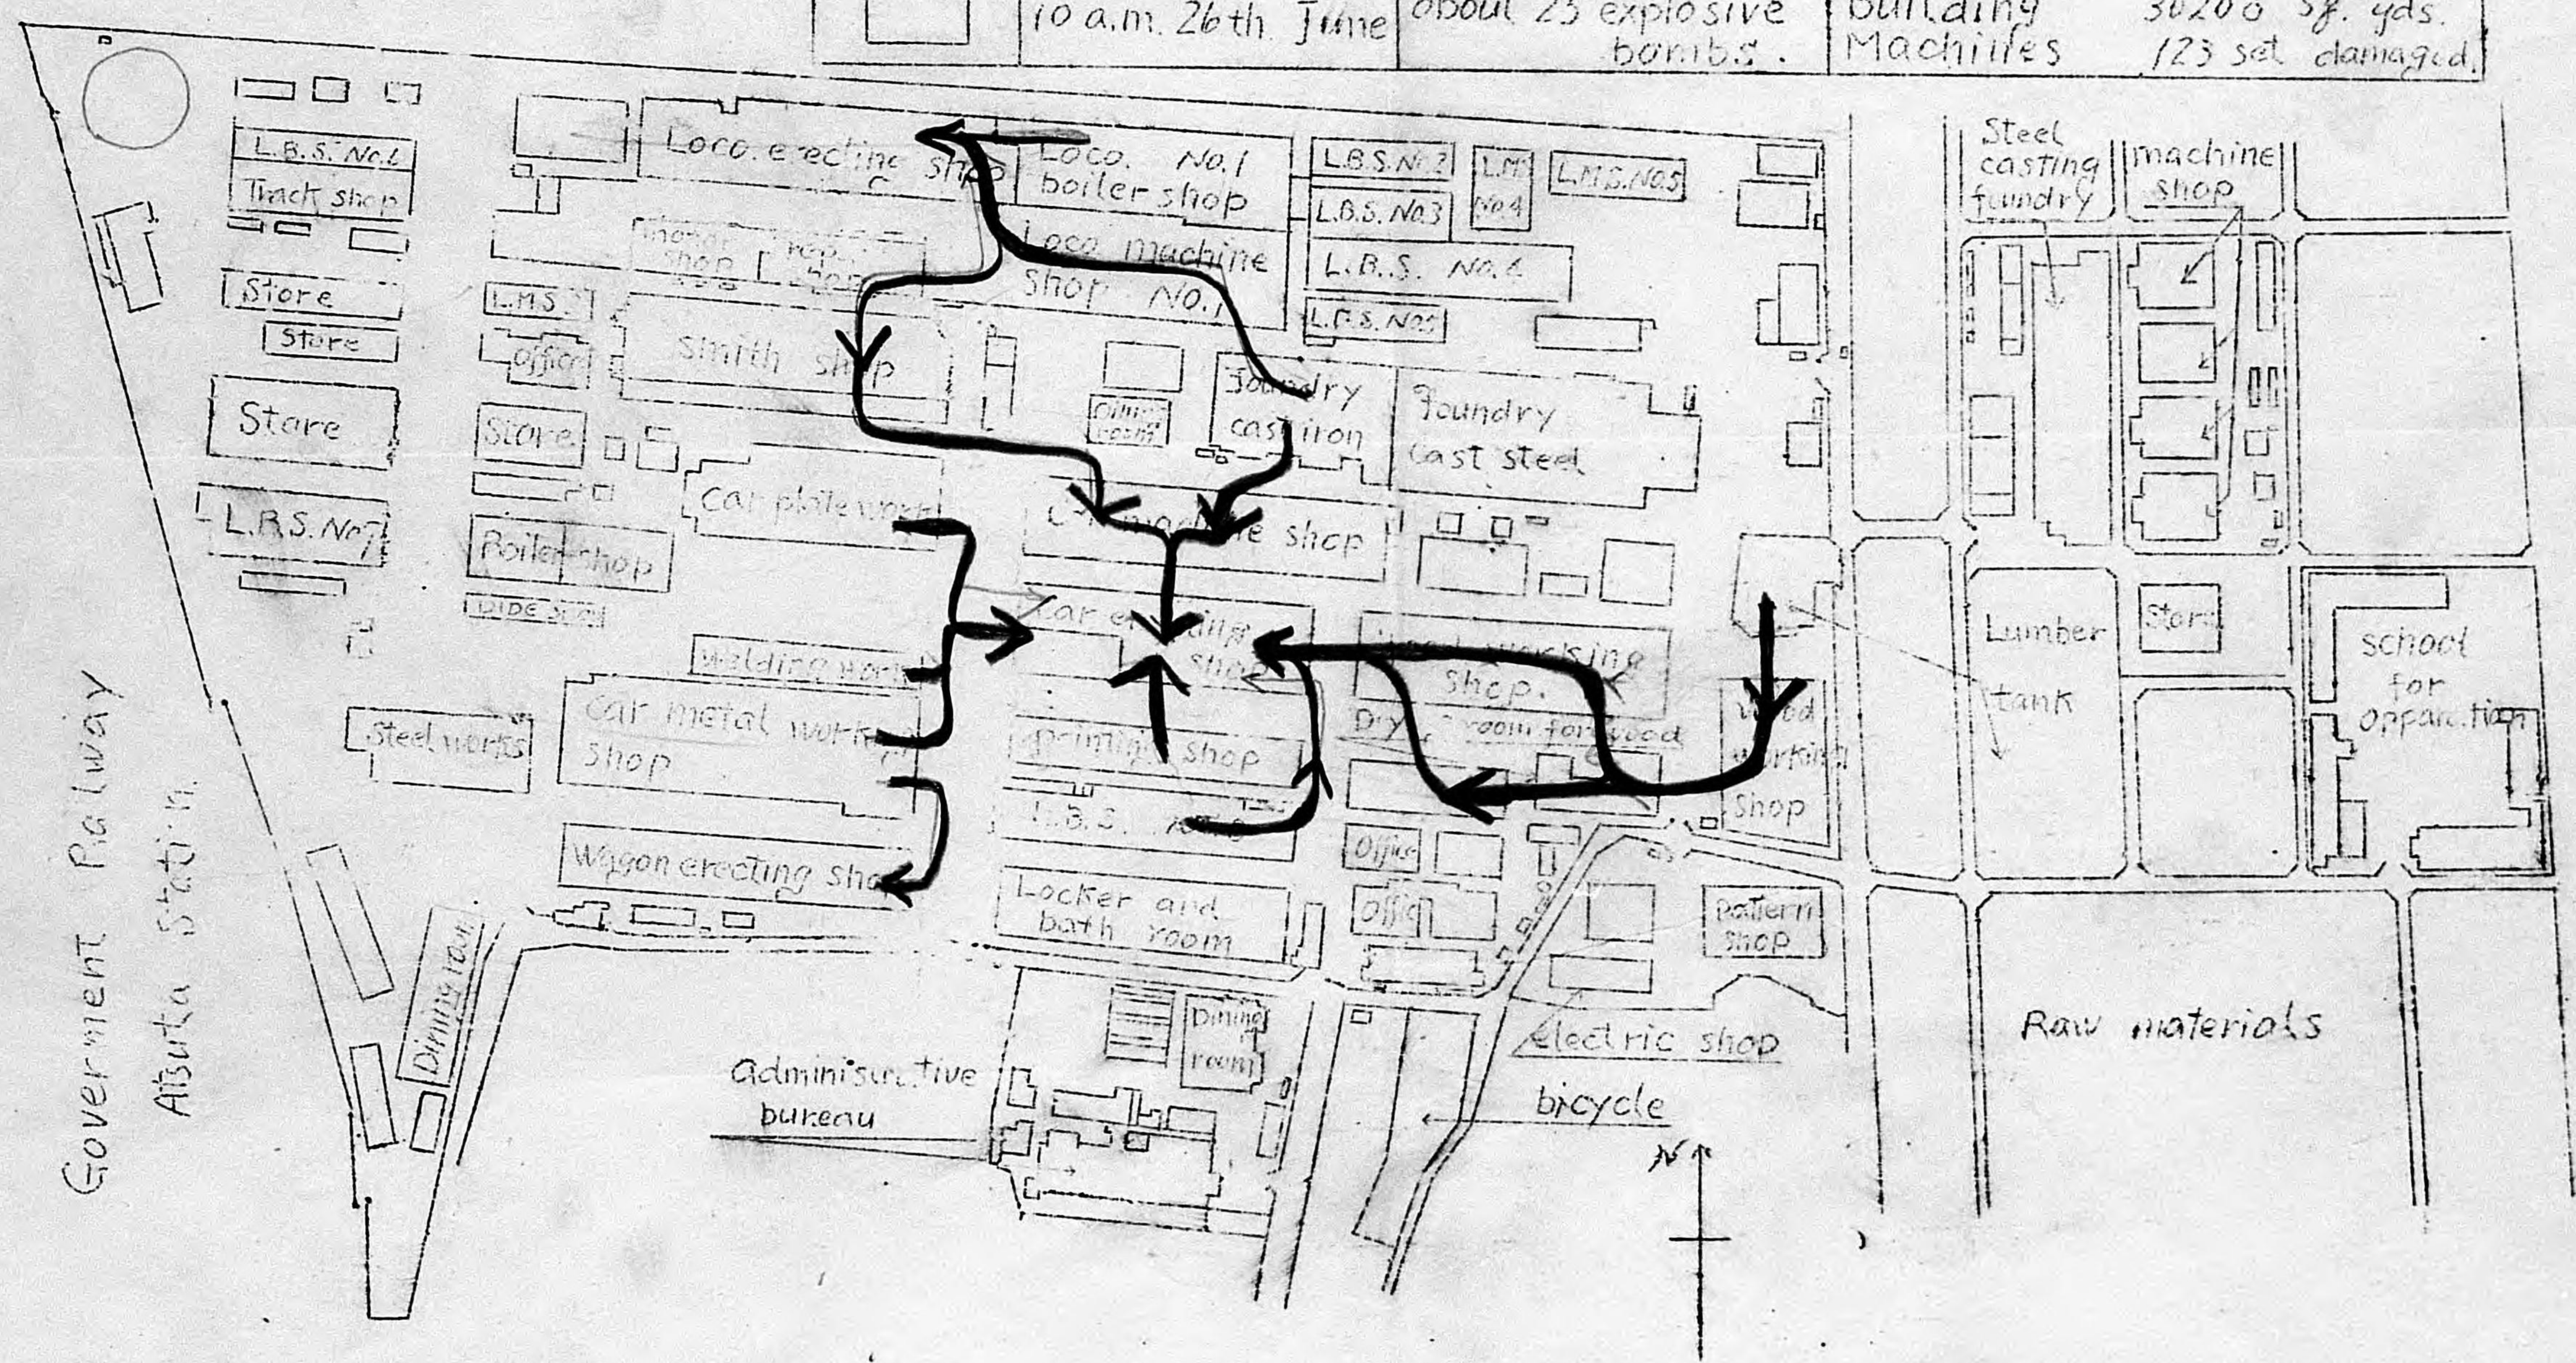
Damage caused by the air raid			
	Date.	Air raid	Damages
□	1945 1 a.m. 8th Jan.	about 300 incandescent bombs	Building 4638 sq. yds. Machines 18 set burnt
□	2 a.m. 17th May	about 200 incandescent bombs	Building 34897 sq. yds. Machines 286 set burnt
□	10 a.m. 26th June	about 25 explosive bombs.	Building 30208 sq. yds. Machines 123 set damaged.

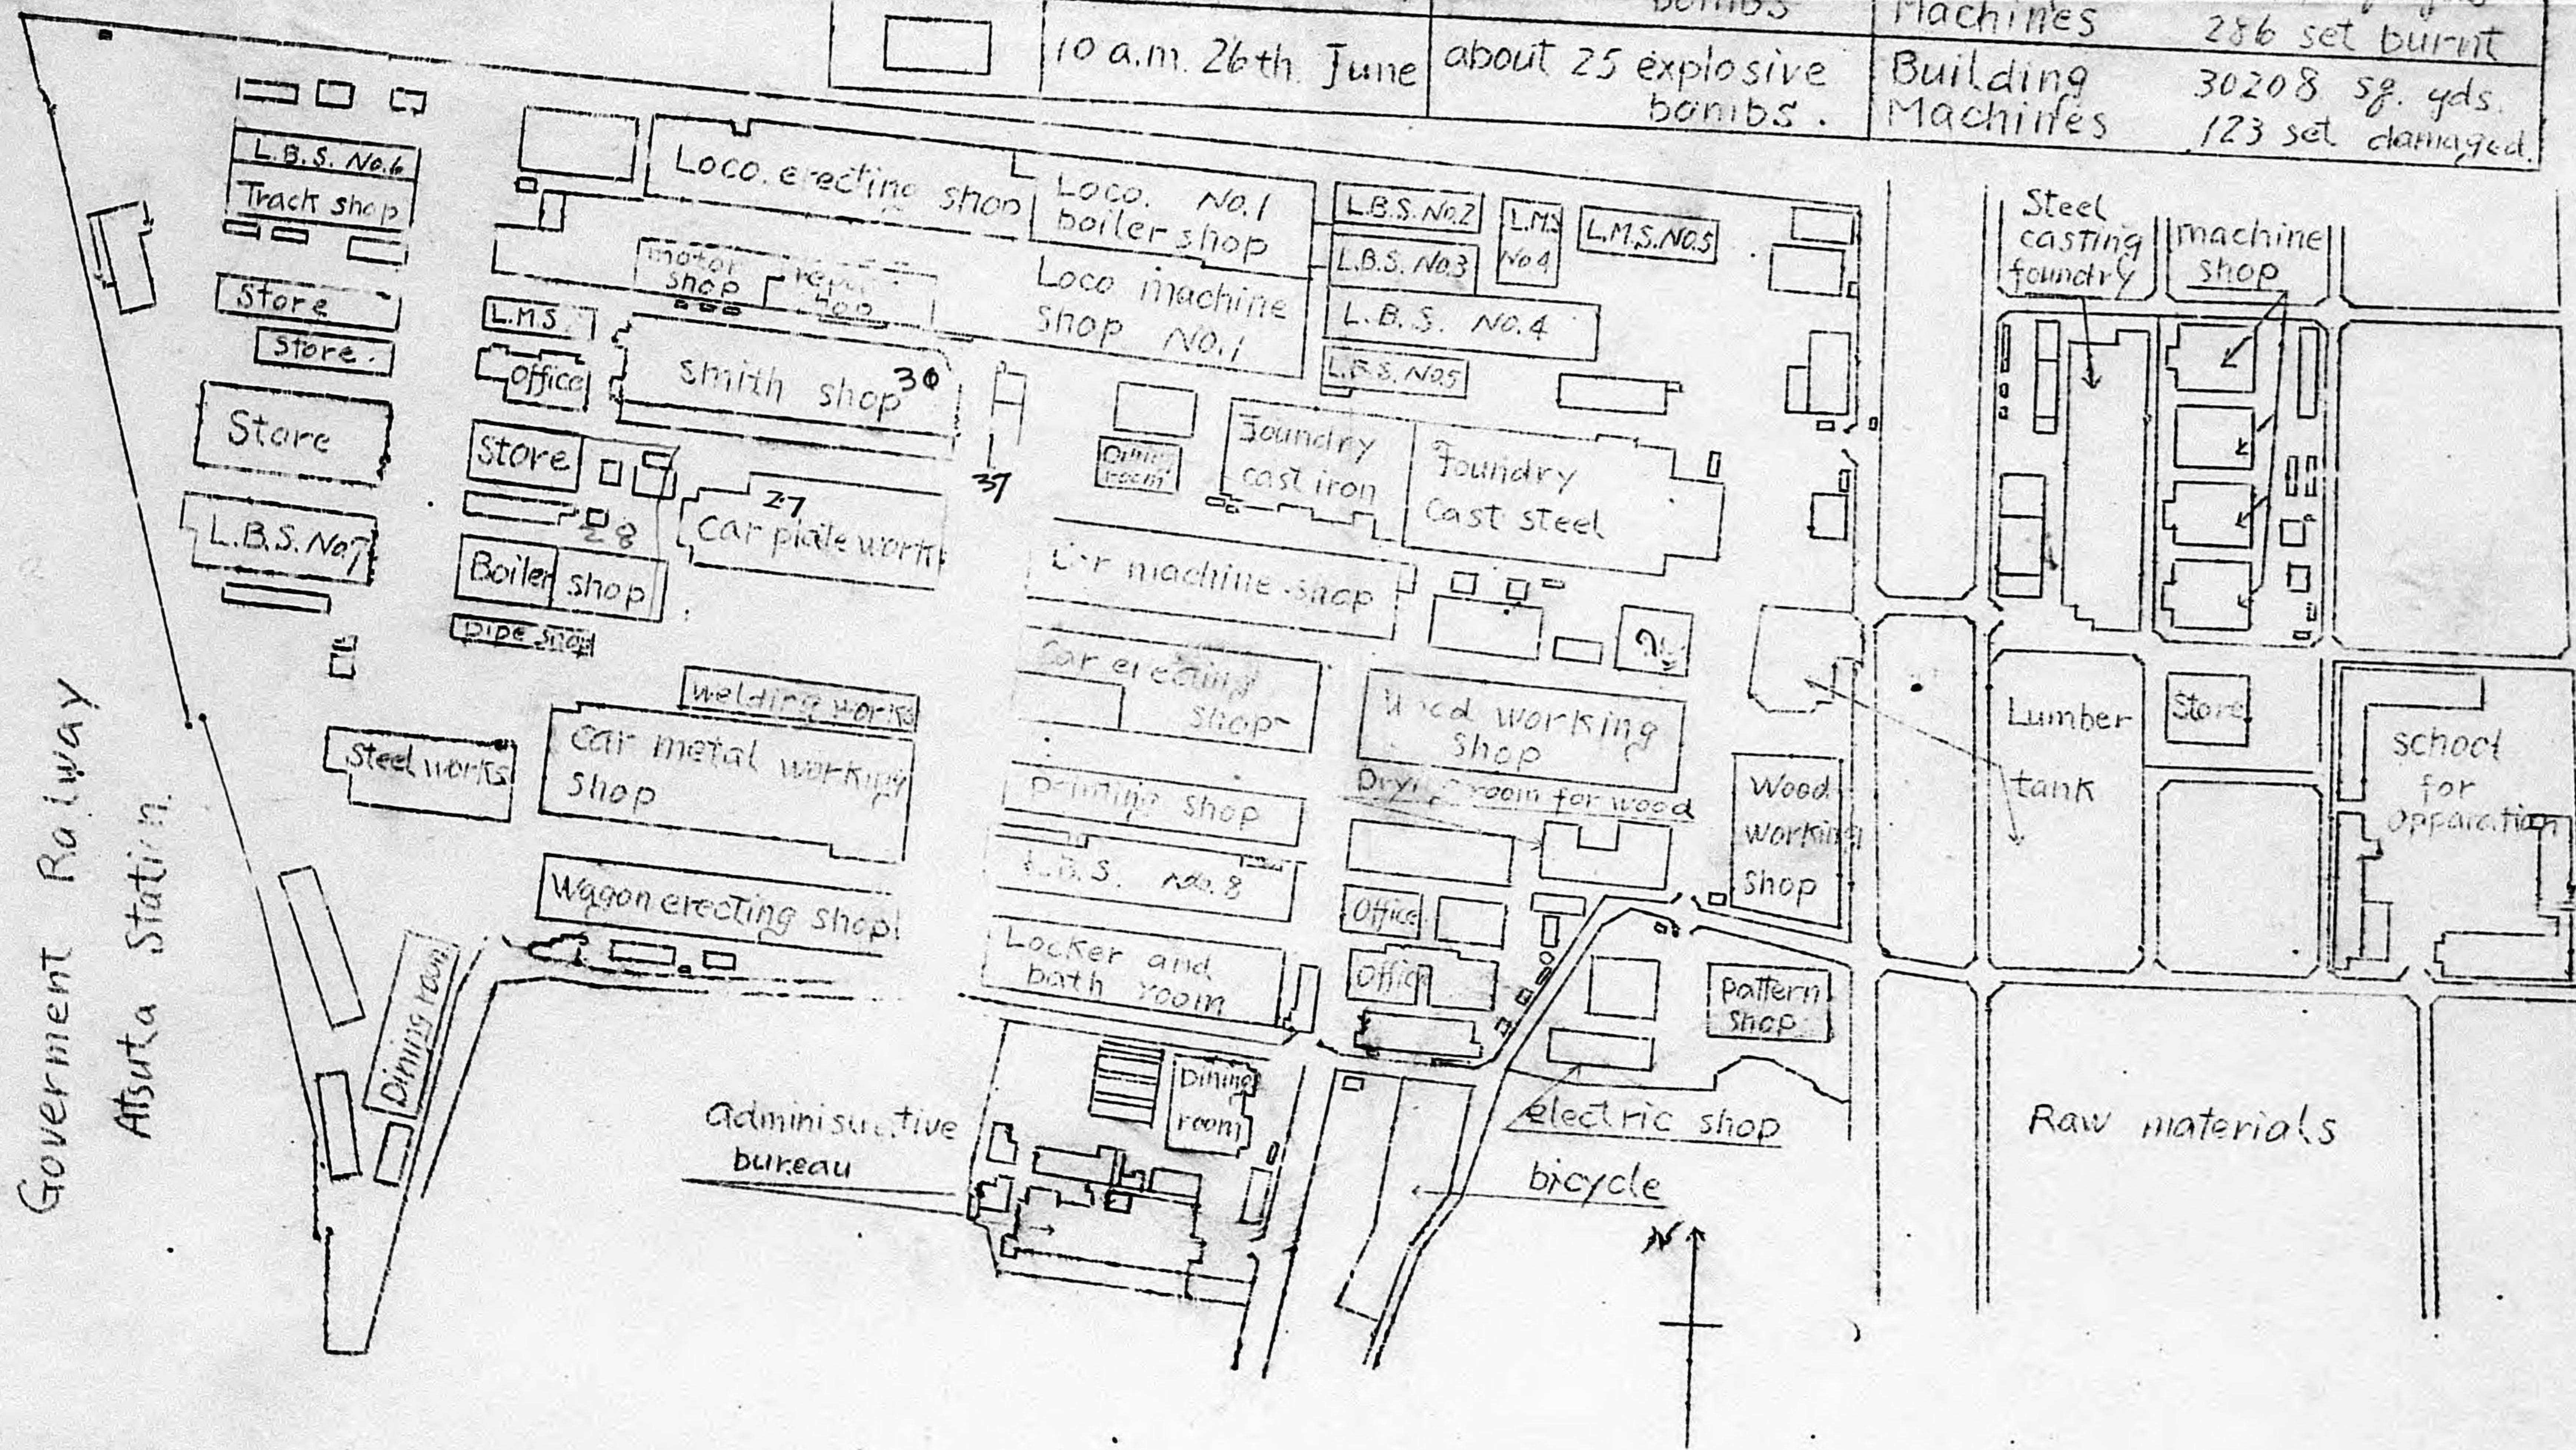
Damage caused by the air raid			
	Date	Air raid	Damages
□	1945 1 a.m. 8th Jan.	about 300 incandescent bombs	Building 4638 sq. yds. Machines 18 set burnt
□	2 a.m. 17th May	about 200 incandescent bombs	Building 34897 sq. yds. Machines 286 set burnt
□	10 a.m. 26th June	about 25 explosive bombs.	Building 30208 sq. yds. Machines 123 set damaged.

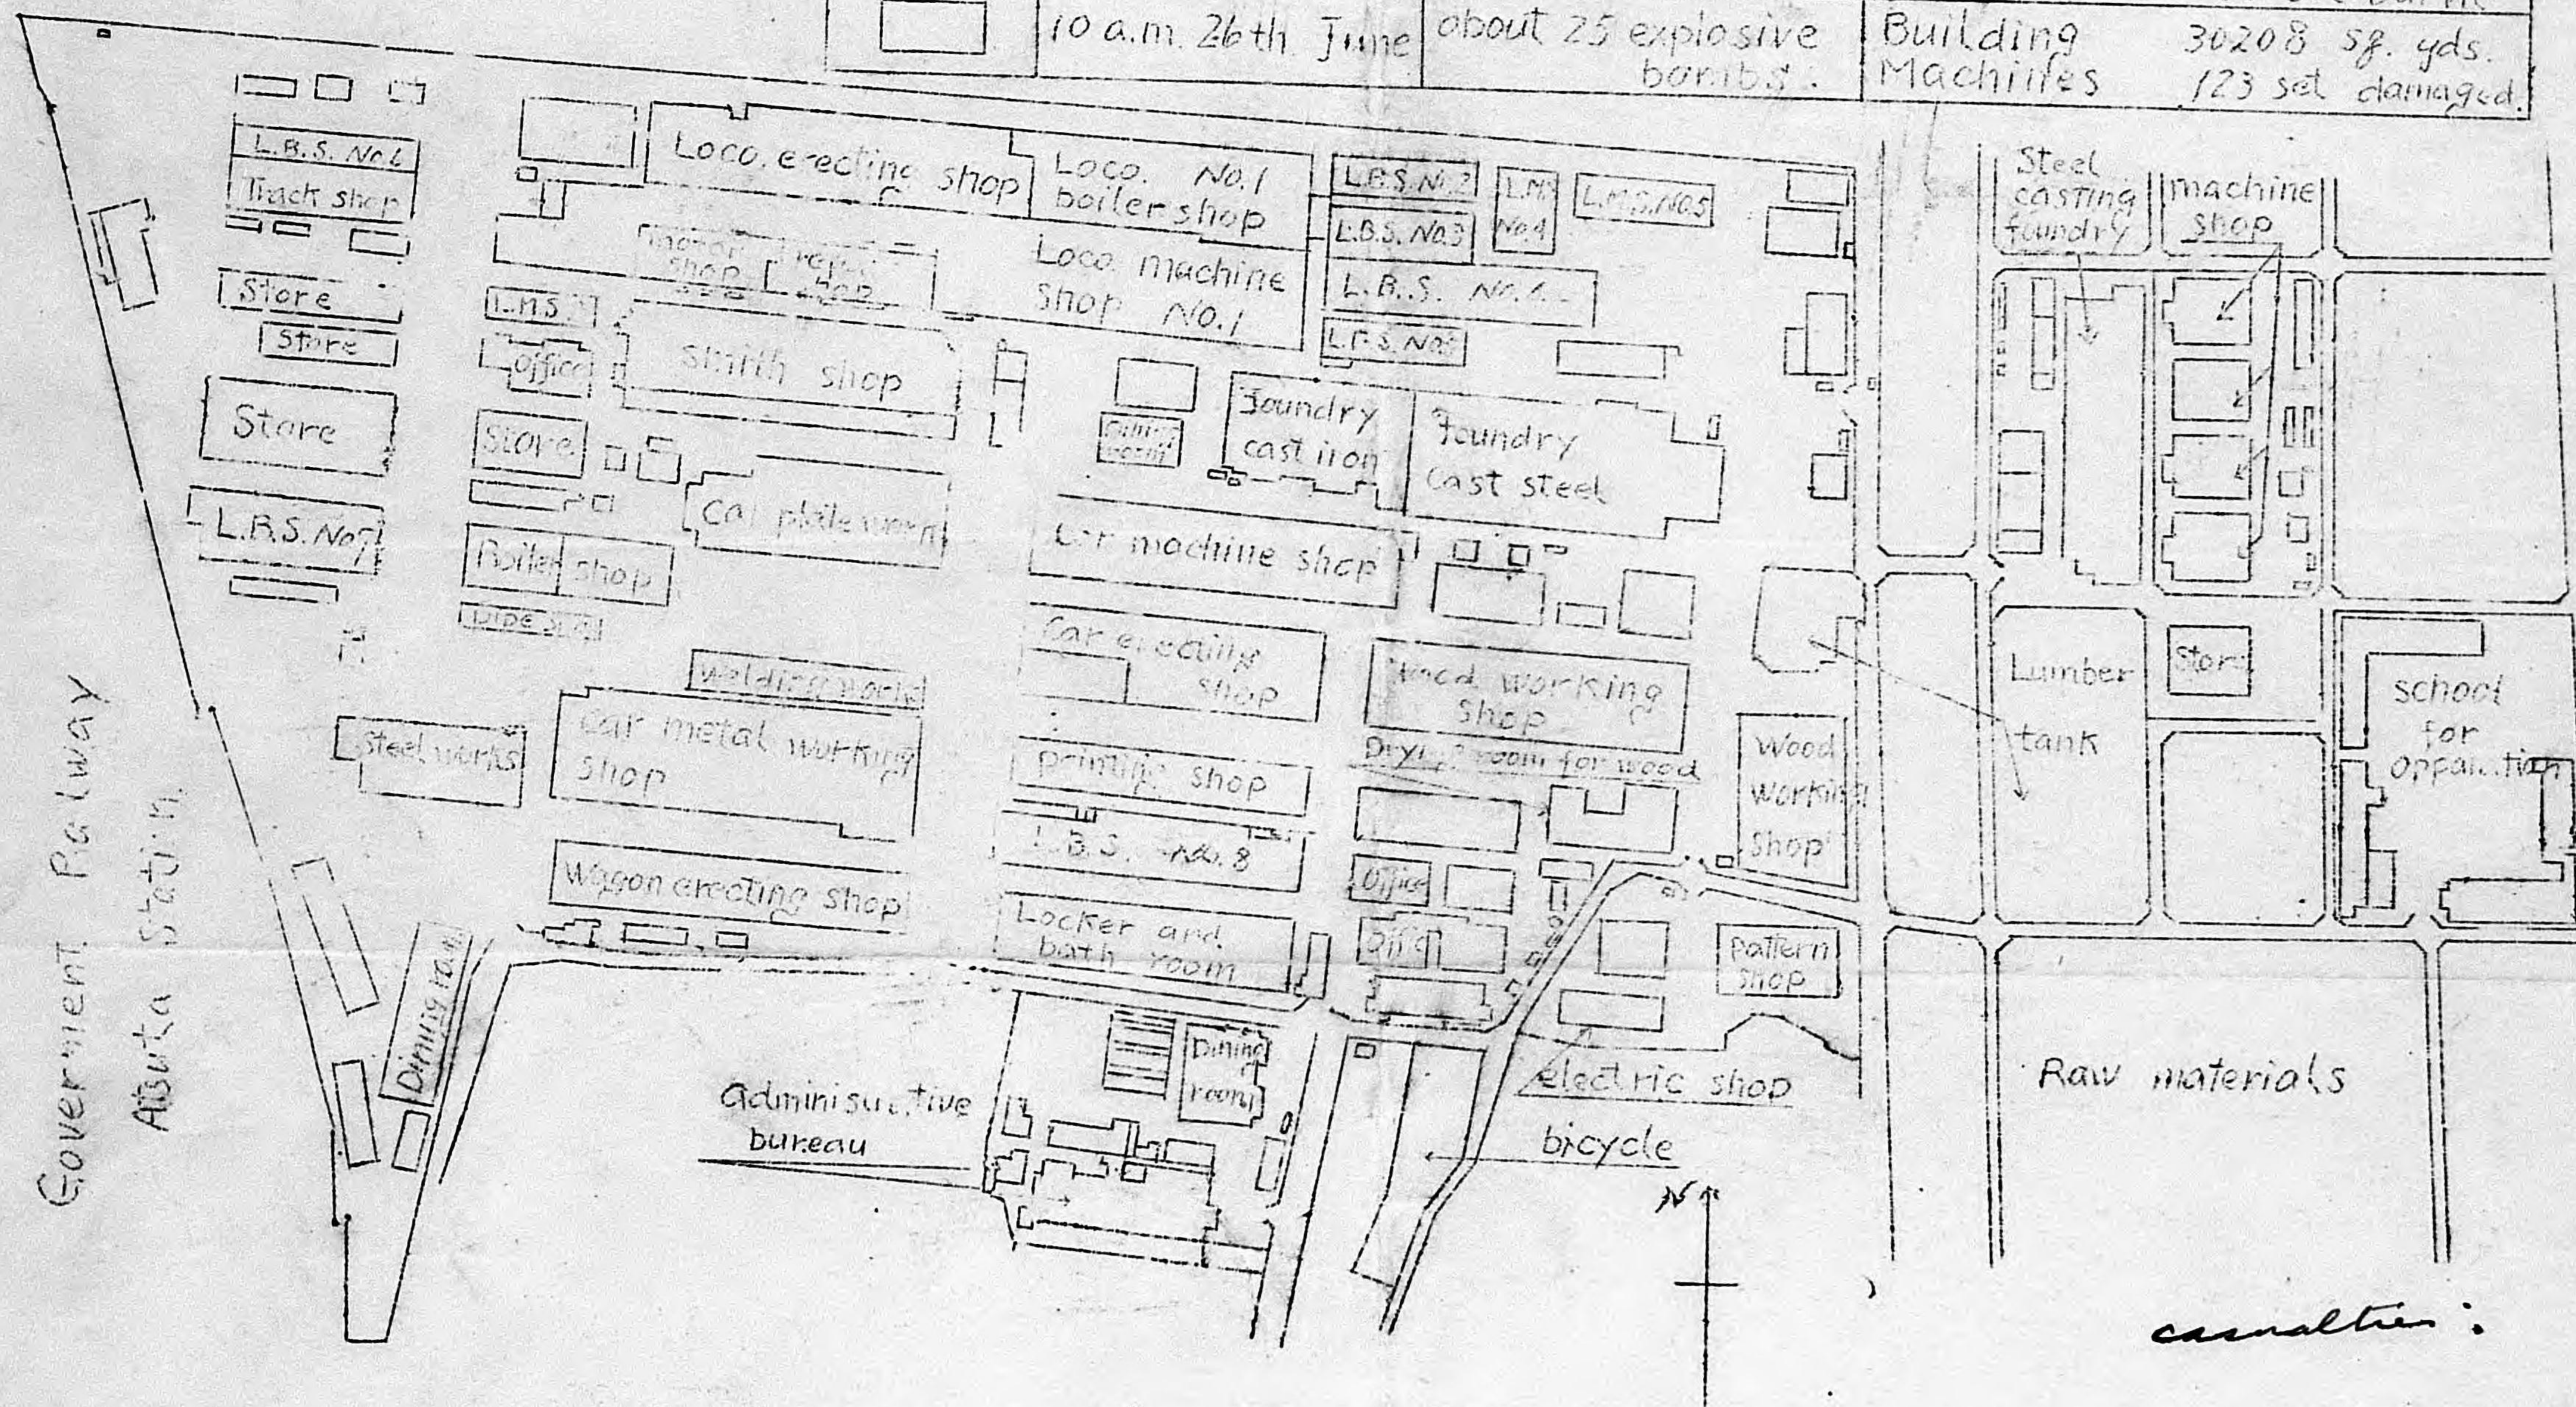
Damage caused by the air raid			
	Date	Air raid	Damages
□	1945 1 a.m. 8th Jan.	about 300 incandescent bombs	Building 4638 sq. yds. Machines 18 set burnt
□	2 a.m. 17th May	about 200 incandescent bombs	Building 34897 sq. yds. Machines 286 set burnt
□	10 a.m. 26th June	about 25 explosive bombs	Building 30208 sq. yds. Machines 123 set damaged

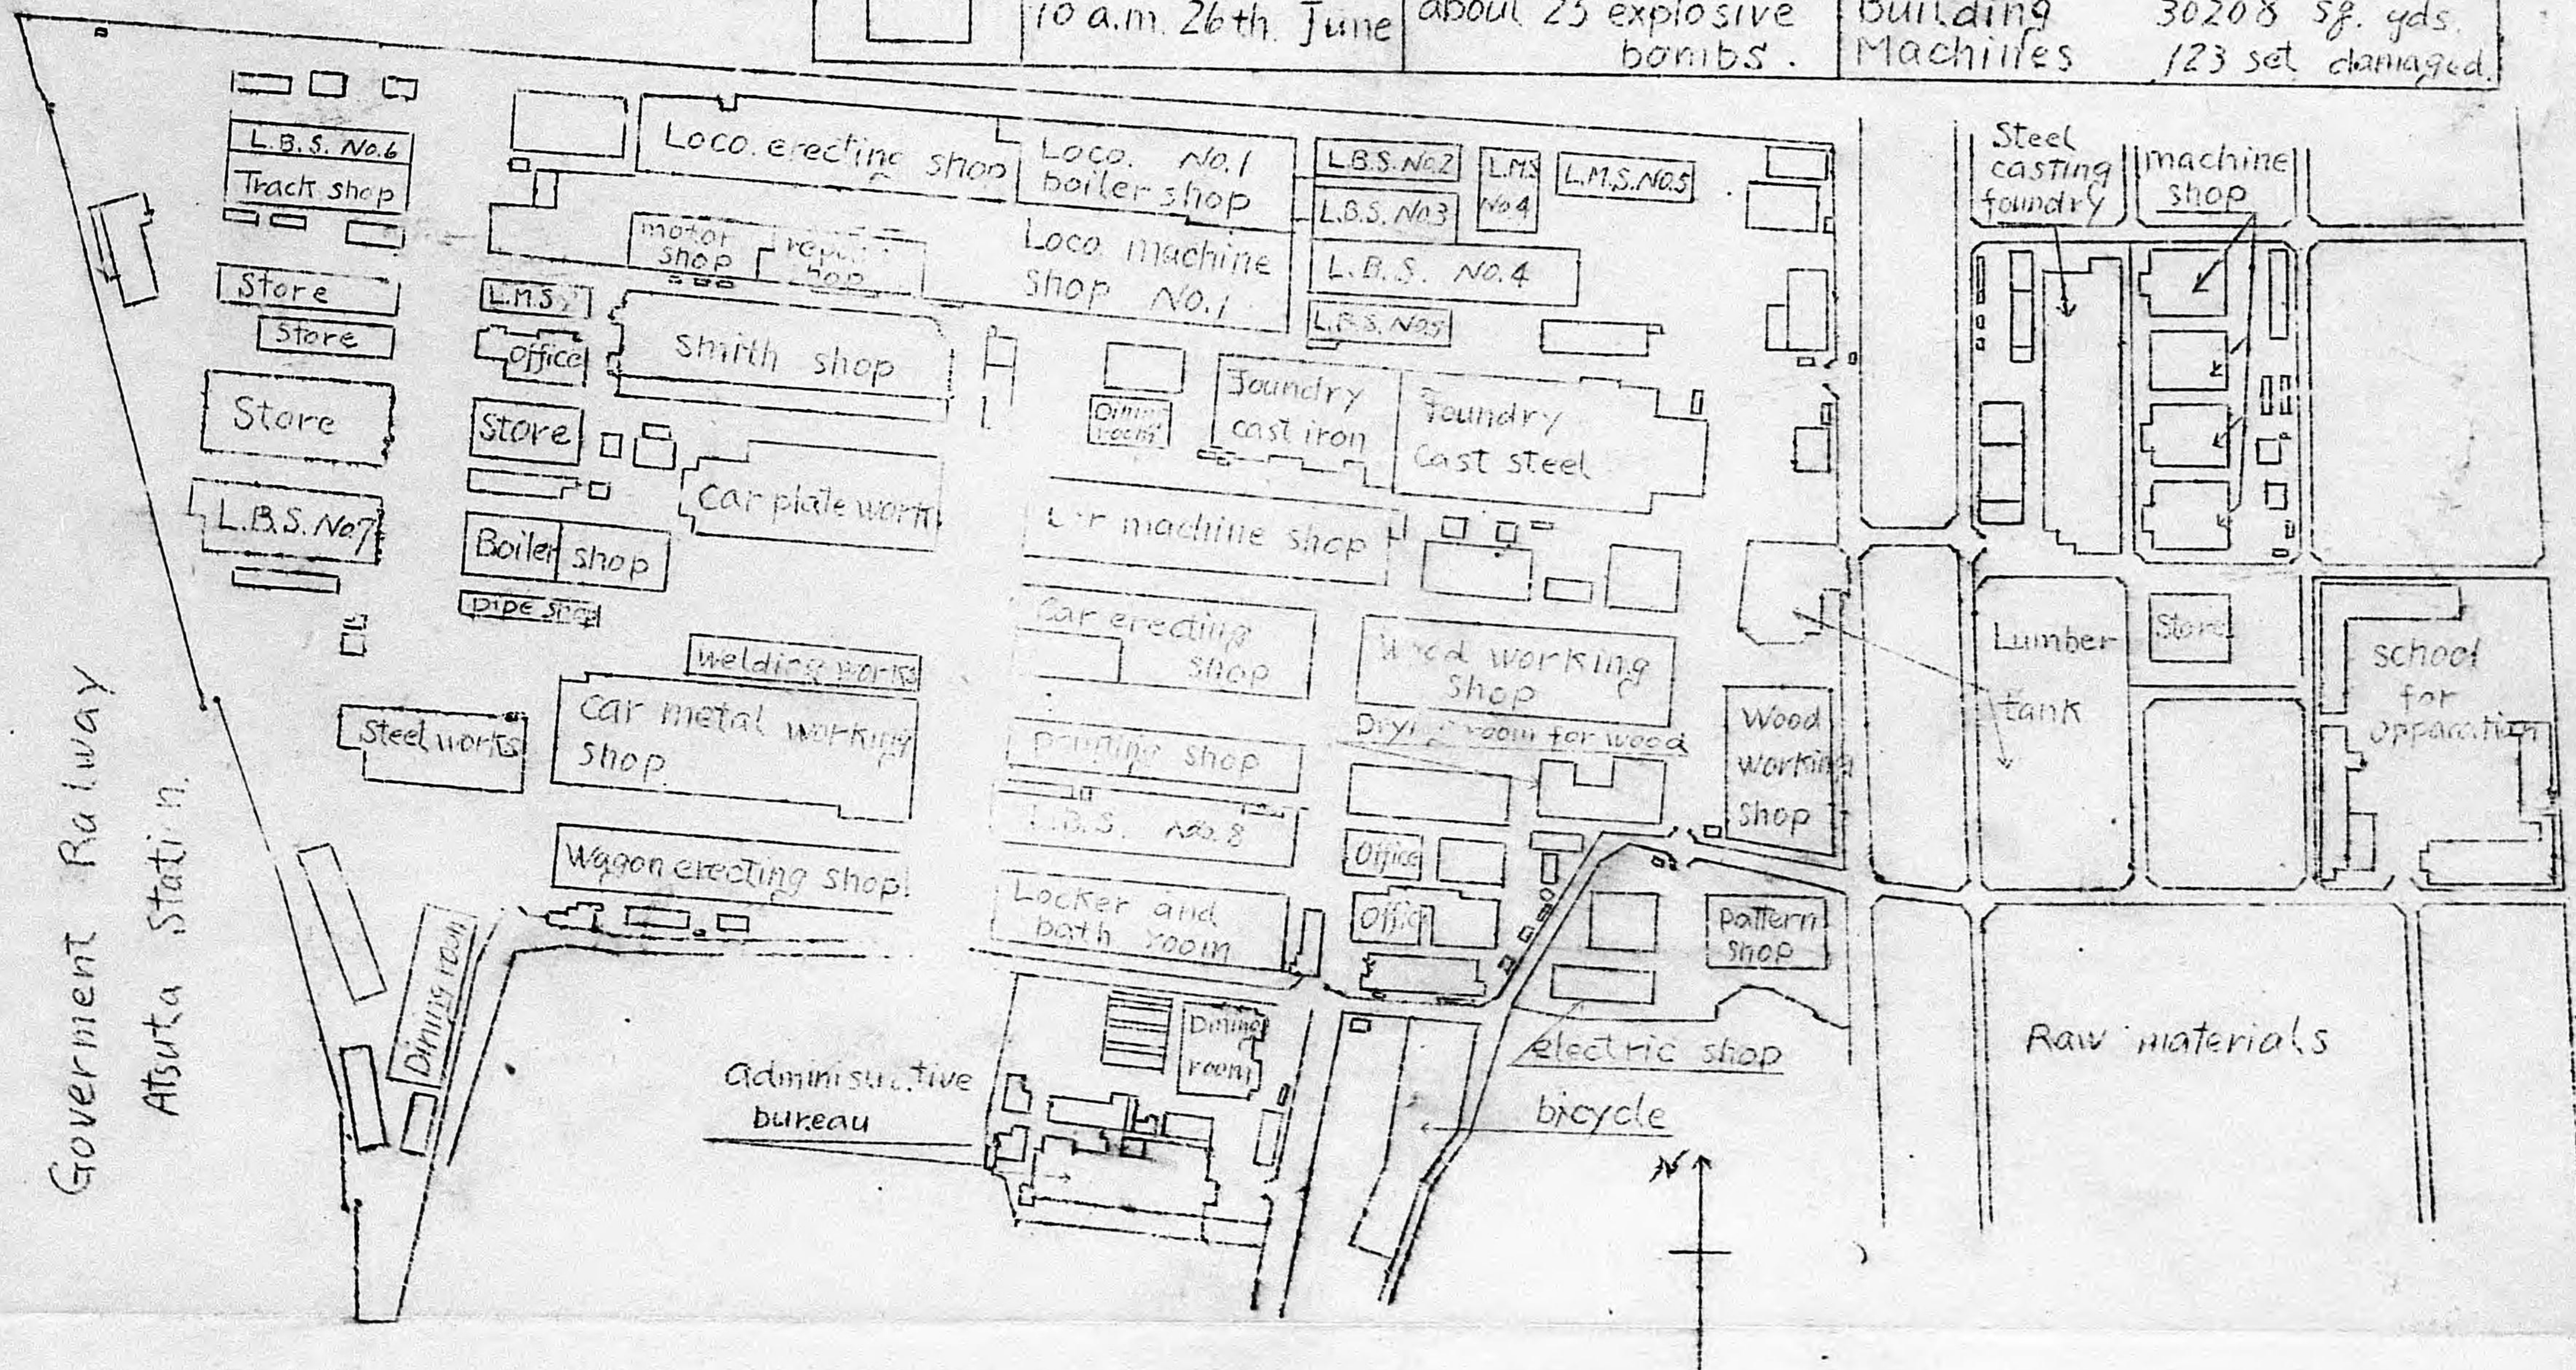
PIC-AA-X5

Damage caused by the air raid			
	Date	Air raid	Damages
□	1945 1 a.m. 8th Jan.	about 300 incandescent bombs	Building 4638 sq. yds. Machines 18 set burnt
□	2 a.m. 17th May	about 200 incandescent bombs	Building 34897 sq. yds. Machines 286 set burnt
□	10 a.m. 26th June	about 25 explosive bombs.	Building 30208 sq. yds. Machines 123 set damaged

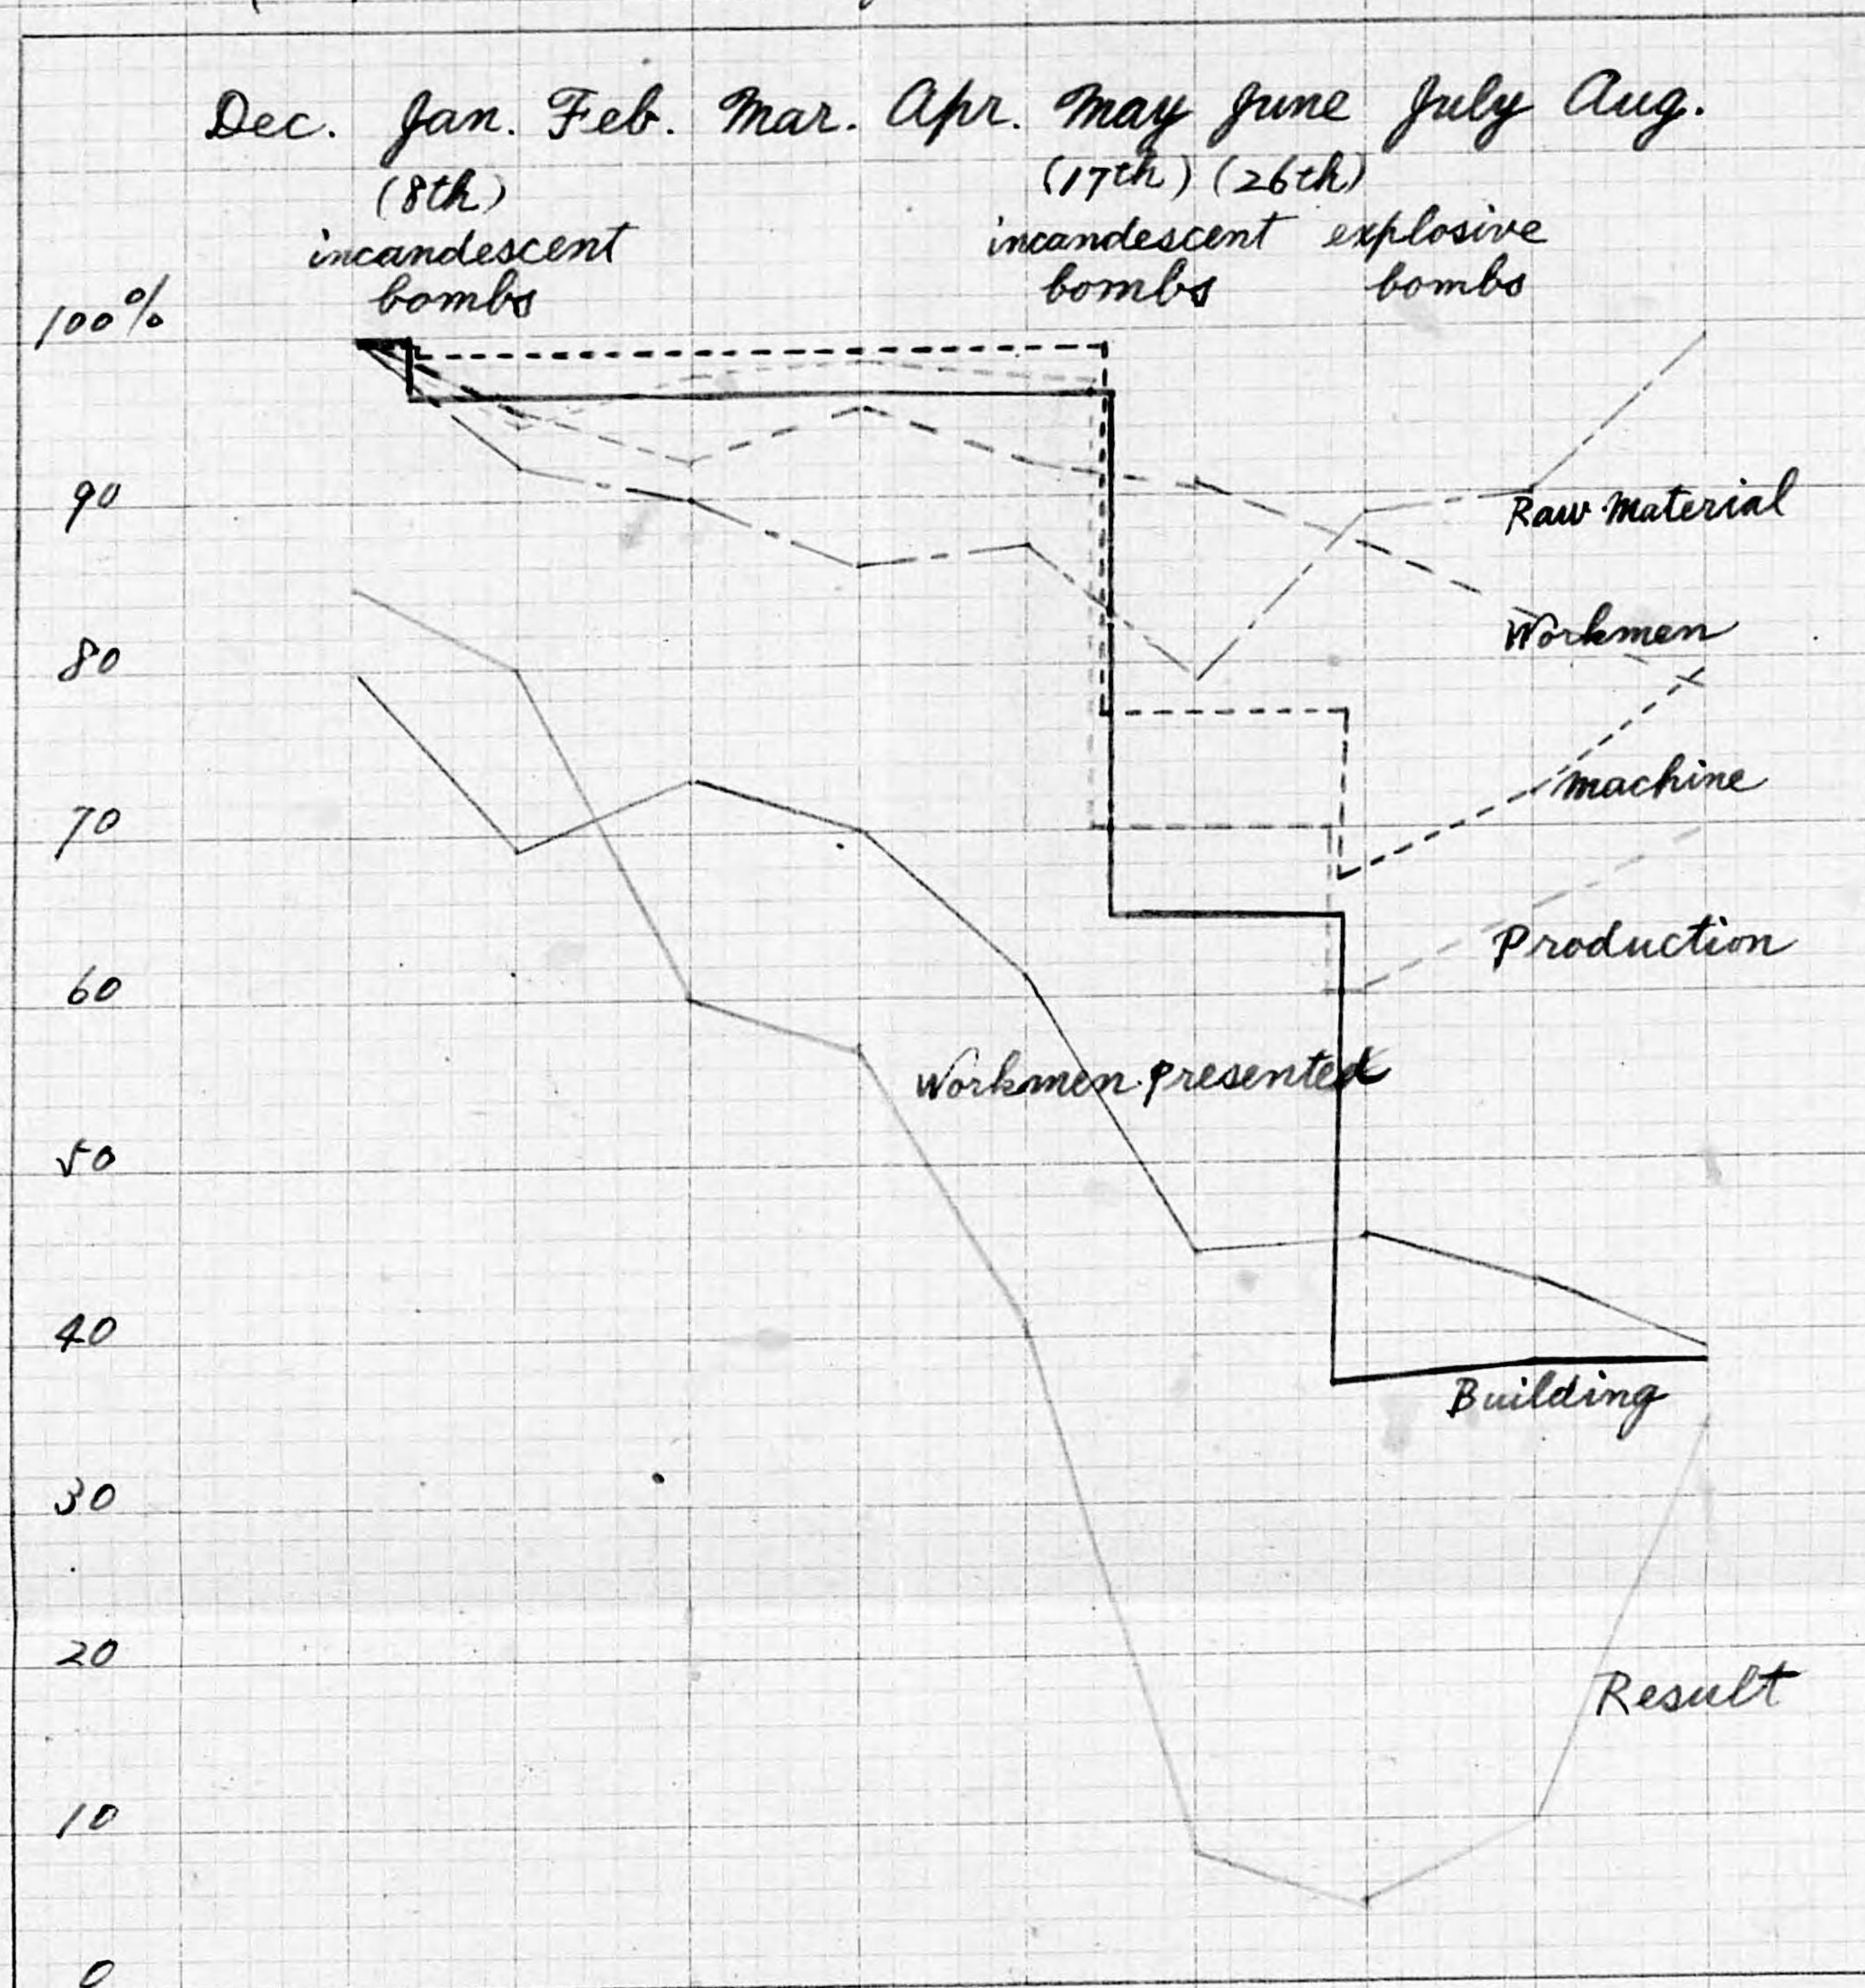
PIC-AA-X5

1. Building area (Sq yds)	110,528	105,892 (-4636) burnt	105,892	105,892	105,892	70,995 (-34,897) burnt	40,715 (-30,280) damaged	41,911 (+1,196) rebuilt	41,911
2. Number of Machines (set)	1,320	1,302 (-18) burnt	1,302	1,302	1,302	1,016 (-286) burnt	893 (-123) damaged	957 (+64) repaired	1,042 (+85) repaired
3. Price of Raw Material & Finished Article (1,000 yen)	6,881	6,300	6,208	5,903	5,966	5,408	5,800	6,152	6,777
4. Number of Workmen & those presented	3,807 3,046	3,624 2,638	3,507 2,767	3,614 2,664	3,494 2,310	3,463 1,725	3,321 1,770	3,127 1,629	2,963 1,499
5. Capacity of Production & Result	810 689	770 651	785 489	795 462	785 330	570 65	485 39	525 83	570 278
