90.20 - 241 - *Nippon Vehicle Mfg. Company*

AREA NO. 90:20	TARGET I. 241	LIMITED DAMAGE INTERPRETATION NO. <u>30</u>	CONFIDENTIAL	D/P
			SHEET NO.	OF

NIPPON VEHICLE COMPANY

NIPPON VEHICLE MANUFACTURING CO.
90.20-241
Lat. 35° 07' N - Long. 136° 55' E
NAGOYA, JAPAN

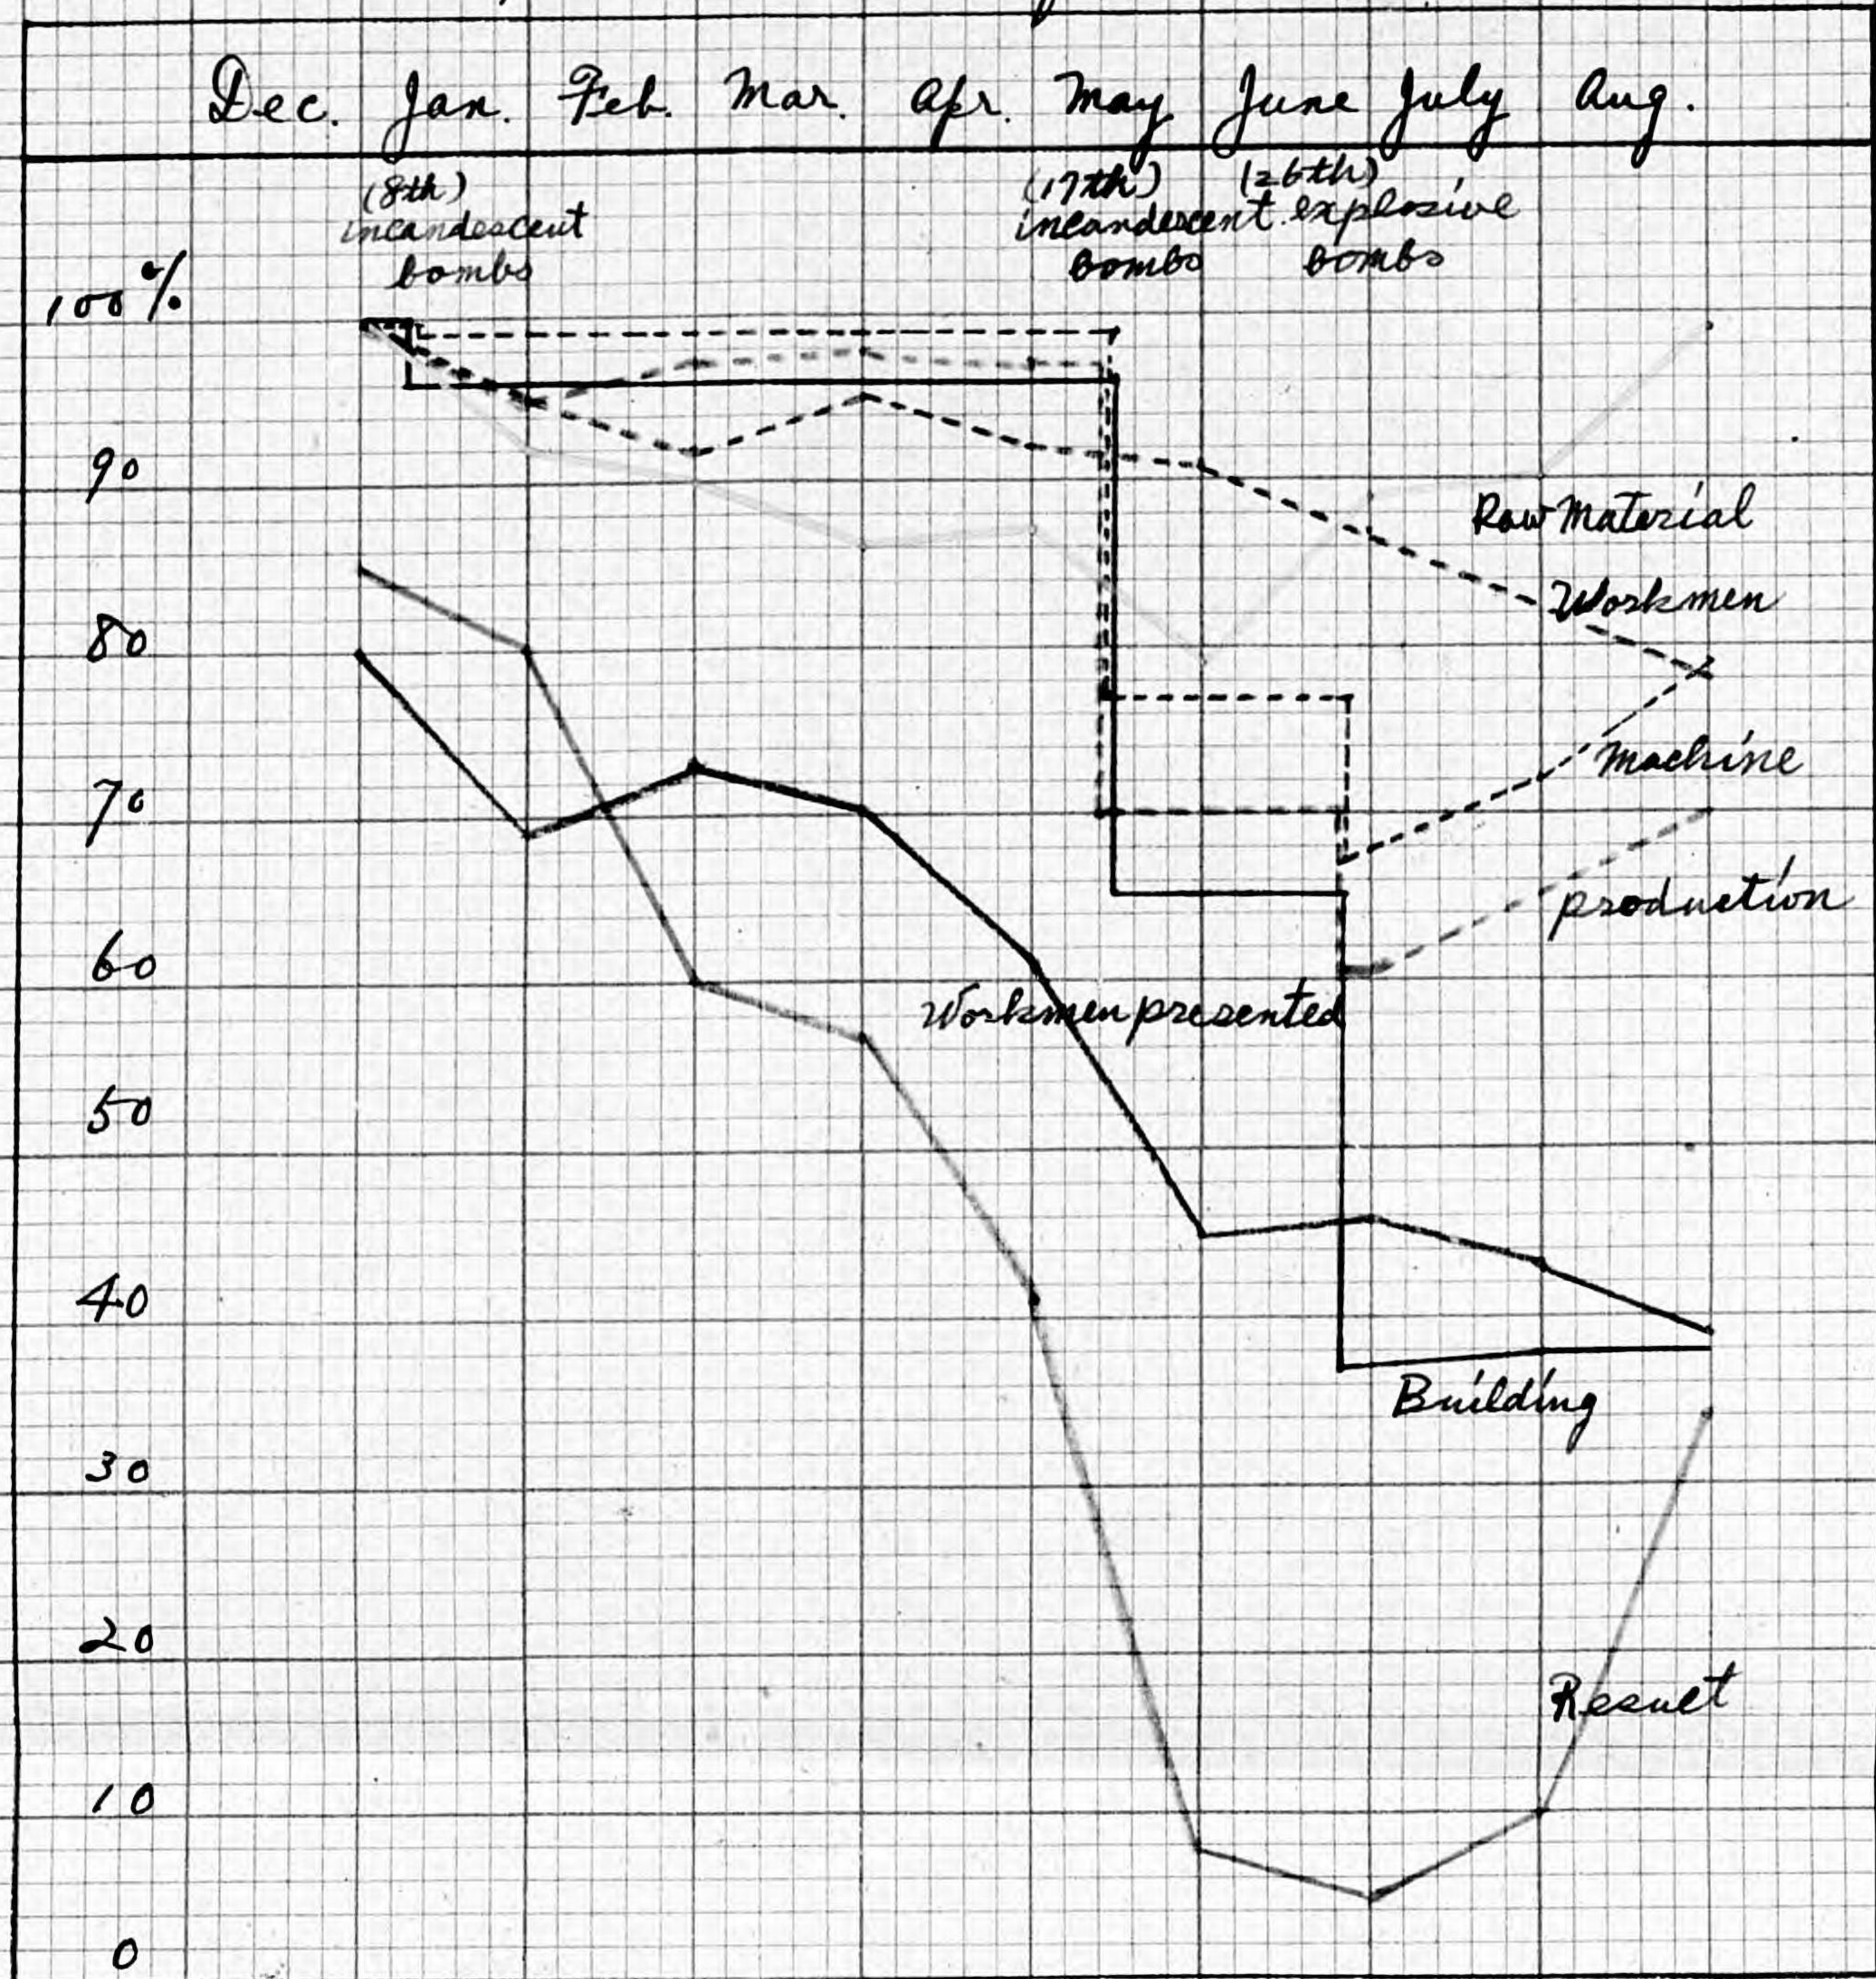
1. Building Area (sq. yds)	110,528	105,892 (-4,636)	105,892	105,892	105,892	70,995 (-34,897)	40,715 (-30,280)	41,911 (+1,196)	41,911
		burnt				burnt	damaged	rebuilt	
2. Number of Machines (set)	1,320	1,302 (-18)	1,302	1,302	1,302	1,016 (-286)	893 (-123)	987 (+64)	1,042 (+85)
		burnt				burnt	damaged	repaired	repaired
3. Price of Raw Material & Finished Article (1,000 yen)	6,881	6,300	6,208	5,903	5,766	5,408	5,800	6,152	6,777
4. Number of Workmen & those presented	3,807	3,624	3,507	3,614	3,494	3,463	3,321	3,127	2,963
	3,046	2,638	2,767	2,664	2,310	1,725	1,770	1,629	1,499
5. Capacity of Production & Result	810	770	785	795	785	570	485	525	570
	689	651	589	462	330	65	39	83	278
