NIST Special Publication 901

The January 17, 1995 Hyogoken-Nanbu (Kobe) Earthquake

*Performance of Structures, Lifelines, and Fire
Protection Systems*

Riley Chung, Team Leader and Editor

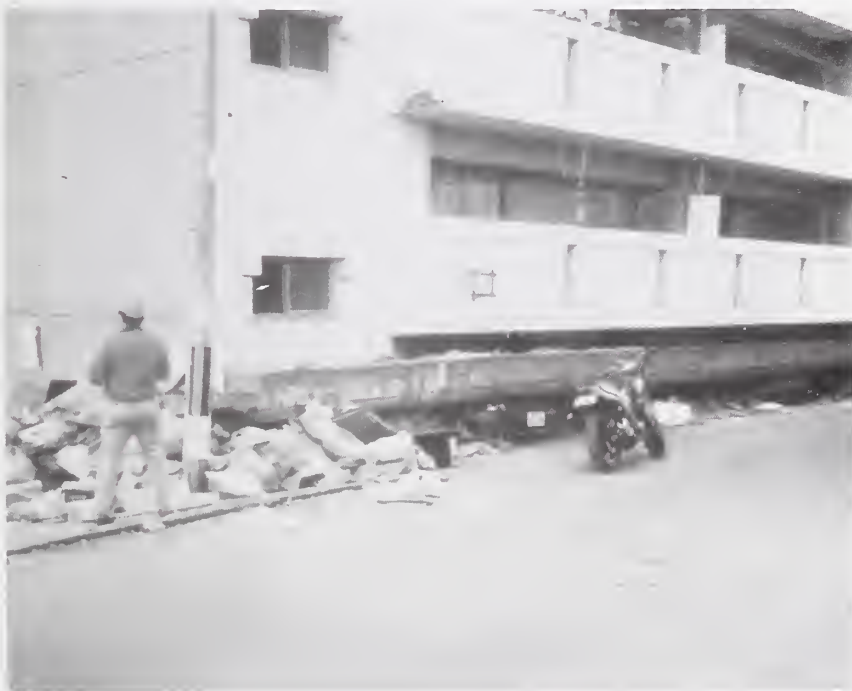
Figure 3.4.5 Failed ground floor shear wall - apartment building.

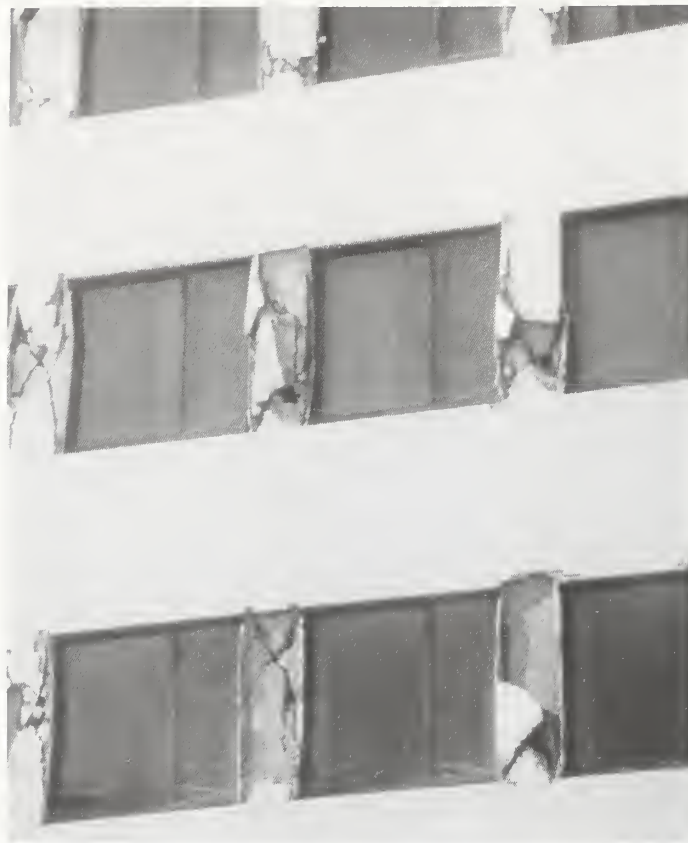
Figure 3.4.10 Short column effects - Otaki Building.

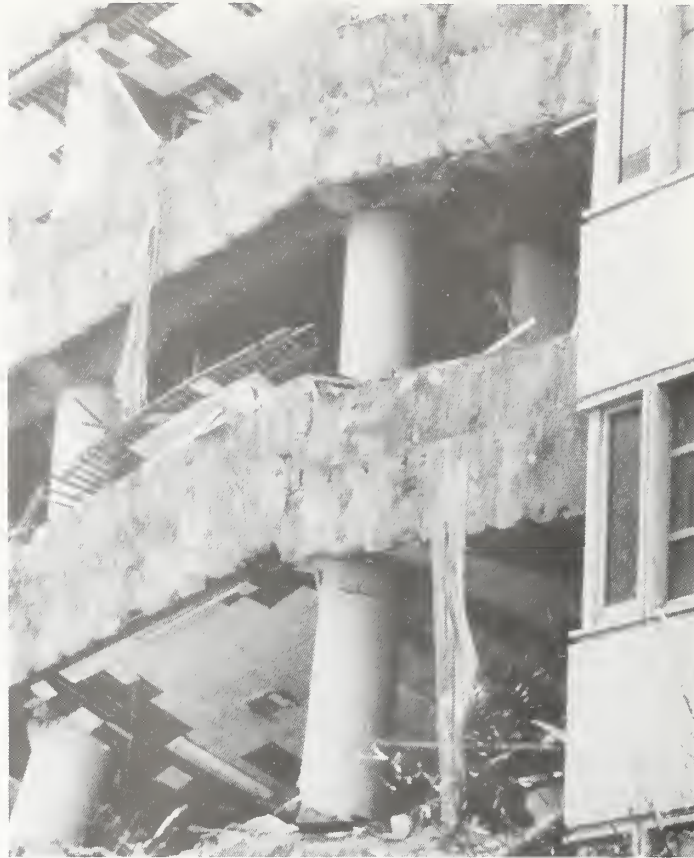
Figure 3.4.13 Strong beam-weak column failure.

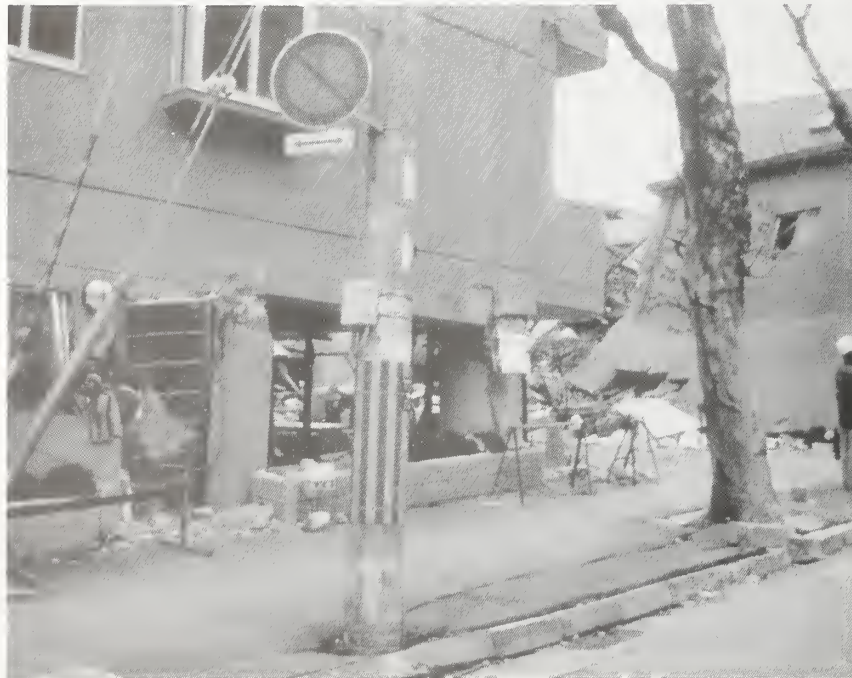
Figure 3.4.14 Collapsed first story near JR Line.

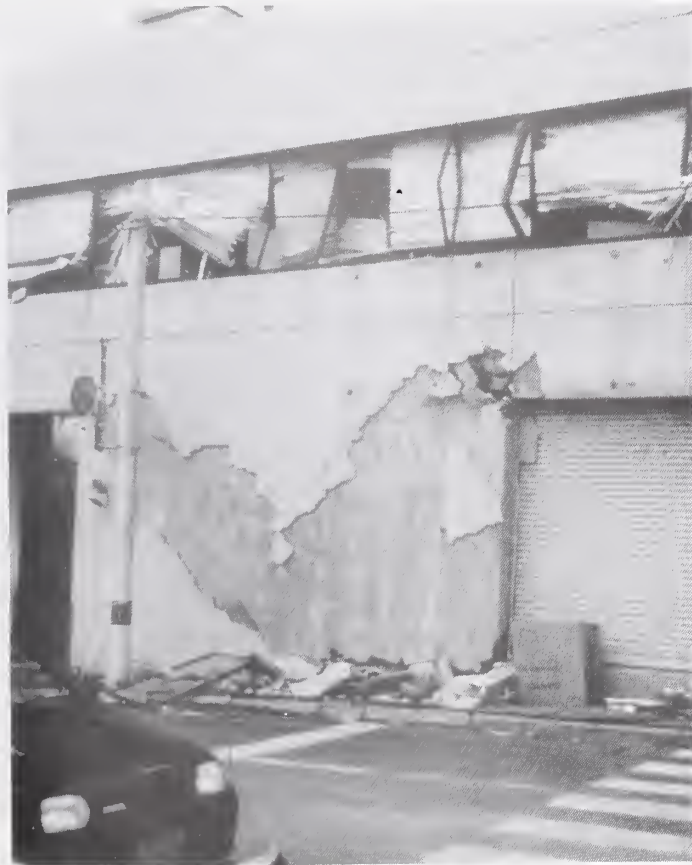
Figure 3.4.17 Second story collapse - Miyagi Hospital.

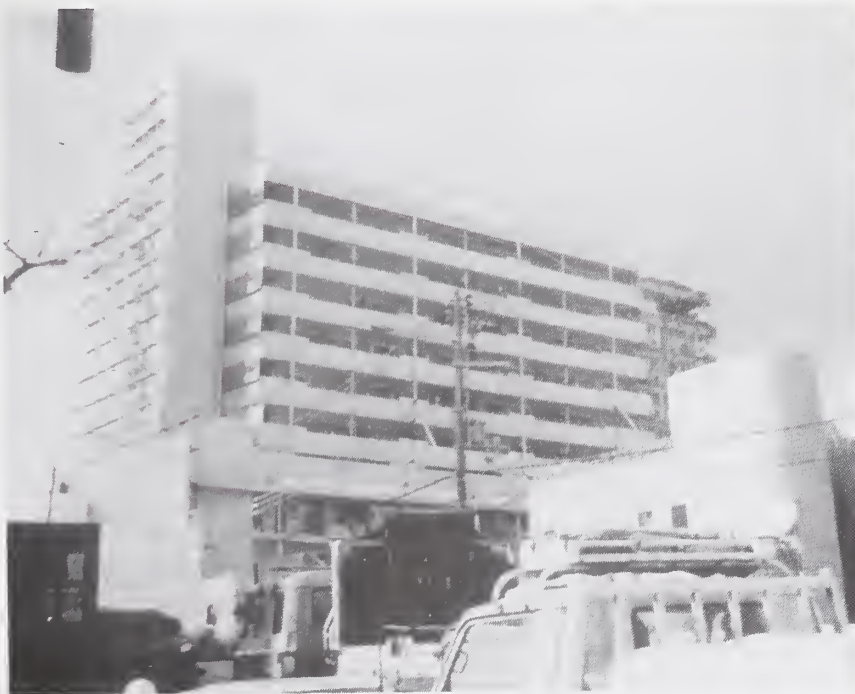
Figure 3.4.18 Fourth story collapse in apartment building.

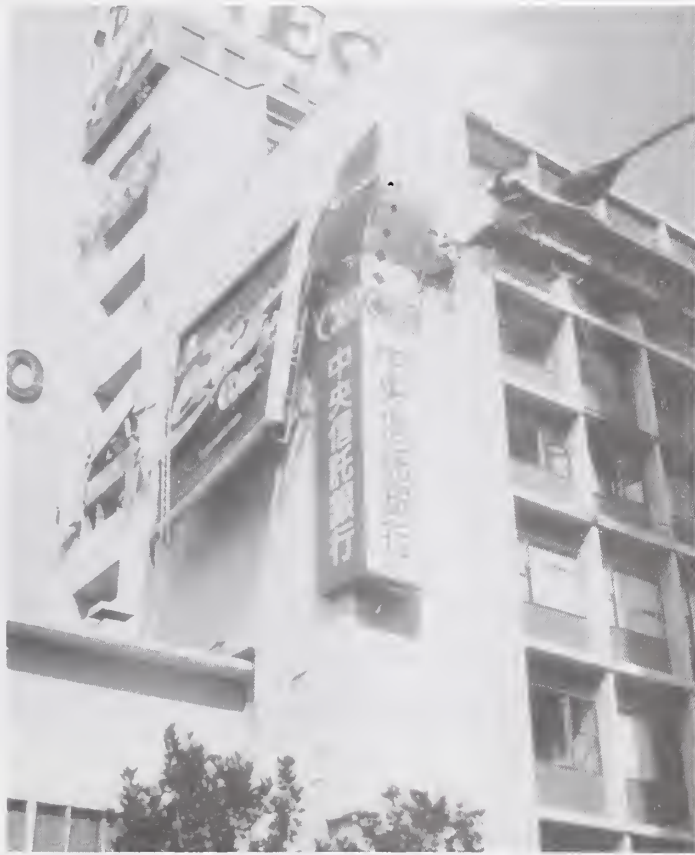
Figure 3.4.21 Upper story collapse - Downtown Kobe.

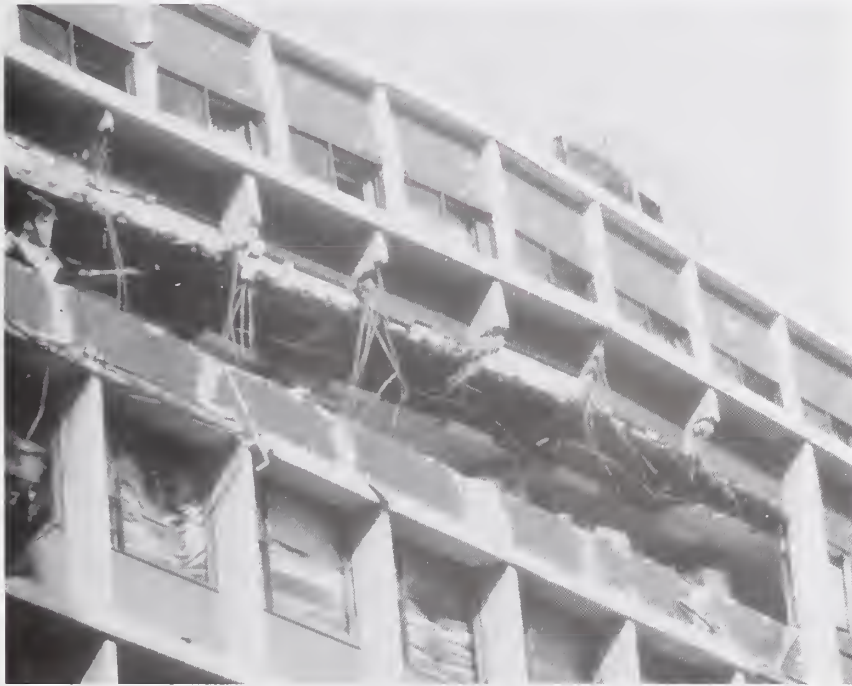
Figure 3.4.22 Upper story collapse - Downtown Kobe.

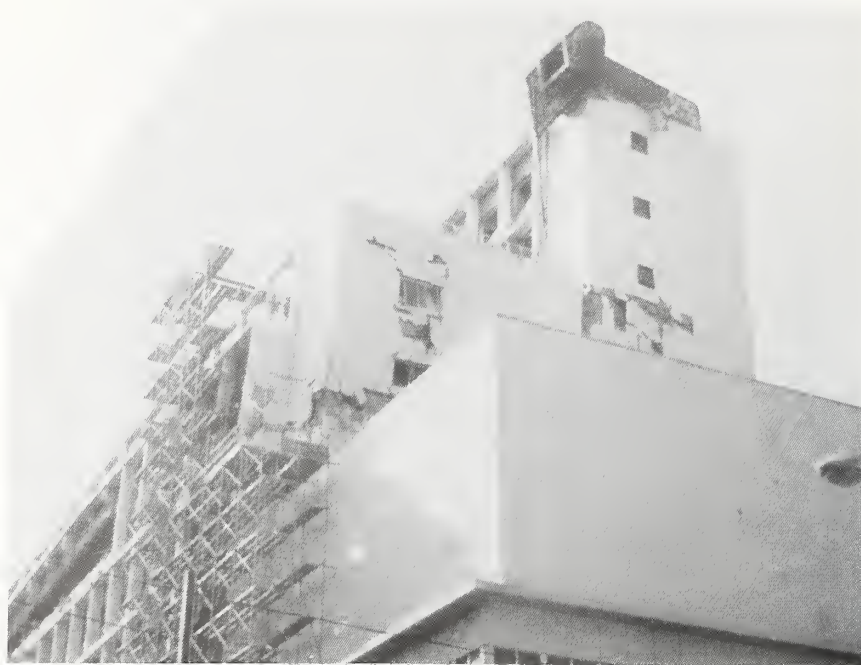
Figure 3.4.23 Collapsed penthouse structure.

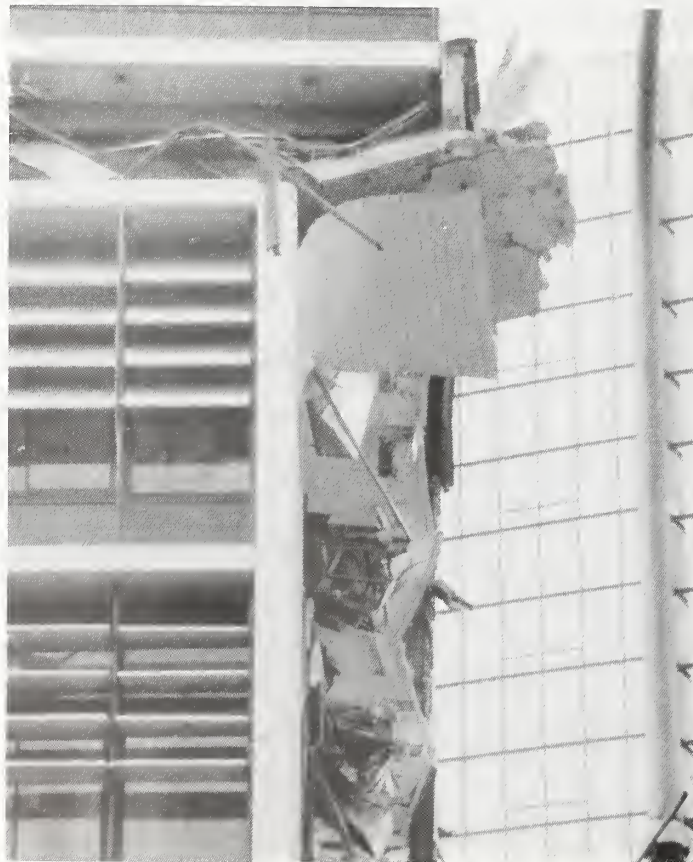
Figure 3.4.24 Collapsed upper story, north end - Kobe City Hall Annex.

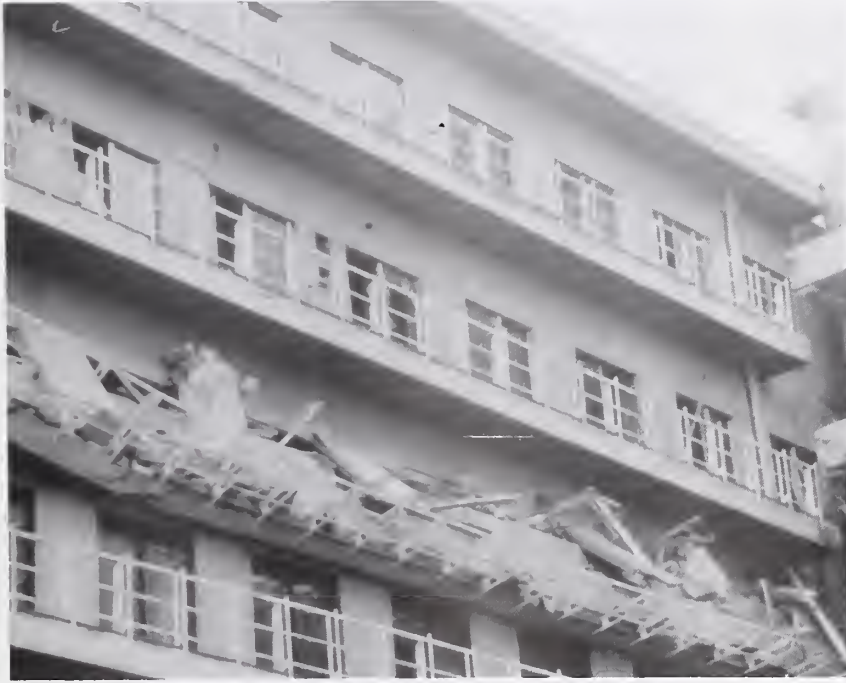
Figure 3.4.25 Collapsed upper story, northeast corner - West Kobe Citizens' Hospital.

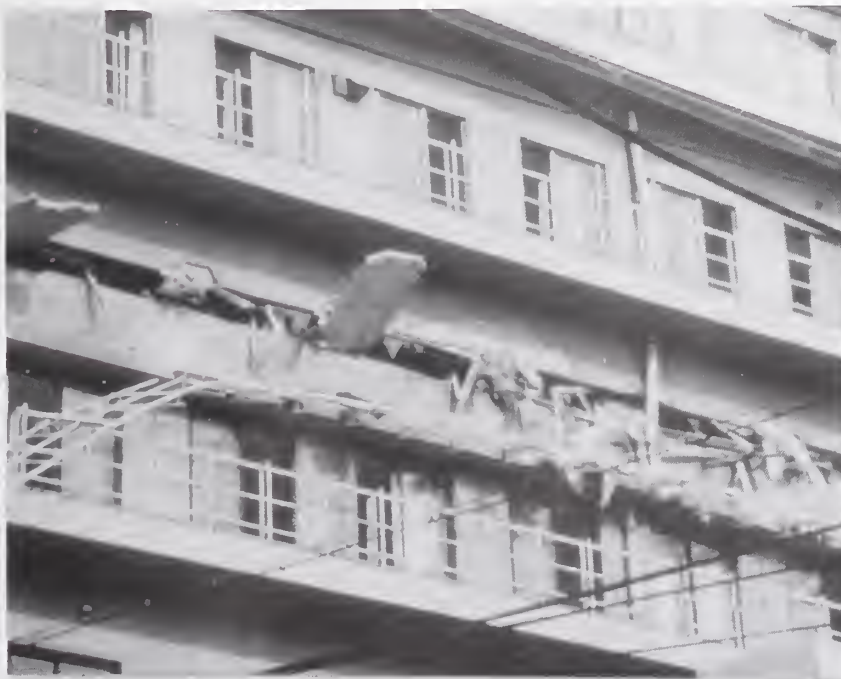
Figure 3.4.26 - Collapsed upper story, northwest corner - West Kobe Citizens' Hospital.

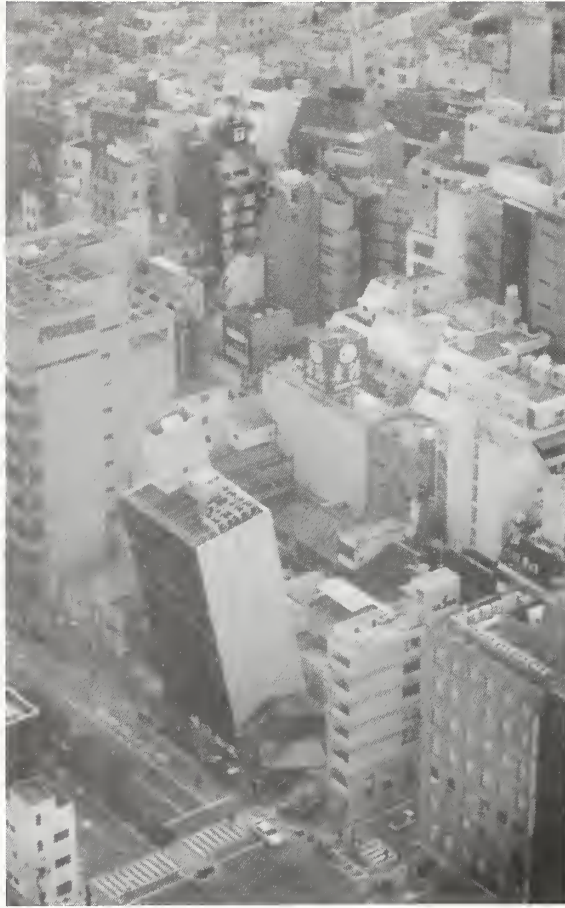
Figure 3.4.27 A leaning 9-story SRC building on Flower Road prior to total collapse.

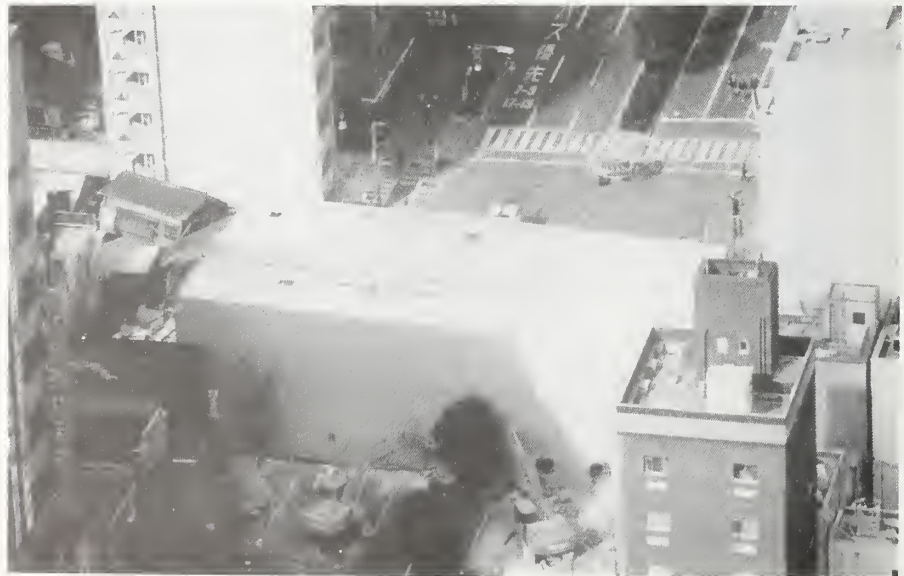
Figure 3.4.28 Totally collapsed building shown in Figure 3.4.27.

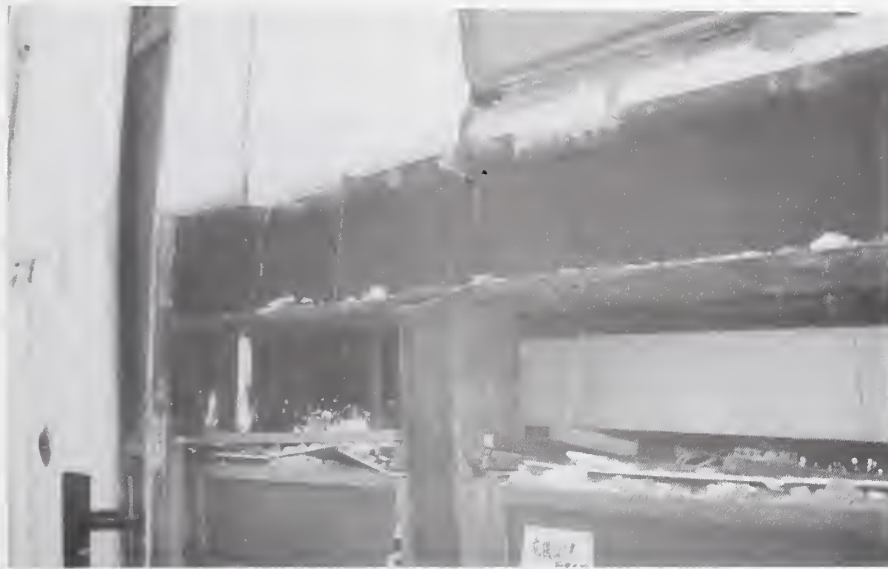
Figure 3.5.20 First floor column to second story column joint fillet weld failure on the east side of the Nairo Hiro Building, downtown Kobe.

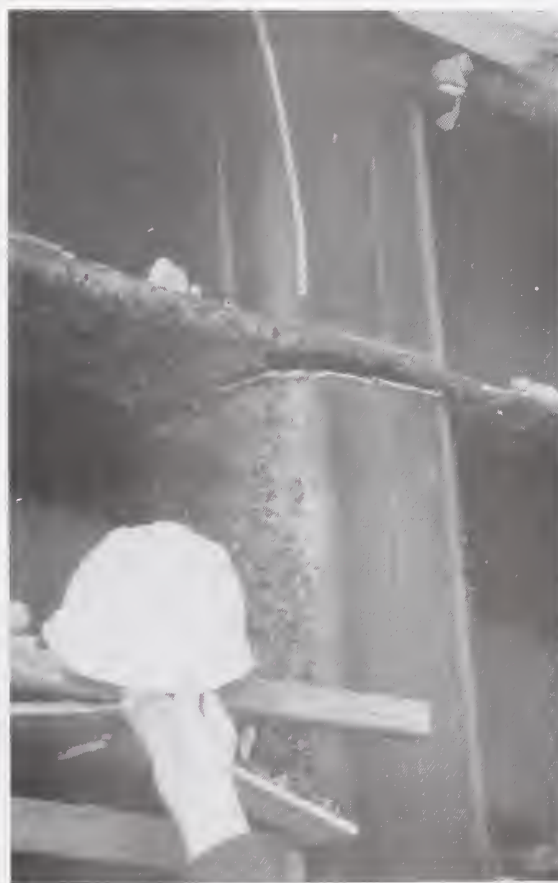
Figure 3.5.21 Closeup photo of column fillet weld failure in the Nairo Hiro building .

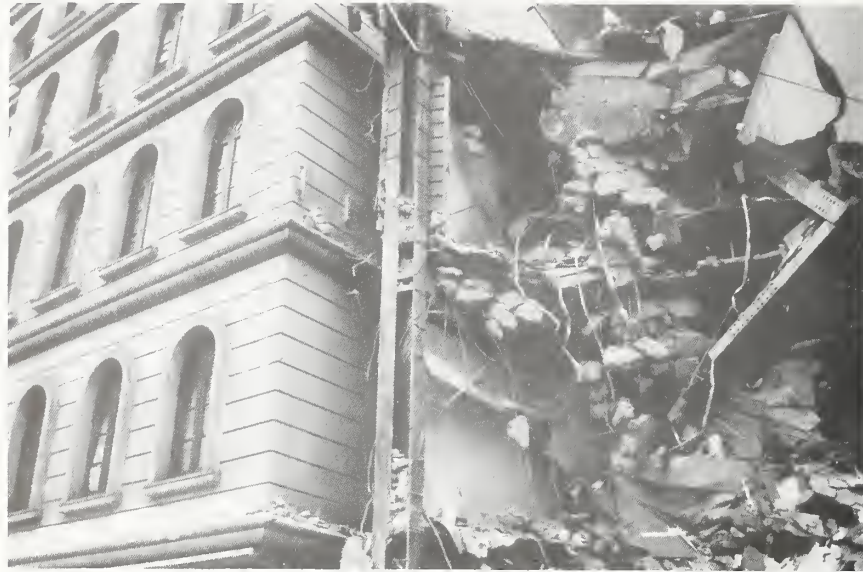
A 3-story steel frame building (Tanigawa Building) on Flower road in downtown Kobe also suffered beam-to-column connection failures (Figures 3.5.22 and 3.5.23). It is clearly seen that weld joint failure caused H-shaped girders to fall.

Figure 3.5.22 Collapse of the 3-story Tanigawa building on Flower Road in Kobe. This two-way steel frame was constructed of H-shape beams welded to columns.

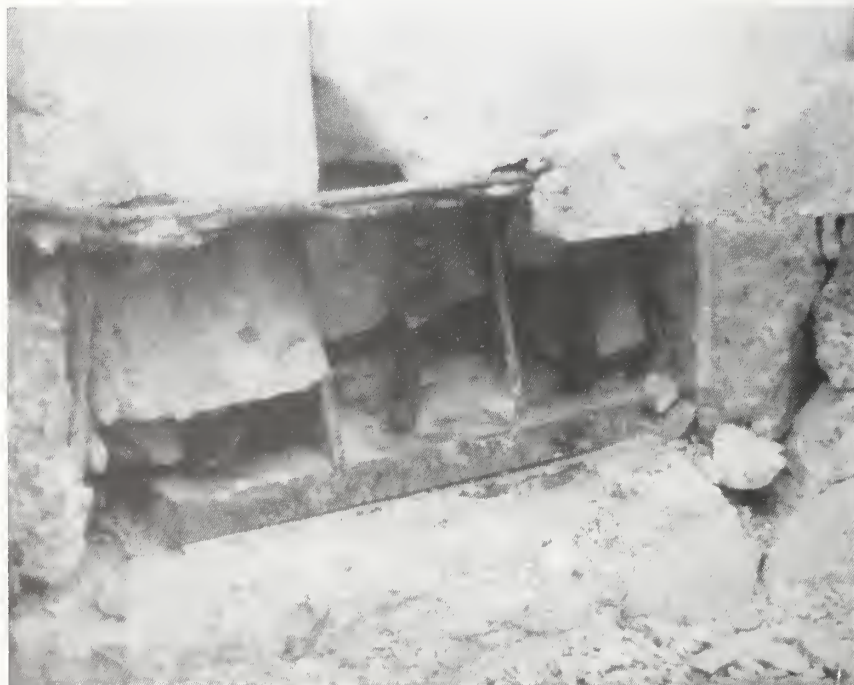
Figure 3.5.36 SAGA Building, anchor bolt was pulled out about 10 cm.

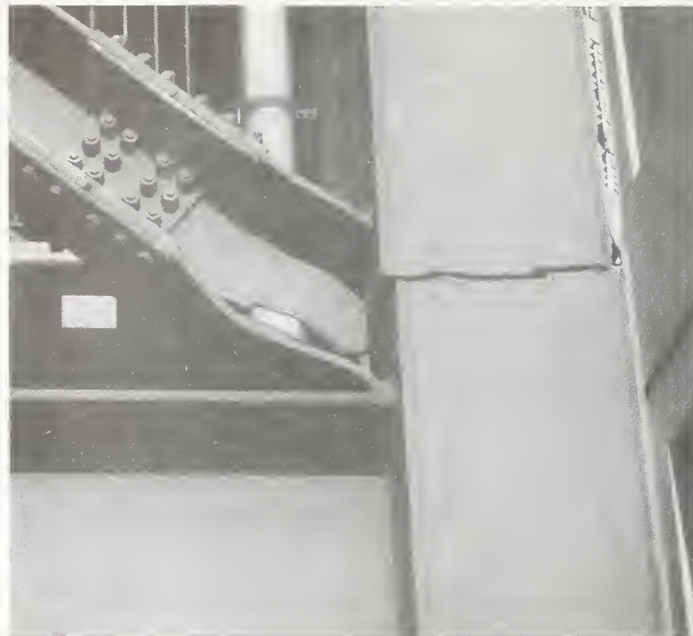
Figure 3.5.41 Complete fracture through a steel column section.

A final note concerning steel structures are the questions raised by the extensive base metal and weld failures observed at the Ashiya Hama Seaside Town (AHST) complex in Ashiya City. A number of thick column sections and diagonal bracing members sustained brittle failures. These failures echo problems first observed in steel structures in the United States following the Northridge earthquake.

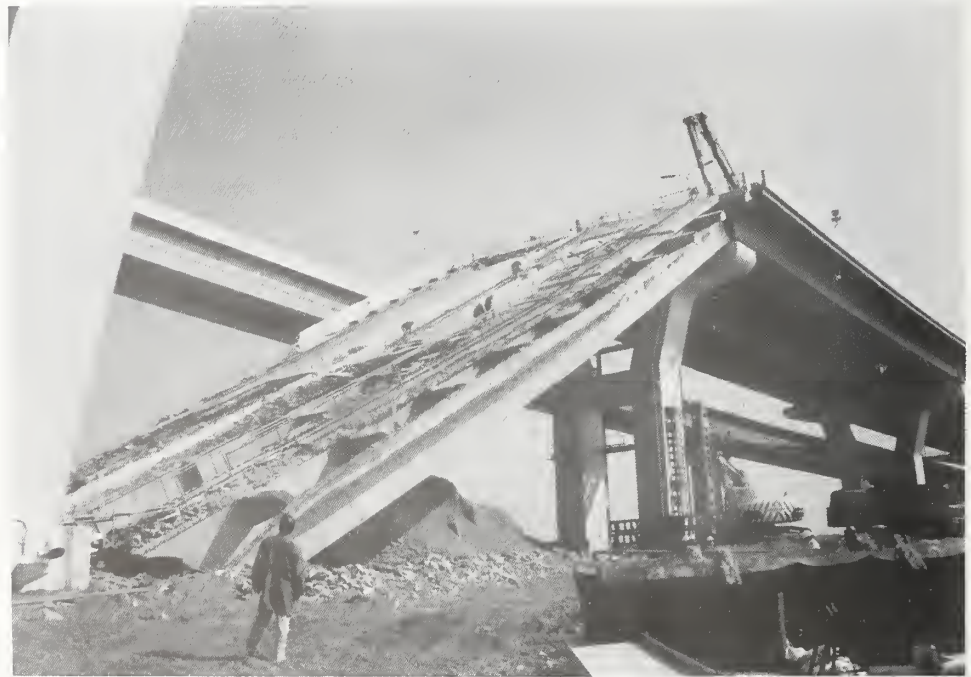
liquefaction of the 10 m to 15 m of granular artificial fill soil at the site. When the fill on both banks of the river channel liquefied each bank moved towards the center of the channel. This lateral movement caused the two end piers of the main span to move towards one another, pushing the approach span off its support.

Figure 4.2.2b Collapsed approach span between Piers 111 and 112, Nishinomiya-ko Bridge.

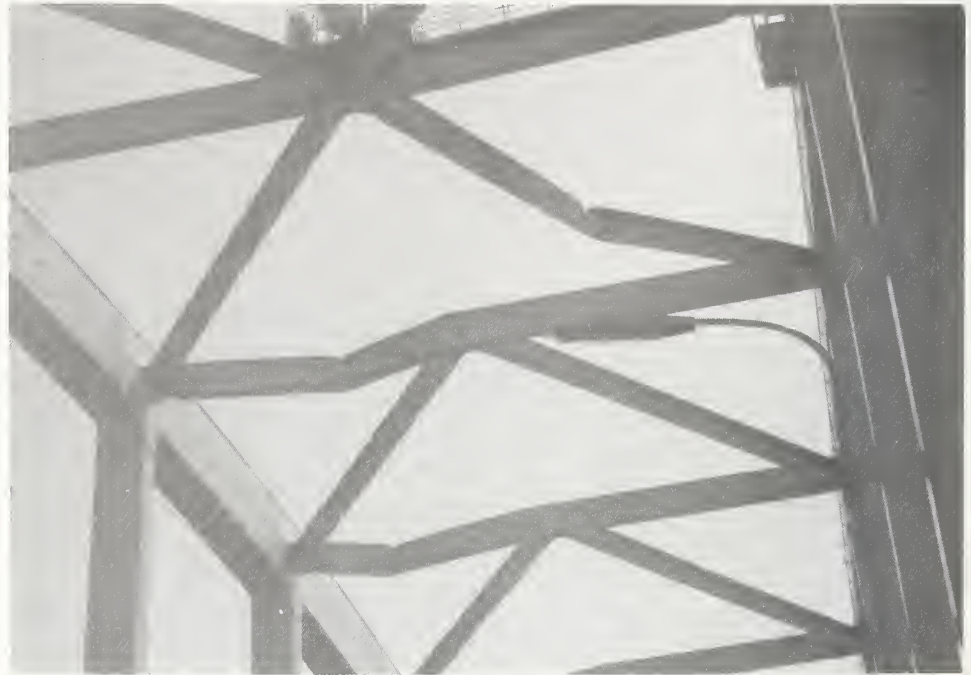
Figure 4.2.8 Buckled cross-members in Upper Chord, Rokko Island Bridge.

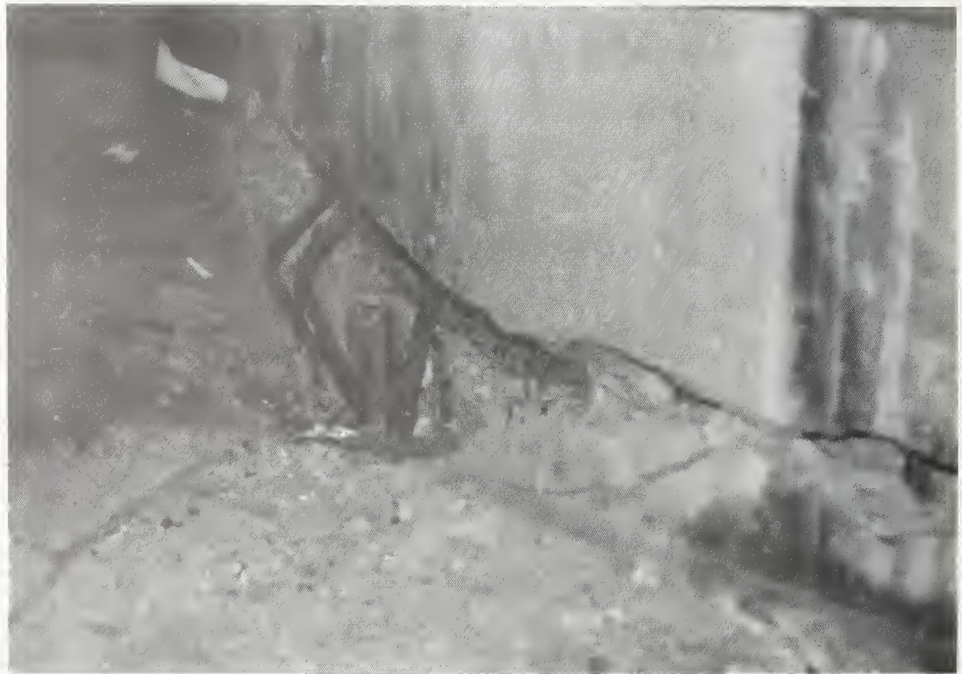
Figure 4.2.12 Failure at top of buried column, Pier P1, Mukogawa Bridge.

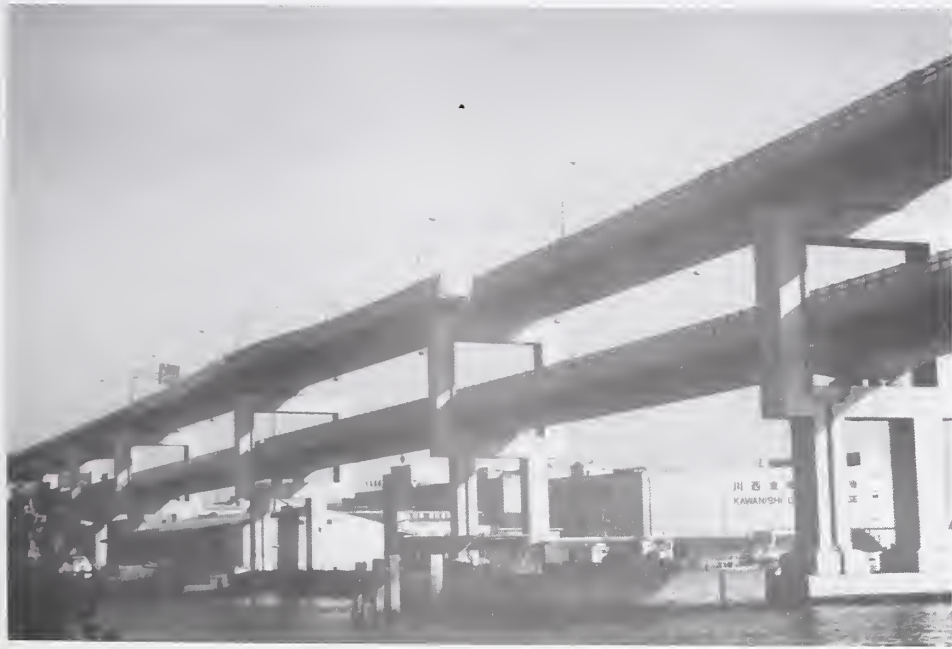
Figure 4.2.13 Lateral offset at Pier 36 in upper level of Hamate By-Pass due to bearing failures at Piers 34 through 38.

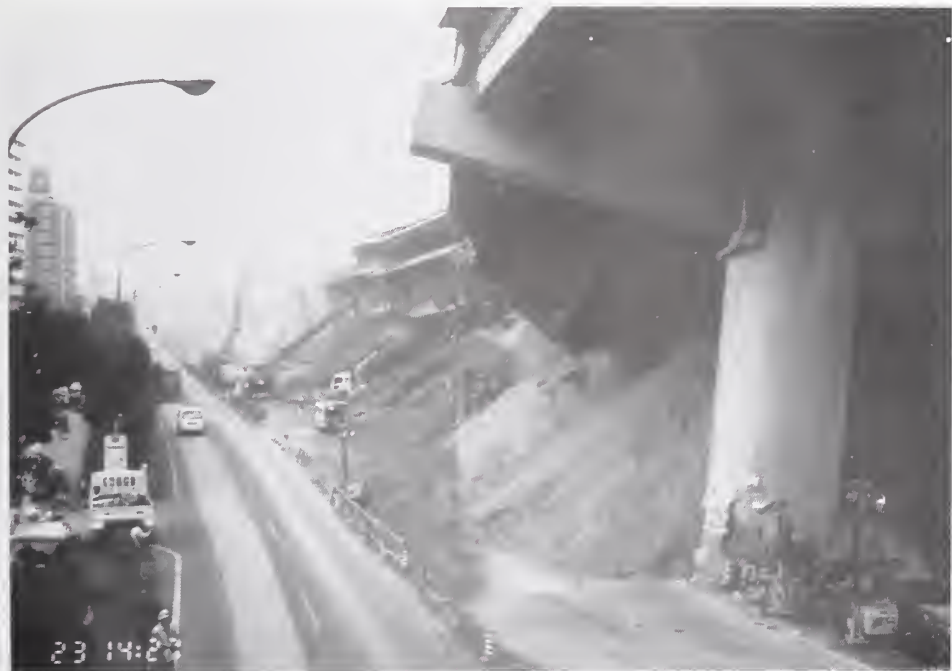
Figure 4.2.14 View of the collapsed Higashi-Nada Viaduct looking west from Pier 125.

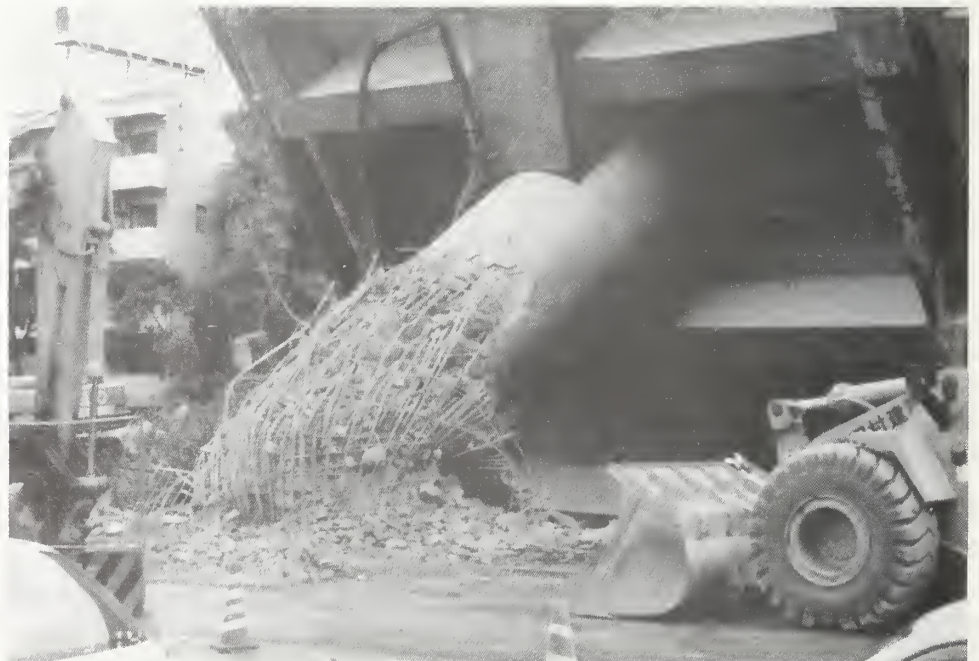
Figure 4.2.16 Higashi-Nada Viaduct, Pier 134.

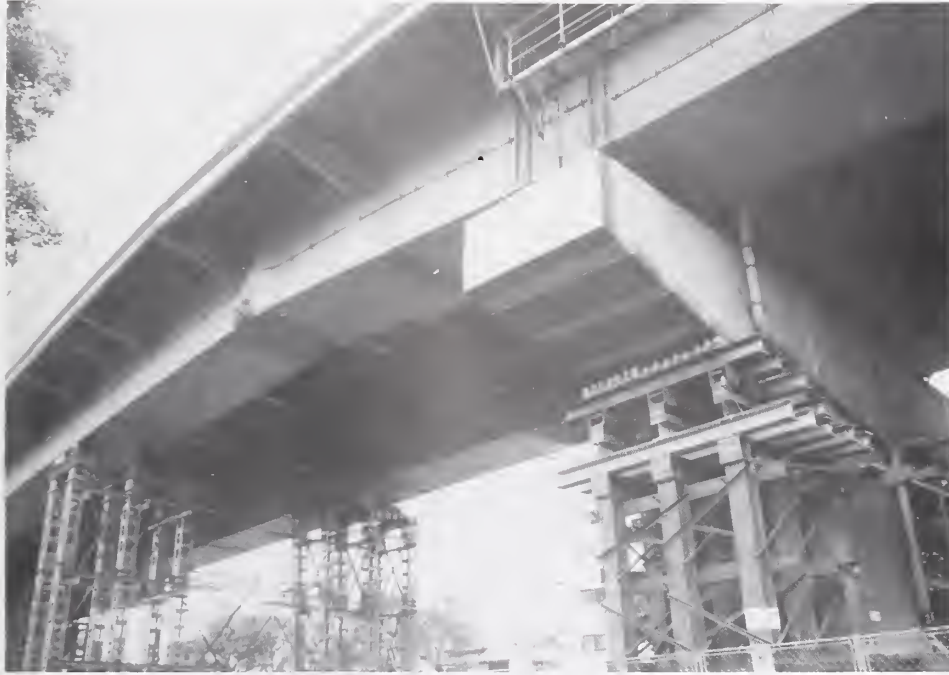
Figure 4.2.20 Compressive failure in lower flange of steel box girder between Piers 238 and 239 of Hanshin Expressway.

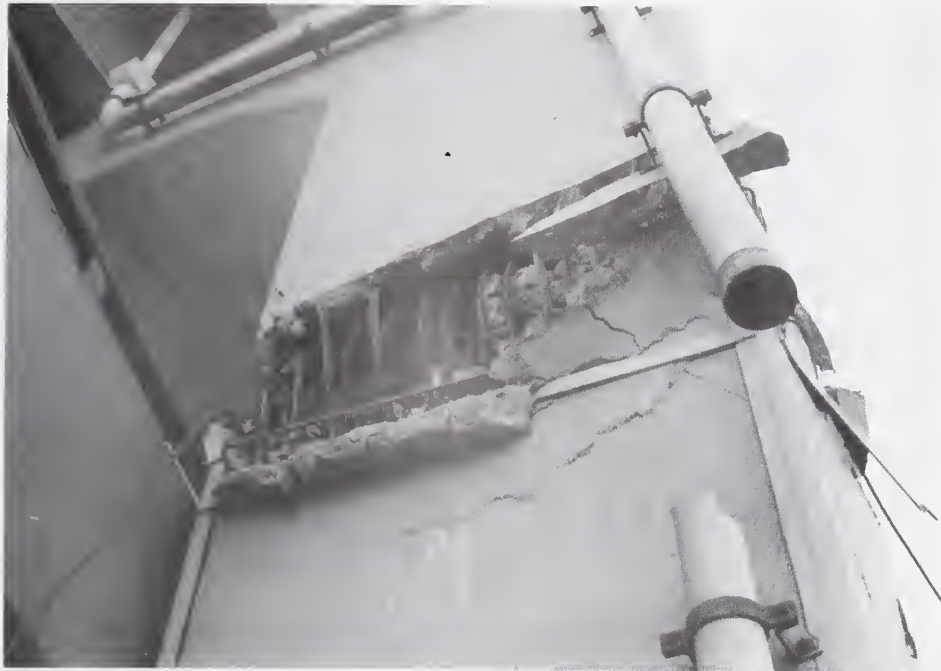
Figure 4.2.26 Hinge formation in east column of Pier 23, Kobe-Ohashi.

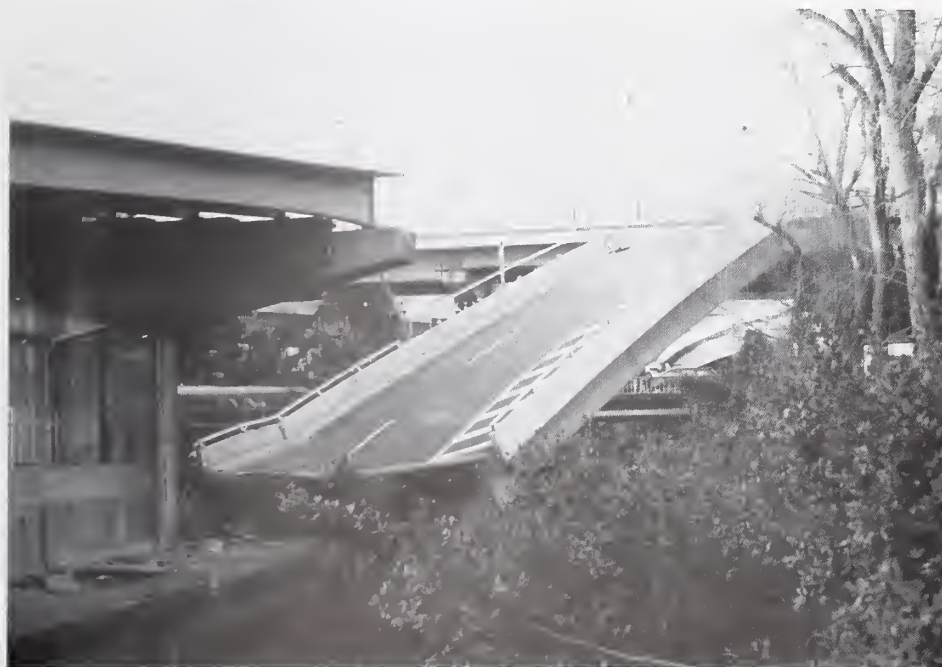
Figure 4.2.27 Collapse of Southeast Ramp at the Minatogawa Interchange.

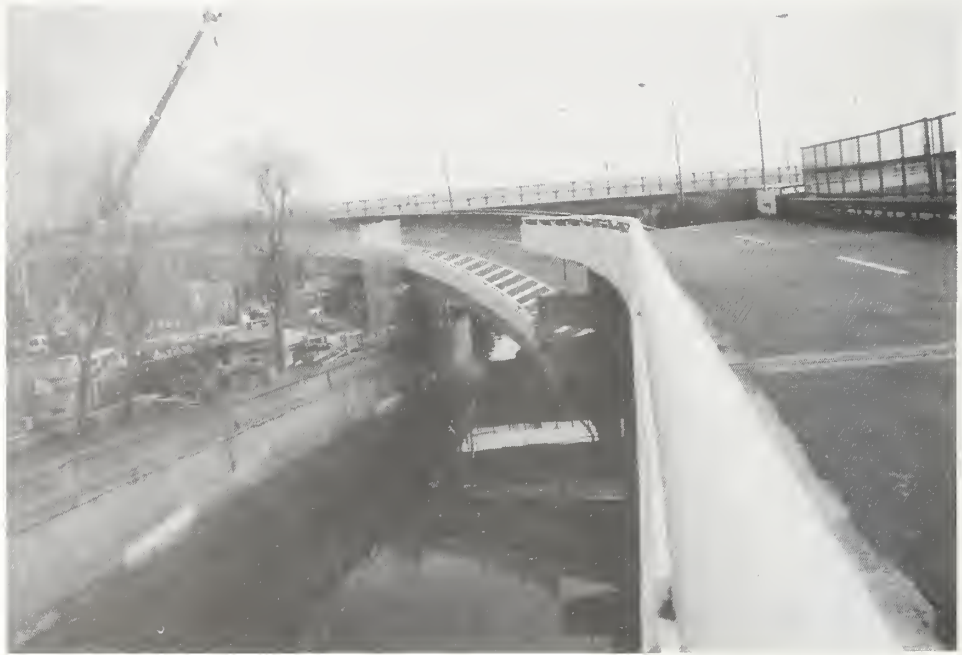
Figure 4.2.28 Collapse of Northeast Ramp at the Minatogawa Interchange.

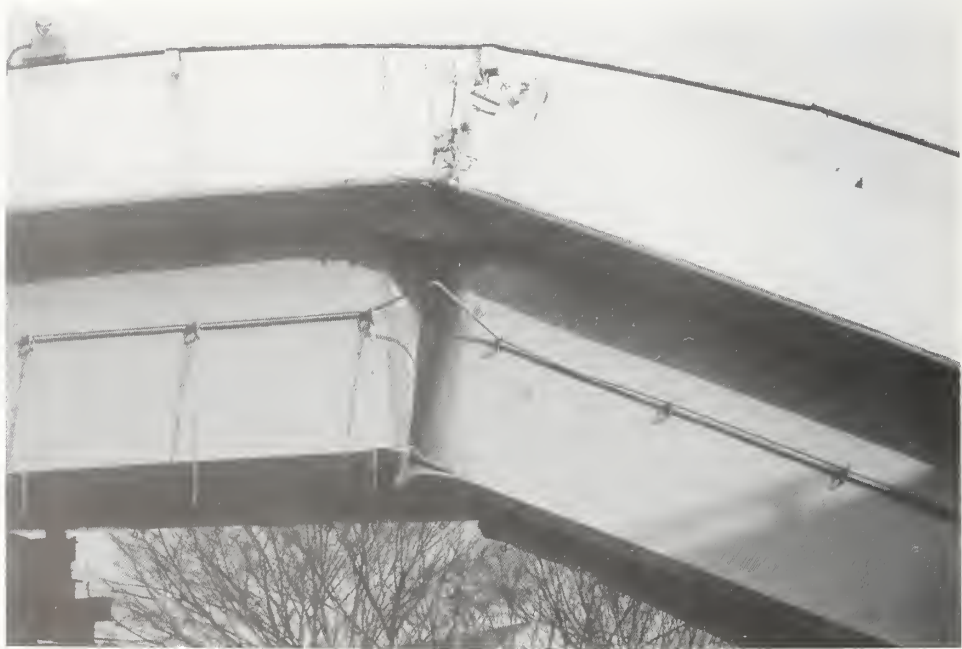
Figure 4.2.29 Girder web failure due to unseating of the Southeast Ramp at Minatogawa Interchange.

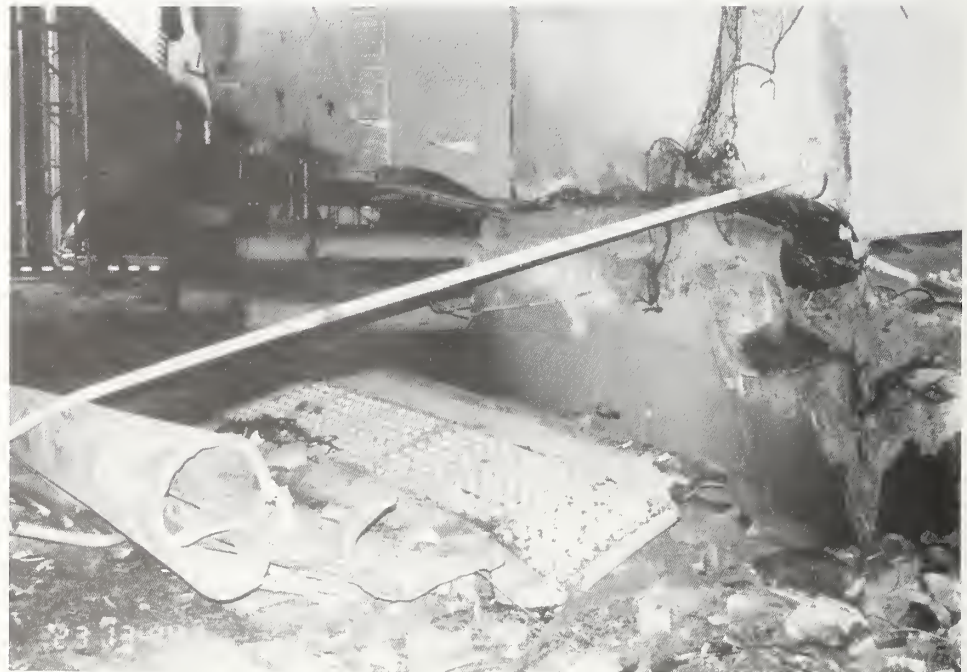
Figure 4.2.34 Pier 55, Route 3 near Tateishi showing buckled steel plate on ground.

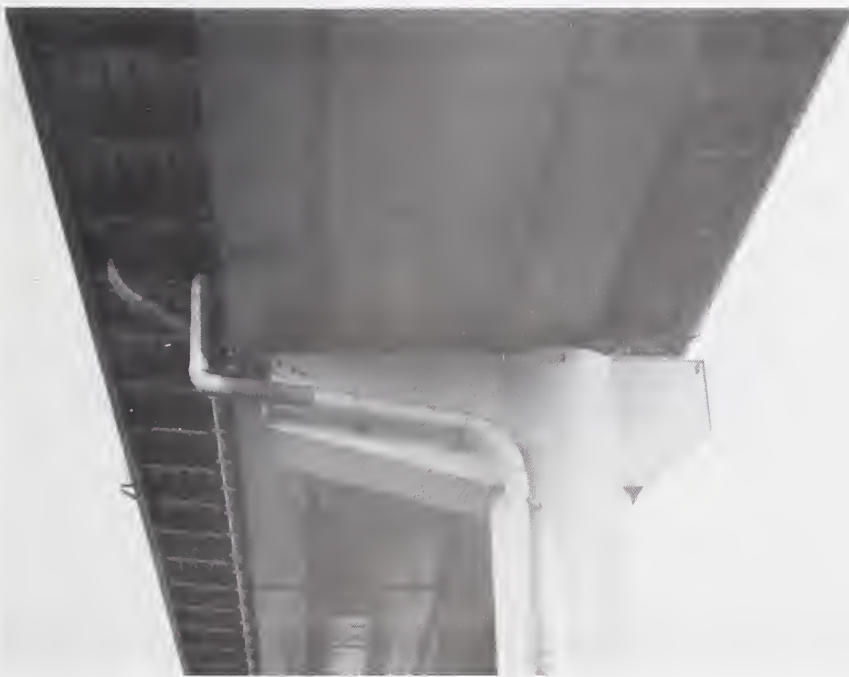
Figure 4.2.38 Failed bearings and lateral offset at top of Pier 586 of westbound Route 3.

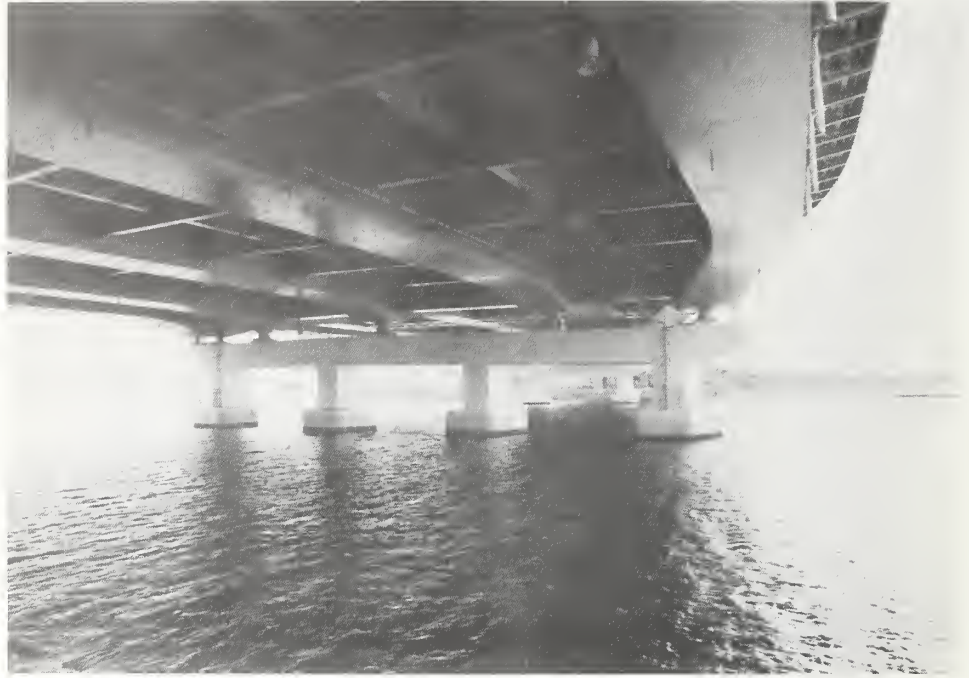
Figure 4.2.41 General view of the Shukugawa Bridge on Route 5.

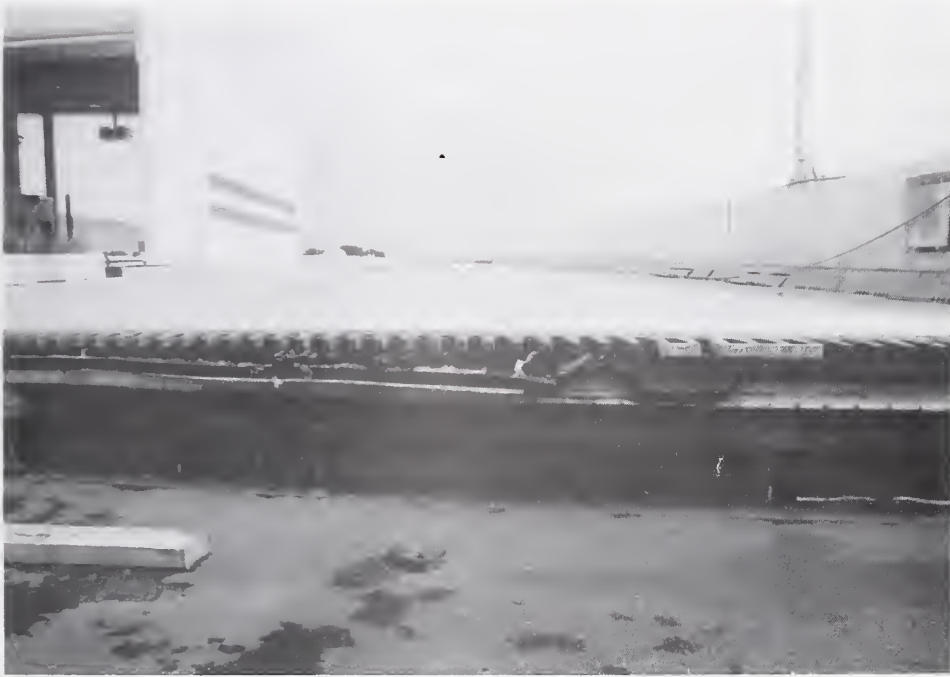
Figure 4.2.43 Vertical offset in the expansion joints above Pier 134 of the Shukugawa Bridge due to bearing failure on the best cap below.

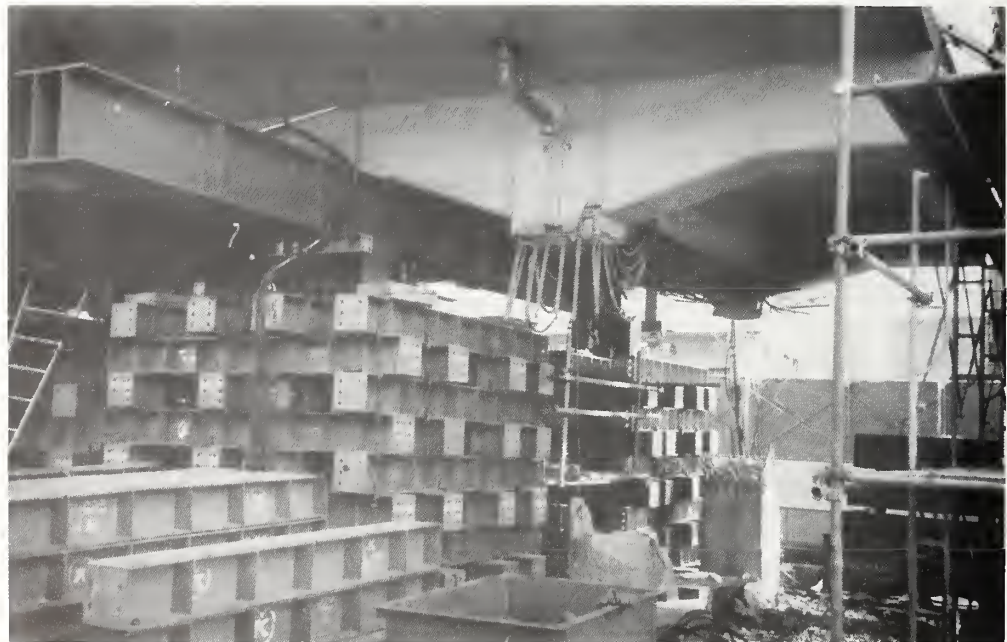
Figure 4.3.6 Column repair - Shinkansen.

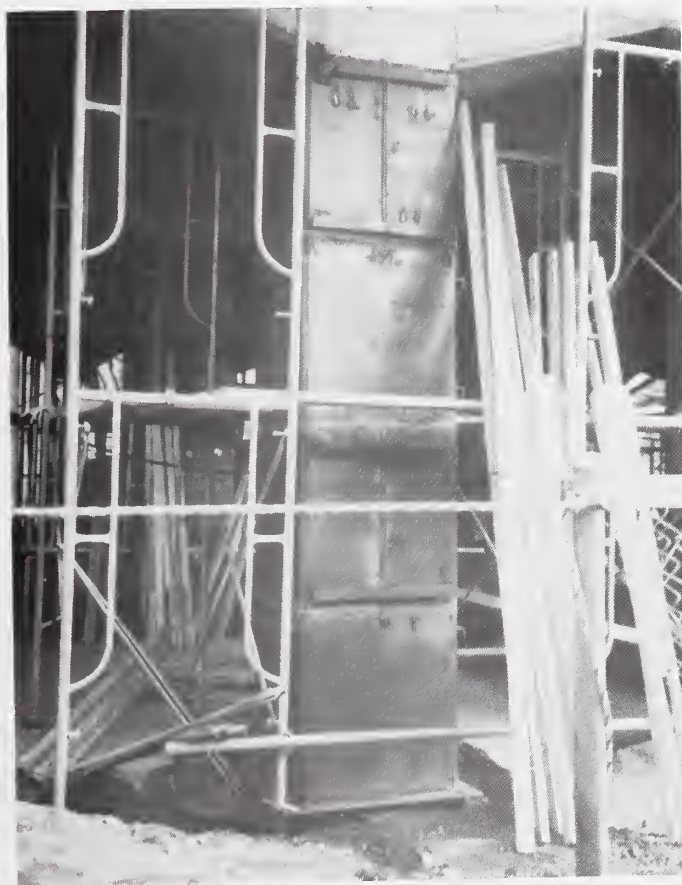
Figure 4.3.8 Jacketed column - JR Main Line.

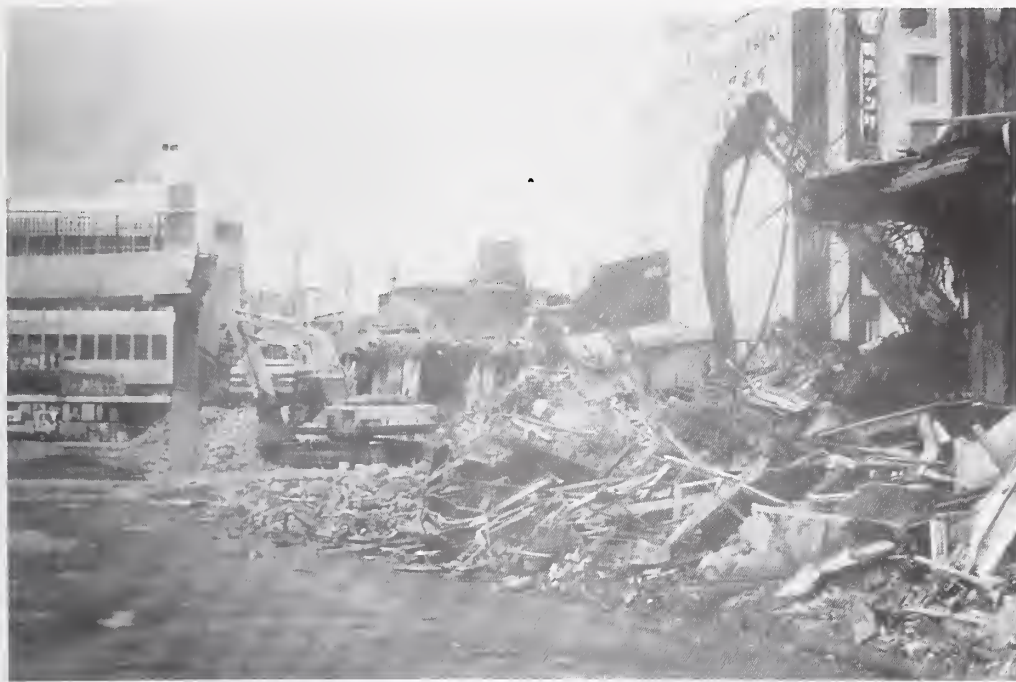
Figure 4.3.11 Collapsed Shin - Itami Station.
