NIST Special Publication 901

The January 17, 1995 Hyogoken-Nanbu (Kobe) Earthquake

*Performance of Structures, Lifelines, and Fire
Protection Systems*

Riley Chung, Team Leader and Editor

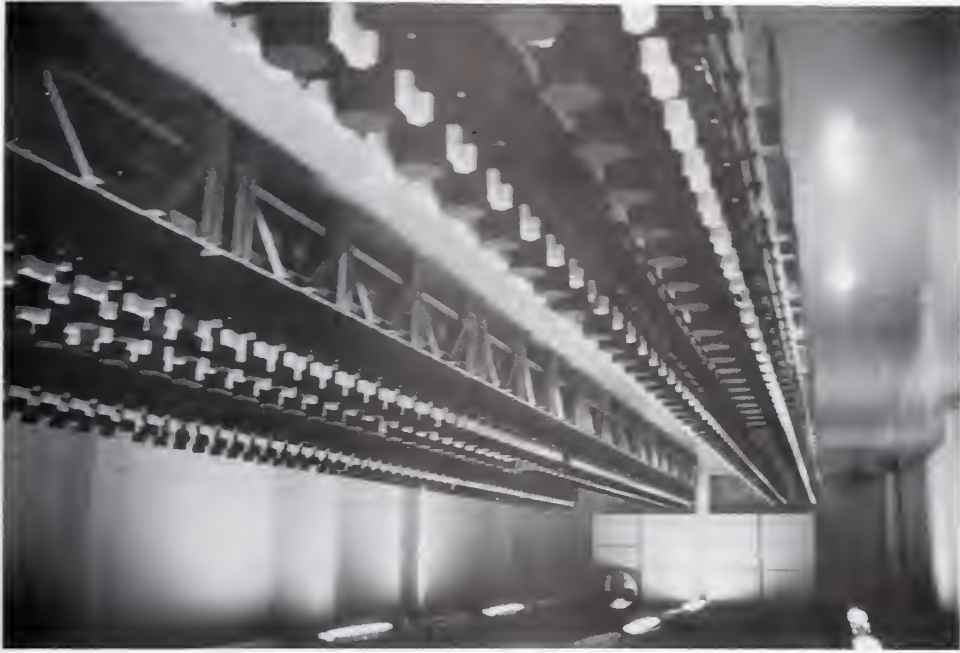
A battery plant provided an uninterruptable power supply. Battery support structures observed in Japan tended to be short and close to the ground, well braced, and provided with rubber spacers between the batteries and their restraints and between cells (Figure 4.4.19). Because of the high operating voltage, very long battery strings were used.

Figure 4.4.19 Very long battery string on low slung battery racks provides emergency power.

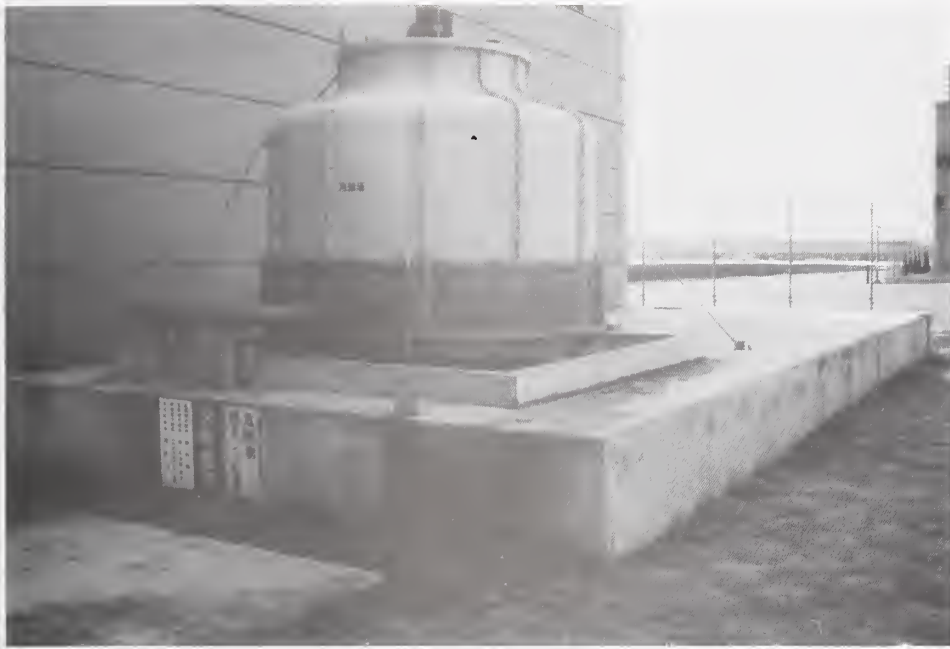
Figure 4.4.22 Cooling tower and water tank for emergency engine-generator.

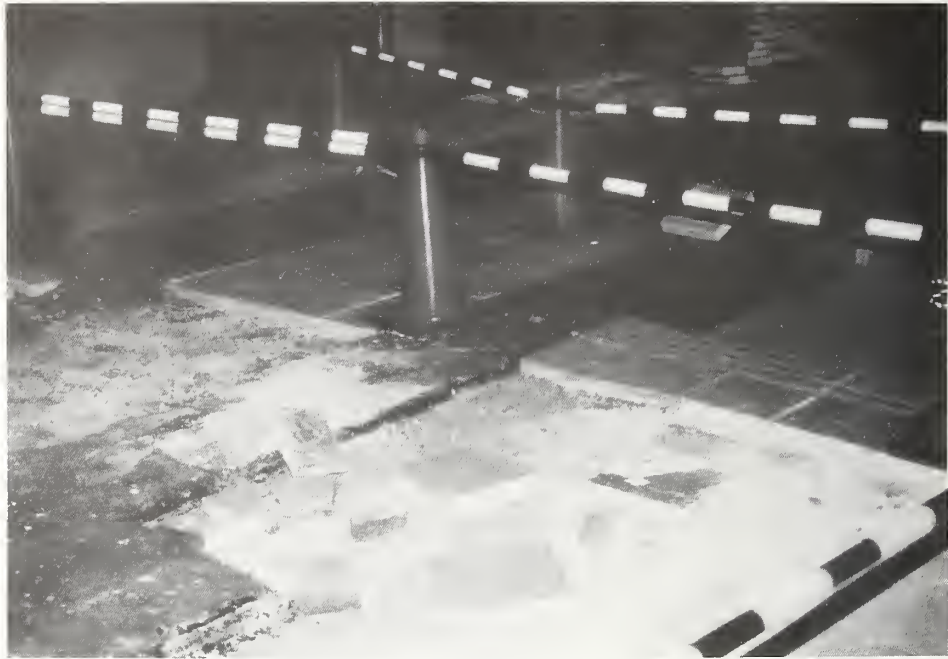
Figure 4.4.26 Subsidence in sidewalk and repaired sidewalk outside the Kansai Terminal Building.

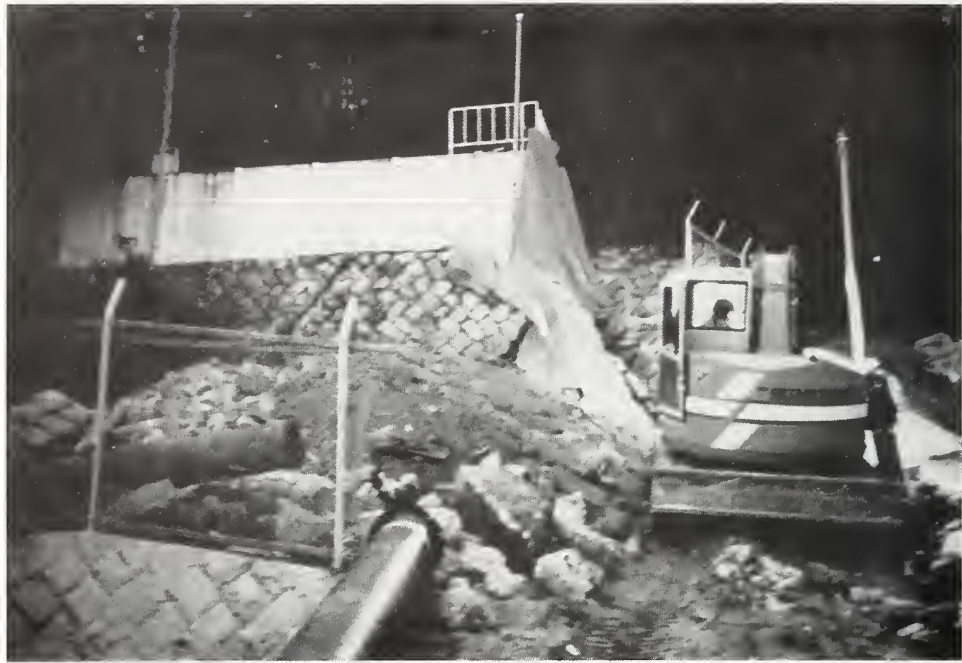
Photo 12 Landslide undermined solids handling building at the Hanshin (Kabutoyama) Plant.

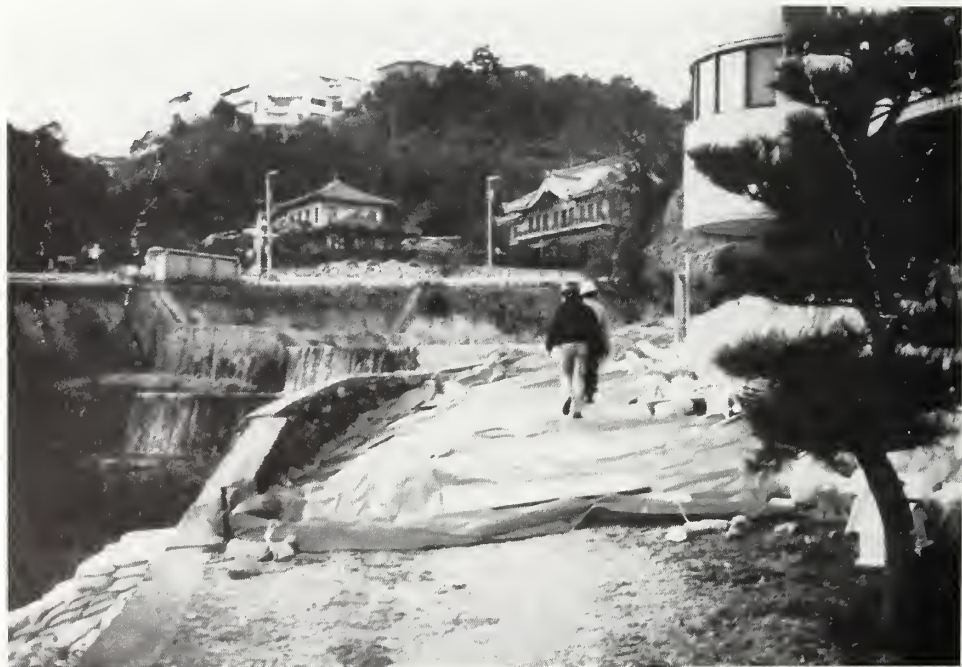
Photo 13 Broken lines to/from backwash tank at the Motoyama Water Purification Plant .

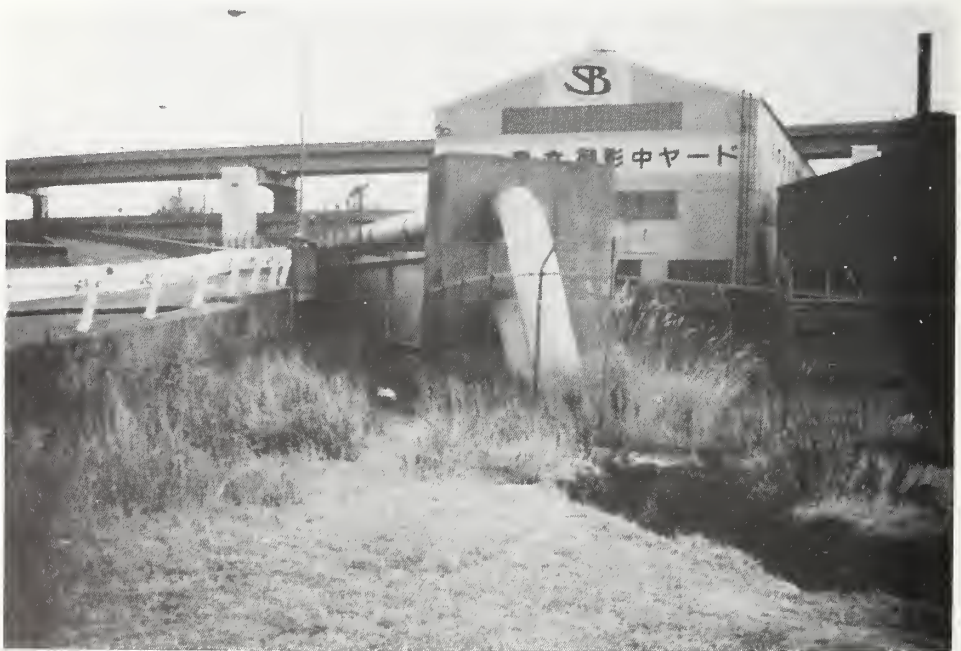
Photo 16 Repair of 700-mm welded steel pipeline which ruptured at a weld on the north side of Port Island in an area affected by liquefaction induced lateral spread. This line carries the entire potable water supply for the island.

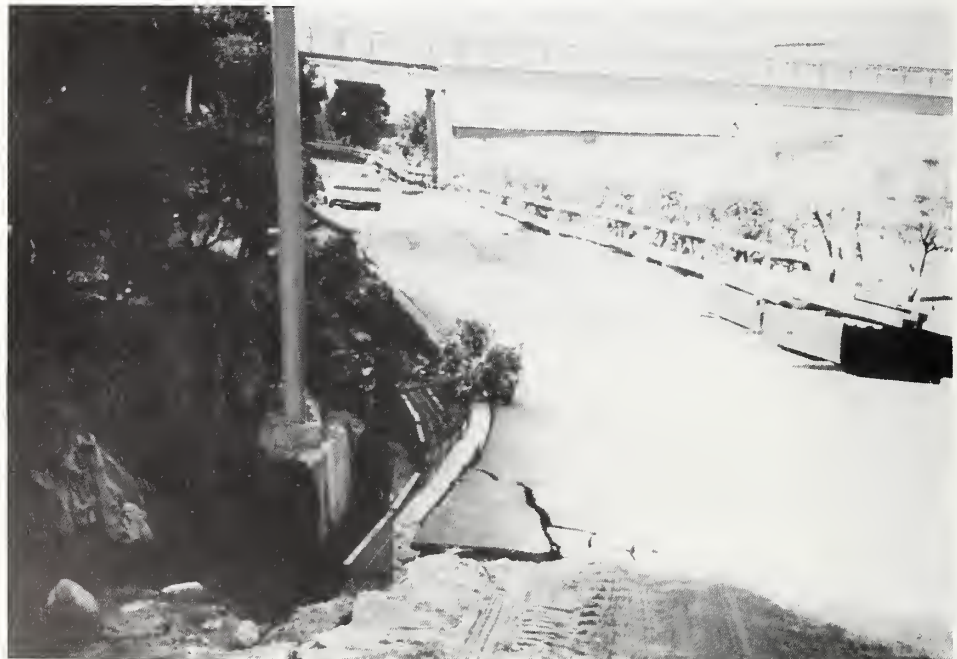
The facility was heavily damaged when the seawall along the north side of the plant adjacent to the channel moved as much as 3 m towards the water as a result of liquefaction (Photos 29, 30). As a result, the entire site settled an average of one meter. Liquefaction-induced lateral spread and settlement were most severe within a distance of 100 m south of the seawall along the southern margin of the channel. Horizontal displacements of 3 m and settlements as large as 2 m were observed within the plant site. Figure 5.2.19 shows the plant layout and notes damage locations.

Photo 29 Retaining wall along the inlet between the island and mainland moved towards the water (north) 2 to 3 meters, resulting in the entire site subsiding an average of one meter.

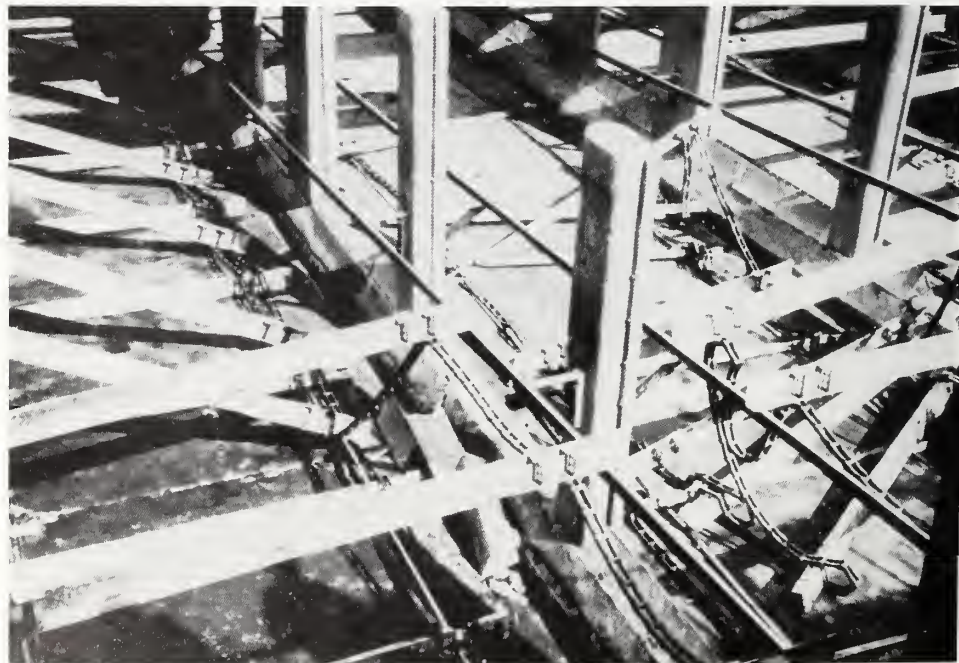
Photo 34 Close up of torn dumbbell rubber water stop in aeration tank.

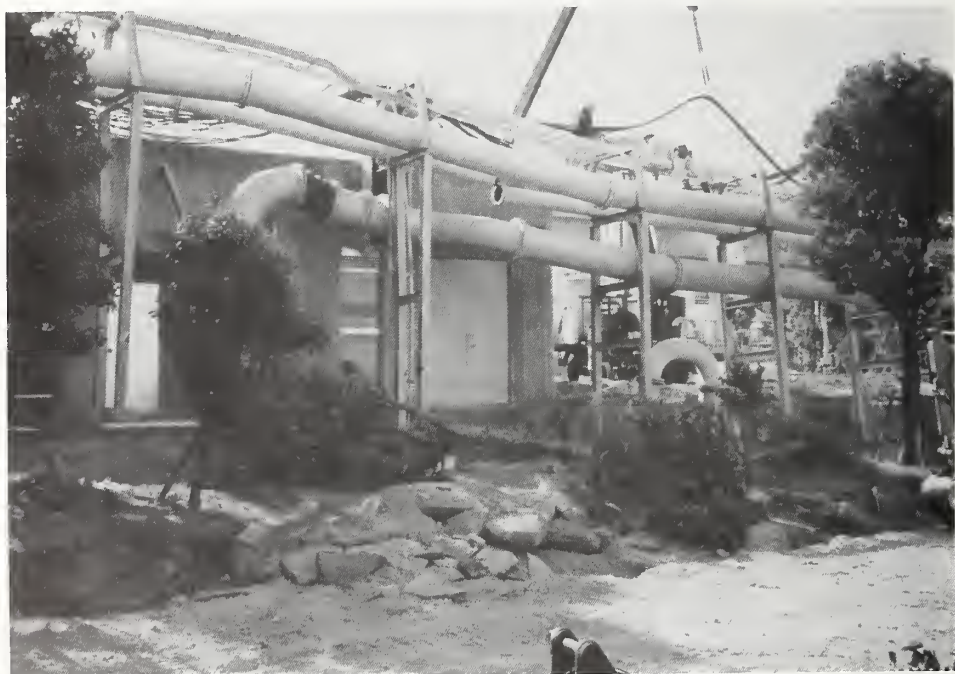
Primary and secondary clarifiers and aeration basins were pile supported. The primary clarifiers were 8 m deep so the pile length subjected to liquefied sand was relatively small. Secondary clarifiers and aeration basins were only 4 m deep which subjected a longer pile length to liquefaction and lateral movement and resulted in some pile damage. Aeration tank joint separation is shown in Photos 33 and 34. Photo 35 shows scrapper chains which came off of sprockets. Concrete piles supporting digester tanks closest to the channel cracked at their tops. Photos 36 and 37 show broken sludge digester connecting piping.

Photo 37 Differential settlement between pipe and non-pile supported structures damaged piping throughout the plant.

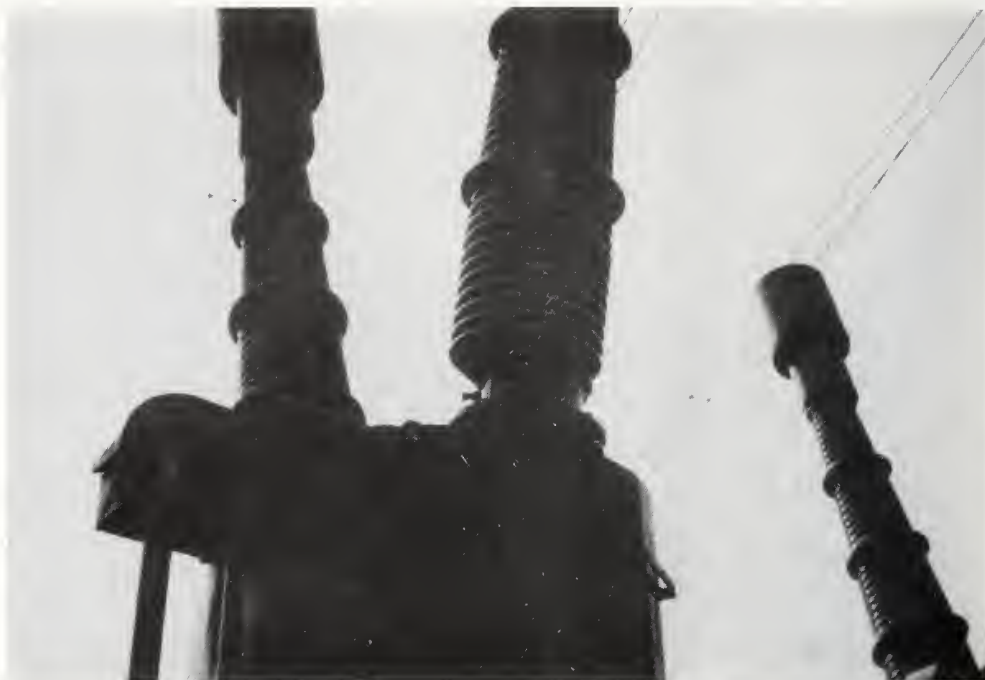
Figure 5.4.25 The porcelain slipped on its lower flange on a 275 kV bulk-oil Circuit breaker.

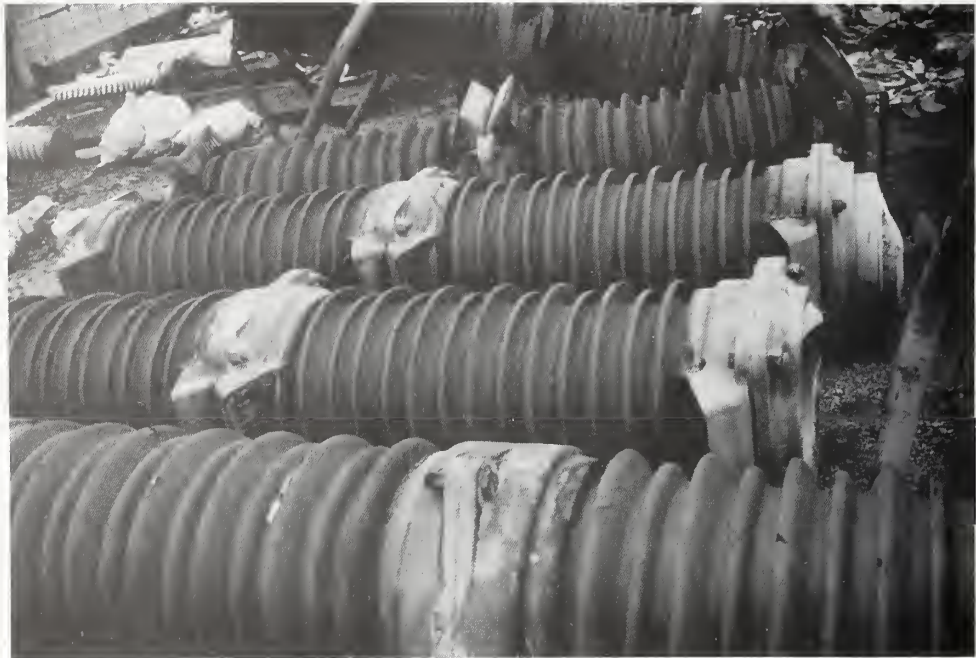
Figure 5.4.31 Damaged 275 kV lightning arrester in the grave yard.

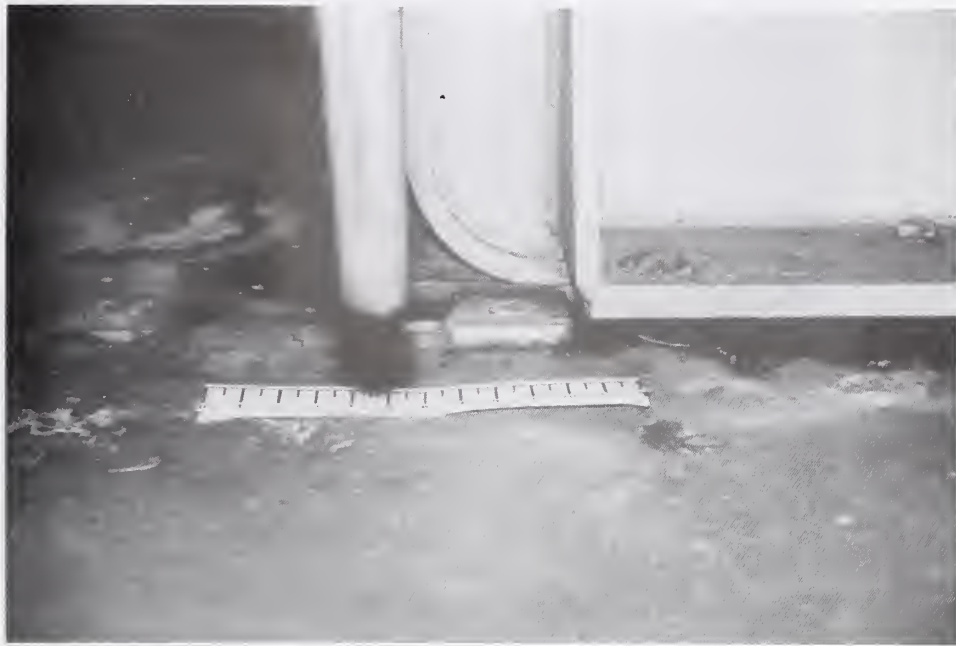
Figure 5.4.33 Bolts anchoring a transformer failed allowing the unit to slide 45 cm and causing damage to bushings.

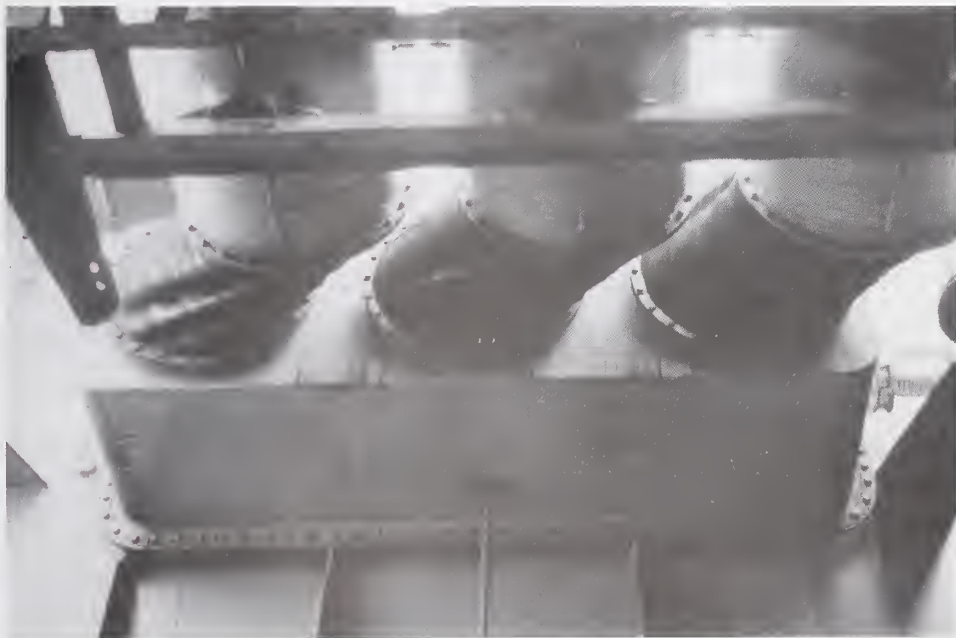
Figure 5.4.34 Offset in bus covers caused by the failure of transformer anchorage and its movement.

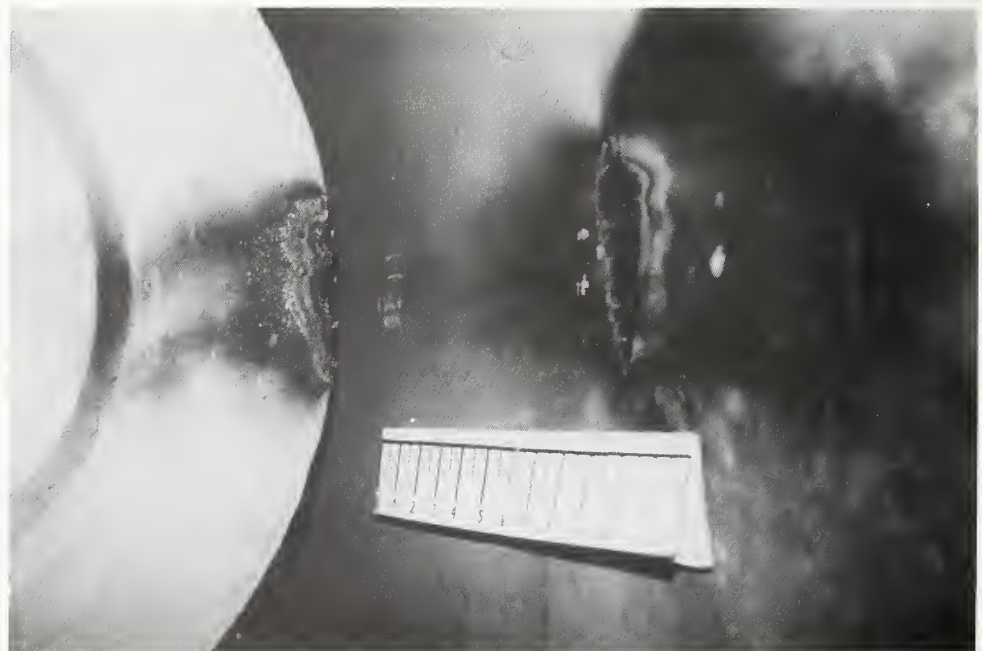
Figure 5.4.36 Movement of transformer damaged cabinet and shorted transformer case the tertiary output.

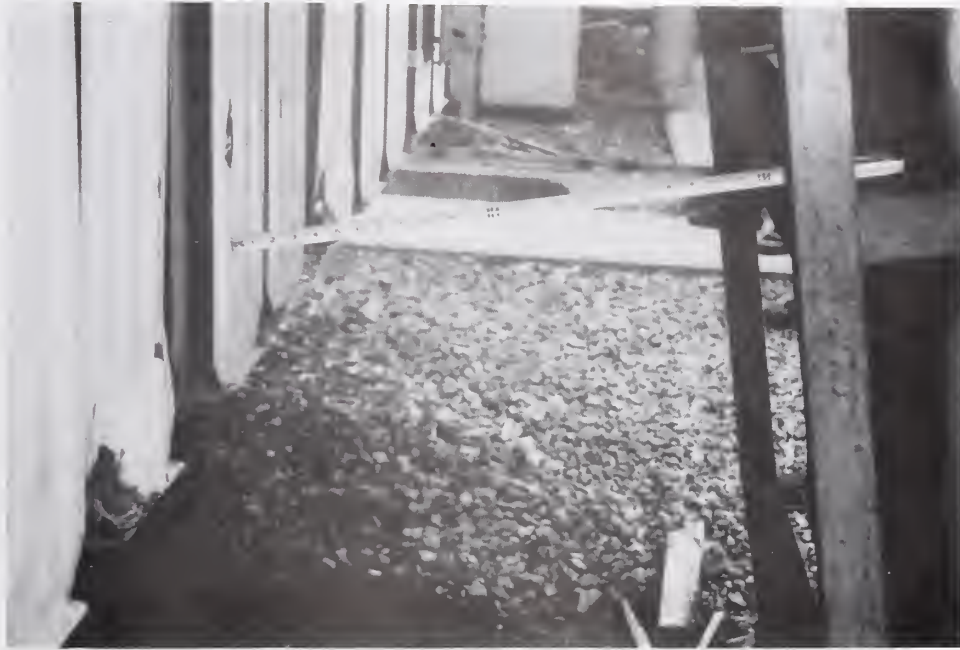
Figure 5.4.64 Movement of the transformer after its anchorage failed allowed the radiators to hit a nearby structural support causing a leak.

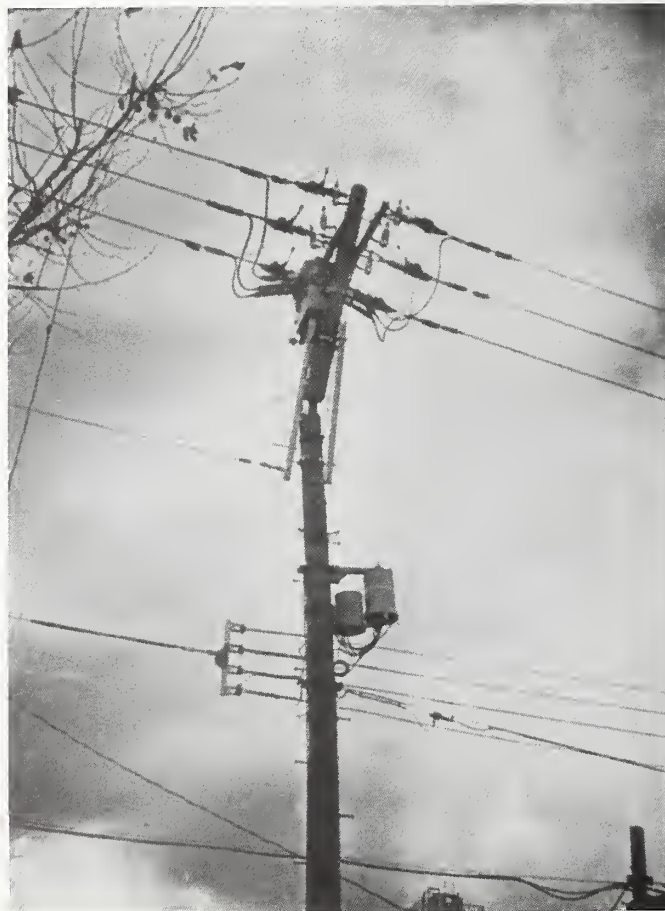
Figure 5.4.67 Damage to the aerial distribution system was severe in many regions.

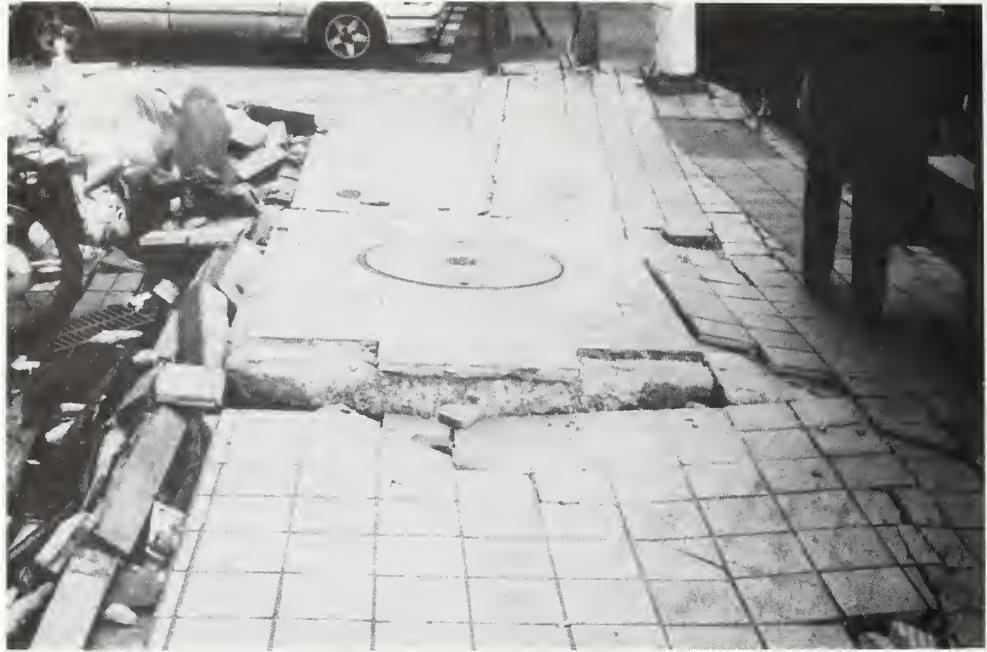
Figure 5.5.9 Conduits carried on bridges were damaged when bridge deck moved.

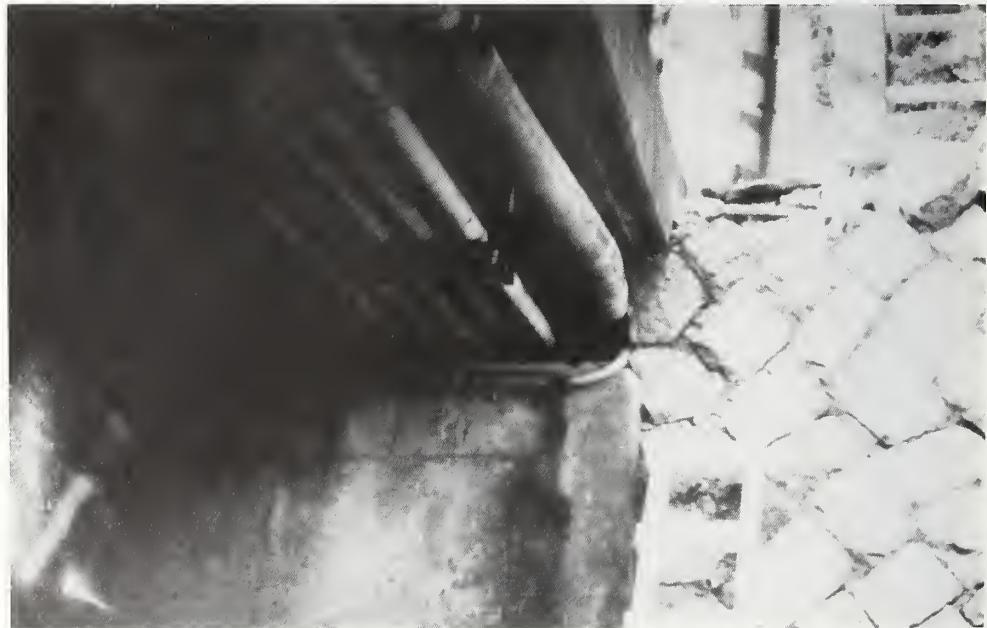
Figure 5.5.10 Large differential settlements in roadways can damage conduit and trunk lines.

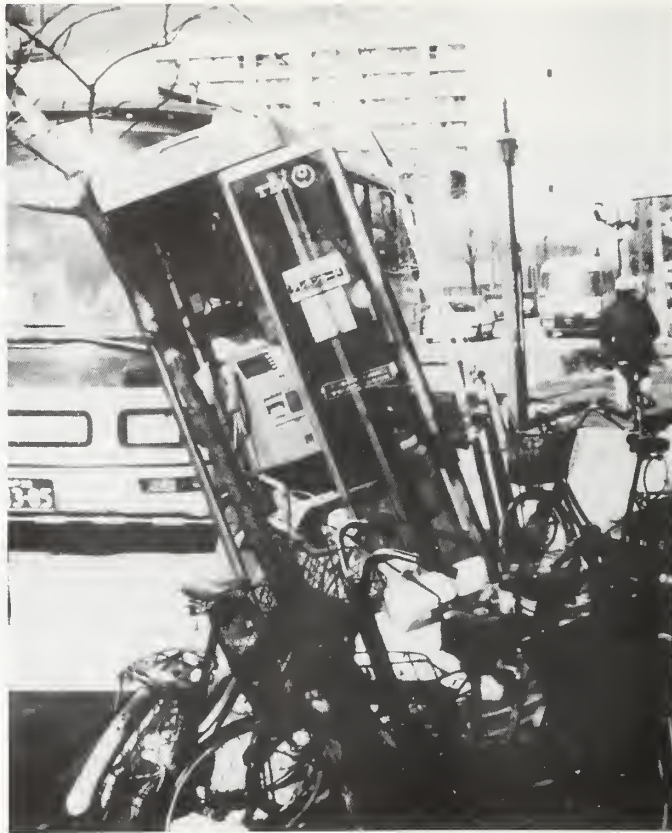
Figure 5.5.12 Soil instability damaged telephone booths.

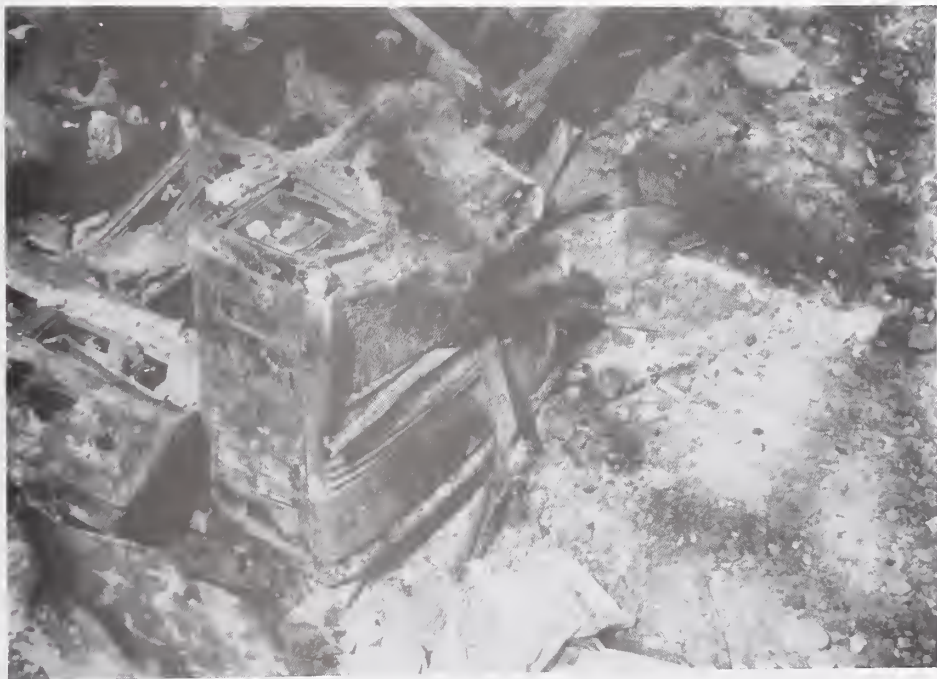
knocked down by the earthquake or torn from collapsed buildings creating potential arcing situations. Some electric lines were still connected to partially collapsed buildings (Figure 6.2.7). These lines may have stretched, creating a reduced cross sectional area of the wire, which could cause

ignition of a fire due to overheating. Insulation may have pulled away from the wires making short circuits or ground faults more likely. The majority of the fire damage occurred in areas of predominantly wooden construction which provided fuels to sustain and spread fires which ignited.

Figure 6.2.7 Example of electric power lines connected to a damaged house.

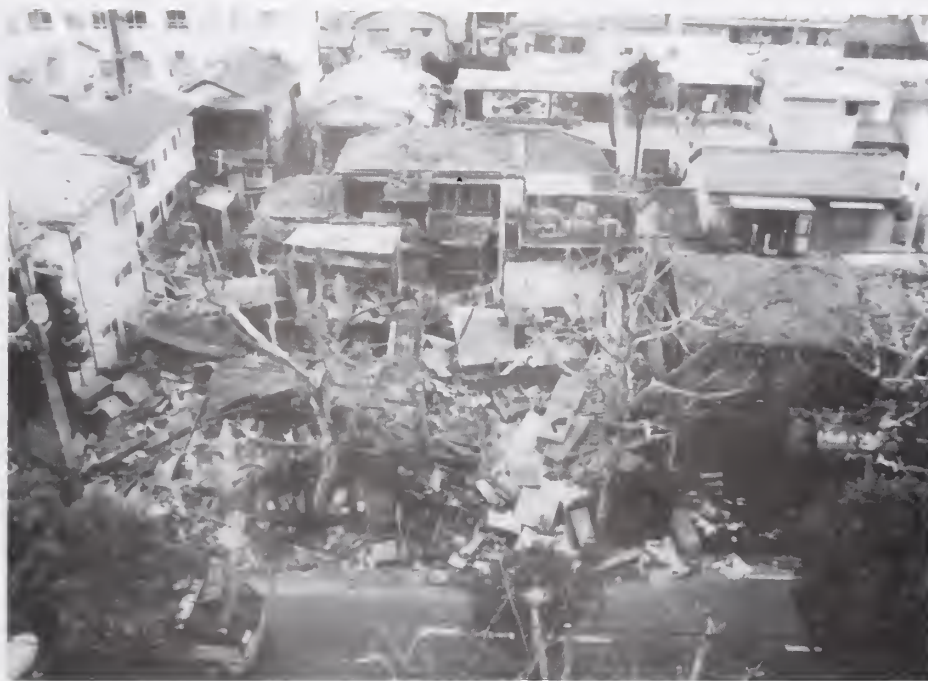
Figure 6.2.10 Collapsed structure across street.

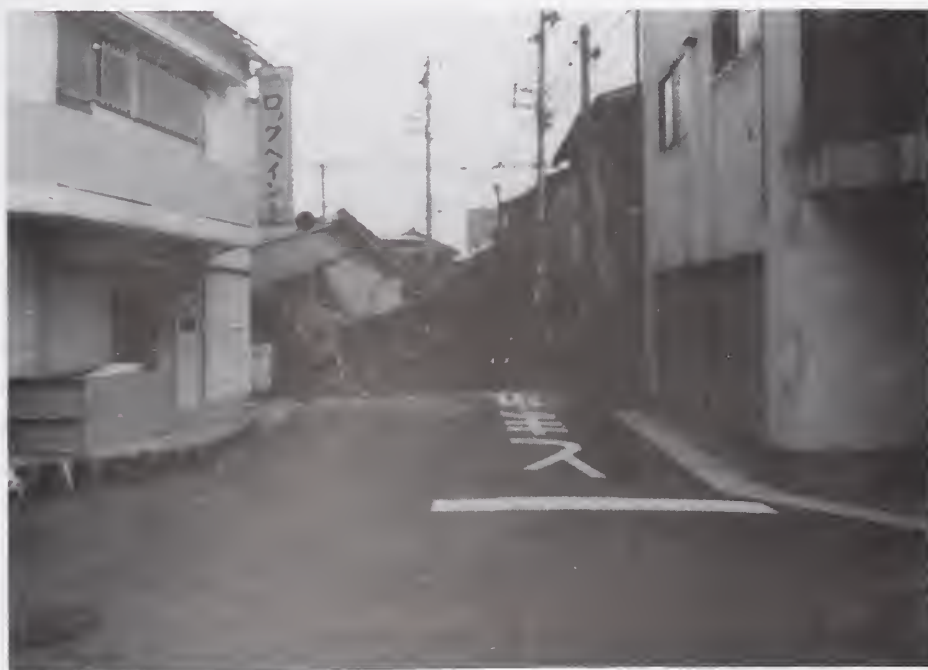
Figure 6.2.11 Parking area where automobiles contributed to fire spread between buildings.

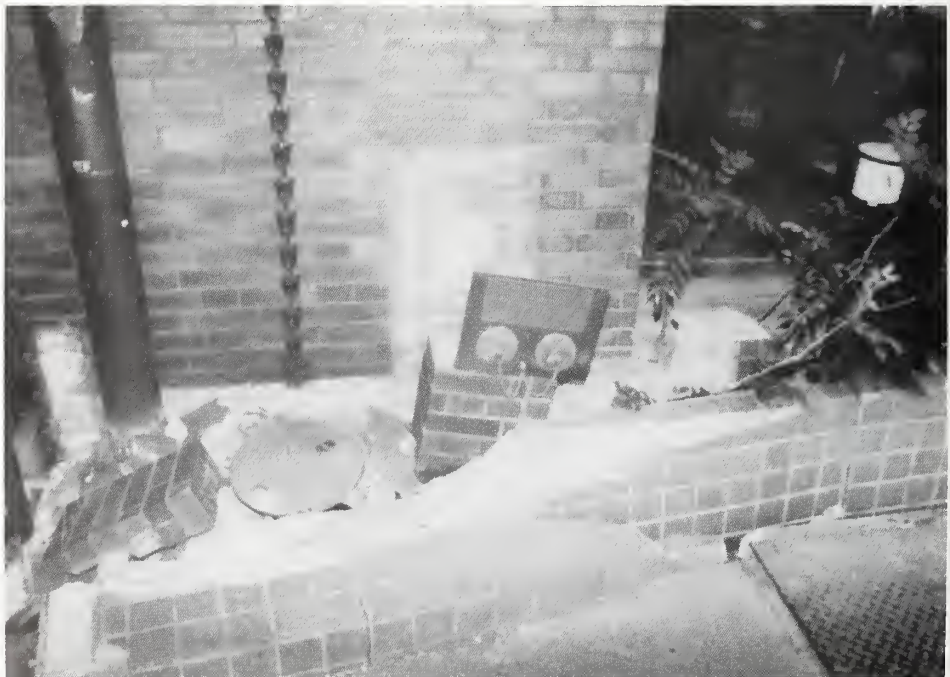
Figure 6.2.13 Example of okabe construction with portions of the fire resistive mortar displaced by the earthquake.

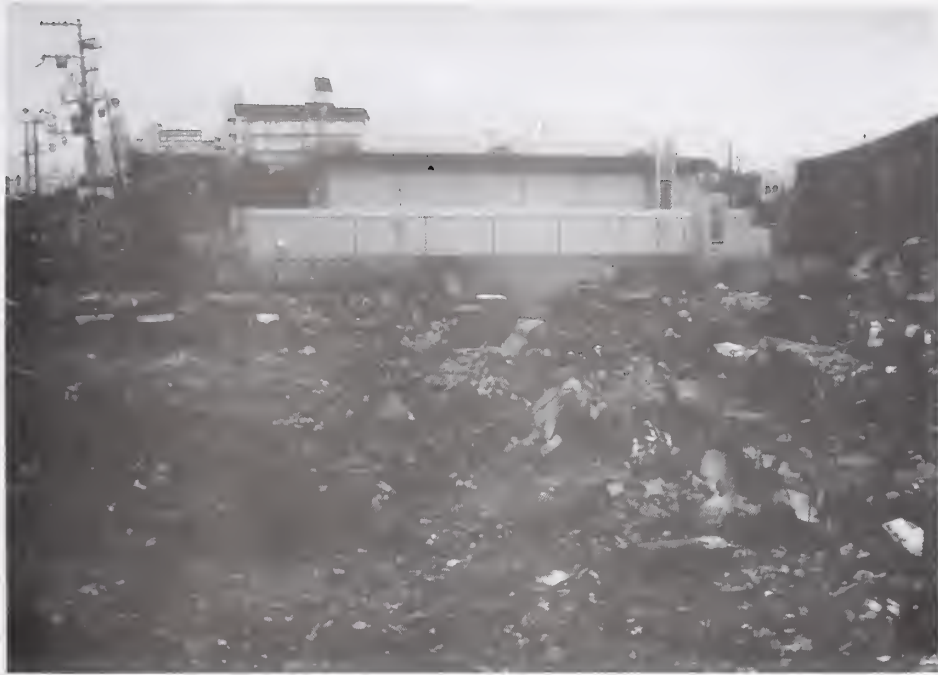
Figure 6.2.18 Burned out structure constructed from fire resistive materials.

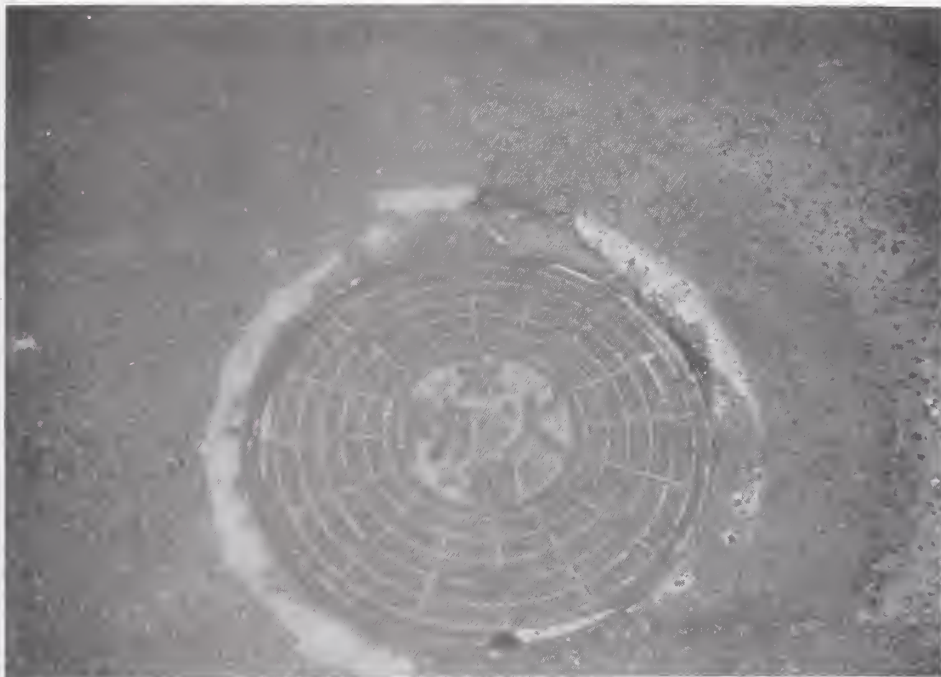
Figure 6.2.22 Access cover to unreinforced fire fighting water cistern .

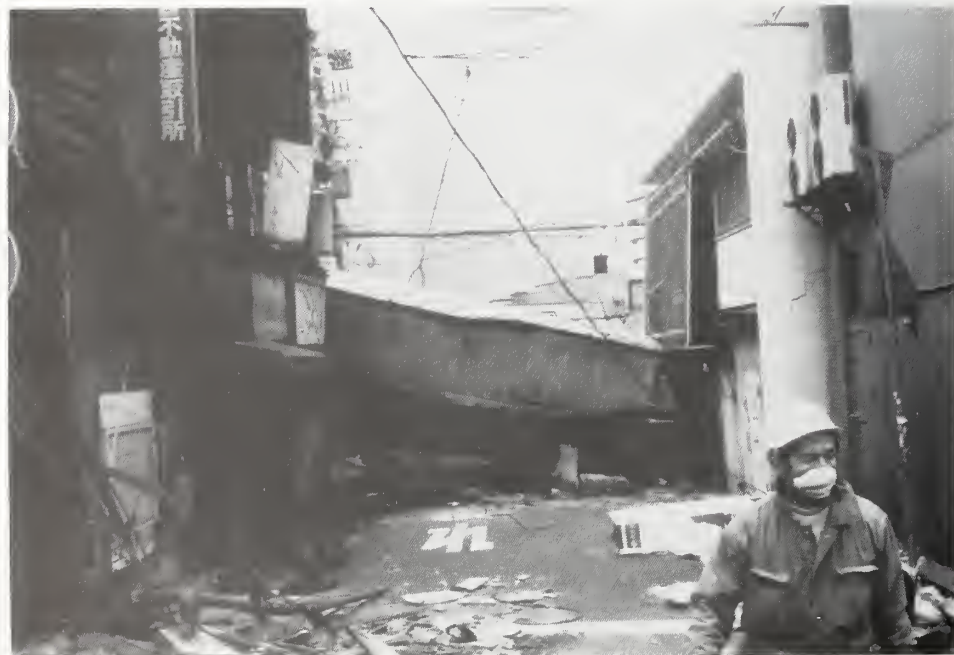
Figure 6.2.24 Road blocked by collapsed structure.

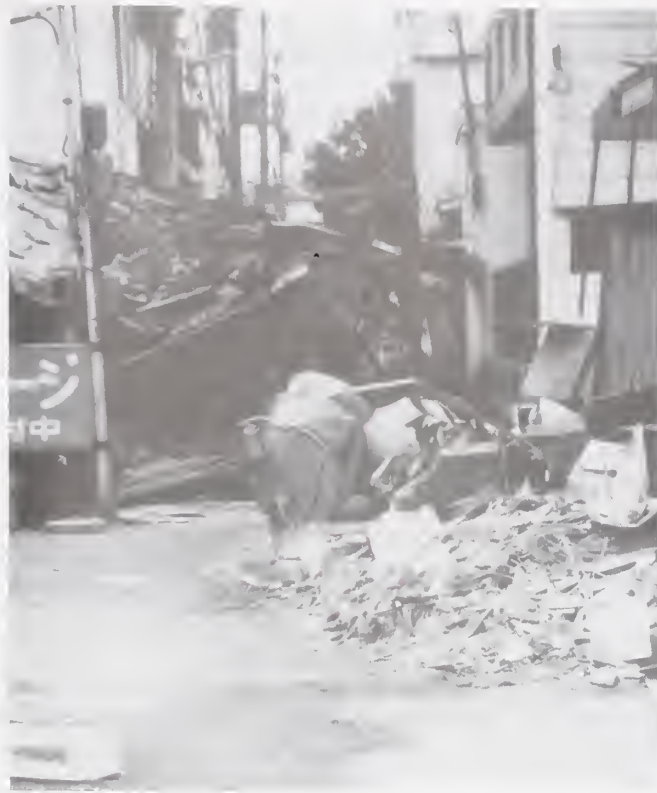
Figure 6.2.25 Road blocked by collapsed structure.

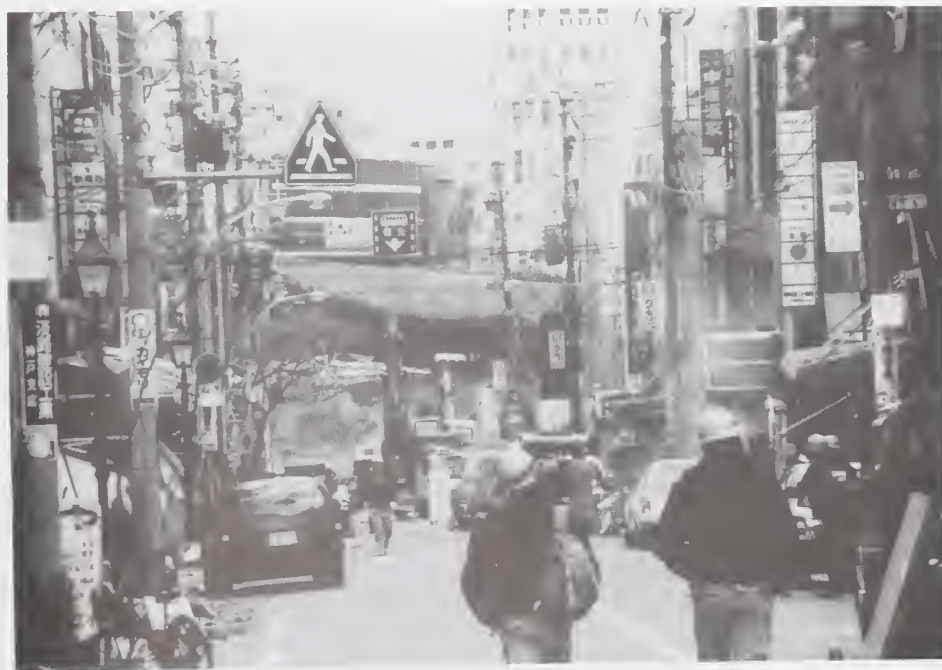
Figure 6.2.26 Collapsed train overpasses such as this one divided Kobe north and south.

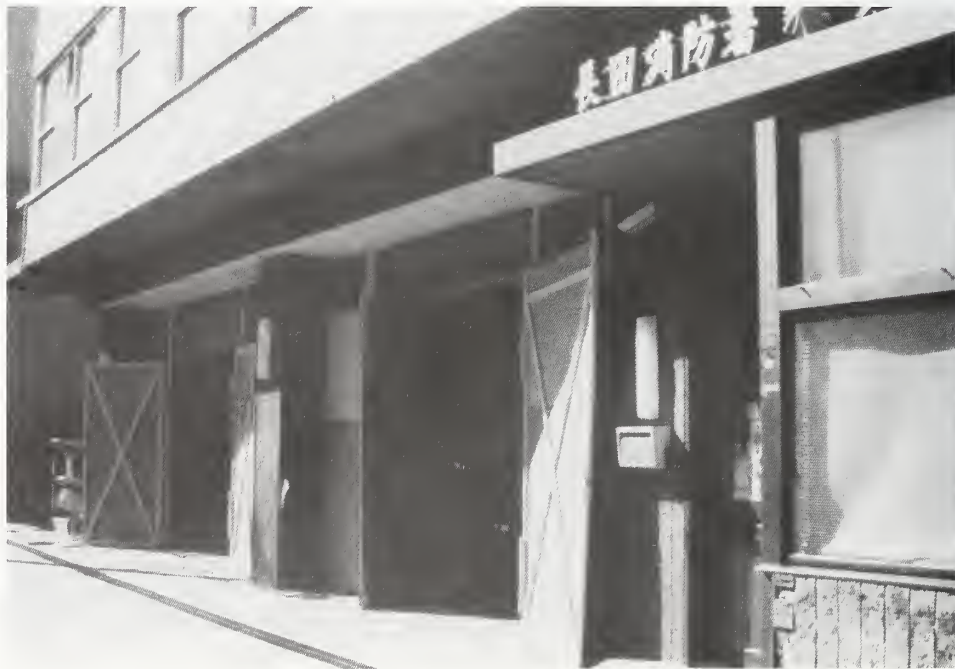
Figure 6.2.28 Fire station damaged by the earthquake.
