USDA FOREST SERVICE
RESEARCH PAPER INT-97
1971

INVESTIGATION OF SLOPE FAILURES IN THE IDAHO BATHOLITH

M. J. Gonsior and R. B. Gardner

INTERMOUNTAIN FOREST AND RANGE EXPERIMENT STATION
Ogden, Utah 84401

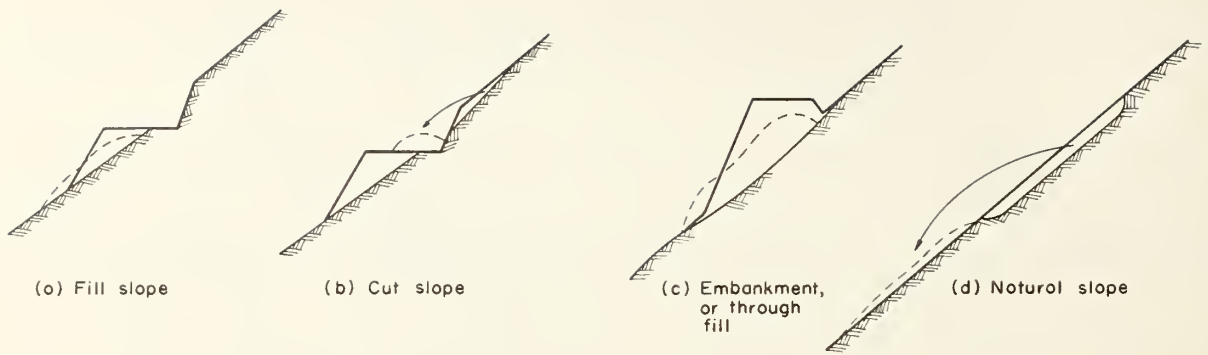
Figure 5.--Failure types.

A preliminary reconnaissance of the Zena Creek study area was made in May of 1967 to identify the extent and types of failures that occurred during the previously discussed 1965 storm event. As a convenience for analysis and discussion, four general failure types were identified, as shown in figure 5.

Based upon the preliminary reconnaissance, eight sites representing the three failure types shown in figure 5(a), (b), and (d) were selected for intensive study (i.e., fill-, cut-, and natural-slope failures, respectively). None of the embankment failures (c) were deemed amenable to analysis, but one stable embankment was selected for sampling and analysis. In addition, four other sampling sites were chosen for analysis of material properties representative of alluvial and bank slough deposits. All 13 sites are identified and briefly described in figure 4 and table 1.

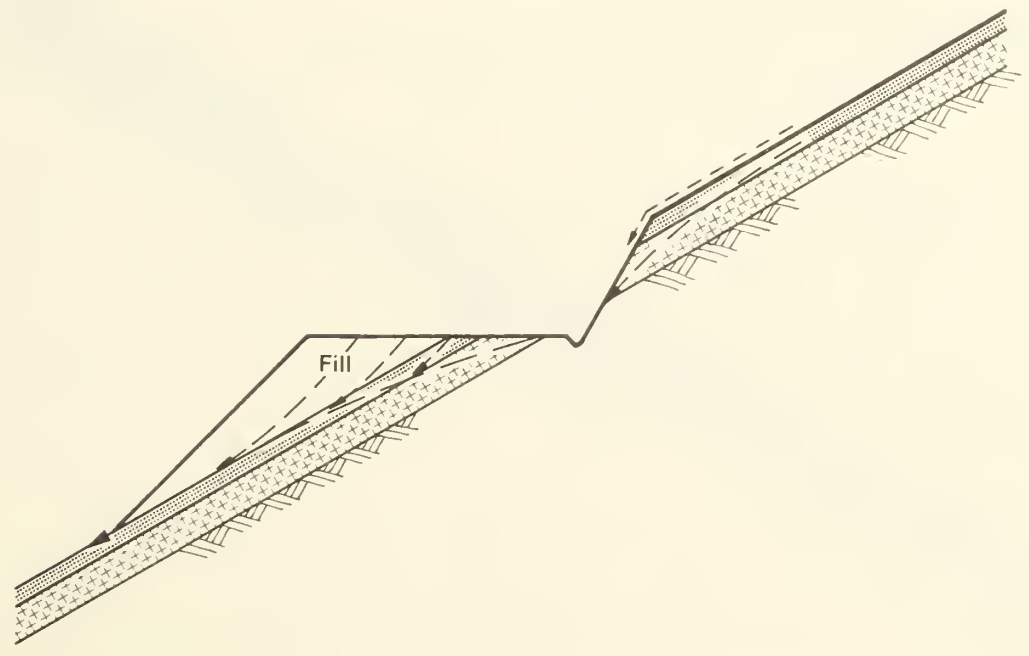
Figure 11.--Post construction profile and flow conditions.

When the natural slope is interrupted by a road prism, the subsurface profile appears typically as shown in figure 11. In this situation, part or all of the relevant flow is interrupted. Above the cut slope, under the most critical conditions, the top flow line is distorted as shown in figure 11. This distortion, or drawdown, is not so critical as would be the case if the top flow line could be maintained coincident with the surface of the slope. Hence, in analyses of the cut slopes, a conservative assumption that no drawdown occurs was used.

Of course, overland flow may be occurring simultaneously, as shown in figure 11, some of which is caused to seep vertically downward to reach the phreatic surface.

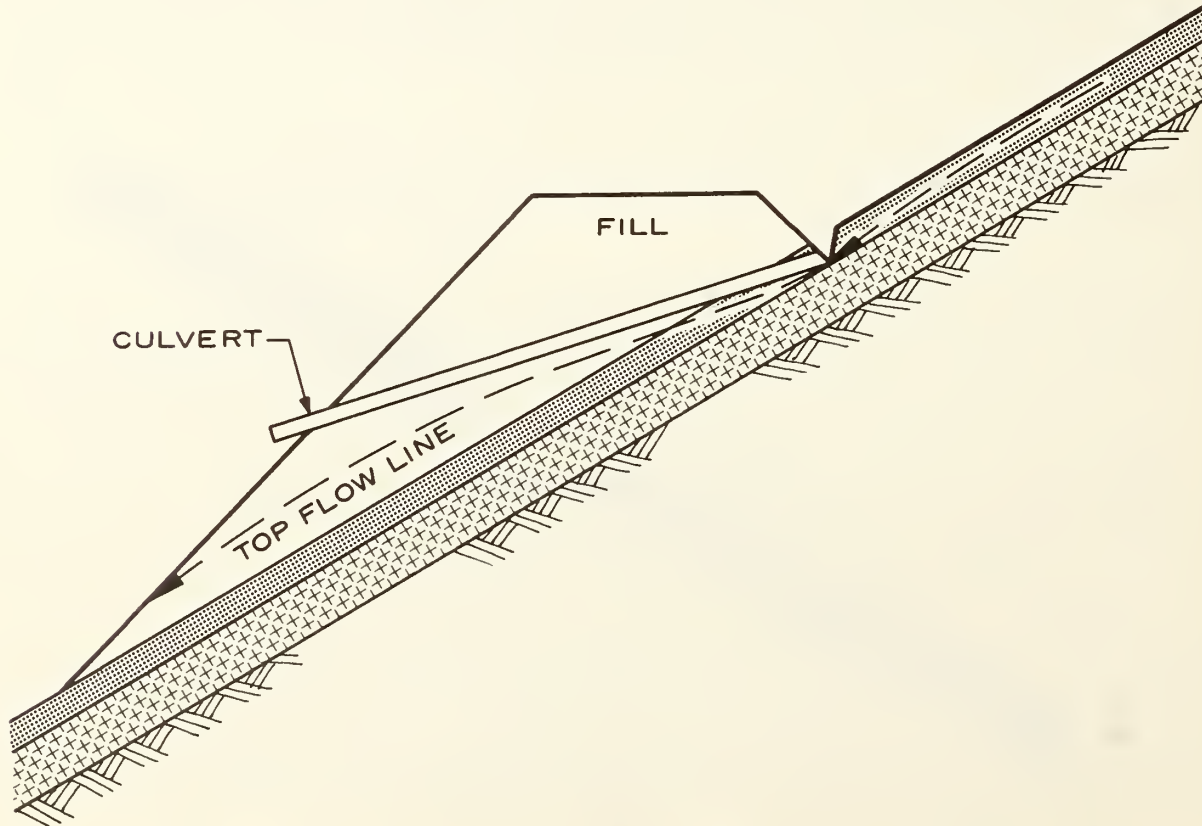
Figure 12.--Subsurface flow conditions for through fills.

Where an embankment or through fill crosses a draw, the situation can be represented as shown in figure 12. The culvert installation may interrupt part of the subsurface flow, thus causing some drawdown of the top flow line above the embankment. Below the culvert inlet, subsurface flow continues, and at some location downslope may again coincide with the ground surface. It is possible for the top flow line to rise above the original ground surface and into the fill material immediately downslope from the culvert inlet. Thus, a conservative assumption in such a case would be one in which the embankment was considered as an earth dam; furthermore, this "dam" would have a free water surface upslope at the elevation of the culvert entrance, and tail-water elevation at the toe of the downstream slope.

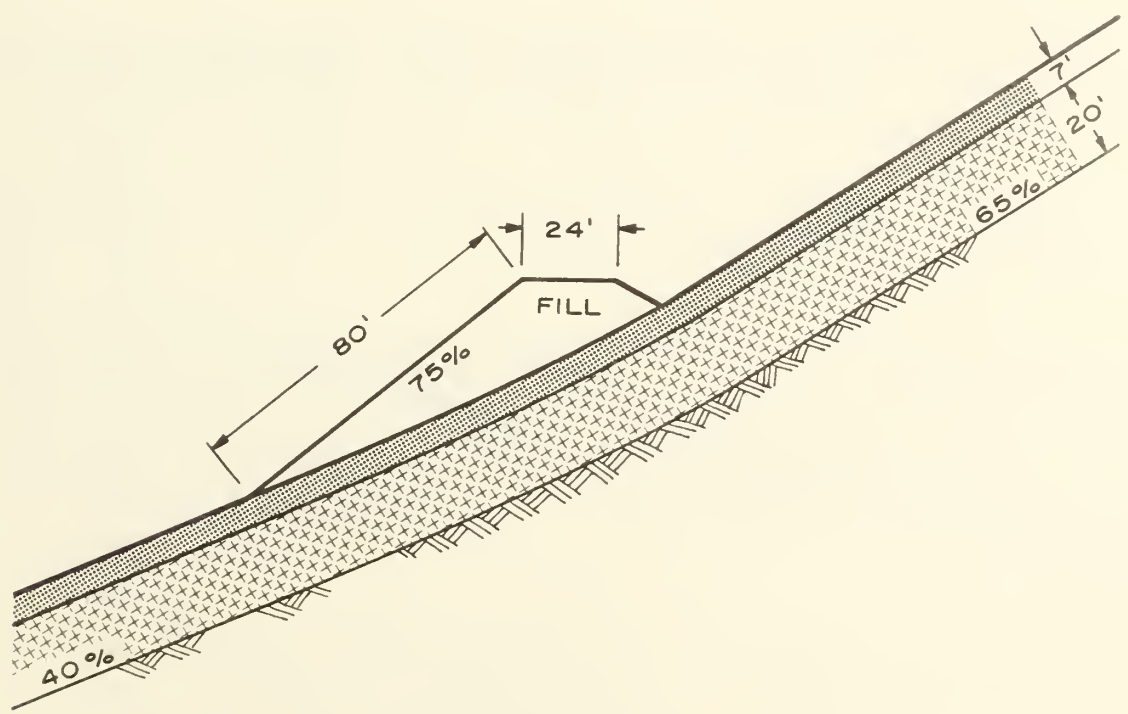
Figure 16.--Representative profile, site 917-1.

Based upon the data available, a representative profile of this site is shown in figure 16.

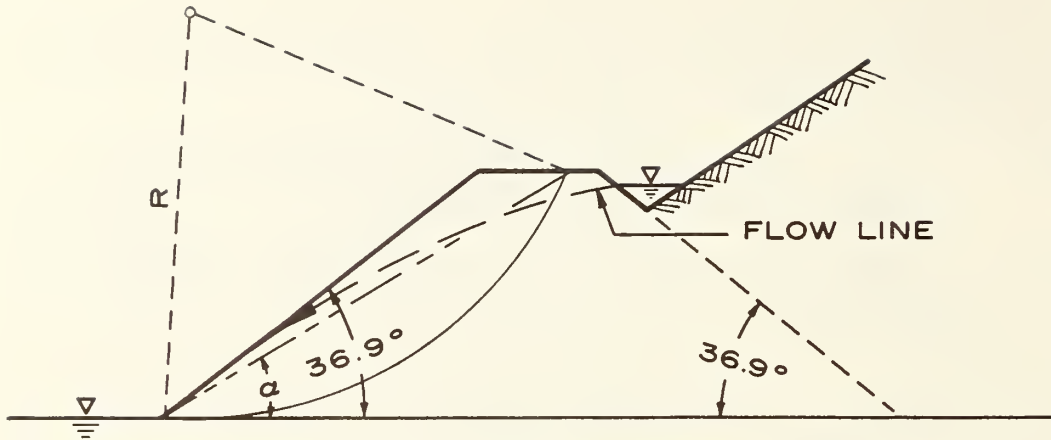
Figure 17.--Assumed conditions for L. Casagrande solution at site 917-1.

A conservative analysis can be performed by assuming a plugged culvert and subsurface flow as shown in figure 12. In this analysis, the L. Casagrande solution for the top flow line through a triangular dam is used² (see Taylor, p. 181). It is arbitrarily assumed that the upstream and downstream slopes of the dam are equal. Figure 17 depicts the assumed cross section.

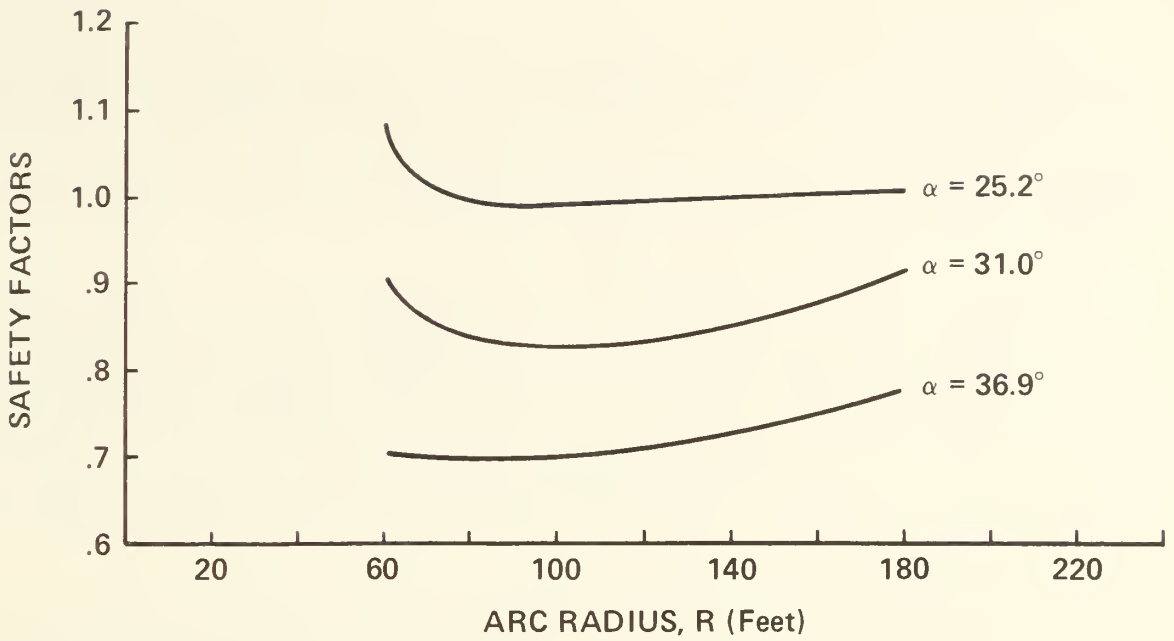
Figure 18.--Safety factors vs. arc radius, R, for conditions given in figure 17.

A series of analyses were conducted, assuming circular failure arcs and using the method of slices. In all cases, failure arcs were assumed to pass through the toe of the fill slope. The material above the top flow line was assumed to weigh the same as that below the top flow line, or 134 p.c.f. The results of these analyses, assuming that $c = 0$ and $\phi = 35^\circ$, are shown in figure 18 and, alternatively, in figure 19, wherein the parameters R and α are as shown in figure 17. Safety factors significantly lower than 1.0 are noted in figures 18 and 19. Three major conclusions can be drawn from these analyses:

- (1) The assumed friction angle of 35° may be too low.
- (2) The material actually possesses a minimum cohesive strength, even when saturated.
- (3) The assumed seepage conditions are significantly more severe than would ever arise naturally.

Although the effective friction angle in the field may exceed 35° , it is believed that the angle stated in the first conclusion is a reasonable estimate based upon the consistency of the laboratory results. Further, where the safety factors are as low as 0.7, a friction angle of 45° would be necessary in the absence of cohesion to increase the safety factor to 1.0. It seems inconceivable that the estimate of the friction angle would be this much in error.

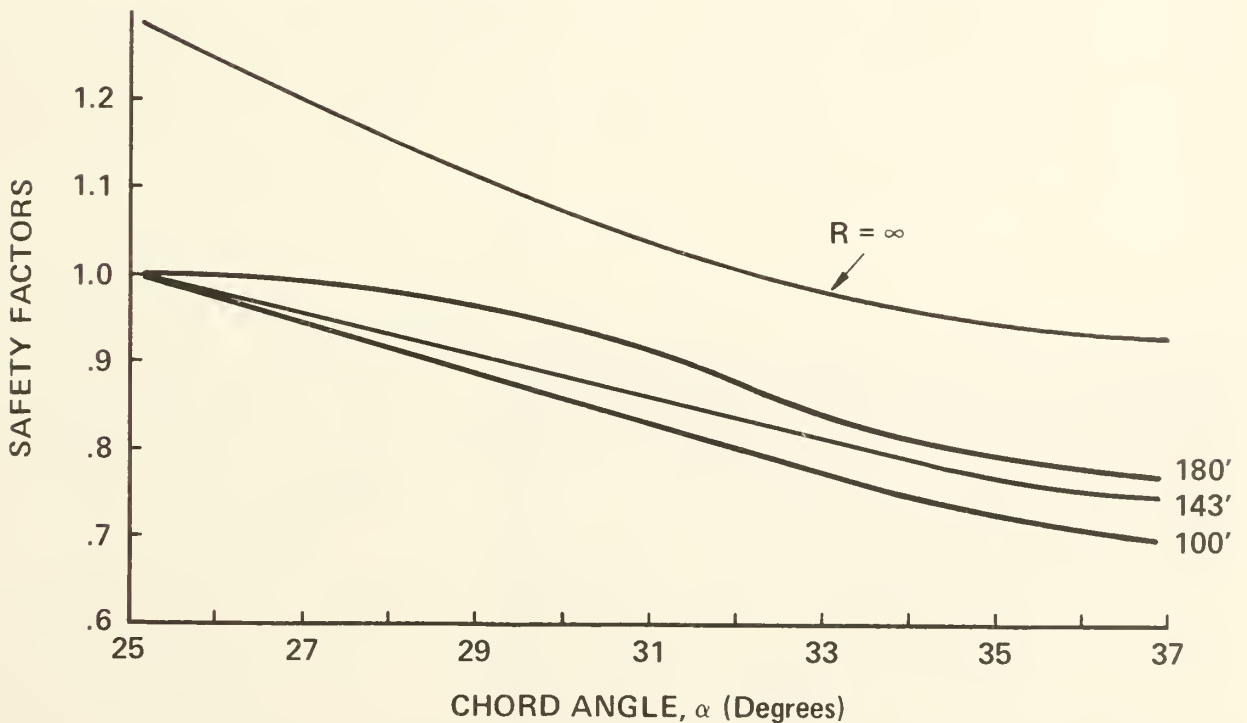
Figure 19.--Safety factors vs. arc chord angle, α , for conditions given in figure 17.

With regard to the second conclusion, it seems possible that this material may possess sufficient cohesive strength, even when saturated, to assure stability at this site. The computed maximum cohesion required for a safety factor of 1.0, among all of the trial failure arcs, was only 175 pounds per square foot (p.s.f.), or about 1.2 pounds per square inch (p.s.i.), assuming $\phi = 35^\circ$. Thus, although it has been concluded that no cohesive strength should be used for design purposes, it must be recalled that even in the saturated triaxial tests on loose material, a cohesive strength of 1 p.s.i. was estimated. Obviously, therefore, some moderate cohesion, combined with a slightly greater estimate for the friction angle, would assure computed safety factors in excess of 1.0 for all the trial failure arcs in this analysis.

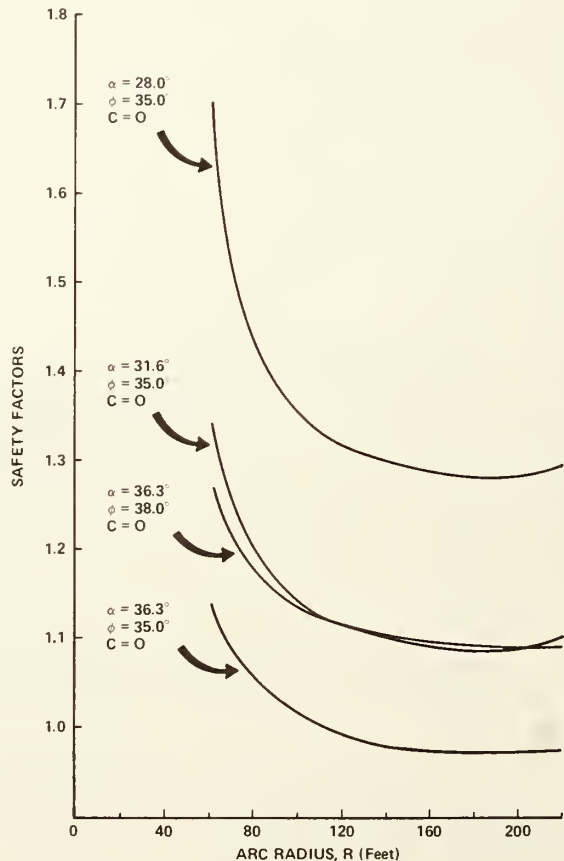
Figure 20.--Safety factors vs. arc radius, R , without seepage for site 917-1.

The third conclusion is undoubtedly correct. There is no evidence that the culvert has ever become plugged at site 917-1. Even in the event of such an occurrence, it is doubtful that a stable seepage condition as severe as that assumed in these analyses would arise. However, since the exact flow pattern cannot be predicted, a series of analyses were conducted assuming no seepage. This was done in order to establish a minimum upper limit for the safety factors at this site. The results of these analyses are shown in figure 20, where the parameters R and α are as defined in figure 17.

Again, it is noted that either the friction angle (ϕ) or cohesion (c) has been underestimated, since safety factors less than 1.0 were calculated. In these analyses, an estimated cohesive strength of 1.0 p.s.i., or 144 p.s.f., would have resulted in a minimum computed safety factor of approximately 1.4.

To evaluate the influence of error in the estimate of ϕ , a series of analyses, again assuming no seepage, were conducted with $\phi = 38^\circ$, $c = 0$, and $\alpha = 36.3^\circ$. The resulting safety factors are shown in figure 20. Thus, only moderate increases in either ϕ or c , or in both ϕ and c , result in computed safety factors indicating stability.

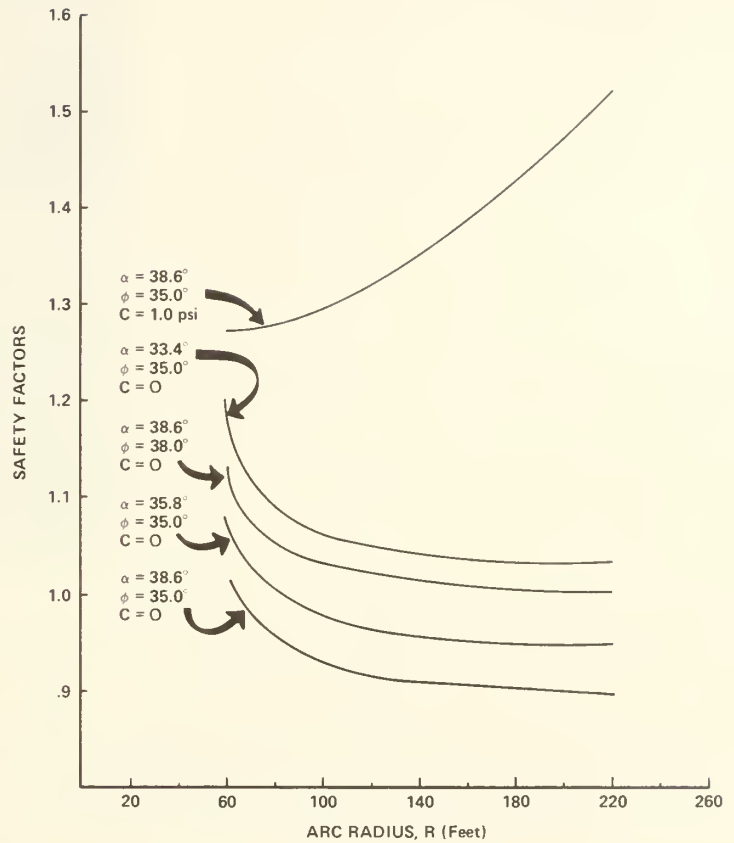
Figure 25.--Safety factors vs. arc radius, R, for site 917-3, with zero boundary neutral stresses.

Apparently the incipient failure surfaces, as is the scar left by the narrow failure, are at relatively shallow depths below the fill slope. Ignoring for the moment any water infiltrating from the road surface, the ground water conditions represented by figure 11 would seem to have minimal influence in the outer portion of the fill where failure occurred and is impending. To evaluate the accuracy of the laboratory estimates for ϕ and c , a series of analyses were conducted assuming circular failure arcs, with an assumed saturated unit weight of 125 p.c.f., but without excess boundary neutral stresses along the failure arc. (From table 2, test pits 917-3-1 and 917-3-3, an average dry unit weight of 100 p.c.f. and $e = 0.66$ provides for a saturated unit weight of 125 p.c.f.). The analyses were made under the condition that all failure arcs passed through the toe of the fill slope, where the fill slope was 70 feet in length and at a slope of 38.6° (profile A-A).

and 38° , respectively. Under the extreme condition that would permit seepage throughout the fill, with a top flow line coincident with the fill slope, the necessary developed cohesion values would be 0.83 and 0.75 p.s.i. for $\phi = 35^\circ$ and 38° , respectively. Such an extreme seepage condition seems unlikely at this site, although it has already been noted that water collected on the road at this location. It is possible, however, that water infiltrating from the road surface combined with the ground water, resulting in emergence of the water at some location above and near the toe of the fill slope. A subsequent "blow out," or quick condition might have occurred locally, and the resultant loss of support at the toe would have allowed the upslope material to slide.

In any case, the analyses of this site and of site 917-1 seem to indicate that a more realistic value for the friction angle in this material might be about 38° .
