RAILROAD ACCIDENT REPORT

HEAD-END COLLISION OF
AMTRAK PASSENGER TRAIN NO. 74
AND CONRAIL TRAIN OPSE-7
DOBBS FERRY, NEW YORK
NOVEMBER 7, 1980

NTSB-RAR-81-4

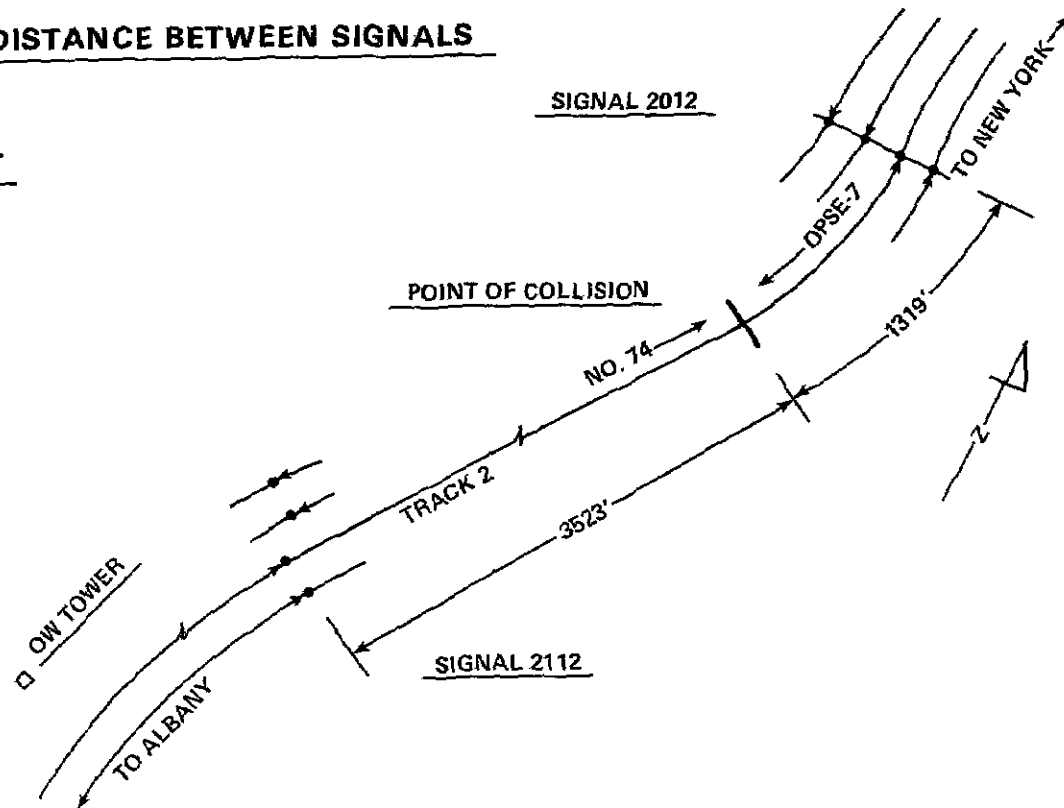
Figure 1.—Sketch of track alignment.

train order to run OPSE-7 westward against the current of traffic on track No. 2, by train order, to the OW interlocking station at Tarrytown, New York; and hold it at OW until the upper Hudson Line dispatcher could take the train when it would not delay the westbound commuter trains.

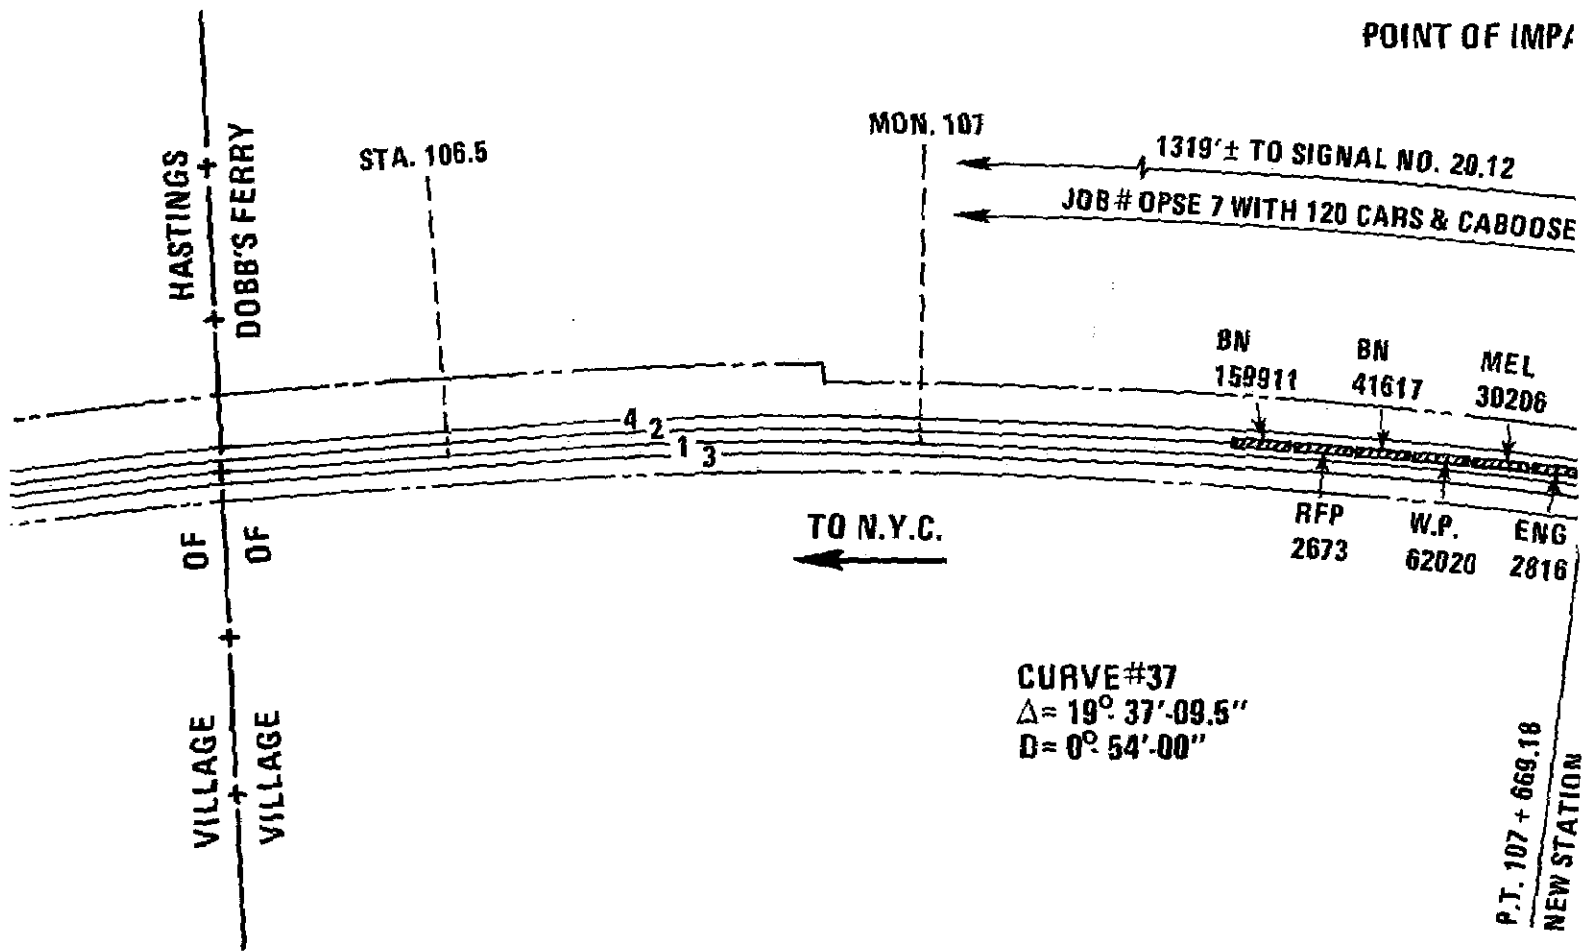
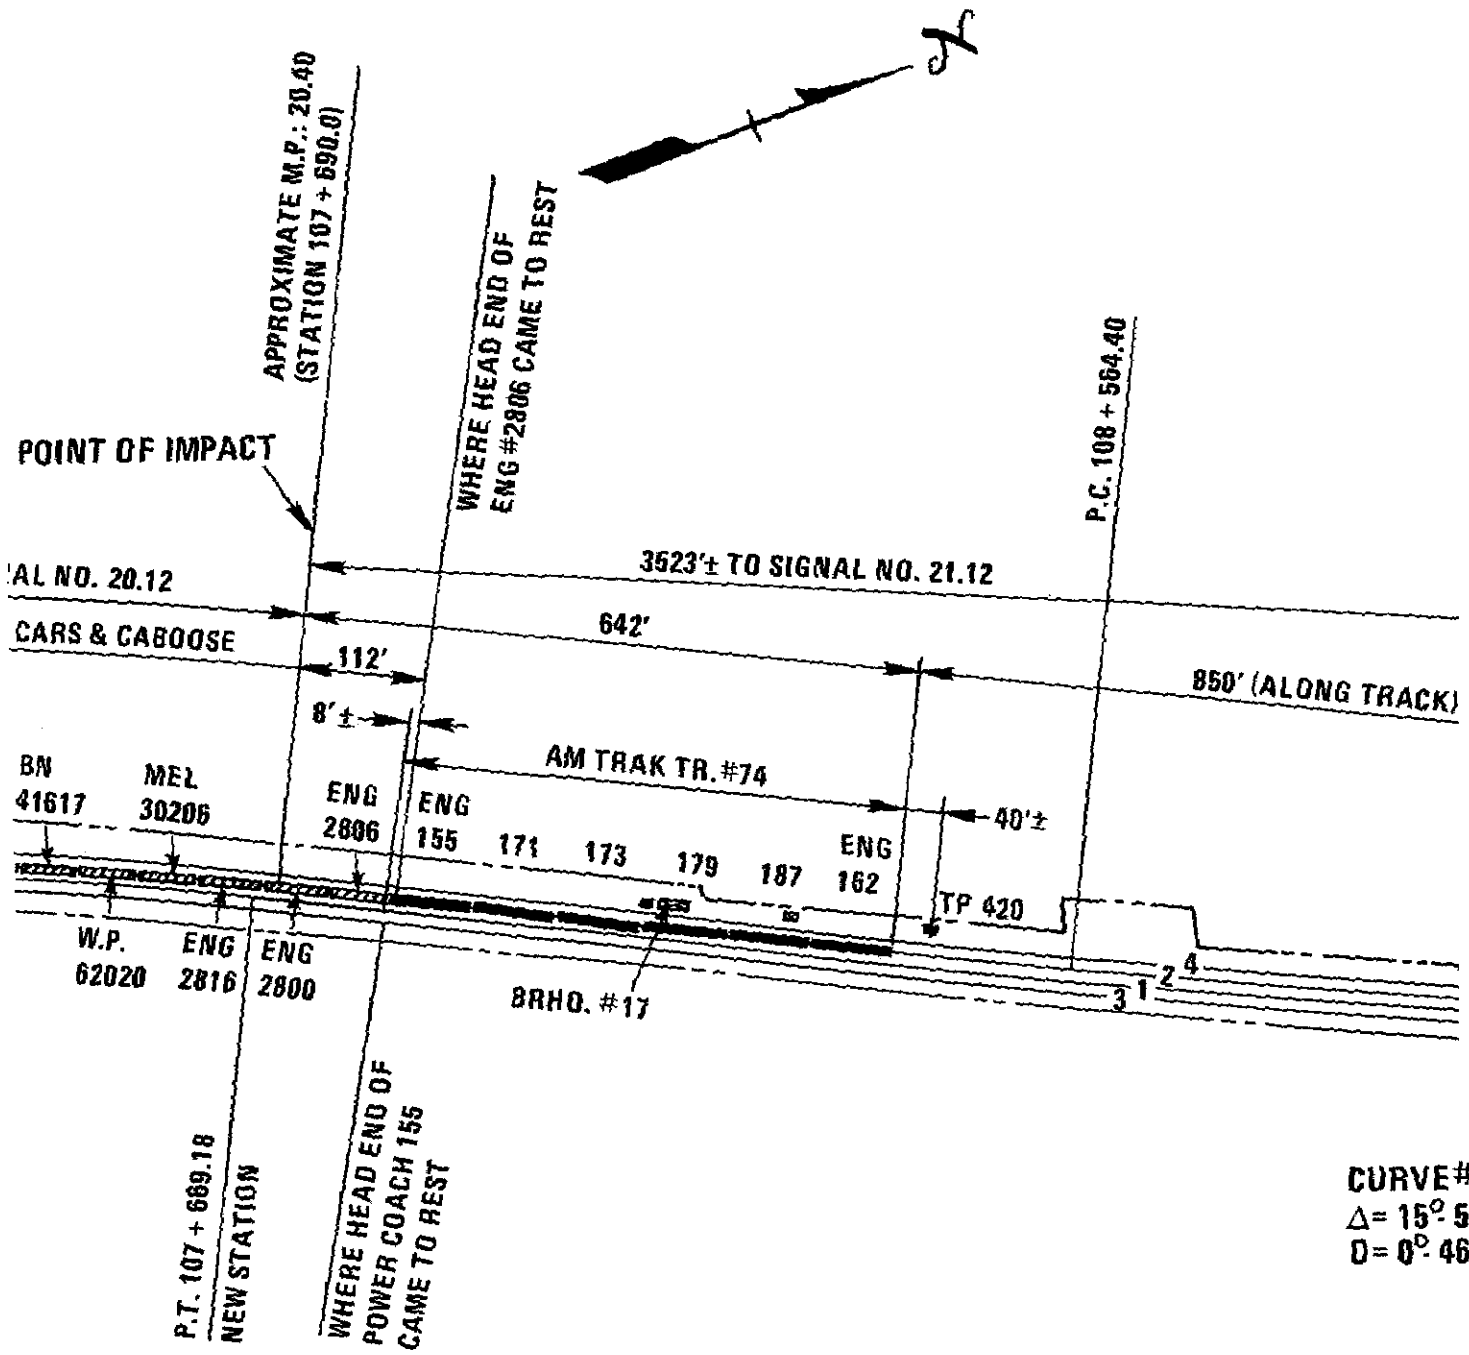
Figure 3. -- DOBBS FERRY ACCI

Moments later, OPSE-7 collided with standing train No. 74 at about 10 mph. The impact derailed the lead unit of OPSE-7 and pushed train No. 74 rearward about 112 feet, derailling the lead power car (see figure 2) and the following three passenger cars. (See figure 3.) Electrical power to the four tracks was shut off after a crewmember boarded the cab of the rear power car and used the radio to request that the power be shut off because of the collision and because passengers were getting onto the tracks. An employee of a restaurant adjacent to the accident site immediately called the Dobbs Ferry Police Department. Within 3 minutes after the accident, emergency forces began to arrive at the accident site.

POINT OF IMPA

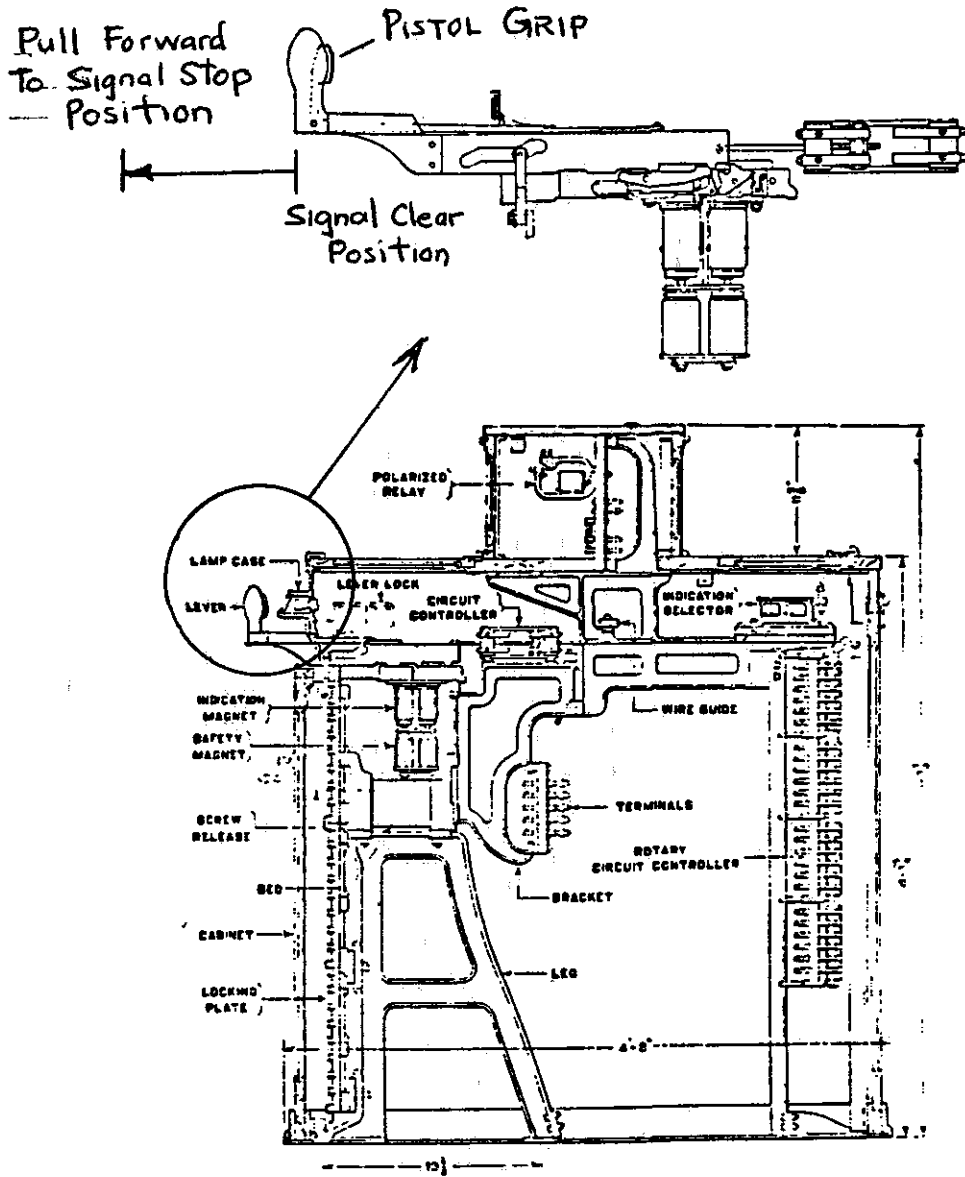
Figure 6.-- Unit lever-type machine.

The OW interlocking tower has a unit lever-type machine. (See figure 6.) The machine is equipped with 56 hand-operated levers: 33 levers control 34 signals; 19 levers control 20 switches, 3 levers control 4 electric locks, and there is 1 spare lever. The levers are a pistol grip-type which can only be moved by depressing the trigger in the handle. (See figure 6.) The blocking devices are metal boxes with opened ends.
