PHYSICAL PROTECTION WORKBOOK

SHEPHARD SITE-PHASE III

(AR-NM-01-829) ALBUQUERQUE DISTRICT

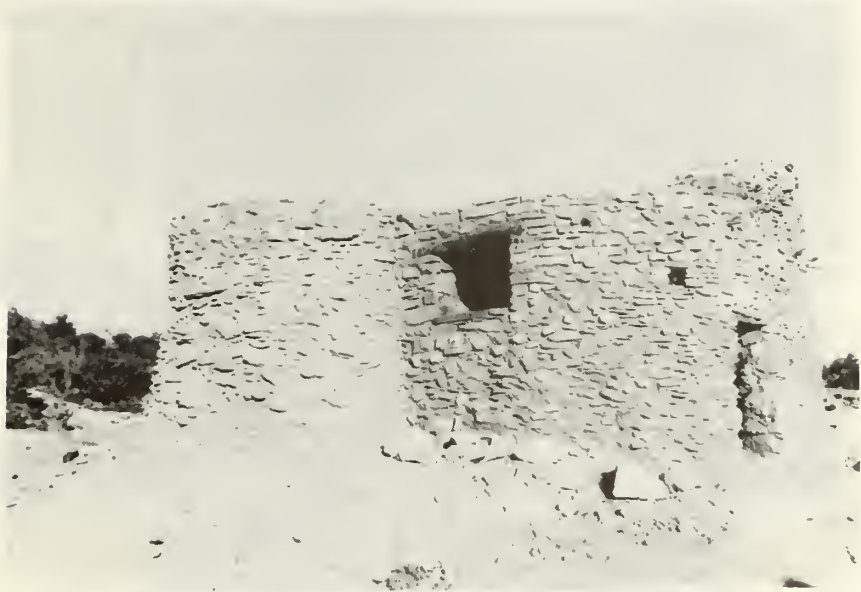
"After" stabilization; the south facing walls of CM-38. (looking northwest)

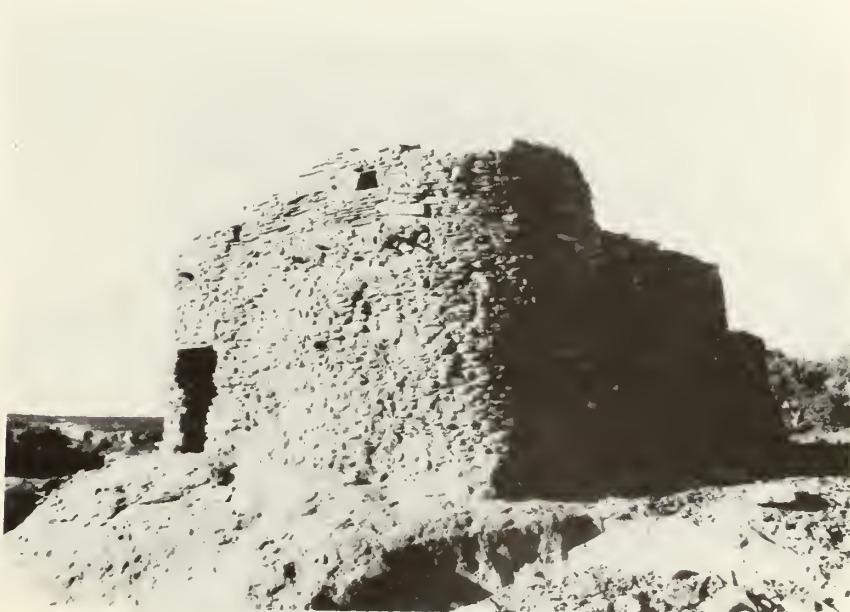
"After" stabilization; the north facing walls of CM-38. (looking southwest)

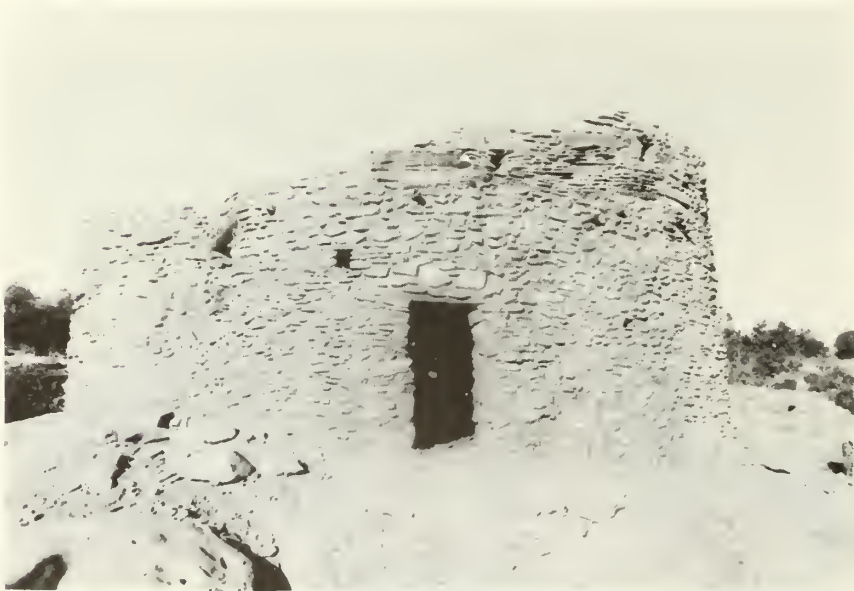
"After" stabilization; the east facing walls of CM-38. (looking west)

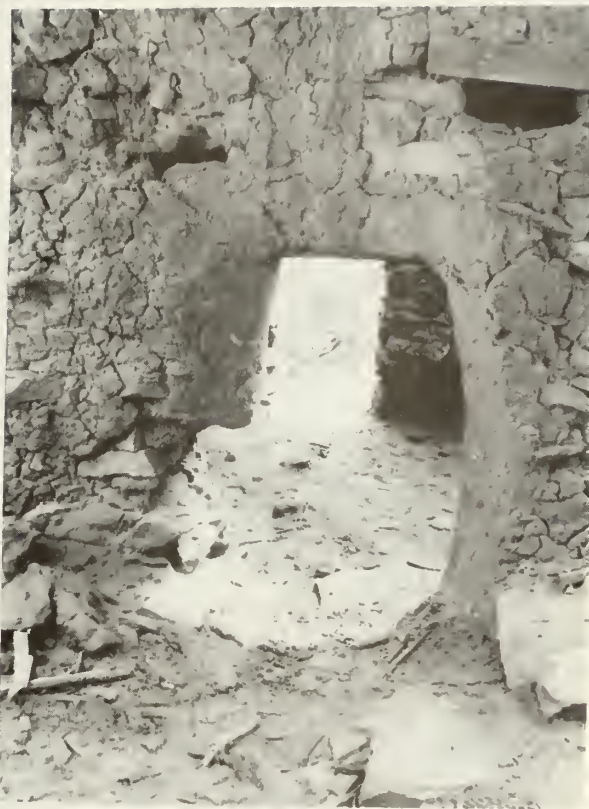
"Before" shot of the doorway
connecting rooms 1 and 2. Note how the
side of the door is eroding out.
(looking east from room 2)

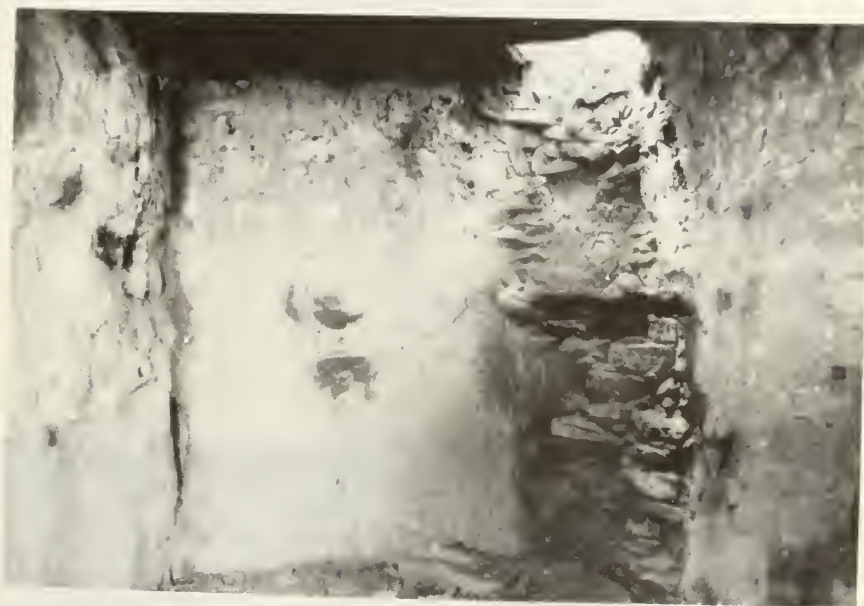
"After" stabilization; the hooded
fireplace. Note the dark areas of
grout on the interior walls.
(looking north)

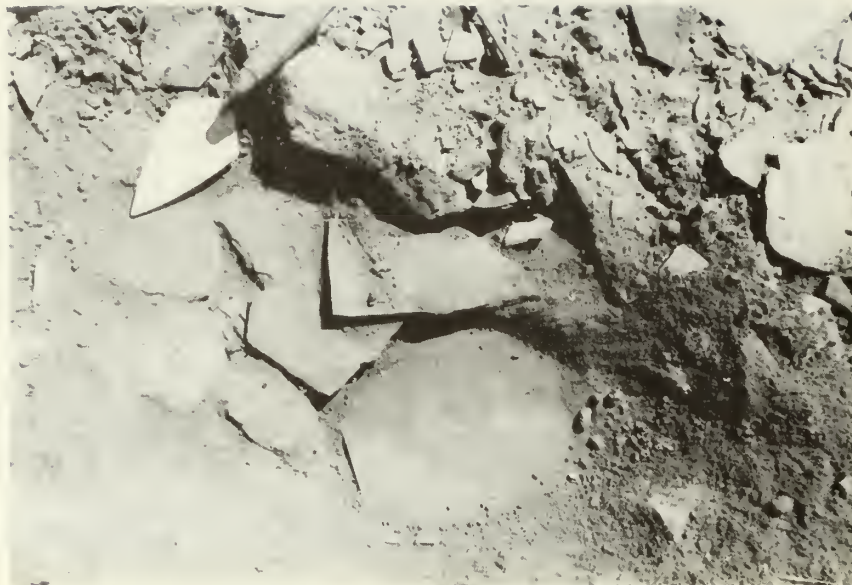
"Before" shot showing the original
slab sandstone roof surface of
room 1.

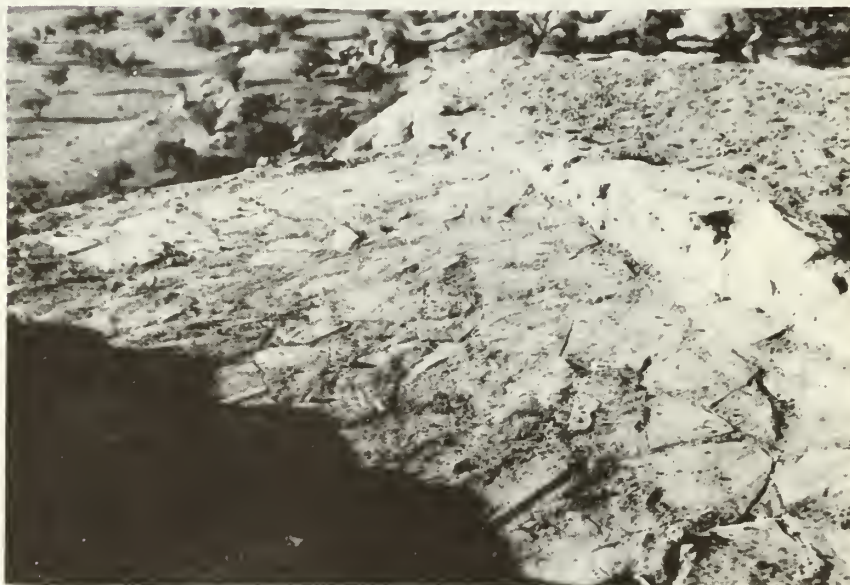
"After" stabilization; the
reconstructed section of the roof on
room 1. Note the sandstone slabs on
the roof surface. (looking southwest)

Two new vigas were added to fill the missing gap, so that the first 2 vigas to the south are new and the remaining 10 are original. The roof was then cleared of about 8 inches of dirt and rock down to the juniper bark covering. Stones that were once part of a chimney around the smoke hole were grouted. Split wood slats were made from dead wood in the site vicinity and layed over the vigas on the missing patch of roof. A layer of juniper bark was added next and then a sheet of .006 inch black polyethylene plastic to seal the roof. A 4 inch layer of mix 2 was placed over the plastic. Flat slabs of sandstone were set into the mud to match the original roof style. The roof was sloped to drain to the east out the drain provided in the parapet wall. The chimney hole was plugged to protect the walls below. This roof will adequately protect all interior features so that spraying with stabilizing spray, F-325, was not necessary.

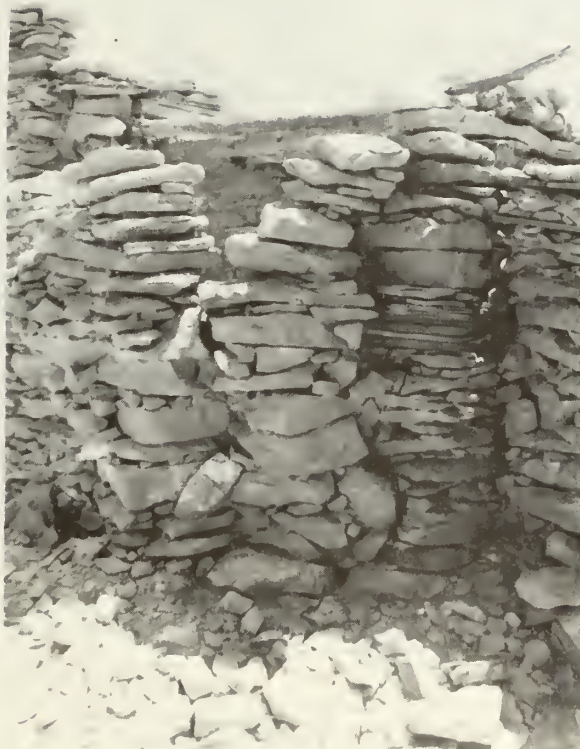
"Before" shot of the poor construction
in corner joint of room 2.
(looking southeast)

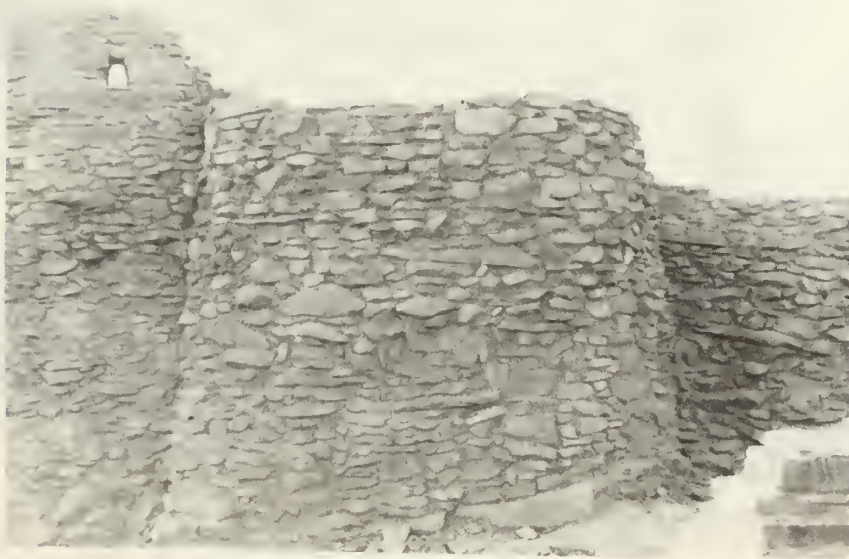
"After" stabilization; the north wall
of room 2. The wall has been built up
to accommodate the reconstructed roof.
(looking south)

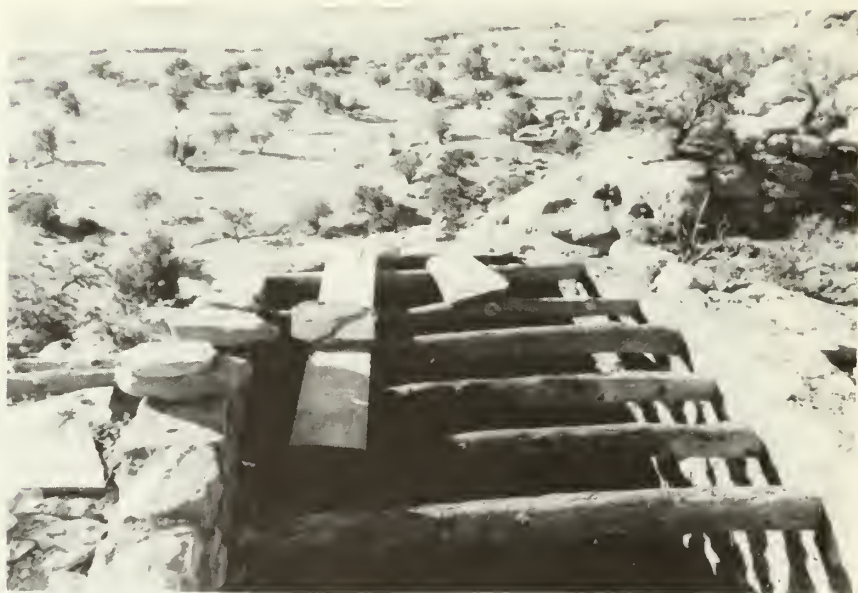
Clearing away the original roofing and
building up the walls.
(looking south)

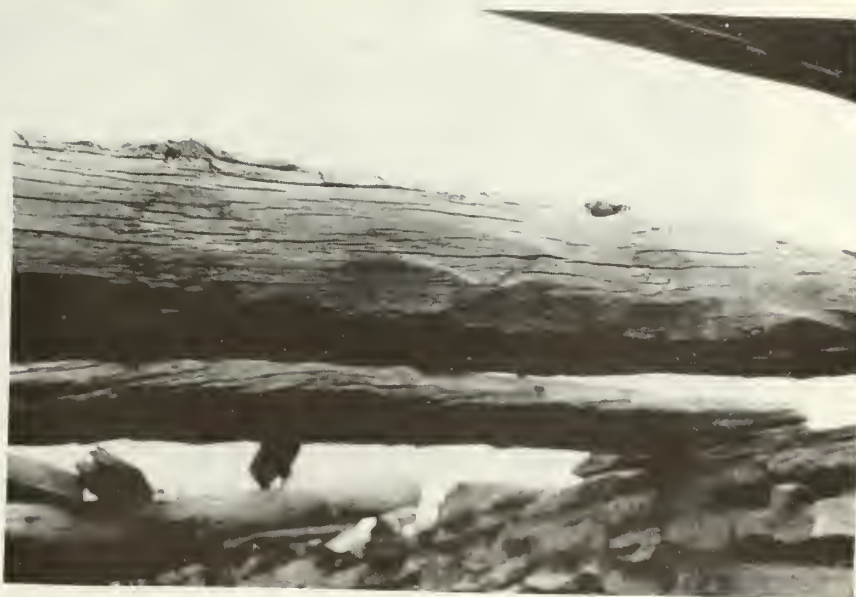
Close-up of an original viga showing
trimming scars which may have been made
by a metal ax. (looking south)

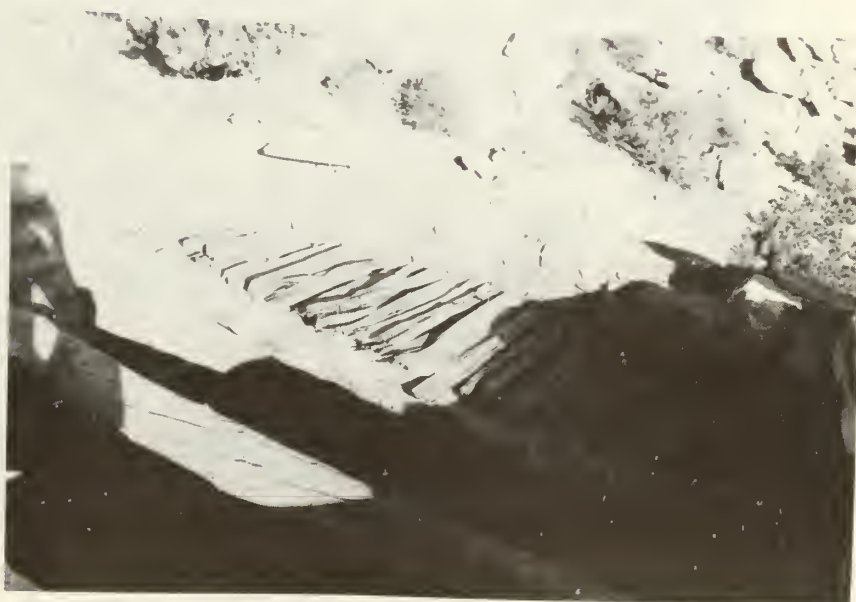
Adding the split wood latillas
transverse to the vigas during the
reconstruction of the roof on room 2.
(looking north)

Six new vigas were cut from dead wood in the site vicinity. These were used to fill gaps and replace original vigas. The resulting pattern has numbers 1 and 2 vigas to the south as new vigas, the third viga is new, replacing a weakened original; 4, 5 and 6 are original vigas; 7 and 8 are new vigas; 9 and 10 are original vigas, and number 11, the last viga to the north, is a new viga. Original vigas were rotated placing the bowed or arched areas upward. As mentioned, these vigas were set into the wall and the wall built about 10 inches over them. The ends of the first row of latillas, or split wooden slats layed over the vigas, were set into the north and south walls and extended to rest on the nearest viga. The rest of the vigas were then covered with these split wooden slats which were layed orientated in a north-south direction. The vigas are aligned east-west. Over the wooden slats, about

about 1 inch layer of juniper bark was spread in imitation of original roof construction. The wooden slats were split from dead wood in the site vicinity. Juniper bark was also gathered in the site vicinity and could be pulled off in long shreds from the rest of the tree. Gathering only a moderate amount of bark from a given tree prevented damage to the tree. Upon the bark a .006 inch sheet of black polyethylene plastic was layed to seal the roof from moisture. Over the plastic a 4 to 5 inch layer of stabilized adobe was added using mixture number 2. This completed the roof reconstruction. A 2 foot square hatch was left between the ~~third~~ and fourth vigas centered in the middle of the roof to facilitate in the removal of fill from the floor of Room 2 in the event of any future excavation. The hatch was covered with rocks and filled with dirt. In the process of drying, large cracks in a "mapped" pattern formed in the stabilized adobe on the roof, due to the fast drying. Buckets of dirt were swept into these cracks and the roof sprayed with water to fuse the dirt-filled cracks with the rest of the roof. The roof was sloped for runoff to flow north over the wall. No drain was left in the wall. The roofing surface was the same height as that of the surrounding walls.

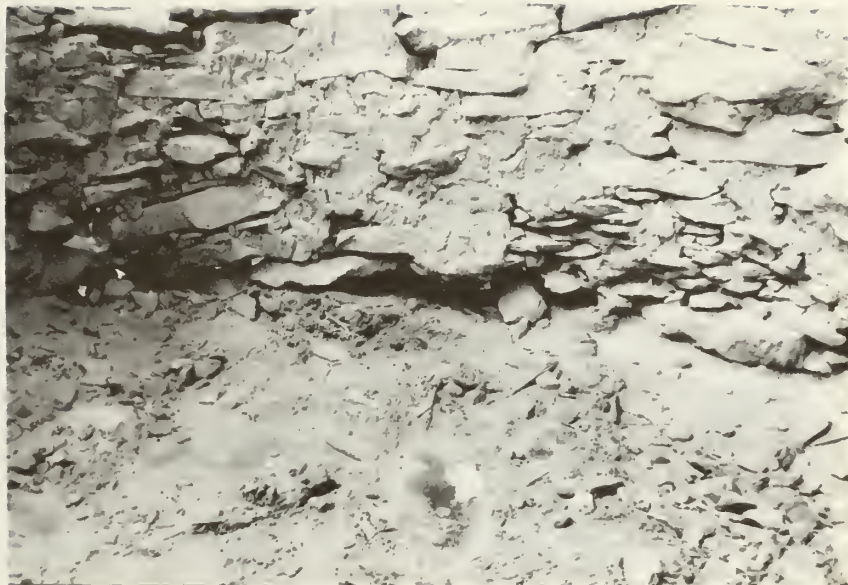
"Before" shot of west wall of room 3
showing base of wall undermined by
erosion. (looking west)

Grouting began on the exterior walls using adobe mortar consisting of the formula mix 1. An undermined section beneath the west wall which had been entirely eaten through by erosion, was filled in. The weakened wall bases in general were built up and reinforced. Cracks and holes on the interior walls alone were grouted in order to preserve that remained of the original plastering.

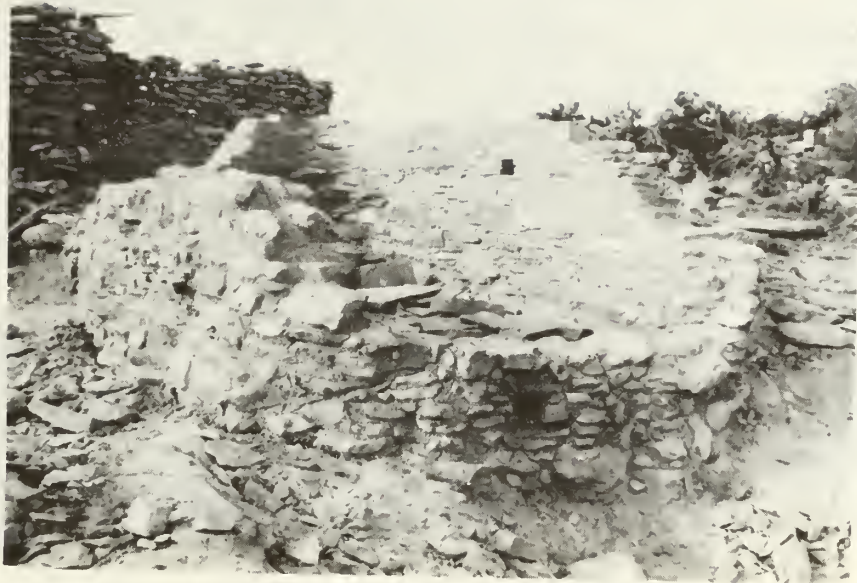
"After" stabilization. Note the
drain in the foreground wall and the
loophole in the west wall.
(looking south)

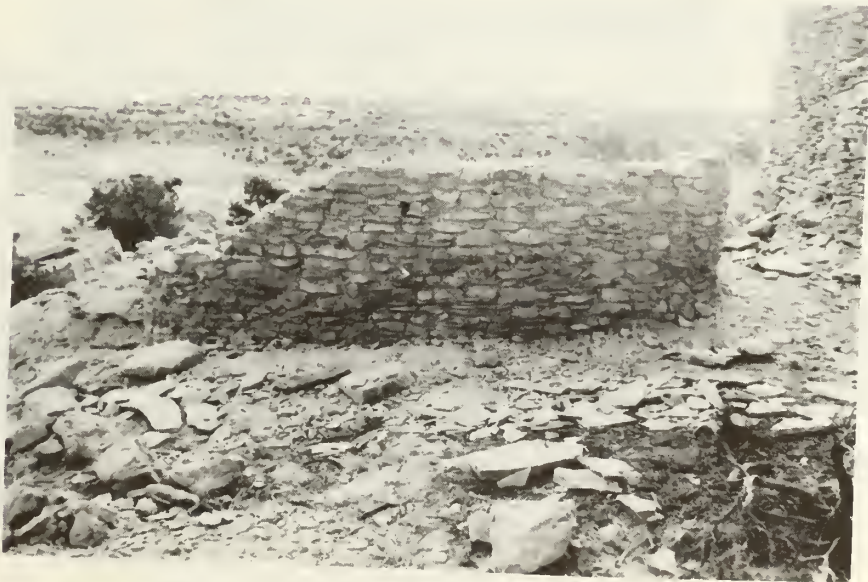
"After" stabilization; the west wall
of room 4. (looking east)

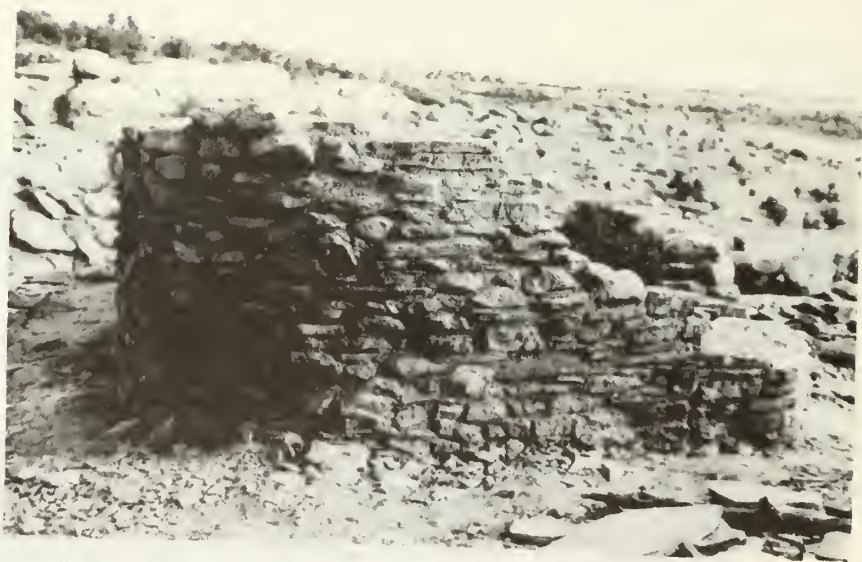
"After" stabilization; the walls have been reconstructed to their former height. (looking north)

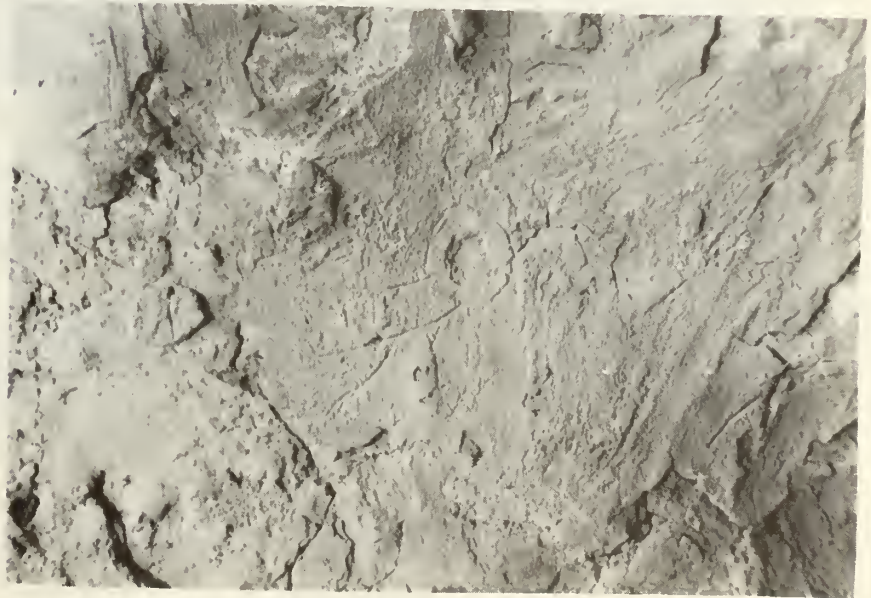
"Birdlike" petroglyph scratched into the plaster on the west wall of room 1.
(looking west)

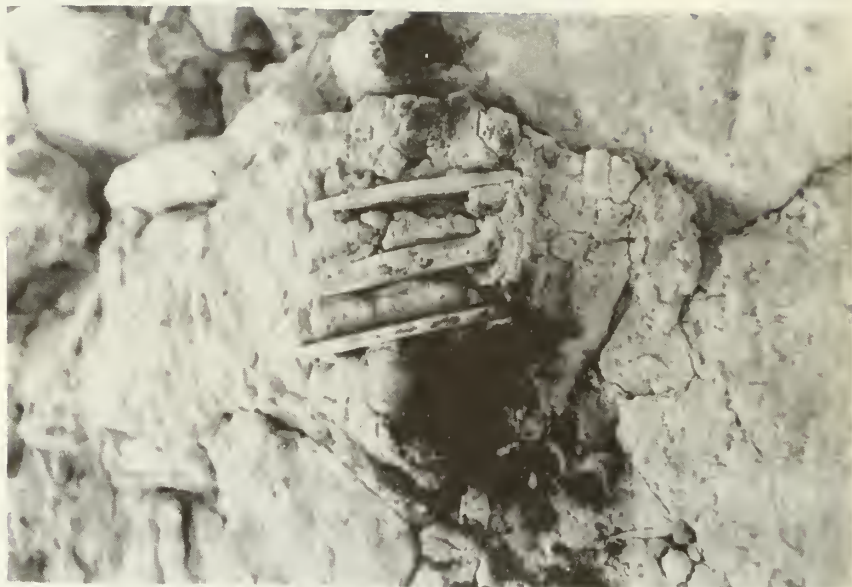
Feature in the hearth area of room 1,
located above the juniper bough, and
probably associated with the fire-
place. (looking northeast)

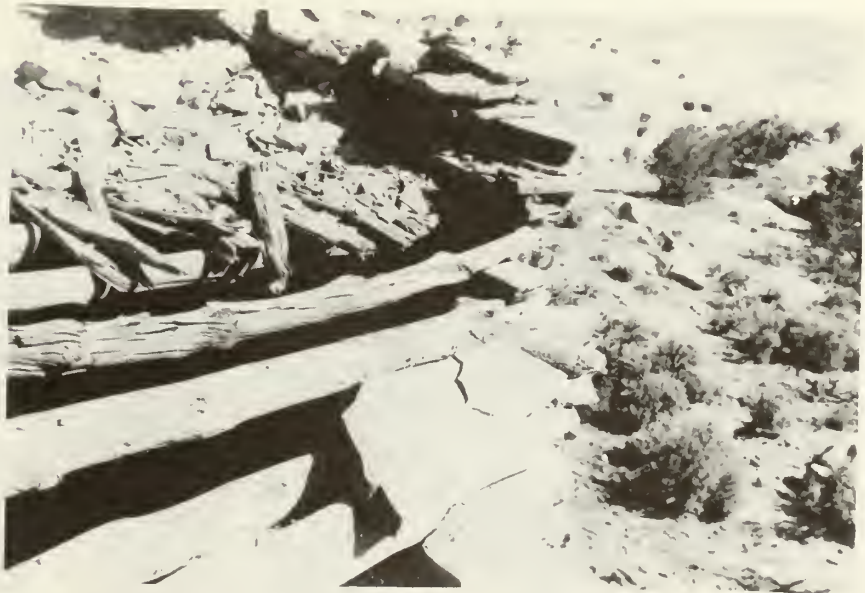
The 2 vigas used to fill the section of
missing roof during the stabilization.
(looking east)

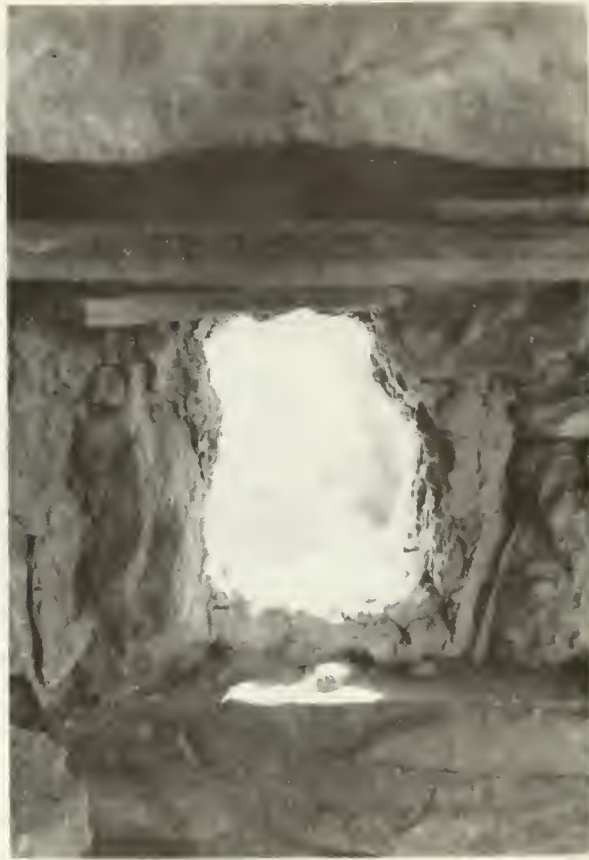
Loop-hole style window in the south-east corner of room 1. Note the adobe and sandstone slabs lining the window.

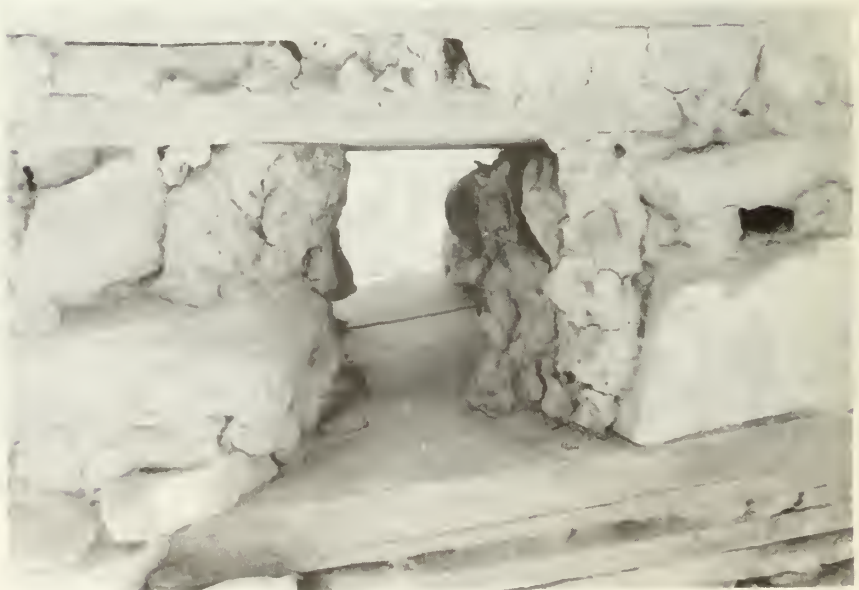
Loop-hole style window in west wall of room 2. Window lines up with winter solstice sunset. (looking west)
