*NIST Special Publication 778*

# *Performance of Structures During the Loma Prieta Earthquake of October 17, 1989*

*H. S. Lew, Editor*

January 1990

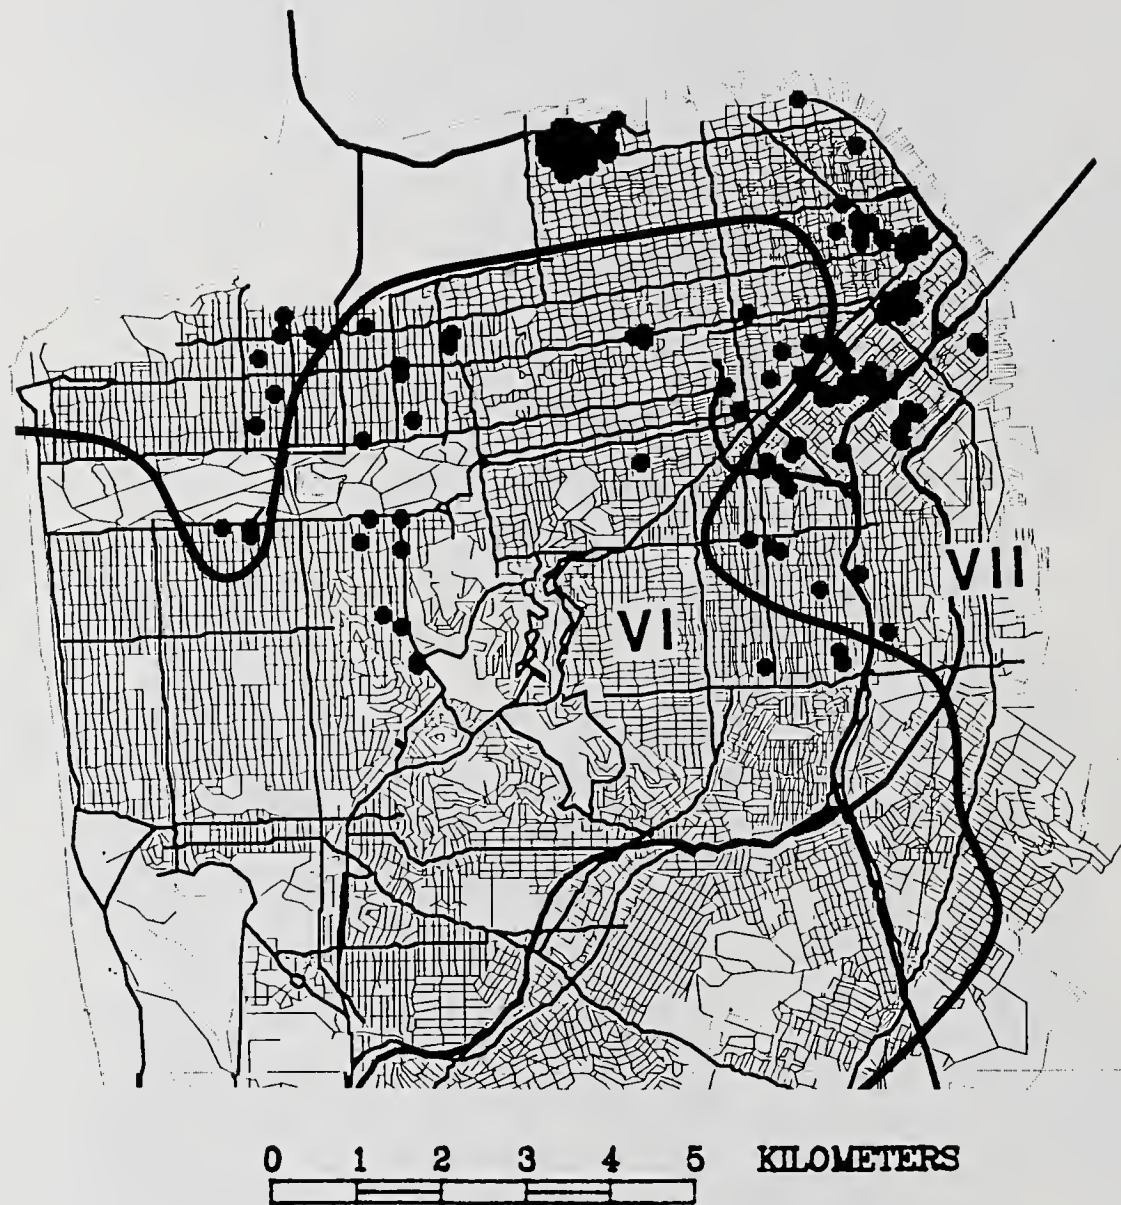
As an example of the wealth of data available, figure 2.4.2 shows some of the safety inspection results available for San Francisco (Lew, 1989). These represent 378 inspected buildings using post-earthquake safety evaluation procedures developed by the Applied Technology Council (ATC, 1989). These are only

Figure 2.4.2 Damage inspections for San Francisco. The figure shows 378 inspections judged as "red" using the ATC postearthquake safety evaluation procedures (ATC, 1989a,1989b). Damage judged sufficiently for a "Red" designation may be caused by either ground shaking, ground failure, or be in a dangerous area. The preliminary intensity contour based on ground shaking effects from figure 2.4.1 is shown for comparison.

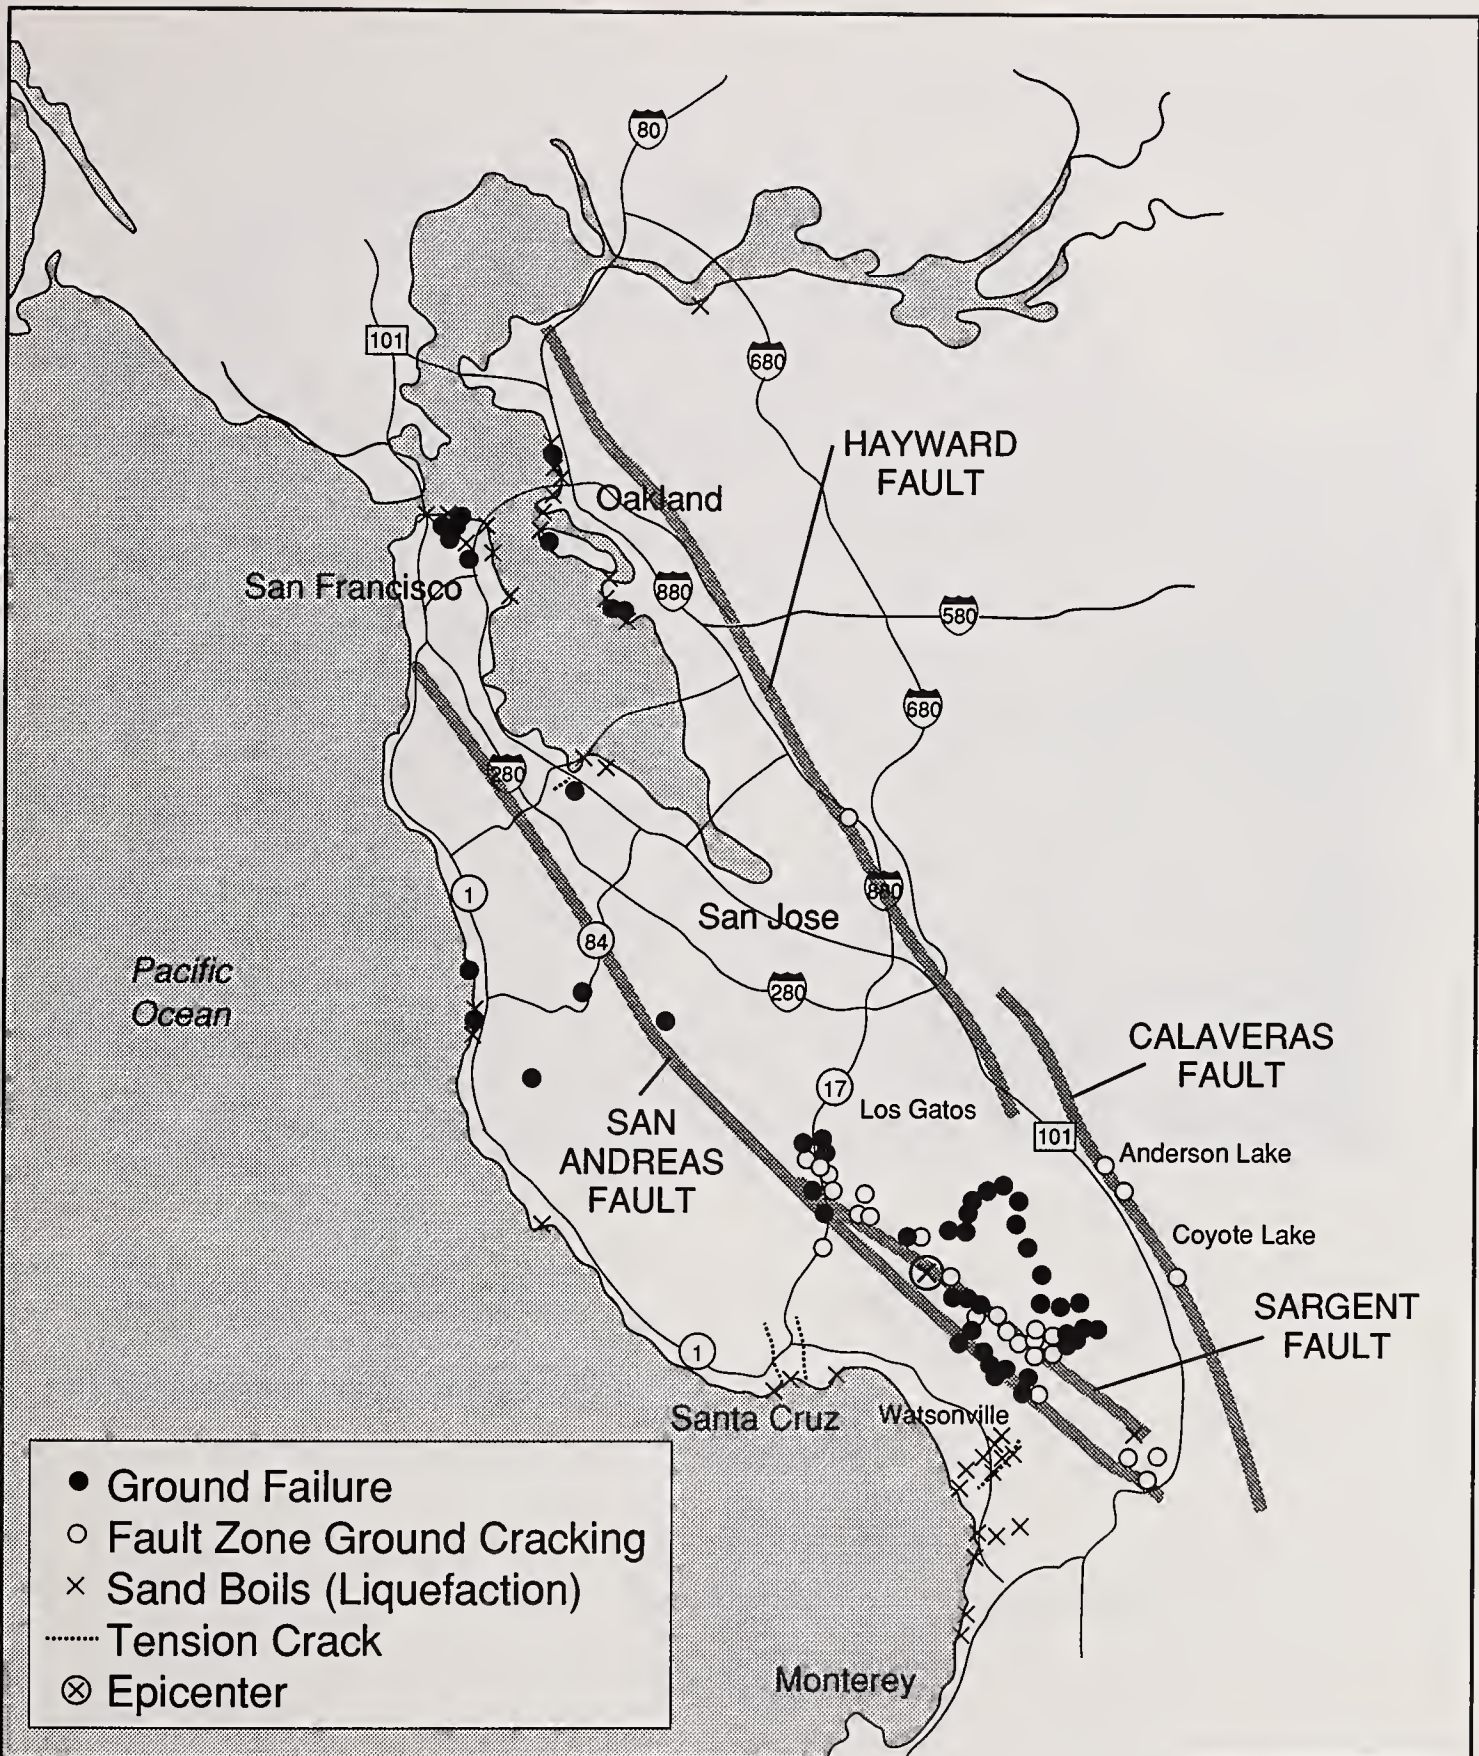
Figure 3.2.1 shows the approximate locations of observed ground failures. Four failure categories are identified: (1) fault zone ground cracking; (2) ground failures; (3) liquefaction; and (4) tension cracks. The observations compiled in the map were recorded by the U.S. Geological Survey in Menlo Park, CA, (prior to October 23, 1989), the University of California at Berkeley (Abolhassan et al., 1989), the U.S. Army Corps of Engineers, and the ICSSC team.

documented by the U.S. Corps of Engineers, and the ICSSC team. The failure categories identified in figure 3.2.1 are not mutually exclusive. For instance tension cracks in embankments may be attributable to a stability failure, in which case they would fall under "ground failures," or to liquefaction.

Figure 3.2.1 Ground failures caused by the Loma Prieta earthquake.

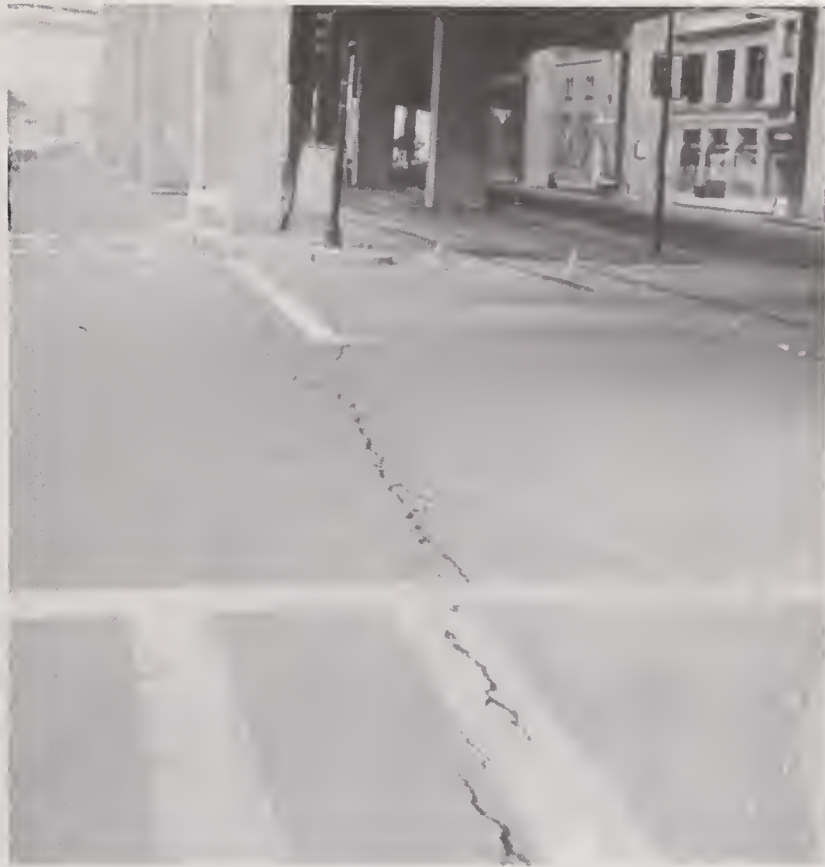
Figure 3.3.5 Tension crack at Mission Street and Embarcadero Freeway.

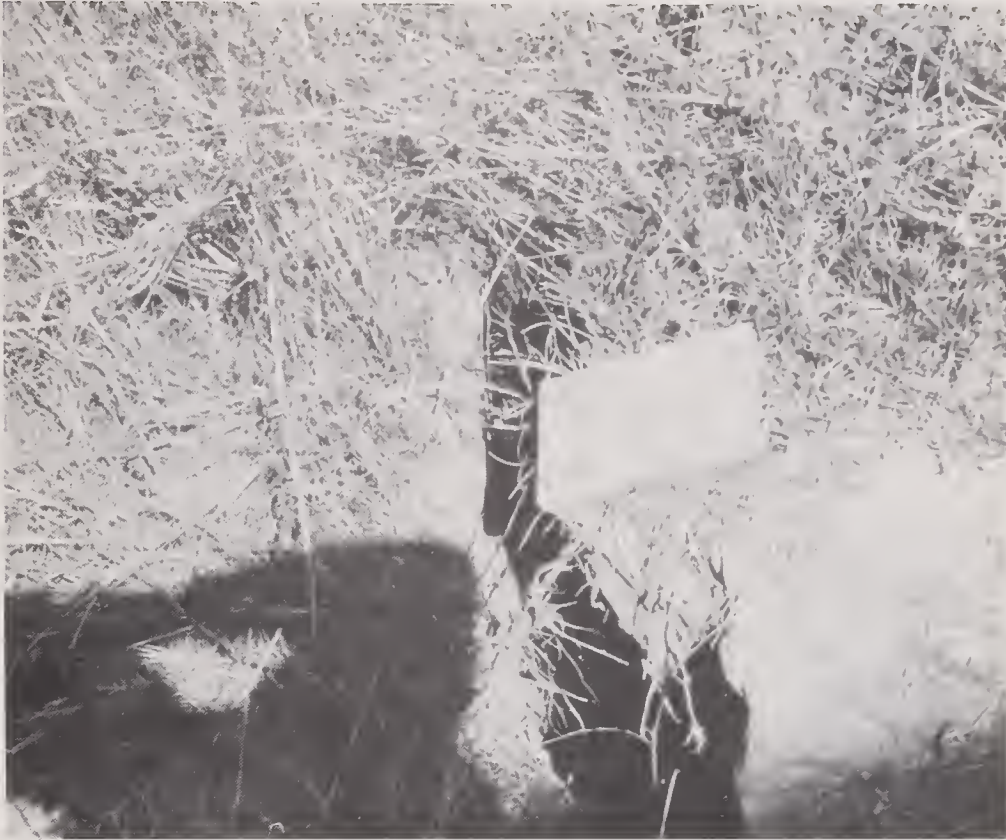
Extensive tension cracking was observed along the embankments of the Pajaro River (fig. 3.2.1). Figure 3.3.8 shows a 2 ft (600 mm) wide tension crack near the bridge of Main Street over the Pajaro River. The crack was parallel to the river between the dike and the river. There was a second parallel crack nearer the river which was approximately 6 in (150 mm) wide. There were also some tension cracks outside the embankment and parallel to it (fig. 3.3.9). The tension cracks in the soil parallel to the

Figure 3.3.8 Tension cracks on Pajaro River bank in Watsonville.

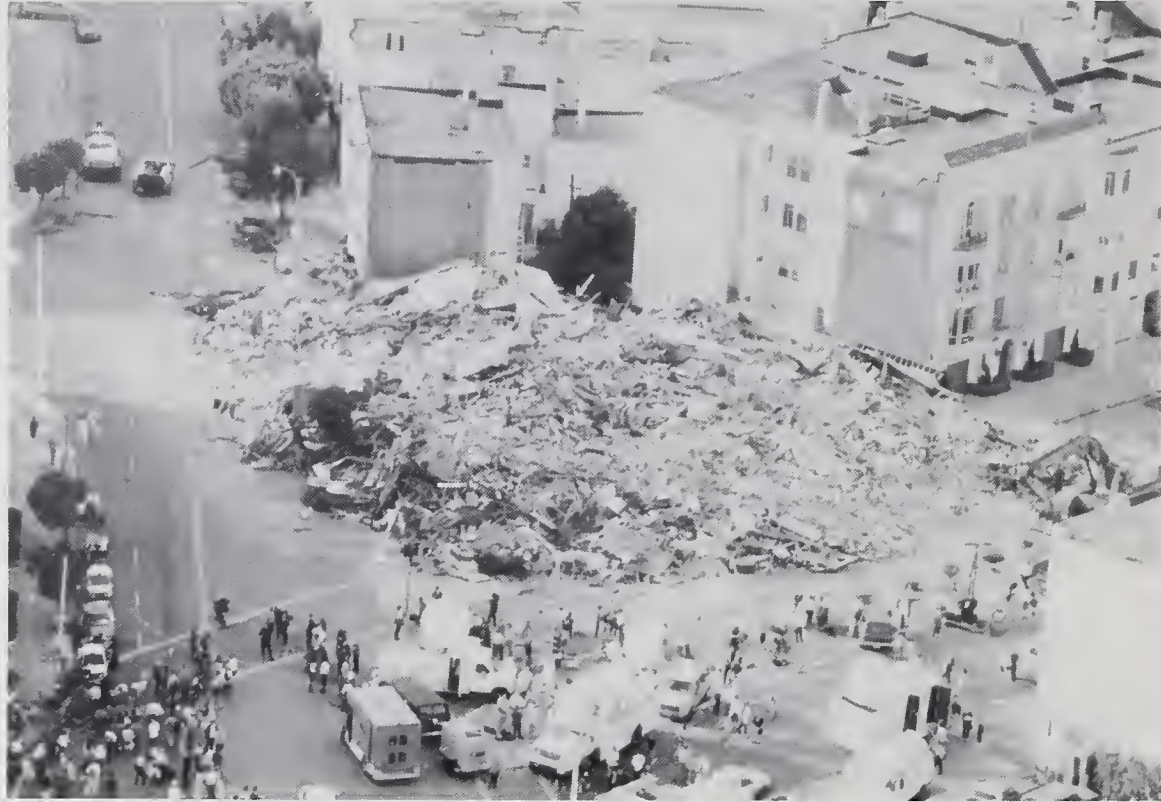
Figure 4.2.4 Aerial view (#2) of demolished building at the intersection of Fillmore St. and Cervantes Blvd.

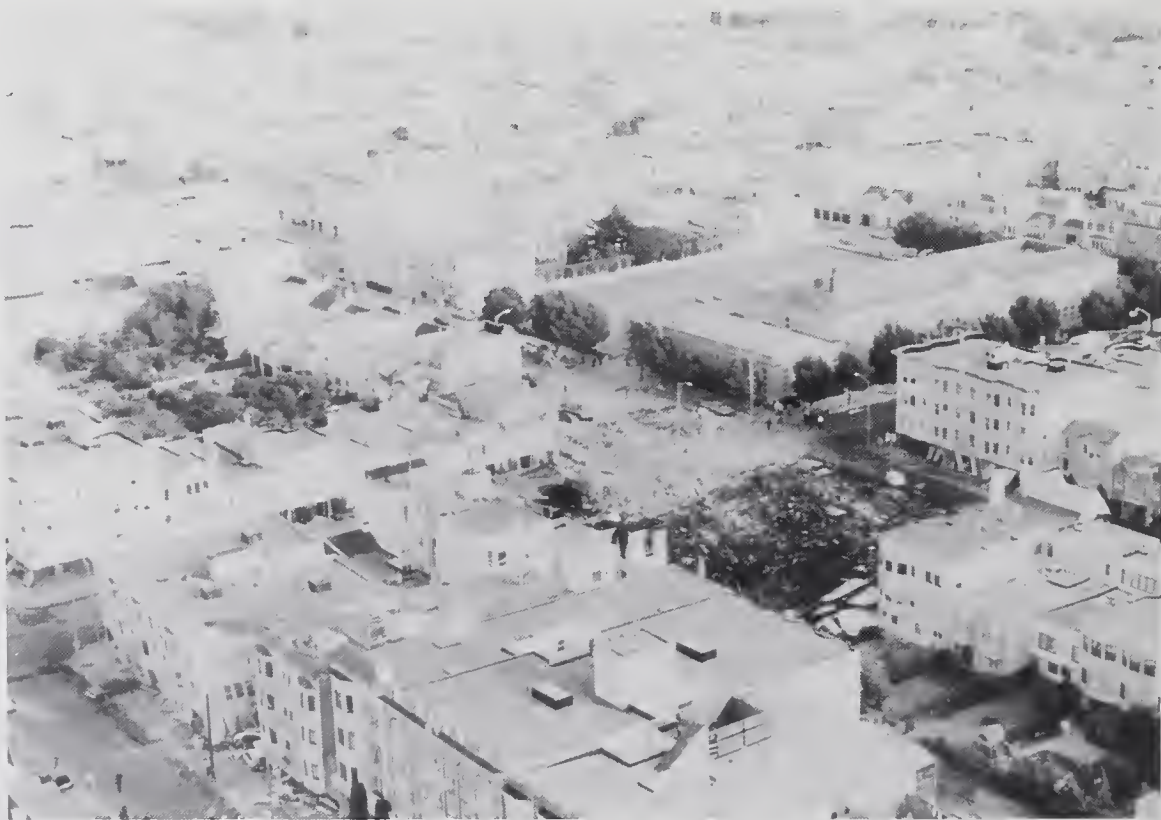
Figure 4.2.5 Aerial view (#3) of portion of the Marina District which suffered extensive damage; dark zone is location of the fire.

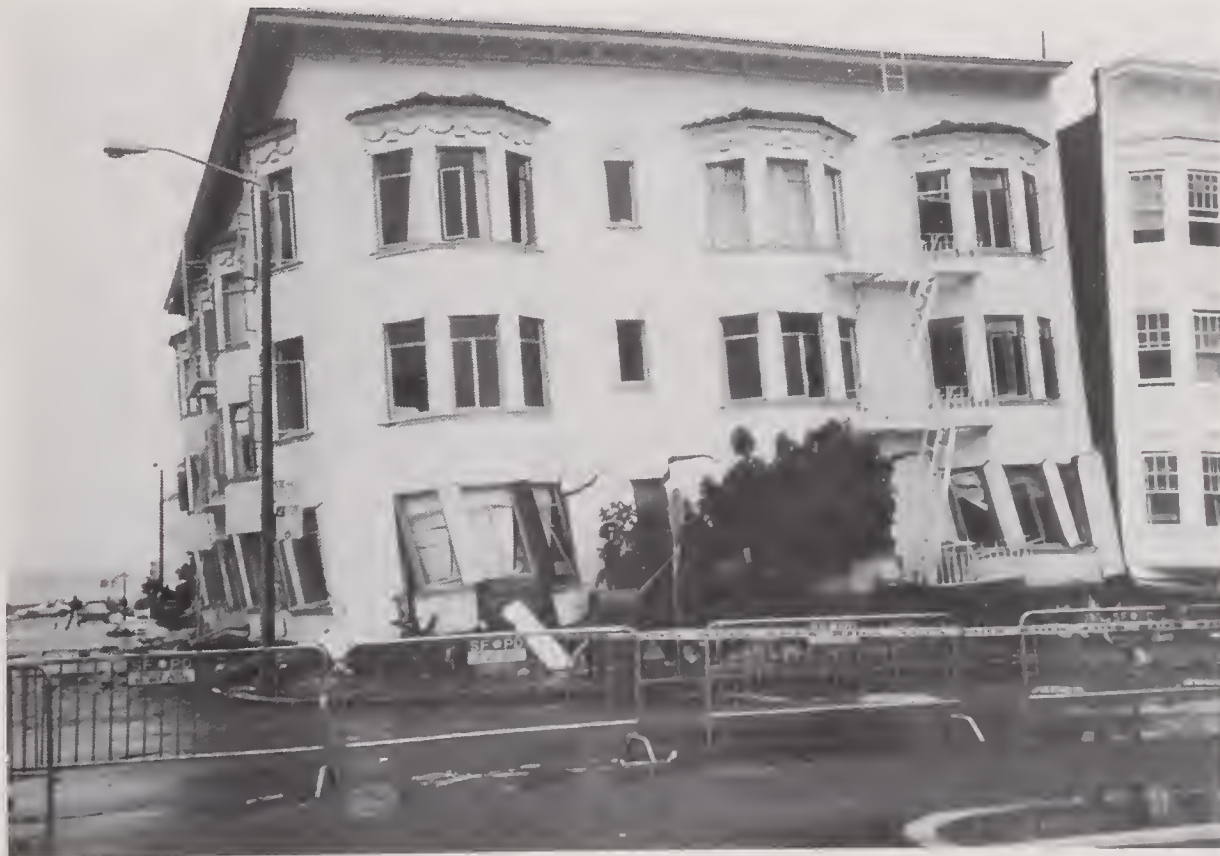
Figure 4.2.7 Two four-story buildings which suffered total collapse of their first stories (location #14).

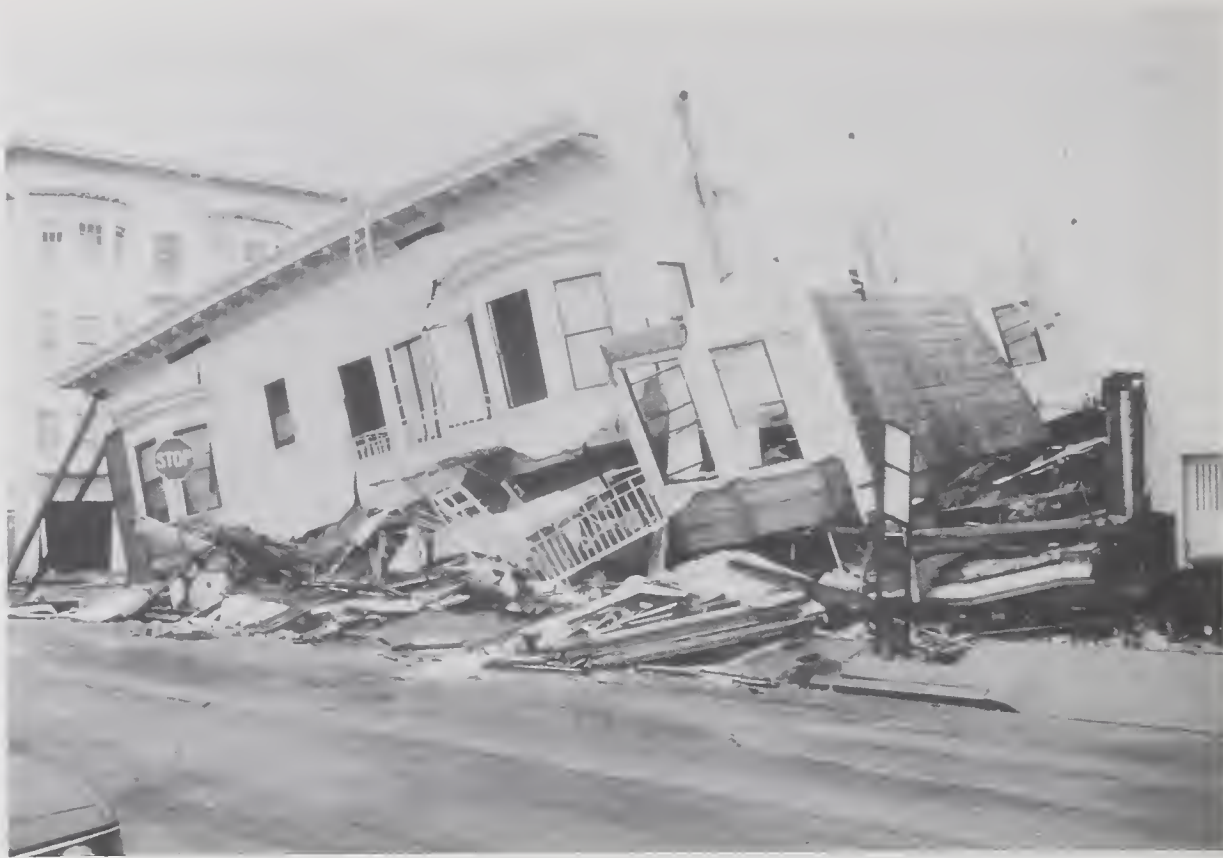
Figure 4.2.8 Four-story building which suffered total collapse of its lower stories (location #3).

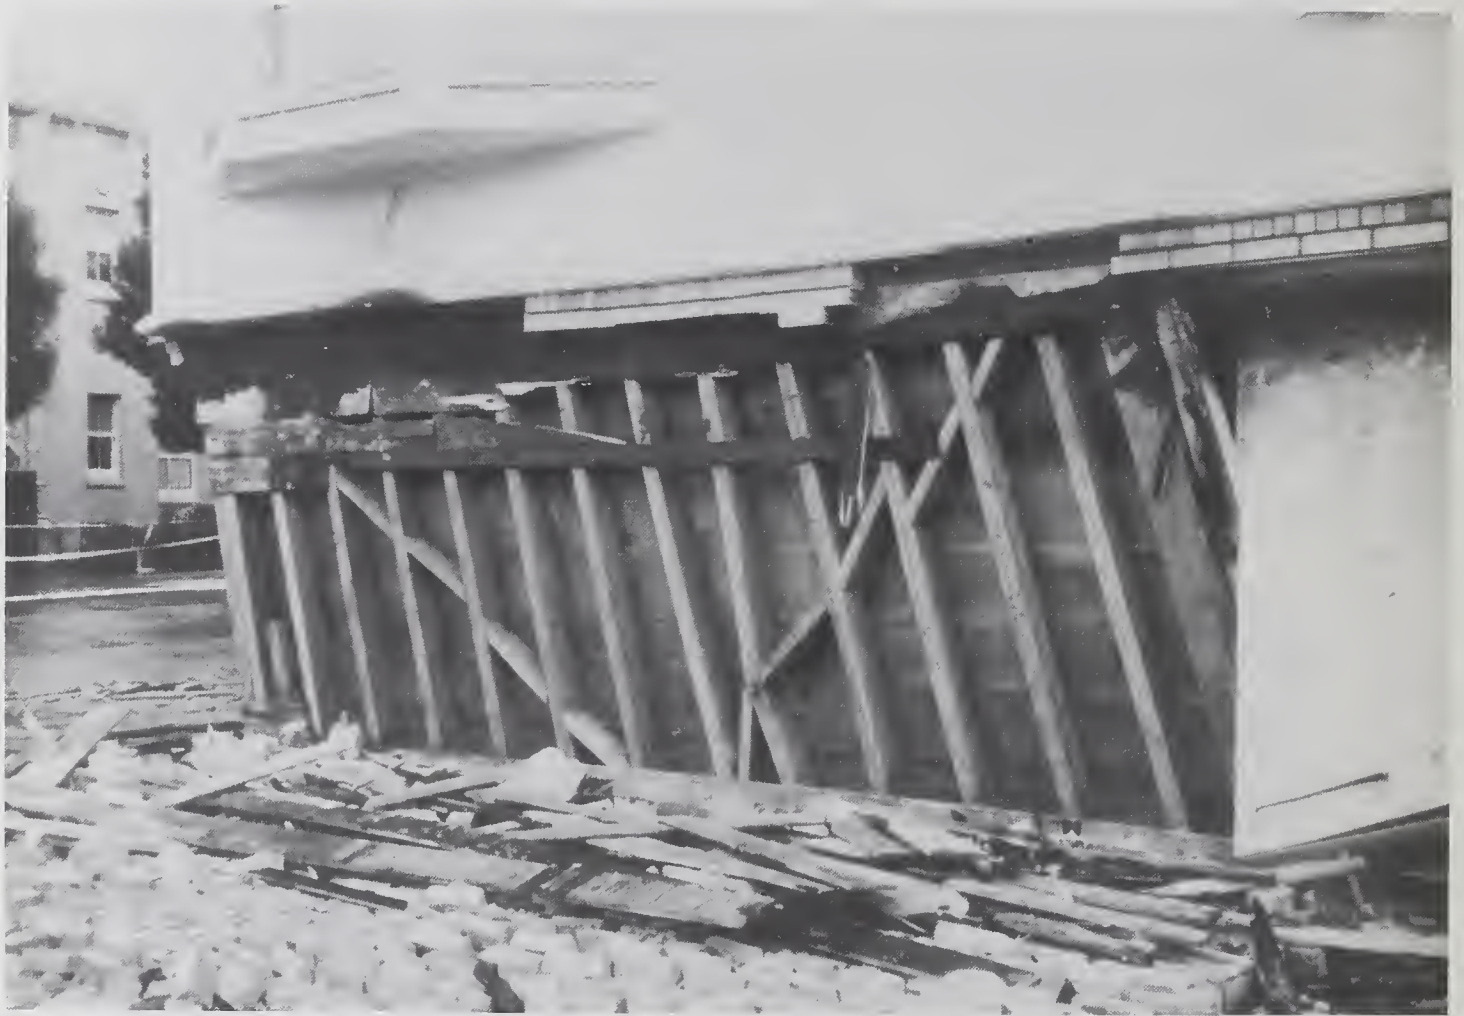
Figure 4.2.16 Detail of ineffective framing system in corner of building at the intersection of Beach and Divisadero Streets (location #5).

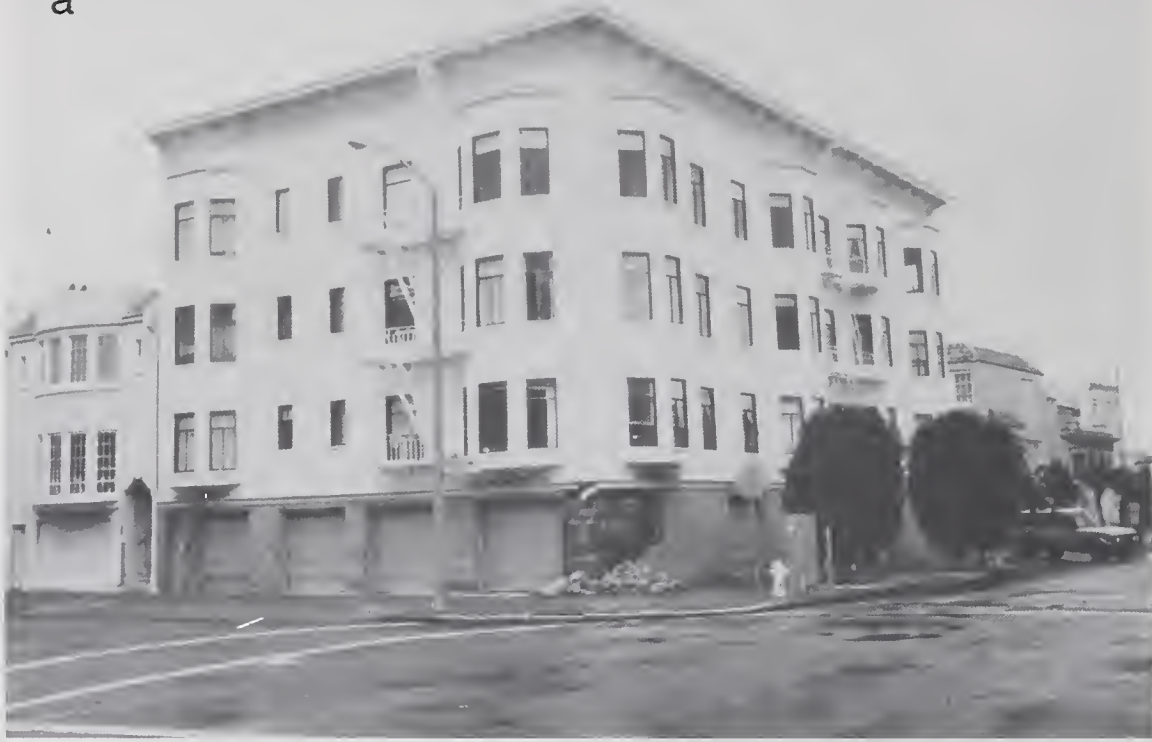
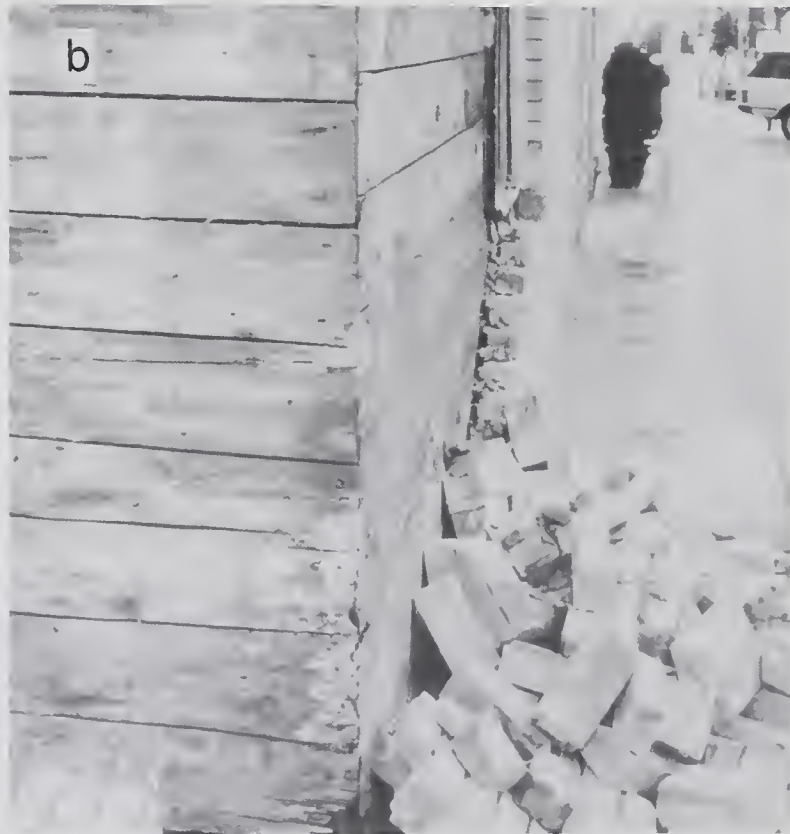
Figure 4.2.19 (a) Example of building with failure of brick masonry facade (location #12) and (b) close-up view of corner showing damaged wood and lack of anchorage to the masonry.

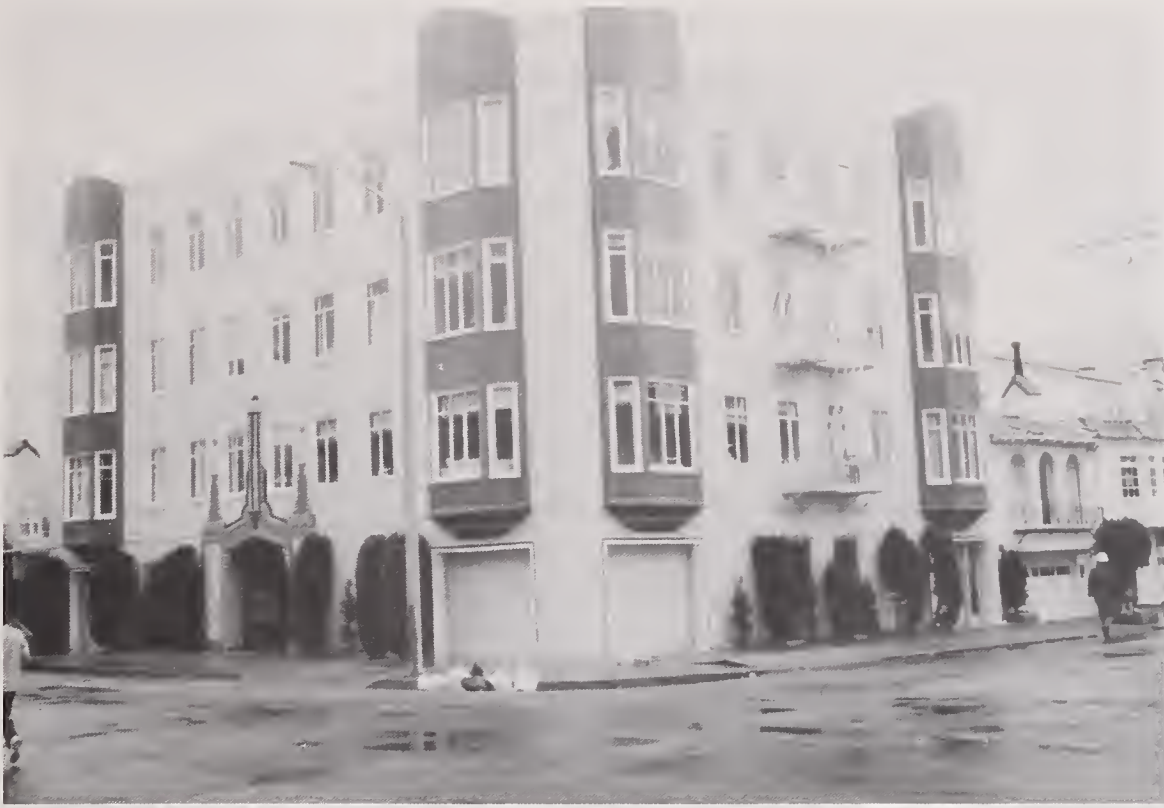
Figure 4.2.20 An undamaged four-story building on the corner of Broderick and Beach Streets (location #7).

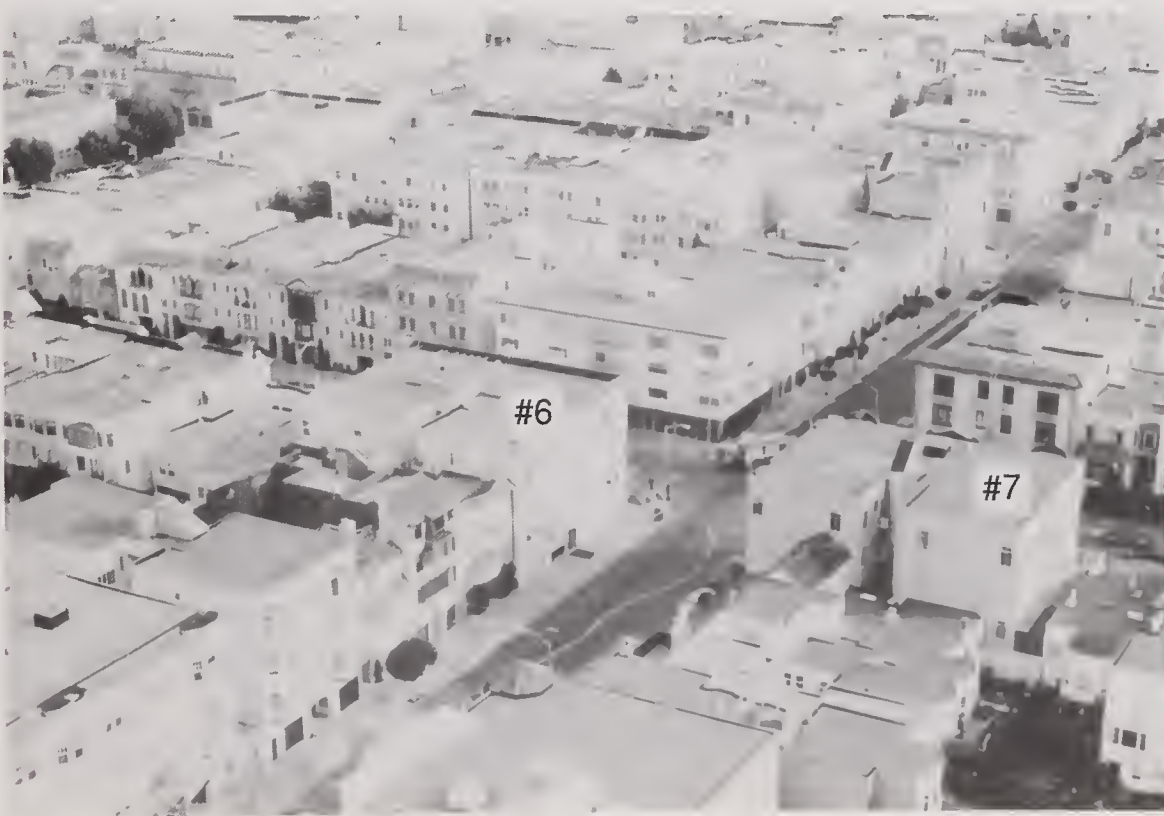
Figure 4.2.21 Aerial view (#4) of the buildings shown in figures 4.2.12 and 4.2.20.

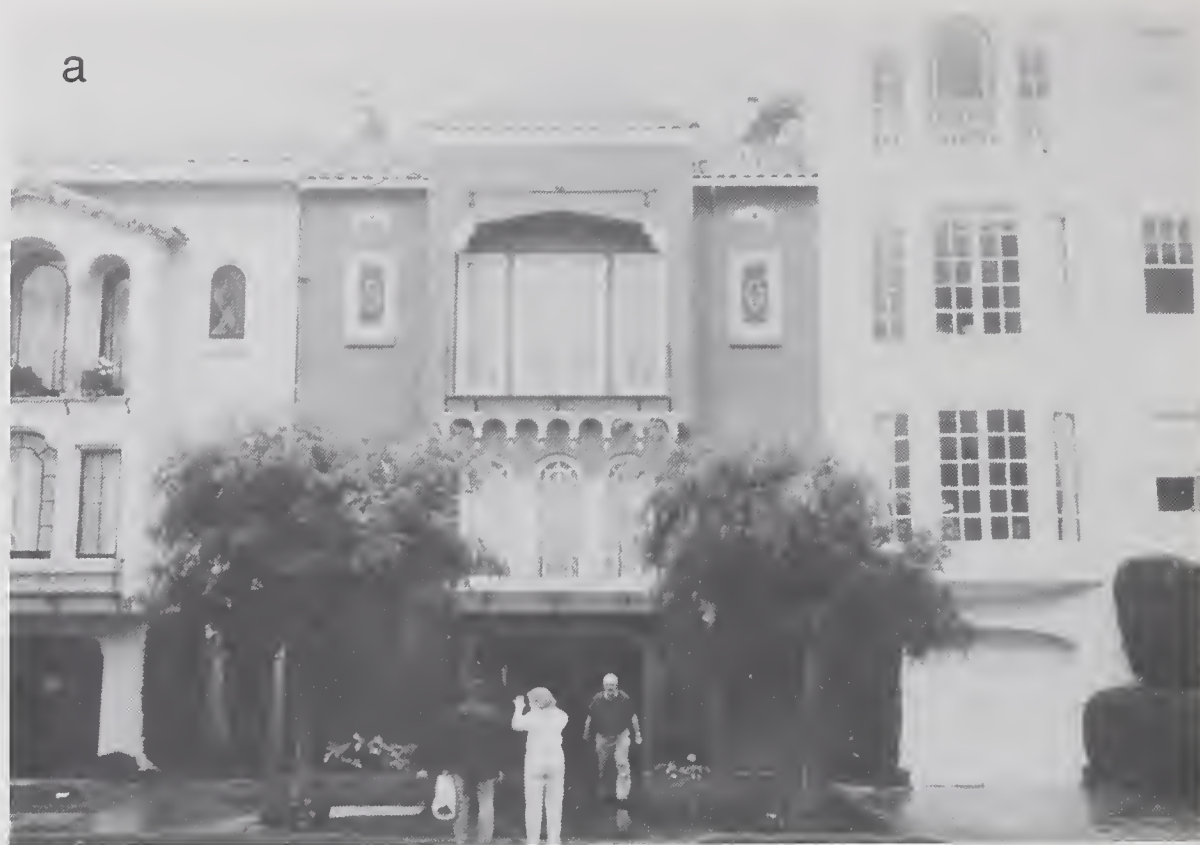
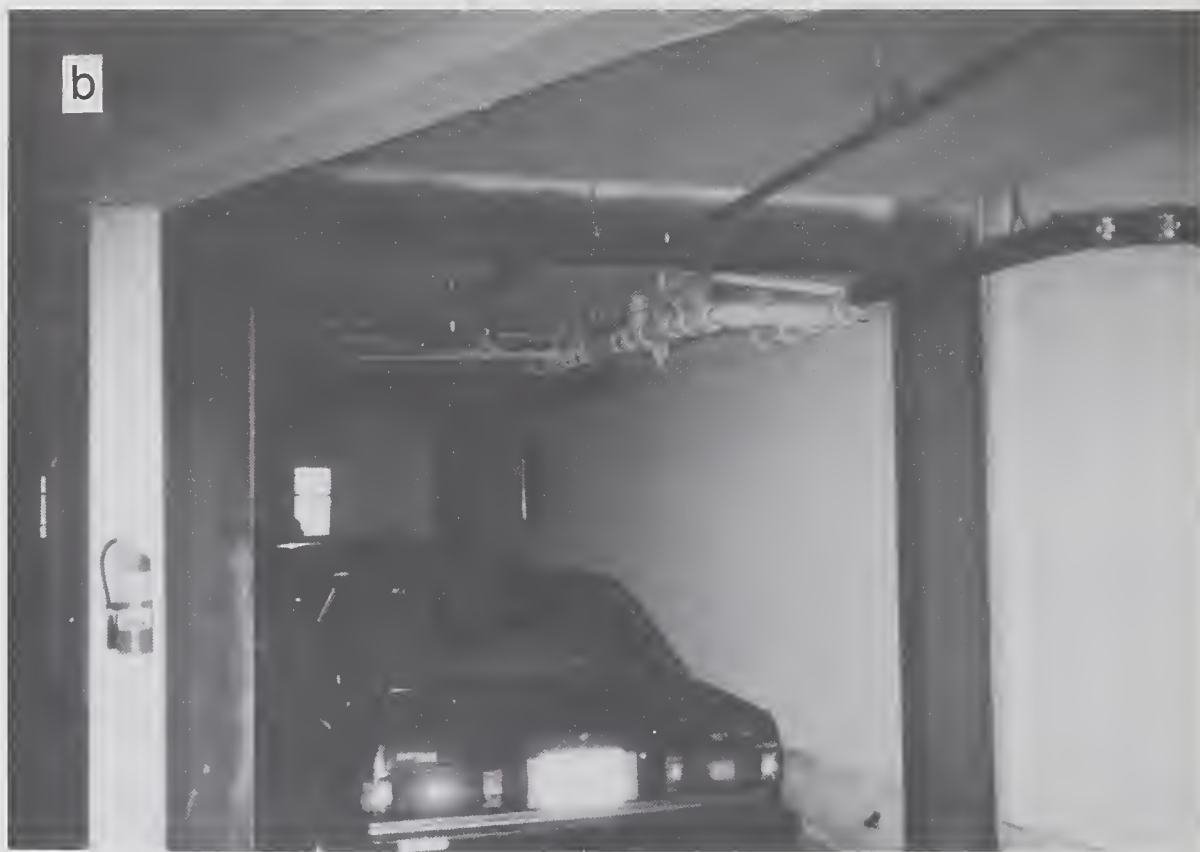
Figure 4.2.22 (a) An undamaged, three-story building (location #8) and (b) view of the moment-resting frame used for retrofitting.

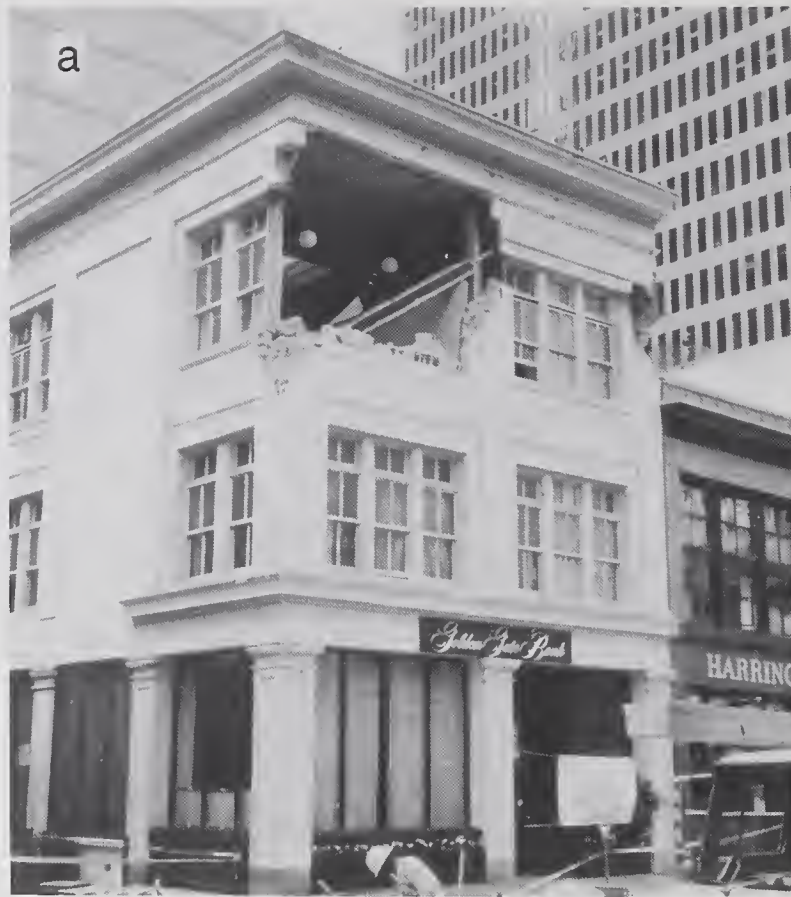
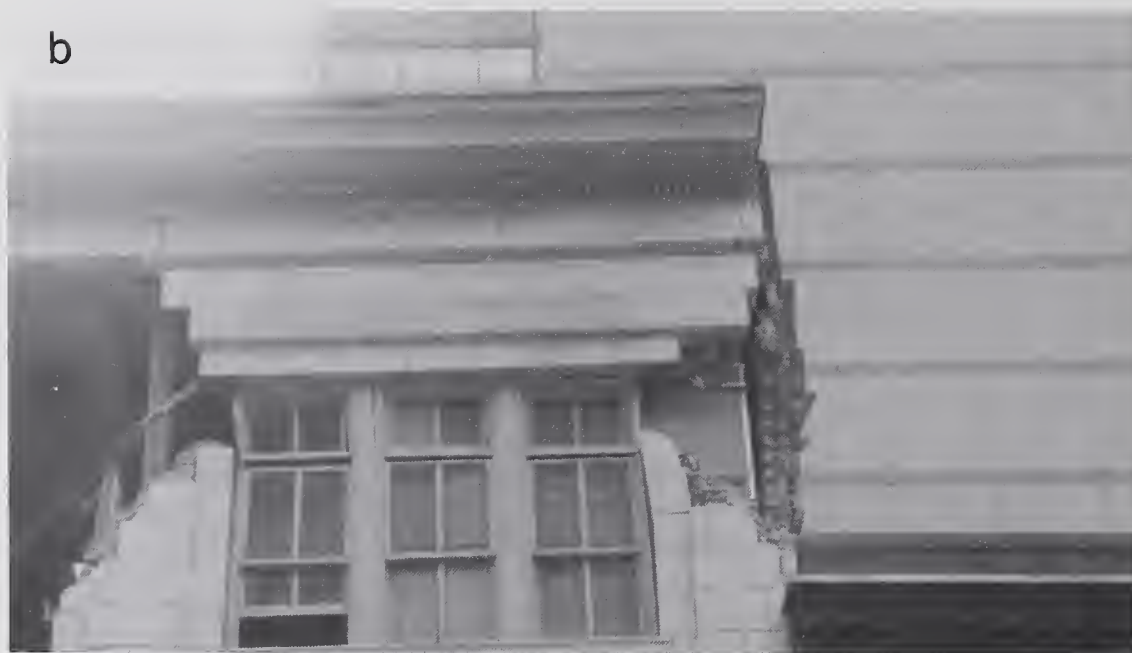
Figure 4.2.28 (a) Damage to the southeastern corner of the Golden State Bank Building; (b) Close-up view of the northeastern corner; damage was likely caused by pounding against the adjacent building.

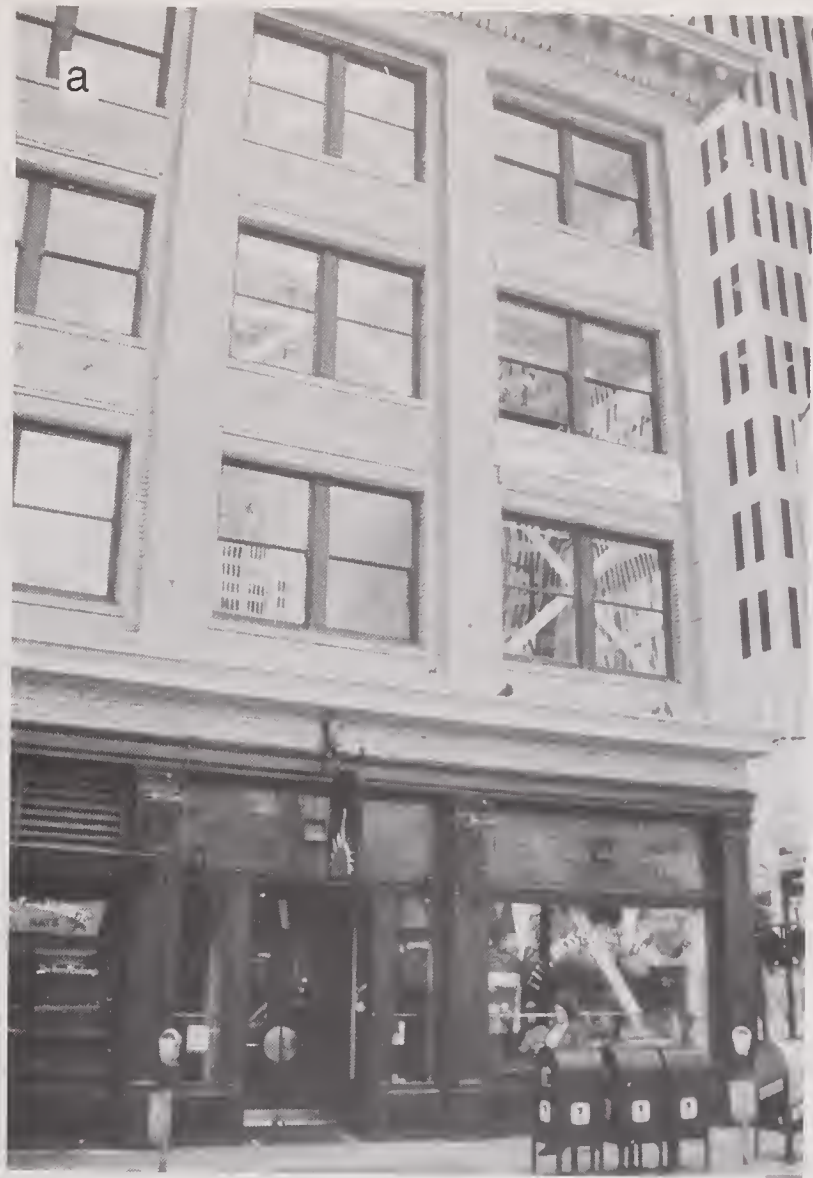
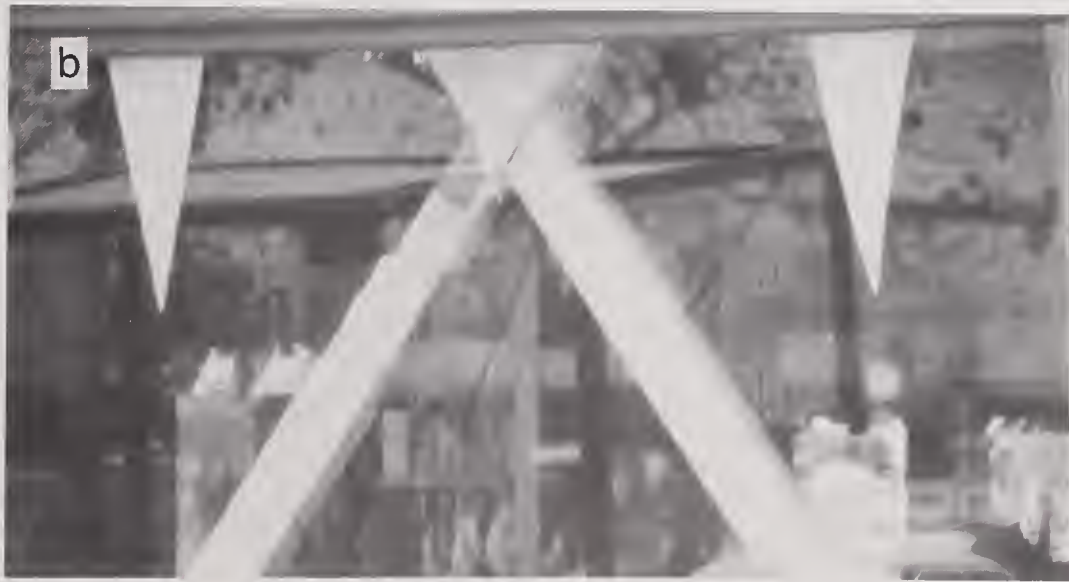
Figure 4.2.29 (a) The historic DeBernardi warehouse building showing the bracing added during seismic retrofitting; (b) close-up view of the bracing showing damage caused by earthquake.

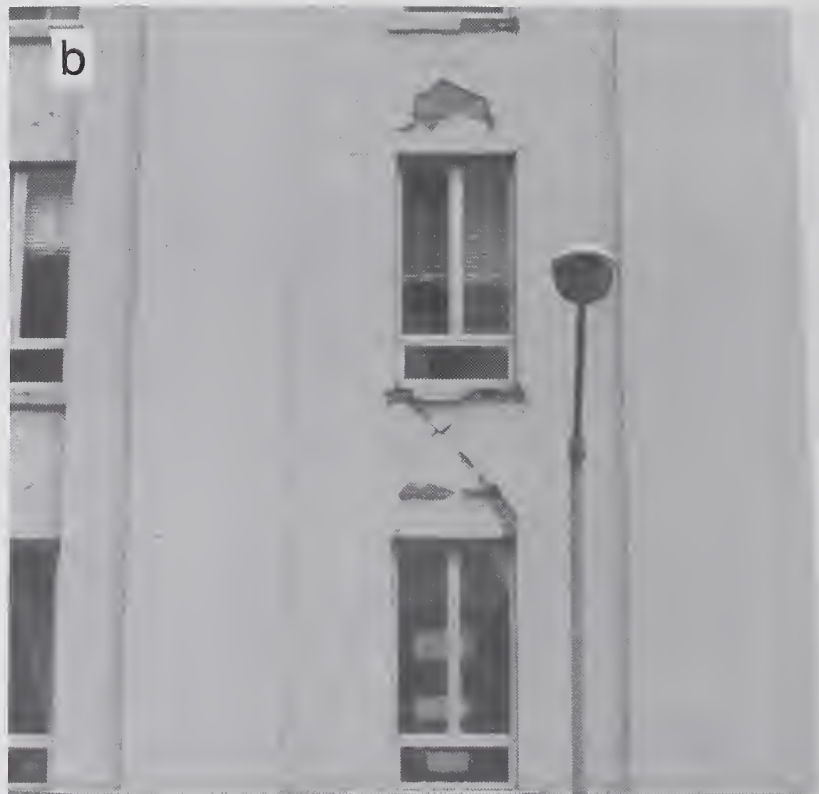
Figure 4.2.33 (a) Reinforced concrete, flat-slab building which sustained severe damage to the exterior walls (location #6); (b) close-up view of damage to spandrels.

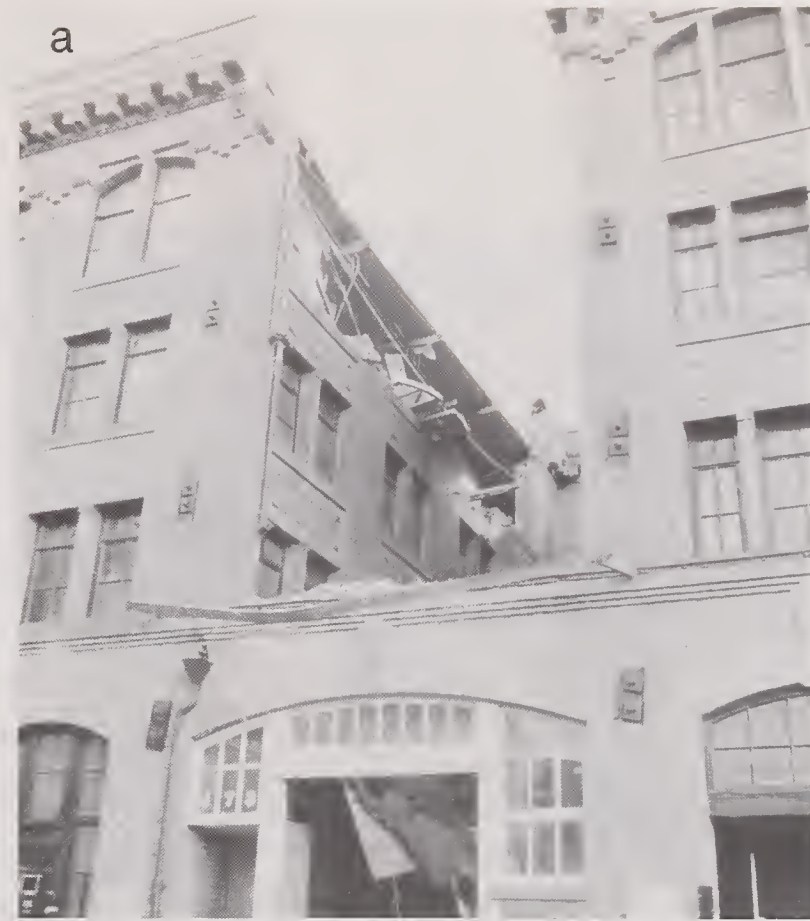
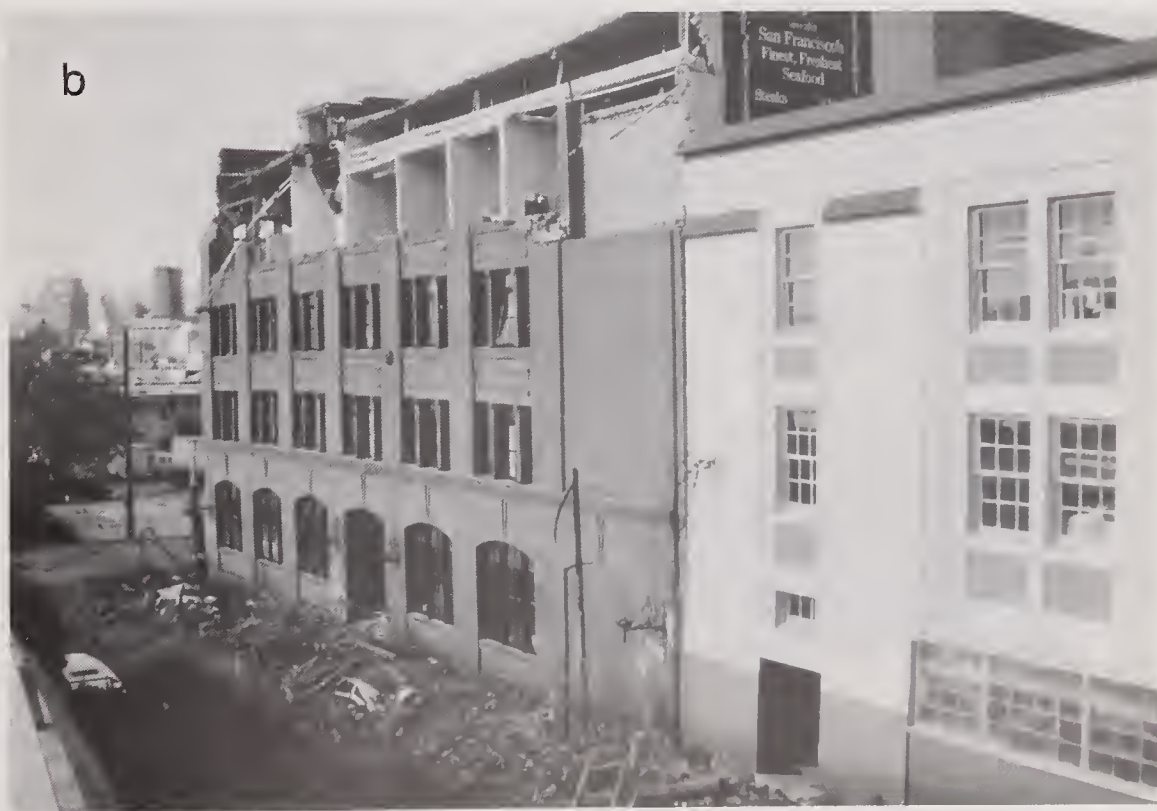
Figure 4.2.34 (a) Damage to upper story of unreinforced masonry building on Bluxome St. (location #8);  
(b) damage to the southwestern wall which resulted in the death of six persons.
