*NIST Special Publication 778*

# *Performance of Structures During the Loma Prieta Earthquake of October 17, 1989*

*H. S. Lew, Editor*

January 1990

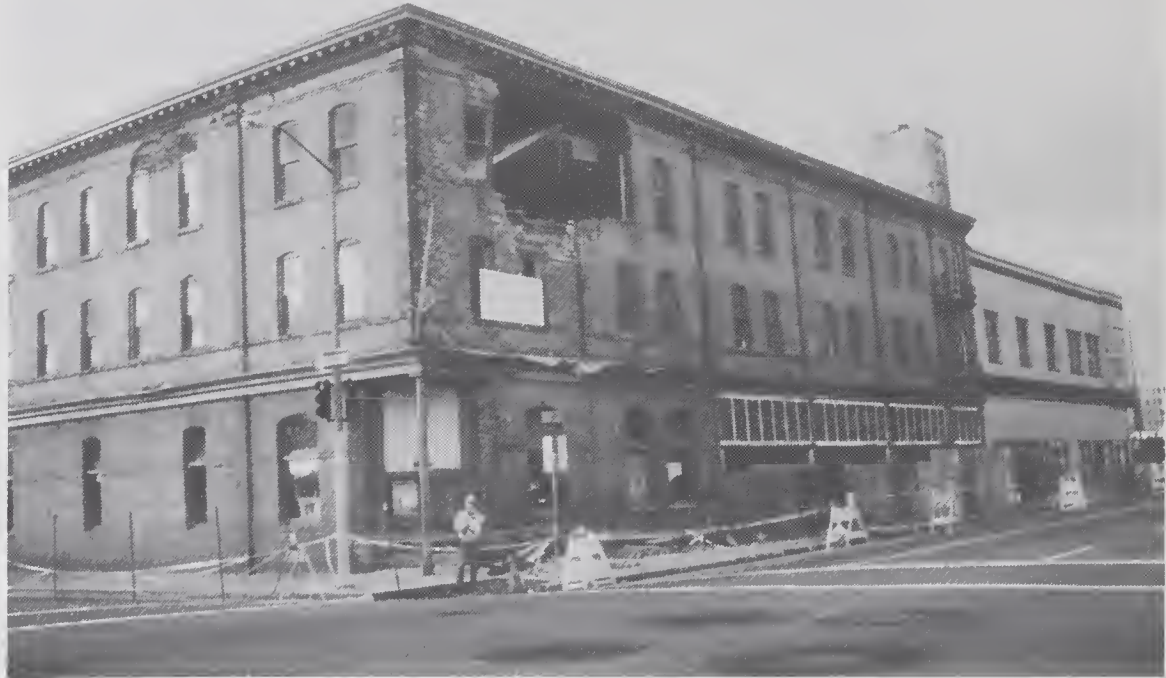
Figure 4.3.4 shows the three-story Clay Building (location #2) which had a serious failure of its unreinforced masonry walls. On the corner opposite to the Clay Building there was a two-story URM

Figure 4.3.4 Damage to the Clay Building, an unreinforced masonry structure (location #2).

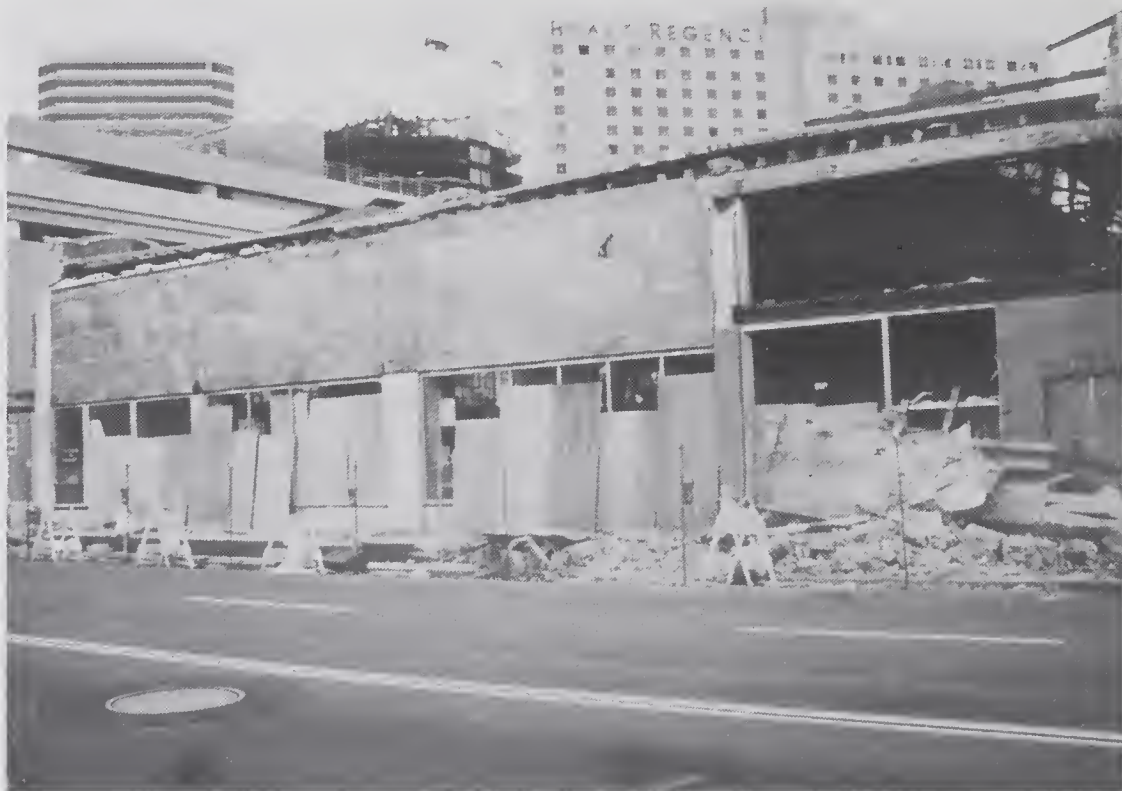
building (location #3) which was apparently built as a produce market in 1917. As is shown in figure 4.3.5, there was failure of the parapet as well as a portion of the infilled wall. The building occupied the entire block, and the eastern portion, which was being renovated, did not appear to have been damaged. Another example of a URM-building failure (location #5) is shown in figure 4.3.6. The collapse of the outer wall crushed three vehicles parked in the adjacent lot. The high-rise steel frame structure, seen in the background of figure 4.3.6, being constructed at 12th Street and Broadway, suffered damage at the top. It was reported<sup>6</sup> that some steel members and the construction elevator fell to the ground. Fortunately there were only some minor injuries from what could have been a serious accident.

Figure 4.3.5 Extensive damage occurred to a two-story unreinforced masonry building built in 1917 (location #3).

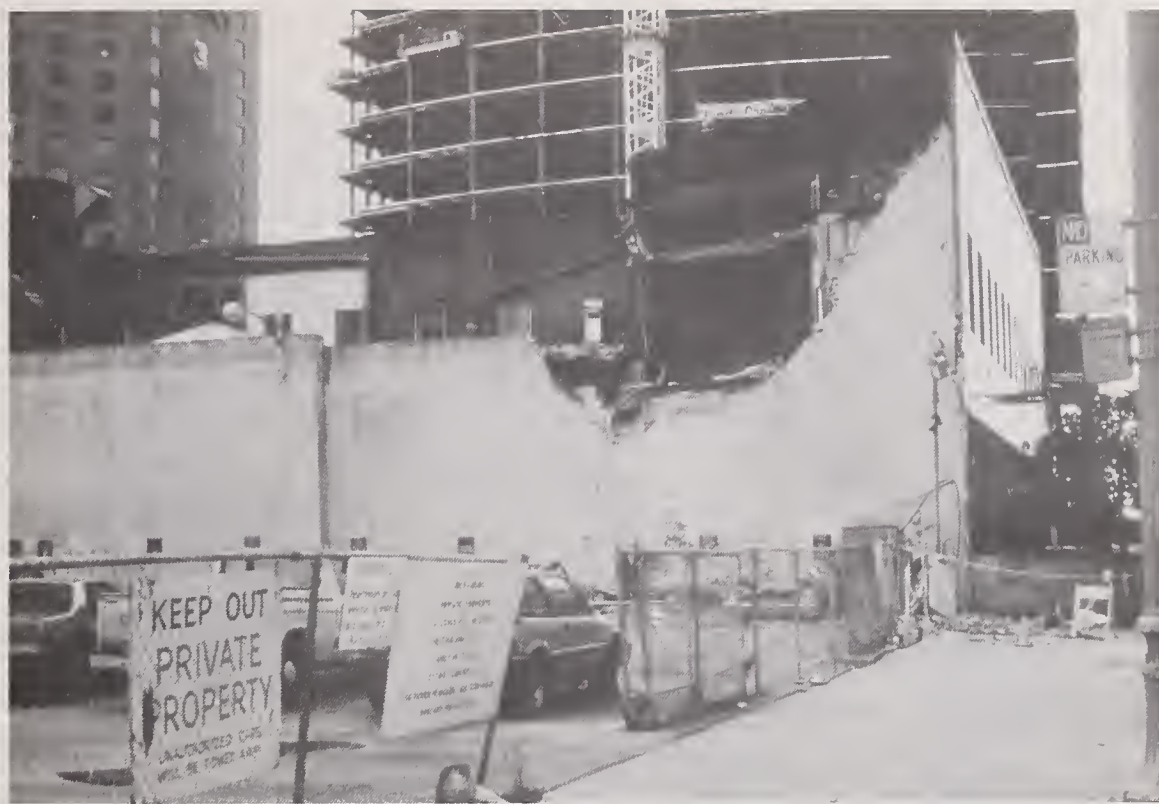
Figure 4.3.6 Collapse of unreinforced masonry wall crushed vehicles in adjacent parking lot (location #5). In background is a steel-framed building under construction which sustained damage.

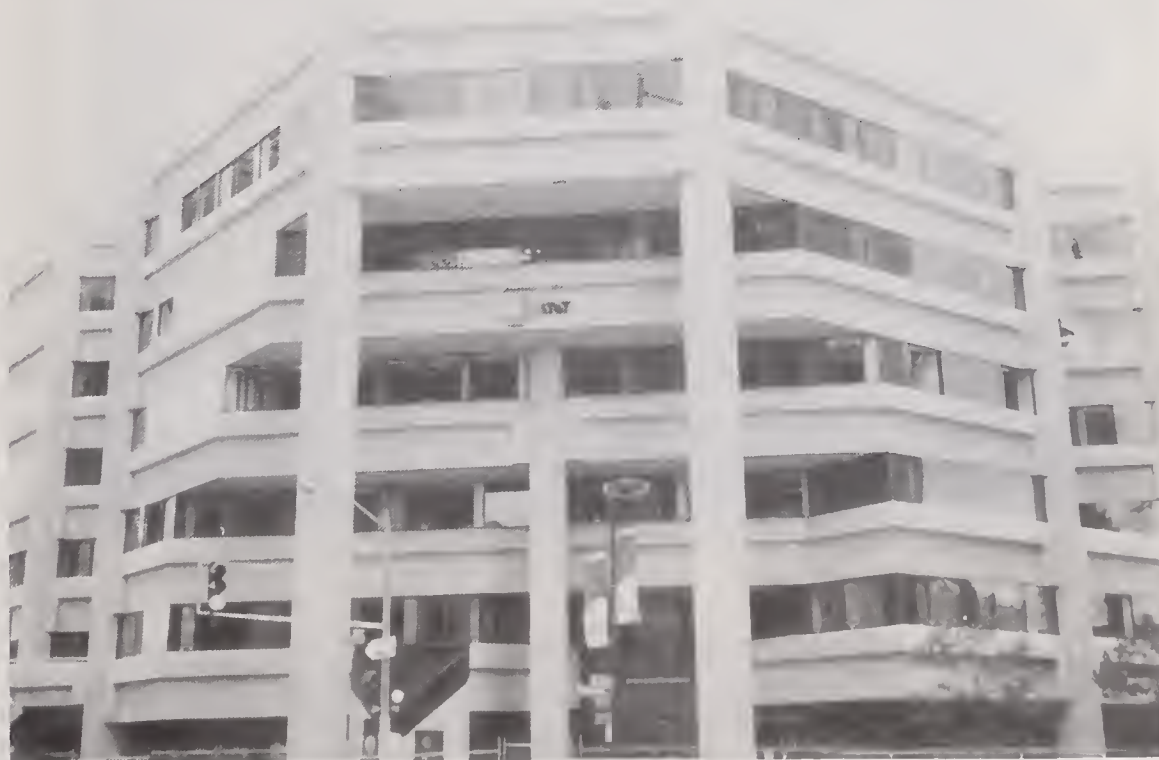
Damage also occurred to some modern buildings. Figure 4.3.7 shows the Trans Pacific Centre at 11th Street and Broadway (location #4). The building had to be evacuated not because of structural damage, but because of ruptured sprinkler lines, broken windows, and fallen ceiling tiles. The 16-story telecommunications building at 20th and Franklin Streets (location #7) suffered damage. The structural system consists of a steel frame with reinforced concrete shear walls. As is shown in figure 4.3.8, extensive damage occurred to the shear walls as well as other concrete structural members.

Figure 4.3.7 Trans Pacific Centre Building which suffered extensive damage due to ruptured water pipes, broken windows, and fallen ceiling tile (location #4).

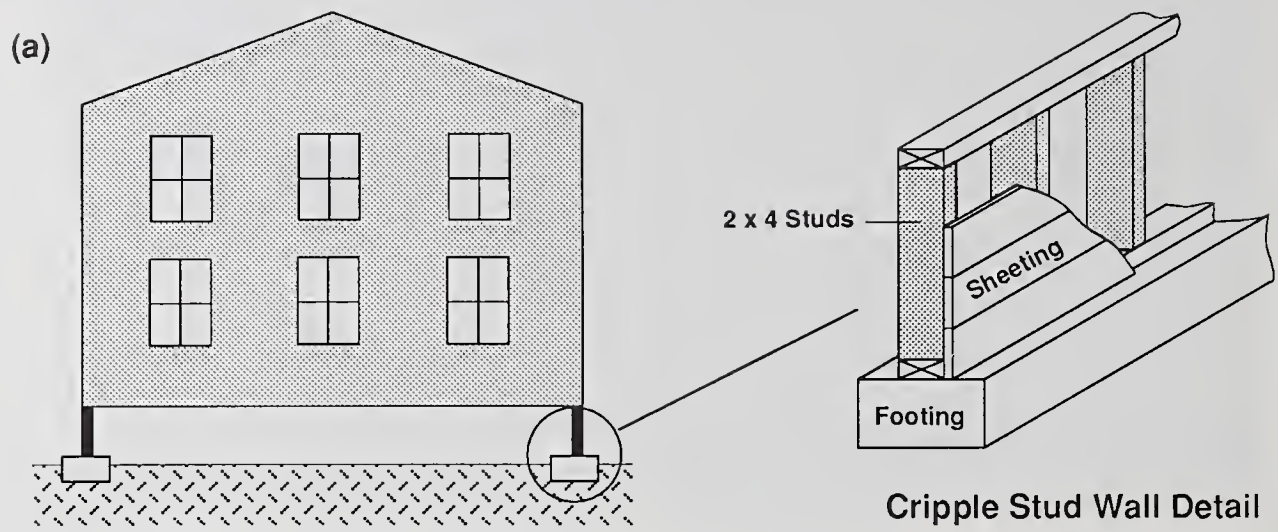
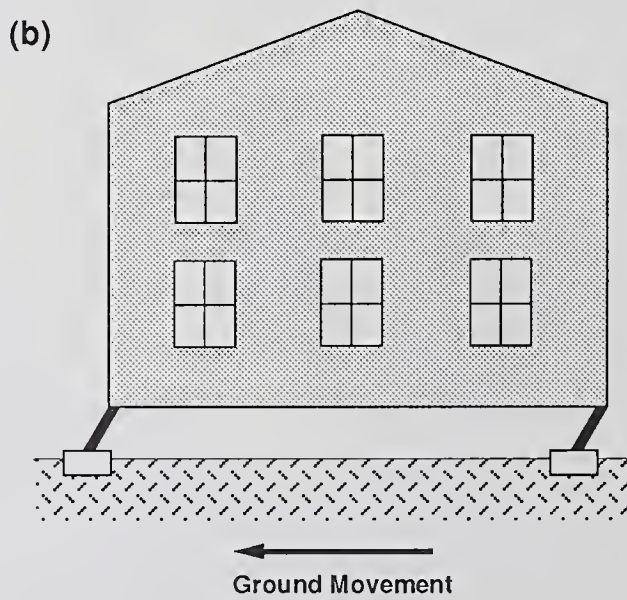
In Los Gatos, about 400 out of 11,000 houses were damaged. Figures 4.4.2 (a) and (b) show examples of damage to wood-framed houses which shifted off of their foundations. The shifting was usually as a result of the failure of the supporting perimeter walls. Figure 4.4.3 illustrates how a house, such as those which failed, is supported. The concrete footings support a short perimeter wall, known as a "cripple stud wall," which supports the frame of the house. The cripple stud walls are typically built using 2-by-4 studs and wooden boards as sheeting. When the ground moved during the earthquake, the cripple stud walls were unable to resist the induced horizontal forces. This caused the walls to sway until they could no longer support the weight of the house. The house crashed to the ground and secondary damage resulted from the impact. The same type of damage was also observed to houses in Watsonville.

Figure 4.4.3 Schematic of failure caused by inadequately braced cripple stud walls: (a) construction of cripple stud wall and (b) failure mechanism.

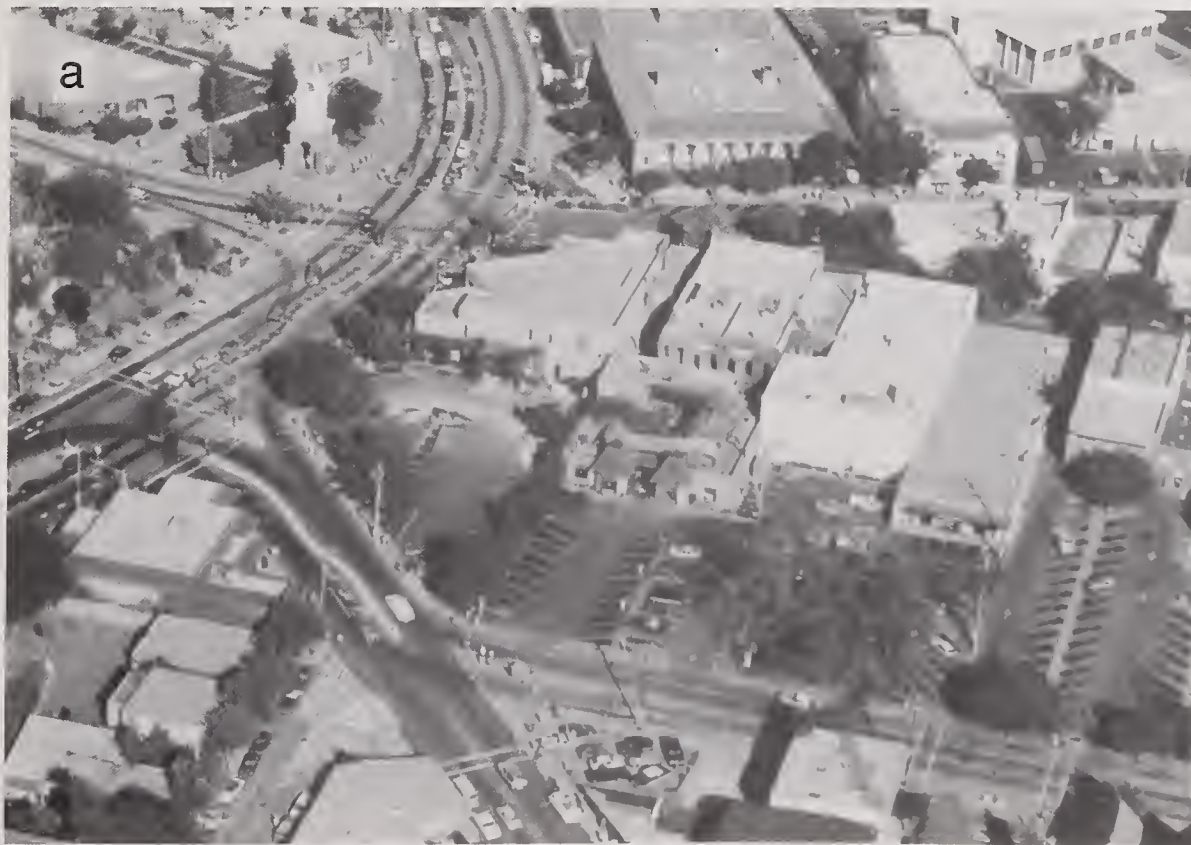
At the center of figure 4.4.8(a) there is a two-story masonry structure at the corner of Pacific Avenue and Water Street (location #1). Figure 4.4.9 shows the appearance of the structure at street level. It was designed about 15 years ago according to the 1973 Uniform Building Code, and it survived without any sign of structural damage. Adjacent to this modern building is an older unreinforced masonry building, which is seen on the left side of figure 4.4.9. Although the facade shows a small amount of damage, the roof of the building collapsed and killed two persons.

Figure 4.4.8 Aerial views of the Pacific Garden Mall: (a) northern portion.

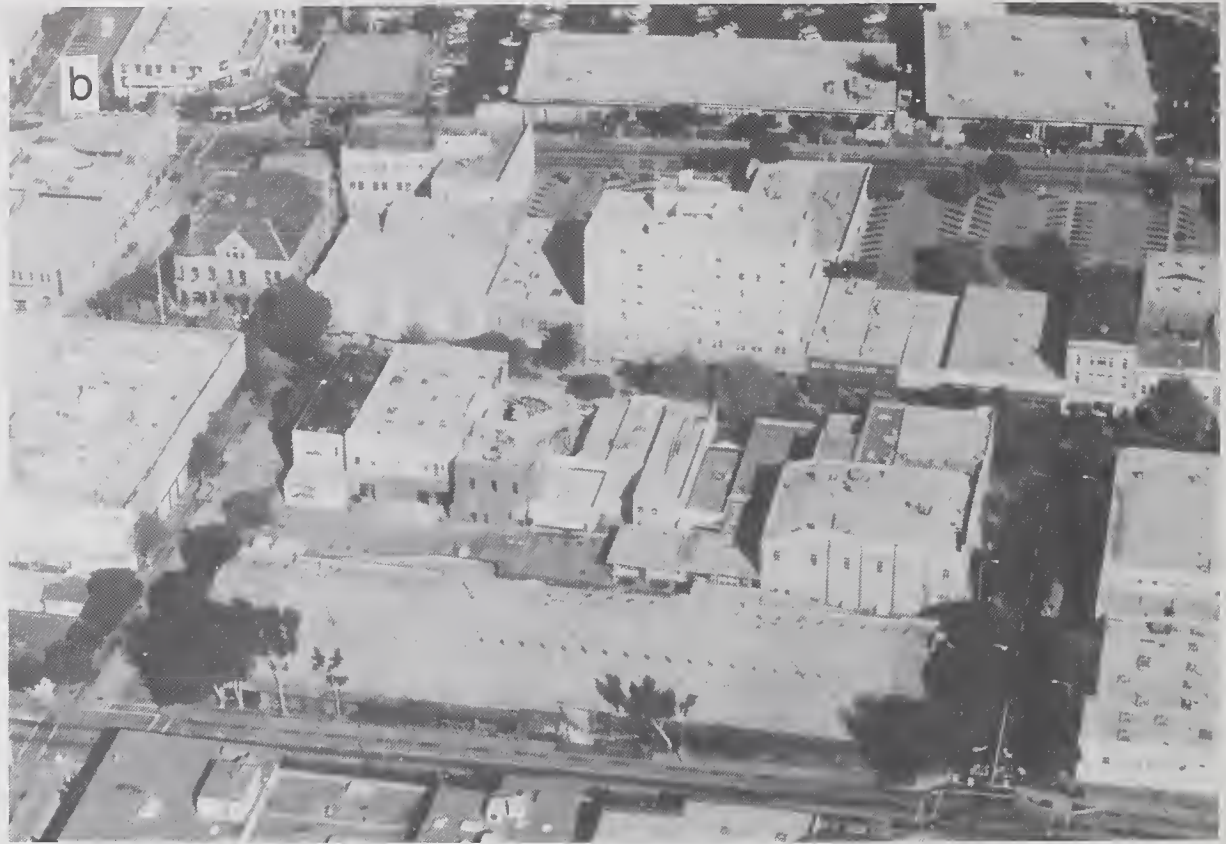
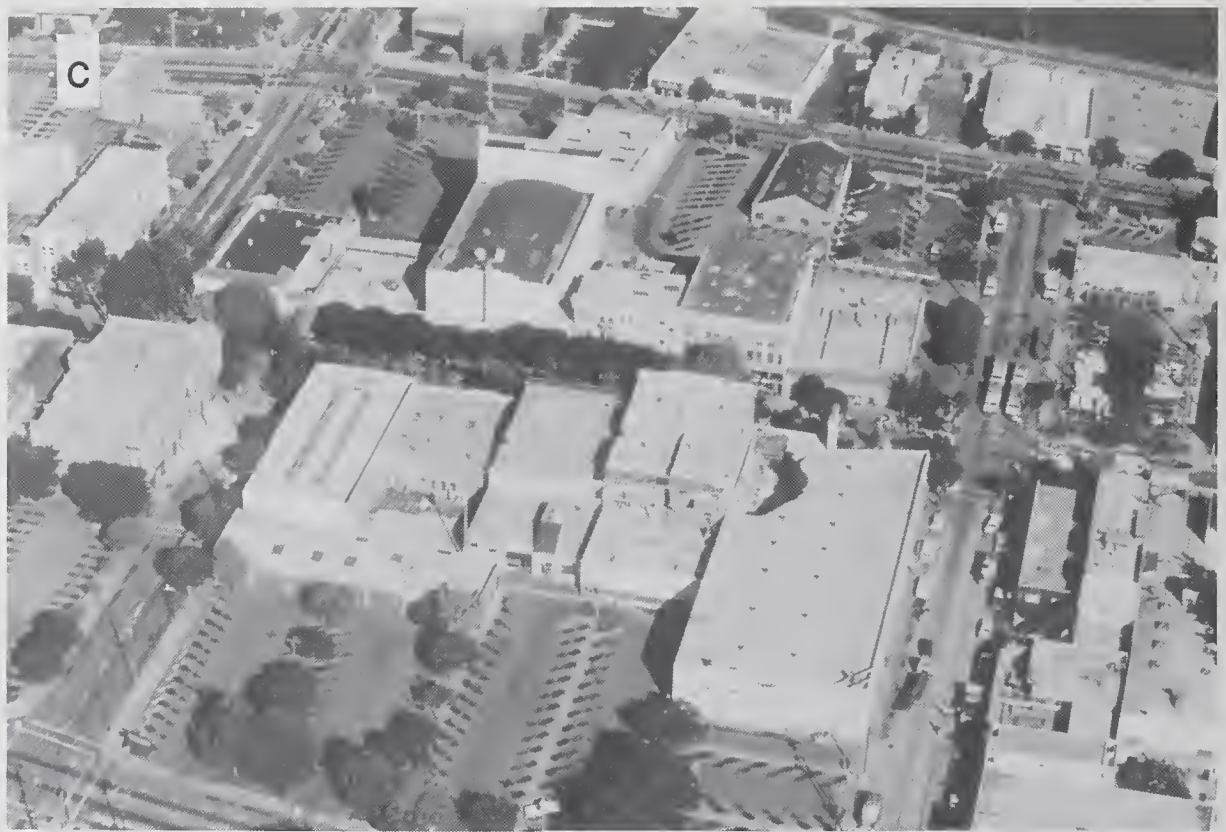
Another roof collapse in the mall caused the death of one person. This failure occurred to the department store on the corner of Pacific Avenue and Cathcart Street, and can be seen in figure 4.4.8(c). The roof failure was caused by the collapse of the top story masonry wall of the adjacent building. This type of damage was observed at several other stores within the mall.

A seven-story building is seen near the center of figure 4.4.8(b) (location #3). This reinforced concrete building, which was reported to have built in the 1920's, was severely damaged. The street level view in

Figure 4.4.8 (Cont'd) Aerial views of the Pacific Garden Mall: (b) central portion, and (c) southern portion.

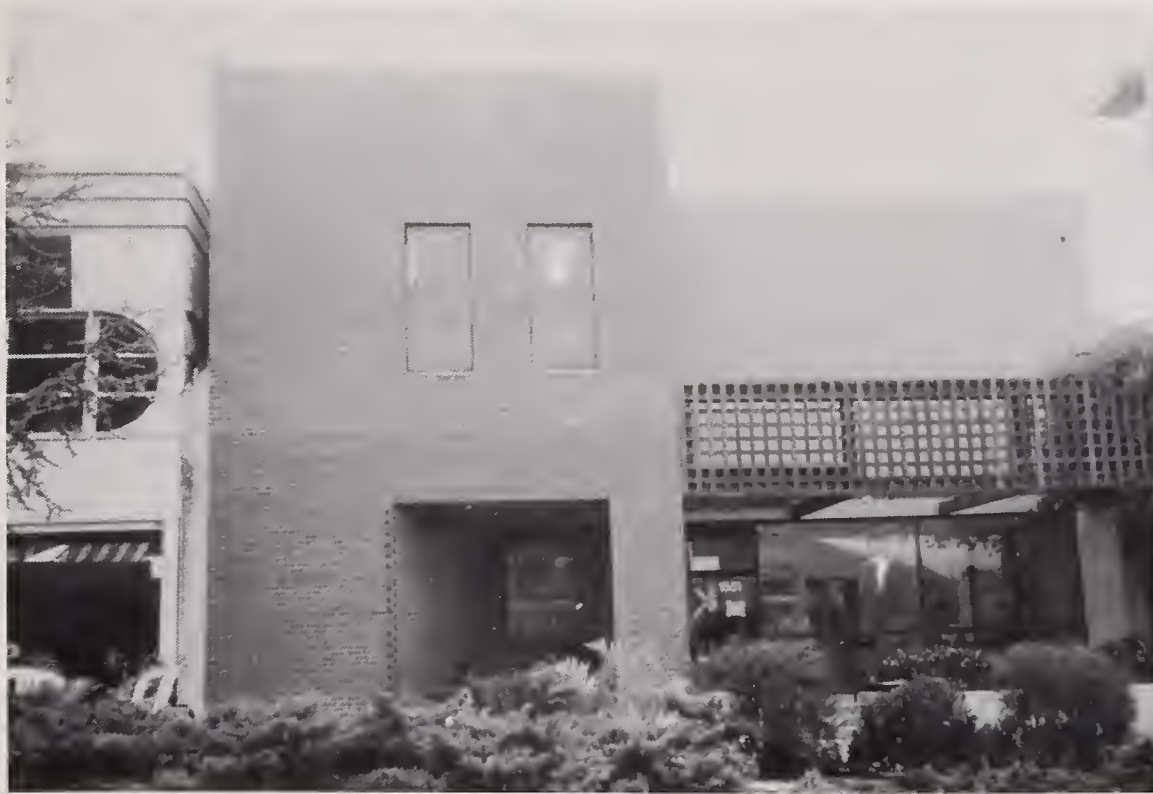
Figure 4.4.9 Modern reinforced masonry structure which was undamaged; building on the left suffered roof failure causing two deaths (location #1).

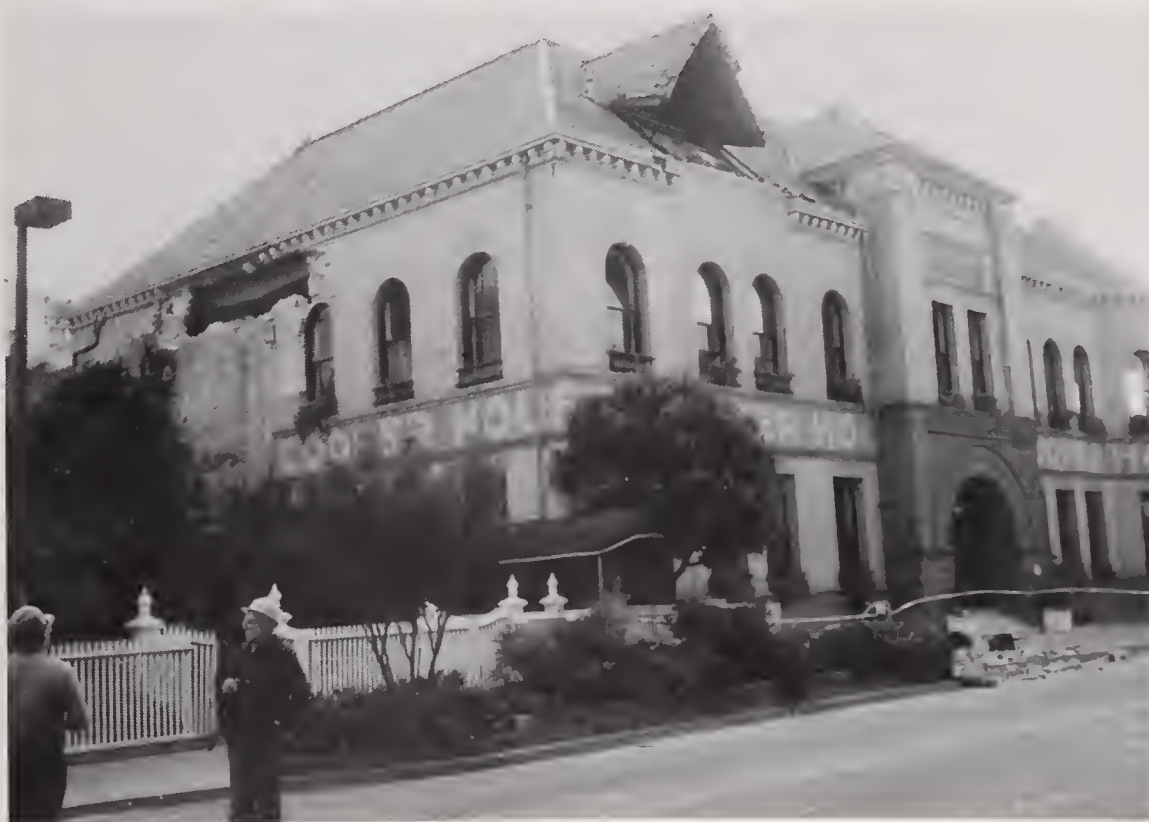
One of the historic structures severely damaged is the Cooper House located on the corner of Pacific Avenue and Cooper Streets (location #2). The unreinforced masonry building was built in the 1880's as the county courthouse. The building was reported to have survived the 1906 San Francisco earthquake<sup>7</sup>, but it was extensively damaged during the Loma Prieta earthquake. As shown in figure 4.4.10, portions of exterior walls collapsed and there were extensive diagonal cracks throughout the exterior walls. The damage was so severe that the building subsequently was demolished.

Figure 4.4.10 Historic Cooper House in Santa Cruz was severely damaged and had to be demolished (location #2).

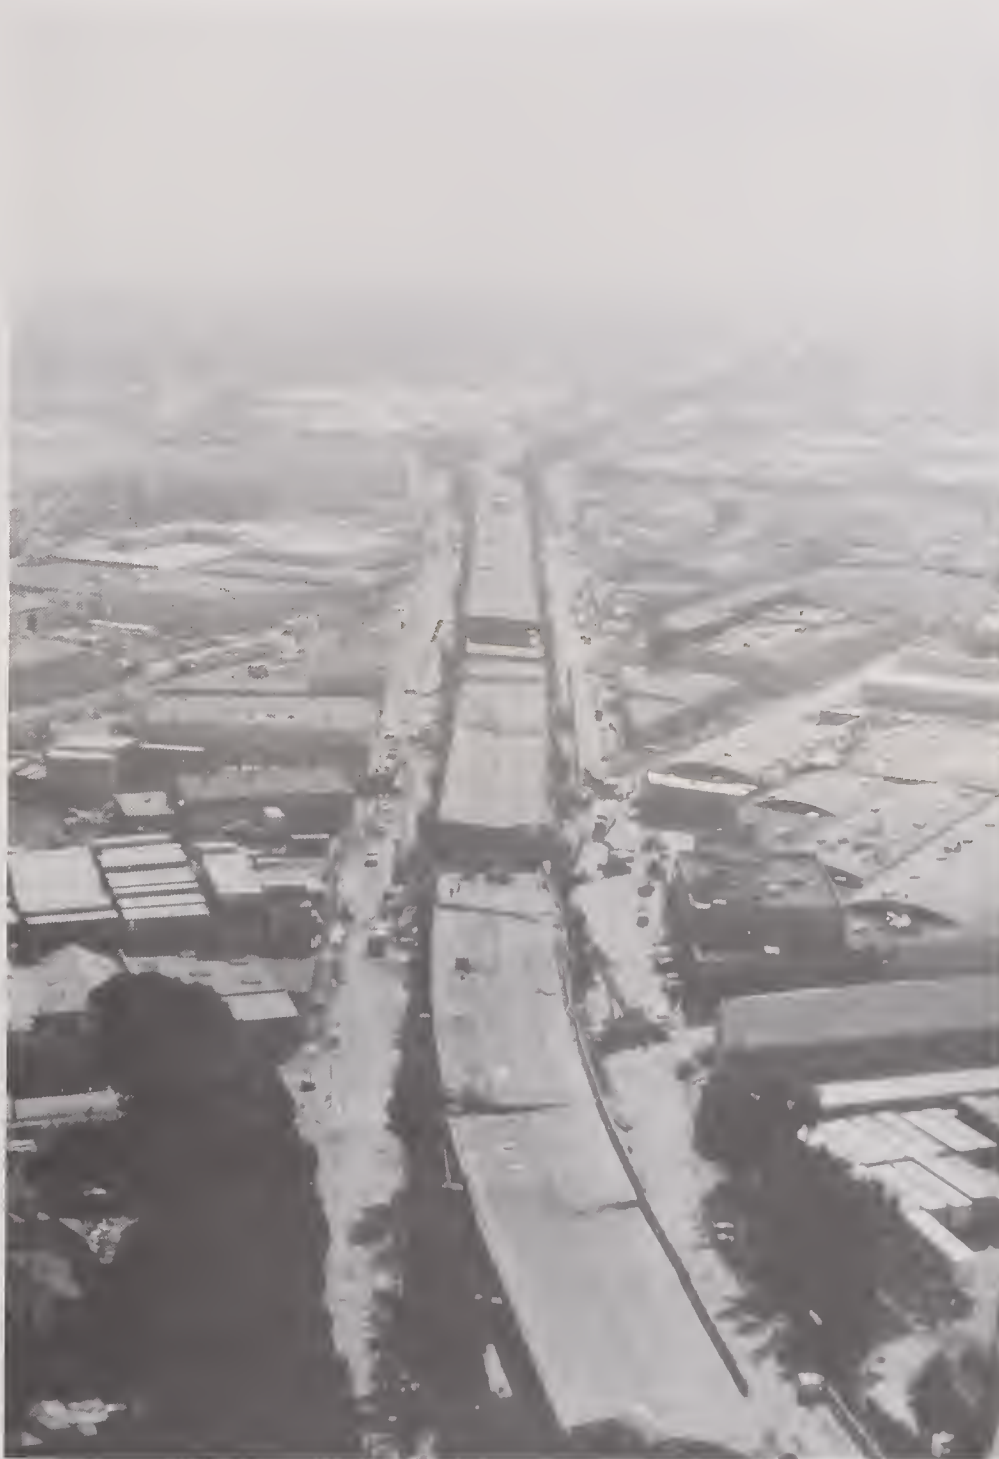
Figure 5.6.10 Aerial photo looking east to the northern limit of the collapsed portion of Cypress Structure between Bents 110-113.

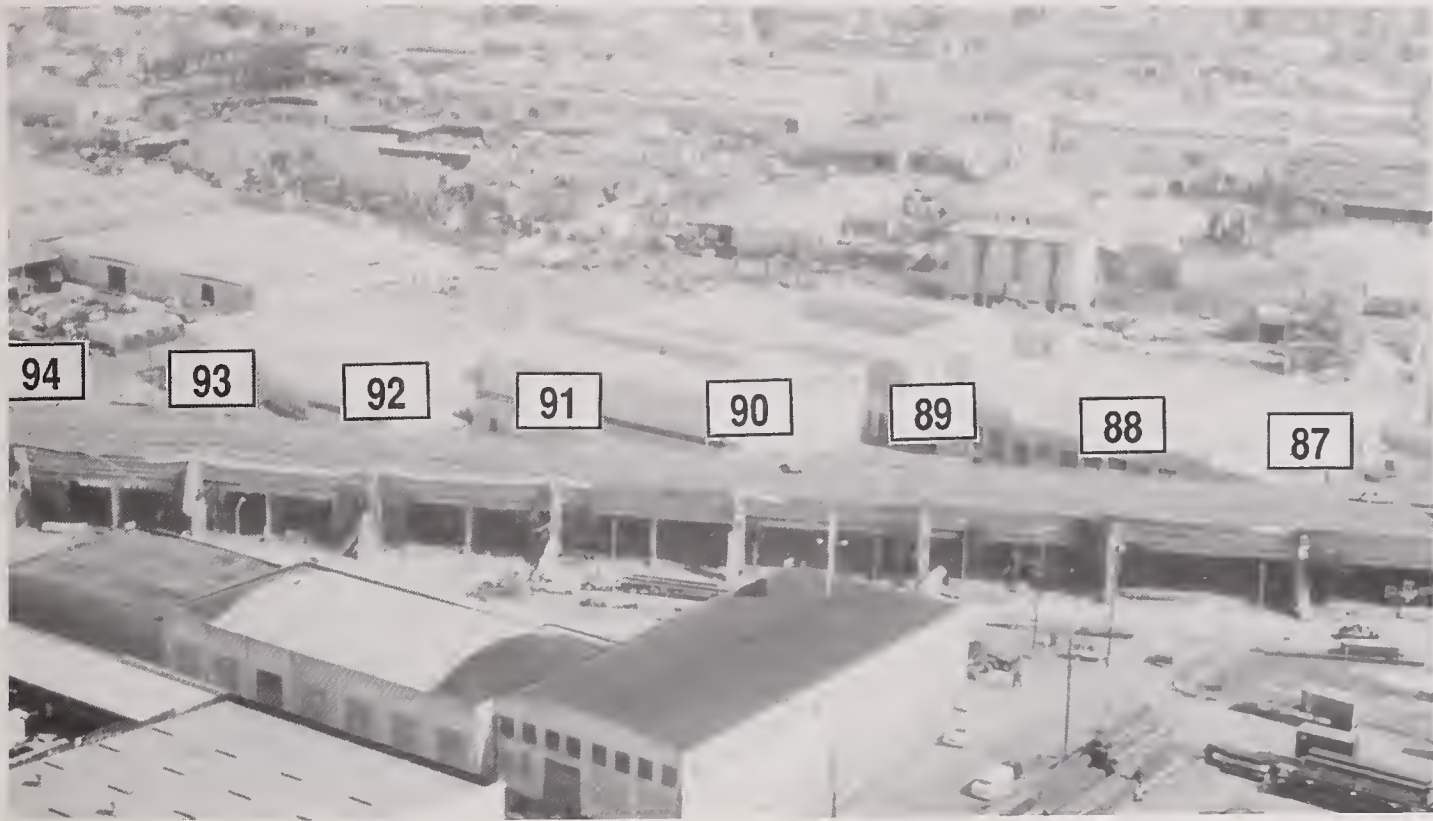
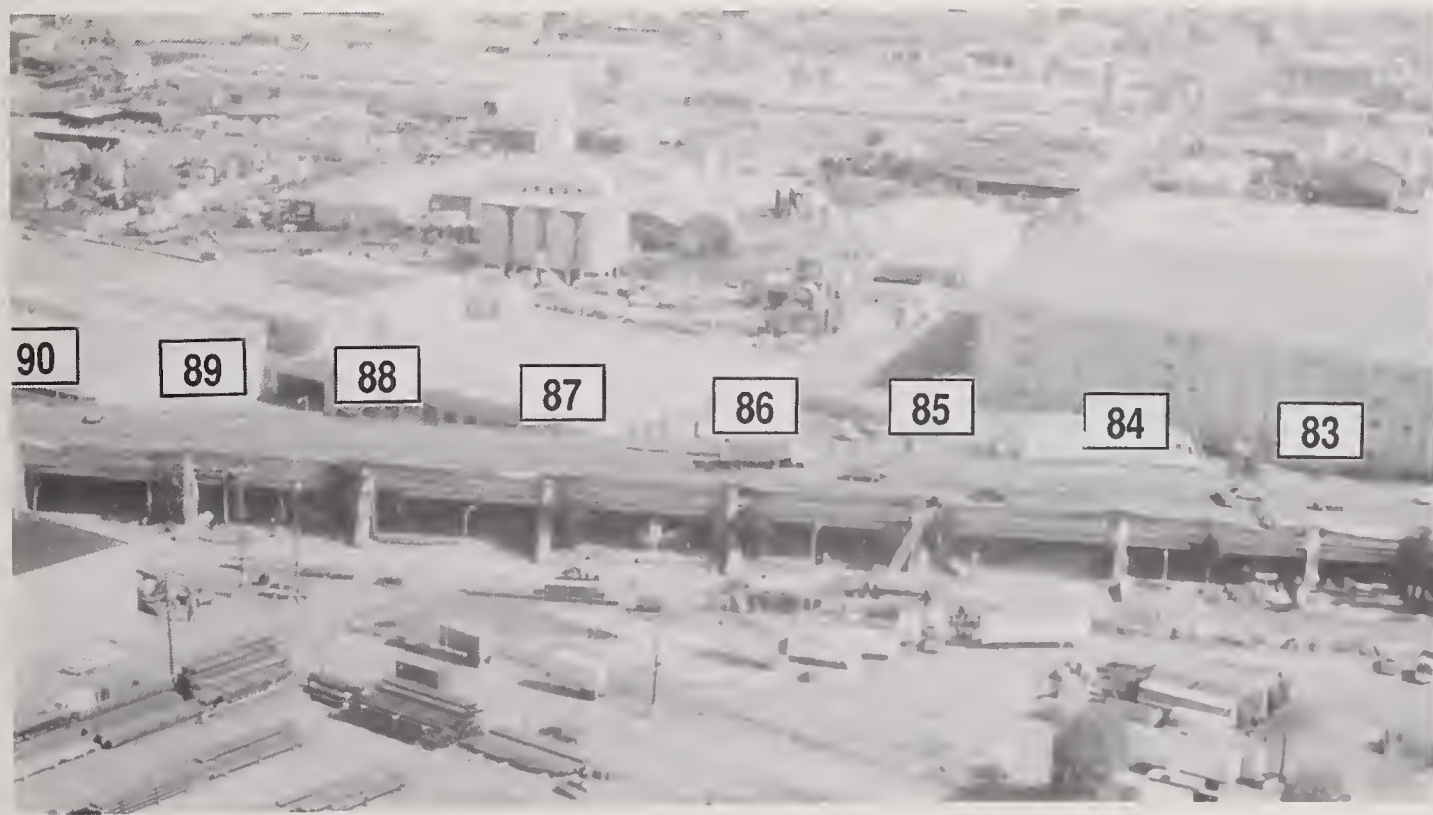
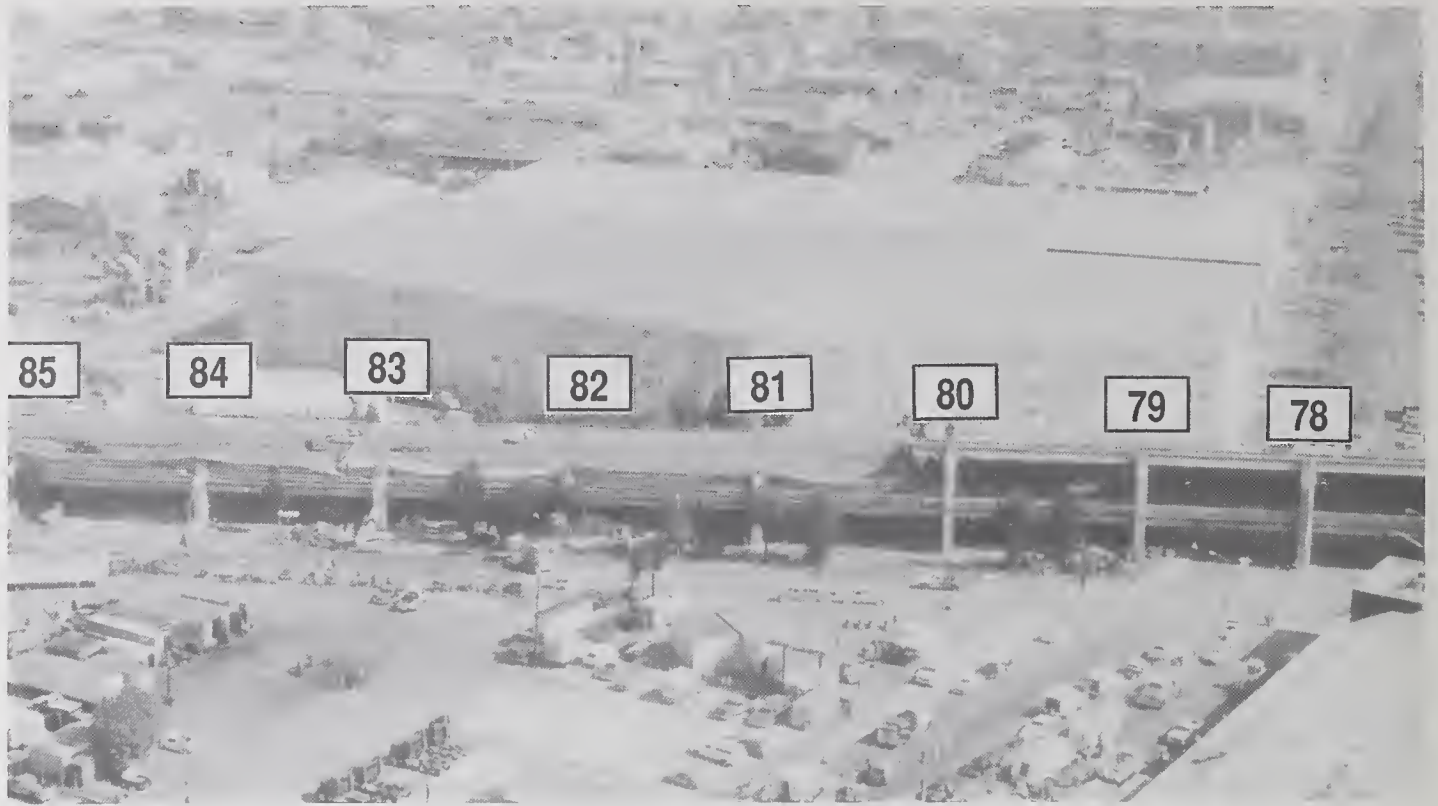
Figures 5.6.16 through 5.6.18 show a uniform section between Bents 94 and 80 in which the upper deck has collapsed directly on top of the lower deck. All of the bents in this section were Type 1 and exhibited a distinctive failure mode in which both upper bent columns sheared at their base from the supporting pedestals and splayed outward as the weight of the upper deck carried the bent down to the lower level girder where the collapse was generally arrested. Beginning at Bent 80 and extending south to Bent 71 (figs. 5.6.18 and 5.6.19) all bents were of the three-hinged post-tensioned variety (Types 2 and

Figure 5.6.16 Aerial photo looking east to the collapsed portion of Cypress Structure between Bents 86-94.

Figure 5.6.17 Aerial photo looking east to the collapsed portion of Cypress Structure between Bents 83-90.

Figure 5.6.18 Aerial photo looking east to the collapsed portion of Cypress Structure between Bents 78-85.

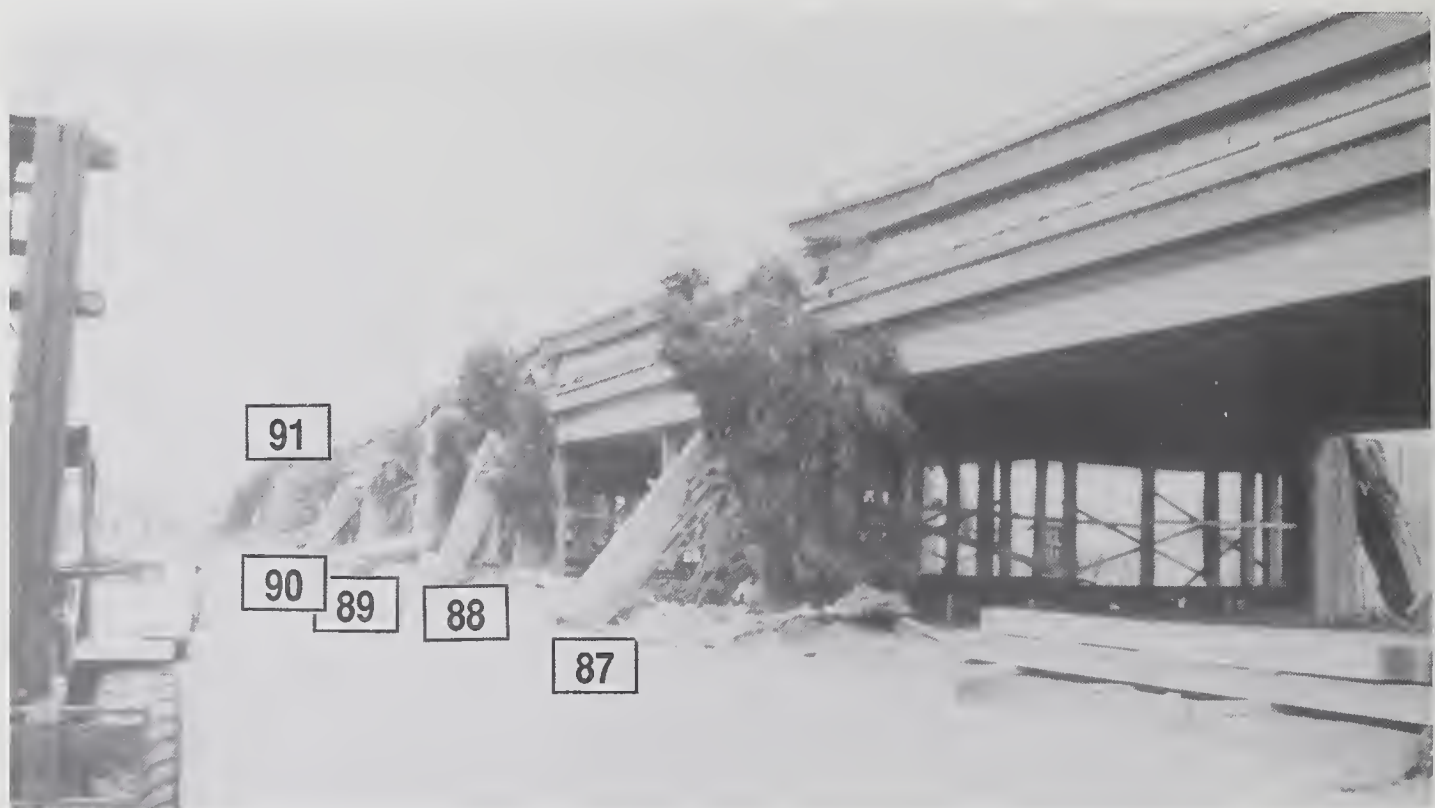
Figure 5.6.23 View of the west side of Cypress Structure looking north between Bents 86-92. These were all Type 1 bents which demonstrate the uniformity of the collapse mechanism.

Figure 5.6.23 shows a ground-level view looking northward from Bent 86 on the west side of the expressway. All of the bents visible in this photo were Type 1 which invariably exhibited a symmetrical failure with both upper columns shearing free at their base and being splayed outward as the upper deck fell. The timber posts visible beneath the lower deck were installed by Caltrans under each bent to insure that there was no subsequent settling of the structure during rescue operations. Further evidence that the upper deck fell nearly squarely on the lower deck with no significant sidesway is shown in figure 5.6.24 which is looking northward from atop Bent 80.

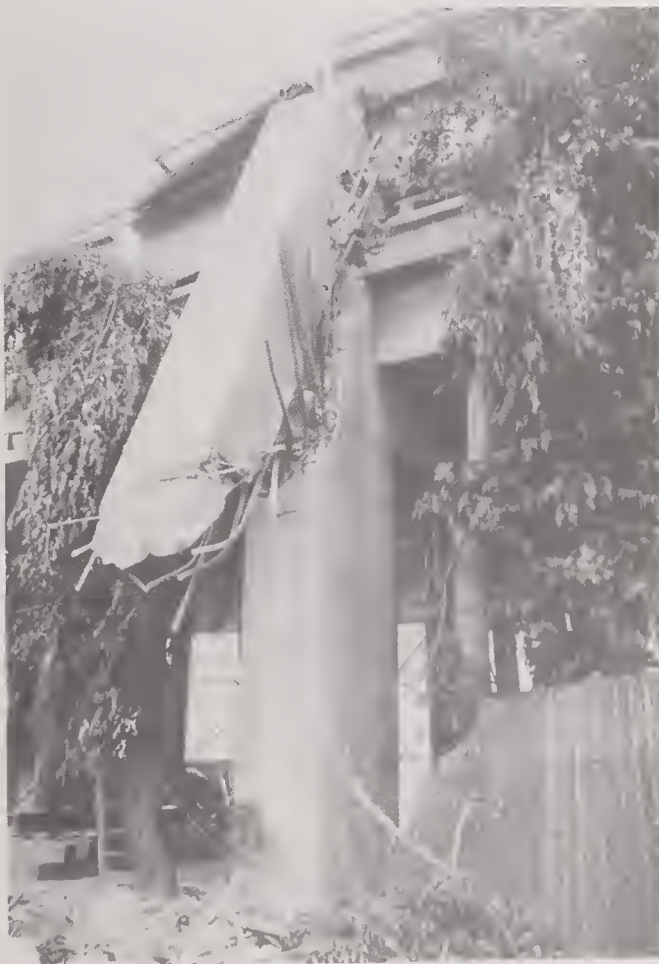
Figure 5.6.25

Figures 5.6.25 through 5.6.28 show four minor variations of Type 1 bent failure. All views are from the west side of the respective bents. At Bent 65 (fig. 5.6.25), it can be seen that the upper column support pedestal is still attached to the base of the column and that an inclined failure plane exists through the failed pedestal. Note that confining reinforcement in the vicinity of the lower girder/column joint is non-existent. As for most Type 1 bent failures, the upper columns remained tenuously attached to the upper bent girder. Bent 85 (fig. 5.6.26) shows a similar situation regarding the upper column support pedestal (beneath the numbers "85" in the figure). Here it is evident that the failure plane for the pedestal ran flush with the curved face formed by the lower bent girder negative moment steel. It is also evident that the seismic loads, in combination with a lack of confining steel in the upper beam/column joint, were sufficient to induce an explosive rupture of concrete at the top of the column, breaking it free from the upper girder steel seen at the top center of the photo. It should be emphasized, and it will become clear in subsequent discussion, that such compressive failures did not initiate the collapse of the bent, despite the lack of lateral confining steel in the upper girder/column joint. At Bent 90, the upper column apparently sheared through the 4-#10 dowel bars at the center of the shear key and was propelled outward

A view of the west side of Bent 65 of Cypress Structure illustrating the predominant failure mode for a Type 1 bent. The upper frame columns sheared through the support pedestal which connected them to the lower frame. In most cases the upper columns remained connected to the upper deck as shown.

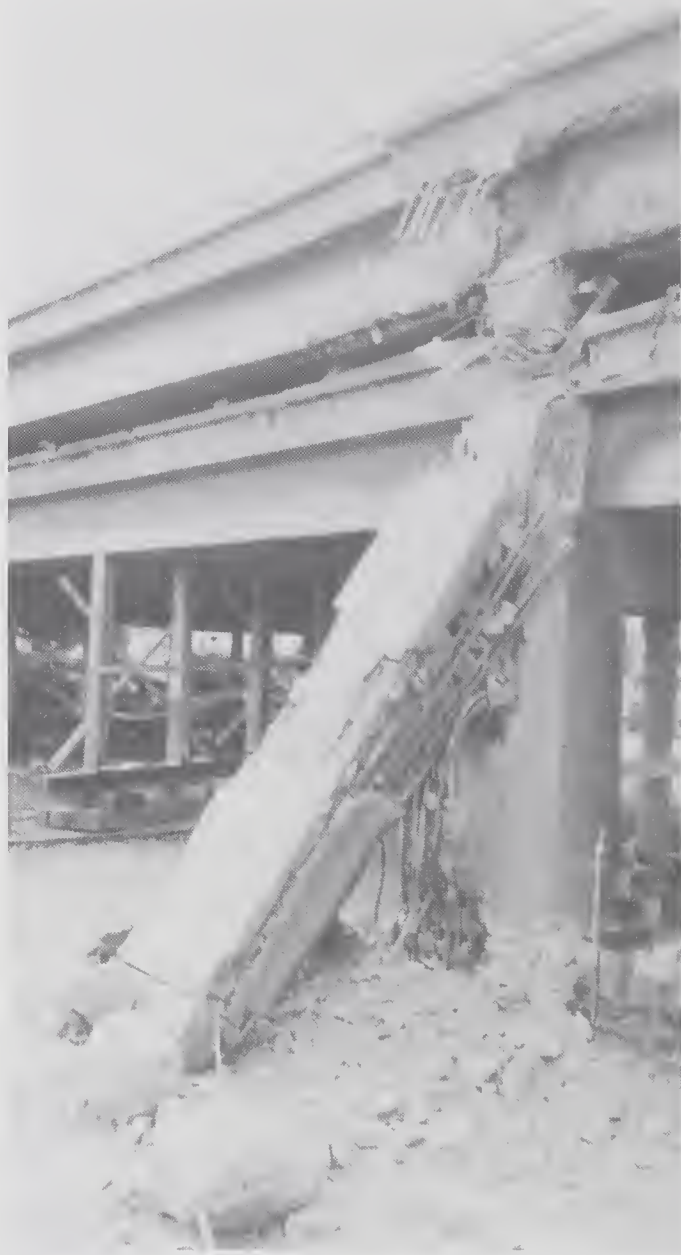
Figure 5.6.26

Failure of the west side of Bent 85. In this particular case a portion of the sheared support pedestal is still attached to the base of the upper column. The top of the column failed explosively and separated from the upper frame girder.

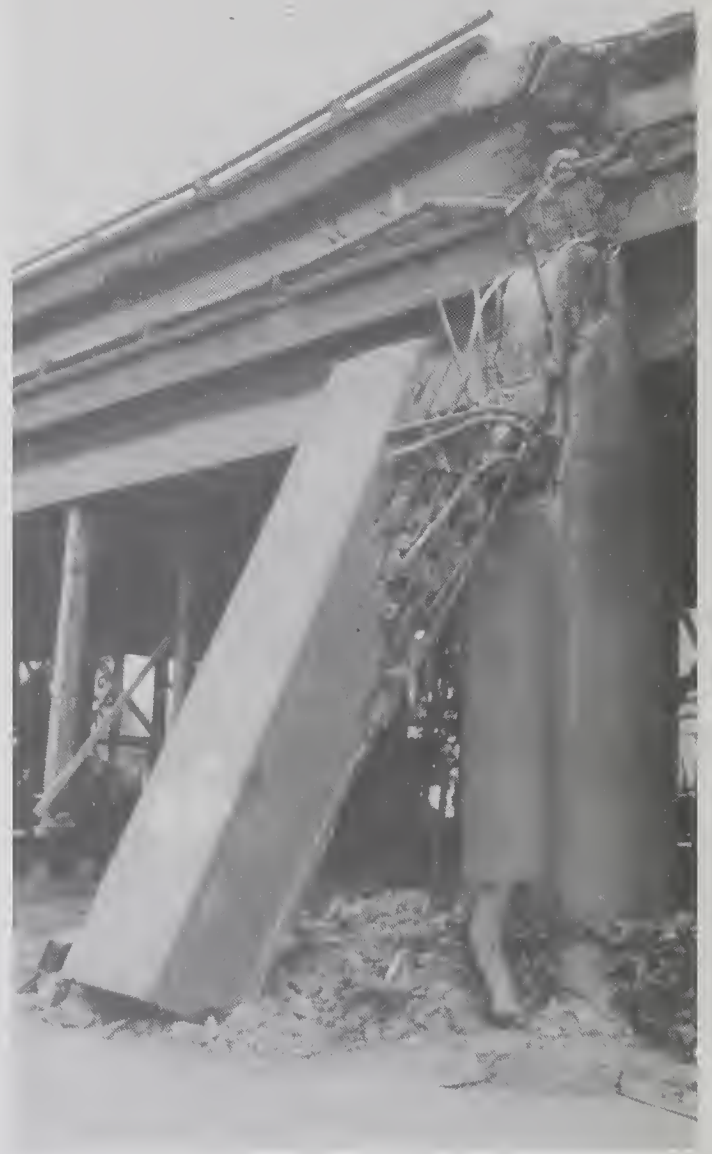
Figure 5.6.27

Failure of the west side of Bent 90. In this case the supporting pedestal for the upper columns was completely disintegrated; only the interior face of axial reinforcement that was present in the pedestal remains imbedded in the lower column. It can be seen that the failure plane followed the face of the curved negative moment steel from the lower frame girder.

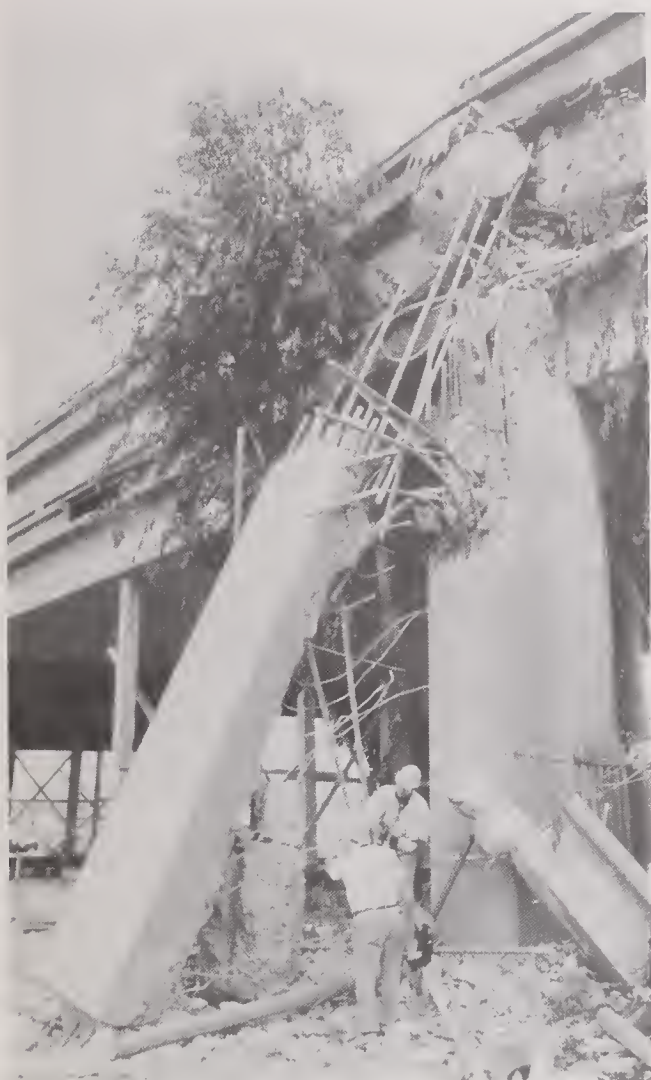
Figure 5.6.28 shows a final variation of a Type 1 bent failure. This particular column, at Bent 94, carried a pipe through its center which drained the upper deck. Given a lack of significant confining reinforcement (note the thin #4 ties which appear as wires compared with the massive #18 axial reinforcement), the presence of this pipe likely served to create the fracture path which split the column.

Failure of the west side of Bent 94. The presence of a central pipe, used to drain the upper deck, permitted a fracture plane to develop through the center of the column. The eastern half of the column disintegrated under compressive load while the western half spalled off.

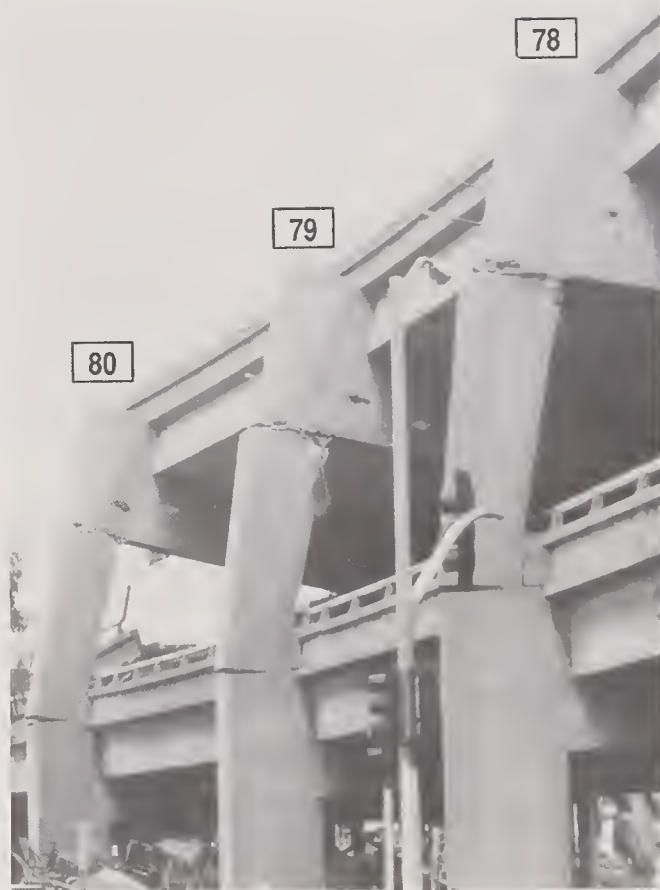
Figure 5.6.29 shows a closeup of a Type 2 bent failure in which the eastern half of a series of three-hinged prestressed bents collapsed, due to shearing failure at the base of the east column, leading to a rigid body rotation of the upper deck about the western, two-hinged columns. As can be seen, the western column shear keys did perform as hinges even under rotations sufficient to cause compressive spalling on the interior face of the columns (fig. 5.6.30). Most of the upper bent girders fractured due to impact-induced bending stresses. This in turn yielded, and subsequently fractured most of the post-tensioning bars which, because they were unbonded, were partially expelled from the girder due to rebound from the release of stored elastic energy, as shown in figure 5.6.31. It is of some significance that Bent 78, the innermost frame in figure 5.6.32, was skewed at an angle of 16 degrees. This difference, although subtle, may be part of the explanation for why this particular section did not fail completely. This performance is to be directly contrasted with Bent 72 (see figs. 5.6.33 and 5.6.34) in which the western two-hinged columns were ejected from the structure. Of particular note in figure 5.6.33 are the bent #10 bars projecting both from the top of the lower bent column as well as the bottom face of the upper bent girder. These represented the only continuous reinforcement through the upper and lower shear keys. Figure 5.6.35 leaves no doubt that lateral confining steel was insufficient to prevent localized fracture of the concrete and the subsequent pullout of these dowels. A closeup of the top of the Bent 71 upper two-hinge column in figure 5.6.35 shows a detail of the still intact shear key, 4-#10 dowel bars, and, in this particular instance, a central drainage pipe. In this case the dowel bars remained intact within the column and pulled out, instead, from the upper girder joint.

A view looking north at the west side of Bents 78-80. These were all Type 2 bents which included prestressing of the upper girders. This particular mode of failure, in which only the east columns of the upper frames failed, is noted as a Type A Failure in subsequent discussions. Type A Failures occurred in Bents 74 through 80 (see figs. 5.6.18 and 5.6.19).
