*NIST Special Publication 778*

# *Performance of Structures During the Loma Prieta Earthquake of October 17, 1989*

*H. S. Lew, Editor*

January 1990

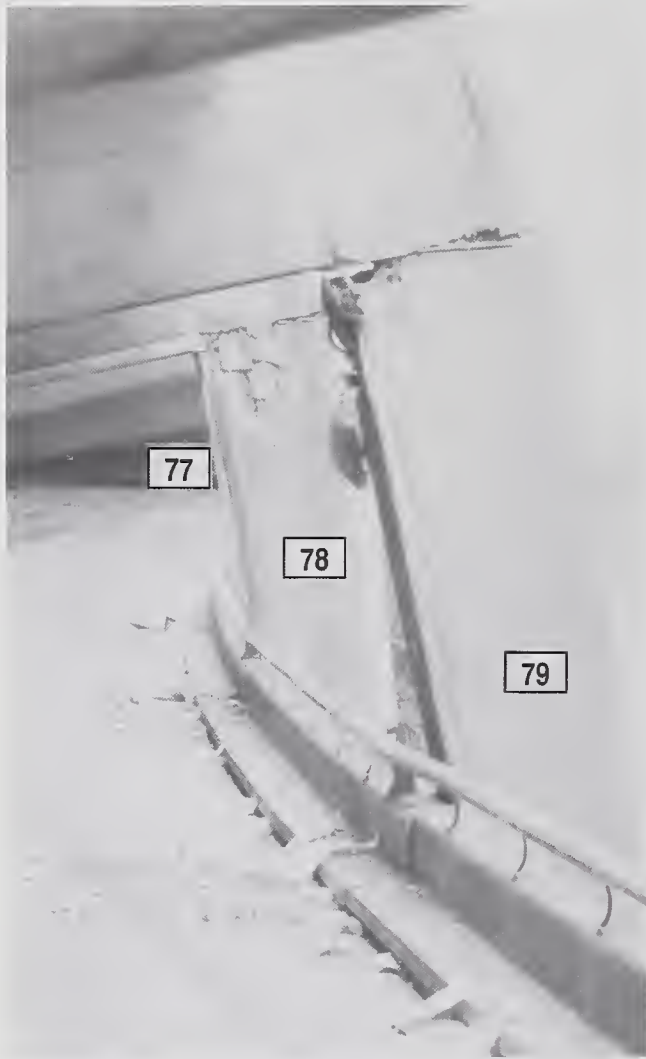
Figure 5.6.30

A close-up view looking south from Bent 80 at the west side of the upper portion of Cypress Structure. Note compression spalling along the interior face of the tops of the columns.

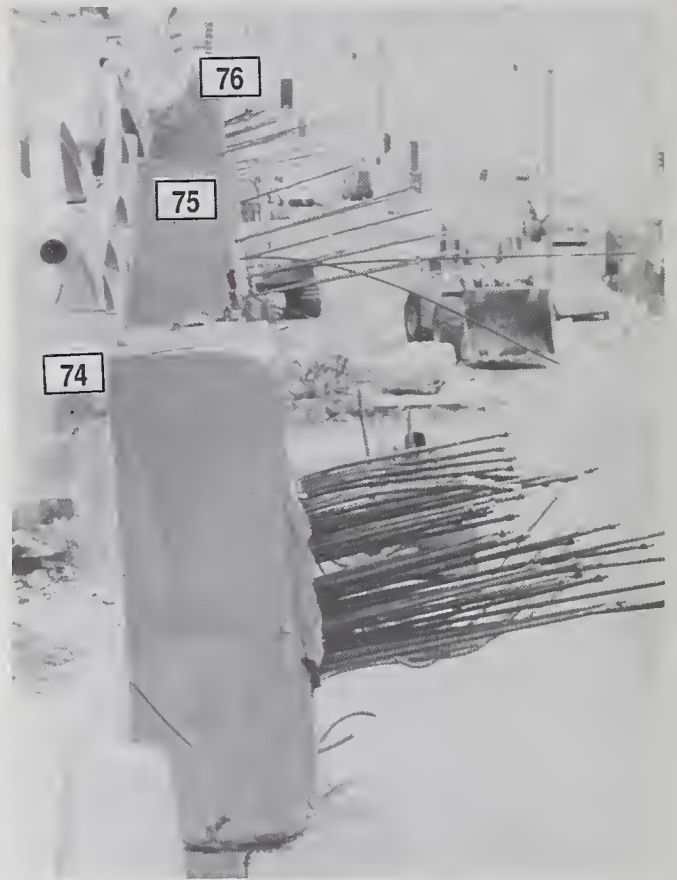
Figure 5.6.31

Due to excessive flexural displacements in the upper frame girder, most of the post-tensioning tendons yielded and then fractured. The tendons were unbonded, to permit extension of the top girder at a later date as part of a planned access ramp. The stored elastic energy drove the tendons from their ducts, as shown here at Bents 74, 75, and 76 on the east side of Cypress Structure.

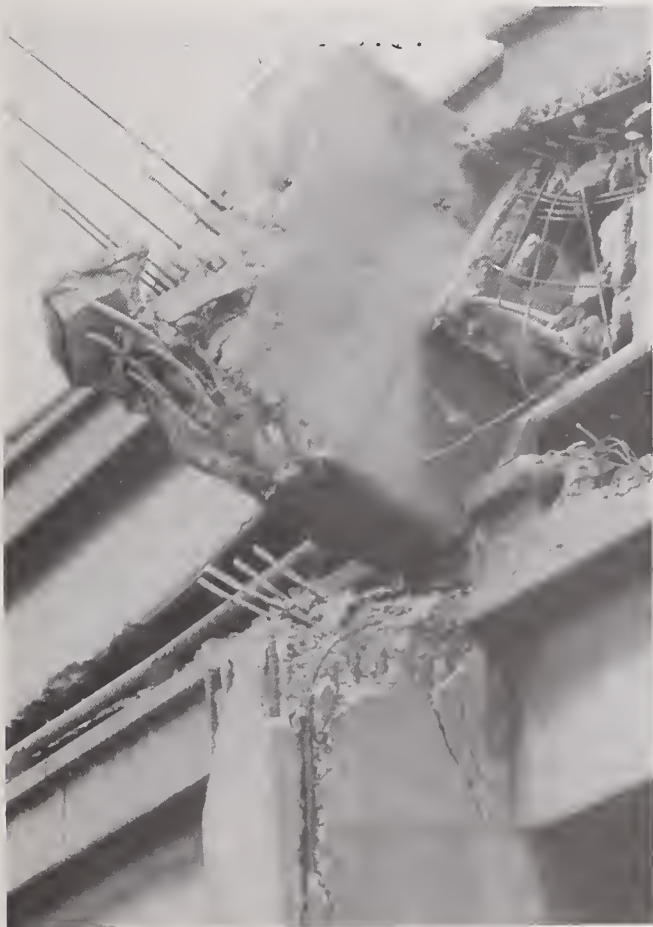
Figure 5.6.33

A close-up of the west side of Bent 72 shows the second, or Type B, variation of failure observed for Type 2 bents. In this case the entire double-hinged upper frame column segment has been ejected from the structure. The 4-#10 bars which passed through the upper and lower shear keys may be seen projecting from the base of the upper girder and the top of the lower column.

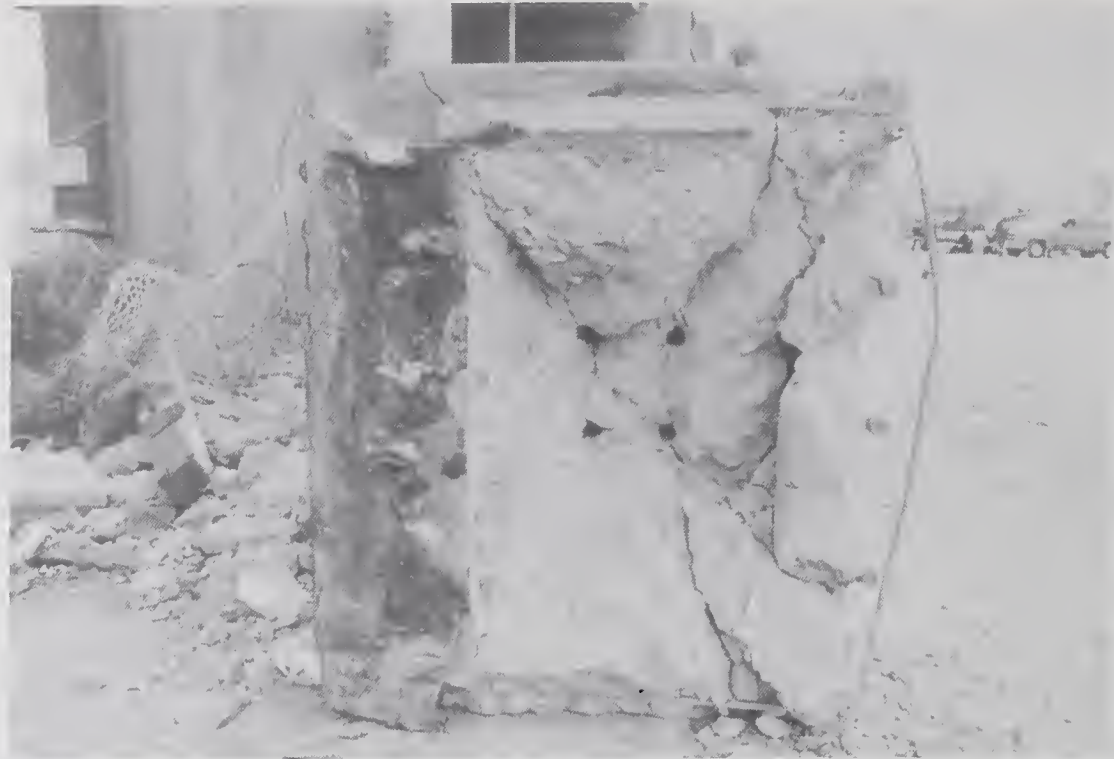
Figure 5.6.34 Detail of the base of the two-hinged column that was ejected from the west side of Bent 72. The 4-#10 dowel bars which passed through the center of the shear key have been pulled free.

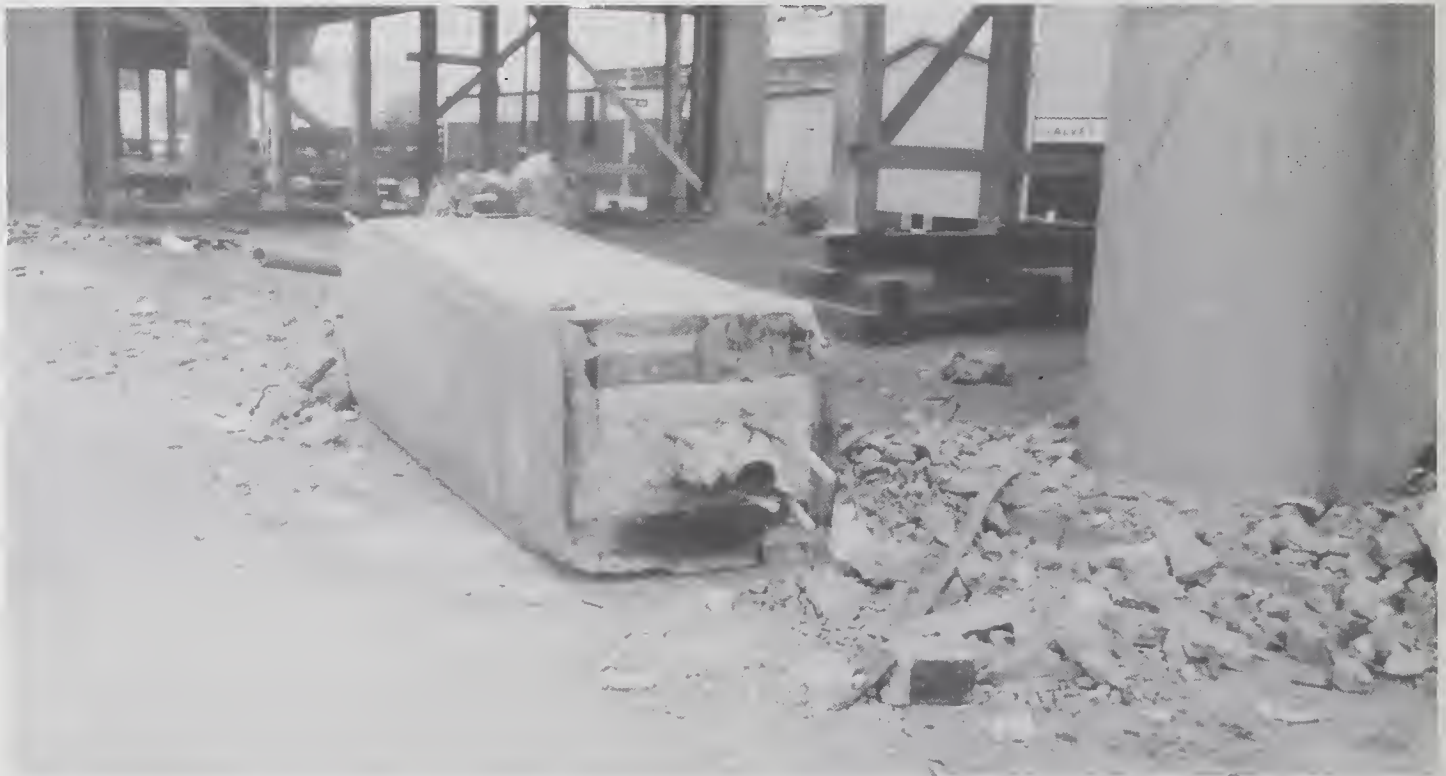
Figure 5.6.35 Detail of the bottom of the two-hinged column that was ejected from the west side of Bent 71 showing central pipe used to drain the upper road deck and the 4-#10 dowel bars used to transfer shear across the hinge.

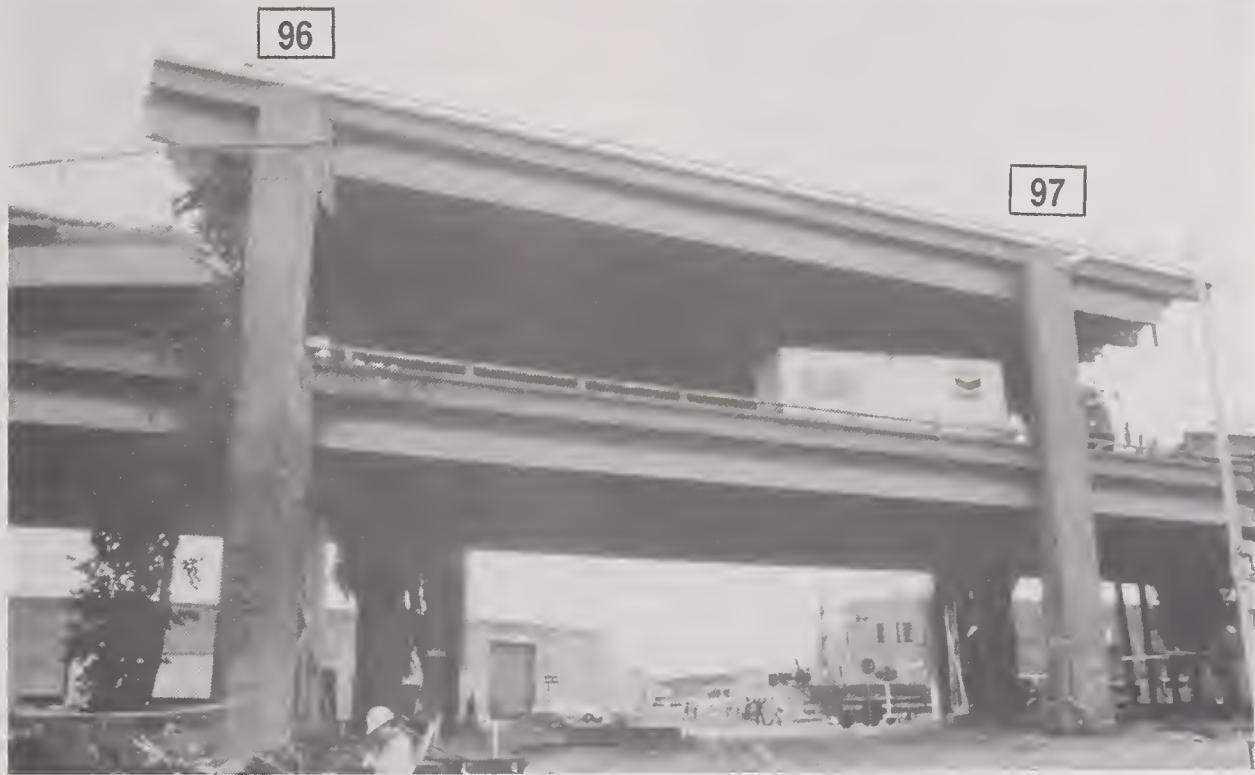
Figures 5.6.36 and 5.6.37 show details of the span between Bents 96 and 97, the only one to remain completely intact between Bents 62 and 113. There are several obvious differences which could account for this. The Type 4 bent, which includes Bents 95-98, contains an additional central column in the lower bent which would serve to limit lateral sway at the first deck level. More importantly, the reinforcing steel at the base of the upper bent columns is continuous with the lower columns, eliminating the pedestal/hinge detail that appears to have contributed to widespread failure in Type 1 bents. Figure 5.6.37 indicates that, despite severe flexurally induced cracking at the lower column/girder joint, the upper and lower

Figure 5.6.36 View looking west towards Bents 96 and 97 which supported the only segment of the upper deck to remain standing between Bents 62 and 113.

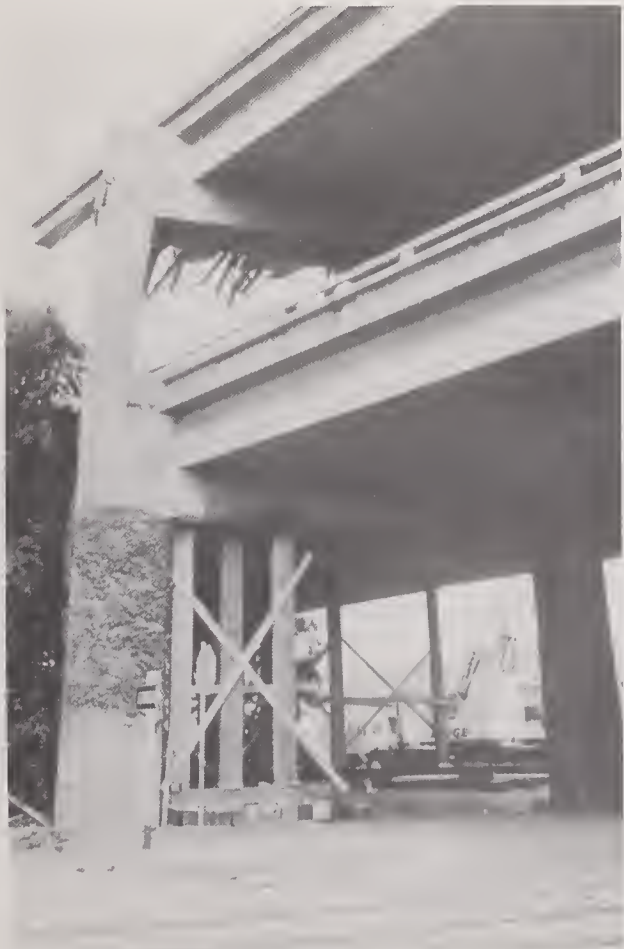
Figure 5.6.37

It is interesting to note that the calculated column shear resistance reported by Priestley et al. (Priestley, 1989) for Type 4 bents (see fig. 5.6.5), when modified to account for the measured compressive strength of the concrete, comes to 398 kips (1770 kN). Accounting for portal frame reaction shear at the column bases for the upper bent, the lateral base acceleration required to achieve failure is 0.38g, i.e., greater than the expected acceleration from the response spectra reported by CDMG (CDMG, 1989b). These frames, as can be seen in figure 5.6.37, suffered significant damage, but remained standing.

Detail of the west side of Bent 97 showing extensive shear cracking at the interior beam/column joint for the lower frame and compression spalling at the upper beam/column joint. Axial reinforcement for the upper frame columns was continuous with the lower frame columns on both east and west sides. This, and the larger cross section, helps to explain why these Type 4 bents did not collapse.

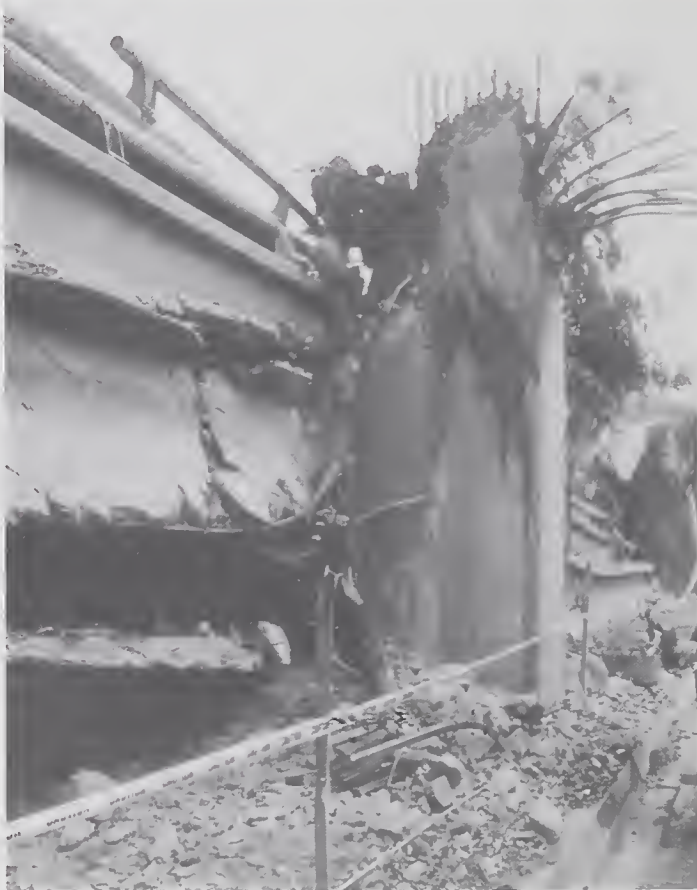
Figure 5.6.39

The section of expressway between Bents 104 and 106 (fig. 5.6.38) contains the only portion of the Cypress Structure to have exhibited complete failure in both upper and lower decks. These were Type 1 bents in an area where the lower road deck was beginning its descent to the northern distribution structure. Beyond Bent 106 both upper and lower decks were superelevated on the east side. Other than these minor differences, there were no particularly distinguishing characteristics which would have made these bents more susceptible to failure. It has been suggested (EERI, 1989) that greater accelerations may have been experienced towards the northern end of the structure due to the presence of Bay Mud deposits, which are deepest towards the northern end of the collapsed section and would have led to soil amplification. This argument is unconvincing in light of geotechnical data subsequently made available (CDMG, 1989b). The remaining possibilities include construction defects and/or resonance of the entire Cypress Structure which could have led to higher forces in this particular area, as a result of random coincidence of modes, than would be expected using the simple Newtonian lateral force approach discussed below. In any event, there was vastly different performance of the lower bent columns to the north of Bent 104, as exhibited, for example, at Bents 105 and 108 shown in figures 5.6.39 and 5.6.40. Bent 108, in particular, exhibited the only gross shear failure of a lower column seen in the entire Cypress Structure.

Close-up of the west side of Bent 105 looking south, illustrating complete shear failure of the lower bent beam/column connection.

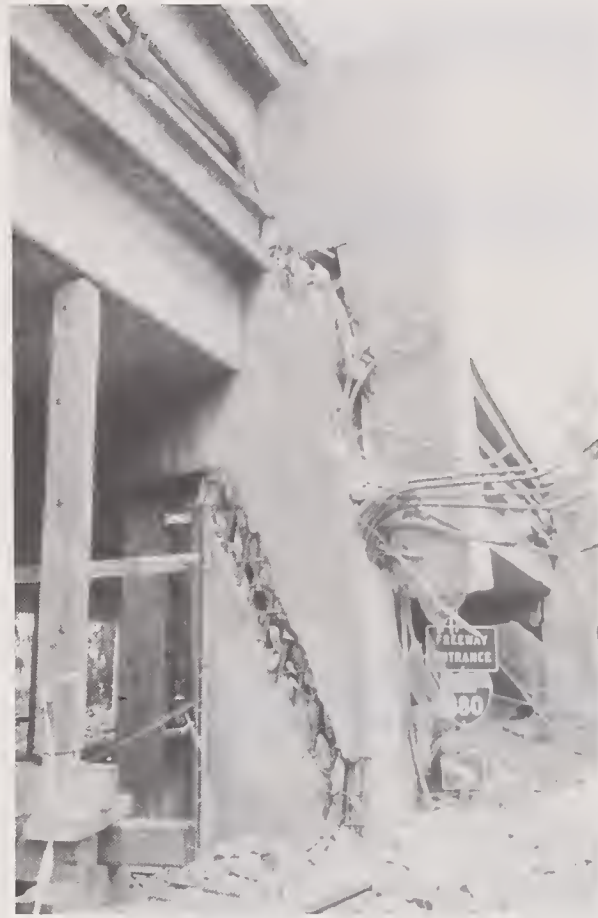
Figure 5.6.40

Close-up view of the east side of Bent 108 looking north. This was the last Type 1 bent prior to the northern limit of the collapse at Bent 113. In addition to the common failure of the pedestal supporting the upper frame column, the column of the lower frame sustained a total shear failure.

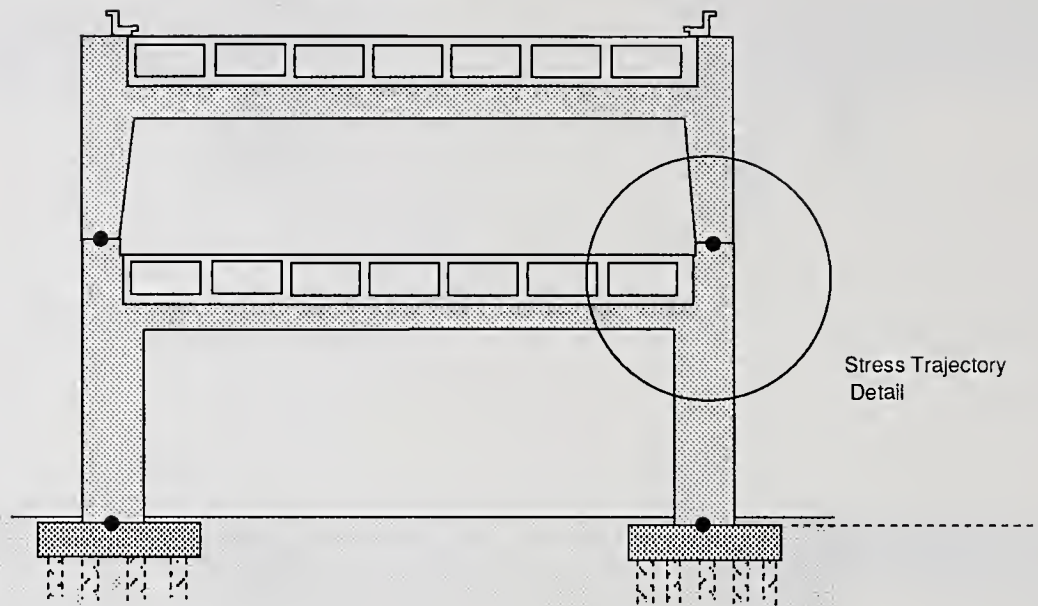
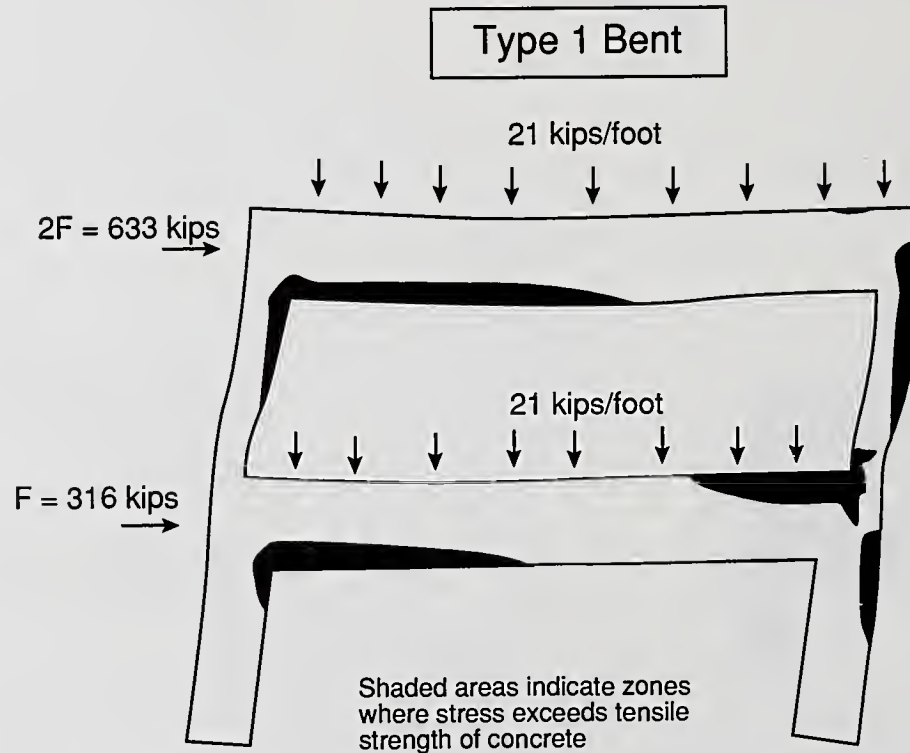
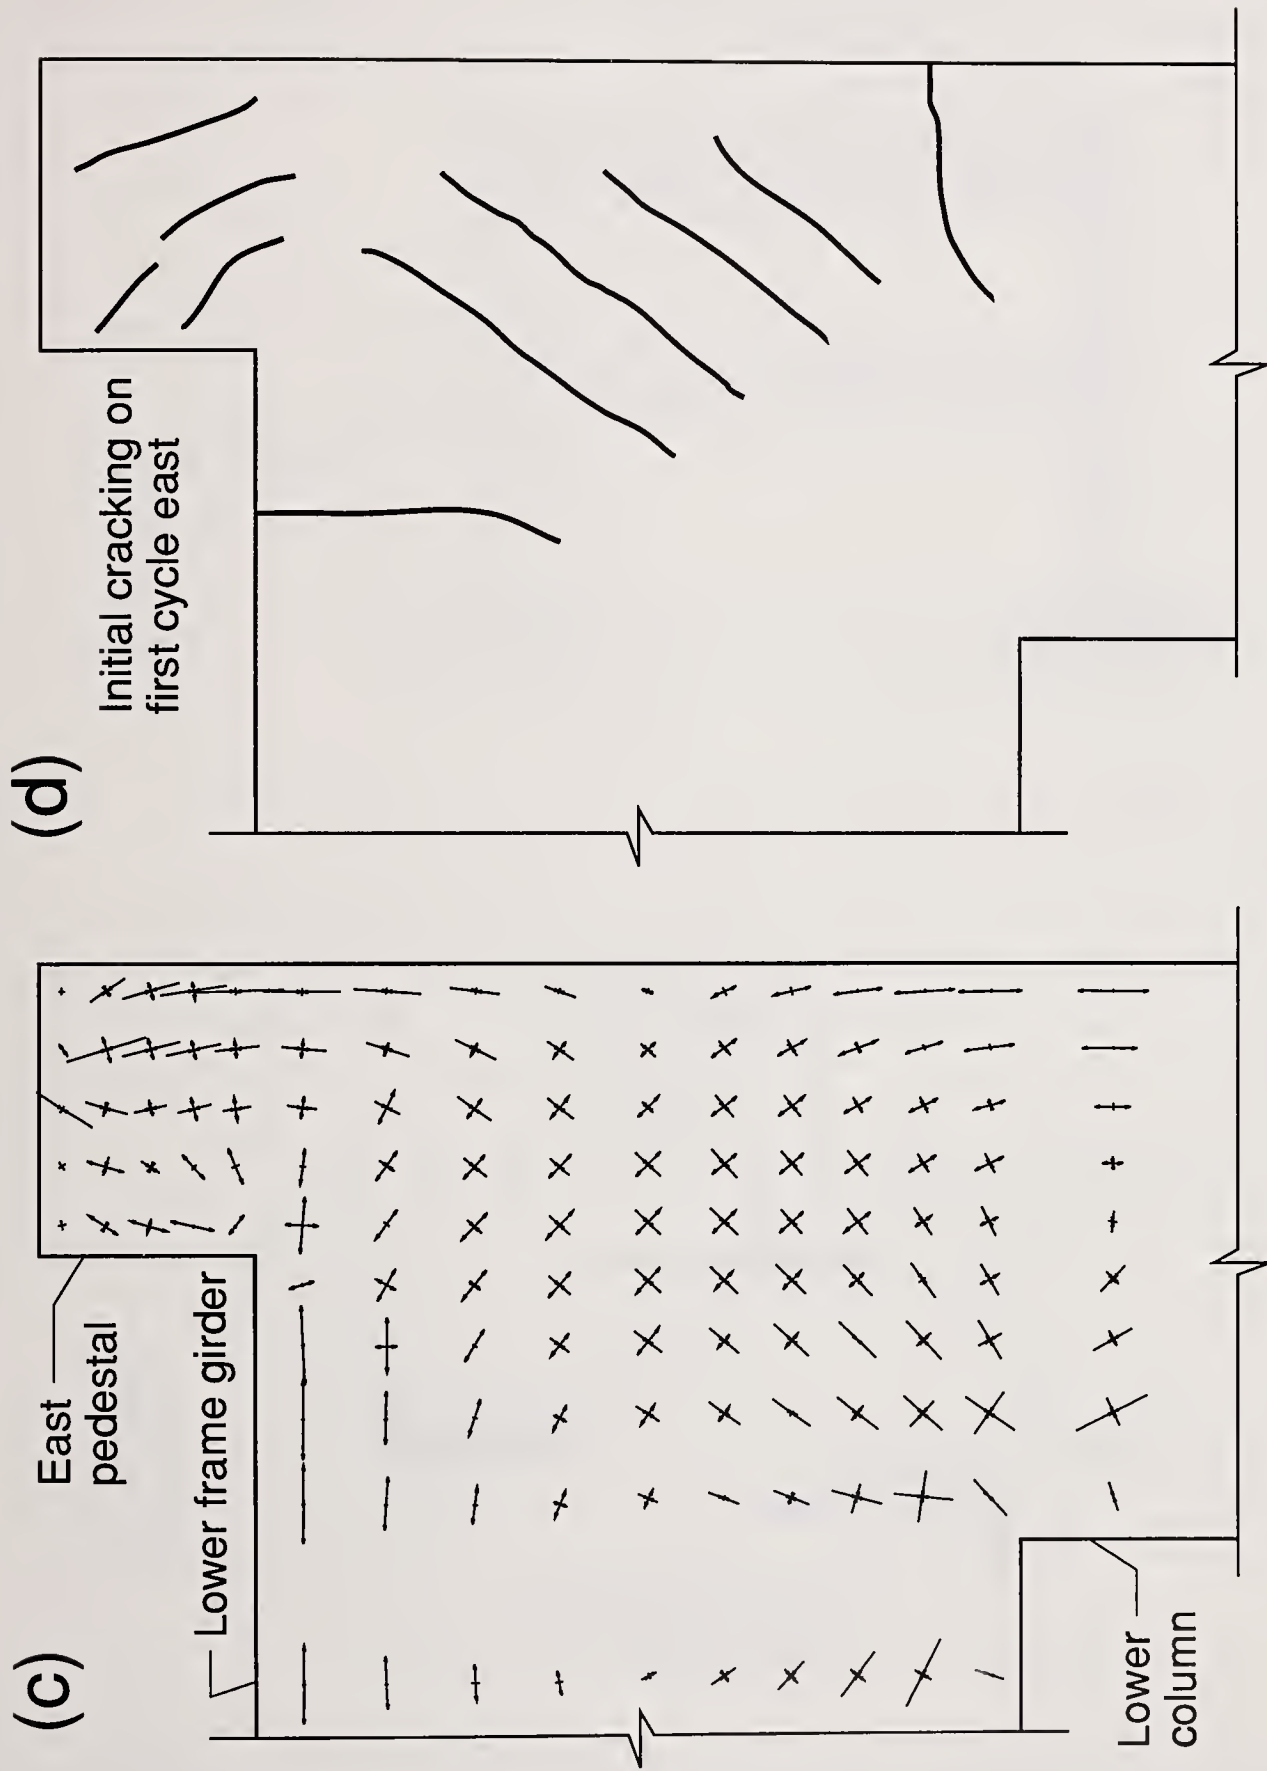
Figure 5.6.44(b) Displaced shape of Type 1 bent under applied loads showing zones of principal tensile stress sufficient to induce cracking.

Figure 5.6.44 (c) Principal stress tensors for pedestal region in Type 1 bent. Scale 0.25 inch = 650 psi (6.3 mm = 4.5 MPa).  
 (d) Predicted cracking during first half-cycle of lateral load.

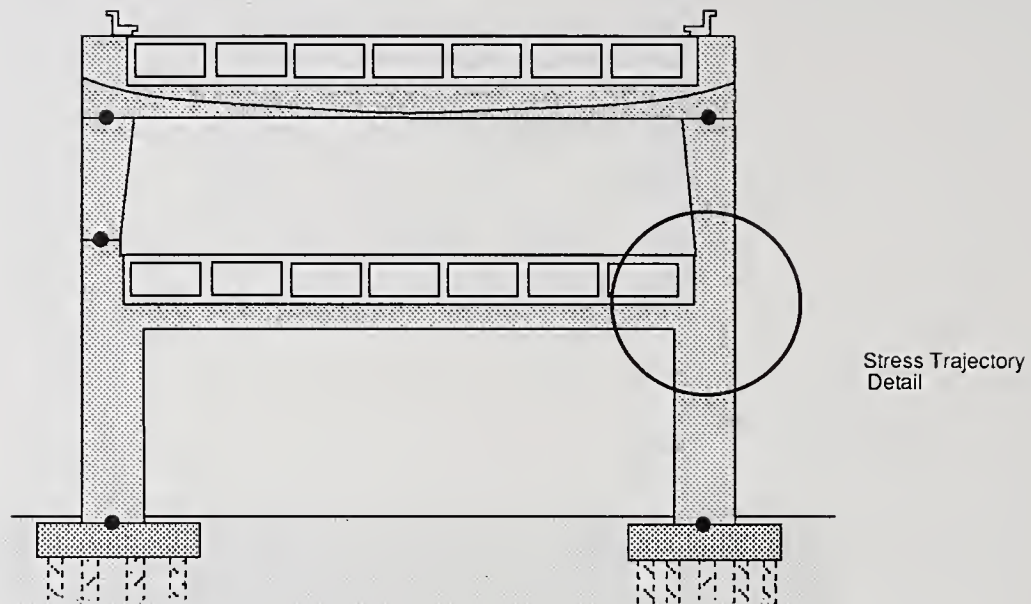
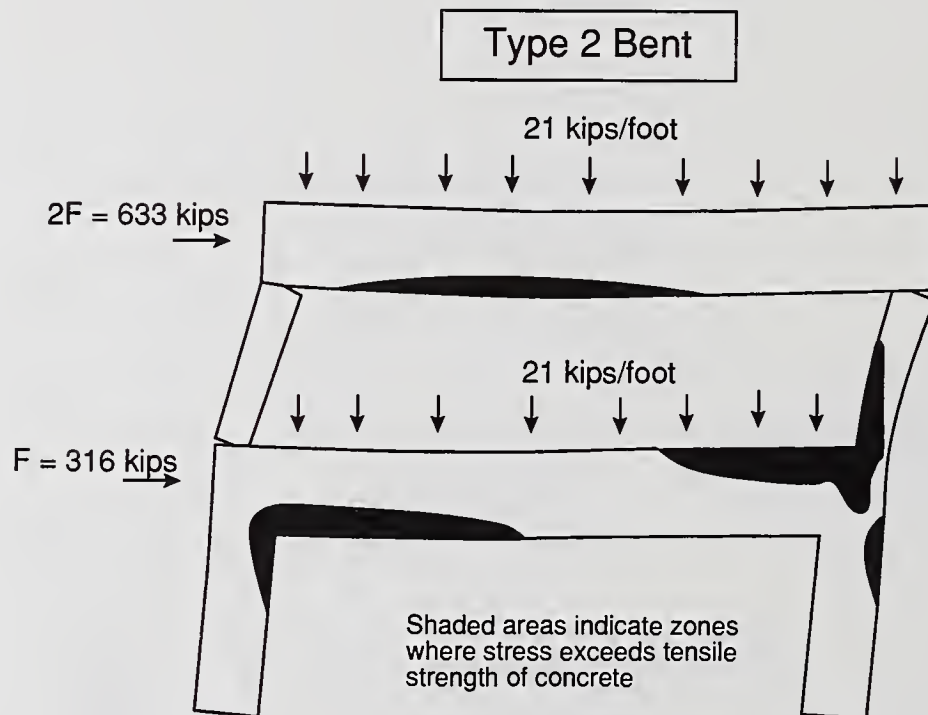
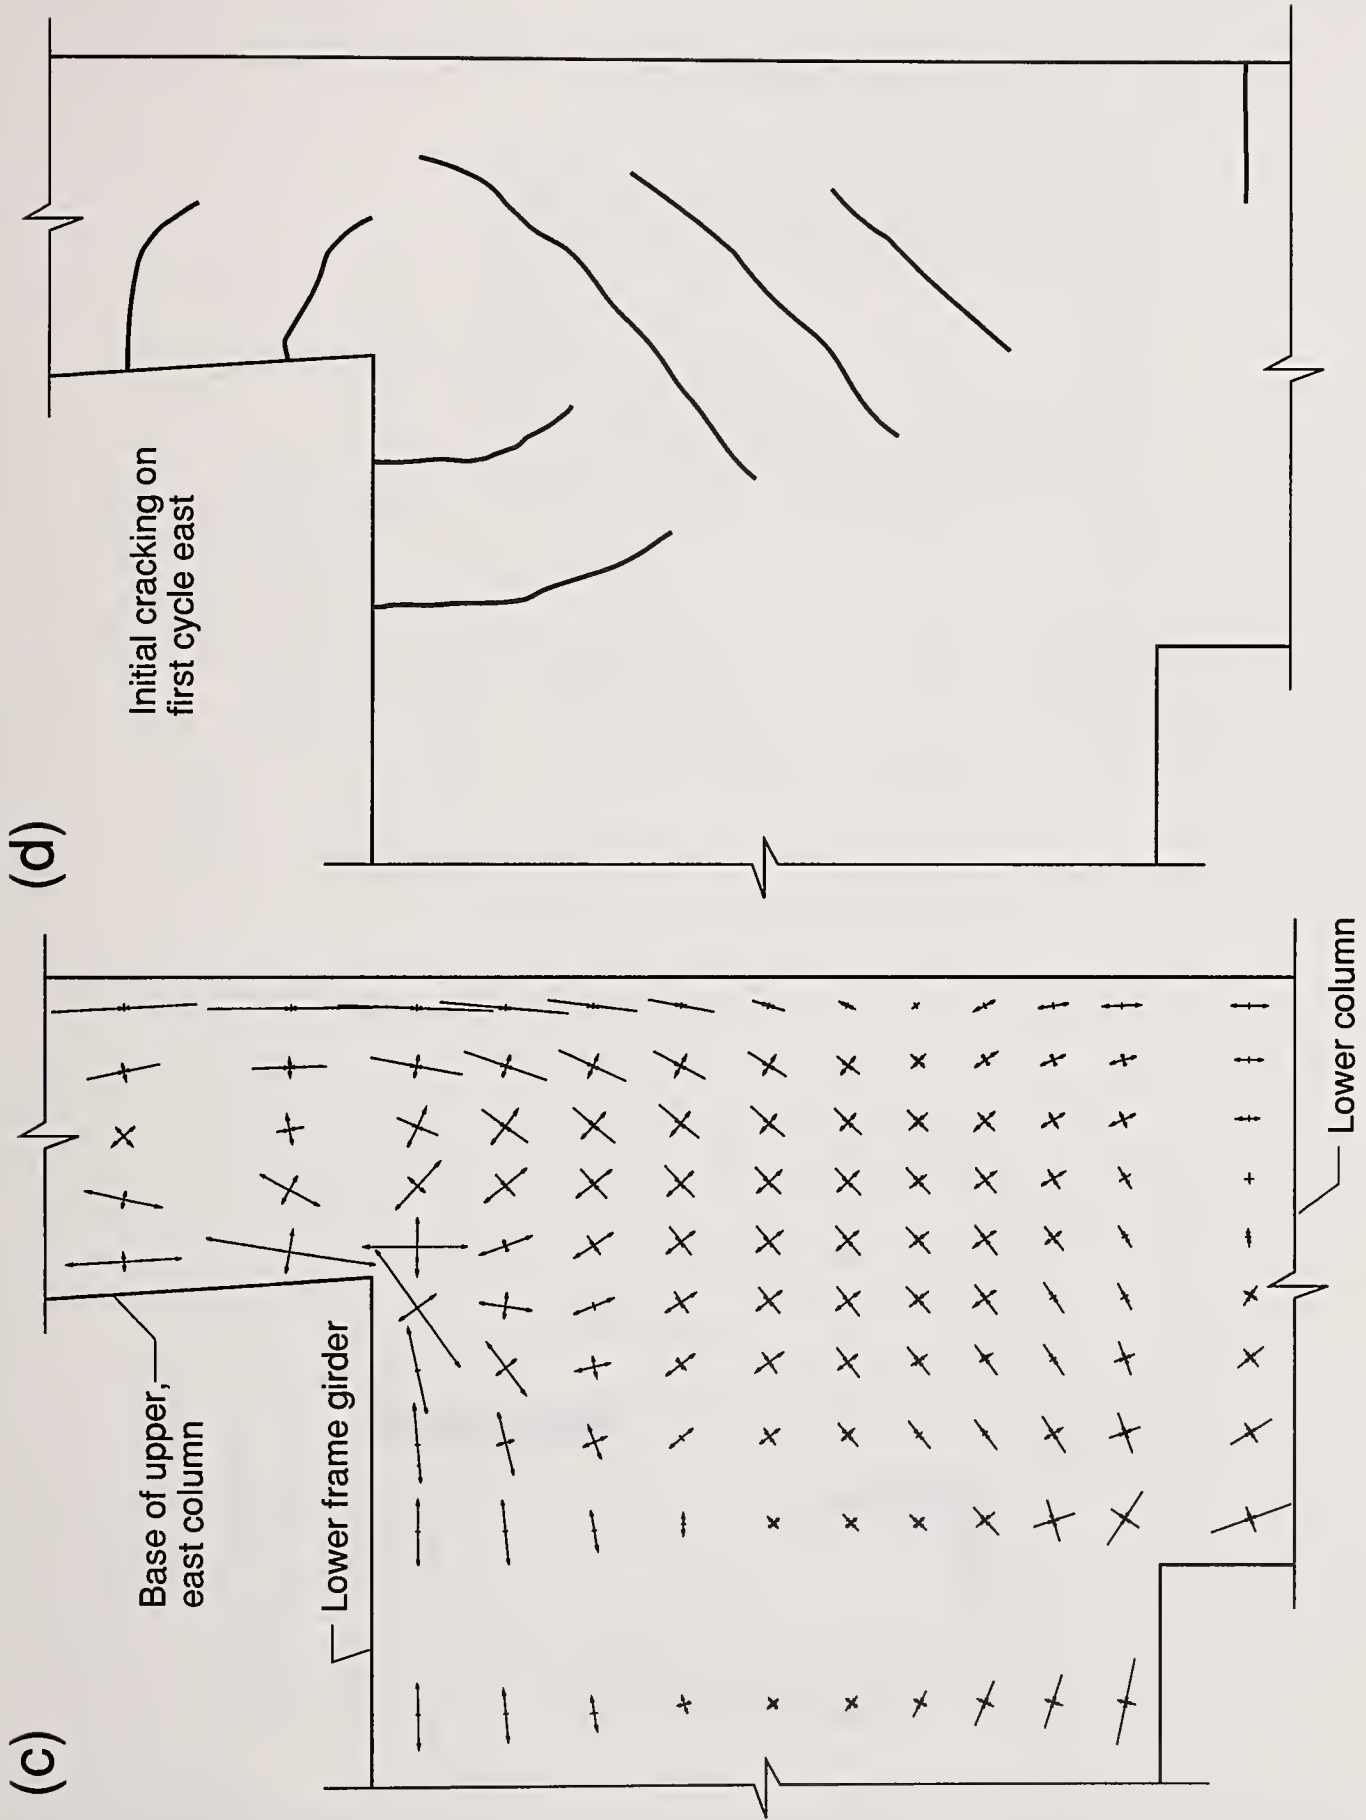
Figure 5.6.45(b) Displaced shape of Type 2 bent under applied loads showing zones of principal tensile stress sufficient to induce cracking.

Figure 5.6.45 (c) Principal stress sensors for pedestal region in Type 2 bent. Scale 0.25 inch = 650 psi (6.3 mm = 4.5 MPa).  
 (d) Predicted cracking during first half-cycle of lateral load.

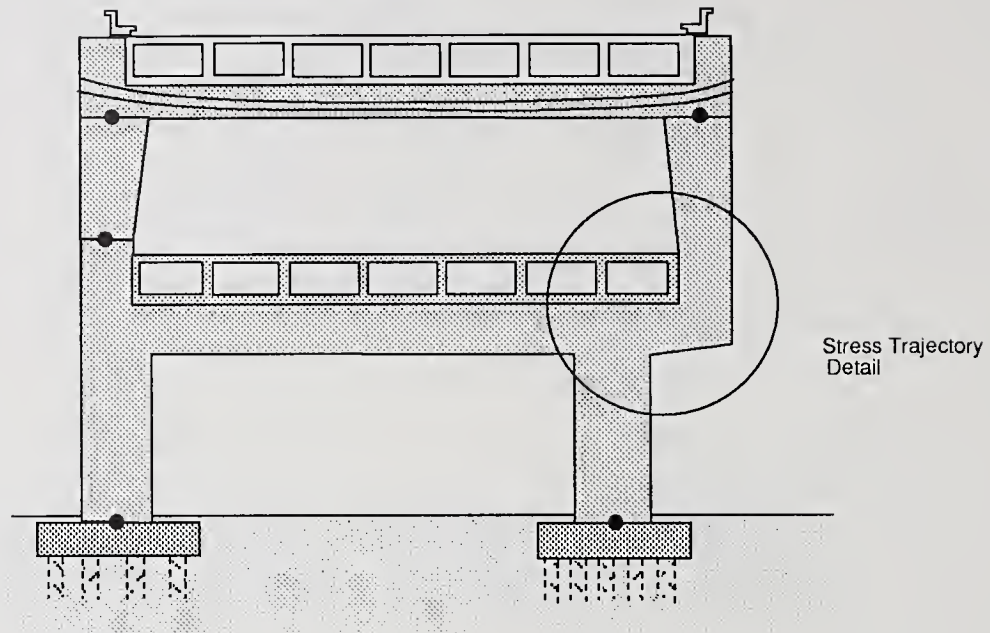
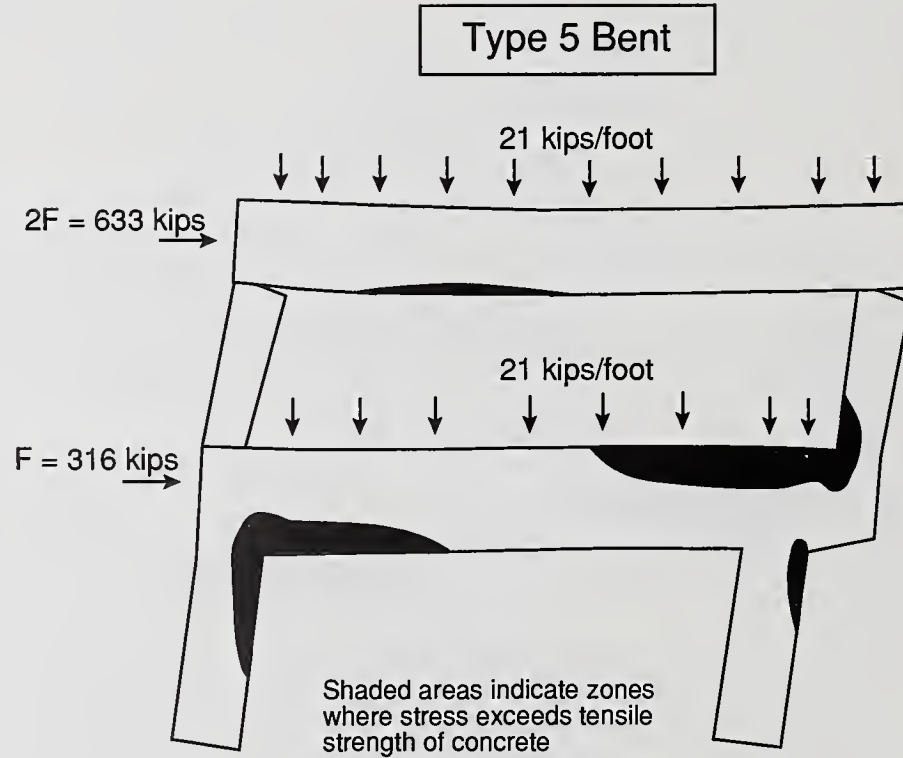
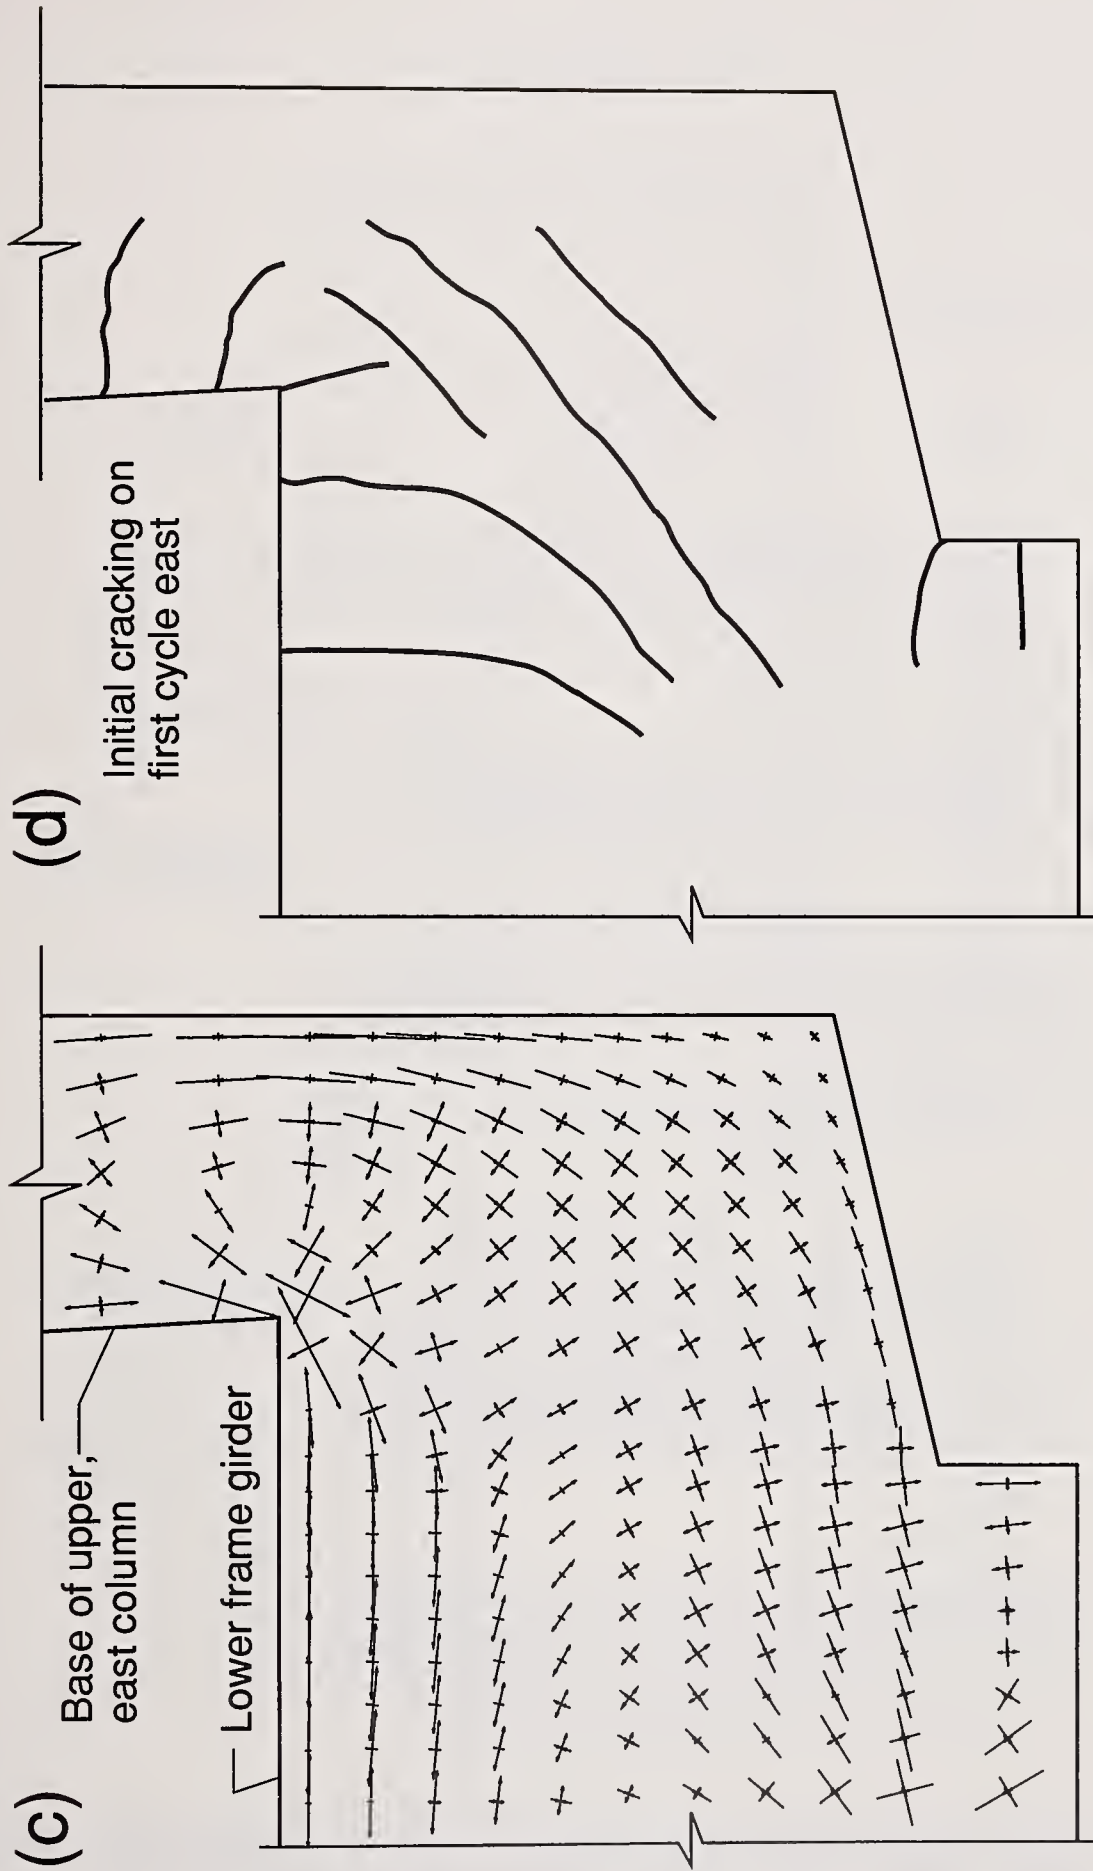
Figure 5.6.46(b) Displaced shape of Type 5 bent under applied loads showing zones of principal tensile stress sufficient to induce cracking.

Figure 5.6.46 (c) Principal stress tensors for pedestal region in Type 5 bent. Scale 0.25 inch = 650 psi (6.3 mm = 4.5 MPa).  
(d) Predicted cracking during first half-cycle of lateral load.

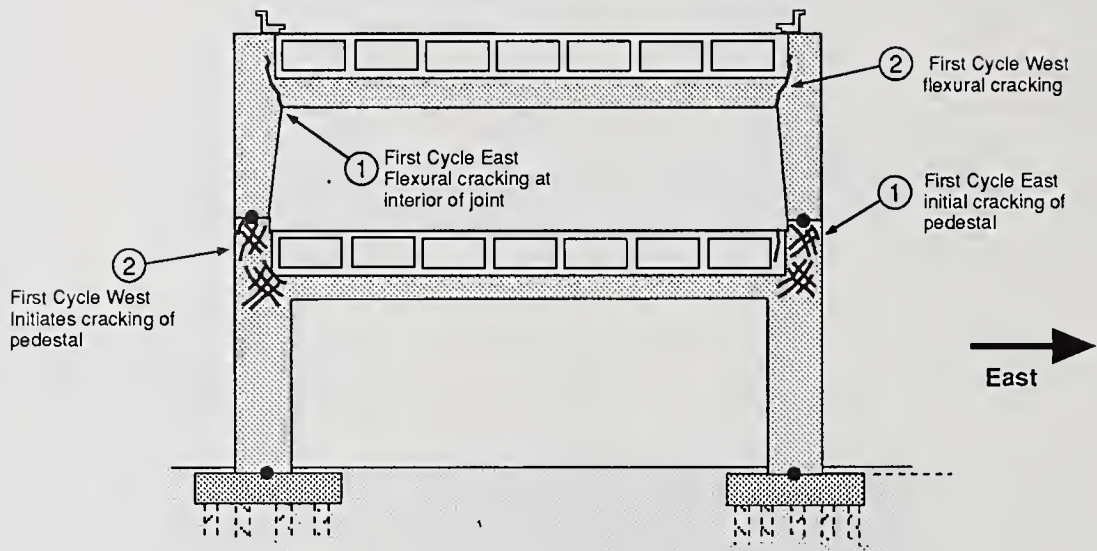
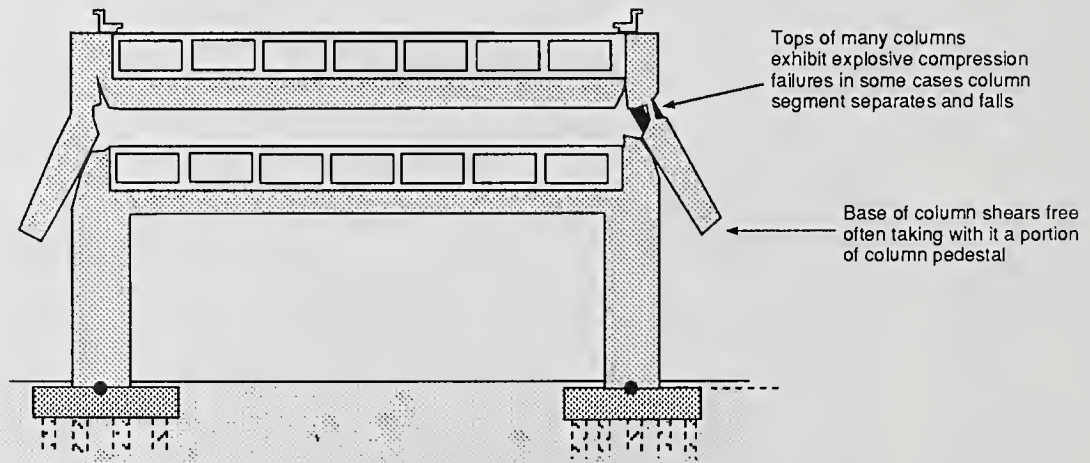
Figure 5.6.47 Top: Anticipated crack initiation sequence for Type 1 bents under lateral loading. Bottom: Observed failure mode for Type 1 bents at Cypress Structure.

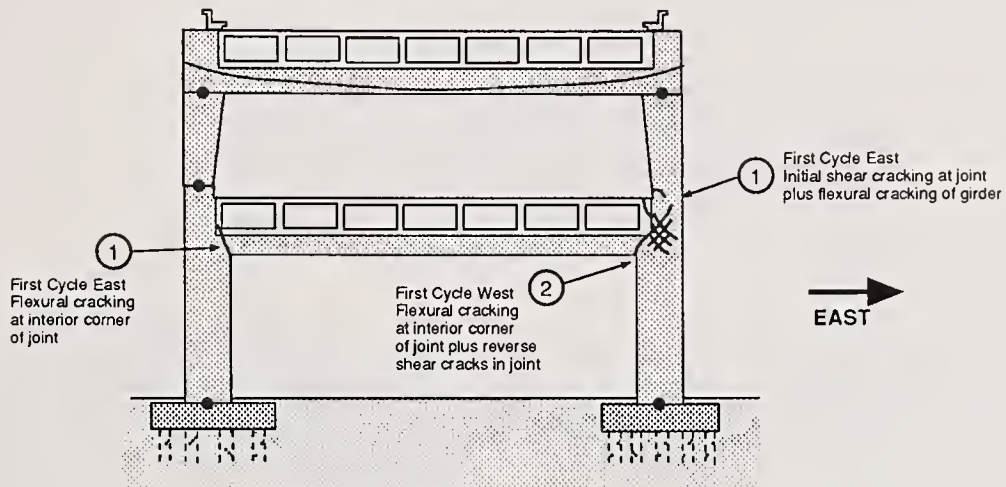
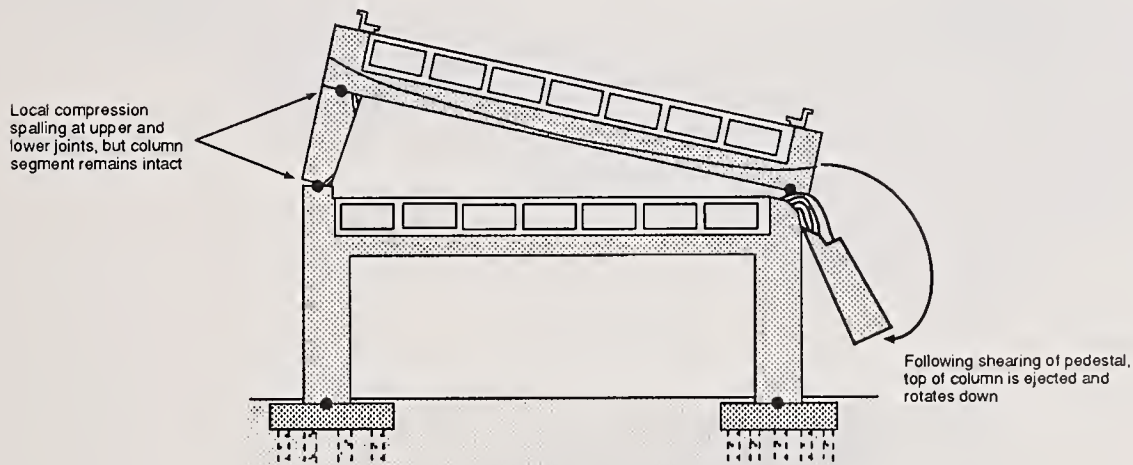
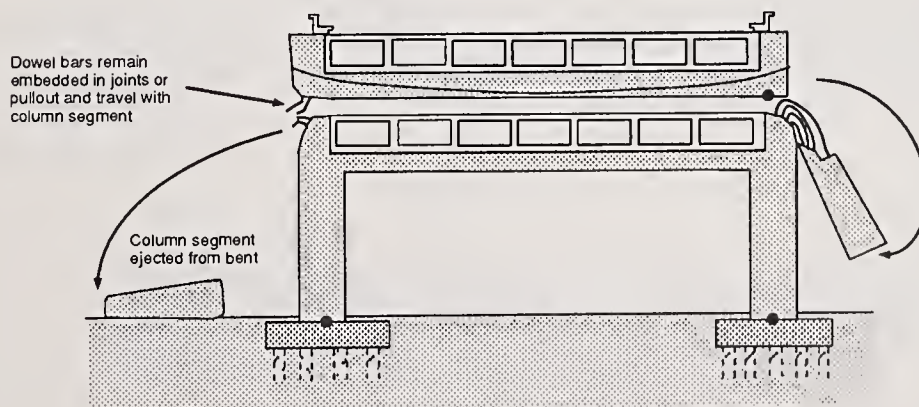
Figure 5.6.48 Top: Anticipated crack initiation sequence for Type 2 bents under lateral loading. Middle: Observed failure mode "A" for Type 2 bents at Cypress Structure. Bottom: Observed failure mode "B" for Type 2 bents at Cypress Structure.

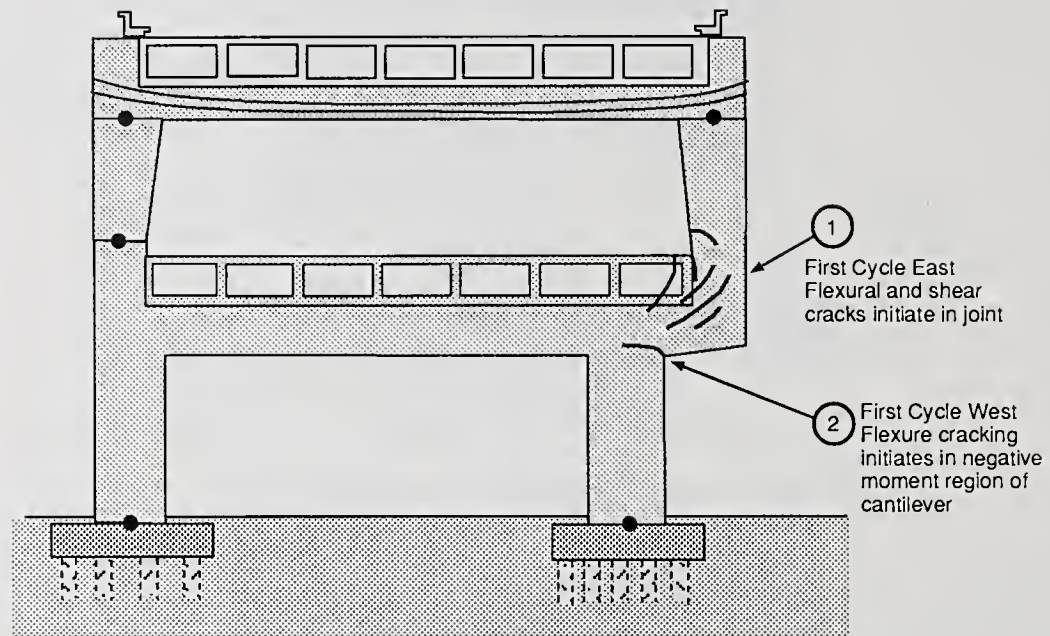
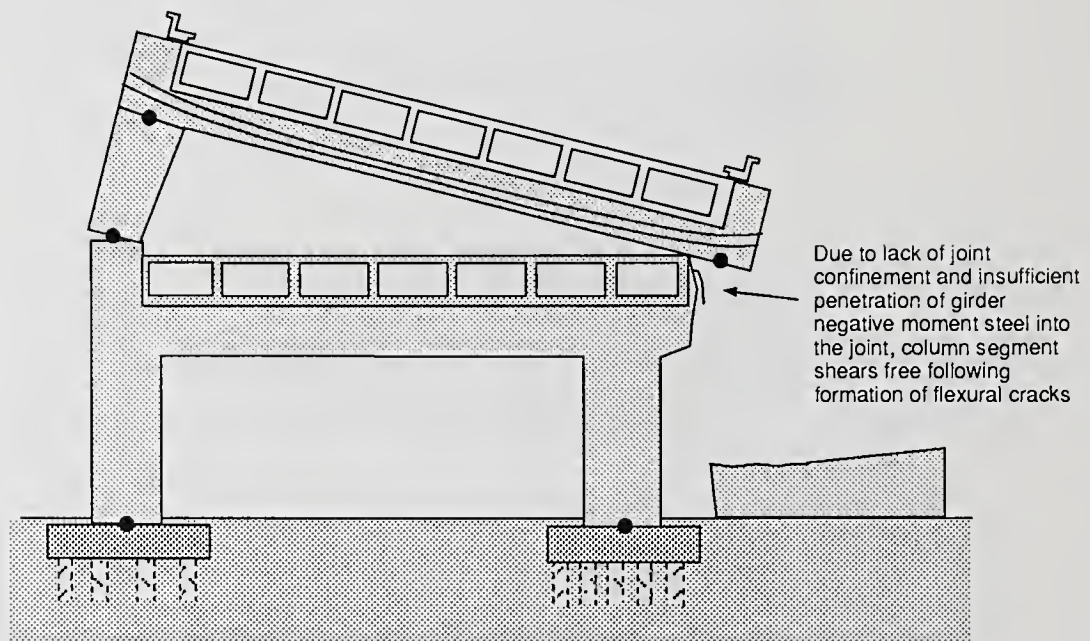
Figure 5.6.49 Top: Anticipated crack initiation sequence for Type 5 bents under lateral loading. Bottom: Observed failure mode for Type 5 bents at Cypress Structure.
