*NIST Special Publication 778*

# *Performance of Structures During the Loma Prieta Earthquake of October 17, 1989*

*H. S. Lew, Editor*

January 1990

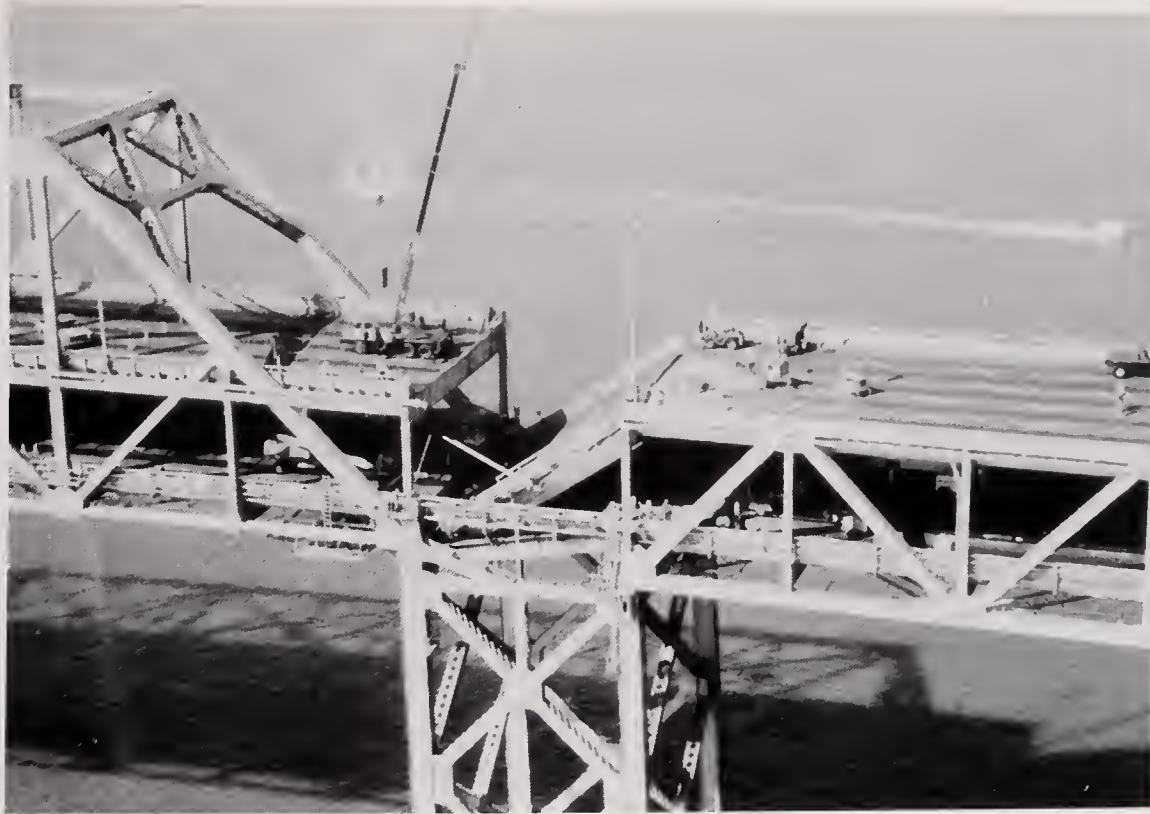
free from the girder restraining bolts and fallen into pier E-9, causing far greater damage<sup>6</sup>. During the fall the upper deck cut through several power and communication lines and additionally severed a water main on the south side, but otherwise the damage was confined to the decks themselves.

Figure 5.7.4 Aerial photo looking north at Pier E-9 on October 19, 1989 showing the collapsed upper and lower 50 foot deck spans.

and that there was some elastic rebound from pier E-10<sup>7</sup>. Within 4 weeks of the quake, Caltrans had replaced the deck girders for the pier E-9 link spans, placed precast concrete panels between them, cast the composite deck, and reopened the bridge for traffic. The 40 1 inch (25 mm) bolts connecting the E-9/E-10 truss shoes to the eastern column tops of pier E-9 were replaced with high strength bolts. Whether this is to the advantage of the bridge during future earthquakes is subject to review. Opinions have been expressed by some<sup>8</sup> that the shearing of these bolts served as a fuse, isolating pier E-9 from otherwise large lateral loads which could have led to disastrous column buckling.

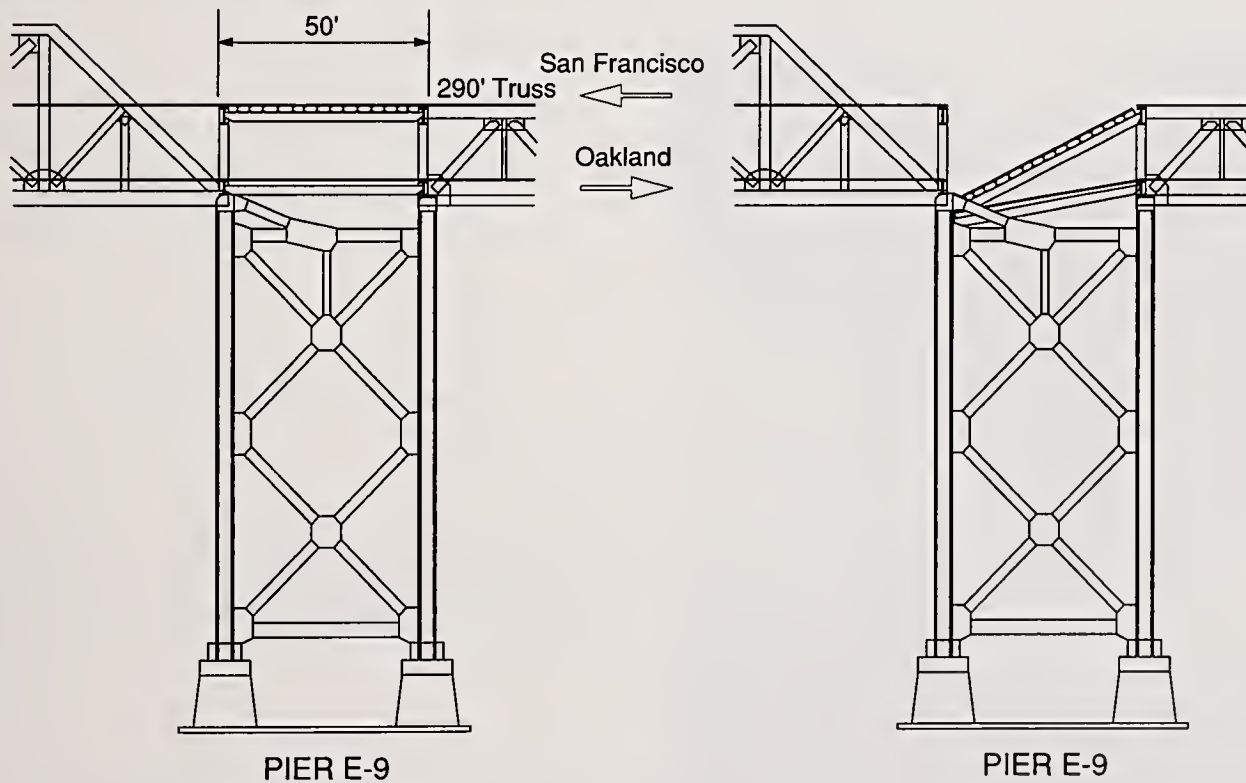
Figure 5.7.5 Schematic detail of Pier E-9 looking north. Evidence indicates that the 290 foot truss segment on the east side of the pier moved eastward, simultaneously unseating both Upper and lower deck segments.

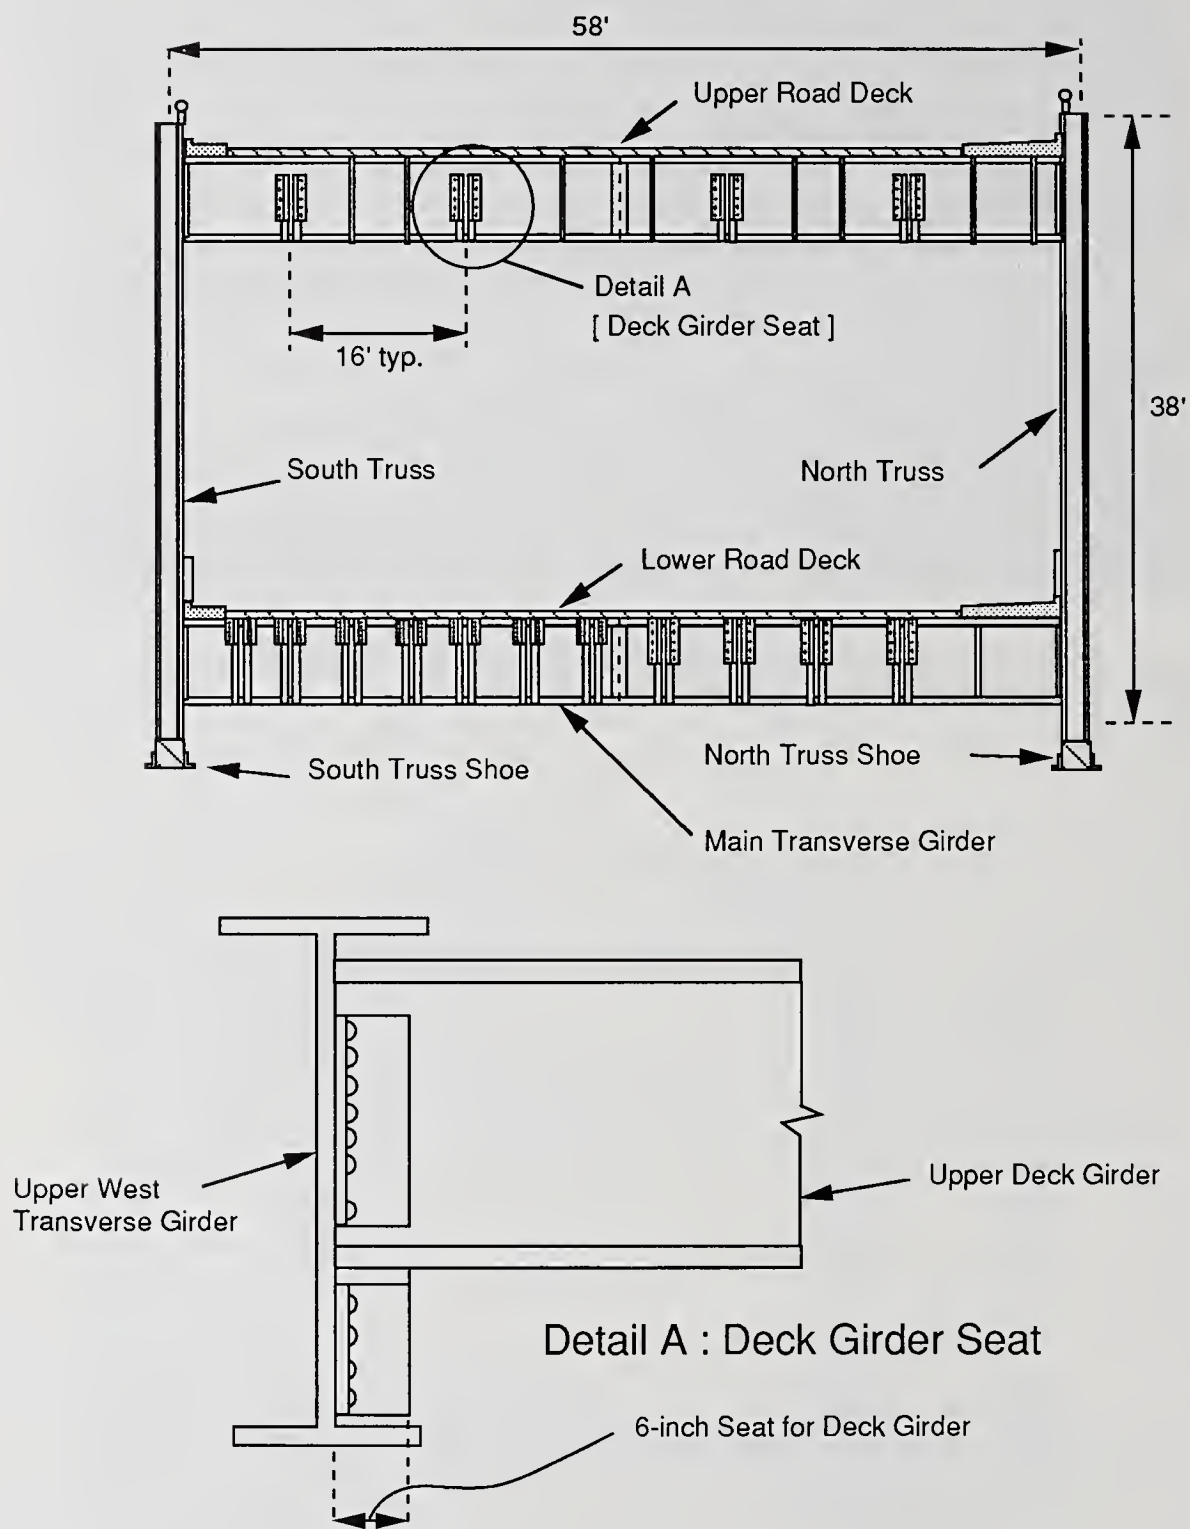
Figure 5.7.6 Cross-sectional detail of the Bay Bridge at Pier E-9, showing upper and lower roadway transverse support girders and longitudinal deck girder seats. The connection of the longitudinal girders to the transverse girders consisted of a simple bearing seat on the west side; The eastern beam seat was bolted.

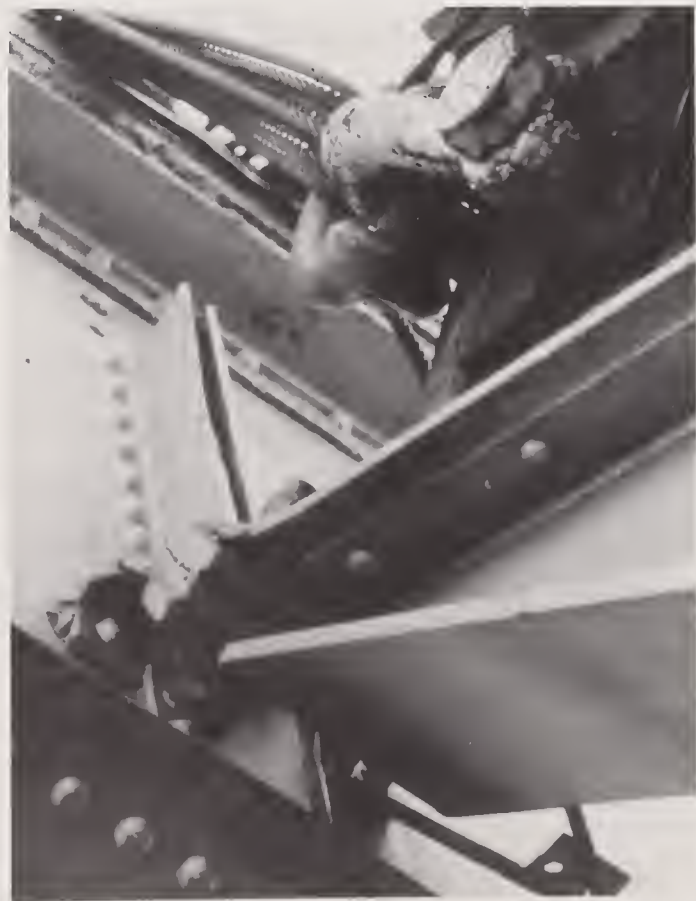
Figure 5.7.8  
Close-up of the eastern seat for the upper deck girder showing distortion of bolted beam seat.

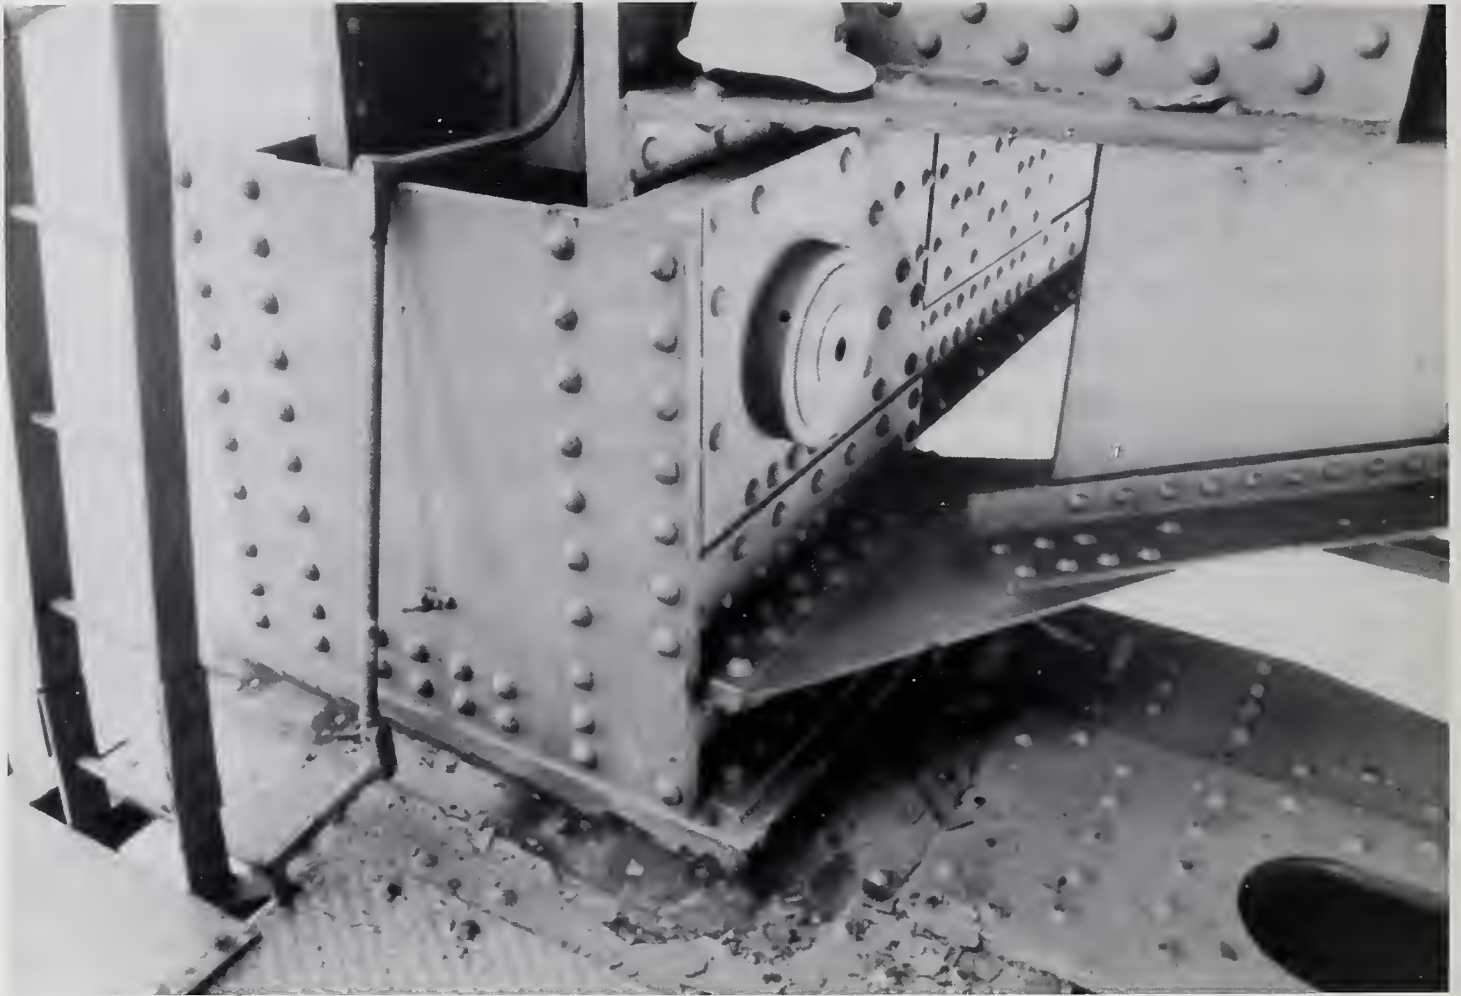
Figure 5.7.9 Close-up of the northeast shoe for the 290 foot truss between Pier E-9 and E-10. During the earthquake this truss moved eastward as much as 10 inches before returning to leave a 5.5-inch residual displacement to the east and 5/8-inch to the north.

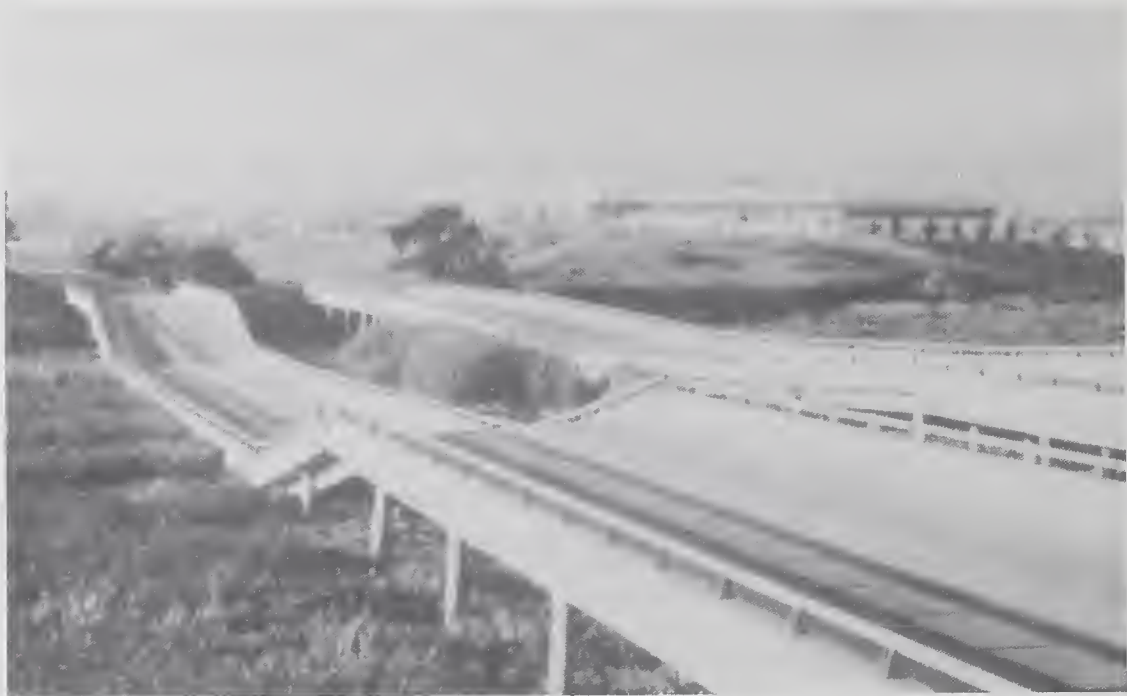
"The hinge restrainers performed well and held the structure together in spite of the large downward movement. Some evidence existed at the site that auto traffic had crossed the bridge during or immediately after the event. The pile extensions under the structure were lightly confined with #3 wire at about 12 inch (305 mm) pitch and failed primarily at the top. Some piles apparently also failed some distance below the ground surface. The soil displacement at the base of several of the piles was in several directions up to a maximum of 18 inches (460 mm). The eastern structure dropped about 5 feet (1.52 m) onto damaged pile extensions. The western structure dropped to the ground surface about 8 to 10 feet below (2.44 to 3.05 m). A few of the piles on the western bridge separated from the bent, displaced, and punched through the deck slab as the superstructure fell to the ground (see fig. 5.8.1)."

Figure 5.8.1 View looking north of State Highway 1 crossing Struve Slough, approximately 1 mile south of Watsonville. Piles on the left bridge separated from the bent, displaced, and punched through the deck slab as the superstructure fell to the ground (photo courtesy EQE Engineering).

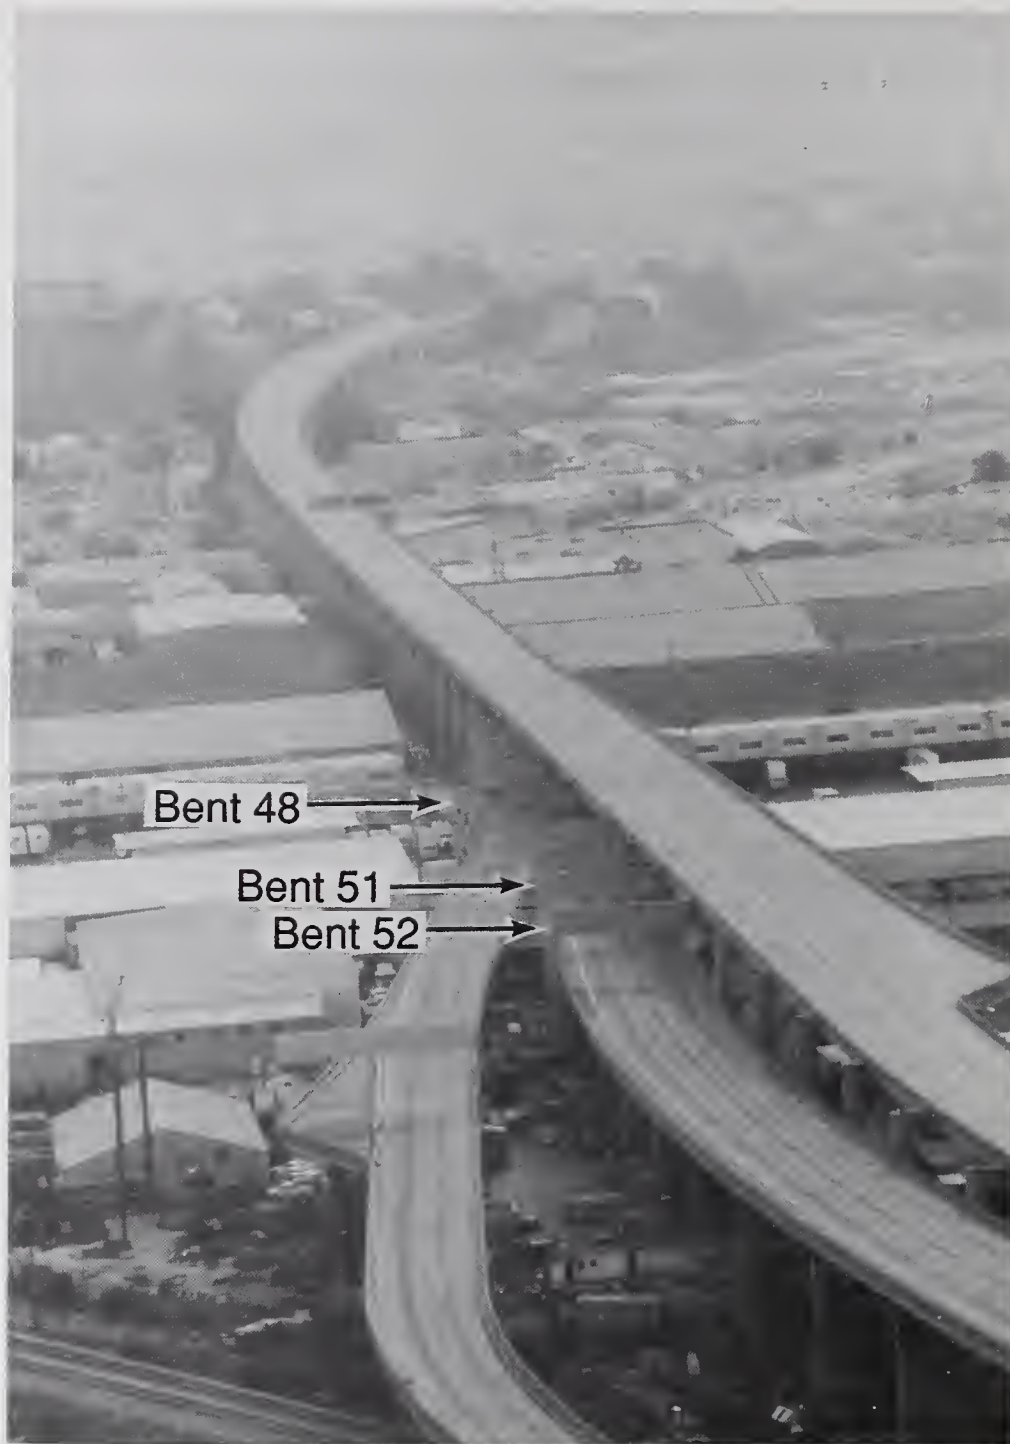
Figure 5.9.2 is an aerial view, looking south, of I-280 south of Army Street. At this location a two-level elevated highway (to the south) transforms into to a single level divided highway (to the north). In addition, there is an exit ramp for the lower level northbound section. Damage was observed at Bent numbers 48, 51, and 52.

Some minor damage occurred due to pounding. It is seen in figure 5.9.2 that where the roadways become side-by-side, the columns supporting the upper roadway are close to the lower roadway. One of these columns which support the upper roadway was damaged due to pounding with the lower roadway, as can be seen in figure 5.9.10.

Figure 5.9.2 Aerial view of I-280 south of Army St., note the transition from a two-level elevated structure to a single-level, divided structure (view is looking south).

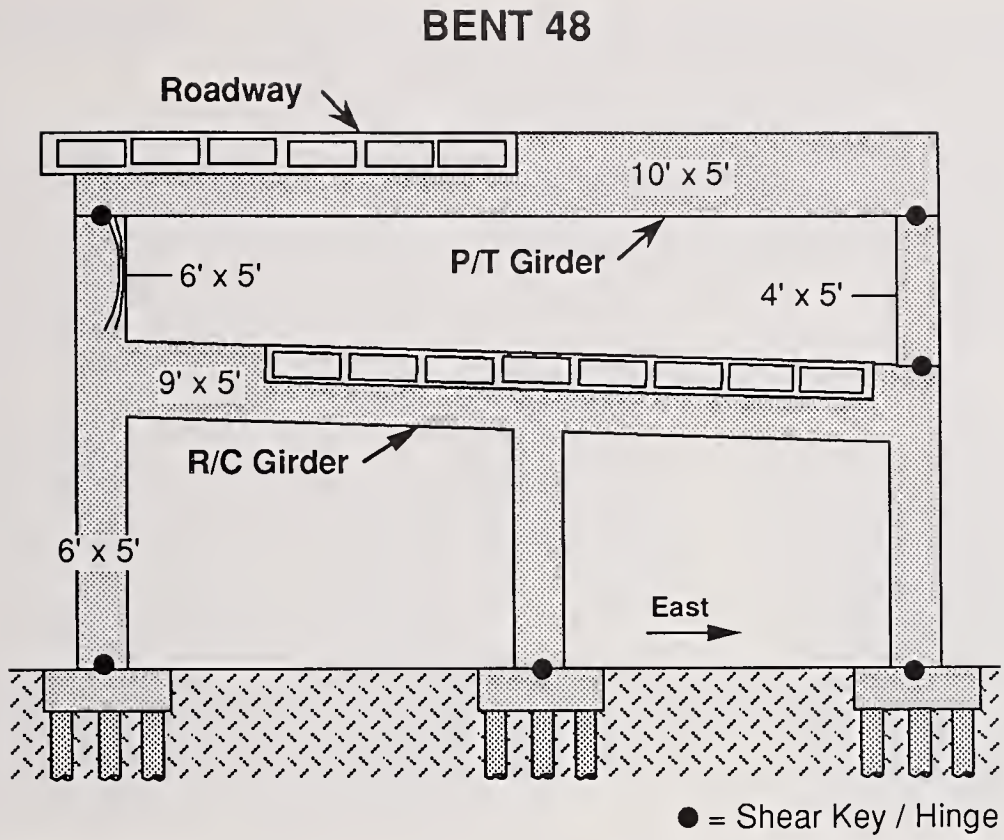
Figure 5.9.3 is a schematic elevation view (looking north) of Bent 48. The top girder is post-tensioned and supports at the columns are designed as pinned connections, with details similar to those used on I-880. The column reinforcement includes #18 longitudinal bars and #4 ties at 12 in. (0.30 m) spacing. The damage occurred at the top of the west-side column. Figure 5.9.4 shows the nature of the damage, which appears to be a combination of diagonal tension failure and splitting parallel to the longitudinal column steel. Note that the girder is permanently displaced toward the east.

Figure 5.9.3 Schematic elevation view of Bent 48 of I-280 (looking north).

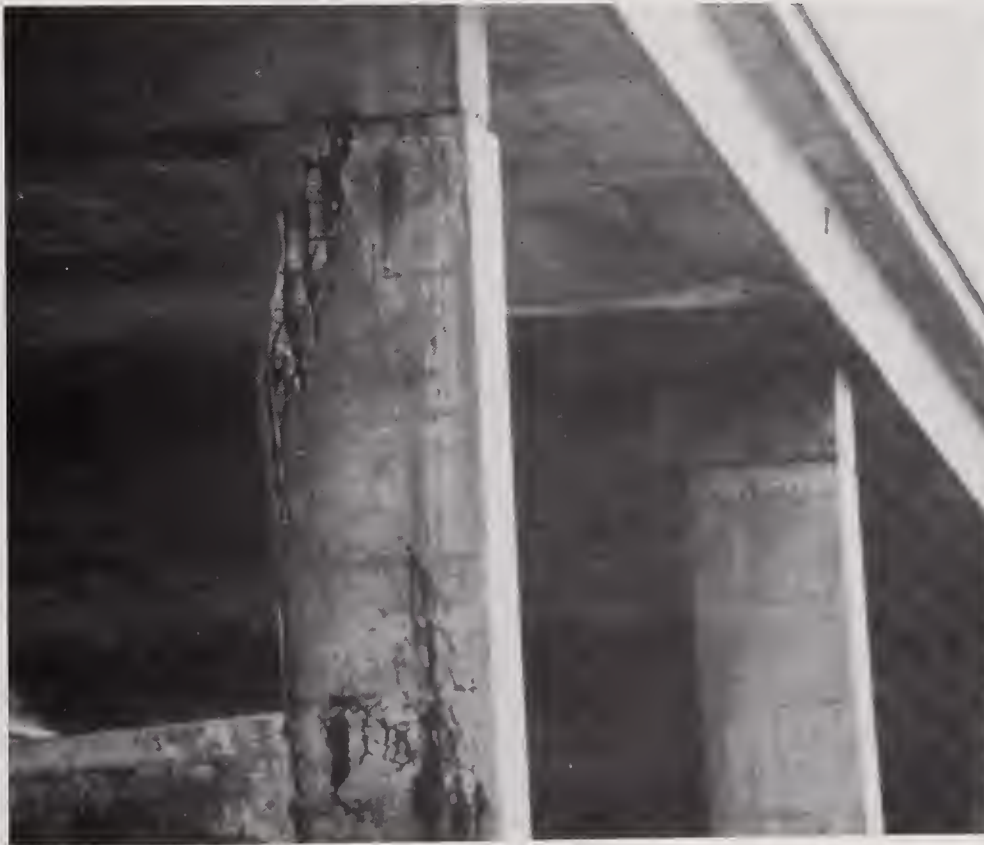
Figure 5.9.4 Damage to west-side column of Bent 48 (looking toward south).

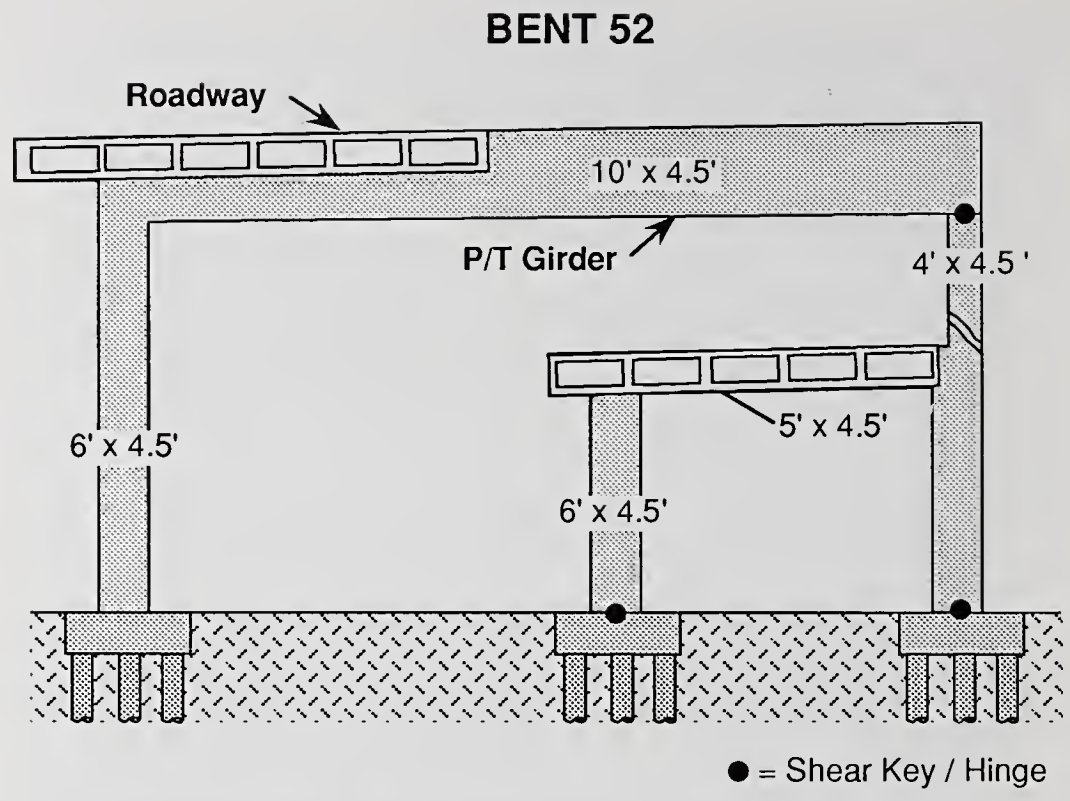
Figure 5.9.5 is a schematic elevation view of Bent 52. The configuration of Bent 51 is similar. The upper, post-tensioned girder is monolithic with the column on the west side and is supported as a pinned connection on the east side. Figure 5.9.6 is view (looking south) as seen from the lower northbound lanes; the upper girder of Bent 52 is in clear view. Damage occurred to the east-side columns of Bents 51 and 52 at approximately the elevation of the roadway. Figure 5.9.7 shows the damage in Bent 52 as it appeared on the northern column face. The damage in Bent 51 was similar as can be seen in figure 5.9.8, which shows that southern column face. Figure 5.9.9 is a close-up view of the damage zone in Bent 51. It is seen that the concrete is extensively fractured and the #4 ties lost their effectiveness because of the inadequate anchorage provided by the 90-degree hooks. The corner #18 bar also appears to have buckled.

Figure 5.9.5 Schematic elevation view of Bent 52 of I-280 (looking north).

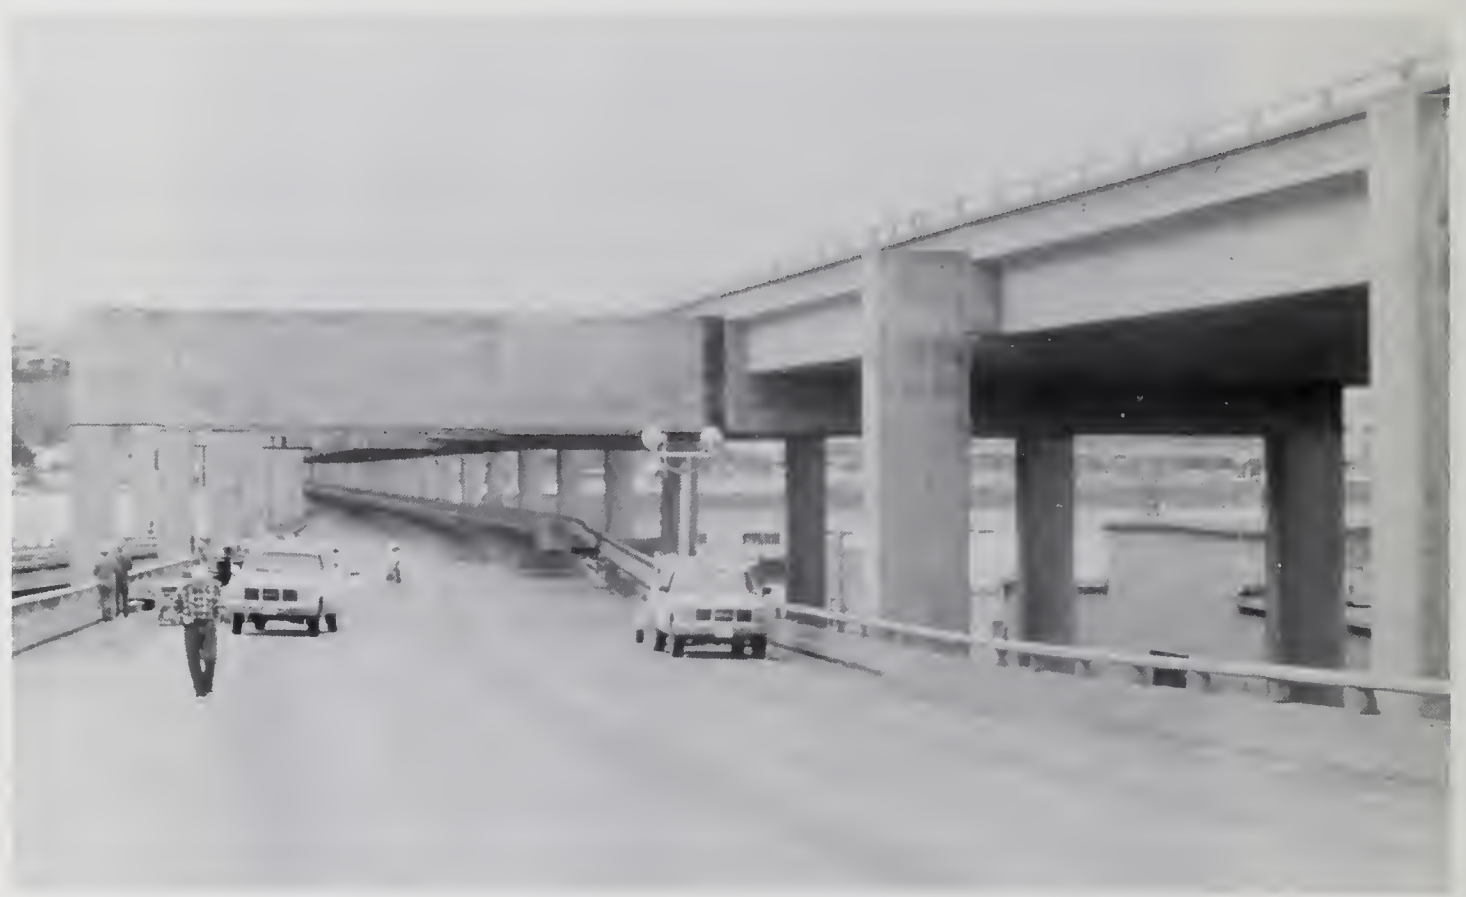
Figure 5.9.6 View looking south on I-280 showing the upper girder of Bent 52.

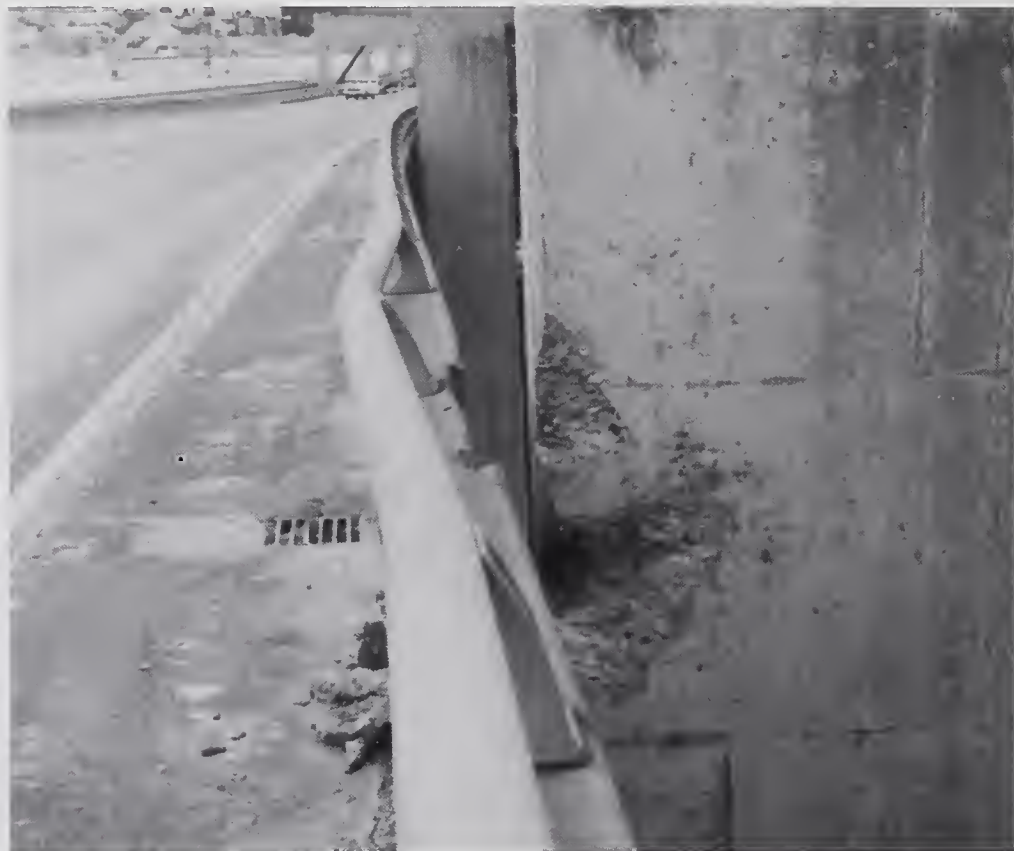
Figure 5.9.10 Pounding damage at I-280 south of Army Street.

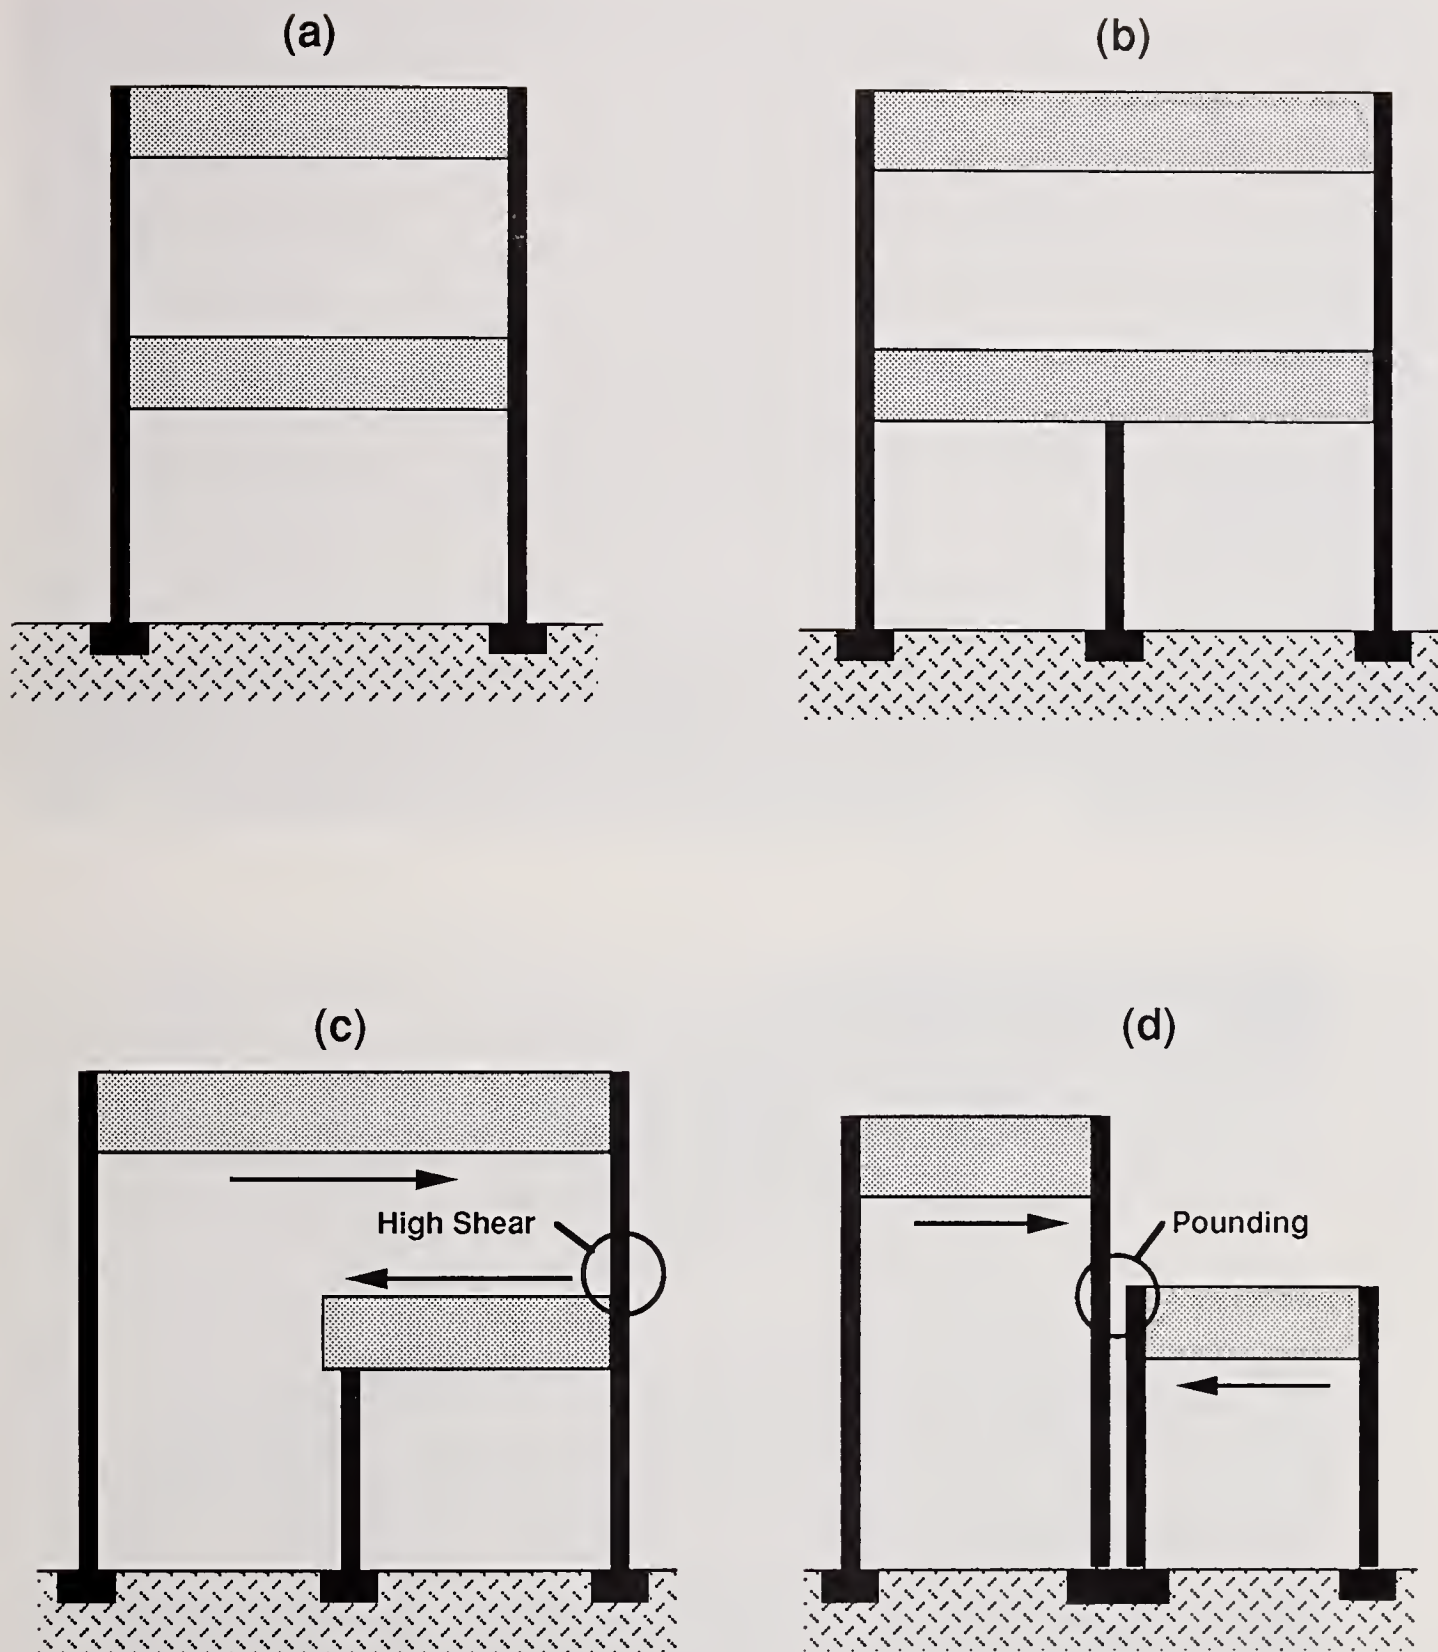
Figure 5.9.11 Schematic illustration of the various structural configurations as I-280 undergoes transition from a two-level to a single-level elevated highway.

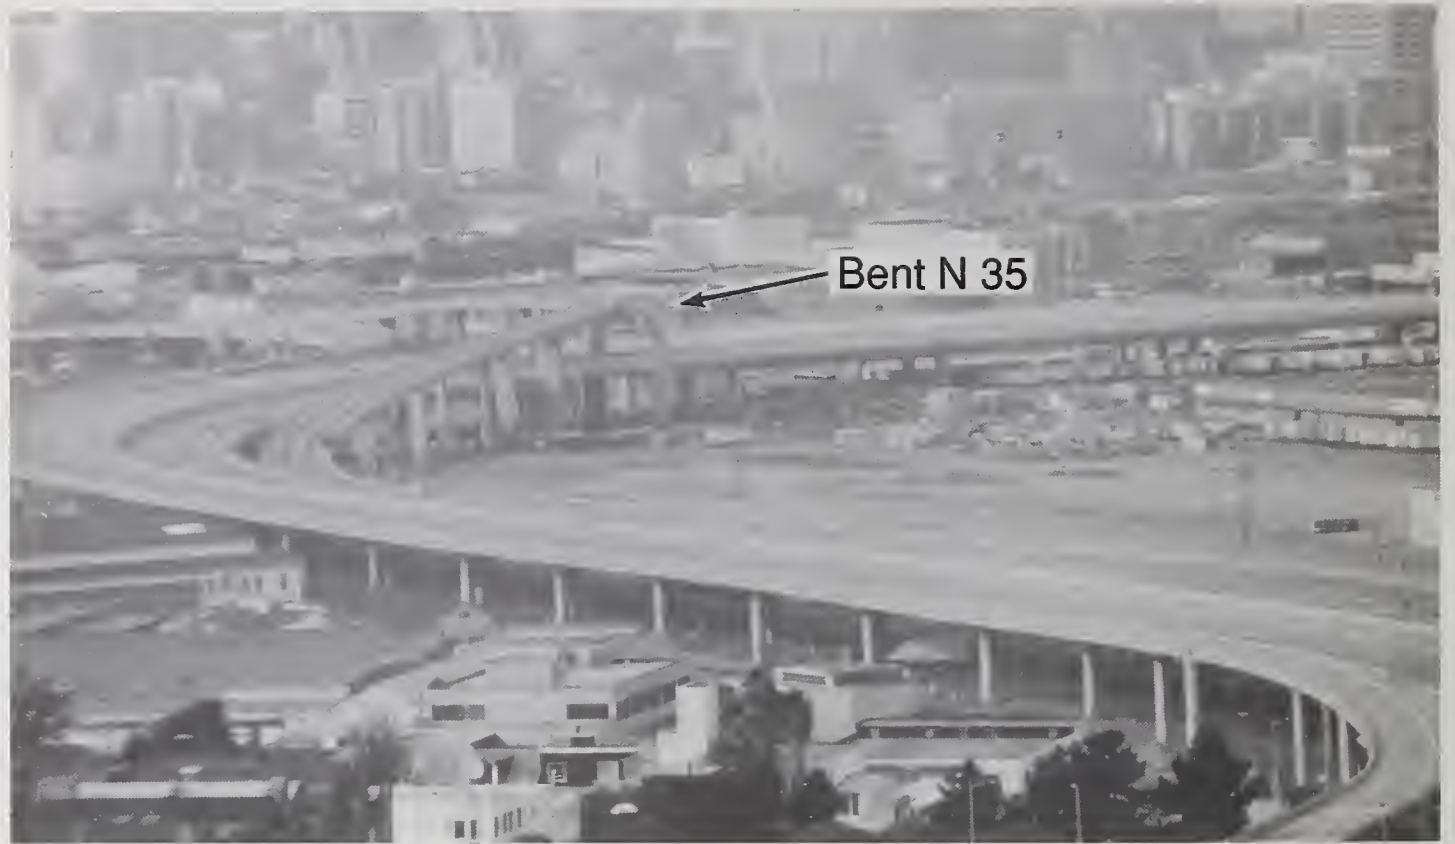
Figure 5.9.12 Aerial view of the Sixth St. exit of I-280.

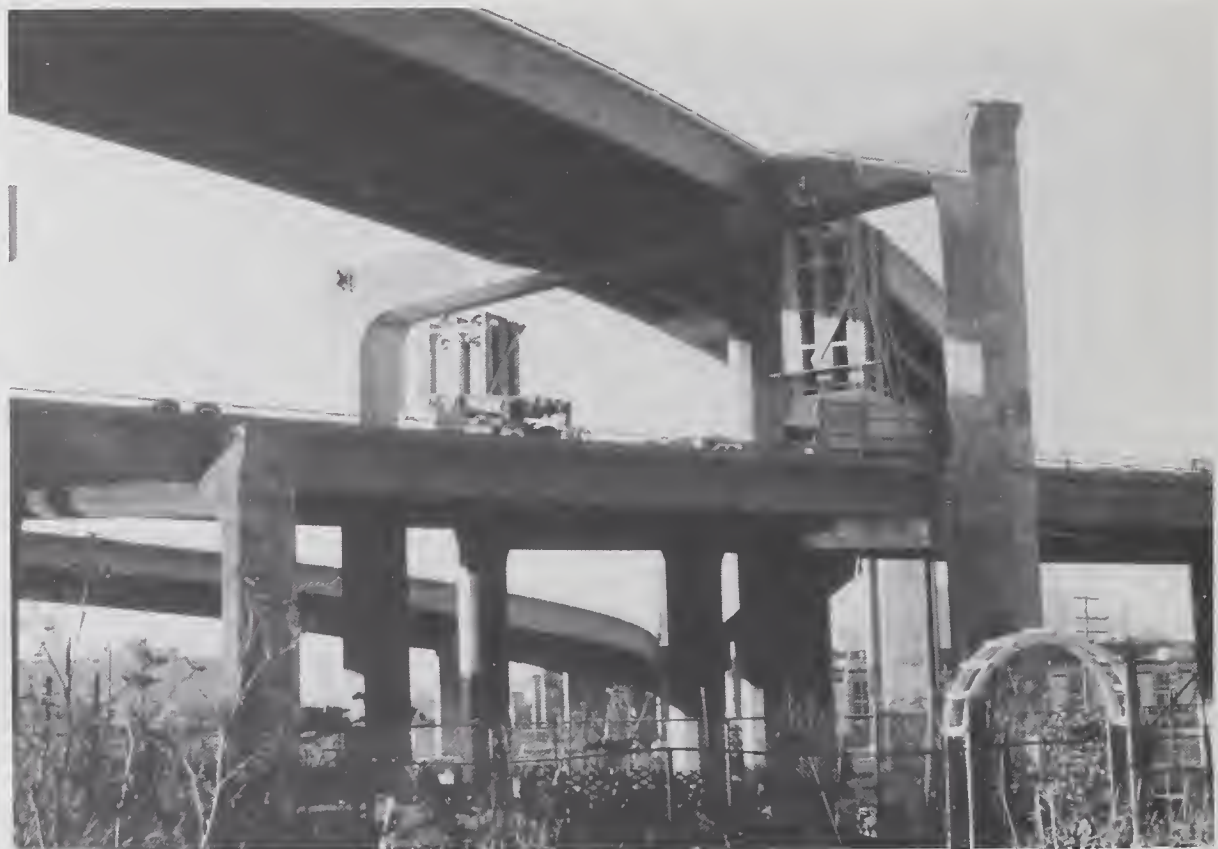
Figure 5.9.13 The Sixth St. exit ramp where it passes over the northbound lanes of I-280. (View is toward west; cribbing was added to provide temporary support.)

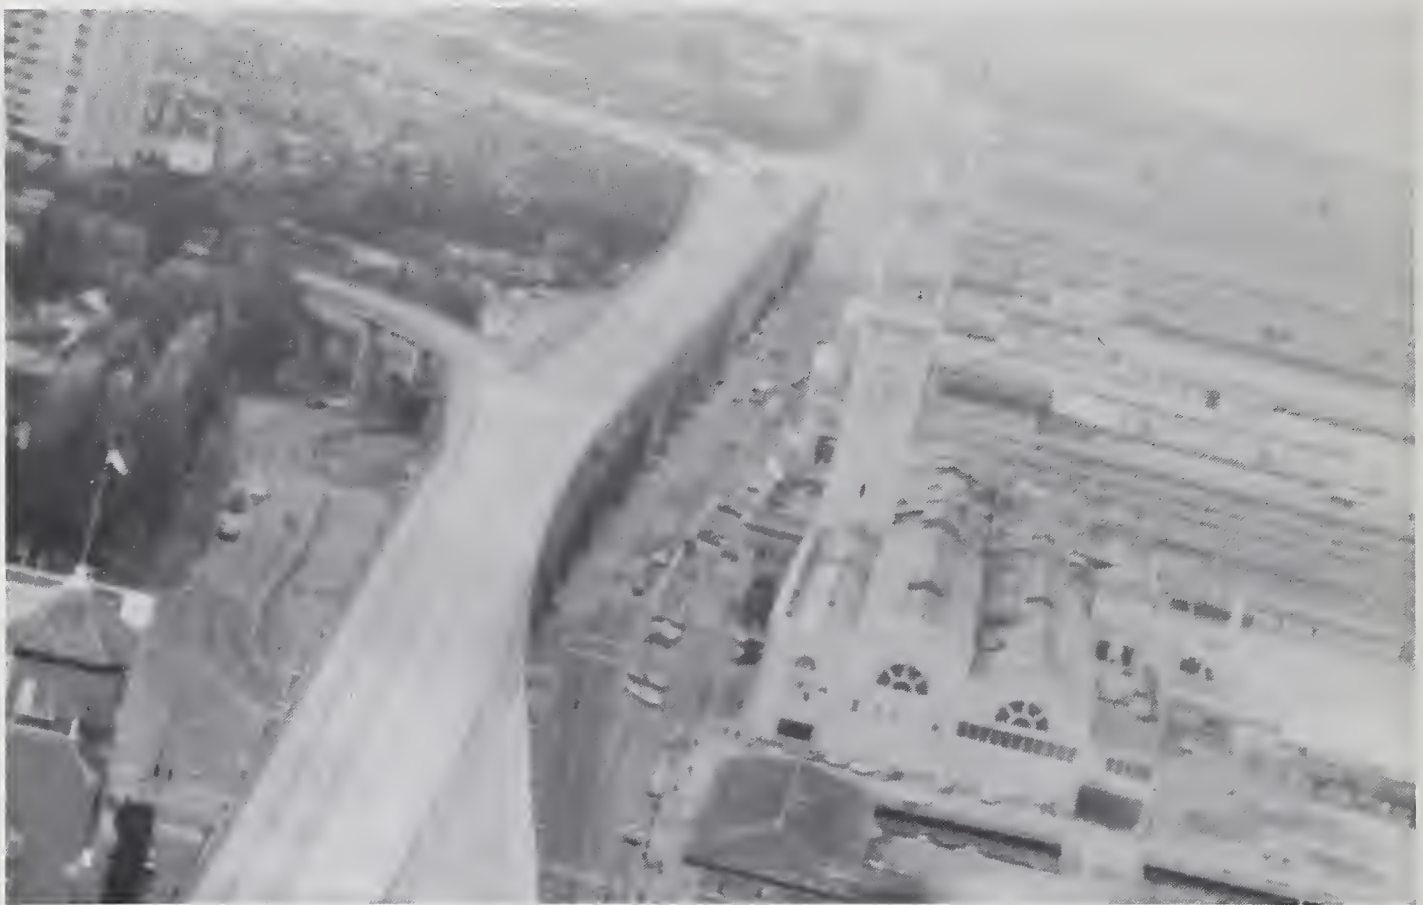
The Embarcadero Freeway (I-480) is a two-level elevated highway which provides the Financial District with access to the San Francisco-Oakland Bay Bridge. According to the as-built drawings supplied by Caltrans, the freeway was designed according to the 1953 AASHO Specifications (AASHO, 1953). Figure 5.10.1 is an aerial view of the portion of I-480 north of Mission Street. The historic Ferry Building is east of the freeway.

Figure 5.10.1 Aerial view of the Embarcadero Freeway north of Mission St.

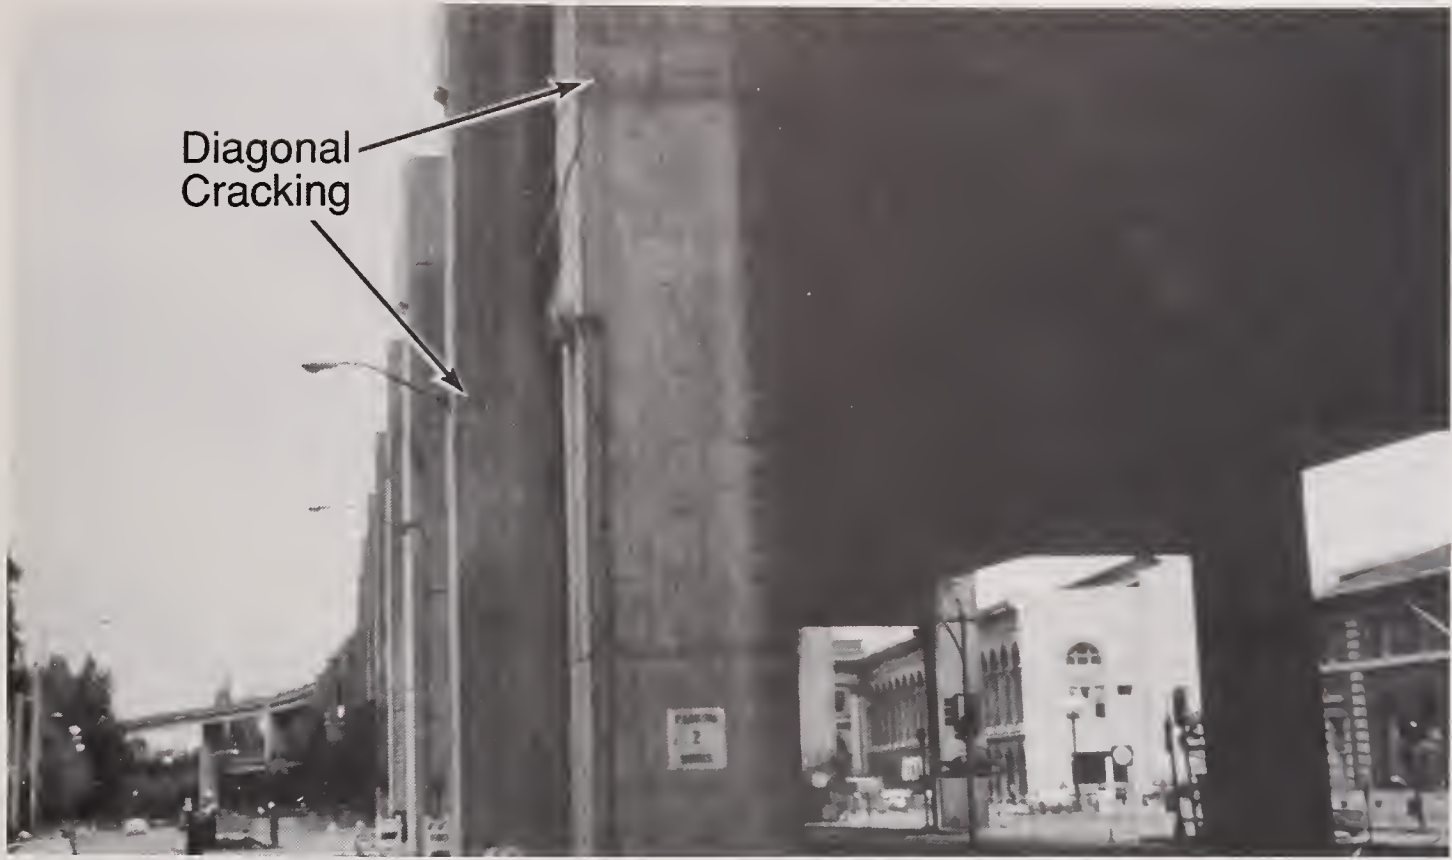
Figure 5.10.2 is a ground-level view looking north along the west side of the freeway; Bent 76 is in the foreground. The vertical metal covers which can be seen at the top girder-column joints protect restraining tendons which were added during the earthquake upgrading in 1972. Figure 5.10.3 is a ground-level view from the east side looking north; Bent 78 is in the foreground. Mission Street is located between Bents 78 and 79 (numbers increase toward the north). The observed damage occurred at the lower girder-column joints in bents located north and south of Mission Street.

Figure 5.10.2 West side of Embarcadero Freeway south of Mission St., Bent 76 is in foreground.

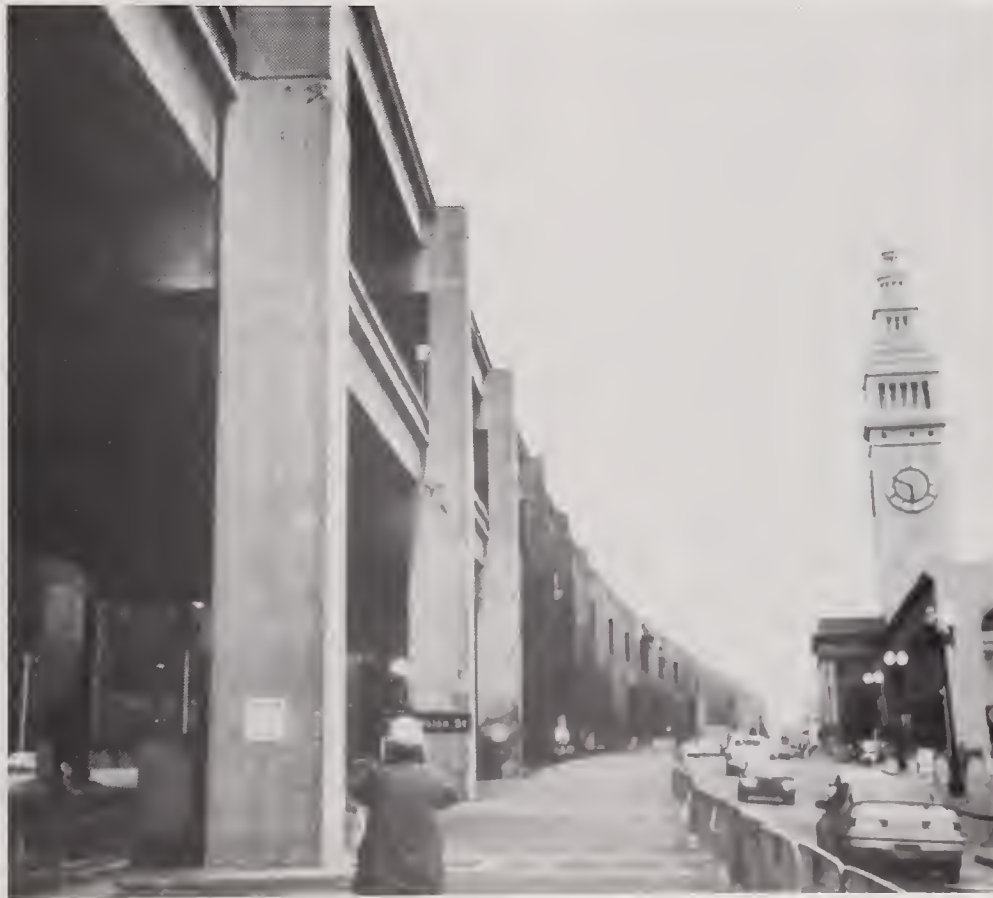
Figure 5.10.3 East side of Embarcadero Freeway at Mission St., Bent 78 is in foreground.
