*NIST Special Publication 778*

# *Performance of Structures During the Loma Prieta Earthquake of October 17, 1989*

*H. S. Lew, Editor*

January 1990

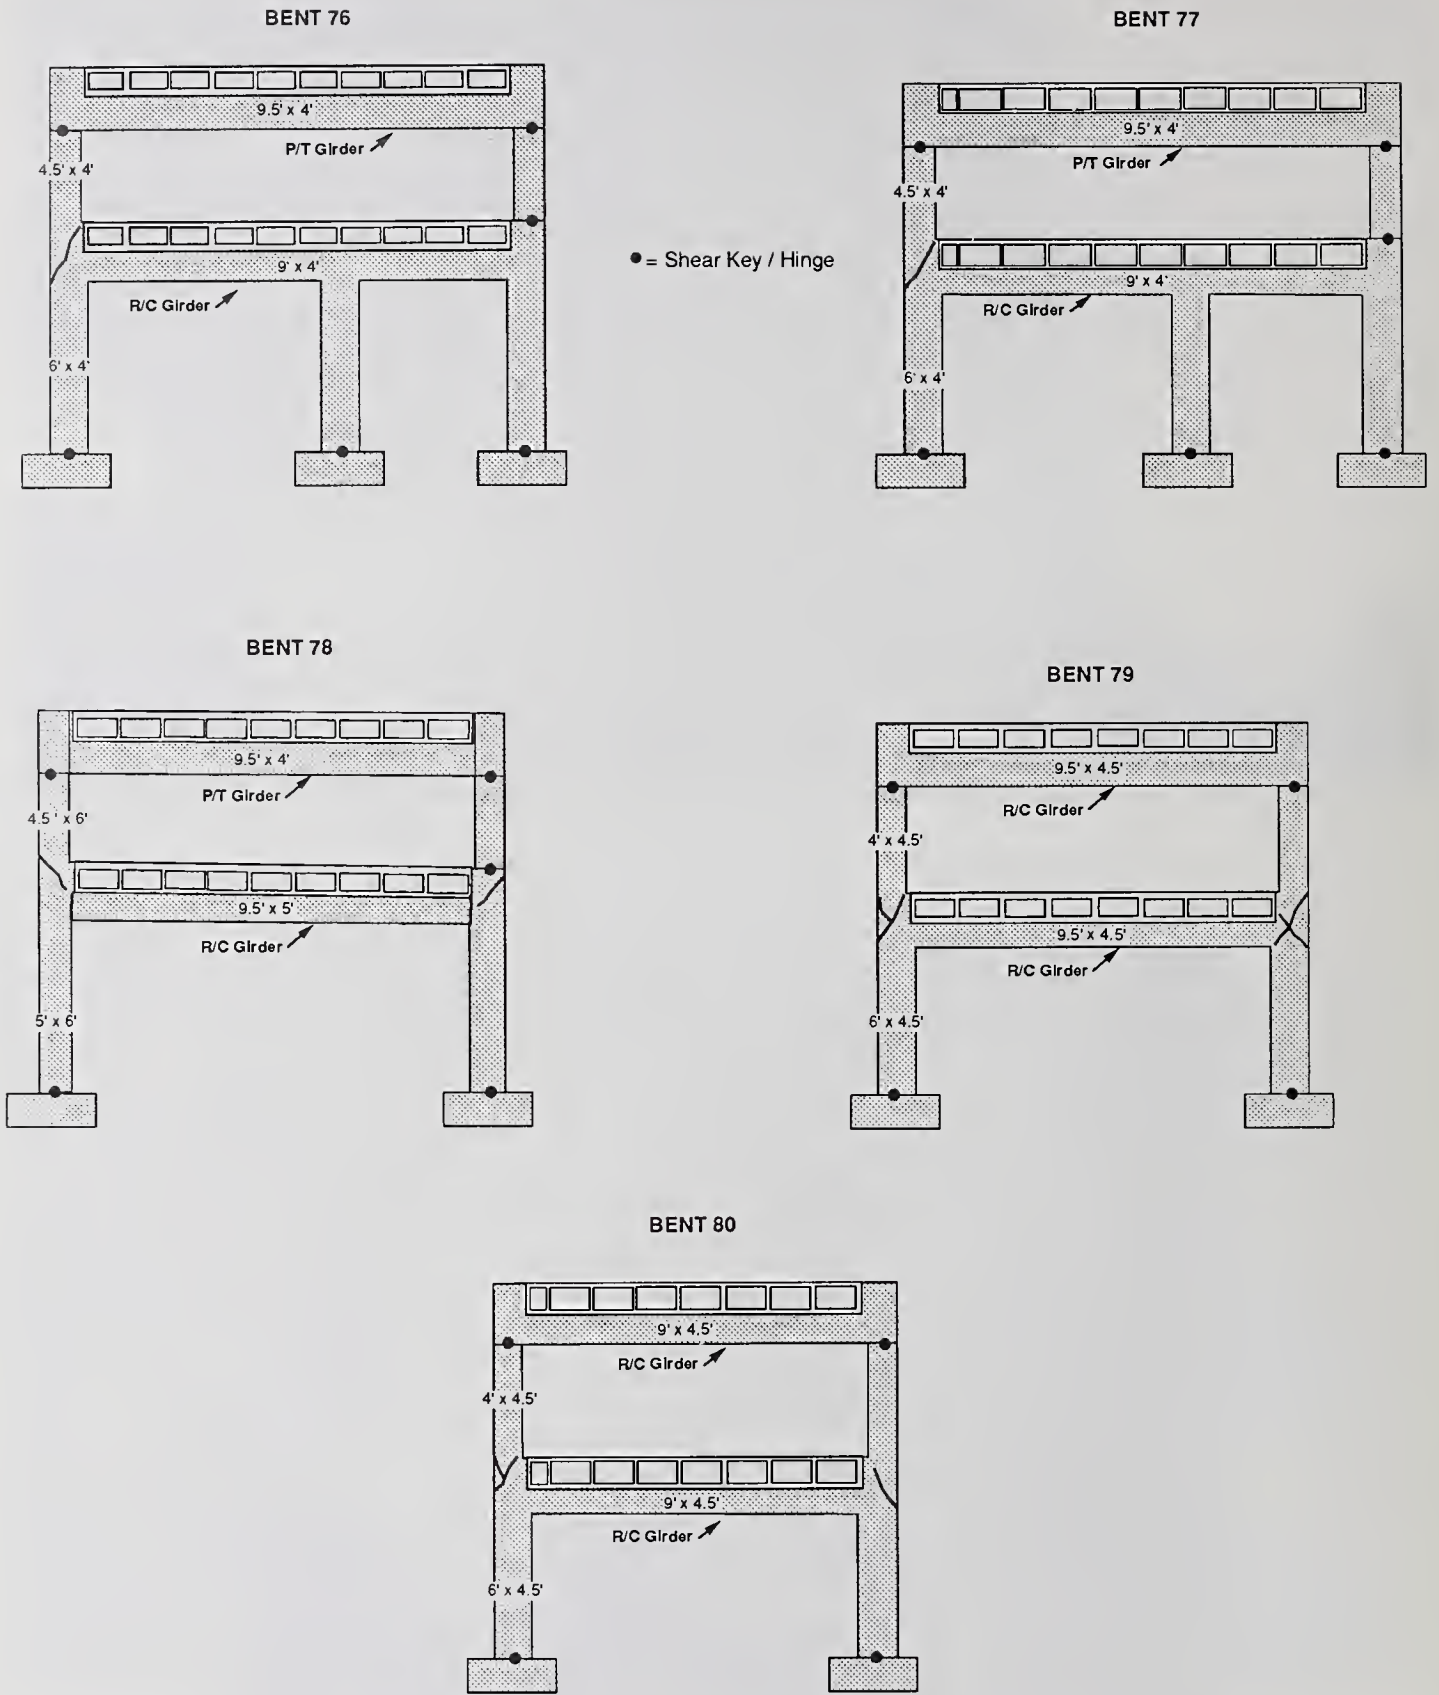
Figure 5.10.4 shows the configurations of the bents to the north and south of Mission Street. As can be seen at the bottom of the aerial photograph in figure 5.10.1, the Embarcadero Freeway undergoes a transition in width south of Mission Street, and this is the reason for the different bent configurations. For the wide portion of the freeway, the upper girder is post-tensioned and supported on pinned joints. A detail similar to that used in the design of I-880 was used for the pinned joints. Likewise, for bents with post-tensioned girders, column segments were pinned at both ends on one of side of the bent. The predominant damage was in the form diagonal cracking within the lower girder-column joint, as indicated by the heavy lines in figure 5.10.4. This indicates that the weakness of the Embarcadero Freeway is similar to that of the collapsed portion of I-880. In no cases were the cracks as severe as those observed in the columns of I-280.

Figure 5.10.4 Schematic of bent configurations and damage at lower girder-column joints.

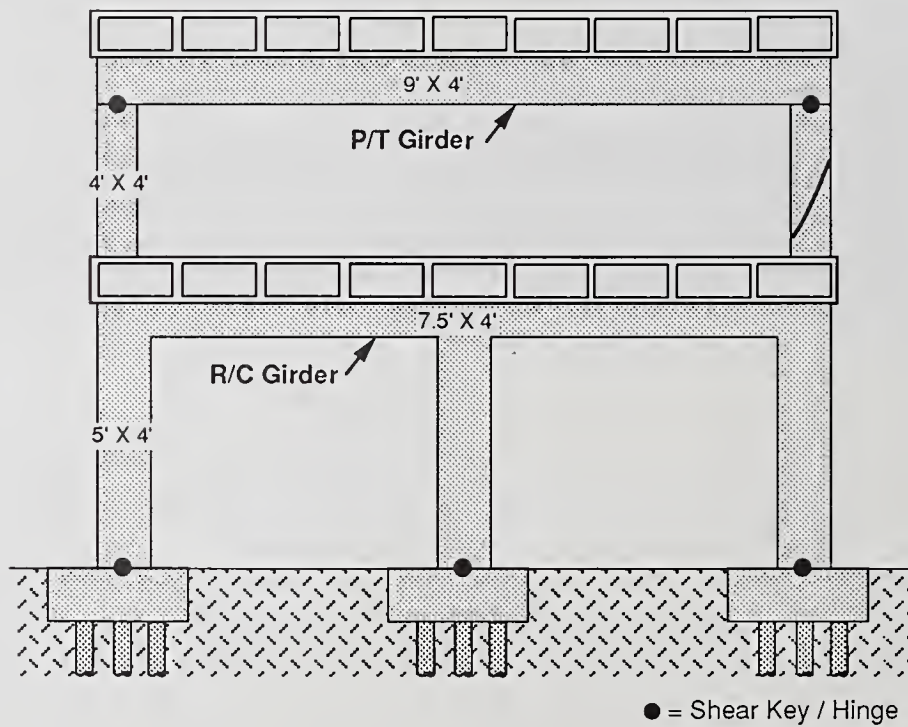
**BENT 43**

Figure 5.11.2 Schematic of Bent 43, which had the more severe damage.
