Report IN-005/2014

Incident involving a BOEING MD-11 aircraft, registration PH-MCU, operated by MARTINAIR CARGO, at the Tenerife South/Reina Sofía airport (Santa Cruz de Tenerife, Spain) on 9 March 2014

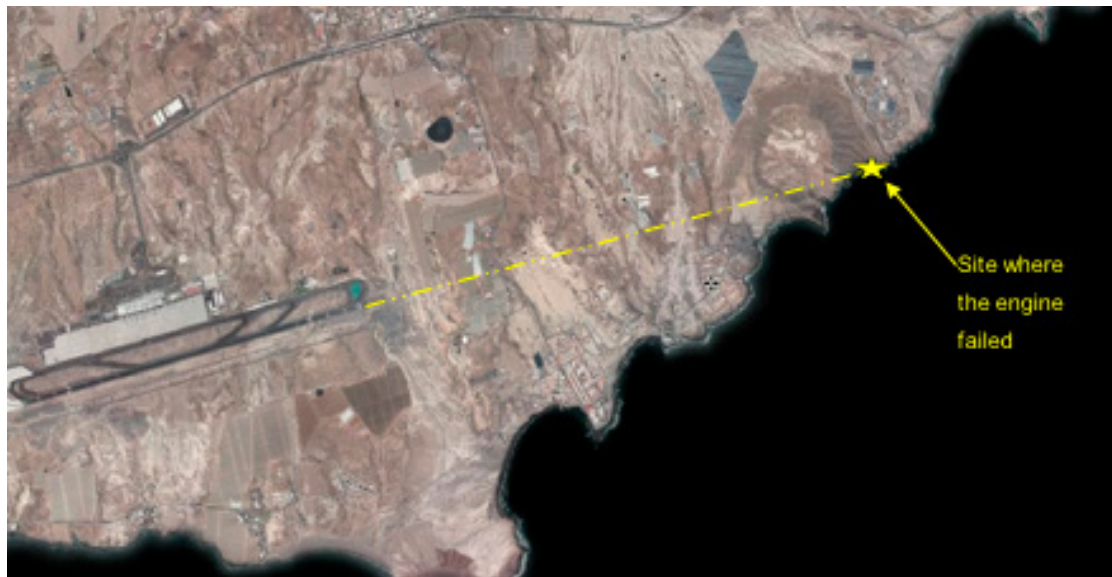
At 00:29:10 there was a sudden drop in the N1 value for engine 3, which fell to 87.4. The table below shows the values of the parameters at that time and in the two seconds that followed. At that moment the aircraft was at coordinates 28° 03' 50.4" N, 16° 30' 43.8" W, which is along the extension of the runway 08 centerline, some 4750 m away from the threshold (see Figure 5).

Figure 5. Aerial view of the general location of the Tenerife South/Reina Sofía Airport, showing the flight path of the aircraft and its location when the engine failed

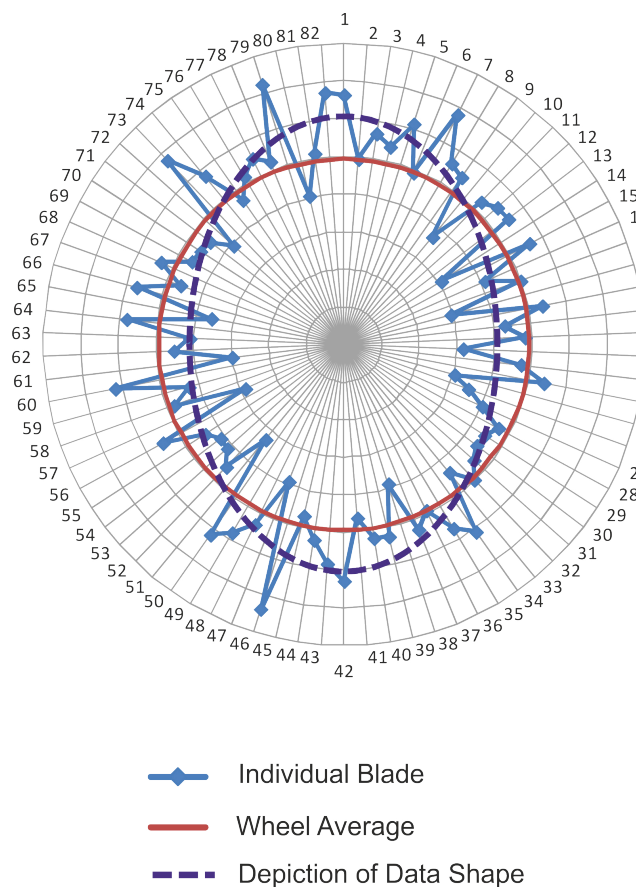
Figure 6 shows a representation of the average values measured for each flow area, the shape formed by these areas, as well as the average for the stage.

Figure 6. Representation of the sizes of the flow areas in stage 2 of the HPT
