# Ballistic damage of graphite-epoxy plates

BALLISTIC DAMAGE OF GRAPHITE-EPOXY PLATES

MASTER OF SCIENCE IN AERONAUTICAL ENGINEERING

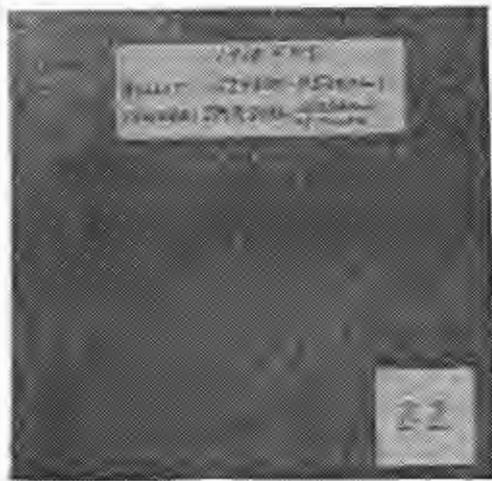
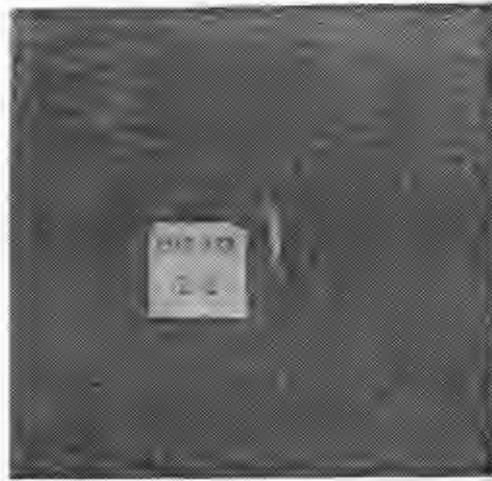
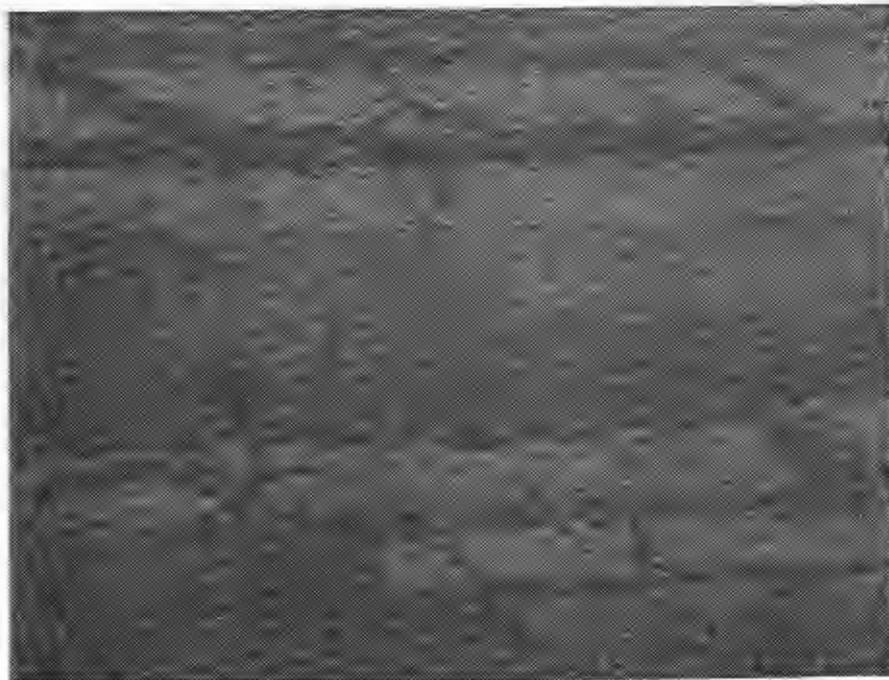
During the first test series the damaged specimens were cut transversely through the center of the hole, and a section along this line was removed for examination. These samples were mounted in cold-set plastic and polished for microscopic examination. Figure 4 shows a specimen ready for the microscope. The samples were examined and photographed at a magnification of 80X. Typical results are shown in Figures 5 through 11.

Figure 6 - MICROGRAPH OF SPECIMEN DAMAGED AT 1410 FPS

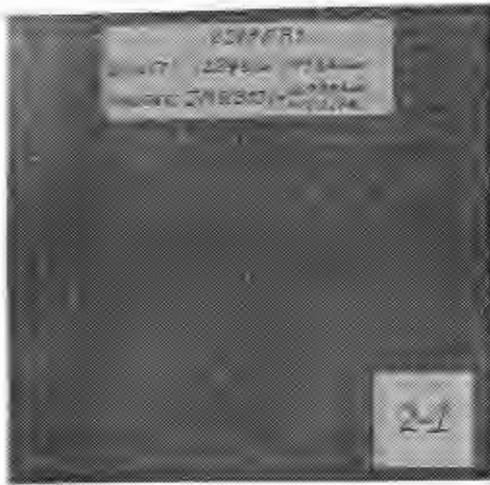
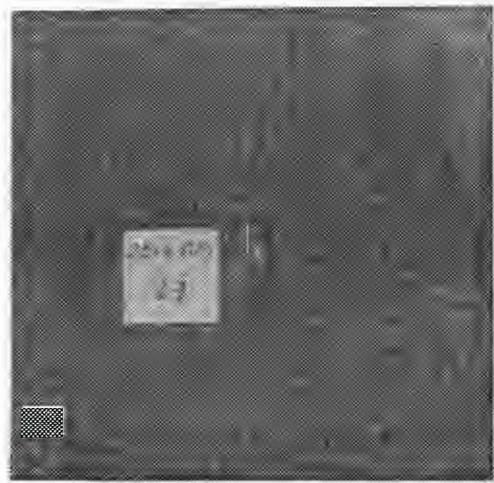
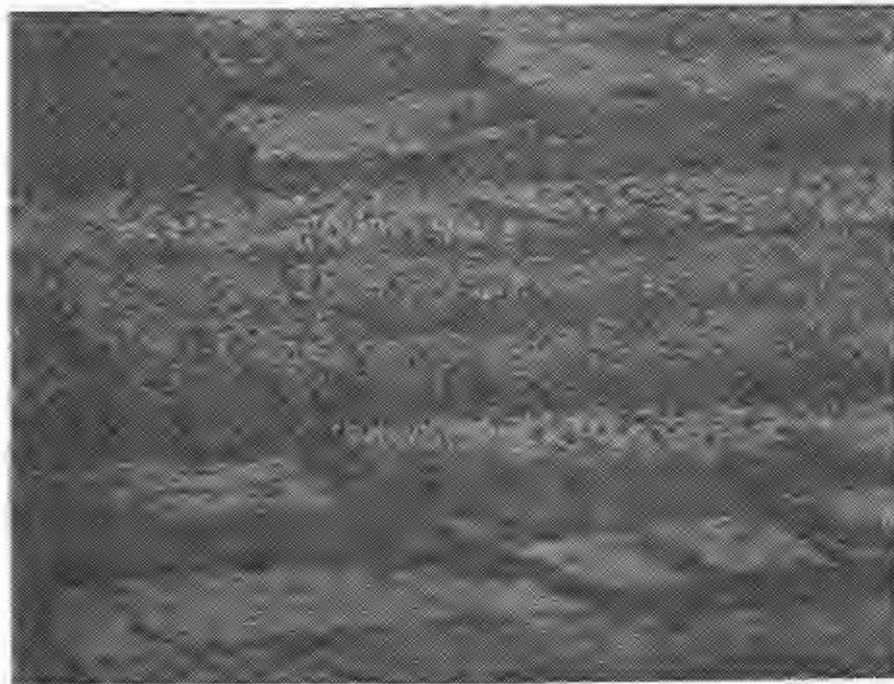
Figure 7 - MICROGRAPH OF SPECIMEN DAMAGED AT 2019 FPS

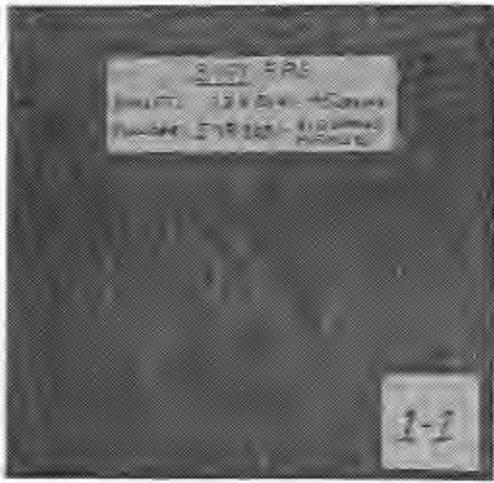
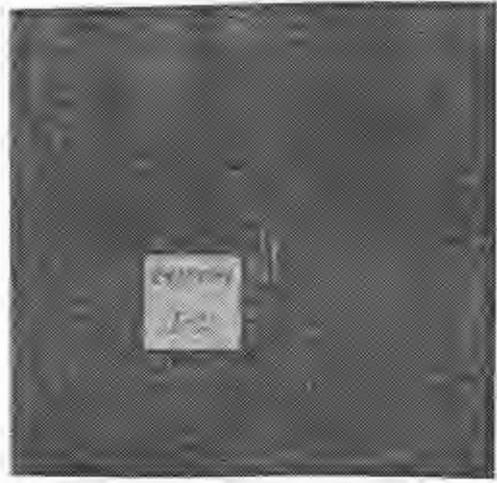
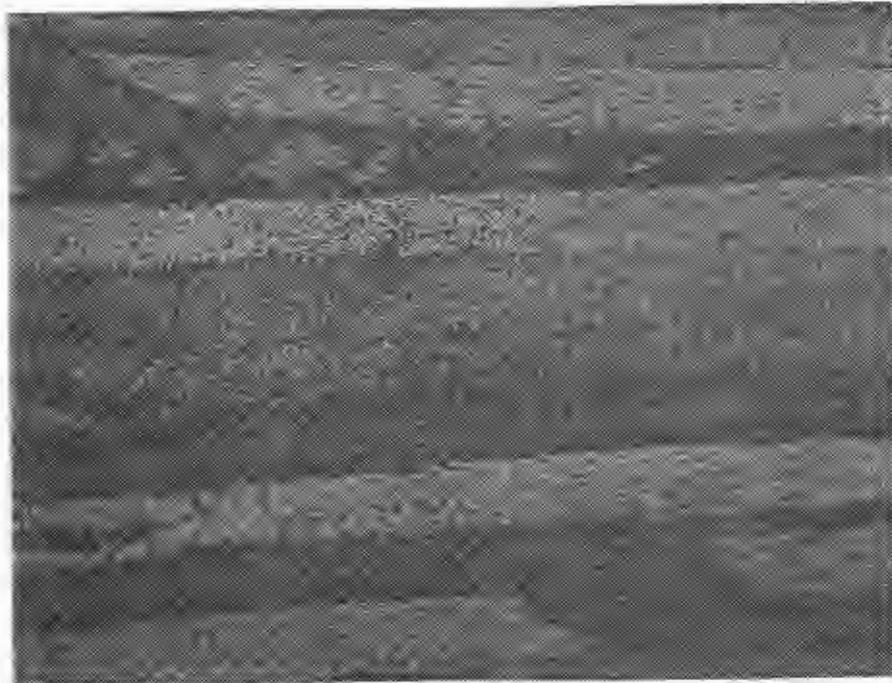
Figure 8 - MICROGRAPH OF SPECIMEN DAMAGED AT 2471 FPS

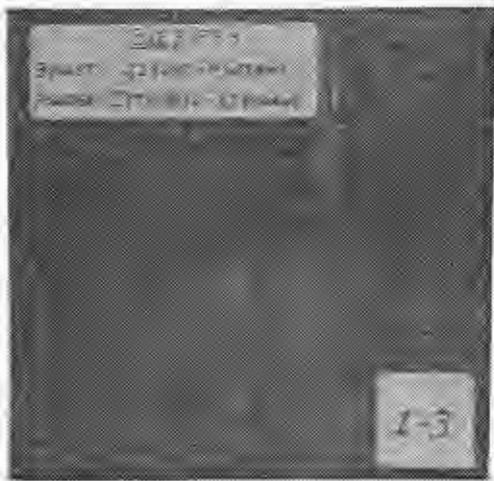
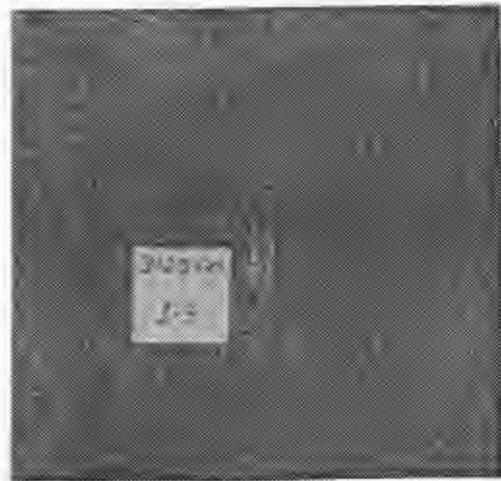
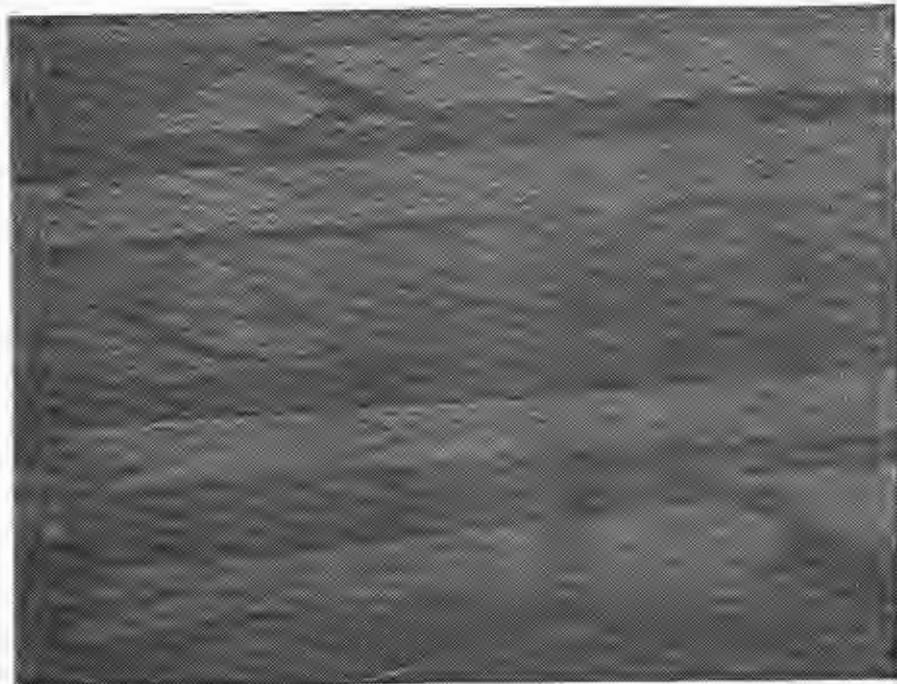
Figure 9 - MICROGRAPH OF SPECIMEN DAMAGED AT 3123 FPS

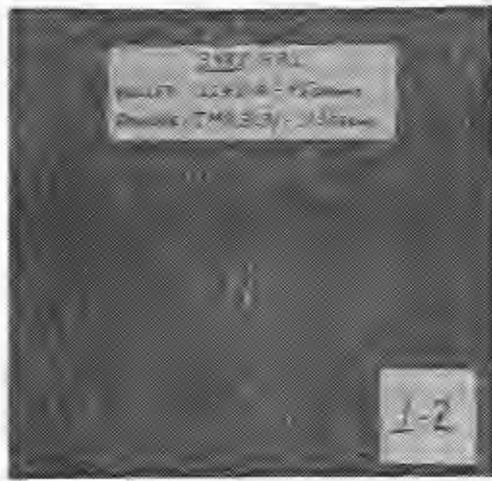
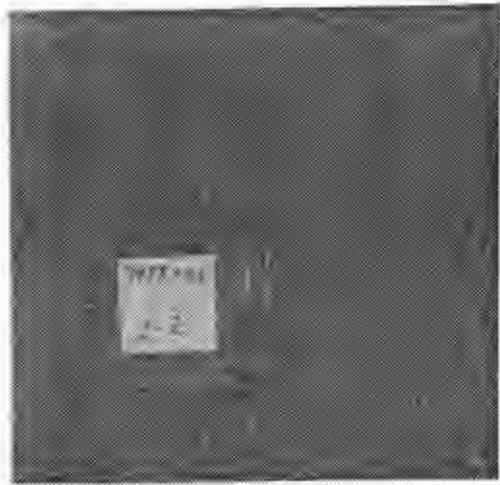
Figure 10 - MICROGRAPH OF SPECIMEN DAMAGED AT 3487 FPS

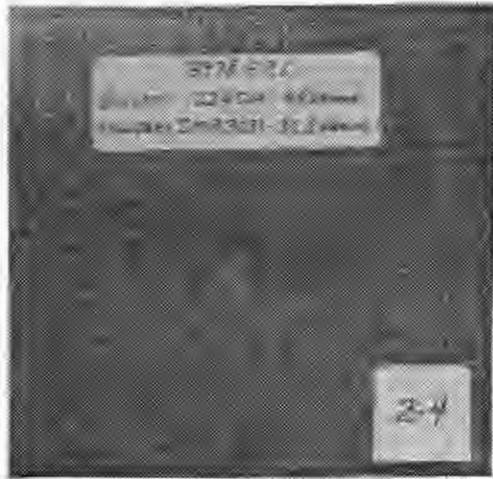
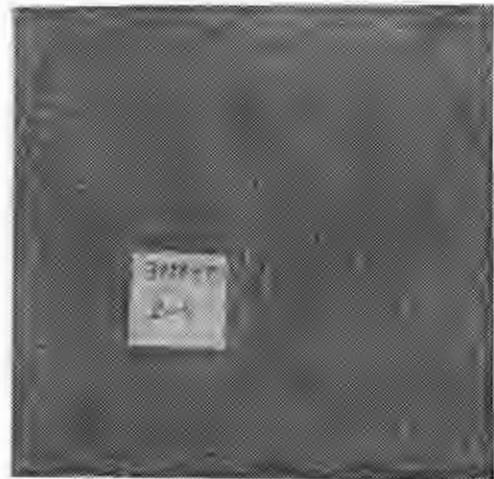
Figure 11 - MICROGRAPH OF SPECIMEN DAMAGED AT 3978 FPS

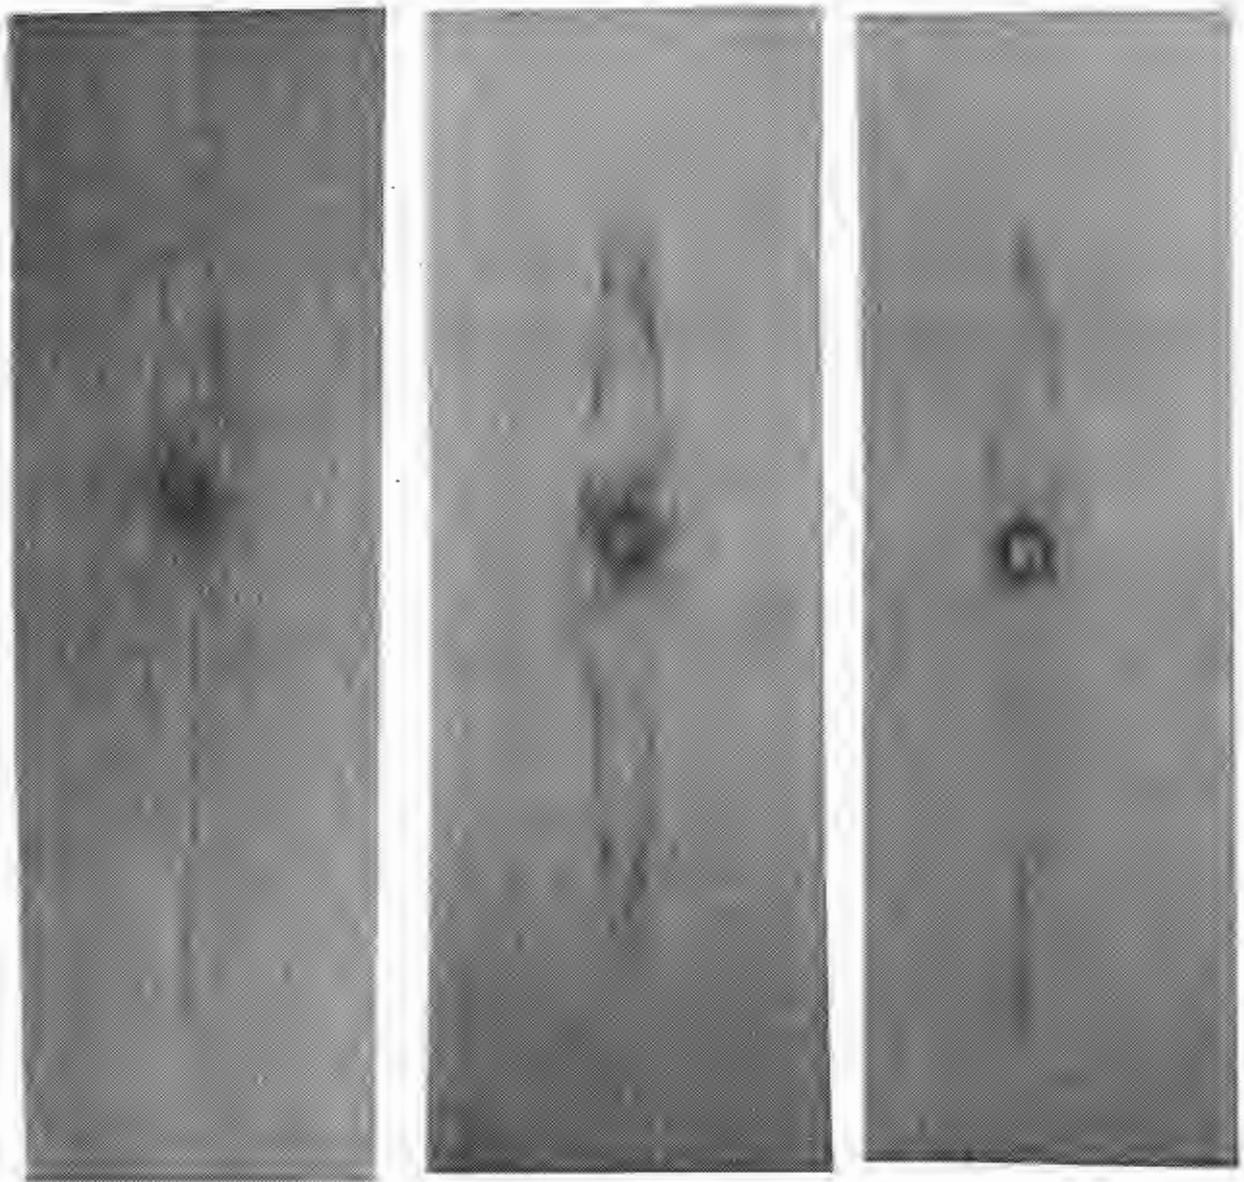
Figure 15 - X-RAYS (WITH RADIO-OPAQUE DYE) OF DAMAGED SPECIMENS

dye (a 29% solution of iodine in meglumine diatrizoate and sodium diatrizoate), was injected into the damaged area. This solution greatly increased the x-ray absorption where present, and thus improved the contrast dramatically. The resulting x-ray photographs are easily readable, even by the untrained observer. Figures 12, 13, and 14 compare both x-ray and light photographs of the same specimens, while Figures 15 through 19 show x-ray photographs of the specimens used in the final test sequence. Note that the x-ray photographs show a dark ring of delamination around the hole as well as splitting and delamination in the 0° direction. This delaminated ring was confirmed by sectioning and microscopic examination.

A. DAMAGE AT 980 FPS    B. DAMAGE AT 993 FPS    C. DAMAGE AT 1046 FPS

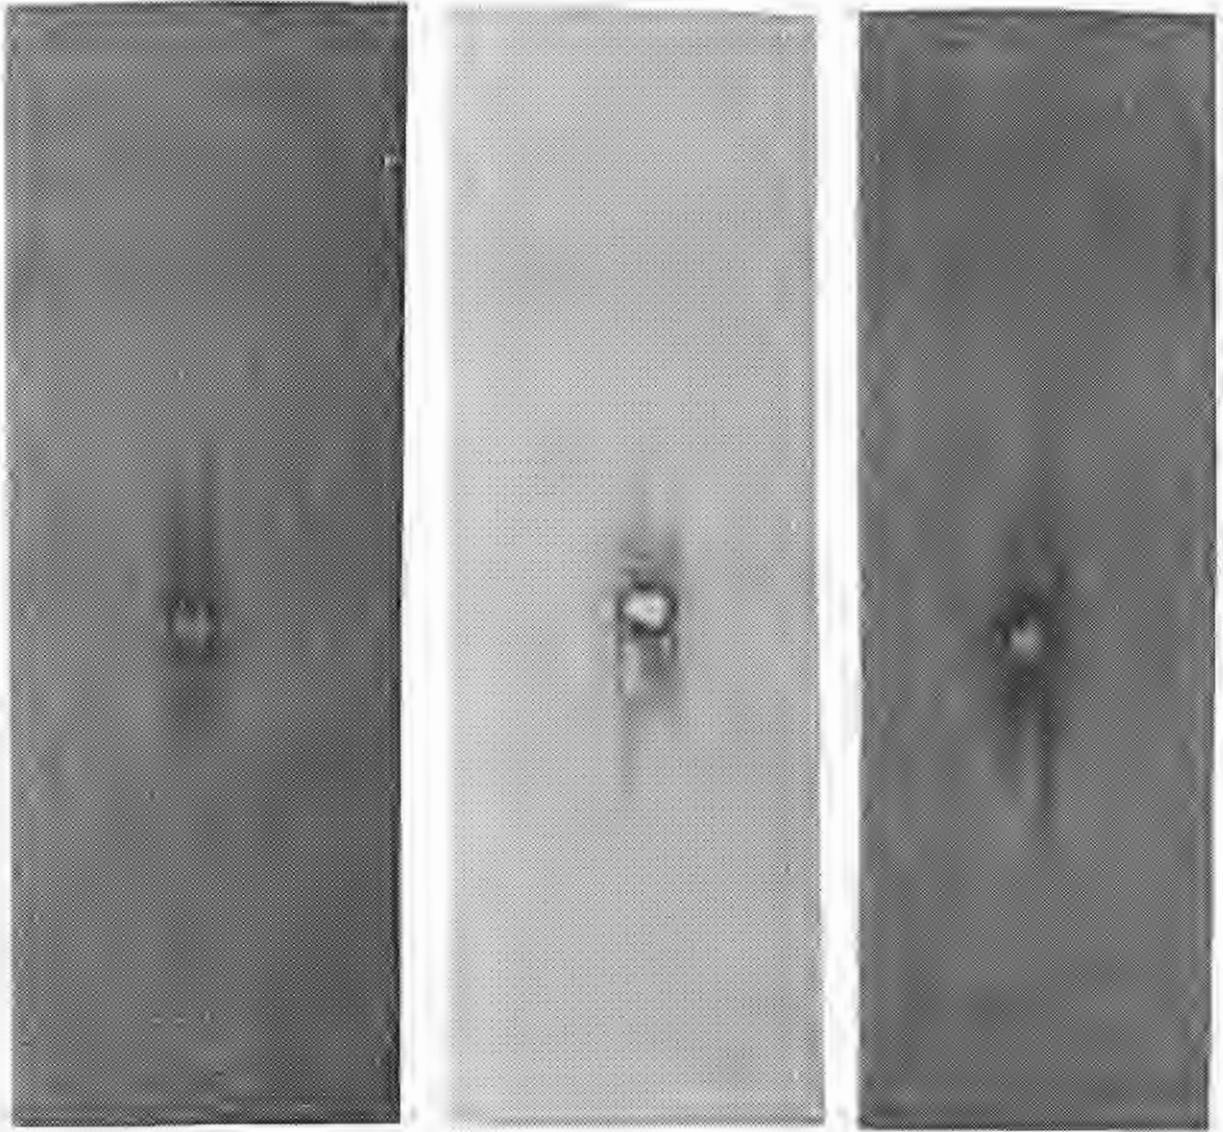
Figure 16 - X-RAYS (WITH RADIO-OPAQUE DYE) OF DAMAGED SPECIMENS

A. DAMAGE AT 2033 FPS B. DAMAGE AT 2058 FPS C. DAMAGE AT 2031 FPS

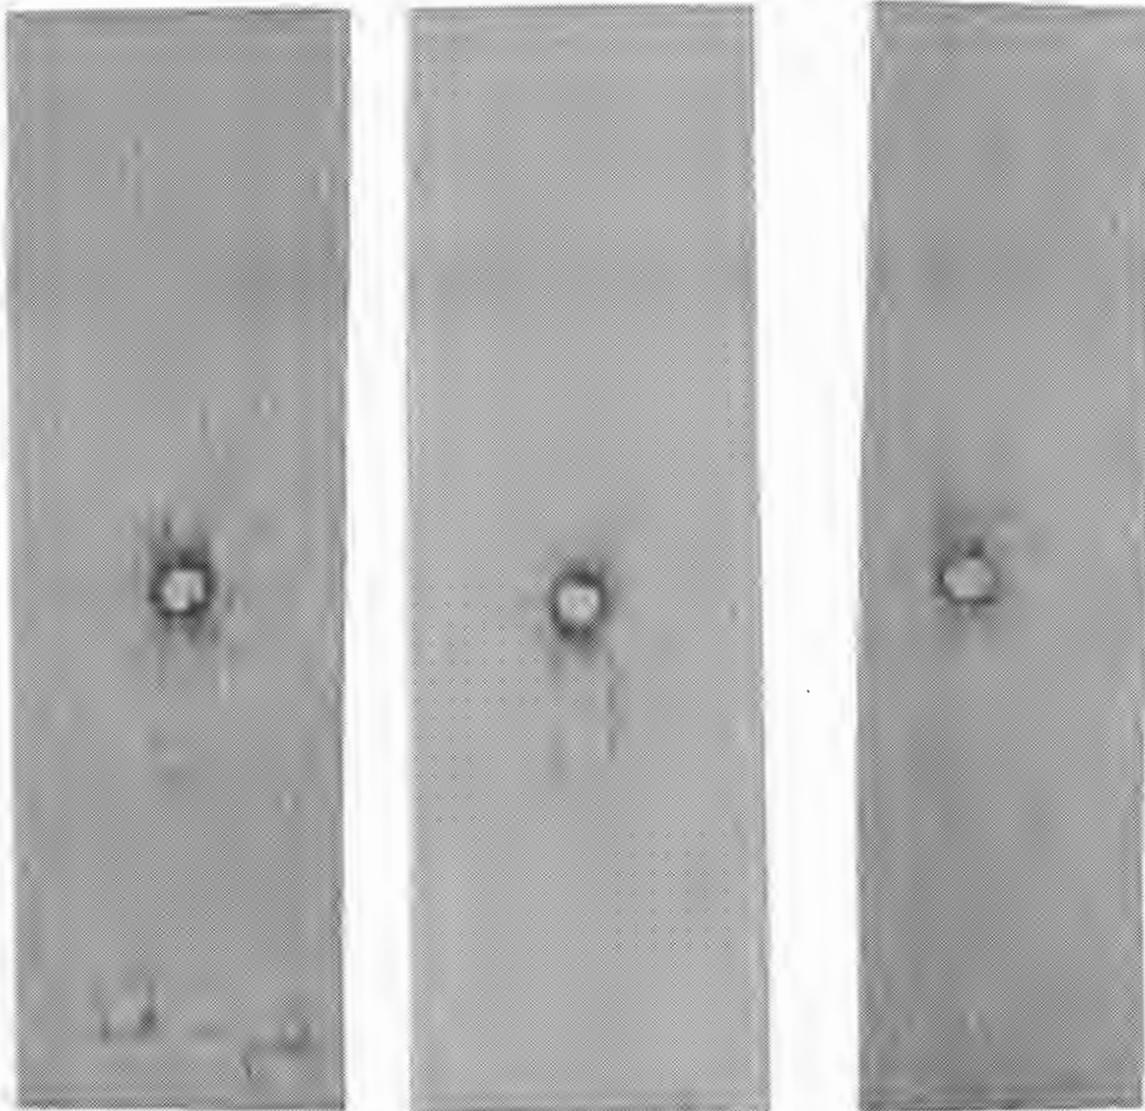
Figure 17 - X-RAYS (WITH RADIO-OPAQUE DYE) OF DAMAGED SPECIMENS

A. DAMAGE AT 2982 FPS    B. DAMAGE AT 3026 FPS    C. DAMAGE AT 3098 FPS

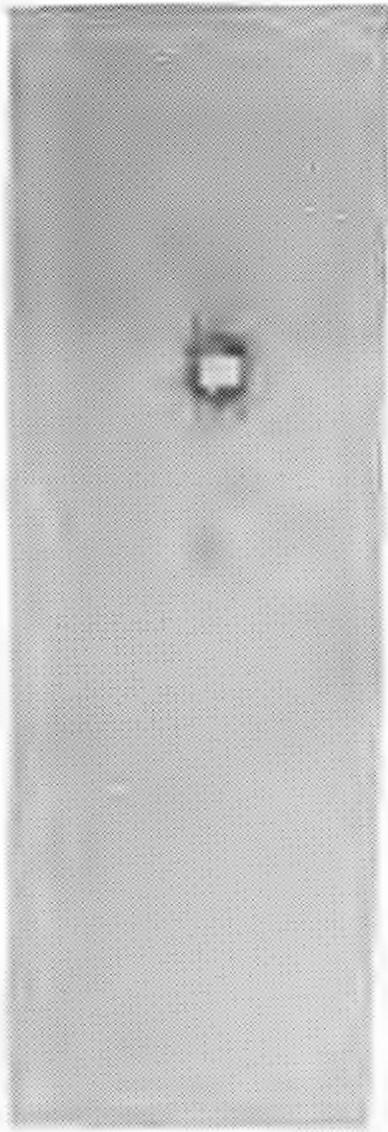
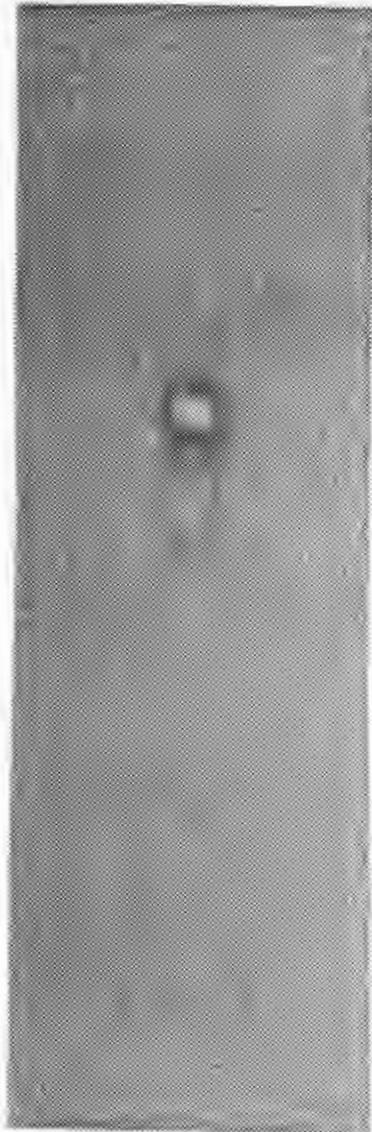
Figure 18 - X-RAYS (WITH RADIO-OPAQUE DYE) OF DAMAGED SPECIMENS

A. DAMAGE AT 3534 FPS

B. DAMAGE AT 3517 FPS

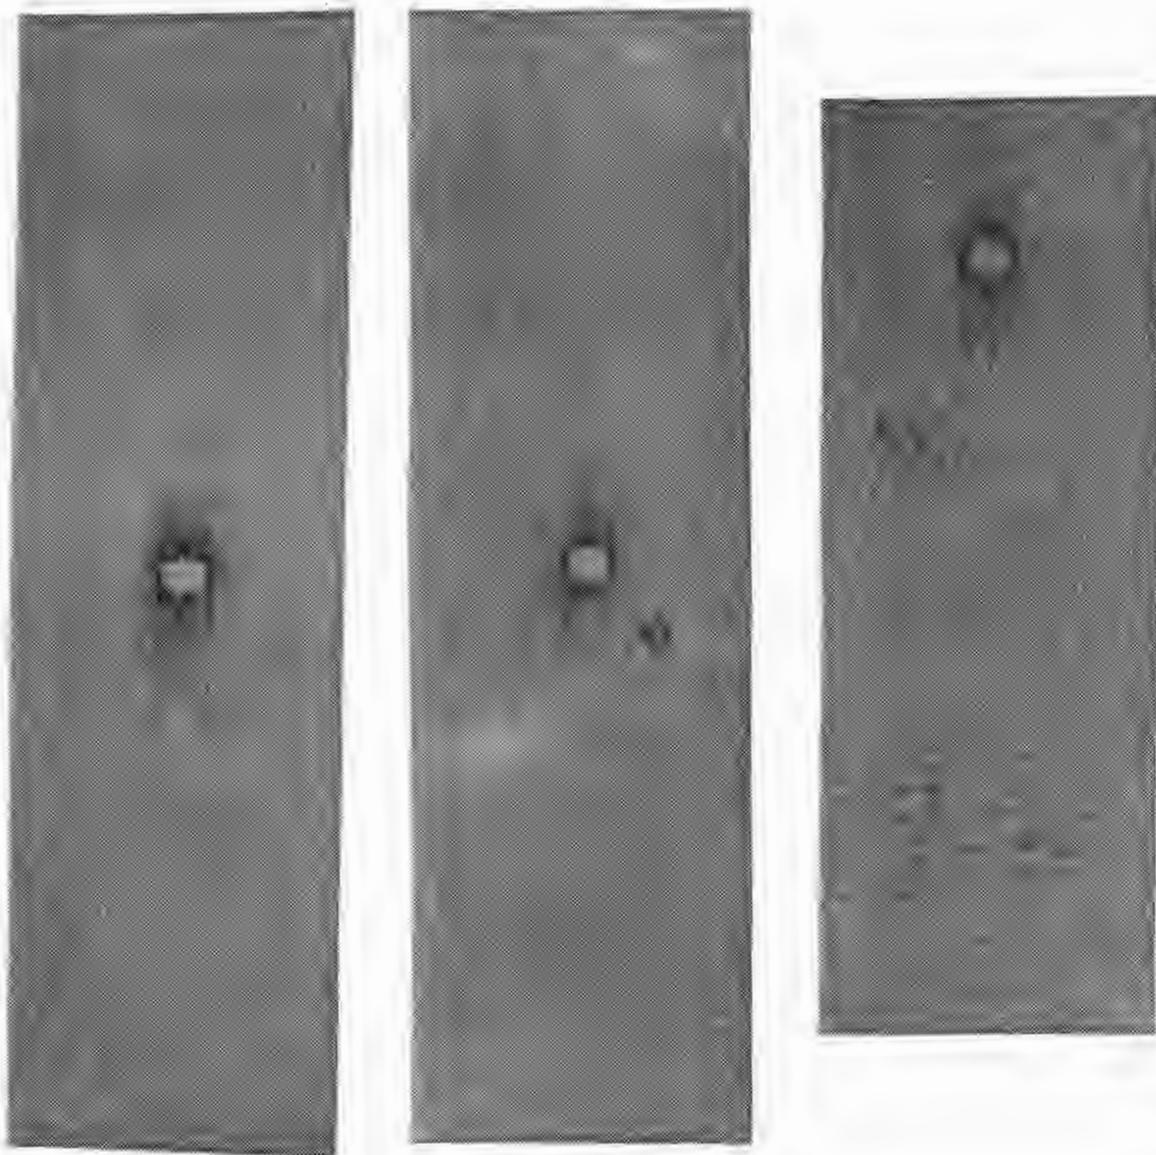
Figure 19 - X-RAYS (WITH RADIO-OPAQUE DYE) OF DAMAGED SPECIMENS

A. DAMAGE AT 4029 FPS    B. DAMAGE AT 3994 FPS    C. DAMAGE AT 4058 FPS

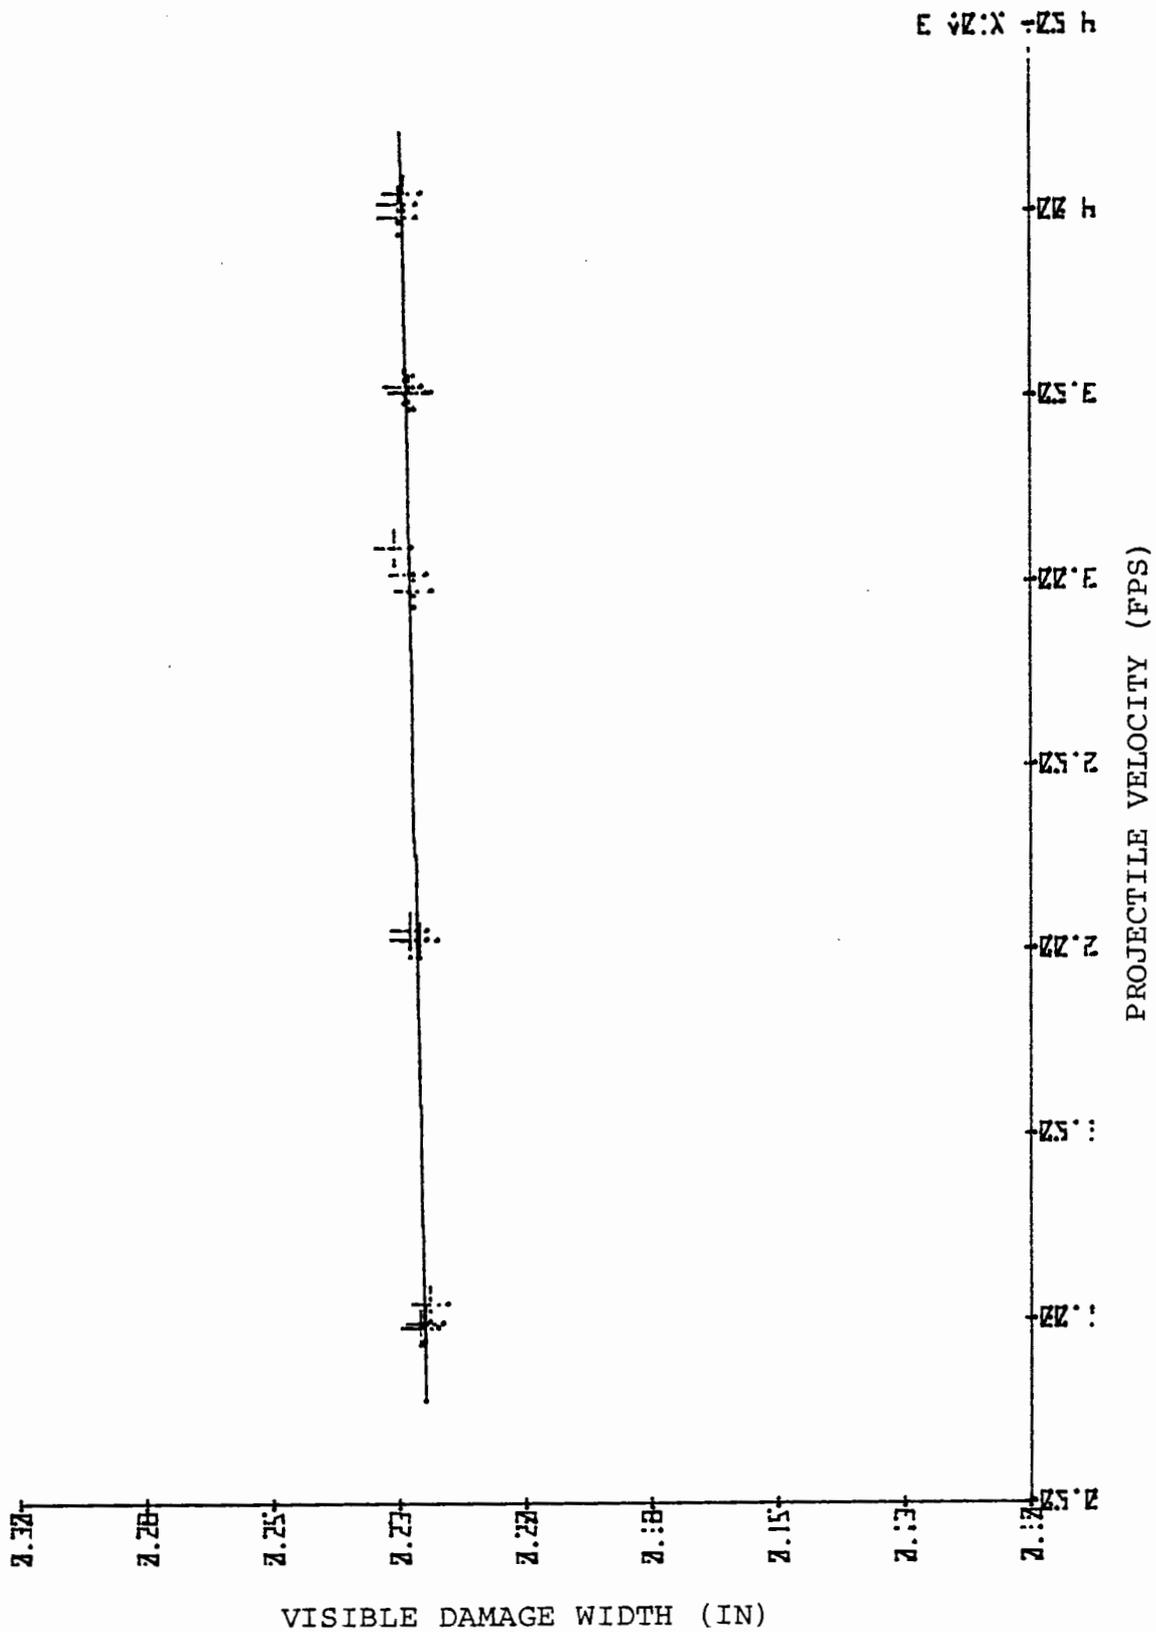
Figure 28 - PROJECTILE VELOCITY VS. VISIBLE DAMAGE WIDTH

Figure 27 plots residual strength vs. projectile velocity and shows that the residual strength is essentially independent of the velocity of the impacting projectile. Figure 28 shows the variation in visible damage width as a function of projectile velocity, while Figure 29 shows the variation in visible damage length as a function of projectile velocity. Consideration of these figures leads to the conclusion that for the specimens tested and the loading scheme (i.e., uniaxial tension) used in this test series, damage length has little or no effect on residual strength. Since projectile diameter was not varied, and velocity changes had little effect on damage width, the effect of damage width on residual strength was not determined. Changes in projectile velocity did cause changes in damage length, but as can be inferred from Figure 27, these changes in damage length did not result in changes in residual strength.
