The Locomotive

THE HARTFORD STEAM BOILER
INSPECTION AND INSURANCE CO.

INDEX TO VOL. 42—1938-1939

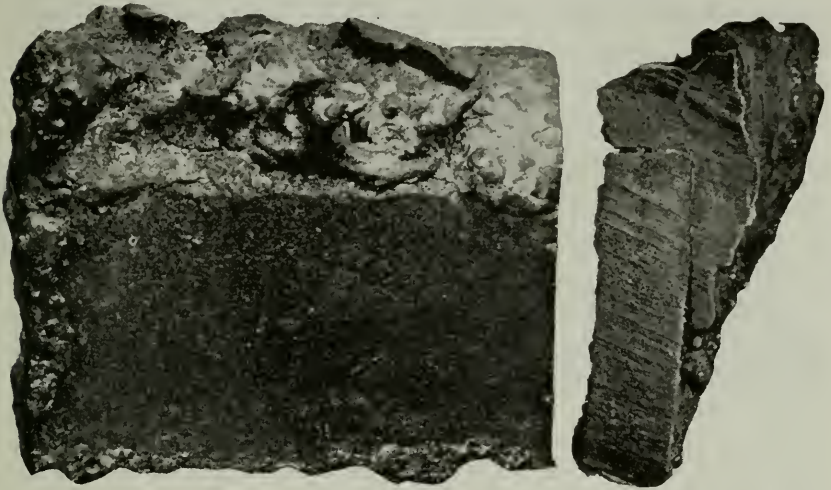
Figure 1. An example of uncontrolled welding. Parts of a 36" x 24" patch on a high pressure boiler are shown. The patch was welded flush with the shell plate and there was very little fusion. How little may easily be ascertained from the photograph at the right showing the cross section of the seam.

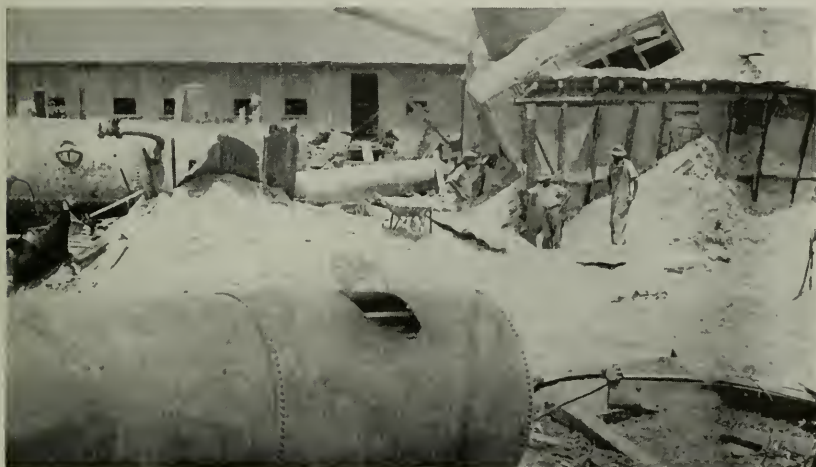
Figure 2. The shell, the hole where the patch shown in Figure 1 was attempted, and some of the debris which followed the explosion. Two other boilers were blown from their settings, the failing boiler rocketed 75 ft, the boiler house was wrecked, and one man was killed. It was reported that the boilers were not insured.

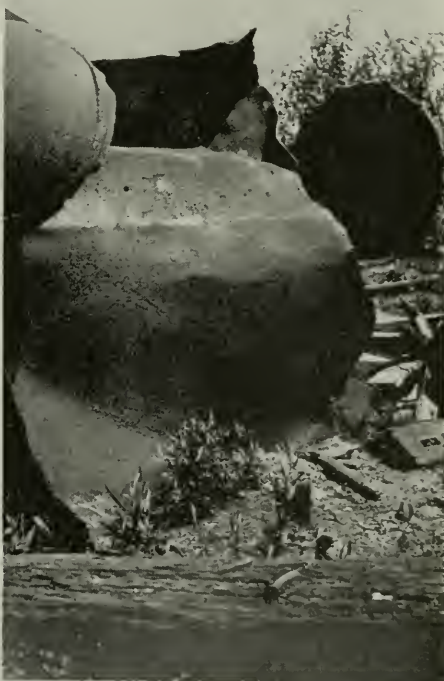
Figure 3. This uninsured air tank failure was traced by the inspector to lack of fusion in the welded longitudinal seam. The blast blew out a cement foundation and the air compressor and motor were hurled against the ceiling of the service station where the tank was used.

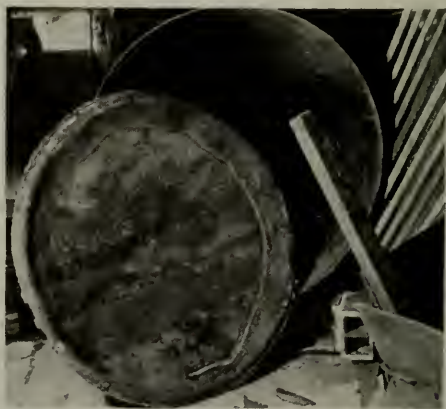
Figure 4. Head of a pneumatic tank which blew out when seal welding failed. Passing through a tile wall, the head damaged supplies in an adjacent room. The shell skidded in the opposite direction, breaking piping and sewer connections. Above the tank, floors and plaster were damaged. Insurance was not carried on the tank.

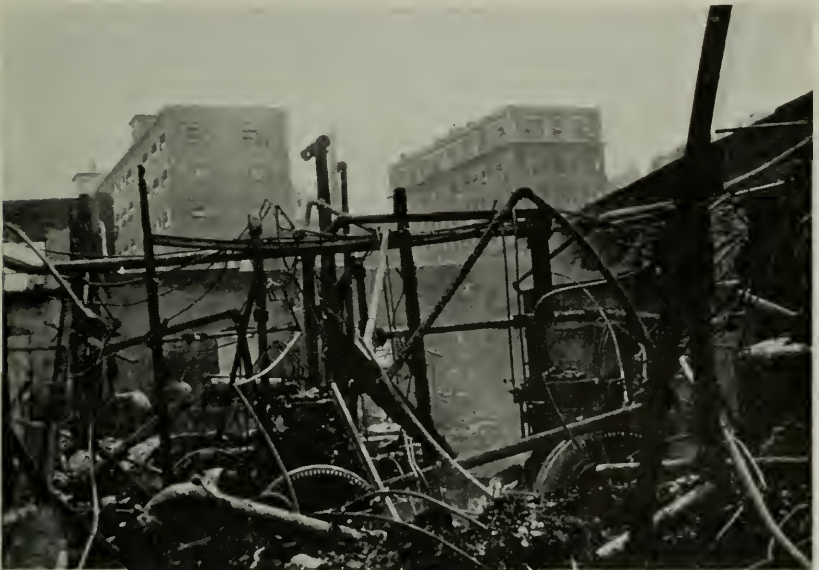
Wreckage following the explosion of a shell type brine cooler, the accident being attributed to tearing at the welded head and along the entire length of the longitudinal seam. There were points on both the longitudinal and head seams which indicated that the welds penetrated only about $\frac{1}{8}$ ". When the exploding cooler struck high voltage lines, a fire ensued which completed the destruction of the entire building.

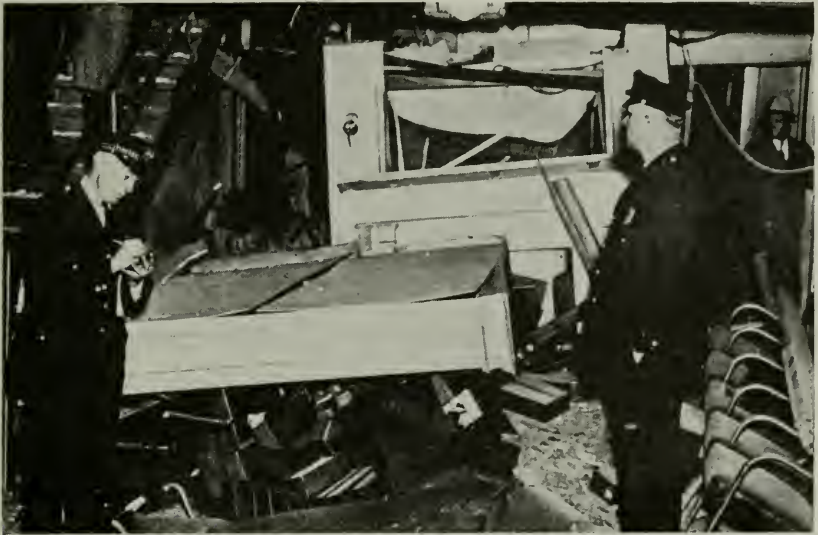
THREE persons were injured and property damage estimated at nearly \$10,000 resulted recently from the explosion of a single flue type steel hot water supply boiler in an Indiana hotel. Rupturing in the furnace sheet about 8" from the bottom of the boiler, the vessel tore loose from its setting, passed through a reinforced concrete floor above it, through the second floor of the building, struck the third floor and crashed down on an office desk. On the first floor was a store, the fixtures in which were wrecked, as is shown in the accompanying photograph.

Damage in a shoe store after an exploding hot water supply boiler had crashed through the floor and the ceiling.

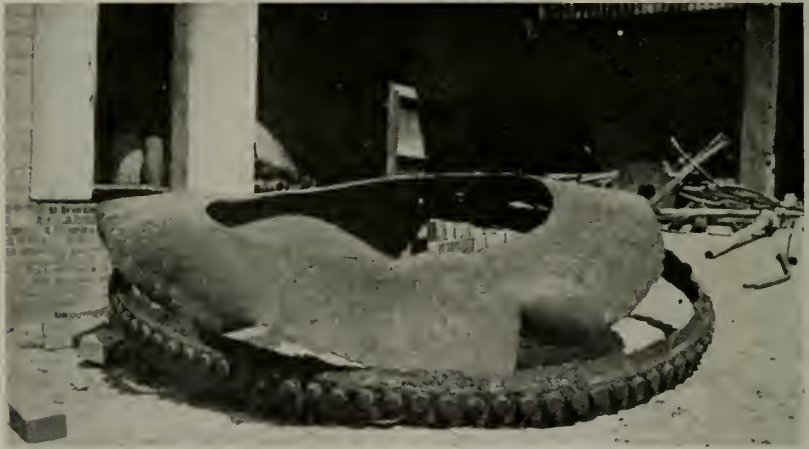
The top head of this tank had become so thinned that it ruptured at an operating pressure of about 72 lbs. The initial tear spread around

Head and seam of rendering tank which exploded after serious thinning because of external corrosion

the head at the knuckle just above the seam, and both head and tank crashed into 6" steel I-beams supporting the floor above. One of the beams was bent and two others dislodged from the brickwork. Wiring, piping and windows were also damaged.

While the head plate was somewhat corroded on its internal surface, the greater part of the thinning, from a normal thickness of $\frac{3}{8}$ " to an average of $\frac{1}{8}$ ", was on the outside. As the head of the tank was only 9" below the charging floor, it had been frequently subjected to moisture when the floor was washed. The photograph shows the defective part of the head, and the seam, which was cut away from the shell following the accident. The tear started at a point just to the left of the lap seam. The rip at the right occurred when the head hit a steel beam.

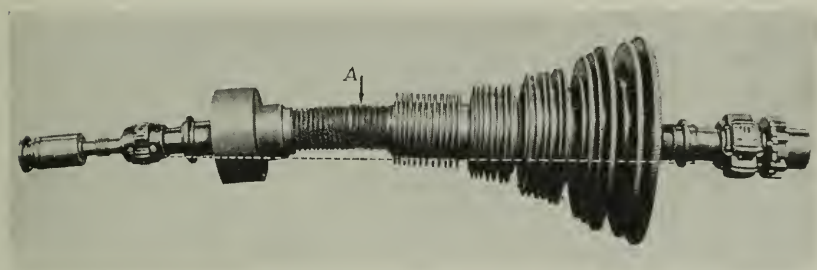
Figure 1—The photograph was purposely distorted to make clear how the shaft was bent and just where heat was applied. The distortion of the shaft is, of course, absurdly exaggerated.

was then applied at "A" (Figure 1) on the top of the spindle (the high side) by means of two oxy-acetylene torches. An asbestos ring was placed around the point that was to be heated, so that a quick heat could be obtained at that location. As soon as the heat was applied at the top, that side of the spindle began to expand and to rise, so that the bow in the spindle was even greater than before the heat was applied. This was seen on the dial indicator, which immediately began to show a plus reading. For the various heats, the torches were applied for periods ranging from 20 to 90 seconds which caused the indicator to show a maximum plus reading of 70 mils for the longest heat, but the best results were obtained by using a heat that raised the spindle only about 30 mils at each heating. As soon as the torches were removed and the top of the spindle began to contract, the drop of the spindle was rapid at first and then more gradual until the indicator again read zero within ten minutes' time. With further cooling of the spindle, the indicator began to show a minus reading until from minus 4 to minus 12 mils for each application was secured after 30 minutes of cooling. This

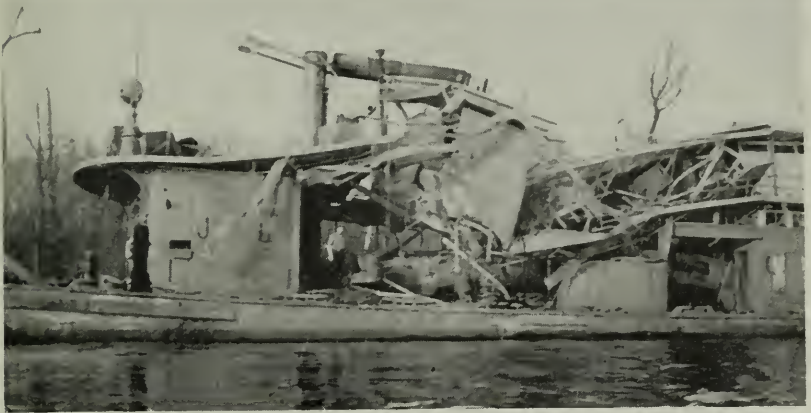
The cause of this accident was not immediately determinable because part of the boiler was blown into the river. Later the failing part of the shell was found. It revealed the probable cause of the accident to be over-heating and bulging of the second course of the boiler because of an accumulation of mud and scale.

As the section of plate which failed went overboard, it took with it the two firemen, who were on the deck. The rest of the boiler moved aft about 23 feet so that the rear head struck a condenser and an evaporator, damaging both. The smokestack and breeching which served the exploded boiler and another mounted with it were damaged, and the other boiler was badly dented. Living quarters of the crew and

Figure 1—Results of an explosion because of over-heating.

captain above the boiler room were wrecked, as is shown in the photograph, and there was other damage to the pilot house, coal bunkers, pipes and machinery.

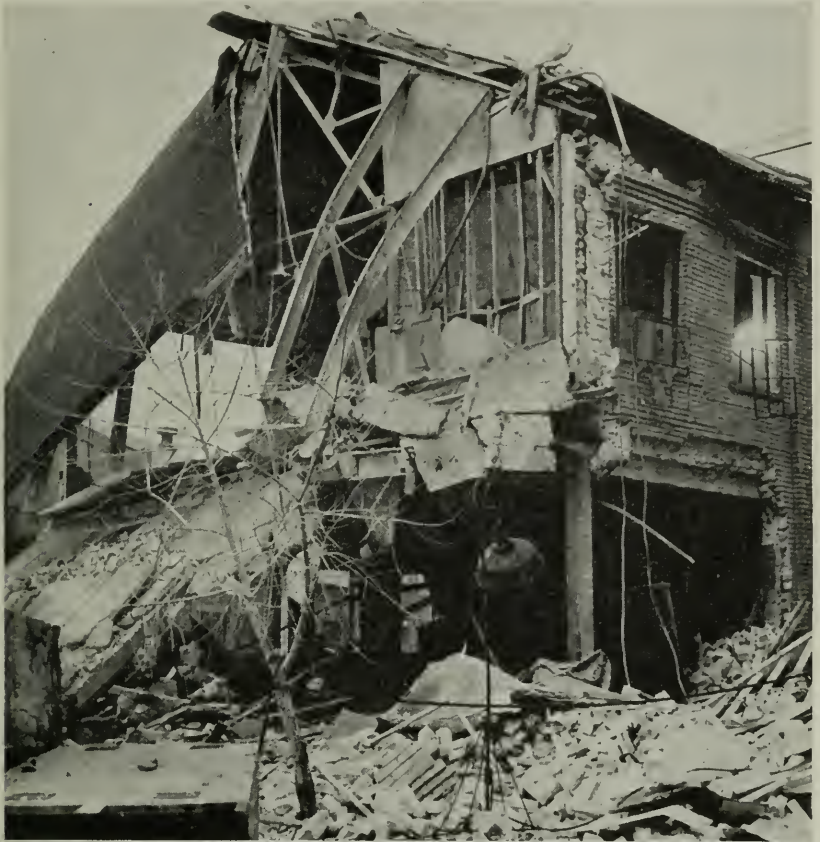
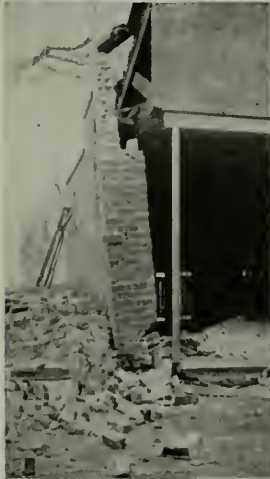
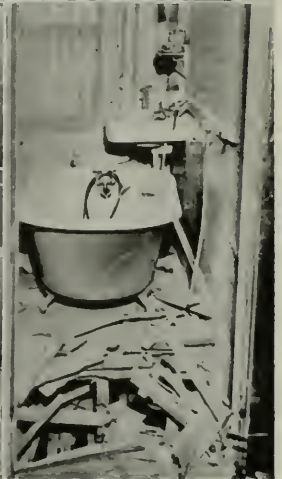
Figure 1—Top—Exterior of a factory building following a hot water tank explosion. Bottom Left—Part of the damage at a garage when a steel hot water heater failed. Bottom Center—Two views of serious damage following a hot water tank accident at an apartment. Bottom Right—The bathroom of a residence that was rendered uninhabitable when a small hot water tank exploded.

\$3,000. The condition of the garage wall following the accident is shown in the picture on Page 43, at the lower left.

In a New England apartment a forgotten gas burner led to a tank explosion which caused extensive property damage, as is shown in the picture on Page 43 at the bottom center. Two persons asleep in a bedroom miraculously escaped with minor injuries. The tank itself passed through the roof and came to rest on the roof of another apartment.

A similar accident in a New England residence so damaged the dwelling that a building inspector pronounced it unsafe for occupancy. The picture at the lower right on Page 43 shows where the tank went through the bathroom floor. According to newspaper accounts, every floor in the house was lifted out of position, walls buckled, and all window glass was smashed. The owner and his wife were sleeping when the blast occurred, and although both suffered from shock, they were able to make their way out of the house safely. Damage was estimated at between \$6,000 and \$7,000. The tank was equipped with a spring-loaded relief valve, but the device obviously failed to function. Windows in an adjacent house were blown in by the force of the explosion. The tank in this case was copper, the pressure having caused the failure at a brazed head seam.

Similar accidents are reported periodically in all parts of the country, and demonstrate the need for inspections of hot water supply equipment. Such inspections include careful checking of the installation, the adequacy and condition of relief devices, and a search for the presence of corrosion or other weakness.

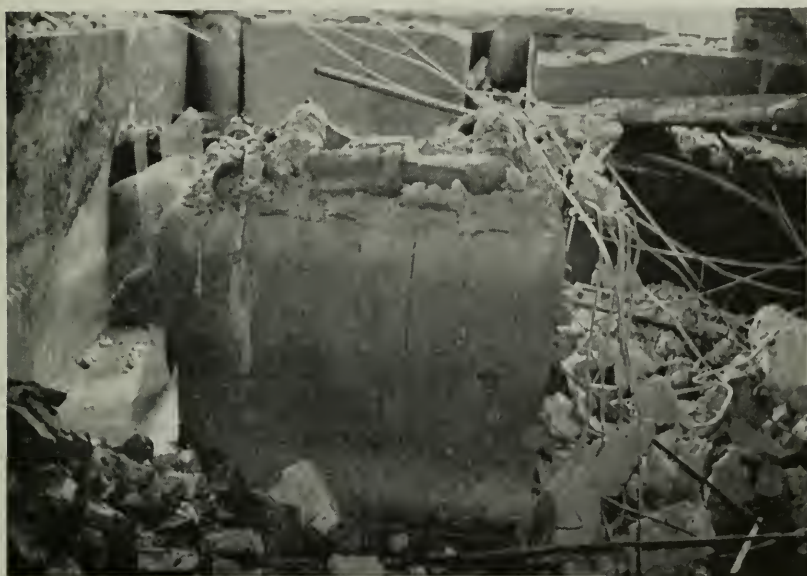
Figure 2—Basement of an automobile showroom after the explosion of hot water equipment. Three automobiles fell through into the basement when the floor was destroyed by the blast.

An explosion involving a hot water heater and tank in an auto dealer's showroom in the Chicago area demolished the basement, ripped up the floor and lifted three automobiles up against the ceiling. They fell back into the basement. Inasmuch as the system was of the closed type and the accident occurred in the evening when no water was being used, it was concluded that over-pressure was the cause. The storage water heater was completely demolished and the bottom head of the tank, which was welded to the shell, blew out. A view of the basement

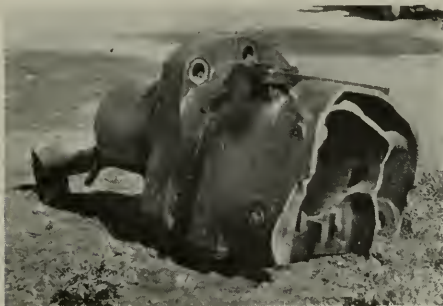
Figure 2—A cylinder from the wrecked engine.

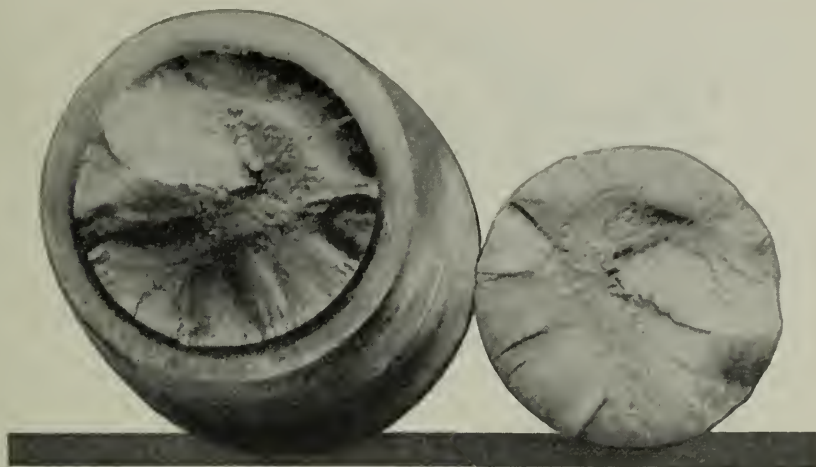
A shaft failure that occurred on a 300 hp wound rotor motor driving rubber rolls through a magnetic clutch and reduction gears. This failure occurred at the inboard end of the journal and at a location not ordinarily accessible for inspection. Vibration developed suddenly and the machine was taken out of service before breakage actually occurred. The shaft was broken in order to study the character of the crack, which was attributed to misalignment or improper adjustment of parts at some prior time.

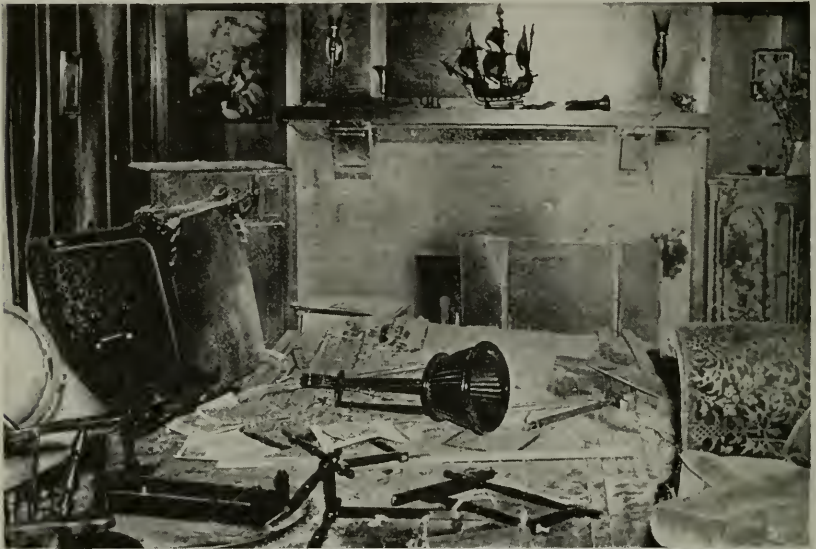
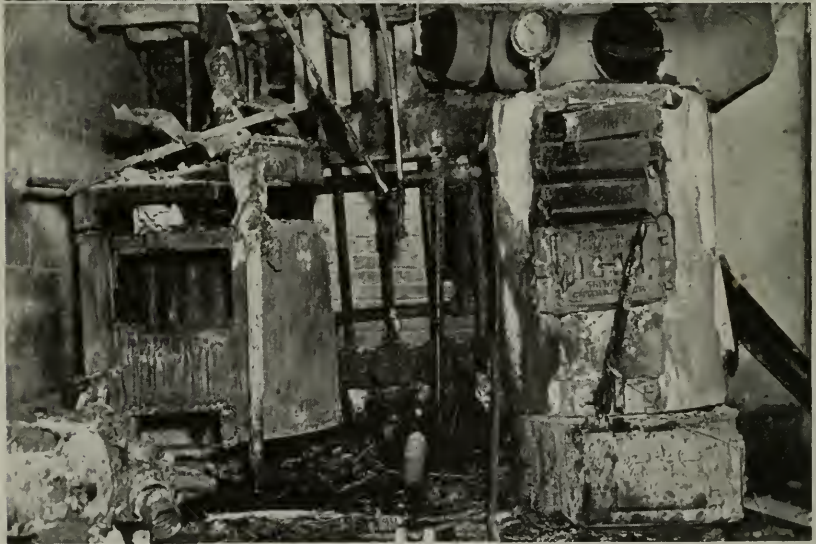
Hot Water Heating Boiler Explosion in Residence

The above views show part of the damage caused by the recent explosion of an oil-fired hot water heating boiler in a residence. Occurring in the boiler at the left, the explosion blew the top section into the floor above, damaging the living room as shown. The foundation of the

boiler was destroyed and walls of the house weakened. Fortunately, no one was injured, but property damage was estimated at \$3,000. An investigation revealed that, because the boiler had been out of service, the supply and return valves on it were both closed, and that there was no direct communication between the boiler and the expansion tank on the third floor. Therefore, when a new oil burner was started, it soon heated the water in the closed boiler to a pressure sufficient to cause the failure.

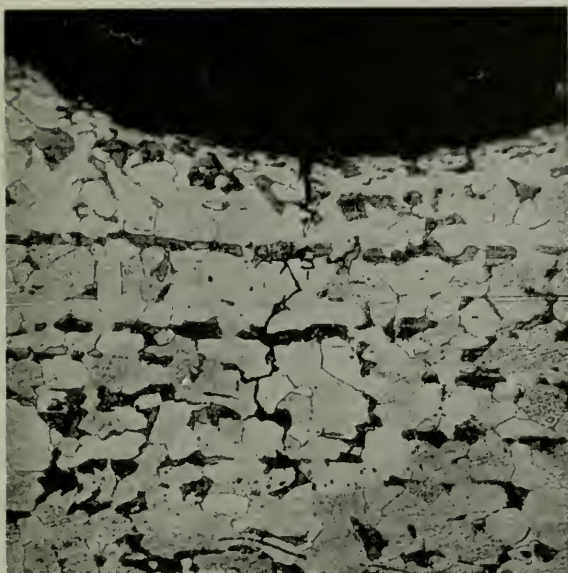
Figure 2—Embrittlement at 225 magnifications. The defect shown here was produced in the University of Illinois tests. The progress of the fissure may be compared to that in Fig. 3.

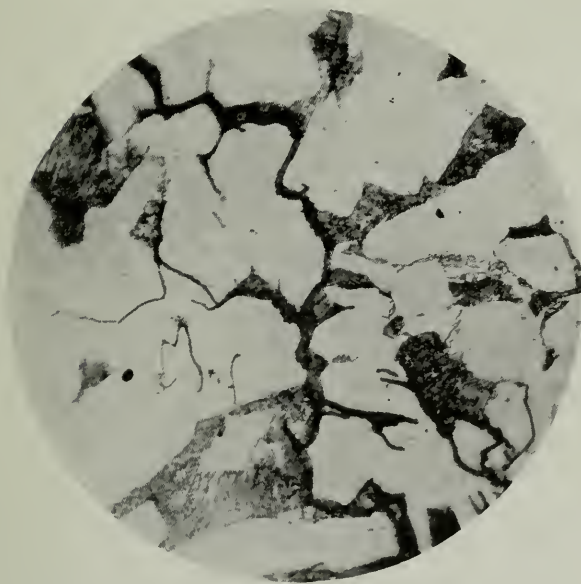
Figure 3—Embrittlement at 500 magnifications. This defect developed in a boiler under ordinary operating conditions. The characteristic intercrystalline path of the disintegration is clearly shown and is directly similar to the disintegration produced in the laboratory and shown in Figure 2.

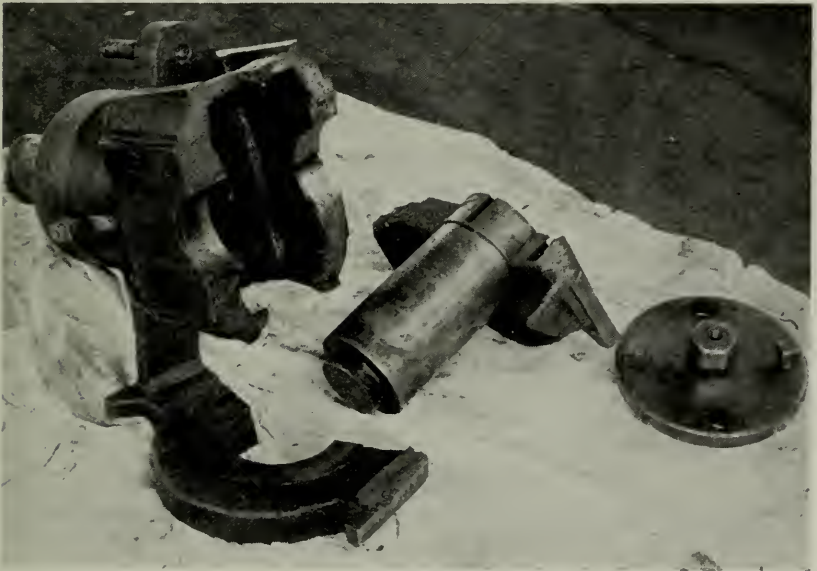
*Figure 1—Broken parts following the failure of a cast iron crosshead.
A dismantled inspection probably would have prevented this accident.*

Figure 1 illustrates a failure that occurred on a cross-compound Corliss engine having a 56" low pressure cylinder. A crack on the back side of the cast iron crosshead, on the high pressure side, progressed until the solid metal on the front side was broken. Both cylinder heads were pushed out with subsequent breaking of other reciprocating parts. The damage amounted to more than \$8,000.

The frequency of cracks in crossheads has brought a recommendation for the replacement of cast iron crossheads with crossheads of steel. The reason for this lies in certain inherent properties of the two metals. Cast iron has very little elasticity or ductility so that the shocks which inevitably occur on a reciprocating engine will more readily start a crack in a cast iron crosshead.

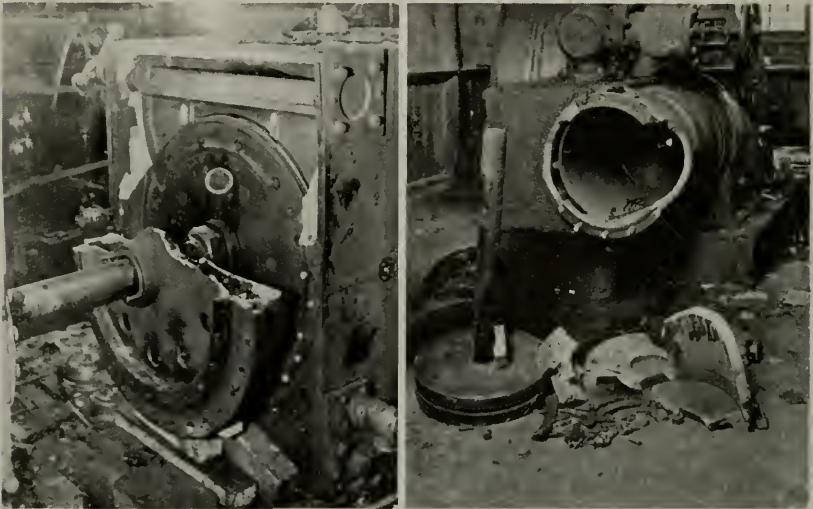
Figure 2—(Left) the result of a connecting rod crack. Figure 3—(Right) the result of a failure in the threads on the piston rod just inside the crosshead.

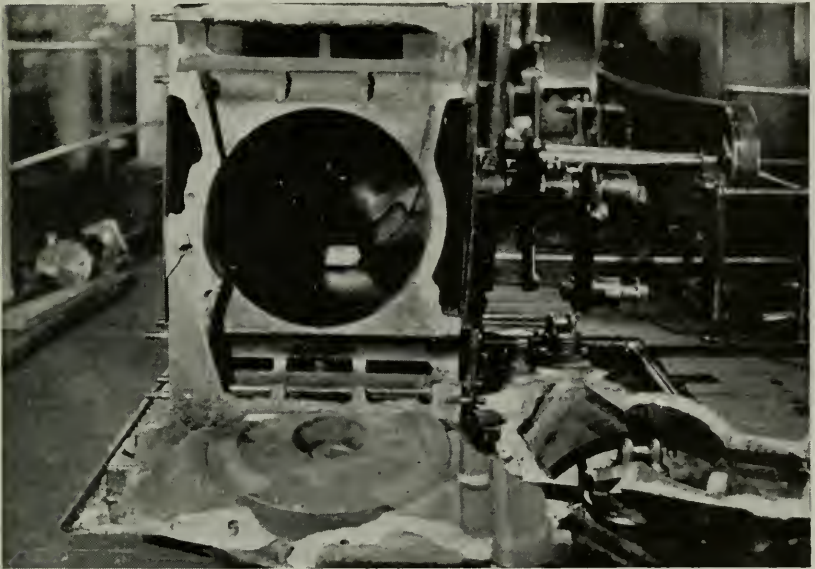
Figure 4—An accident attributed to the failure of follower bolts.

It is a rather common mistake, when piston follower bolts are screwed "home," to place excessive leverage on the wrench. This is almost certain to damage the bolts in that a small crack is started at the root of a thread or directly under the bolt heads. This practice has led to numerous serious cylinder breaks such as the one shown in Figure 4, in which a follower bolt failed from a progressive crack. Follower bolts should be regularly inspected because they are especially subject to fatigue cracks.

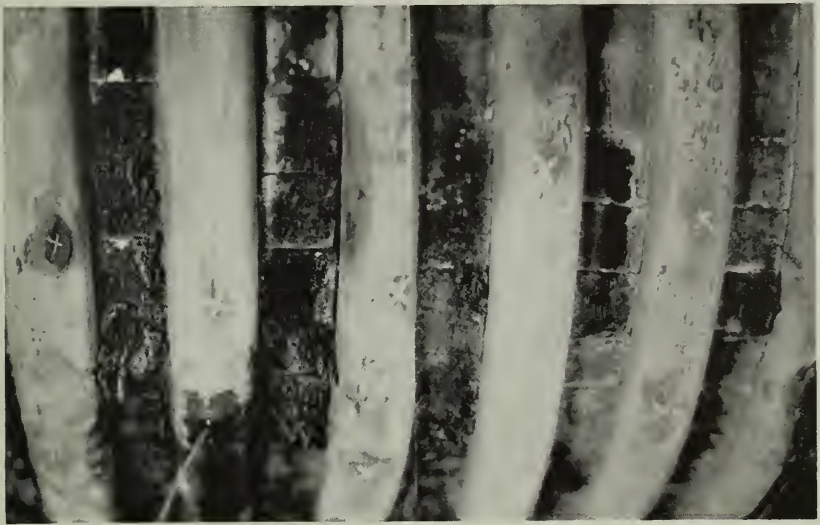
Figure 1—Deposits of scale at the bends in these tubes permitted general over-heating of an entire row. Finally one of the tubes burst (second from the left in the picture), but the warning came too late.

Figure 1 shows 6 of 17 water wall tubes in a medium sized boiler. One of the tubes has ruptured and wherever an "X" has been placed on the photograph, there, bulging and thinning has occurred. The eleven other water wall tubes were similarly damaged. Several factors may have played a part in this accident. Examination after the accident revealed the presence of $1/32''$ to $1/16''$ scale at the bend in the water wall tubes immediately above the stoker at a point of high radiant heat impingement. As an identical boiler in another part of the country operates satisfactorily scale-free, it was evident that the troublesome variable at the plant where the accident occurred was the feedwater or the feedwater treatment. In this case a condition which may have aggravated the situation was an attempt to operate at extremely high ratings by means of forced draft.

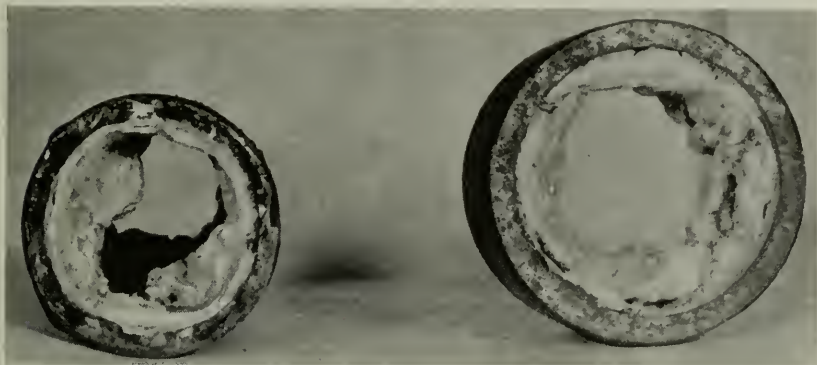
Figure 2—Superheater tubes from two boilers in widely separated parts of the country. Carry-over of solids in the steam rapidly builds up such deposits.

from affected sections of the superheaters, contain a hard scale which in some of the tubes nearly filled the steam space. These deposits occurred in boilers operated only four or five weeks and were from wet steam carried over from the drums. Impurities in the feedwater were the primary cause, but other factors such as the height of the water in the boiler, the arrangement of steam scrubbers, circulation and gas passes were contributory.

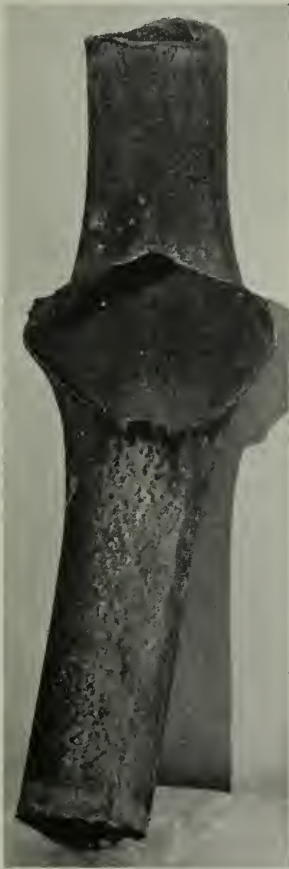
Another type of failure involving circulation and combustion difficulties is the oxidizing of the interior tube surfaces. In several recent cases a combination of high furnace temperatures and insufficient steam velocity in the tubes has resulted in the formation of magnetic oxide of iron, Fe_3O_4 . When in contact with steel at elevated temperatures, steam breaks down into hydrogen and oxygen, the latter combining with the iron to form magnetic oxide. At temperatures of 1000°F. the rate of oxidation by decomposition of the steam becomes rapid enough to be serious. Figure 3 shows a bank of tubes in which the above type of failure occurred and in which considerable quantities of the characteristic black magnetic oxide adhered to the inner surface of the

Figure 1—A close-up of the tube which signalled the difficulty illustrated in Figure 3. The rupture is 7" across.

tube in sufficient amount to bring about the tube rupture shown in Figure 4. When the bursting of one tube signalled that there was trouble in the boiler, the over-heating had progressed so far that it was necessary to remove 272 tubes. This boiler contained no oil, scale or sediment and there was no evidence of low water. It is sought to prevent a repetition of the difficulty by a change in the arrangement of baffles.

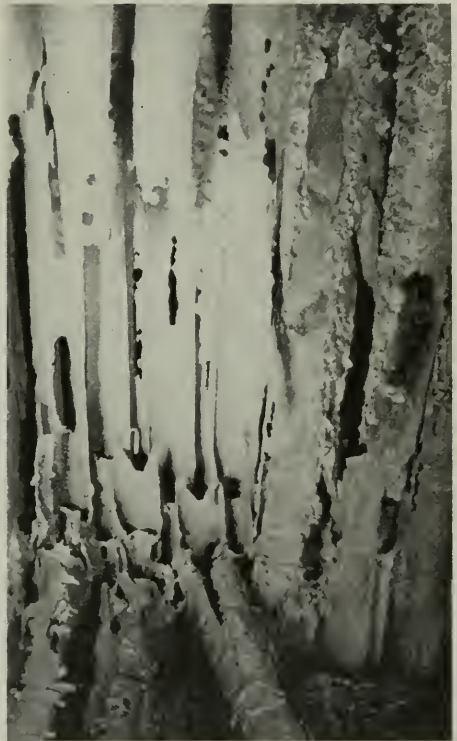
Figure 5—Rear wall of the furnace after forgotten open blow-off valves had drained the tubes.

Figure 5 illustrates the costly results of a forgotten open blow-off line with the boiler in service. Forty tubes were burned in the manner illustrated. Other instances of low water have been brought about by

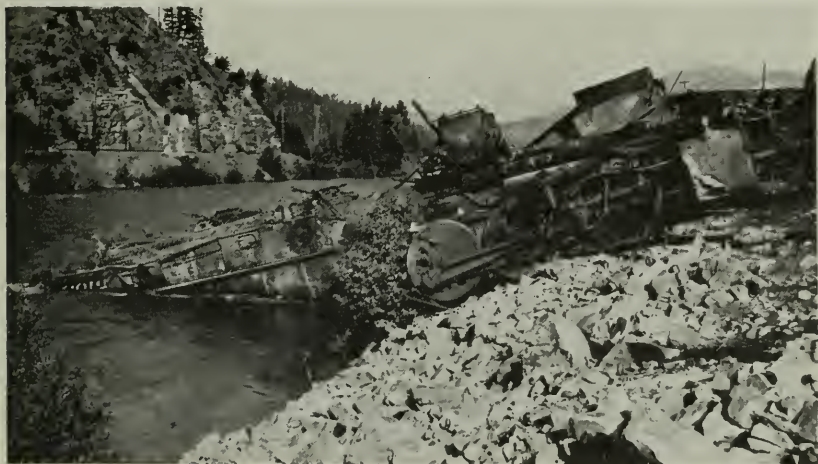
Figure 1—300 tons of locomotive toppled into a Montana river by the explosion of the boiler.

The most serious accident was the explosion at about 11:00 P. M. on July 7 of a large Z-6 type freight locomotive (4-6-6-4 wheel arrangement) in Montana. The 300-ton locomotive up-ended, fell across transmission wires and crashed into the Clark Fork River as shown in Figure 1. In addition to the engine, property damage included destruction of about 200 feet of track and 7 boxcars. The engineman, fireman, brakeman and two transients were killed and four transients were seriously injured when the sudden stop knocked them from the train or piled them up inside of cars. The fact that the accident occurred at night added to the confusion.

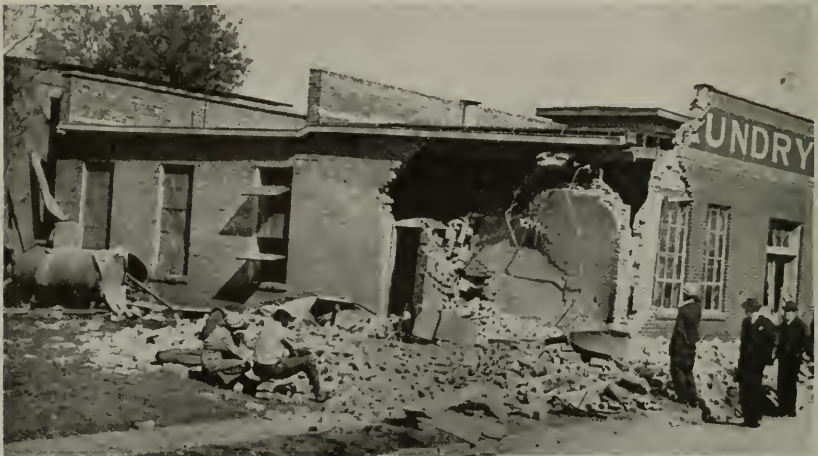
Figure 3—Damage following a boiler explosion at a laundry.

of this type of boiler to a stationary installation. The laundry where it was used was stopped because of the accident. It so happened that the boiler was hurled across the street into a cemetery instead of into the main part of the laundry, so that employes escaped injury.

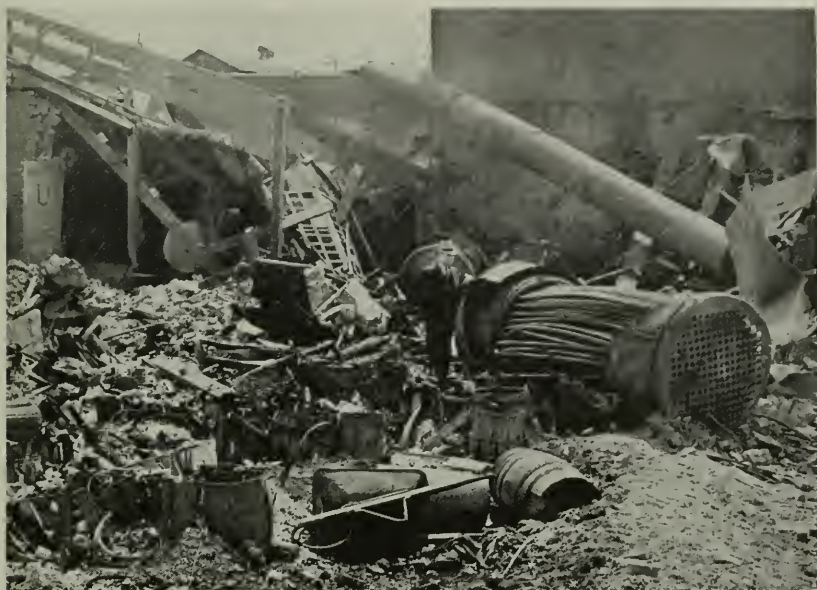
Figure 4—A building demolished by an explosion of a vertical tubular boiler which had been poorly patched by welding.

Figures 4 and 5 reveal the tragic effects of attempts to repair fire tube boilers by means of welded patches. Although welding engineering has advanced rapidly in recent years, the technique of welding boiler

patches on fire tube boilers of all types is still far from standardized. Such repairs are not yet recommended.

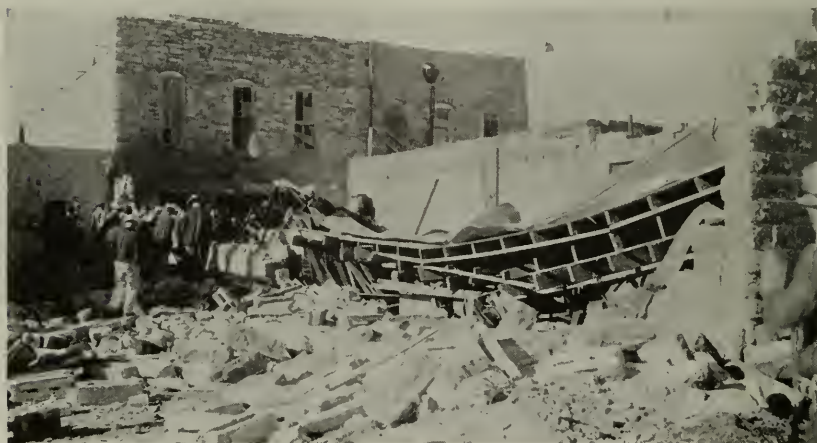
Figure 5—Wreckage after the failure of a welded patch on a Scotch-Marine type boiler.

In the case shown in Figure 5 at a Southern tailor shop, the explosion of a Scotch-Marine type boiler, which failed at a welded patch, leveled a part of the building and blew out the front of the structure. Part of the boiler went through a neighboring store and windows were broken in buildings across the street.

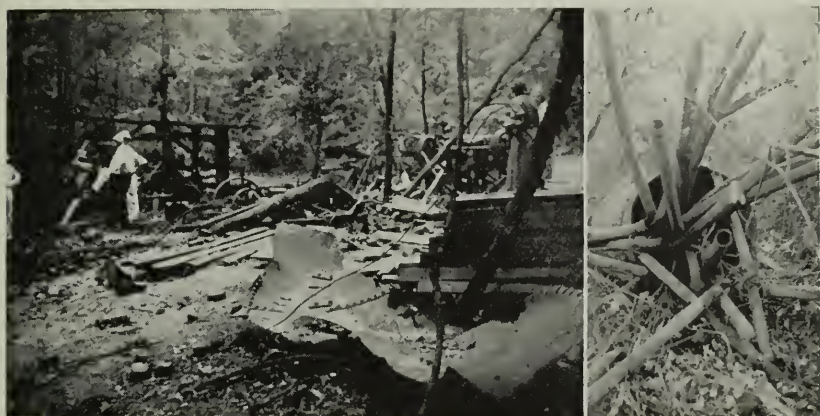
Figure 6—Left—Scene of an explosion in which two persons were killed and two injured. Right—Result of a lap seam crack. Three persons were injured by the explosion.

similarly with respect to several explosions at Southern lumber mills. Corrosion, failure to maintain relief devices properly or actual lack of them, lap seam cracks and careless operation figure in most of these explosions with their toll of deaths and injuries. Figure 6 shows two lumber mill scenes, that at the left revealing a plant demolished by a boiler explosion and that at the right showing parts of a boiler at rest in a wooded area.

The second accident demolished the mill and injured 3 men. Insurance was carried in neither case. In fact, an inspector, on visiting the second accident scene, wrote, "Had this boiler been subject to inspection, its hazardous condition would have been detected and the catastrophe averted."

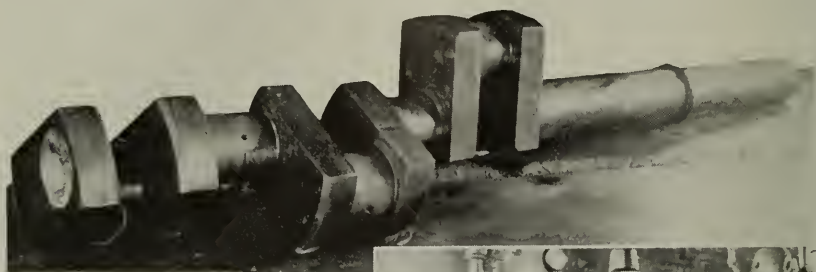
Engine Crankshaft Failure

THE breakage of this crankshaft in a 140 hp Diesel engine used at a New England ice plant was attributed chiefly to torsional vibration. Starting around the circumference of the shaft under a fillet at a web, cracks progressed into the shaft and so weakened it that it broke after about one year's service.

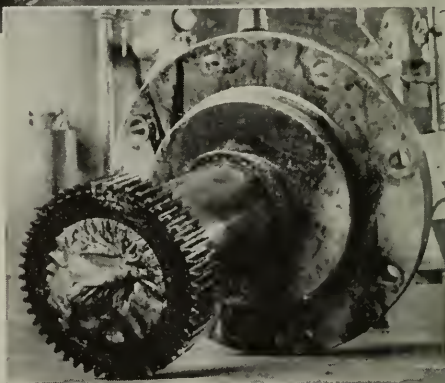
The failure, which was roughly conical in shape, is typical of torsional vibration breaks with their radial failure lines. In this installation the timing gear was immediately adjacent to the break. Beyond it (to the left in the top picture) was a main bearing and outside this a 5,700 lb flywheel. It is felt that the weight of the wheel added to the stress at the point of failure and hastened the break. The direct damage loss, which amounted to nearly \$4,000, was covered by Hartford Steam Boiler.

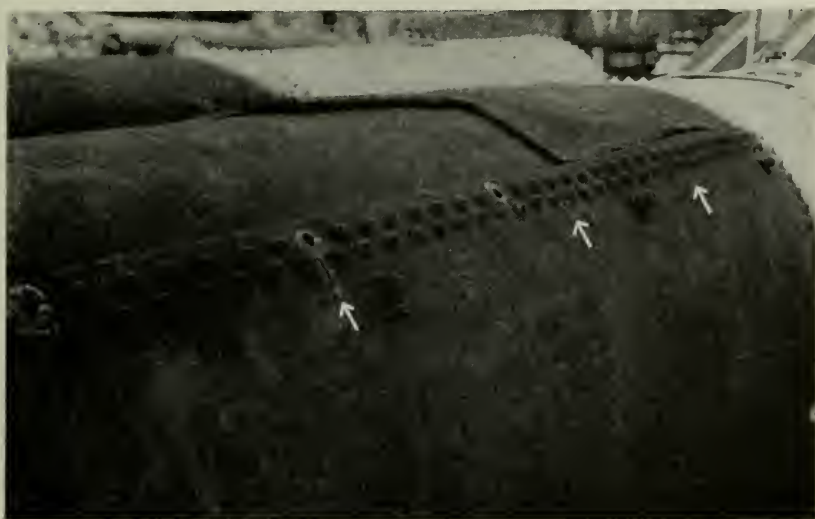
Figure 4—Failure in Boiler No. 3 after the hydrostatic test. The break at the right is clearly from embrittlement. The continuation of the failure across the boiler is a stress tear similar to that in Boiler No. 2, which exploded under steam pressure. The lap seam crack slots are indicated by the arrows.

rivet hole to rivet hole for a distance of 45 in. from the third girth seam as shown in Figure 4. At that point the path of the break changed to a girthwise direction with another change to a longitudinal direction when the top of the boiler was reached. There was a third change to a path diagonal with the girth seam and longitudinal seam. The entire length of the rupture was nearly 100 in.

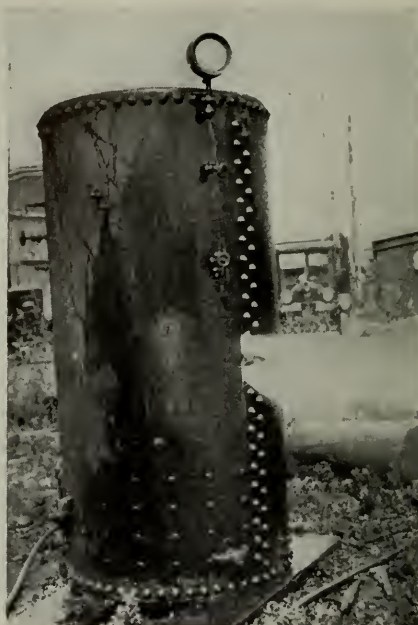
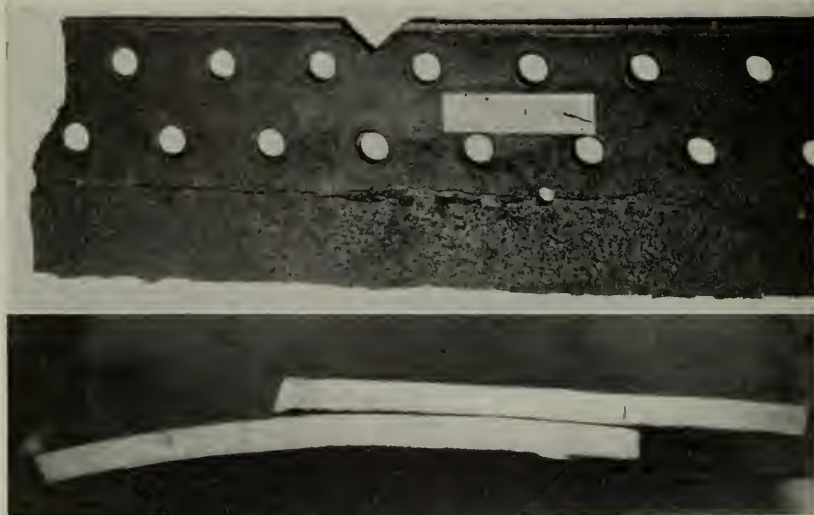
If a lap seam crack had developed to a depth of $\frac{1}{8}$ in. from the inside surface of the plate, where such a crack normally develops on a line close to the edge of the rivet heads, as shown in Figure 5, some of the slots would have reached the crack and permitted leakage when the hydrostatic test was applied. Such leakage did not occur.

Figure 5—Top and end views of a typical lap seam crack. Notice that this defect is on the opposite side of the seam from the failures shown in Figures 1, 3, and 4. The picture at the upper right shows a lap seam failure under hydrostatic test.

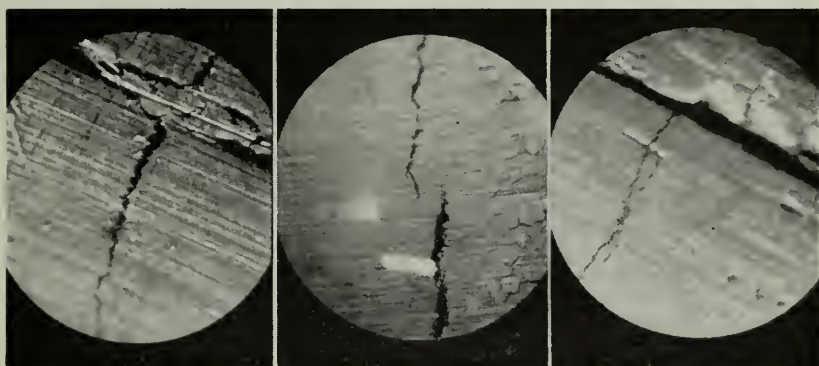
Figure 6—Embrittlement defects from Boilers Nos. 1, 2 and 3 (from left to right) as seen in rivet holes through the Hartford Steam Boiler magniscope.

Many of the defects were then visible to the naked eye. Photographs of these defects at 40 magnifications in boilers Nos. 1, 2 and 3 are shown in Figure 6. In Figure 7 is shown a defect of the same sort at 225 magnifications as photographed at the University of Illinois laboratories during recent embrittlement research. In Figure 8 is a photograph at 500 magnifications of an embrittlement defect from the No. 1 boiler.

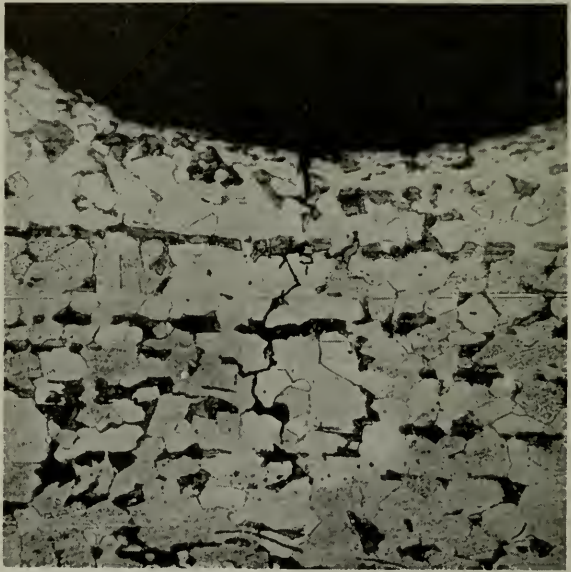
Figure 7—Embrittlement disintegration at 225 magnifications as produced in the laboratory.

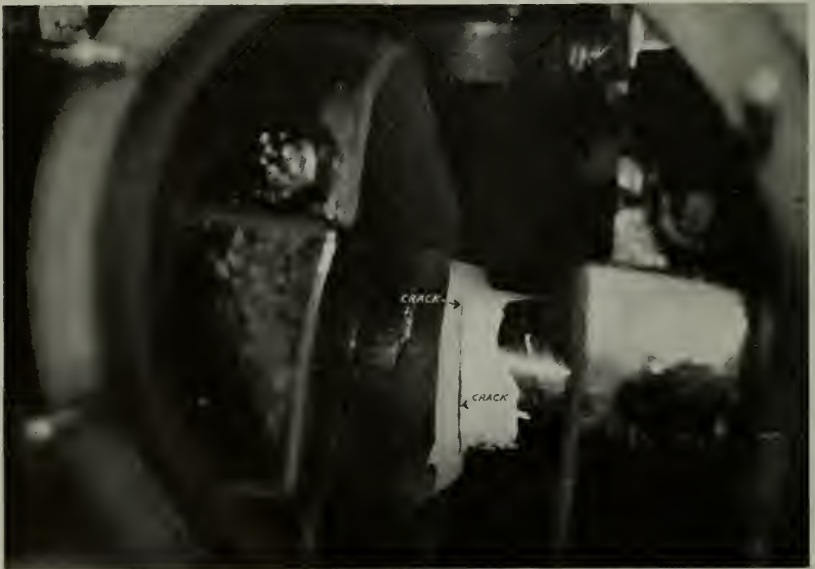
Figure 1—Crack in the fillet of the crankweb and crankpin of a Diesel engine. It was located by means of the whitewash test without dismantling the engine.

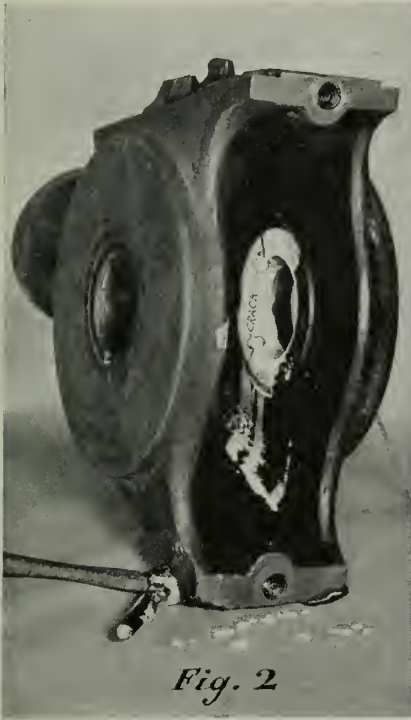
Fig. 2

Figures 2 and 2A—Whitewash test showing crack across one of the eyes on the inside of a crosshead.

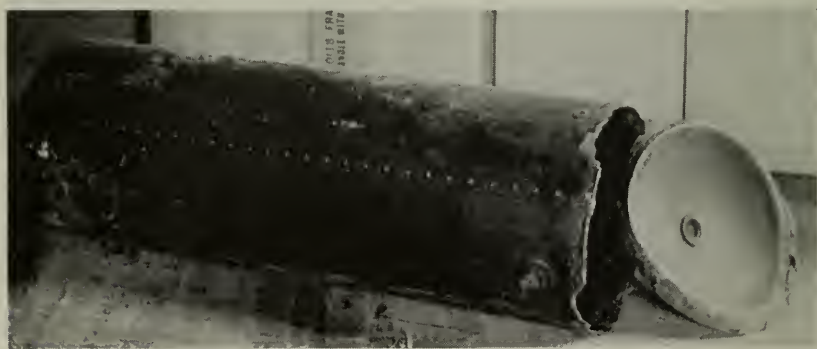
Figure 2—Reversed minus head An improperly adjusted safety valve permitted the building up of excessive pressure.

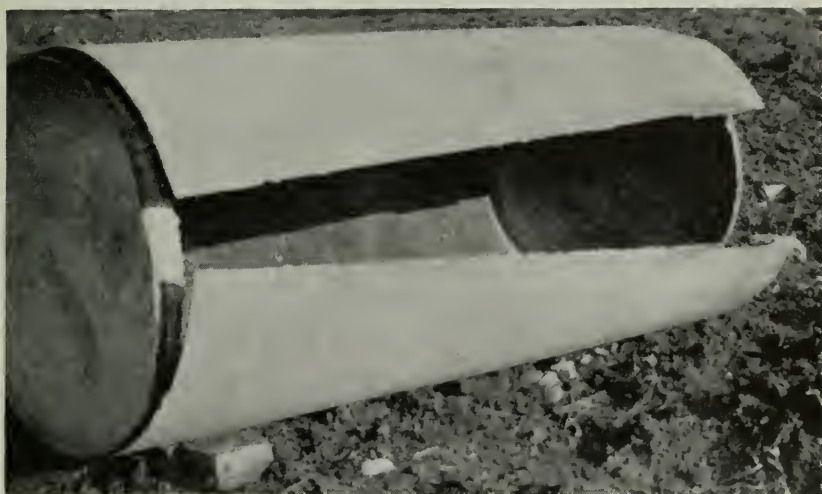
Figure 3—Failure of the longitudinal seam. Faulty welding was given as the cause of this accident.

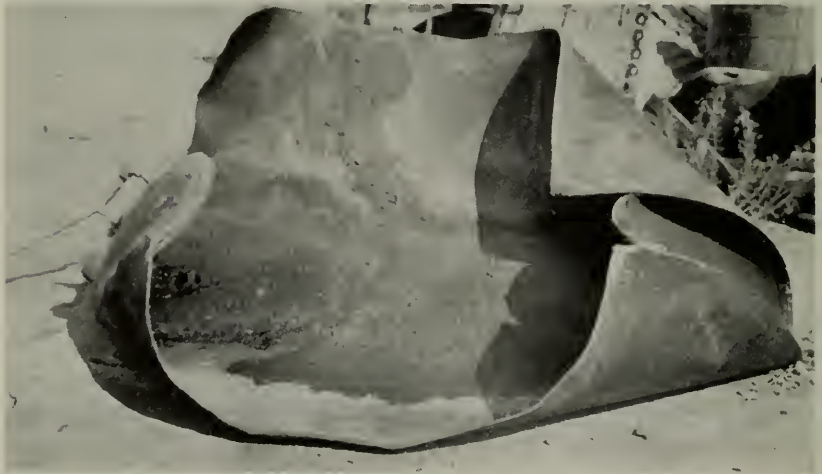
The causes of these accidents were much the same as those for air tanks. One failure (See Figure 5) occurred because of progressive cracks in the crimped edges of the shell, five were over-pressure failures such as that shown in Figure 6, one resulted from a lap seam crack and the eighth because the minus head was made of steel which was too light for the pressures carried. In four of the five accidents

Figure 6—Hydro-pneumatic tank which ripped open because of over-pressure.

caused by over-pressure the failure was attributed to non-operation of pressure relief valves or electrical cutoffs to the motor or both. The fifth tank was equipped with no relief devices whatsoever.

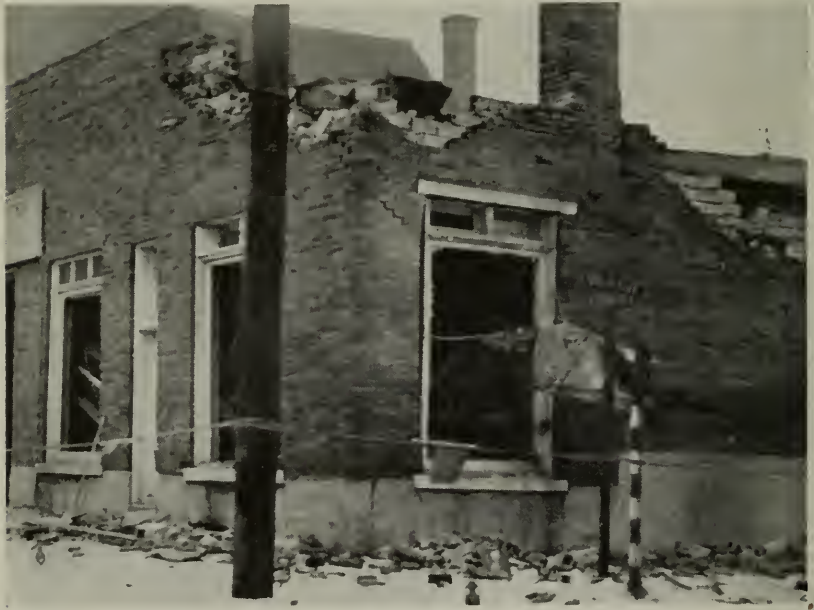
THE explosion in January of a hot water storage tank mounted in a basement room of a Michigan garage resulted in a property loss estimated at \$5,000. The tank was beneath an office, which was virtually demolished by the blast. Cement floors were ripped open and brick walls were either blown out or weakened beyond repair for

Figure 1—Damage to the exterior of a large garage because of a hot water tank explosion.

a distance of 30 feet each way from the corner of the building, as shown in Figure 1.
