The Locomotive

THE HARTFORD STEAM BOILER
INSPECTION AND INSURANCE CO.

INDEX TO VOL. 42—1938-1939

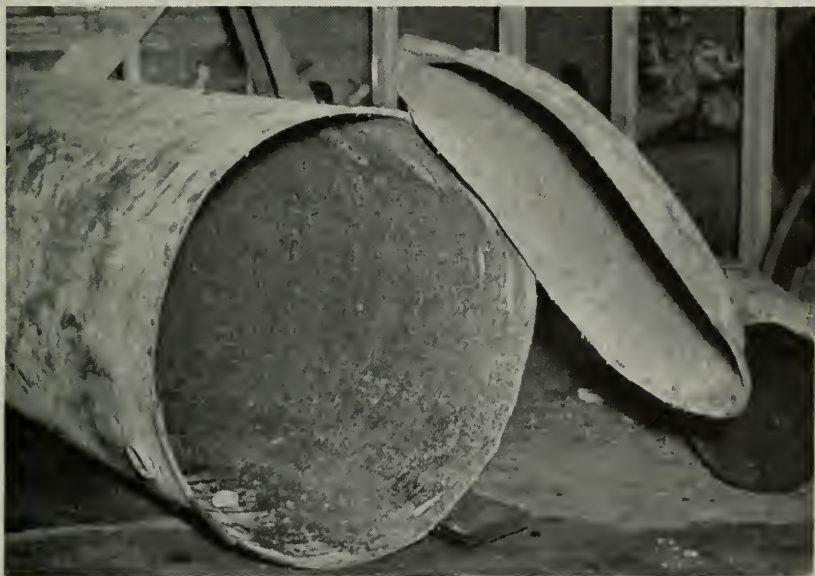
The boiler which supplied water to the tank was blown from its base and a steel heating boiler damaged. The brick chimney, part of which is shown in the photograph, was so damaged that it had to be torn down. As the safety valve opened readily at 100 lb when tested after the accident, it was considered that the most likely cause of the explosion was a minus head of a construction which was inadequate for the pressure carried. This head reversed as shown in Figure 2.

that the expansion of water due to heat in a system from which no water is being used increases the pressure rapidly, provided there is a check valve in the inlet pipe, as there was in this case. This increase in pressure can set up high stresses in the tank, and if during this process enough heat is applied to raise the temperature considerably above the atmospheric boiling point, conditions are ripe for a violent explosion in case a rupture of any part of the shell occurs.

Figure 2—The tank which failed. The reversed minus head is clearly shown.

the hot water supply boiler did not permit a rapid enough lowering of the temperature and pressure before the tank failed. Although the safety valve tested satisfactorily after the accident, it may not have functioned fully before because it might have been partially stuck. Stuck valves have often been jarred loose by the force of an explosion.

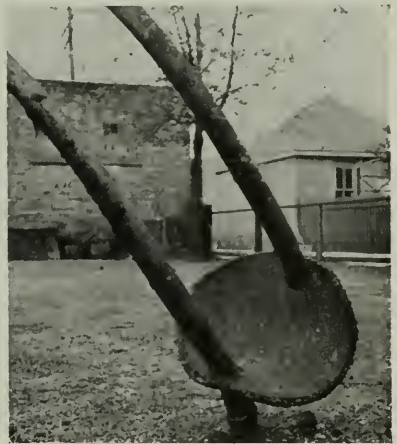
Figure 1—Head from a refrigerating vessel which failed at 150 lb pressure when the welded head seam gave way.

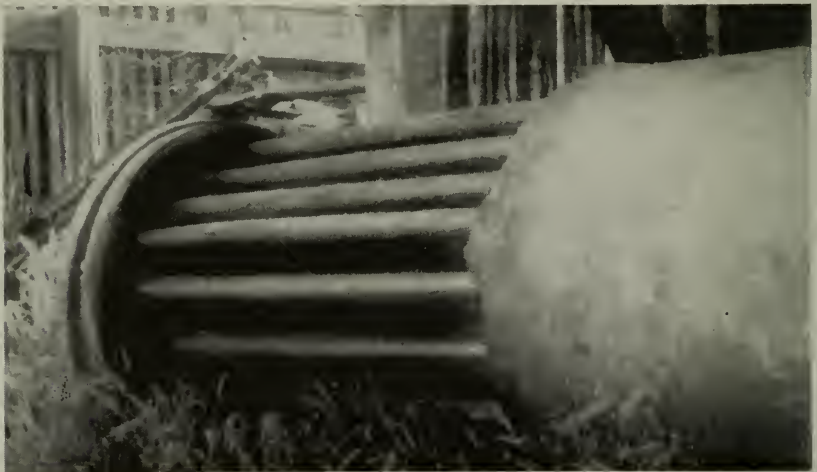
Figure 2—Condenser which exploded when poor girth seam welding permitted a 34" piece of plate to tear out.

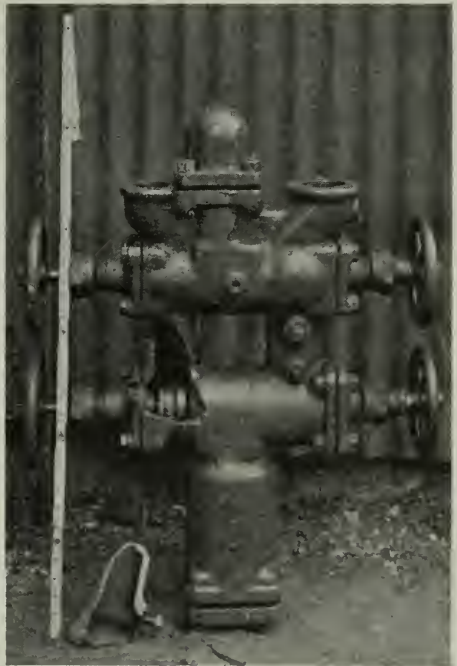
Figure 4—Ammonia compressor manifold which exploded because of an excess of pressure within it. The failure led to the death of an engineer, who was drenched with the refrigerant.

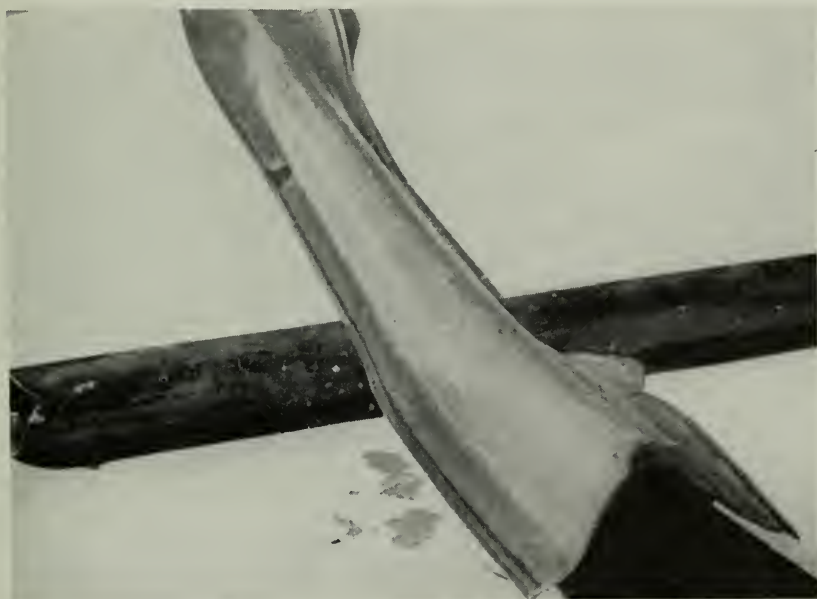
Mistakes in operation sometimes play an important part in accidents. Figure 5 shows a piece of stainless steel pipe which blew open for a distance of 67 inches. The pipe was a part of a cooling coil installation in a brewery, the beer being cooled by running it over the coil. Contrary to orders, a workman had used boiling water to wash this piping while it was under pressure with the system charged, a procedure which is believed to have cracked the piping along a special fin. Its

Figure 5—Stainless steel ammonia piping which tore open in a brewery.

subsequent failure released a large amount of ammonia and shut down the plant.

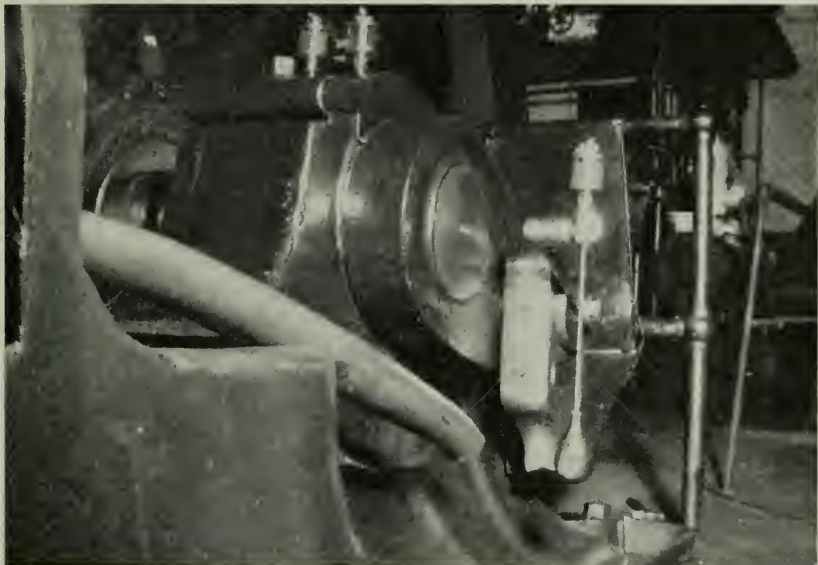
Figure 6—Broken connecting rod of a 150 lb ammonia compressor. The accident was attributed to an attempt to start the compressor 3 times in spite of burned out fuses. The discharge valve had not been opened.

through: Periodic dismantled inspection to detect incipient cracks and other faulty conditions such as valve troubles, adequate purging of non-condensable gases, proper draining of lines and proper charging to eliminate slugs of liquid, proper attention to compressor cooling water and compressor lubrication, opening of discharge valves on starting, and not using welding for repair purposes when there is a likelihood that that repair may set up stresses which will lead to cracks.

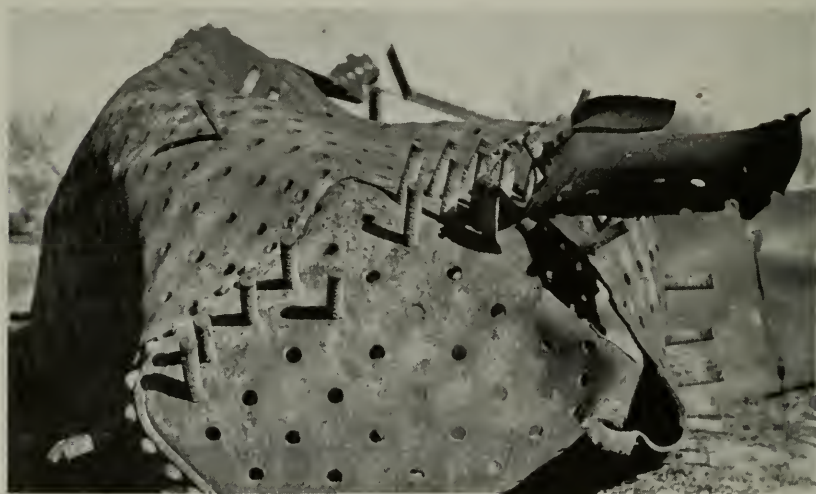
Figure 1—Firebox of a locomotive type boiler in an oil field after its explosion due to low water and over-heating.

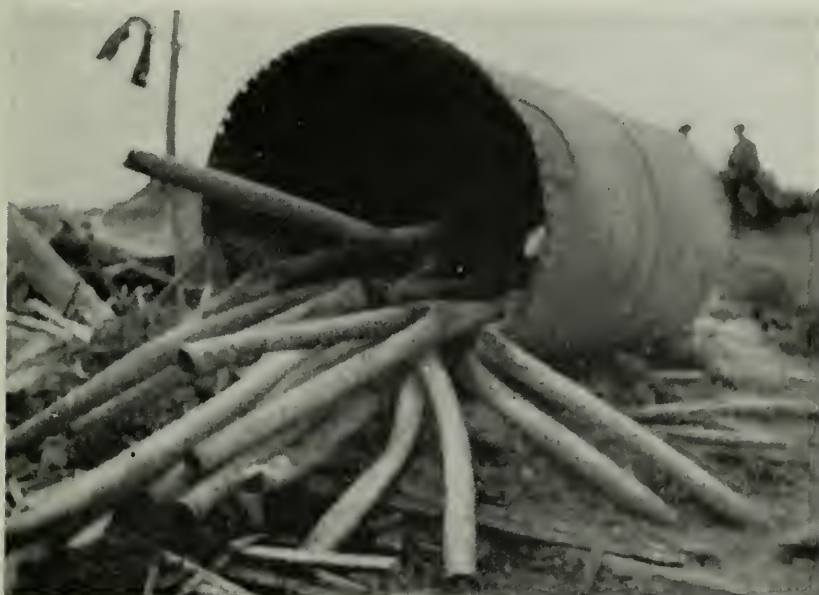
Figure 2—Two courses of a three-course horizontal tubular boiler which exploded because of corrosion.

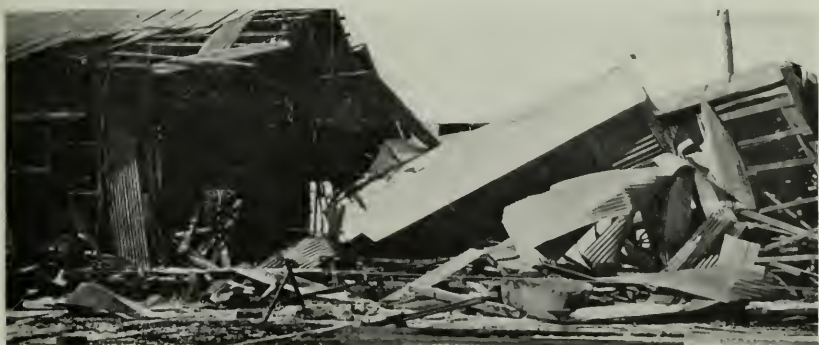
Figure 3—Wreckage following the explosion of a horizontal tubular boiler in New Mexico.

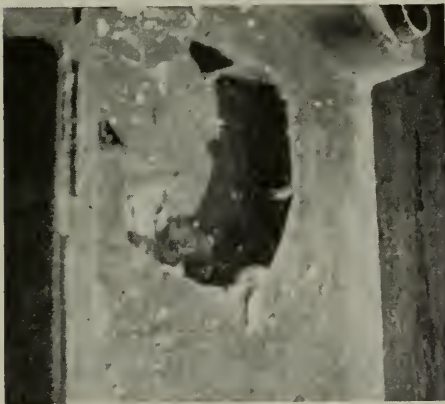
Four hundred fifty persons walked in orderly fashion from an Illinois theater after a cast iron hot water heating boiler exploded beneath the stage. Although the stage was wrecked and some of the debris was blown into the seating floor of the theater, all but two women escaped, and they suffered but minor injuries. The boiler exploded, it was said, because of the non-operation of the relief valve. A piece was blown out of the boiler as shown in Figure 4 and sections were torn apart. It was estimated that the damage was approximately \$4,000.

Figure 4—Failing section of a hot water heating boiler in a theater.

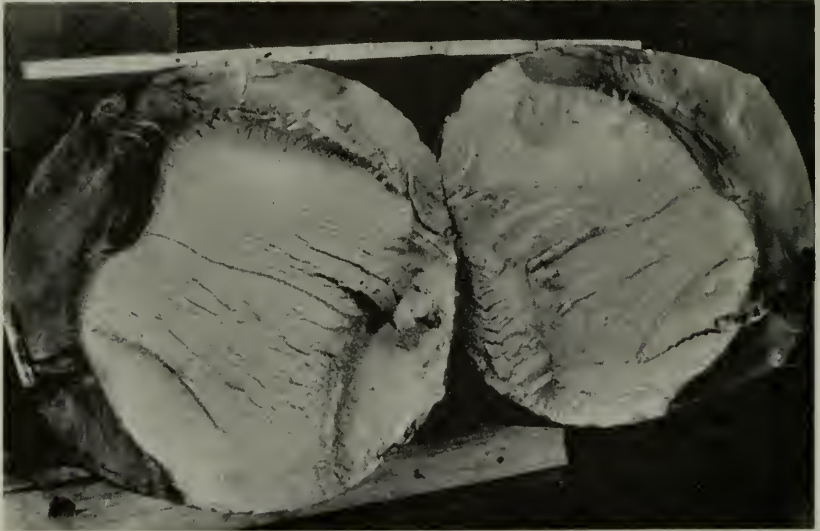
"Yes, the size doesn't make much difference. Notice this picture showing the shaft in two pieces. When Benson found the crack it was

"The darker metal shows how far the crack has progressed."

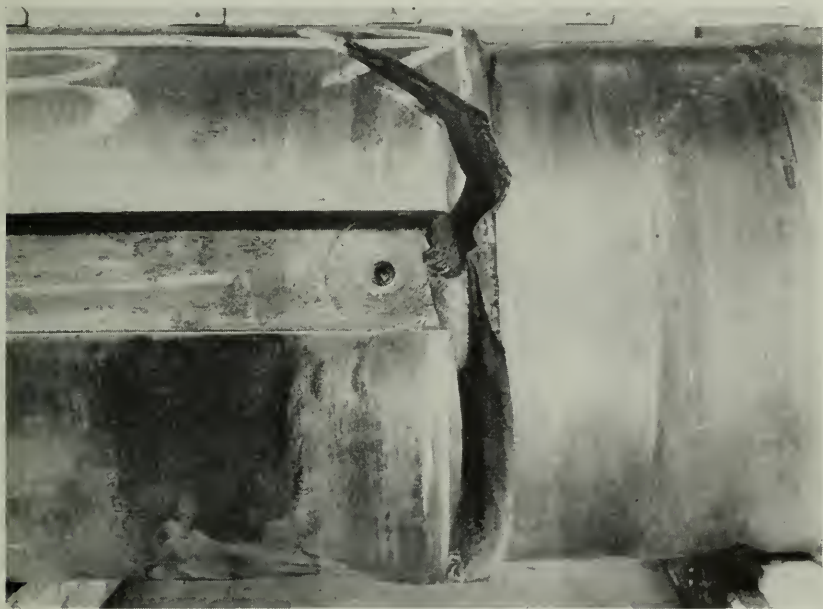
"The two ends of the shaft are held together."

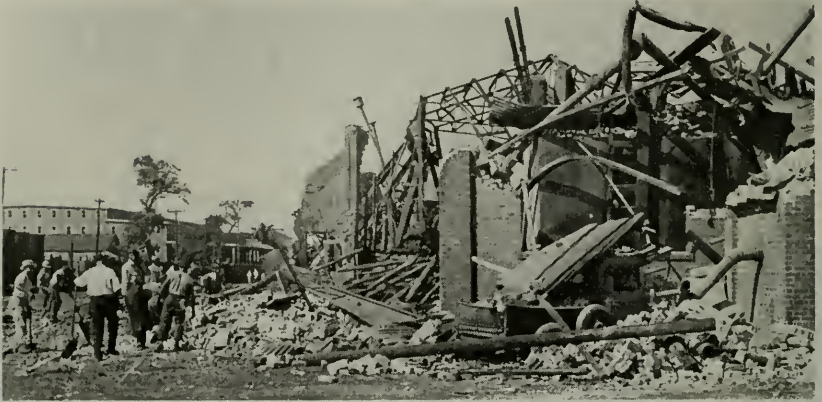
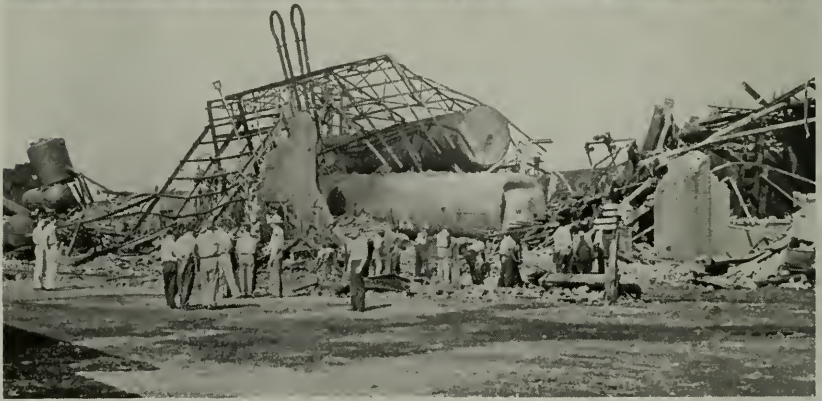
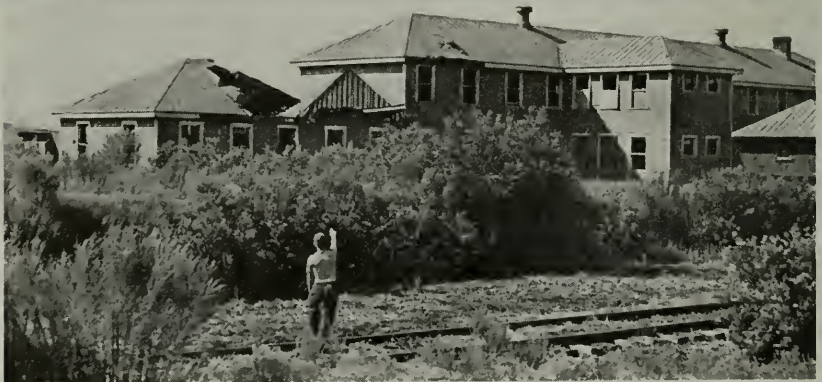
Figure 1—Top page 226—Damage after the explosions of a creosote tank and a water tube boiler at a southern plant.

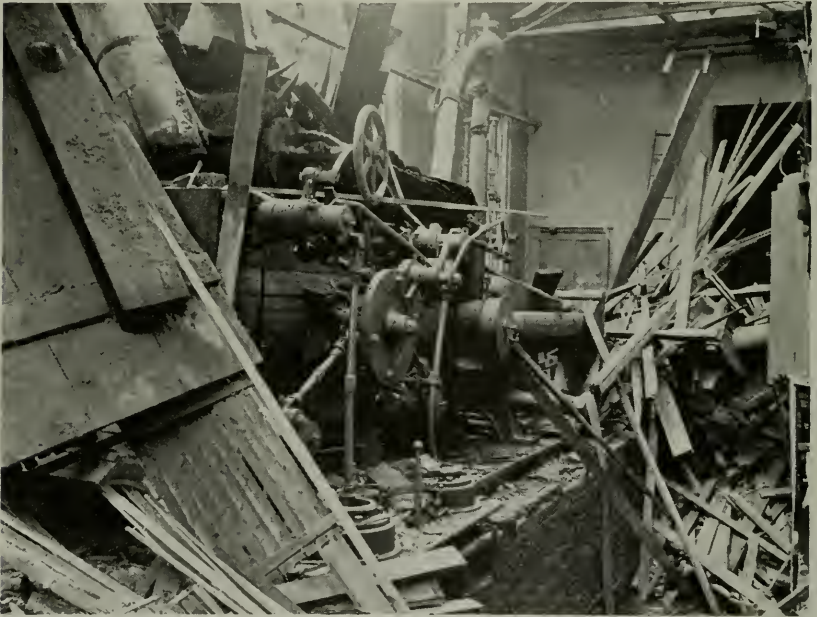
A FLYWHEEL explosion at an eastern manufacturing plant caused the havoc presented in the accompanying photograph.

Parts of the wheel went through the roof of the engine room, causing it to fall, and also crashed through an adjacent roof into a room where about 100 women were working. In the ensuing confusion, according to a newspaper account, two of the women were injured when

they fell to the floor. An operator who was near the engine was killed. The steam engine was wrecked, and several other machines were damaged because of the over-speed. To reassemble the control devices following an accident of this sort in a search for the cause of the accident is not easy. In this case two factors probably contributed to the failure. One was a breaking governor belt and the other the fact that the safety cams were undoubtedly out of adjustment because, although they were set at the farthest point of adjustment away from the latch arm, they did not prevent the opening of the steam valves with the governor in its lowest position, as they should have done. There was no insurance on the engine.

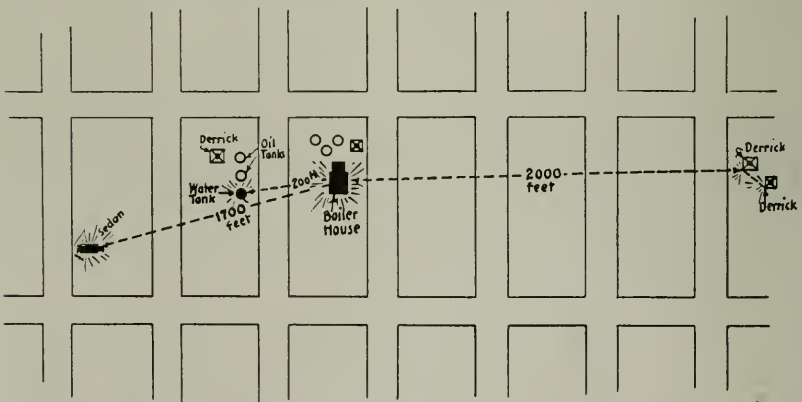
This diagram represents several sparsely settled city blocks in a western town where oil drilling operations are under way. The explosion of a horizontal tubular boiler early in the year demonstrated more than the terrible force of such failures; it gave evidence of uncanny marksmanship. About 1700 feet away was a small automobile. A piece of the boiler tubing crashed into it. About 2000 feet in the opposite direction was an oil derrick. The door of the boiler not only hit it but ricocheted into another derrick nearby. About 200 feet away was a water tank, an easier mark, into which smashed the shell of the boiler, crushing the tank nicely. A partially wrecked boiler house, an automobile buried in debris beside it, and bricks scattered like bird shot in all directions were other details. The accident was attributed to mud choked safety valves and over-pressure.

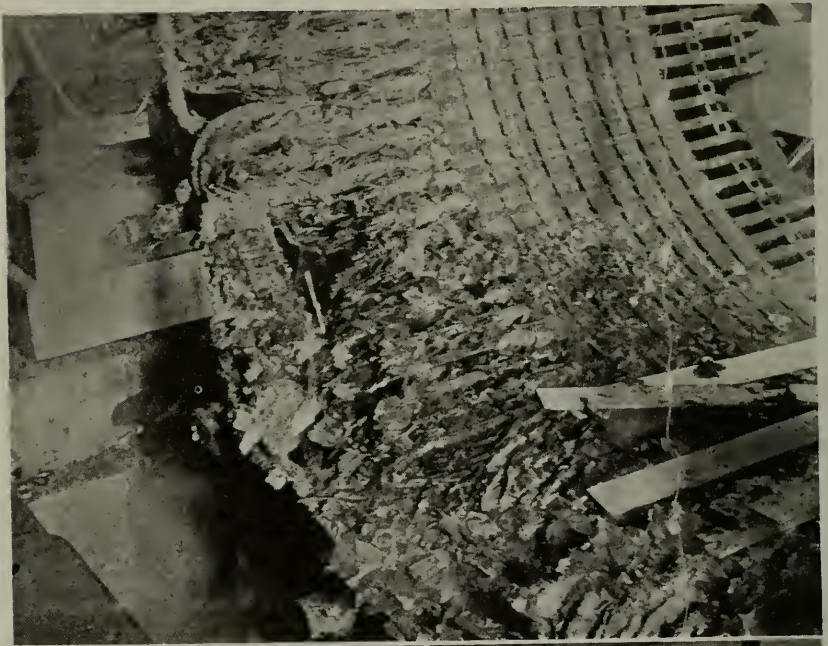
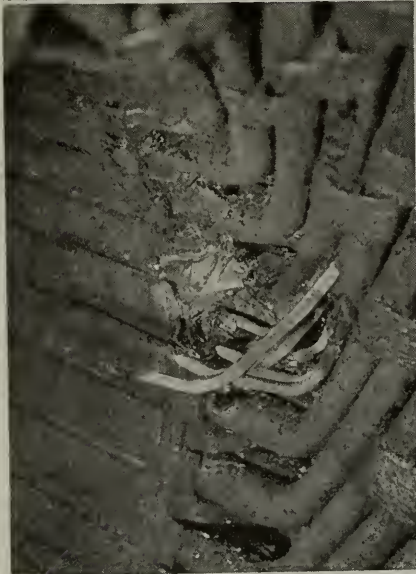
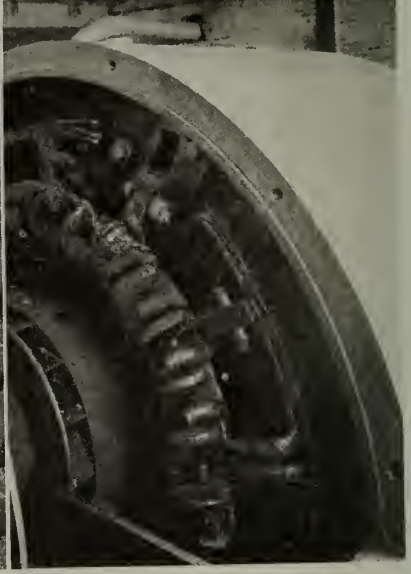
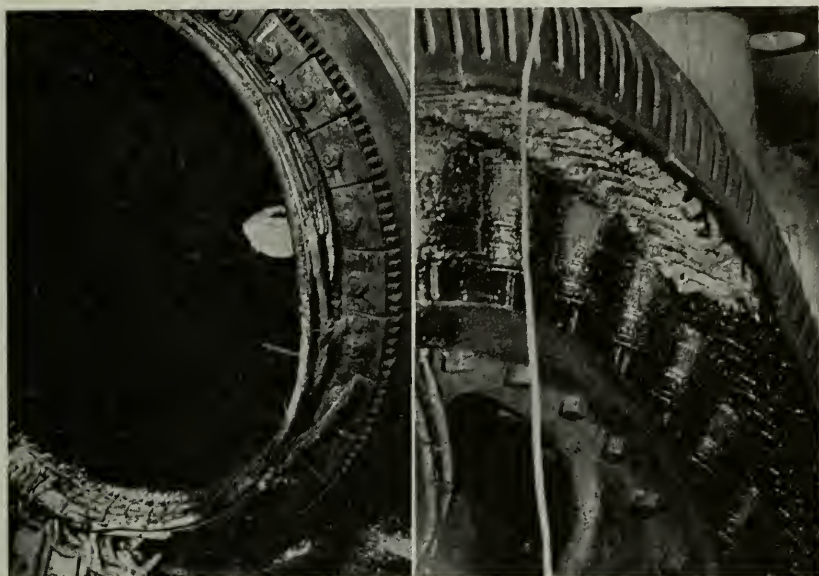
Top, Page 2—Stator burnout on starting. The machine is a 2500 kva AC generator, part of a frequency-changer set, at a county utility. Bottom, Page 2—Two failures of turbo-generators because of lightning. The picture at the left shows a 3,000 kw machine at an oil refinery and that at the right a 750 kw generator at a municipal utility. Above—Left—A high frequency 1125 kw motor-driven alternator used at a boiler factory. Half of the coils were damaged when insulation failed on end turns. Right—Short circuiting of turns in one coil brought damage to about 60 other coils of a 168 kw generator driven by a steam engine at a manufacturing plant.

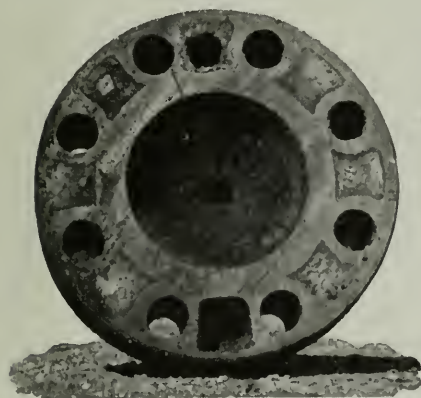
Figure 1—Diesel cylinder-head completely choked with scale. The faulty water condition in connection with an open cooling system caused repeated failure of the cylinder-heads on this engine.

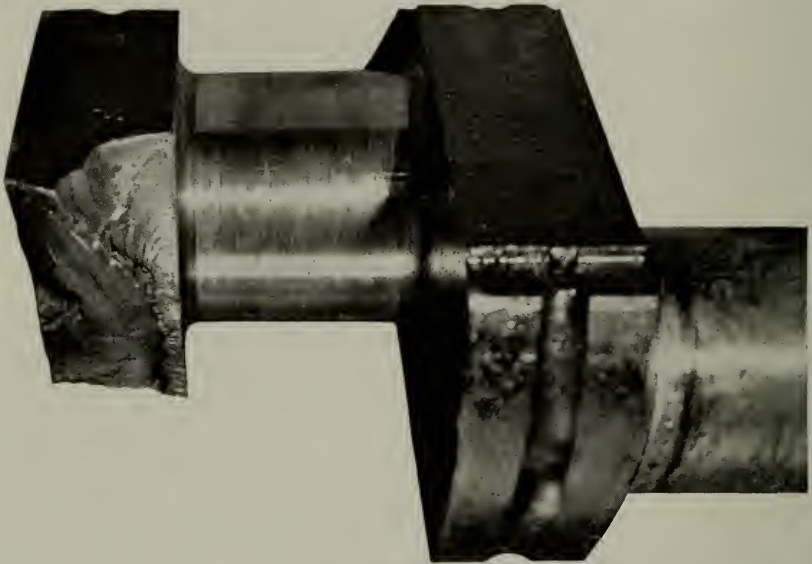
Figure 2—Crank distortion caused by bearing misalignment resulted in the breaking of this crankshaft. The fatigue cracks started in the fillet on the journal side of the crankweb.

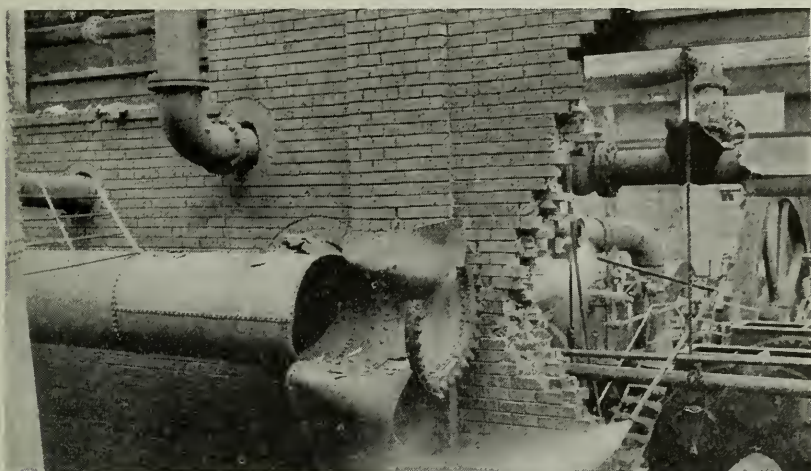
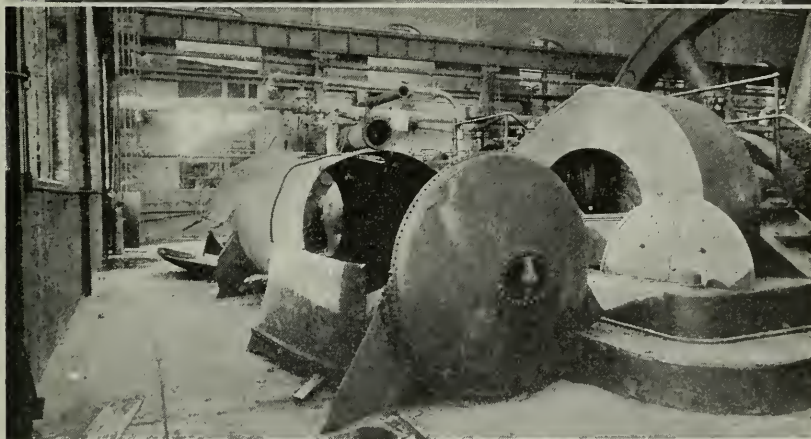
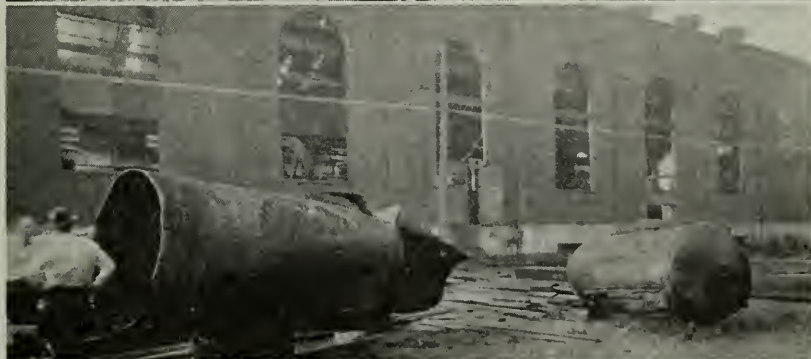
Results of a combustion explosion in an air line and two large air receivers.

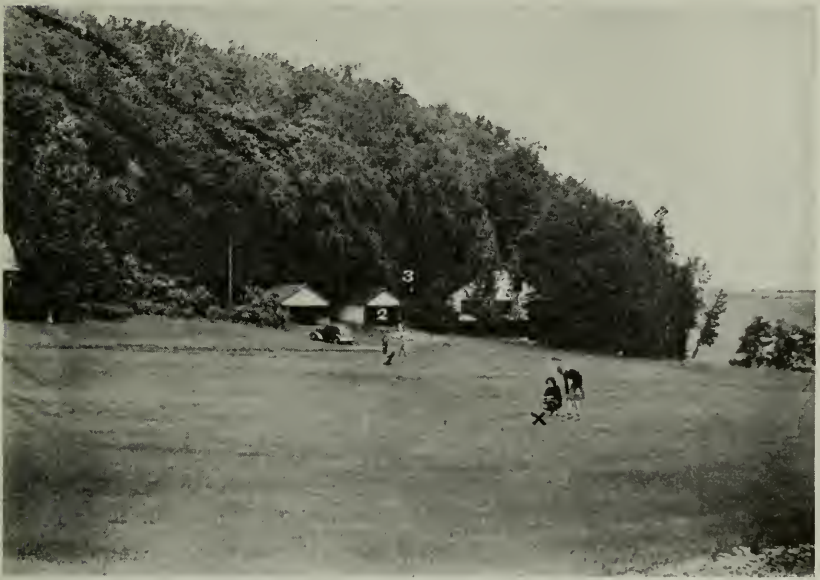
This pleasant spot on the shore of Lake Champlain witnessed the deaths of two men and a young girl one evening last summer. A hot water tank exploded in a small building at the location marked "3," struck the two men who were about 15 feet away, caromed into the garage "2," struck the girl at "1" and finally came to rest at "X" after traveling 750 feet. The accident illustrates the tremendous force inherent in hot water under pressure and above the atmospheric boiling point. In some way the building housing the tank had caught fire. The heat from this was believed to have brought about the explosion as it rapidly raised the pressure in the tank to a point which it could not withstand.

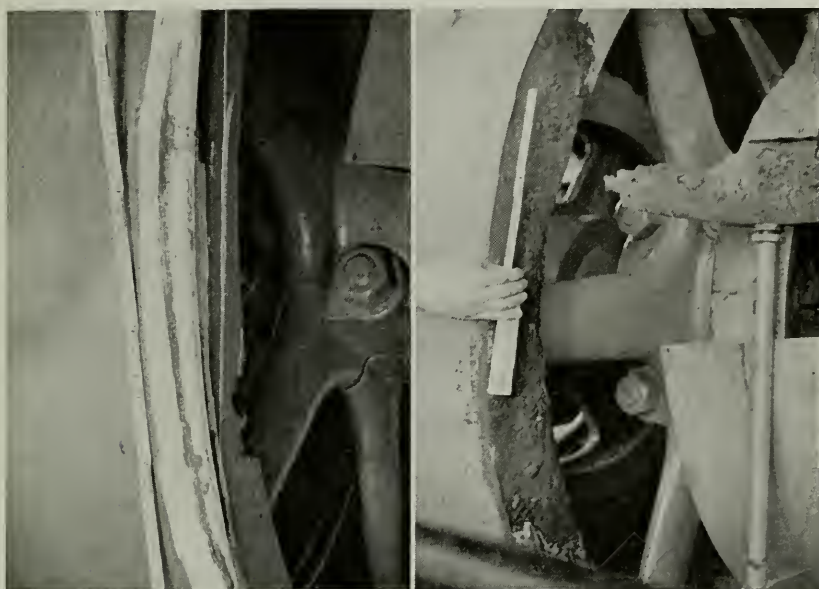
The illustrations show a casting defect in a 40-year-old flywheel. The engine on which this wheel was used had not been in operation for two years as it was kept as a stand-by for emergency service. It was given a test run each week.

The presence of the circumferential crack was suspected, and a whitewash test applied with the results shown in the photographs. By means of a few well-directed hammer blows large slabs of cast iron came off the wheel rim. Apparently, the defect was attributable to faulty casting practice at the time the wheel was poured.

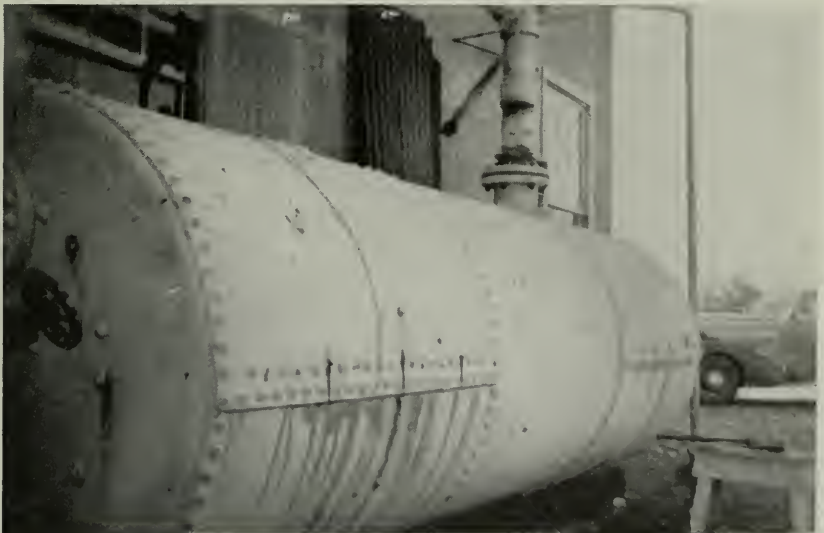
AN explosion of a large air tank was undoubtedly prevented when longitudinal cracks were discovered recently by cutting slots in one of the seams. As this tank was of lap riveted construction the inspector suspected a crack when he found leakage, although slight, along the caulking edge of a seam that showed signs of repeated caulking. On his recommendation, the seam was slotted at several points and leakage through these slots with the vessel under hydrostatic pressure showed definitely that a crack had developed in the plate forming the outside lap of the seam. As is usual with this type of crack, it started from the hidden side of the plate and could not be seen. The slots, made at right angles to the direction of the probable cracks, are shown in the accompanying photograph of the tank.

Possible explosion of this air tank was averted when hidden cracks were found by slotting the seams.

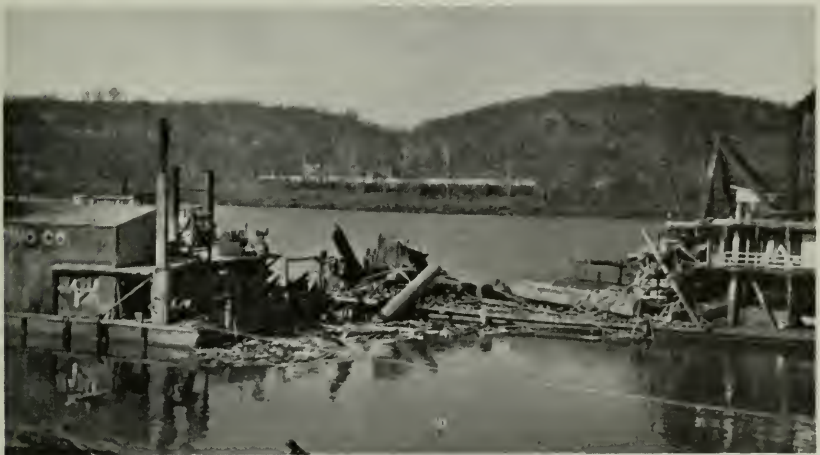
The power plant for the steamboat consisted of three marine-type fire-tube boilers, lap-seam construction, with maximum approved pressure of 240 lb per sq in. According to the reports, two of the boilers exploded while the pressure was only 150 lb. The boat had been tied to the dock for washing out the boilers and steam was being raised again when the accident occurred.

The exact cause of the explosion was not stated. According to the news accounts, new shell sheets had been installed on the boilers within three years—some in 1937 and the remainder in 1939.

View of the wreckage following a boiler explosion in an Ohio river steamboat.

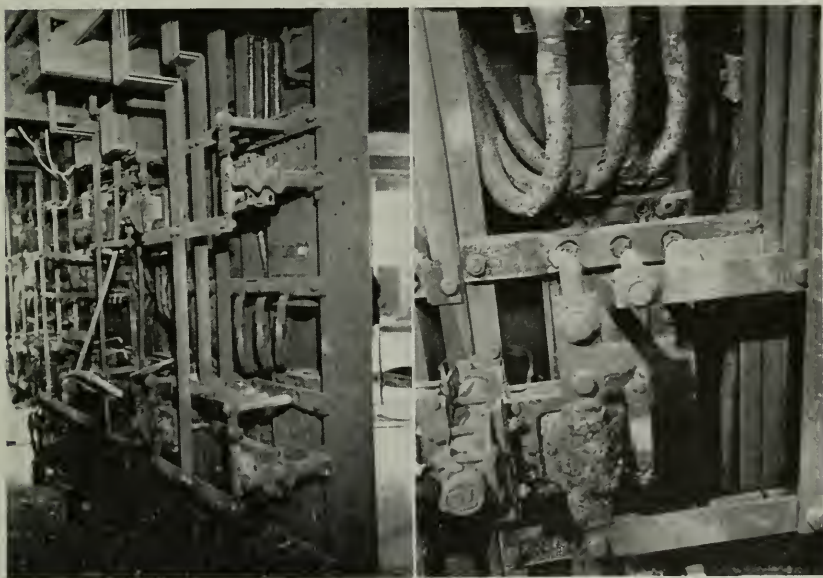
NEARLY all the electrical equipment on a seven-panel switchboard in a textile mill was badly damaged recently by what appeared to be a phase to phase short circuit. The ensuing fire destroyed cable insulation, wiring and instrument transformers, and only the copper bus bars escaped damage. In use only a few months, the switchboard had cost about \$7,000. The total cost of repairs and replacement of parts was approximately \$5,000.

Examination of the electrical equipment after the accident showed that there had been arcing across the studs of circuit breakers on four of the seven panels. The remainder of the damage appeared to have been caused by the ensuing fire and intense heat from the short circuits. One of the two pictures on this page shows some of the burned insulation and damage to the back of the switchboard, while the other is a close-up view of one section showing the studs burned through at one

Left—Back of a seven-panel switchboard badly damaged by phase to phase short circuit and by ensuing fire.

Right—The connecting studs burned through at one circuit breaker, and damage to a current transformer and to cables is clearly shown in this close-up view of one section of the same switchboard.

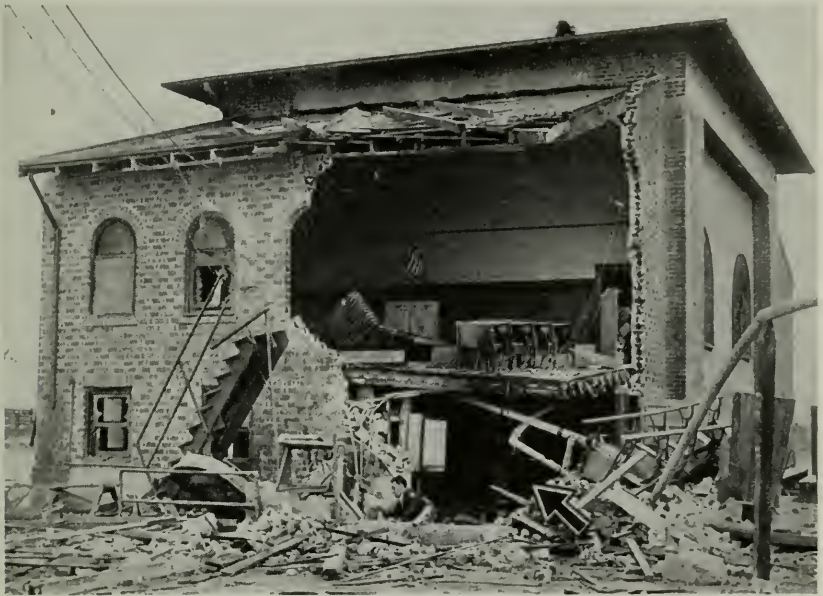
The damage to this school was caused by an explosion of a hot water tank.

The tank, 3' in diameter by 6' long, was constructed with $\frac{3}{8}$ " saucer heads welded to the shell, without any skirt or flange, and with the longitudinal lap seam of the $\frac{1}{4}$ " shell tack-riveted and fillet-welded. Both the tank and the cast iron hot water supply boiler to which it was connected normally operated under a pressure of 55 lb per sq in. A thermostat, set for a maximum temperature of 160°F, and a pressure relief valve were provided to control the temperature and guard against over-pressure.

After the accident it was found that the tank had failed at the welded joint of one head and that there was very poor fusion of the metal in this joint. While the poor quality of the welding and the design of the vessel affected its strength, the violence of the explosion

indicates the probability that failure of the thermostat control permitted the temperature of the water in the tank to reach the boiling point corresponding to the service pressure. The water relief valve either was inoperative or unable to discharge all the steam generated and consequently the tank was subjected to excess pressure.

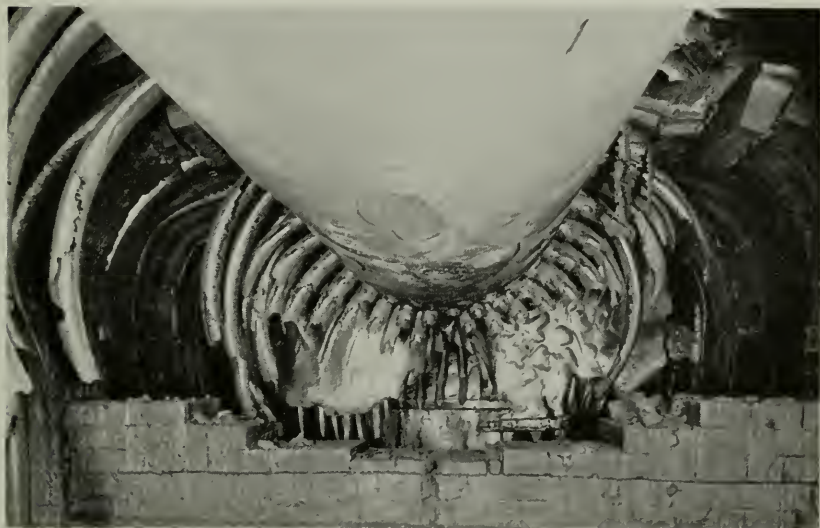
Damage to this water tube boiler was reported to have been caused by overheating when the feedwater was shut off and the automatically controlled stoker continued in operation. Installed about 7 months previously at a cost of \$12,000, the boiler was so badly burned that replacement was necessary.

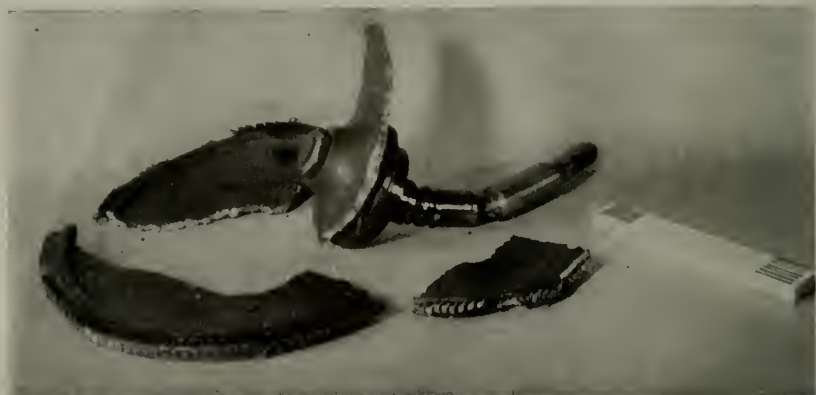
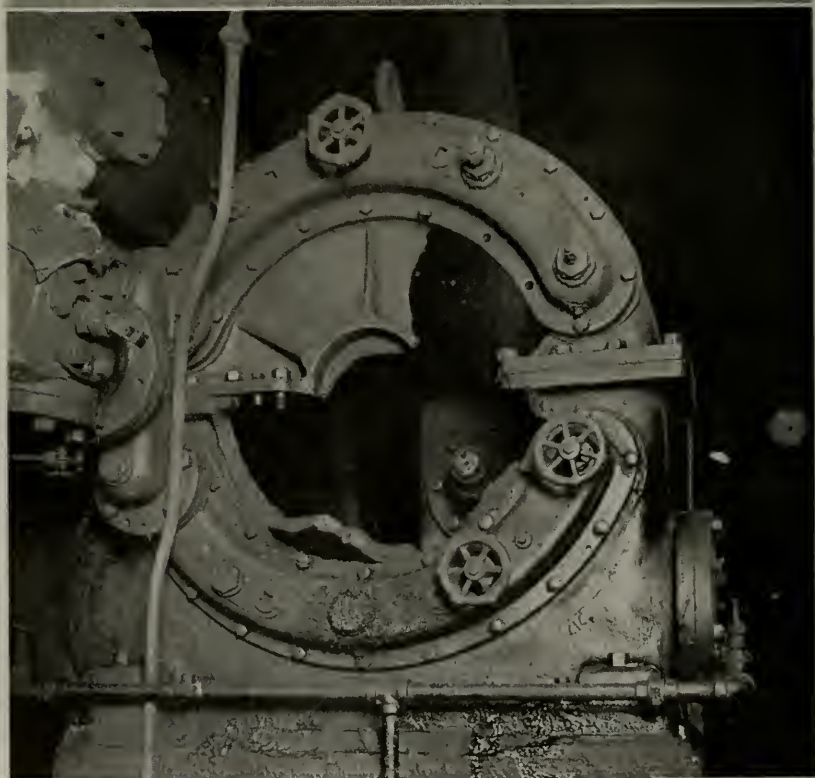
Top—Two men were injured when the rotor—pictured above—of a small steam-turbine burst from excessive speed.

Bottom—Explosion of this steam-turbine draft-fan unit was attributed to overspeed after the load was lost.

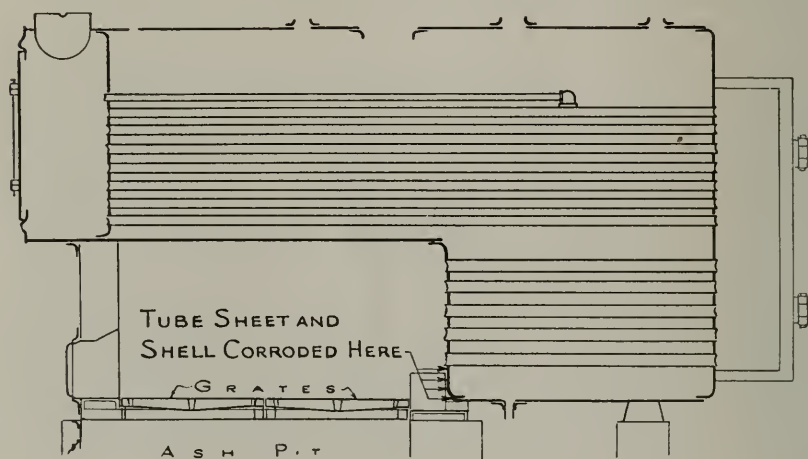
Figure 3—Drawing of an economic-type boiler indicating areas concealed by grates or brickwork where external corrosion is likely to occur.

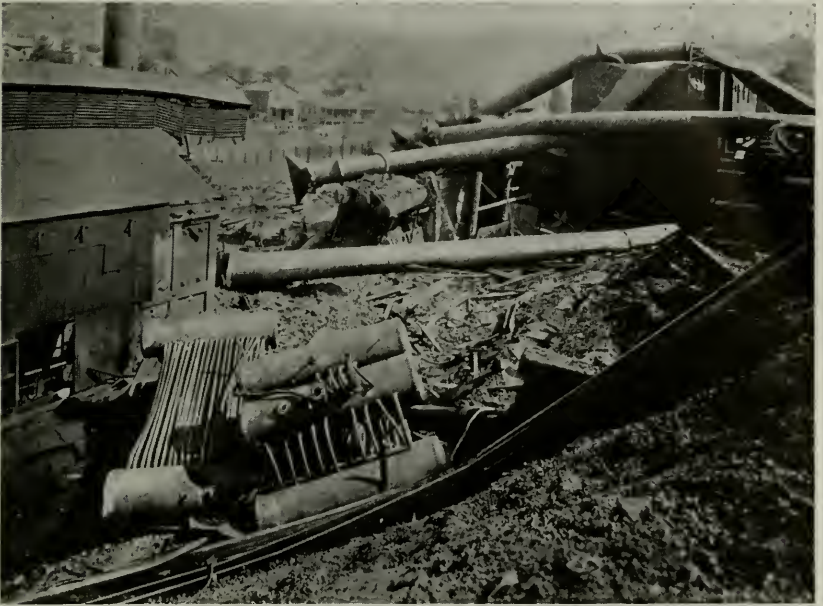
Figure 4—Wreckage at a steel mill following an explosion of a water tube boiler. Caused by external corrosion of one head of the lower drum which had been concealed in brickwork, the explosion killed two people and injured five others. Property loss was about \$75,000.

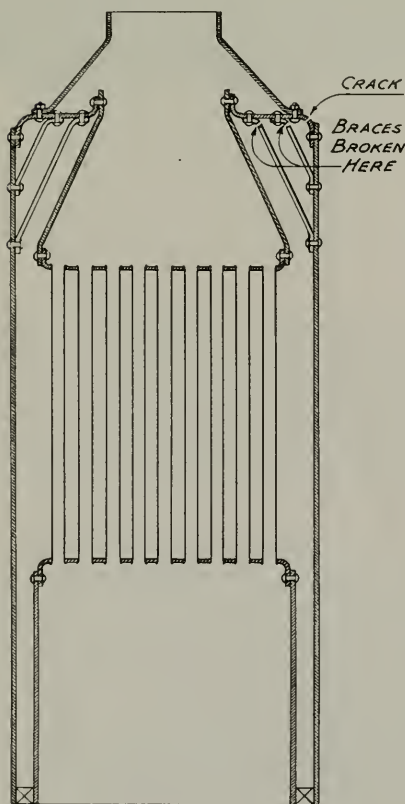
Figure 5—Three men were badly scalded when the top head of a small vertical tubular boiler, similar to the one drawn here, tore open at the flange along the line of a previous crack.

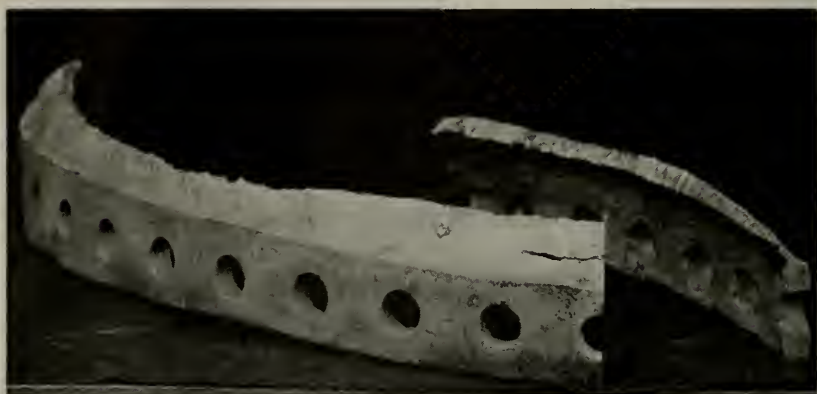
Figure 6—Parts of the lower drum of a water tube boiler showing the manner external corrosion wastes away the metal and weakens the head.

examination of hidden parts and such repairs should be planned with that thought in mind. Before the boiler surfaces are re-covered, following an examination, a valuable protection can be given them by applying a suitable coating of moisture-absorbing material next to the surfaces, beneath the usual insulation of masonry or magnesia blocks.

A program of permanently rearranging the design and application of brickwork or insulation, so that hidden surfaces can be readily examined during a normal shutdown period, should be given serious consideration. Where such a program is not possible the uncovering of hidden parts remains of utmost importance as many defects do not make their presence known in advance of failure.

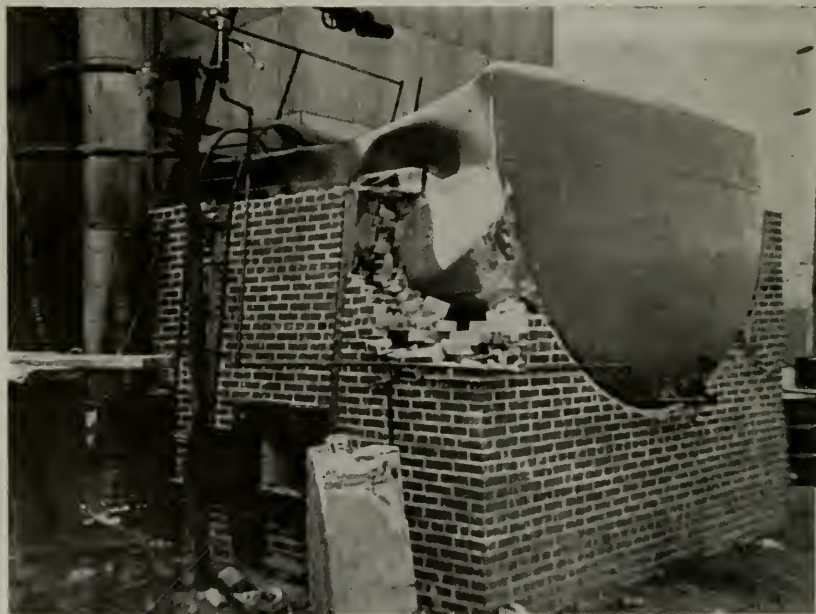
Constructed with welded seams, the vessel was 10' in diameter by 12' long and made of tank steel $\frac{1}{4}$ " thick in the upper half and $\frac{3}{8}$ " thick in the lower half. According to accepted engineering standards, the structure was adequate for a maximum safe vacuum of only 6".

View of a large tank after it had collapsed while being given a vacuum test.

accepted standards of construction. Many states and cities have laws governing the construction of several classes of pressure vessels, and the purchaser should determine whether or not the vessel he requires will come within such laws. If it does, he should specify that the vessel be constructed in accordance with those requirements. Otherwise, in order to assure proper construction and workmanship, it is recommended that the vessel be built in accordance with the A.S.M.E. Code.

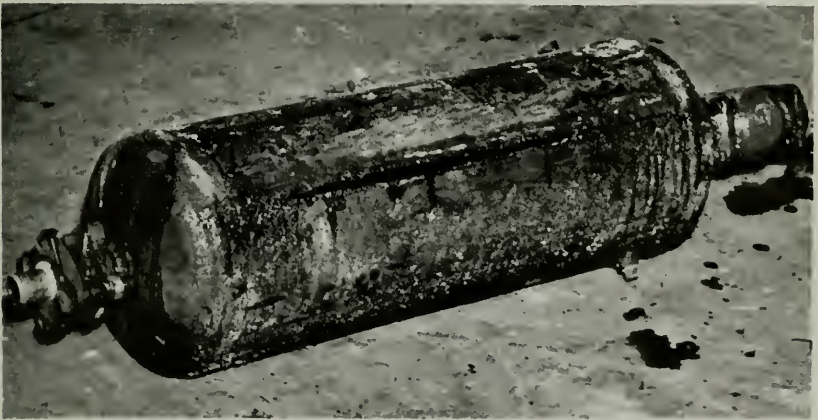
Figure 1—Five men were injured (three of them fatally) by the rupture of this ammonia receiver along a welded seam. Overpressure from expansion of the ammonia when an acetylene torch was used to cut a connected pipe was the probable cause of the failure.

to have been pumped out of the receiver before the work was started. One of the men was cutting a connected pipe line with an acetylene torch while the others were unbolting the receiver supports when the vessel suddenly burst along a welded longitudinal seam as shown in Figure 1.

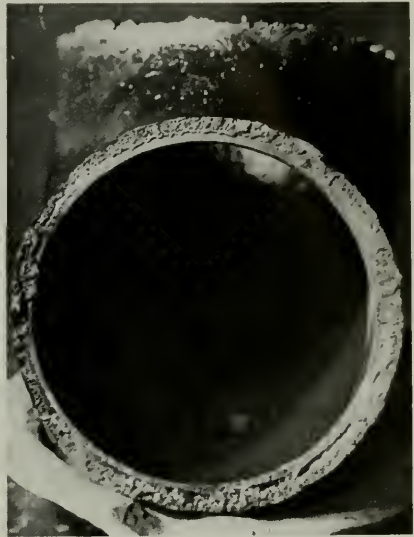
Figure 4—Lack of fusion in this welded seam in a fitting for an ammonia by-pass line brought about circumstances which resulted in damages estimated at \$20,000 to a refrigerating plant.

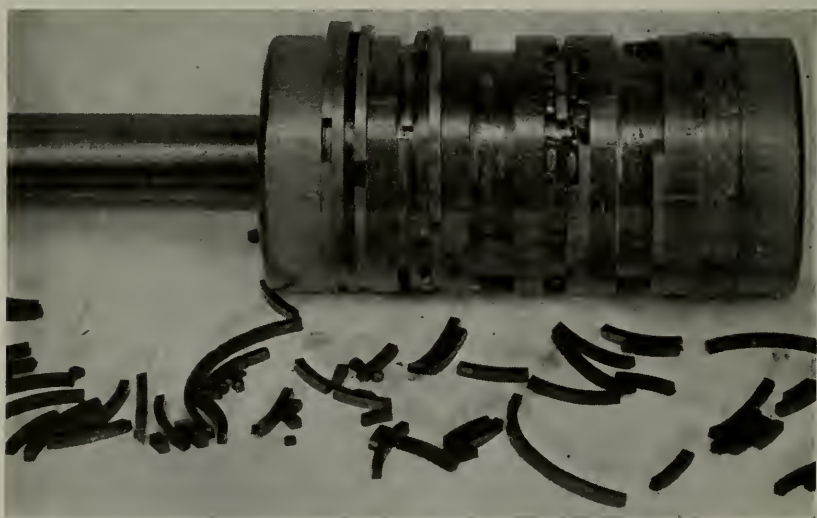
Another refrigerating compressor accident involved a single cylinder carbon-dioxide compressor in a hotel. Jamming against a small piece of a valve spring which had worked its way between the piston and cylinder, the piston rings broke and scored the piston and cylinder surfaces. The cylinder was scored so deeply that a new cylinder was necessary. Because replacement was less costly and more satisfactory than attempting to recondition the old parts, a new piston and rings were installed. Figure 5 shows the damaged piston and broken rings.

Figure 5—Carbon-dioxide compressor piston and rings damaged by a piece of valve spring which worked its way between the piston and cylinder wall.

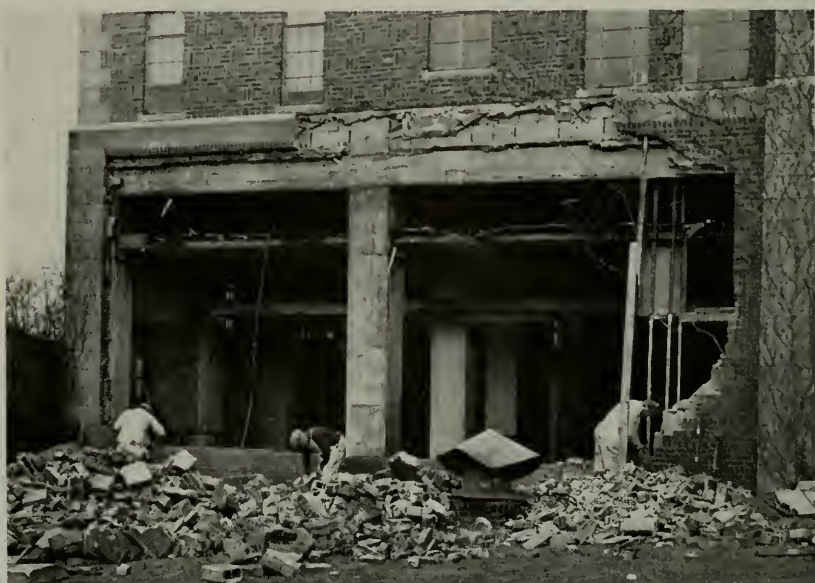
Figure 1—Top—Section of a brick wall in a large apartment house demolished by an explosion in a cast iron steam heating boiler.

Examination of the broken parts of the rear section revealed that the cast stays which supported the flat surfaces had been broken previously as there was a thin hard scale on the broken ends of the stays. Because of the weakened condition of this part of the section, the explosion may have been caused by steam and water pressure even though that pressure was comparatively low. It is also possible that the accident resulted from an explosion of accumulated fuel gases in the firebox and in the gas passages of the boiler. However, neither from the facts that were obtained nor by careful consideration of the nature and extent of the damage, could it be determined definitely whether internal pressure or ignition of accumulated fuel gases caused the explosion.

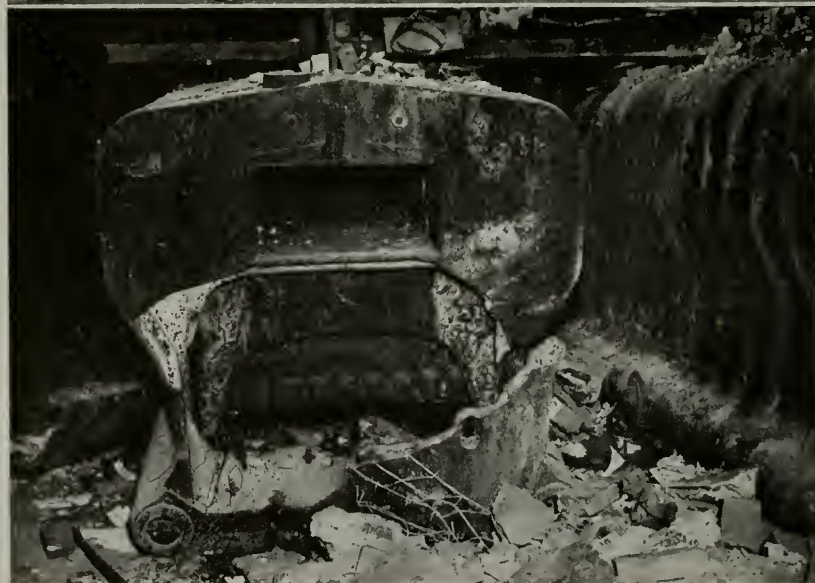
Figure 2—Bottom—Front view of the boiler in which occurred the explosion that resulted in the damage shown in the top photograph.

iron steam heating boiler shown in Figure 2. About three hundred tenants were in the building at the time of the accident but fortunately no one was injured. Local papers carried the story of the blast as front page news and although an estimate of the property damage was not given it undoubtedly amounted to several thousand dollars.
