The Locomotive

THE HARTFORD STEAM BOILER
INSPECTION AND INSURANCE CO.

INDEX TO VOL. 42—1938-1939

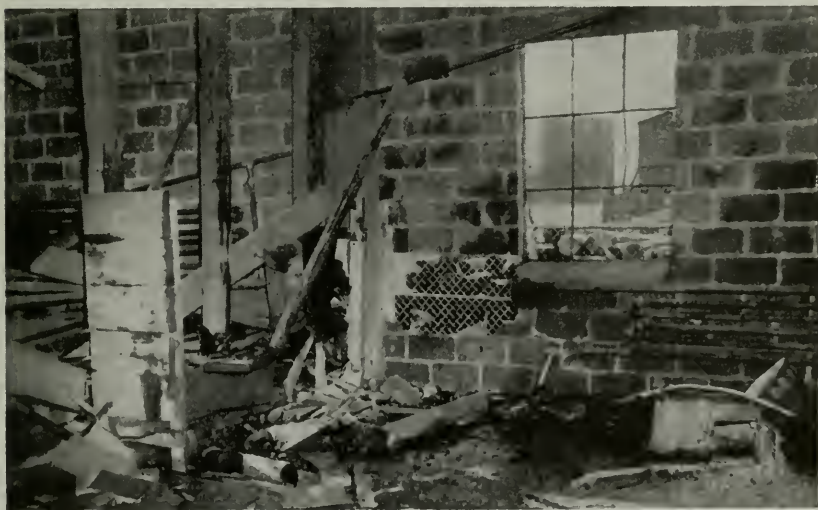
Evidence of the terrific force of the concussion, of which some indication may be seen in Figure 3, was the fact that the outer shell was broken into many small pieces while the remainder of the boiler and its base were hurled in different directions several feet away. In addition, a large area of the cement-block wall adjacent to the boiler was blown out, several holes were made in the roof by small pieces of cast iron, doors were broken and windows shattered both in the garage and in another building a considerable distance away.

Figure 3—After an explosion of a cast iron hot water heating boiler in a garage. Originally located adjacent to the hole in the rear wall, the base of the boiler was hurled several feet to the right.

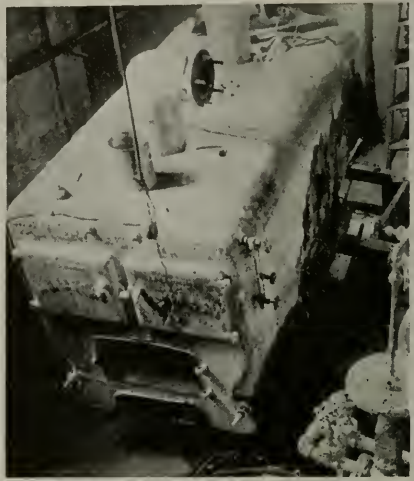
Last March an inoperative safety valve prevented release of excess pressure in a cast iron steam heating boiler and as a result the rear section burst. Located at a Texas college, the boiler was gas fired and supplied steam for heating purposes. According to the report of the investigation, a diaphragm was broken in the valve which automatically controlled the gas fuel, so that regulation of the fuel was dependent upon manual operation. The attendant said that he had looked at the steam gage about an hour after lighting the fire in the furnace and the gage did not register any pressure. A few minutes later there was an explosion. As the steam gage was tested subsequently and registered satisfactorily, it is probable that the pointer had made a complete revolution, leading the operator to believe there was no pressure in the boiler. On this assumption, the pressure was undoubtedly considerably higher than 30 lb, as the gage was graduated to that amount.

Damage to the boiler itself was not extensive as only the rear section was broken, although the remainder of the boiler was pushed from its base about 18", part of the insulation was blown off and the steam and

Figure 5—Cast iron steam heating boiler partly pushed off its foundation by an explosion in the rear section. Over-pressure and a defective safety valve caused this accident.

return lines were broken. Figure 5 shows some of this damage. In addition window glass was broken, door and window frames were bent or thrown out of place in the boiler room and in other parts of the building, and repairs were required to a feedwater

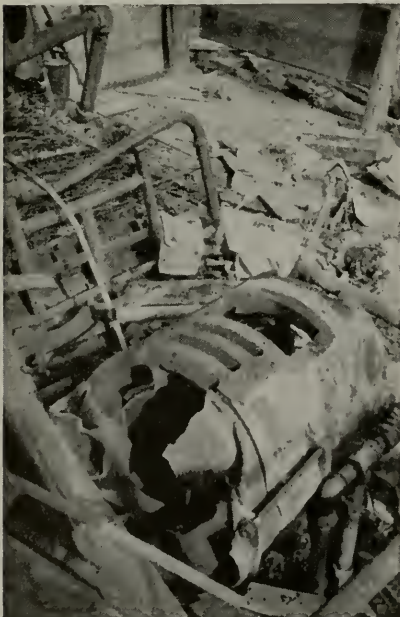
April of a four-section cast iron steam heating boiler in a Michigan greenhouse. Pieces of the boiler were found over a radius of 80'. Excessive steam pressure was believed to have been the cause of the explosion. Whether or not there was a safety valve on the boiler was not determined but none was found afterward. As indicated by Figure 6, the boiler room was completely wrecked.

Figure 6—Some of the wreckage caused in a greenhouse boiler-room by the explosion of a round cast iron sectional steam heating boiler.

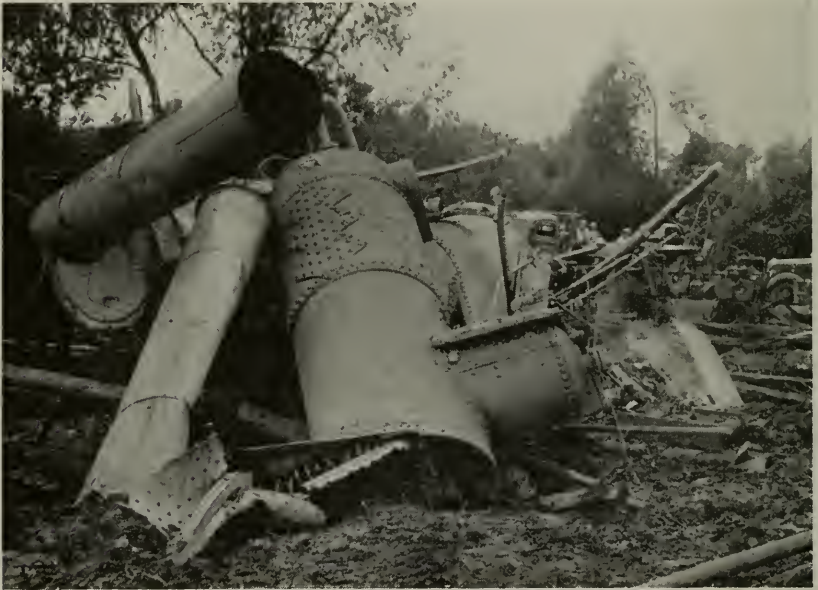
An explosion of a locomotive type boiler, one of a battery of four, caused this wreckage. Located a few miles from New Orleans, La., these boilers furnished power for oil-well drilling operations. In addition to extensive damage to the boilers, piping and other equipment used for the operation of this drilling rig, a fireman was killed and his helper injured.

As can be seen in the picture, the failure occurred in the firebox section of the boiler. Although no reason for the accident was given in the news account, it is probable that the cause was low water, or scale and sediment, which resulted in over-heating of either the crown sheet or side sheets. Investigations of other similar oil-well drilling boiler explosions have borne out this assumption as in a large number of such cases, inferior feedwater or inadequate attention to the maintenance of a safe water level have caused overheating and the subsequent explosion.

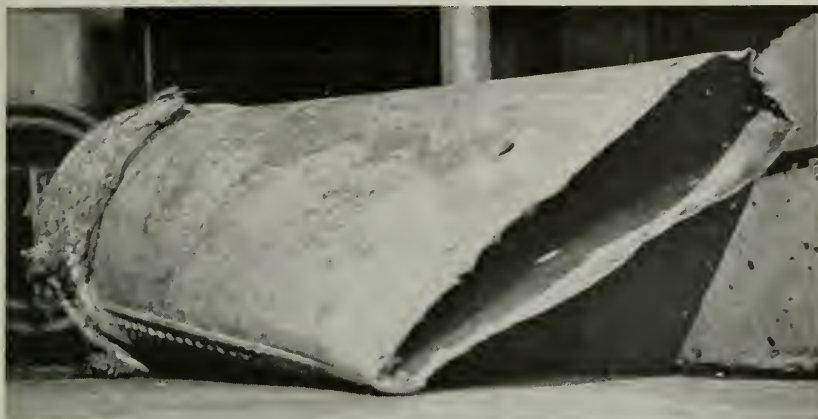
Figure 1—Over-pressure caused explosion of this hot water tank in a laundry. The property loss was over \$5,800.

Figure 1 shows a picture of a new hot water tank after it had exploded from over-pressure. This failure occurred in a cleaning plant and resulted in damage amounting to more than \$5,800.

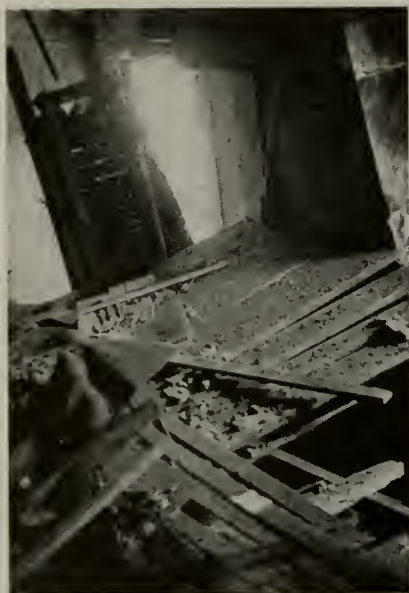
Figure 2—Part of the damage to the first floor of a residence from an explosion of a hot water tank.

pletely, is shown in Figure 2. Plaster was knocked down, flooring torn apart and furniture upset and broken. Brick foundation walls and the sills were jarred out of place and the outside walls were blown apart at one corner. In fact, the damages were so extensive, it was reported that the house might have to be dismantled and rebuilt.

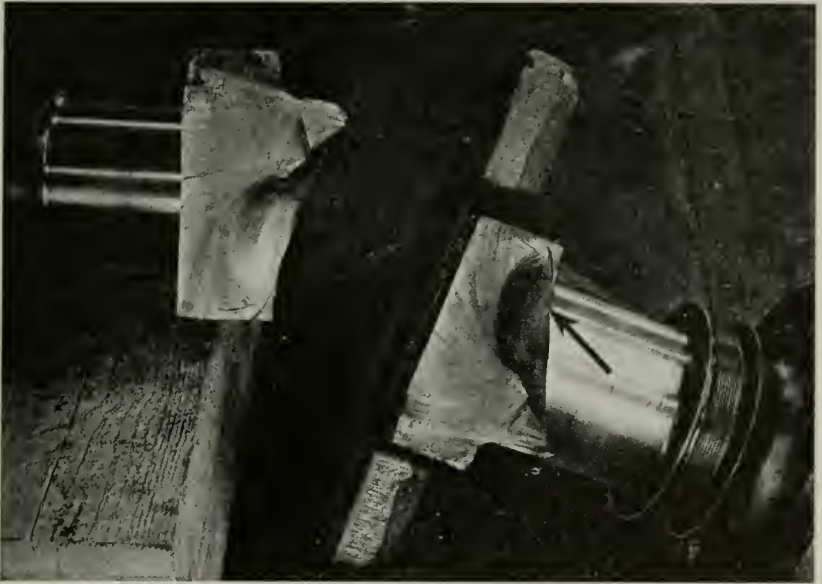
Broken crankshaft on an 180 hp Diesel engine which had been operated only 1000 hours. The failure lines in the surfaces of the break show that it started with a small crack on the main-bearing side of the web (see arrow) and also clearly indicate the progress of the crack through the web. Evidently caused by high local stress produced by misalignment, this failure illustrates the value of timely and thorough inspections of Diesel engines. Many similar failures have been prevented by such inspections.

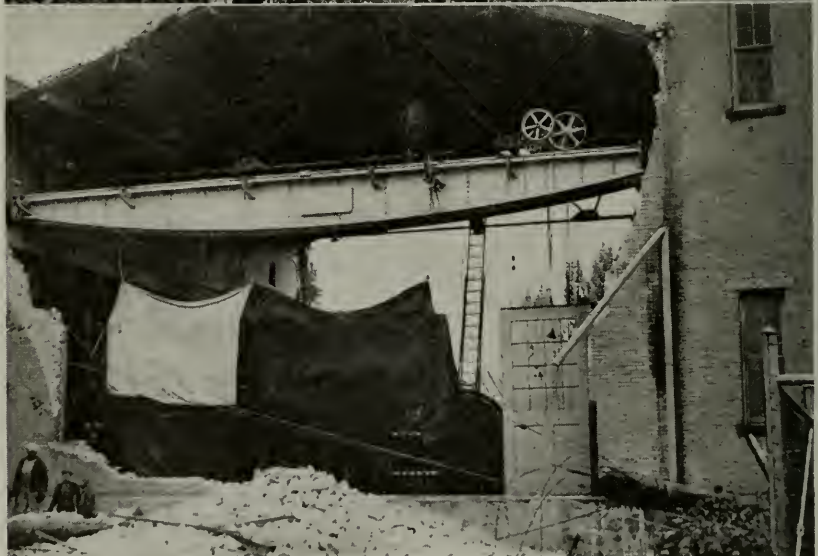
Two views of a utility sub-station after an explosion, caused by a direct stroke of lightning, blew out the end-walls.

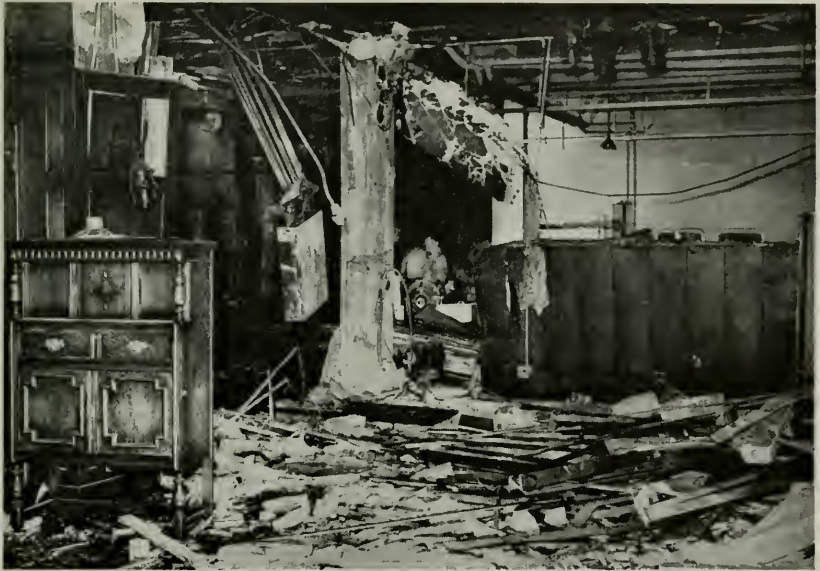
These ruins in a hotel grill-room resulted from an explosion of gas which had been generated in an oil-insulated transformer.

in oil-insulated transformers. One of these is overloading. As the amount of heat to be absorbed by the cooling medium varies approximately with the square of the current, an overload, particularly for a long period, is likely to result in volatilization of the oil. Similarly, oil may be vaporized from overheating of the transformer because of insufficient oil. Loose terminal connections or accumulation of dirt or other matter at these connections may cause arcing and provide the source of heat for generating oil vapors. In an endeavor to prevent explosions from lightning surges as well as to avoid breakdowns of transformer windings and other electrical equipment, it is advisable that adequate lightning arrestor protection be afforded and that the arrestors be kept clean and properly grounded. In many installations in which transformers are located within buildings or confined places and there is danger of a large amount of damage from explosion and fire, other than to the transformers themselves, a non-flammable fluid may be used for insulating and cooling medium.

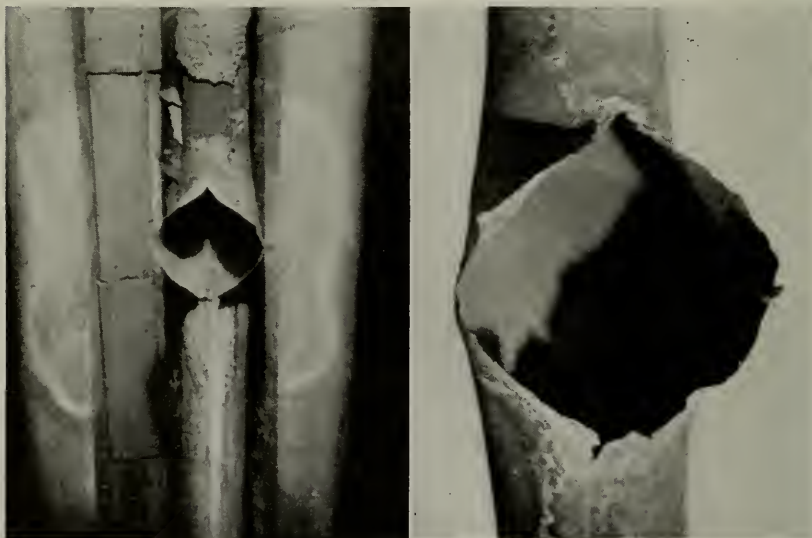
Two views of a ruptured tube for a water tube boiler reported to have been operated at a higher rating than that for which it was designed. Steam pocketed in the tubes, causing one of them to overheat and rupture. Because of the resultant loss of water and the high furnace temperature, 100 additional tubes were distorted and had to be replaced.

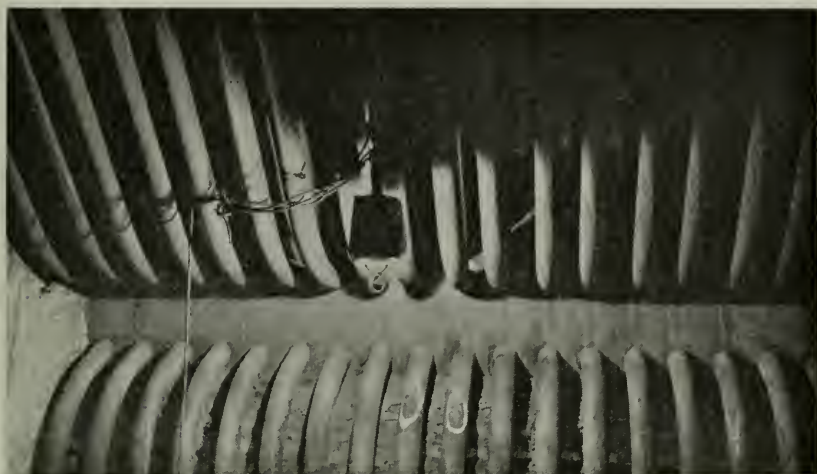
Scale resulted in overheating and bulging of a number of water-wall tubes in this boiler. Change in the feedwater supply without proper adjustment of the feedwater treatment caused the scale accumulation. Two of the damaged tubes are marked. Cost of repairs was not large but several hours of production were lost before steam could be supplied by spare boilers.

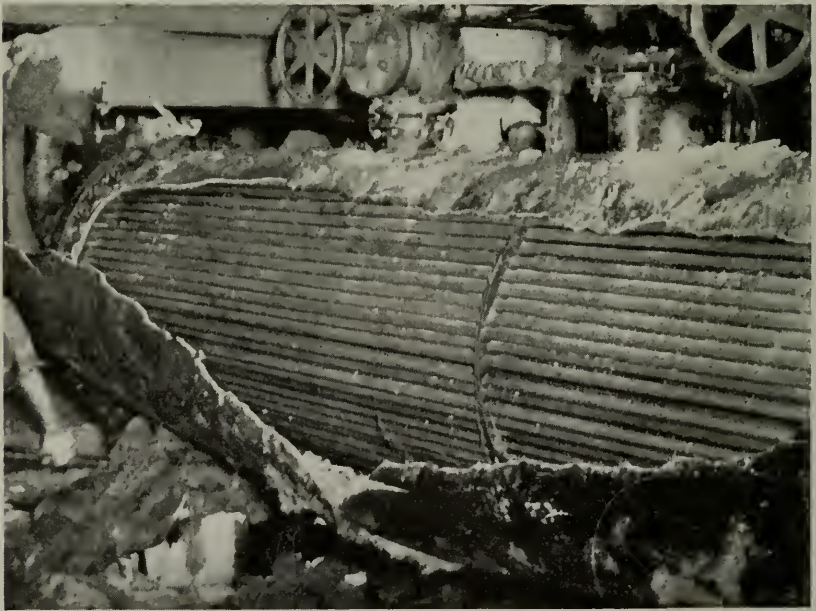
When this brine cooler exploded violently last August four men were seriously injured, one of them being burned so severely by ammonia that he died three days later. Estimated at more than \$40,000, damage to the building and contents was caused principally by escaping water and ammonia.

The brine cooler was 43" in diameter by 16' long. It contained ammonia in the shell and brine in the tubes. Apparently a pressure greater than normal caused the explosion although the reason for the excessive pressure is not known as the piping arrangements, location and condition of valves, method of operation and the events preceding the accident were not obtained.

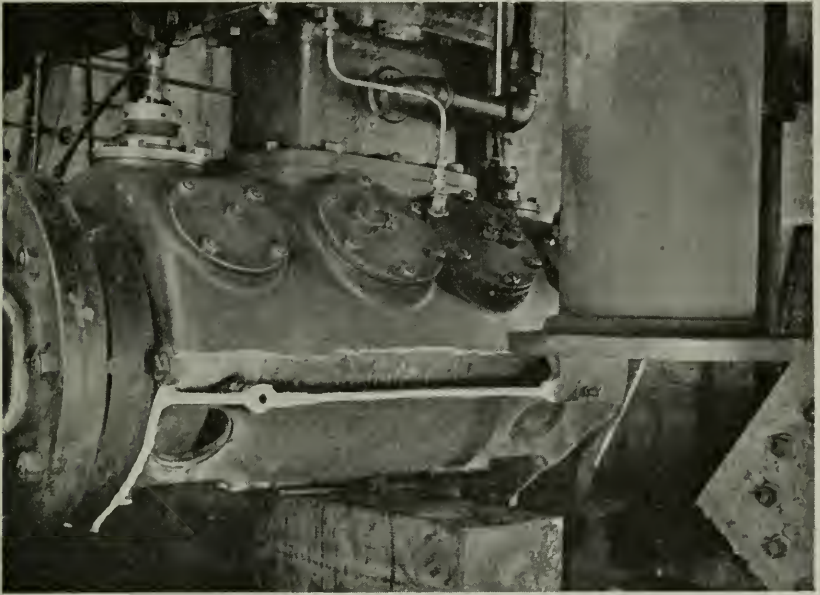
Figure 1—High pressure cylinder on a two-stage motor-driven air compressor damaged by an explosion. Excessive air pressure or a combustion explosion may have been the cause. The operating engineer was killed.

From this discussion of causes and examples of air compressor explosions, the advisability of regular examinations of both intake and discharge valves is apparent. These valves should be checked for tightness at regular intervals of 400 to 500 hours of operation. It is recommended also that compressor cylinders, discharge piping, and air receivers and tanks located near the compressor, be cleaned periodically with soapy water. Under no circumstances should flammable solvents be used for this purpose.

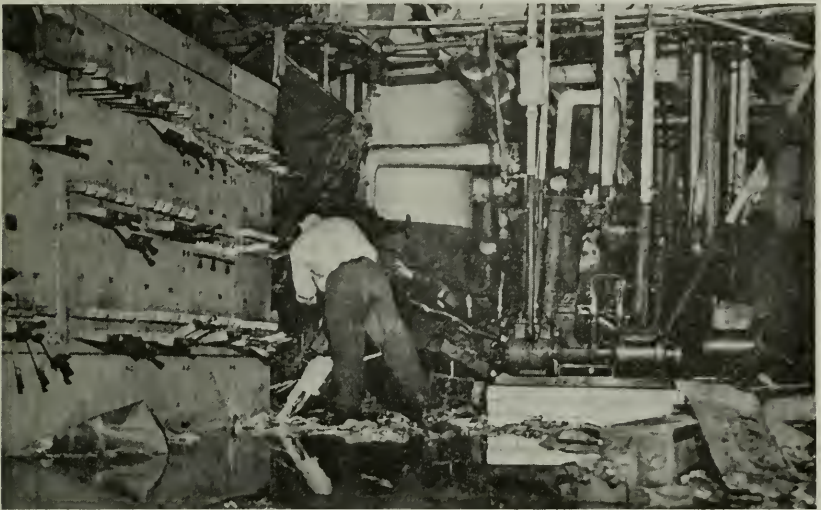
This cast iron heater was approximately 8' long and 5' in diameter. Large sections of it were hurled several feet, some of the pieces breaking a number of small high pressure steam pipes as well as damaging water piping and other equipment. All the windows were shattered in the engineer's office on the first basement level and considerable other damage was caused by the escaping steam and water. An estimate of \$4,000 was given as the total cost of repairs.

Steam for both power and heating was obtained from a battery of water tube boilers, and engine-generator sets furnished electric power. The exhaust from the engines was discharged to the feedwater heater through a 20" line to which other steam piping was connected for supplying heat to a separate building. In order to maintain an even pressure for the heating system as well as limit the pressure in the heater, a control valve was installed in one of two pipe lines which ran from the heater to the atmosphere. In the other line there was a stop valve which was opened only slightly. When the pressure exceeded 2 lb, the control valve was intended to relieve the excess steam to the atmosphere. A by-pass line, having a stop valve and an atmospheric relief valve, was connected around the section of piping containing the control valve but during normal operation this stop valve was closed and the relief valve loaded down. Since the heater itself did not have a safety valve, there was no way of preventing excess pressure if the control valve failed.

Some of the damage caused by an explosion of an open-type cast iron feedwater heater. Originally the heater was installed near the place where the man is standing and parts of it can be seen to the man's right and over his head. The explosion caused the death of 3 men and property damage of approximately \$4,000.

Because of the low pressure at which open-type feedwater heaters are operated, owners and engineers may not think of them as a possible source of serious accidents. But occasionally these vessels are so installed that no safeguard against excess pressure is afforded. Through oversight valves may be shut off or may be closed by vibration, with the heater in service. On any installation having a stop valve between the heater and the atmospheric relief valve, the stop valve should either be removed or locked in a fully open position. It is also important that relief valves be examined and tested regularly in order to be sure that they will function properly when required.

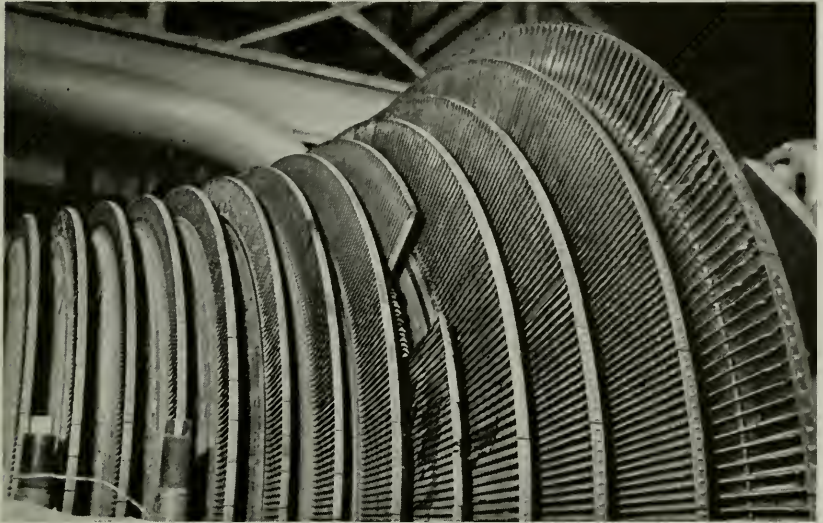
A FEW months ago a 23,000 kw steam turbine in a Texas utility plant was damaged when a section, about 12" long and containing 18 blades, broke from the rim of the disc of the nineteenth stage wheel. Having a rated speed of 1800 rpm, the turbine contained twenty-three stages and was operating at a pressure of about 185 lb at the time of the accident. Figure 1, which is a view of the top-half of thirteen of the lower pressure stages, shows where the break occurred. Although the broken parts, in striking the diaphragms and blading in the remaining stages, nicked and bent some of the nozzles and blades, the defects were not sufficiently serious to require replacement of these parts. Some additional damage, however, was sustained by the turbine through the diaphragm packings becoming badly worn by the whipping action of the shaft.

Figure 1—Part of the upper half of a 23,000 kw steam turbine showing damage to the nineteenth stage wheel when a 12" section of the disc broke near the rim. The cause was attributed to a progressive crack.

The original point of failure occurred at the rim of the wheel in the shoulder of the groove in which the blades were fastened. Figure 2, which was taken with the aid of a mirror, gives both a top and side view of the fracture. The appearance of the broken metal indicated that part of the crack had existed for some time. Just what caused the crack originally could not be determined but as a burr was found on the dove-tail of one of the broken blades, the thought was expressed that when this blade was installed the tight fit produced sufficient wedging action to start a small crack on the inside of the shoulder. Then, progressing gradually along the rim of the wheel and through the shoulder, the crack finally so weakened the disc that it broke from centrifugal force.

This accident is a good illustration of the importance of careful observation of a turbine's vibration. When an appreciable increase is noted, the unit should be shut down immediately. In this case, through discovery of the damaged condenser tubes and the subsequent investigation, it is quite likely that a much more costly accident was avoided, for if the turbine had been operated for an appreciable time with the broken wheel, the continual vibration created by the unbalanced rotor might have caused further damage to the unit.

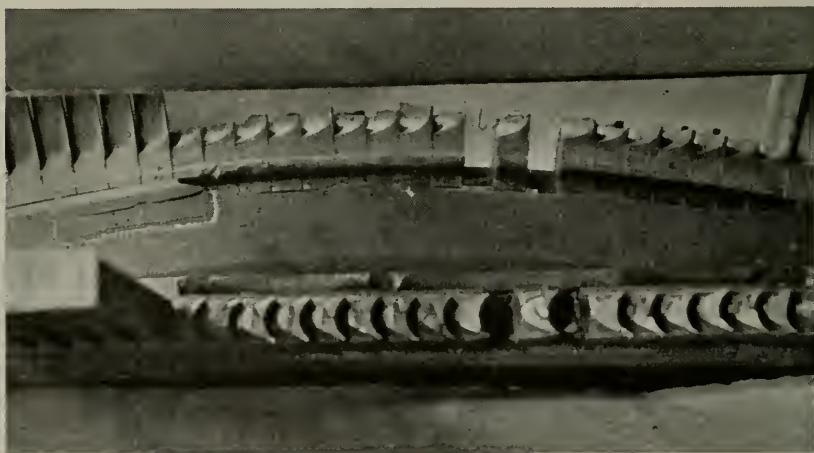
Figure 2—Taken with the aid of a mirror, this picture gives a close-up view of both the top and one side of the broken section in the turbine rotor shown in Figure 1.

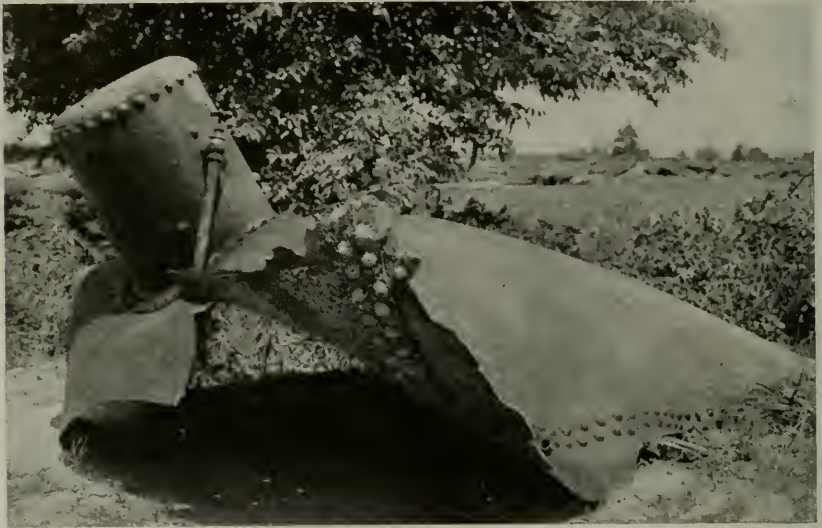
Figure 1—A crack in a longitudinal lap-seam caused the explosion of this boiler. Three men were killed and twelve others injured, eight of them seriously.

been set at 140 lb. From an examination of the wreckage the cause was definitely established as a crack in a longitudinal lap-seam, the crack extending for a distance of several feet along the hidden surface of the outside plate. Figure 1 shows a part of the boiler 400' from its original setting. The sheet in the left foreground is the one in which the initial failure occurred.

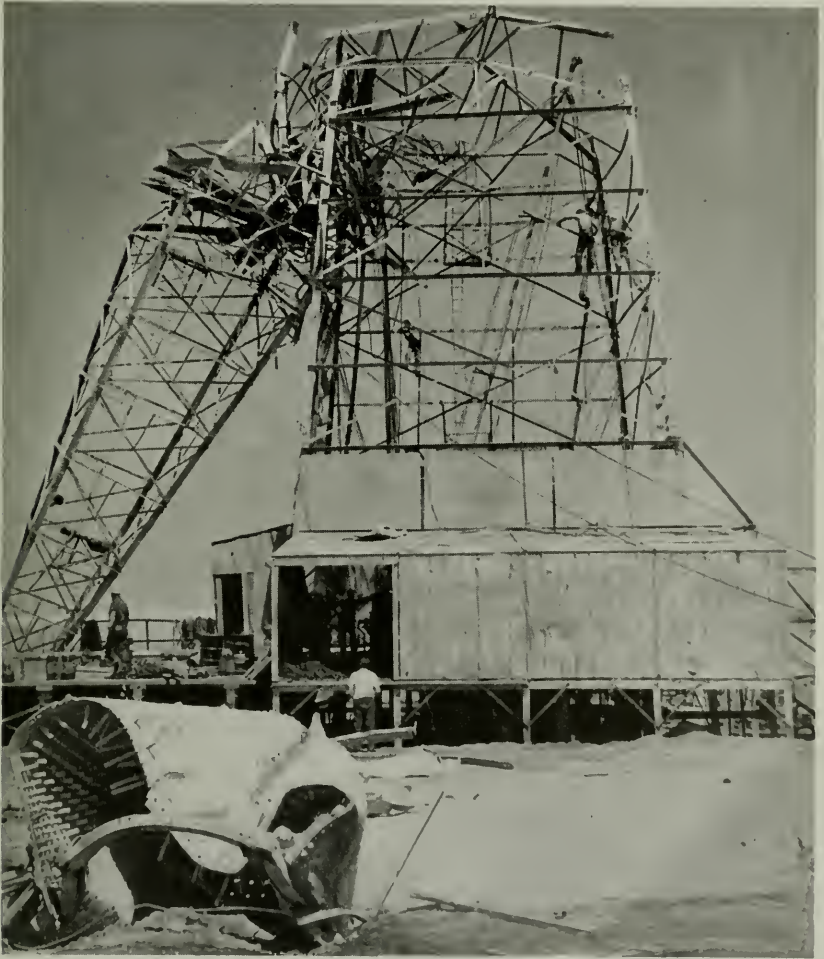
Figure 2—Derrick in an oil field wrecked by an explosion of an oil-well drilling boiler which was located a quarter of a mile away. The boiler's fire box that crashed into the derrick is shown in the foreground.

In most cases the property damage caused by explosions of oil-well drilling boilers is limited to the boiler itself, or to other boilers and equipment used in that drilling operation, as the power plant is in the open and usually located a considerable distance from other property. An explosion a few months ago, however, in a California oil field was unique in this respect in that the boiler was blown through the air a quarter of a mile where it crashed through a derrick of another drilling contractor. The wrecked derrick and the fire box section of the boiler which did the damage are shown in Figure 2 on Page 179.

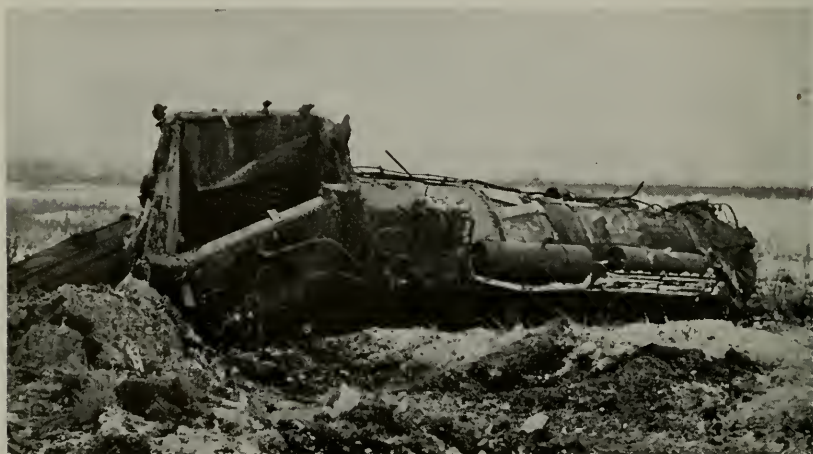
Figure 3—Weighing more than 40 tons, this track locomotive boiler was hurled 500' when low water caused failure of the crown sheet.

yards at Denver. A news account of this latter explosion stated that the boiler and cab were lifted from the undercarriage, hurled 60' in the air and thrown upside down on an empty railway express car over 200' away. It was reported also that at least twenty-two persons were injured, some of them seriously. In the four freight train explosions, eight trainmen were killed and two injured. News reports on most of these accidents indicated that they involved failure of the crown sheets because of low water. Figure 3, showing one of the freight train locomotives, was taken after the heavy boiler had been torn from the running gear and hurled 500' by the force of the explosion. As shown in the picture the failure occurred in the fire box.

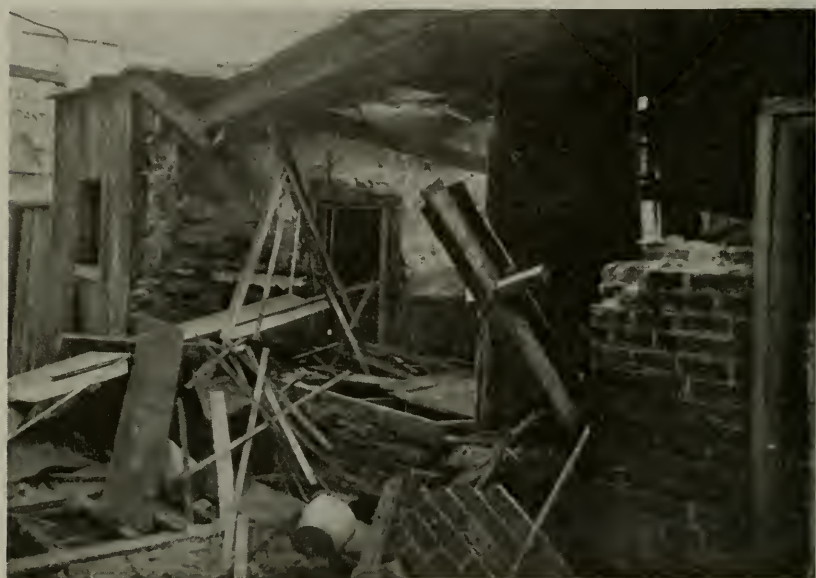
A small vertical flueless boiler only 20" in diameter and 57" high, blew up early this year in a Virginia laundry. The boiler went through

Figure 4—Part of the damage to a laundry building caused by an explosion of a small vertical flueless boiler.

the roof of the laundry building, sailed over an alley and an adjacent two-story building, and landed in a yard a half block away. Part of the wreckage is shown in Figure 4.

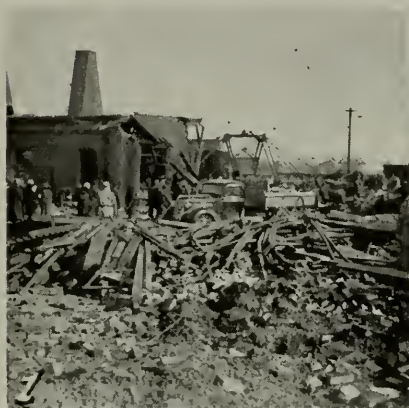
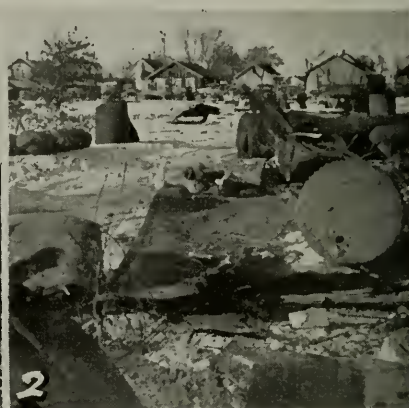
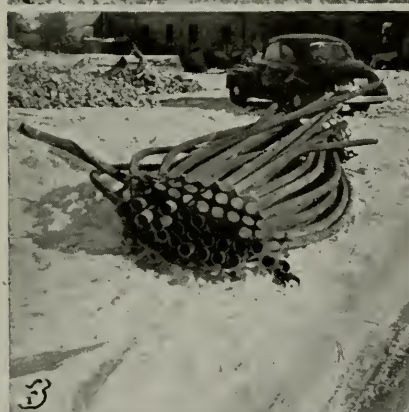
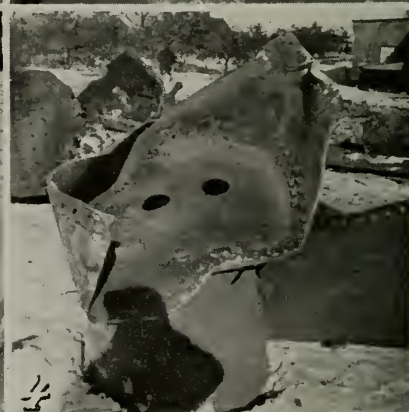
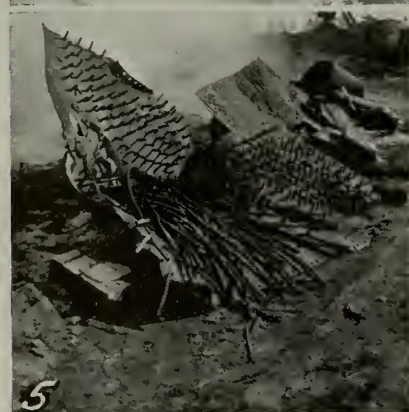
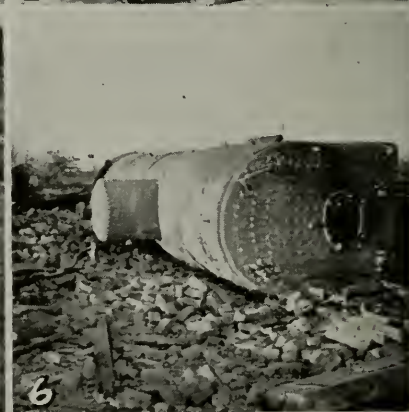
A Boiler Explosion Caused this Wreckage

The photograph in Figure 1, giving a general view of the wreckage, was made as a search of the debris for the missing workmen was being started. Of the several parts of the disrupted boiler and stack shown in Figure 2, the flat sheet in the center is the manhole course in which the initial point of failure is believed to have occurred. The tubes, steam dome and the wrapper sheet are shown in Figures 3, 4 and 5, respectively. All these and other parts of the boiler were scattered over a wide area. Figure 6 shows another boiler of the same size and type, which was also in operation, where it was thrown by the concussion, 60' from its setting. Several automobiles in the roundhouse were damaged, a wooden coal bin was wrecked, and various other pieces of equipment such as a feed-water heater, an air receiver, two feed pumps, piping and wiring were destroyed. In addition, stained glass windows were broken in two churches, as also were a number of windows in residences, all several blocks away.

Although a complete investigation was made in an attempt to determine the exact sequence of events which brought about the explosion, the definite cause remains largely a mystery. The boiler had been shut down a few days previously for cleaning, inspection and repairs, and apparently it had not been fired again until about two and one-half hours before it blew up. Information could not be obtained from the operators who may have known what happened, as unfortunately they were killed, but from an examination of the shattered parts of the boiler, the conclusion was reached that over pressure was the probable cause.

Approved pressure for the boiler was 110 lb and the safety valve was stated to have been set at about 100 lb. However, when the safety valve was tested after the accident, it did not open until a pressure of 250 lb had been reached. Moreover, the main-steam stop-valve for the boiler was reported as having been closed, indicating that there had been no outlet for the steam as it was generated. In this type of boiler a common cause of explosions is overheating and failure of the crown

sheet from low water, but in this case no evidence was revealed by the investigation to support an opinion that the accident was brought about by a low-water condition, nor was there any evidence to indicate that the boiler contained any weakness which might have led to its failure.

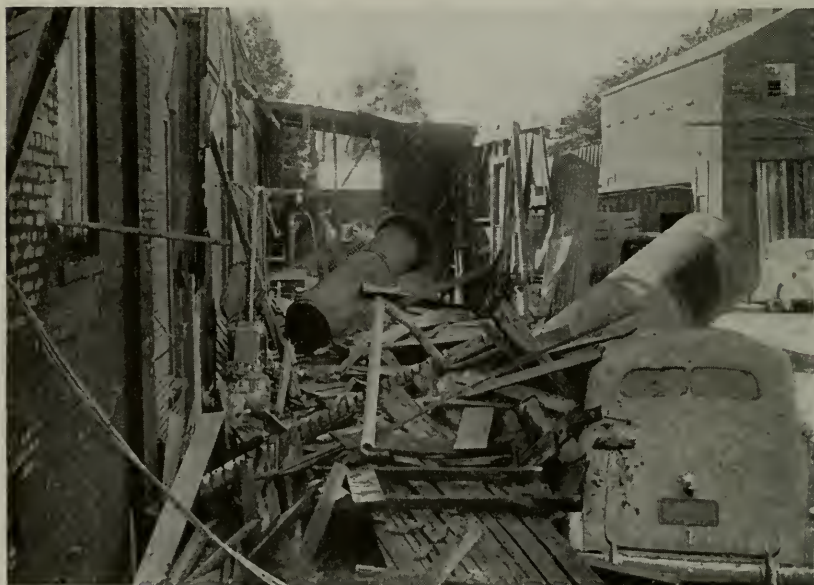
Damage at a creamery and cold storage plant caused by a boiler explosion as a result of low water which, in turn, was attributed to failure of automatic controls. The furnace in the boiler overheated, collapsed and ruptured. Property loss was nearly \$5,900.

The boiler in which this disaster occurred was of the Scotch-marine type, 78" in diameter, with its safety valve set at 92 lb. At the time of the accident gas fuel was being used although the boiler was equipped to burn either gas or oil fuel. Operation was entirely automatic, as controls were provided for regulating the feed-water supply, the damper and the burner. Furthermore, it was reported that the boiler was checked about once an hour when the plant was in operation.

In this case the cause of the explosion was definitely determined, for as a result of low water the furnace had overheated, collapsed and ruptured. The exact cause of failure in the automatic controls was not established as all fittings, attachments and other equipment connected to the boiler, except the safety valve, were so badly damaged that any conclusions reached, even after a careful examination had been made of these parts, would not have been reliable. Actually lack of proper testing and servicing of the controls might more appropriately have been stated as the real cause.

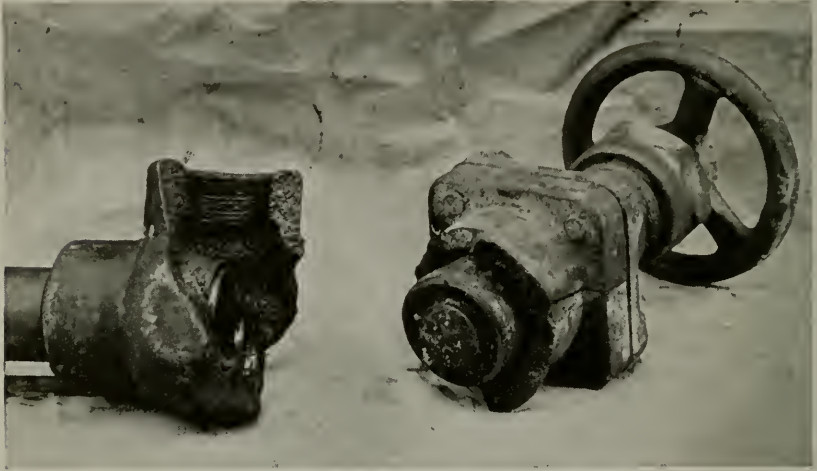
which combustible mixtures of air and ammonia become ignited. When a part breaks in a compressor and permits ammonia to escape, such a combustible mixture may be formed. Then if this mixture is ignited, there is likely to be a violent explosion and heavy damage. An accident of this kind occurred a few years ago in an ice manufacturing and cold storage plant. A by-pass valve broke on an ammonia compressor, the escaping ammonia mixed with air and a few minutes later there was a terrific detonation. The source of ignition was not known, although it was thought to have been an arc produced by the opening of a circuit breaker. Four people were injured and the property damage exceeded \$37,000. Taken after a new by-pass and valve had been installed, Figure 1 shows part of the compressor and indicates where the break occurred. The broken valve is shown in Figure 2 on Page 204.

Figure 2—View of the broken by-pass valve which led to the violent explosion described on Page 203.

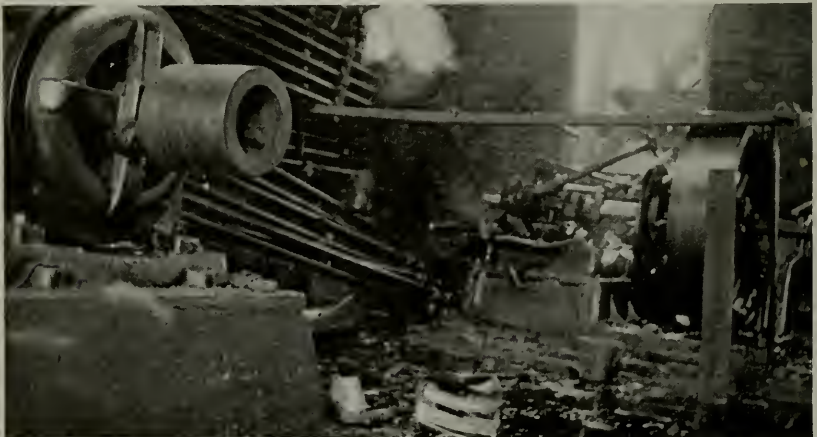
The following account of an explosion shows the danger in running a motor-driven compressor with the stop valve closed in the discharge line and also shows the value of an overpressure-actuated cut-out for the driving motor. According to the statement of the operator who barely escaped being killed, the explosion was accompanied by a blinding flash of fire. It was found that he had started the compressor with the discharge-line stop valve closed and had operated the machine in that manner for nearly four hours. As a result, the ammonia gas temperature increased greatly and the compressor overheated. What actually happened then isn't known but the conjecture is that a piston seized and caused a shock which broke the crankcase. The hot oil vapor or

Figure 4—Only the bottom of the crankcase, the shaft and the wheel remained after this vertical twin-cylinder belt-driven ammonia compressor exploded. The cause was attributed to a combustion explosion in the crankcase. \$7,500 was the estimated damage.

ammonia gas thus released mixed with the air and was ignited almost instantly as evidenced by the sudden flash of fire.

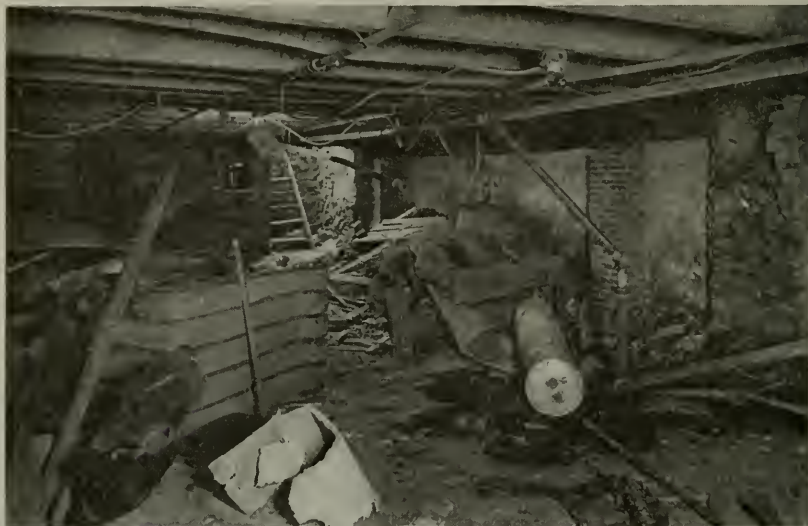
Figure 1 (Top)—An explosion of a cast iron sectional heating boiler caused this damage. A new boiler, it had been placed in service for the first time only a short while previously.

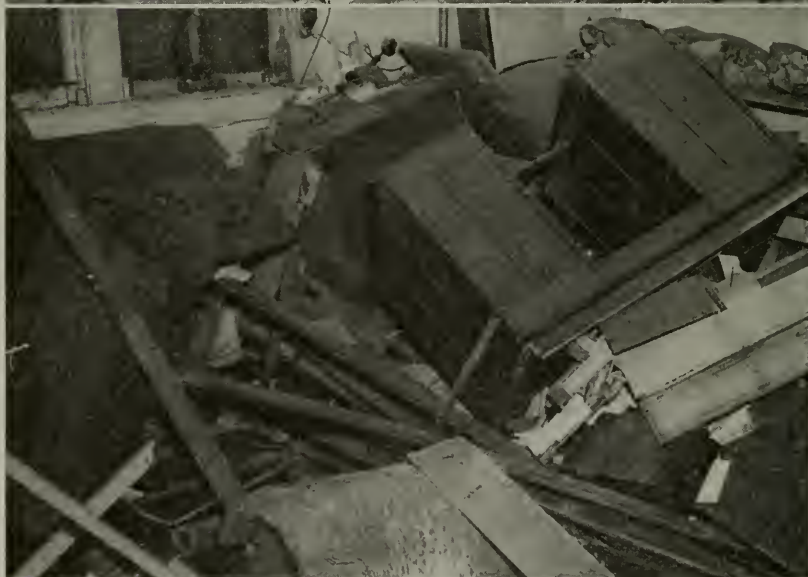
Figure 2 (Bottom)—View in a hotel office showing havoc caused by an explosion of a small hot water supply boiler. The damage was estimated at \$2,000.

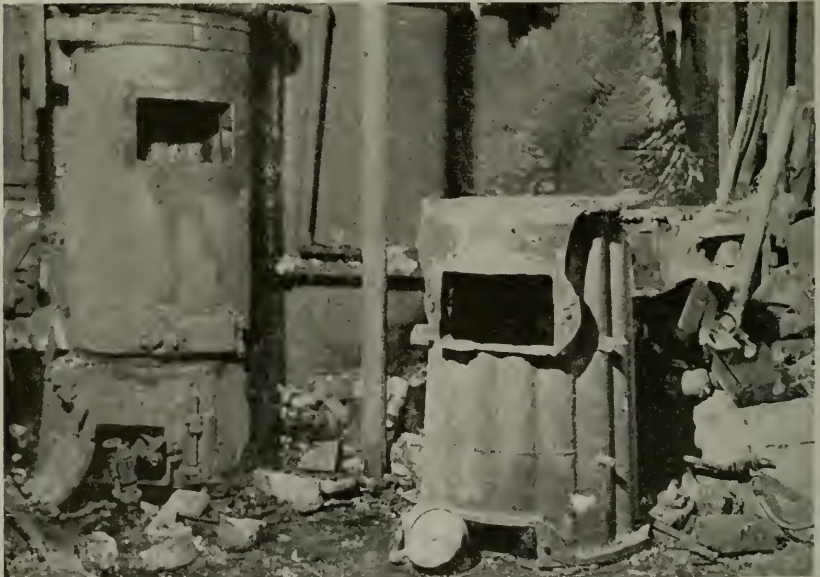
Figure 4—Through an operating mistake, a small hot water supply boiler was changed to a steam boiler. As its water relief valve did not afford suitable protection, the boiler exploded from overpressure.

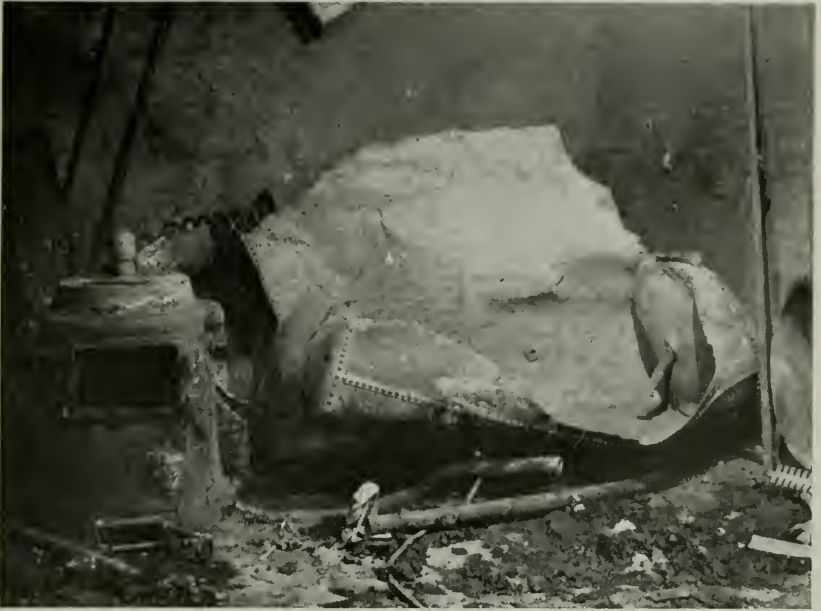
In three cases involving failure of hot water supply equipment the hot water storage tanks were the weakest points in the supply systems rather than the boilers or coil heaters in which the water was heated. One explosion occurred in a nurses' home in Tennessee, another in a residence in Connecticut and the third in a store and apartment building in Illinois. Damage to the buildings was extensive as the total for the three explosions, according to the reports, was approximately \$10,000. The news accounts for the first two of these accidents stated that the blasts resulted from the safety valves having been stuck. Although an inspector made an investigation of the Illinois accident, piping, valves and fittings were so badly twisted and broken that he found it impossible to reach a definite conclusion as to the cause. The exploded tank, which was 2-ft. in diameter by 5-ft. long and constructed of galvanized steel, is shown in Figure 5.

Figure 5—The damage resulting from the explosion of this hot water tank was estimated at \$4,000. The cause was not determined.

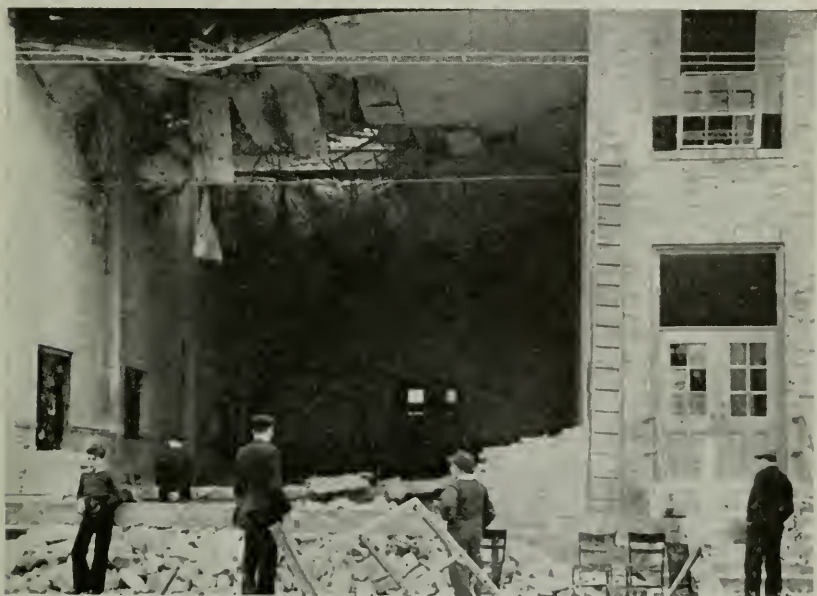
Part of the damage to an Ohio school from an explosion of a welded steel hot water heating boiler is shown in Figure 1. Although positive proof was lacking, the nature and extent of the damage indicated that overpressure was the probable cause. The boiler was stoker-fired and automatically controlled. The theory generally accepted for the explosion was that the water circulation in the system had been greatly reduced or stopped entirely and that a water temperature control for the stoker had failed, resulting in the pressure increasing until the boiler burst. If the water relief valve functioned at all, it must have been of inadequate discharging capacity to relieve the pressure at the high temperature which undoubtedly had been reached when the boiler exploded, as at that temperature a large amount of water would have

Figure 1—An explosion of a steel hot water heating boiler was responsible for the damage to this Ohio school. Excessive pressure was believed to have been the cause.

flashed into steam when the valve opened. Fortunately, the accident occurred on a holiday, so no one was injured. But the property damage, which was estimated at \$50,000, shows how costly a heating boiler explosion may be.

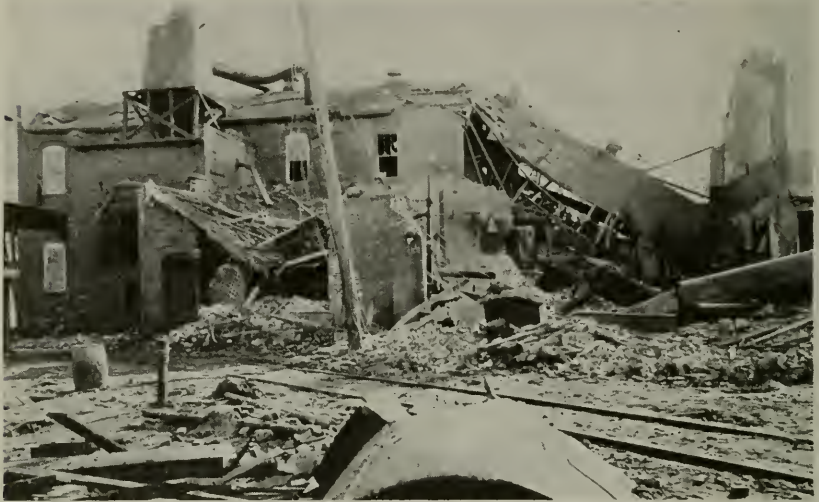
Figure 2—View of a North Carolina manufacturing plant wrecked by an explosion of a horizontal tubular boiler. Overheating from an accumulation of scale and sediment caused the accident.

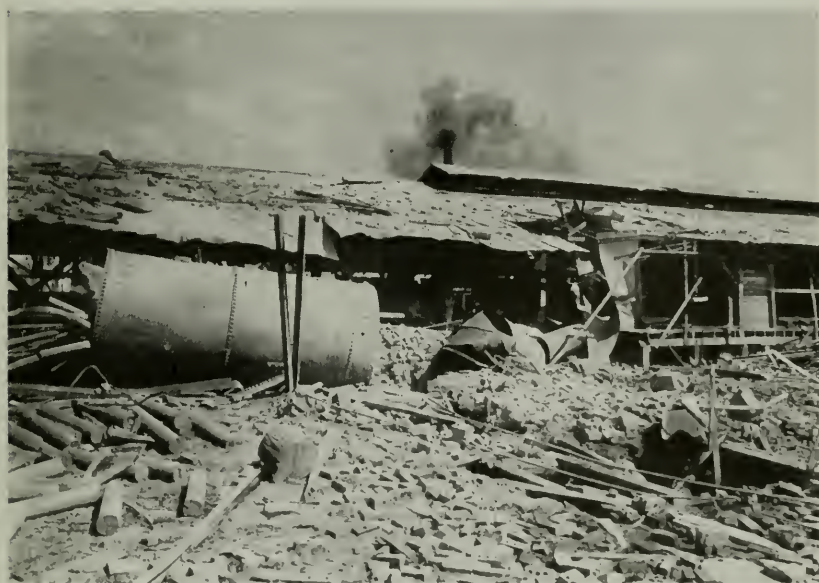
Figure 3—Georgia sawmill extensively damaged by an explosion of a horizontal tubular boiler. The feedwater contained tannic acid which resulted in rapid internal corrosion.

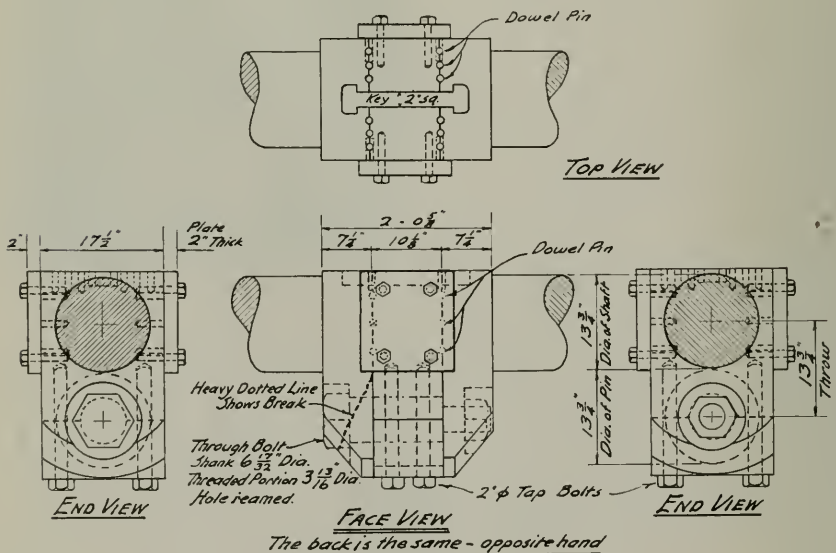
r 621.18
L76
v. 42-43
1938-41

Sketches showing method used in making a temporary repair to a large shaft for a 3,000 hp Diesel engine.

with the sixth cylinder cut out. A temporary repair was accomplished by removing the connecting rod, blocking the piston in such a position that the exhaust and scavenging ports were closed, and installing between the webs a solid steel block with a cap, both machined to fit around the pin and both securely held in place, thus firmly connecting the two ends of the shaft together. As shown in the accompanying sketches, this block and cap were fastened to the shaft by a steel link at the top, a through bolt at the bottom, and two steel plates bolted to the block, one on the front and the other on the back. Four 2-in. tap-bolts fastened the cap to the block.

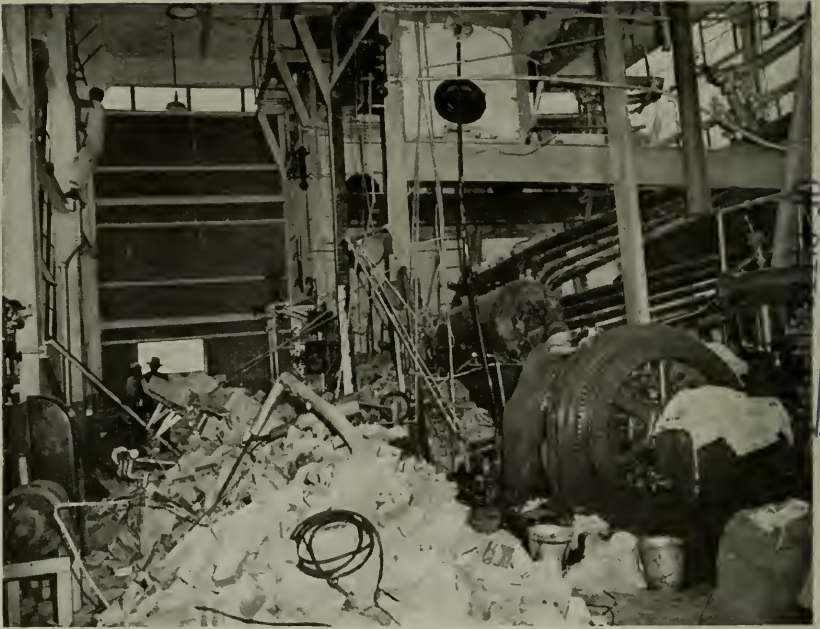
ALTHOUGH many accidents in power plants may not be as damaging as the one that caused the wreckage shown above, they can happen wherever power equipment is operated. Often, the resultant indirect loss from curtailment of output is far greater than the direct loss from property damage.
