NBS TECHNICAL NOTE 807

Building Performance in the 1972 Managua Earthquake

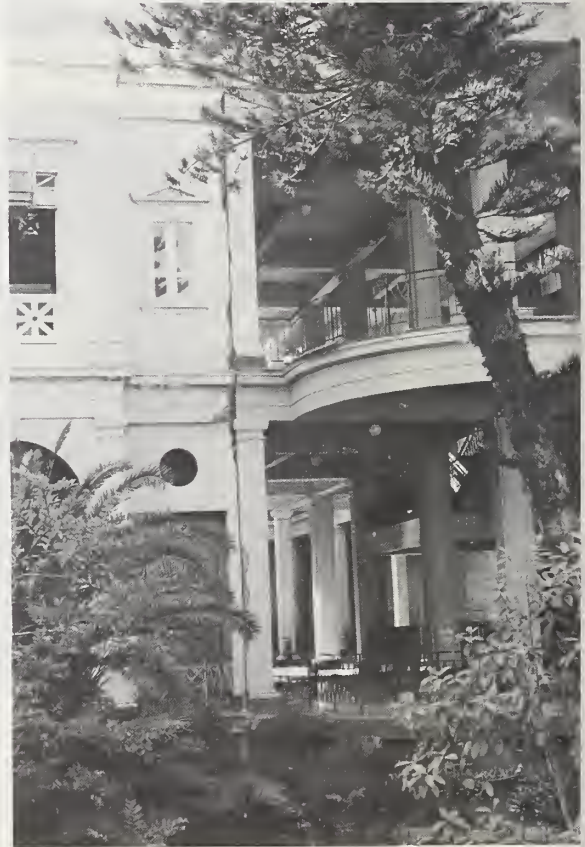
north wing, central building and south wing at their zones of contact, figure 3-4.

Figure 3-4 Pounding between central building and north wing, Palacio Nacional.

None of these damages appear to have severely limited the safety of the structure. However, these damages should be repaired so that the structural resistance is returned to its original level and a careful inspection should be conducted to determine whether other damages have occurred. The structure may be cleaned of broken glass and concrete which endanger occupants and returned to function while the major repairs are conducted.

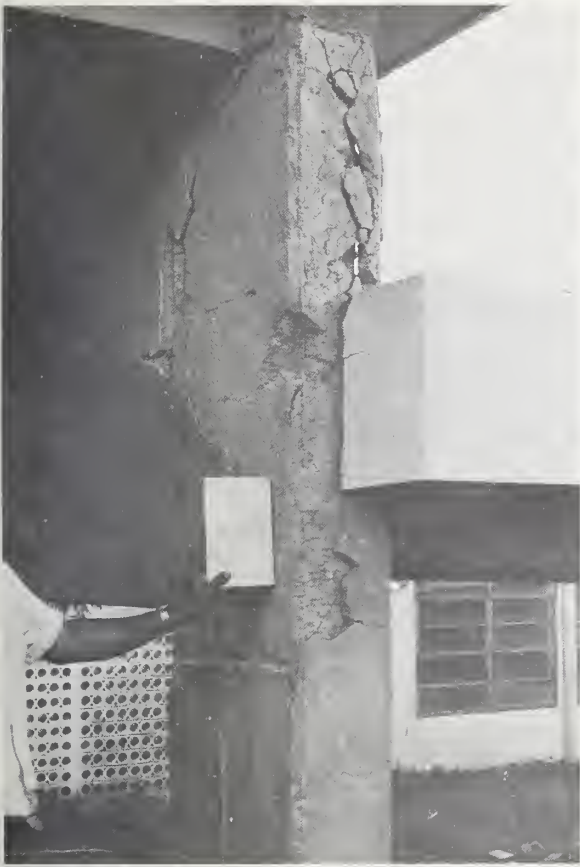
Figure 4-3 Damaged canopy columns at change of canopy elevation, Mercado Periferico Oriental.

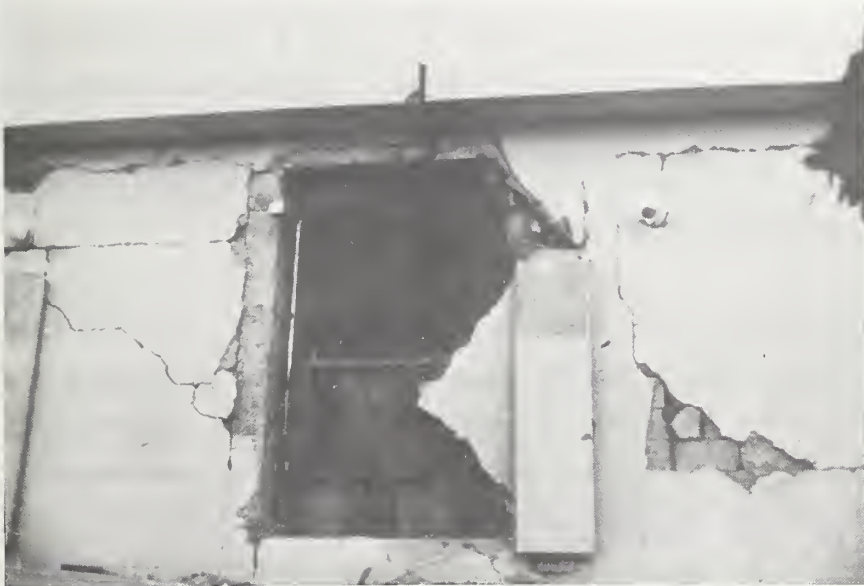
Figure 4-4 Wall and column damage in market building, Mercado Periferico Oriental.

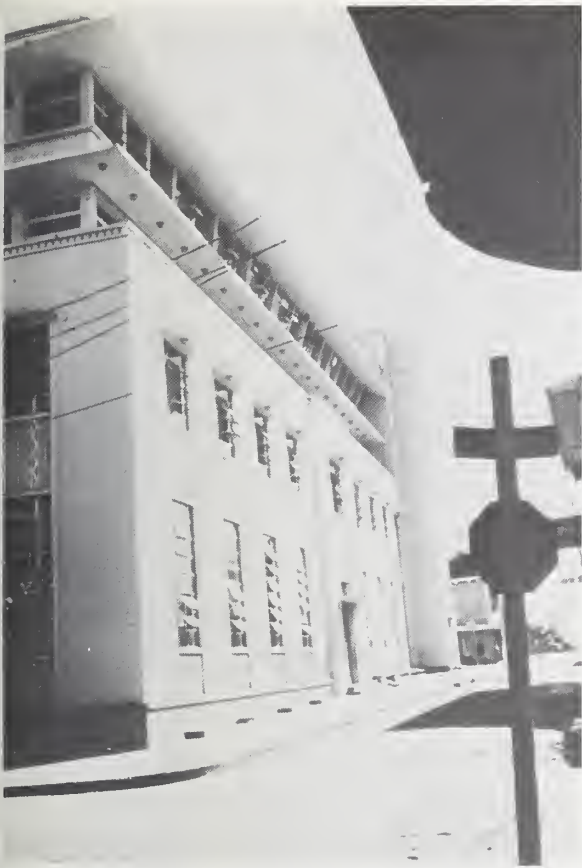
Figure 5-3 Side of the Palacio de Comunicaciones, note the tottering fourth floor walls and roof.

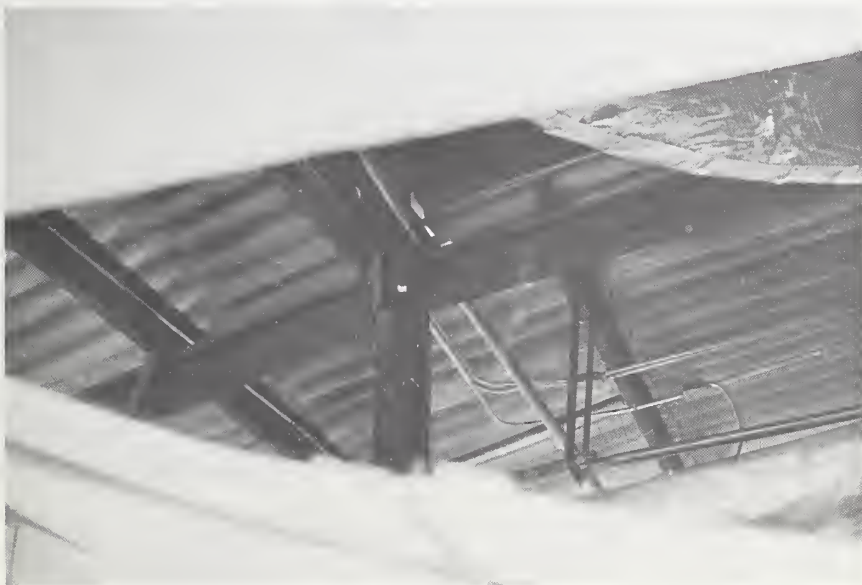
Figure 5-4 Tube column split by pulling of roof framing, Palacio de Comunicaciones.

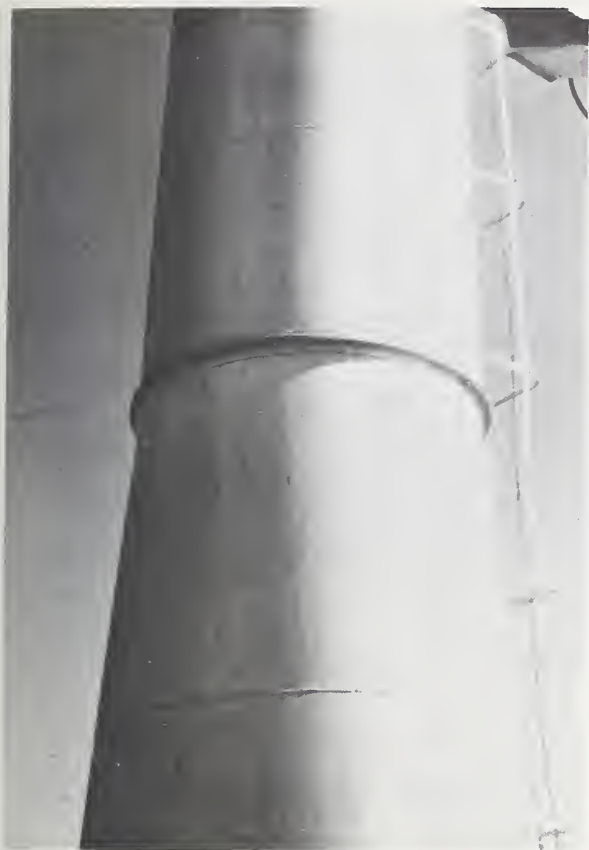
Figure 22-3 Cracked weld in stack,
Planta Electrica ENALUF.

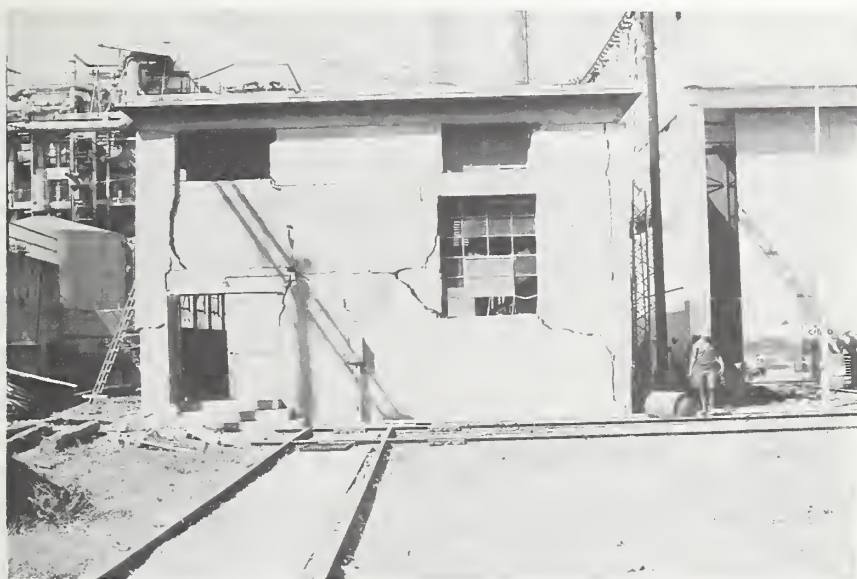
Very severe damage; fortunately, the critical medical supplies stored in a warehouse behind the hospital were on steel shelving, figure 55-8, which supported the building when its walls fell and columns sheared and kept these supplies available for use following the earthquake. Radio communications were dependent on a very feeble building, figure 62-1; however, it was far enough south of town that the collapse was incipient rather than actual. Similarly, the vital switch gear at the power generation plant, figure 22-4, were located in a weak masonry building with a very heavy roof; the building was close to collapse.

Figure 22-4 Severely damaged concrete block bearing
walls of switch gear house at Planta
Electrica ENALUF.

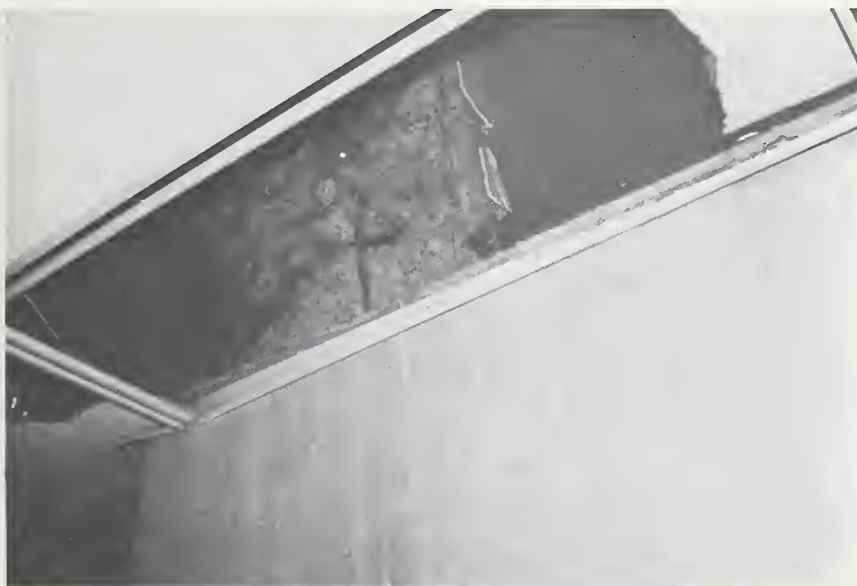
Shear wall-frame buildings were much stiffer; the limited deformations resulted in very little property loss and continuation of functionality. However, some of these buildings showed sufficient structural damage to call into question their safety for an earthquake of similar intensity but longer duration. For instance, the ENALUF (electric utility company) administration building looked sound from the outside, figure 23-1, but exhibited definite structural damage. There was localized crushing of certain shear walls on the ground floor at interruptions for a duct,

Figure 23-4 Shear wall crushing near ceiling on first floor where penetrated by duct, Edificio Administrativo ENALUF.

Since the damages to the shear wall represent a partial failure of the structure, a detailed engineering inspection and repairs of the damages are required before the structure is returned to service.

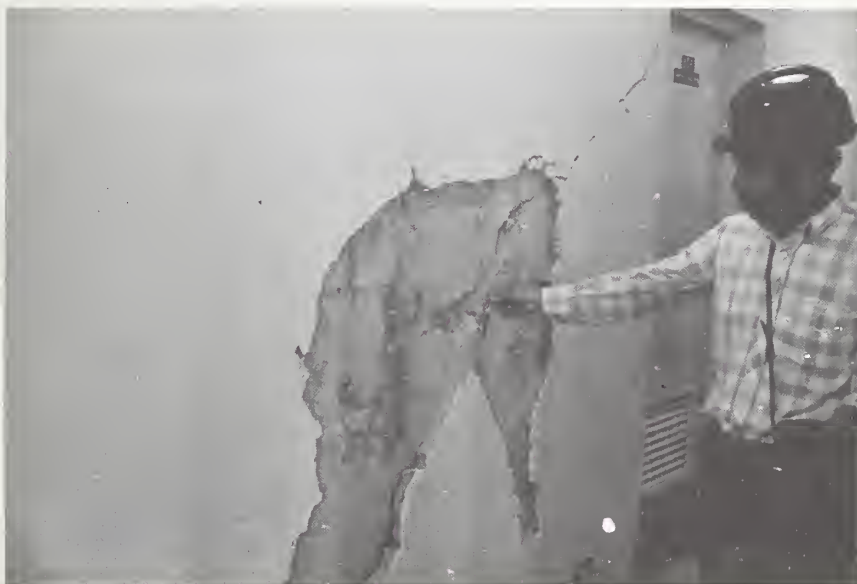
figure 23-4, and for a telephone chase, figure 23-3. On the upper floors there were many diagonal cracks in the shear wall, figure 23-5. The 17 story Banco de American Building also looked quite sound from the outside and showed little nonstructural damage on the inside, figure 54-2. However, many tie beams connecting the four shear wall towers at the corners of the core broke in shear at their mid-span where they were penetrated for ducts, figure 54-1.

Figure 23-5 Cracking in shear wall on third floor, Edificio Administrativo ENALUF.

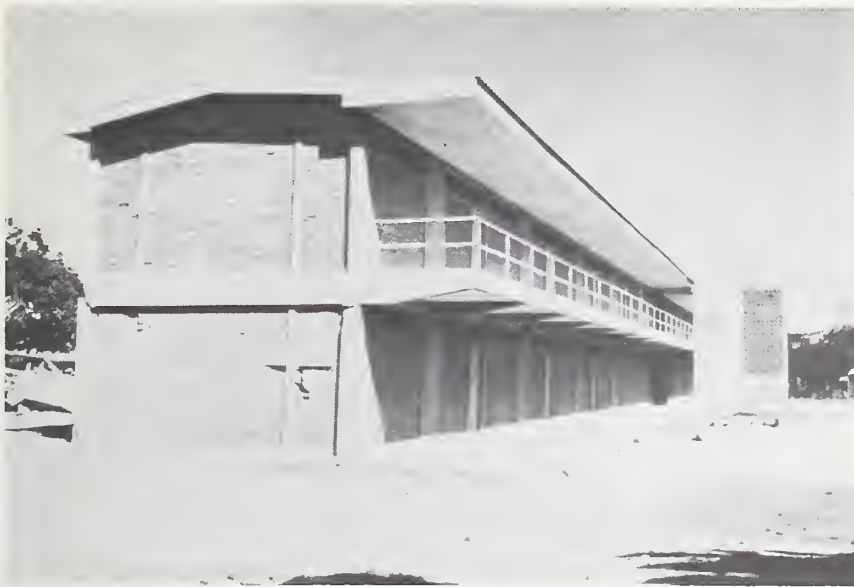
Figure 35-2 New building of reinforced concrete and masonry construction, Centro Escolar Simon Bolivar.

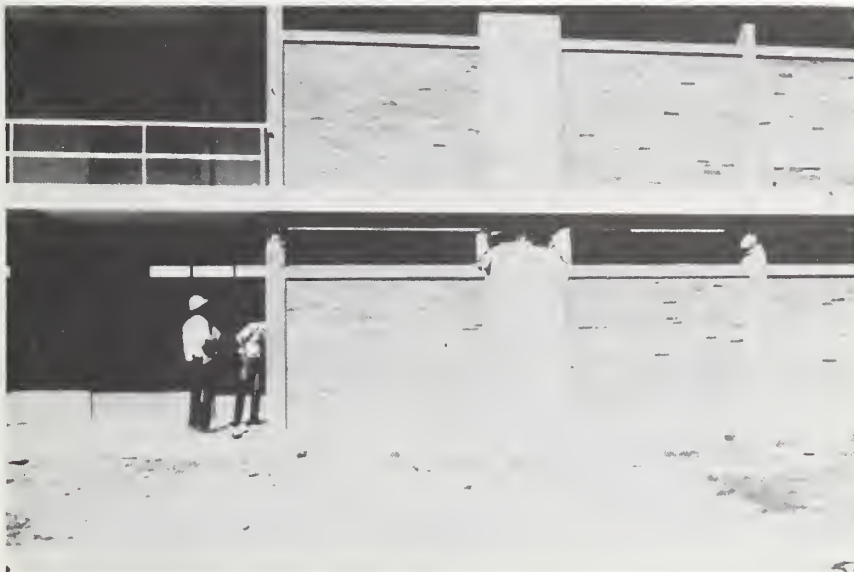
Figure 35-3 Sheared columns above infill wall, Centro Escolar Simon Bolivar.

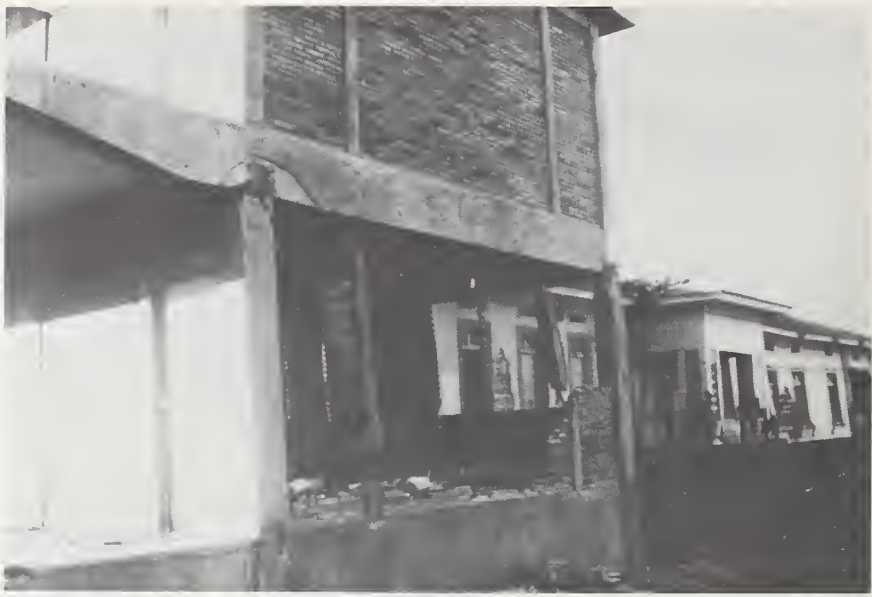
Figure 35-4 Fallen end wall and sheared columns, Centro Escolar Simon Bolivar.

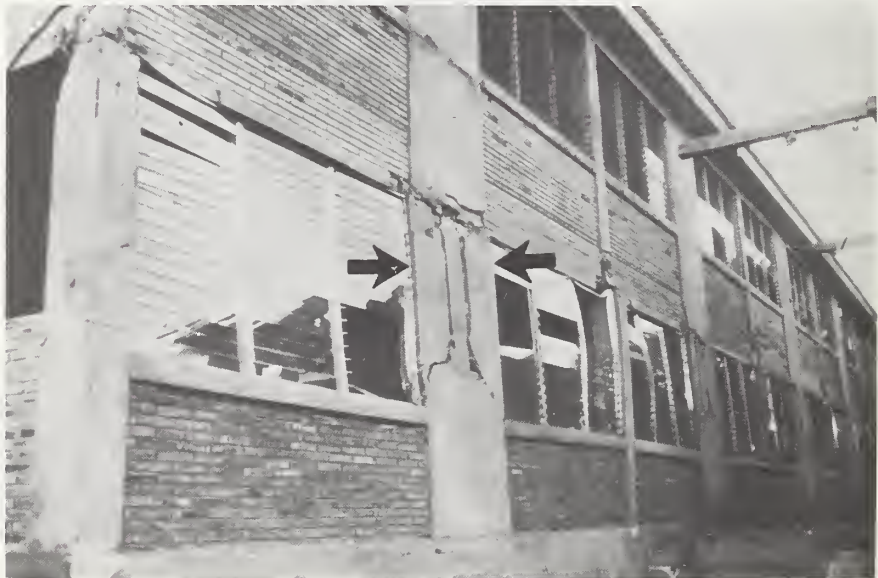
Figure 35-5 Arrows show masonry piers on either side of reinforced concrete columns were ineffective, Centro Escolar Simon Bolivar.

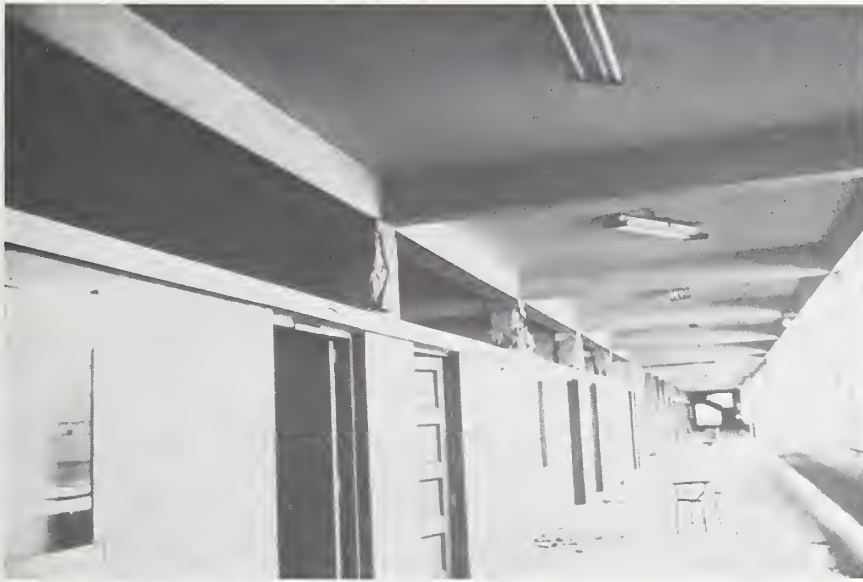
On the second floor of the east wing and on both floors of the south wing, the interior columns are broken and sheared at the top of the partial height infilled wall which separates the rooms from the corridor, figure 38-1. The small section of column subject to deformation at the interior column line is much stiffer than the exterior columns, attracts more load, fails, then the exterior columns must carry the total earthquake and gravity forces.

Figure 38-1 Sheared columns above partial height wall, Instituto Nacional Ramirez Goyena.

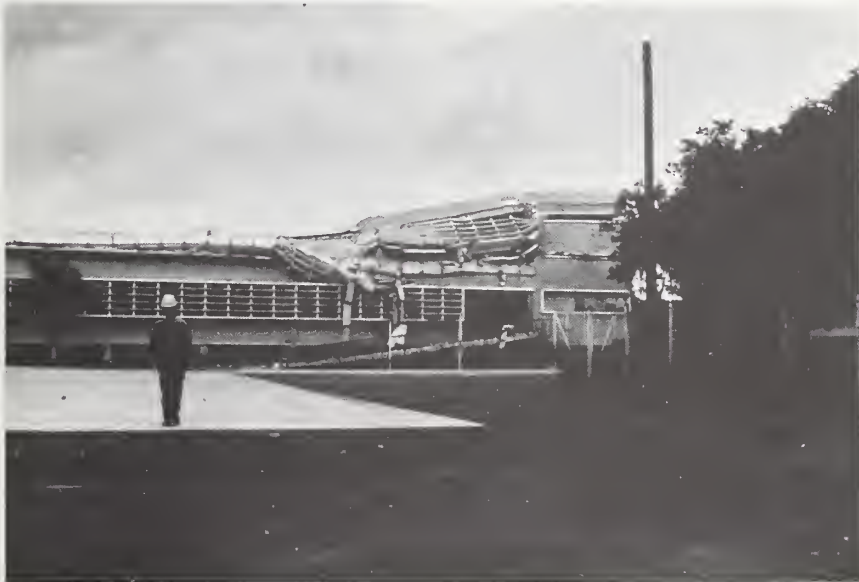
The top two stories of the west wing and the stair tower at its northern end are completely collapsed, very likely from progressive failure after the type of failure of the interior columns observed in the other two wings, figure 38-2 and 38-3. It was apparent that undeformed reinforcing steel had been used in the construction of this building which was completed in 1954.

Figure 38-2 Collapse of upper two stories of the west wing from the courtyard, Instituto Nacional Ramirez Goyena.

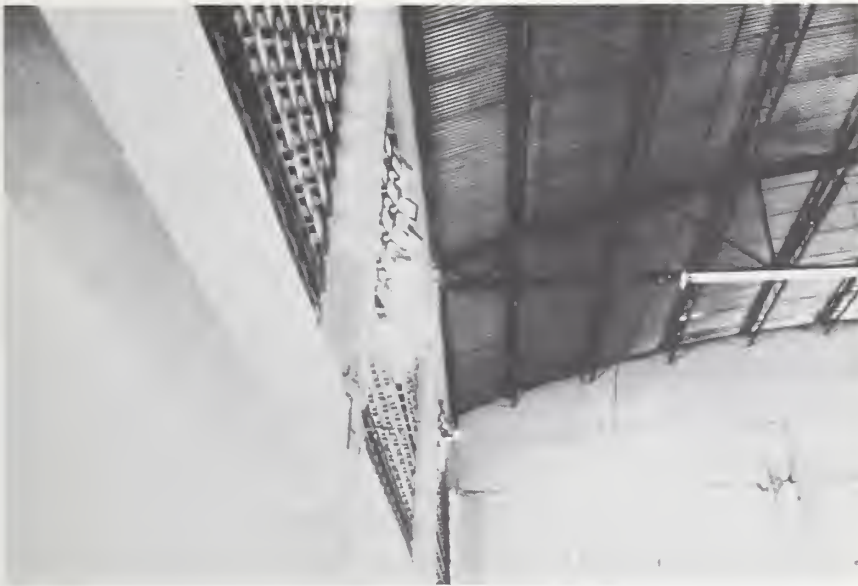
west ends. Therefore, the trusses have shifted north as much as 12 in which fractured the columns and wall on the south side, where connections to the east wing of the building stiffened the supporting columns and wall, and bulged the north wall of the building, figure 38-4. The westerly columns and wall were severely cracked in shear but not strongly displaced, figures 38-5 and 38-6.

Figure 38-5 Lesser damage of south wall of gymnasium at more flexible west end, Instituto Nacional Ramirez Goyena.

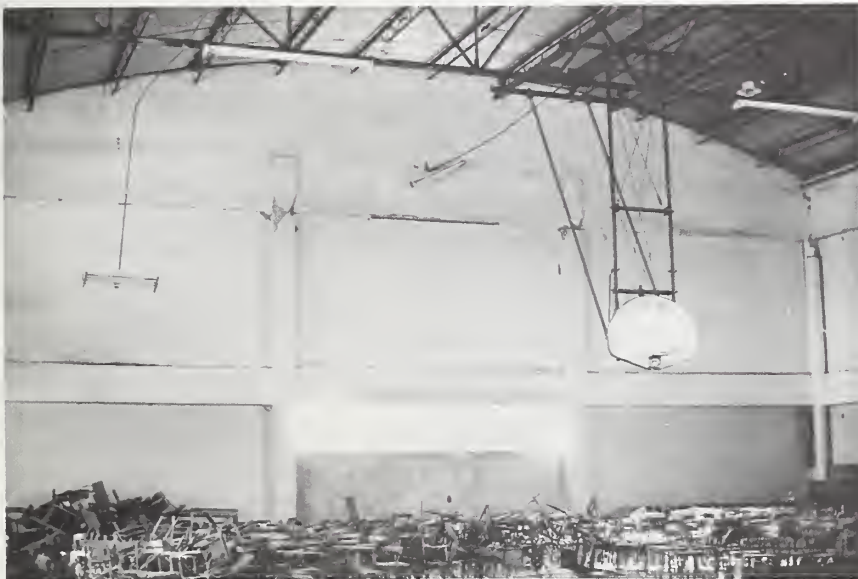
Figure 38-6 Shear of columns at west wall of gymnasium, Instituto Nacional Ramirez Goyena.

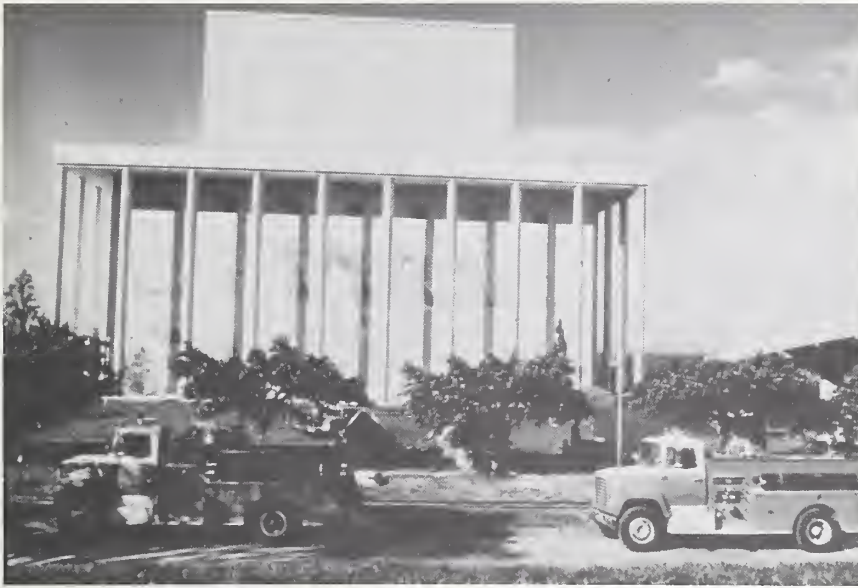
The only damages visible from the outside of the building involve the breaking of a few panes of glass and some damage to exterior masonry walls. The interior could not be carefully inspected because of the lack of electric illumination. There were some interior damages to the Chiltepe block and a few panels of the suspended ceiling had fallen, figure 41-3 and 41-4. However, there were no visible evidences of structural damage. A careful examination of the structure should be carried out as part of the repair program, but it appears that the structure will be ready for use following the minor cosmetic repairs.

Figure 41-1 South facade of theatre showing some loss of finish, Teatro Ruben Dario.

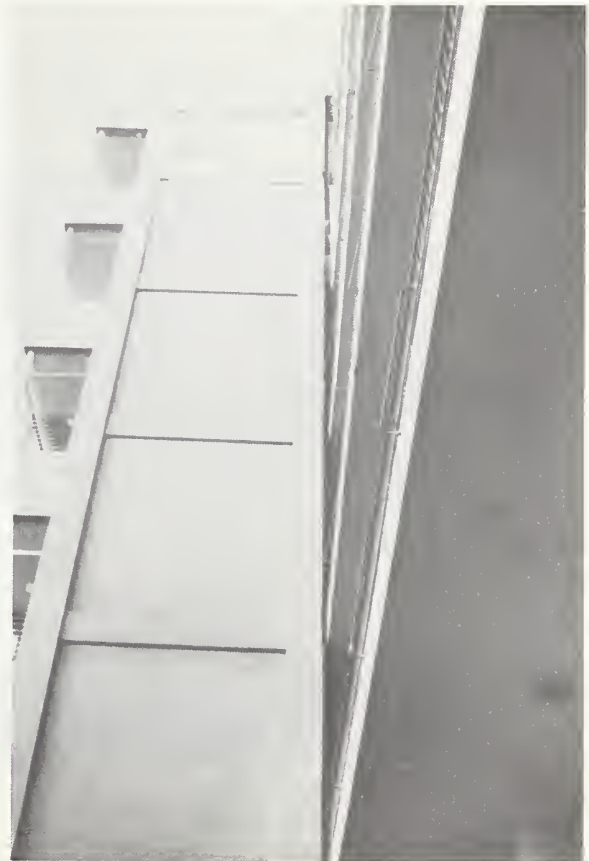
This "Reticular" flat plate building has a permanent deformation of approximately 15 cm toward the west at the top floor, figure 46-2. Cracks exist at bottoms of slabs along column lines where bottom reinforcement was stopped or lapped, figure 46-3. Flexural cracks appear in columns, figure 46-4. The structure is still intact and the building may be restored by adding reinforced concrete shear walls after an appropriate analysis. It should be closed until repaired.

Figure 46-2 Displacement of building and cracking of slabs, Instituto Pedagógico.

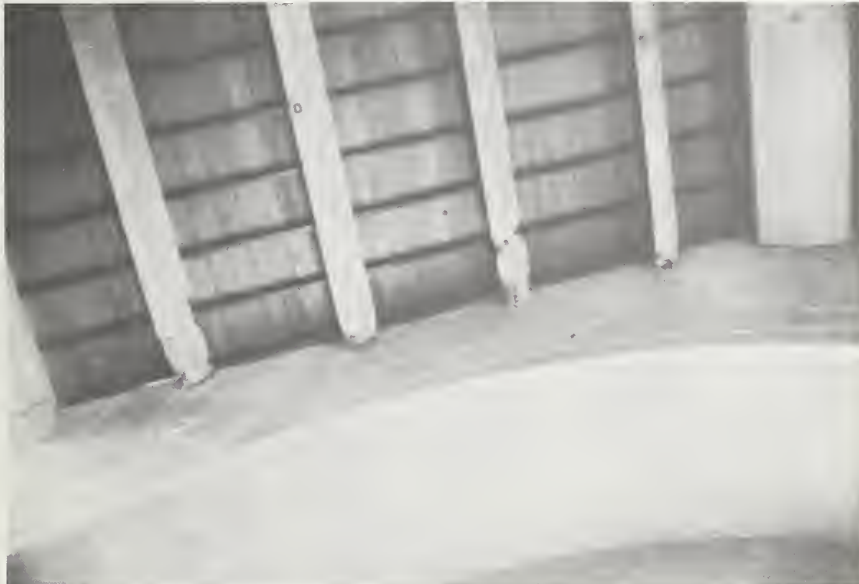
Several arches were structurally damaged by transverse motion, as well as the structure near the east end, figures 46-5 and 46-6. The building is not in danger of collapse but should be repaired (after an appropriate analysis) as soon as possible. It should be closed until repaired.

Figure 46-6 Damages at ends of beams at connections to arch, Instituto Pedagógico.

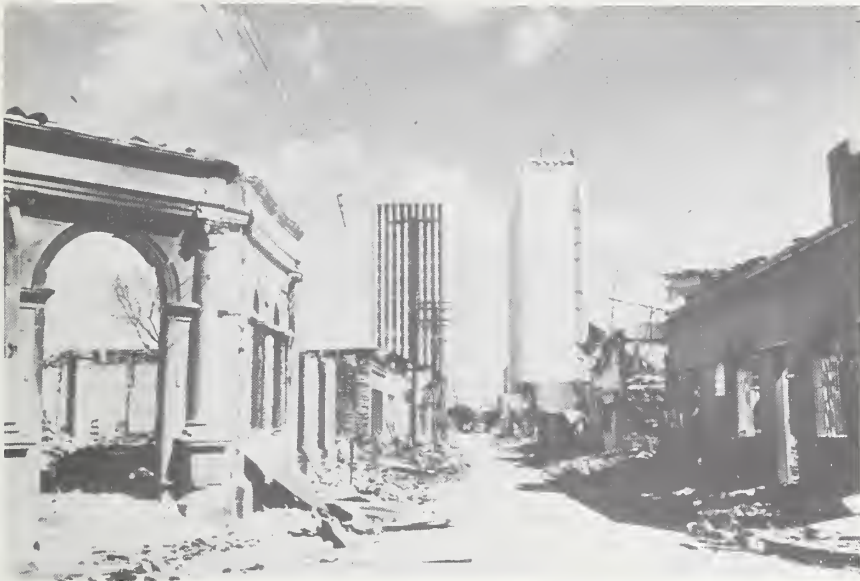
Figure 52-2 Collapsed auditorium and cracked infill walls on framed tube tower.

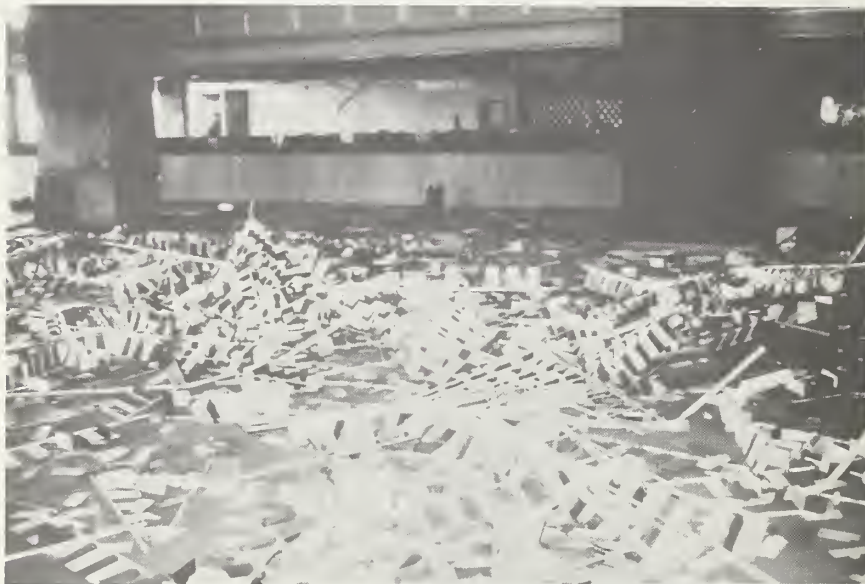
The frame was sufficiently flexible to allow extensive non-structural interior damage, figures 52-3 and 52-4.

Figure 52-4 Suspended ceiling fallen to floor of main lobby, Banco Central.

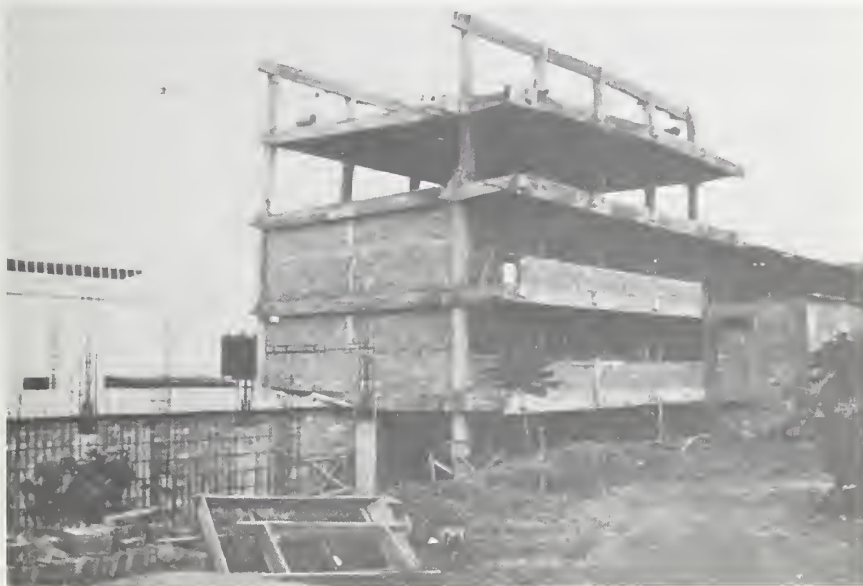
Figure 53-4 Frame failures in building under construction, Seminario Catolico.

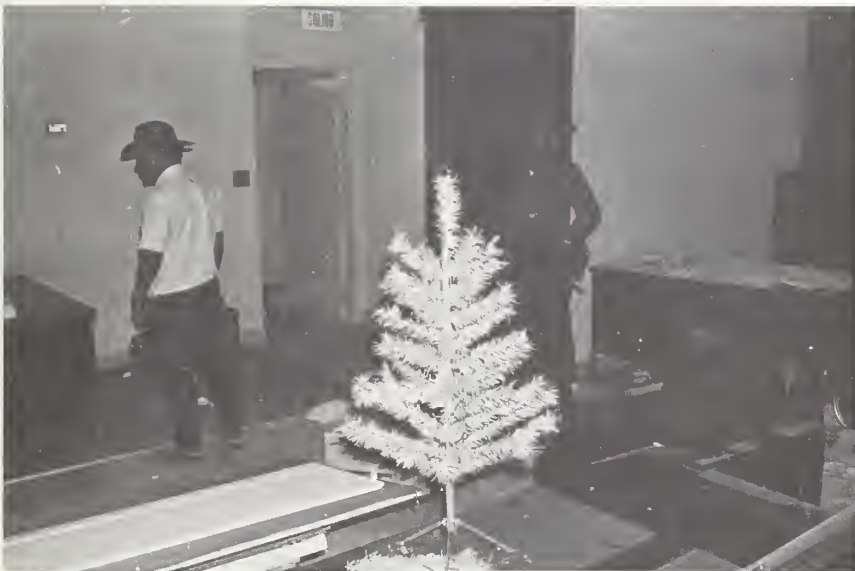
The good condition of the interior shows the advantages of the drift restraint provided by shear walls, figure 54-2.

Figure 54-2 Good condition of interior due to control of drift, Banco de America.

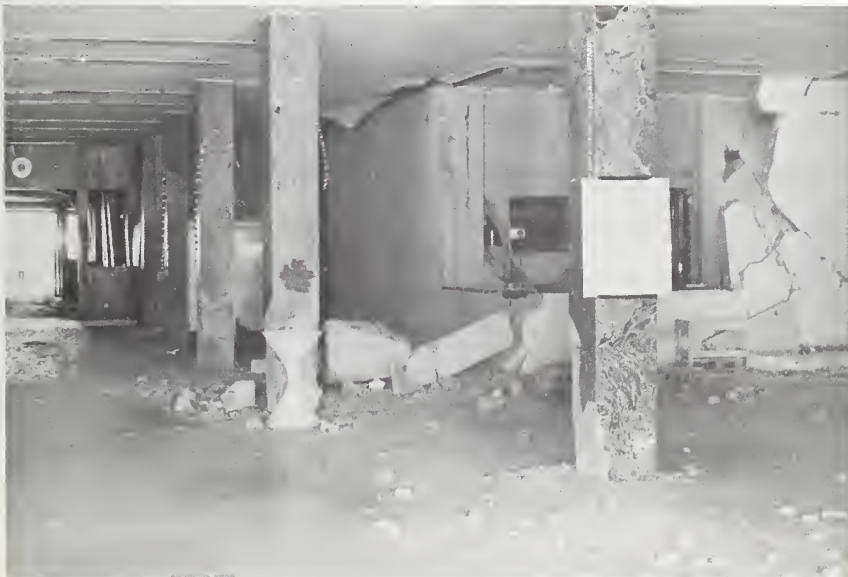
Figure 55-6 Interior view at main entrance, only nonstructural damage apparent, Hospital General El Retiro.

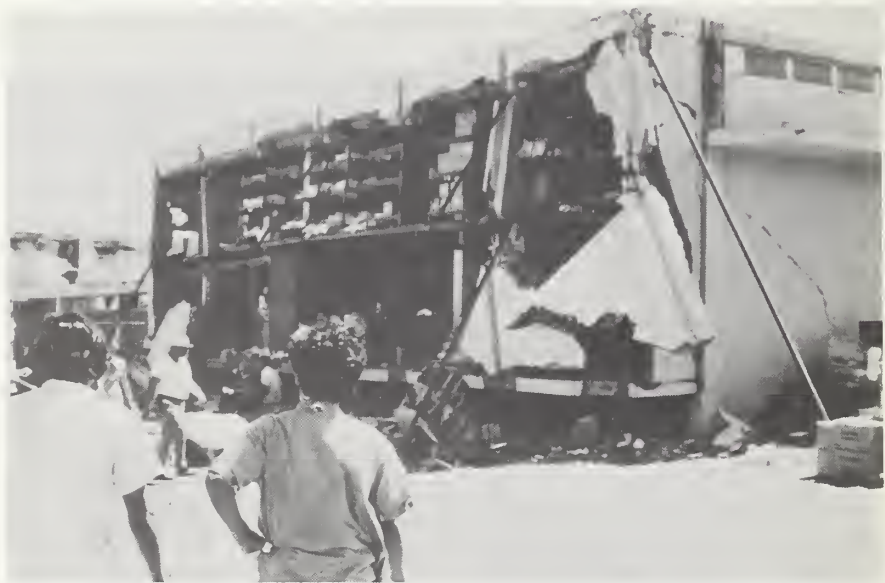
The insubstantial warehouse for medicines was essentially collapsed; the vital supplies conserved by the strength of their shelving, figure 55-8.

Figure 55-8 Medical supply warehouse supported by shelving inside, Hospital General El Retiro.

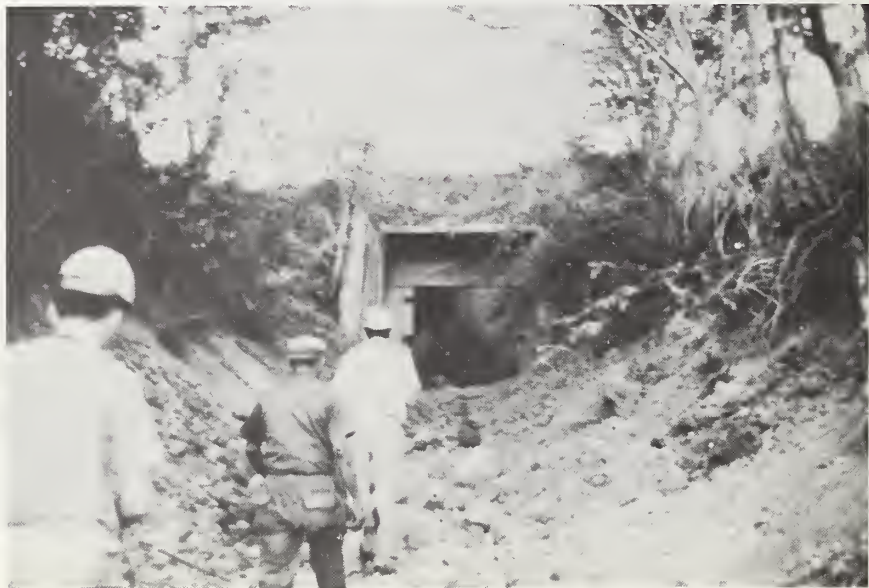
The structures are in good condition except that the wing walls at the entrances of storerooms 14 and 15 have fallen and should be repaired prior to the rainy season, figure 57-3. The metal door of storeroom 15 should be adjusted for easier use.

Figure 57-3 Wing wall collapsed at right of entrance, Bodegas de Almacenamiento de y Morocon.

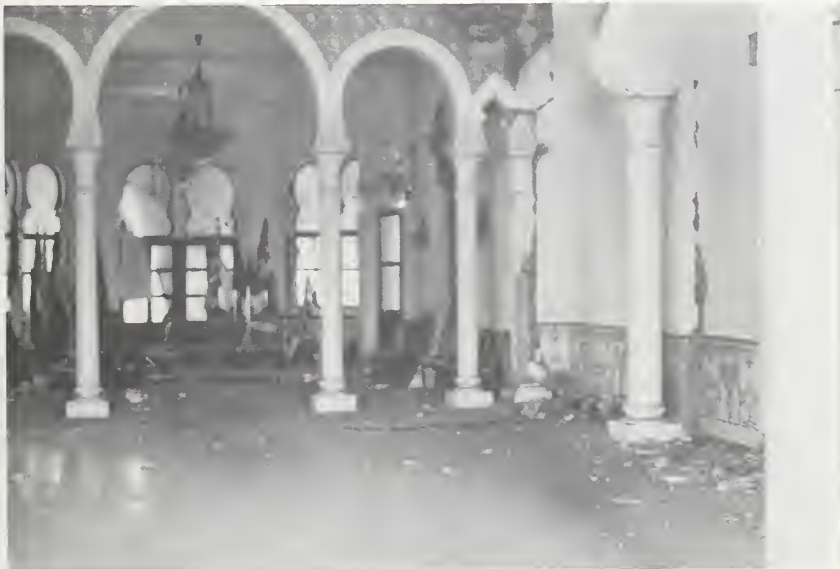
The coverings of terraces at the northeast and northwest of the principal entrance have fallen, figures 57-1 and 60-2. These were steel truss roof elements supported by reinforced concrete columns and beams. The ground floor of the building shows extensive cracking in the reinforced concrete walls and columns with a concentration of cracking at the levels penetrated by doors and windows, figures 60-3 and 60-4. In these areas, the reinforcing was revealed to be undeformed bars. The floor at the back of the main lobby is settled; it was not ascertained whether there was earthfill or damaged structure below this. The western portion of the second floor shows very little damage. In the central portion, the fireplace wall shows extensive cracking and the south central portion of the floor is displaced south toward the crater lake Tiscapa. The roof of the building does not show cracking but major elements of the building are separated.

Figure 60-4 Interior damage in main lobby, Casa Presidencial.

The building requires extensive and expensive repairs. However, it would be essential to assure stability of the foundations of the building prior to any consideration of repairs. At present, the building site appears to be sliding both to the north down the side of the hill and to the south into the crater lake, figures 60-5 and 60-6.

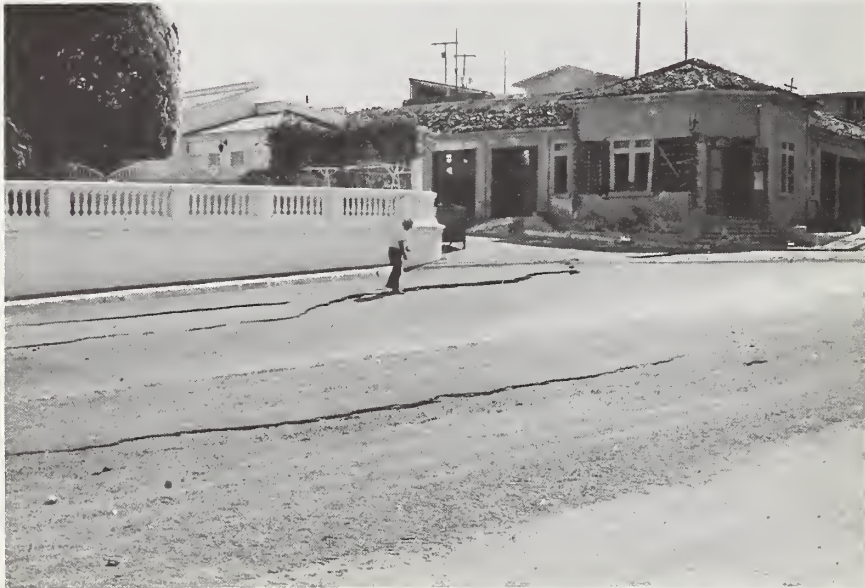
Figure 60-6 Subsidence cracking in road at northwest of Casa Presidencial.

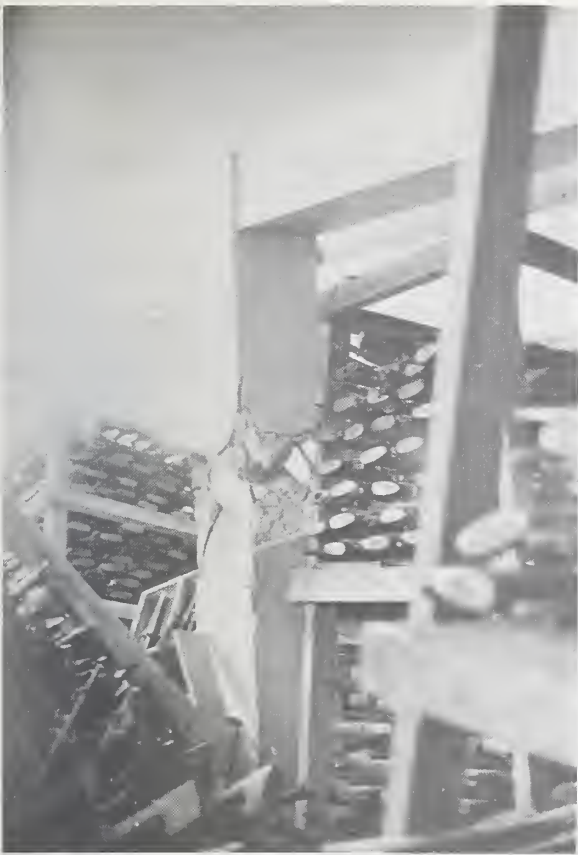
One of the two roof towers has fallen and penetrated the ceiling of the lobby at the entrance of the first floor, figures 61-1 and 61-2. The other tower is sheared and ready to fall. There is extensive wall, beam, and column cracking in the first floor of the building. In the basement of the building there is heavy cracking of the walls, light cracking of some columns, and heaving of the floor or penetration of the wall footings. At the west end of the basement, the east wall is heavily cracked, a west end column is crushed at mid height, figure 61-3, and many columns are lightly cracked.

Figure 61-3 Column crushed in basement, Residencia Jefe Director.

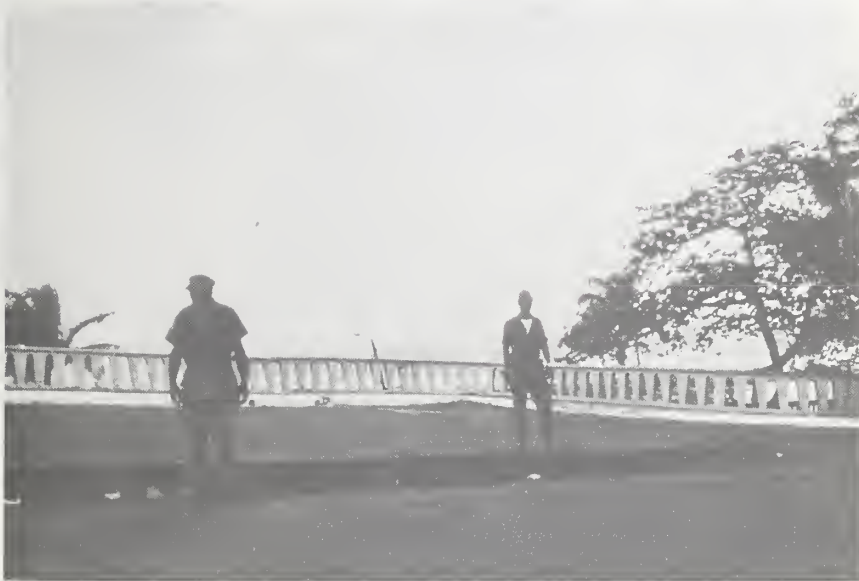
The foundations of the building and the site in general show evidence of instability, figure 61-4. In this area, the movement of the building appears to be down and south into the crater lake. Repair of the building would be an extensive and expensive operation. It should not be undertaken unless stability of the foundations can be assured.

Figure 61-4 Slide movement in front of Residencia Jefe Director.

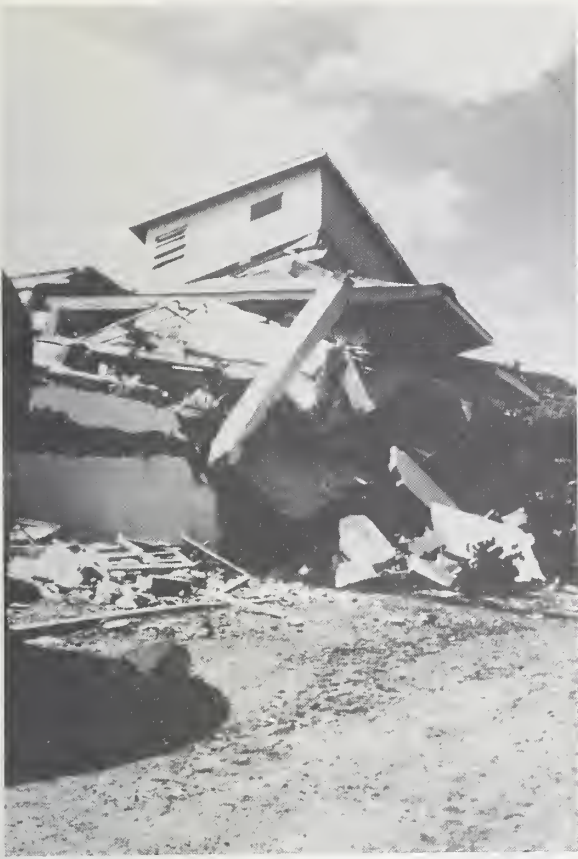
The buildings of the Gerente General, the warehouse immediately west, and the vehicle storage building to the southwest were inspected. The two story building of the Gerente General which had a reinforced concrete frame employing undeformed reinforcing, was completely collapsed, figures 68-1 and 68-2. The warehouse was made up of barrel shells, about 30 ft wide and 200 ft long, supported by reinforced concrete columns at the edge lines on approximately 20 ft spacing. The exterior columns have failed completely at the top of partial height infill walls which increased the column stiffness and thereby the column shear, figures 68-3 and 68-4. Interior columns showed some damages at the top. Repair may be possible, but will require substantial reconstruction and improvement of the roof support system.

Figure 68-1 View of general collapse, Aduana General de Managua.

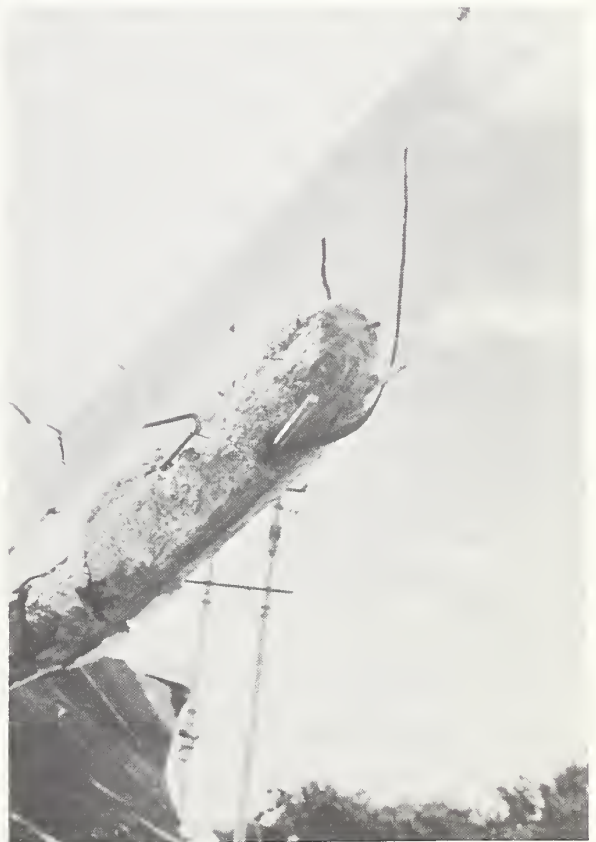
Figure 68-2 Close up of columns showing undeformed, lightly tied reinforcement, Aduana General de Managua.

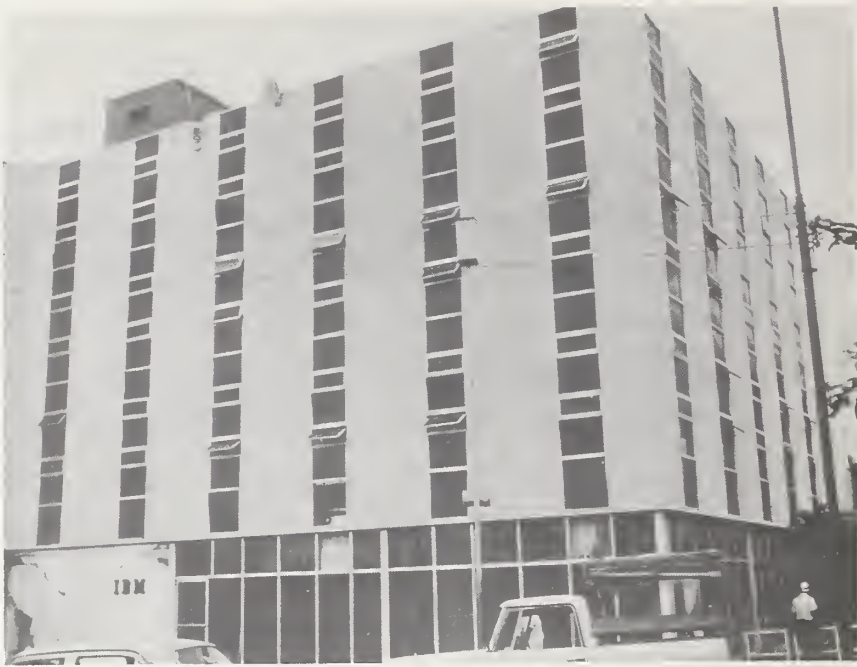
This is a four story steel frame building without a basement, figure 72-1. It is a moment resistant frame with corrugated metal floor decking on steel bar joists with 1 1/2 in of concrete floor surfacing. The exterior wall cladding is steel above the first floor level.

Figure 72-1 General view of IBM building.

The building appears safe for occupancy. Structural connections should be checked individually to look for weld cracking that is difficult to see in a cursory inspection. A more careful investigation should be conducted to define whether it is necessary or desirable to straighten the deformed columns in the first story.

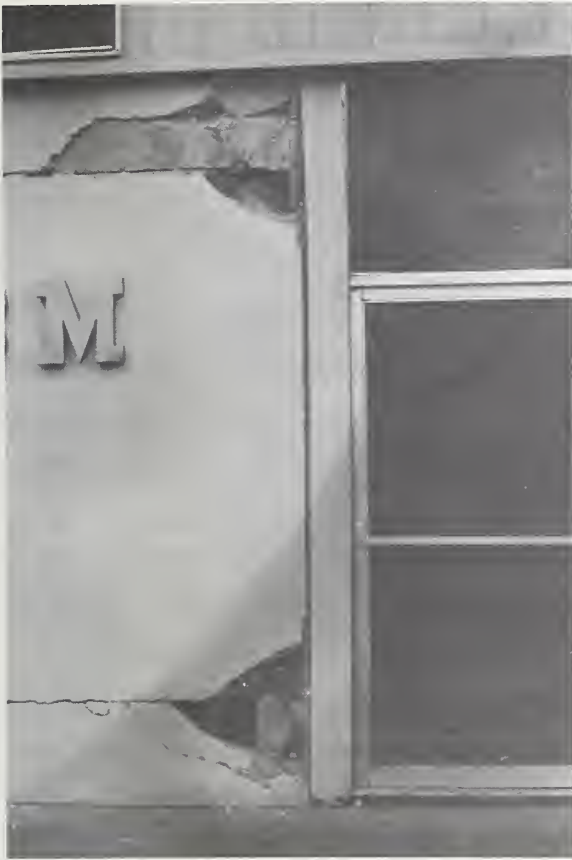
There is evidence of inelastic deformation in the first floor columns. Anchor bolts are lifted as much as 1/4 in along the north side of the building, figure 72-2. Infill concrete block panels at the first floor entrance have cracked; the resulting concentration of deformation has deformed the column at the door frame on the west side, figure 72-3. The weld of the staircase framing to the columns has fractured in this vicinity. At the east side of the south wing of the building, partial height partition walls have led to concentration of deformations in the columns, figure 72-4. This has broken a 6 by 6 in reinforced concrete column reinforced with four number three bars and has deformed the W12X31 steel columns about two in horizontally to the north in the first story at the southeast corner of the building.

Figure 72-3 Column deformation at IBM building caused by cracked infill panel.

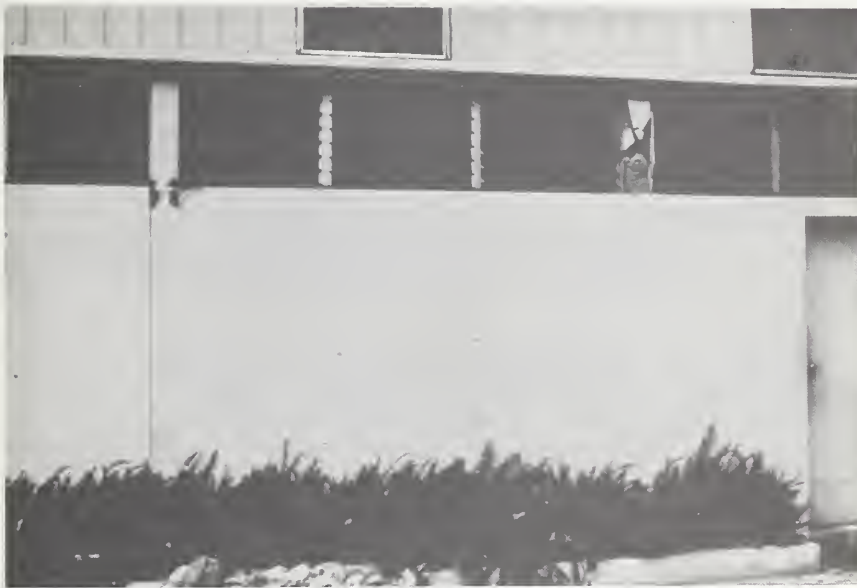
Figure 72-4 Column damage caused by partial height infill wall, IBM building.

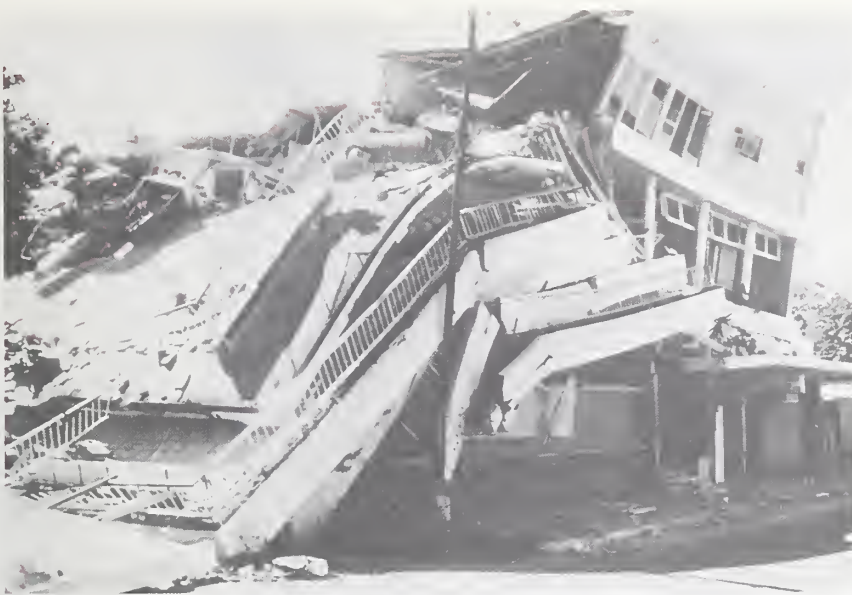
This was a five story reinforced concrete frame building at the corner of Calle 27 de Mayo, one block from Bolivar Avenue. One column observed was reinforced with six No. 8 plain bars. A large portion of the building has collapsed, figures 74-1 and 74-2. In the remaining part of the building, it is evident that partial height infill walls contributed to failures of the columns.

Figure 74-1 Four of five stories collapsed, Edificio Guerrero Pineda.
