NBS TECHNICAL NOTE 807

Building Performance in the 1972 Managua Earthquake

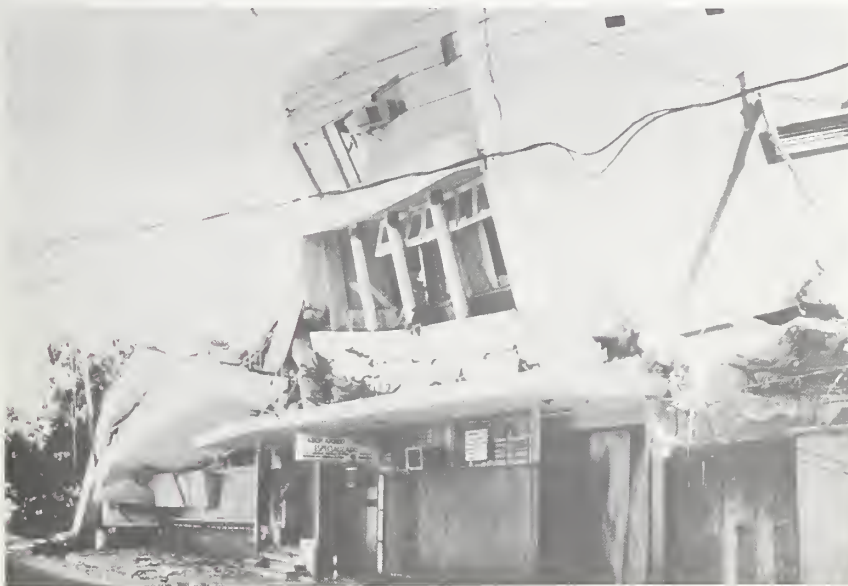
This was a five story reinforced concrete frame building at the corner of Calle 27 de Mayo, one block from Bolivar Avenue. One column observed was reinforced with six No. 8 plain bars. A large portion of the building has collapsed, figures 74-1 and 74-2. In the remaining part of the building, it is evident that partial height infill walls contributed to failures of the columns.

Figure 74-2 Three of five stories of the Edificio Guerrero Pineda standing at this end.

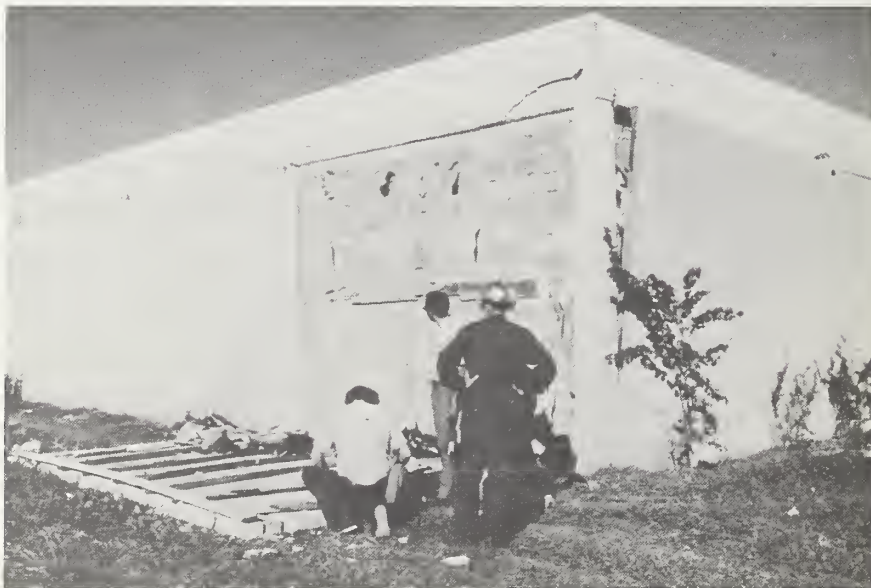
The building is extensively damaged. The cavity walls which were not tied together across the cavity or tied to the columns or beams have suffered a number of failures, some leaning out, some completely fallen, figure 75-2. Exterior columns are sheared at the top. Much of the suspended ceiling has fallen inside the building.

Figure 75-2 Falling of cavity walls and shearing of
frame columns, Instituto Geografico
Nacional.

The building should be evacuated and repaired before further use. Special attention is required to repair and reinforce the exterior walls and columns. It may be desirable to provide a shear wall in place of the present curtain walls.
