DUTCH
SAFETY BOARD

Gear collapse during landing

The Hague, May 2018.

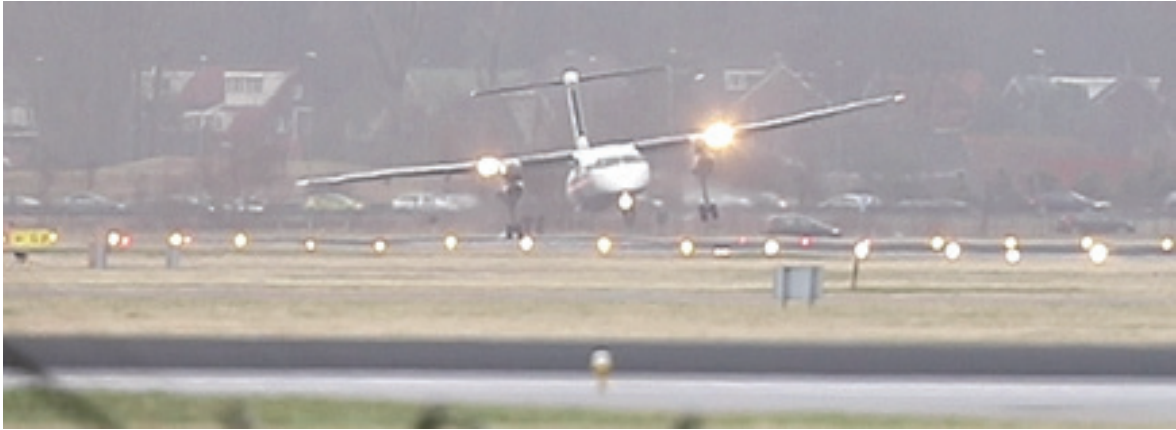
Figure 3: moment of touchdown, frontal view. (still of video)

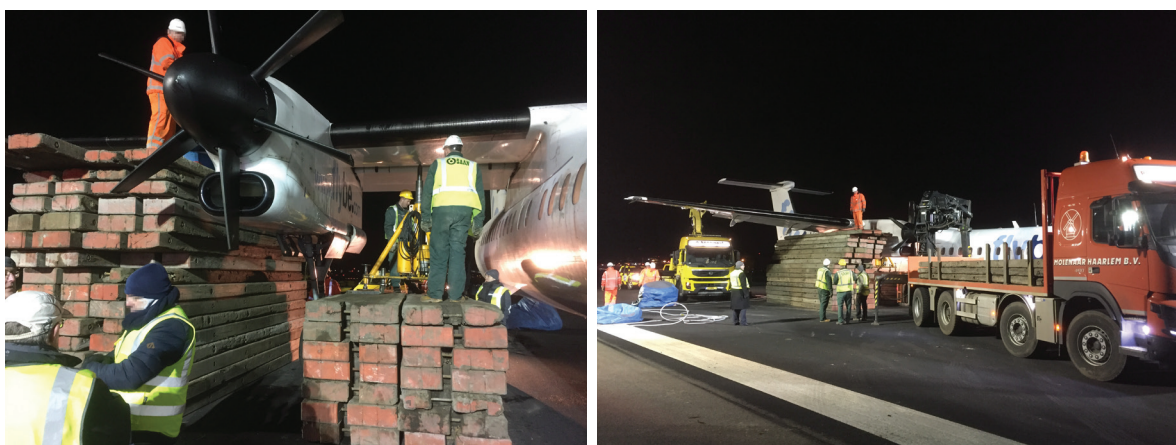
After the accident the aircraft was inspected for damage in the right-hand main landing gear area. The right-hand MLG was positioned in the wheel well, the wheel well was resting on the tarmac. After it was determined that there was no obvious damage, the aircraft was salvaged using long wooden beams, air cushions and hydraulic jacks. The jacks were positioned in accordance with the maintenance manual. The aircraft was raised high enough to make the extension of the right hand main landing gear possible. There was no visible damage to the gear attachment points and no evidence of contact between the tires and the nacelle side walls. The MLG was then manually lowered and locked into position without problems, without use of hydraulic power. There were no visible abnormalities on the main landing gear or the main landing gear support after the gear was lowered. After the aircraft was standing on its three landing gears, the aircraft was slowly towed into a hangar for further inspection.

Figure 6/a: lifting the aircraft using large wooden beams and hydraulic jacks. (Source: Dutch Safety Board)

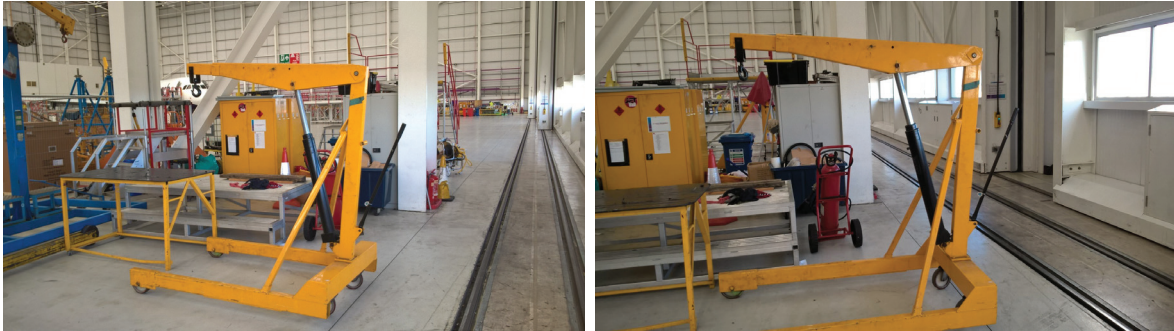
On the evening before the day of the occurrence, maintenance had been performed on the aircraft at one of the company’s sub-contractor’s maintenance facilities. Here, as part of scheduled maintenance, the right hand landing gear stabiliser brace assembly was replaced. The stabilizer brace assembly comes with pre-installed proximity sensors, thus by replacing the brace, the sensors are also replaced. Brace assembly with serial number MAL-SP-0556 was replaced with MAL-SP-0547. The maintenance crew reported nothing unusual was found during and after the maintenance activities.

Figure 7: example of manual cranes used to lift the main wheels from the ground when replacing the brace assembly. (source: maintenance facility)

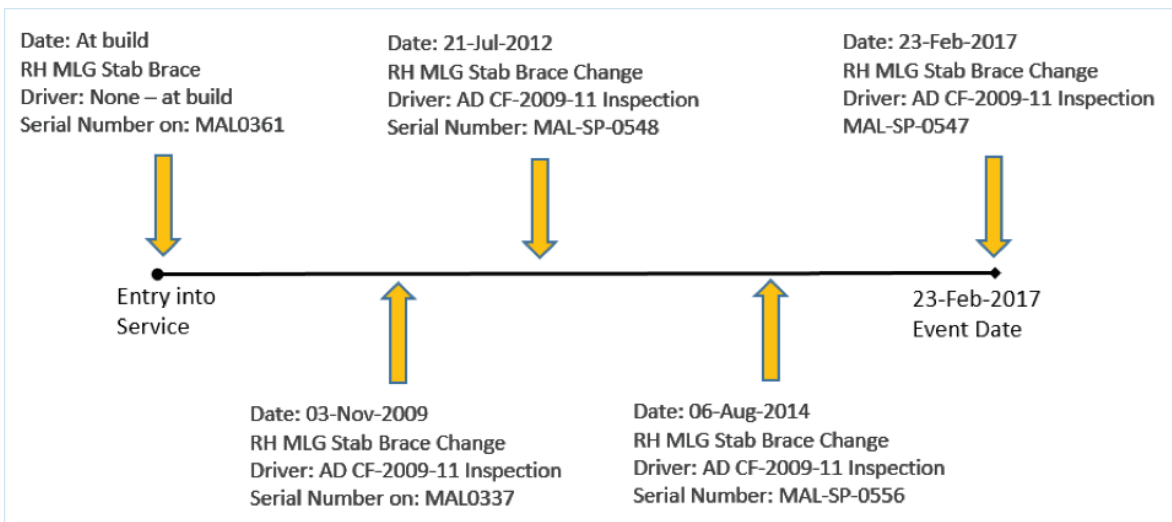
The operators Part-M maintenance records indicated the main gear fitting was original fit to the aircraft and has not been overhauled since delivery. There have been 5 stabilizer-braces installed to this leg during its service life. These changes have all been planned events due, either to, scheduled maintenance / modifications requirements or mandatory instruction (e.g. Airworthiness Directive). For illustration purposes, the following delineates the timeline of aircraft entry into service and associated stabilizer brace changes to event date are depicted in Figure 8.

Figure 8: timeline of aircraft entry into service and associated stabilizer brace changes.

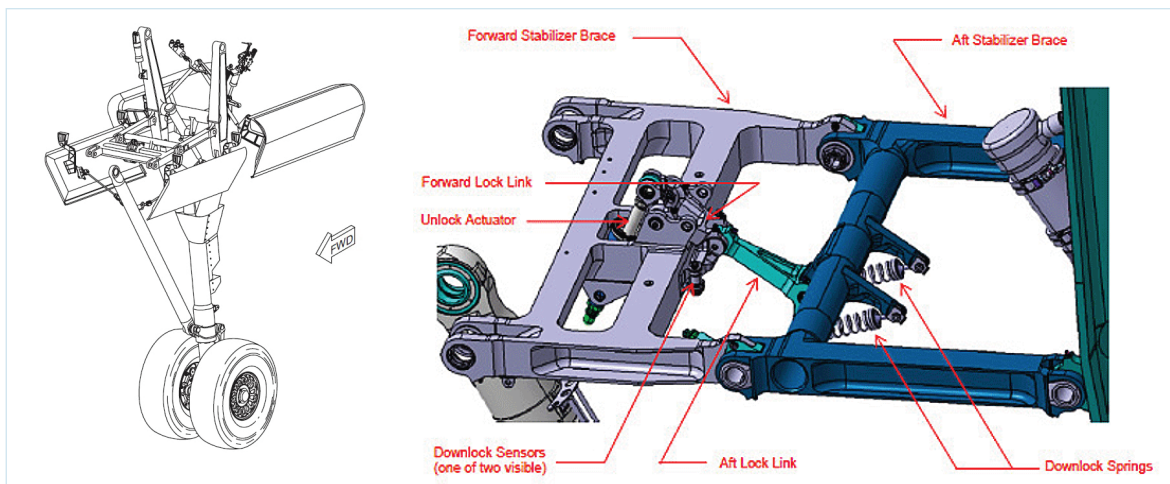
The stabilizer brace is a 2-piece folding structural component (figure 14). The stabilizer brace keeps the yoke and the shock strut in position when the MLG is in the extended or retracted position. The forward section of the stabilizer brace is attached to the airframe structure in the forward section of the nacelle / landing gear bay with 2 hinge points. The aft section of the stabilizer brace is attached to the yoke of the MLG, also with 2 hinge points.

Attached between the 2 sections of the stabilizer brace is an over-centre link sub-assembly that comprised of forward and aft lock links. The mechanical lock is released by the unlock actuator. The forward and aft stabilizer braces are moved into a mechanical lock position by the down lock springs during the MLG extension sequence. Two lock springs keep the links in the mechanical lock position when the MLG is extended. If there are no anomalies present on the gear, unlock actuator extend pressurization is not required to keep the gear down in lock for original certification load cases.

Figure 14: landing gear and stabilizer brace, locked position, retraction actuator coloured yellow. (source: landing gear manufacturer)

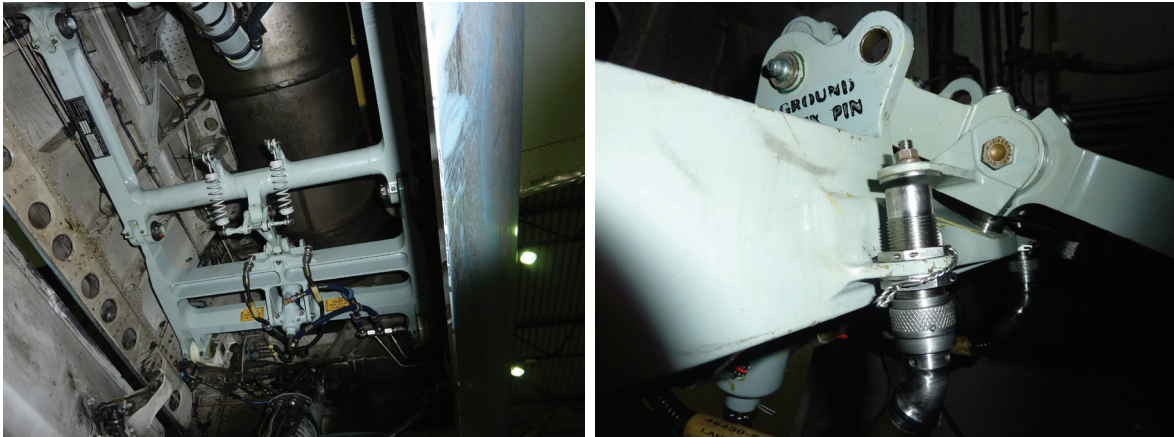
Figure 15: stabilizer brace assembly (left) with gear proximity sensors and target plate (right).

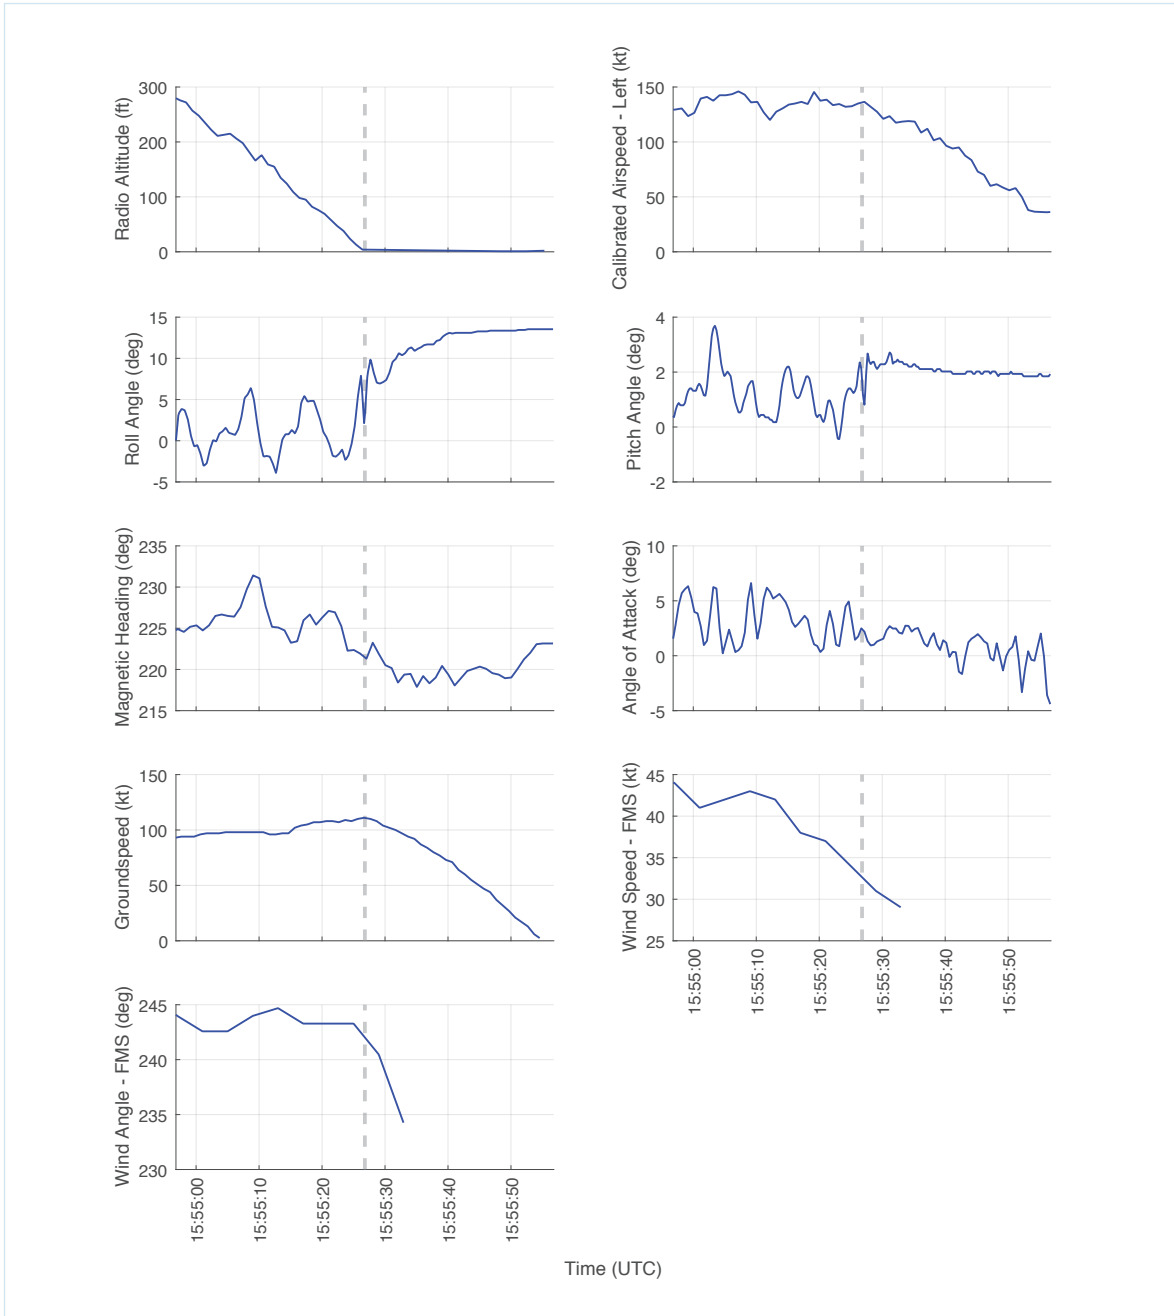
During final approach the calibrated airspeed, roll angle, pitch angle and angle of attack were observed to show large fluctuations. In addition, average wind speed was recorded at approximately 40 knots coming from a mean direction of 243°. The flap position was set at 15 degrees. Furthermore, the propeller rotation velocity for both propellers was constant, slightly above 1000 rpm.

Figure 20: Time-history plot of the aircraft state and wind related parameters as obtained from the decoded FDR data.

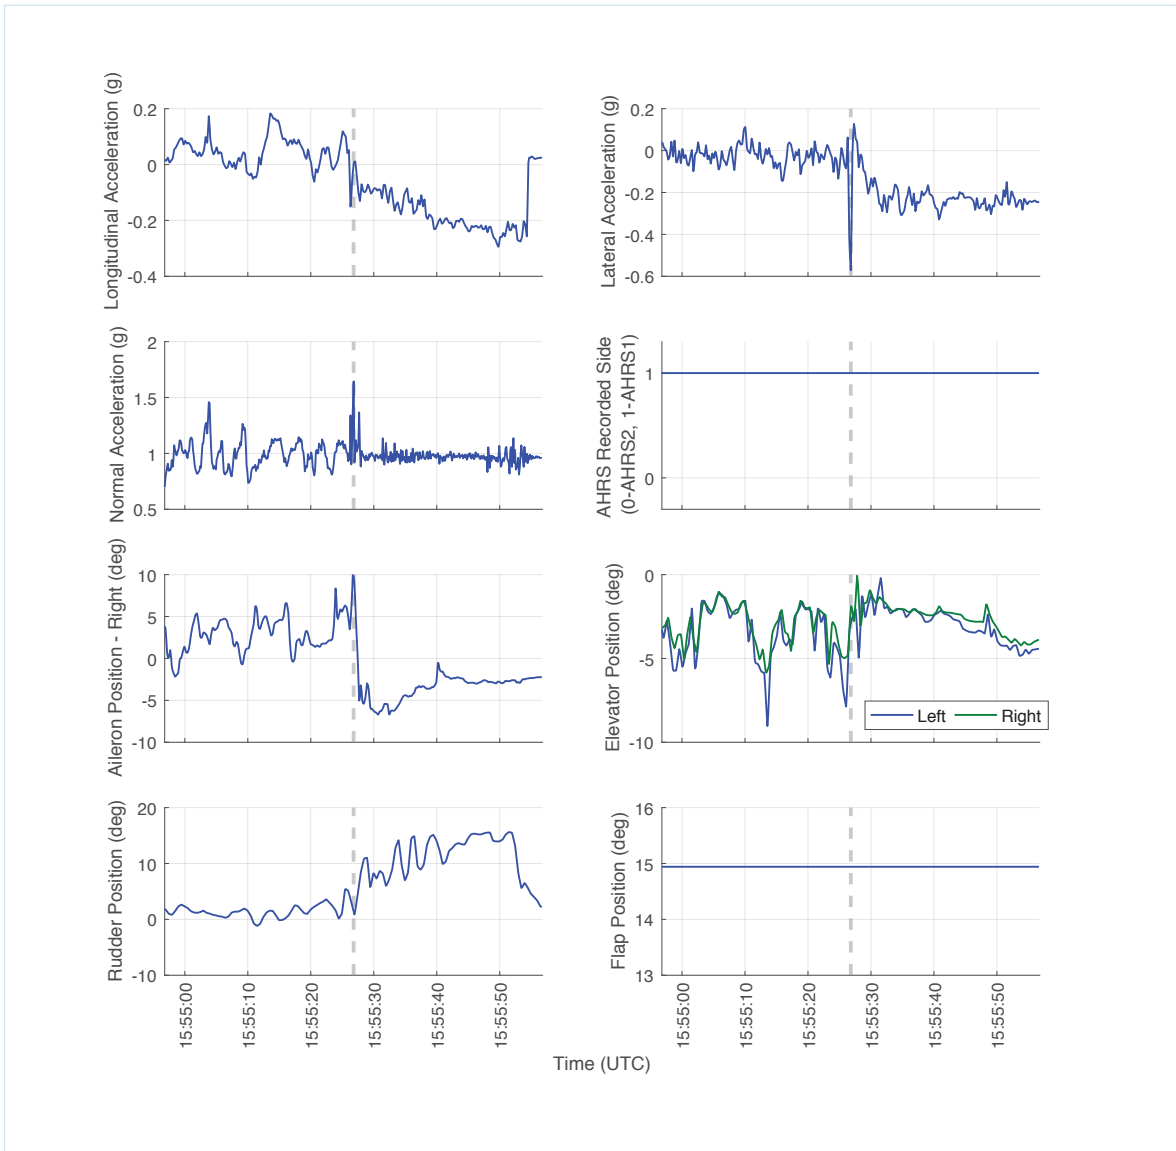
The selected source of the recorded data for longitudinal, lateral and normal accelerations, shown in Figure 21, was attitude and heading reference system (AHRS) number 1. Both AHRS systems are mounted in approximately the same location, at Fuselage Station (FS)³ 373, near the centre of gravity (CG).

Control activity, shown in Figure 21, shows that directly after the initial contact with the runway and only a fraction of a second before the second large magnitude peak in normal acceleration, a positive aileron deflection⁶ of 10 degrees was recorded. Rudder activity then increases and the rudder deflection fluctuates between 7 and 16 degrees. Also, approximately 3 seconds after initial contact with the ground, the right propeller rotation velocity (NP2) falls sharply from around 1,000 rpm to 650 rpm.

Figure 21: Time-history plot of the linear accelerations and position of the control surfaces as obtained from the decoded FDR data.

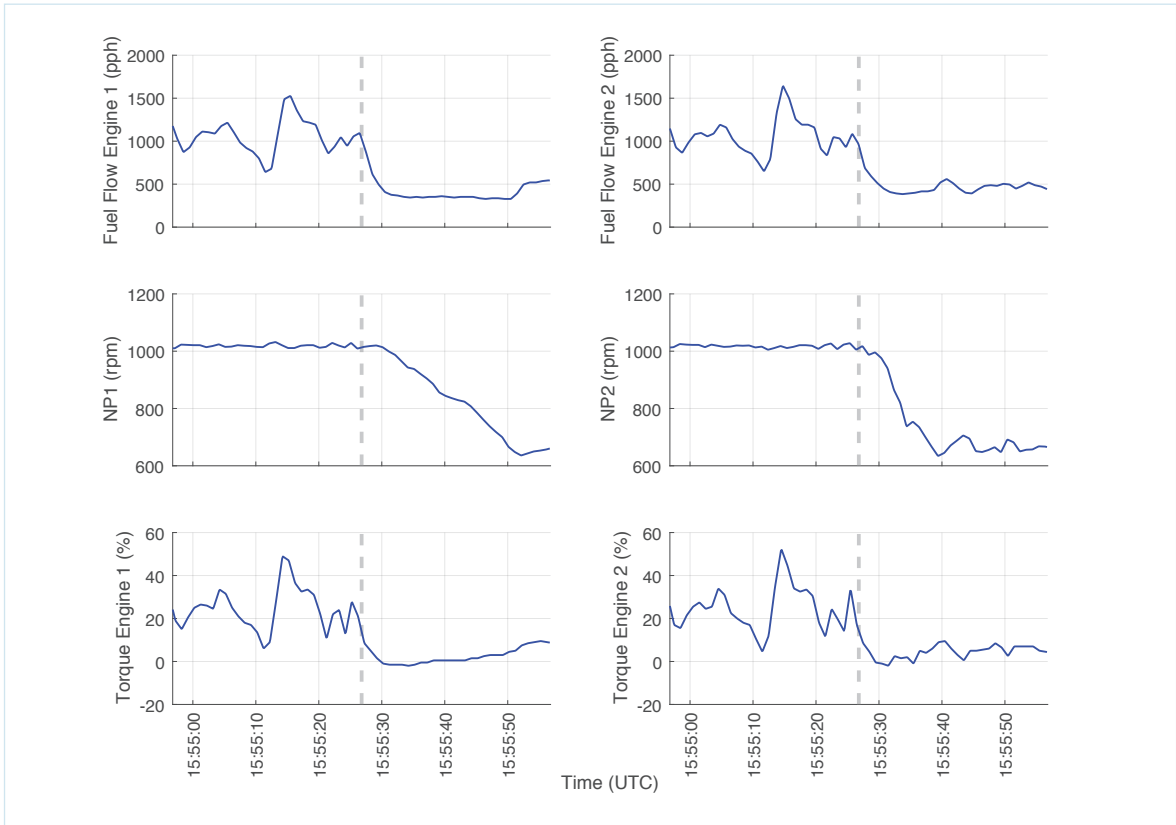
Figure 23: Time-history plot of the fuel flow, propeller rotation velocity and engine torque as obtained from the decoded FDR data.

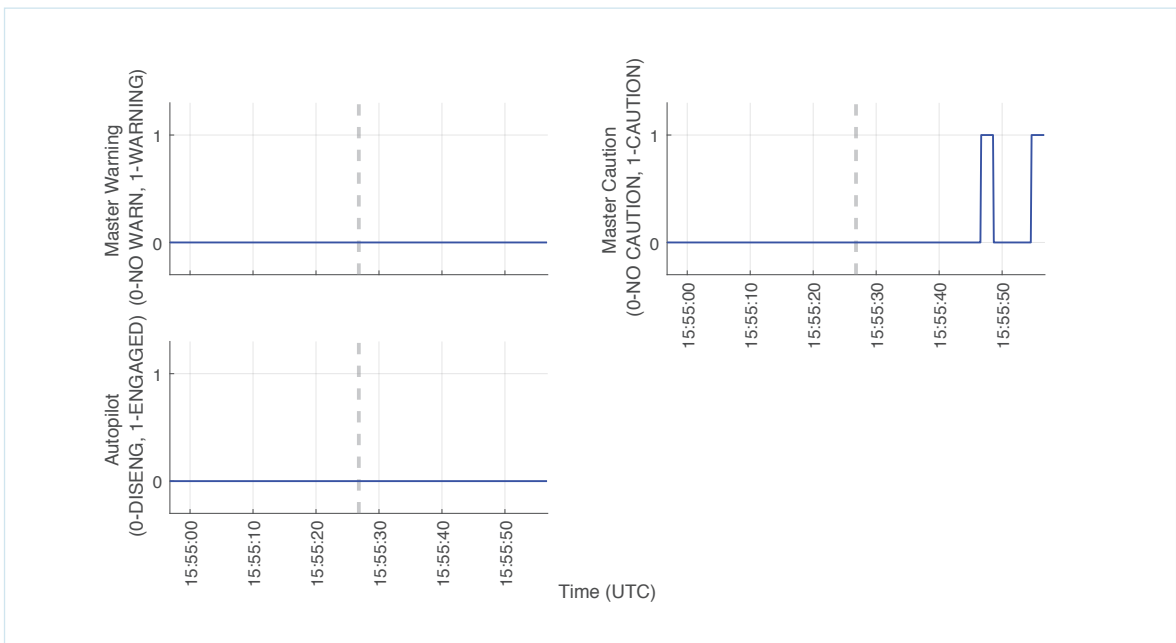
Two master cautions were observed; the first at 15:55:46 – 15:55:48 UTC, the second one was activated at 15:55:54 UTC. No master warnings were recorded.

Figure 24: Time-history plot of the fuel master warning, master caution and autopilot engagement as obtained from the decoded FDR data.
