Name of Target SHIZUOKA A/C PLANT

Location of Target SHIZUOKA

Team No. VI PDD - Job #2

Date 4 Nov 45 **Team Comdr.** Guill

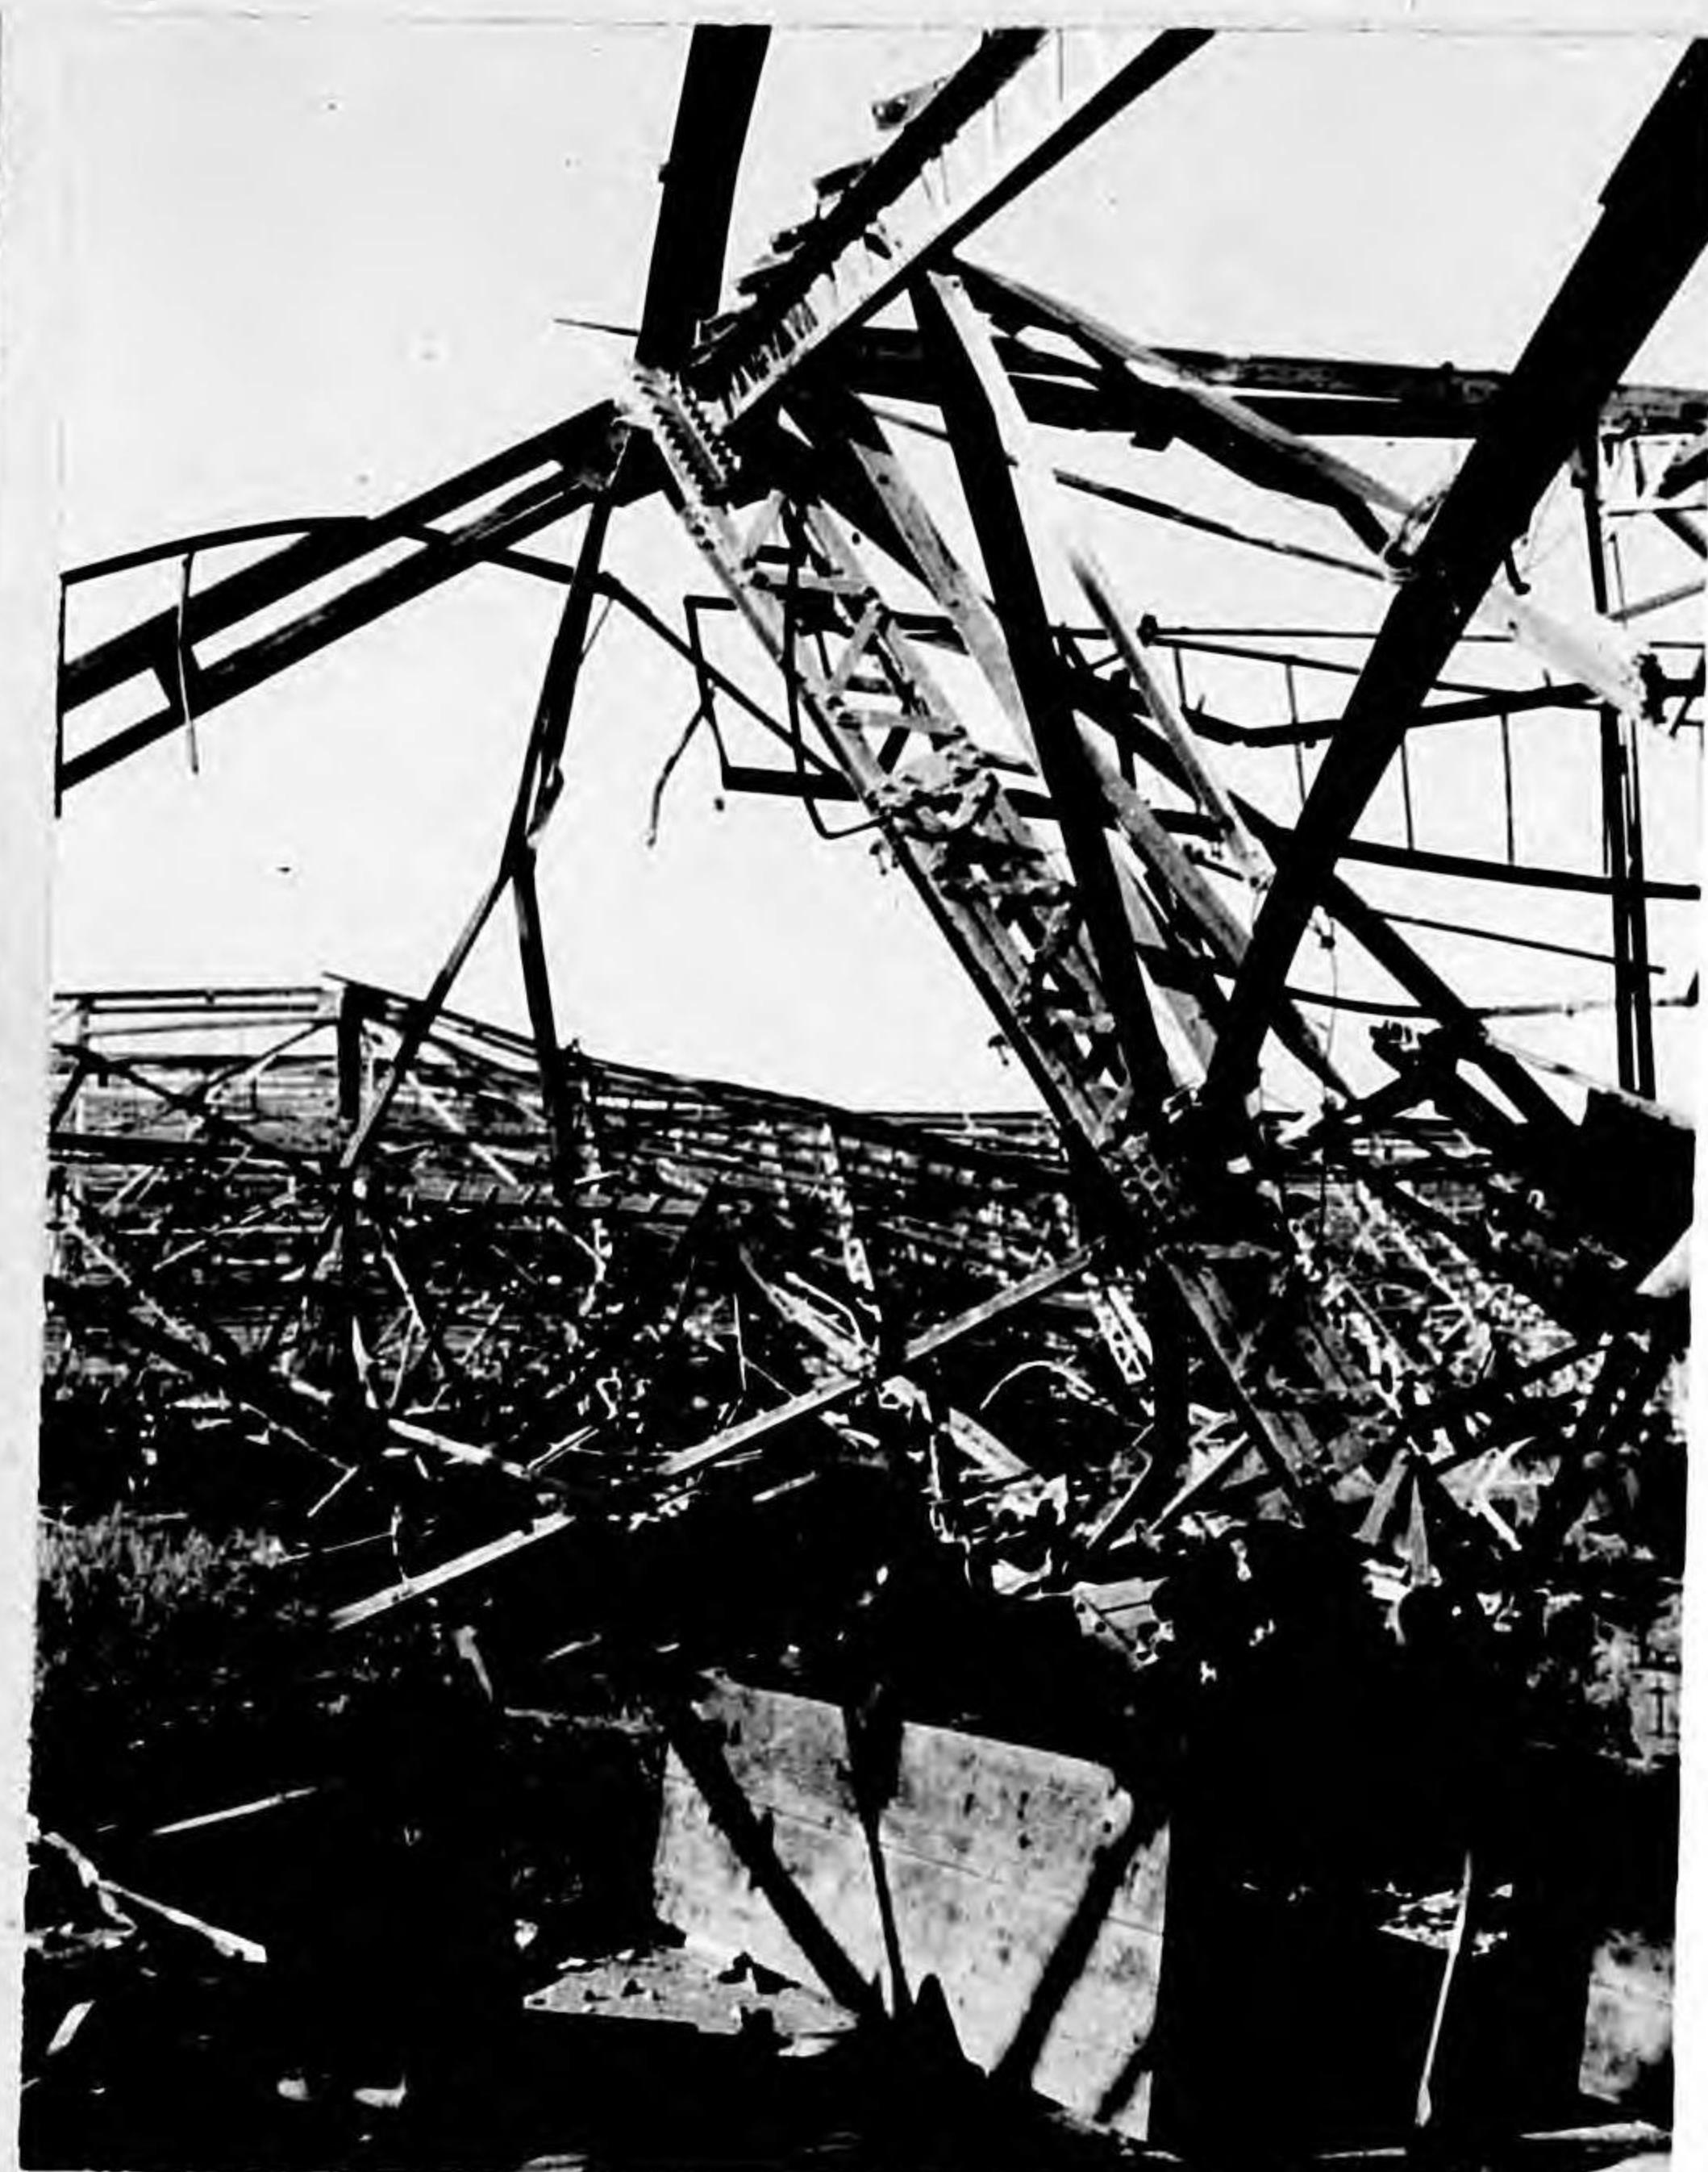
Photo 14 - In the foreground is Column 12-F sheared at the base by Bomb 18 and pushed over, causing partial collapse of the roof.

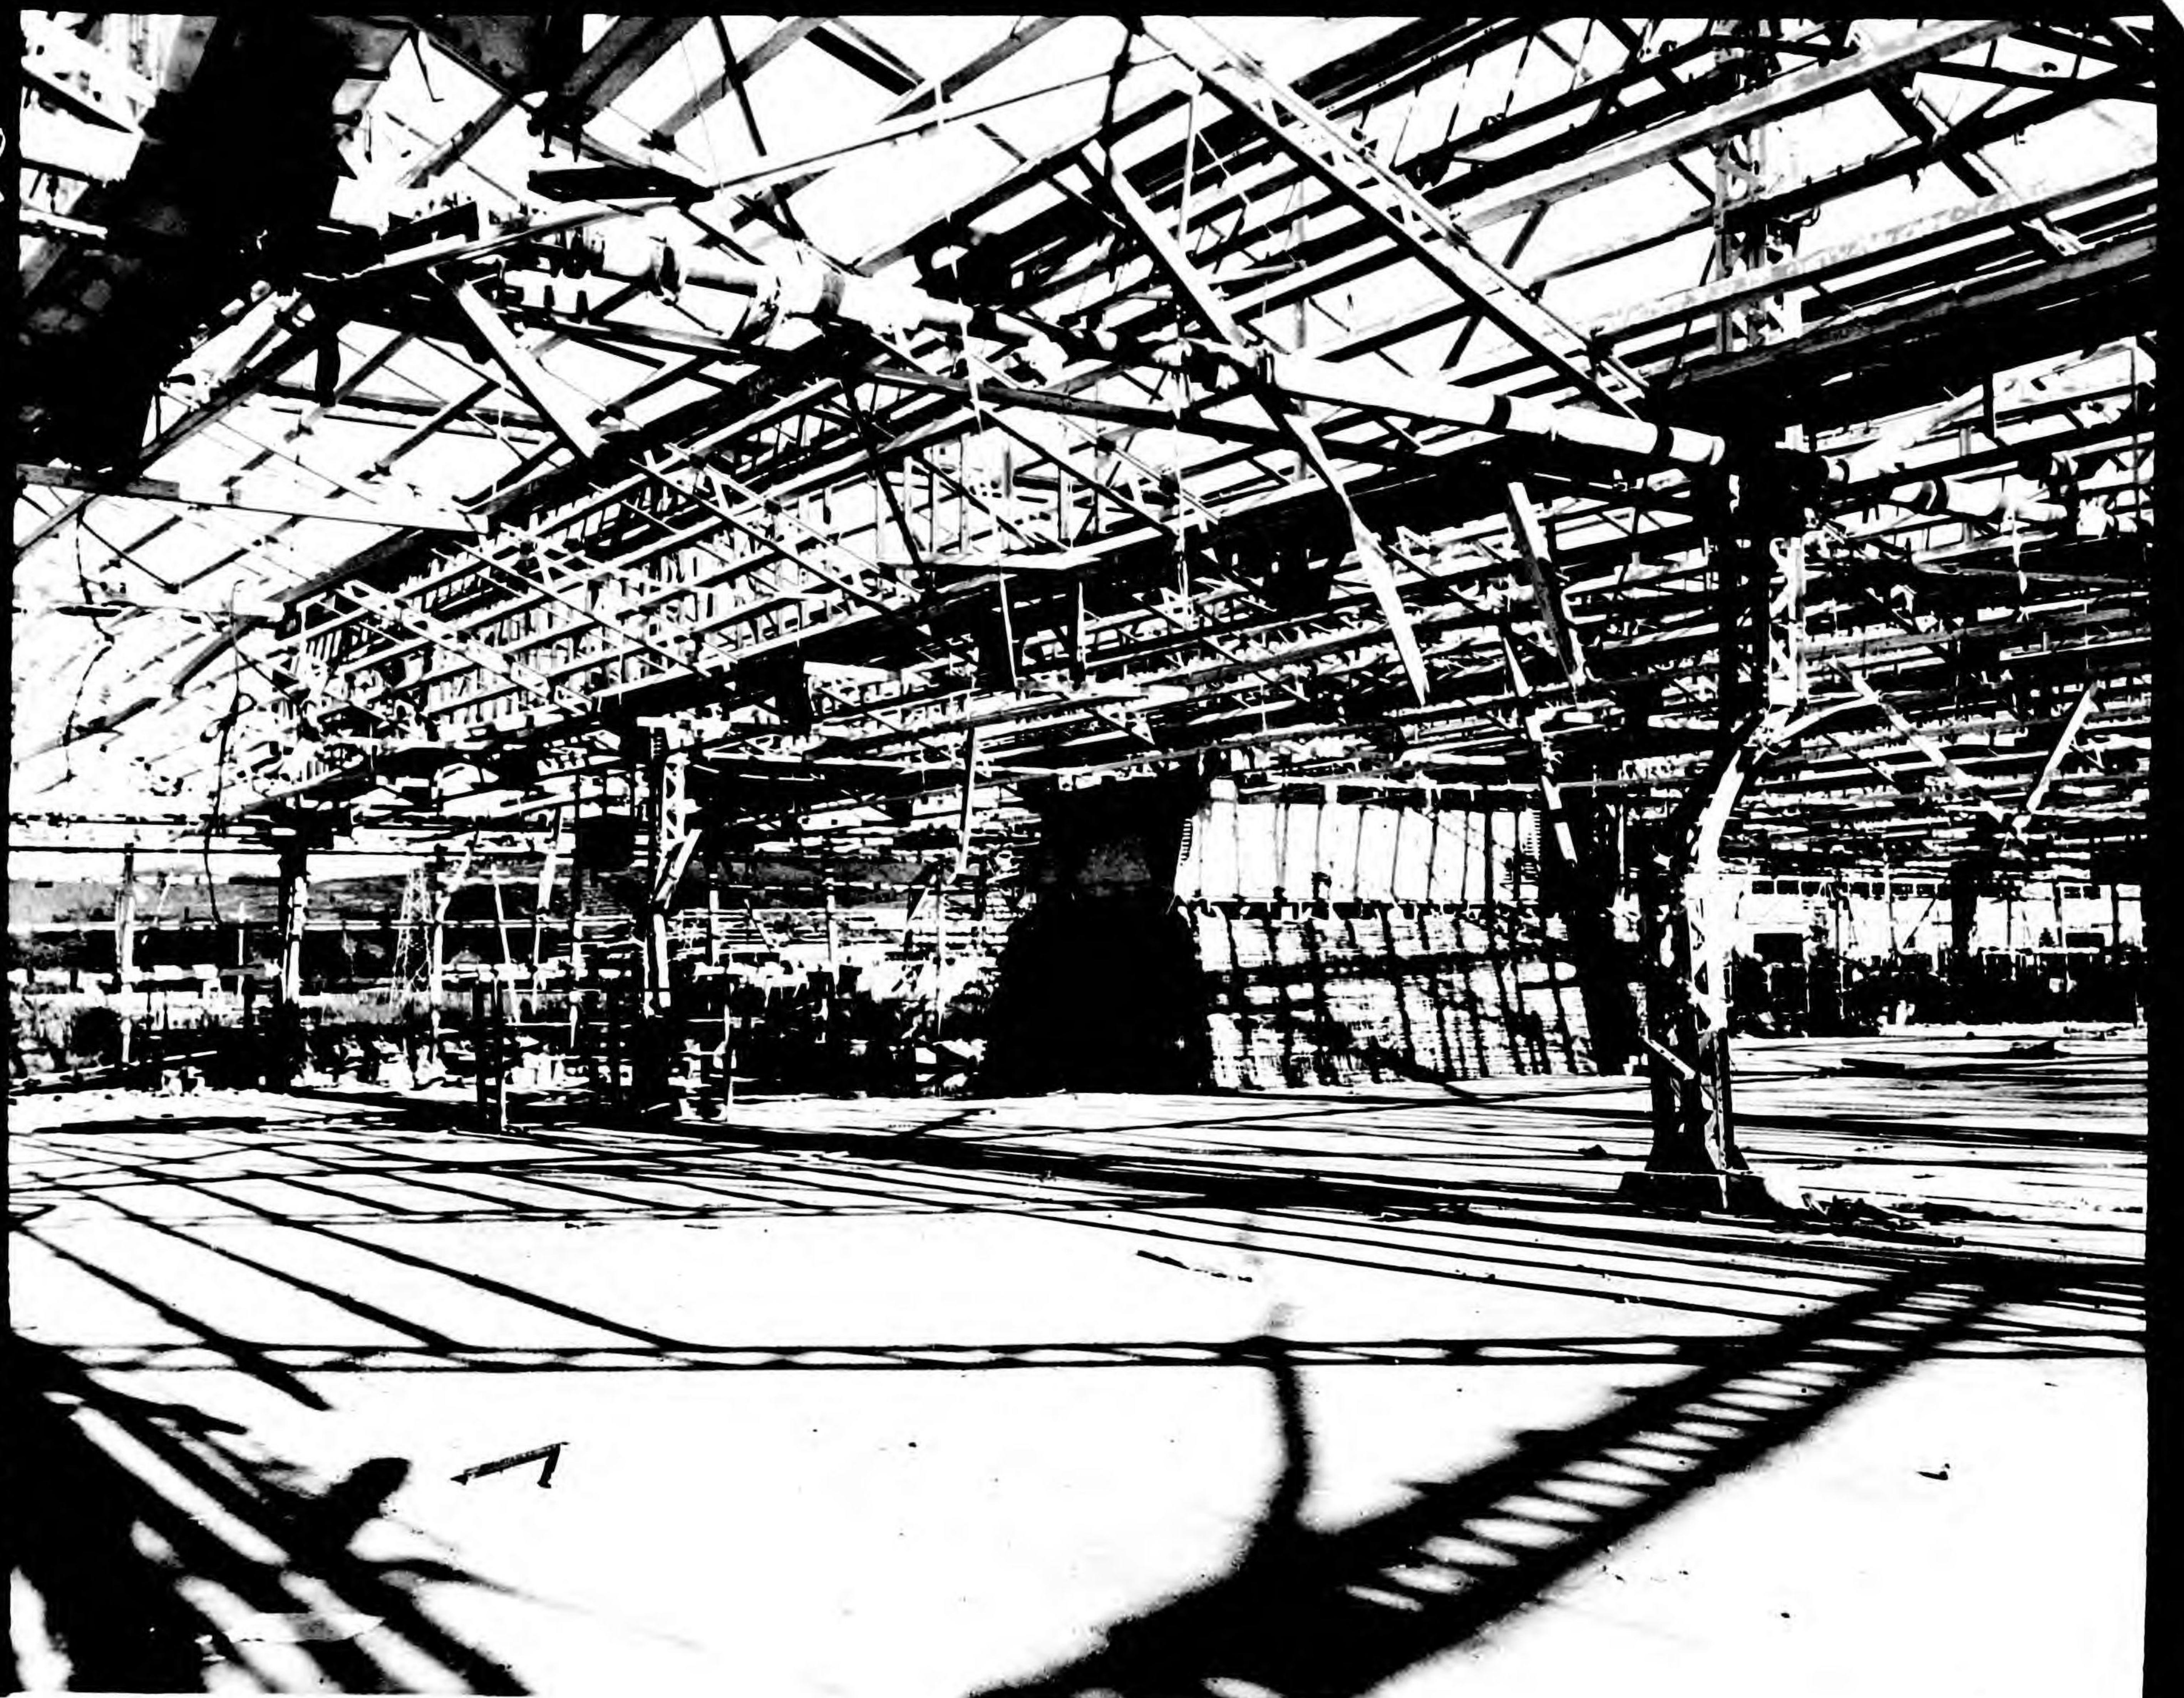
Photo 21 - A detail of Columns 10-J, 10-K and 10-L, showing how the collapse of the roof structure caused by Bomb 19, which detonated out of the picture to the right, racked the structural members and pulled these columns toward the collapsed section. Although not damaged directly by blast, these columns are useless as load-bearing members.

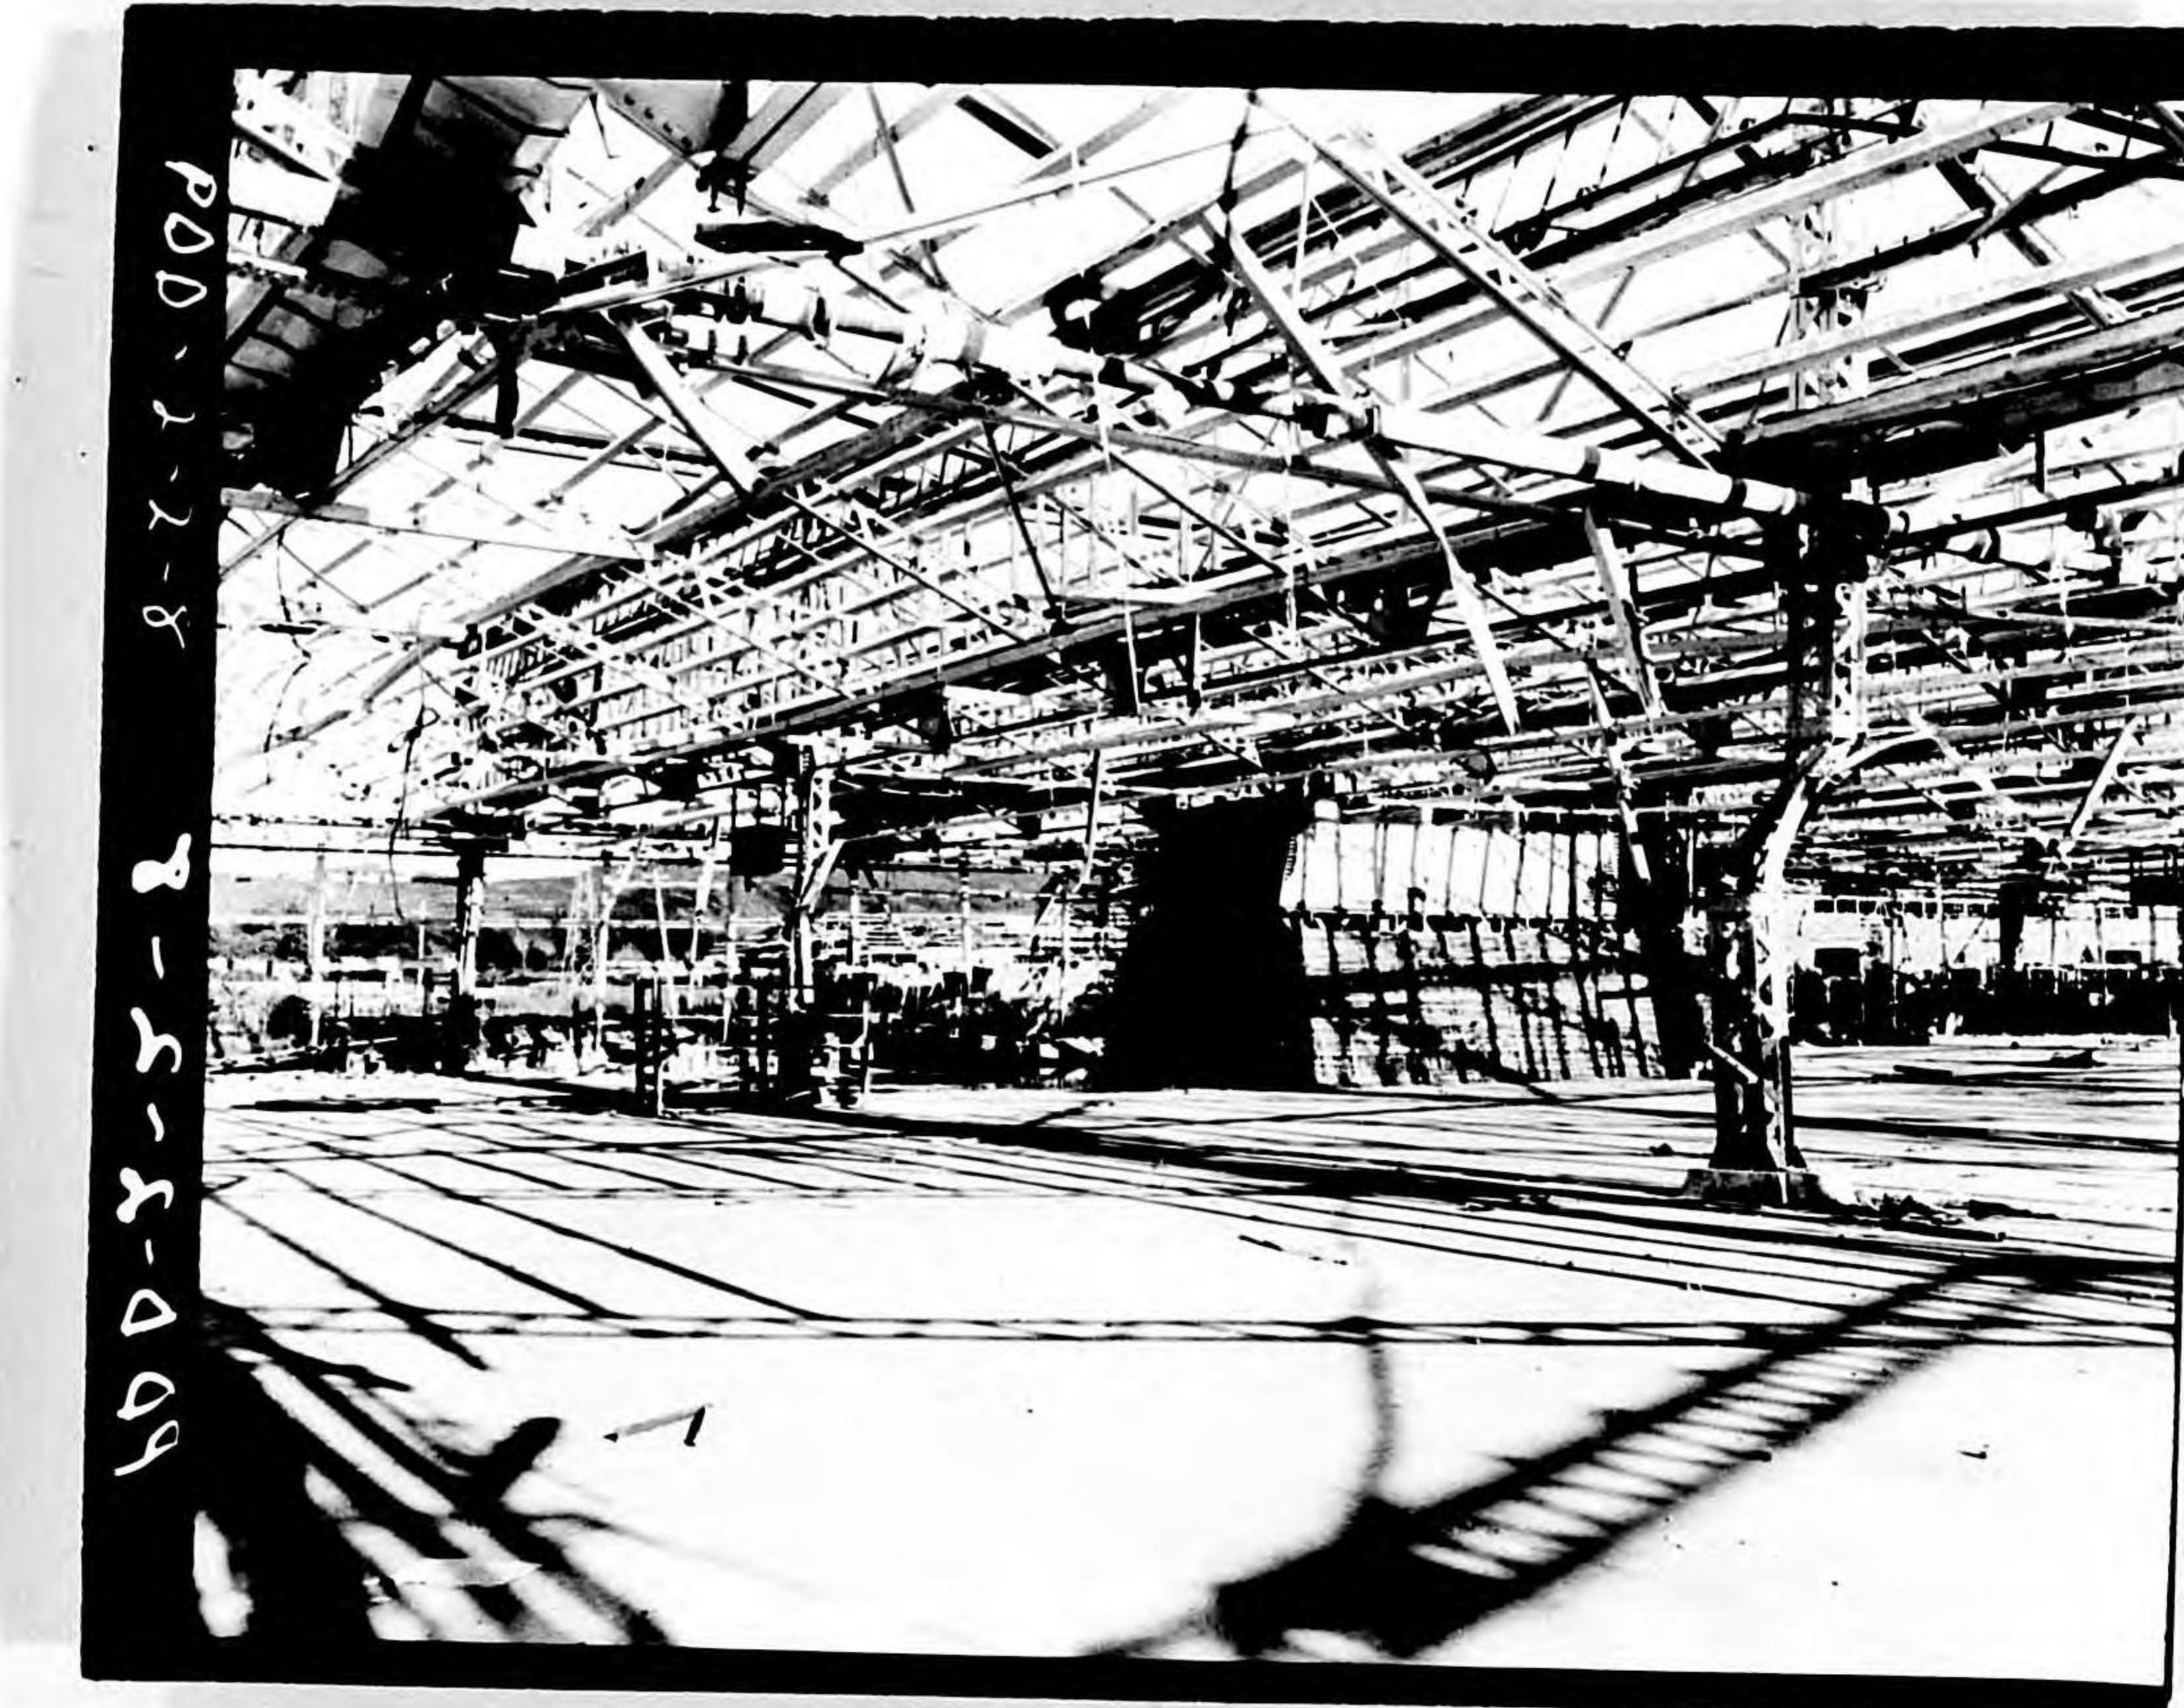
POD-2-2-7

Photo 20 - Damage caused by Bomb 19, indicating very clearly the effect of a well placed, correctly fuzed bomb. The entire roof structure collapsed, and the strain of this collapse extended well into the remaining structure.

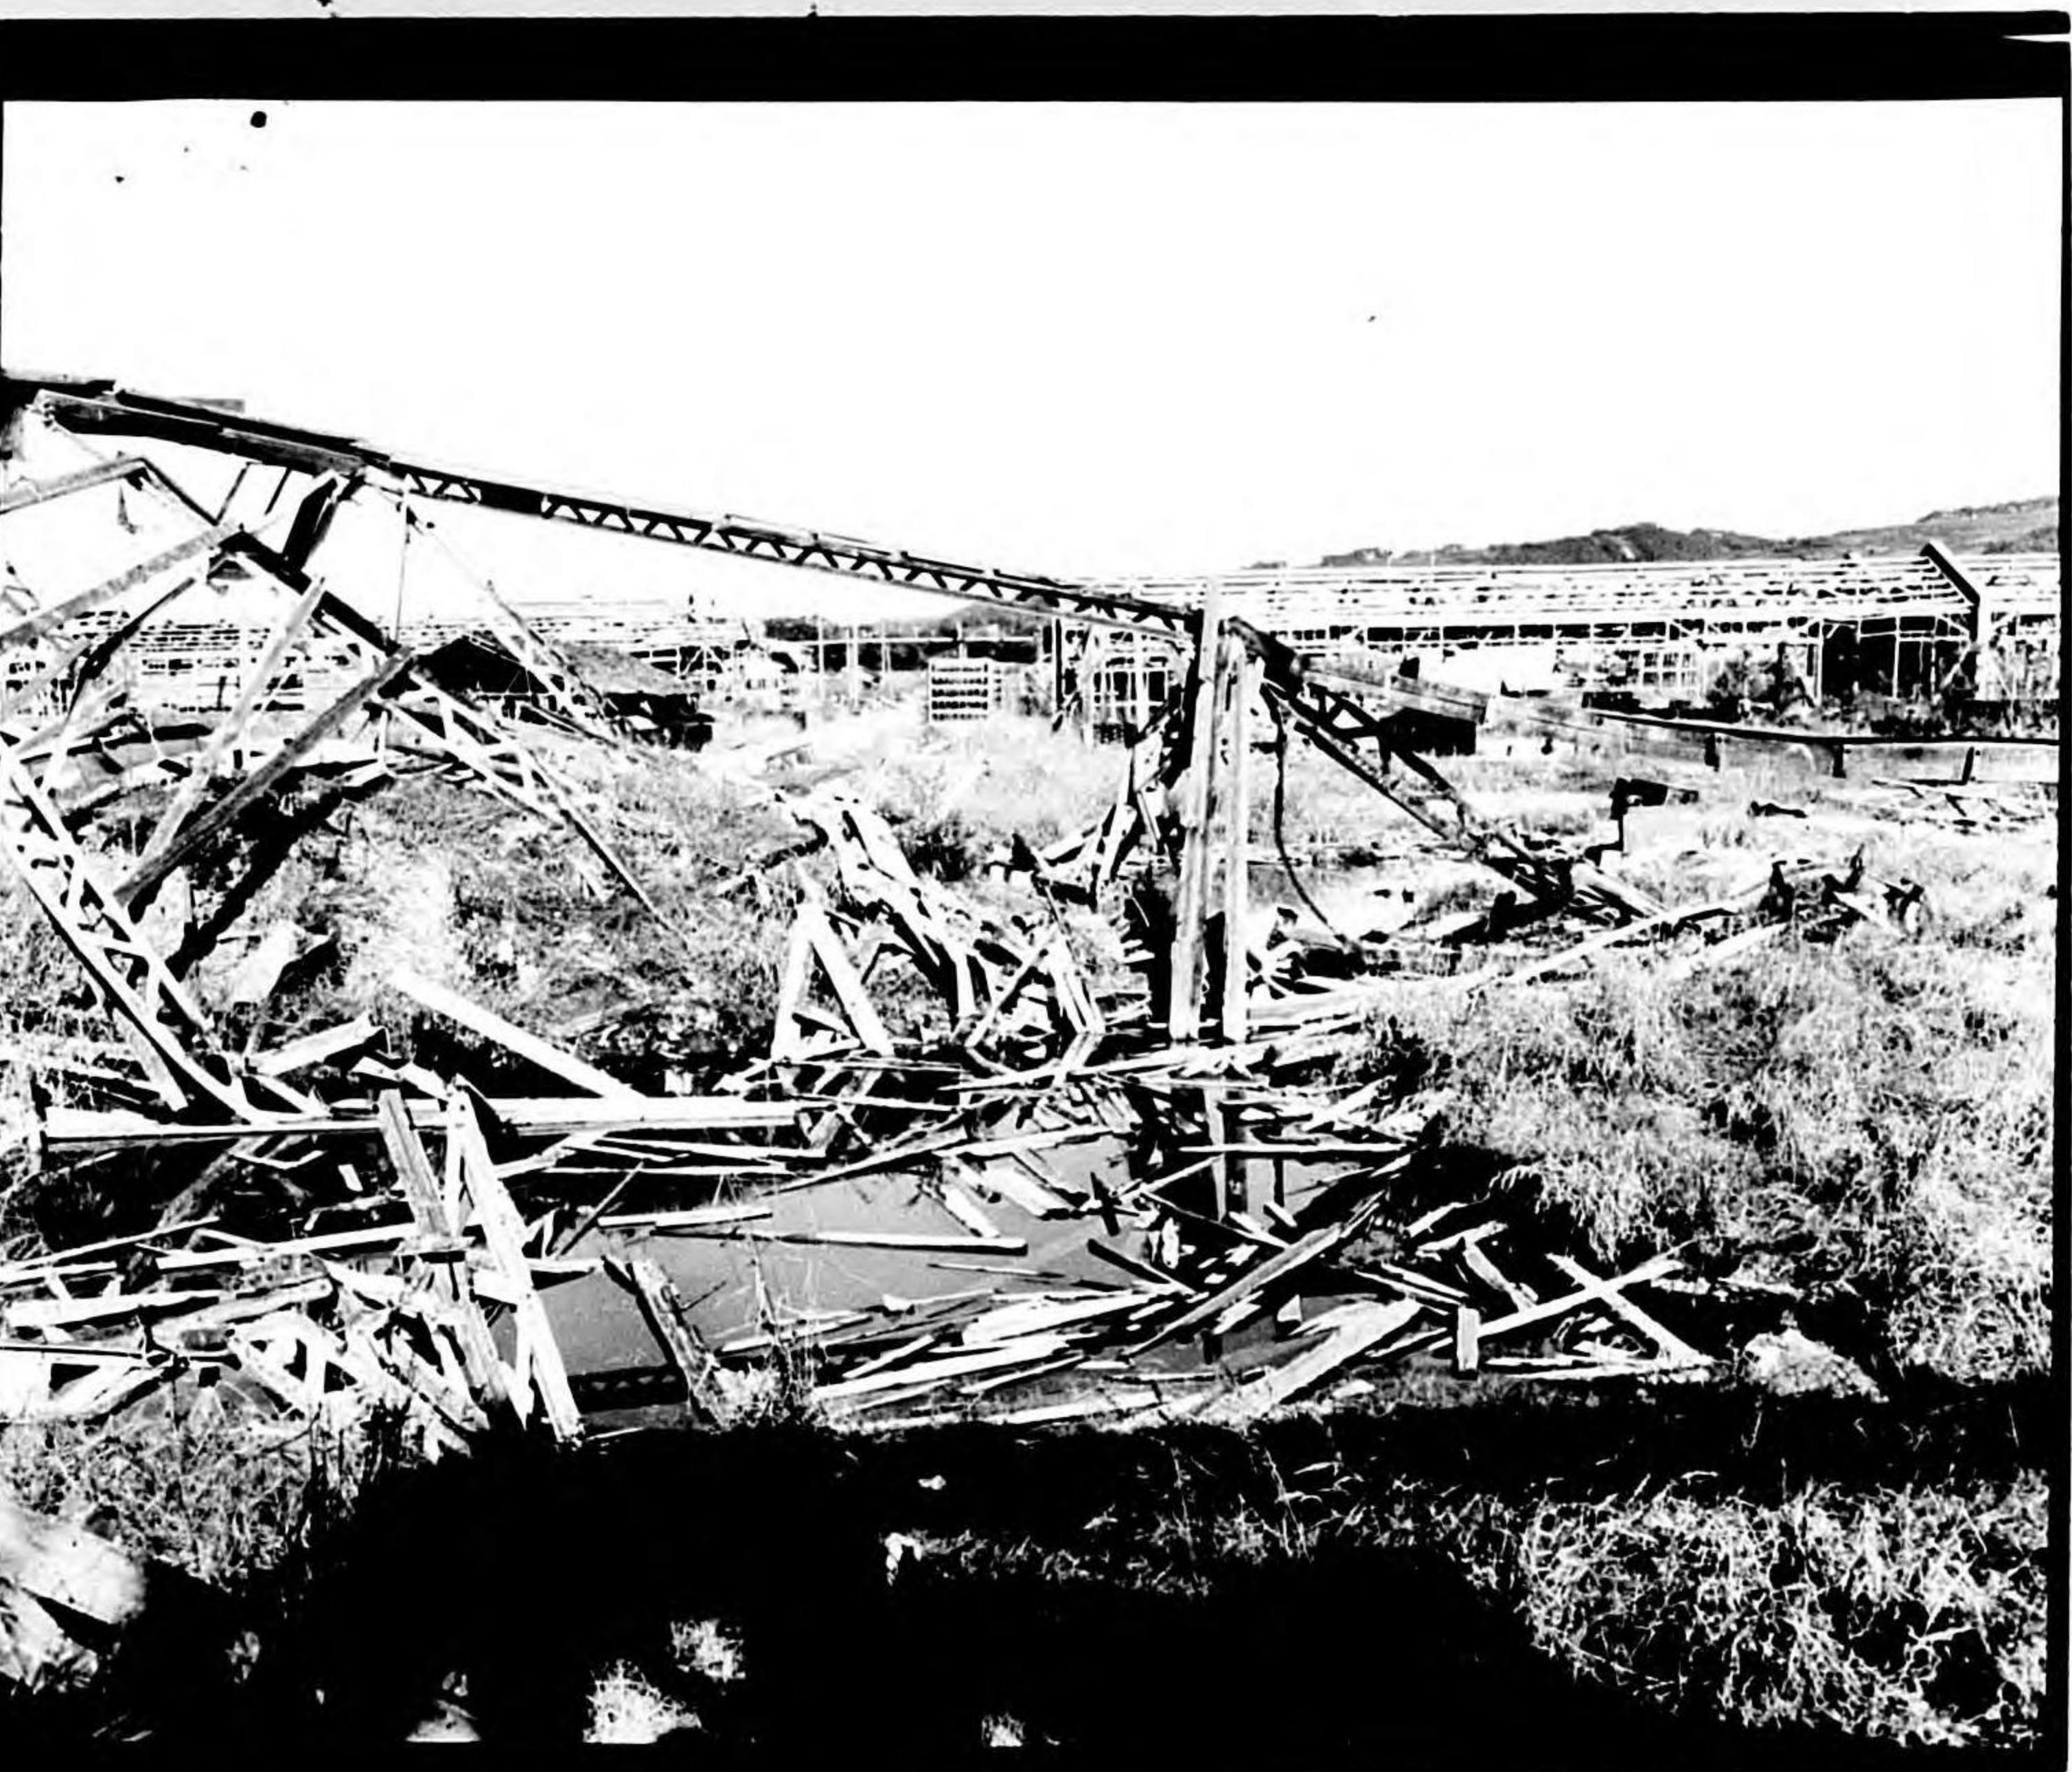
PJD-2-1-6

Photo 4 - Damage from Bomb 11 (foreground), a direct hit, and Bomb 10 (background), a near miss. This portion of Bldg 1 was destroyed.
