**KOMITE NASIONAL KESELAMATAN TRANSPORTASI
REPUBLIC OF INDONESIA**

Aircraft Accident Investigation Report

PT Sriwijaya Air

Boeing 737-500; PK-CLC

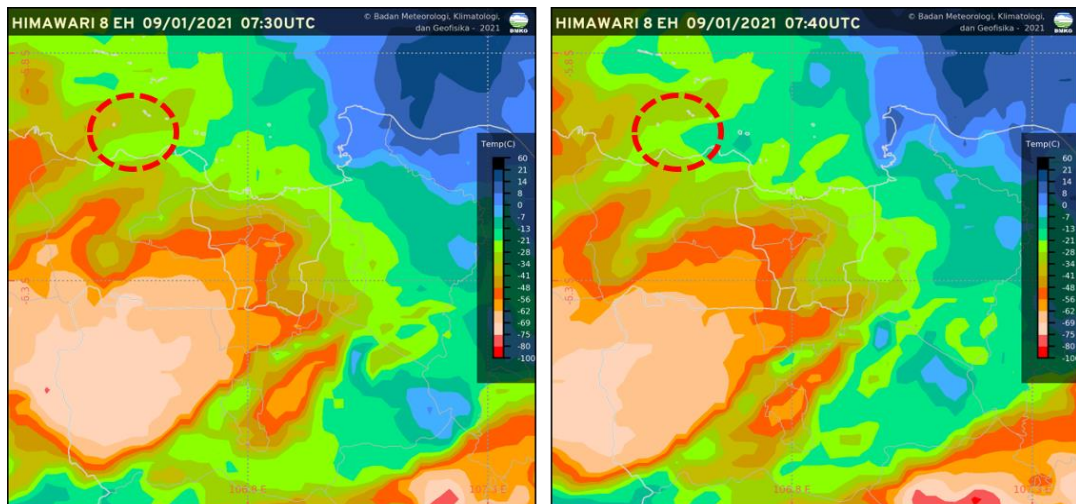
Figure 7: Enhanced infrared satellite image at 0730 UTC and 0740 UTC at accident site (red-dotted circle)

The *Badan Meteorologi Klimatologi dan Geofisika* (BMKG – Bureau of Meteorology, Climatology and Geophysics) provided enhanced infrared satellite images. The enhanced infrared satellite images at 0730 UTC (1430 LT) and 0740 UTC (1440 LT) indicated that the cloud top temperature at the accident site (red circle) was from -34°C to -21°C.

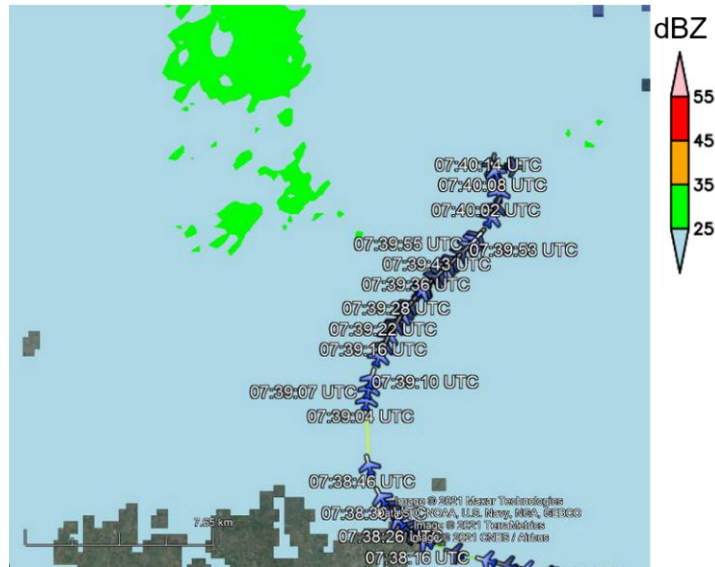
Figure 8: The superimposed accident flight profile based on ADS-B- with BMKG radar weather image at 1438 LT

The superimposed ADS-B-based flight profile with radar weather image at 1438 LT provided by the BMKG indicated that the radar intensity level along the flight profile was not more than 25 dBz¹³, which means that the flight path did not indicate any significant development of clouds.

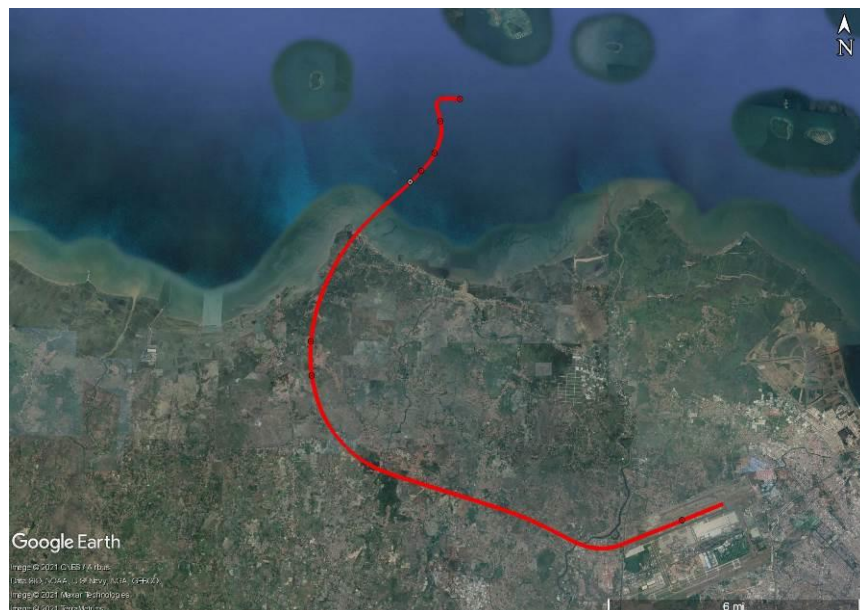
Figure 16: Aircraft flight track based on the FDR imposed to Google Earth

The accident site was located about 11 Nm northwest of Jakarta, and about 80 meters southeast of the last known aircraft position recorded by the ADS-B. The wreckage distributed over an area of about 80 by 110 meters on the seabed at a depth of approximately 16 meters.
