# NAVAL POSTGRADUATE SCHOOL

A-10/GAU-8 LOW ANGLE FIRINGS VERSUS  
SIMULATED SOVIET TANK BATTALION  
(HONEYWELL LOT NUMBER 0L78D043-016)  
(ARRAY 3)

2 FEBRUARY 1979

R.H.S. STOLFI  
R.R. MCEACHIN

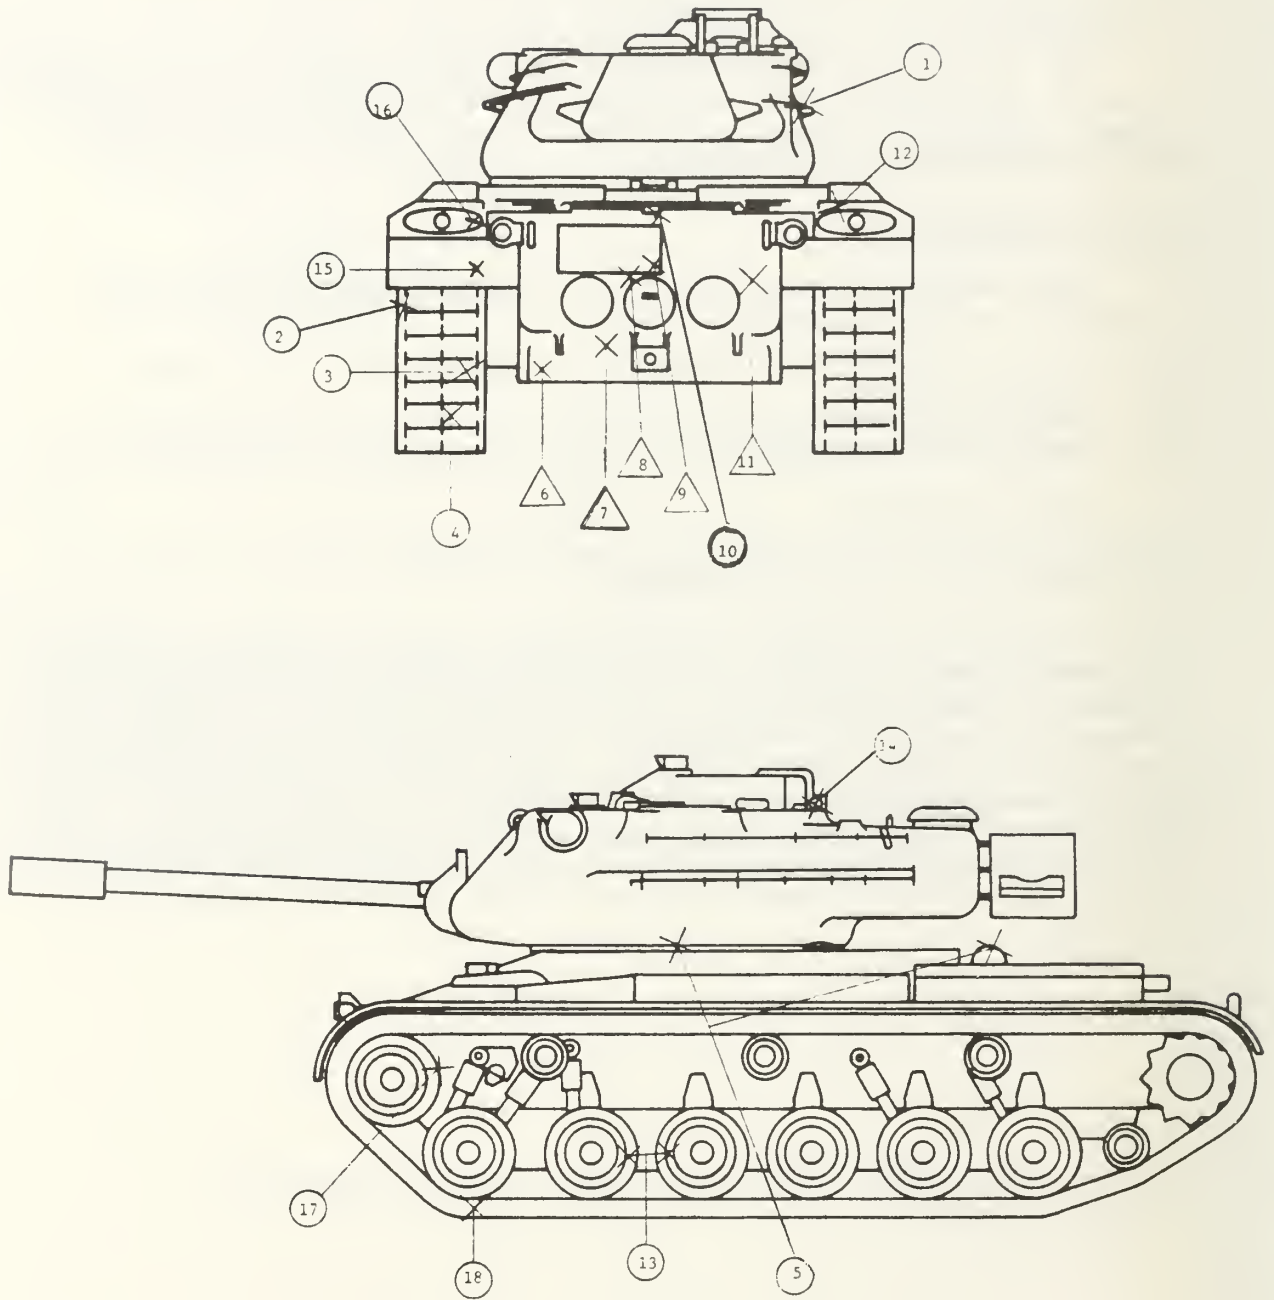
FIGURE 7. Impact Diagram, Target 2.

100% M-Kill, resulting from the following projectile impacts, shown in Figure 7:

Five of the impacts (numbers 6, 7, 8, 9, and 11) shown in Figures 8, 9, 10, 11, and 12, respectively, achieved perforations of the armored envelope. Behind-the-plate effects of Impact 6, shown in Figure 8, could not be determined because of the location of the strike. The remaining perforations could have resulted in a mobility kill through penetrations into the transmission case, or rupture of transmission oil cooler lines. Impacts 2, 3, 4, and 18 made contributions to the kill through minor damage to the track and suspension system.

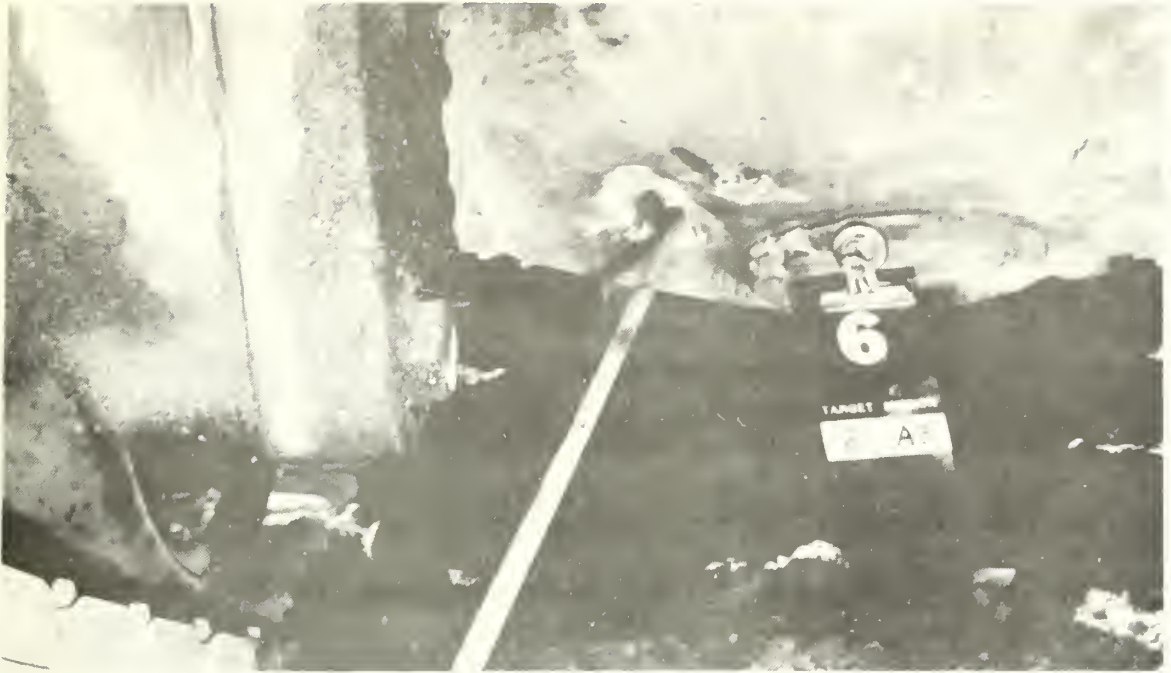
FIGURE 8. Impact Six, Target 2, Perforation of Rear Bottom Hull Armor into Transmission Compartment.

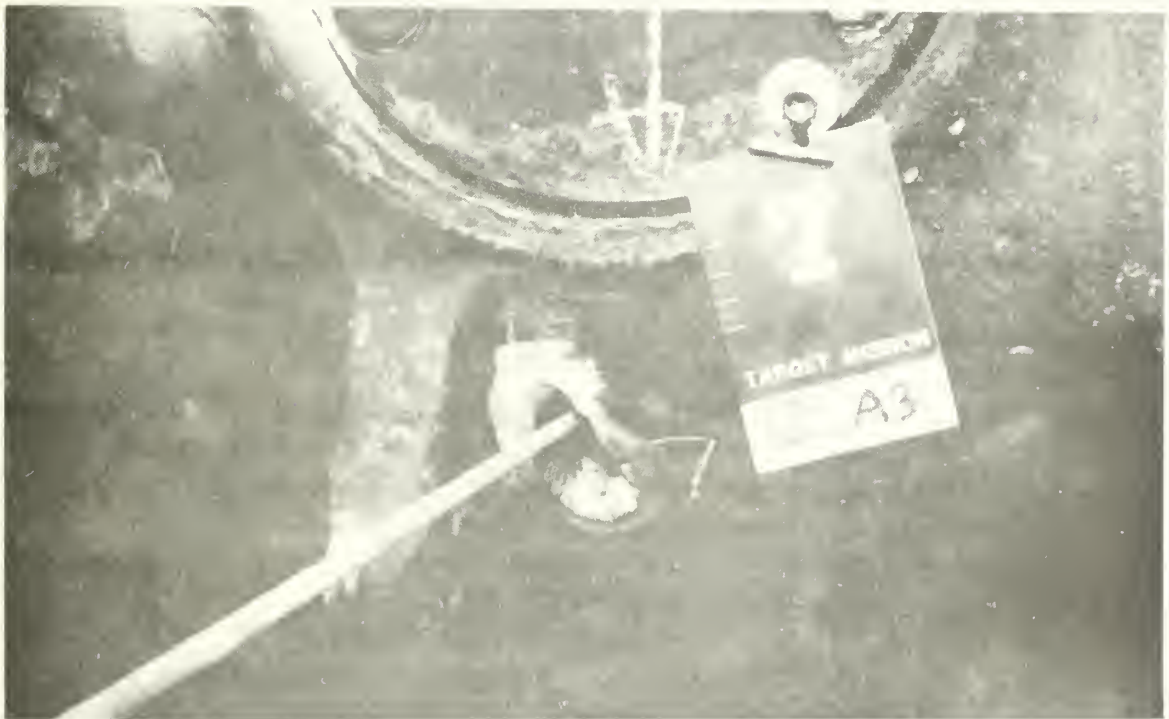
FIGURE 9. Impact Seven, Target 2, Perforation of Rear Hull Armor and Penetration into Transmission Case.

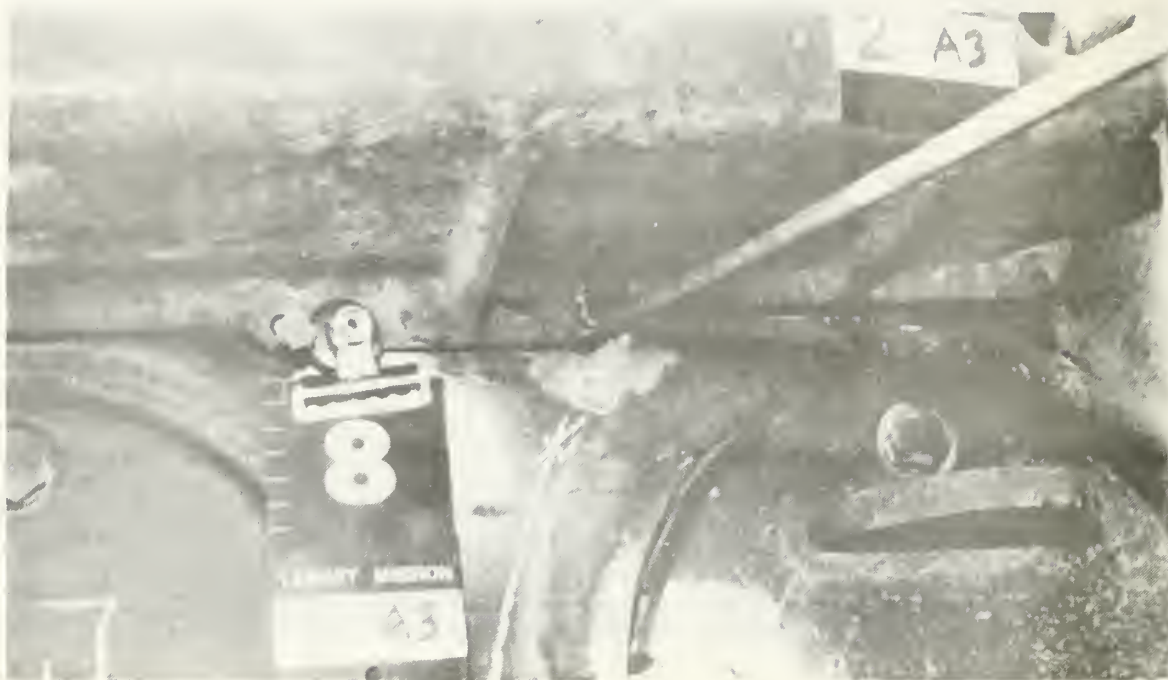
FIGURE 10. Impact Eight, Target 2, Perforation of Rear Hull Armor and Penetration into Transmission Case.

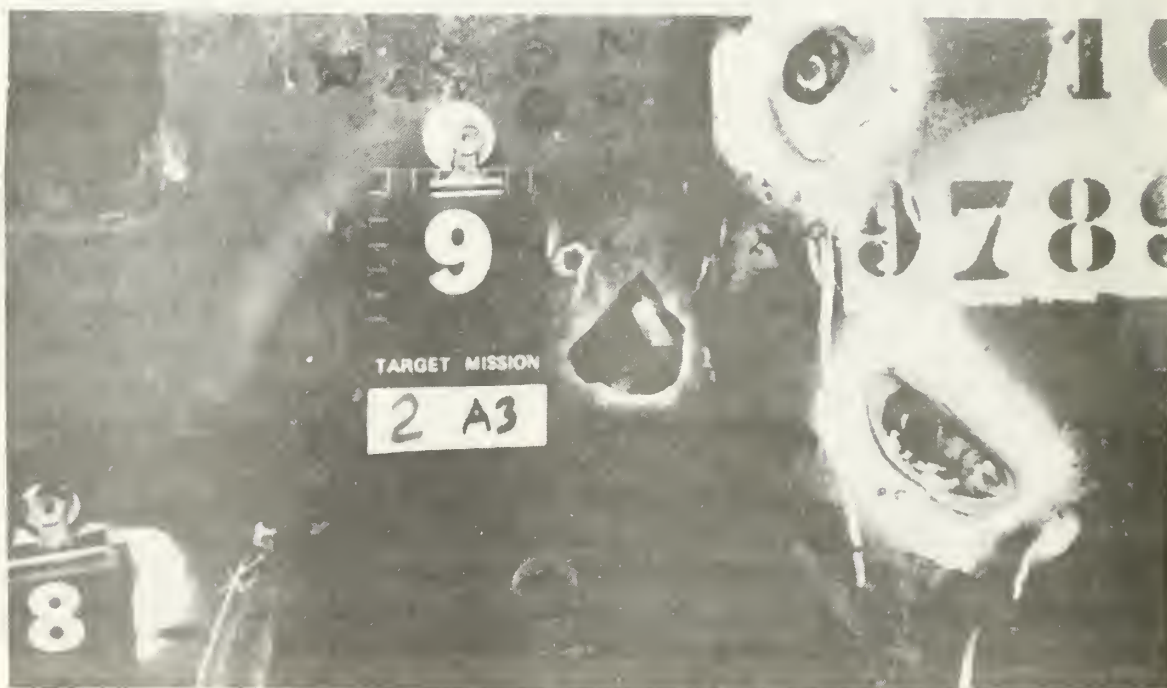
FIGURE 11. Impact Nine, Target 2, Perforation of Rear Hull Armor and Penetration into Transmission Case.

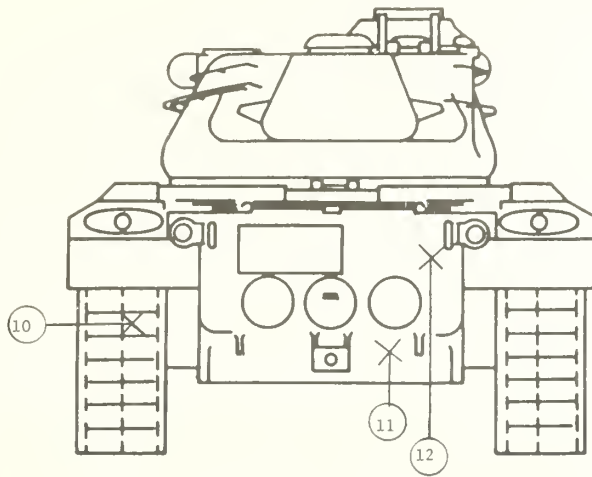
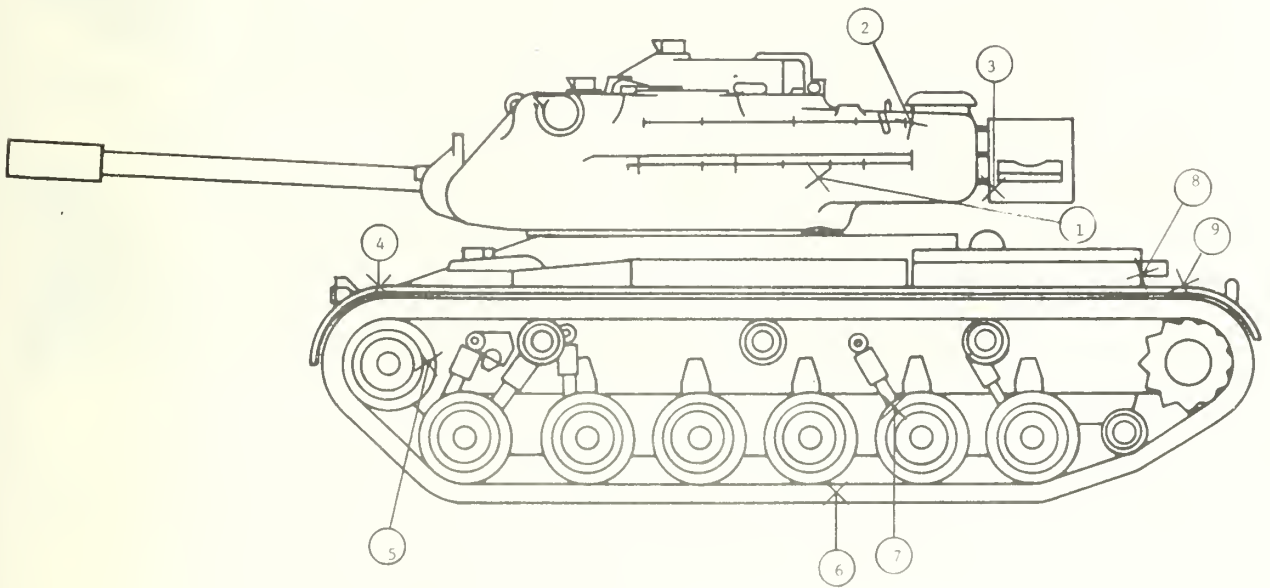
FIGURE 13. Impact Diagram, Target 4.

100% M-Kill, resulting from the following projectile impacts, shown in Figure 13:

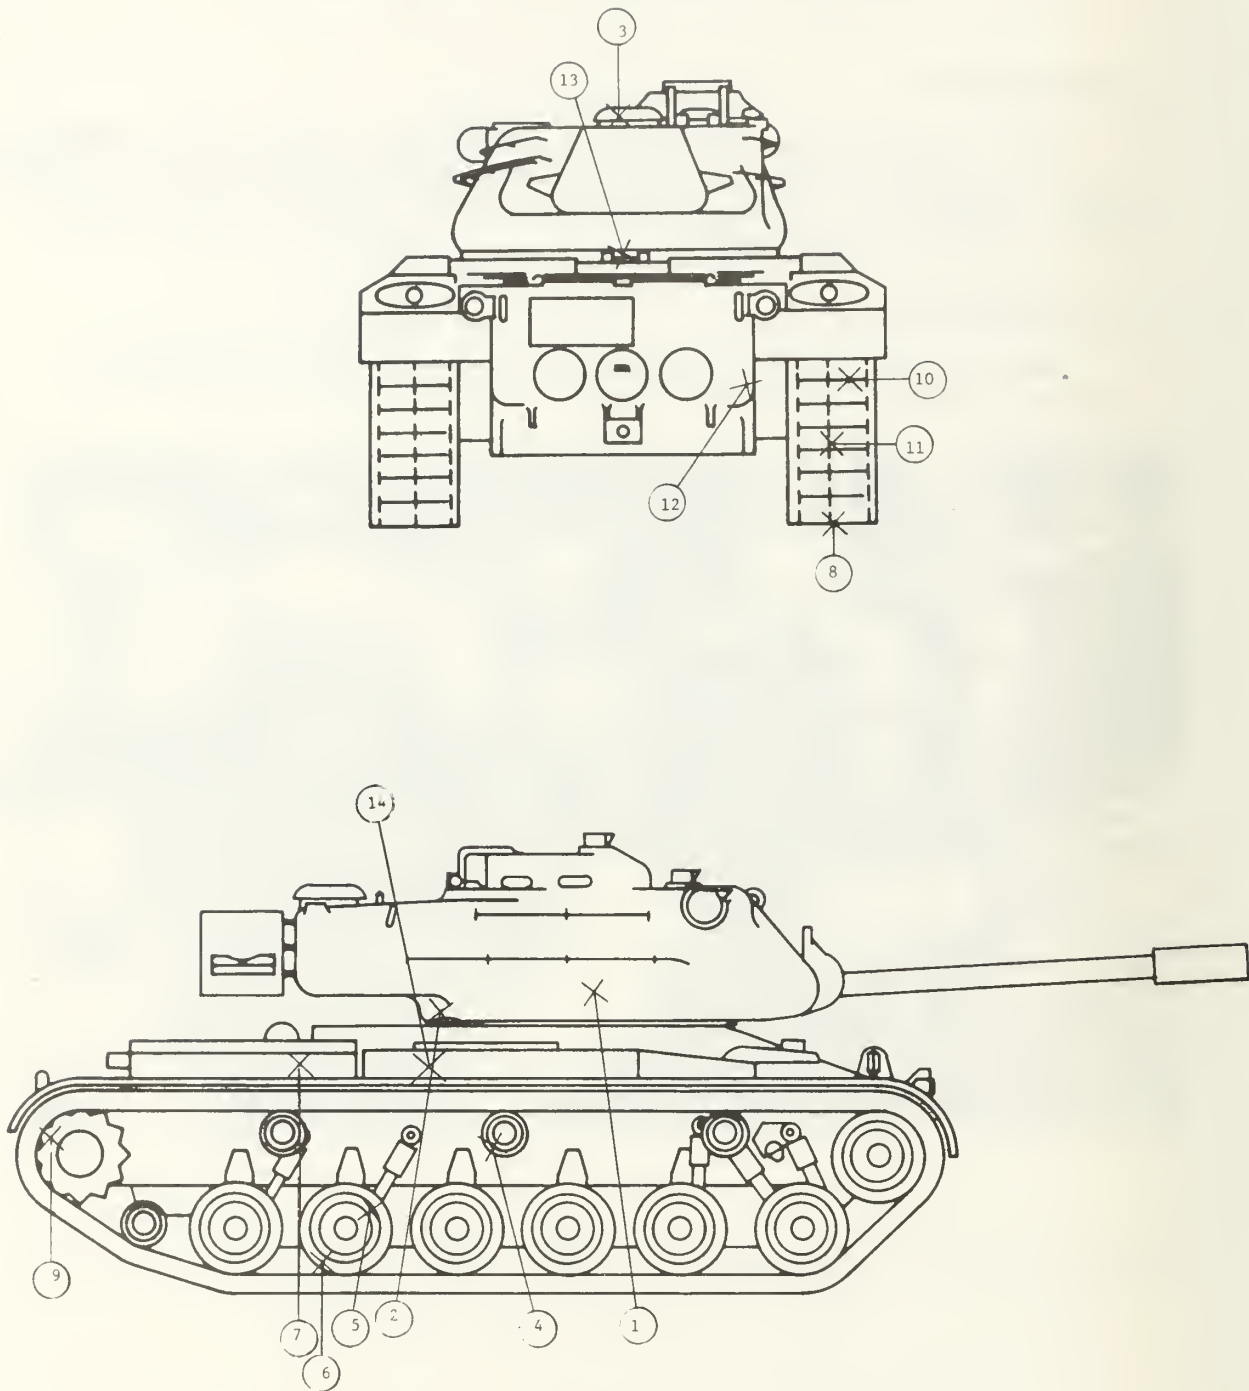
FIGURE 15. Impact Diagram, Target 7.

20% M-Kill, resulting from the following projectile impacts, shown in Figure 15:

Mobility was estimated to have been degraded by 20%, due to cumulative damage to the track and suspension system resulting from seven hits. Impact 9, shown in Figure 16, is representative of the most severe damage inflicted during this attack pass.

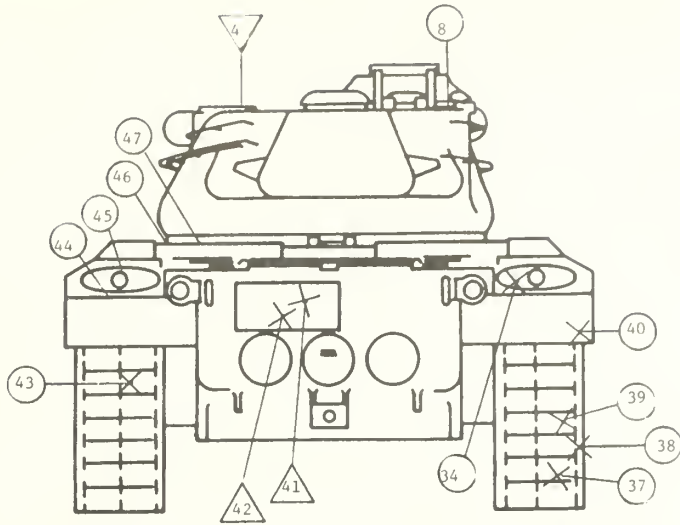
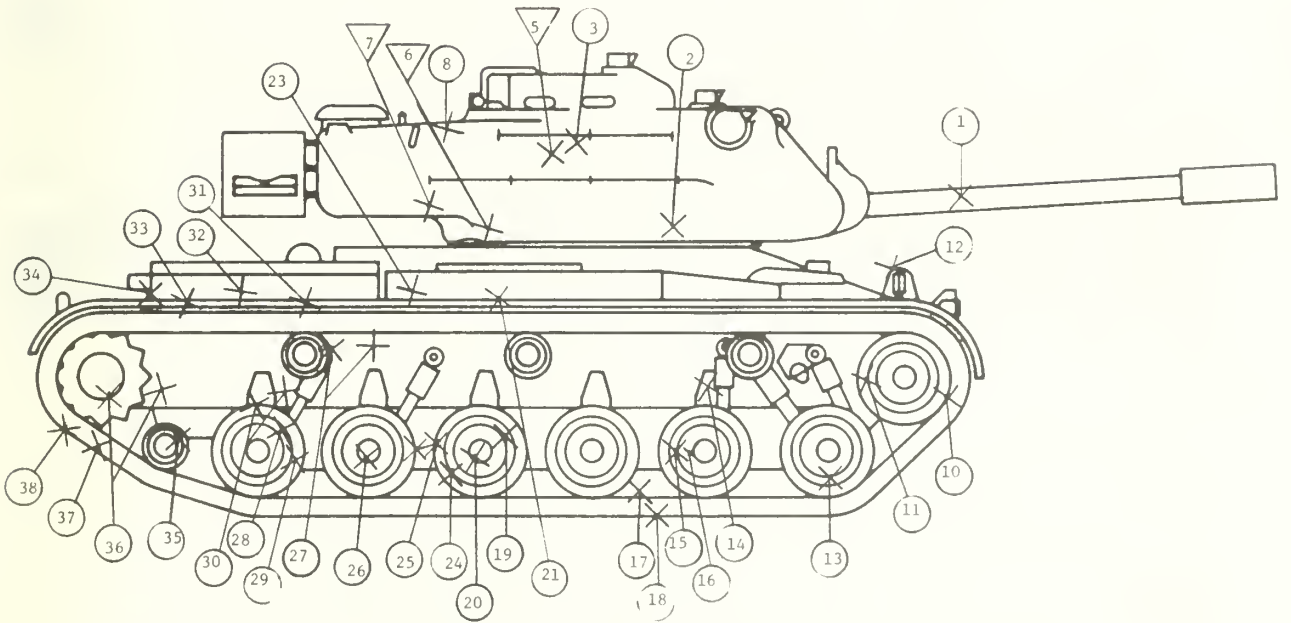
FIGURE 17. Impact Diagram, Target 17.

100% K-Kill, resulting from the following projectile impacts shown in Figure 17:

The right side of the turret was perforated by impacts 5, 6, and 7, shown in Figures 18, 19, and 20, respectively. Any of these impacts was capable of wounding or killing all personnel in the fighting compartment and, possibly, of igniting propellant of rounds stowed in the ready racks. Impact 4, which perforated the top of the turret at the loaders station, contributed to damage in the fighting compartment.

The rear hull was perforated by Impacts 41 and 42, which perforated the transmission case and severed an oil cooler line. Either of these impacts could have ignited oil in the transmission compartment.

A small fire, which could not be extinguished by the crew due to casualties, provides the best scenario for assessment of a K-Kill. The most likely place of origin of the fire is the transmission/engine compartment.

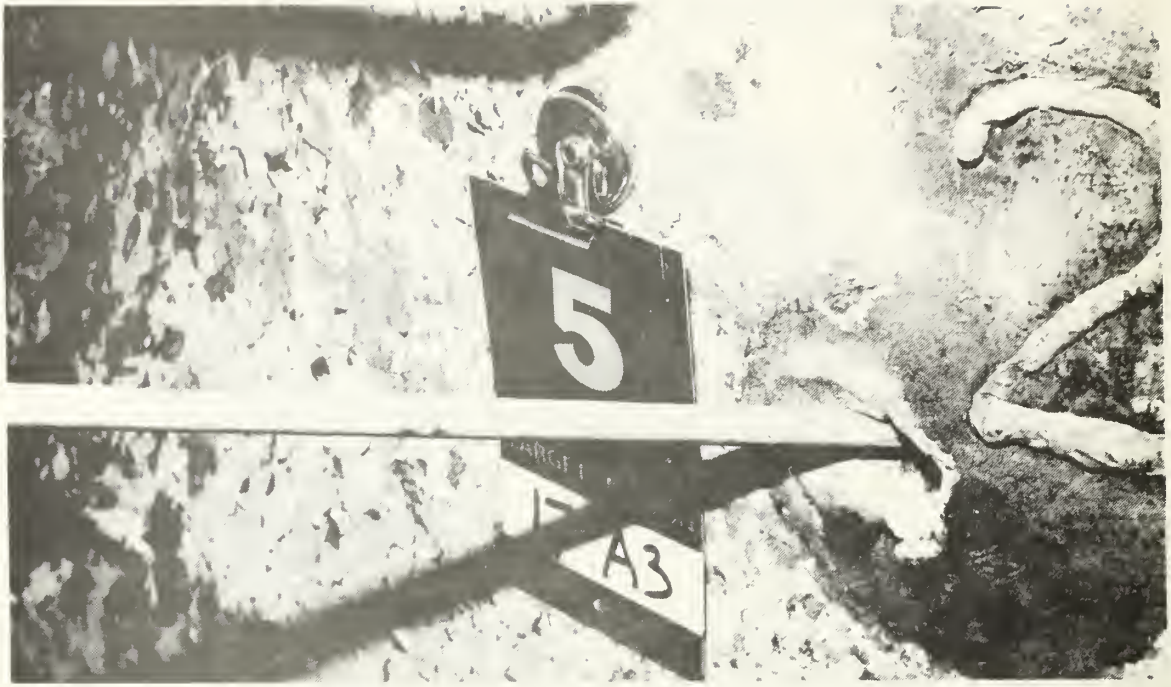
FIGURE 18. Impact Five, Target 17, Perforation of Right Side of Turret.

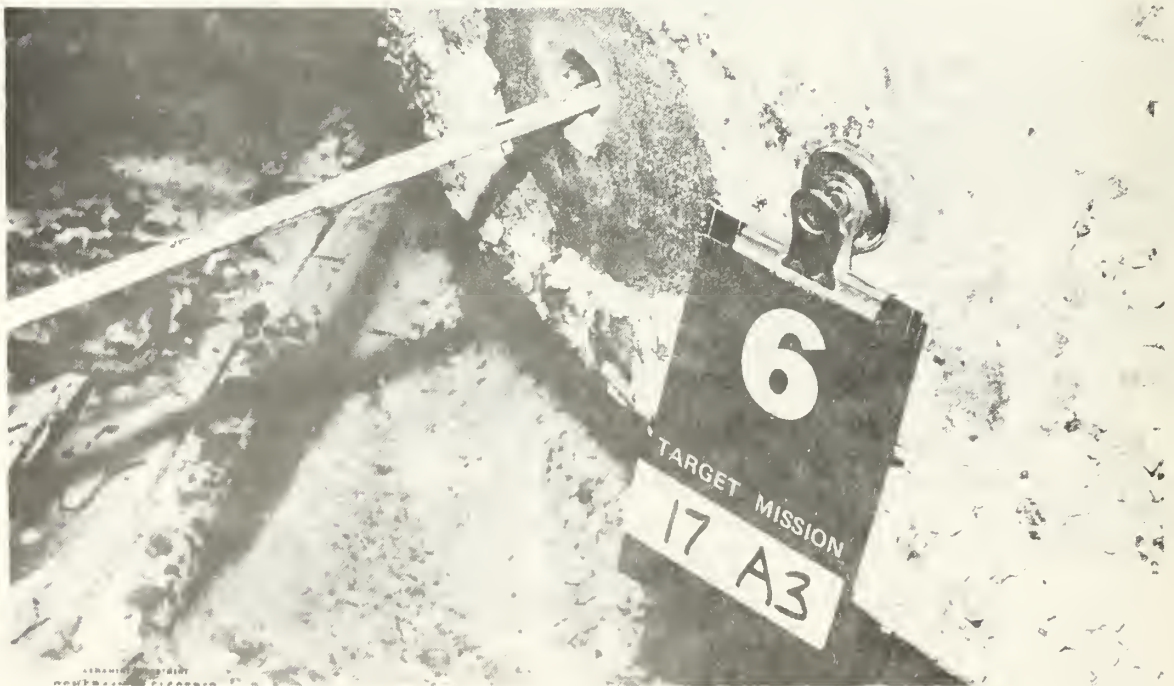
FIGURE 19. Impact Six, Target 17, Perforation of Right Side of Turret.

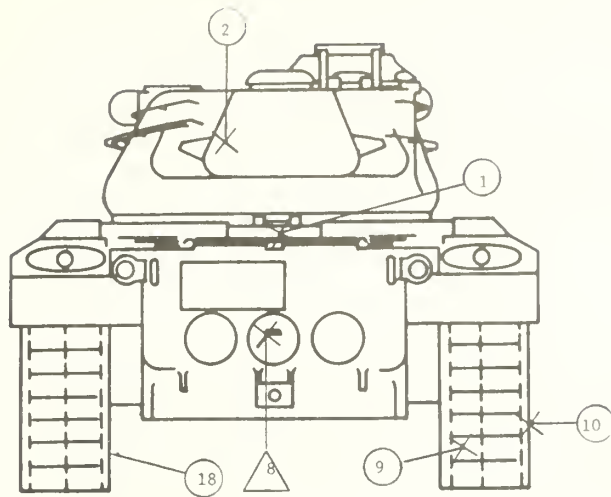
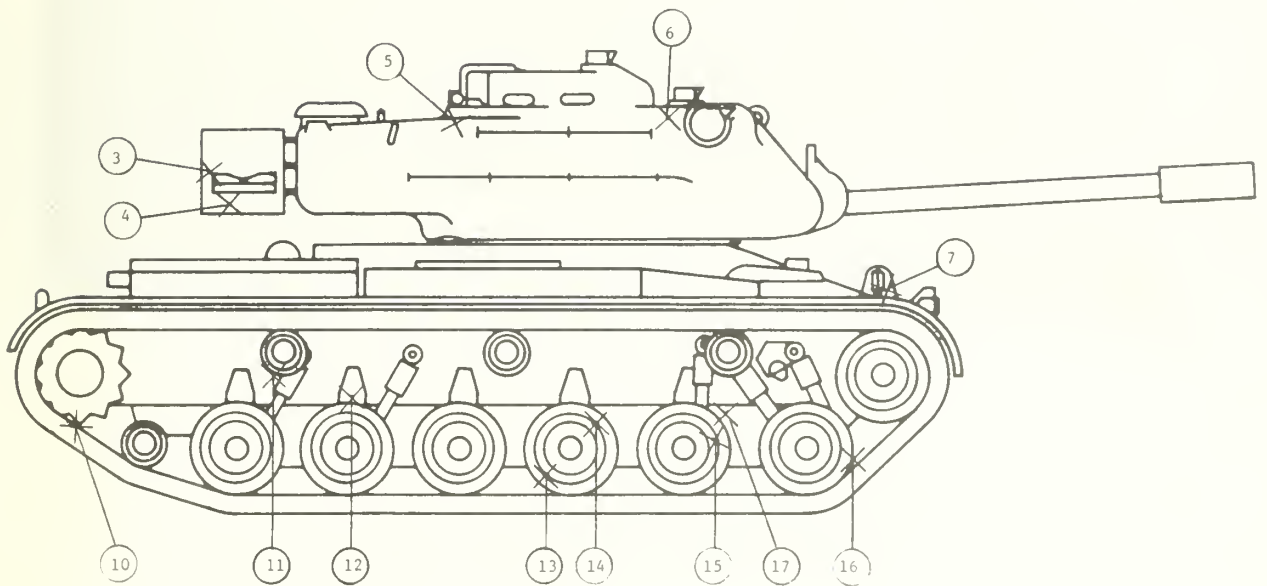
FIGURE 21. Impact Diagram, Target 19.

100% M-Kill, resulting from the following projectile impacts, shown in Figure 21:

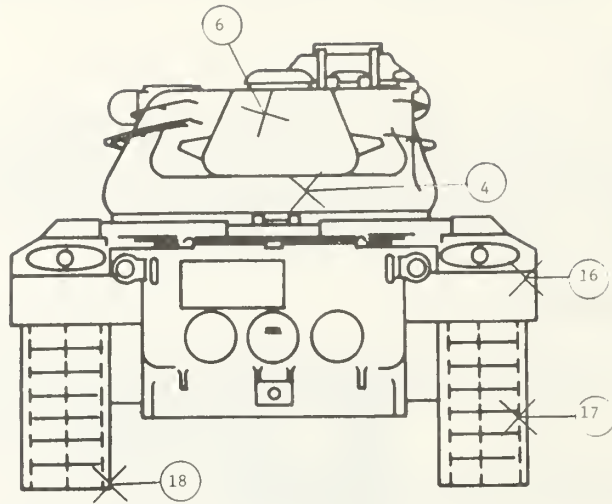
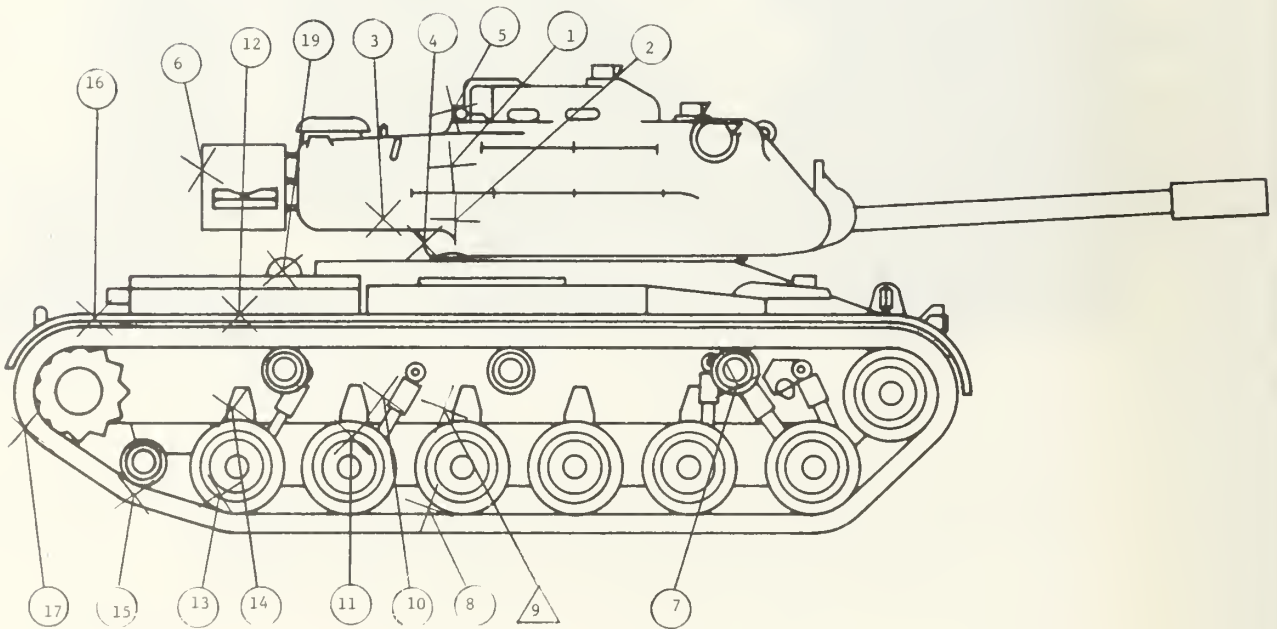
FIGURE 23. Impact Diagram, Target 20.

100% M-Kill, resulting from the following projectile impacts, shown in Figure 23:

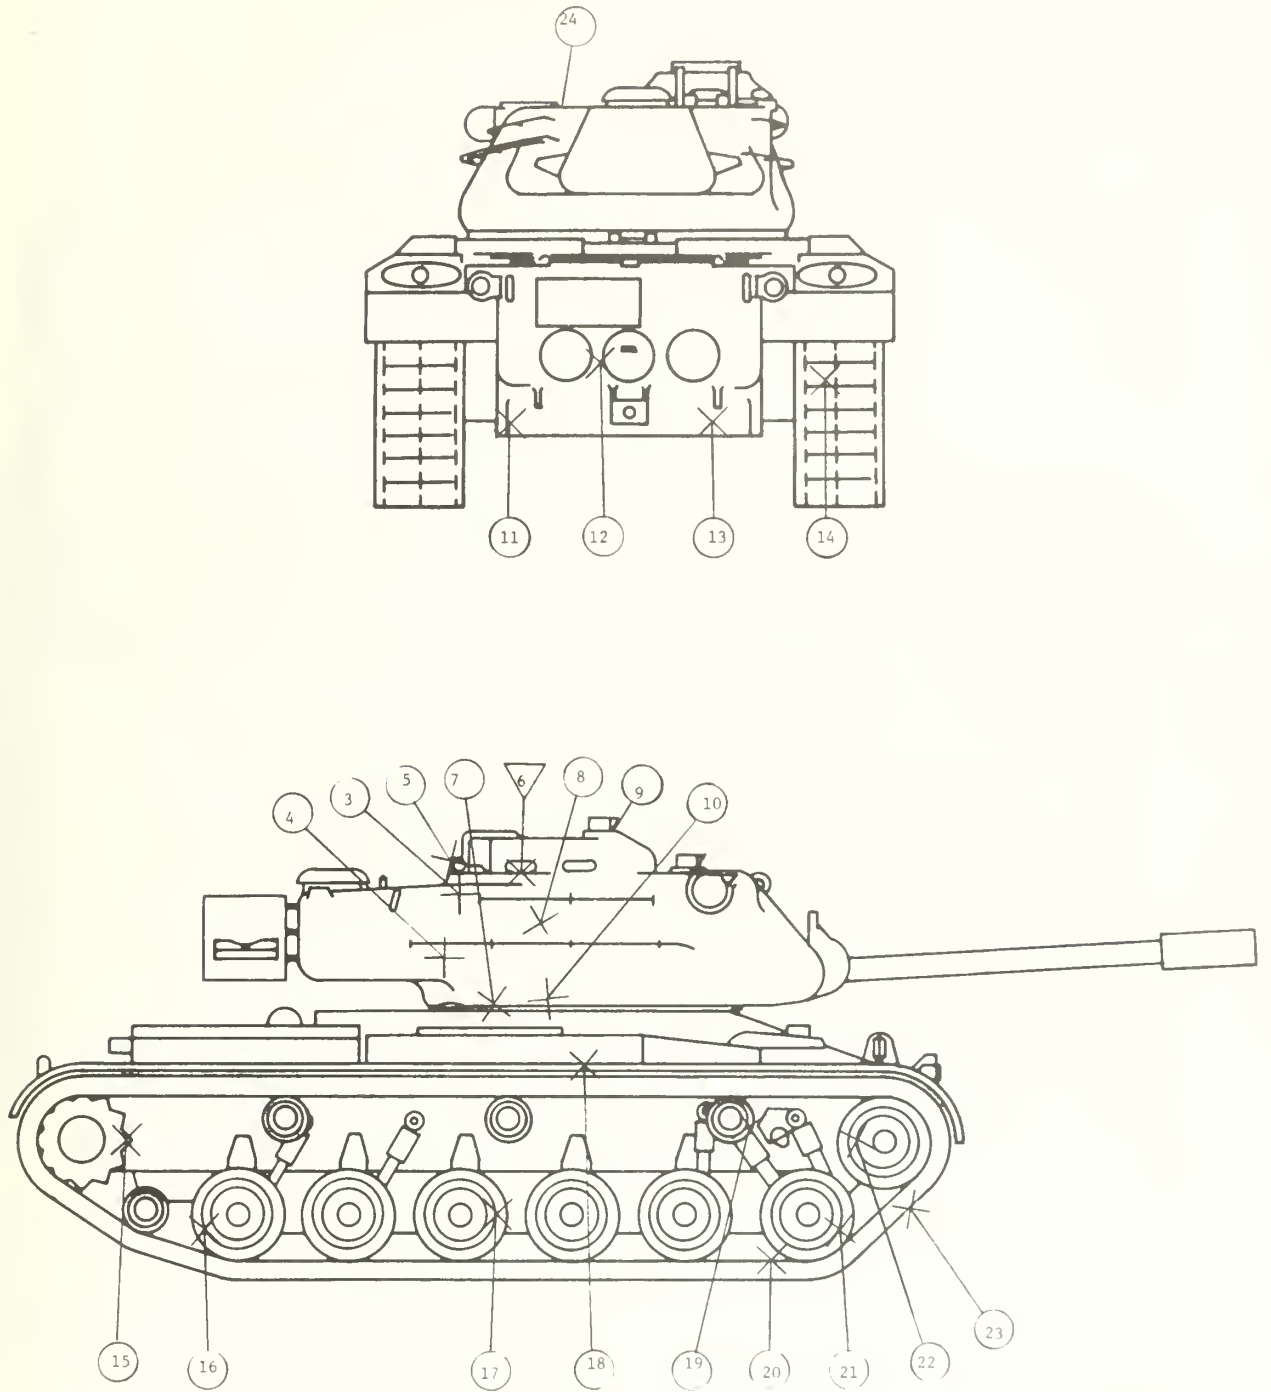
FIGURE 25. Impact Diagram, Target 21.

75% M-Kill and 100% F-Kill resulting from the following projectile impacts, shown in Figure 25:

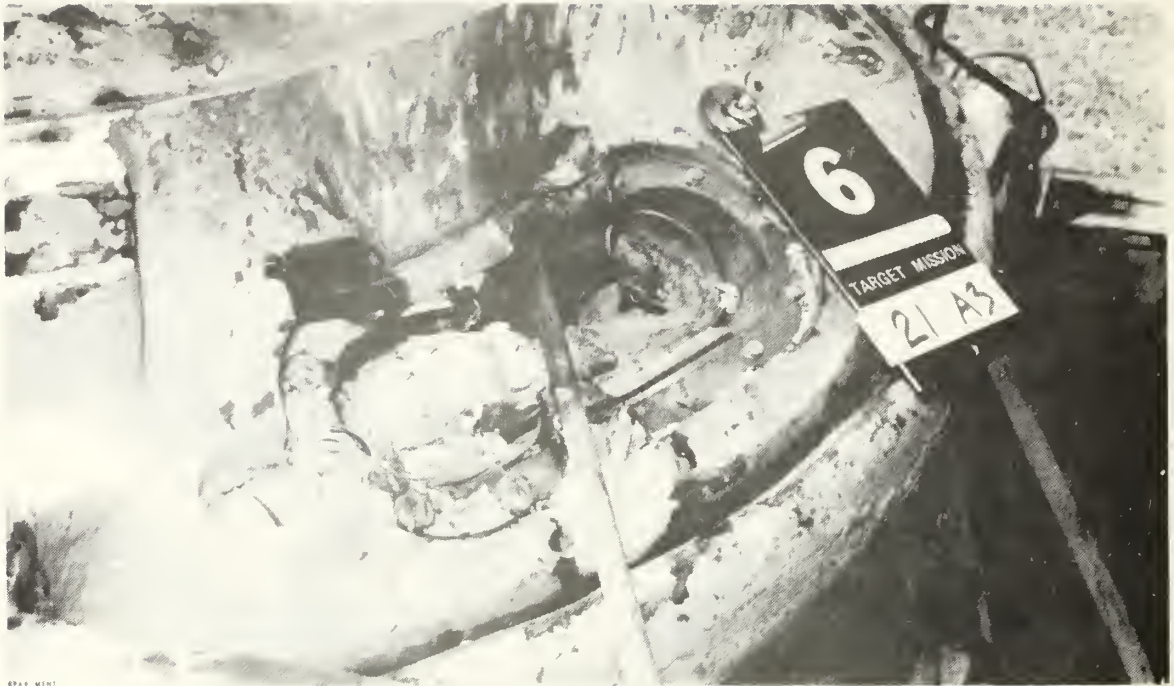
- a. M-Kill: An overall 75% M-Kill was assessed, based primarily (65%) on crew casualties (tank commander and gunner) caused by impacts 6 and 9, shown in Figures 26 and 27, respectively, and secondarily (10%) on cumulative damage to the track and suspension system caused by three other impacts.
- b. F-Kill: 100% F-Kill was due to crew casualties from impacts 6 and 9, and to impact 7 (Figure 28) which jammed the turret, preventing it from traversing.

FIGURE 26. Impact Six, Target 21, Perforation into Fighting Compartment Through Vision Block in Commander's Cupola.

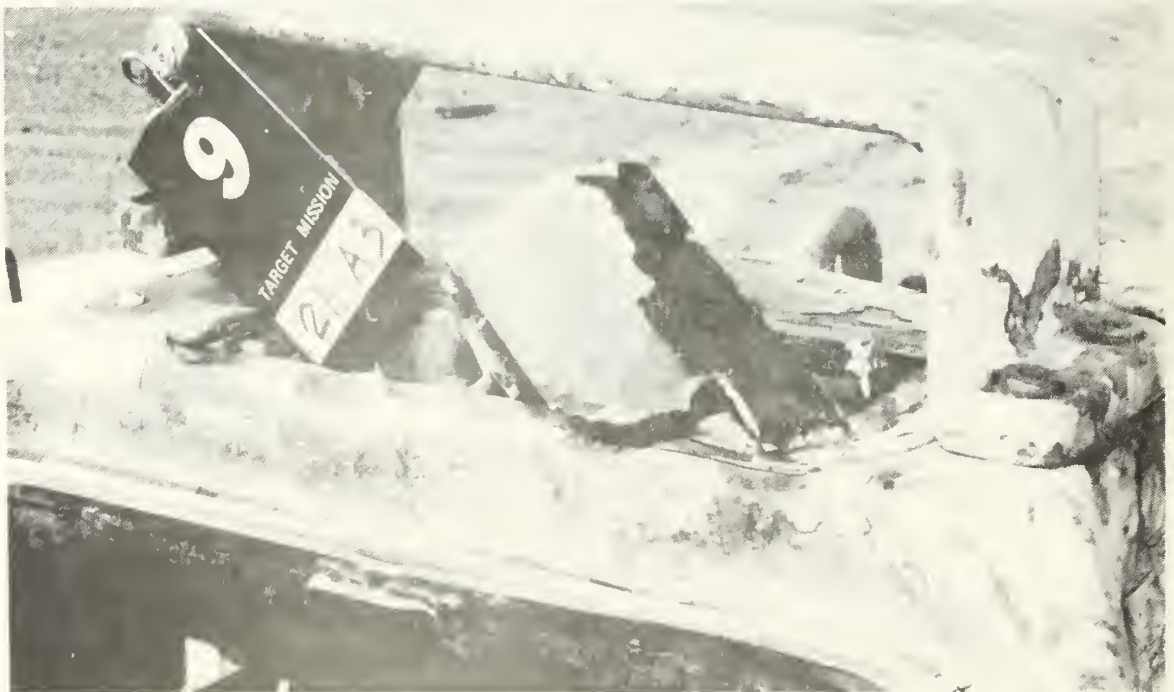
FIGURE 27. Impact Nine, Target 21, Showing Destroyed Periscope Head at Commander's Station.

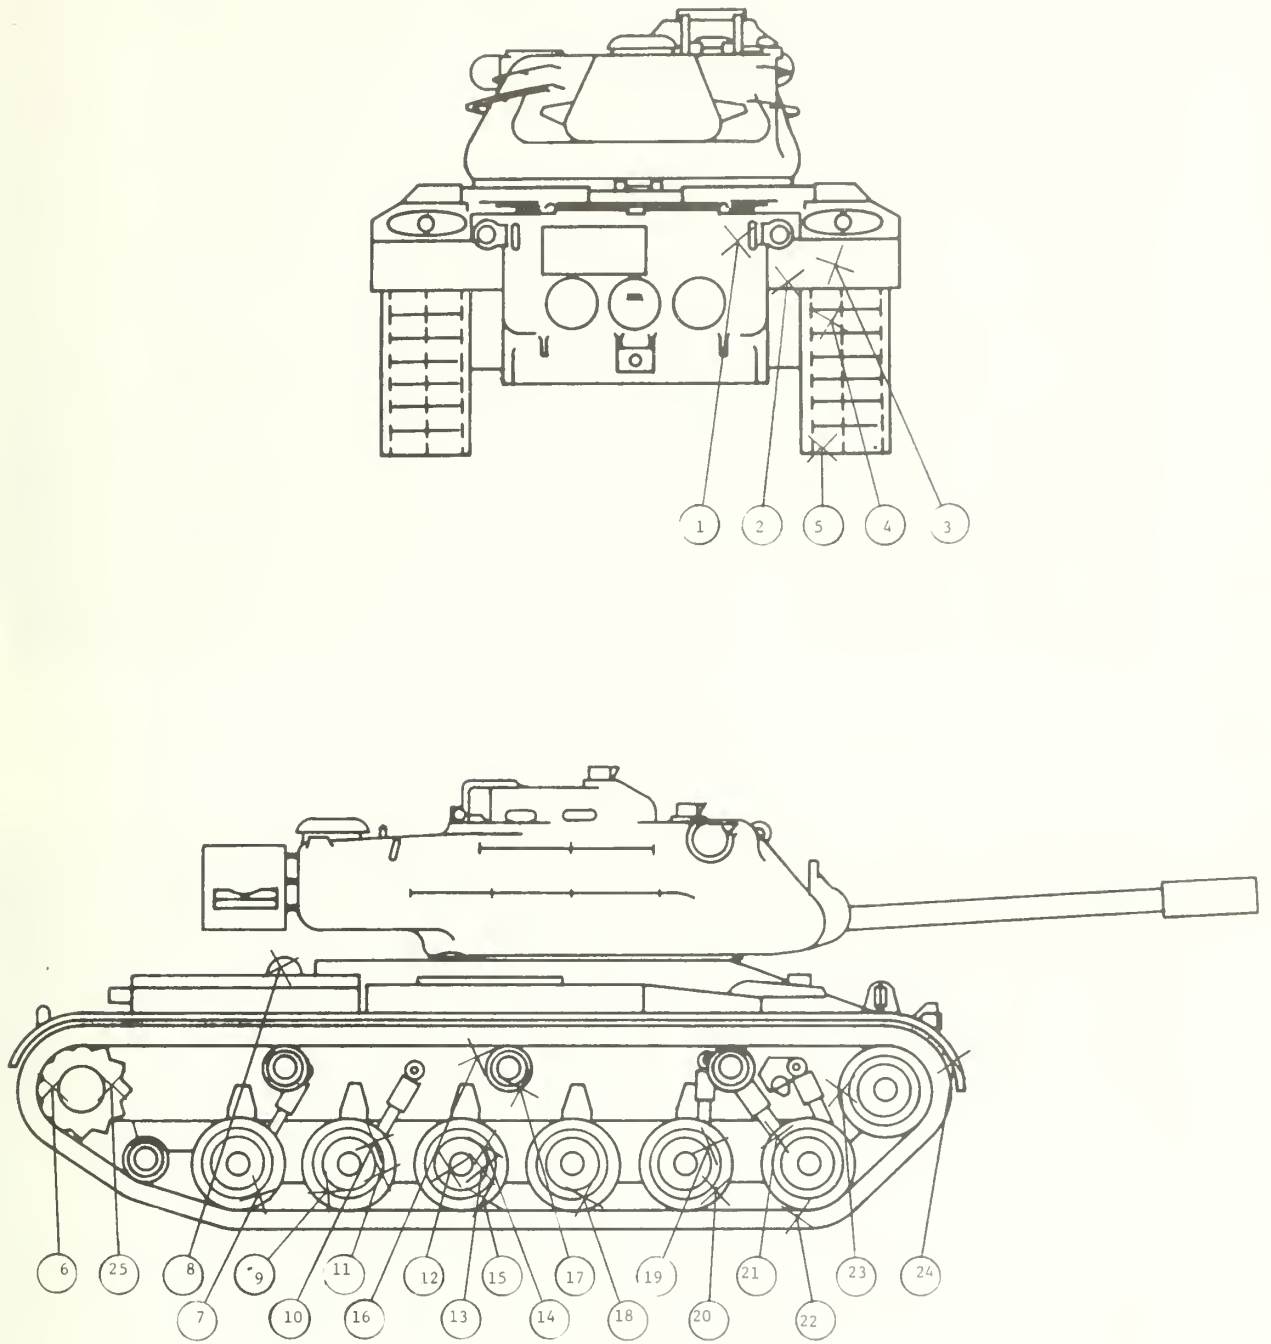
FIGURE 29. Impact Diagram, Target 22.

100% M-Kill, resulting from the following projectile impacts, shown in Figure 29:

The primary contributors to the kill were impacts 10 and 12, shown in Figures 30 and 31, respectively, which destroyed the right #4 roadwheel bearing spacer and hub, damaging the spindle; and impacts 6 and 25, shown in Figures 32 and 33, respectively, which severely damaged the right drive sprocket. Cumulative damage from four other impacts contributed to the kill.

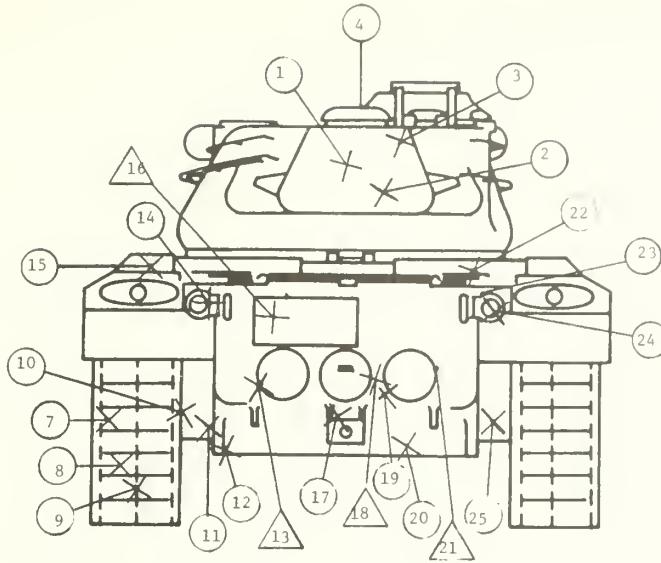
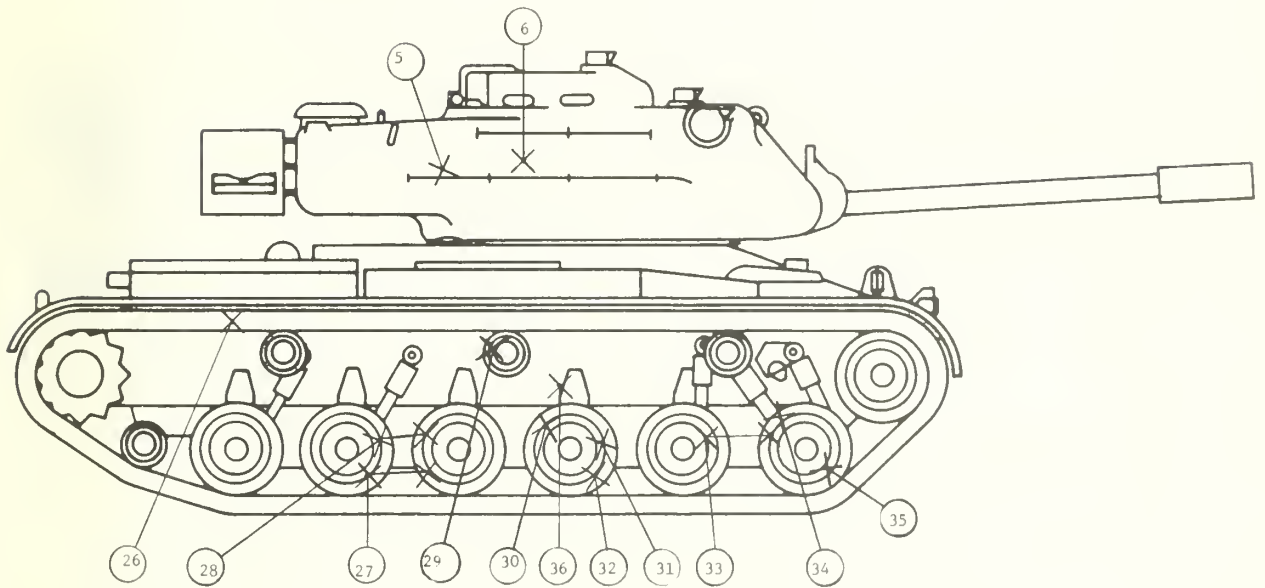
FIGURE 34. Impact Diagram, Target 23.

100% M-Kill, resulting from the following projectile impacts, shown in Figure 34:

Cumulative damage to the track and suspension system from 11 other impacts (numbers 7, 8, 9, 28, 29, 30, 31, 32, 34, 35, 36 contributed to the kill).

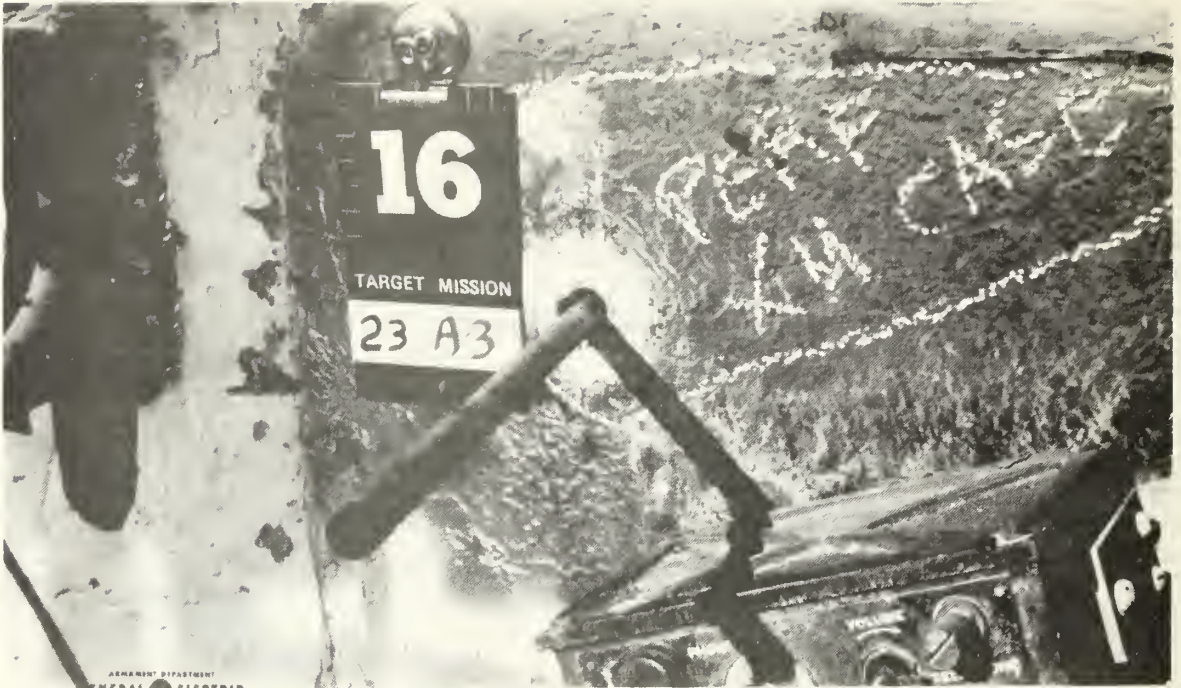
Impact 16 (Figure 35) perforated the rear hull armor and penetrated the transmission thermostat and cross-over line. Impacts 18 and 21, shown in Figures 36 and 37, respectively, perforated the rear hull armor and penetrated the transmission case. One other perforation (Impact 13) had no behind-the-plate effects.

FIGURE 35. Impact Sixteen, Target 23, Perforation of Rear Hull Armor into the Transmission Compartment, Which penetrated the Transmission Thermostat and Cross-Over Line.

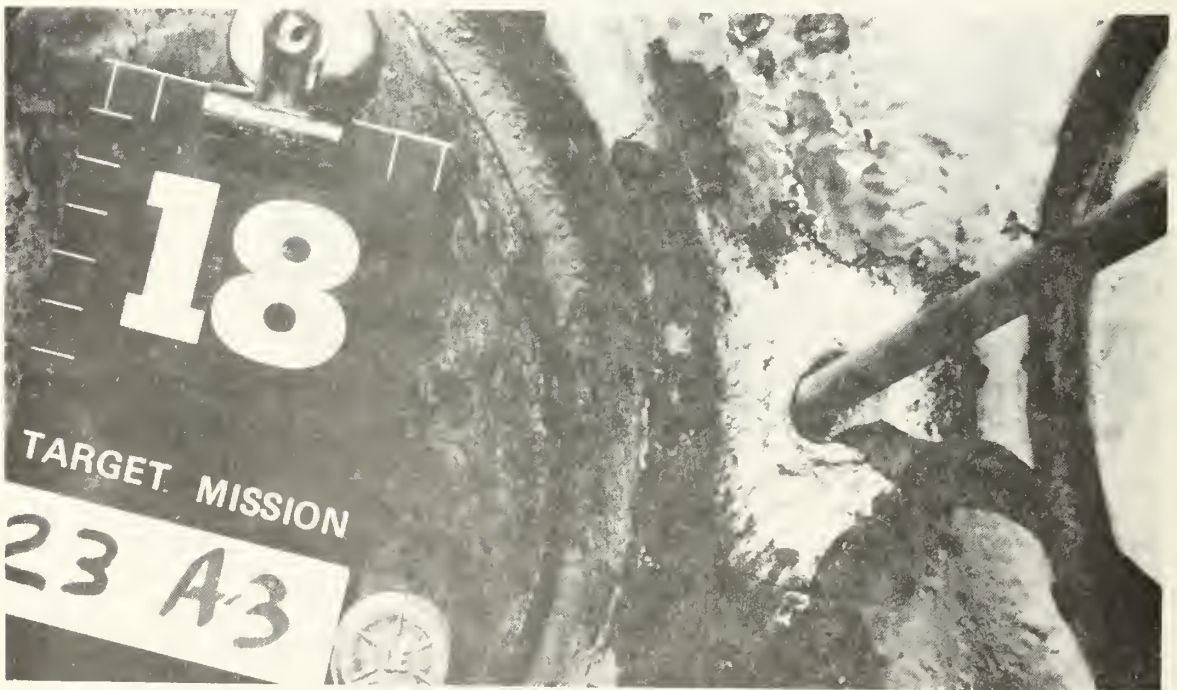
FIGURE 36. Impact Eighteen, Target 23, Perforation of Rear Hull Armor and Penetration into the Transmission Case.

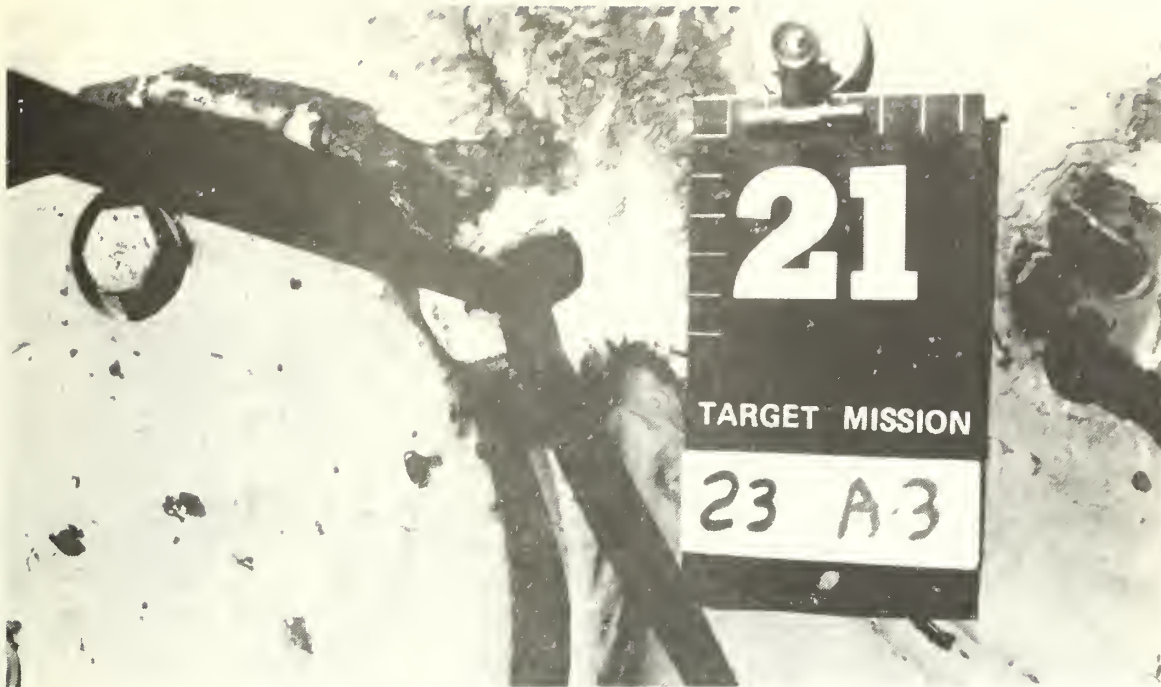
FIGURE 37. Impact Twenty-One, Target 23, Perforation of Rear Hull Armor and Penetration into the Transmission Case.
